# WEST CLIFF LONGWALL 38 END OF PANEL LANDSCAPE REPORT

DATE 23/03/2016

This report has been prepared by the South32 Illawarra Coal Environmental Field Team (ICEFT) as part of the West Cliff Area 5 (WCA5) End of Panel (EoP) Report. It summarises the monitoring of surface features undertaken by the ICEFT within the Longwall 38 Extraction Plan Area.

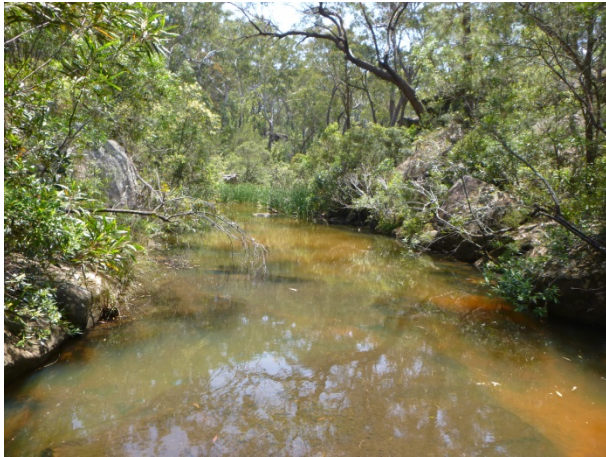
During the extraction of Longwall 38 the ICEFT identified iron staining along a 20m section of the Georges River downstream of GR\_Pool 49. This impact has been reported as WCA5\_LW38\_009 (**Photo 1**) and is a Level 1 Trigger under the TARPs in the EP (**Table 1, Appendix A**).

**Photo 1:** WCA5\_LW38\_009, the extent of iron staining downstream of GR\_Pool 49. Photo taken looking downstream. Taken on 10/12/2015.

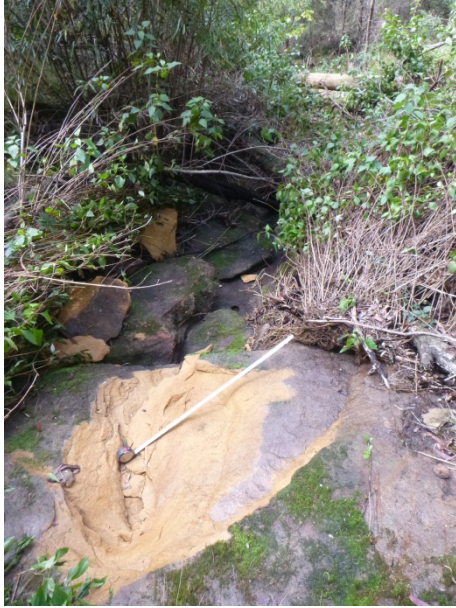
Fracturing and associated uplift was identified at a rockbar in GR104 (impact WCA5\_LW38\_001) (**Photo 2**). As this impact was located outside the zone of influence of Longwall 38 it is likely to be a result of a previous mining.

**Photo 2:** WCA5\_LW38\_001, fracturing and dislodged rock in GR104. Taken on 24/04/2015.

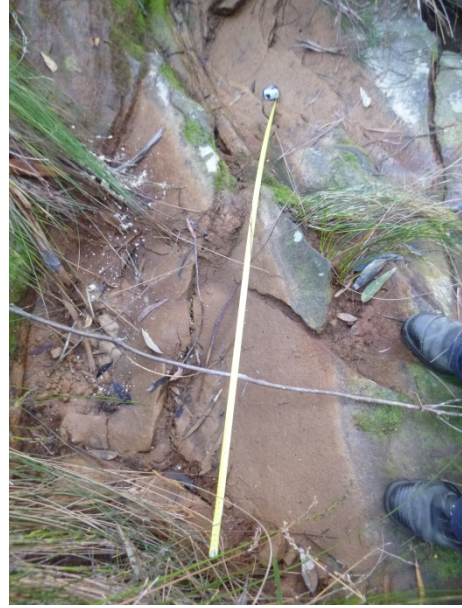
Three zones of fracturing and uplift were identified in GR108 during the extraction of Longwall 38. These impacts have been reported as WCA5\_LW38\_002, WCA5\_LW38\_003 and WCA5\_LW38\_005 (**Photos 2 to 5**). Minor iron staining was noted at impacts WCA5\_LW38\_002 and WCA5\_LW38\_005. No flow diversion was noted at WCA5\_LW38\_005. No flow was present during the inspections of WCA5\_LW38\_002 and WCA5\_LW38\_003 therefore changes to flow conditions are undetermined.

**Photo 3:** WCA5\_LW38\_002, fracturing perpendicular to bedding plane with minor iron staining in Rockbar 6A, GR108. Taken on 03/08/2015.

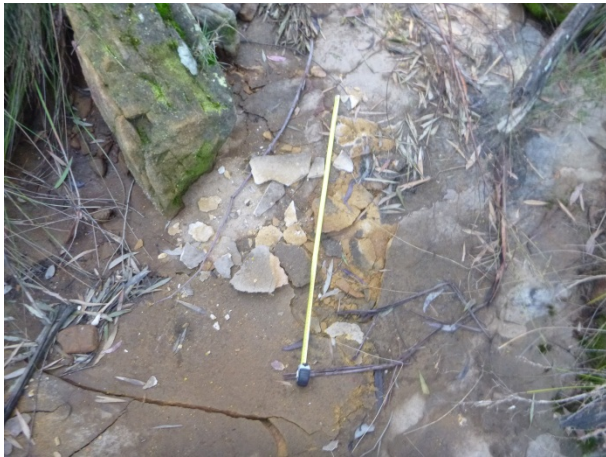
**Photo 4:** WCA5\_LW38\_003, fracturing and uplift within Channel 2, GR108. Taken on 03/08/2015.

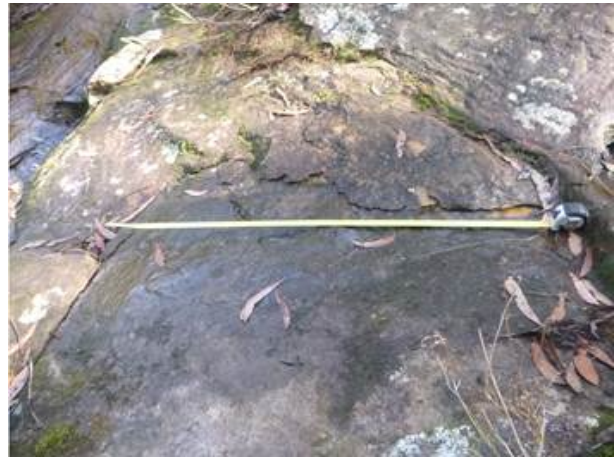
**Photo 5:** WCA5\_LW38\_005, fracturing and uplift downstream of Pool 1 in GR108. Taken on 20/08/2015.

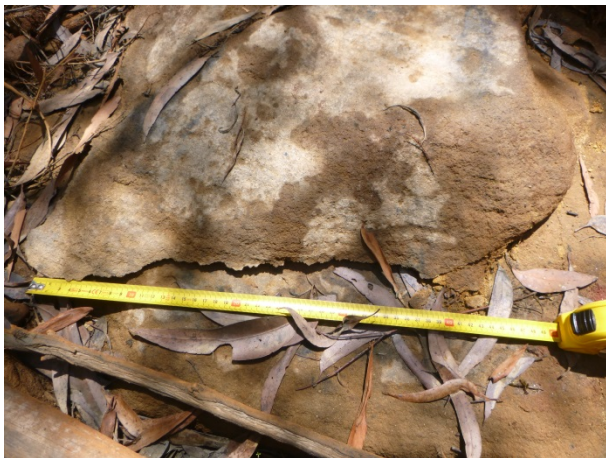
Fracturing to the base of GR110 with associated loss of flow was identified (impact WCA5\_LW38\_007) (**Photo 6**).

**Photo 6:** Impact WCA5\_LW38\_007, fracturing to base of GR110. Taken on 16/11/2015.

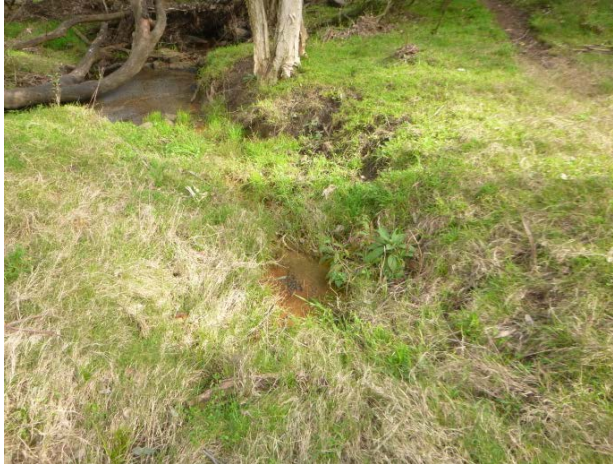
During a Longwall 36 post-mining inspection (conducted during the extraction of Longwall 38) iron staining was identified within a 400m section of Mallaty Creek (**Photos 7 to 9**). This impact (WCA5\_LW38\_004) is located more than 2300m from Longwall 38 and is likely associated with previous mining.

**Photo 7:** WCA5\_LW38\_004, Point of origin of iron staining at MC107, looking downstream. Taken on 19/08/2015.

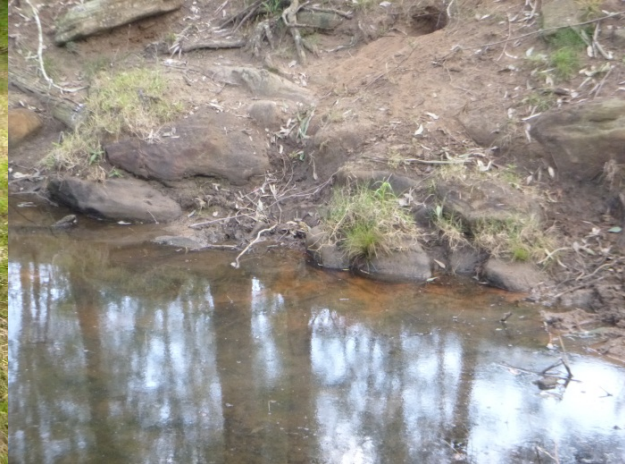
**Photo 8:** WCA5\_LW38\_004, most downstream point of visible iron, upstream of pool MC120. Taken on 19/08/2015.

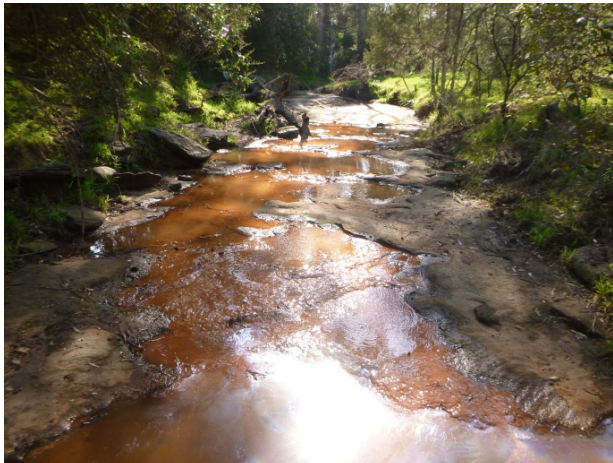
**Photo 9:** WCA5\_LW38\_004, Iron staining observed in Mallaty Creek. Taken on 19/08/2015.

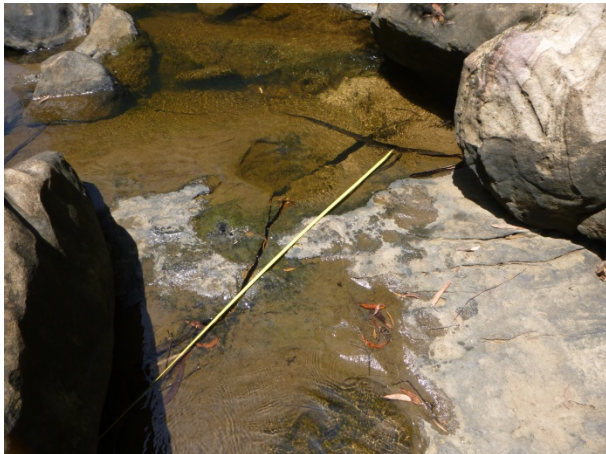
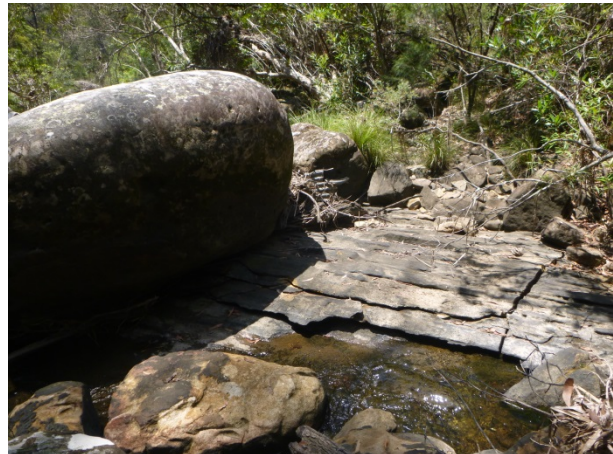
Fracturing was identified in the Georges River at GR\_Rockbar\_49 (impact WCA5\_LW38\_008) (**Photos 10 & 11**). The largest fracture at this site is 10m long and 0.04m wide. Flow diversion was observed at this site and the impact has been reported as a Level 2 Trigger under the TARPs in the EP (**Table 1, Appendix A**).

**Photo 10:** WCA5\_LW38\_008, fracturing on the Georges River. Taken on 10/12/2015

**Photo 11:** WCA5\_LW38\_008, fracturing on the Georges River. Taken on 10/12/2015

Remediation options for impacted sections of the Georges River as a result of Longwalls 32 to 38 will be addressed in the *Georges River Remediation Plan* (currently under review).

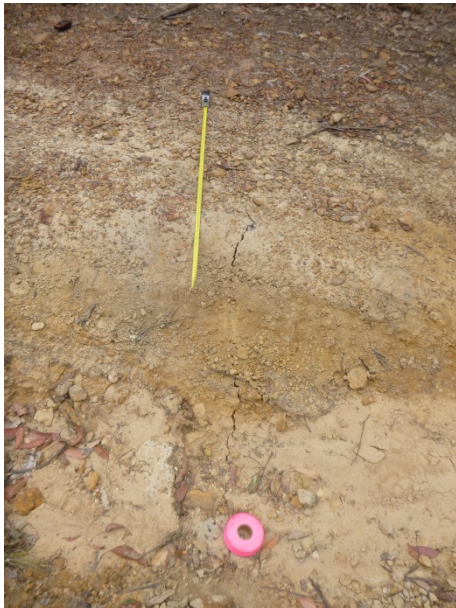
WCA5\_LW38\_006 is a soil crack which occurred to an access track adjacent to Georges River (**Photo 12**). The crack is approximately 3m long, 0.08m deep and has a maximum width of 0.01m. It does not impact access and is likely to naturally remediate.

**Photo 12:** WCA5\_LW38\_006, soil crack looking across the access track. Taken on 25/09/15.

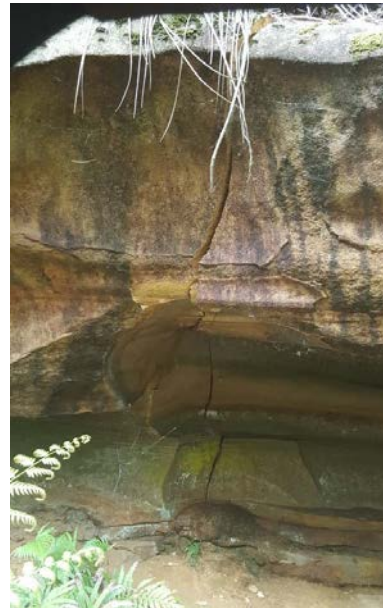
WCA5\_LW38\_010 is a zone of fracturing to a rock outcrop adjacent to GR110 (**Photo 13**). The largest fracture is approximately 2.1m long, 0.03m wide and has a measurable depth of 0.414m.

**Photo 13:** WCA5\_LW38\_010, Fracturing to rock outcrop adjacent to GR110. Taken on 17/02/16.

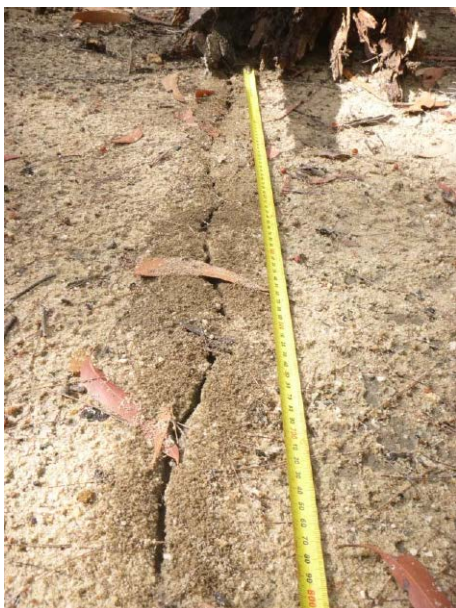
WCA5\_LW38\_011 is a zone of soil cracking on an access track adjacent to the Georges River (**Photo 14**). The largest crack is up to 3m long and 0.004m wide. It does not impact access and is likely to naturally remediate.

**Photo 14:** WCA5\_LW38\_011, soil crack on access track. Taken on 16/03/16.
