West Cliff Area 5 Longwall 38, Georges River Update Report

27th of March 2015

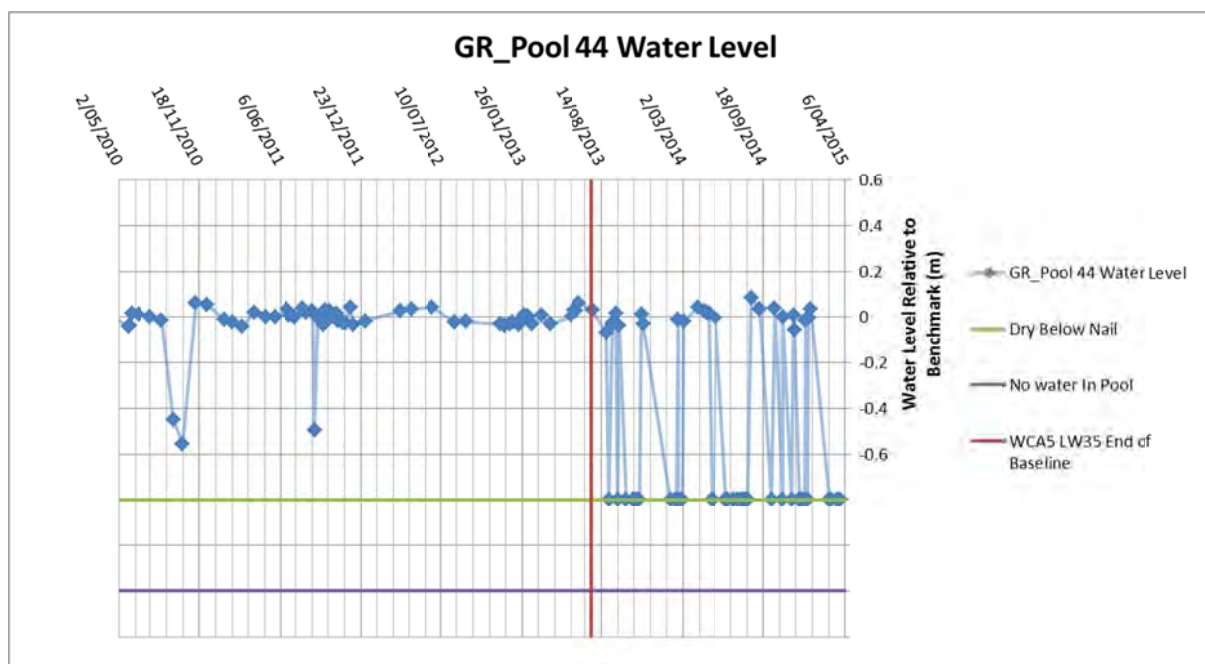
Graph 1: Water levels recorded in GR_Pool 44.

GR_Pool 44 remains 'Dry Below Nail' (Graph 1). This water level has been reported previously, is below baseline levels and is a trigger in the GRMP. Photos 1 and 2 show the latest pool conditions.

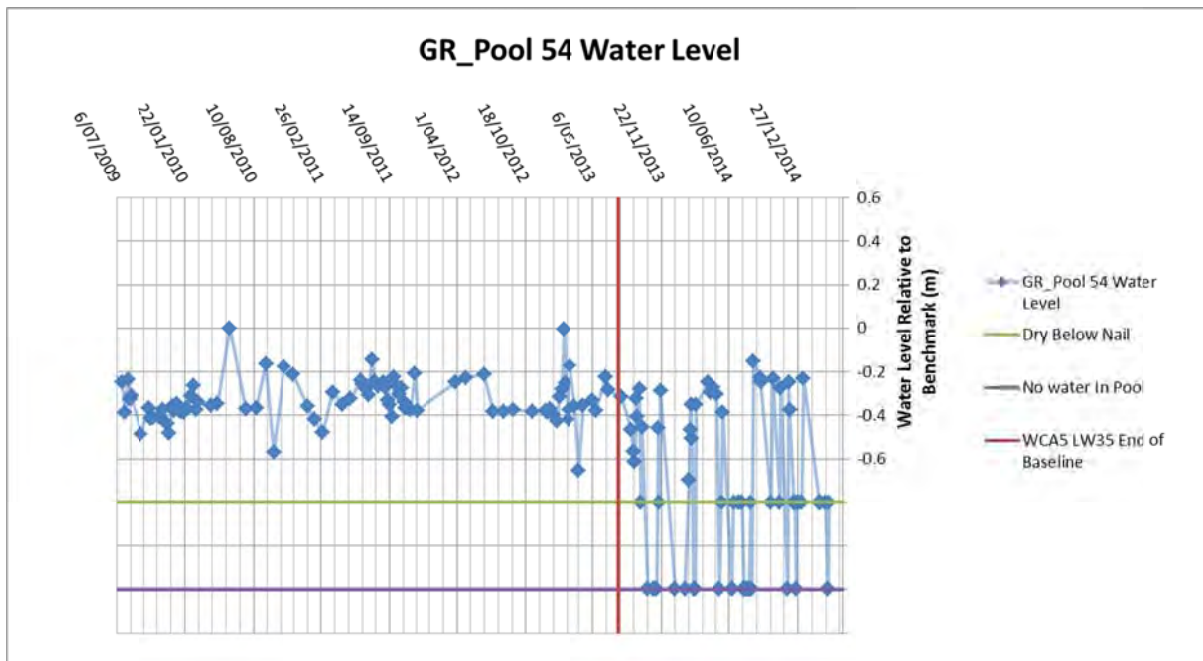
Graph 2: Water levels recorded in GR_Pool 54.

Water level in GR_Pool 54 remains below baseline. On the latest inspection the pool was 'Dry Below Nail' (Graph 2). This has been reported previously, is below the lowest level experienced in the baseline period and is a trigger according to the GRMP. Photos 3 and 4 show the latest pool conditions.

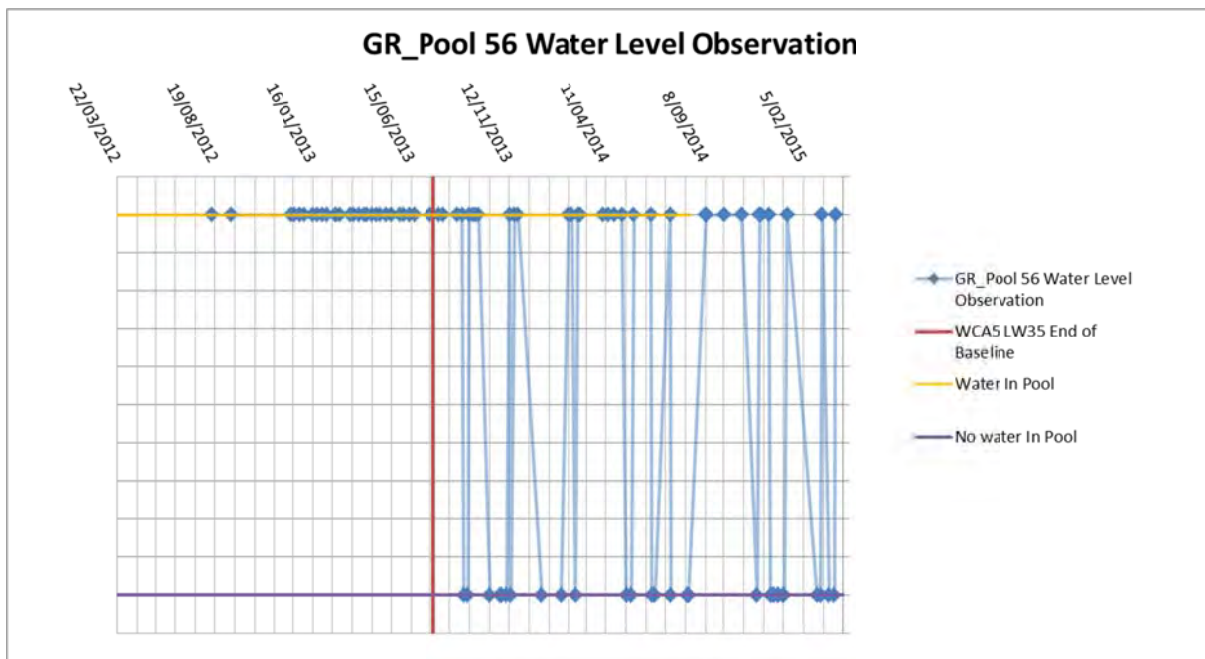
On the latest inspection GR_Pool 56 had surface water present (Graph 3). Photos 5 and 6 show the latest pool conditions.

On the latest inspection of GR_Pool 57, water level was recorded as 'Dry Below Nail' (Graph 4). This remains a trigger according to the GRMP. Photos 7 and 8 show the latest pool conditions.

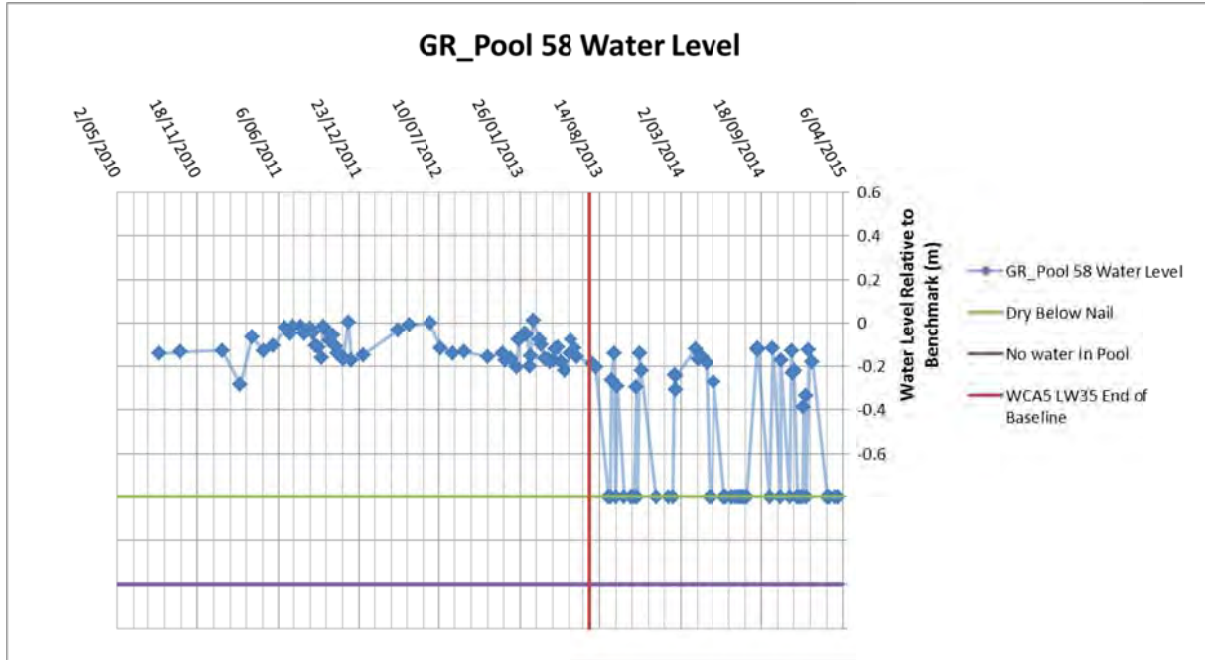
Graph 5: Water levels recorded in GR_Pool 58

Water level in GR_Pool 58 remains 'Dry Below Nail' (Graph 5). This has been reported previously, is below the lowest level experienced in the baseline period and is a trigger according to the GRMP. Photos 9 and 10 show the latest pool conditions.

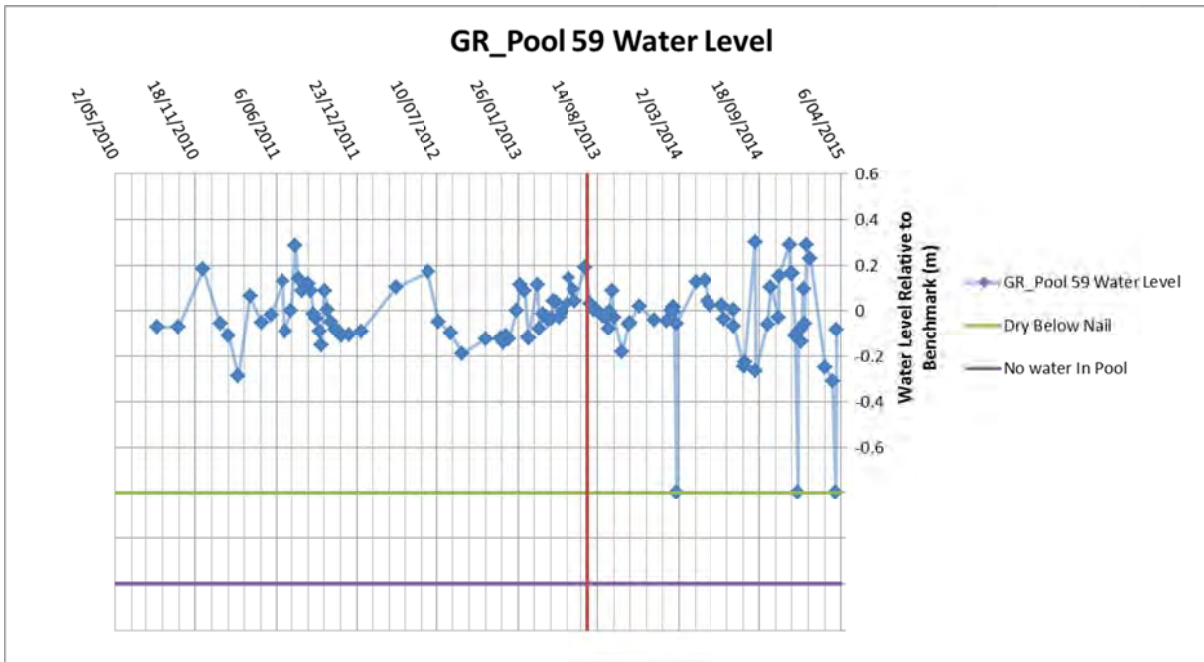
Graph 6: Water levels recorded in GR_Pool 59

On the inspection carried out on 24th March 2015, water level in GR_Pool 59 was observed to be below baseline levels. This has been reported previously and is a trigger according to the GRMP. The follow up inspection on 26th March 2015 revealed that water level in the pool had returned to above baseline levels (Graph 6). Photos 11 and 12 show the latest pool conditions.

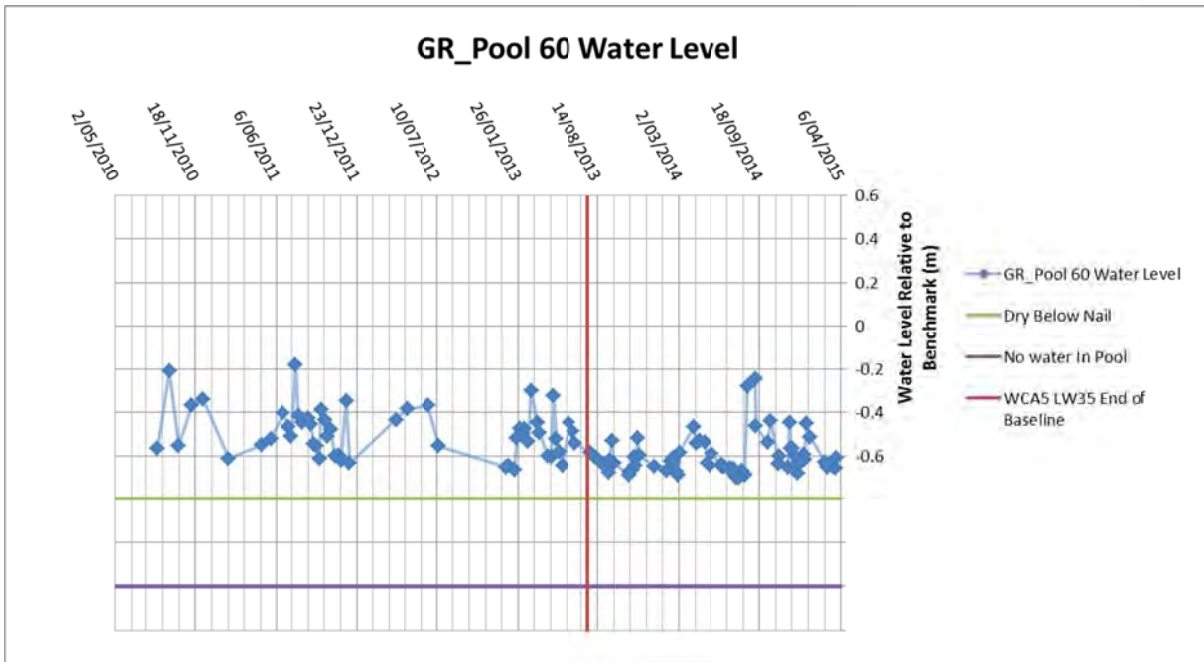
Graph 7: Water levels recorded in GR_Pool 60

On the inspection carried out on 24th March 2015, water level in GR_Pool 60 was observed to be below baseline levels. This has been reported previously and is a trigger according to the GRMP. The follow up inspection on 26th March 2015 identified that water at returned to the pool above baseline levels (Graph 7). Photos 13 and 14 show the latest pool conditions.

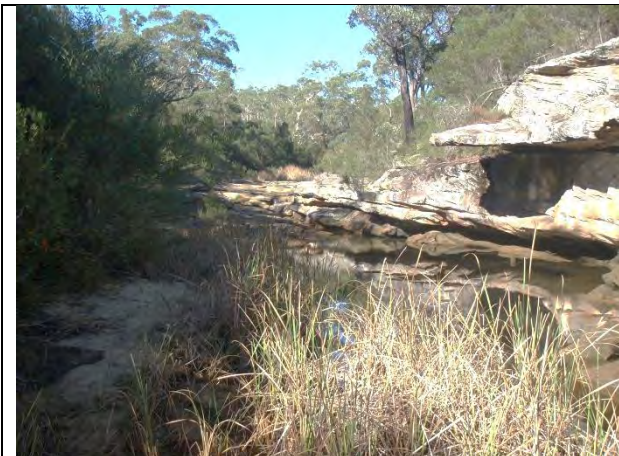
GR_Pool 44 was observed to have high water level and flow. The water level was above the lowest level experienced in the baseline period. Photos 1 to 4 show a comparison of the latest observed pool conditions to the previously reported low water levels.

Photo 1: GR_Pool 44 looking upstream. Taken on 26/03/2015

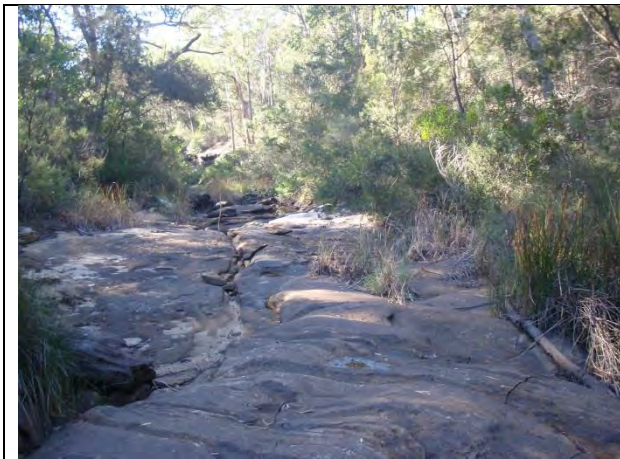
GR_Pool 54 was observed to have high water level and flow. The water level was above the lowest level experienced in the baseline period. Photos 5 to 8 show a comparison of the latest observed pool conditions to the previously reported low water levels.

Photo 5: GR_Pool 54 looking upstream. Taken on 26/03/2015

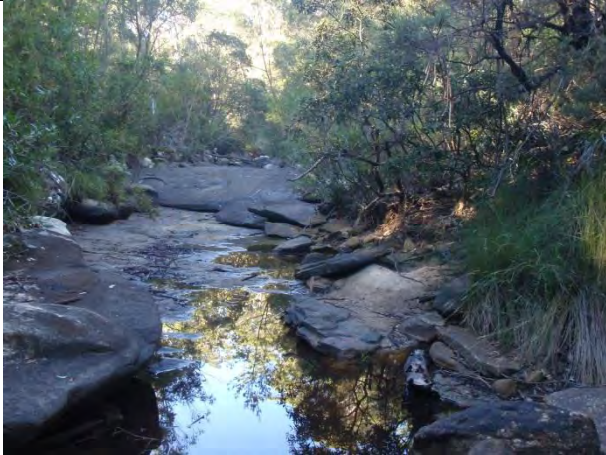
GR_Pool 57¹ was observed to have high water level and flow. The water level was above the lowest level experienced in the baseline period. Photos 9 to 12 show a comparison of the latest observed pool conditions to the previously reported low water levels.

Photo 9: GR_Pool 57 looking upstream. Taken on 26/03/2015

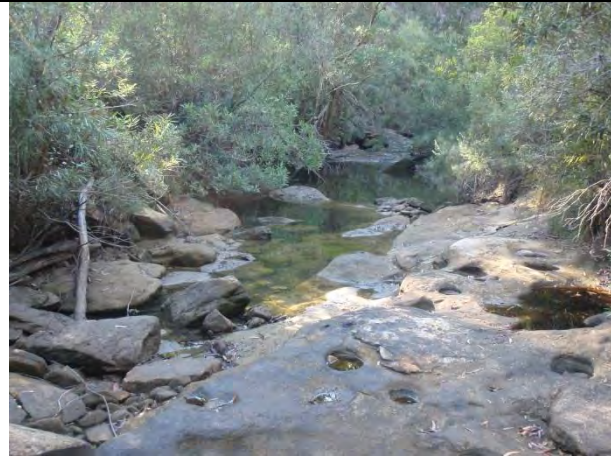
GR_Pool 58 was observed to have high water level and flow. The water level was above the lowest level experienced in the baseline period. Photos 13 to 16 show a comparison of the latest observed pool conditions to the previously reported low water levels.

Photo 13: GR_Pool 58 looking upstream. Taken on 26/03/2015

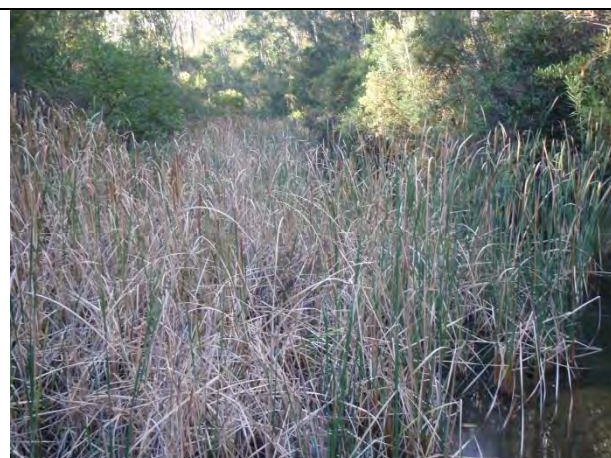
GR_Pool 59 was observed to have high water level and flow. The water level was above the lowest level experienced in the baseline period. Photos 17 to 20 show a comparison of the latest observed pool conditions to the previously reported low water levels.

Photo 17: GR_Pool 59 looking upstream. Taken on 26/03/2015

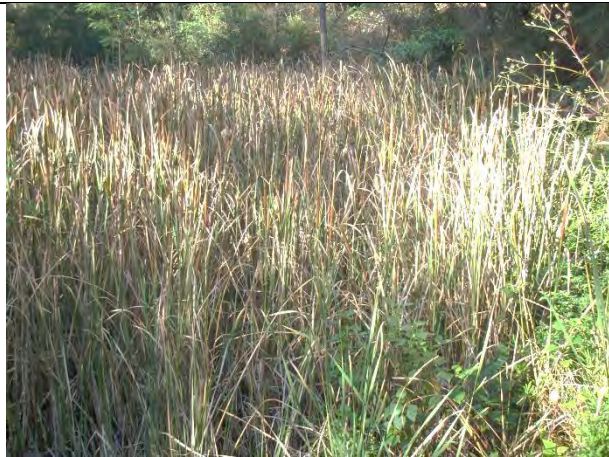
GR_Pool 60 was observed to have high water level and flow. The water level was above the lowest level experienced in the baseline period. Photos 21 to 24 show a comparison of the latest observed pool conditions to the previously reported low water levels.

Photo 21: GR_Pool 60 looking upstream. Taken on 26/03/2015

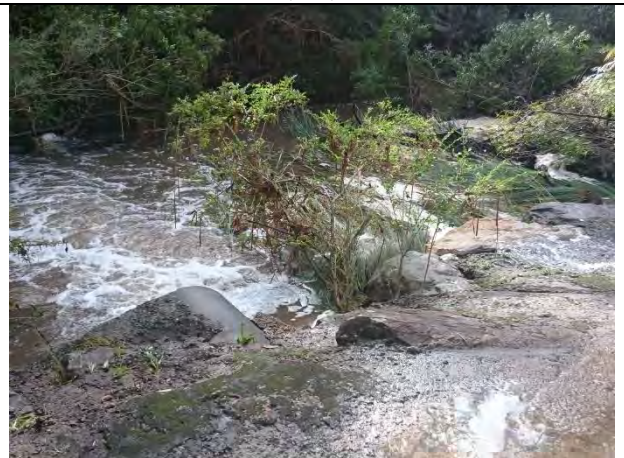
Photo 24: GR_Pool 60 looking downstream. Taken on 24/04/2015

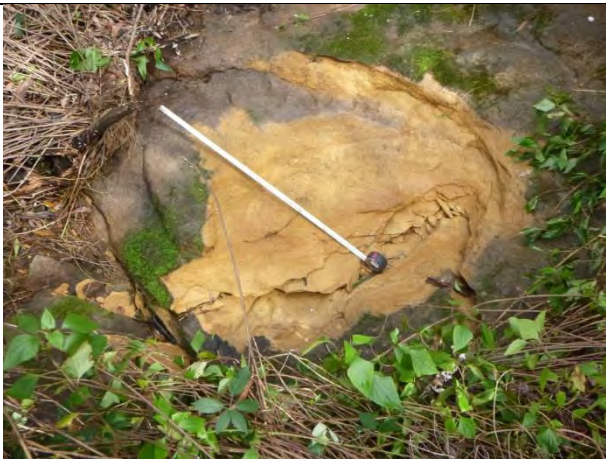
Fracturing to a rockbar of tributary GR104 downstream from Impact WCA5_LW36_001 was identified during the inspection on 24 April 2015. The downstream section of the fracturing is up to 3m long and extends under a small step on the rockbar (Photo 25). Rock fragments up to 0.05m³ have been dislodged and transported downstream (Photos 26 and 27). The upstream section of the fracturing is up to 4m long, extending across the rockbar and under sediment on the southern bank of the tributary (Photos 28 to 30). Rock fragments up to 0.08m³ have been dislodged during the recent flood event.

Much of the vegetation and debris which covered the rockbar was removed during the flood event which enabled the rockbar and associated fracturing to be identified. It is likely that the fracturing occurred during the previous longwall.

Photo 25: WCA5_LW38_001- fracturing and uplift, looking across stream. Taken on 24/04/2015

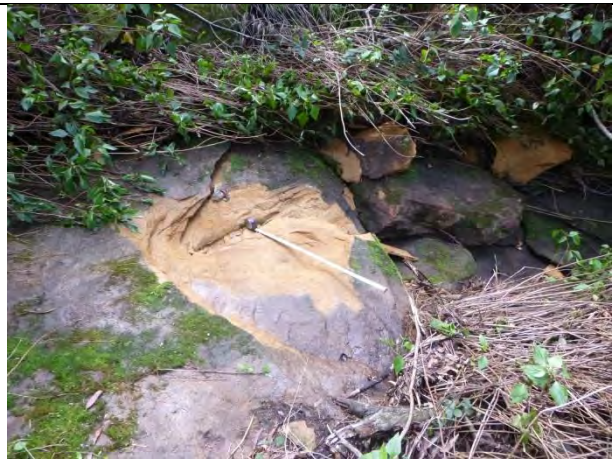
Photo 26: WCA5_LW38_001- fracturing with dislodged rock fragment. Taken on 24/04/2015

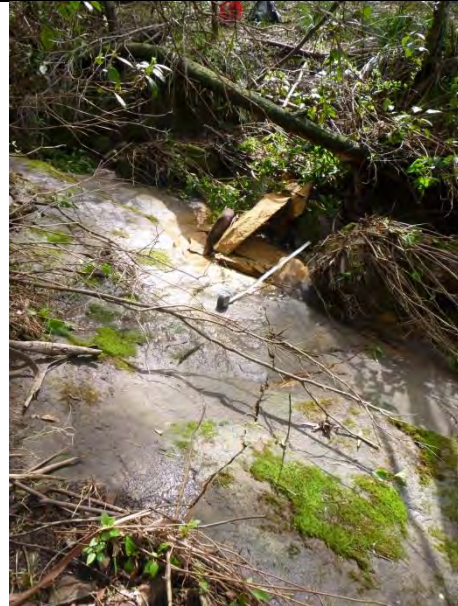
Photo 28: WCA5_LW38_001- upstream section of fracturing, looking across stream. Taken on 24/04/2015

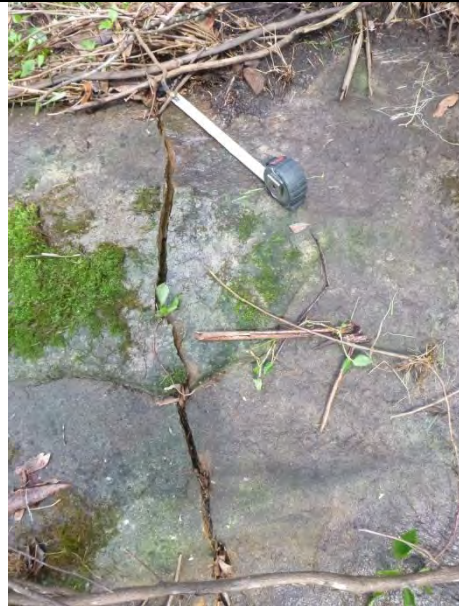
Photo 30: WCA5_LW38_001- upstream section of fracturing, extending in to sediment. Taken on 24/04/2015

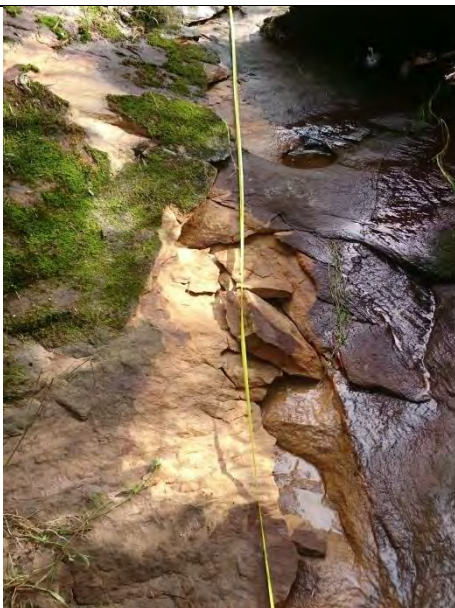
Fracturing and uplift to site GR104_Pool 1 was initially identified 19 September 2014. On the latest inspection changes to the fracturing were identified. The fracturing is now up to 4.5m long with multiple sections of uplift (Photos 31 to 33). Fractured rocks up to 0.07m³ have been dislodged and transported downstream due to the recent flood event (Photo 34). It is likely that the *recent* changes to this fracturing are due to the flood event and not additional subsidence. Flow is subsurface through the fracturing.

Photo 31: WCA5_LW36_001- fracturing and uplift looking upstream. Taken on 24/04/2015

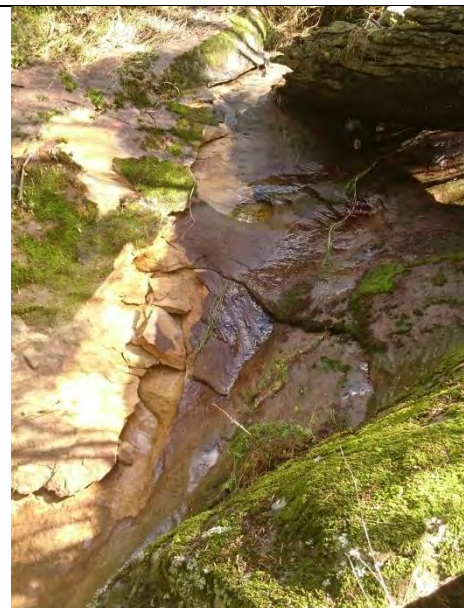
Photo 32: WCA5_LW36_001- fracturing and uplift looking upstream. Taken on 24/04/2015

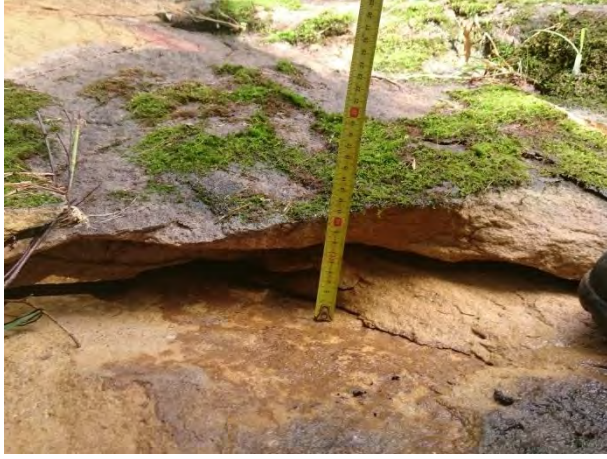
Photo 33: WCA5_LW36_001- fracturing to incised bedding plane. Taken on 24/04/2015

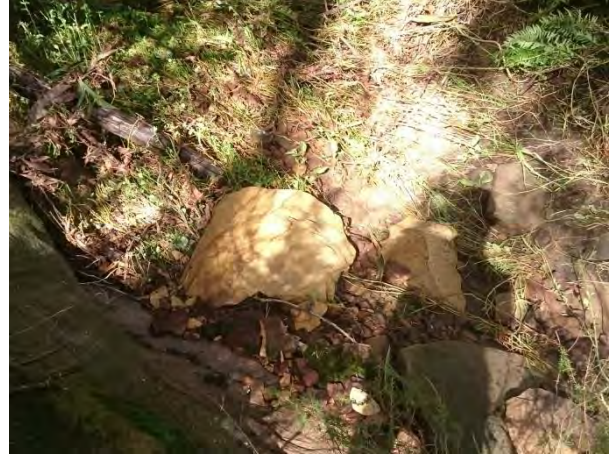
Photo 34: WCA5_LW36_001- dislodged rock fragment, looking downstream. Taken on 24/04/2015

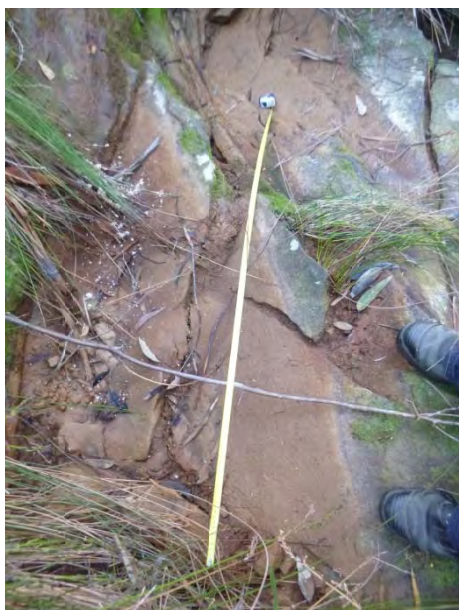
Fracturing and extension of a bedding plane has been identified within Rockbar 6A of the tributary GR108. Maximum fracture measurements within the rockbar were approximately 1.4m long, 0.008m wide and 0.002m deep (Photos **Photo 1** and **Photo 2**). Extension of a bedding plane measured approximately 0.7m long, 0.008m wide and at least 0.025m deep (Photo 3). No flow was present at the time of inspection and minor iron staining was evident at the rockbar (**Photo 1**).

Photo 1 : WCA5_LW38_002 – Fracturing perpendicular to bedding plane. Taken on 03/08/2015.

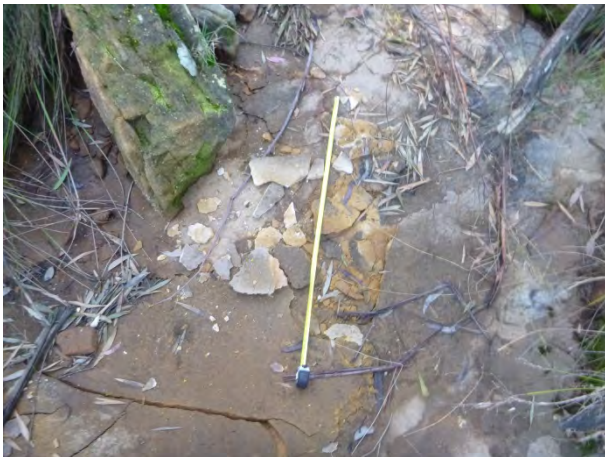
A zone of fracturing and uplift has been identified within Channel 2 of tributary GR108 (Photo 4). The zone of fracturing is approximately 10m long by 2m wide (20m^2). Maximum length of fracturing is approximately 10m, with a width of 0.015m and a maximum measurable depth of 0.25m (Photos Photo 5 and Photo 6). Uplift is approximately 4m long, with 0.032m of uplift (Photos Photo 7 and Photo 8). No flow was present at the time of inspection, no iron staining was visible.

Photo 4: WCA5_LW38_003 – Fracturing and uplift within Channel 2. Taken on 03/08/2015.

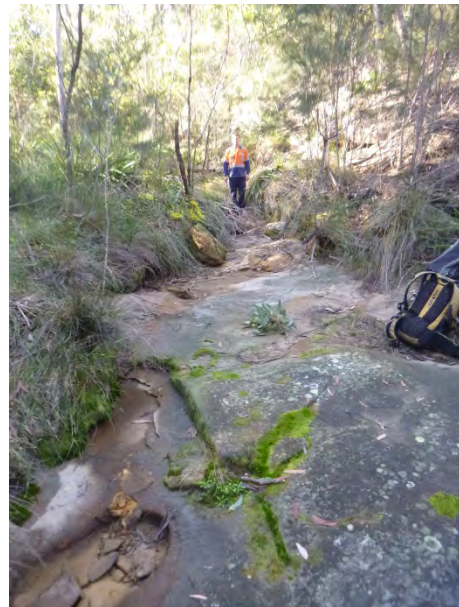
Photo 5: WCA5_LW38_003 – Length of fracturing within Channel 2. Taken on 03/08/2015.

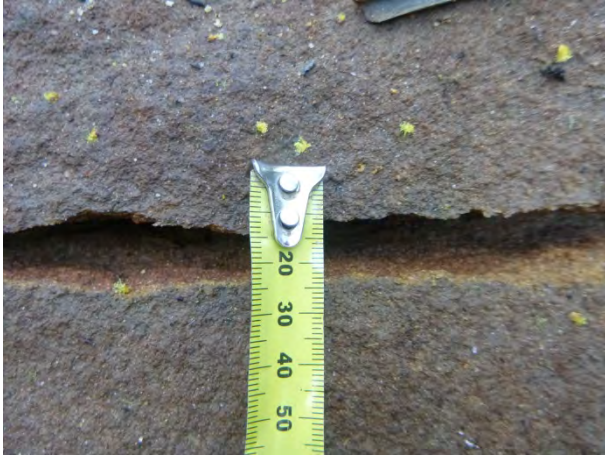
Photo 6: WCA5_LW38_003 – Widest and deepest crack within Channel 2. Taken on 03/08/2015.

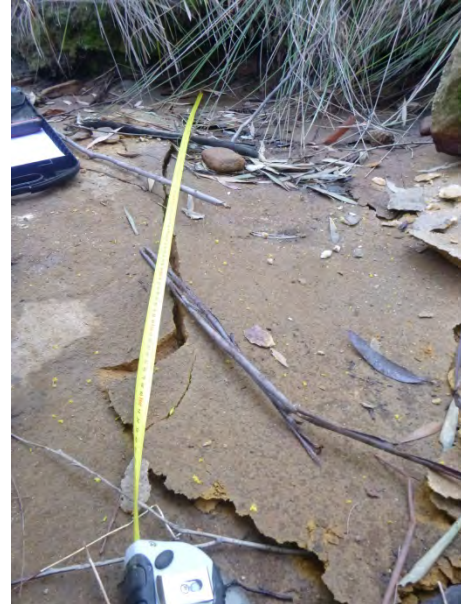
Photo 7: WCA5_LW38_003 – Longest section of uplift within fracture zone. Taken on 03/08/2015.

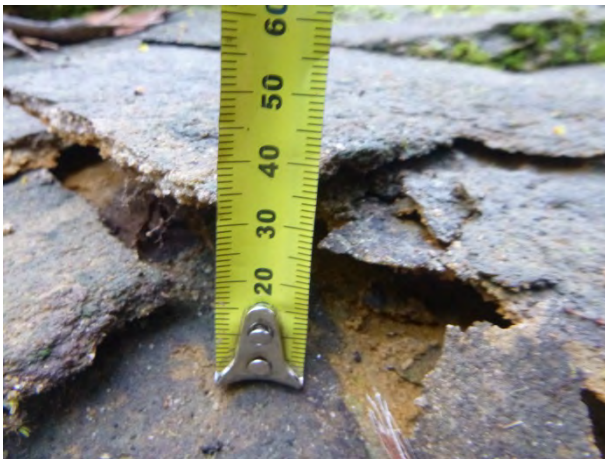
Photo 8: WCA5_LW38_003 – Maximum uplift within fracture zone. Taken on 03/08/2015.

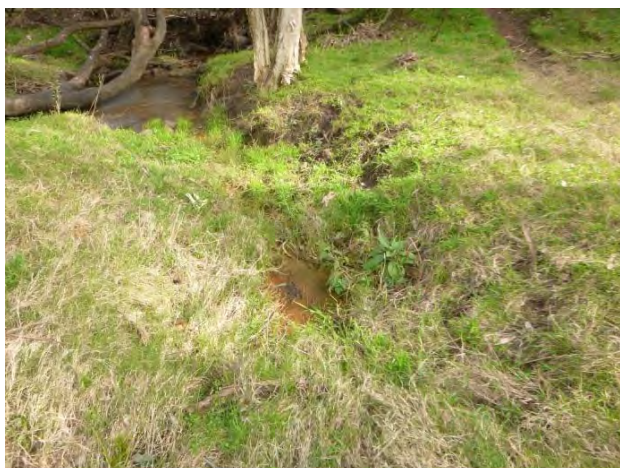
Iron staining was observed originating from a seepage point adjacent to pool MC107 (Photos 1). The iron staining extends downstream along Mallaty Creek for approximately 400m until the upstream end of pool MC120 (Photos 2 to 5). No fracturing or change in surface flow conditions was observed. Monitoring and reporting will continue as required with results included in the End of Panel Report and AEMR.

Photo 1: WCA5_LW38_004 – Iron staining- point of origin at MC107, looking downstream. Taken on 19/08/2015.

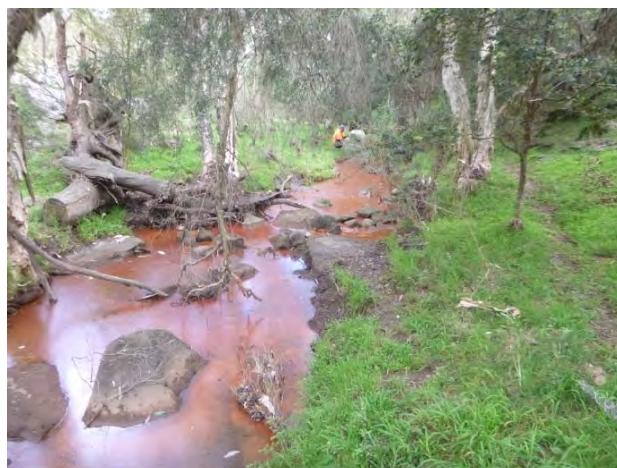
Photo 2: WCA5_LW38_004 – Iron staining observed upstream from pool MC108, looking downstream. Taken on 19/08/2015.

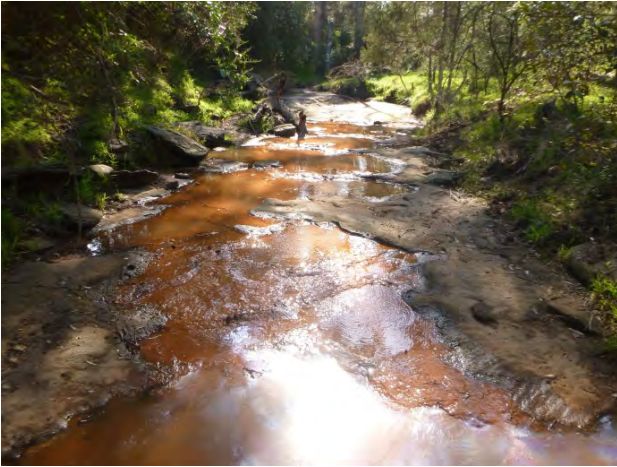
Photo 3: WCA5_LW38_004 – Iron staining observed at pool MC108, looking upstream. Taken on 19/08/0215.

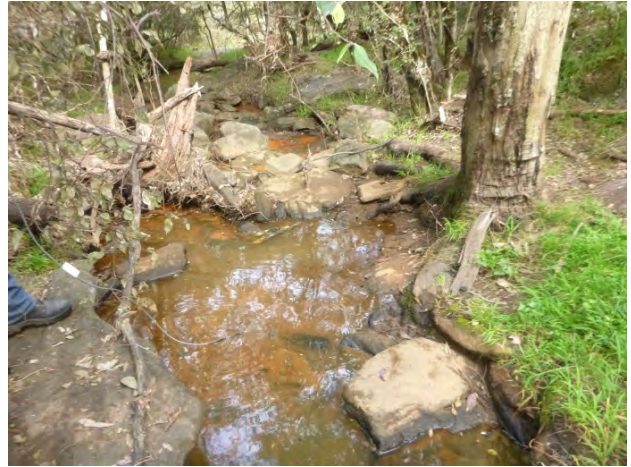
Photo 4: WCA5_LW38_004 – Iron staining observed at pool MC109, looking downstream. Taken on 19/08/0215.

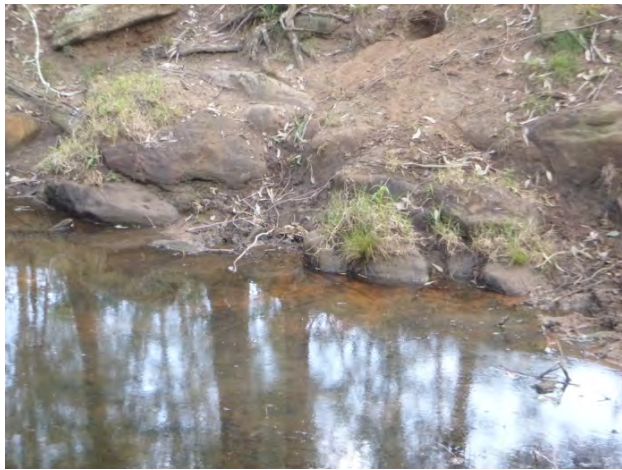
Photo 5: WCA5_LW38_004 – most downstream point of visible iron, pool MC120. Taken on 19/08/0215.

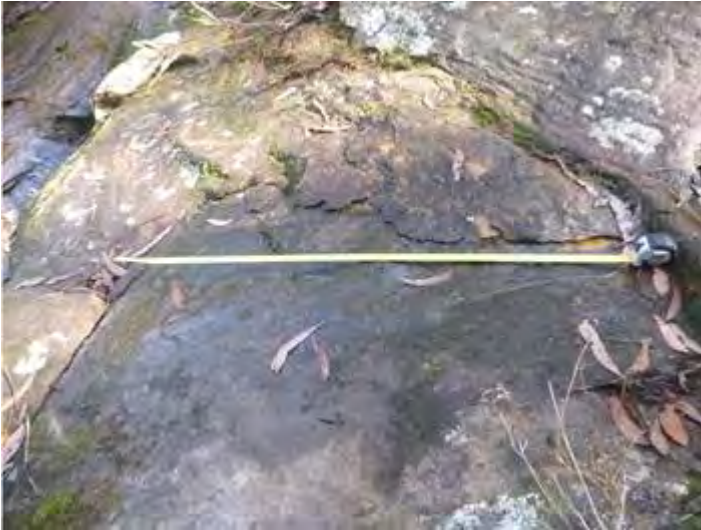
A zone of fracturing and uplift has been identified on tributary GR108, downstream from monitoring site GR108_Pool 1. The fracturing covers an area of approximately 3m², with the largest fracture approximately 1.2m long with uplift of 0.03m (Photo 6). The fracture extends under a water filled pothole with no active flow diversion evident (Photos 7 and 8). Some iron staining was also evident, originating from further upstream and previously reported. Monitoring and reporting will continue as required with results included in the End of Panel Report and AEMR.

Photo 6: WCA5_LW38_005 – Fracturing and uplift on tributary GR108. Taken on 20/08/2015.

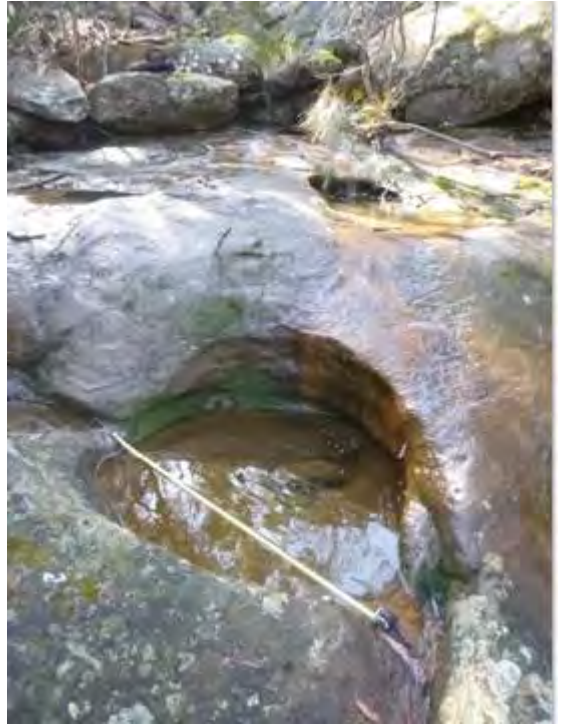
Photo 7: WCA5_LW38_005 – Fracturing and uplift on tributary GR108. Taken on 20/08/2015.

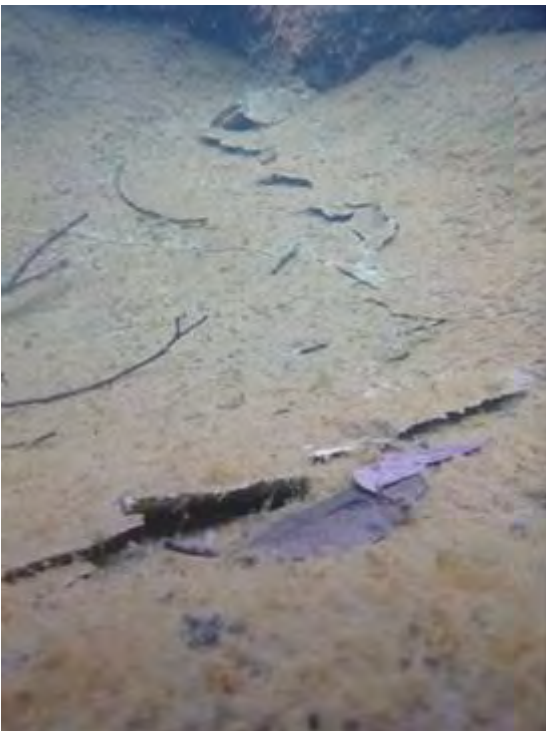
Photo 8: WCA5_LW38_005 – Fracturing and uplift on tributary GR108. Taken on 20/08/2015.

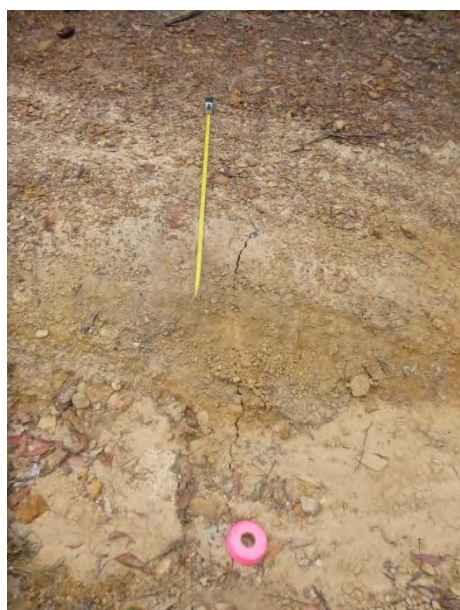
Soil cracking was identified along a fire trail adjacent to the Georges River. The crack extended across the fire trail for approximately 3m, with a maximum width of 0.01m and measurable depth of 0.08m. The cracking appears stable and is not expected to result in erosion. The crack does not pose any hazard to people walking along the track. Monitoring and reporting will continue as required with results included in the End of Panel Report and AEMR.

Photo 1: WCA5_LW38_006 – Soil crack looking across the fire trail. Taken on 25/9/15

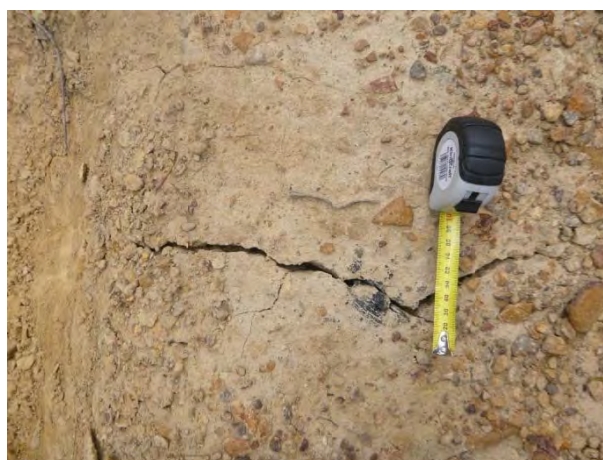
Photo 2: WCA5_LW38_006 – Soil crack at its widest point. Taken on 25/9/15

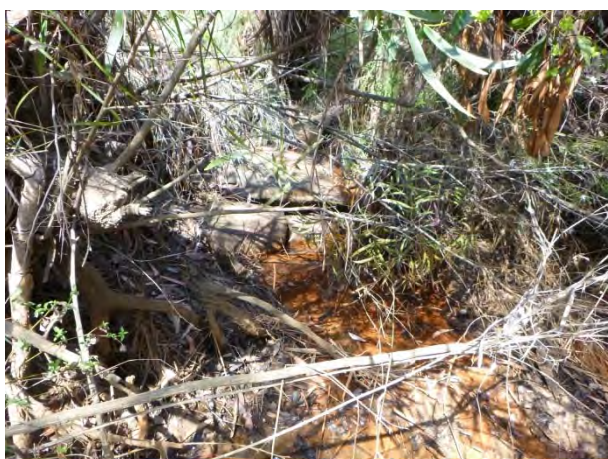
Inspection within tributary GR110 identified that surface flow has been lost from that channel (Photo 1). Additionally, a fracture has been identified within a boulder (Photo 2).

Photo 1: WCA5_LW38_007 – Confluence between GR110 and Georges River, Looking upstream. Taken on 2/10/15

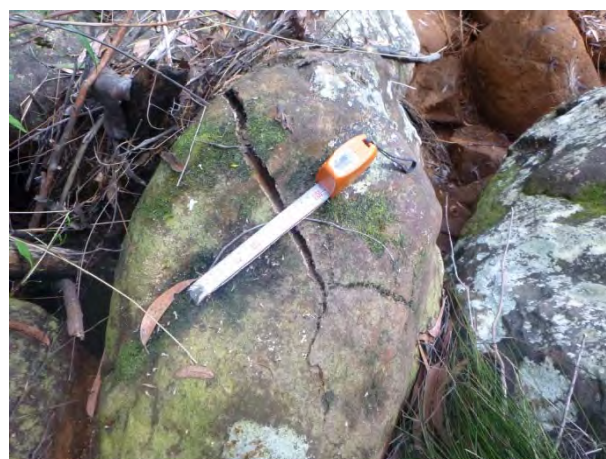
Photo 2: WCA5_LW38_007 – Fractured boulder within GR110. Taken on 2/10/15

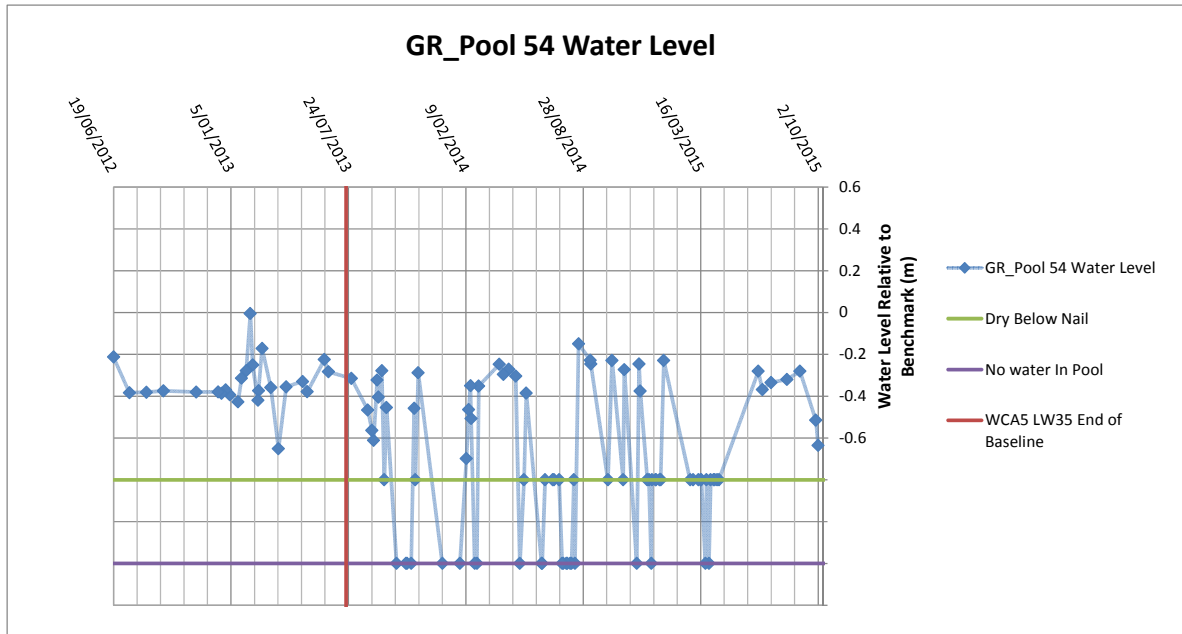
Graph 1: Water levels recorded in GR_Pool 54

On the latest inspection of GR_Pool 54 water level was lower than the baseline period (Graph 1). This water level has been reported previously and is a trigger according to the Longwall 37 and 38 Extraction Plan. Photos 3 and 4 show the latest pool conditions.

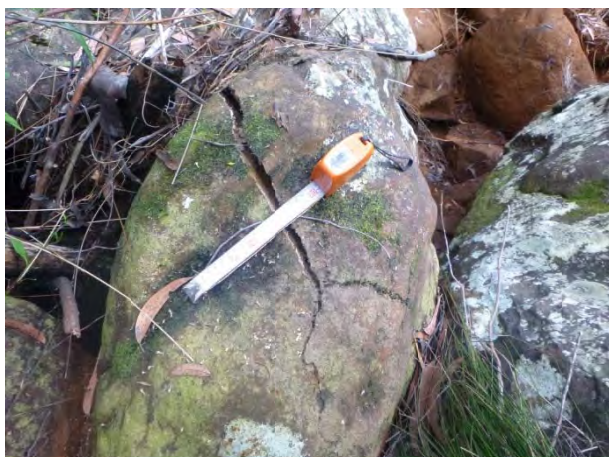
Photo 1: Impact WCA5_LW38_007- initial fracturing identified on tributary GR110. Taken on 2/10/2015.

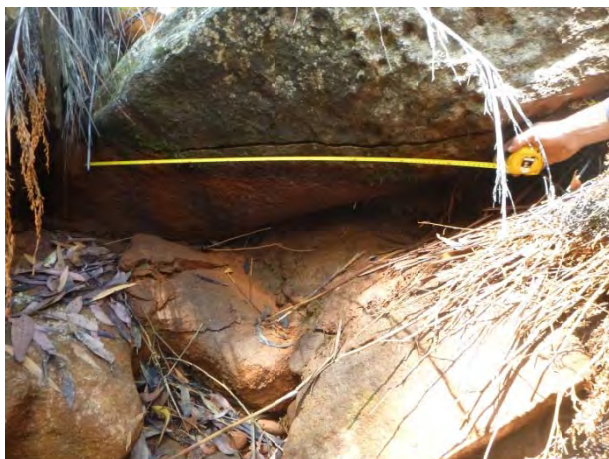
Photo 3: Impact WCA5_LW38_007- additional fracturing to boulder in GR110. Taken on 16/11/2015.

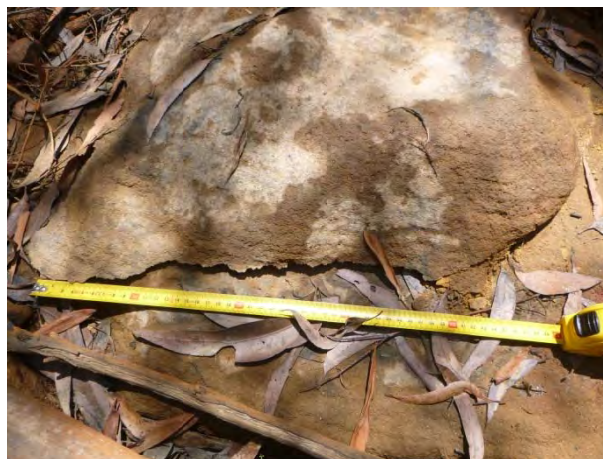
Photo 4: Impact WCA5_LW38_007- additional fracturing to base of GR110. Taken on 16/11/2015.

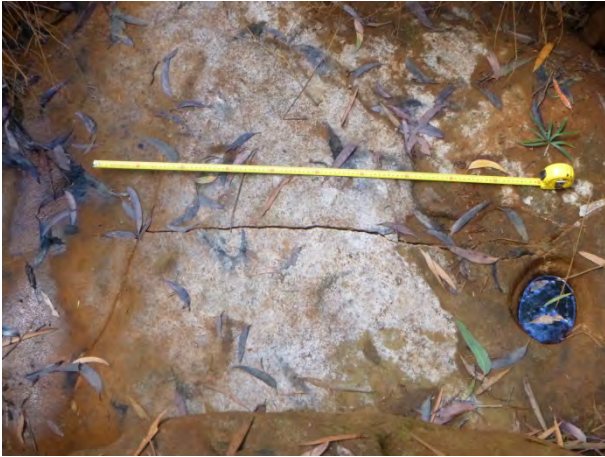
Photo 5: Impact WCA5_LW38_007- additional fracturing to base of GR110. Taken on 16/11/2015.

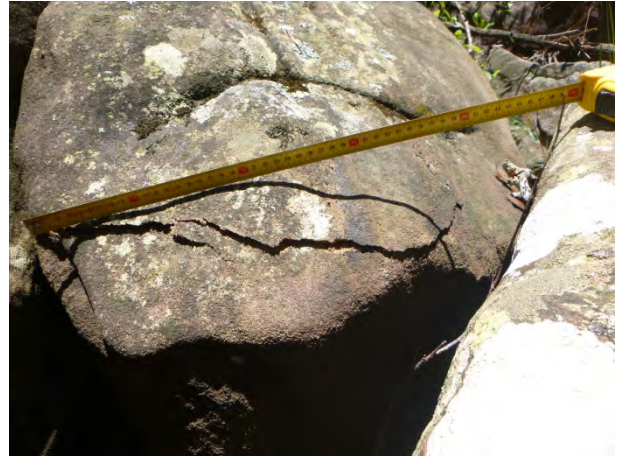
Photo 6: Impact WCA5_LW38_007- additional fracturing to boulder on GR110. Taken on 16/11/2015.

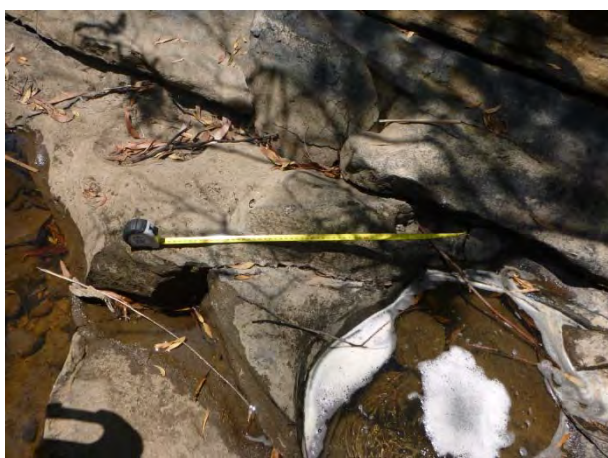
Photo 1: Impact WCA5_LW38_008- Fracturing identified on the Georges River. Taken on 10/12/2015.

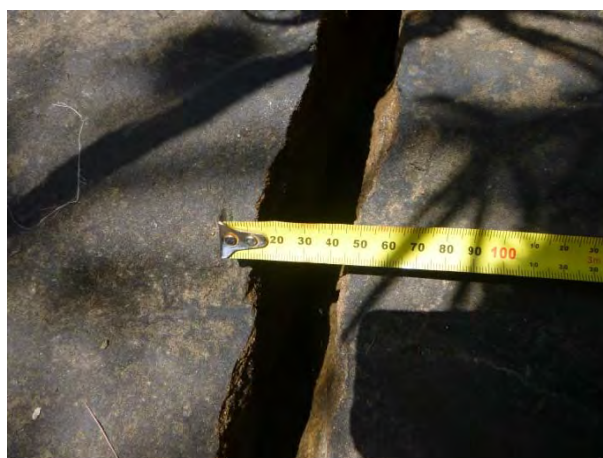
Photo 2: Impact WCA5_LW38_008- Fracturing identified on the Georges River. Taken on 10/12/2015.

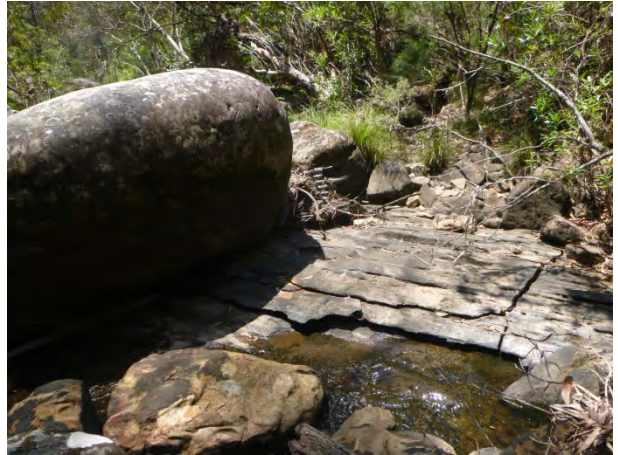
Photo 4: Impact WCA5_LW38_008- Fracturing identified on the Georges River. Taken on 10/12/2015.

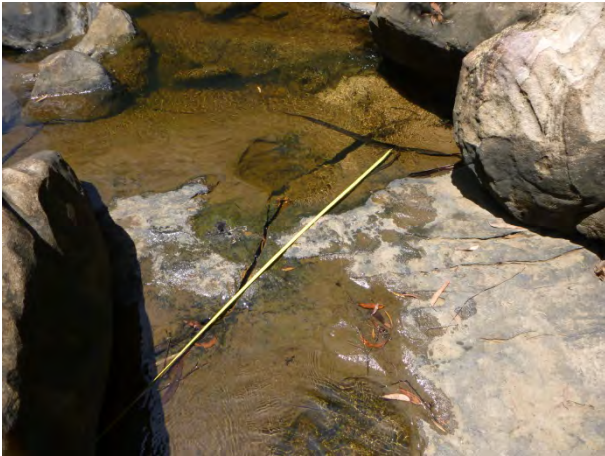
Photo 5: Impact WCA5_LW38_008- Fracturing identified on the Georges River. Taken on 10/12/2015.

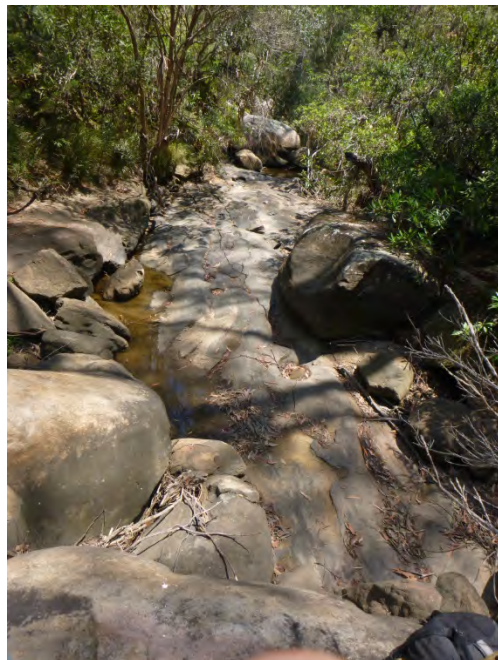
Photo 6: Impact WCA5_LW38_008- Fracture running along base of GR_Pool 49. Taken on 10/12/2015.

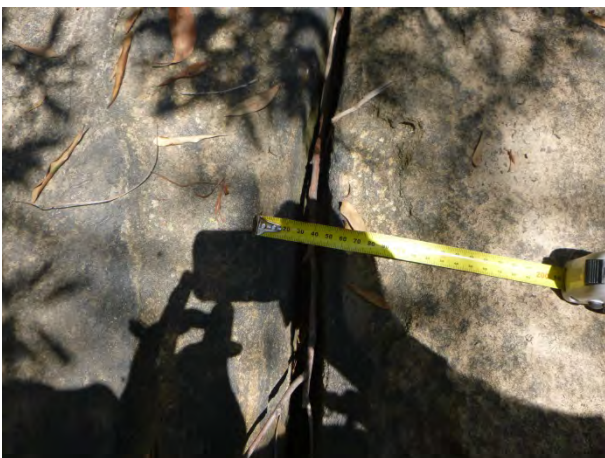
Photo 7: Impact WCA5_LW38_008- Debris infilling fracture on the base of GR_Pool 49. Taken on 10/12/2015.

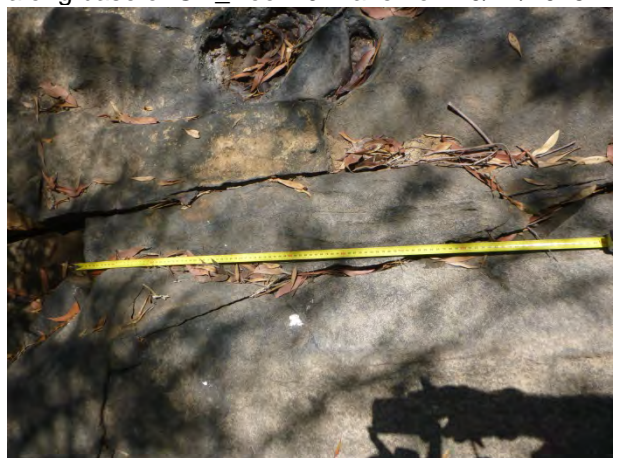
Photo 8: Impact WCA5_LW38_008- Displacement of pool bed rock material . Taken on 10/12/2015.

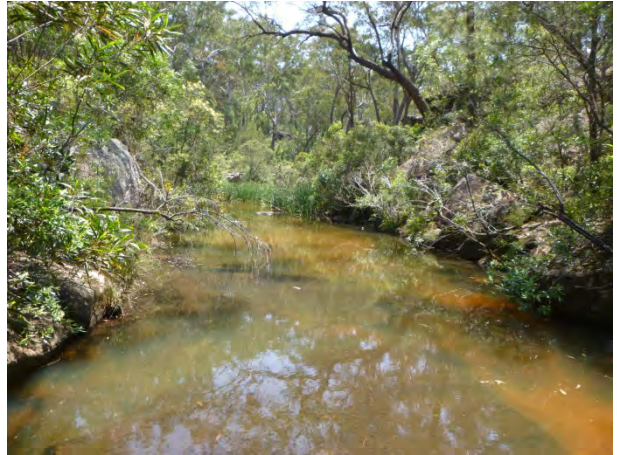
Photo 10: Impact WCA5_LW38_009- The extent of iron staining looking downstream. Taken on 10/12/2015.

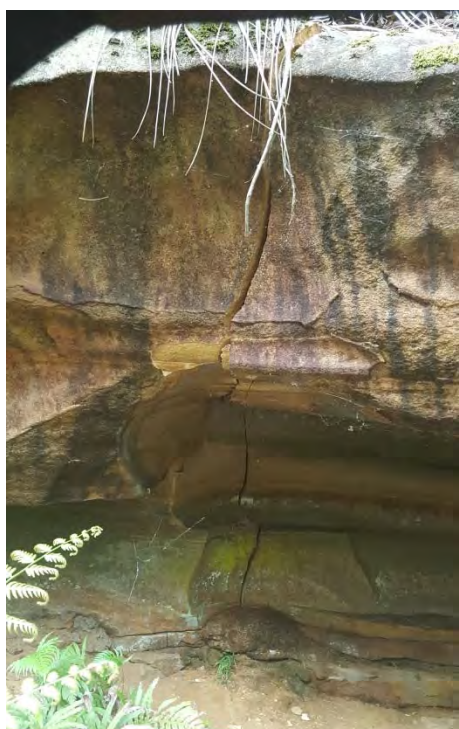
Photo 1: WCA5_LW38_010 – Vertical fracturing to rock outcrop adjacent to GR110. Taken on 17/02/16.

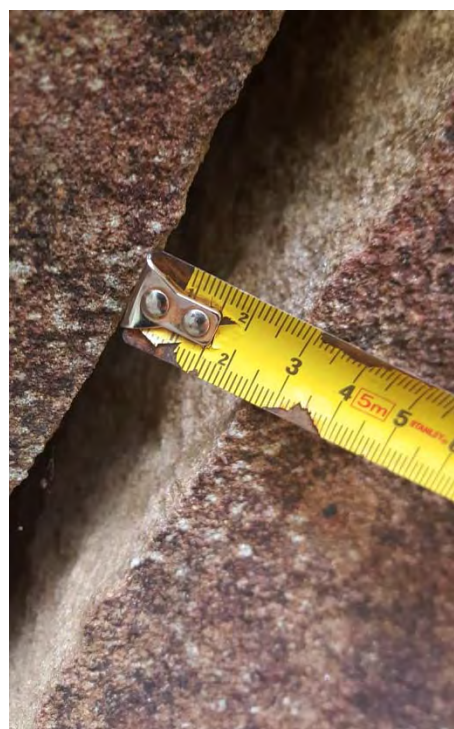
Photo 2: WA5_LW38_010 – vertical fracture. Taken on 17/02/16.
