West Cliff Area 5 Longwall 38, Georges River Update Report

27th of March 2015

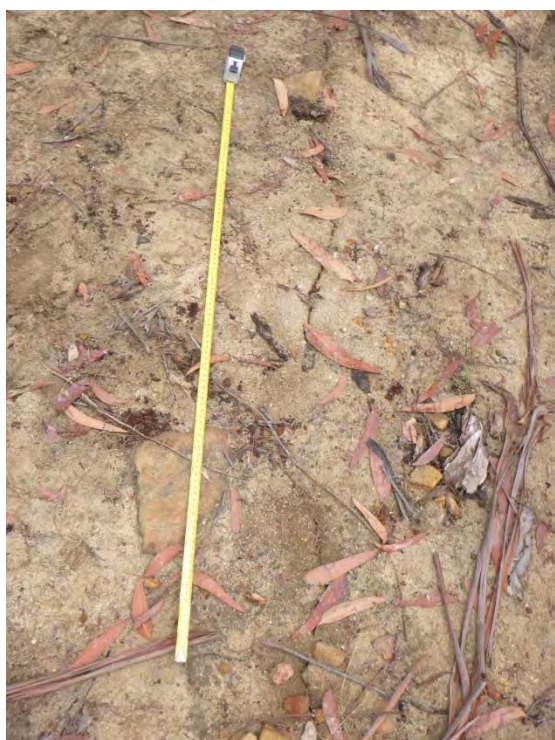
Photo 1: WCA5_LW38_011 – Soil cracking on access track. Taken on 16/3/16.

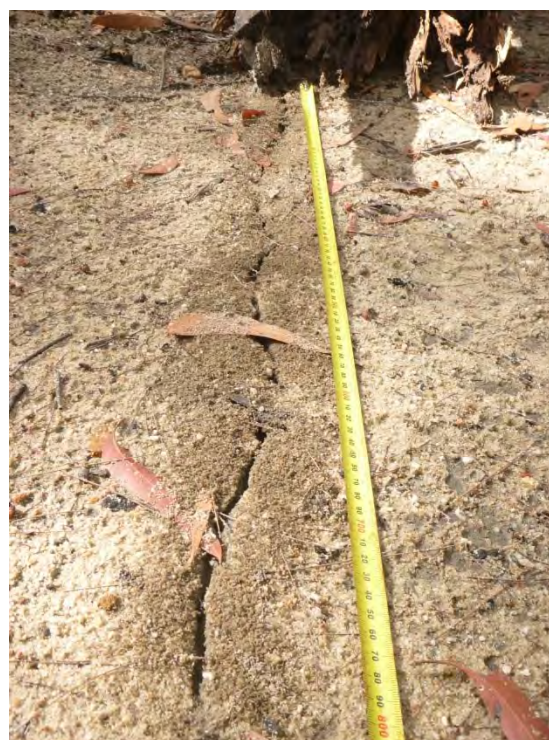
Photo 2: WCA5_LW38_011 – Width of widest soil crack identified. Taken on 16/3/16.
