**Re: West Cliff Colliery, Longwall 38 End of Panel Report - Aboriginal Heritage Assessment**

# West Cliff Colliery, Longwall 38 End of Panel Report: Aboriginal Heritage Assessment

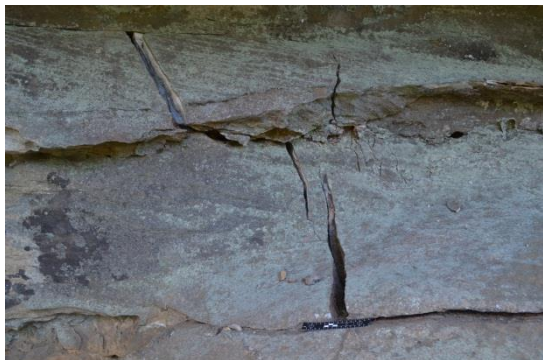
AHIMS site number	Site Name	Results of inspection	Photograph of current condition of site
52-2-2243	Georges River 2	Impacts to this shelter had been noted in Niche (2014). Observations found that impacts had not increased and remained in the same condition as described by Niche in 2014, due to the extraction of Longwall 36. The Thin, vertical cracking previously observed in the shelter roof to the right side of the art panel remains the same as previously described.

<p>Northern end of shelter examples of horizontal and vertical cracking that remain the same as previously described.</p>

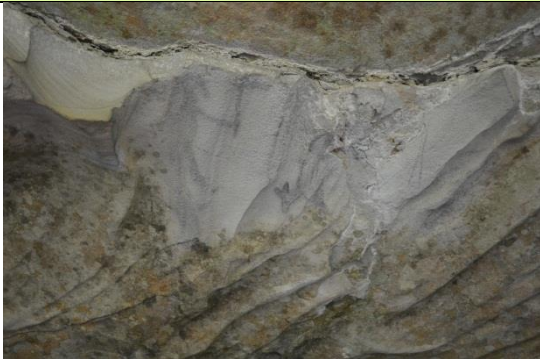
AHIMS site number	Site Name	Results of inspection	Photograph of current condition of site
		<p>The cracking does not appear to have altered seepage or water movements in the shelter, and there is no evidence of water flow or recent micro-vegetation growth associated with the cracking.</p> <p>The art panel remains in the same condition as described in Biosis Research 2007 and Niche 2013b, 2014, 2015 and has not been affected by the observed changes.</p>

<p>Picture of art panel still in same condition as described by Biosis 2007, Niche 2013b and 2014</p>

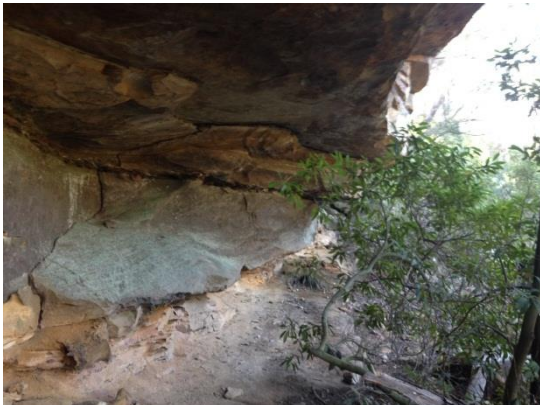
<p>View of the shelter facing north. Same as depicted by Biosis 200, Niche 2013b and Niche 2014.</p>
52-2-2244	Georges River 3	<p>This shelter was in the same condition as described by Niche in 2014. There has been no further movement of the horizontal bedding plane joints of the shelter and the cracking and exfoliation observed in relation to Longwall 35. The site remains the same as previously described.</p> <p>The cracking does not appear to have altered seepage or water movements in the shelter, and there is no evidence of water flow or recent micro-vegetation growth</p>

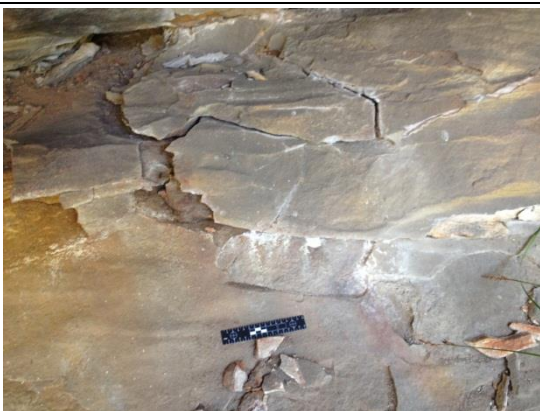
<p>Example of the cracking along the back wall of the shelter, in the same condition as depicted in Niche 2014.</p>

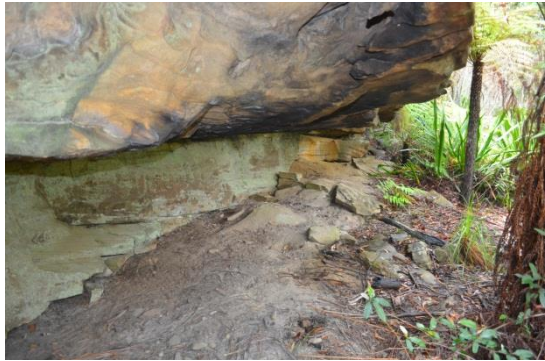
AHIMS site number	Site Name	Results of inspection	Photograph of current condition of site
		<p>associated with the cracking.</p> <p>The art panel remains in the same condition as described in Biosis Research 2007, Niche 2013b, 2014 and 2015.</p>	
52-2-2242	Georges River No 4	<p>Shelter and Art are in the same condition as described by Biosis Research 2007 and Niche Environment and Heritage 2011, 2013, 2014 and 2015. The art has started to loose granular substrate and there has been some cracking and flaking to the panel due to case hardening. Artefacts were not observed in the drip-line of the shelter.</p>

<p>52-2-2242 remains in the same condition as described and pictured 2007.</p>

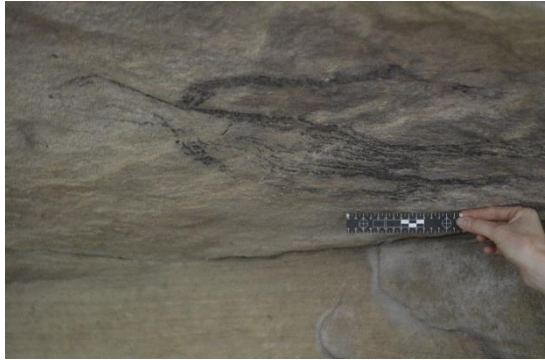
<p>Charcoal infill art present at 52-2-2242 remains in the same condition as described in Biosis Research 2007 and Niche Environment and Heritage 2013, 2014 and 2015.</p>

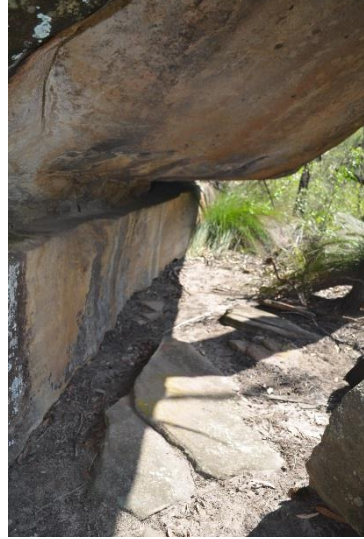
General photograph facing north of Georges River 1

AHIMS site number	Site Name	Results of inspection	Photograph of current condition of site
52-2-2234	Georges River 1	<p>This shelter is in the same condition as previously described in both Biosis Research 2007 and Niche Environment and Heritage 2011, 2013, 2013b and 2014. Natural weathering of the art panel has caused further granular loss, and a white leeching process has occurred over the infill kangaroo.</p>

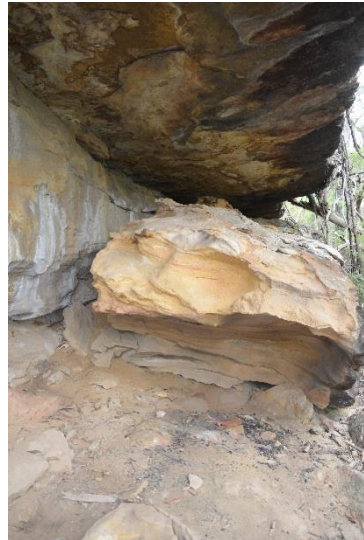
52-2-2241	Georges River 5	<p>Shelter and Art are in the same condition as described by Biosis Research 2007 and Niche Environment and Heritage 2011, 2013 and 2014. The previously reported charcoal drawings were in the same condition as described previously by Biosis 2007.</p> <p>The single quartz artefact was not observed in the shelters drip line during this assessment.</p>

General photograph of Georges River 5 facing east of boulder with infill charcoal kangaroo.
