WEST CLIFF AREA 5
LONGWALL 37 END
OF PANEL REPORT
MAY 2015

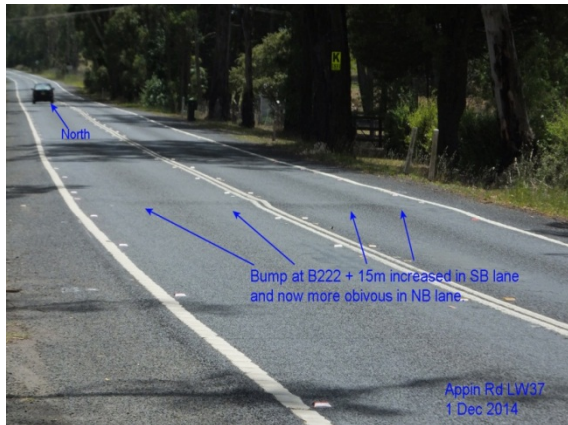
- A small bump 9m north of B223 (B223 plus 9m).
- A bump 15m north of B222 (B222 plus 15m) across the road, which became more pronounced as mining progressed.
- A small bump in the northbound shoulder 19m north of B230, and a slight dip across the carriageway in this location. Minor cracking in the road shoulder was also observed.

Photo 1: Bump at B222 + 15m, 1/12/2014 (Photo courtesy of Colin Dove).

Photographs of the impacts are provided below in Photos 1 to 3. The bump (B222 plus 15m) was remediated by

milling and patching the pavement. Further rehabilitation of the mining affects along Appin Road is being planned.

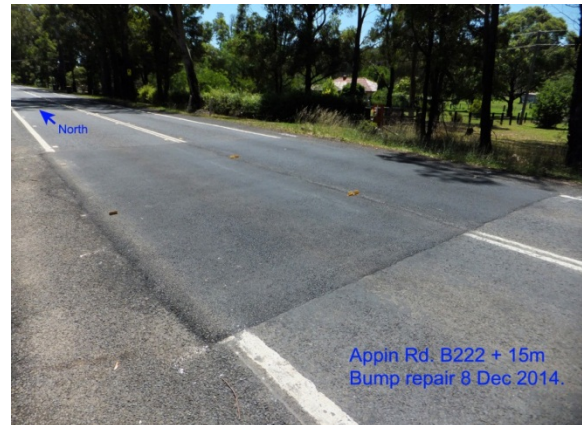
Photo 2: Pavement repair at B222 + 15m, 8/12/2014 (Photo courtesy of Colin Dove).

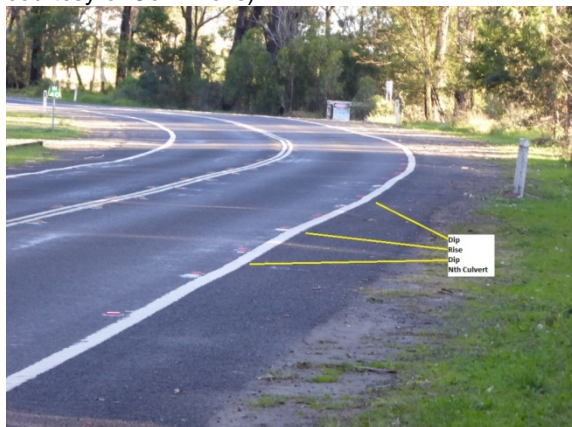
Photo 3: Cracking in road shoulder at B230 + 19m, 4/12/2014 (Photo courtesy of Colin Dove).

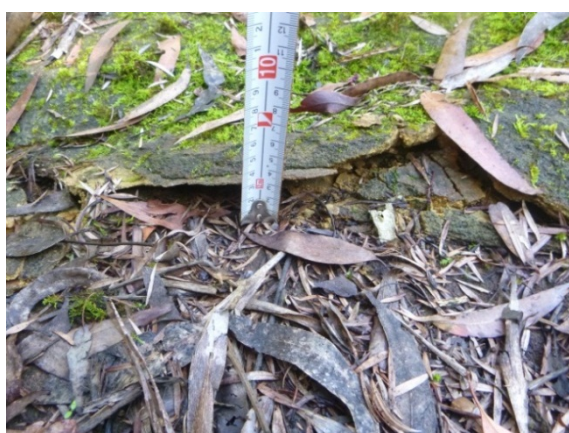
Two surface impacts were observed during the extraction of Longwall 37, including rock fracturing and uplift (impact reference WCA5_LW36_001), and a rock fall from an overhang (impact reference WCA5_LW35_026); refer to Figure 4-6 for locations. Both these impacts were likely a result of Longwall 36 and 35 respectively, due to their location and distance from the Longwall 37 face at the time of observation. Detailed descriptions of the impacts and triggers are provided in **Attachment C** and relevant impact reports are provided as **Attachment C-1**. Photos of these impacts are provided as Photo 4 and 5.

Photo 4: WCA5_LW36_001, fracturing and uplift of rock bed.

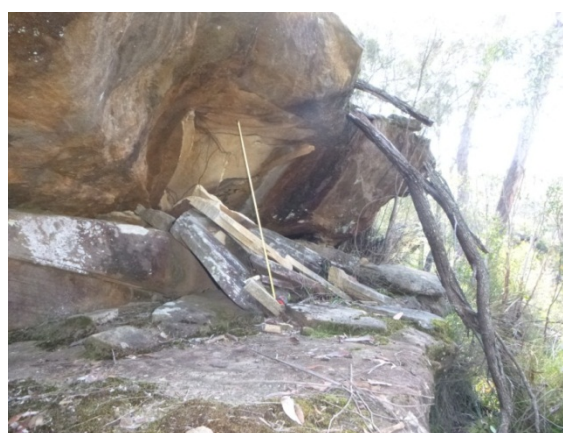
Photo 5: WCA5_LW35_026, rock fall (17th July, 2014)

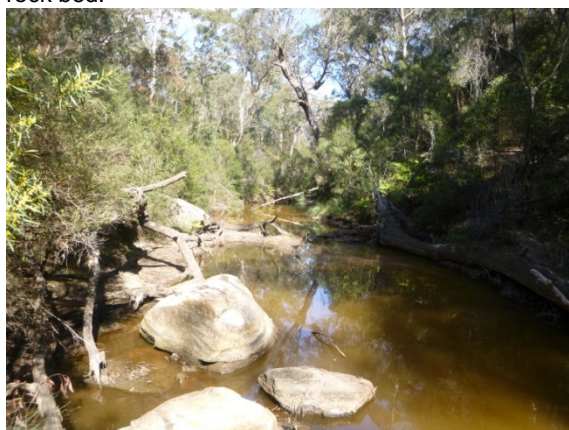
During periods of low flow in the river, iron staining was visible and evident from Pool 58 to downstream of Pool 67 (Photo 6). For the duration of these low flow periods pool appearance downstream at GR100 showed no sign of residual iron staining in the water from upstream (Photo 7). When flows returned to higher levels there was no evidence of iron staining in the Georges River.

Photo 6: Pool appearance at GR_Pool 61, taken on 14th August 2014.

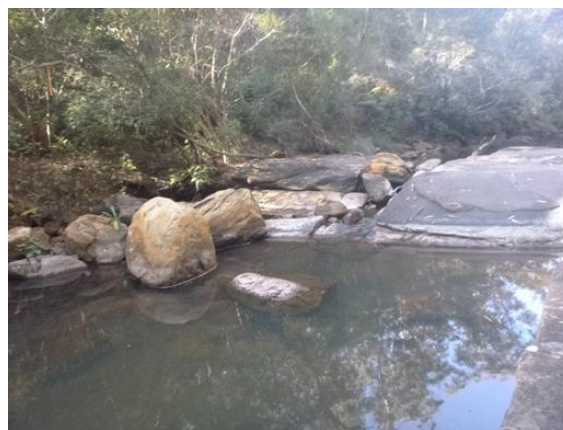
Photo 7: Pool appearance at GR100, taken on the 14th August 2014.
