Mine Rehabilitation and Closure 6

6 MINE REHABILITATION AND CLOSURE

EASTERN LEASES PROJECT

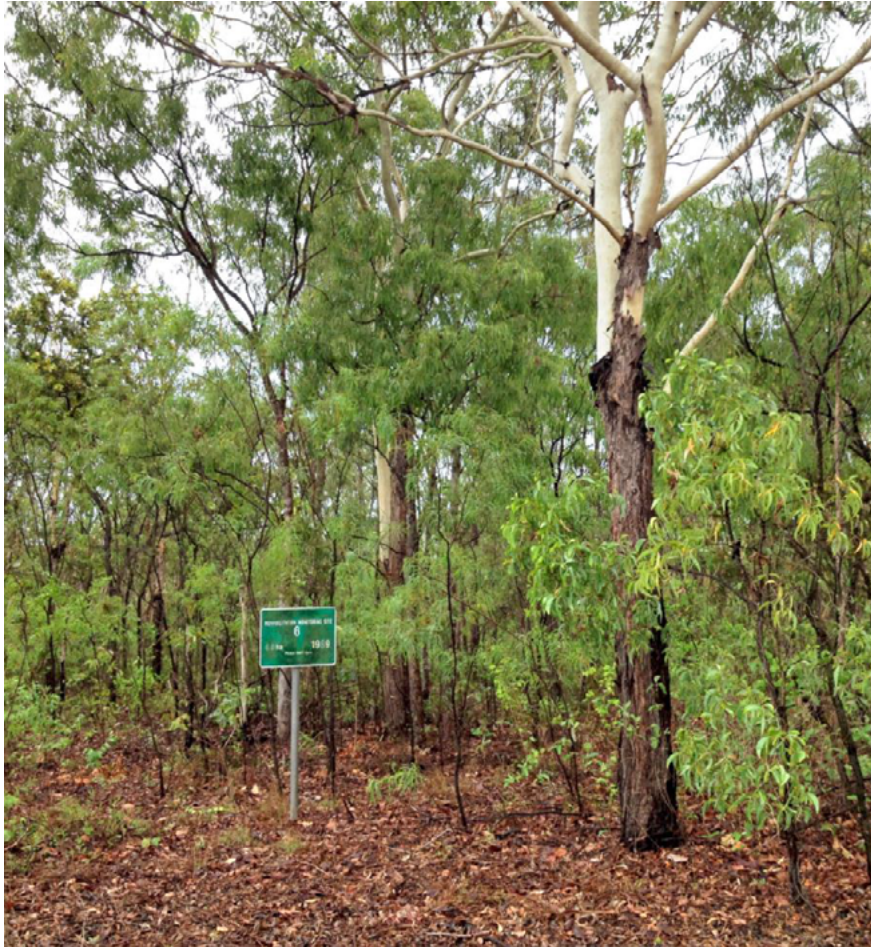
Plate 6-1 **View of 26 year-old Rehabilitation at the Existing Mine
(Darwin Woollybutt in foreground)**

Plates 6-1 to 6-3 show examples of rehabilitation sites at various ages and completion criteria.

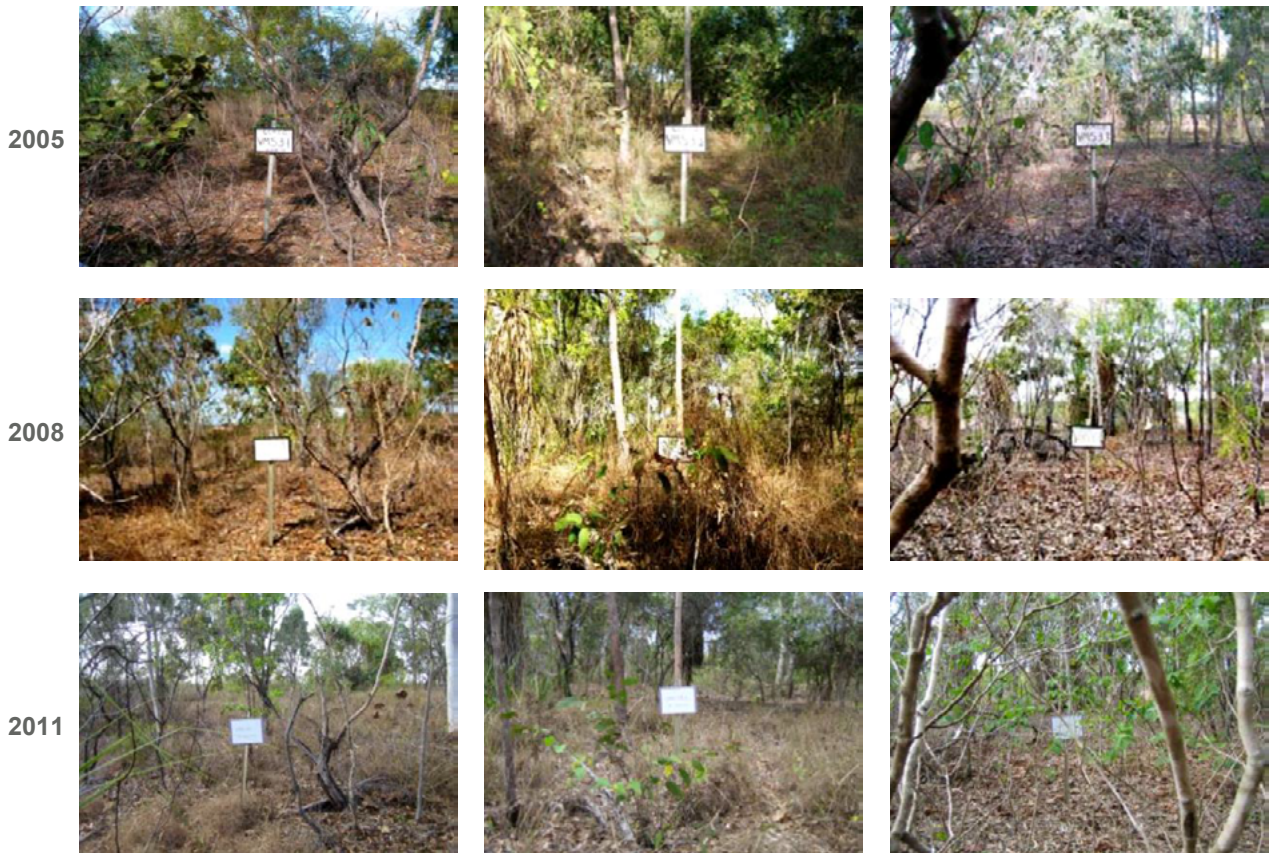
Plate 6-2 Photo-point Monitoring at Rehabilitation Site VMS3

<i>Location (Figure 3-8 for location of D Quarry):</i>	<i>D Quarry</i>
<i>2011 GIS Classification:</i>	<i>5</i>
<i>Year Planted:</i>	<i>1992</i>

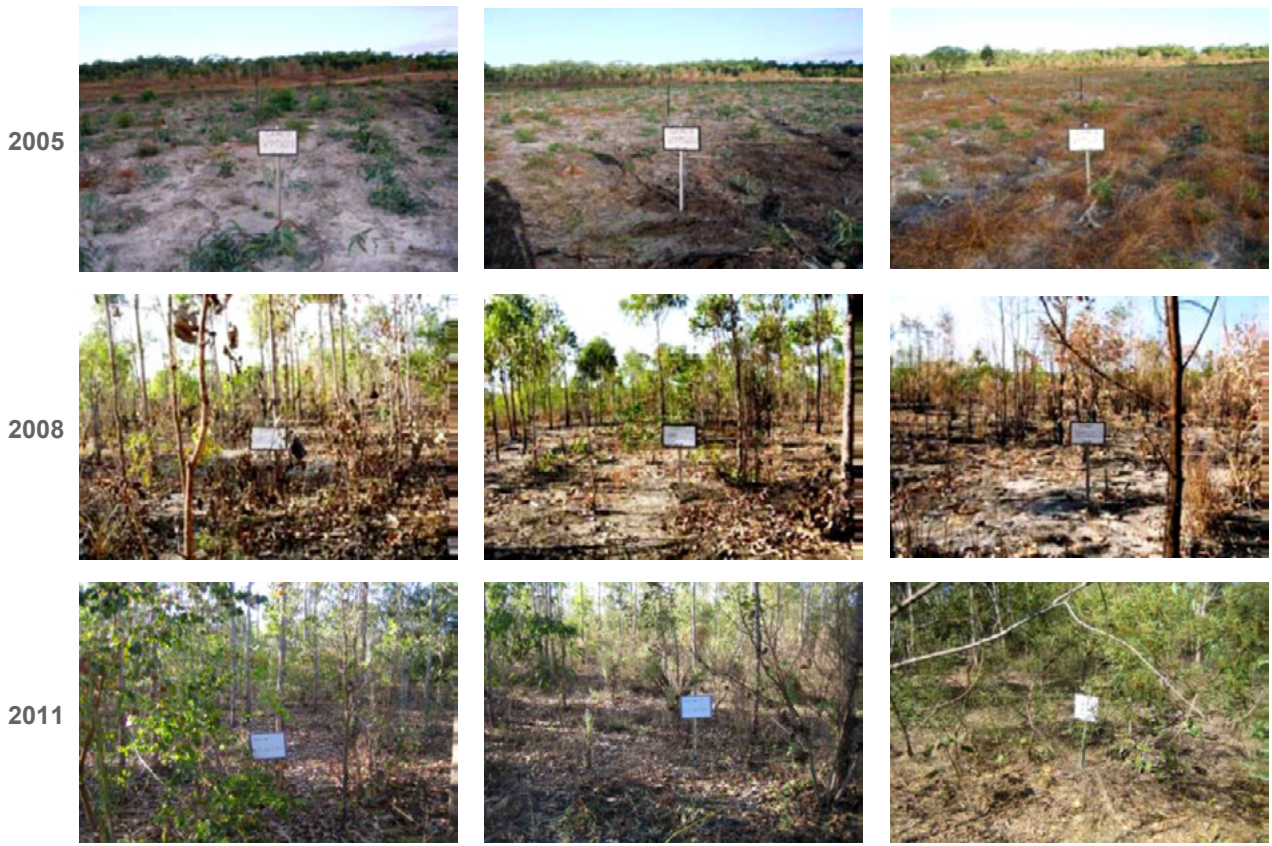
Plate 6-3 Photo-point Monitoring at Rehabilitation Site VMS22

Location (Refer Figure 3-8 for location of G Quarry):

G Quarry

2011 GIS Classification:

5

Year Planted:

2005
