EASTERN LEASES PROJECT

Aquatic Ecology Assessment Report

May 2015

Report No. Q14002RP2

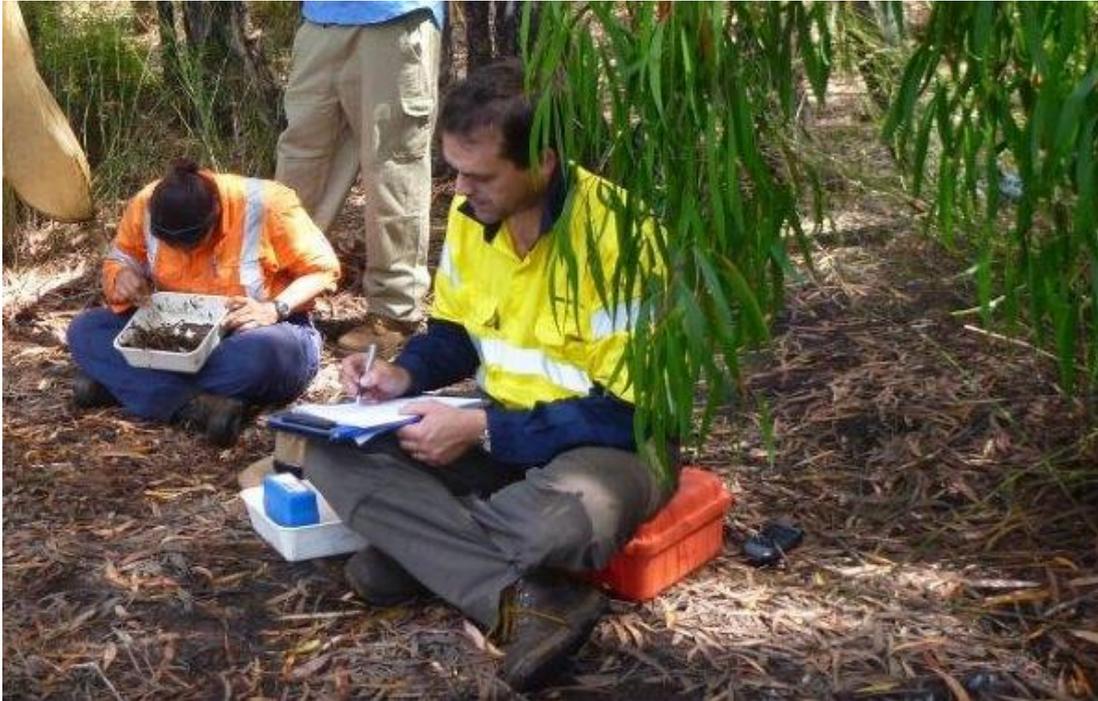
Photograph 3.1 Sorting of organic fraction for macroinvertebrates

The samples were washed through nested sieves, including a 10 mm coarse sieve to remove the large organic fraction, and a 250 micron fine sieve. Components of the organic fraction were washed and checked for macroinvertebrates prior to being discarded, and the sample from the 250 micron sieve was stored in a solution of 70% ethanol for transport to the laboratory for identification. ALC rangers assisted with checking the organic fraction for macroinvertebrates during the October 2014 survey period.

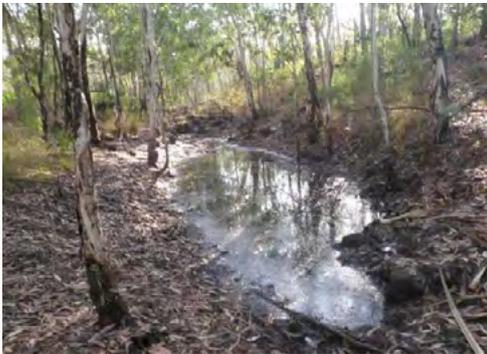
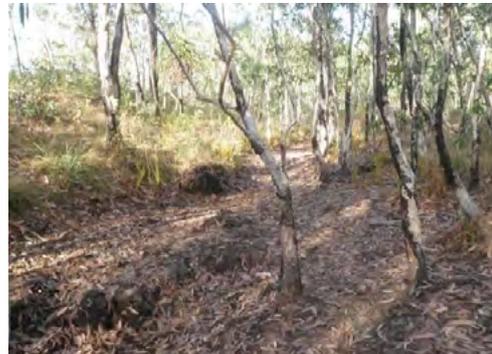
Site A17 - upstream (October 2014)

Site A17 - downstream (October 2014)

During the October 2014 field surveys, with the exception of some very small remnant pools (e.g. site A17 – see **Photograph 4.1**), the Emerald River – Main Channel was dry for its entire length in the Northern EL and also where the haul road corridor intersects the river to the west. **Photograph 4.2** shows the comparative conditions of the Emerald River – Main Channel in May and October 2014 at survey site A2, where the haul road corridor intersects the main channel. The vast majority of all the upstream pools in the project site had dried out and only very shallow puddles remained at some locations. The pools were not flowing and water clarity was very poor. These pools may dry out further towards the end of the dry season, depending on the rainfall regime of any given year. Accordingly (and consistent with the findings of the EIS Groundwater Report), it is not considered likely that the Emerald River – Main Channel, where it occurs within the project site, is augmented by groundwater. Downstream of the project site near Yedikba, the Emerald River was observed to still be flowing in October 2014; most likely due to the influence of springs, groundwater inflows and remnant inflows from minor water bodies downstream of the EL.

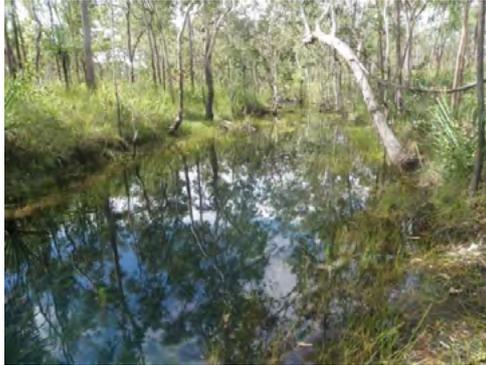
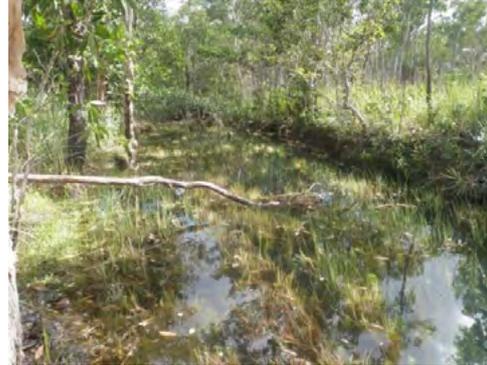
Site A9 - upstream (May 2014)

Site A9 - downstream (May 2014)

The western half of the Southern EL is drained by the Emerald River – Tributary 2. The upstream (eastern) section of this tributary is ephemeral and during both survey periods, was found to be largely dry with the exception of remnant water pools (e.g. sites A9 and A10; see **Photograph 4.1**).

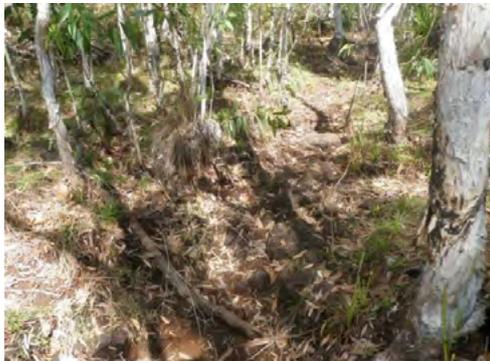
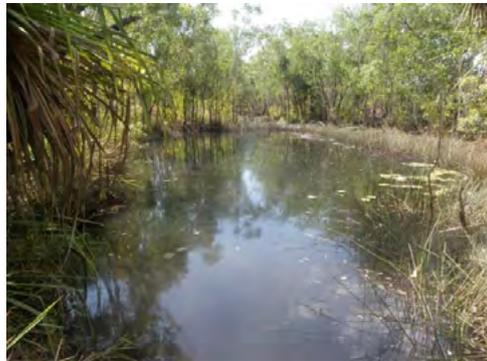
Site A10 - upstream (October 2014)

Site A10 - downstream (October 2014)

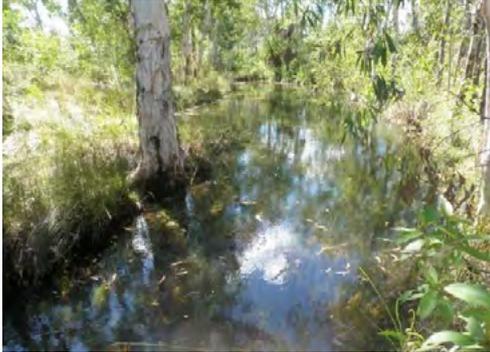
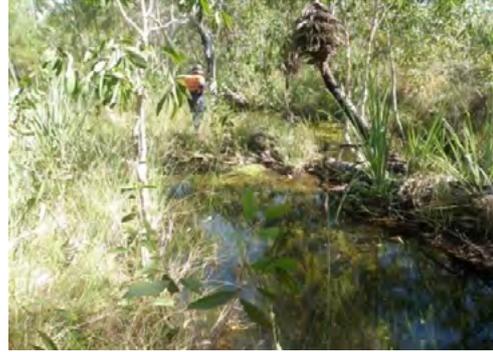
Site A3 - upstream (May 2014)

Site A3 - downstream (May 2014)

During the May 2014 field surveys the Emerald River - Tributary 3 was flowing rapidly in a narrow channel (refer to site A3 –**Photograph 4.1**). The water was clear, and macrophytes such as *Eriocaulon setacum* (Water Pincushions) were present. No distinct riparian zone was present, and the vegetation fringing the watercourse was typical of surrounding vegetation with the exception of *Melaleuca viridiflora* that was observed to be growing in close proximity to the water. The substrate within the survey site (A3) was dominated by sand and silt/clay sediments with occasional occurrences of boulders.

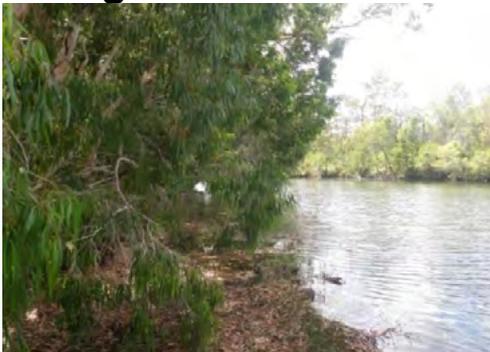
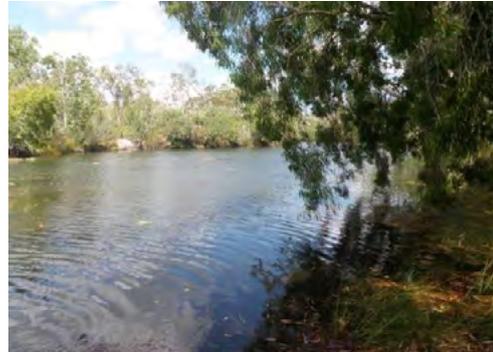
Site A11 - upstream (October 2014)

Site A11 - downstream (October 2014)

was noted to be characterised by a wide, slow flowing river (refer to site A11; see **Photograph 4.1**).

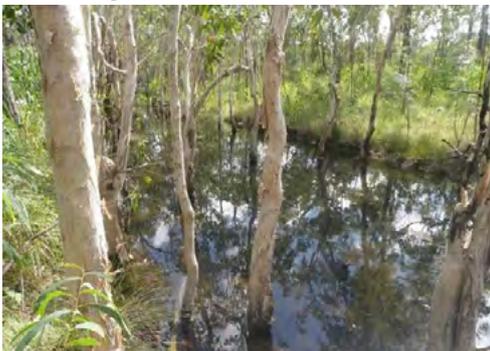
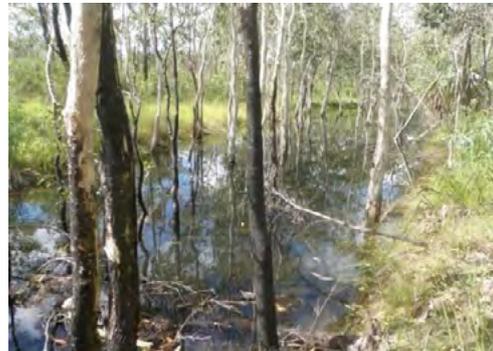
Site A5 - upstream (May 2014)

Site A5 - downstream (May 2014)

The Amagula River – Tributary 1 was flowing in May 2014 (see site A5; **Photograph 4.1**), and several large pools were present, particularly towards the south of the Southern EL. Water clarity was relatively good, despite being heavily stained from decaying organic material and leaf litter.

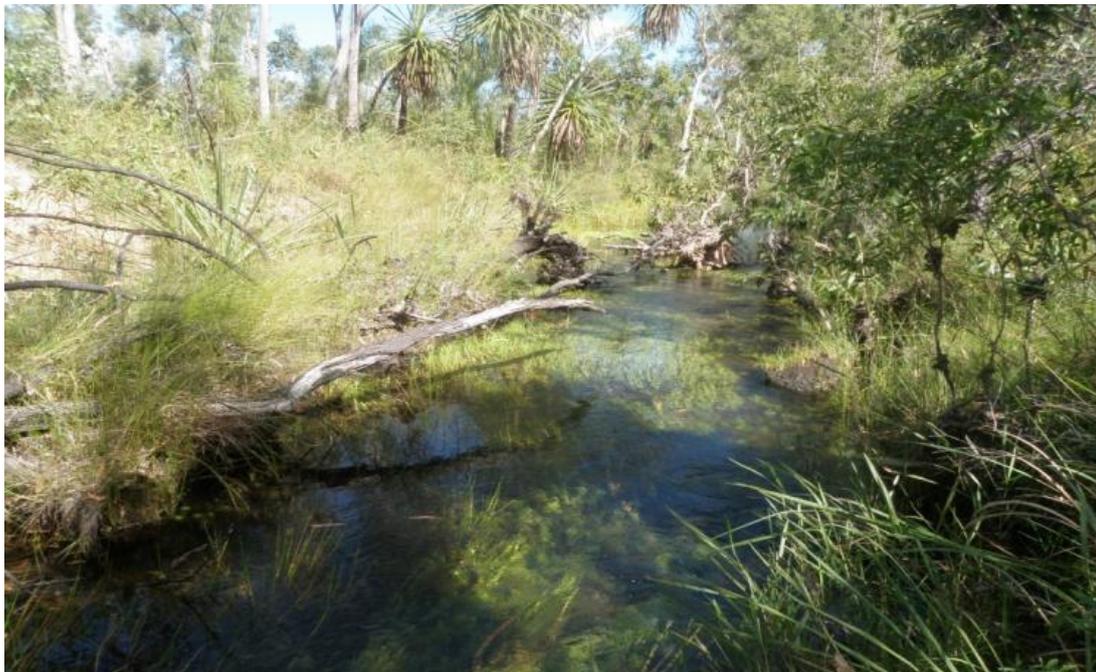
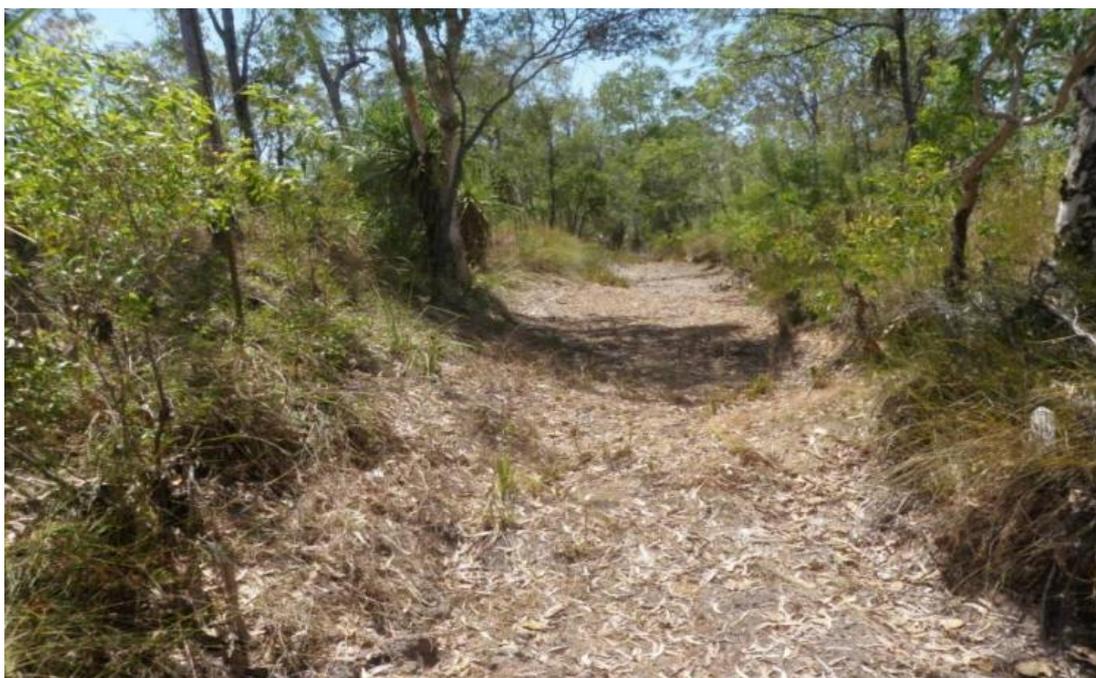
Photograph 4.2 Emerald River – Main Channel (Site A2 – May and October 2014)

During the May 2014 field surveys, the Emerald River – Main Channel was dry in the upstream eastern reaches of the Northern EL; however towards the west, several isolated water pools were present (e.g. survey site A1), and further west it formed a flowing stream towards the western boundary of the Northern EL. Where the haul road corridor intersects the Emerald River it was flowing relatively fast in a narrow channel (site A2; see **Photograph 4.1**). The substrate within the survey sites was dominated by sandy sediment with occurrences of silt/clay sediments and cobbles. Water clarity was very good. Generally, no distinct riparian zone was present, and the vegetation fringing the watercourse was typical of surrounding vegetation with the exception of *Melaleuca viridiflora* that was observed to be growing in close proximity to the water.

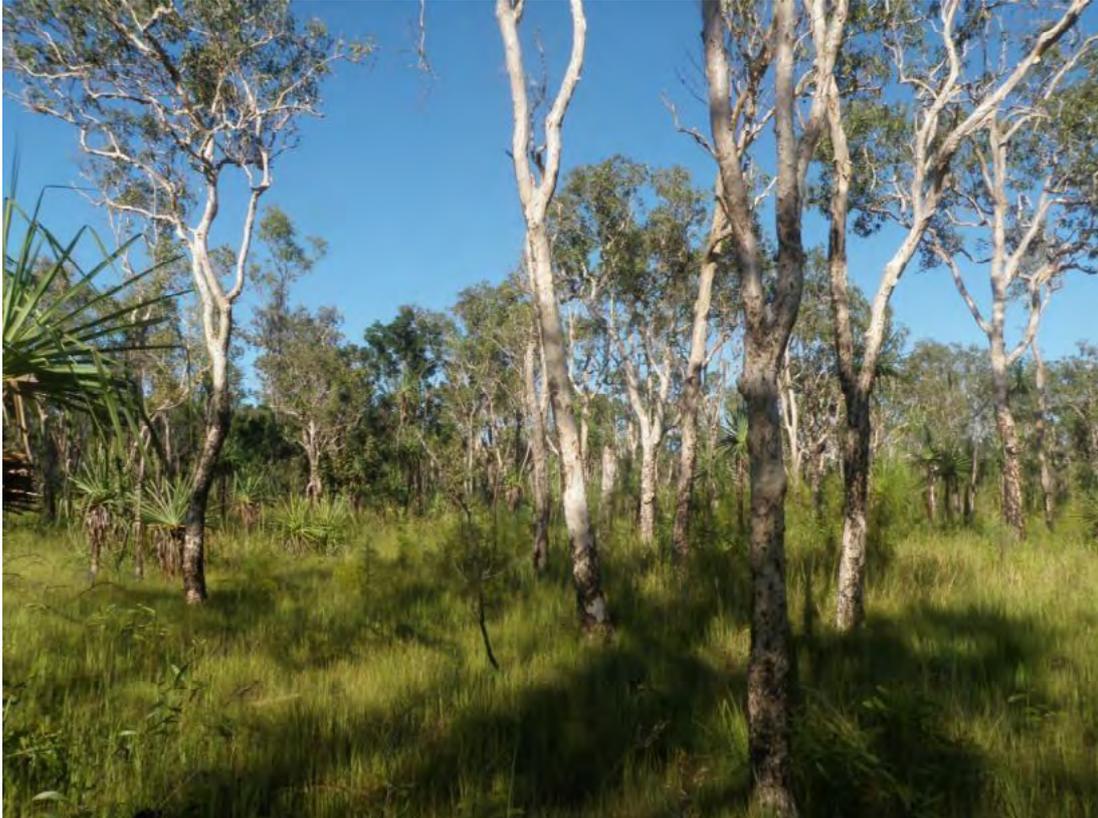
Photograph 4.3 Seasonal wetland area to the north of Emerald River – Tributary 1 (May 2014).

The Emerald River – Tributary 1 was dry during both survey periods. Semi-aquatic habitats in the form of small patches of seasonal wetlands were present to the north of Emerald River – Tributary 1 (**Photograph 4.3**). These seasonal wetlands mainly had water-logged soils and surface water was limited to shallow surface pools, generally with a depth <10cm.

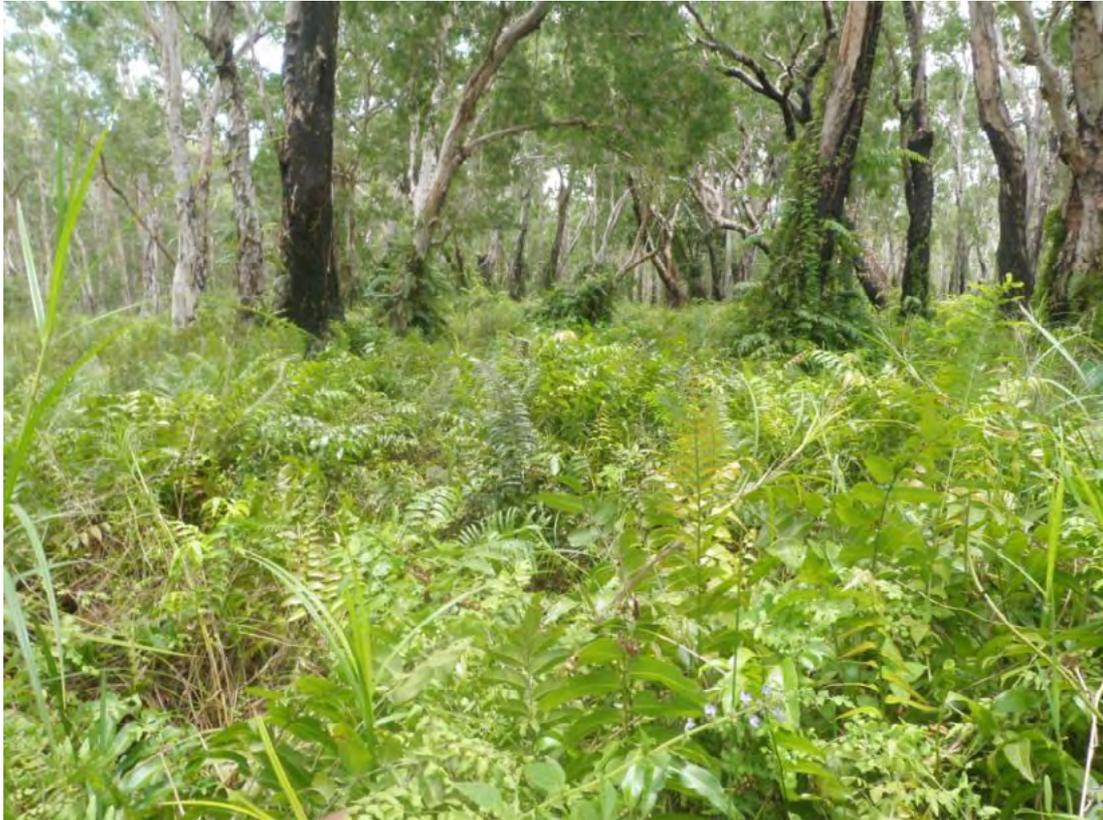
Photograph 4.4 *Melaleuca leucadendra* closed forest along a groundwater-fed section of the Emerald River - Tributary 2 (photograph taken at Site A15)

The western section of the Emerald River – Tributary 2 that is groundwater fed, displayed noticeably different water characteristics (e.g. Alkalinity) between the two survey periods (see **Section 4.6**). Water clarity was very high in this area during both survey periods.

The substrate within the western parts of the Emerald River – Tributary 2 (Sites A8, A15 and A16) consisted of sand or silt/clay sediments. In contrast, substrates in the eastern parts (Sites A9 and A10) consisted largely of bedrock and boulders.

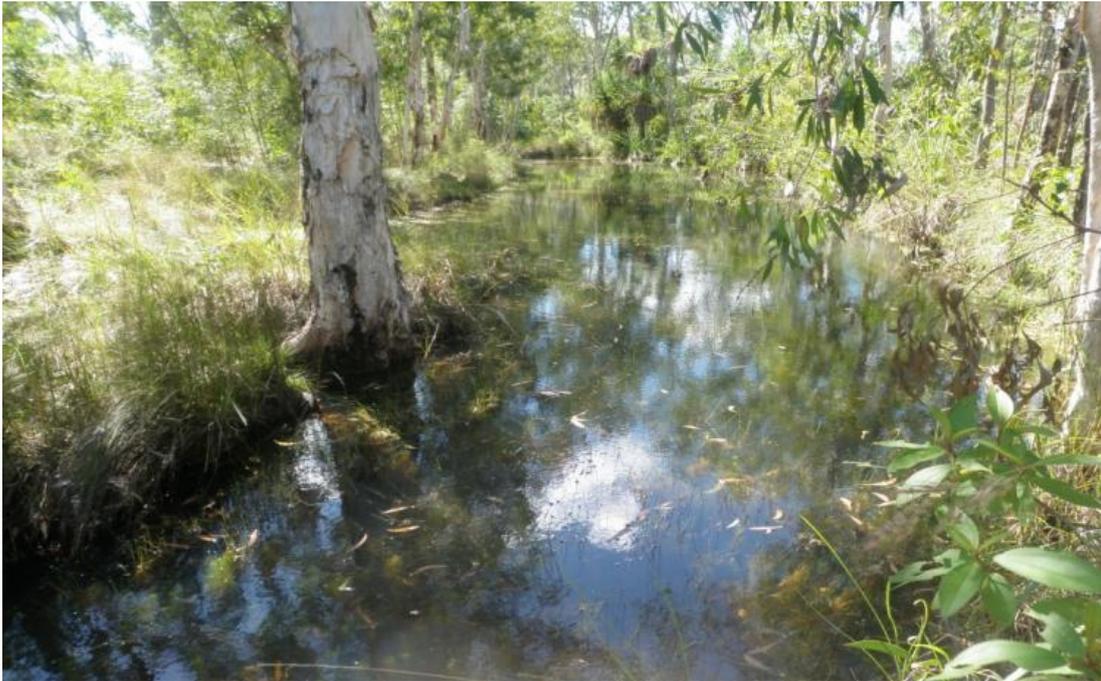
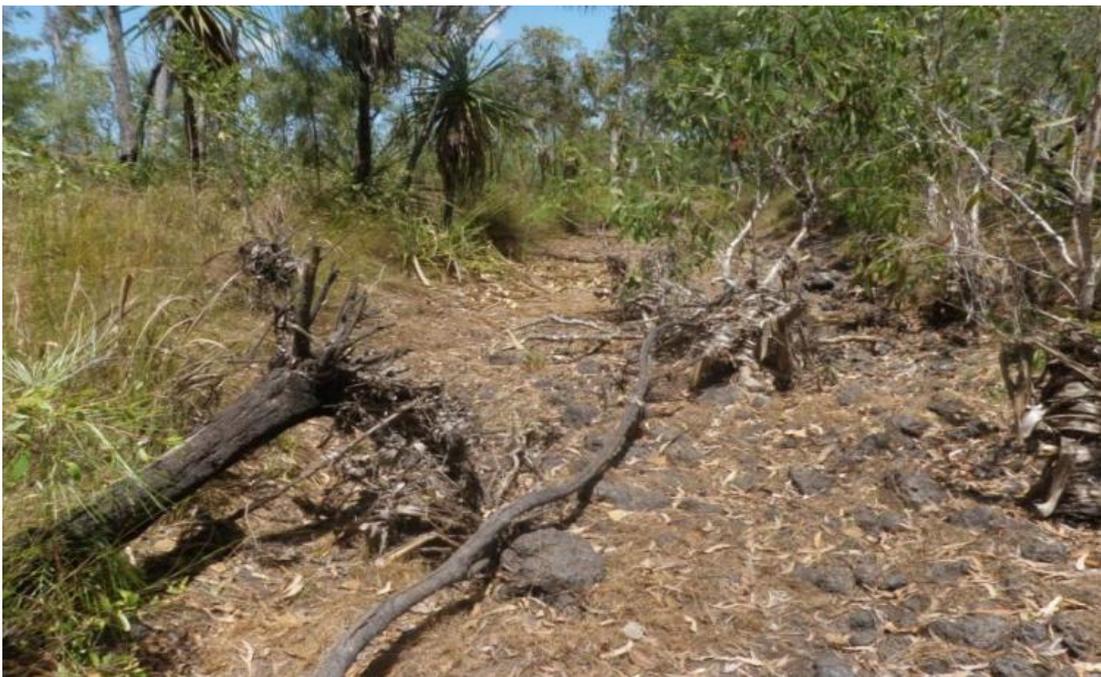
Photograph 4.5 Emerald River – Tributary 3 (Site A3 – May and October 2014)

During the October 2014 field surveys, the Emerald River - Tributary 3 was found to be dry at survey site A3 (see **Photograph 4.5**).

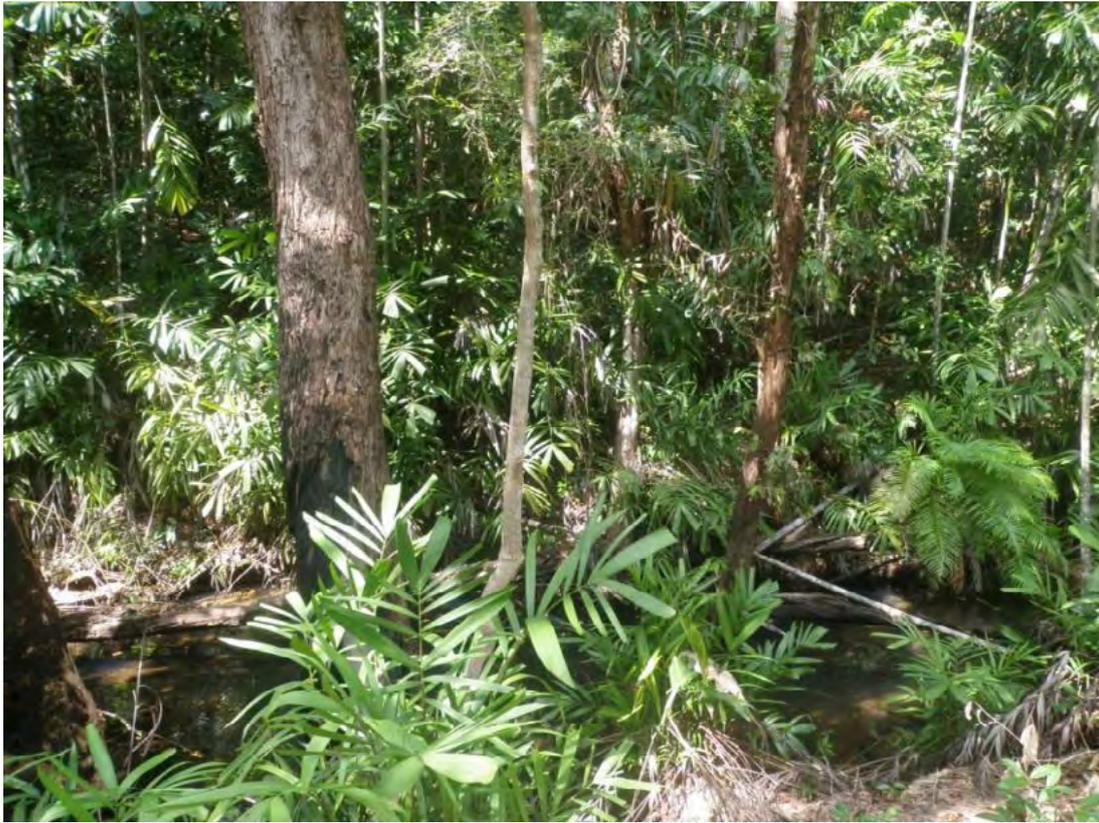
Photograph 4.6 Amagula River - Tributary 1; Rainforest Vegetation downstream of A12

Towards the southern boundary of the Southern EL, where the Amagula River – Tributary 1 approaches the Amagula River – Main Channel, there appears to be a surface expression of groundwater where the elevation of the watercourse drops below the water table. Flows were observed in the tributary downstream from this area in October 2014 (refer to Figure 7). This EIS Groundwater Report identified potential groundwater inflows in this location. The riparian zone in this area, and downstream from it, is characterised by rainforest vegetation such as *Melaleuca leucadendra*, *Dillenia alata*, *Canarium australianum* and *Syzigium nervosum* (see **Photograph 4.6**). This vegetation type only extends for approximately 3 m beyond the banks of the watercourse, where after the vegetation rapidly returns to the sclerophyll/eucalypt vegetation commonly found across most of the project site.

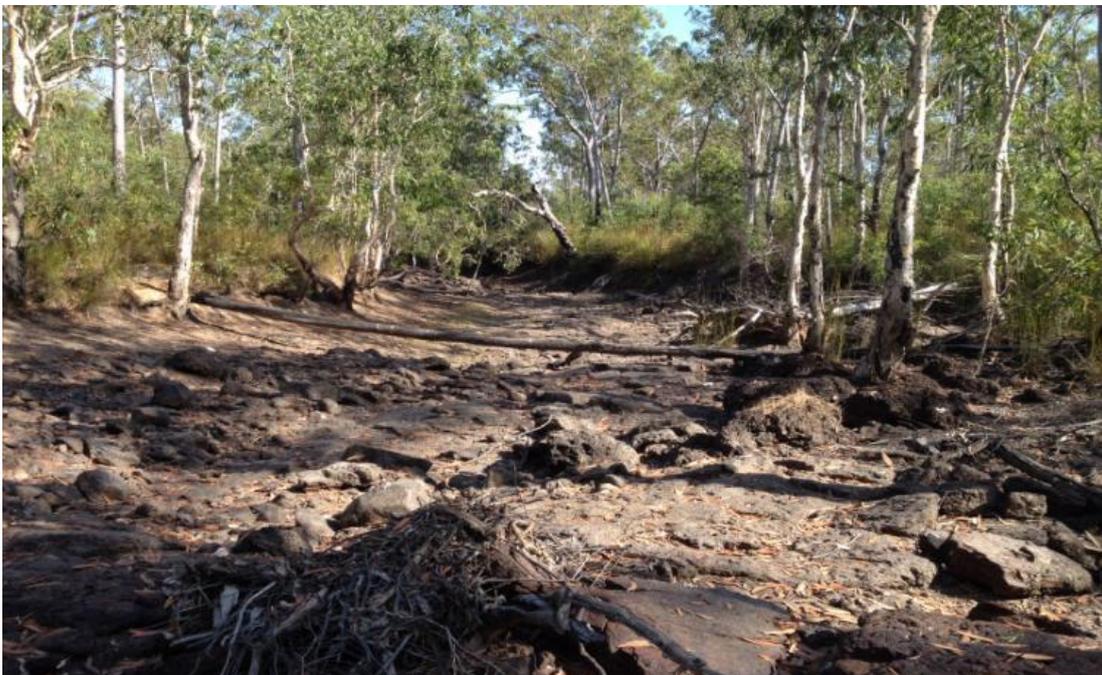
Photograph 4.7 Amagula River – Tributary 2 (Site A7 – May and October 2014)

It is considered unlikely that any surface expression of groundwater is occurring in this tributary within the project site. This is consistent within the findings of the EIS Groundwater Report.
