Hermosa Spring and Seep Catalog

Hermosa Project Area

SPRING AND SEEP CATALOG Hermosa Project Area

DATE: August 31, 2022

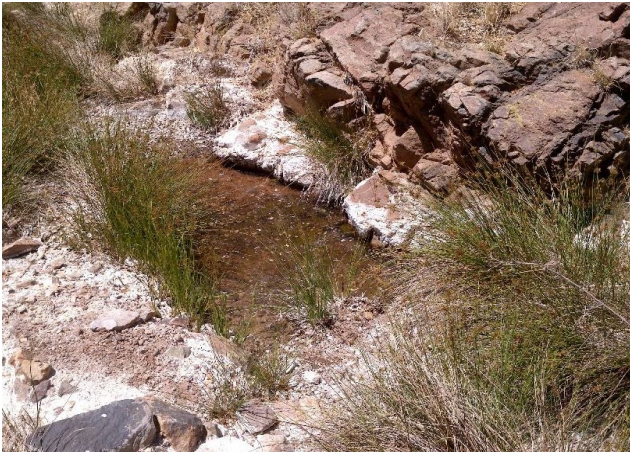
Dry Season Photo (5/24/2018)

Aquatic and Vegetation Survey Findings: Site is located in cobbly and rocky section of Alum Gulch with exposed bedrock. Generally, water is present in shallow pools and runs. Aquatic beetles and boatmen have been observed. No aquatic vertebrates have been observed. Overstory tree coverage is sparse within the drainage dominated by oak (*Quercus* spp.). Perimeter vegetation is dominated by riparian obligate rushes (*Juncus* spp.). Hillsides of drainage dominated by oak (*Quercus* spp.).

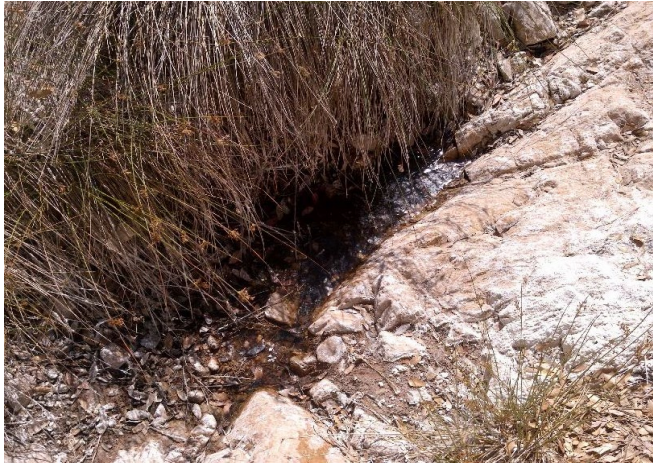
Dry Season Photo (5/25/2018)

Aquatic and Vegetation Survey Findings: Site is located in exposed bedrock section of Alum Gulch. Generally, water is present in shallow pools. Aquatic beetles and boatmen have been observed. No aquatic vertebrates have been observed. Deer tracks have been noted at this site. No overstory tree coverage is present and perimeter vegetation is dominated by *Juncus balticus*. Hillsides of drainage dominated by oak (*Quercus* spp.). Invasive plant species observed are Lehmann lovegrass (*Eragrostis lehmanniana*) and Bermudagrass (*Cynodon dactylon*).

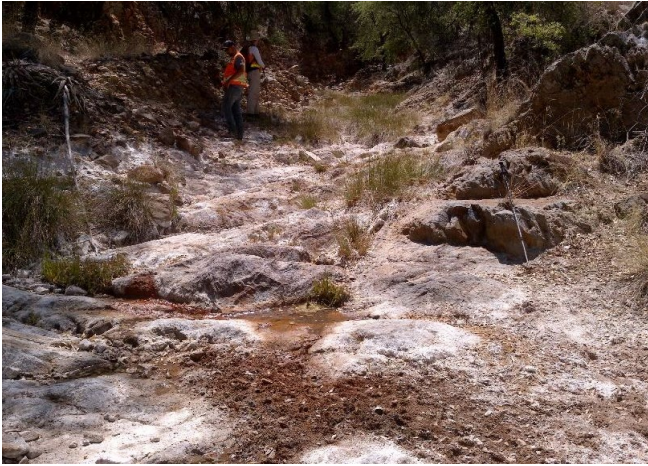
Dry Season Photo (5/25/2018)

Aquatic and Vegetation Survey Findings: Site is located in exposed bedrock section of Alum Gulch. Generally, water is present in shallow pools. Aquatic beetles and boatmen have been observed. No aquatic vertebrates have been observed. Deer tracks and bear scat have been noted at this site. Overstory tree coverage is dominated by an individual Fremont cottonwood (*Populus fremontii*) and also includes oak (*Quercus* spp.) and mesquite (*Prosopis velutina*). Perimeter vegetation is dominated by riparian obligate rushes (*Juncus* spp.), deergrass (*Muhlenbergia rigens*), and cane bluestem (*Bothriochloa barbinodis*). Hillsides of drainage dominated by oak (*Quercus* spp.). Invasive plant species observed are Lehmann lovegrass (*Eragrostis lehmanniana*) and Bermudagrass (*Cynodon dactylon*).

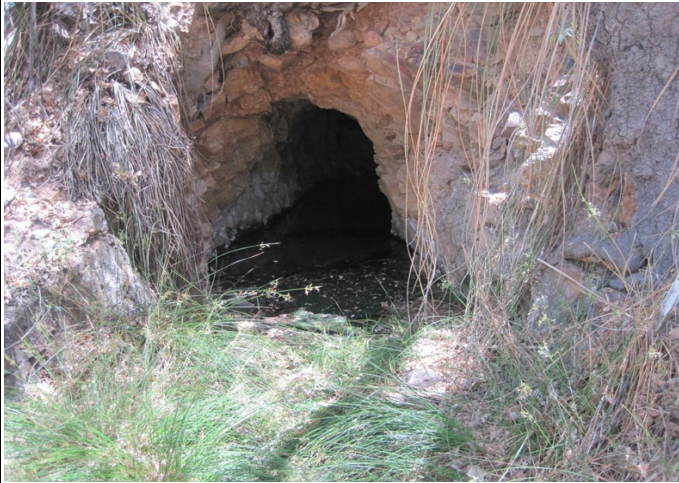
Dry Season Photo (5/28/2018)

Aquatic and Vegetation Survey Findings: This site is located at an adit with a concrete spring box that retains water at the adit entrance within Alum Gulch. Rushes (*Juncus* spp.), a riparian obligate genus, and deergrass (*Muhlenbergia rigens*) are present at the adit opening. Overstory cover dominated by oak (*Quercus* spp.) with individual Fremont cottonwood (*Populus fremontii*), and Mexican pinyon (*Pinus cembroides*) present. Invasive plants observed include Bermudagrass (*Cynodon dactylon*) and horehound (*Marrubium vulgare*). Aquatic beetles have been observed. No aquatic vertebrates have been observed.

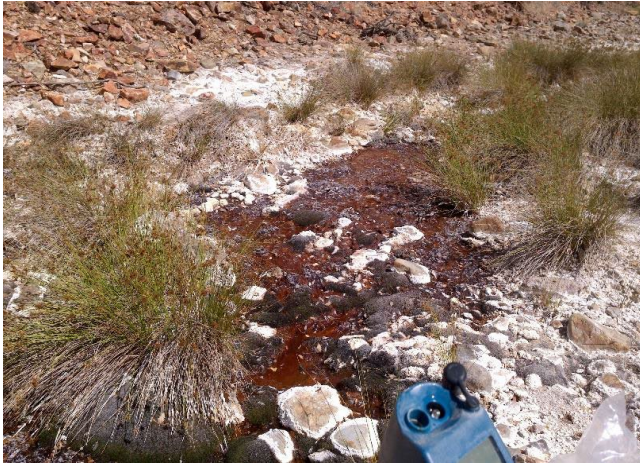
Dry Season Photo (5/29/2018)

Aquatic and Vegetation Survey Findings: Site is located in exposed bedrock section of Alum Gulch. Generally, water is present in shallow pools. No overstory tree coverage is present within the drainage at this site. Perimeter vegetation is dominated by riparian obligate *Juncus balticus*. Hillsides of drainage dominated by oaks (*Quercus* spp.). Invasive plant species observed are Lehmann lovegrass (*Eragrostis lehmanniana*).

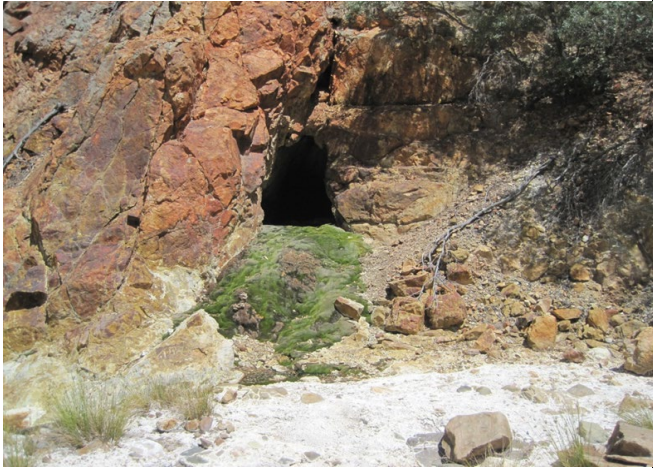
Dry Season Photo (5/29/2018)

Aquatic and Vegetation Survey Findings: This site is located at an adit within a rocky section of Alum Gulch. Water is present in the adit and discharges into the drainage. A large moss mat and some riparian obligate rushes (*Juncus* spp.) are present at the adit entrance. Although there is no overstory canopy at the site, overstory tree species along the drainage are dominated by oak (*Quercus* spp.) and Chihuahuan pine (*Pinus leiophylla*). Aquatic invertebrates observed include damselflies, beetles, boatmen, and backswimmers. No aquatic vertebrates have been observed.

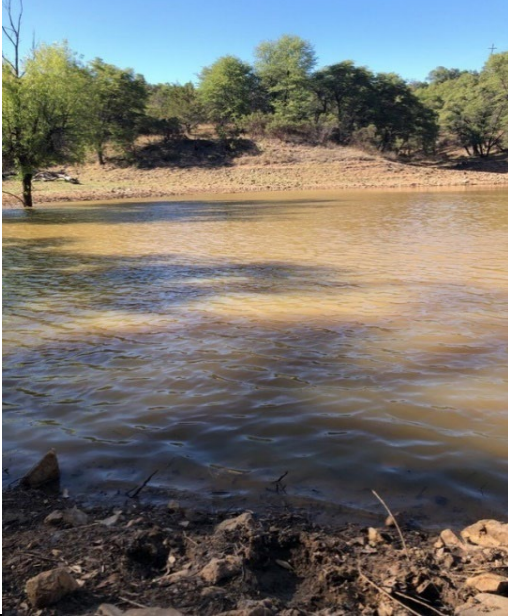
Dry Season Photo (5/22/2019)

Aquatic and Vegetation Survey Findings: This site is a large earthen stock tank located within Adams Canyon drainage. Two willow trees (*Salix* sp.) occur as emergent and canopy vegetation for the tank. Perimeter vegetation is dominated by non-native barnyard grass (*Echinochloa crus-galli*) and riparian obligate spikerush (*Eleocharis* sp.). The upland overstory vegetation is dominated by Emory oak (*Quercus emoryi*). Invasive Bermudagrass (*Cynodon dactylon*) and American bullfrogs (*Lithobates catesbeianus*) have been observed at this site.

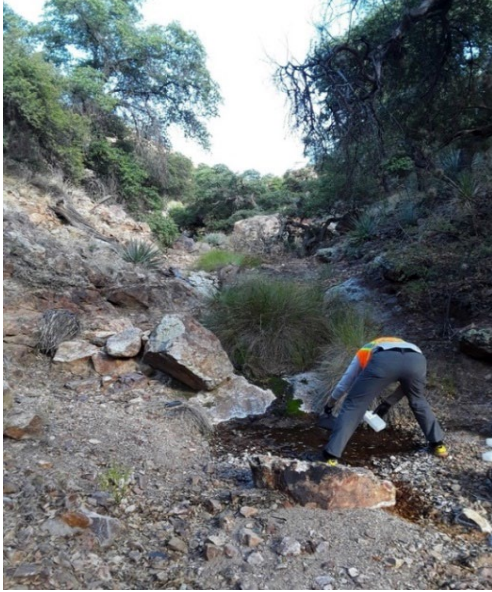
Dry Season Photo (5/27/2019)

Aquatic and Vegetation Survey Findings: This feature is a seep located within a section of exposed bedrock in Blue Eagle Canyon. Water is present in small pools. Herbaceous ground cover is dominated by riparian obligate Baltic rush (*Juncus balticus*). Also present is rockloving spikemoss (*Selaginella rupincola*) and sotol (*Dasylirion wheeleri*). Overstory vegetation is dominated by oaks (*Quercus* spp.). Aquatic invertebrates observed include backswimmers. No aquatic vertebrates have been observed.

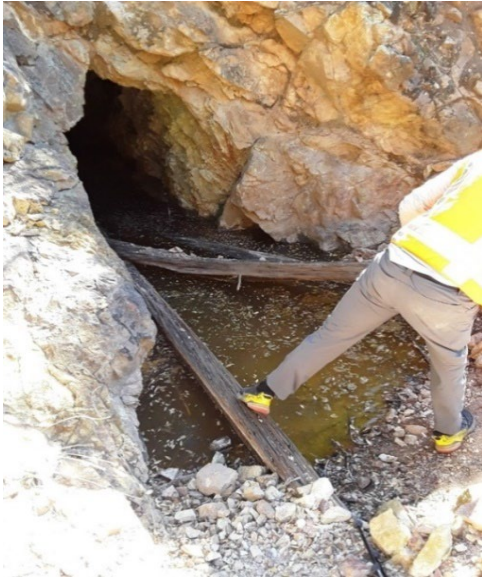
Dry Season Photo (5/27/2019)

Aquatic and Vegetation Survey Findings: This site is located at an adit within Blue Eagle Canyon with a rocky berm that dams water at the adit entrance. The site does not support emergent or perimeter vegetation. Oaks (*Quercus* spp.) dominate the overstory within the adjacent drainage. Rockloving spikemoss (*Selaginella rupicola*), hopbush (*Dodonaea viscosa*), and bullgrass (*Muhlenbergia emersleyi*) were also noted near the site. Aquatic invertebrates observed include beetles, boatmen, and backswimmers. No aquatic vertebrates have been observed.

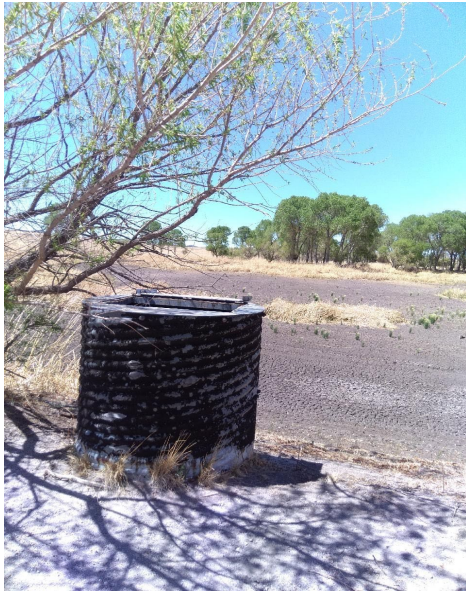
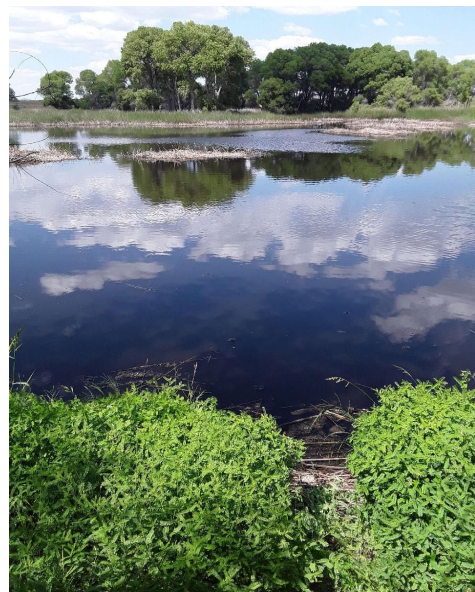
Dry Season Photo (05/27/2021)

Aquatic and Vegetation Survey Findings: Pondered water fills massive Cienega in dammed drainage. When water is present, water ponds in the area about 500 feet long and 700 feet wide. Adjacent vegetation is semidesert grassland with scattered Fremont cottonwoods (*Populus fremontii*). During the 05/27/21 visit, a dead Sonoran mud turtle (*Kinosternon sonoriense*) and a monarch butterfly (*Danaus plexippus*) were observed.

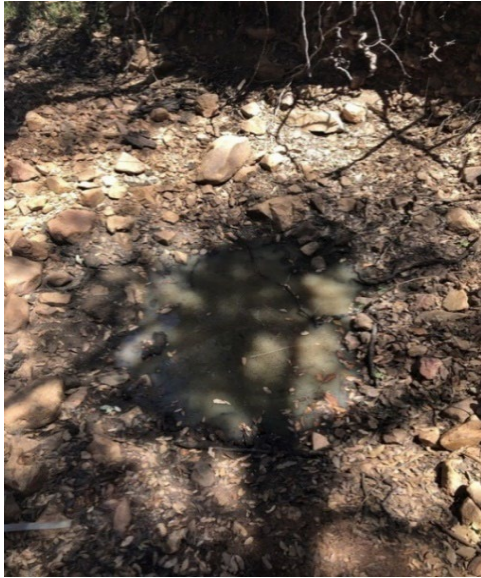
Dry Season Photo (5/22/2019)

Aquatic and Vegetation Survey Findings: This site occurs in a gravelly/rocky channel of Chino Draw. The overstory vegetation is dominated by Emory oak (*Quercus emoryi*) and alligator juniper (*Juniperus deppeana*). Understory vegetation is dominated by skunkbush sumac (*Rhus trilobata*), pinyon ricegrass (*piptochaetium fimbriatum*), and other grama grasses (*Bouteloua* spp.), and invasive vegetation observed includes Lehmann lovegrass (*Eragrostis lehmanniana*). No aquatic invertebrates or vertebrates have been observed at this site.

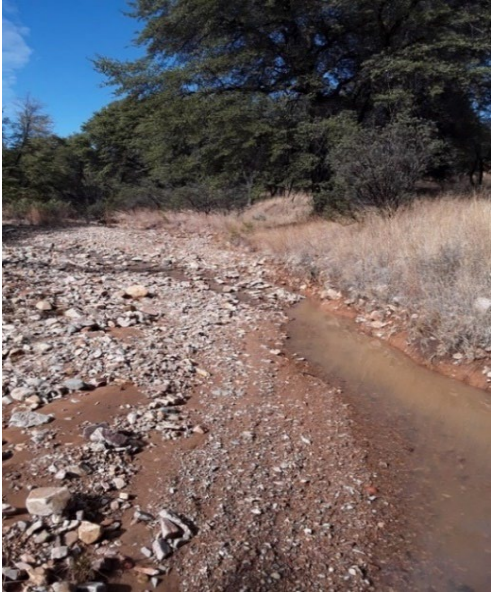
Dry Season Photo	Wet Season Photo (12/6/2019)
<p data-bbox="365 478 553 506">No photo taken</p>

Aquatic and Vegetation Survey Findings: This site is a metal open-topped cistern, fed from an adjacent solar well in Chino Draw. This cistern has two attached side drinkers. Water is present within the cistern and the side drinkers as well as an adjacent wetted area as spillover. The overstory vegetation is dominated by Emory oak (*Quercus emoryi*). Understory vegetation is dominated by grasses (*Bouteloua* sp. and *Aristida* sp.), weakleaf bur ragweed (*Ambrosia confertiflora*), and riparian obligate spikerush (*Elocharis* sp.). Invasive vegetation observed includes Bermudagrass (*Cynodon dactylon*). Aquatic invertebrates observed include beetles and boatmen. No aquatic vertebrates have been observed.

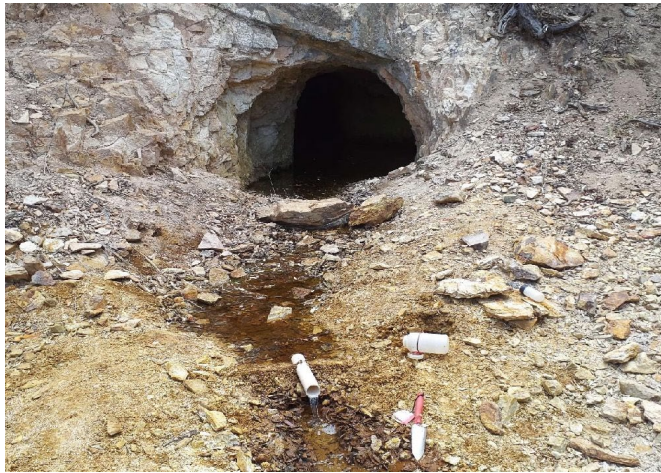
Dry Season Photo (06/01/2021)

Aquatic and Vegetation Survey Findings: Water flows from an adit on the eastern side of the canyon in upper Cox Gulch, staining the ground surface yellow-orange at the adit entrance. The adit entrance is mostly bare of vegetation; however, water present at entrance supports algae. The overstory cover is dominated by Emory oak (*Quercus emoryi*) in the immediate surrounding area. Aquatic beetles have been present at the adit entrance, but no aquatic vertebrates have been observed. Vertebrate wildlife or sign observed included Mearn's quail (*Cyrtonyx montezumae*) and deer.

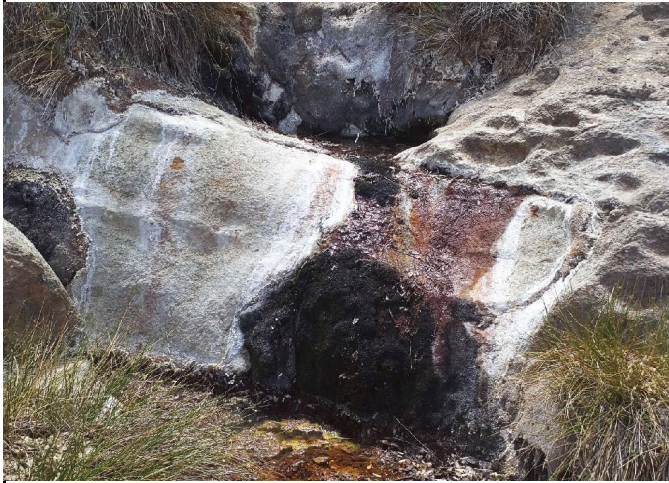
Dry Season Photo (06/01/2021)

Aquatic and Vegetation Survey Findings: Water seeps from granite joints and flows atop bedrock outcrop in Cox Gulch. Steep and terraced channel with several tinajas. Vegetation is predominantly rushes (*Juncus balticus*) and mosses, with an overstory of Emory oak (*Quercus emoyi*). Invasive Lehmann lovegrass occurs (*Eragrostis lehmanniana*). Aquatic beetles and backswimmers have been present. During the site visit on 06/01/2021, Mexican jays (*Aphelocoma wollweberi*) and Dusky-capped flycatchers (*Myiarchus tuberculifer*) were observed in the vicinity.

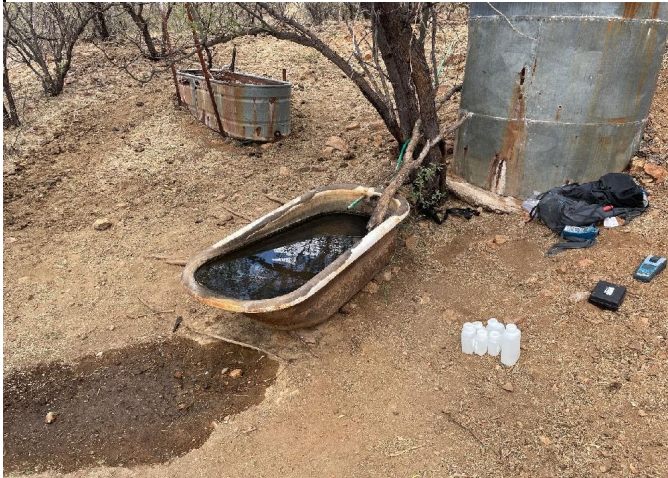
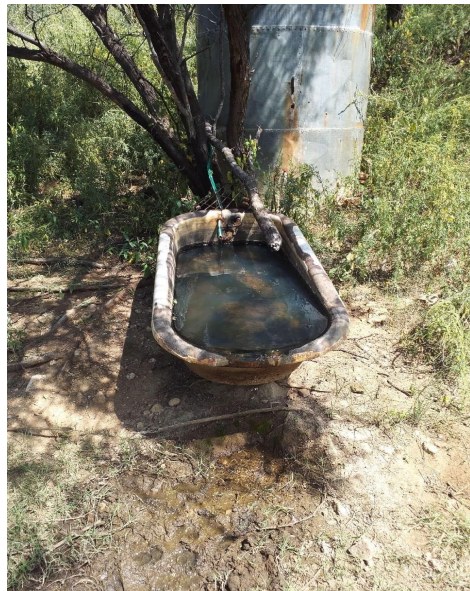
Dry Season Photo (06/01/2021)

Aquatic and Vegetation Survey Findings: Water flowing into a bathtub fed by an artesian well. During visits, overflow from the bathtub results in wetted stretch of soil typically extending approximately 6 feet. No aquatic invertebrates or herpetofauna have been observed; evidence of cattle, deer, and coyotes have been observed.

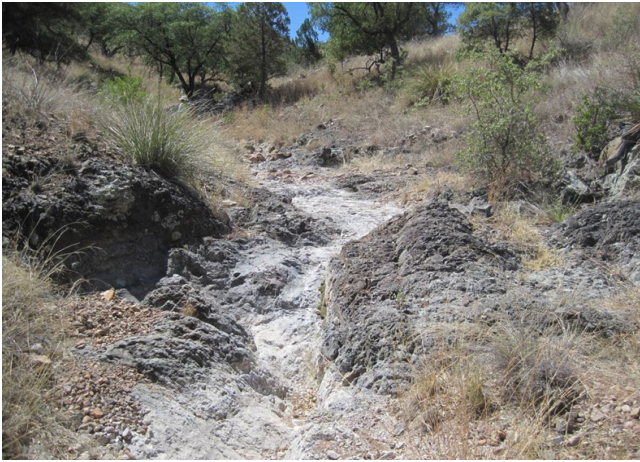
Dry Season Photo (5/30/2018)

Aquatic and Vegetation Survey Findings: This site is located in cobbly and gravelly section of Flux Canyon with some exposed bedrock. Generally, water is present in shallow, isolated pools near bedrock. Rocky Mountain rush (*Juncus saximontanus*), a riparian obligate species, plains lovegrass (*Eragrostis intermedia*), and bullgrass (*Muhlenbergia emersleyi*) are dominant perimeter vegetation along the drainage bottom. Seep monkeyflower (*Mimulus guttatus*), a wetland associated plant, was noted at this site. Green sprangletop (*Leptochloa dubia*) and other grasses dominate the adjacent hillsides. Arizona white oak (*Quercus arizonica*) provides the limited amount of overstory tree coverage at this site. Invasive plant species observed includes Lehmann lovegrass (*Eragrostis lehmanniana*). Aquatic invertebrates previously noted within the Flux Canyon drainage including beetles, boatmen, backswimmers, dragonflies, and damselflies. No aquatic vertebrates have been observed.
