Spring and Seep Catalog

Hermosa Project Area

Originally published: September 2020

Hermosa Project Spring and Seep Survey Sample Site Summary, Patagonia, Arizona

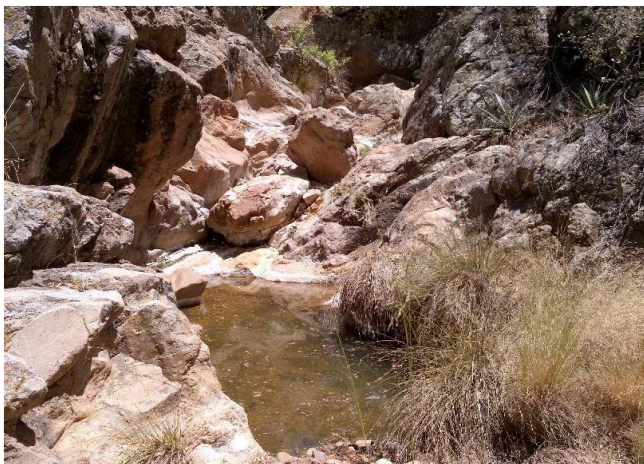
Dry Season Photo (5/24/2018)

Aquatic and Vegetation Survey Findings: Site is located in cobbly and rocky section of Alum Gulch with exposed bedrock. Water is present in pools. Aquatic beetles have been observed. No aquatic vertebrates have been observed along drainage. Overstory tree coverage is limited to upland tree species (oak [*Quercus* sp.] and juniper [*Juniperus* sp.]) within the drainage. Drainage and hillside vegetation dominated by oak woodland and grasses. Some riparian obligate rushes (*Juncus* spp.) present along perimeter of drainage channel.

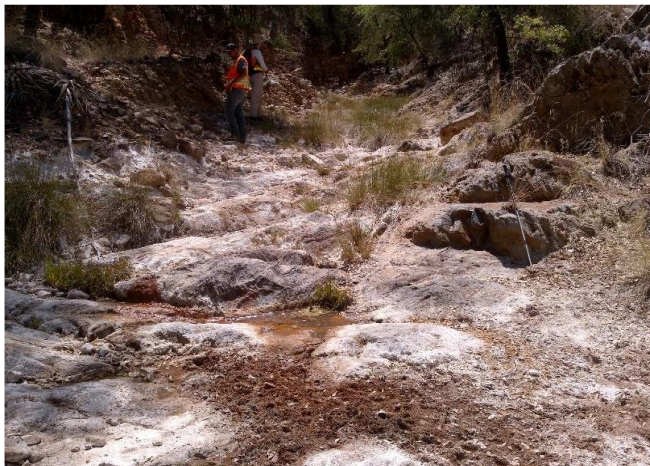
Dry Season Photo (5/25/2018)

Aquatic and Vegetation Survey Findings: Site is located in exposed bedrock section of Alum Gulch. Generally, water is present in shallow pools. Aquatic beetles and boatmen have been observed. No aquatic vertebrates have been observed. Deer tracks and bear scat have been noted at this site. Overstory tree coverage is dominated by an individual Fremont cottonwood (*Populus fremontii*) and also includes oak (*Quercus* spp.) and mesquite (*Prosopis velutina*). Perimeter vegetation is dominated by riparian obligate rushes (*Juncus* spp.), deergrass (*Muhlenbergia rigens*), and cane bluestem (*Bothriochloa barbinodis*). Hillsides of drainage dominated by oak (*Quercus* spp.). Invasive plant species observed are Lehmann's lovegrass (*Eragrostis lehmanniana*) and Bermudagrass (*Cynodon dactylon*).

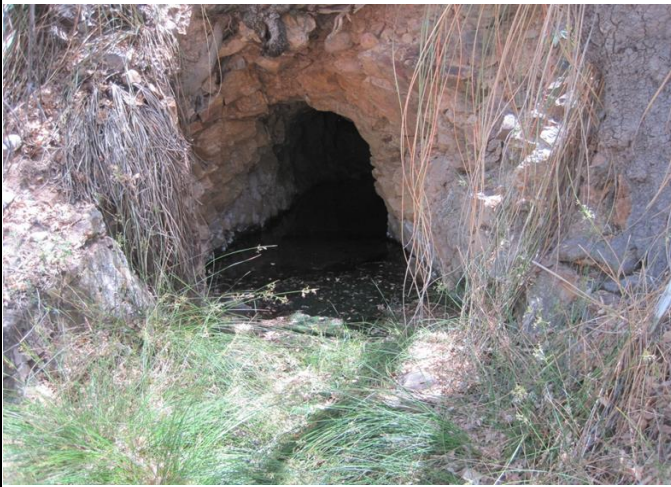
Dry Season Photo (5/28/2018)

Aquatic and Vegetation Survey Findings: This site is located at an adit with a concrete spring box that retains water at the adit entrance within Alum Gulch. Rushes (*Juncus* spp.), a riparian obligate genus, and deergrass (*Muhlenbergia rigens*) are present at the adit opening. Overstory cover dominated by oak (*Quercus* spp.) with individual Fremont cottonwood (*Populus fremontii*), a preferential riparian tree species, and Mexican pinyon (*Pinus cembroides*) present. Invasive plants observed include Bermudagrass (*Cynodon dactylon*) and horehound (*Marrubium vulgare*). Aquatic beetles have been observed. No aquatic vertebrates have been observed.

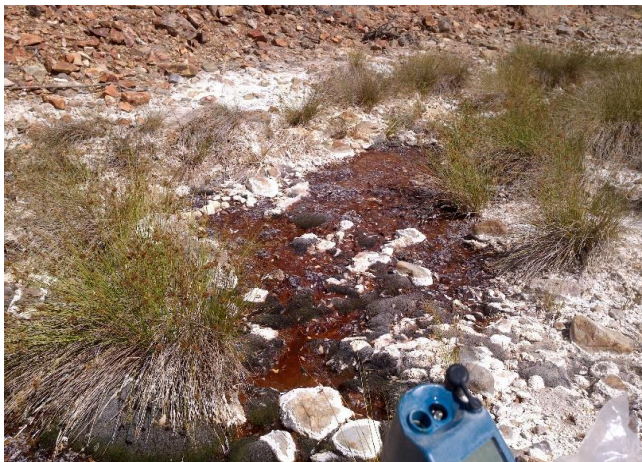
Dry Season Photo (5/29/2018)

Aquatic and Vegetation Survey Findings: Site is located in exposed bedrock section of Alum Gulch. Generally, water is present in shallow pools. No overstory tree coverage is present within the drainage at this site. Perimeter vegetation is dominated by riparian obligate *Juncus balticus*. Hillsides of drainage dominated by oaks (*Quercus* spp.). Invasive plant species observed are Lehmann's lovegrass (*Eragrostis lehmanniana*).

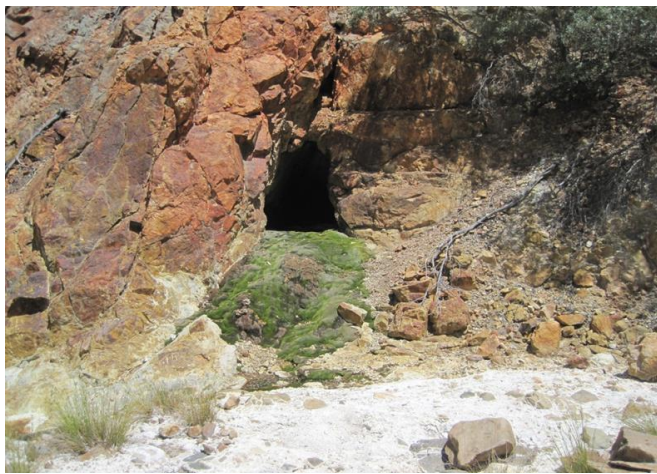
Dry Season Photo (5/29/2018)

Aquatic and Vegetation Survey Findings: This site is located at an adit within a rocky section of Alum Gulch. Water is present in the adit and discharges into the drainage. A large moss mat and some riparian obligate rushes (*Juncus* spp.) are present at the adit entrance. Although there is no overstory canopy at the site, overstory tree species along the drainage are dominated by oak (*Quercus* spp.) and Chihuahuan pine (*Pinus leiophylla*). Aquatic invertebrates observed include damselflies, beetles, boatmen, and backswimmers. No aquatic vertebrates have been observed.

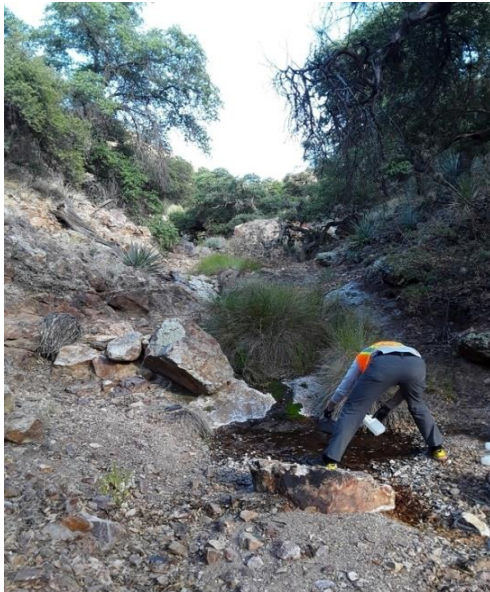
Dry Season Photo (5/27/2019)

Aquatic and Vegetation Survey Findings: This feature is a seep located within a section of exposed bedrock in Blue Eagle Canyon. Water is present in small pools. Herbaceous ground cover is dominated by riparian obligate Baltic rush (*Juncus balticus*). Also present is rockloving spikemoss (*Selaginella rupicola*) and sotol (*Dasylirion wheeleri*). Overstory vegetation is dominated by oaks (*Quercus* spp.). Aquatic invertebrates observed include backswimmers. No aquatic vertebrates have been observed.

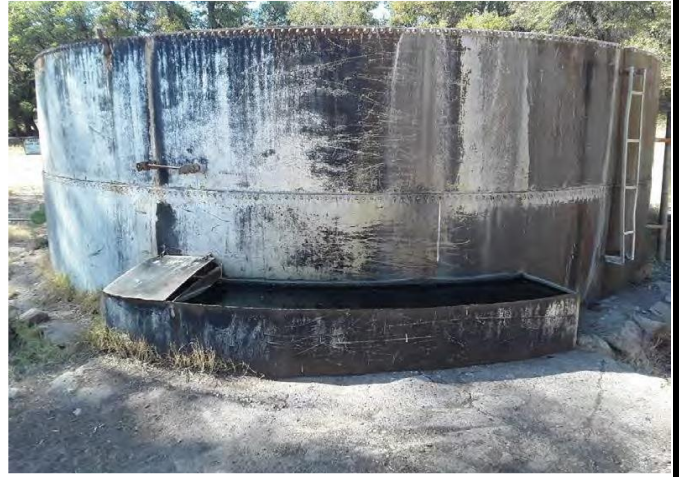
Wet Season Photo (10/16/2020)

Aquatic and Vegetation Survey Findings: This site is a metal open-topped cistern, fed from an adjacent solar well in Chino Draw. This cistern has two attached side drinkers. Water is present within the cistern and the side drinkers as well as an adjacent wetted area as spillover. The overstory vegetation is dominated by Emory oak (*Quercus emoryi*). Understory vegetation is dominated by grasses (*Bouteloua* sp. and *Aristida* sp.), weakleaf bur ragweed (*Ambrosia confertiflora*), and riparian obligate spikerush (*Elocharis* sp.). Invasive vegetation observed includes Bermudagrass (*Cynodon dactylon*). Aquatic invertebrates observed include beetles and boatmen. No aquatic vertebrates have been observed.

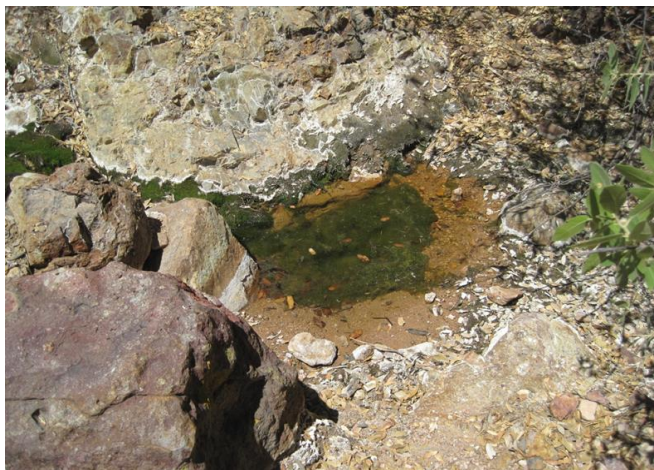
Dry Season Photo (5/20/2018)

Aquatic and Vegetation Survey Findings: This site is located in rocky and cobbly section of Flux Canyon with exposed bedrock. Generally, water is present in shallow pools. Moss is present in the drainage bottom on exposed bedrock. Little to no understory or herbaceous cover exists. Limited overstory tree coverage is dominated by oak (*Quercus* spp.) and Mexican pinyon (*Pinus cembroides*). Aquatic invertebrates previously noted within the Flux Canyon drainage including beetles, boatmen, backswimmers, dragonflies, and damselflies. No aquatic vertebrates have been observed.

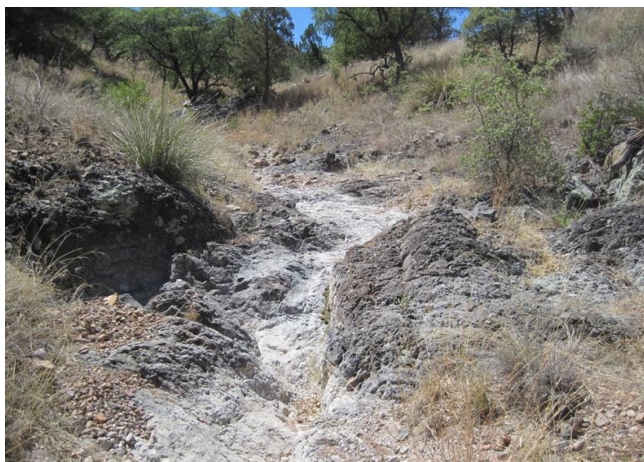
Dry Season Photo (5/30/2018)

Aquatic and Vegetation Survey Findings: This site is located in cobbly and gravelly section of Flux Canyon with some exposed bedrock. Generally, water is present in shallow, isolated pools near bedrock. Rocky Mountain rush (*Juncus saximontanus*), a riparian obligate species, plains lovegrass (*Eragrostis intermedia*), and bullgrass (*Muhlenbergia emersleyi*) are dominate perimeter vegetation along the drainage bottom. Seep monkeyflower (*Mimulus guttatus*), a wetland associated plant, was noted at this site. Green sprangletop (*Leptochloa dubia*) and other grasses dominate the adjacent hillsides. Arizona white oak (*Quercus arizonica*) provides the limited amount of overstory tree coverage at this site. Invasive plant species observed includes Lehmann lovegrass (*Eragrostis lehmanniana*). Aquatic invertebrates previously noted within the Flux Canyon drainage including beetles, boatmen, backswimmers, dragonflies, and damselflies. No aquatic vertebrates have been observed.

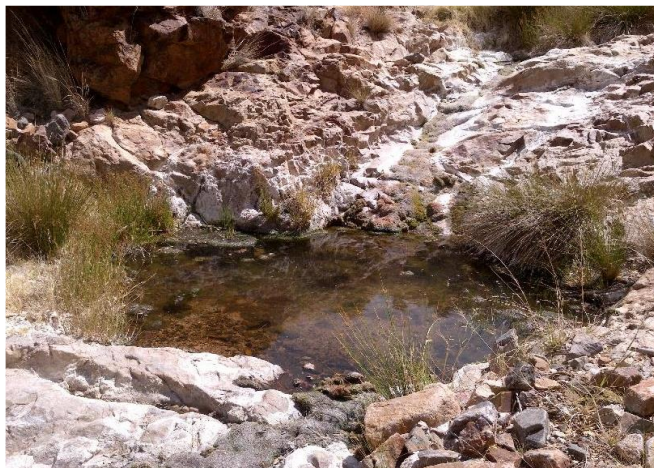
Dry Season Photo (5/31/2018)

Aquatic and Vegetation Survey Findings: Site is located in bedrock bottom section of Flux Canyon. Generally, water is present in shallow pools. Aquatic beetles and boatmen have been observed. No aquatic vertebrates observed have been observed. Deer tracks have been noted at this site. No overstory tree coverage is present at this site in the drainage. Emergent and perimeter vegetation is dominated by riparian obligate *Juncus* spp., Bermudagrass (*Cynodon dactylon*), and bullgrass (*Muhlenbergia emersleyi*). Drainage lacks riparian vegetation. North-facing slopes are dominated by Emory oak (*Quercus emoryii*) and hopbush (*Dodonaea viscosa*), while south-facing slopes are dominated by grasses with sotol (*Dasyilirion wheeleri*) and Palmer agave (*Agave palmeri*) present. Invasive plant species observed are Bermudagrass (*Cynodon dactylon*).

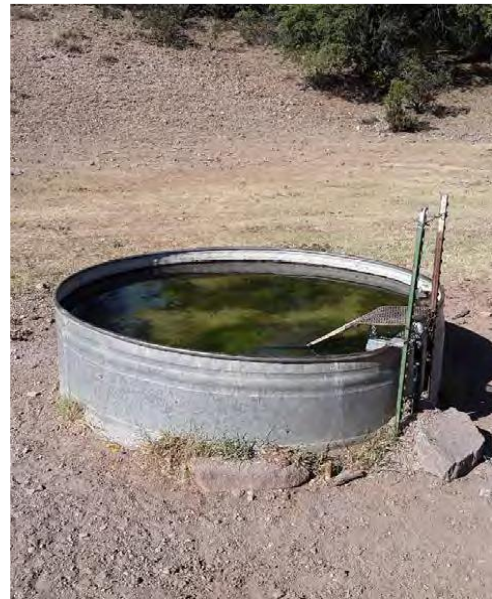
Wet Season Photo (10/6/2020)

Aquatic and Vegetation Survey Findings: This site consists of a metal, circular stock drinker (approx. 1.8m in diameter) located in Goldbaum Canyon. The drinker is fed by an adjacent windmill and well. There is some accumulated silt along the bottom of the drinker. Submerged algae (*Chara* sp.) is typically present in this drinker. No overstory vegetation is present. Invasive Bermudagrass (*Cynodon dactylon*) occurs around the base of the drinker. Aquatic invertebrates observed include beetles, backswimmers, boatmen, dragonflies, water scorpion, leeches, and snails. No aquatic vertebrates or herpetofauna have been observed. Livestock has been observed around the stock tank and the site is heavily grazed.

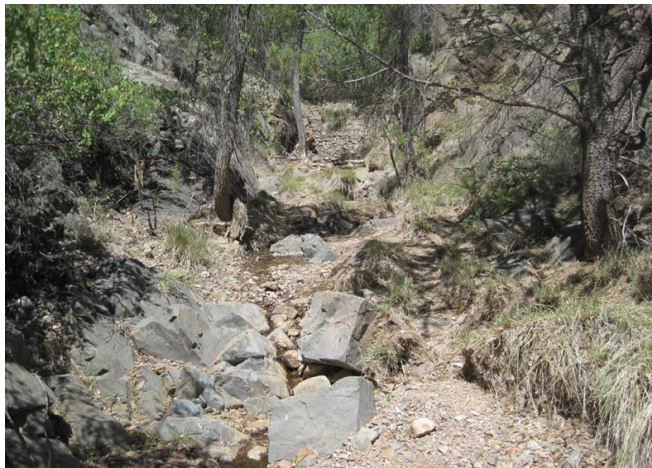
Dry Season Photo (5/16/2018)

Aquatic and Vegetation Survey Findings: Feature consists of a relic dam that has silted in along Harshaw Creek. A pipe driven into the bottom of the dam allows for the passage of water within the alluvium behind the dam to the downstream drainage. During monsoons, flowing water is consistently present below the dam. Aquatic invertebrates but no aquatic vertebrates have been observed. Drainage substrate is mix of bedrock, boulders, gravel, and sand. Arizona white oak (*Quercus arizonica*), alligator juniper (*Juniperus deppeana*), and Fremont cottonwood (*Populus fremontii*) dominate the overstory. Understory vegetation includes deergrass (*Muhlenbergia rigens*), silktassel (*Garrya wrightii*), Arizona grape (*Vitis arizonica*), seepwillow (*Baccharis salicifolia*), and skunkbush sumac (*Rhus trilobata*).
