# Terrestrial Ecology Impact Assessment

**Bulli Seam Operations  
Mine Safety Gas Management Project  
Section 75W Modification**

Prepared for South32 Illawarra Coal

June 2016

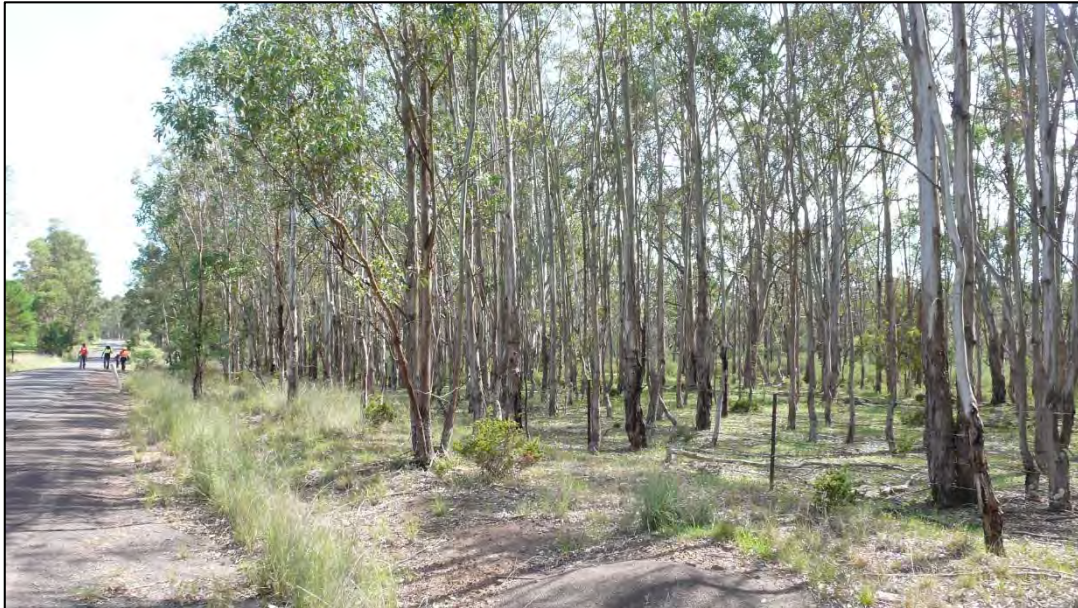
**Photo 1. Example of CPW condition within road easement - Sporadic shrubs and native grasses amongst introduced Africa Love Grass (*Eragrostis curvula*)**

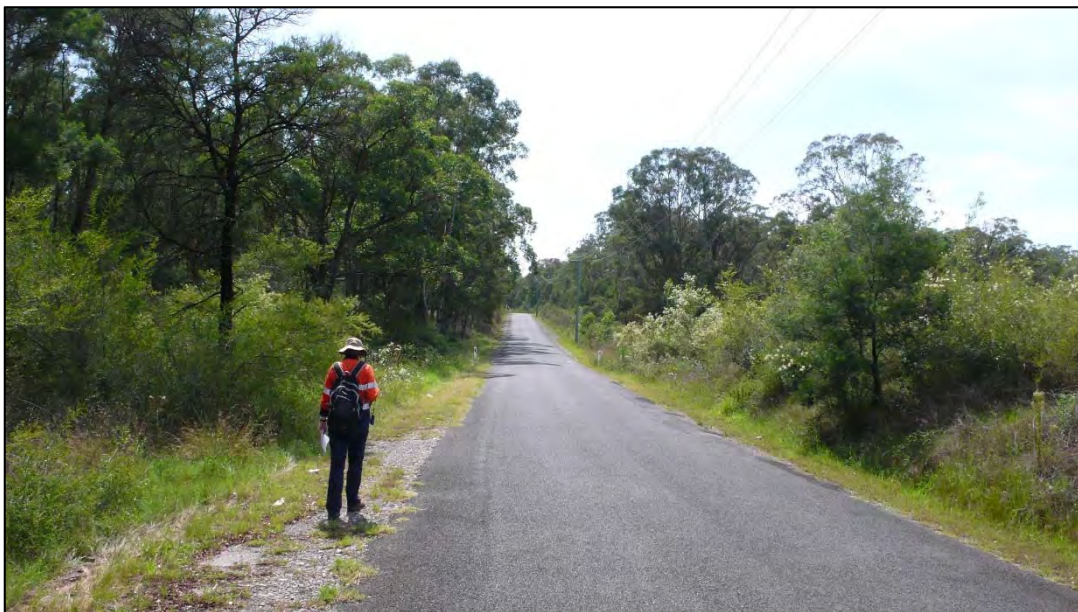
**Photo 2. CPW regeneration on both sides of road easement. Introduced Rhodes Grass (*Chloris gayana*) throughout.**

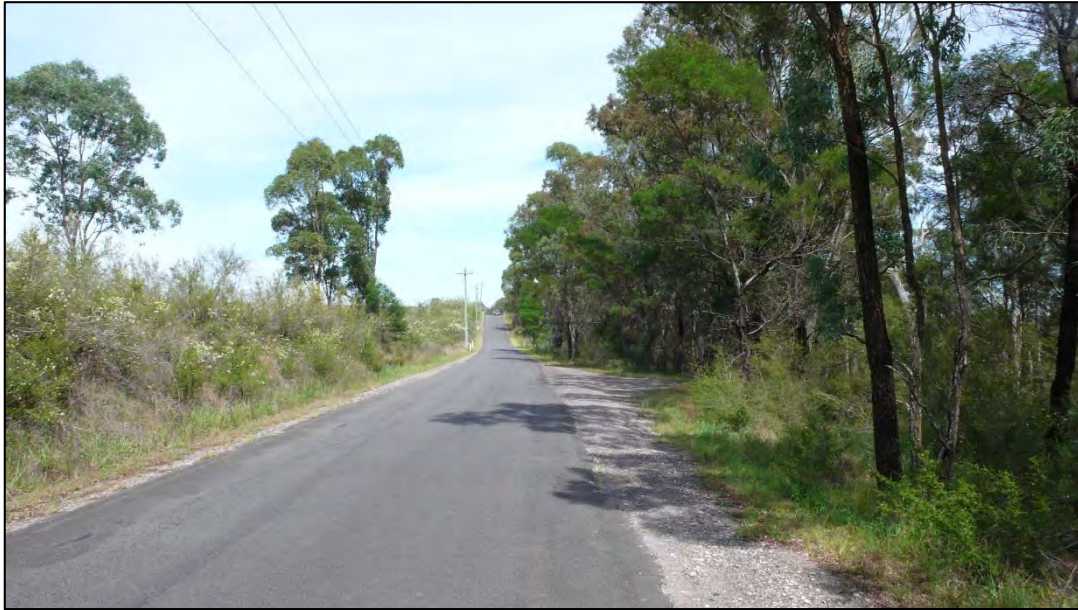
**Photo 3. CPW regeneration on both sides of road easement. Introduced Rhodes Grass (*Chloris gayana*) throughout.**

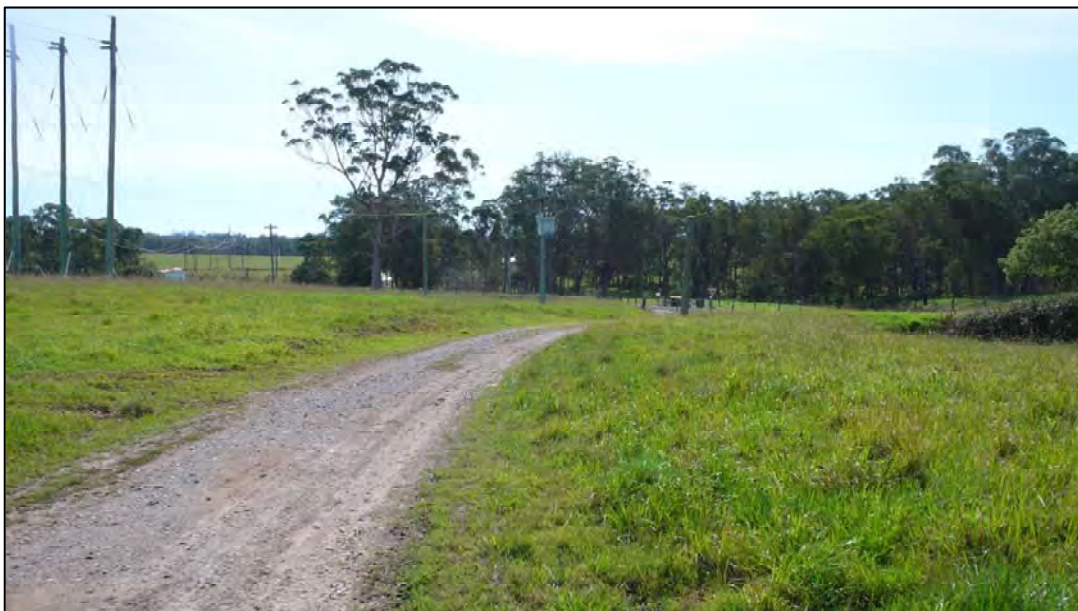
**Photo 4. Exotic grassland**

A large portion of the study area has been aligned to an exotic grassland vegetation unit. This area contains many introduced grass species with weeds, and occasional native species. Introduced species include: *Axonopus fissifolius*, *Paspalum dilatatum*, *Pennisetum clandestinum*, *Chloris gayana*, *Verbena bonariensis* and *Bidens pilosa*. Native species include: *Themeda australis*, *Geranium solanderi* and *Sporobolus creber*. Given the highly degraded condition, less than 50 percent of the ground cover is native, this vegetation is therefore has been aligned to a non-native vegetation unit.

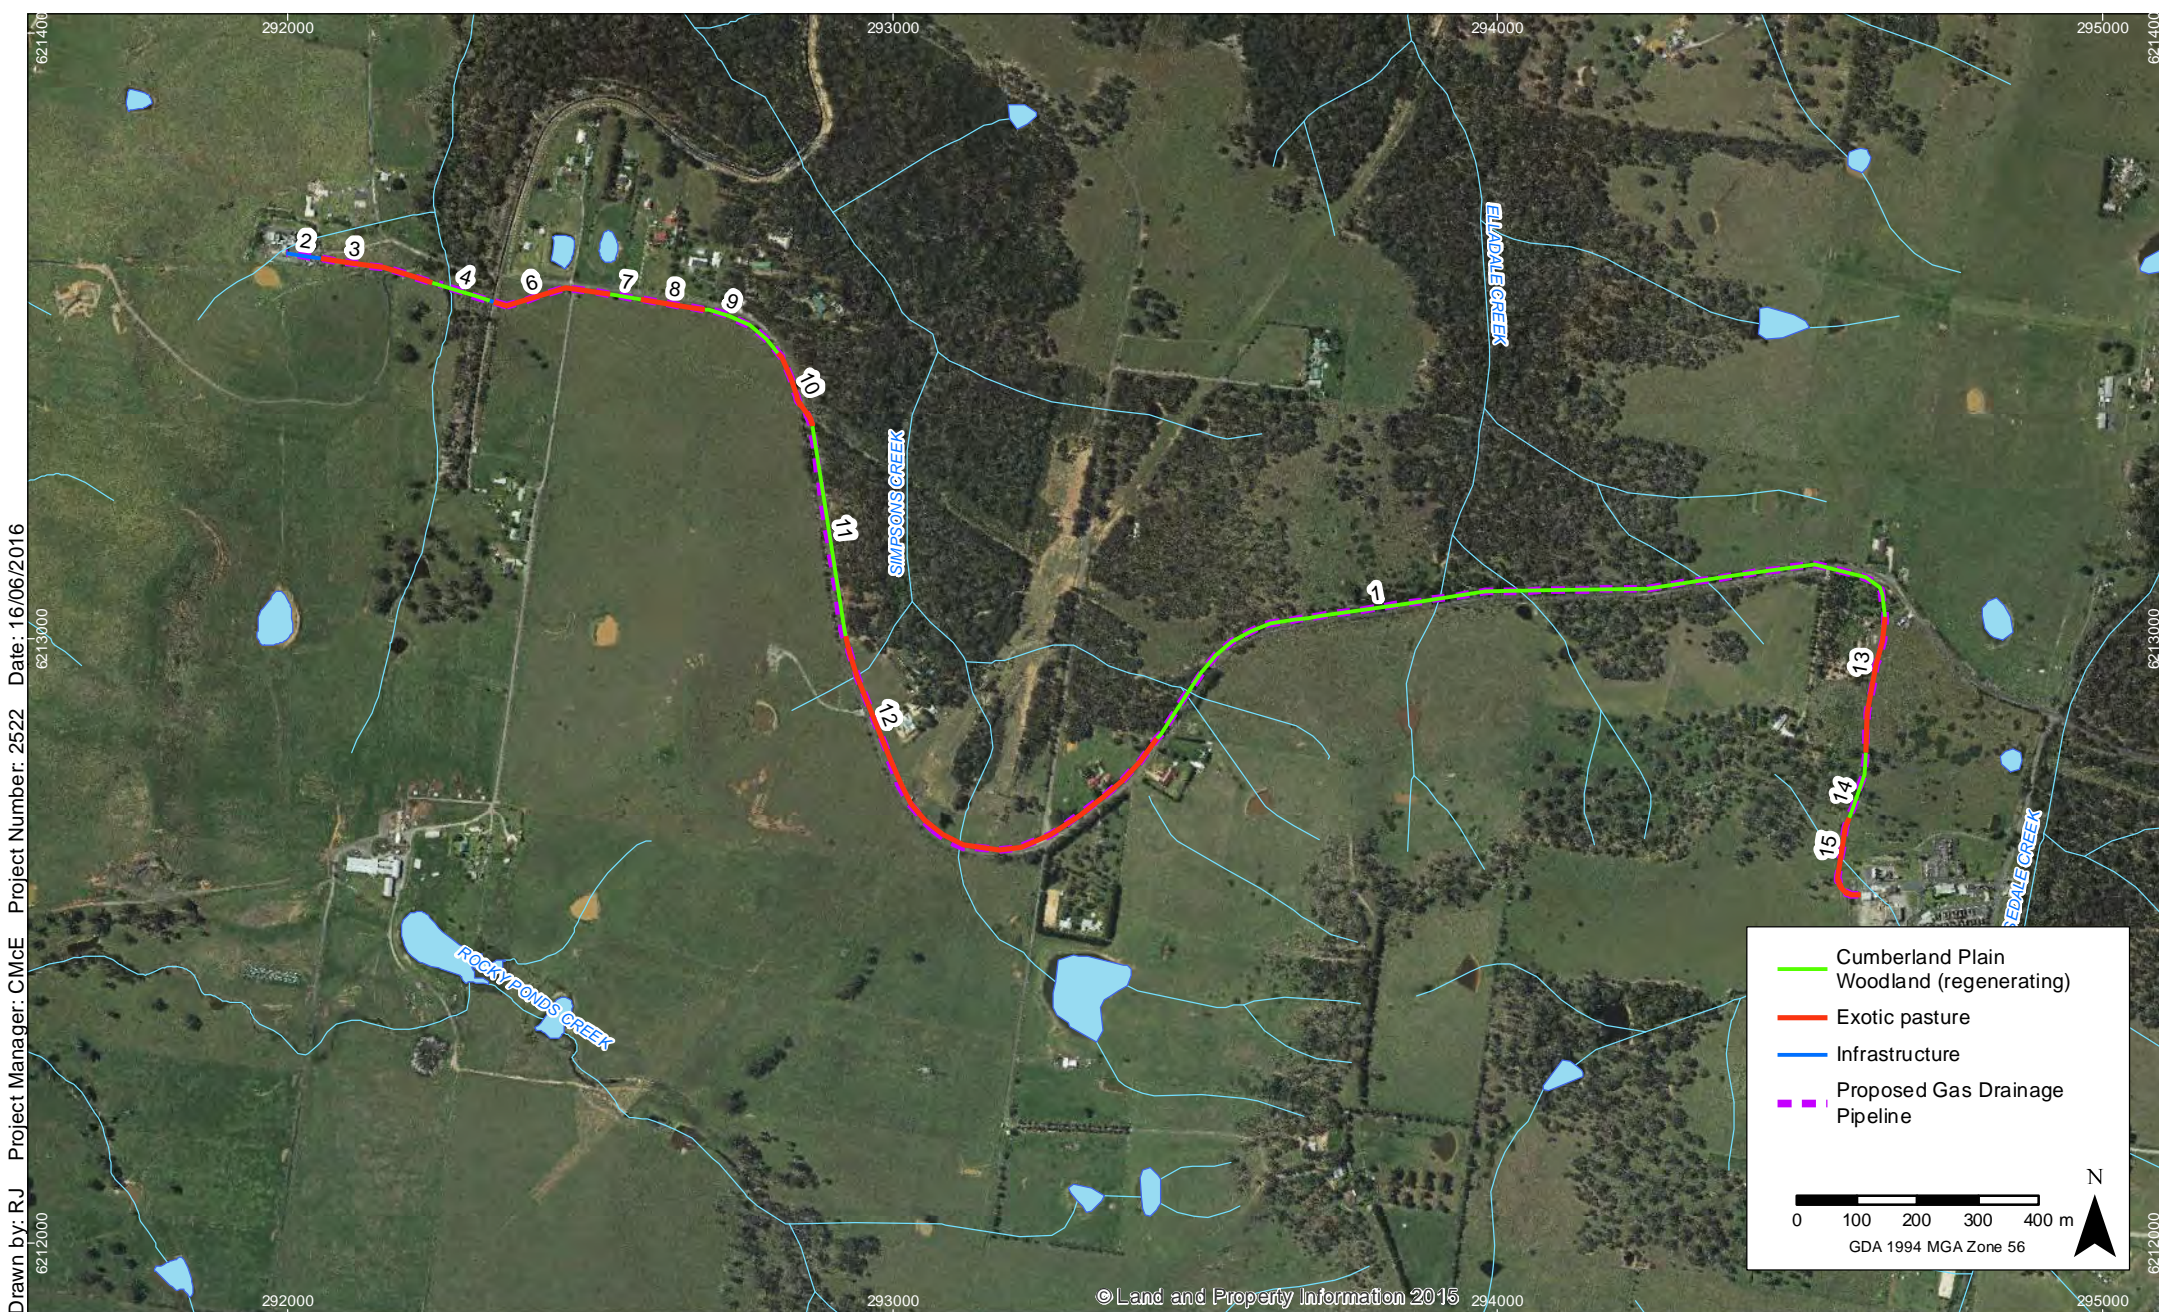
Field survey has addressed these discrepancies and provided a validation of the vegetation actually present. The validated vegetation mapping is provided in Figure 5, and is described in the sections below.
