APPIN MINE AREAS 7 AND 9 LONGWALLS 709 TO 711 AND 905 HERITAGE MANAGEMENT PLAN

<i>This document UNCONTROLLED once printed</i>				Page 1 of 29
Document ID		Version	1.1	
Last Date Updated	October 2021	Next Review Date	October 2024

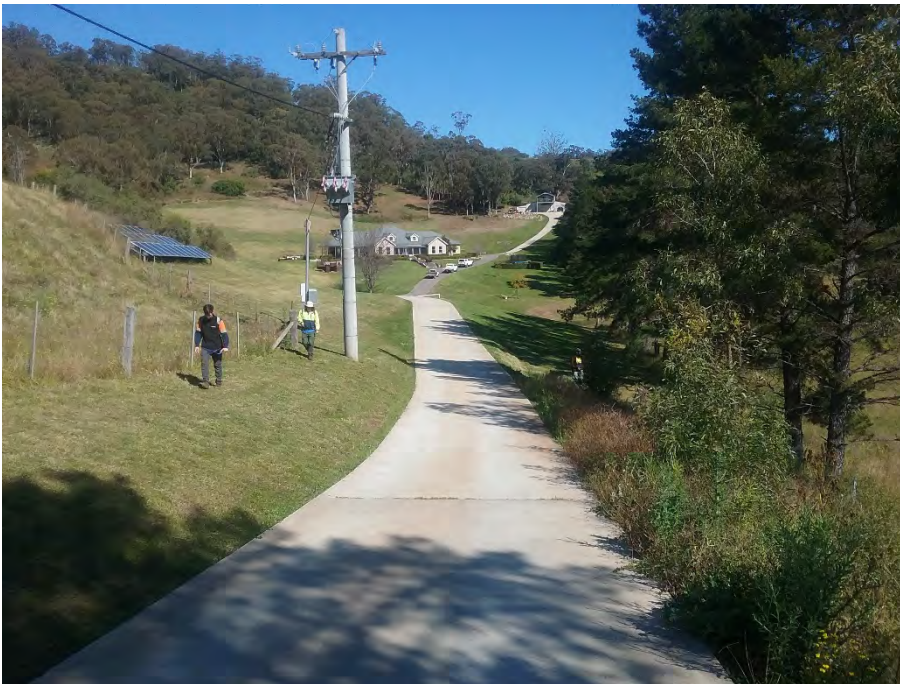
Photo 5 West facing photo showing disturbances from residential development

Disturbance in the study area is associated with natural and human agents. Natural agents generally affect small areas and include the burrowing and scratching in soil by animals, such as wombats, foxes, rabbits and wallabies, and sometimes exposure from slumping or scouring. Disturbances associated with recent human action are prevalent in the study area and cover large sections of the land surface. The agents include residential development such as landscaping and construction of residential buildings (Photo 5); farming

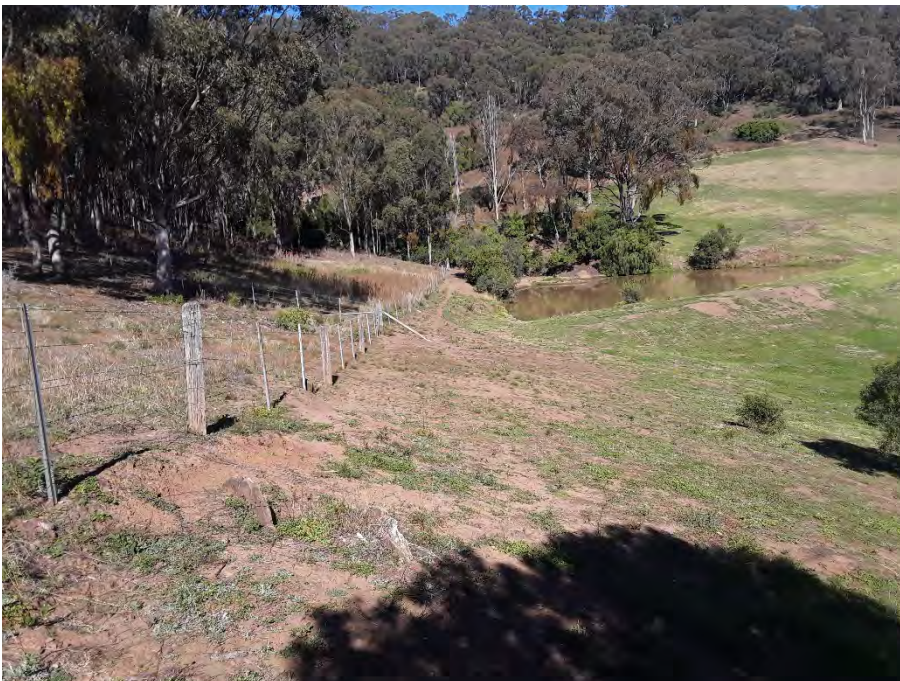
Photo 6 North facing photo showing disturbances from the construction of dams

practices, such as initial vegetation clearance for creation of paddocks, fencing and stock grazing (Photo 6); agricultural practices such as fruit orchards; and creation of artificial dams throughout the entire study area (Photo 7).

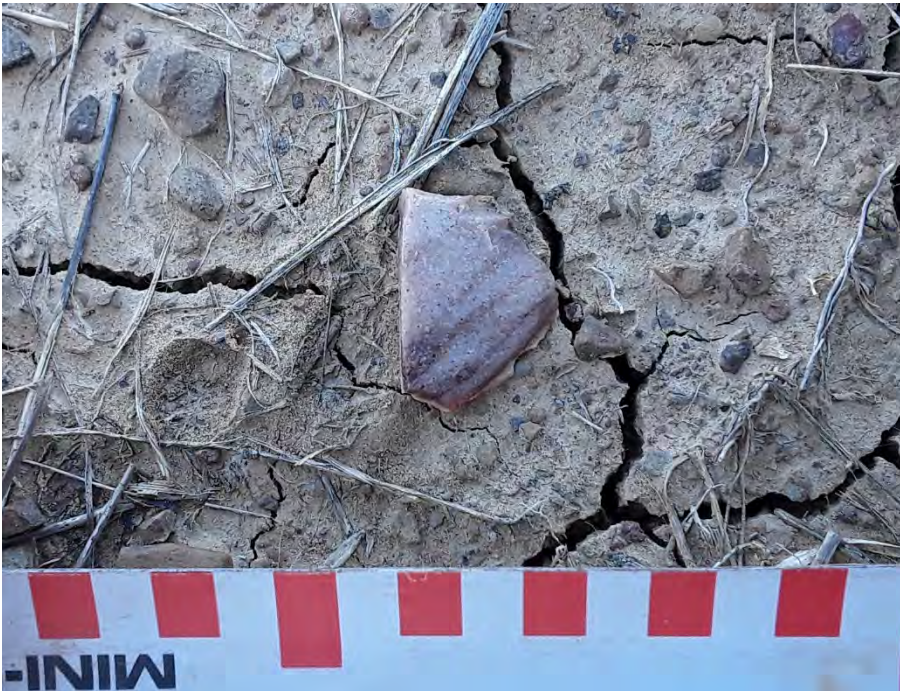
Photo 8 Hawkey Road ISO1

The site is located on a small crest adjacent to a drainage line in the southern part of Lot 81 DP880173. The artefact consists of a silcrete distal flake fragment with a plunge termination measuring 25.21 millimetres (mm) long by 20.45 mm wide and 4.04 mm thick (Photo 8).
