# APPIN MINE HERITAGE MANAGEMENT PLAN

| <b>Document ID</b> | APNMP0119 | <b>Version</b> | 1.0 | |

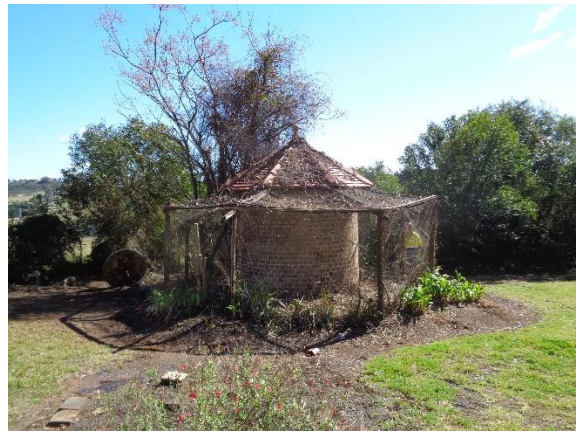
Plate 16: The Garden Building (recently used as a chicken hutch).

A small, single-storey, Garden Building is located to the north of the Main House. The Garden Building is a face brick structure of circular plan with a concrete floor. It has a slate roof with terracotta capping. The building is enclosed with chicken wire mesh from when it was used as a chicken hutch (Plate 15 and Plate 16).

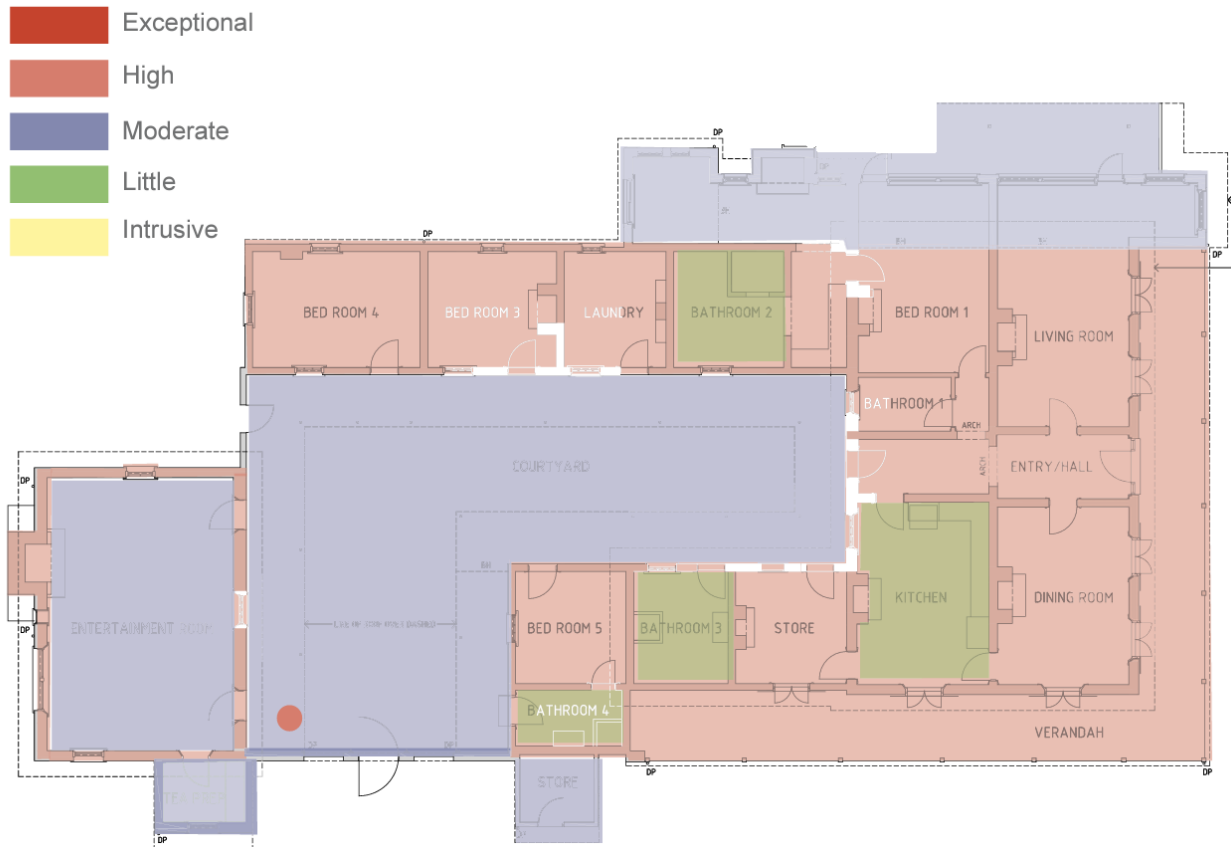
Figure 5: Grading of Significance of the Main House part of the Mountbatten Group (Source: GB&A 2013)

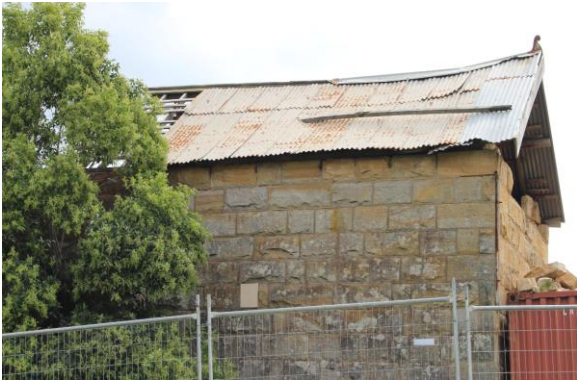
**Plate 11.** Closer view of remaining roof on western side of the building.

In general the sandstone building is in a current dilapidated state due to subsidence and collapse. The roof and roof structure are missing from half the building. The remaining roof is in very poor condition and structurally unstable. The walls are deteriorated and particularly the eastern and western walls show significant damage and cracking while portions of the walls have collapsed.

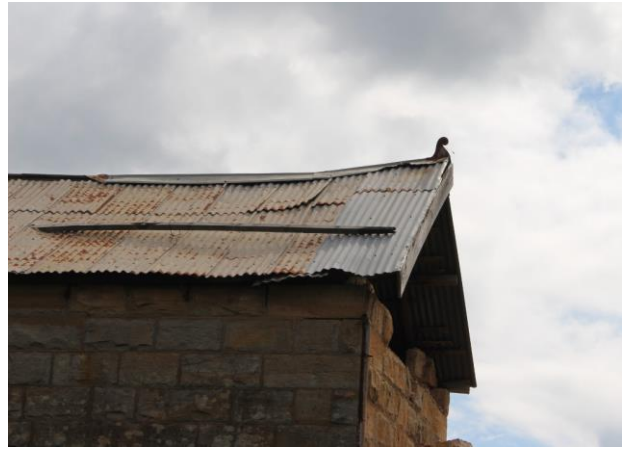
**Plate 12.** Closer view of remaining roof on western side of the building.

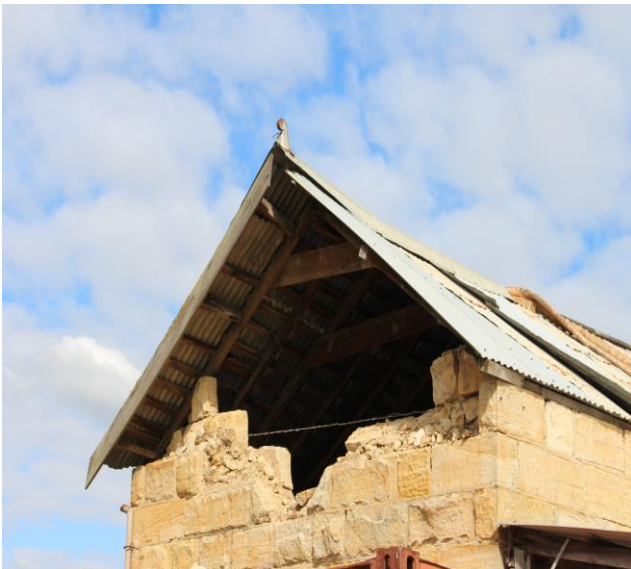
**Plate 13.** View of top western wall and remaining roof.
