APPIN AREA 7
LONGWALL 706 END OF
PANEL REPORT

ATTACHMENT B –
SUBSIDENCE REVIEW

SOUTH32 ILLAWARRA COAL:
Appin Colliery - Longwall 706

End of Panel Subsidence Monitoring Report for Appin Longwall 706

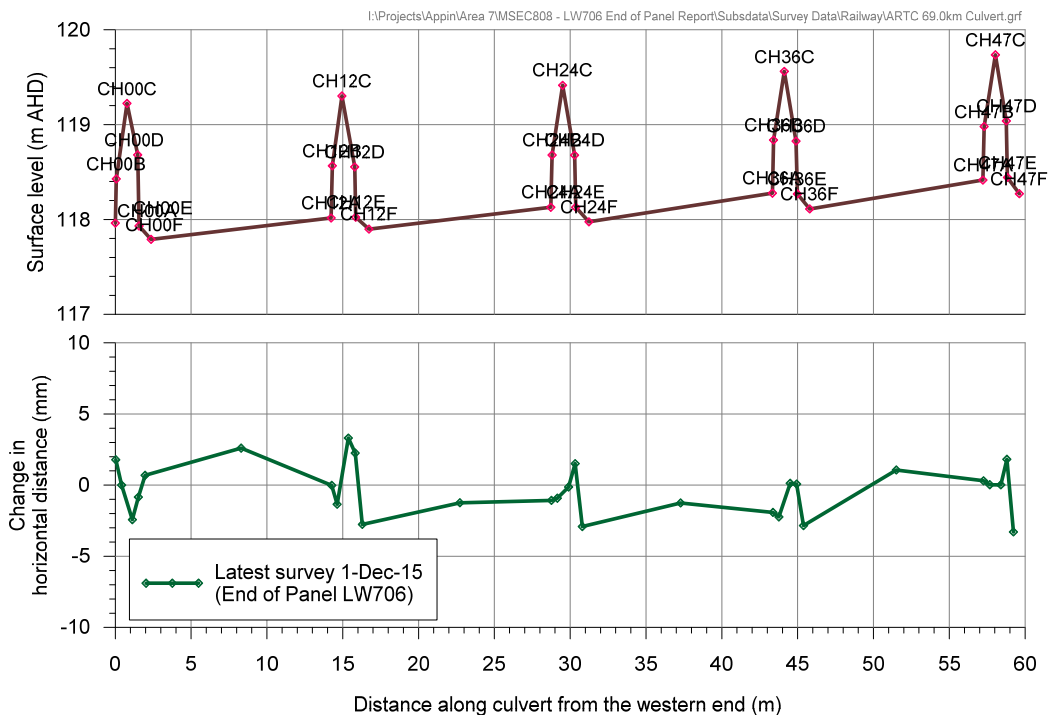
Fig. 2.2 Changes in Horizontal Distance along the ARTC 69.0km Culvert Invert during the Extraction of Longwall 706

The mine subsidence movements along a railway culvert were measured by South32 using a 3D ground monitoring line, referred to as the ARTC 69.0km Culvert. The locations of the monitoring points are shown in Drawing No. MSEC808-01 in Appendix B, and the measured changes in horizontal distance along the culvert invert are shown in Fig. 2.2.

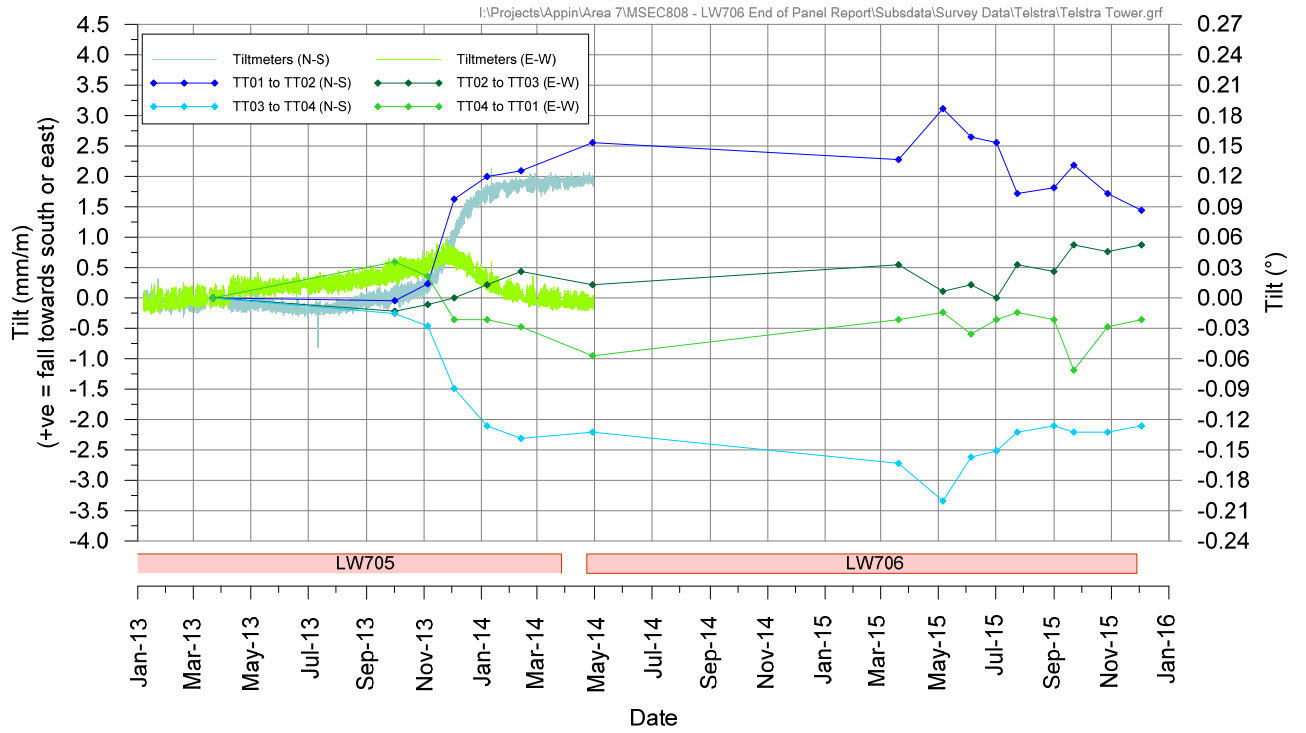
Fig. 2.16 Observed Changes in Tilt at Telstra Tower

The observed changes in tilt across the base of the Telstra Tower, during the extraction of Longwall 706, are illustrated in Fig. 2.16.

It can be seen that there was a reasonable correlation between ground surveys of tilt at the Tower and high accuracy tiltmeter measurements.

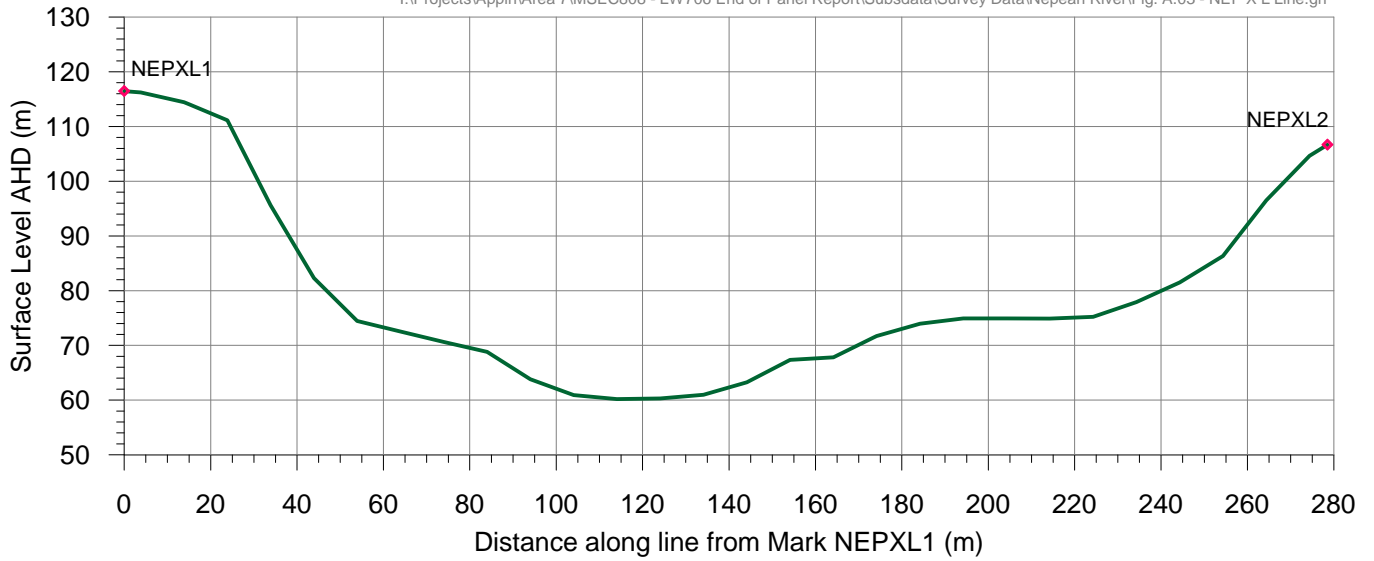
I:\Projects\Appin\Area 7\MSEC808 - LW706 End of Panel Report\Subsdata\Survey Data\Nepean River\Fig. A.03 - NEP X L Line.grf

Comparisons between the observed and predicted profiles of total closure along each of the Nepean River cross lines, resulting from the extraction of Longwalls 702 to 706, are provided in Figs. A.03 to A.08 in Appendix A.

Nepean River L-Line Total Closure Profiles

LW706 approximately 1050 metres north-west of Mark NEPXL2

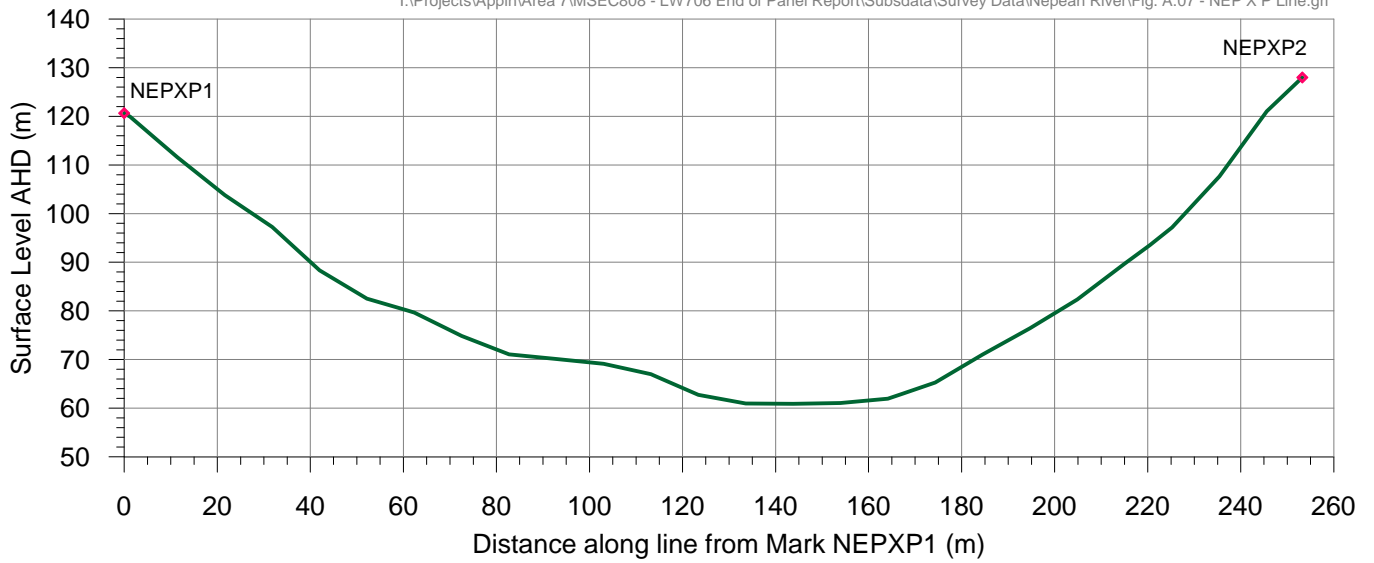
I:\Projects\Appin\Area 7\MSEC808 - LW706 End of Panel Report\Subsdata\Survey Data\Nepean River\Fig. A.07 - NEP X P Line.grf

Appin Colliery - Longwall 706 Nepean River P-Line Total Closure Profiles

LW706 approximately 560 metres south-west of Mark NEPXP2
