**APPIN AREA 9
LONGWALL 901 END OF PANEL
LANDSCAPE REPORT
November 2017**

This report has been prepared by the South32 Illawarra Coal Environmental Field Team (ICEFT) to summarise the observed and measured subsidence effects on watercourse and landscape features resulting from the extraction of Longwall 901.

Extraction of Appin Longwall 901 commenced on the 19th of January 2016 and was completed on the 8th of September 2017.

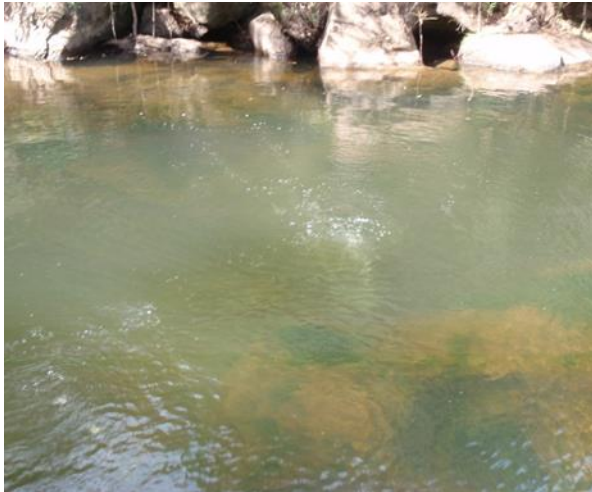
Impact AA9_LW901_001 was identified on the 2nd of March 2016 and consisted of a gas release zone on the Nepean River (Figure 2). The zone was comprised of one constant release and three other intermittent releases, of light to moderate intensity, over an area of approximately 5 m by 5 m. This site was passed by Longwall 901 at an approximate distance of 370 m. During the latest inspection on the 7th of November 2017, this gas release zone was observed as inactive.

Photo 1: Impact AA9_LW901_001 looking across stream. Taken on 2/03/2016.

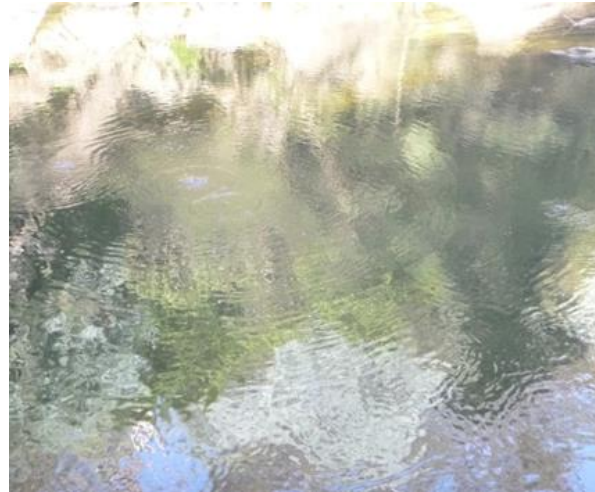
Impact AA9_LW901_002 was identified on the 7th of March 2016 and consisted of a gas release zone on the Nepean River, located approximately 60 m upstream of monitoring point 'NR0' (Figure 1 and Figure 2). The zone was comprised of five constant release points and approximately seven intermittent release points, of light to moderate intensity, over an area of approximately 12 m by 5 m (Photo 2). This site was passed by Longwall 901 at an approximate distance of 340 m. During the latest inspection on the 7th of November 2017, this gas release zone was inactive.

Photo 2: Impact AA9_LW901_002 looking downstream. Taken on 08/03/2016.

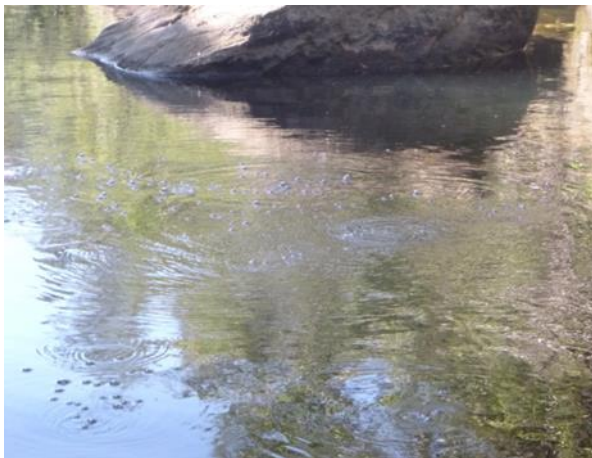
Impact AA9_LW901_003 was identified on the 7th of March 2016 and consisted of a gas release zone on the Nepean River, extending from approximately 18 m upstream and 27 m downstream of monitoring site 'NR0' (Figure 1 and Figure 2). The zone consisted of multiple gas release points, of light to moderate intensity, over an area of approximately 45 m by 6 m (Photo 3). The gas release zone was comprised of both intermittent and constant gas release points. This site was passed by Longwall 901 at an approximate distance of 350 m. During the latest inspection on the 7th of November 2017, this gas zone was inactive.

Photo 3: Impact AA9_LW901_003, looking downstream. Taken on 08/03/2016.

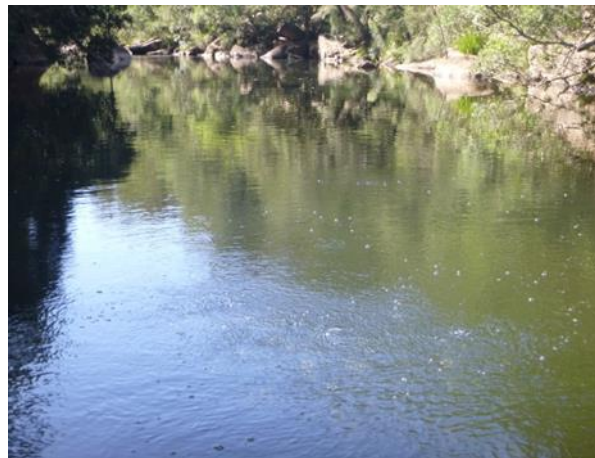
Impact AA9_LW901_004 was identified on the 7th of March 2016 and consisted of a gas release zone on the Nepean River, approximately 63 m downstream of monitoring point 'NR0' (Figure 1 and Figure 2). The zone was comprised of approximately twenty gas release points, of light to moderate intensity, over an area approximately 20 m by 8 m, most of which, had a constant release (Photo 4). This site was passed by Longwall 901 at an approximate distance of 357 m. During the latest inspection on the 7th of November 2017, this gas zone was inactive.

Photo 4: Impact AA9_LW901_004, looking downstream. Taken on 08/03/2016.

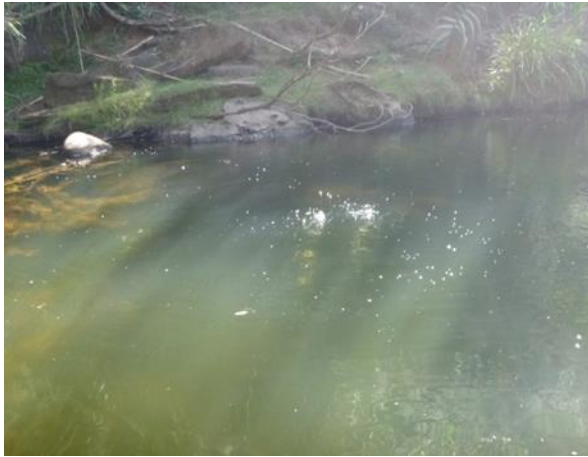
Impact AA9_LW901_005 was identified on the 7th of March 2016 and consisted of a gas release zone on the Nepean River, approximately 67 m upstream of monitoring point 'SW3' (Figure 1 and Figure 2). The zone was comprised of approximately ten gas release points, of light to moderate intensity, with constant releases over an area of approximately 7 m by 2 m (Photo 5). This site was passed by Longwall 901 at an approximate distance of 380m. During the latest inspection on the 7th of November 2017, this gas zone was inactive.

Photo 5: Impact AA9_LW901_005, close-up. Taken on 08/03/2016.

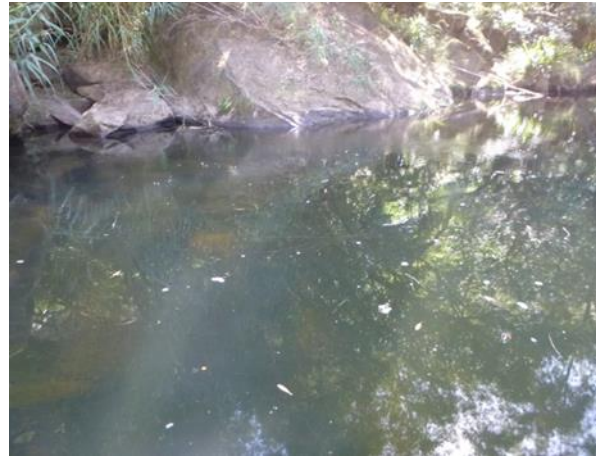
Impact AA9_LW901_006 was identified on the 7th of March 2016, which consisted of a gas release zone located on the Nepean River, approximately 32 m upstream of monitoring point 'SW3' (Figure 1 and Figure 2). The zone was comprised of approximately six gas release points, of light intensity, with constant releases, over an area of approximately 3 m by 4 m (Photo 6). This site was passed by Longwall 901 at an approximate distance of 380 m. During the latest inspection on the 7th of November 2017, this gas zone was inactive.

Photo 6: Impact AA9_LW901_006, looking downstream. Taken on 08/03/2016.

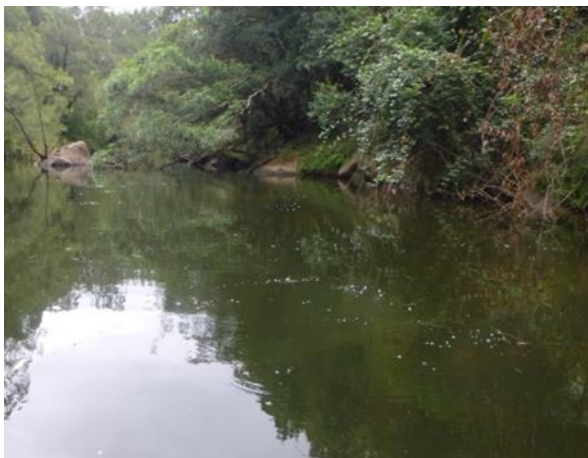
Impact AA9_LW901_007 was identified on the 15th of March 2017 and consisted of a gas release zone on the Nepean River, approximately 320 m downstream of monitoring point 'SW4' (Figure 1 and Figure 2). The zone was comprised of approximately 30 individual gas release points, of light intensity, over an area approximately 24 m by 15 m (Photo 7). This site was passed by Longwall 901 at an approximate distance of 517 m. During the latest inspection on the 7th of November 2017, this gas zone was inactive.

Photo 7: Impact AA9_LW901_007, looking upstream. Taken on 15/03/2016.

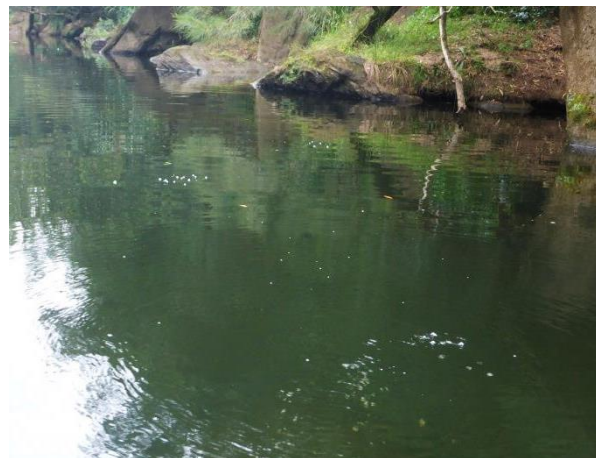
Impact AA9_LW901_008 was identified on the 18th of March 2016 and consisted of a gas release zone on the Nepean River, approximately 35 m downstream of monitoring point 'SW3'; and 40 m upstream from the Allens Creek and Nepean River confluence (Figure 1 and Figure 2). The zone was comprised of approximately eight gas release points, of light intensity, with release rates ranging from constant to intermittent, over an area of approximately 7 m by 4 m (Photo 8). This site was passed by Longwall 901 at an approximate distance of 400 m. During the latest inspection on the 7th of November 2017, this gas zone was inactive.

Photo 8: Impact AA9_LW901_008, looking downstream. Taken on 18/03/2016.

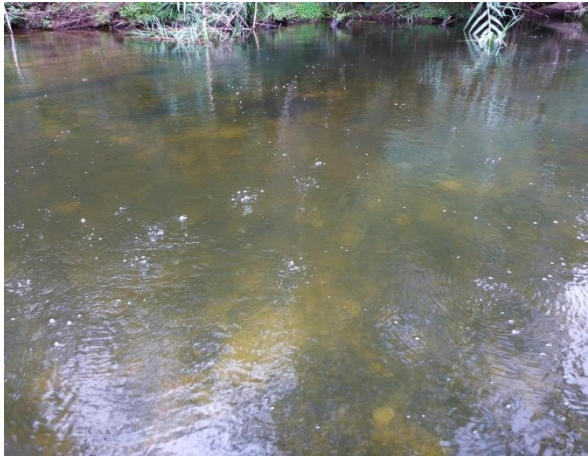
Impact AA9_LW901_009 was identified on the 18th of March 2016 and consisted of gas release on the northern bank of the Nepean River, approximately 80 m downstream of monitoring point 'SW4' (Figure 1 and Figure 2). The zone was comprised of approximately 35 individual gas releases, of light intensity, over an area of approximately 6 m by 8 m (Photos 3 to 5). The gas release rates range from intermittent to constant. This site was passed by Longwall 901 at an approximate distance of 390 m. During the latest inspection on the 7th of November 2017, this gas zone was active, comprised of multiple light intensity gas releases at a constant rate, in an area approximately 6 m by 3 m.

Photo 9: Impact AA9_LW901_009, looking across stream. Taken on 21/03/2016.

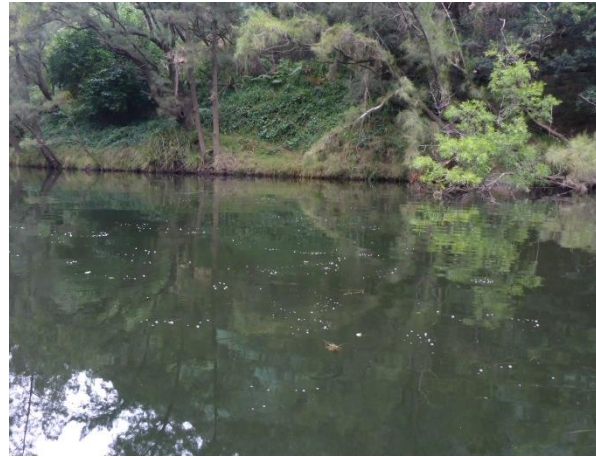
Impact AA9_LW901_010 was identified on the 18th of March 2016 and consisted of a gas release zone on the Nepean River, approximately 150 m downstream of monitoring point 'SW4' (Figure 1 and Figure 2). The zone was comprised of approximately 80 individual releases, of light to moderate intensity, over an area of approximately 50 m by 20 m (Photo 9). The gas release rates range from intermittent to constant. This site was passed by Longwall 901 at an approximate distance of 390 m. During the

latest inspection on the 7th of November 2017, this gas zone was active, comprised of multiple light intensity gas releases at a constant rate, in an area approximately 2 m by 3 m.

Photo 10: Impact AA9_LW901_010, looking across stream at upstream end. Taken on 18/03/2016.

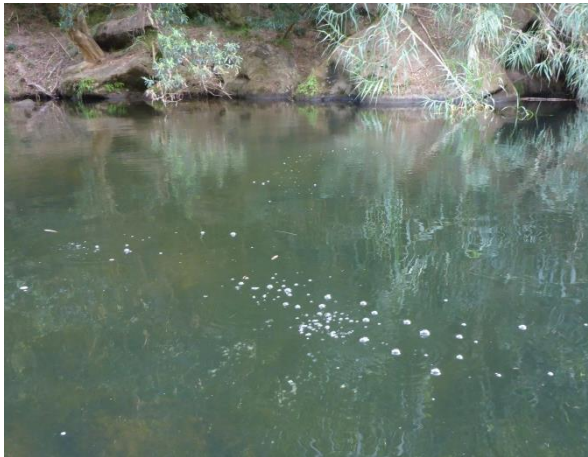
Impact *AA9_LW901_011* was identified on the 21st of March 2016 and consisted of a gas release zone on the Nepean River, approximately 5 m downstream of monitoring point 'SW3' (Figure 1 and Figure 2). The zone was comprised of approximately 22 constant gas releases, of light intensity, over an area of approximately 7 m by 8 m (Photos 10 and 11). This site was passed by Longwall 901 at an approximate distance of 400 m. During the latest inspection on the 7th of November 2017, this gas zone was inactive.

Photo 11: Impact AA9_LW901_011, looking across stream. Taken on 21/03/2016.

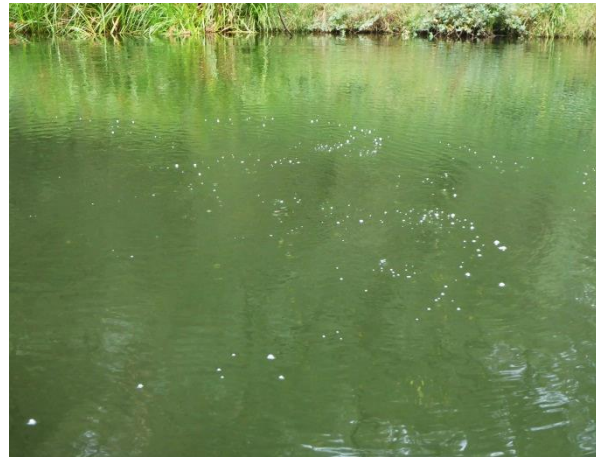
Gas release zone *AA9_LW901_012* was identified on the 21st of March 2016 and consisted of a gas release zone on the Nepean River, adjacent to monitoring site 'SW4' (Figure 1 and Figure 2). The zone was comprised of two areas of constant release, separated by approximately 8 m (Photo 12). The upstream area consists of 12 individual releases, of light intensity, over a 6 m by 5 m area; and the downstream area consists of 10 releases, of light intensity, in a 5 m by 5 m area. This site was passed by Longwall 901 at an approximate distance of 385 m. During the latest inspection on the 7th of November 2017, this gas zone was active, comprised of multiple light intensity gas releases at an intermittent rate, in two areas approximately 5 m by 5 m and 0.3 m by 0.3 m.

Photo 12: Impact AA9_LW901_012, looking across stream. Taken on 21/03/2016.

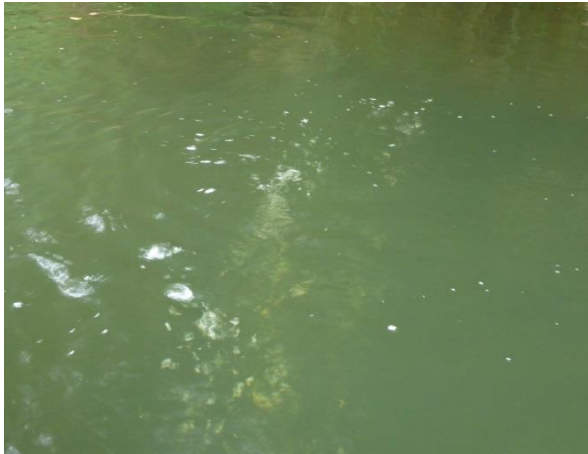
Gas release zone AA9_LW901_013 was identified on the 21st of March 2016 and consisted of a gas release zone on the Nepean River, approximately 210 m downstream of monitoring point 'SW4' (Figure 1 and Figure 2). The zone was comprised of approximately 15 constant releases, of light to moderate intensity, over an area of approximately 8 m by 8 m (Photo 13). This site was passed by Longwall 901 at an approximate distance of 420 m. During the latest inspection on the 7th of November 2017, this gas zone was active, comprised of two light intensity releases at an intermittent rate, in an area approximately 0.1 m by 0.1 m.

Photo 13: Impact AA9_LW901_013, close-up of largest releases. Taken on 21/03/2016.

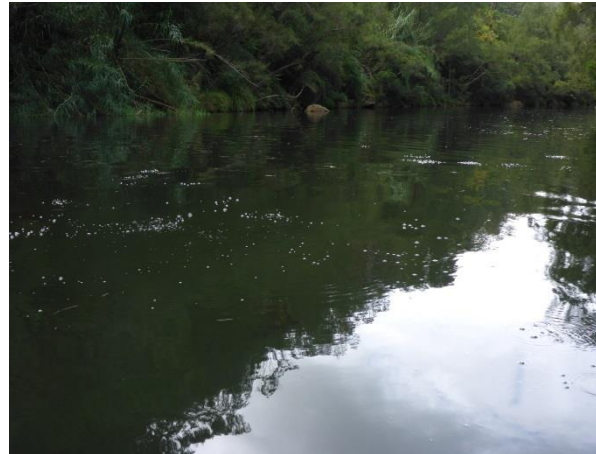
Gas release zone AA9_LW901_014 was identified on the 21st of March 2016. It is located approximately 400 m downstream of monitoring point 'SW4' (Figure 1 and Figure 2). The zone consists of approximately 30 constant gas releases, of light to moderate intensity, over an area of approximately 30 m by 10 m (Photo 14). This site was passed by Longwall 901 at an approximate distance of 580 m from Longwall 901 (Figure 1). During the latest inspection on the 7th of November 2017, this gas zone was active, comprised of one light intensity release at a constant rate, in an area approximately 0.1 m by 0.1 m.

Photo 14: Impact AA9_LW901_014, looking downstream. Taken on 21/03/2016.

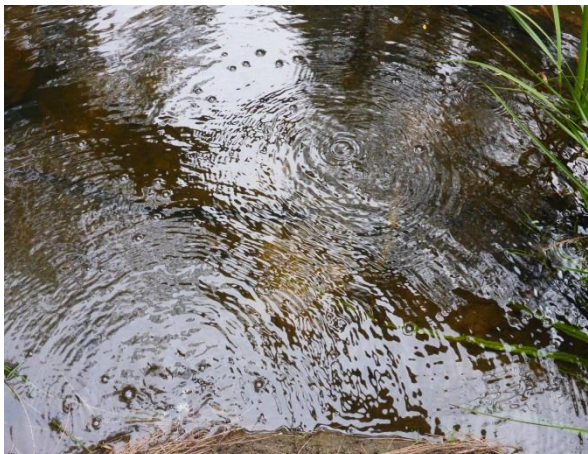
Impact AA9_LW901_015 was identified on the 29th of March 2016 and consisted of a gas release zone on Allens Creek, approximately 20 m upstream of the Allens Creek – Nepean River confluence, adjacent to monitoring site 'SW2' (Figure 1 and Figure 2). The zone was comprised of three intermittent gas release points, of light intensity, over an area of approximately 1 m² (Photo 15). This site was passed by Longwall 901 at an approximate distance of 410 m. During the latest inspection on the 7th of November 2017, this gas zone was inactive.

Photo 15: Impact AA9_LW901_015, looking downstream. Taken on 29/03/2016.

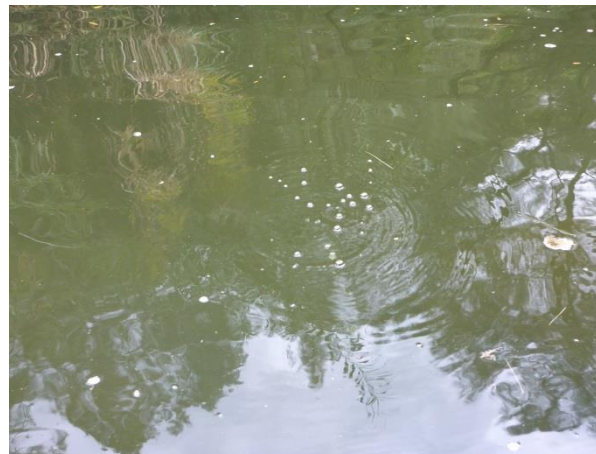
Impact AA9_LW901_016 was identified on the 4th of April 2016 and consists of a gas release zone on the Nepean River (Figure 1 and Figure 2). The zone was comprised of five gas release points, of light intensity, ranging from intermittent to constant, over an area of approximately 1 m by 2 m (Photo 16). This site was passed by Longwall 901 at an approximate distance of 580 m. During the latest inspection on the 7th of November 2017, this gas zone was inactive.

Photo 16: Impact AA9_LW901_016, close up of one of the constant release points. Taken on 04/04/2016.

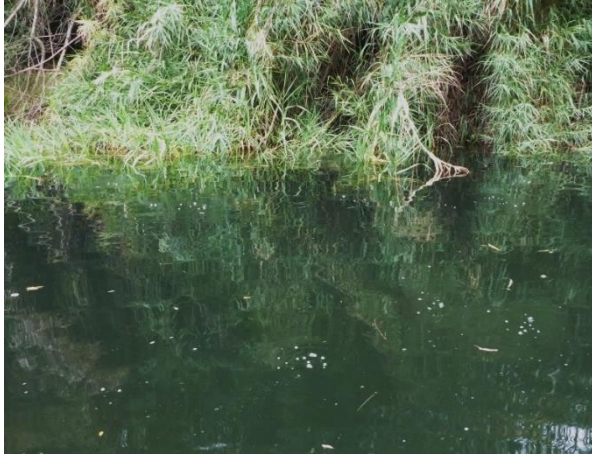
Impact AA9_LW901_017 was identified on the 8th of April 2016 and consisted of a gas release zone on the Nepean River, approximately 50 m downstream of the Nepean River and Allens Creek confluence (Figure 2). The zone was comprised of 14 intermittent gas release points, of light intensity, over an area of approximately 5 m by 6 m (Photo 17). This site was passed by Longwall 901 at an approximate distance of 430 m. During the latest inspection on the 7th of November 2017, this gas zone was inactive.

Photo 17: Impact AA9_LW901_017, looking across stream. Taken on 08/04/2016.

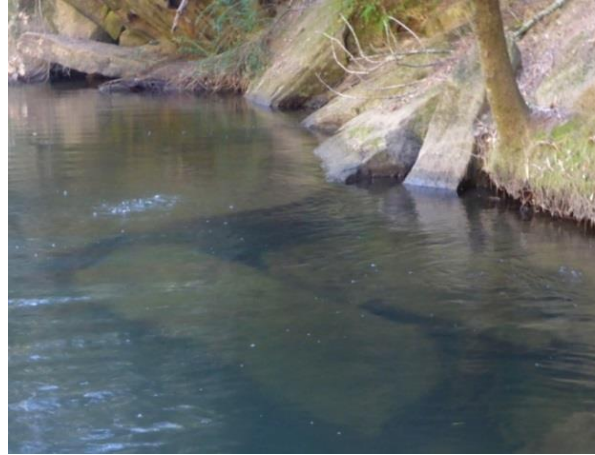
Impact AA9_LW901_018 was identified on the 21st of April 2016 and consisted of a gas release zone on the Nepean River between previously reported impacts AA9_LW901_013 and AA9_LW901_007 (Figure 2). The zone was comprised of approximately 20 constant gas release points, of light intensity, over an area of approximately 25 m by 2 m (Photo 18). This site was passed by Longwall 901 at an approximate distance of 375 m. During the latest inspection on the 7th of November 2017, this gas zone was active, comprised of multiple light intensity gas releases at an intermittent rate, in an area of approximately 0.1 m by 0.1 m

Photo 18: Impact AA9_LW901_018, looking upstream. Taken on 21/04/2016.

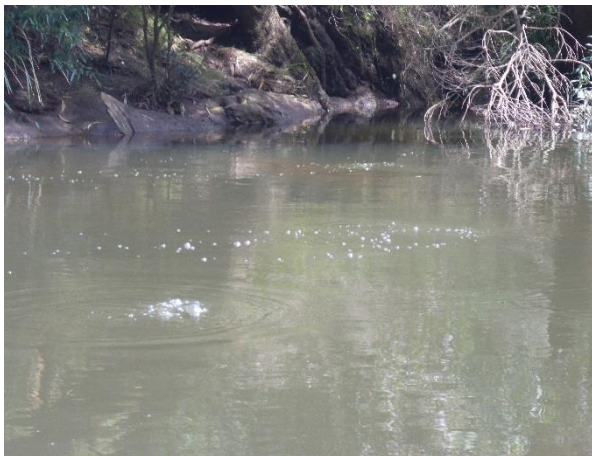
Impact AA9_LW901_019 was identified on the 4th of April 2017 and consisted of a gas release zone on the Nepean River (Figure 2). The zone was comprised of approximately 16 release points, of moderate intensity, ranging from constant to intermittent, over an area of approximately 20 m by 4 m (Photo 19). This site was passed by Longwall 901 at an approximate distance of 850 m. During the latest inspection on the 7th of November 2017, this gas zone was active, comprised of two light intensity gas releases at a constant rate, in an area of approximately 2 m by 2 m.

Photo 19: Release at Gas Zone AA9_LW901_019, Nepean River. Taken on 4/04/2017.

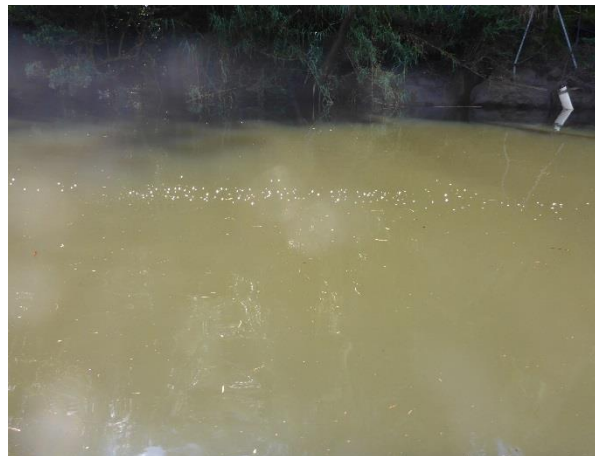
Impact AA9_LW901_020 was identified on the 4th of April 2017 and consisted of a gas release zone on the Nepean River (Figure 2). The zone was comprised of approximately 15 release points, of light to moderate intensity, ranging from constant to intermittent, over an area of approximately 12 m by 6 m (Photo 20). This site was passed by Longwall 901 at an approximate distance of 940 m. During the latest inspection on the 7th of November 2017, this gas zone was inactive.

Photo 20: Release at Gas Zone AA9_LW901_020, Nepean River. Taken on 4/04/2017.

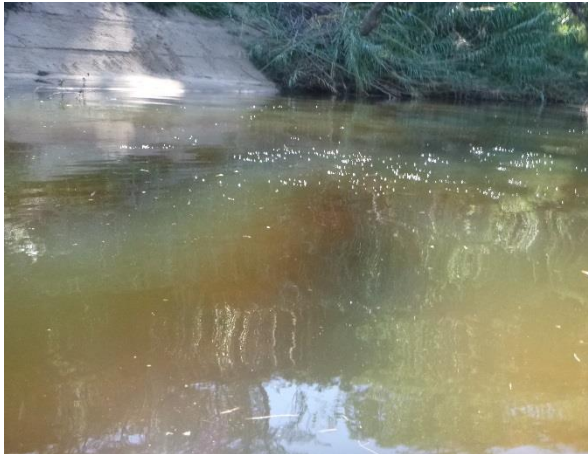
Impact AA9_LW901_021 was identified on the 26th of April 2017 and consisted of a gas release zone on the Nepean River (Figure 2). The zone consists of approximately 45 intermittent releases, of light intensity, over an area approximately 30 m by 10 m (Photo 21). This site was passed by Longwall 901 at an approximate distance of 1000 m. During the latest inspection on the 7th of November 2017, this gas zone was active, comprised of multiple light intensity gas releases at constant rate, in an area of approximately 0.1 m by 0.1 m.

Photo 21: Release at Gas Zone AA9_LW901_021, Nepean River. Taken on 26/04/2017.

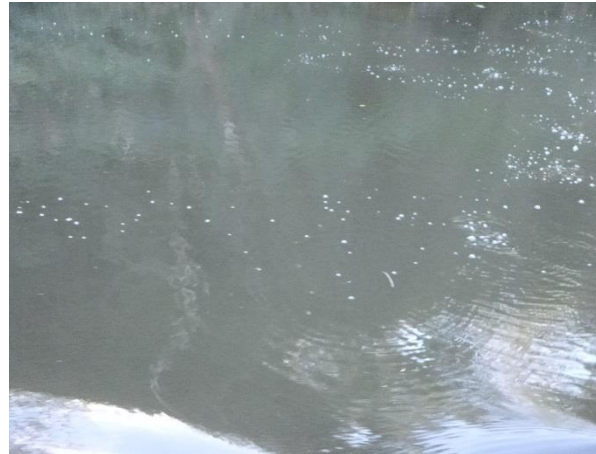
Impact AA9_LW901_022 was identified on the 26th of April 2017 and consisted of a gas release zone on the Nepean River (Figure 2). The zone was comprised of approximately 20 intermittent releases, of moderate intensity, over an area of approximately 8 m by 5 m (Photo 22). This site was passed by Longwall 901 at an approximate distance of 1000 m. During the latest inspection on the 7th of November 2017, this gas zone was active, comprised of two light intensity gas releases at an intermittent rate, in an area of approximately 0.1 m by 0.1 m.

Photo 22: Release at Gas Zone AA9_LW901_022, Nepean River. Taken on 26/04/2017.

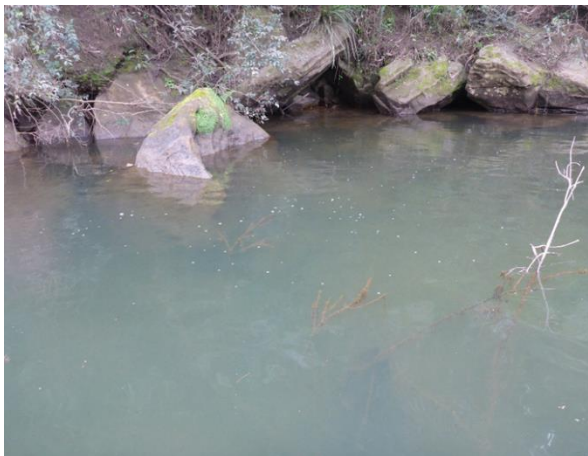
Impact AA9_LW901_023 was identified on the 17th of July 2017 and consisted of a gas release zone on the Nepean River (Figure 2). The zone was comprised of one intermittent release, of light intensity, over an area of 1 m² (Photo 23). This site was passed by Longwall 901 at an approximate distance of 1000 m. During the latest inspection on the 7th of November 2017, this gas zone was inactive.

Photo 23: Photo 1: AA9_LW901_023, looking downstream taken 17/07/2017.

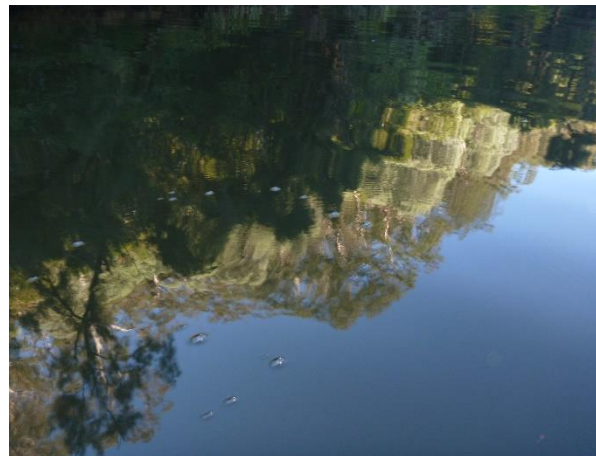
Impact AA9_LW901_024 was identified on the 24th of May 2017 and consisted of a gas release zone on the Nepean River (Figure 2). This site was passed by Longwall 901 at an approximate distance of 1000 m. The zone consisted of one intermittent release of light intensity. During the latest inspection on the 7th of November 2017, this gas zone was inactive.

Photo 24: AA9_LW901_024, close-up. Taken on 24/5/2017.

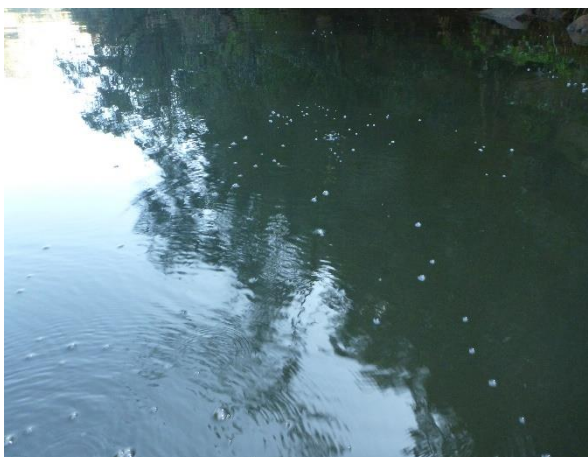
Impact AA9_LW901_025 was identified on the 24th of May 2017 and consisted of a gas release zone on the Nepean River (Figure 2). This site was passed by Longwall 901 at an approximate distance of 1000 m. The zone consisted of one intermittent release of light intensity. During the latest inspection on the 7th of November 2017, this gas zone was inactive.

Photo 25: AA9_LW901_025, close-up. Taken on 24/5/2017.
