# **APPIN MINE ANNUAL REVIEW FY21**

The Annual Review has been prepared to meet the requirements of Condition 4 of Schedule 6 of the BSO Project Approval 08\_0150 (the Project Approval) and the NSW Resources Regulator requirement to submit an Annual Environmental Management Report (AEMR) under the Mining Leases for Appin Mine.

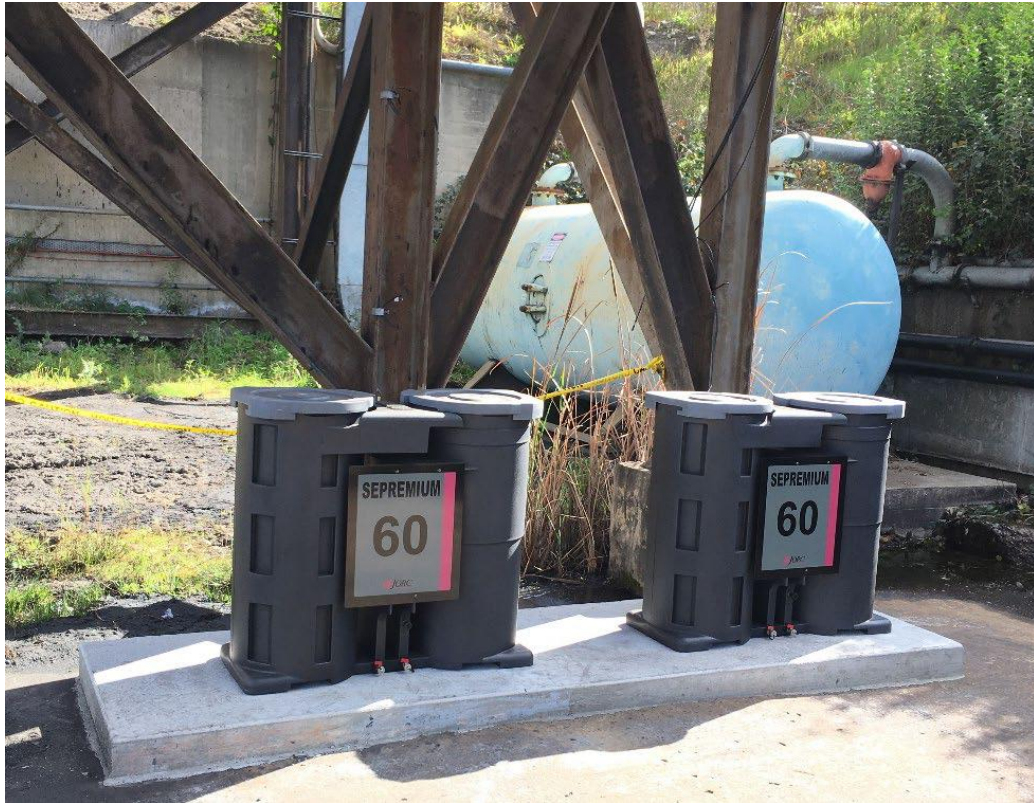
**Plate 1: JORC™ Condensate Oil/Water Separators**

The units were installed and commissioned in June 2021.

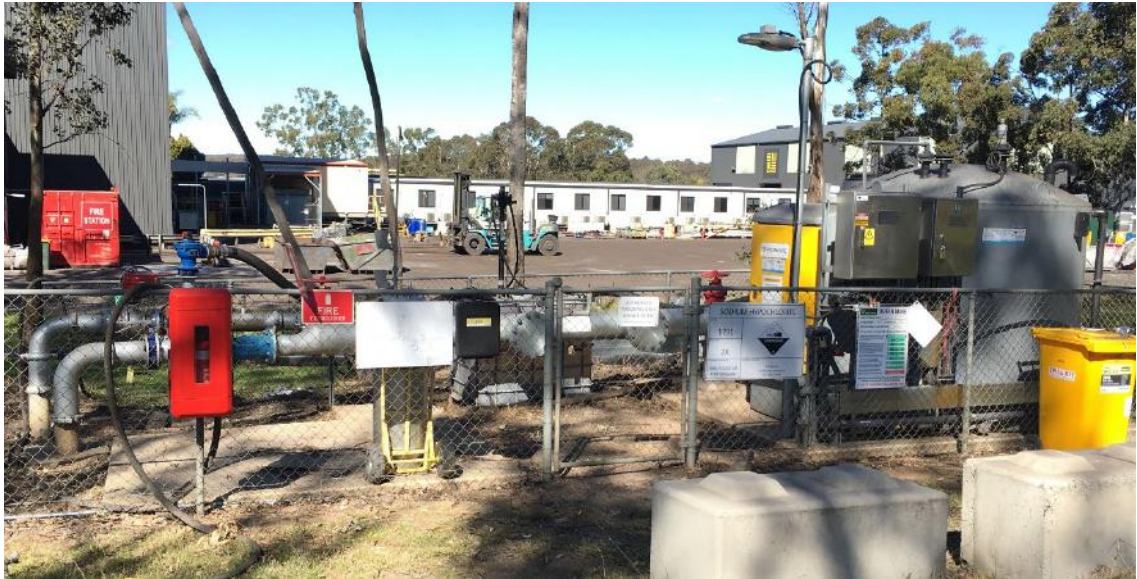
**Plate 2: Recirculation Line Dosing System**

This required the installation of a sodium hypochlorite dosing system on the Appin West surface, with the associated pipework to feed water into the existing process water tanks, ready for underground use, as shown in Plate 2.

This work was completed and commissioned in November 2020.

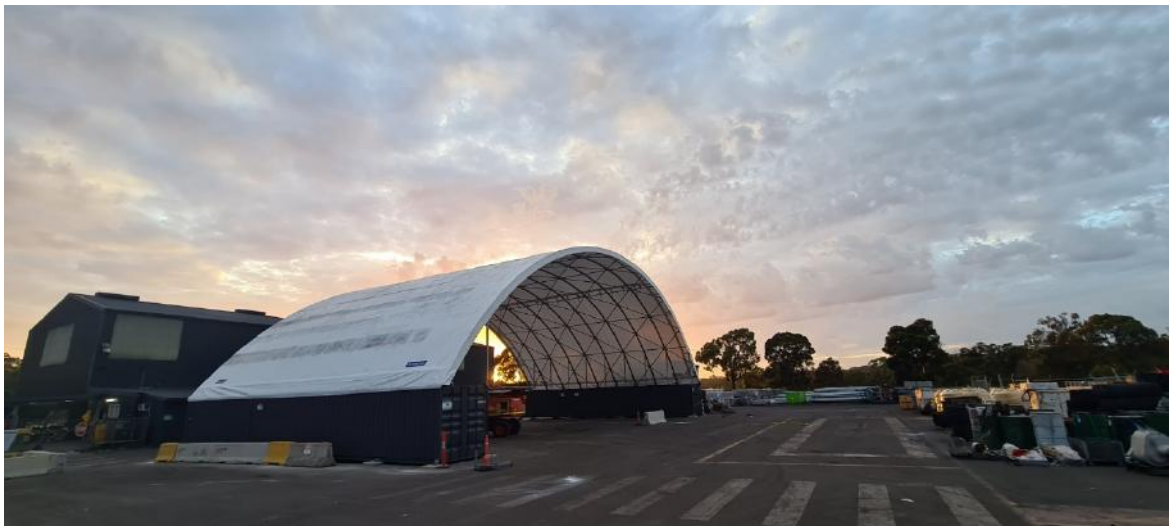
**Plate 3: Undercover Storage Area**

This included the erection of 650 m<sup>2</sup> of undercover storage area in March, to protect dry chemicals from the elements (Plate 3), and the installation of a 20” self-bunded storage container in April, dedicated to hydrocarbon storage (Plate 4).

As part of an ongoing initiative to improve environmental standards with respect to chemical and hazardous goods storage, IMC modified and improved its dry-chemical and hazardous liquids storage areas throughout FY21.

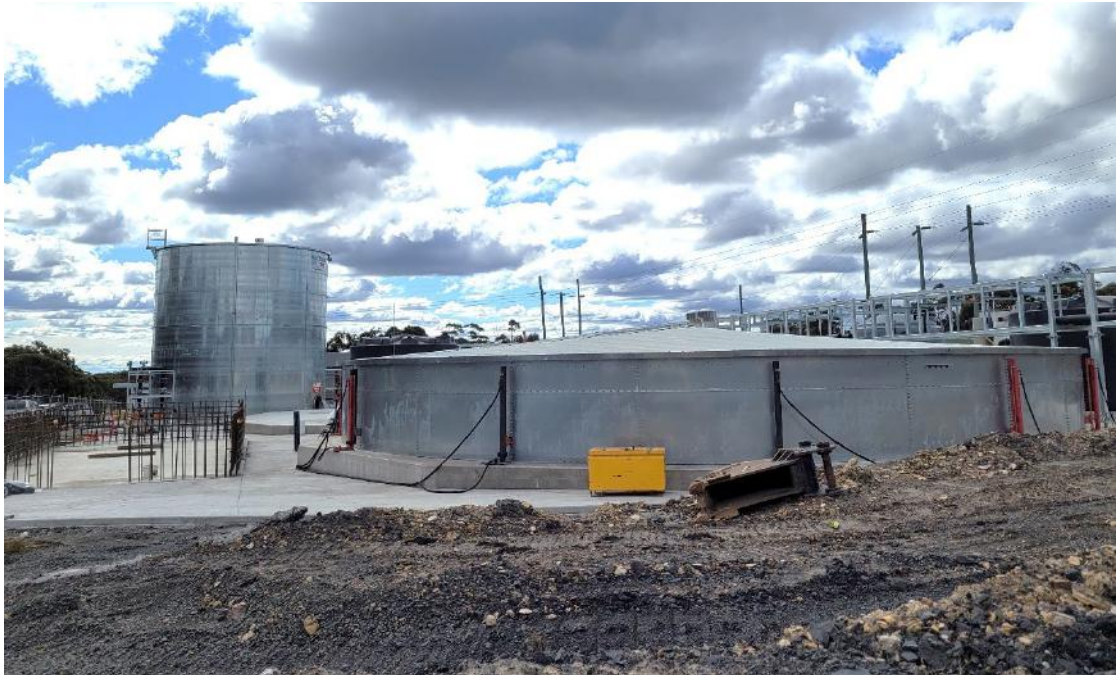
**Plate 5: Appin North WTP construction as at August 2021**

Construction of the WTP began in December 2020 with civil works and the pipeline installation from the WTP to the discharge location. This included the construction of a below ground ~2km pipeline along the Dam Road to the discharge location. Bulk earthworks commenced in March 2021 with concrete slabs being poured in April. Civil works continued to the end of June 2021, with major mechanical works, including the placement of brine tanks and mechanical equipment installation commencing in July 2021. The placement of water treatment tanks and state of construction as of August 2021 can be seen in Plate 5.

In FY20 IMC committed to the construction of an ultrafiltration WTP at Appin North to allow for the treatment of groundwater pumped to the surface from Area 5, in addition to water from the CWEA underdrainage. The treated water will be directly discharged to Brennans Creek as permeate via LDP 40.

COVID 19 restrictions caused delays to equipment supply, contractor availability and construction activities during FY21. A variation to amend the date for completion from March 2021 to November 2021 was submitted to and approved by the Environment Protection Authority (EPA).

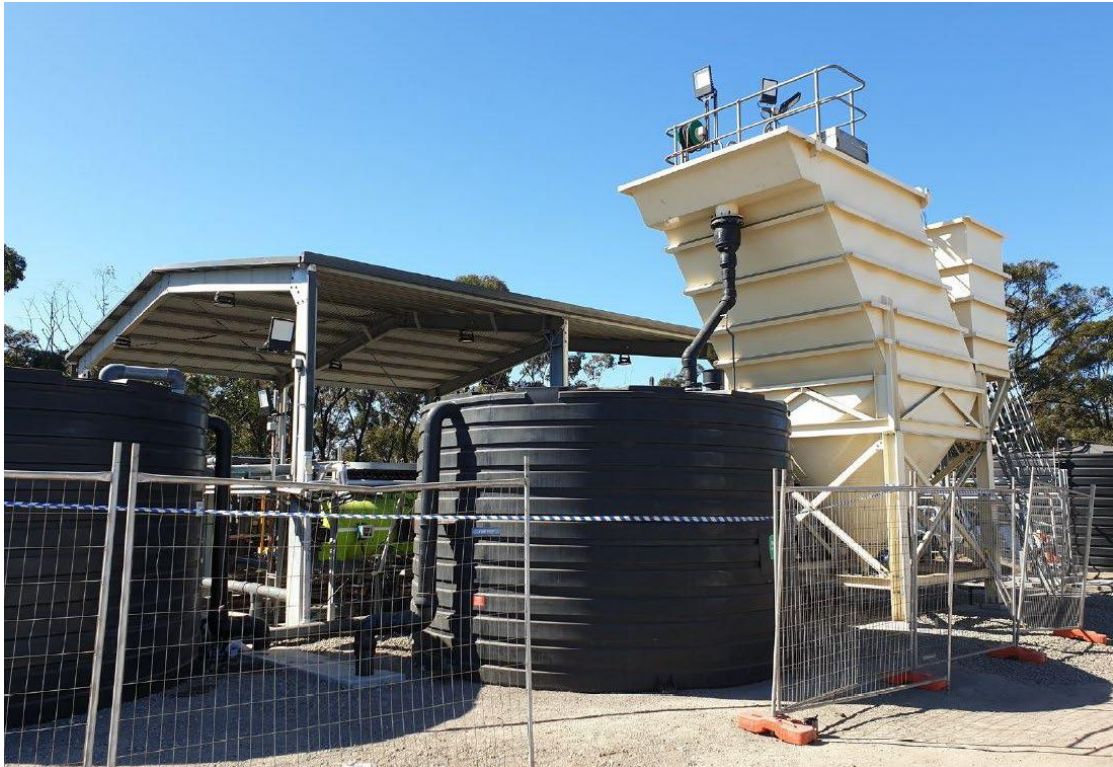
**Plate 6: Appin North Temporary WTP**

Civil works for the Temporary WTP commenced in December 2020, with mechanical and electrical fittings commencing in February and March 2021 respectively. Commissioning commenced in April 2021 with the plant becoming operational on 27 May 2021. The temporary WTP is shown in Plate 6.

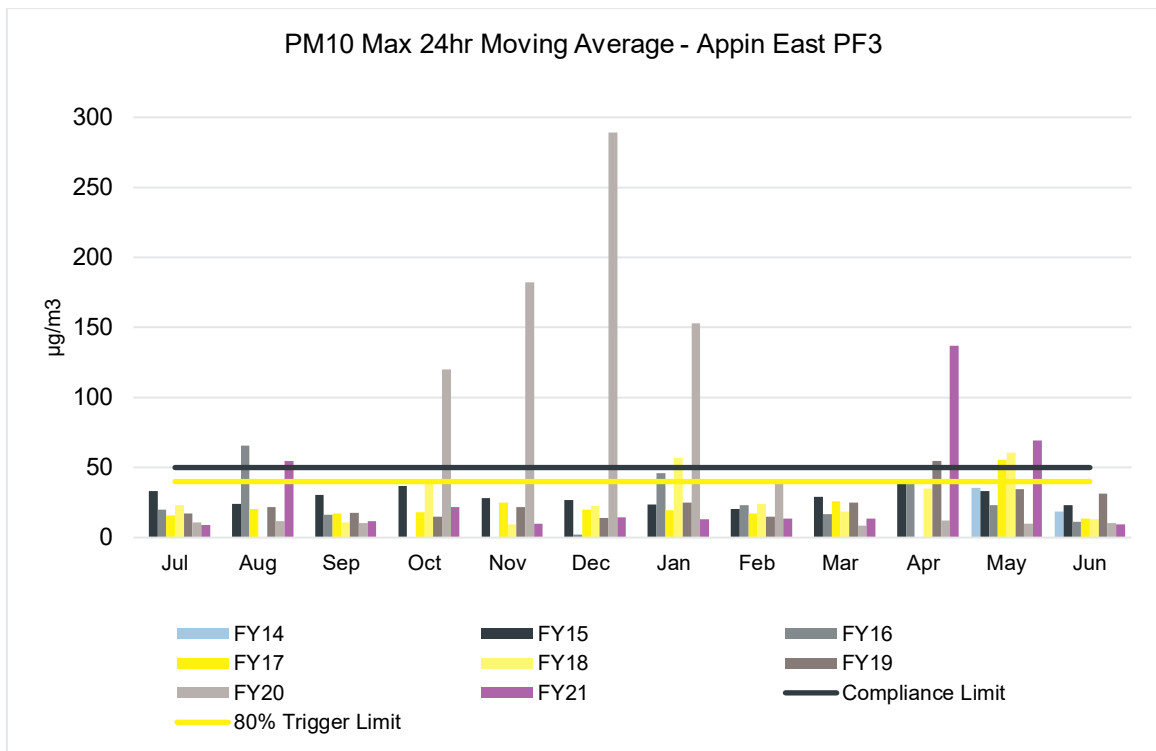
**Figure 5: PM<sub>10</sub> Maximum 24-hour Moving Average at Appin East PF3**

AE-PF1 at Appin East and W-PF1 at Appin North, also recorded exceedances over these months. Refer to Figure 5, Figure 6, Figure 7 and Figure 8 for maximum 24 hour moving averages for the photometers.

These events included severe weather (high winds in August), and hazard reduction burns (Avon Dam and Dharawal National Park across April and May). As a result of these extraordinary events, the HVAS was not run (when applicable).

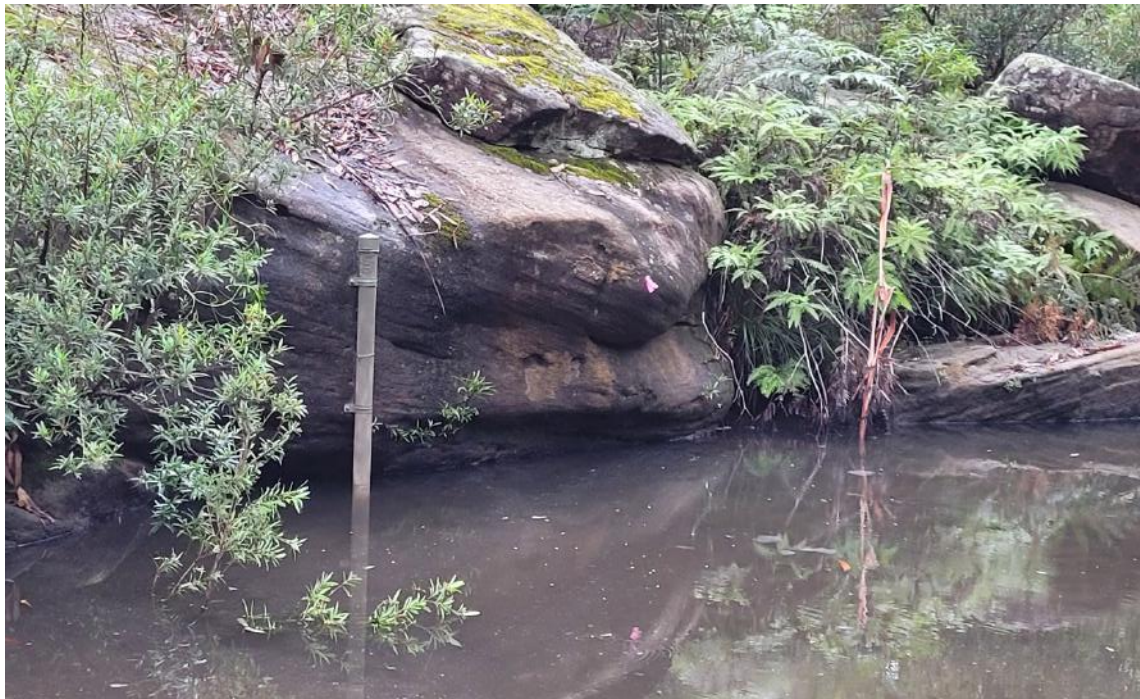
**Plate 7: Water level logger installed in Georges River monitoring site Point 11**

Pool level monitoring was implemented through the installation of water level loggers called “Divers” in February 2021 (see Plate 7). This data can then be used in conjunction with a rating table/curve, and spot flow gaugings, to produce flow data.

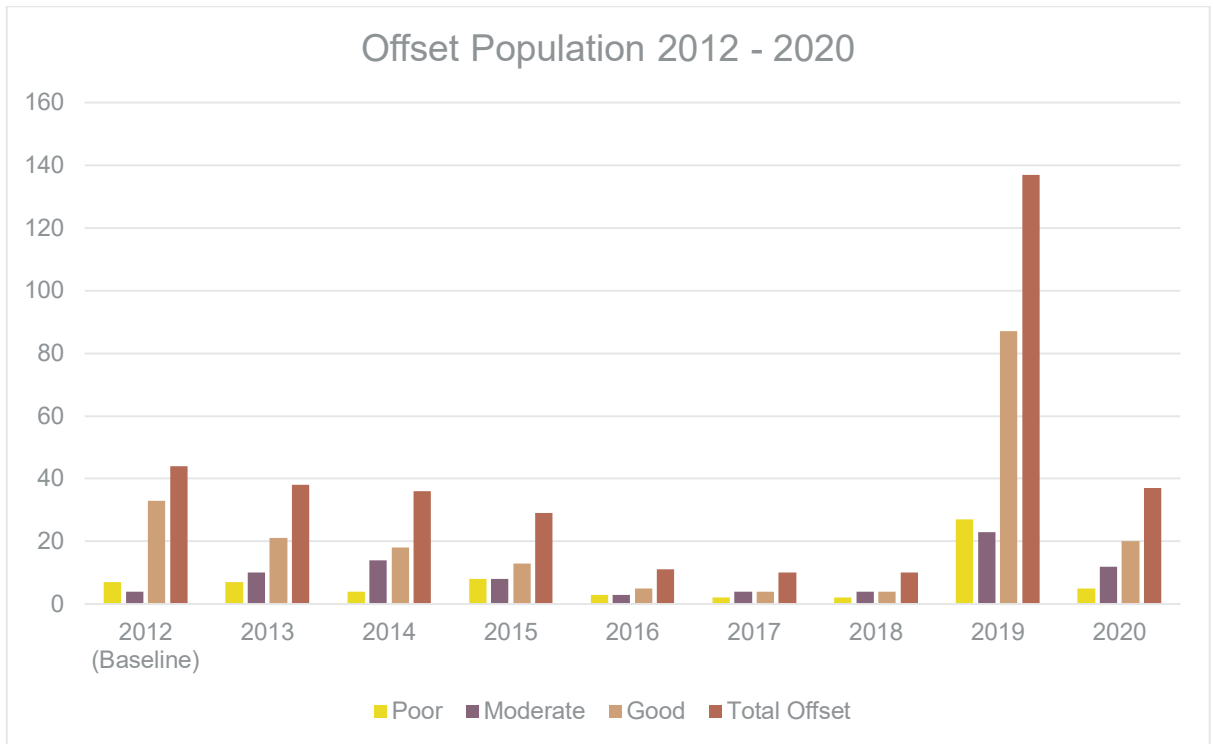
**Figure 9: *P. hirsuta* condition and population within the Offset**

In May 2021, a second translocation was carried out with 90 *P. hirsuta* in the Stage 2 CWEA rehabilitation area. The site consists of a 50 m x 50 m plot within which plants are roughly 1 m apart, each with mammal plant guards to protect against predation (Plate 8). The translocates are between two and four years old and were from propagative material collected from several wild populations to include a wide level of genetic diversity. The translocation will be watered and monitored by Mount Annan Australian Botanic Garden as well as IMC personnel with the aim of the translocation being to supplement the existing population at Appin North.

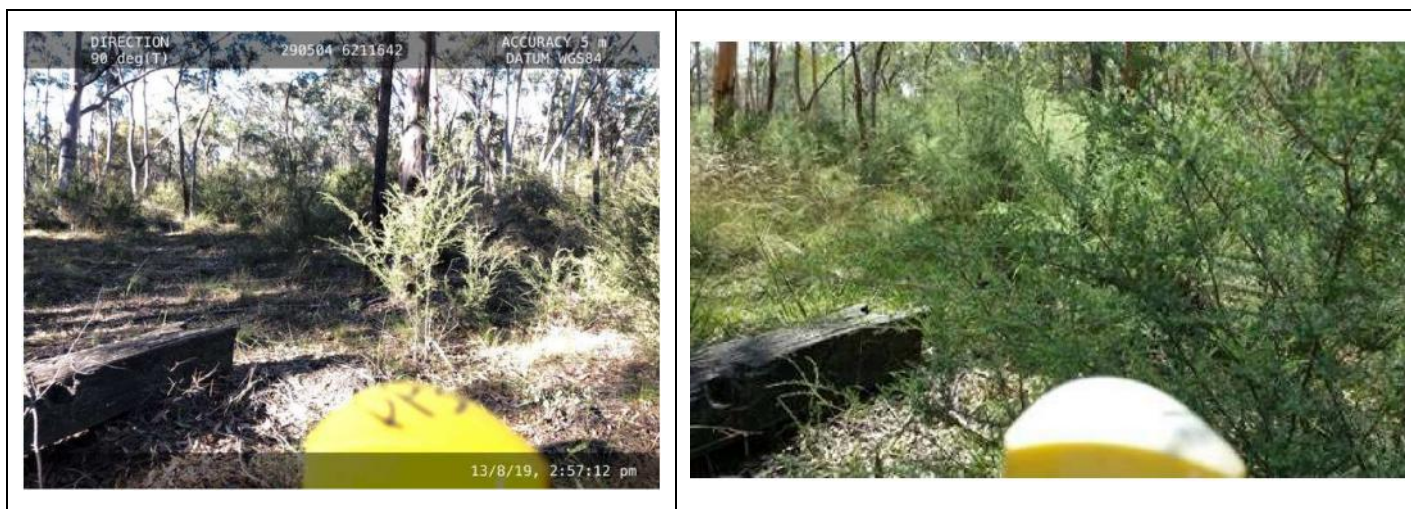
**Plate 9: Comparison of vegetation growth from photo point 3. FY20 (LHS image) and FY21 (RHS Image) at the Cataract River Biobank Site**

Additionally, exclusion fencing and security signage was installed at the Douglas Park Drive entrance of the site in the last reporting period and no stock or evidence of grazing was observed. Since the previous reporting period there was a noticeable increase in the native vegetation and (to a lesser extent) weed growth across the site, which is likely attributed to an increase in rainfall during the reporting period and the installation of the exclusion fencing. An example of this notable increase in vegetation can be seen in the comparison figures below in Plate 9, which shows an image of photo point 3 from last year compared to this year's monitoring.

Three areas from which asbestos was removed were rehabilitated in 2020 with 500 seedlings of local grass, shrub species and 50 seedlings representing canopy species local to the area. The most recent 2021 monitoring observed a high success rate of seedlings on the previously disturbed site.

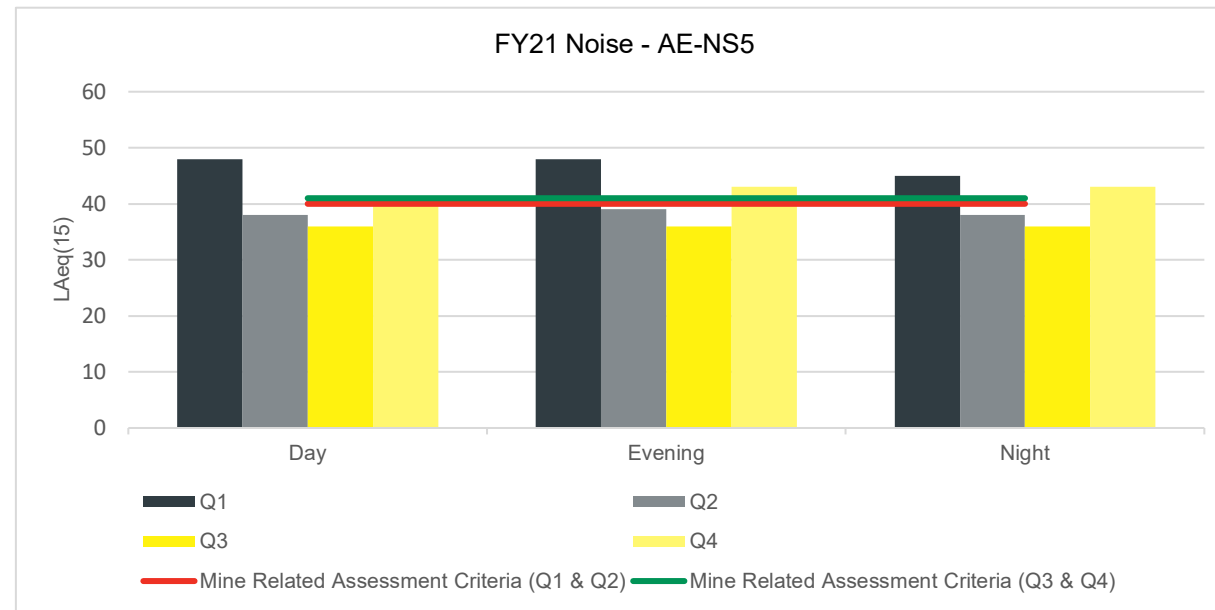
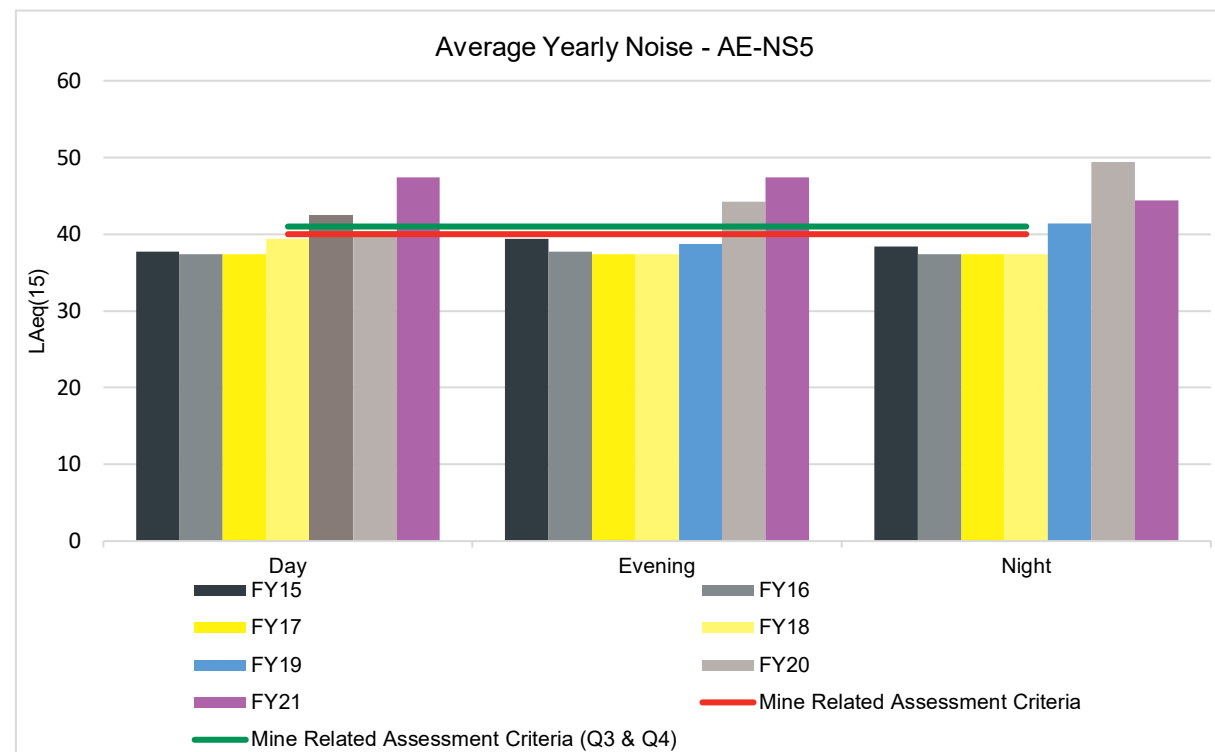
**Non-compliant**

Site noise was clearly audible in FY21 and was observed to be the dominant noise source across all quarters. Three (3) non-compliances of noise criteria greater than 2 dBA over the assessment criteria in the NMP were recorded at AE-NS5:

Northamptondale Road between the No.2 Shaft Site and power plant project and the nearest residential receivers in the South to East quadrant from site. Noise levels between Shaft Site and the nearest residential receivers to the SE

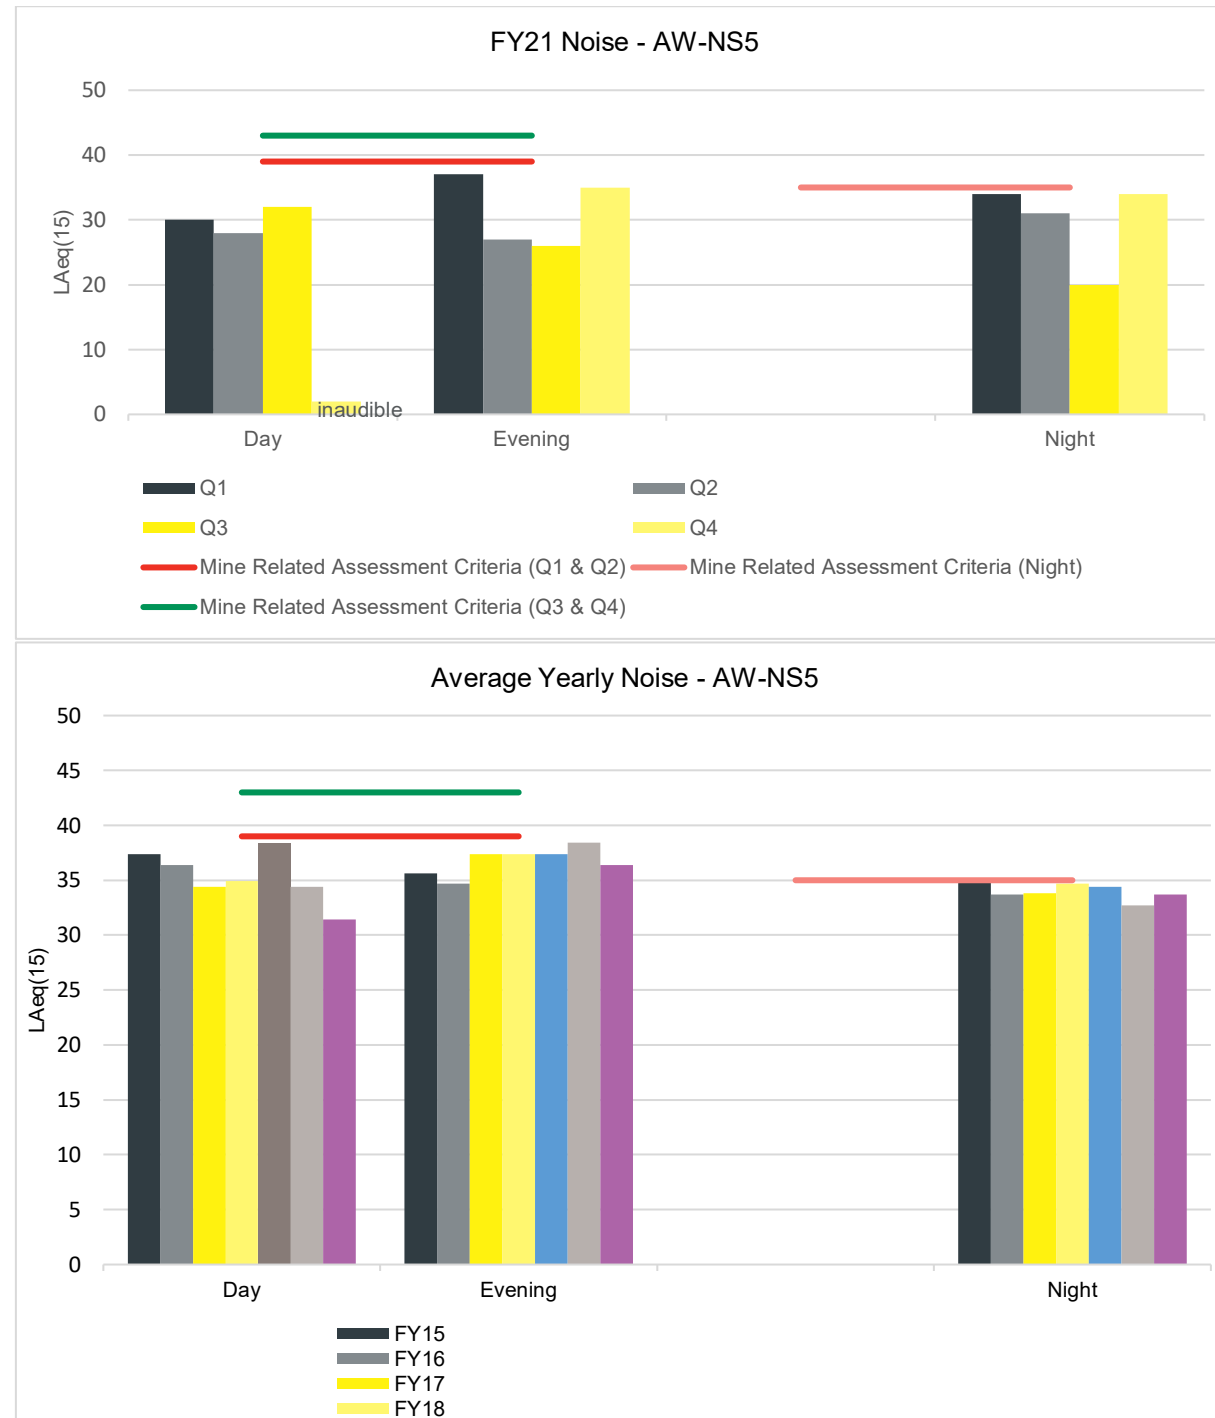
**Compliant**

FY21 exhibited compliance with the assessment criteria.

Between nearest residential receivers on Douglas Park Drive and the Appin West Pit Top  
Noise level at AW property boundary; Noise levels between AW and nearest residential receivers on Douglas Park Drive

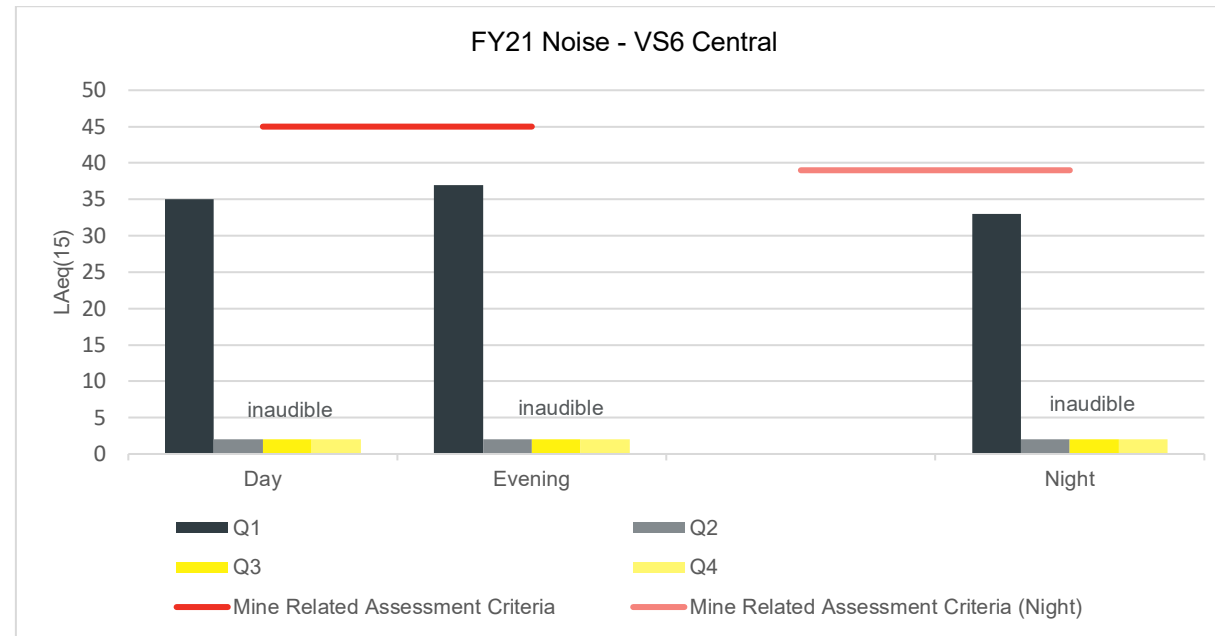
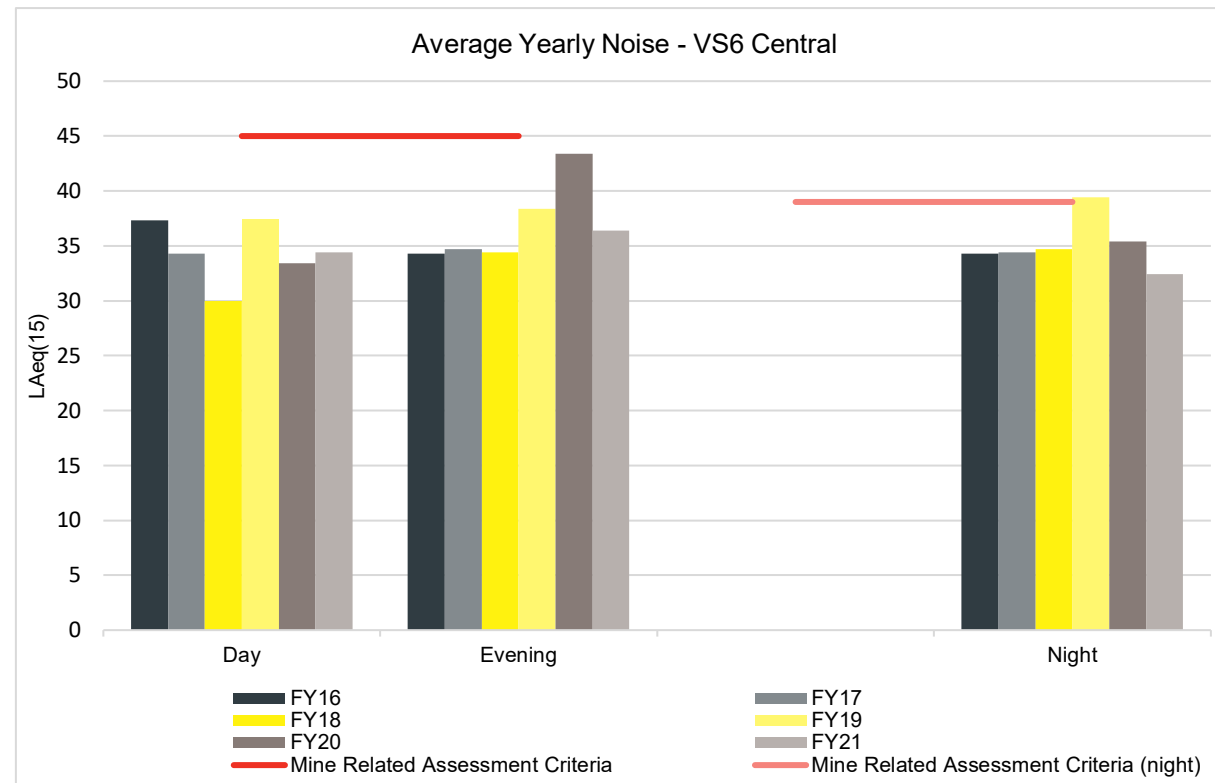
**Compliant:**

In Q1 site noise was clearly audible and was observed to be the dominant noise source across each sampling period. Noise measured was below the sleep disturbance criteria. Q2, 3, and 4 all returned 'inaudible' results across all sampling periods.

VS6 Central	Attended	Douglas Park Township and Receivers	45 day and evening) 49 (night)	Duggan Street behind Douglas Park Public School	Noise level between VS6 area and the nearest residential receivers to the West of site
			39 (night)

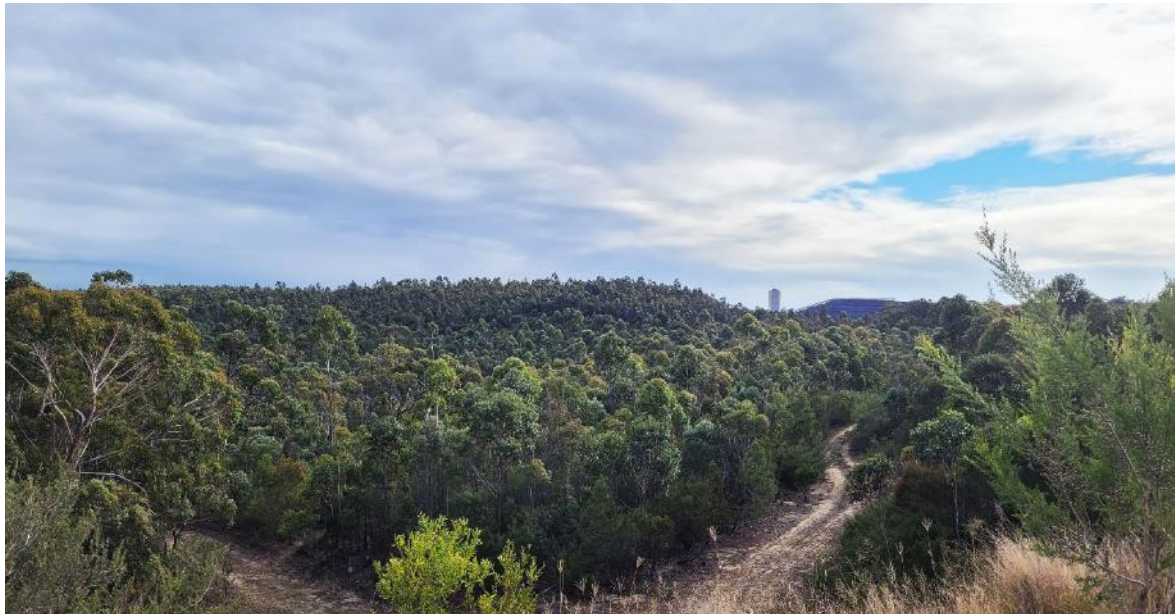
**Plate 10: Stage 2 emplacement rehabilitation FY21 (Seeded in 2007)**

Plate 10 shows the performance of rehabilitation on Stage 2 of the emplacement.

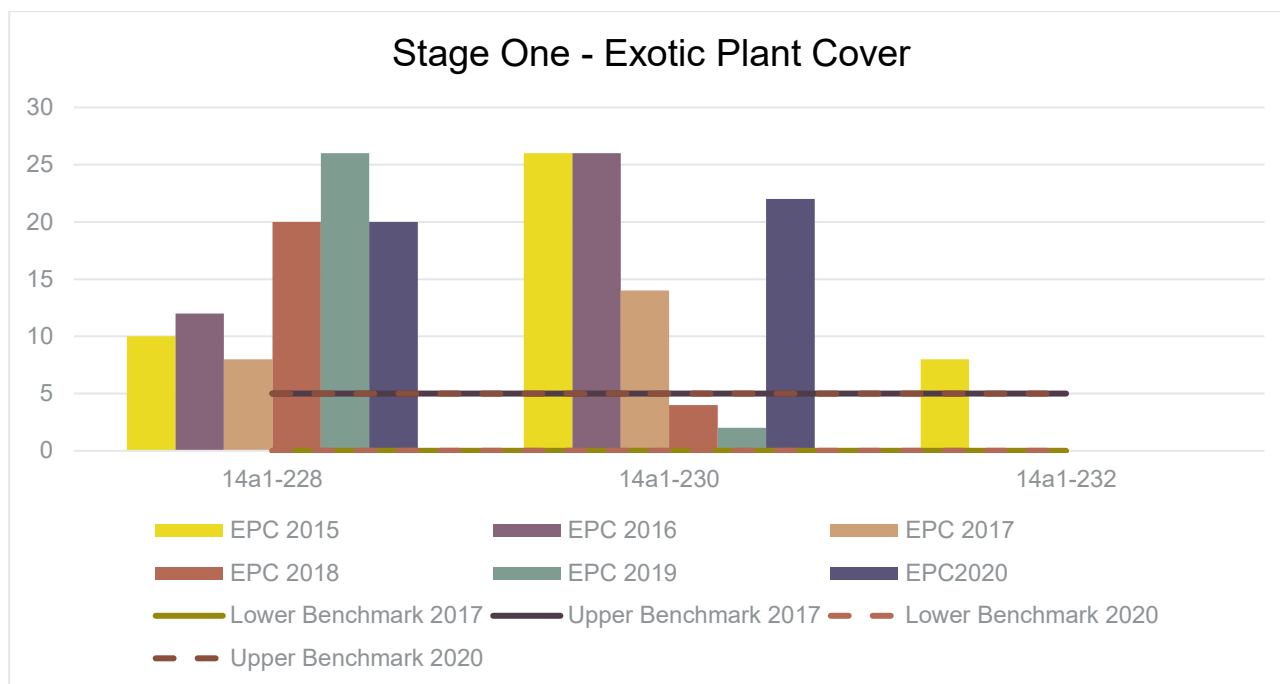
Figure 17: Exotic Plant Cover - Stage One

Out of the three sites in Stage One, two are at or above 20% exotic plant cover (Figure 17), it is suggested that weed management occur in this area mainly for exotic grasses.

There is no local benchmark for exotic plant cover. Whilst it is assumed that there would be 0 – 5% exotic plant cover within the control plots, a target of <20% has been established in the KPIs for all rehabilitation areas.

The dominant weeds recorded include *Eragrostis curvula* (African lovegrass), *Andropogon virginicus* (Whisky Grass), *Conyza bonariensis* (Fleabane), and *Hypochaeris radicata*. *Pennisetum clandestinum* (Kikuyu), *Cortaderia selloana* (Pampas grass) and *Cynodon dactylon* (Common Couch) are all exotic perennial grasses that have dominated localised patches within the CWEA and also require management.

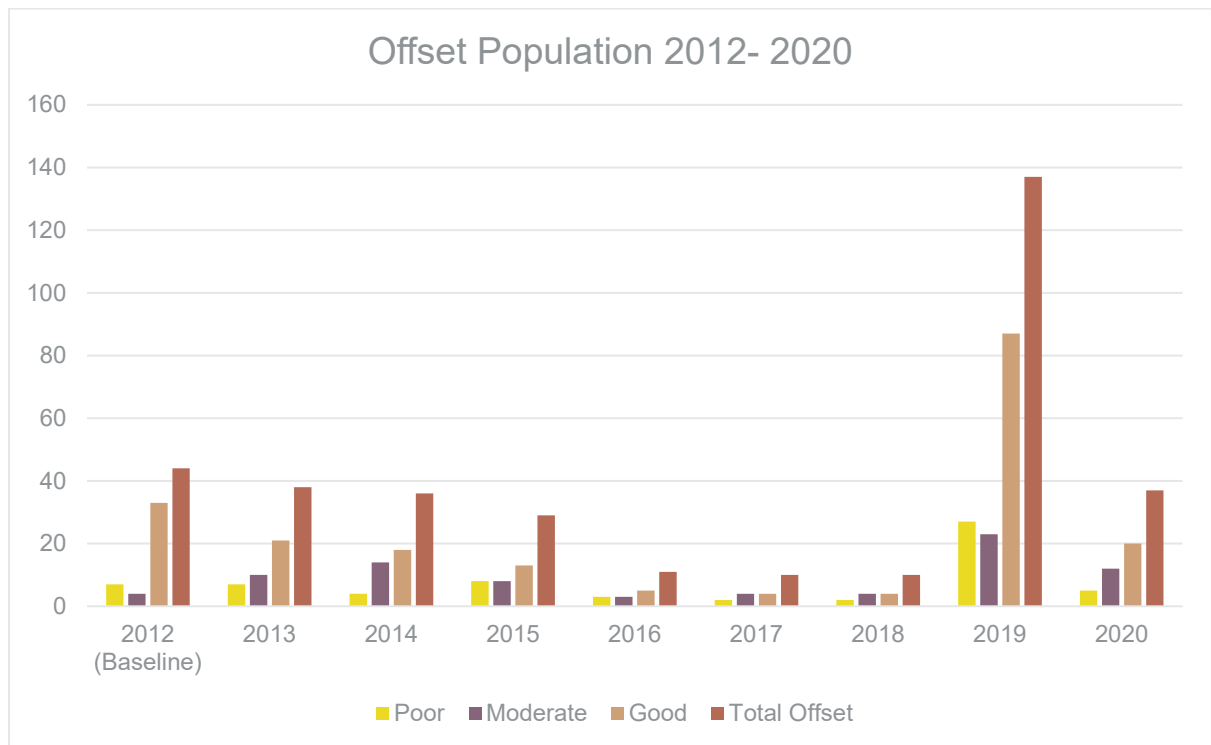
**Figure 1: Comparison of *Persoonia hirsuta* condition and population within the Offset across years:**

- There were 28 individuals of translocated *Persoonia hirsuta* alive in the translocated area in December 2020 (PB002, PB005, PB007, PB008, PB022, PB025, PB030, PB038, PB039, PB045, PB046, PB047, PB052, PB053, PB054, PB060, PB062, PB064, PB070, PB075, PB076, PB077, PB088, PB090, PB093, PB103, PB113, PB124).

- The total individuals combined with the offset and translocated population is 38.

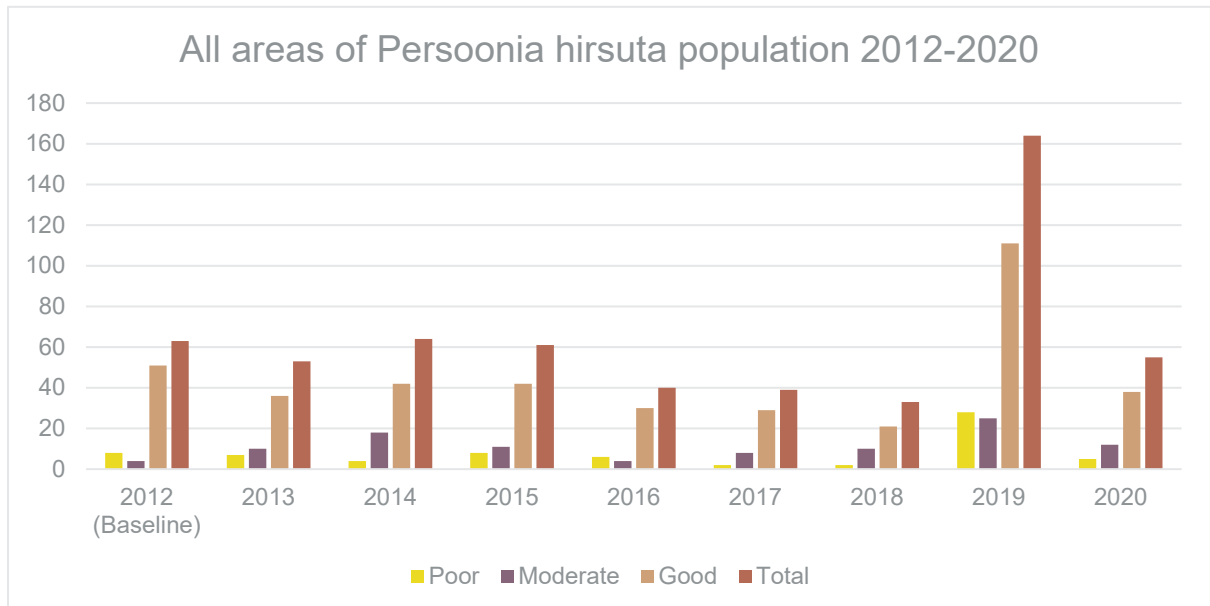
**Figure 2: Comparison of condition and population of all plants across years**

- The total count for live *P. hirsuta* plants at Appin North in summer 2020 was 49, including plants that have been identified post-baseline (2012) and the additional 28 plants translocated that are still alive (Figure 2). Excluding these, there has been a decrease of 105 plants in 2020, 98 of the translocated individuals and seven in the non-impacted area along the Dam Road.
