# **APPIN MINE ANNUAL REVIEW FY22**

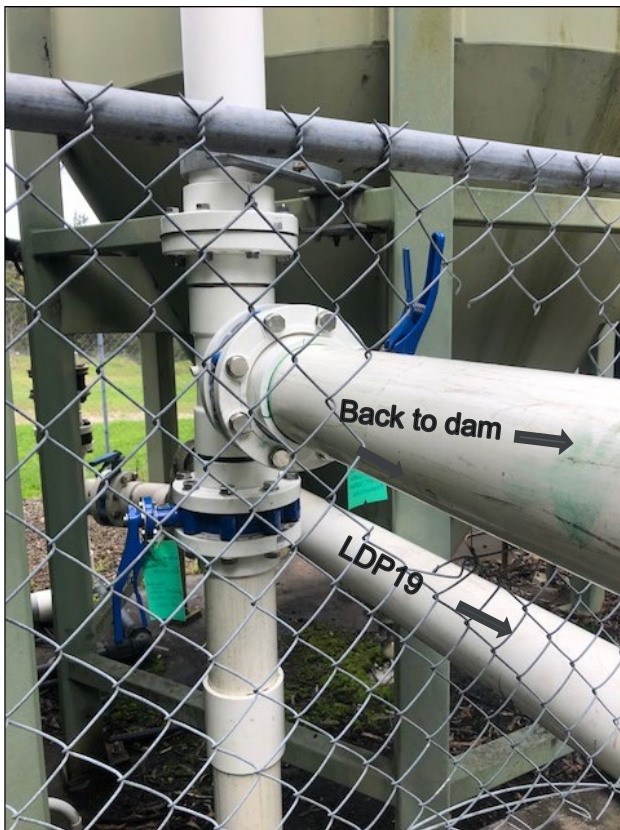
Plate 1: Recirculating valve after Dynasand filter

The units were installed and commissioned in July 2021. The set up is shown in Plate 1.

During the reporting period, IMC had identified that a recirculation system was required to reduce the risk of a potential non-compliance with water quality parameters from LDP 19. After treatment via flocculation, settling and filtering methods, if the treated water is determined to be non-compliant with licence conditions, the recirculation system can be initiated until compliance is achieved.

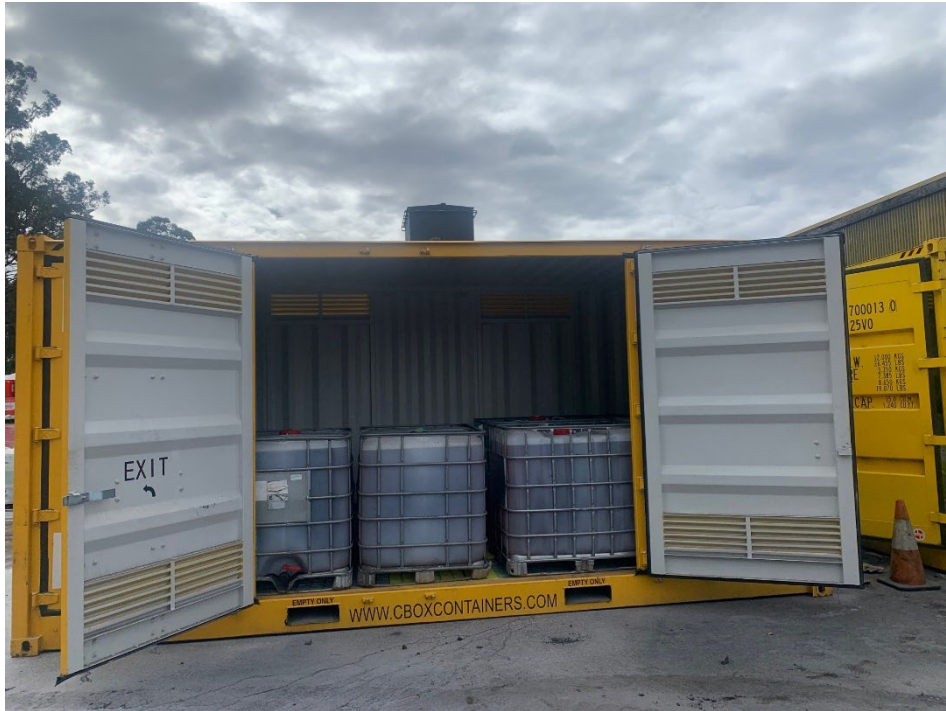
**Plate 2: Self Bunded Storage Container**

As part of an ongoing initiative to improve environmental standards with respect to chemical and hazardous goods storage, IMC installed an additional 20" self-bunded storage container in May 2022, dedicated to hydrocarbon storage (Plate 2).

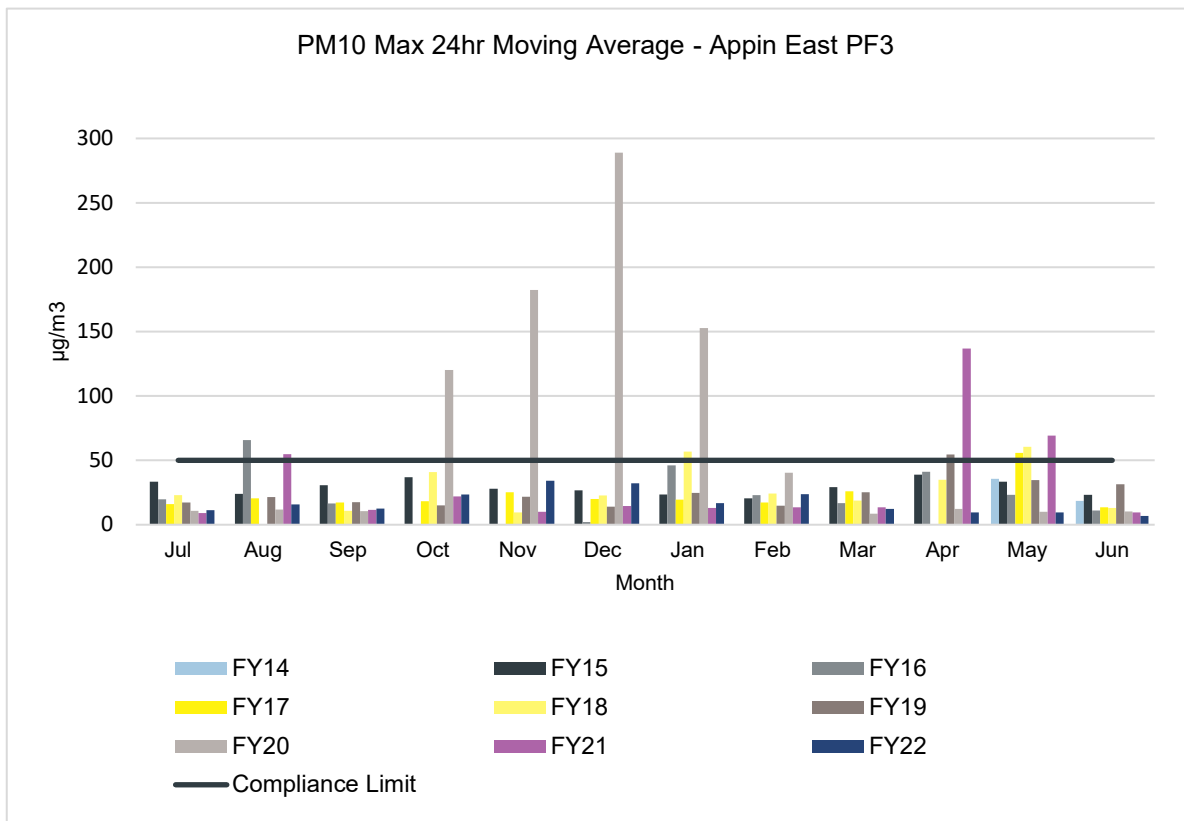
**Figure 2: PM<sub>10</sub> Maximum 24-hour Moving Average at Appin East PF3**

No exceedances against the short-term criteria were observed at AE-PF3 at Appin East during this reporting period. AE-PF1 at Appin East, W-PF1 at Appin North and VS6-PF1 at Ventilation Shaft 6, also recorded no exceedances over this reporting period. Results from the optical photometers are presented in Figure 2, Figure 3, Figure 4 and Figure 5 respectively.

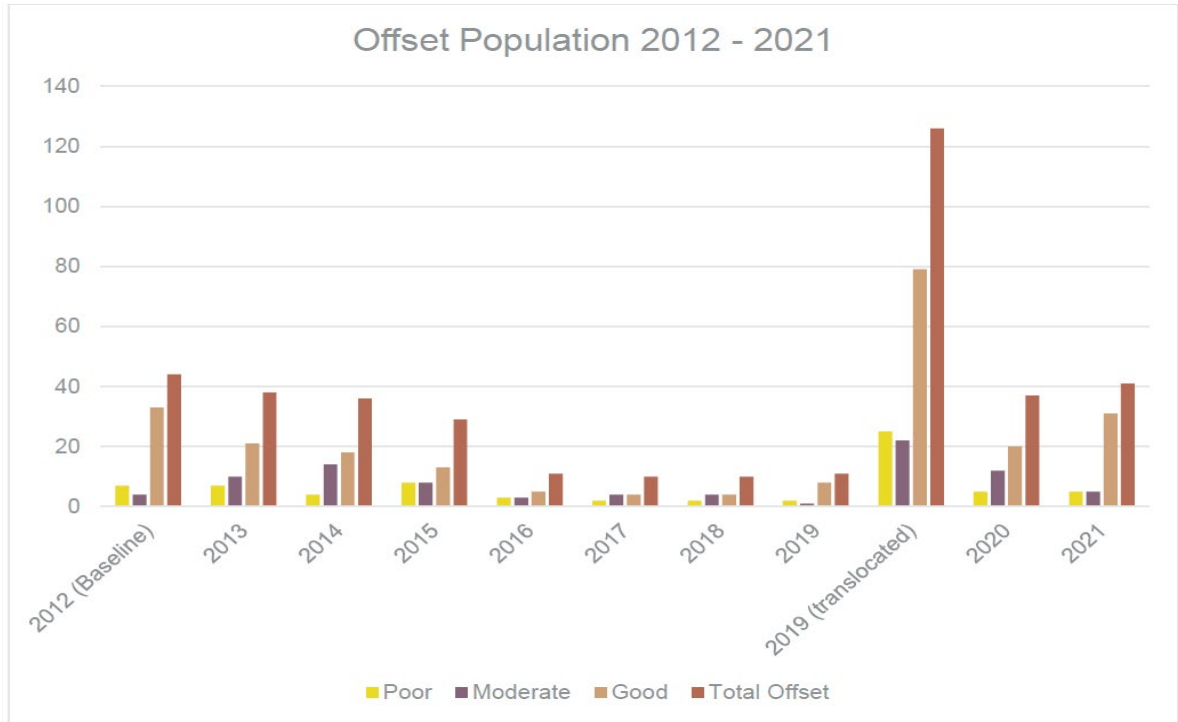
**Figure 6: *P. hirsuta* condition and population within the Offset during the 2021 Spring monitoring**

In May 2022, a third translocation was completed in the *Persoonia hirsuta* offset area at Appin North. This translocation included 102 individuals in an area roughly 50 m x 50 m in which plants are generally 1 m or greater apart. Each plant was planted with the installation of a mammal plant guard to protect against predation. The translocates were sourced from similar locations to the Stage 2 propagative material, having several different wild populations amongst the translocation. This encourages genetic diversity amongst the plants and will promote outcrossing. The plants were watered after planting to promote good root connection with the external soil, and natural wet weather events continued to supplement the establishing plants with sufficient watering post May 2022. This translocation will be included in the 2022 *Persoonia hirsuta* spring monitoring.

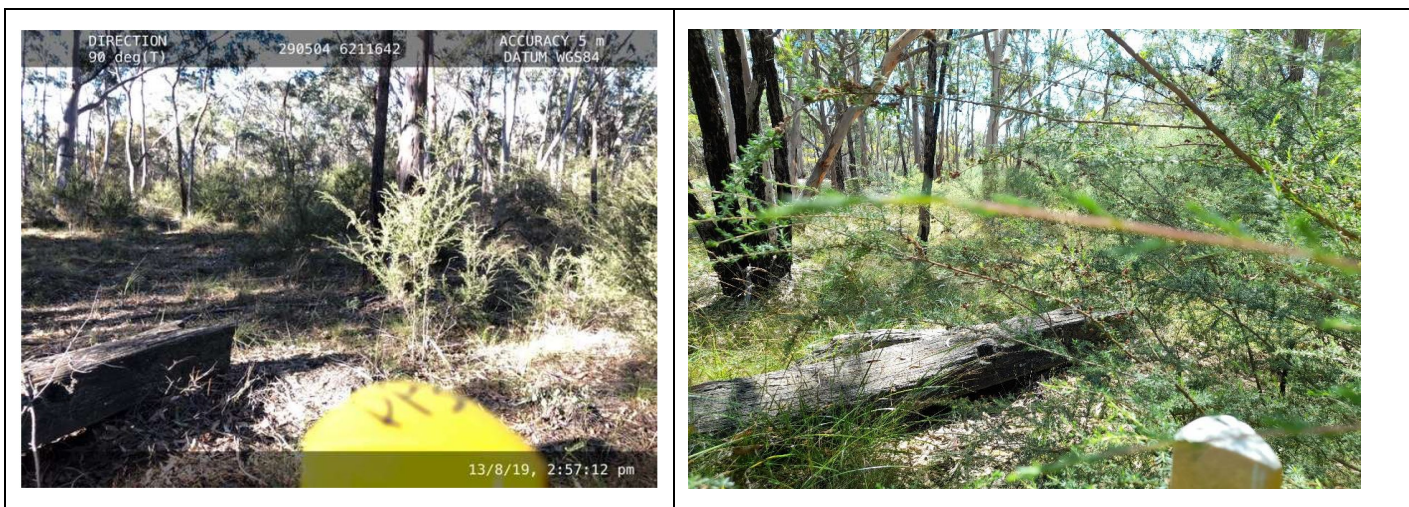
**Plate 6: Comparison of vegetation growth from photo point 3. FY20 (LHS image) and FY22 (RHS Image) at the Cataract River Biobank Site**

Additionally, exclusion fencing and security signage was installed at the Douglas Park Drive entrance of the site in the 2021 reporting period and no stock or evidence of grazing was observed over the 2022 reporting period. Since the previous reporting period there was a noticeable increase in the native vegetation and (to a lesser extent) weed growth across the site, which is likely attributed to an increase in rainfall during the reporting period and the installation of the exclusion fencing. An example of this notable increase in vegetation can be seen in the comparison figures below in Plate 6, which shows an image of photo point 3 from last year compared to this year's monitoring.

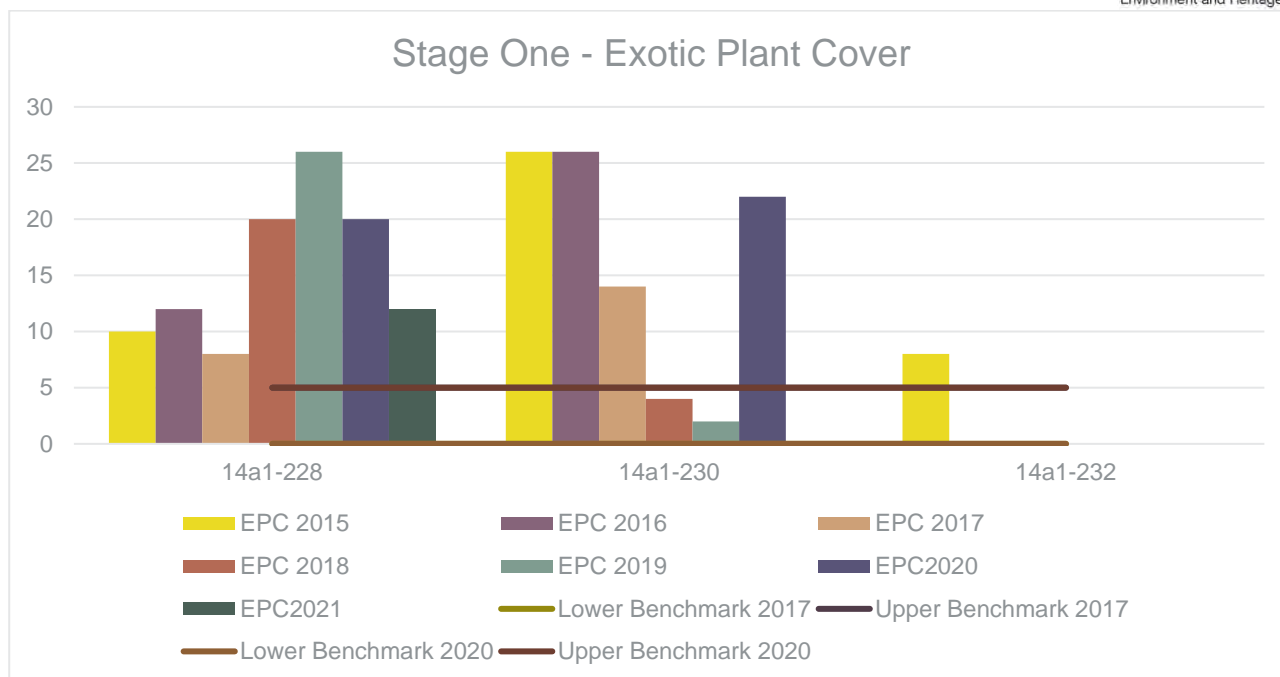
Figure 17: Exotic Plant Cover - Stage One

Out of the three plots in Stage One, only one was above 5% exotic plant cover in 2021 (Figure 17) and none are above 20%. It is recommended that weed management occur in this area, mainly to control exotic grasses.

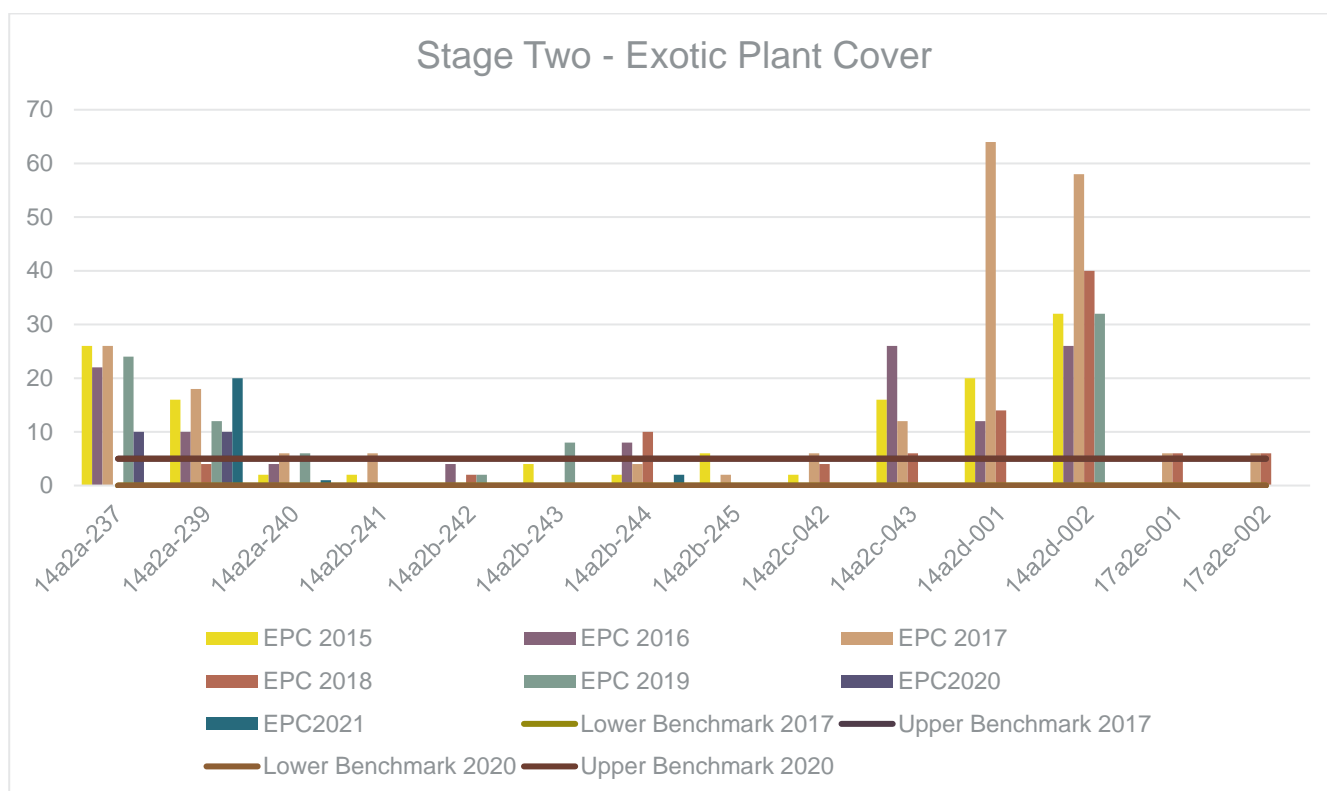
Figure 18: Exotic Plant Cover - Stage Two (Areas 2a, 2b, 2c, 2d and 2e)

Within Stage Two, only plot 14a2a-239 had 20% exotic plant cover. The rest of the plots in Stage Two ranged between 0-2% exotic plant cover (Figure 18).

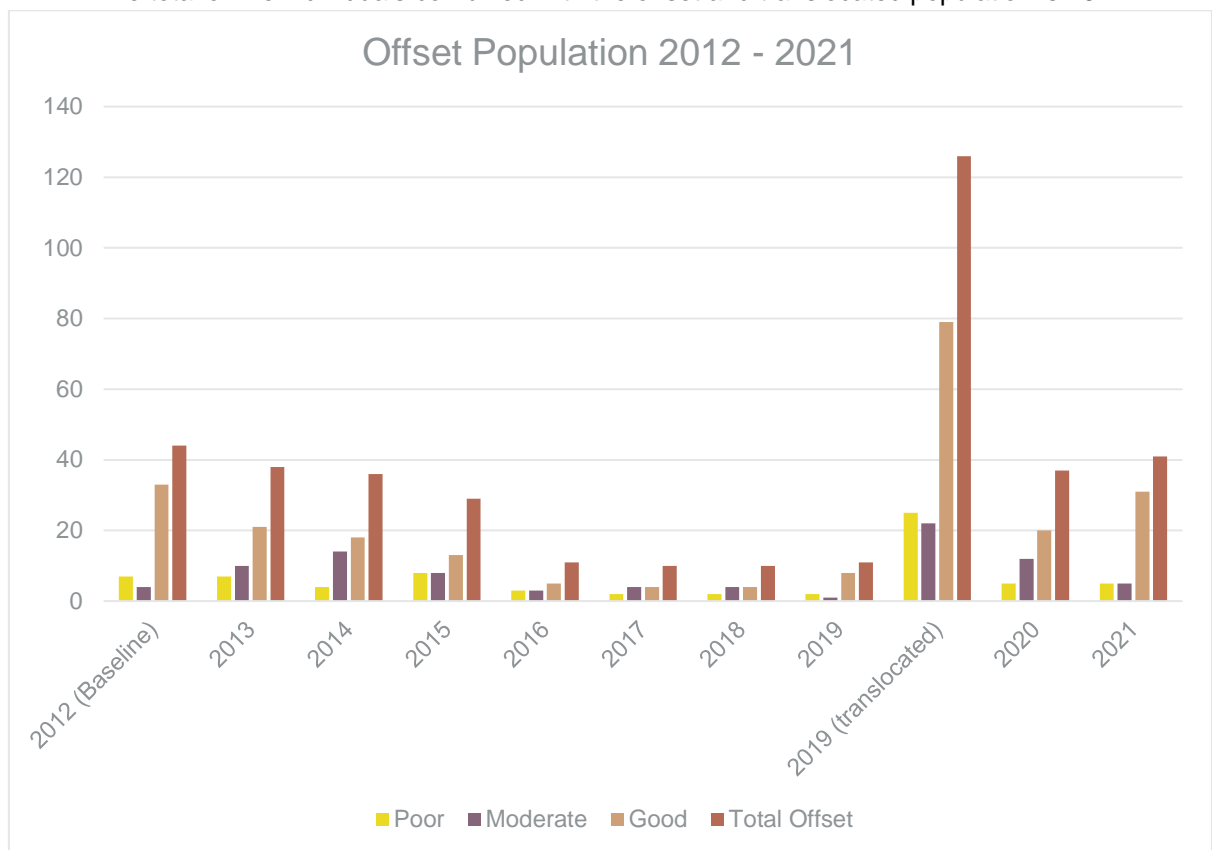
**Figure 1: Comparison of *Personia hirsuta* condition and population within the Offset across years**

- A total of 90 plants were translocated in 2021 (PB128-PB217) (Figure 1). One plant has died since translocation, likely due to stresses when initially planted, leaving 89 living plants.

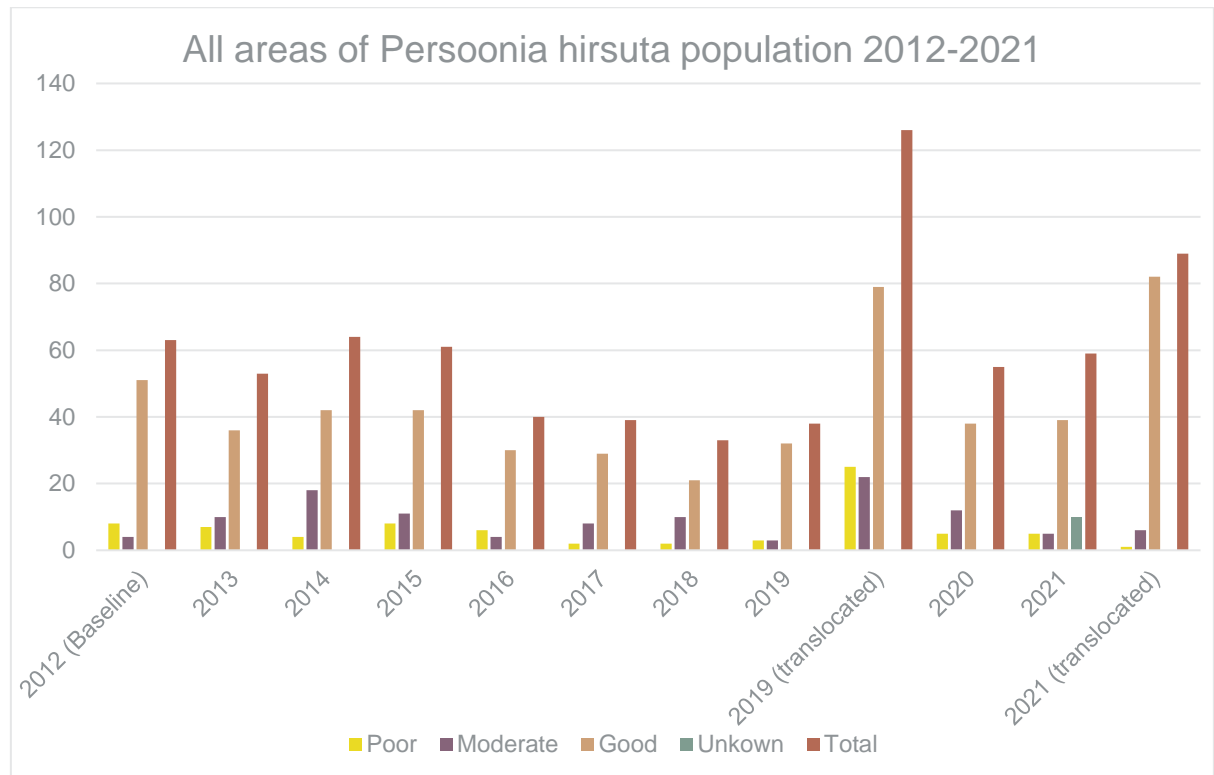
Figure 2: Comparison of condition and population of all *Persoonia hirsuta* plants across years

plants, there has been a decrease of 3 plants in 2021, all three are from within the non-impacted area along Dam Road.

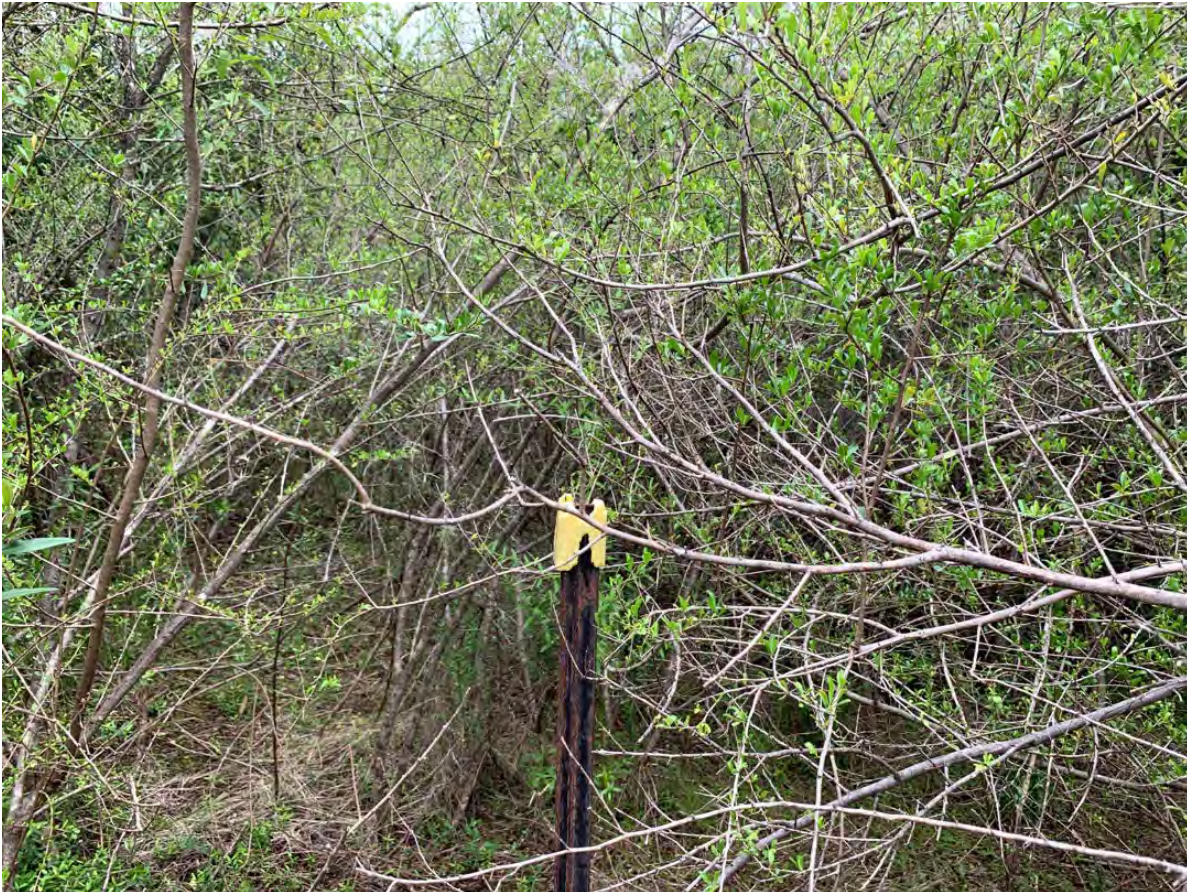
**Plate 2. Blackthorn thicket in plot MZ5-004 in 2021**

Woody weeds such as African Olive and African Boxthorn are persisting in the woodland area throughout MZ5 and MZ6 and it is recommended that woody weed control continue to be undertaken in this area in 2022. The African Olive can dominate the ground cover with juvenile individuals sprouting rapidly underneath the canopy.

As recommended in previous monitoring reports, bush regeneration works should continue and focus on the removal of African Olive and Blackberry within the vicinity of plot MZ5\_004 and MZ6\_010, due to the presence of the threatened plant, *Pimelea spicata*, at MZ5\_004. Any management in this area should be conducted with care so as to minimise any impact to *Pimelea spicata* individuals. In this area the population of *Pimelea spicata* is largely associated with the Blackthorn thicket.
