### **Appendix 1: EPL 2504 Annual Return - 2022/2023**

**Common name (if any)** : 3. APPIN COLLIERY - NORTH (AND WESTCLIFF COAL PREP PLANT)  
**Premises** : WEDDERBURN ROAD APPIN 2560 NSW

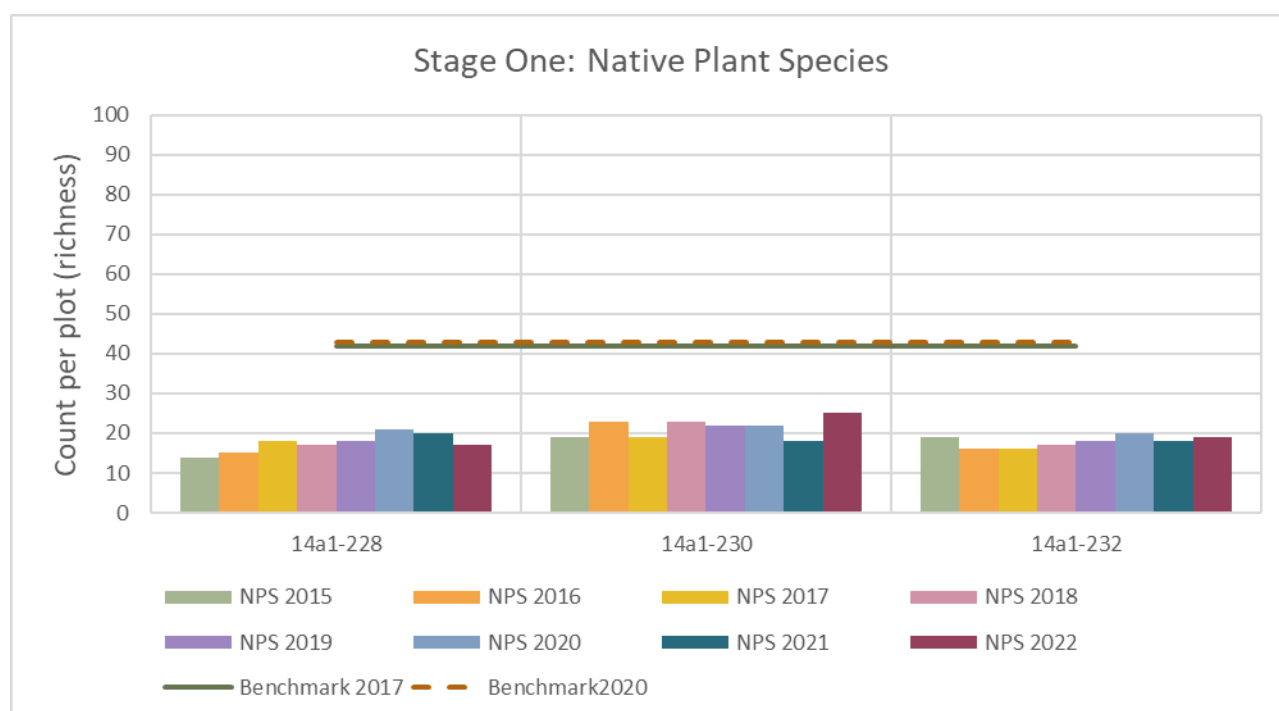
**Figure 1. Stage One NPS richness per plot from 2015 to 2022 and the Benchmark 2020  $\geq$  43 (previous Benchmark 2017  $\geq$  42).**

The plots in Stage One had a mean NPS richness of 20.3. This was slightly higher than the mean of 18.7 in 2021 and slightly lower than the mean of 21 in 2020. All plots remain below the Benchmark 2020.

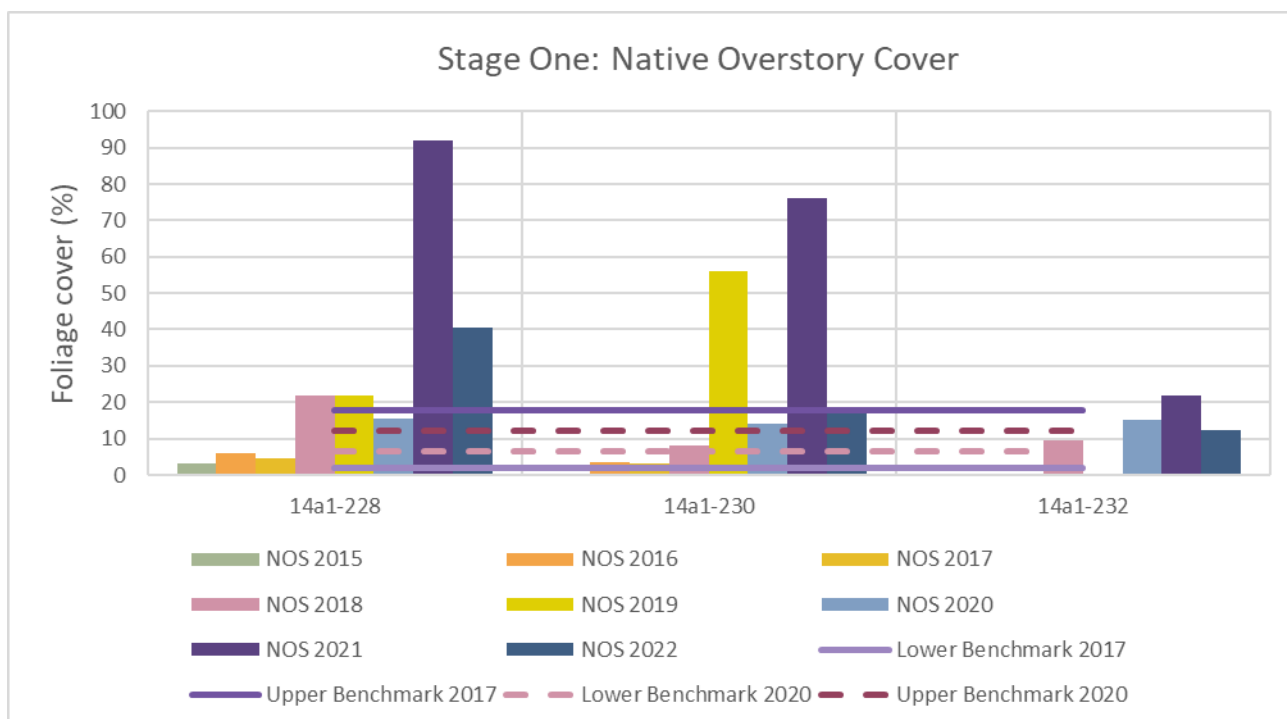
**Figure 4. Stage One NOS cover per plot from 2015 to 2022 and the lower and upper Benchmark 2020 6.6 – 12.0% (previous Benchmark 2017 1.9 – 17.7%).**

The plots in Stage One had a mean NOS cover of 23.3%. This was markedly lower than the mean of 63.3% in 2021 and higher than the mean of 14.9% in 2020. All plots were above the upper Benchmark 2020.

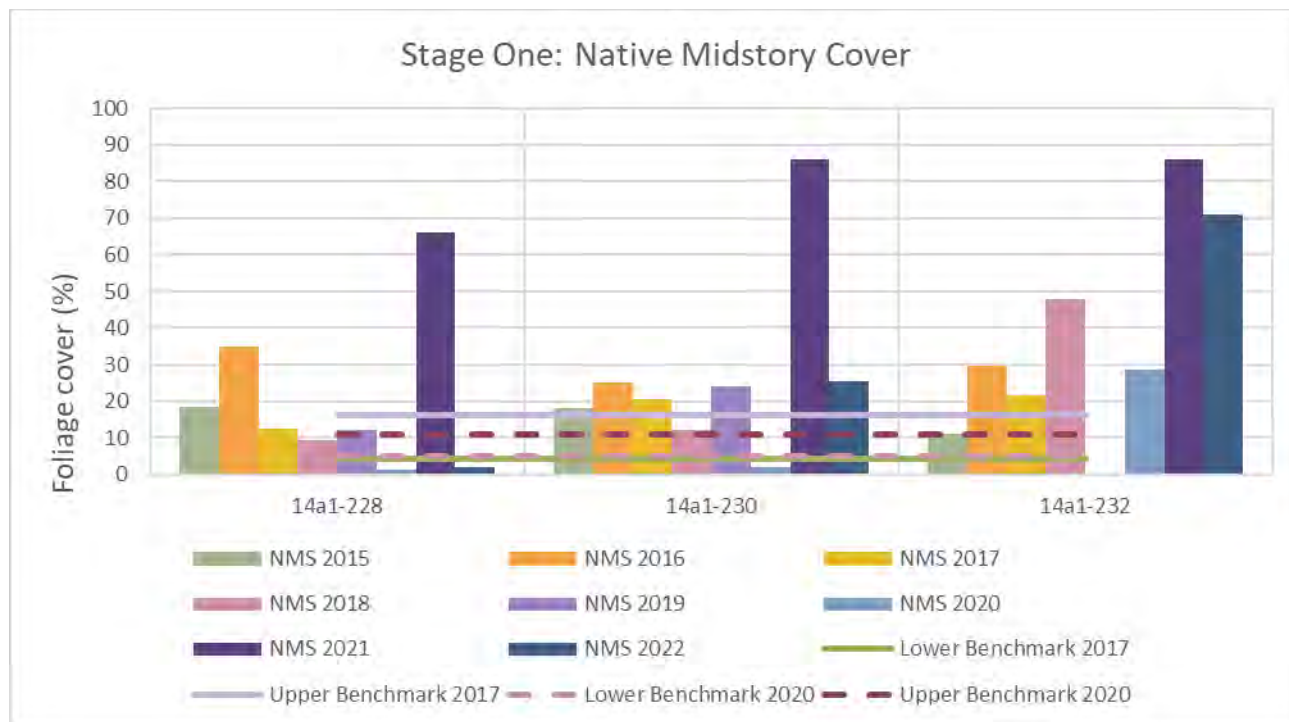
**Figure 4. Stage One NMS cover per plot and the upper and lower Benchmark 2020 4.9 – 11.0% (previous Benchmark 2017 4.4 – 16.0%).**

The plots in Stage One had a mean NMS cover of 32.9%. This was markedly lower than the mean of 79.3% in 2021 and markedly higher than the mean of 10.7% in 2020. Plot 14a1-228 was below the lower Benchmark 2020, while the remaining plots were above the upper Benchmark 2020.

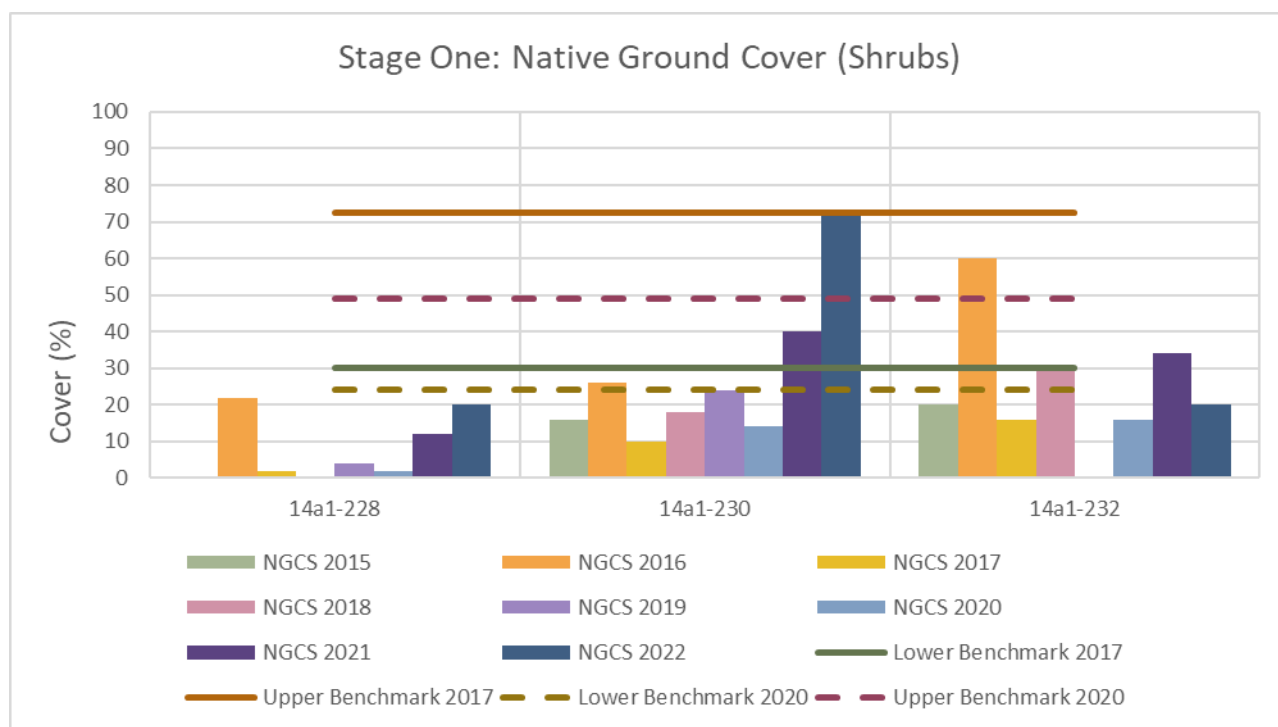
**Figure 6. Stage One NGCS per plot from 2015 to 2022 and the upper and lower Benchmark 2020 24.0 – 49.0% (previous Benchmark 2017 30.0 – 72.6%).**

The plots in Stage One had a mean NGCS of 37.3%. This was higher than the mean of 28.7% in 2021 and markedly higher than the mean of 10.7% in 2020. Plots 14a1-228 and 14a1-232 were below the lower Benchmark 2020, while plot 14a1-230 was above the upper Benchmark 2020.

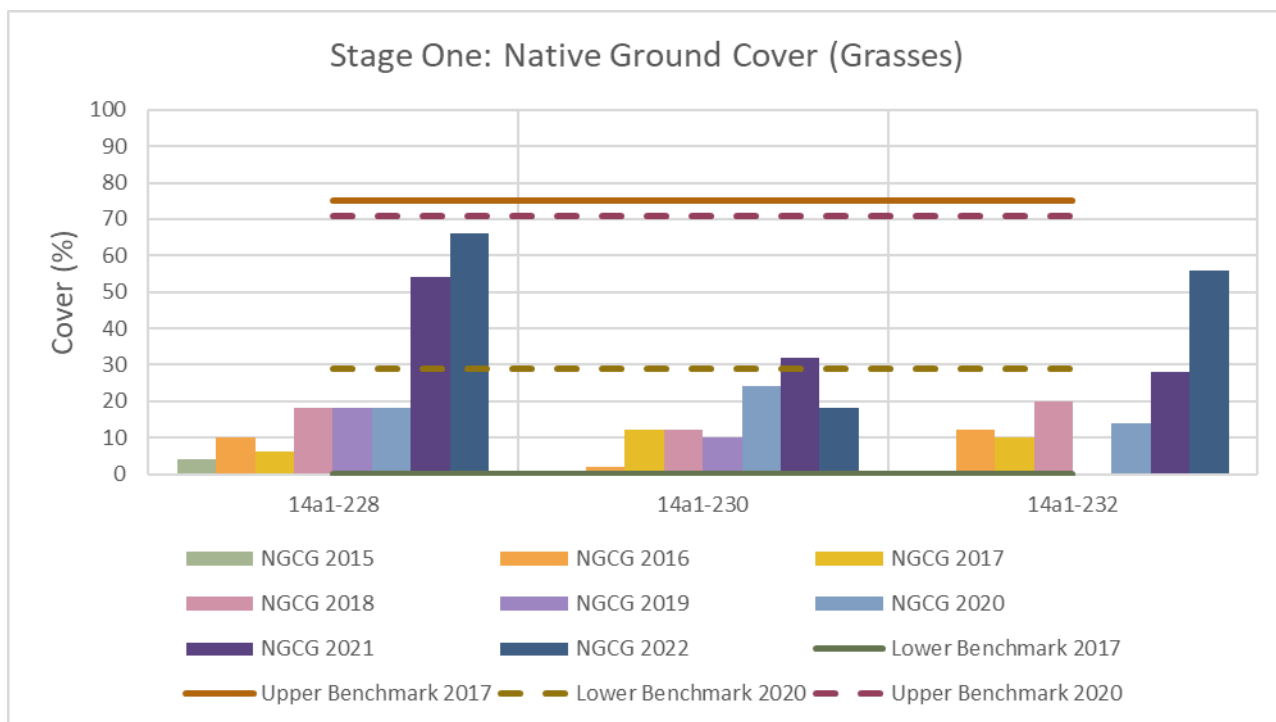
**Figure 9. Stage One NGCG per plot from 2015 to 2022 and the upper and lower Benchmark 2020 29.0 – 71.0% (previous Benchmark 2017 0.0 – 75%).**

The plots in Stage One had a mean NGCG of 46.7%. This was higher than the mean of 38% in 2021 and markedly higher than the mean of 18.7% in 2020. Plots 14a-228 and 14a1-232 fell within the range of the Benchmark 2020, while plot 14a1-230 fell below the lower Benchmark 2020.

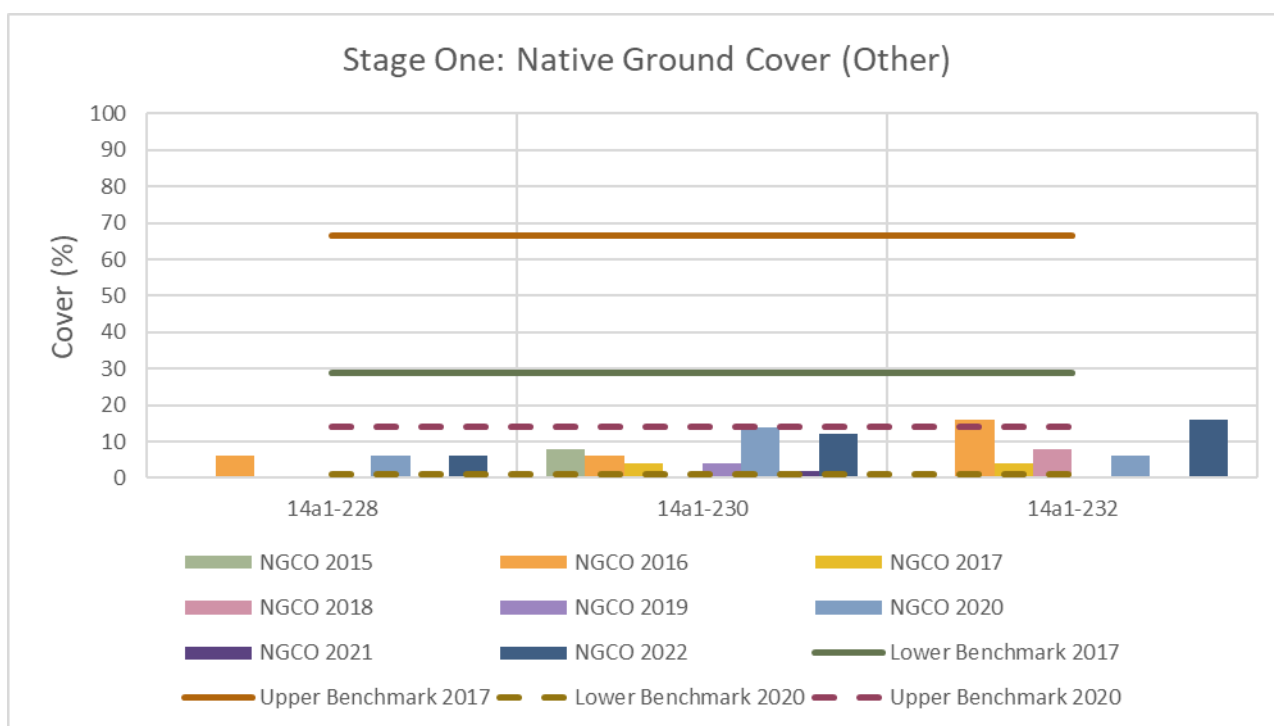
**Figure 12. Stage One NGCO per plot from 2015 to 2022 and the upper and lower Benchmark 2020 1 – 14% (previous Benchmark 2017 28.8 – 66.6%).**

The plots in Stage One had a mean NGCO of 11.3%. This was markedly higher than the mean of 0.7% in 2021 and slightly higher than the mean of 8.7% in 2020. Plots 14a1-228 and 14a1-230 fell within the range of Benchmark 2020, while plot 14a1-232 was higher than the upper Benchmark 2020.

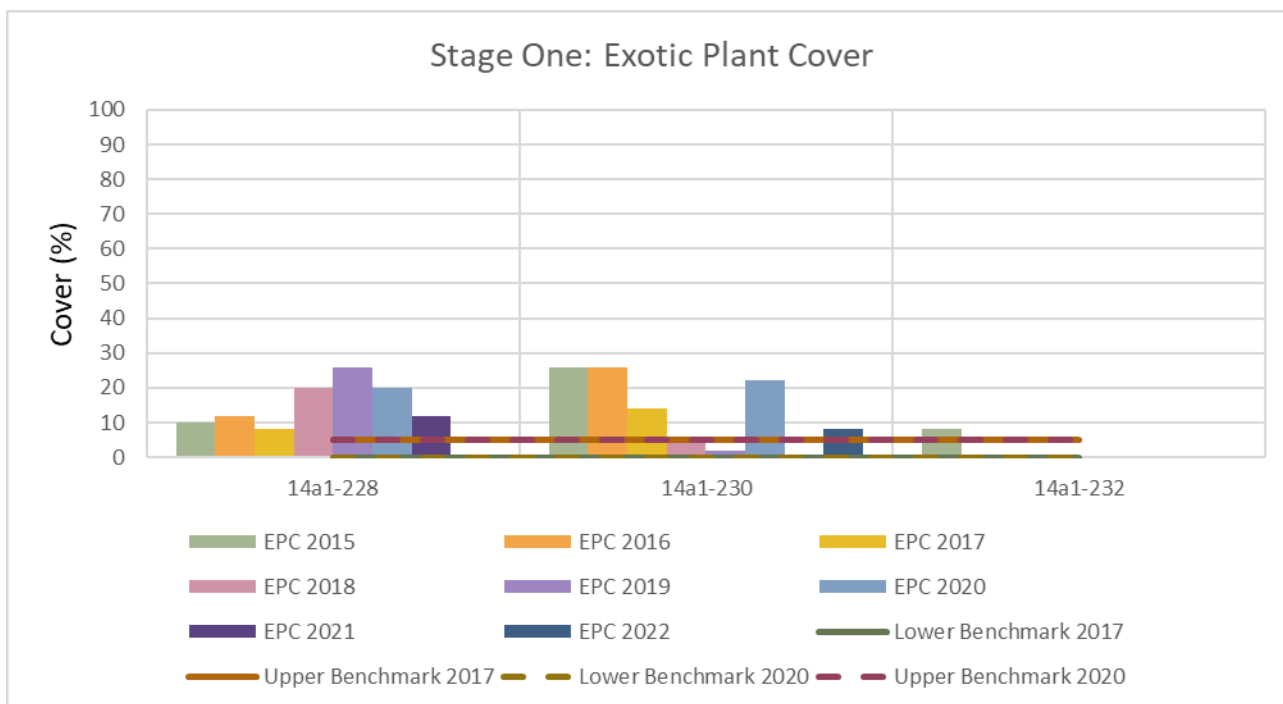
**Figure 15. Stage One EPC per plot from 2015 to 2022 and the upper and lower Benchmark 2020 0 – 5% (previous Benchmark 2017 0 – 5%)**

The plots in Stage One had a mean EPC of 2.7%. This was lower than the mean of 4% and 14% in 2021 and 2020, respectively. Plot 14a1-230 was above the upper Benchmark 2020, while the remaining plots were below. All plots had an EPC of <20%.

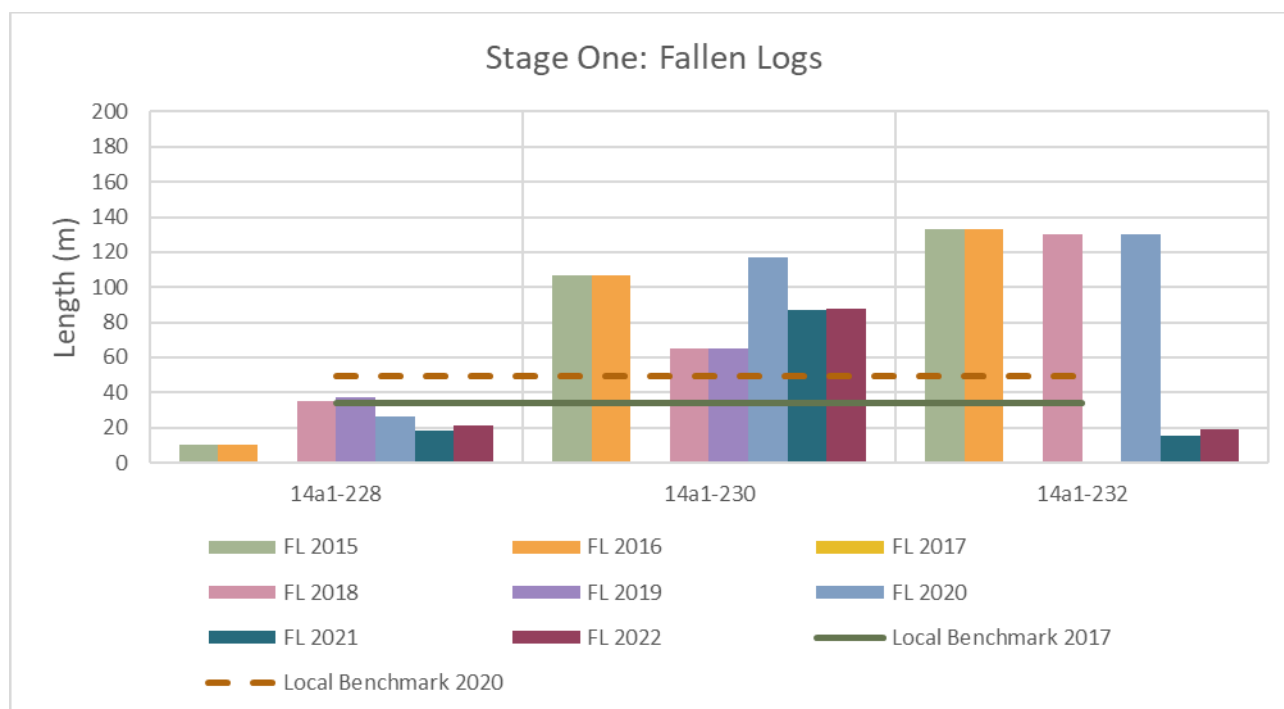
**Figure 18. Stage One FL per plot from 2015 to 2022 and the mean FL of the Benchmark 2020  $\geq 49.3$  (previous Benchmark 2017  $\geq 34$ ).**

The plots in Stage One had a mean FL length of 42.7m. This was slightly higher than the mean of 40m in 2021 and markedly lower than the mean of 91m in 2020. Plots 14a1-228 and 14a1-232 failed to reach the Benchmark 2020.

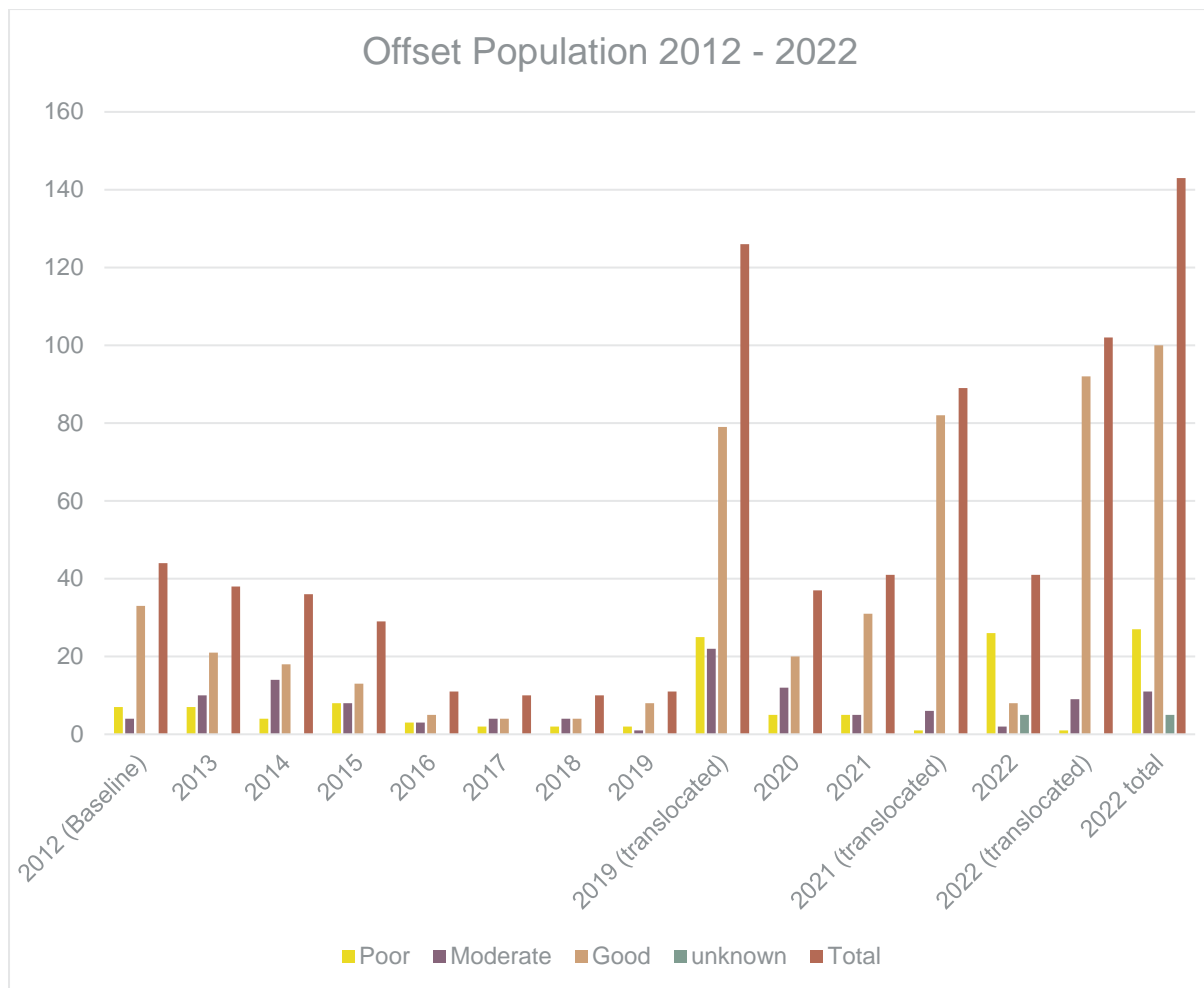
**Figure 1: Comparison of *Persoonia hirsuta* condition and population within the Offset across years**

- The total of live individuals within the offset area excluding the 2022 translocated population (including the 2019 translocated population) is 41.
- The total of live individuals combined with the offset and translocated population is 143.
