**Illawarra Coal
Bulli Seam Operations**

Annual Environmental Management Report

1 July 2013 to 30 June 2014

BSO Project Approval 08_0150 Schedule 6, Condition 4

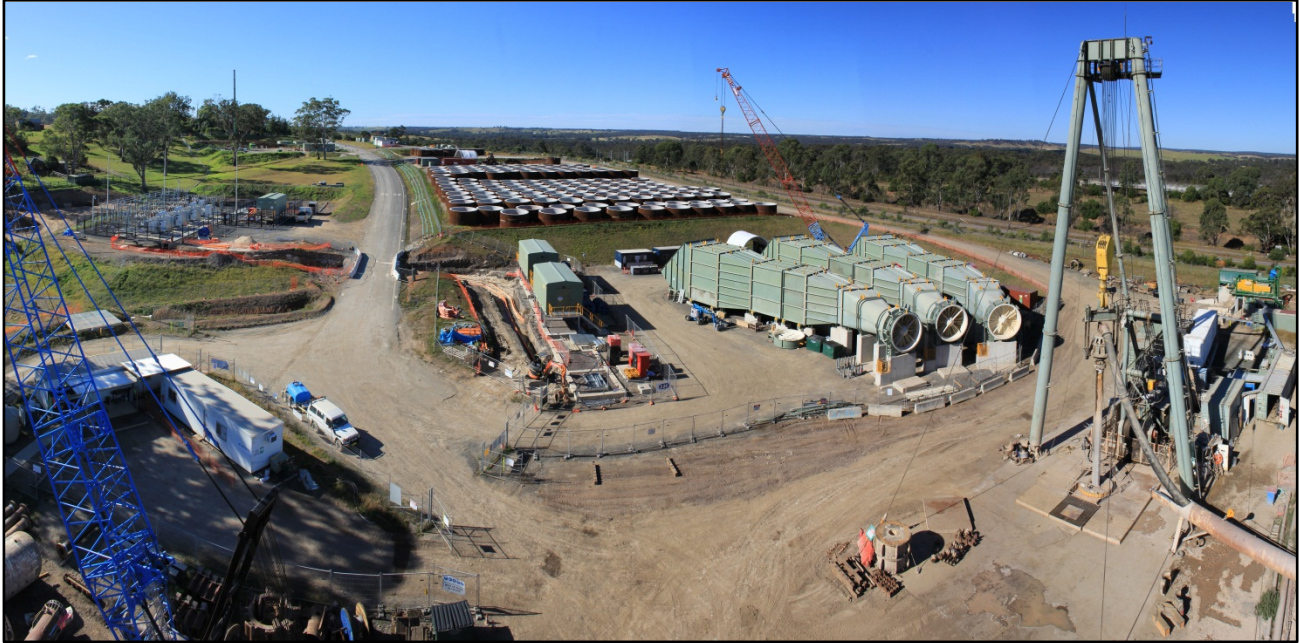
Figure 1: An elevated view of the VS#6 precinct showing the shaft drilling activities (foreground on right), fan and ducting construction (green structure behind drill rig), shaft liners (background on right), and electrical substation (centre on left).

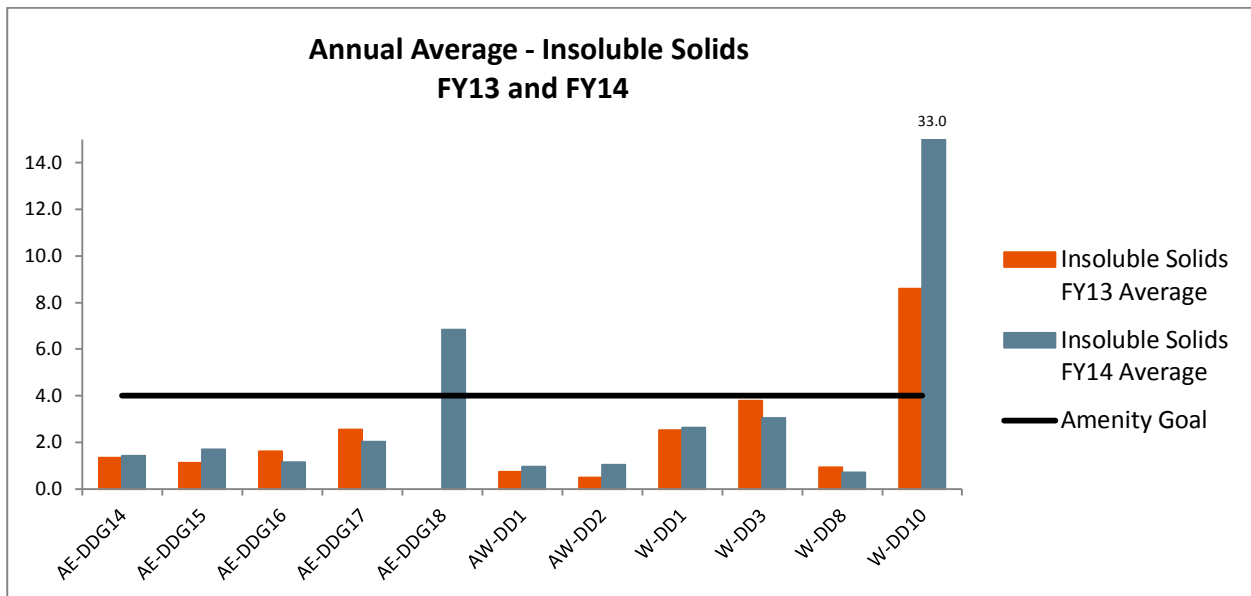
Figure 3: Comparison between FY13 and FY14 annual averages for insoluble solids across the BSO. The long term criteria (amenity goal) applies to particulate emissions on any residence on privately owned land – As the gauges are located within the mine site i.e. operational land, they provide an indication only of how the sites are tracking against the criteria at any residence on privately owned land located nearby.

The Appin East and West Cliff sites operated well below the long term criteria/amenity goal of 4 g/m²/month for deposited dust (Figure 3). This is evident at all sites located on the perimeter of the Appin and West Cliff sites (i.e. AE-DDG14, 15, 16 and 17; and AW-DD1 and 2; and WC-DD1, 3 and 8). AE-DDG18 (which is located adjacent to the Coal loading bins) and WC-DD10 (which is located on the side of an internal haul road) are both site dust control performance references. The elevated dust levels at these two sites were localised (Figure 3).

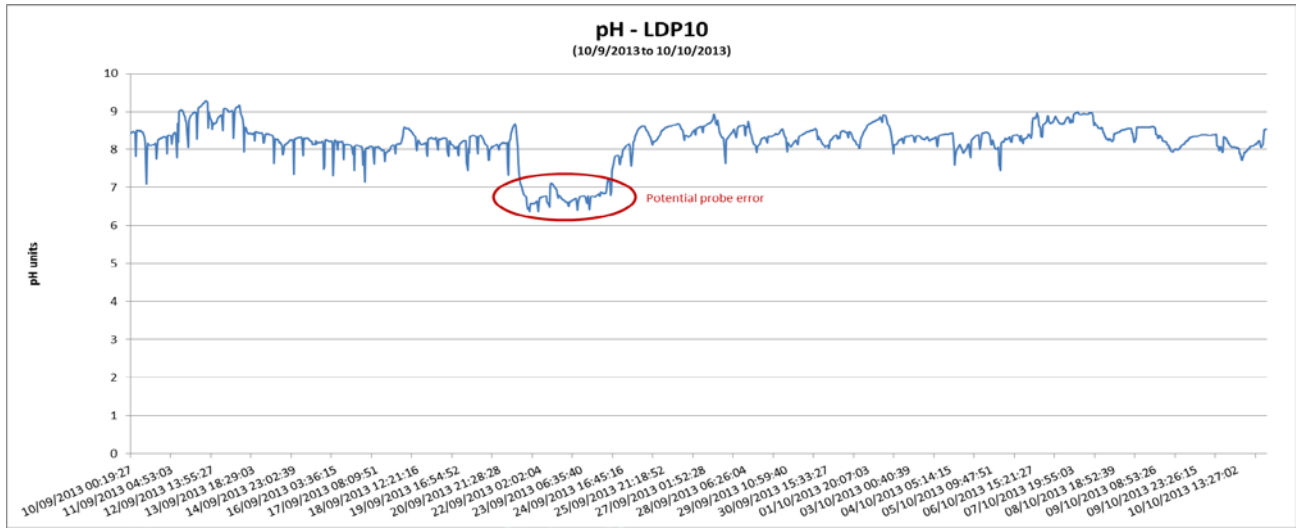
Figure 6: pH trend: LDP10 (10th September to 10th October 2013).

The pH probe was recalibrated on the 27.09.2013 and no further non-compliances have occurred. The following actions have been, or are planned to be, undertaken as a result of this issue: High and low level alarms (sent via email) against pH limits (upper and lower) have been set up in the sites monitoring system (SCADA) to alert the site Environmental personnel of a potential issue.

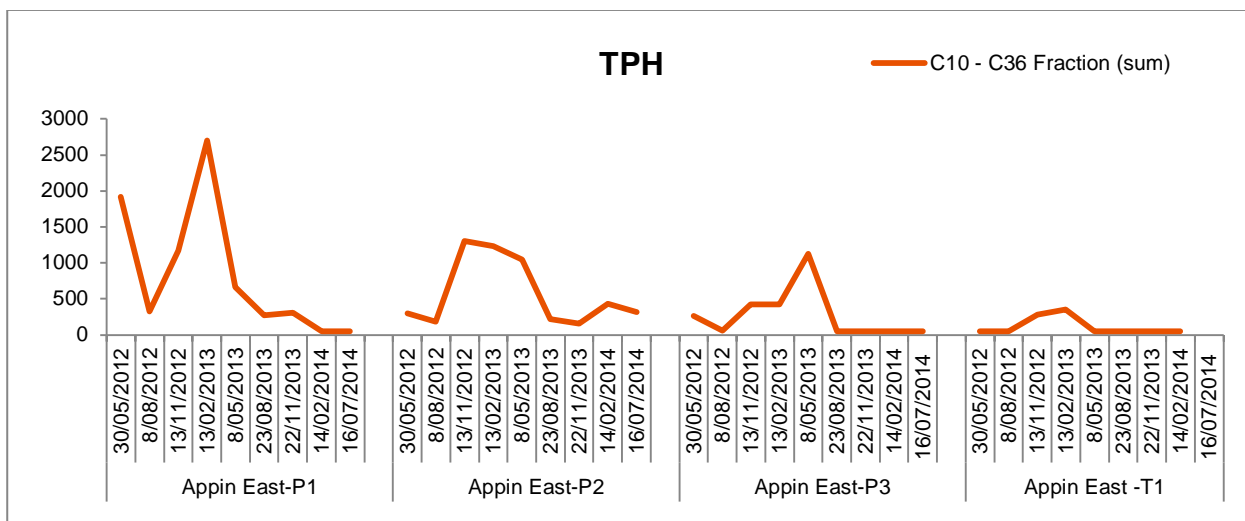
Figure 10: Total Petroleum Hydrocarbons (C10 – C36 Fraction (Sum)) since monitoring began in 2012 at Appin East.

As discussed in last years AEMR, the exact cause of the elevated TPH levels in late 2012/early 2013 is unknown; however this may have been due to asphaltting works during that period. TPH concentrations have since returned to trace levels in at P1 and P2 and below detection limit at P3. Site P3 and T1 are essentially uncontaminated with respect to TPH.

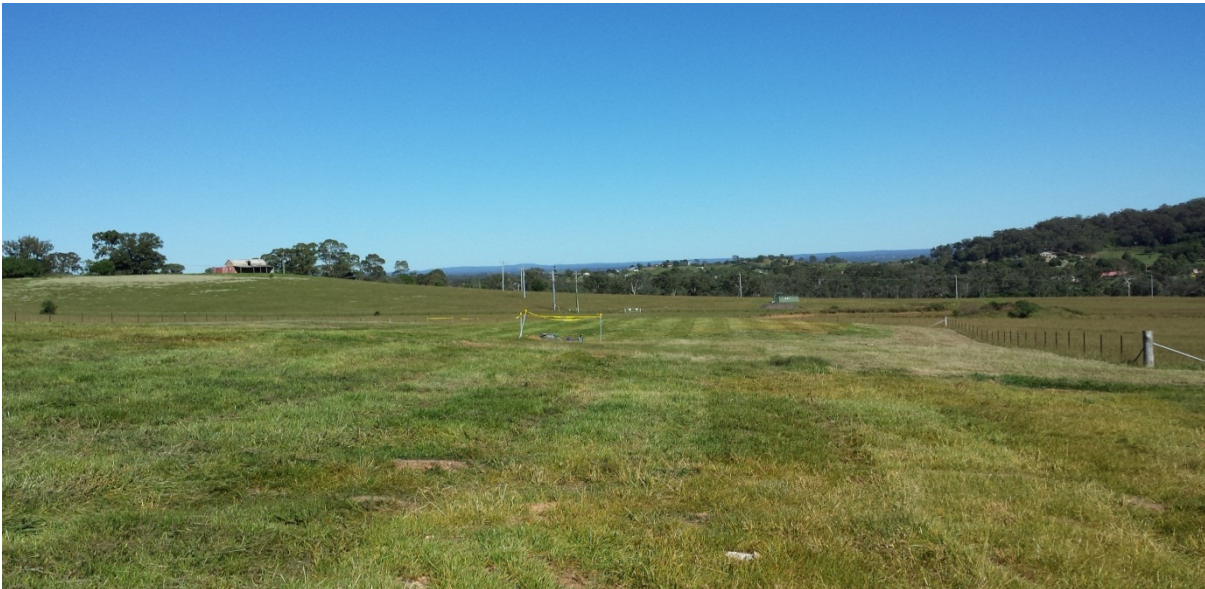
Figure 12: LW 704 pads during rehabilitation works

- Shielding wells from residences as practicable. This included utilising natural topography and vegetation to screen operations and optimising the position of pad infrastructure;
- Where possible infrastructure was green coloured, or housed in a green coloured compound;
- Green coloured noise barriers were installed at the perimeter of sites within sight of residences. During 2013/2014 noise barriers remained in place around Area 9 operational sites; and
- Revegetation of exposed areas as soon as practicable. Pads associated with Longwall 704 were re-vegetated in 2013/14.

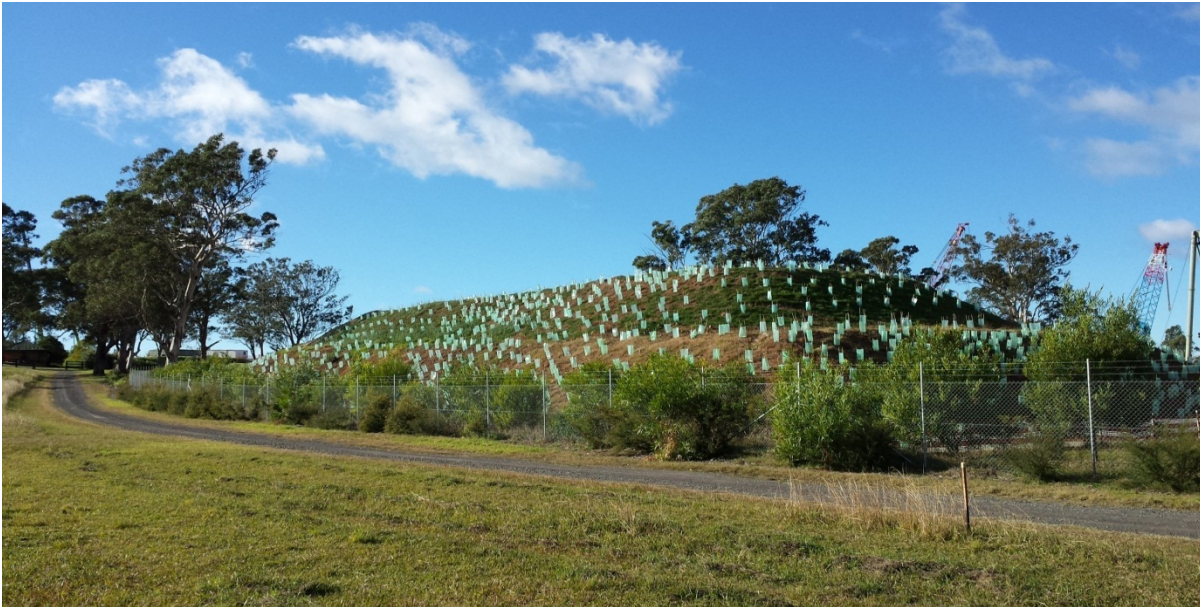
Figure 13: VS#6 Spoil revegetation.

Construction activities for the VS#6 precinct continued throughout 2013/14. To minimise the visual disturbance from these activities, exposed areas were revegetated progressively as final landform was achieved. The most significant feature being re-vegetated was the shaft spoil stockpile, which was grassed and tubestock installed.

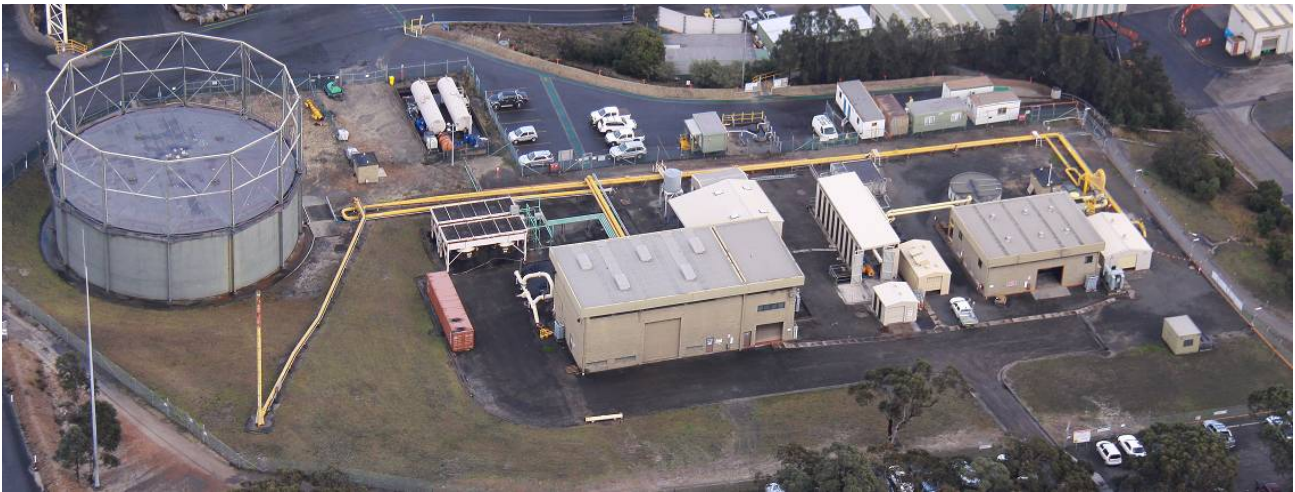
Figure 14: Methane extraction plant – West Cliff

The mine methane drainage gas extracted from Area 5 (the current longwall mining area) had an average CH₄ concentration of 54% and a CO₂ concentration of 6%. The extracted drainage gas was transported by a 6.8 km overland pipeline for utilisation at the Appin East EDL Power Plant. The amount of gas transferred was accounted for in the section above. The West Cliff Methane Drainage Extraction Plant and the gas blower station for transport of drainage gas via the overland pipeline is shown in the figure below.
