ILLAWARRA COAL
BULLI SEAM OPERATIONS

ANNUAL REVIEW FY2016

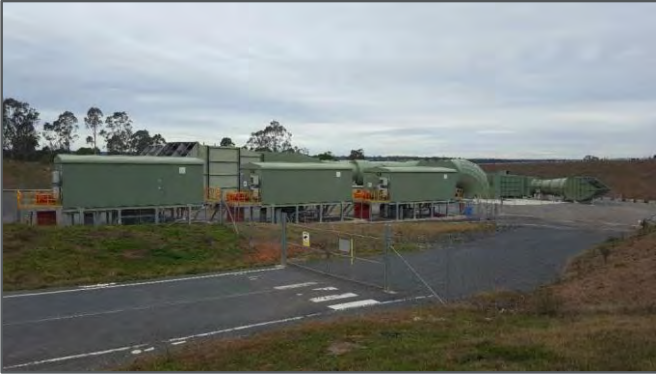
The primary construction activity completed during the reporting period was the earthen noise barrier. This was constructed using coal wash and capped with topsoil and planted with native vegetation. Shaft was commissioned in August 2015.

Figure 1: VS#6 precinct during commissioning.

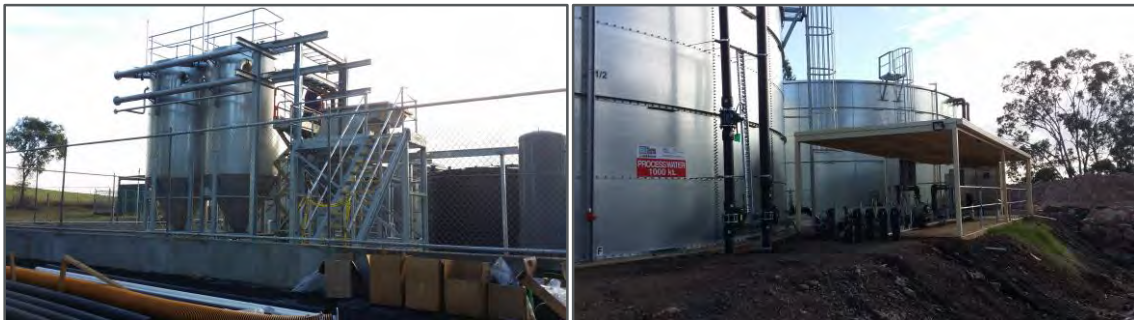
- Commenced construction of the *pre-treatment* plant upgrade
- Bulk storage and blending plant which included the installation of two 1,000KL water tanks
- Increase the processing capacity of mine water – Civil works have commenced which included clearing and reshaping of land. Project has moved into the detail design phase and commissioning is planned for 2017.

Figure 2: Pre-treatment Plant and storage tanks.

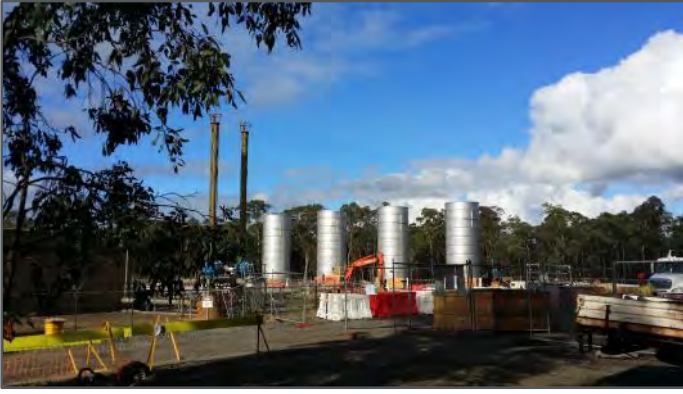
The Appin West (tower) Gas Drainage Plant has been upgraded to increase the volume of gas extracted and transported to the EDL operated power station. The upgrade included the installation of a 900mm gas extraction pipe down the existing (unused) bulk coal winder shaft as well as flaring units. The flares abate the methane content of the gas when there is no power generation occurring at the EDL power station. This project generates Australian Carbon Credit Units (ACCU's) as regulated by the Commonwealth Government Clean Energy Regulator. Gas flaring units are also partway through construction at the Appin East (Central) Gas Drainage Plant. These also generate ACCU's.

Figure 3 Upgraded gas drainage plant at Appin West.

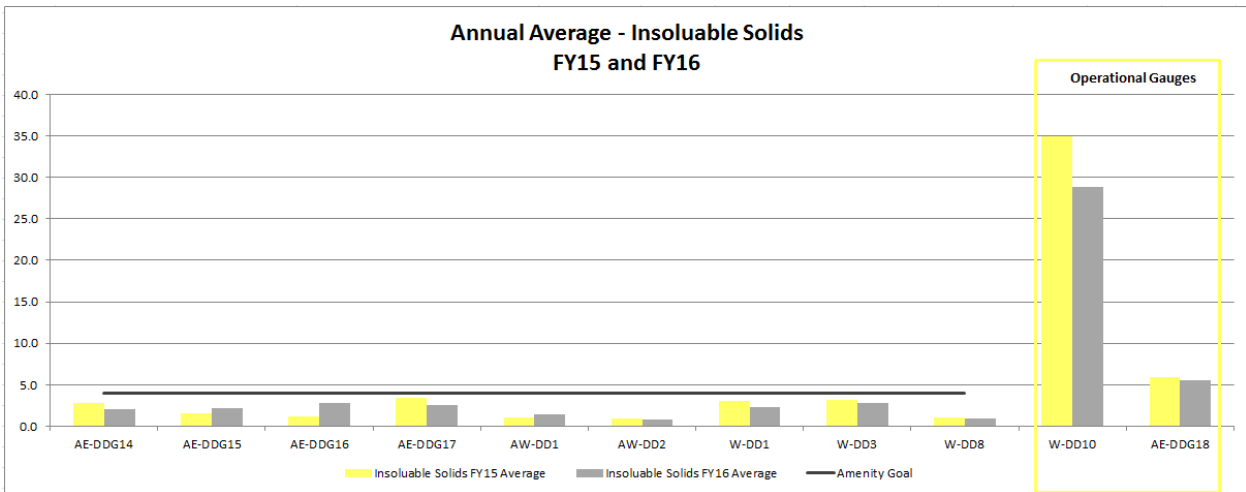
The Appin East (Central) and West Cliff (Appin North) sites non-operational gauges were below the long term criteria/amenity goal of 4 g/m²/month for deposited dust during the reporting period (Figure 5). This is evident at all sites located near the perimeter of the Appin and West Cliff (Appin North) sites (i.e. AE-DDG14, 15, 16 and 17; and AW-DD1 and 2; and WC-DD1, 3 and 8).

Figure 5: Comparison between FY15 and FY16 annual averages for insoluble solids across the BSO.

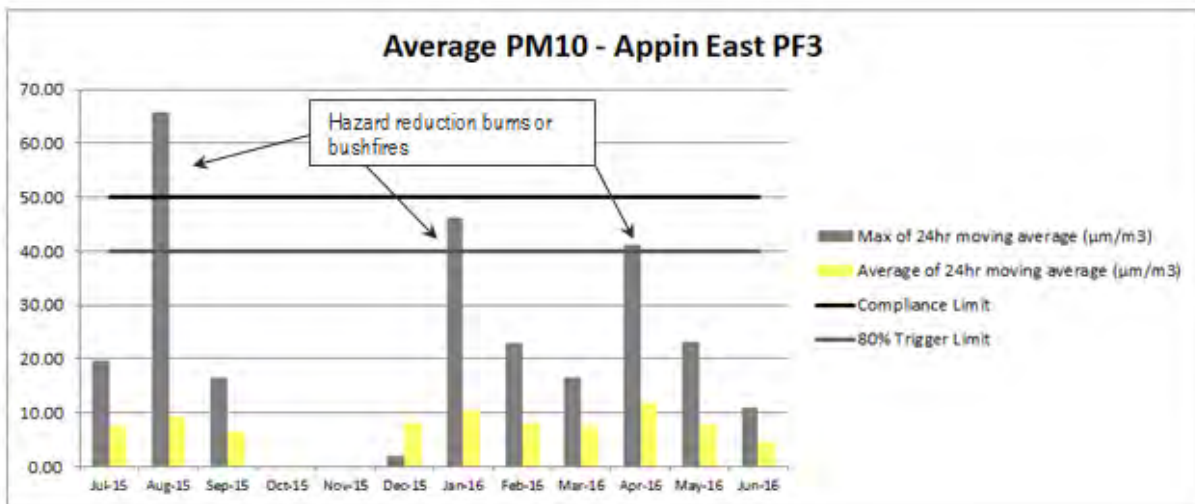
As described in the BSO AQMP, if the optical photometer at Appin East (Central) (AE-PF3) indicates dust levels greater than 80% of the Air Quality Criteria (refer to Schedule 4, condition 9 of the BSO project approval) additional monitoring will be undertaken using the HVAS (AE-HV1) in order to assess compliance. At several times during FY16 the apparent PM10 dust levels were measured above the 80% criteria. Where this occurred it was due to regional air quality problems associated with bush fires and hazard reduction burning. HVAS samples were taken following these and they confirmed the non-operational nature of the exceedances. These were also reported in the 14 day reports (Figure 6). Currently, the optical photometers are unable to determine the difference between dust, rain and fog. High results are often the result of dense fog in the Appin area. A heated inlet was installed on the optical photometer AE-PF3 to reduce the influence of water vapour in the air.

Figure 6: PM10 average 24 hour levels and maximum 24 hour levels at Appin East (Central).

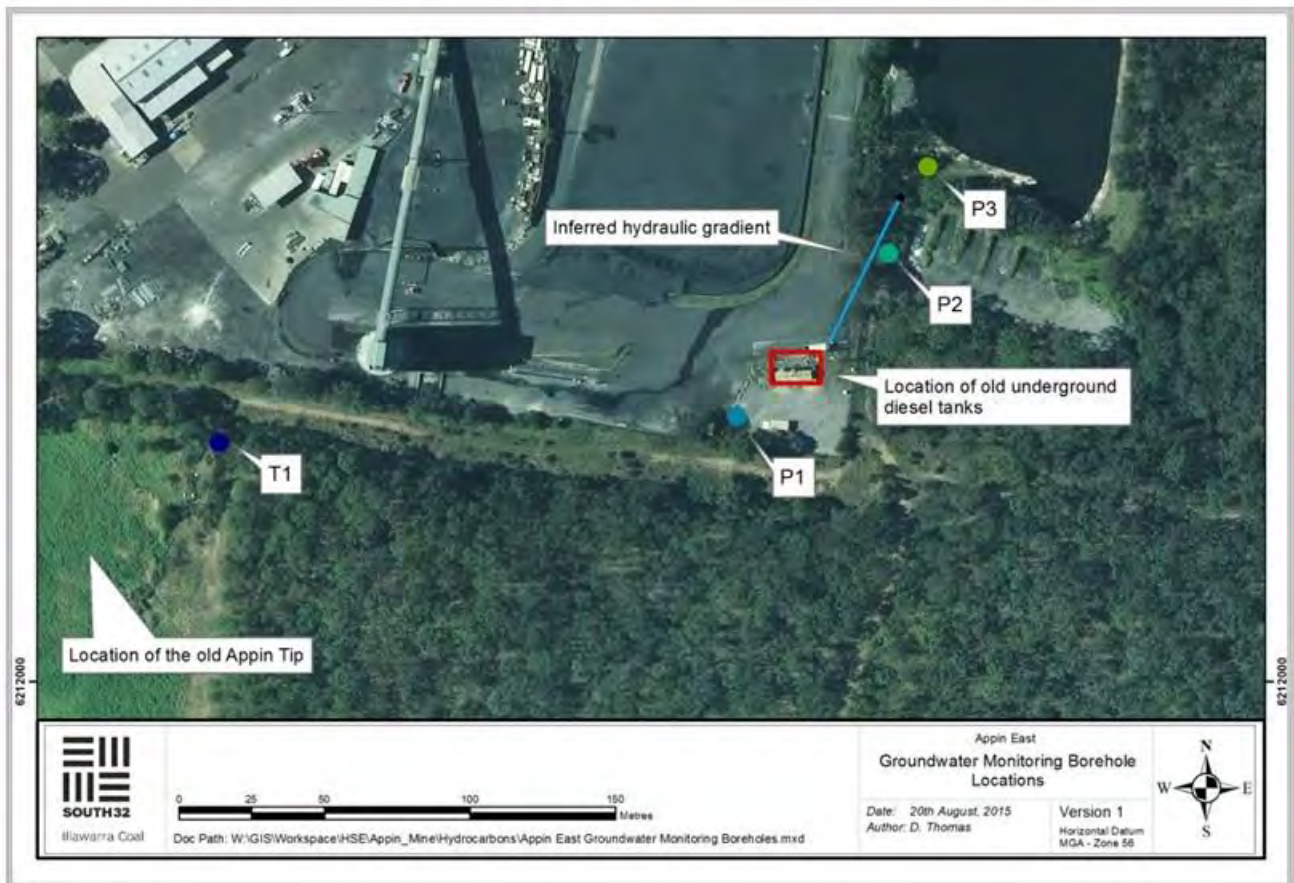
Validation sampling of the floor of the excavated area continued to show elevated concentrations of Total Petroleum Hydrocarbons but concentrations of aliphatic and aromatic hydrocarbon compounds were below the NEPC (1999) guidelines for human health. The consultant's validation report indicated that the land remaining in the investigation area and around the UST excavations is suitable for continued industrial land use based on application of the NEPC (1999) guidelines and that the remaining in-situ contamination is not perceived to compromise the ongoing use of the site for industrial purposes. A quarterly monitoring program was established in 2011, with sampling conducted at four locations – T1, P1, P2 and P3. T1 is used to monitor for potential contamination from the old Appin Tip which is located upstream of the site (Figure 7).

Figure 7: Groundwater Monitoring Bores locations at Appin East (Central).

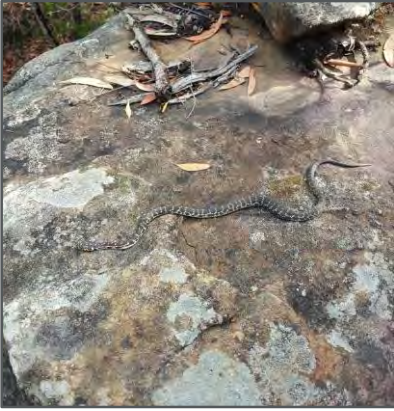
Figure 10: Female Broad-headed Snake captured and relocated during a pre-clearing survey in April 2016.

There has been one instance that required the implementation of mitigation measures for Broad-headed Snakes (as outlined in the approved management plan). On the 5th April, 2016, an individual Broad-headed Snake was located during a pre-clearing inspection in the Stage 3 emplacement area.

The snake was approximately 40 cm long and showed no signs of injury, parasites or other ill-health. The Snake was captured and relocated in accordance with the Broad-headed Snake Management Plan.

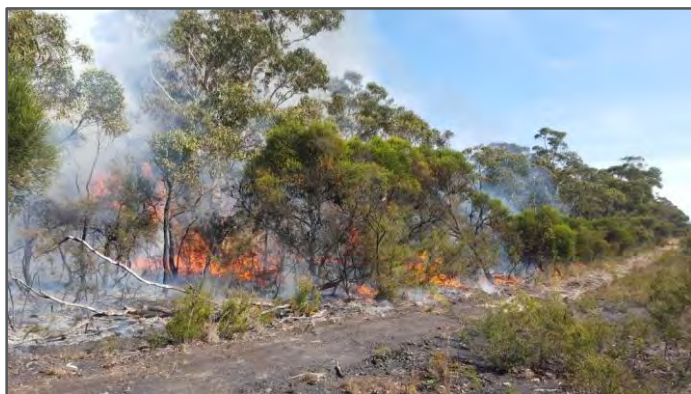
Figure 11: *Persoonia* ecological burn – April 2016.

In April 2016, IC engaged the NSW Rural Fire Service to conduct an ecological burn in the West Cliff (Appin North) *Persoonia* Offset. The aim of the burn is to promote germination of *P. hirsuta* and increase the density of the species within the area. It is known that fruits of *Persoonia* maintain seeds in a dormant state, which is hard to break artificially and is not well understood (Myerscough et al. 2000). The general consensus is that the species requires physiological disturbance to break dormancy. The exact germination mechanisms are not yet known; however, it is suspected the combination of heat and smoke from a fire would be a trigger (Auld and Ooi 2008). This is generally supported by observations from other known populations that have been subject to wildfire in the past two years (Alison Haynes Thesis 2015; David Gregory *Pers. Obs.*), and other *Persoonia* species and Proteaceae in general. The Offset has not experienced a fire for at least 25 years.

The burn site will be monitored over the coming year to identify new seedlings.

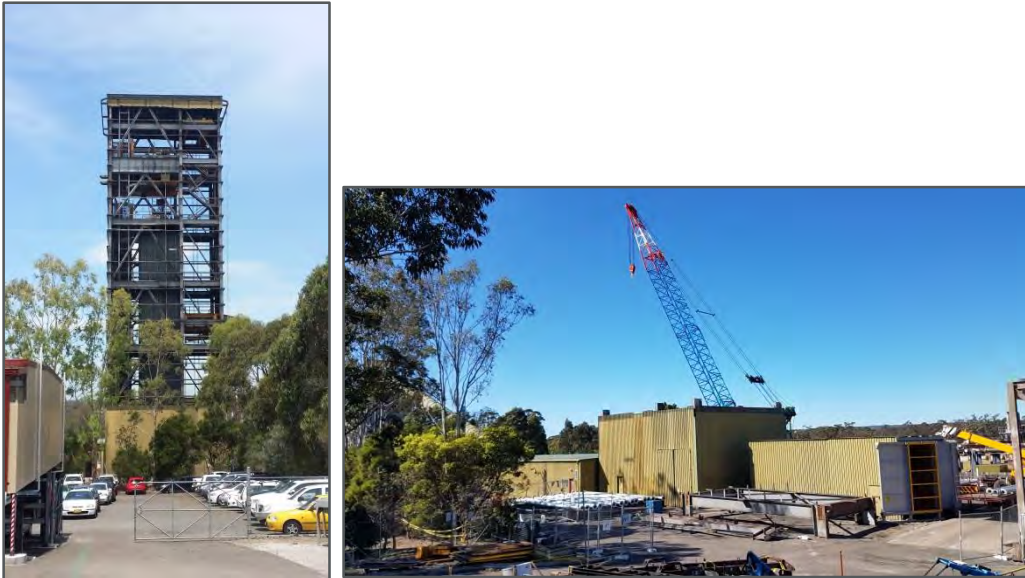
The Appin West bulk coal winder building was modified for the installation of new gas drainage infrastructure (see photos below).

Figure 13: Demolition of the bulk coal winder building

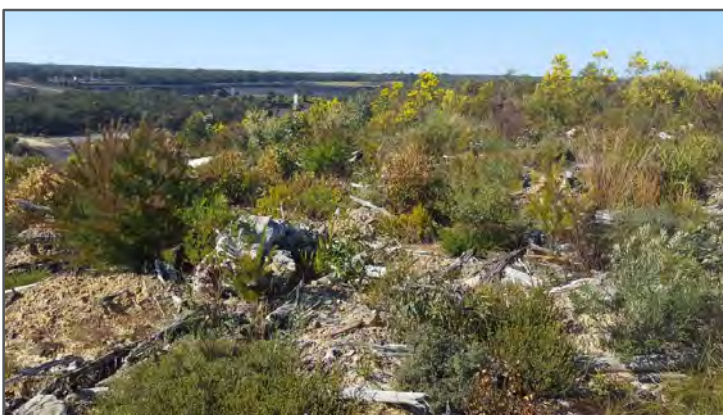
Progressive rehabilitation of the West Cliff (Appin North) Emplacement has been undertaken during the reporting period in accordance with the approved West Cliff (Appin North) Coal Wash Emplacement Area Management Plan. Refer to Appendix A: Annual Rehabilitation Report for further detail of the success of the rehabilitation of the Emplacement area. Plan 12 – Land Preparation Plan outlines the rehabilitation undertaken over the reporting period.

Figure 14: Stage 2 emplacement rehabilitation after two years showing dense cover of shrubs and high native species diversity.

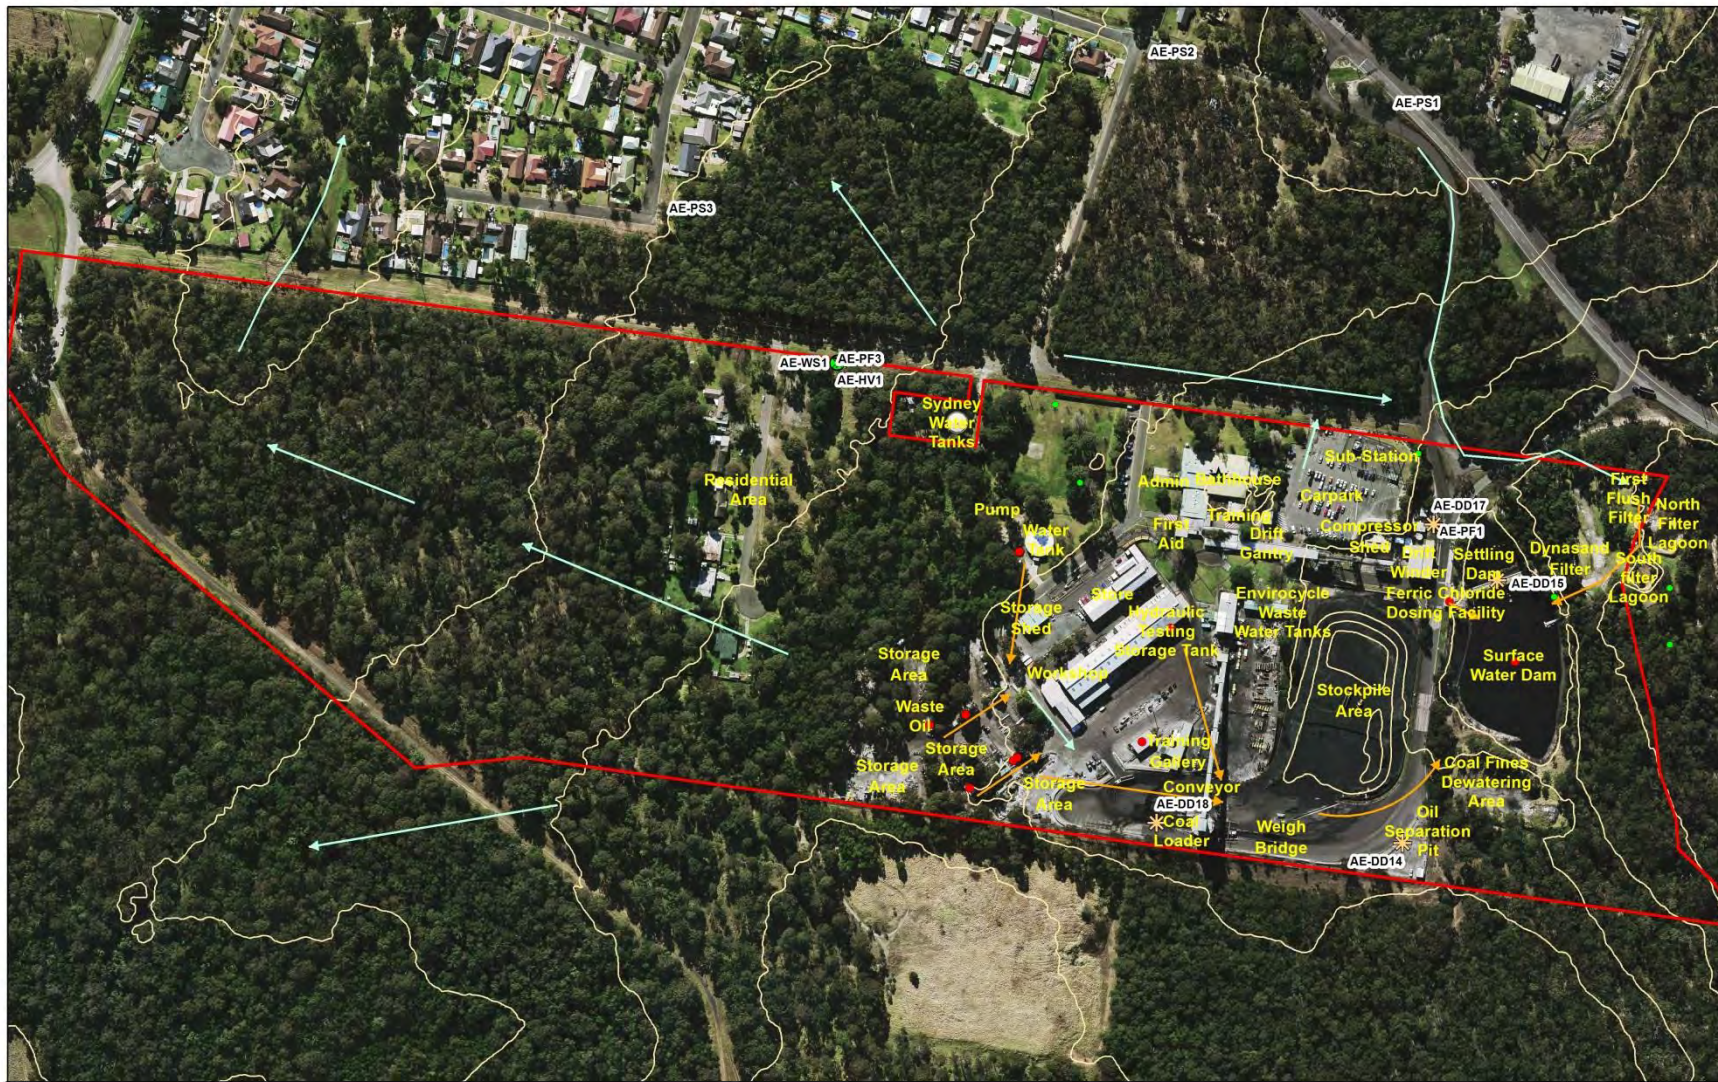
PLAN 2 - APPIN EAST (CENTRAL) MINE SITE

Legend				Bulli Seam Operations Annual Environmental Management Report Appin East		
	<ul style="list-style-type: none"> ● Noise Monitoring ▲ Discharge Volume Monitor Dust 	<ul style="list-style-type: none"> ● HVAS ★ Meteorological Monitoring Station Spillway Overflow 	<ul style="list-style-type: none"> ◆ Surface Water Monitor ◆ Temperature Potentially Contaminated Surface Water Overland Flow 	<ul style="list-style-type: none"> Domain Boundary ● Chemical Storage 	Date: 20th of August, 2015 Author: B. Davis	Horizontal Datum MGA - Zone 56	
Plan No. - HSE-2012-133-REV-1

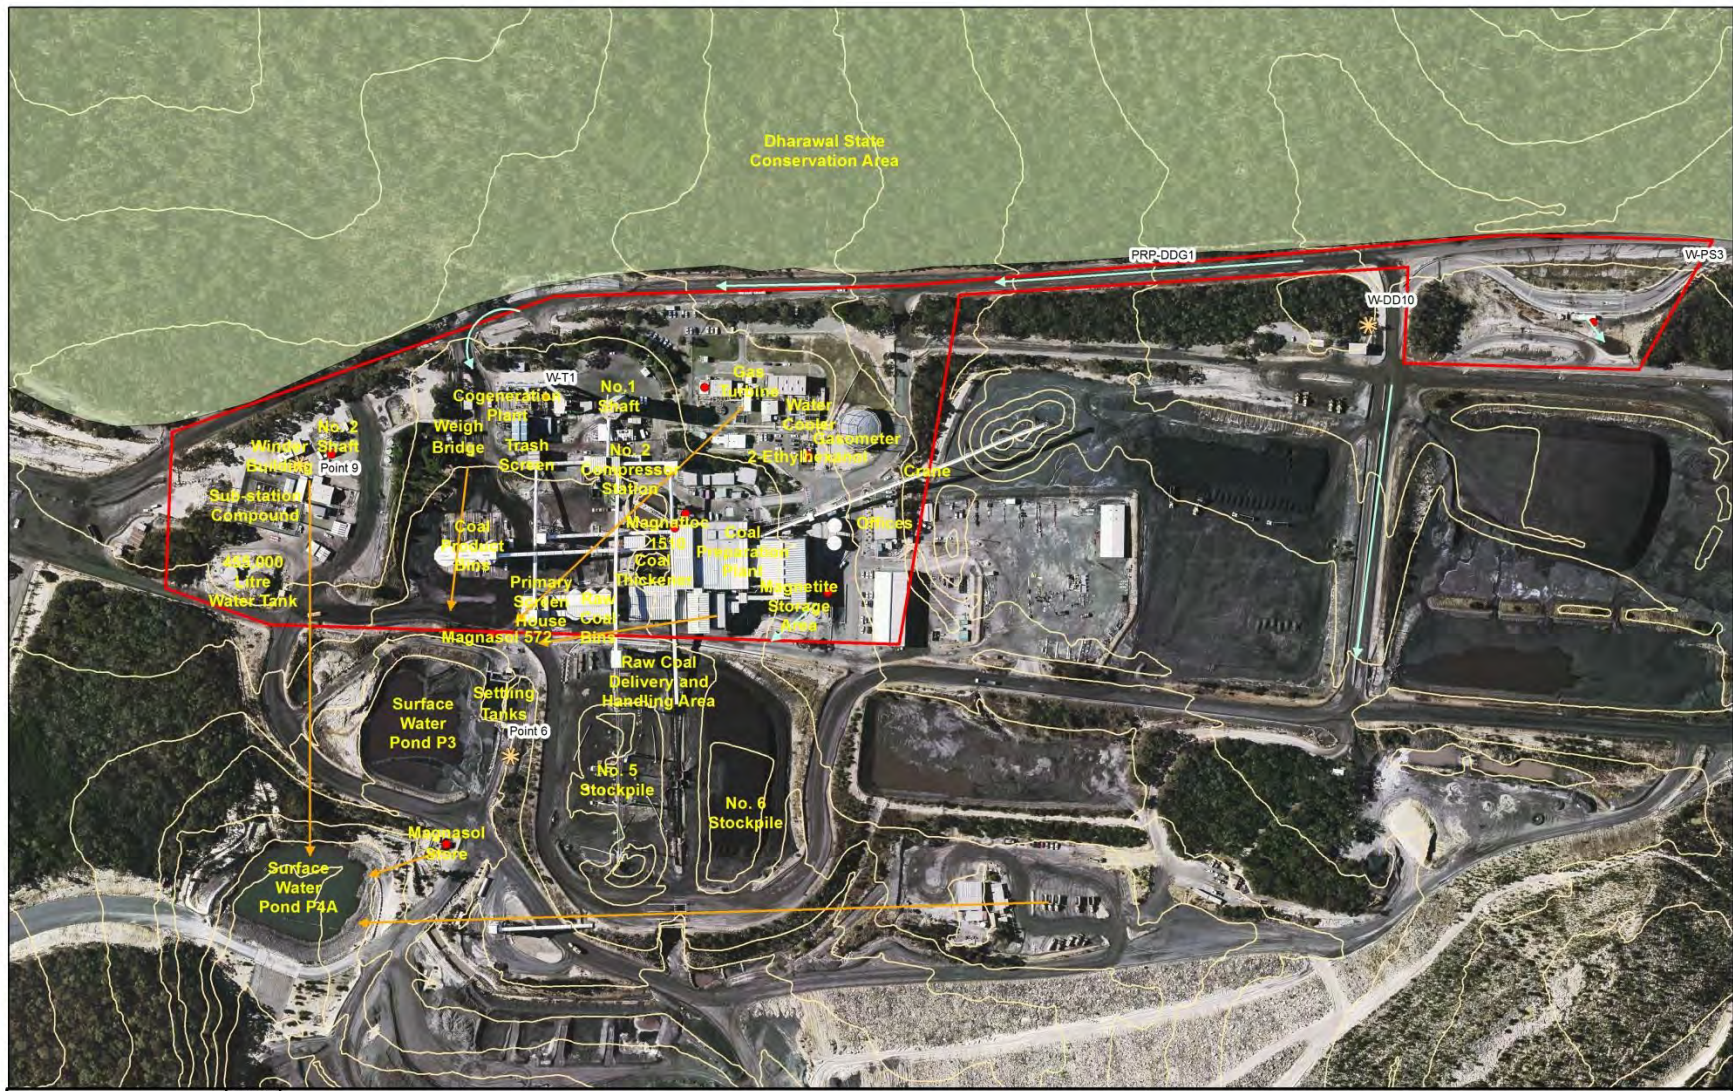
PLAN 9 – WEST CLIFF NORTH SIDE

SOUTH32 Illawarra Coal	Discharge Volume Monitor	Noise Monitor	Potentially Contaminated Surface Water	Chemical Storage
Dust	Spillway Overflow	Overland Flow	West Cliff North	
HVAS	Surface Water Monitor	Temperature		
Meteorological Monitoring Station

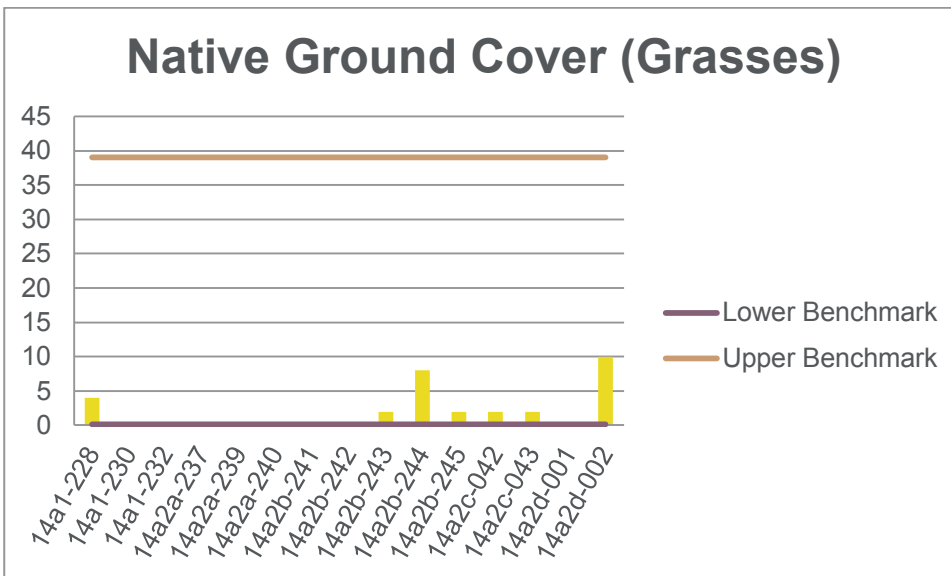
Figure 4 Native ground cover – Grasses at the monitoring plots for rehabilitation areas 1, 2a, 2b, 2c and 2d for 2015.

Given that zero (0) is the lower benchmark for Native Groundcover (Grasses), all treatments are within benchmark for this attribute. This is entirely reasonable given that the translocated soils are from Sydney Coastal Dry Sclerophyll Forests which are naturally higher in cover for herbs and forbs than grass cover. Grass cover also requires an open environment and since most of the treatments have resulted in a relatively dense mid-storey and shrub layer, native grass is difficult to establish. Percent cover of native grasses is not necessarily indicative of ecosystem health in Sydney Coastal Dry Sclerophyll Forests and the attribute is within benchmark in all treatment areas.

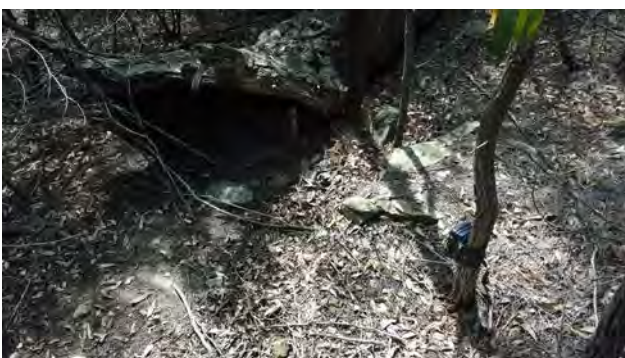
Figure 8: Example of a camera site (Camera Trap site 1, emplacement Stage 1).

Camera traps were deployed for 12 days across three sites in the mature rehabilitation areas (864 camera hours). Each trap targeted specific habitat features that were created during the rehabilitation process Figure 8). Site 1 is located in Stage 1 and consists of a large tree hollow. Site 2 is located in Stage 2 and consists of a small rock overhang; Site 3 is also located in Stage 2 and consists of an artificial pond.
