ILLAWARRA COAL  
BULLI SEAM OPERATIONS

# ANNUAL REVIEW FY2017

The Review has been prepared to meet the requirements of Schedule 6 Condition 4 of the BSO Development Consent and the Department of Resources and Energy (DRE) requirement to submit an Annual Environmental Management Report (AEMR) under the Mining Lease for the BSO.

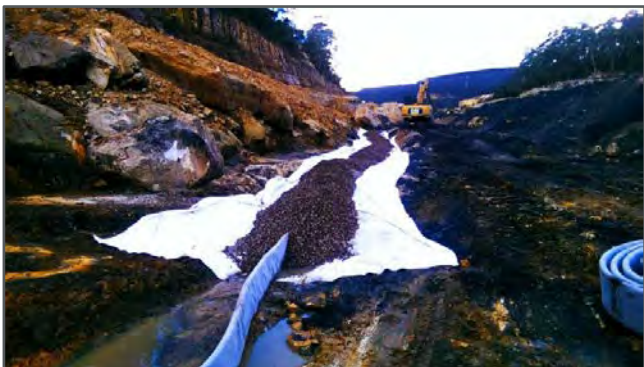
Figure 1: Extending the emplacement underdrainage network as Stage 3 coalwash emplacement progresses down the valley.

- Seeding of approximately 7Ha to complete rehabilitation in Stage 2;
- Extension of the emplacement underdrainage channel and relocation/re-construction of a new dam to capture the underdrainage.

Plan 11 – Land Preparation Plan, illustrates the works completed.

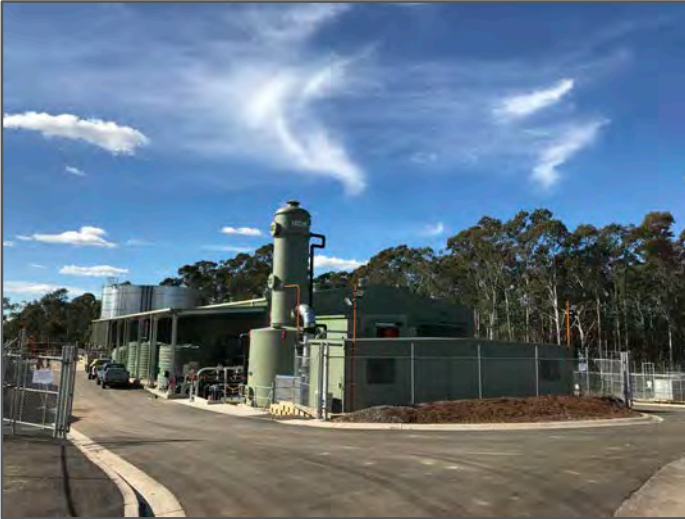
Figure 2: Water Filtration Plant Expansion - Main processing facility

- Bulk storage total of 2000KL and blending plant completed – enabling additional surface storage of treated water and reducing potable water usage for underground operations.
- Pretreatment system has been installed to increase the capacity to pre-treat underground pump-out water, with ongoing further scoping and design. Full plant expected to be operational in January 2018.
- The new main processing facility, Integrated Membrane Plant 2, is nearing completion. During the reporting period, civil works including clearing and reshaping of designated land at Appin West have been ongoing. Commissioning expected in August 2017.

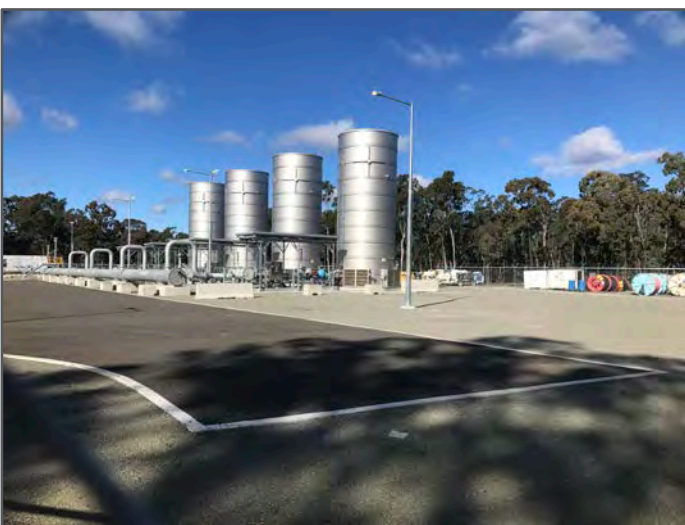
Figure 3: Upgraded gas drainage plant at Appin West

The Appin West (tower) Gas Drainage Plant (GDP) has been upgraded and commissioned to increase the mine gas extraction capacity and provide capacity to flare gas (Figure 3). The upgrade included the installation of a 900mm gas extraction pipe down the existing (unused) bulk coal winder shaft and a 5km 900mm pipe line underground. The flares abate the methane content of the gas and are used when there is more gas available from the mine than can be consumed by EDL. This flaring project generates Australian Carbon Credit Units (ACCU's) as regulated by the Commonwealth Government Clean Energy Regulator.

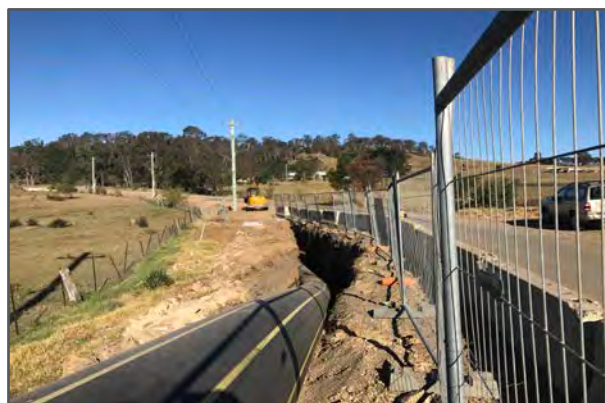
Figure 5: Buried gas pipeline along Brooks Point Road

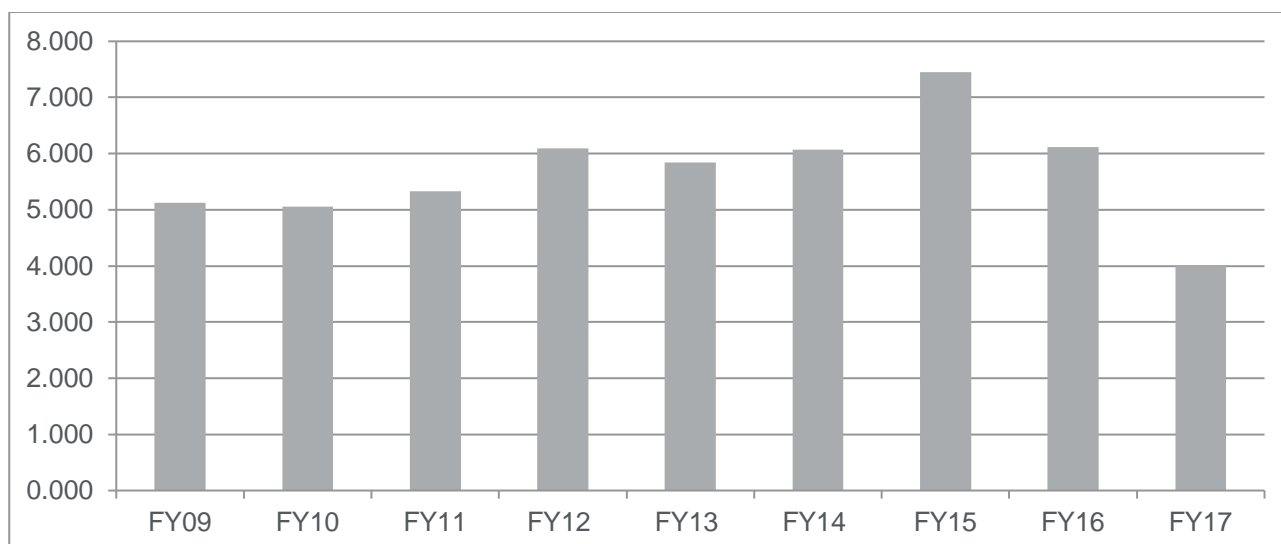
Figure 6: ROM production – BSO

Appin and Westcliff extracted 3.99 Million Tonnes of 'Run of Mine' (ROM) coal via roadway development and longwall extraction methods for the reporting period, a 35% decrease from the 2015/16 reporting period. The ROM production levels from FY09 through to the current reporting period are provided in Figure 6. Note that forecast figures for FY18 are not yet available.

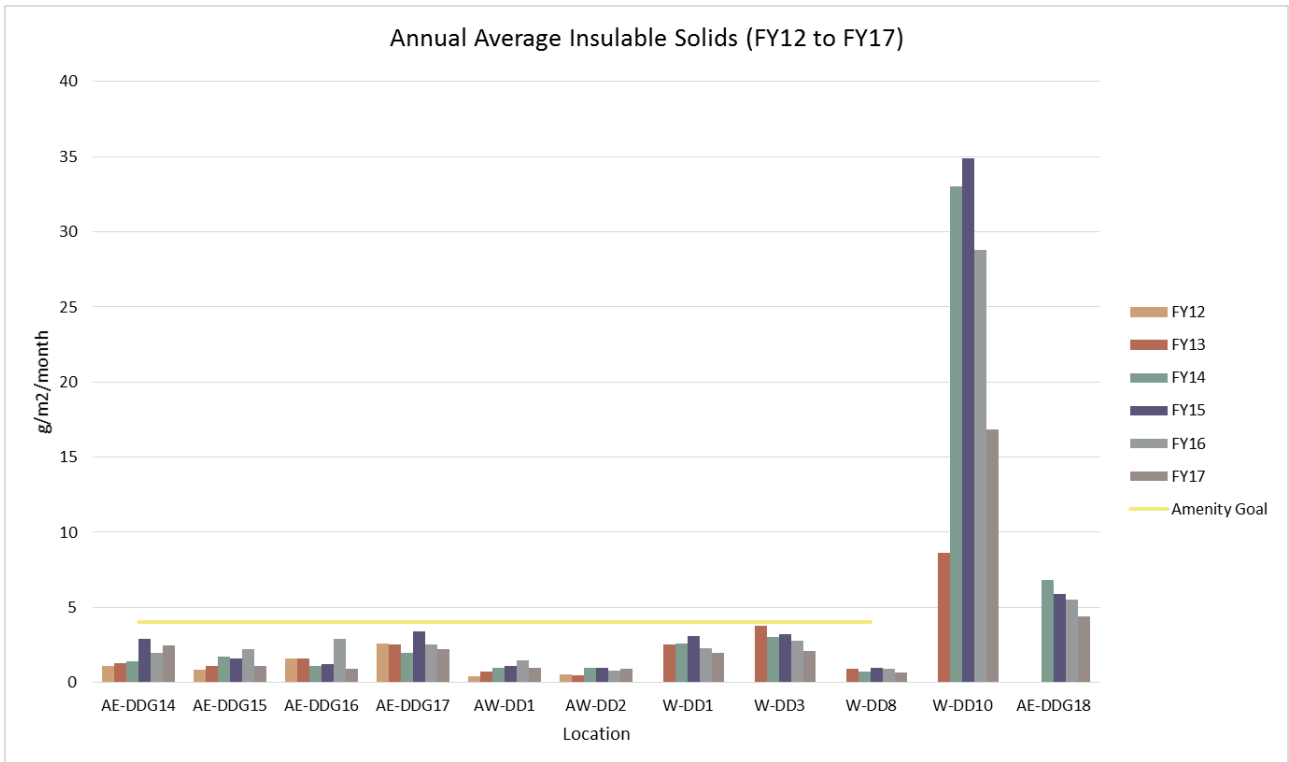
Figure 7: Comparison annual averages from FY12 to FY17 for insoluble solids across the BSO.

The Appin East (Central) and West Cliff (Appin North) sites non-operational gauges were below the long term criteria/amenity goal of 4 g/m<sup>2</sup>/month for deposited dust during the reporting period (Figure 7). This is evident at all sites located near the perimeter of the Appin and West Cliff (Appin North) sites (i.e. AE-DDG14, 15, 16 and 17; and AW-DD1 and 2; and WC-DD1, 3 and 8).

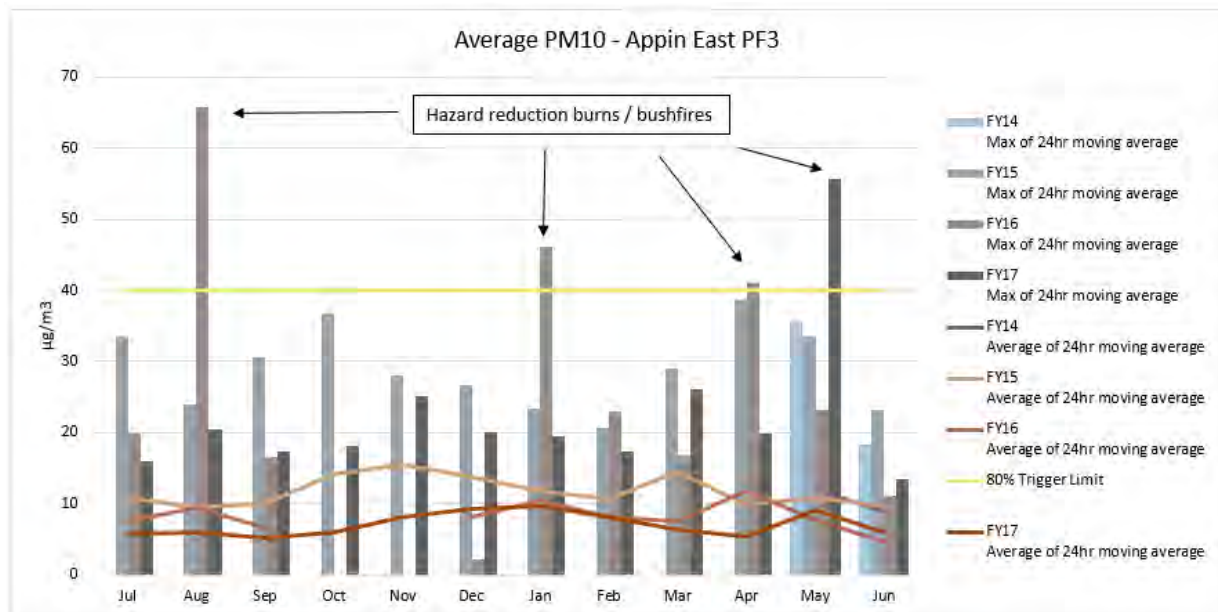
Figure 8: PM10 average 24 hour levels and maximum 24 hour levels at Appin East (Central).

As described in the BSO AQMP, if the optical photometer at Appin East (Central) (AE-PF3) indicates average dust levels greater than 80% of the Air Quality Criteria (refer to Schedule 4, condition 9 of the BSO project approval) additional monitoring will be undertaken using the HVAS (AE-HV1) to assess compliance. The apparent maximum average PM10 dust levels were measured above the 80% criteria once during 2017. This was attributed to regional bush fires and hazard reduction burning.

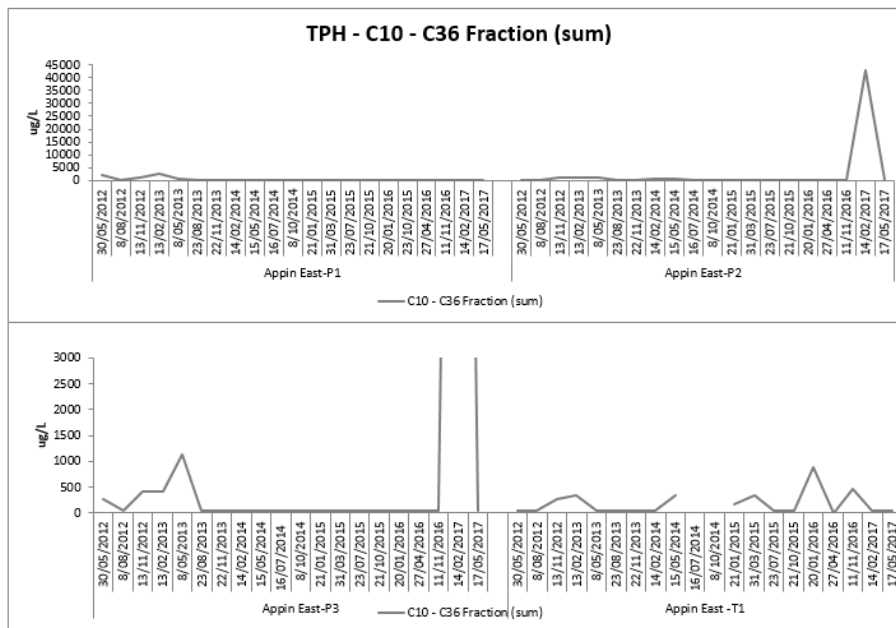
Figure 10: Total Petroleum Hydrocarbons (C10 – C36 Fraction (Sum)) since monitoring began in 2012 at Appin East (Central).

During the reporting period Boreholes P2 and P3 indicated elevated levels of TPH (Figure 10). Samples taken in February 2017 revealed higher levels than previously seen at any of the boreholes. These results were attributed to contamination of the samples as the most recent samples taken in May indicated TPH levels below or close to lowest observable limit (LOR- 50 µg/L). The most recent sample taken at T1 showed TPH levels below LOR indicating that there was no potential contamination from the old Appin Tip.

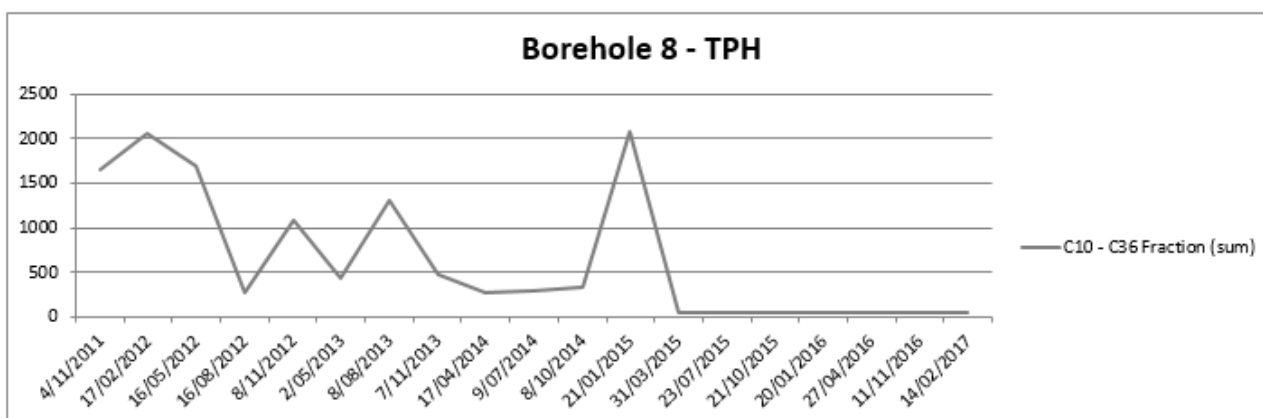
Figure 11: Total Petroleum Hydrocarbons (C10 – C36 Fraction (Sum) µg/L) since monitoring began in 2012 in BH8 at West Cliff (Appin North).

During the reporting period TPH was below the observable limit.

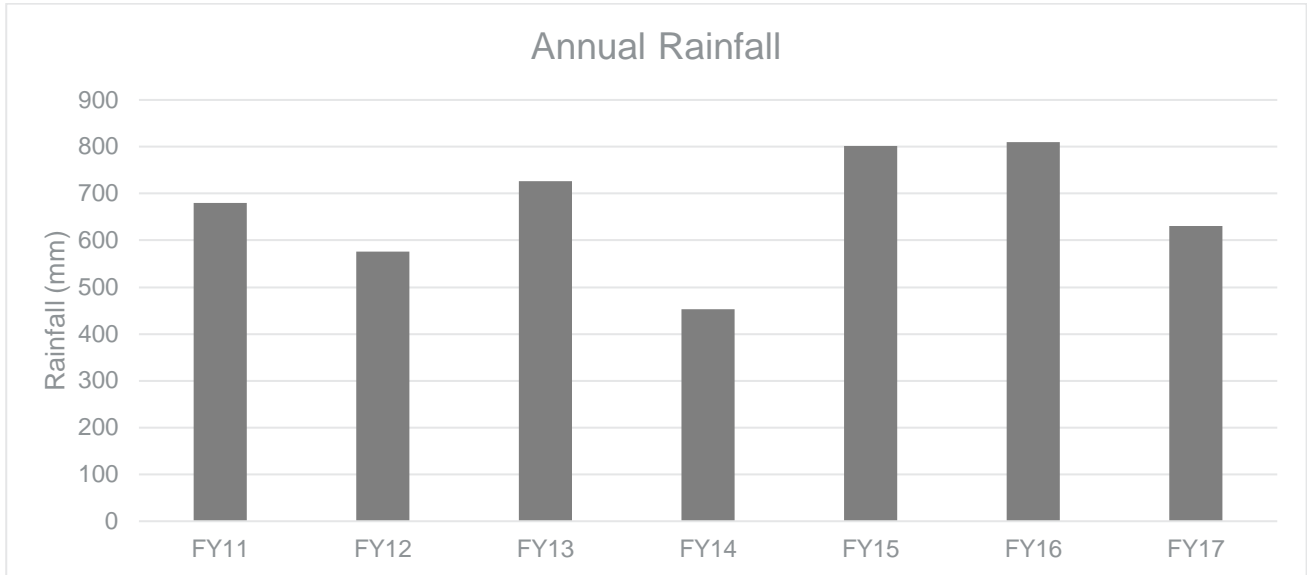
Figure 14: Annual rainfall – Menangle (BOM site #68216).

Figure 14 below displays the annual rainfall for the region since FY11 at Menangle, NSW.

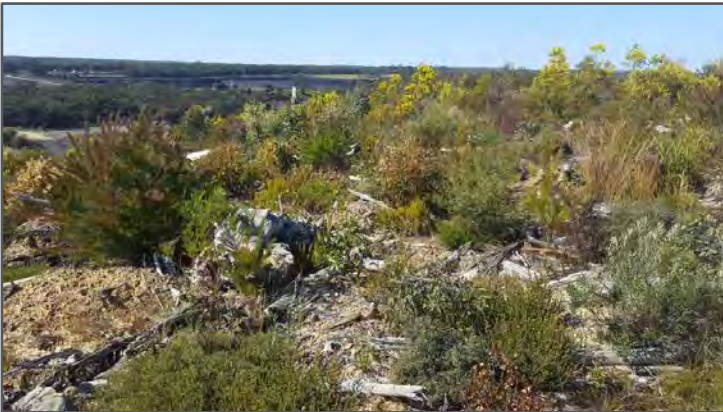
Figure 15: Stage 2 emplacement rehabilitation after two years showing dense cover of shrubs and high native species diversity.

Progressive rehabilitation of the West Cliff (Appin North) Emplacement has been undertaken during the reporting period in accordance with the approved West Cliff (Appin North) Coal Wash Emplacement Area Management Plan. Refer to Appendix A: Annual Rehabilitation Report for further detail of the success of the rehabilitation of the Emplacement area. Plan 11 – Land Preparation Plan outlines the rehabilitation undertaken over the reporting period.

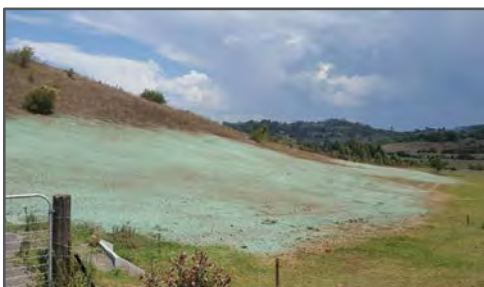
Figure 16: Longwall 706 Well site during rehabilitation

- Grouting of all four Longwall 706 wells to surface and one site has been rehabilitated with topsoil emplacement and grass seeding (Figure 16).
- Grouting of both Longwall 707 wells to surface and one site has been rehabilitated with topsoil emplacement and grass seeding (Figure 17).

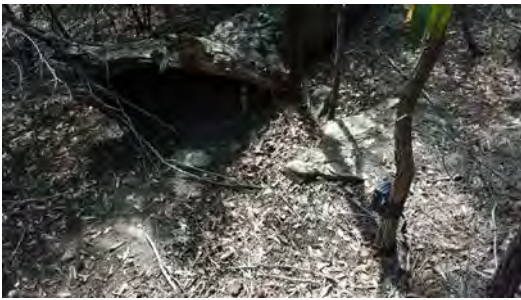
**Figure 9: Example of a camera site (Camera Trap site 1, emplacement Stage 1).**

Camera traps were deployed across five sites in the mature rehabilitation areas (2640 camera hours) between May and June 2017. Cameras were placed to target specific habitat features (Figure 9 and Table 6).

Site Name	Feature	Location
Site 1	Log Hollow	Stage 1 Rehabilitation E299740, N6210188
Site 2	Rock Shelter	Stage 2 Rehabilitation E299631, N6210209
Site 3	Fallen log	Stage 2 Rehabilitation E299254, N6210337
Site 4	Pond	Stage 2 Rehabilitation E299594, N6210337
Site 5	Animal Path	Stage 2 Rehabilitation E299142, N6210530
