ILLAWARRA COAL  
BULLI SEAM OPERATIONS

# ANNUAL REVIEW FY2018

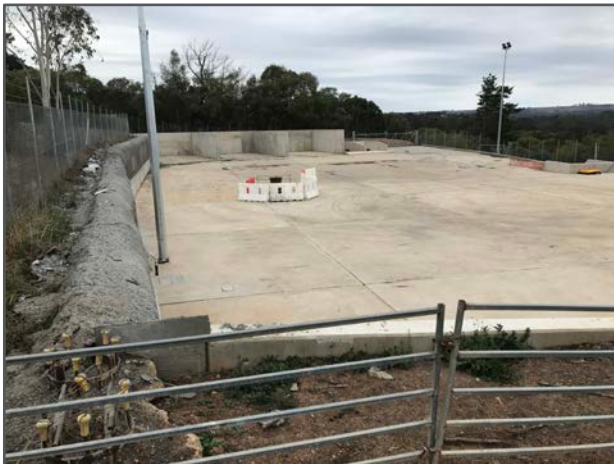
Figure 1: Concrete pad construction at the Vent Shaft 6 site concrete/ballast borehole.

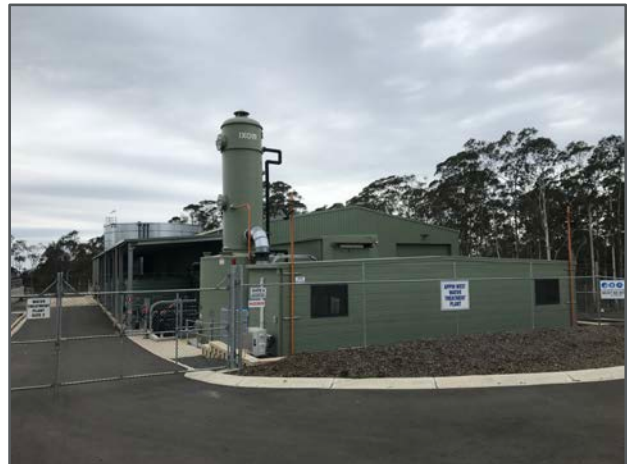
Figure 2: Water Filtration Plant Expansion - Main processing facility.

Works to expand the Appin West Water Filtration Plant continued during the reporting period (Figure 2). The project completion date reported as August 2018 in the FY17 AEMR has been postponed to fix the following defects/issues that emerged during the dry/initial wet commissioning:

- Degasser vessel wall damage following an unplanned vacuum in the vessel when filling/inadequate overflow capacity.
- RO module feed pumps power supply rectification via installation of sine wave filters.
- Permeate tank discharge pump upgrade.

The projected final operational date for the Water Filtration Plant upgrade is November 2018. Other activities that must be completed prior to final operation are:

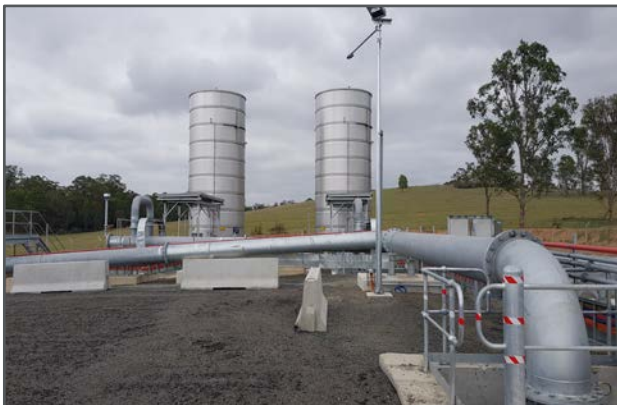
Figure 3: Gas flaring units constructed at the Appin East GDP.

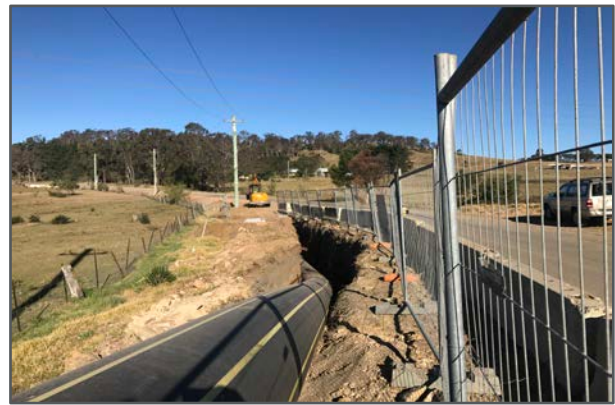
Figure 4: Buried gas pipeline along Brooks Point Road during the construction phase of the project.

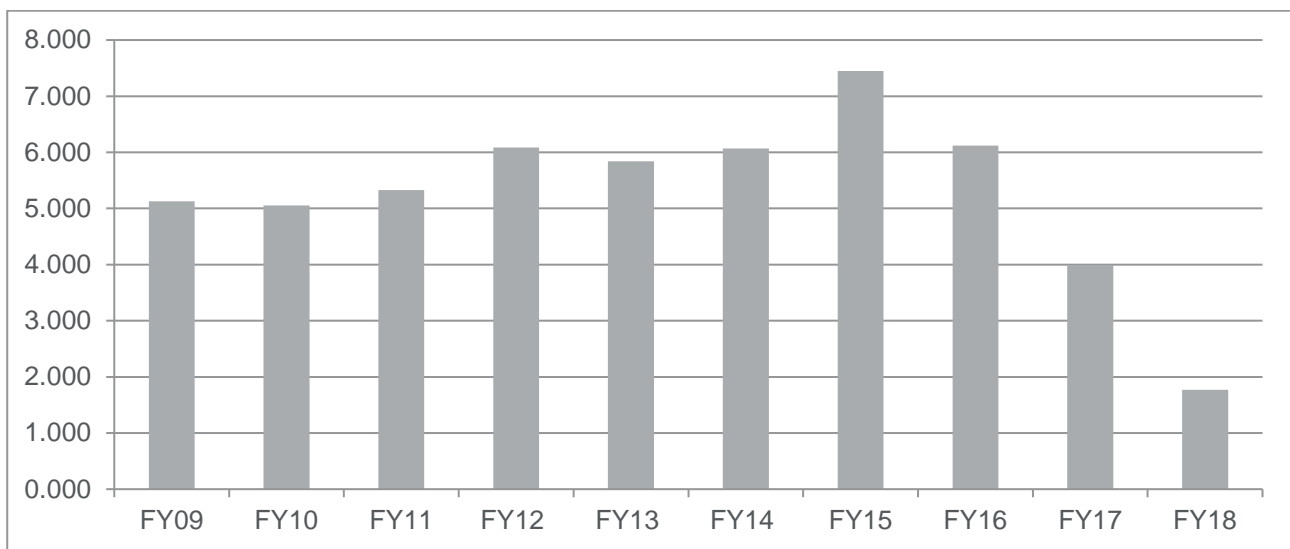
Appin extracted 1.77 million tonnes of 'Run of Mine' (ROM) coal via roadway development and longwall extraction methods for the reporting period, a 56% decrease from the 2016/17 reporting period. The ROM production levels from FY09 through to the current reporting period are provided in Figure 5. Note that forecast figures for FY19 are not yet available.

Figure 5: ROM production – BSO

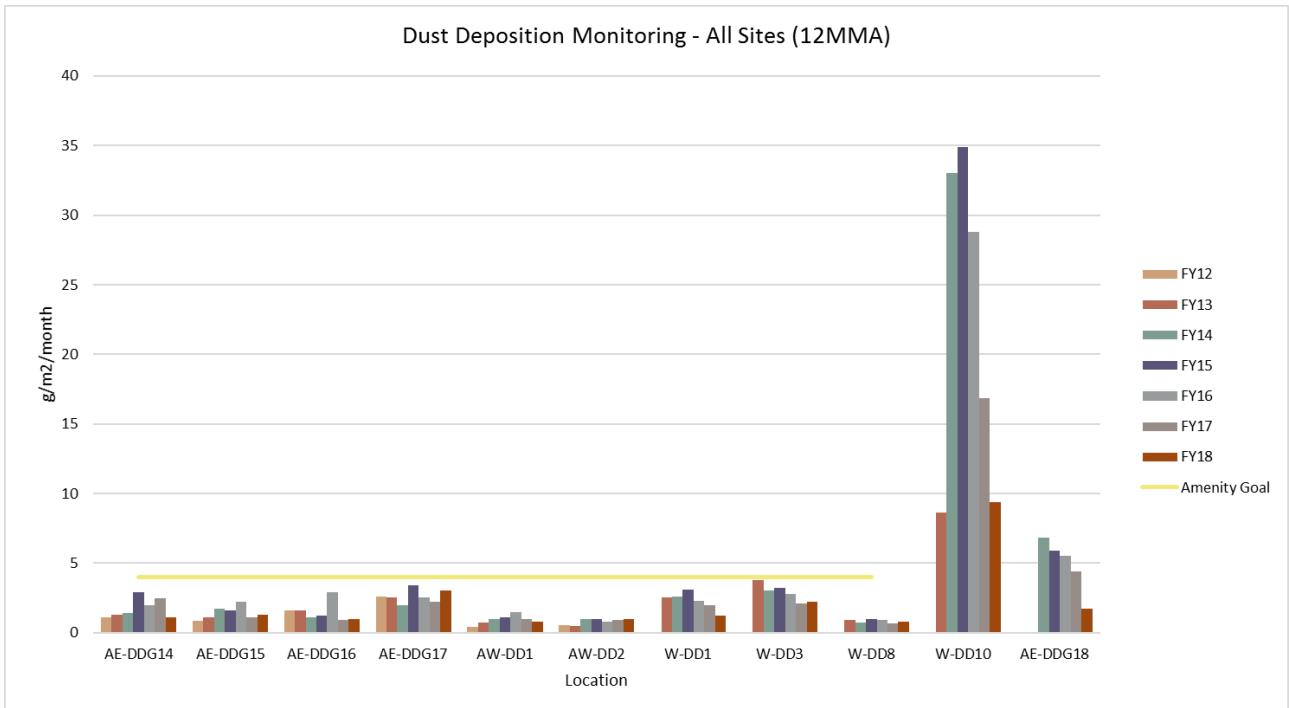
The Appin East (Central) and West Cliff (Appin North) sites non-operational gauges were below the long-term criteria/amenity goal of 4 g/m<sup>2</sup>/month for deposited dust during the reporting period (Figure 6). This is evident at all sites located near the perimeter of the Appin and West Cliff (Appin North) sites (i.e. AE-DDG14, 15, 16 and 17; and AW-DD1 and 2; and WC-DD1, 3 and 8).

Figure 6: Comparison annual averages from FY12 to FY18 for insoluble solids across the BSO.

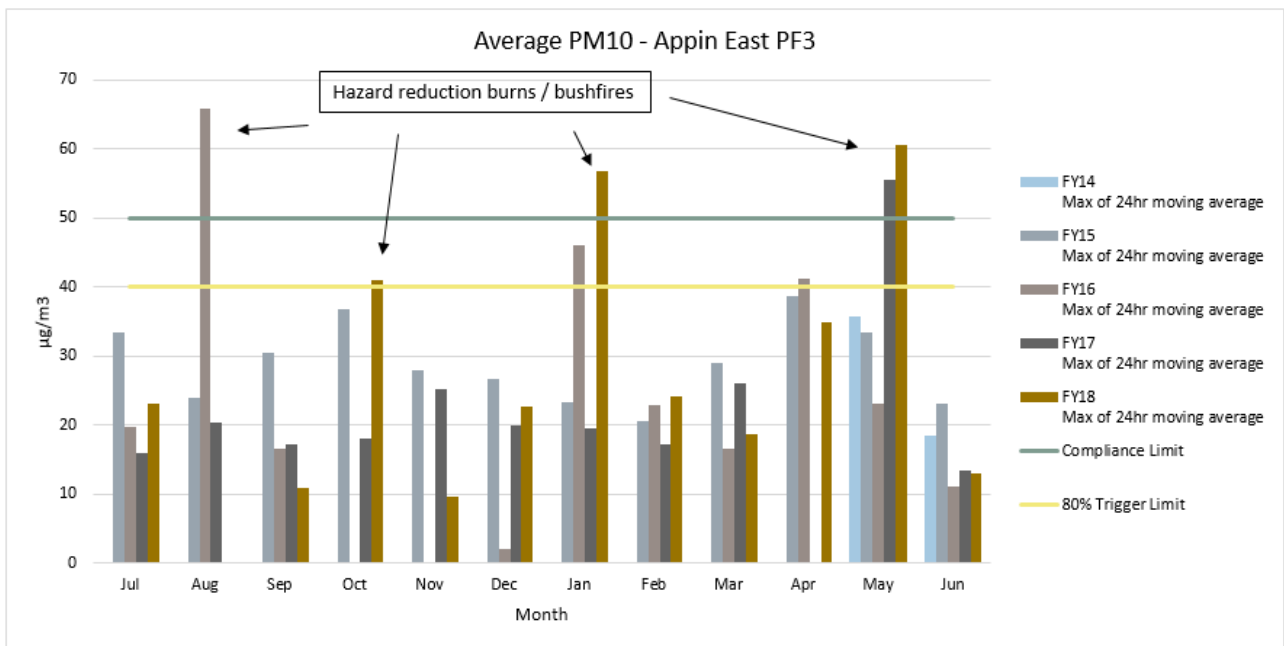
As described in the BSO AQMP, if the optical photometer at Appin East (Central) (AE-PF3) indicates average dust levels greater than 80% of the Air Quality Criteria (refer to Schedule 4, condition 9 of the BSO project approval) additional monitoring will be undertaken using the HVAS (AE-HV1) to assess compliance. The apparent maximum average PM10 dust levels were measured above the 80% criteria three times during the reporting period. These exceedances were attributed to regional bush fires and hazard reduction burning rather than dust emissions generated by BSO activities.

Figure 7: PM10 average 24 hour levels and maximum 24 hour levels at Appin East (Central).

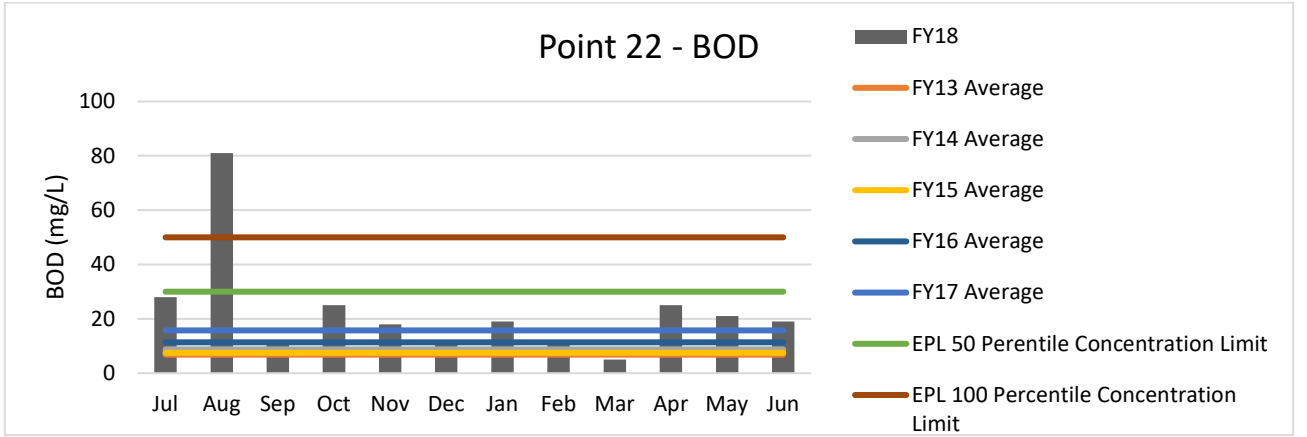
BOD sample result over the EPL 100 percentile limit in August. The exact cause of the exceedance is unknown. A likely contributing factor could be lack of material moving through the system as a result of reduced mining due to the prohibition notice. The average BOD for FY18 is below the 50 percentile concentration limit.

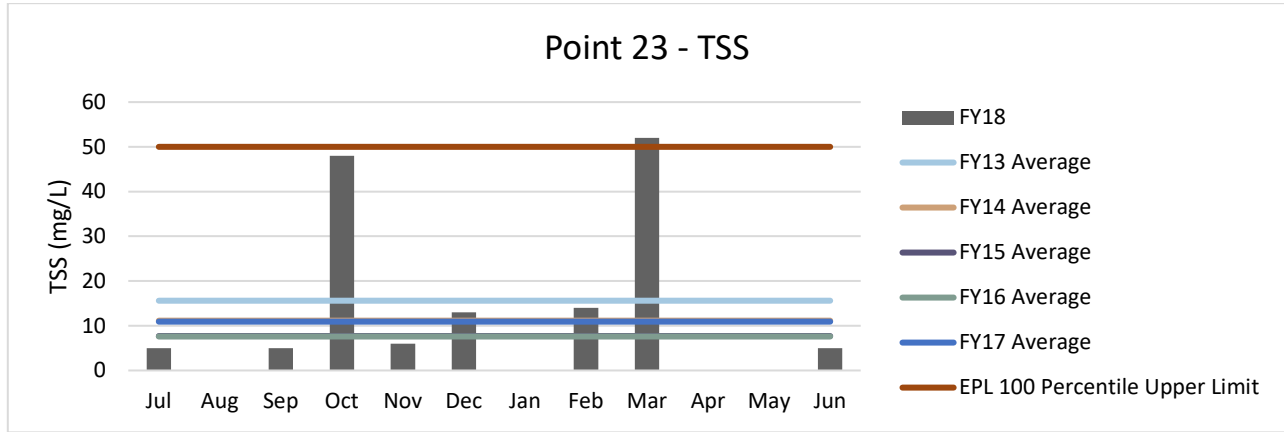
Point 23 No

TSS sample result over the EPL 100 percentile concentration limit on March. Cause attributed to incorrect replacement of filter medium in filter cartridges prior to discharge. Results for next sample and all others for FY18 below limit.

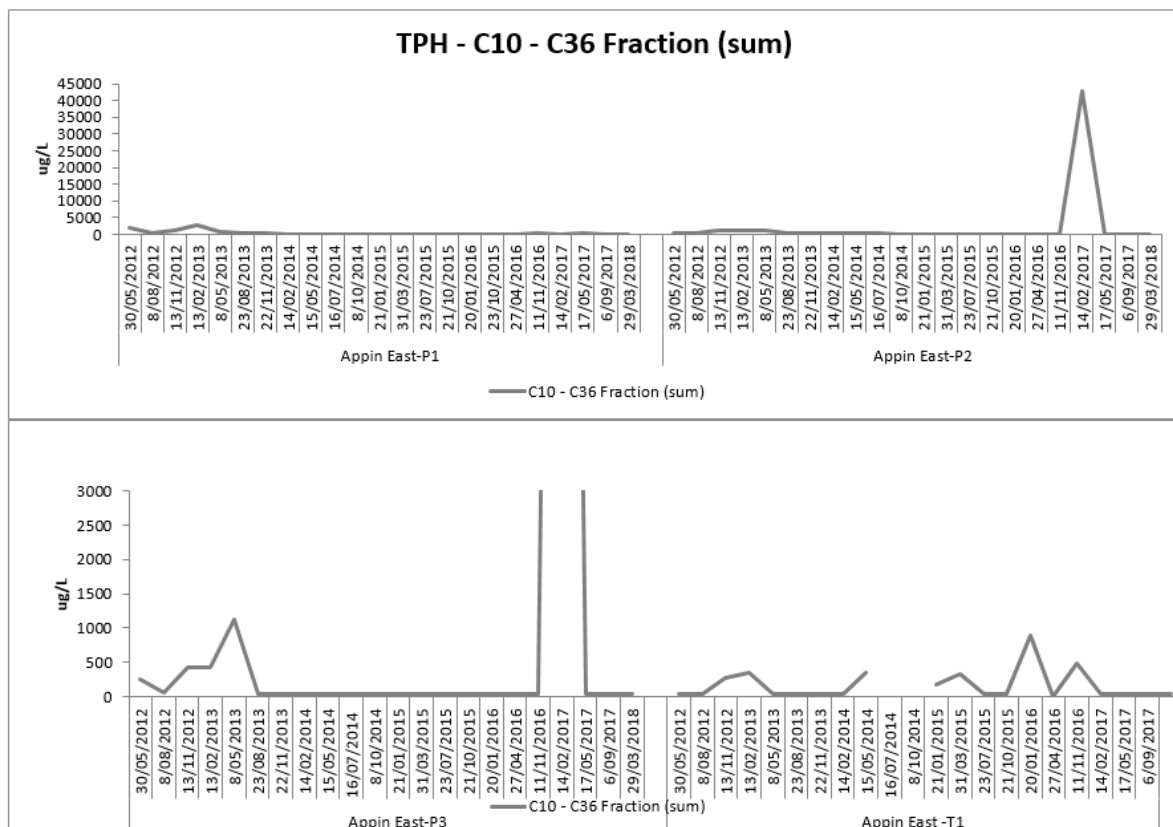
During the reporting period all boreholes showed below the observable limit for TPH (50 µg/L). Samples taken at three of the boreholes in the previous reporting period show elevated levels of TPH, however this is attributed to potential contamination during the sampling process as samples taken since show TPH below the observable limit. The most recent samples taken at T1 showed TPH levels below the Limit Of Reporting (LOR), indicating that there was no potential contamination from the old Appin Tip.

Figure 9: Total Petroleum Hydrocarbons (C10 – C36 Fraction (Sum)) since monitoring began in 2012 at Appin East (Central).

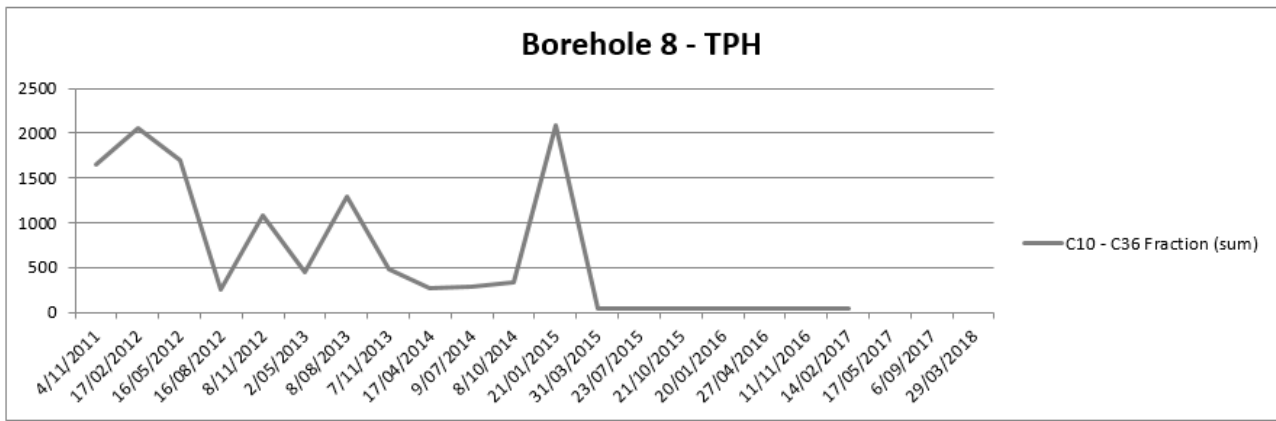
Since the first sampling campaign, TPH concentrations had generally trended downwards in BH8. TPH concentrations had ranged between 2050 µg/L in Feb 2012 down to 260 µg/L in August 2012 (Figure 10). The carbon chain range for BH8 are between C10 – C28 indicating that diesel is a potential source of contamination at this location. This is consistent with data reported in the validation report which was submitted to the EPA in August 2010 which indicated there was a small hot spot of contamination remaining.

During the reporting period the borehole was found to be dry due to sustained periods of low rainfall on two occasions. In March 2018 the borehole was found to be buried by adjacent roadworks. Actions to uncover the borehole have been initiated but not completed by the close of FY18.

Figure 10: Total Petroleum Hydrocarbons (C10 – C36 Fraction (Sum) µg/L) since monitoring began in 2012 in BH8 at West Cliff (Appin North).

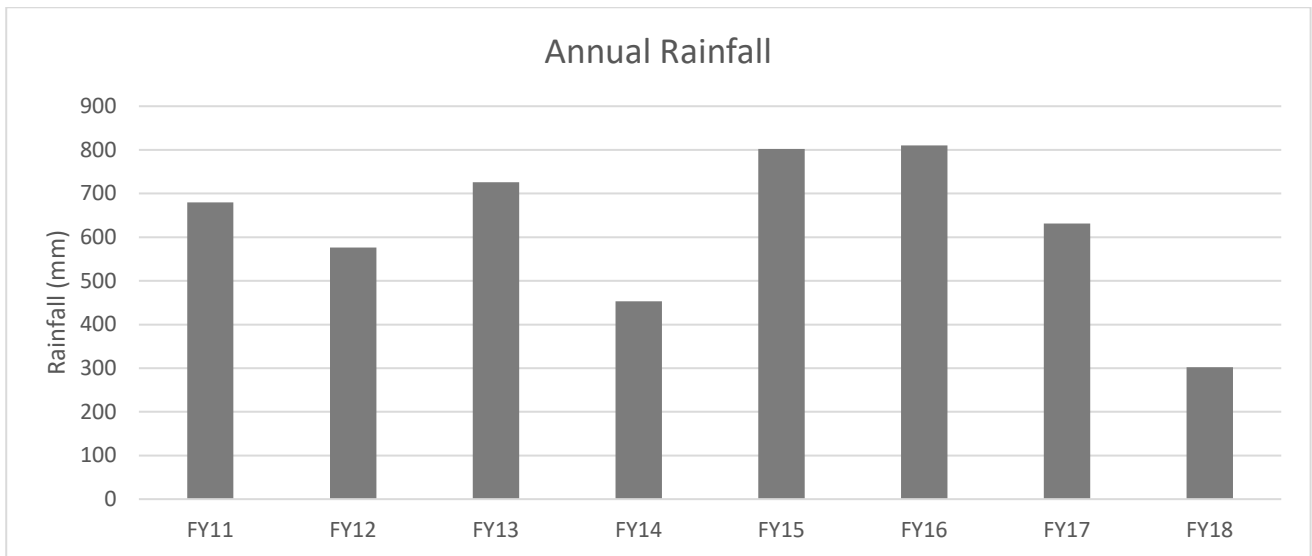
Figure 11: Annual rainfall – Menangle (BOM site #68216).

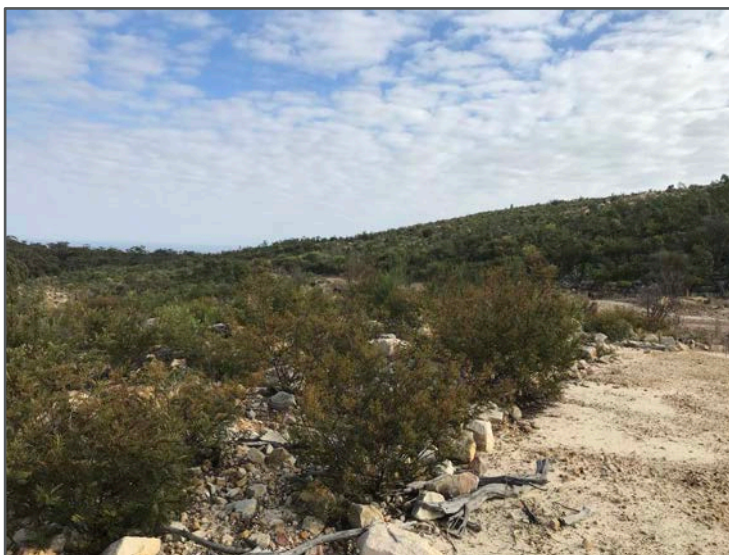
Figure 12: Stage 2 emplacement rehabilitation after two years showing dense cover of shrubs and high native species diversity.

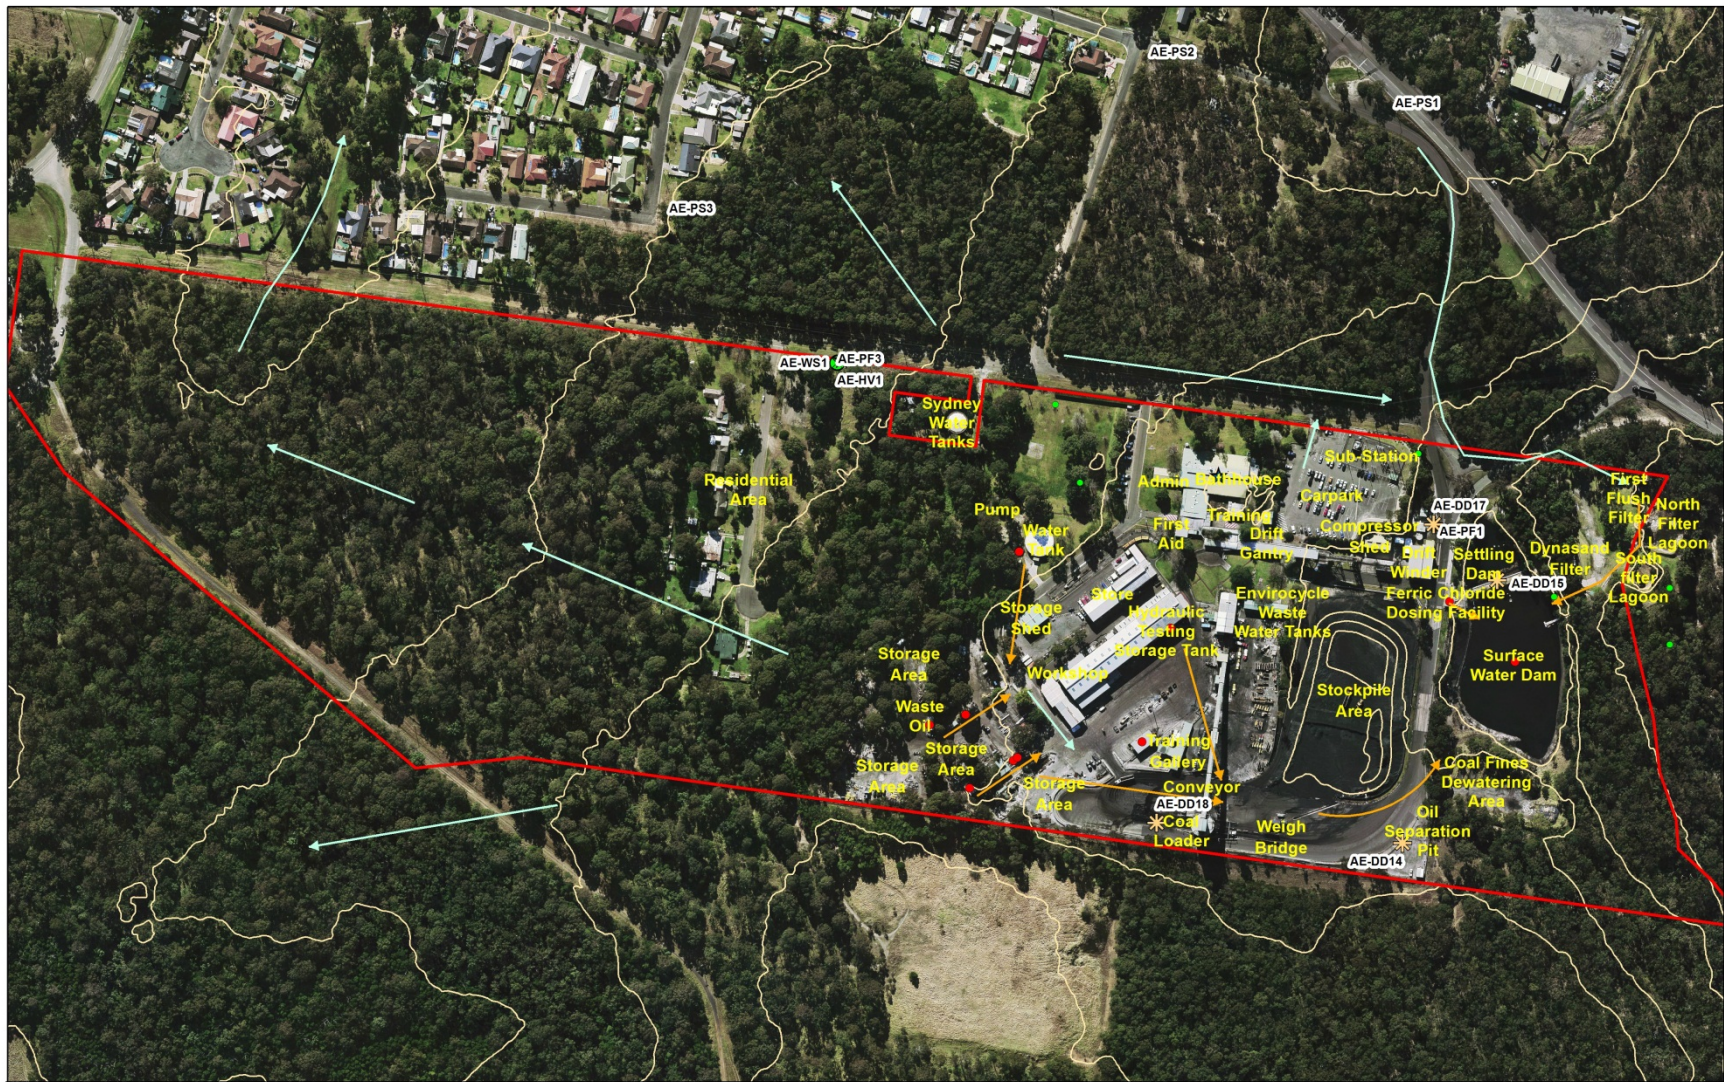
**PLAN 2 - APPIN EAST (CENTRAL) MINE SITE**

<b>Legend</b>				
	<ul style="list-style-type: none"> <li><span style="color: green;">●</span> Noise Monitoring</li> <li><span style="color: purple;">▲</span> Discharge Volume Monitor</li> <li> Dust</li> </ul>	<ul style="list-style-type: none"> <li><span style="color: green;">●</span> HVAS</li> <li><span style="color: blue;">★</span> Meteorological Monitoring Station</li> <li> Spillway Overflow</li> </ul>	<ul style="list-style-type: none"> <li><span style="color: blue;">◆</span> Surface Water Monitor</li> <li><span style="color: orange;">◆</span> Temperature</li> <li> Potentially Contaminated Surface Water</li> <li> Overland Flow</li> </ul>	<ul style="list-style-type: none"> <li><span style="border: 1px solid red; display: inline-block; width: 10px; height: 10px;"></span> Domain Boundary</li> <li><span style="color: red;">●</span> Chemical Storage</li> </ul>	
<b>Bulli Seam Operations</b> Annual Environmental Management Report Appin East		Date: 20th of August, 2015 Author: B. Davis		Horizontal Datum MGA - Zone 56

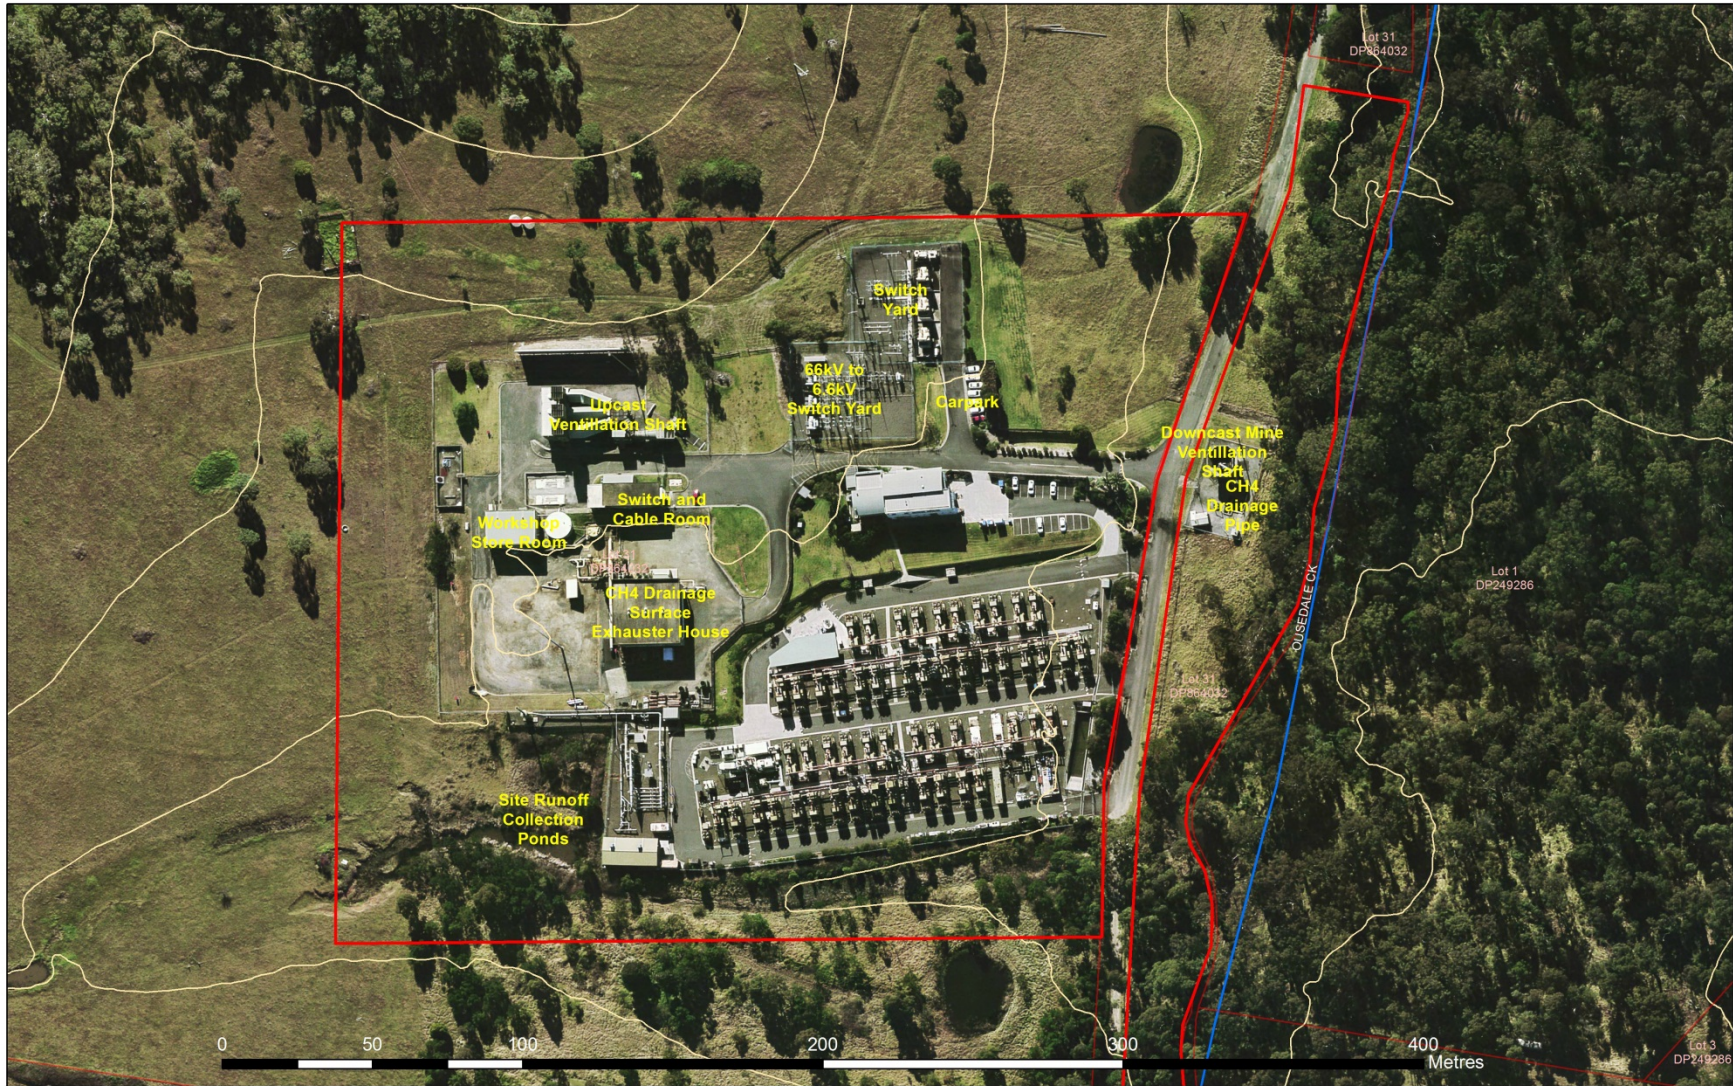
**PLAN 4 – NO.1 & NO.2 SHAFT SITE**

<b>Legend</b>	<ul style="list-style-type: none"> <li><span style="border: 1px solid black; display: inline-block; width: 15px; height: 10px; margin-right: 5px;"></span> Cadastral Parcels</li> <li><span style="background-color: #f0f0f0; border: 1px solid black; display: inline-block; width: 15px; height: 10px; margin-right: 5px;"></span> Crown Land</li> <li><span style="border: 2px solid red; display: inline-block; width: 15px; height: 10px; margin-right: 5px;"></span> Domain Boundary</li> </ul>	<ul style="list-style-type: none"> <li><span style="color: blue; font-weight: bold;">—</span> Creeks</li> <li><span style="color: yellow; font-weight: bold;">—</span> Bull Seam 5m Contours</li> </ul>
