Dendrobium Mine

Monthly report on water quality sampling
for the NSW Dams Safety Committee:
February 2016

South32 (Illawarra Coal)

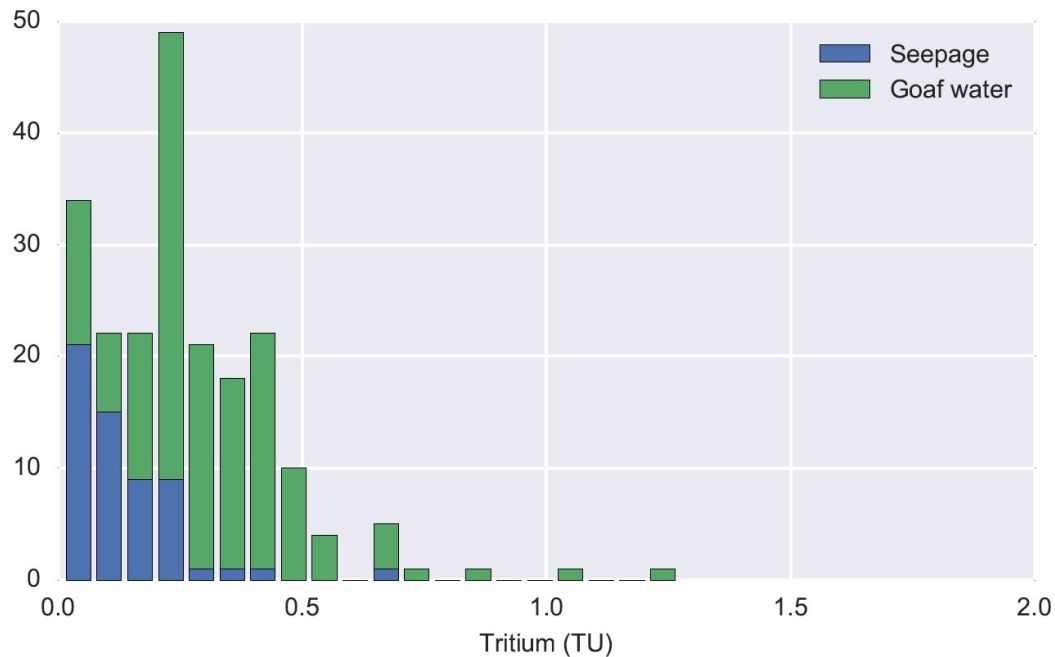
Figure 3.2. Tritium in mine inflow samples (excluding water supply)

Tritium concentrations in mine water are typically low (<0.3 TU), consistent with a negligible proportion of surface water entering the mine workings. Samples that are identified as direct mine seepage tend to have lower tritium concentrations than general goaf water samples which can contain water from a mixture of sources including surface water supplies (Figure 3.2)

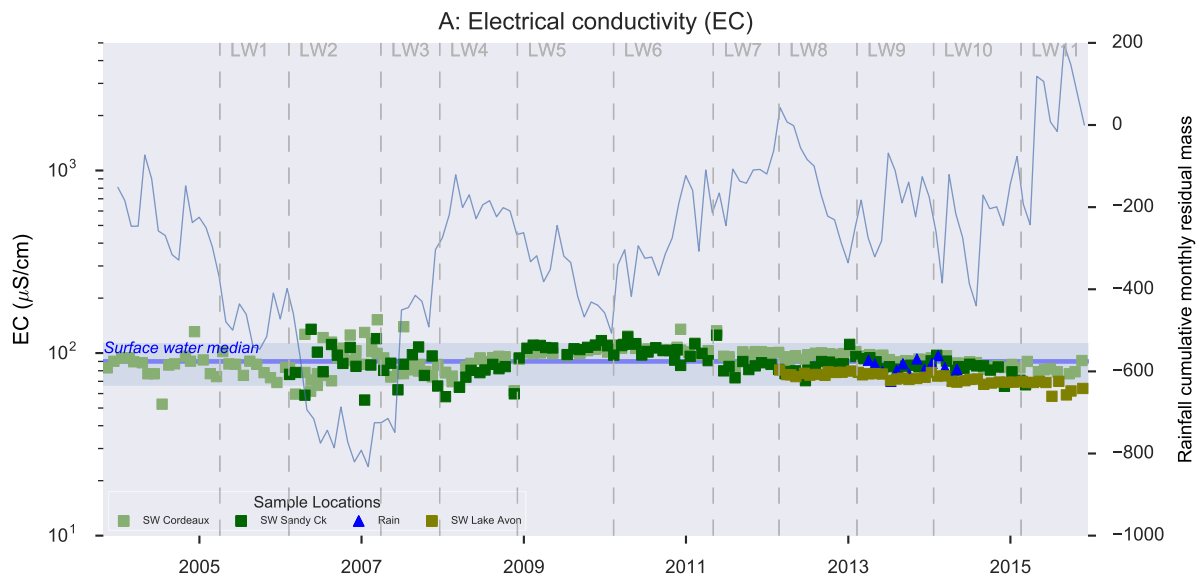
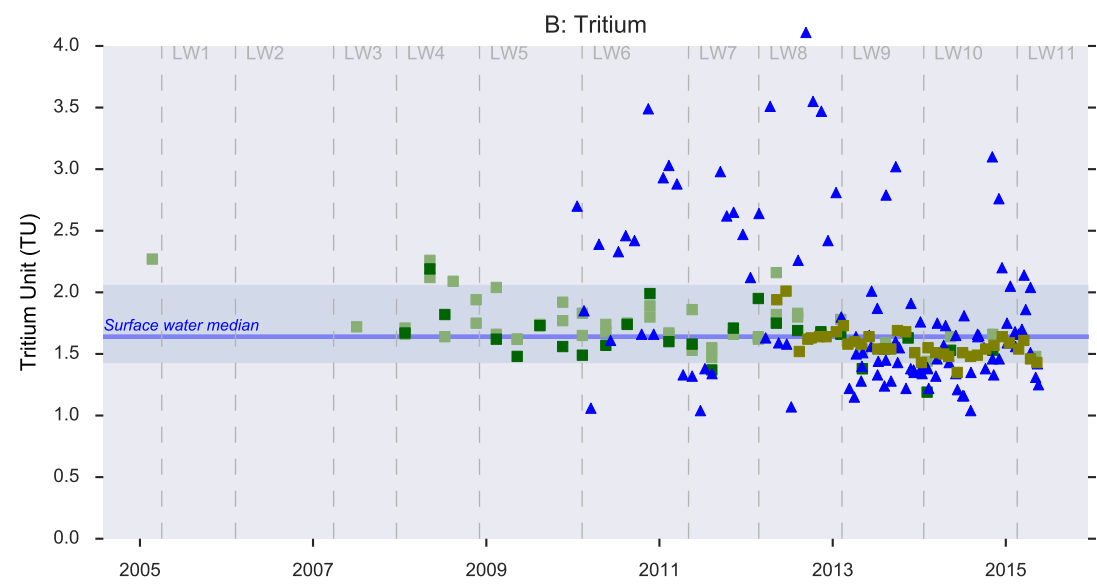
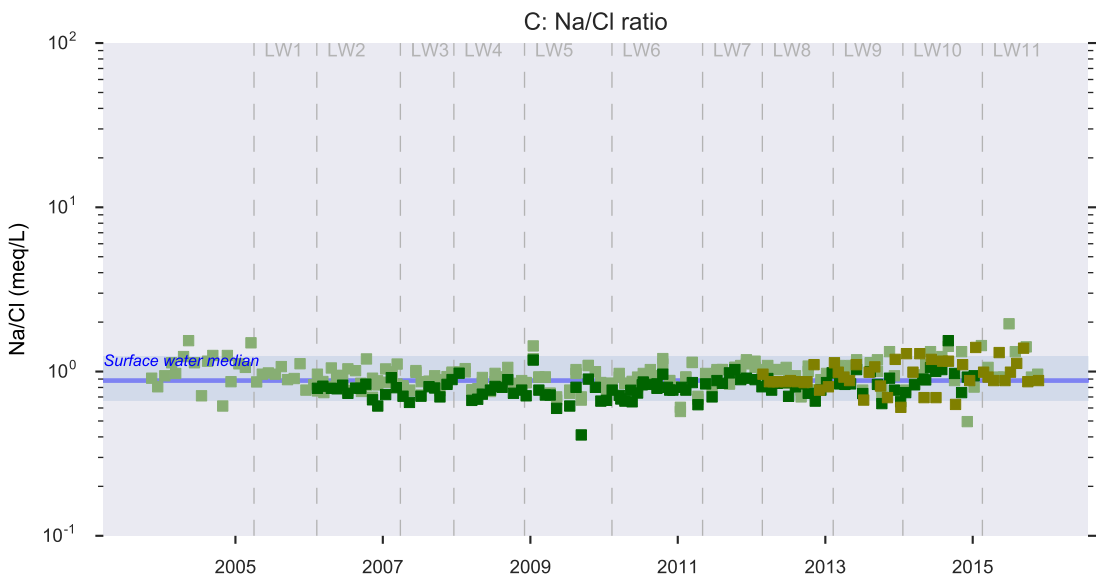
Figure 4.1: Surface water chemistry

Water results for the January 2016 sampling period are summarised in Table 4.1, compared with results for the previous two years. Time series plots for each water source category are shown in Figures 4.1 to 4.10. The plots show all water quality analyses and are colour coded to show individual sample sites.

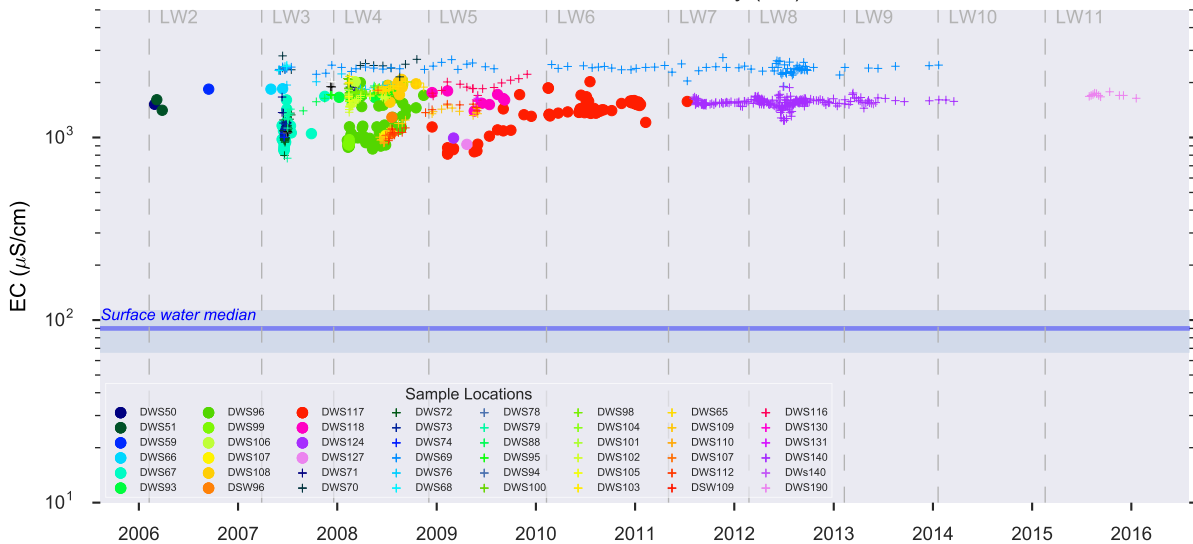
Figure 4.4: Mine inflow chemistry: Area 2

No additional Tritium analyses were obtained in this reporting period. Tritium levels in the 8 most recent samples collected from Mine Area 2 between July and October 2015 are the highest since 2008 with a mean of 0.50 TU (n = 8), and exceed the 95th percentile value for Area 2 goaf waters over the last 2 years (P95 = 0.40 TU).

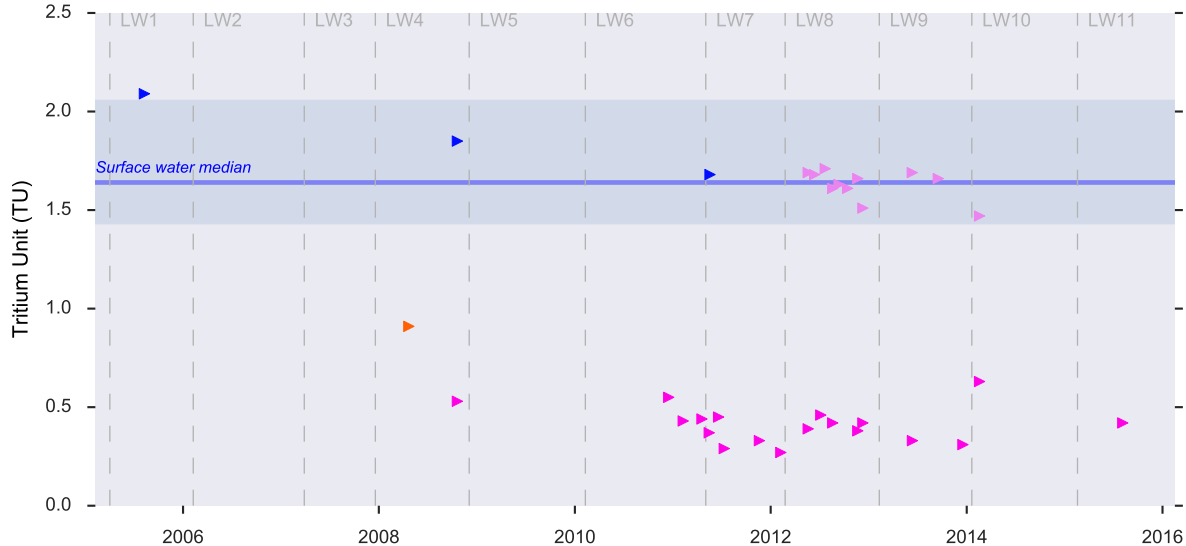
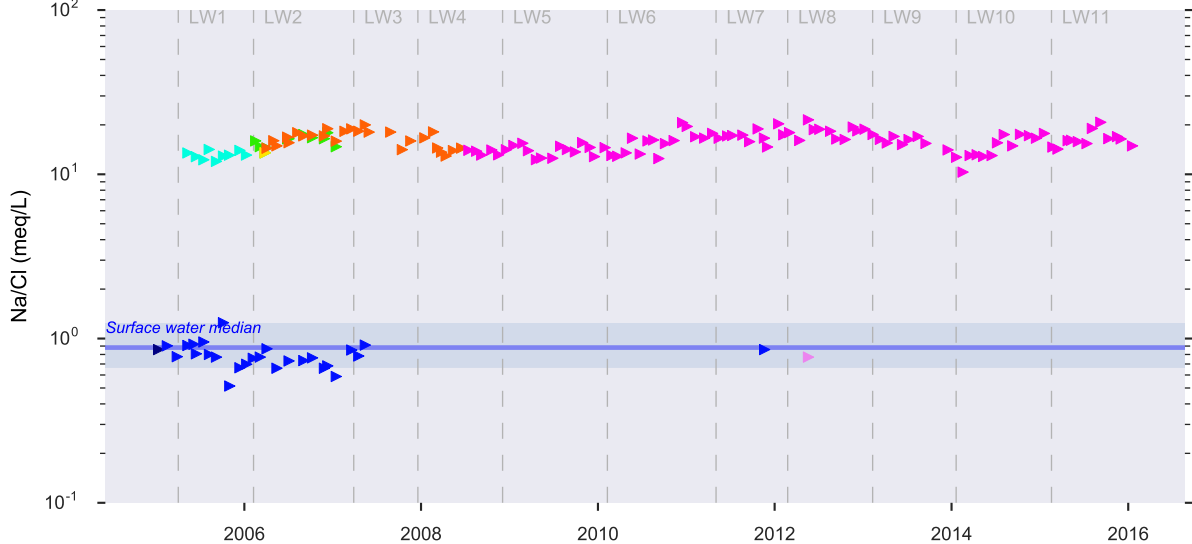
Figure 4.7: Mine water chemistry: Water supply

Water supply	DWS28A	Median EC and Na/Cl ratio for 1 water supply sample collected from Nebo Mains in January 2016 falls within the 5 th to 95 th percentile range for the previous 2 years (Table 4.1). No adverse or anomalous trends are noted in time-series (Figure 4.7).
Adjacent workings		Not sampled this period	
Groundwater in overlying strata		Not sampled this period	
Surface water	Lake Cordeaux	Not sampled this period	
	Lake Avon	Not sampled this period
