29 May 2017

RE: Review of Aquatic Flora and Fauna for Dendrobium Area 3B Longwall 12

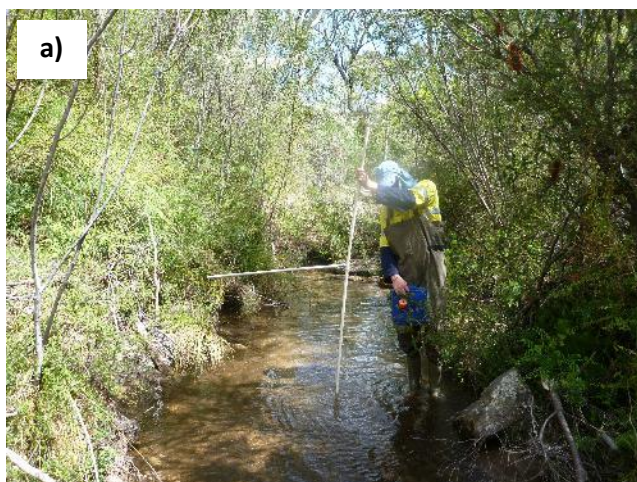
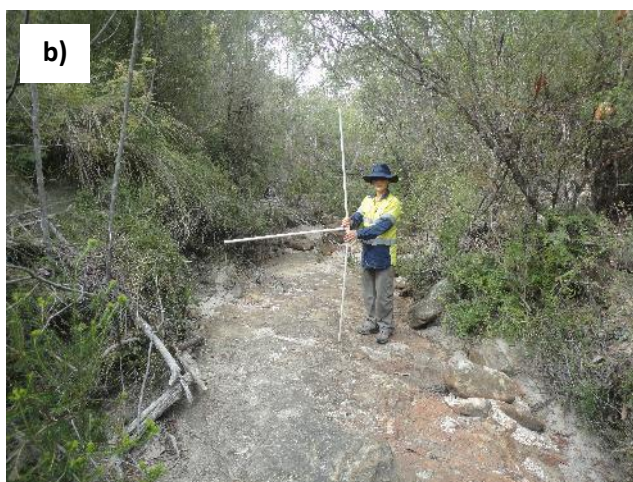
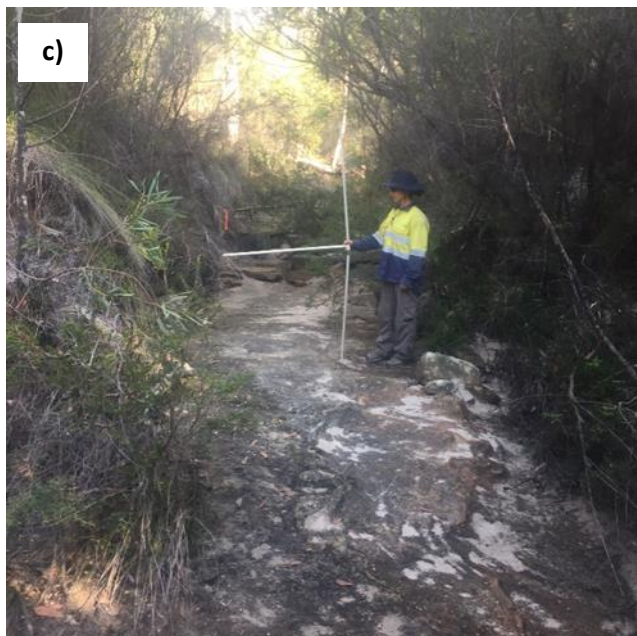
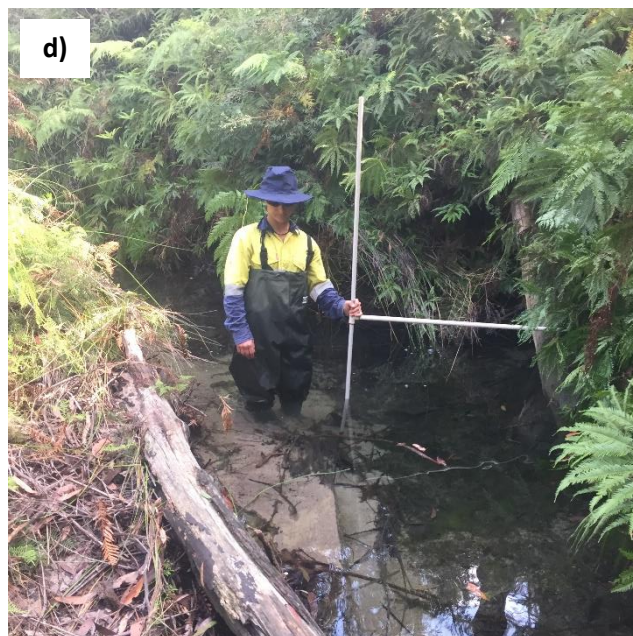
During the latest aquatic ecology monitoring survey in April 2017, the only aquatic habitat at X2 in WC21 consisted of a few small and disconnected pools, likely derived from rainfall (**Plate 1a-c**). This site is above Longwall 9 and approximately 900 m downstream of Longwall 12. Fracturing was also present at the upstream section of this site. Mining-related fracturing of bedrock, flow diversions and associated reductions in pool water levels and flow were first observed in WC21 by Illawarra Coal in December 2013. Associated loss of aquatic habitat was first observed by Cardno in early 2014 (CEL 2015). By 2015, there was a complete loss of surface water base-flow at aquatic ecology monitoring site X2 (approximately 100 m long) and surface water was restricted to a few small, disconnected pools. By March 2016 the length of WC21 that had been affected by reduction in surface flow and pool water levels was 1,050 m (South32 Pers. Comm. March 2016) and by April 2017 it was approximately 1,600 m (South32 Pers. Comm. April 2016). This reduction in aquatic habitat availability and connectivity in WC21 represents a significant impact to aquatic ecology with respect to this tributary.

Plate 1: Site X2 on WC21 in a) November 2013 b) November 2015 and c) April 2017 and d) Site X3 further upstream on WC21 in April 2017

It is recommended that further during and post mining aquatic ecology monitoring is completed in DA3B and in WC21 in line with the AFFR and SMP. South32 should continue to monitor WC21 and other watercourses that have been affected by extraction of Longwall 12 and the findings of these will be used to assess whether TARPs have been triggered with respect to Longwall 12.
