# DENDROBIUM MINE

End of Panel Surface Water and Shallow Groundwater  
Assessment: Longwall 13 (Area 3B)

**HGEO Pty Ltd**

Date: July 2018

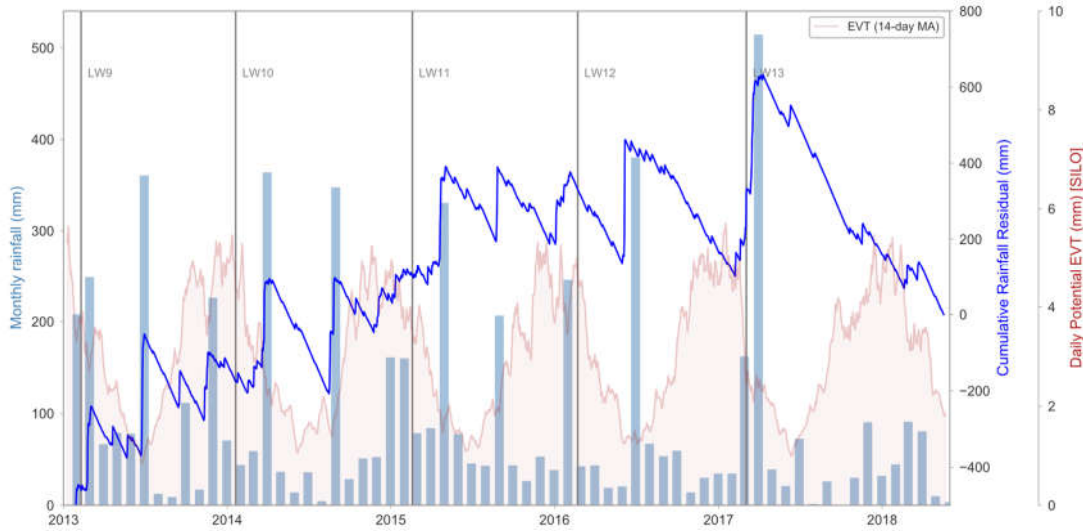
Figure 3. Rainfall and potential evapotranspiration (EVT) at Area 3 for the reporting period

proportion of the annual rainfall to be delivered in a small number of large rainfall events, during which significant surface water runoff and groundwater recharge is generated.

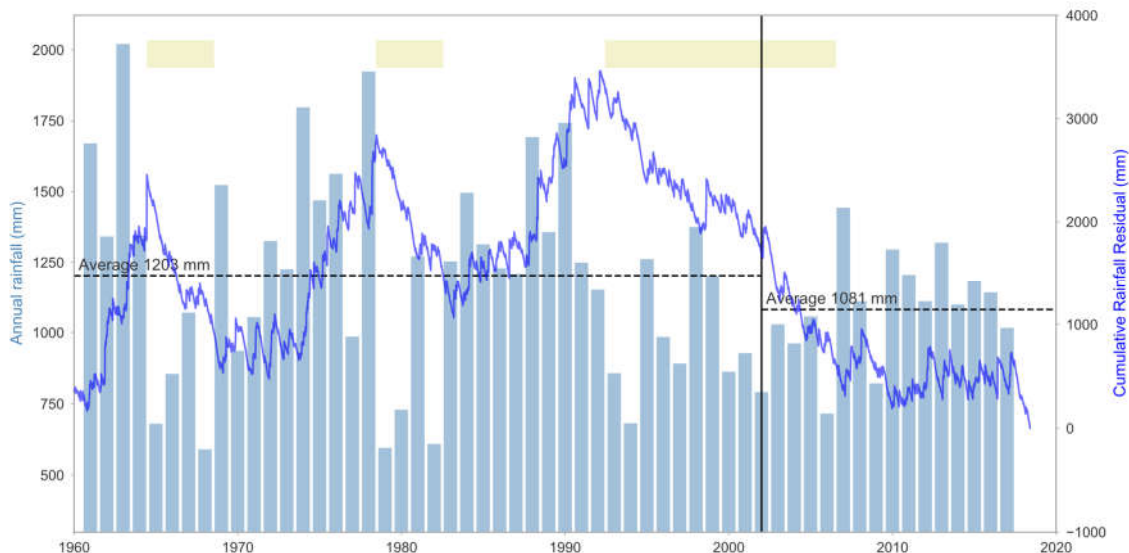
**Figure 6. Long-term rainfall trends at Dendrobium (1960-2018)**

Figure 6 shows longer term rainfall trends between 1960 and 2018 and is derived from SILO data (and is therefore slightly different from site measurements). Since 1960 there have been three periods of drought on the plateau (yellow shading), the last being the severe Millennium Drought, ending in 2004. The last decade has been characterized by relatively consistent rainfall as measured across calendar years. The plot shows that the period from 2002 for which rainfall data have been collected at Dendrobium is slightly below the long-term average (~1200 mm), accounting for the difference in appearance of the cumulative rainfall trends in Figure 3 (based on site data) and Figure 6 (based on long term SILO data).

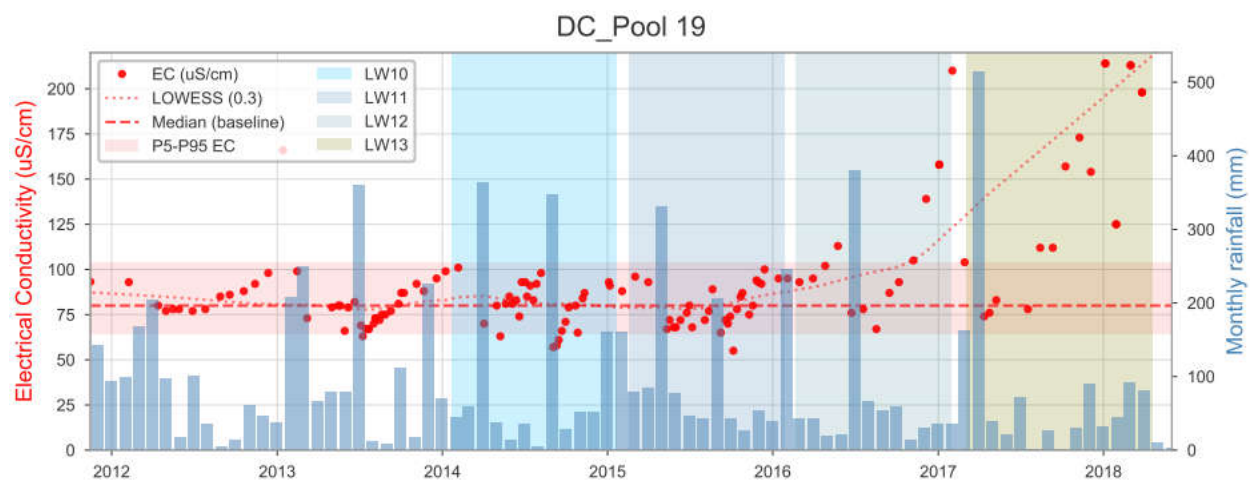
Figure 11. Field measured EC at Donald's Castle Creek Pool 19

Electrical conductivity of surface water has increased to levels significantly higher than baseline ranges at several pool monitoring sites across mining Area 3B during the extraction of Longwall 13, most notably at Pools 19 and 20 on the main first-order tributary of Donalds Castle Creek (e.g. Figure 11). The trend is accompanied by a decline in DO to levels lower than baseline range and a slight decline in water pH (Appendix A). This tributary crosses the previously mined Longwalls 9 to 11, but does not cross above Longwall 13.

The elevated EC levels during the extraction of Longwall 13 coincide with an unusually dry period on the plateau, during which, pool levels were low (or dry) and gauges record low-flow or no-flow conditions (e.g. at DCS2 located at Pool 20 and just 22 m upstream of Pool 19). The increase in pool salinity is considered to reflect higher than usual concentration of dissolved salts due to pool evaporation during the no-flow periods. Pool-water EC values above the baseline range have been noted in other pools across mining Areas 3A and 3B, including LA3\_Pool 4 (860 m south of Longwall 13), WC15\_Pool 28 (395 m from LW13), Sandy Creek SC10\_S1 (no active mining beneath the catchment). Therefore, the effect is not restricted to this tributary, nor other tributaries that cross active or previously mined panels.

However, it is noted in Section 5.2.4 that measured tributary catchment yields at DCS2 have likely reduced, and cease-to-flow days have likely increased, since Longwall 9 passed beneath the tributary. Therefore, mine subsidence and stream diversions are likely to have contributed to and exacerbated the water quality effects at the DC\_Pool 19 and Pool 20 sites. As noted in the previous section, EC levels at the downstream location DCU were also elevated but remain within the baseline range and did not trigger the EC TARP.

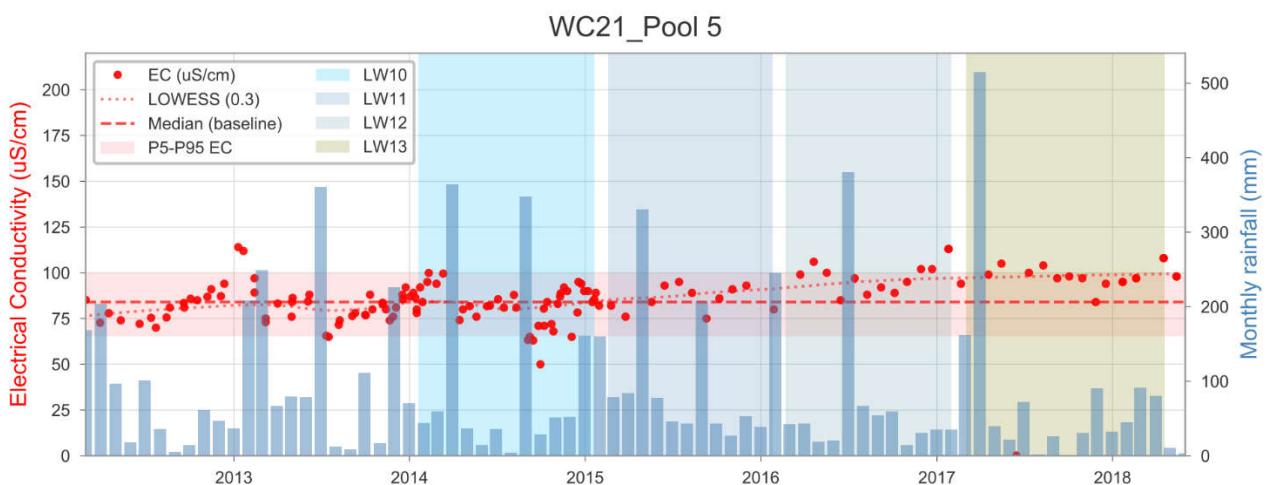
Figure 15. Field measured EC at WC21 Pool 5, downstream of Area 3B

Monitoring location WC21\_Pool 5 is located downstream (to the north) of mining Area 3B. The EC of water at this location was elevated above the baseline P95 during Longwall 13 on three occasions (Figure 15). Water EC in WC21 at Pool 5 has remained slightly elevated above the baseline mean since Longwall 11. While low rainfall and high summer evaporation conditions can account for periods of elevated EC in the past, it is likely that subsidence impacts and redirection of water through fracture networks is contributing to the elevated EC in WC21 at Pool 5. It should be noted that the EC in Pool 5 is still well below the TARP level for the downstream site on Wongawilli Creek at FR6 (TARP level 154.1  $\mu\text{S}/\text{cm}$ ). Water pH in Pool 5 has also remained elevated above the baseline mean since Longwall 10, but remains in the near-neutral range (Figure 16).

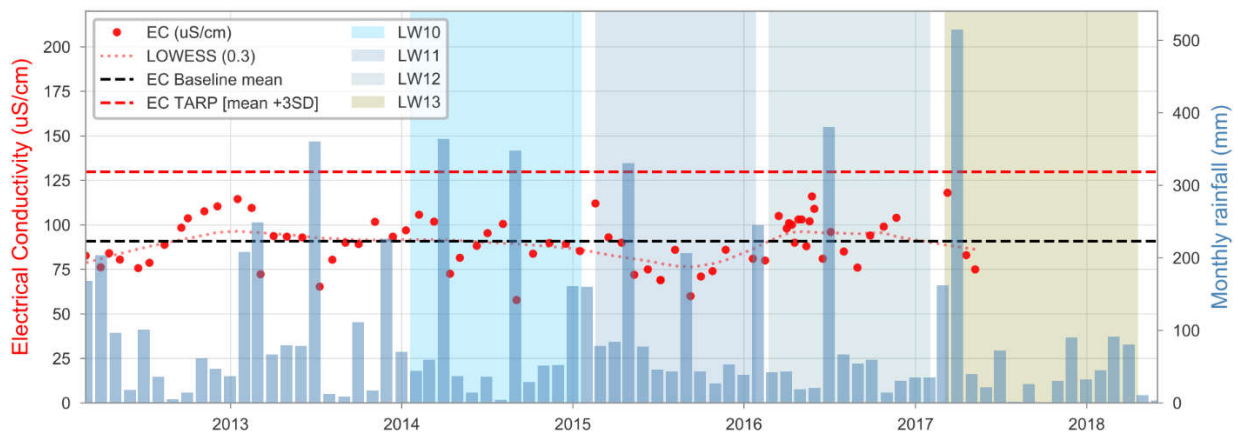
**Figure 19. Field measured EC at Lake Avon tributary (LA4\_S1)**

Ground subsidence associated with Longwalls 12 and 13 has resulted in the development of surface cracking of the stream bed of LA4 near the gauging station weir LA4\_S1 (Table 5). This resulted in the diversion of flows just upstream of the LA4\_S1 gauge and measurable reduction in flow at the gauge, as reported previously (HGEO 2017b; South32 2017), and in this report (Section 5.2). As a consequence of the flow diversion and the low rainfall during the extraction of Longwall 13, most of the pools and sampling points on the LA4 watercourse were dry and could not be sampled for water chemistry. Of the sampling events that were carried out, none triggered TARPs related to water chemistry (Figure 19). A time series plot of water EC measured at LA4\_S1 near Lake Avon is shown in Figure 19.

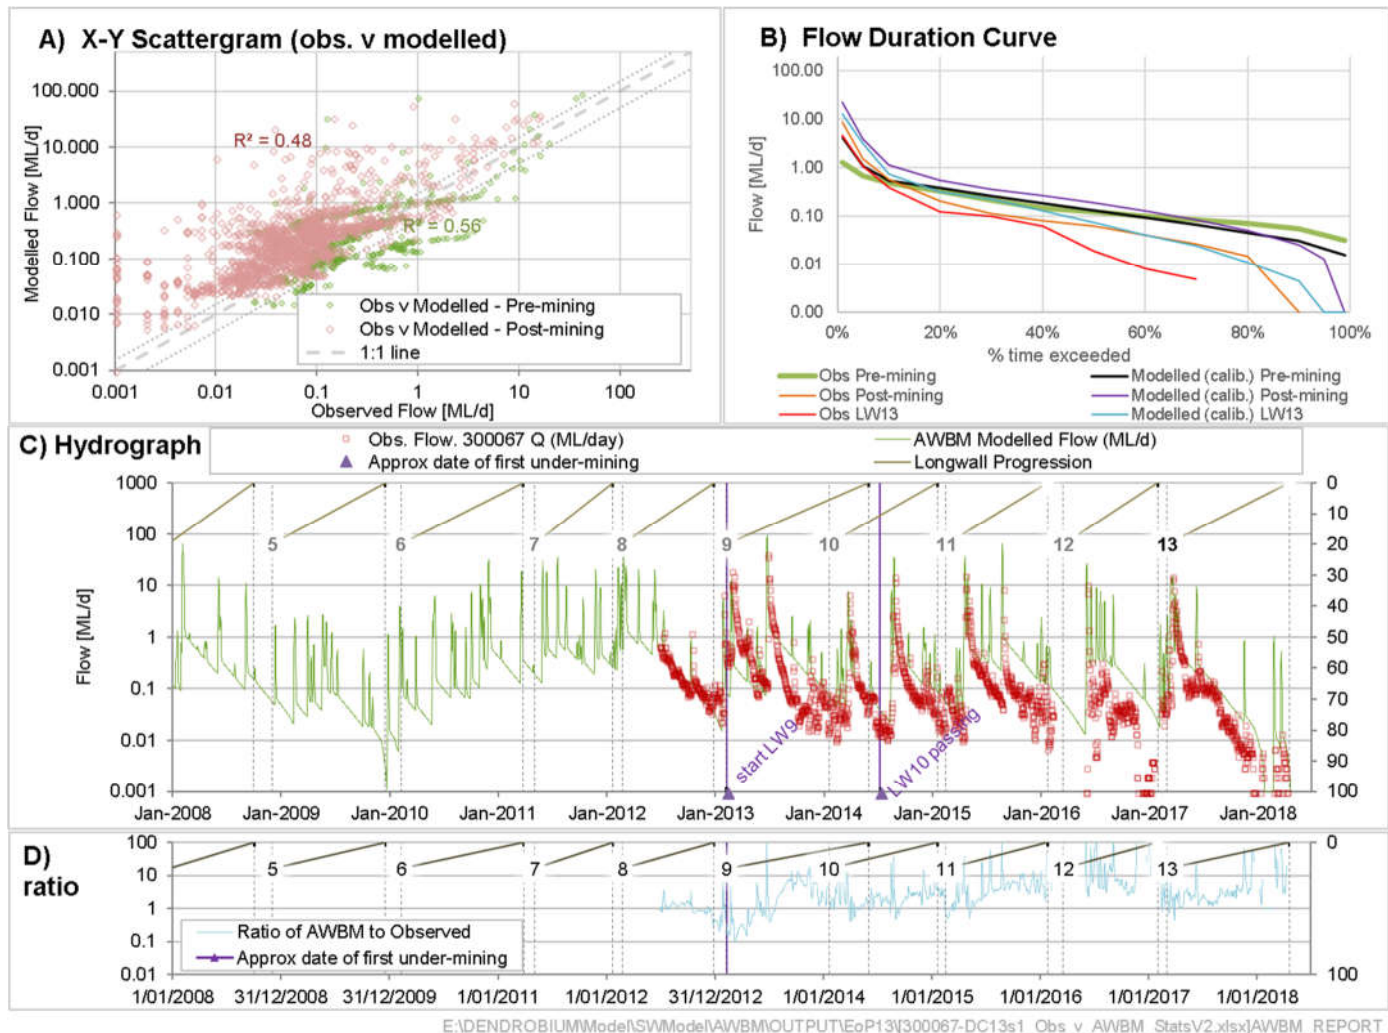
**Figure 20. Comparison of observed and simulated flows in Tributary DC13S1**

This tributary lies across the centre of several Area 3B panels. The catchment to DC13S1 was first mined under at the commencement of Longwall 9, and has been undermined by Longwall 10 and Longwall 11. Longwalls 12 and 13 did not directly mine under this sub-catchment.

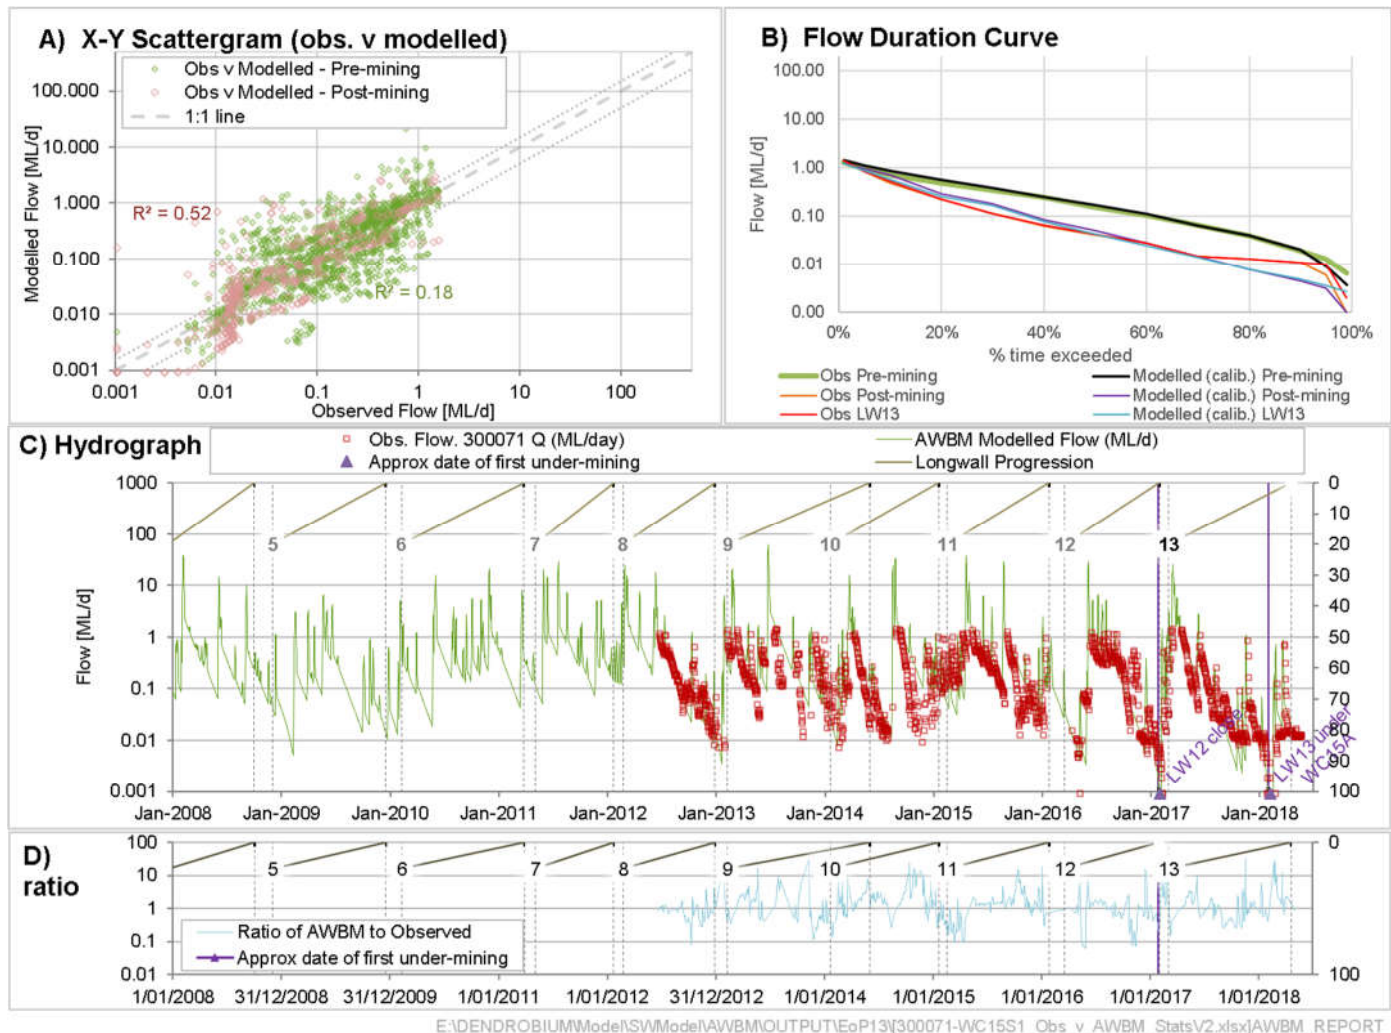
**Figure 23. Comparison of observed and simulated flows in Tributary WC15S1**

This tributary to Wongawilli Creek lies above Longwalls 13-17 of Area 3B, with its confluence with Wongawilli Creek approximately 320 m from Longwall 13. Prior to this, this sub-catchment had not been directly mined under, although Longwall 12 came within 100 m of the catchment.

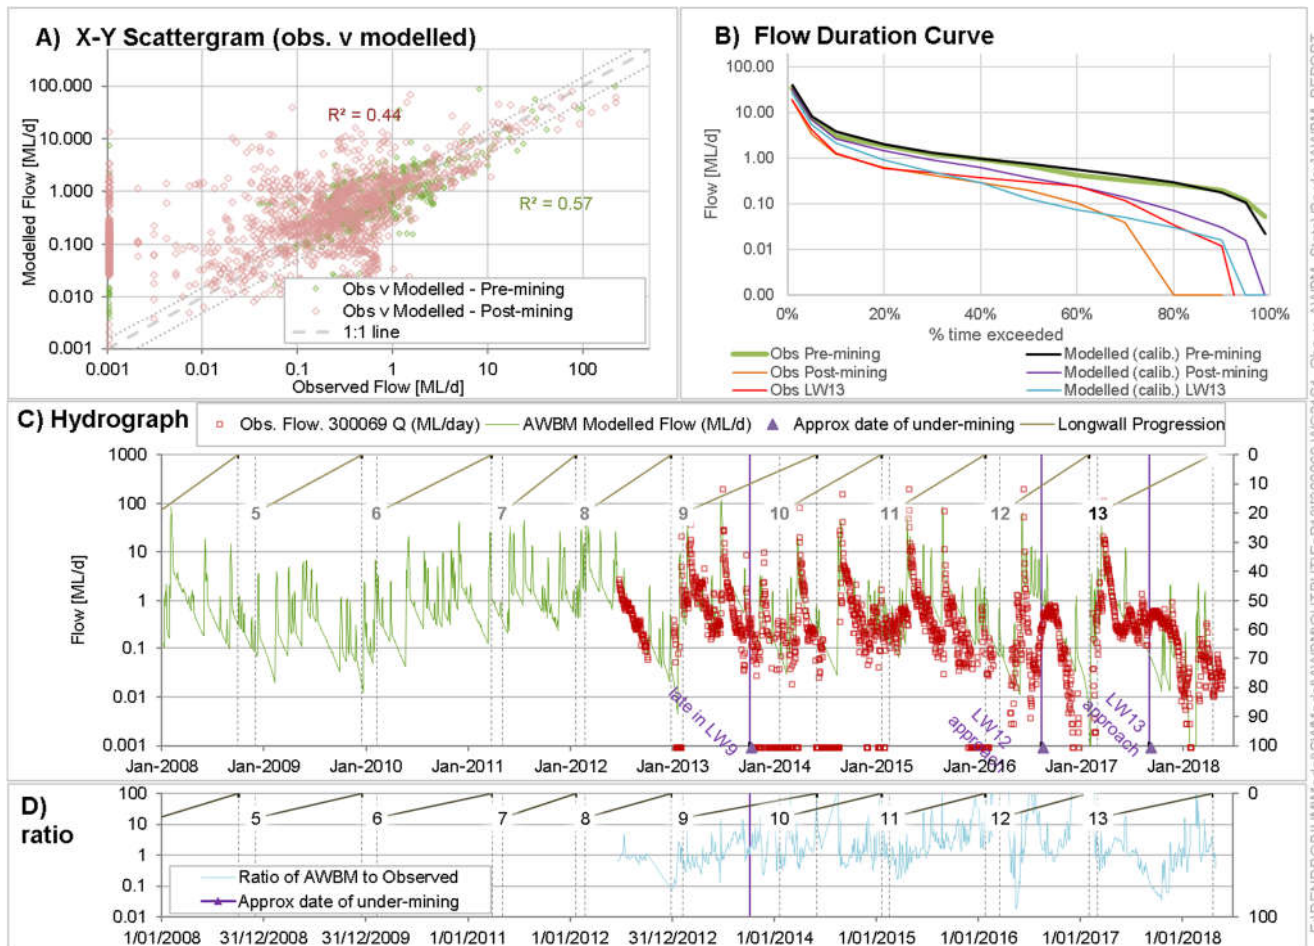
Figure 24. Comparison of observed and simulated flows in Tributary WC21S1

WC21, a tributary to Wongawilli Creek, flows above Longwalls 9-15, entering Wongawilli Creek just north of Longwall 9. This catchment was therefore mined under late in Longwall 9, has since been undermined by Longwalls 10-13, and it is planned to be mined under by Longwalls 14-15.

- A** The scattergram shows that during the pre-mining period the model is a good fit to observed data, as shown by the graphical correlation to the 1:1 line and the R<sup>2</sup>. This correlation declines somewhat in the post-mining period.

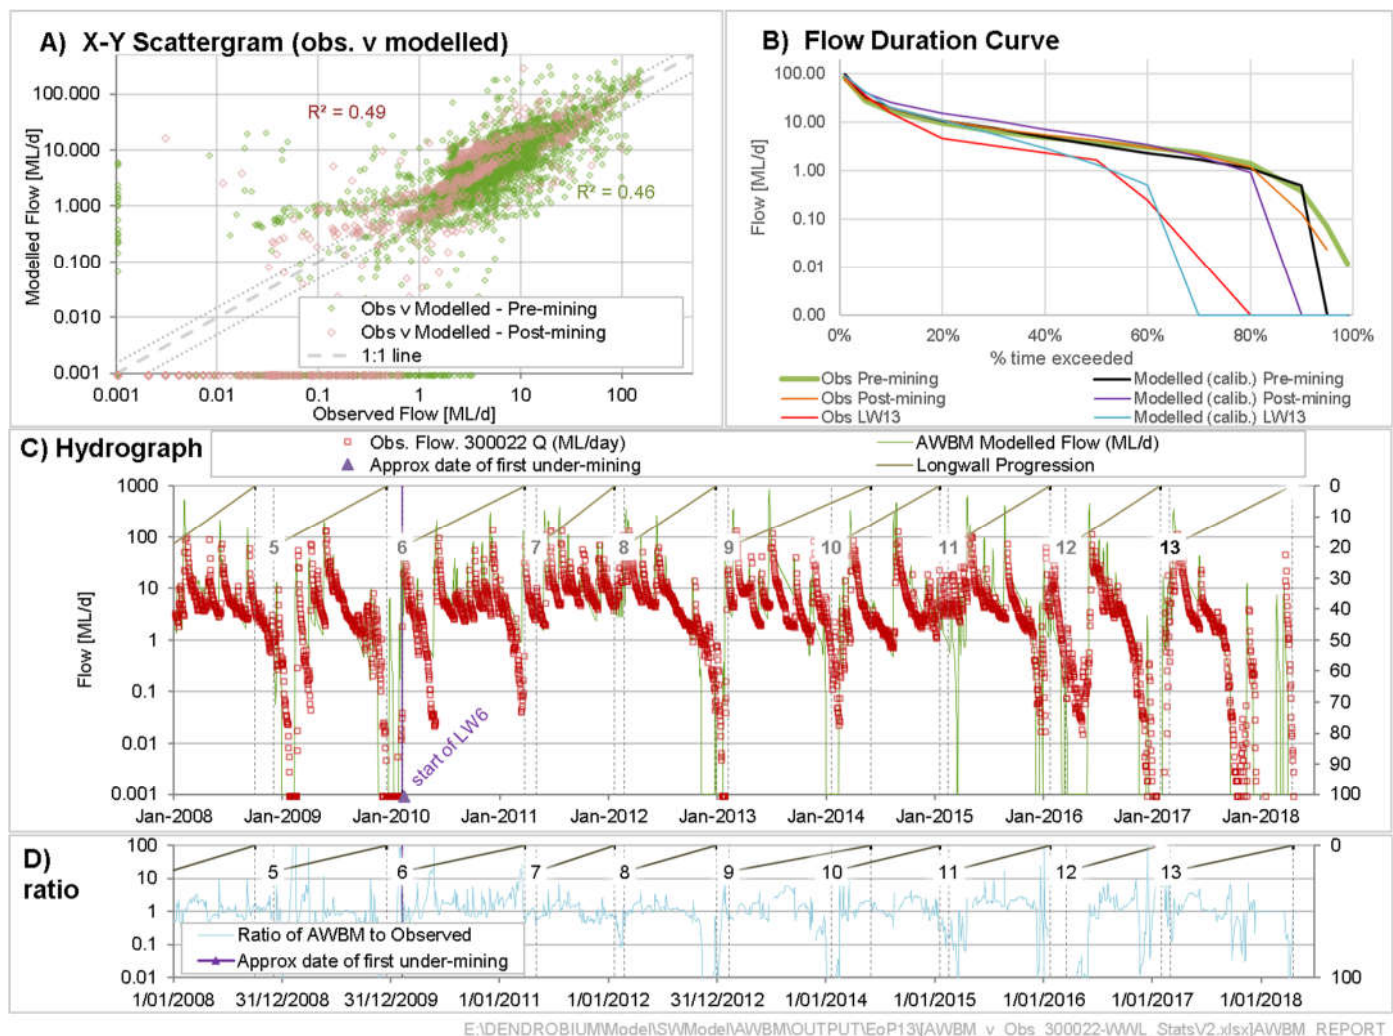
**Figure 25. Comparison of observed and simulated flows in Wongawilli Creek to WWL**

Wongawilli Creek lies between Areas 3A and 3B and the main stream is not directly mined under (by longwalls), although some tributaries have been or will be mined under by panels in those areas, including during Longwall 13.

- Rainfall-runoff modelling (using the AWBM) did not indicate a significant deviation between the model (calibrated to pre-mining conditions) and observed flows at WWL on Wongawilli Creek (as is the case in this review). Therefore, local diversion and/or reduction in baseflow has not resulted in a detectable reduction in flow at the downstream gauge.

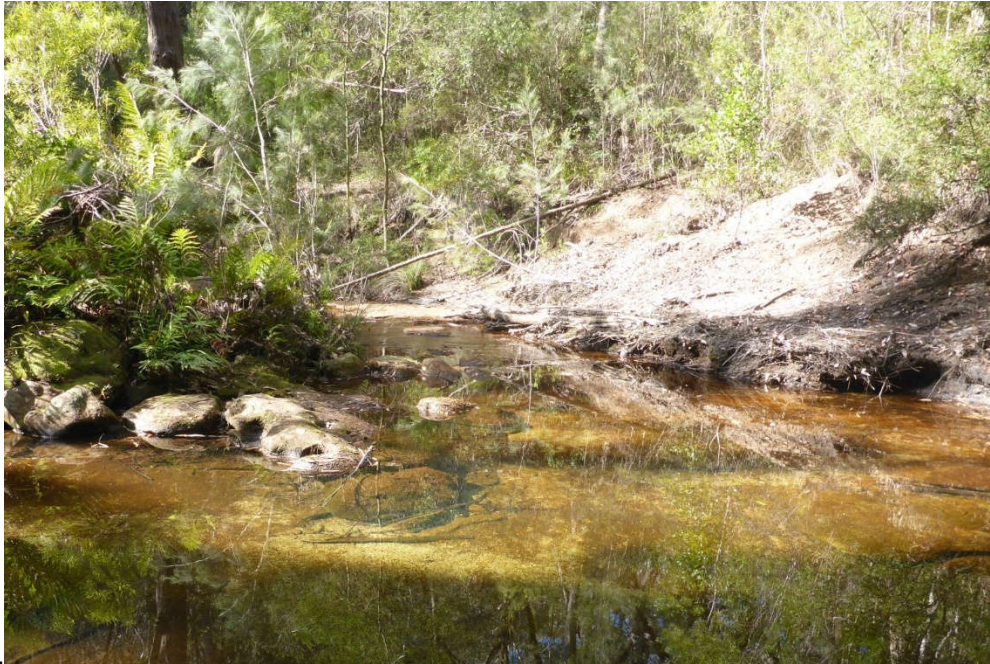
**Figure 27. Pool 43a looking downstream to rock bar control on 26/07/2017**

This section summarizes observations at Wongawilli Creek Pool 43a. Pool 43a is located on Wongawilli Creek, 348 m east of Longwall 9 in Area 3B (extracted between 9/2/2013 and 2/6/2014) and 315 m northwest of Longwall 6 in Area 3A (9/2/2010 - 28/3/2011). Pool 43a is controlled by a rock bar as shown in Figure 27 (pool overflowing) and Figure 28 (Pool dry at downstream end).

The photos are taken from slightly different locations, but note the fallen tree angled at about 30° from horizontal in both photos for reference.

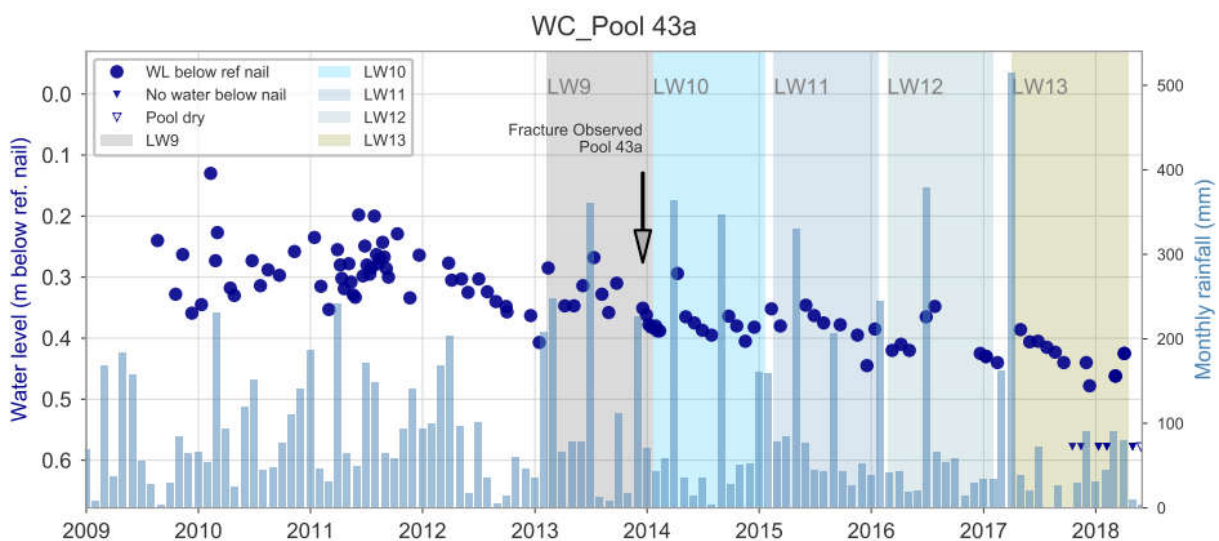
Figure 29. Time series plot of water level observations in Pool 43a

The water level in Pool 43a on Wongawilli Creek has declined since 2012, and a TARP level 3 impact was recorded when water levels dropped below baseline on 20/11/2017, following the identification of a stream bed fracture in 2013. Assessment of the declining water levels in Pool 43 has been hindered by the unusually dry conditions during the extraction of Longwall 13 which has affected pools outside the influence of mining. However, the steady decline in water levels at Pool 43a since 2012 appears independent of the rainfall trends and, combined with observations of drawdown in groundwater pressures in the sandstone substrate, suggests that water level trends at Pool 43a may be due to induced baseflow reduction. Rainfall-runoff modelling of flows at the downstream gauge (WWL)

Nevertheless, it is recommended that pool water levels and flows upstream and downstream of Area 3B be reassessed after a period containing moderate to heavy rainfall (at or above the mean) or after the end of Longwall 14, whichever occurs first.

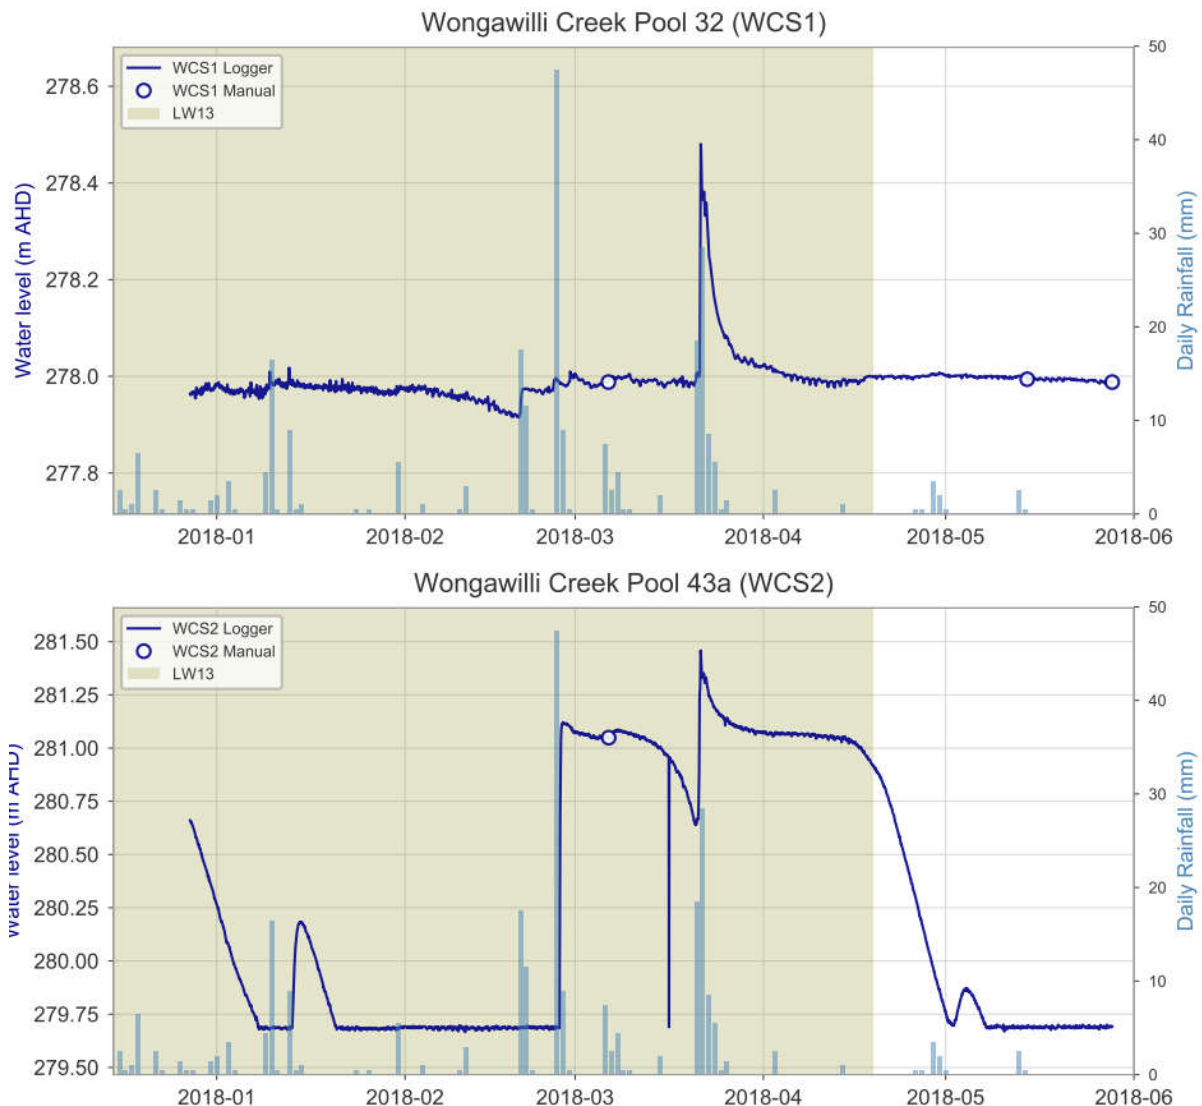
**Figure 31. Water level hydrographs at WCS1 and WCS2 (Pool 43a)**

In late December 2017, water level dataloggers were installed in Pool 43a (logger location WCS2) and at WCS1, located 785 m downstream of Pool 43a (Pool 32), and downstream of Mining Area 3A and 3B. The dataloggers measure the water level at hourly intervals relative to a surveyed benchmark at the respective sites. Hydrographs for both sites are shown in Figure 31. Water levels at each site show different recession characteristics related to the geometry of the pools and their control points. The monitoring period is currently insufficient to assess time-series trends but will provide important high-resolution information for ongoing assessment.

Assessment of the declining water levels in Pool 43 has been hindered by the unusually dry conditions during the extraction of Longwall 13 (Section 2.4) compared with the baseline period. Observations at other pools that are outside the influence of mining (e.g. Pool 49; Figure 32) certainly suggest that the dry conditions contribute to the low water levels during Longwall 13. However, the steady decline in water levels at Pool 43a since 2012 appears independent of the rainfall trends and may indicate progressive local flow diversion and/or baseflow reduction. Based on the information reviewed here, the latter mechanism (baseflow reduction) may be dominant.

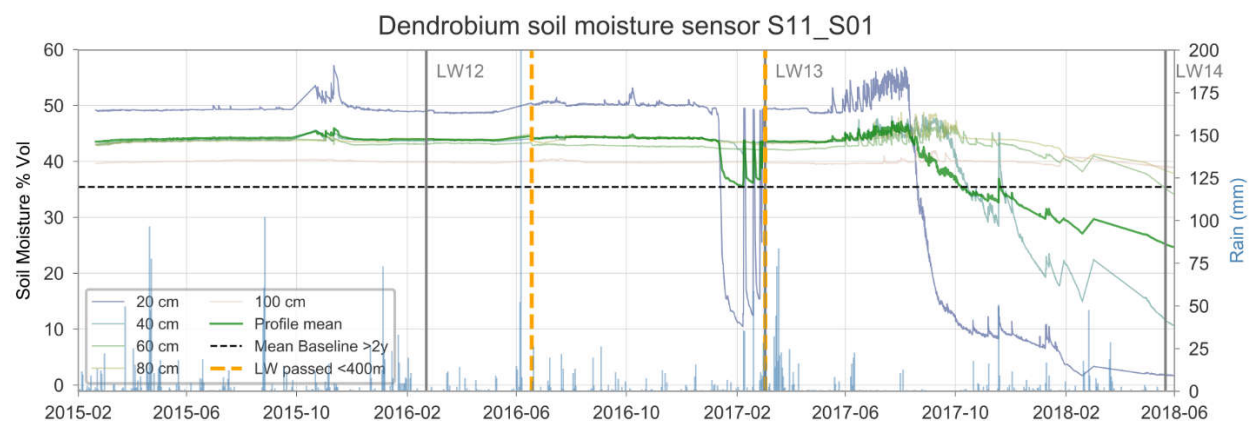
**Figure 33. Soil moisture hydrograph for site S11\_S01 at Swamp 11**

At Swamp 11, soil moisture dipped below baseline during Longwall 12 and Longwall 13 in all sensors, triggering a Level 3 TARP during Longwall 12. The decline in average soil moisture content is notable after Longwall 13 passed within 400 m of the sites, particularly at sensor S01 (Figure 33).
