**DENDROBIUM AREA 3B  
LONGWALL 13 END OF  
PANEL REPORT**

**August 2018**

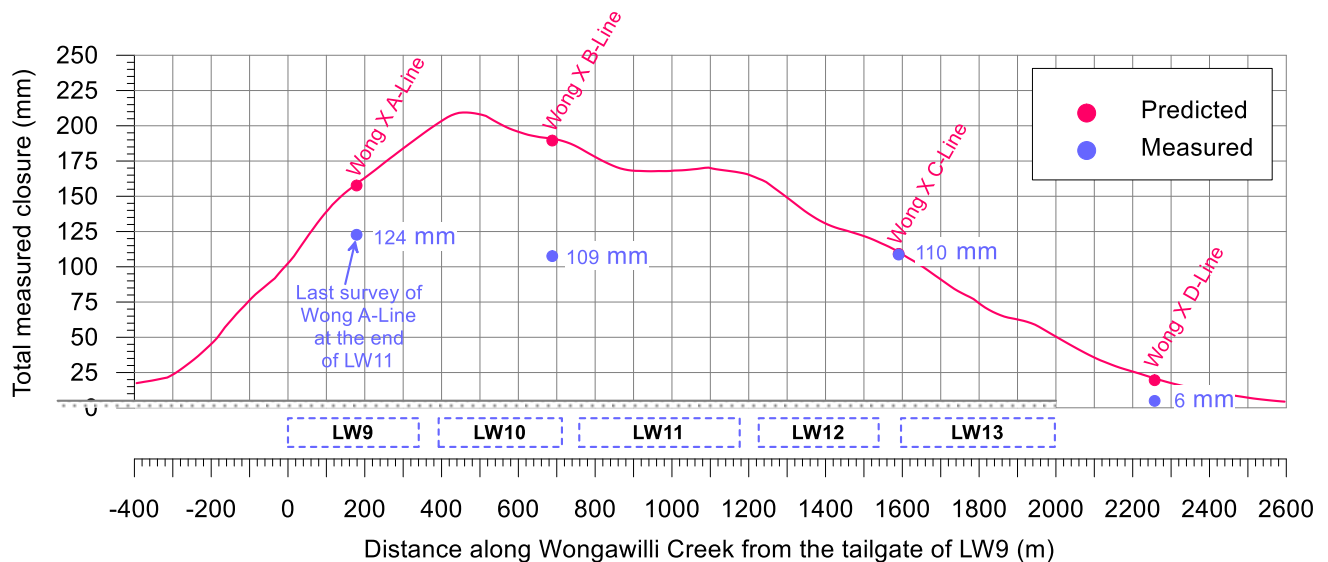
The maximum measured total closures at each of the Wongawilli Creek closure lines are equal to or less than the predictions after the completion of Longwall 13 (Figure 2).

Figure 2: Measured and predicted total closure along Wongawilli Creek after the extraction of LW13. Source: MSEC (2018).

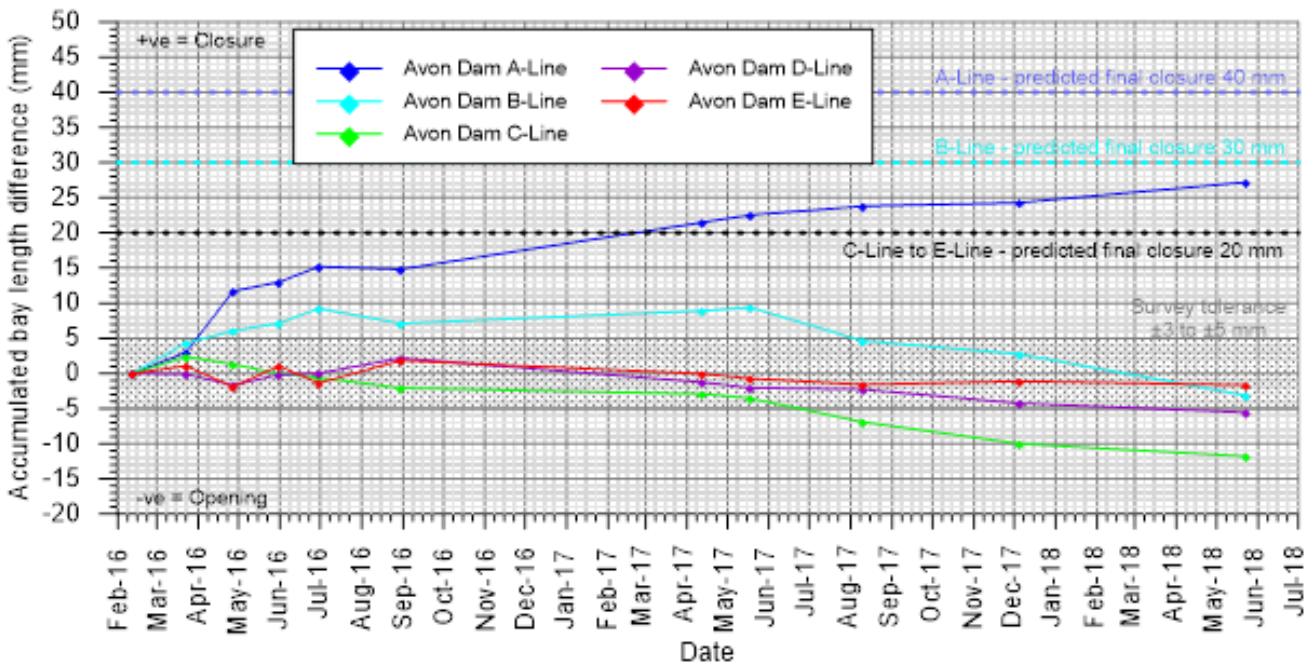
The maximum measured cumulative closures at the Avon Dam closure lines are less than the predicted closures after the completion of Longwall 13. The extraction of Longwall 13 resulted in additional closure at the A-Line but reduced closure at the other monitoring lines. The final measured movements at the B-Line, D-Line and E-Line are similar to the order of accuracy of the survey measurements.

Figure 3: Measured and predicted closure for the Avon Dam closure lines. Source: MSEC (2018).

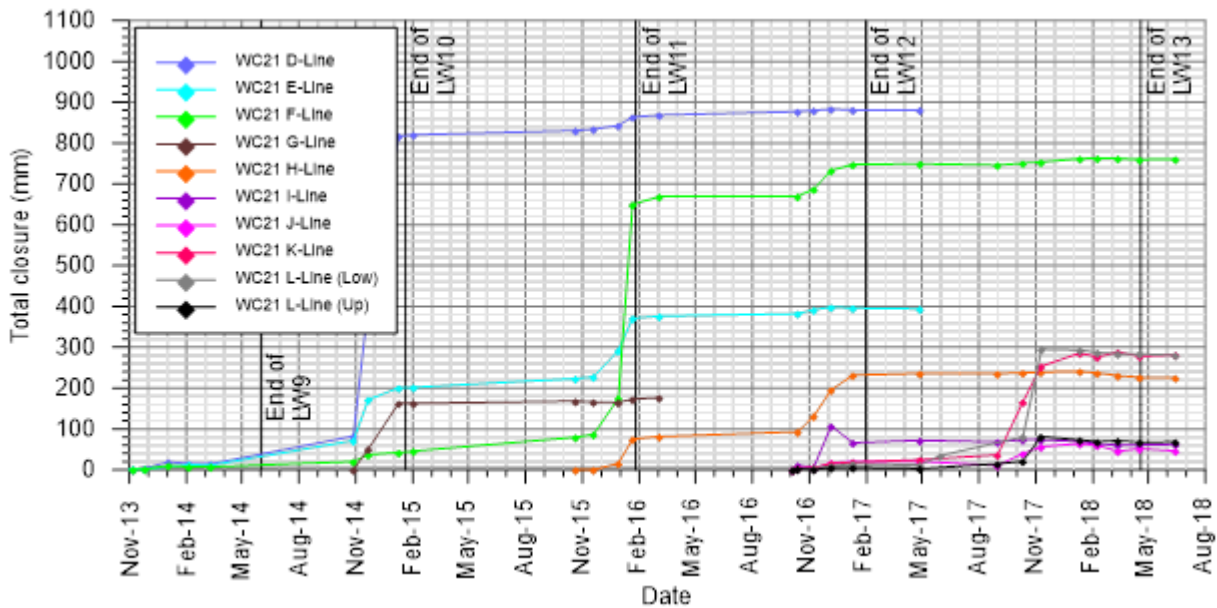
Figure 4: Measured and predicted closure for WC21 cross lines. Source: MSEC (2018).

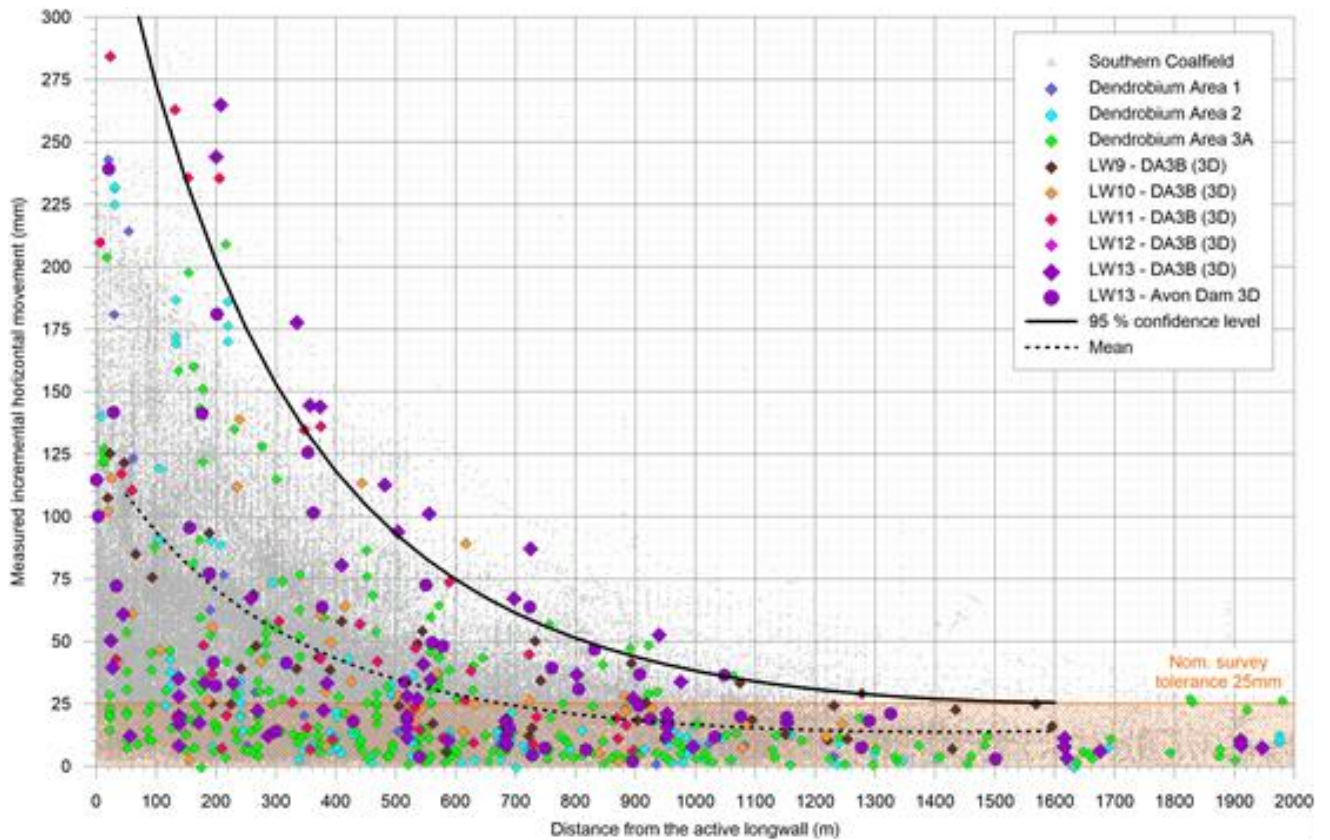
The comparison between the maximum measured incremental horizontal movements at the DA3B 3D and Avon Dam 3D monitoring points with those previously measured in Dendrobium Area 1 (DA1 3D) and Dendrobium Area 2 (DA2 3D), Dendrobium Area 3A (DA3A 3D), as well as other collieries in the Southern Coalfield, is provided in Fig. 2.4. The mean and the 95 % confidence level for the 3D monitoring data at Dendrobium Mine are also shown in this figure. The measured incremental horizontal movements resulting from the extraction of Longwall 13 (i.e. purple diamonds and circles) are typically within the range of those measured at similar distances from previously extracted longwalls at Dendrobium Mine (i.e. blue, cyan, green, brown, orange, red and magenta diamonds) and elsewhere in the Southern Coalfield (i.e. grey triangles).

Figure 5: Measured incremental horizontal movements at Dendrobium Mine. Source: MSEC (2018).

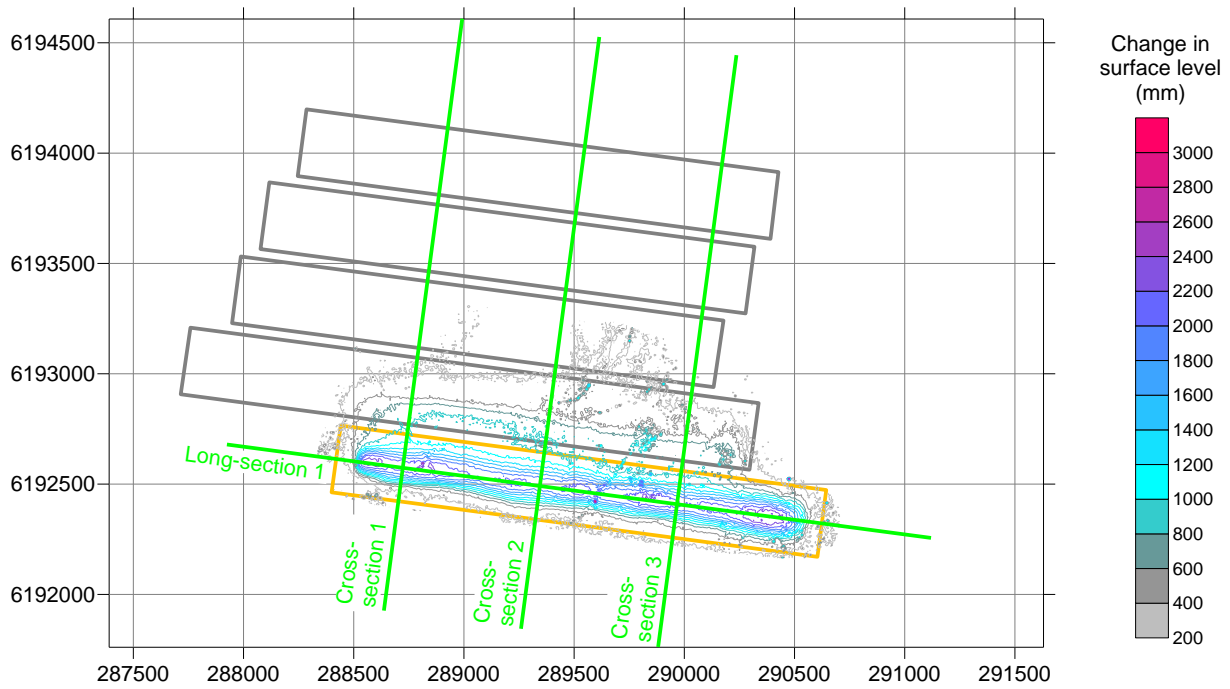
The profiles of the measured changes in surface-level reasonably match the predicted profiles of vertical subsidence along each of the cross-sections and long-section (Figure 9, Figure 10, Figure 11 and Figure 12). The maximum measured changes in surface level above each of the longwalls are less than the maximum predicted values. Also, the measured changes in surface level above each of the chain pillars are similar to, but slightly less, than the predicted values in these locations.

Figure 7: Measured incremental changes in surface level due to the extraction of Longwall 13. Source: MSEC (2018).

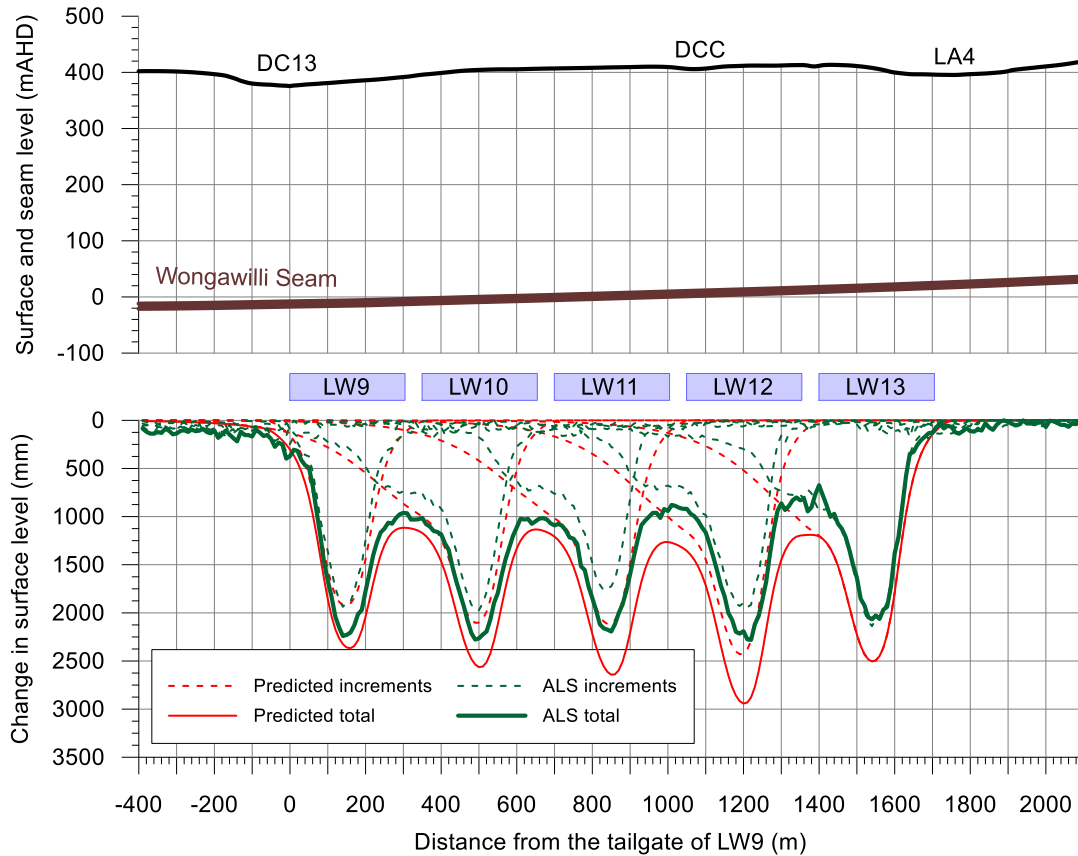
There are localised areas outside of the longwalls where the measured changes in surface level exceed the predicted vertical subsidence. However, these are artefacts of the LiDAR surveys and are not real movements. It is considered that the subsidence movements measured using the LiDAR surveys are consistent with the predicted subsidence movements.

Figure 9: Measured changes in surface level and predicted vertical subsidence along Cross-section 1.

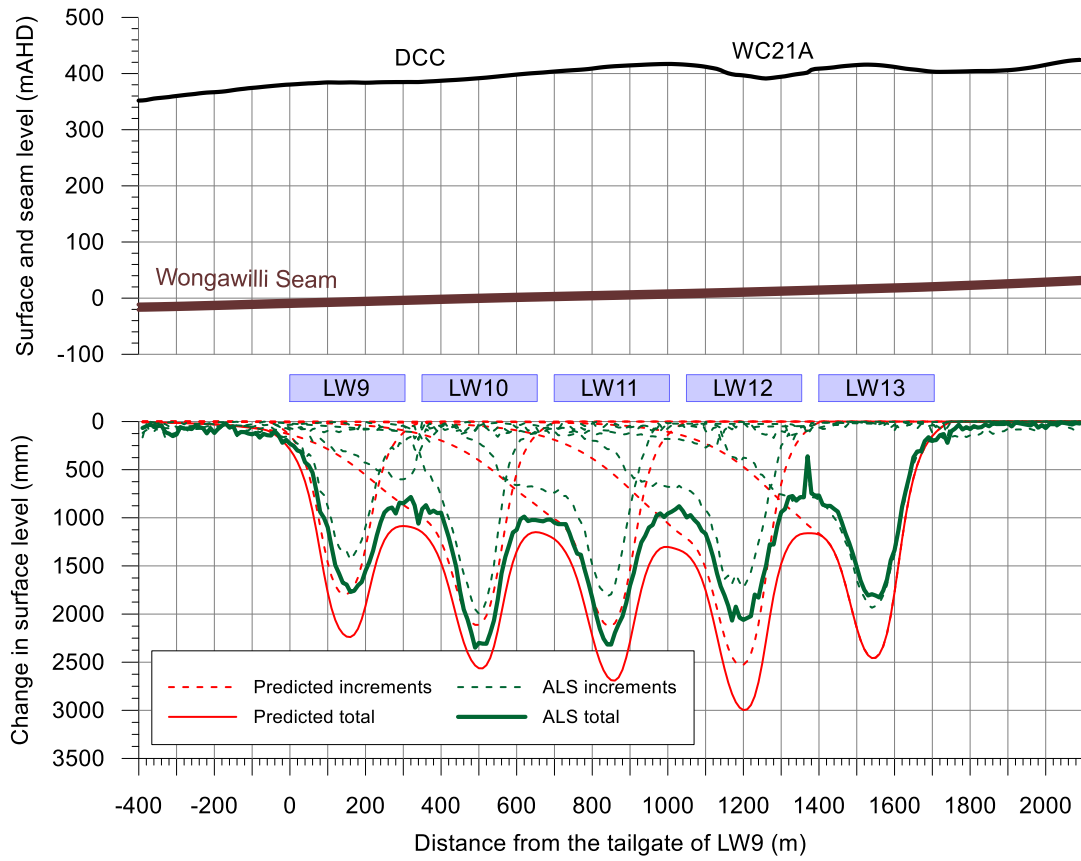
Figure 10: Measured changes in surface level and predicted vertical subsidence along Cross-section 2

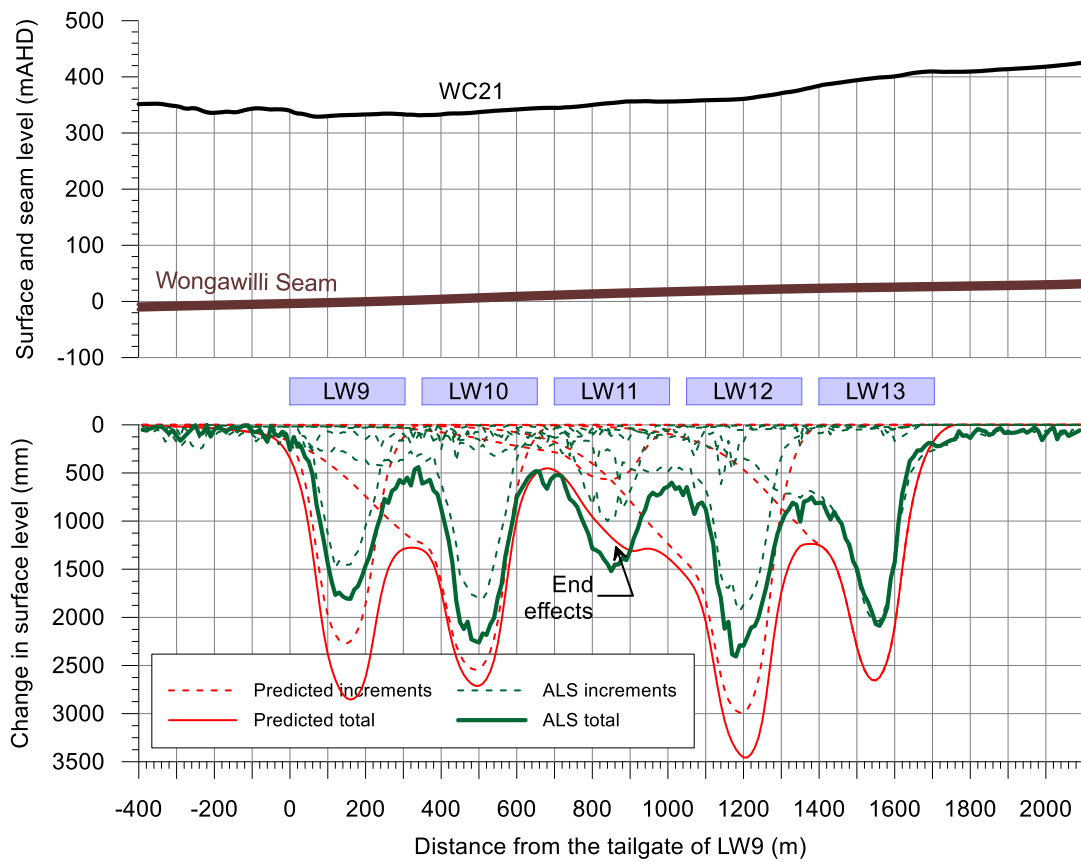
Figure 11: Measured changes in surface level and predicted vertical subsidence along Cross-section 3.

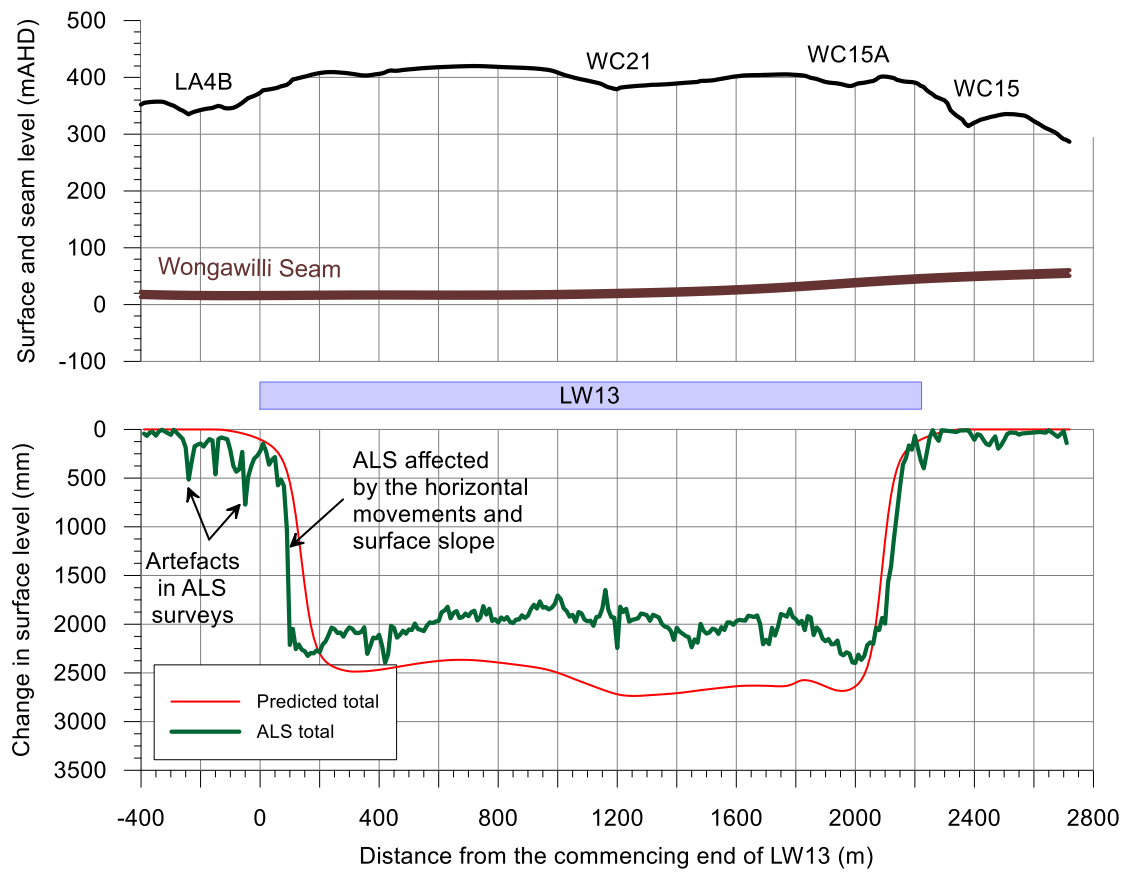
Figure 12: Measured changes in surface level and predicted vertical subsidence along Long section 1.

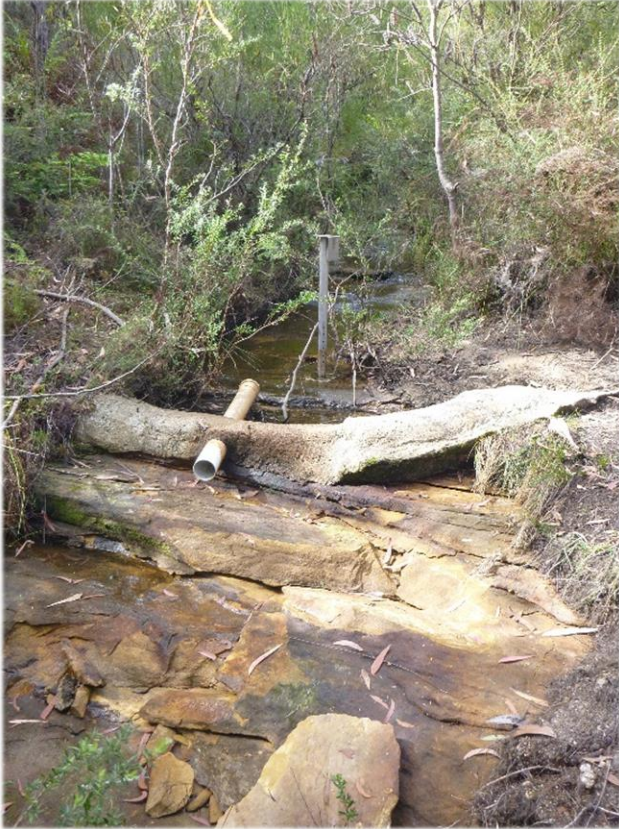
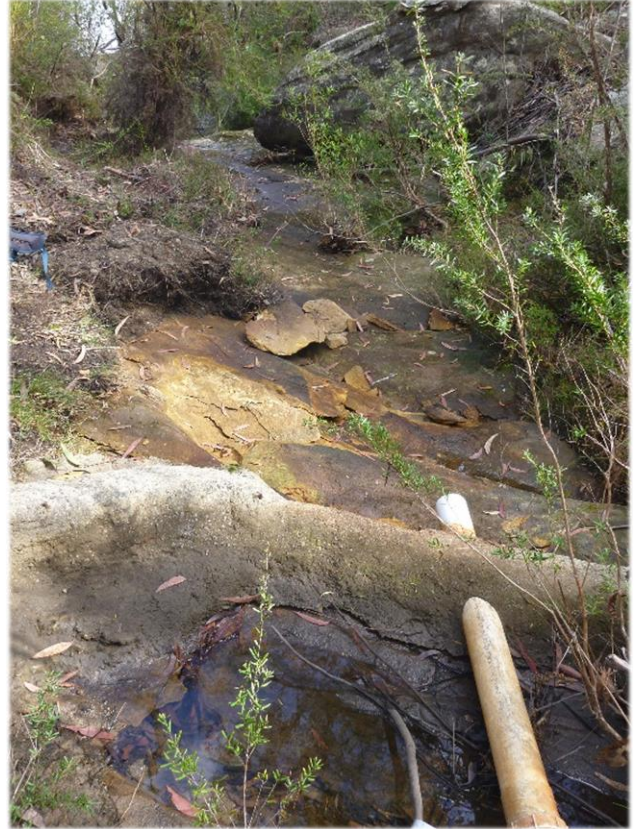
Rock fracturing to the downstream end of tributary LA4 was initially reported on the 4<sup>th</sup> May 2016. Following the impact, high discharge flow events have likely caused the dislocation and downstream transport of large rock fragments. An inspection on the 19<sup>th</sup> April 2017 revealed fracturing to the base of the pool at monitoring site LA4S1 (Photo 1 and Photo 2). Flow diversion was observed through the fracturing, directly upstream from the installed concrete weir, which forms part of the flow monitoring installation at the site (Photo 3 and Photo 4).

Level 2: Crack or fracture between 100 and 300 mm width at its widest point or any fracture which results in observable loss of surface water or erosion.

Photo 1: Fracturing downstream from concrete weir, looking upstream. Taken on 19<sup>th</sup> April 2017.

Photo 2: Fracturing downstream from concrete weir, looking downstream. Taken on 19<sup>th</sup> April 2017.

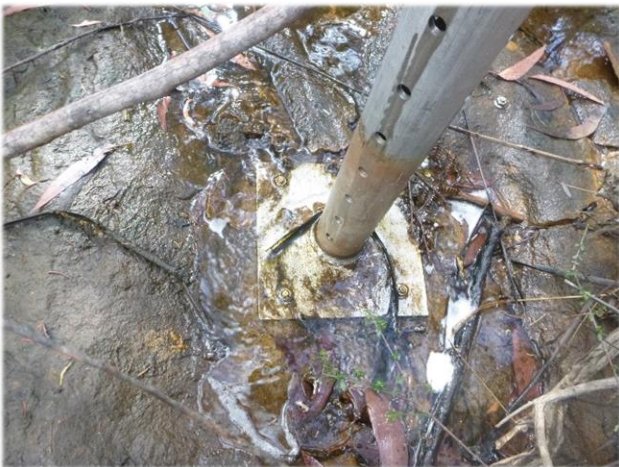
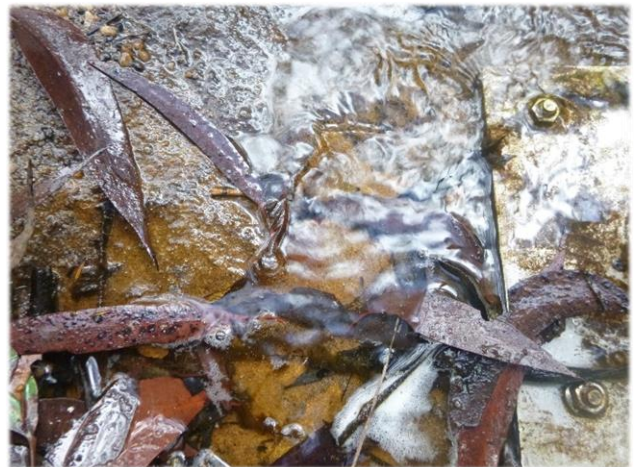
Photo 3: Flow diversion adjacent to monitoring equipment at LA4S1. Taken on 3<sup>rd</sup> May 2017.

Photo 4: Flow diversion through fracturing in base of pool. Taken on 3<sup>rd</sup> May 2017.

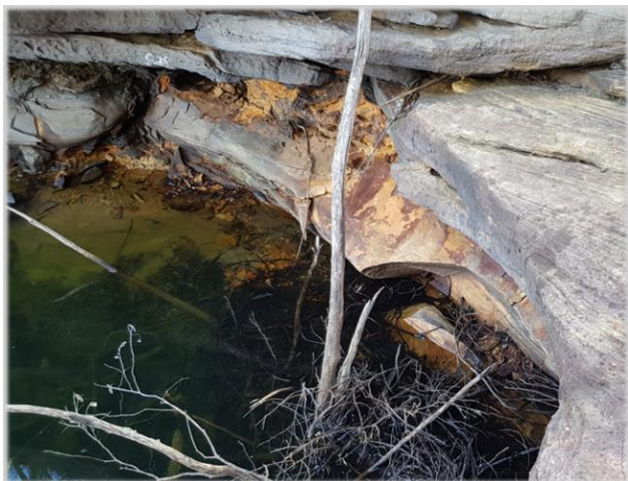
Impact *DA3B\_LW13\_043* is located on *LA4*, a tributary to *Lake Avon*, 300m from the commencing end of Longwall 13, and 300m from the southern edge of Longwall 12. The impact was identified on the 18<sup>th</sup> May 2018. The impact is comprised of rock fracturing, associated rock fragmentation and iron staining to *LA4\_Step 0* (Photo 9), which is the most downstream feature before entering *Lake Avon*. The fracturing is 2 m in length and 0.02 m in width; the rock fragment is 1.5 m in length, 0.5 m in width and 0.3 m in height (Photo 9). These impacts are not evident in baseline photos from 2011 (Photo 6). There was no surface flow at the site during the inspection; however, diversion of flow is likely to occur to some degree. Given the proximity of the site to the

Level 2: Crack or fracture that results in observable loss of surface water or erosion and/or observable increase in iron staining within the mining area continues to outside the mining area.

Photo 5: *LA4\_Step 0*, looking across stream; the pooling to the left of the image is *Lake Avon reservoir* water. Taken 18<sup>th</sup> May 2018.

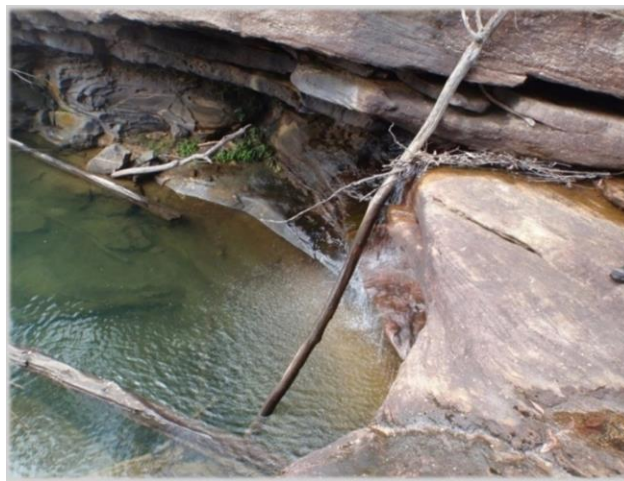
Photo 6: *LA4\_Step 0*, looking across stream; the pooling to the left of the image is *Lake Avon reservoir* water. Taken during baseline mapping of the area 14<sup>th</sup> November 2011.

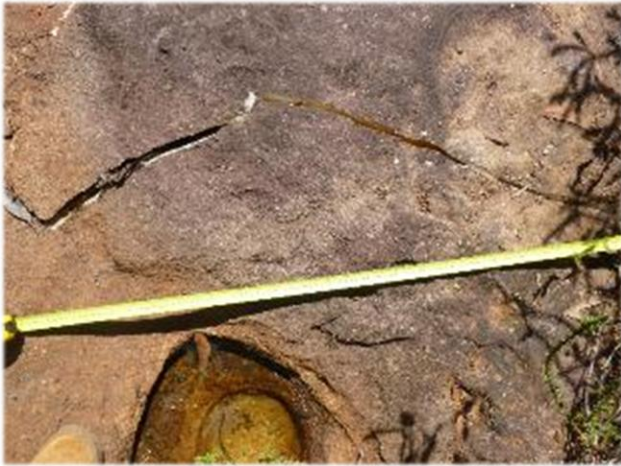
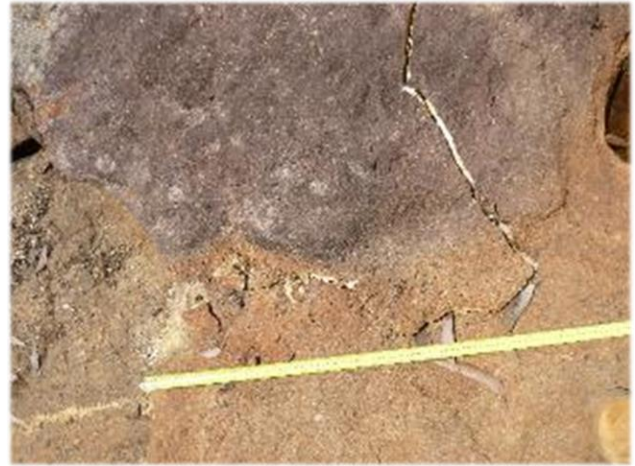
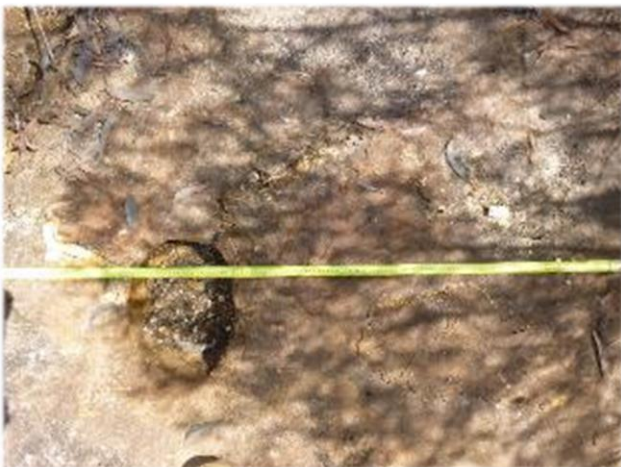
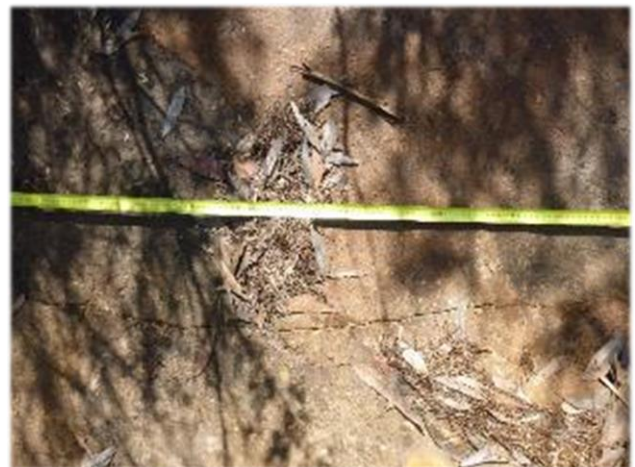
*DA3B\_LW13\_021* is located towards the upstream extent of *WC15\_Rockbar 18*. The site was passed by Longwall 13 at an approximate distance of 185 m on the 29<sup>th</sup> March 2018. The impact consists of a rock fracture, which extends across the extent of the rockbar (Photo 7 to Photo 10). The fracture is approximately 5.7 m in length, with widths ranging from hairline to a maximum of 0.015 m. The maximum measurable depth is 0.06 m. Additionally, there is a small section of plating, which measures approximately 0.3 m by 0.15 m.

Level 2: Crack or fracture between 100 and 300 mm width at its widest point or any fracture which results in observable loss of surface water or erosion.

Photo 7: DA3B\_LW13\_021, looking at the widest section of fracturing. Taken 29<sup>th</sup> March 2018.

Photo 8: DA3B\_LW13\_021, looking at the widest section of fracturing. Taken 29<sup>th</sup> March 2018.

Photo 9: DA3B\_LW13\_021, looking at the small section of plating. Taken 29<sup>th</sup> March 2018.

Photo 10: DA3B\_LW13\_021, looking at the narrowest section of fracturing. Taken 29<sup>th</sup> March 2018.

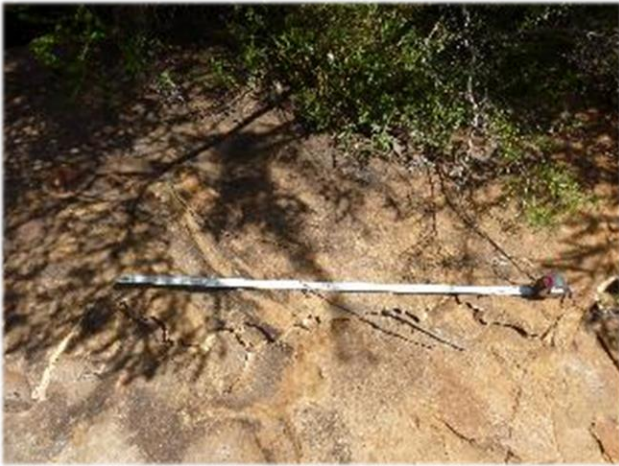
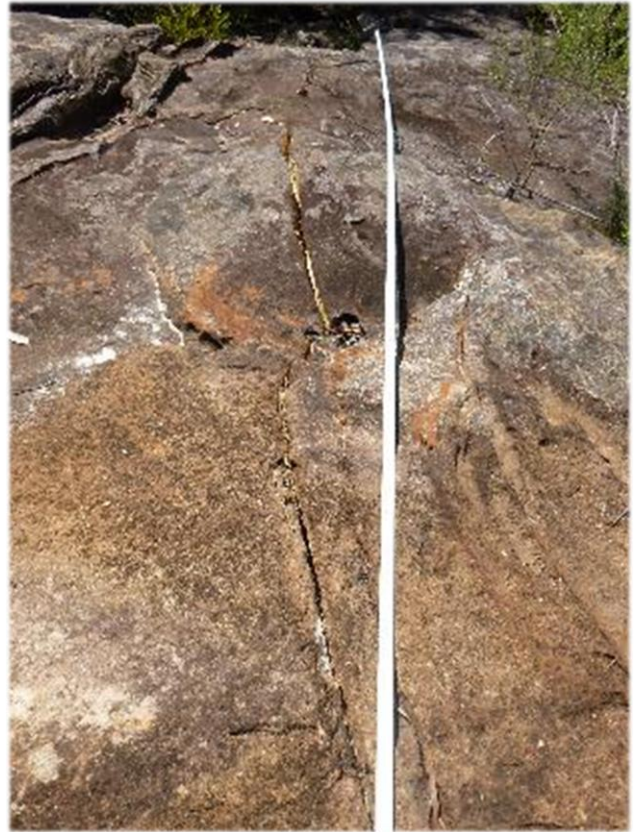
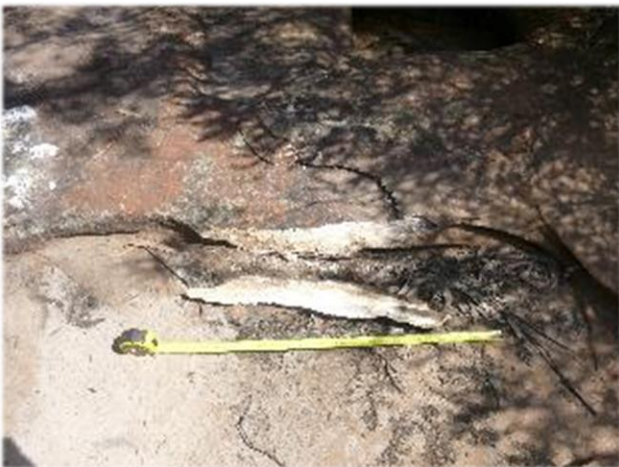
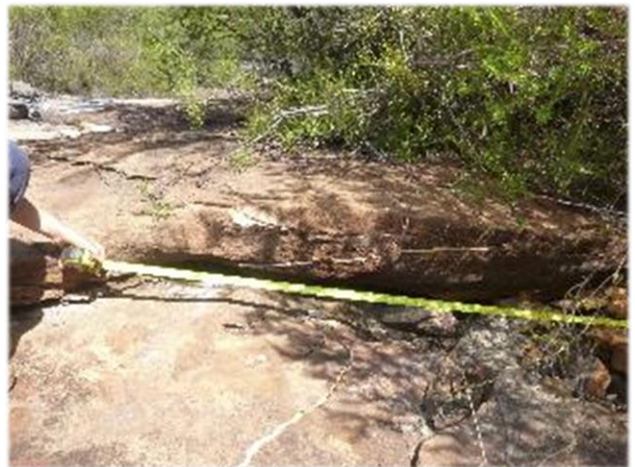
DA3B\_LW13\_022 is located on WC15\_Rockbar 18, approximately 35 m downstream of DA3B\_LW13\_021. The site was passed by Longwall 13 at an approximate distance of 157 m on the 29<sup>th</sup> March 2018. The impact is a rock fracture zone, which is comprised of approximately 10 fractures, with associated uplift (Photo 11 to Photo 14) and rock fragmentation (Photo 13), within an area of approximately 7.2 m by 6 m. Each fracture within the zone is greater than 0.5 m in length, the longest of which, is approximately 3 m. The fractures range from hairline to a maximum of 0.015 m in width; the maximum measurable depth is approximately 0.04 m. Additionally, there are lateral fractures to the face of a 0.3 m high step (Photo 14).

Level 2: Crack or fracture between 100 and 300 mm width at its widest point or any fracture which results in observable loss of surface water or erosion.

Photo 11: DA3B\_LW13\_022, looking across stream towards section of uplift. Taken 29th March 2018.

Photo 12: DA3B\_LW13\_022, looking downstream towards longest fracture. Taken 29th March 2018.

Photo 13: DA3B\_LW13\_022, looking upstream towards a small rock fragment. Taken 29th March 2018.

Photo 14: DA3B\_LW13\_022, looking upstream towards lateral fracturing on face of step. Taken 29th March 2018.

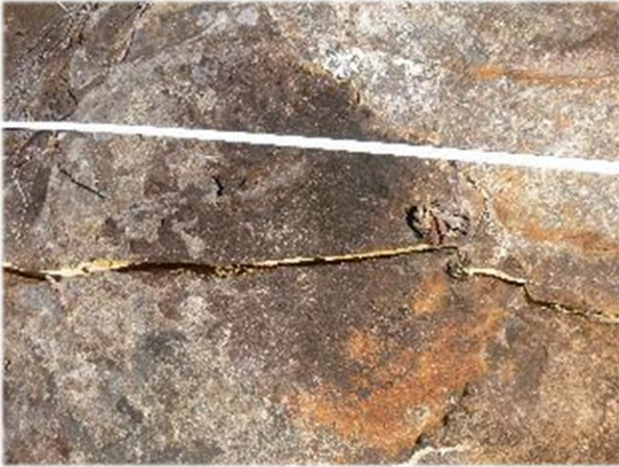
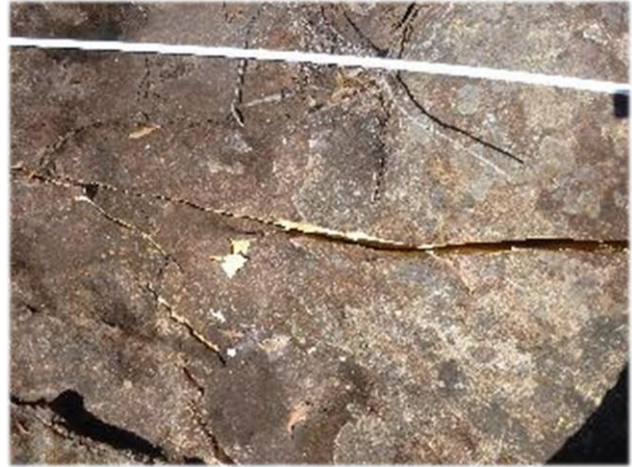
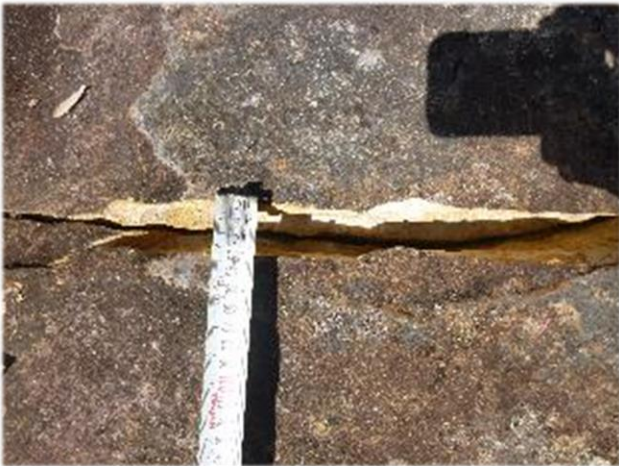
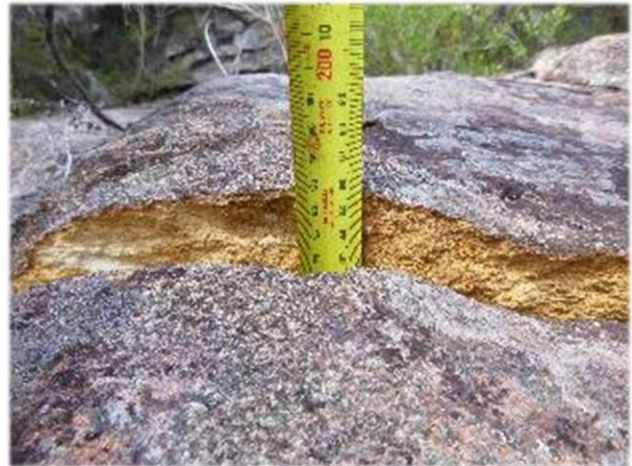
DA3B\_LW13\_023 is located on WC15\_Rockbar 18, approximately 7 m downstream of DA3B\_LW13\_022. The site was passed by Longwall 13 at an approximate distance of 150 m on the 29th March 2018. The impact is comprised of a rock fracture approximately 5.6 m in length and 0.03 m at its widest point (Photo 15 to Photo 18); the maximum measurable depth of the fracture is 0.16 m (Photo 18). There was no observable surface flow at WC15\_Rockbar 18 during the inspection, however, surface flow has previously been observed at the feature. Given the extent and nature of the fractures, it is likely that these impacts would cause some degree of flow diversion if surface flow was present at WC15\_Rockbar 18.

Level 2: Crack or fracture between 100 and 300 mm width at its widest point or any fracture, which results in observable loss of surface water or erosion.

Photo 15: DA3B\_LW13\_023, widest section of fracturing. Taken 29<sup>th</sup> March 2018.

Photo 16: DA3B\_LW13\_023, widest section of fracturing. Taken 29<sup>th</sup> March 2018.

Photo 17: DA3B\_LW13\_023, closeup of the widest section of fracturing. Taken 29<sup>th</sup> March 2018.

Photo 18: DA3B\_LW13\_023, closeup of the deepest section of fracturing. Taken 29<sup>th</sup> March 2018.

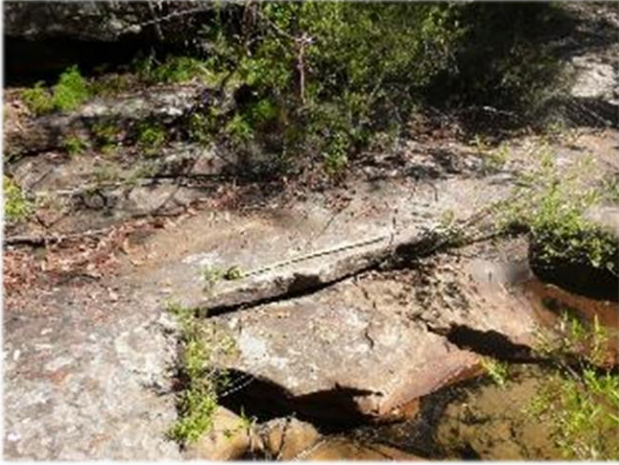
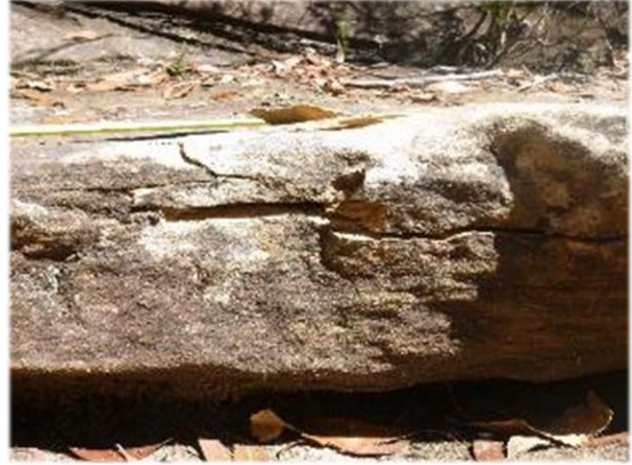
DA3B\_LW13\_028 was identified on the 5<sup>th</sup> April 2018 and is located on the tributary WC15; the site was passed by Longwall 13 on the 29<sup>th</sup> March 2018 at an approximate distance of 124 m. The impact is comprised of lateral fractures, with associated uplift and plating, to the rockbar shelf on the northern extent of WC15\_Pool 18. The largest fracture is 1.4 m in length and 0.018 m in width (Photo 19 and Photo 20). There was no evidence of flow diversion at the site.

Level 1: Crack or fracture up to 100mm at its widest point with no observable loss of surface water or erosion;  
Crack or fracture up to 10m length with no observable loss of surface water or erosion

Photo 19: DA3B\_LW13\_028, looking upstream at the extent of the impact. Taken 5<sup>th</sup> April 2018.

Photo 20: DA3B\_LW13\_028, looking upstream at largest section of fracturing. Taken 5<sup>th</sup> April 2018.

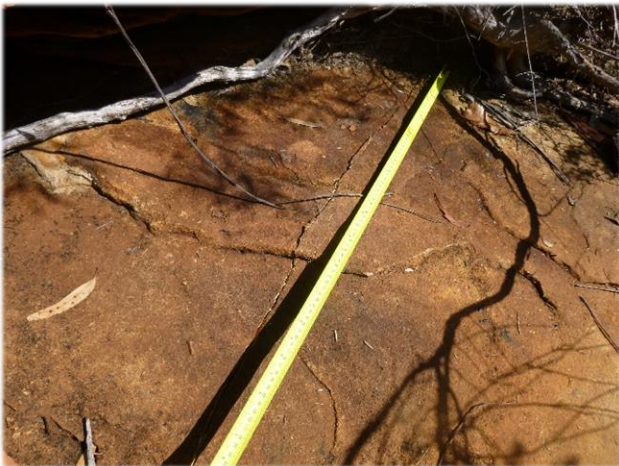
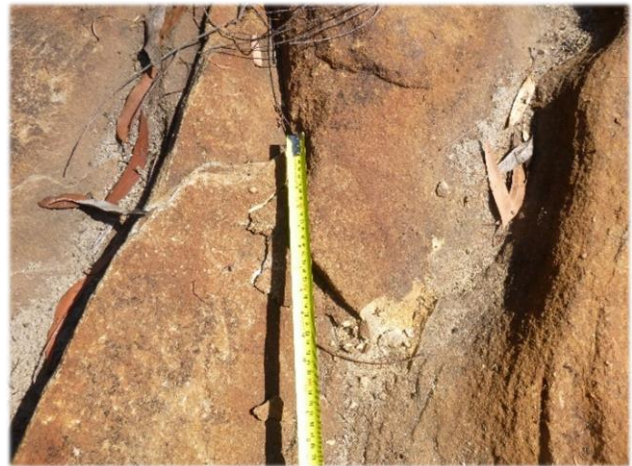
DA3B\_LW13\_035 was identified on the 23<sup>rd</sup> April 2018 and is located on the tributary WC15; the site was passed by Longwall 13 on the 18<sup>th</sup> March 2018 at an approximate distance of 280 m. The impact is comprised of multiple small fractures near the upstream extent of WC15\_Rockbar 21 (Photo 21 and Photo 22 ). The largest fracture is 1.6 m in length and 0.002 m in width. Additionally, there is a small section of plating and uplift (approximately 0.1 m by 0.05 m) at the site. There was no evidence of flow diversion at the site.

Level 1: Crack or fracture up to 100mm at its widest point with no observable loss of surface water or erosion;

Crack or fracture up to 10m length with no observable loss of surface water or erosion.

Photo 21: DA3B\_LW13\_035, looking across stream at the largest fracture. Taken 23<sup>rd</sup> April 2018.

Photo 22: DA3B\_LW13\_035, looking across stream at the section of plating and uplift. Taken 23<sup>rd</sup> April 2018.

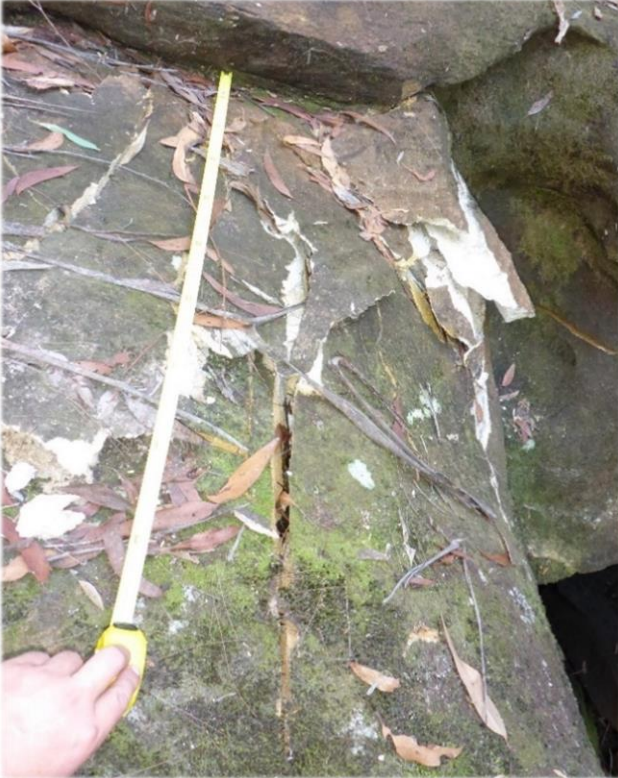
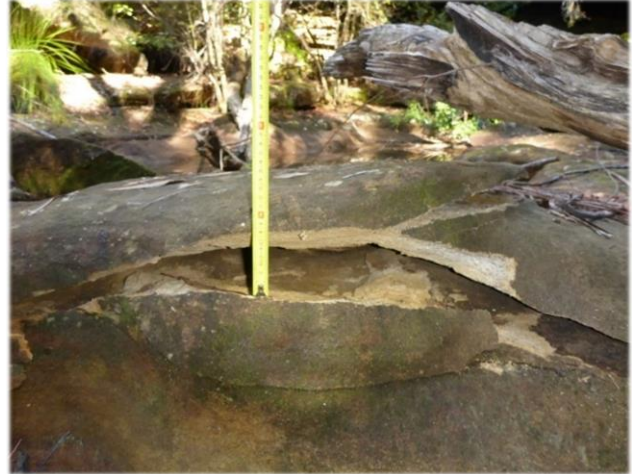
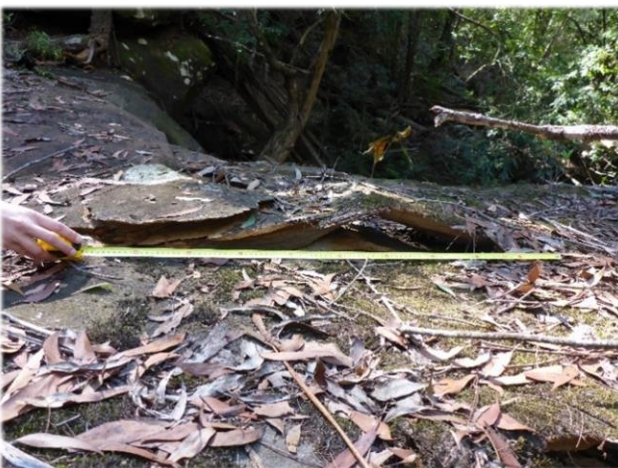
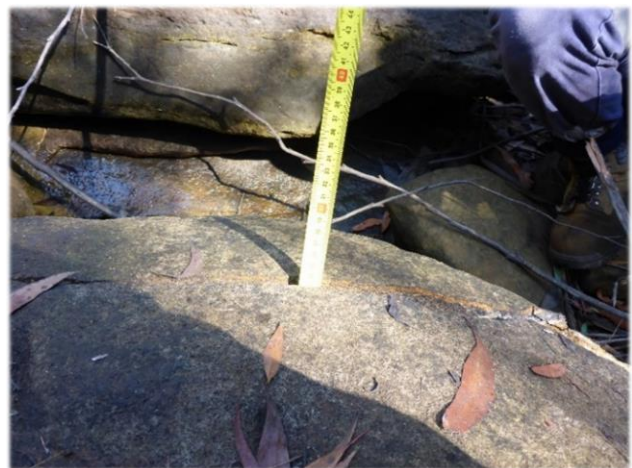
DA3B\_LW13\_040 is situated on Wongawilli Creek tributary WC15. The impact zone extends 20 m from the top of WC15\_Step 0 to WC15\_Pool 2 which is approximately 80 m from the confluence with Wongawilli Creek. The site is approximately 262 m from the end of Longwall 13. The impact is comprised of rock fracturing and uplift, which has a maximum measurable length of 5.5 m, a maximum width of 0.05 m and a maximum measurable

Level 2: Crack or fracture between 100 and 300mm width at its widest point or any fracture which results in observable loss of surface water or erosion.

Photo 23: DA3B\_LW13\_040, looking at a section of rock fracturing and uplift. Taken 7<sup>th</sup> May 2018.

Photo 24: DA3B\_LW13\_040, looking at a section of rock uplift. Taken 7<sup>th</sup> May 2018.

Photo 25: DA3B\_LW13\_040, looking at a section of rock fracturing and uplift. Taken 7<sup>th</sup> May 2018.

Photo 26: DA3B\_LW13\_040, looking at the maximum measurable depth of the rock fracturing. Taken 7<sup>th</sup> May 2018.

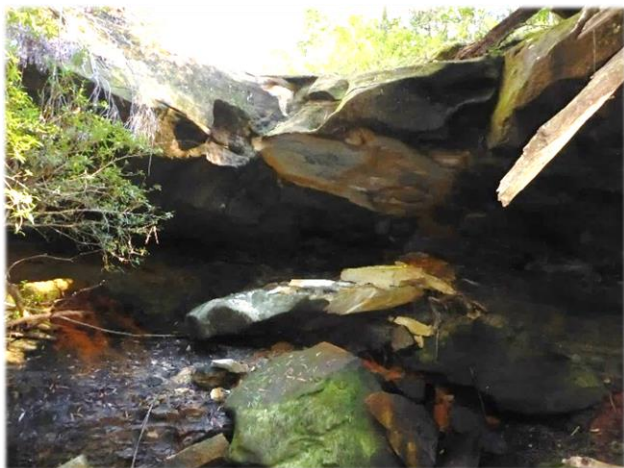
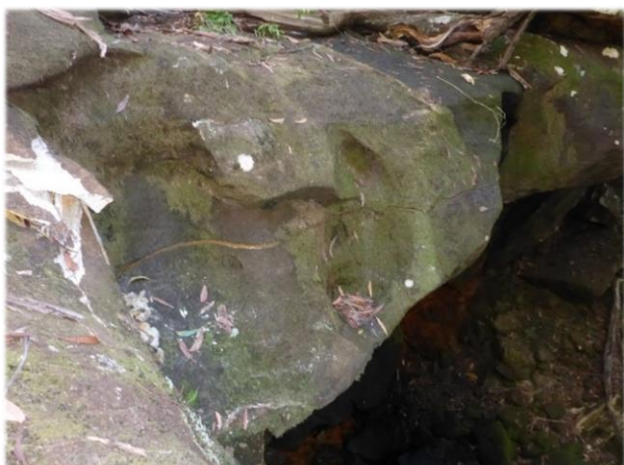
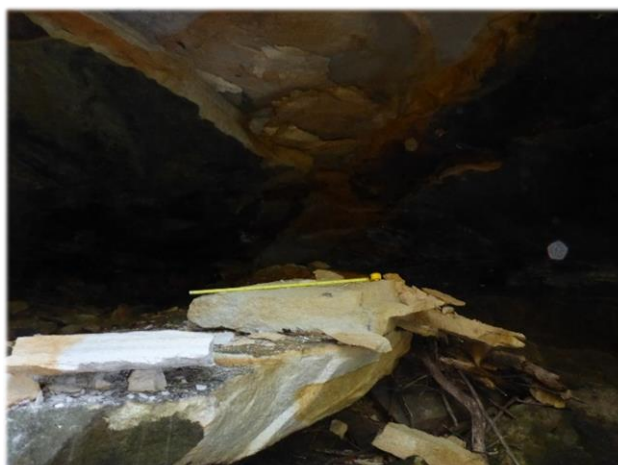
the end of Longwall 13. The impact is comprised of rock fracturing which has resulted in a rockfall. The rock fracturing has a maximum length of 12 m, a maximum width of 0.05 m and the maximum depth is unknown due to access difficulties (Photo 27 to Photo 30).

Level 2: Crack or fracture between 100 and 300mm width at its widest point or any fracture which results in observable loss of surface water or erosion. Crack or fracture between 10m and 50m length.

Photo 27: DA3B\_LW13\_041, an overview of the area impacted by the rockfall. Taken 7<sup>th</sup> May 2018.

Photo 29: DA3B\_LW13\_041, looking at the rock fracturing from the top of the step. Taken 7<sup>th</sup> May 2018.

Photo 30: DA3B\_LW13\_041, looking at the accumulation of rock that resulted from the rockfall. Taken 7<sup>th</sup> May 2018.

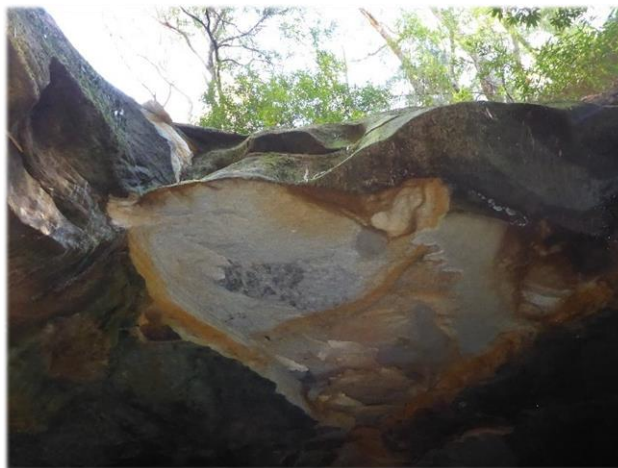
Photo 28: DA3B\_LW13\_041, looking at the extent of the rockfall. Taken 7<sup>th</sup> May 2018.
