**DENDROBIUM AREA 3B  
LONGWALL 13 END OF  
PANEL REPORT**

**August 2018**

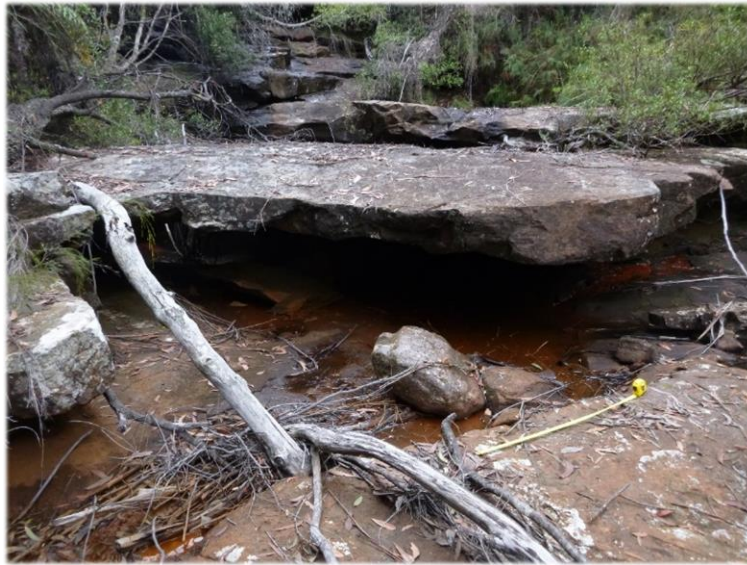
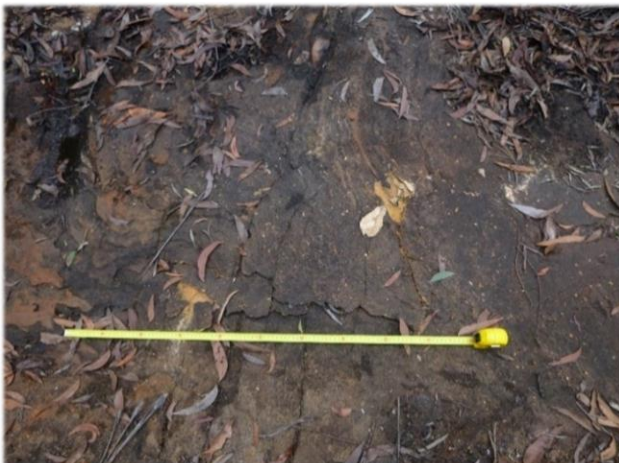
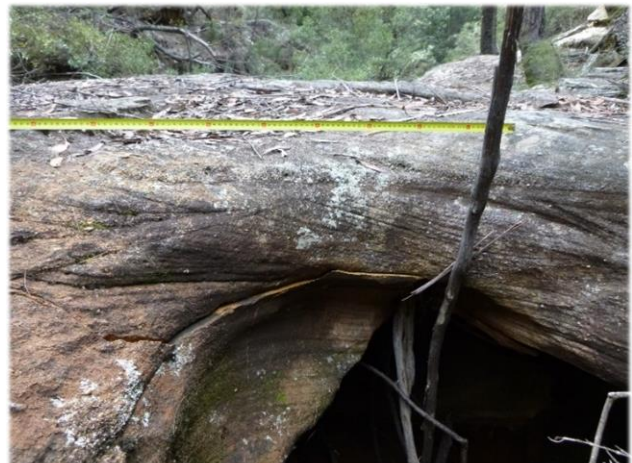
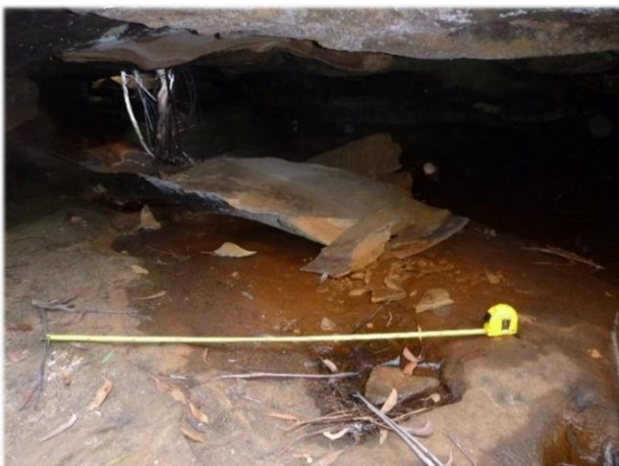
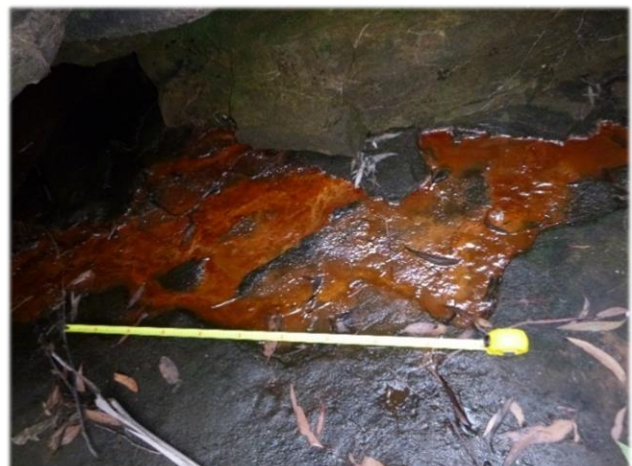
Impact DA3B\_LW13\_042 is situated on WC15, approximately 150 m from the end of Longwall 13. The impact is comprised of multiple rock fractures, with associated rock fragmentation and iron staining to WC15\_Rockbar 7, an undercut rockbar (Photo 31), approximately 295 m from the WC15 confluence with Wongawilli Creek. The impact zone extends 15 m across the upper extent of WC15\_Rockbar 7 (Photo 32 and Photo 33), below WC15\_Step 7B. The rock fracturing has a maximum length of 4.5 m, a maximum width of 0.01 m and a maximum measurable depth of 0.19 m. Two large rock fragments have been displaced from the underside of the rockbar, the largest of which is approximately 1 m in length, 1 m width and 0.30 m height. Flow diversion through the fractures was observed at the site. Iron staining was observed downstream of the flow diversion in the pool below WC15\_Rockbar 7 (Photo 34 and Photo 35).

Level 2: Crack or fracture between 100 and 300 mm width at its widest point or any fracture which results in observable loss of surface water or erosion.

Photo 31: WC15\_Rockbar 7, looking upstream, highlighting the undercut nature of the rockbar.

Photo 32: DA3B\_LW13\_042, looking at a section of rock fracturing and uplift. Taken 16<sup>th</sup> May 2018.

Photo 33: DA3B\_LW13\_042, looking at a section of rock fracturing. Taken 16<sup>th</sup> May 2018.

Photo 34: DA3B\_LW13\_042, looking at largest rock fragment and iron staining. Taken 16<sup>th</sup> May 2018.

Photo 35: DA3B\_LW13\_042, looking at a section of iron staining. Taken 16<sup>th</sup> May 2018.

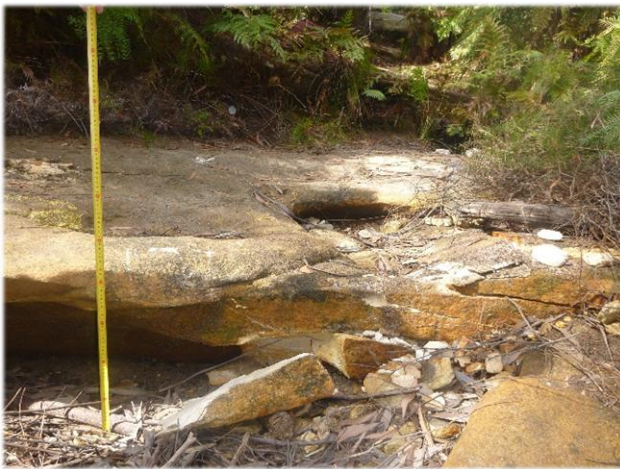
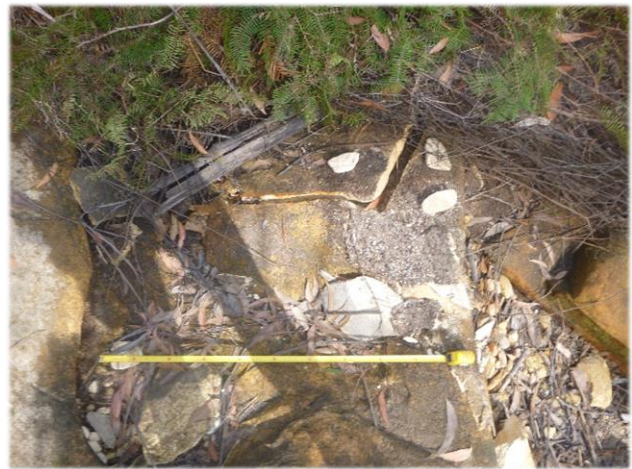
Impact *DA3B\_LW13\_006* is comprised of fracturing to the upstream extent of *WC21\_Pool 48*. The fracturing is up to 5 m long and 0.03 m wide with some dislodged fragments (Photo 36 and Photo 37). The fracturing has resulted in an observable loss of surface water within the pool (Photo 36). The absence of surface water extends downstream before reappearing at the base of *WC21\_Step 38*, which is directly downstream from *WC21\_Pool 38* (see *Impact DA3B\_LW13\_007*).

Level 2: Crack or fracture between 100 and 300 mm width at its widest point or any fracture which results in observable loss of surface water or erosion.

Photo 36: Impact *DA3B\_LW13\_006*, looking upstream. Taken on 3/10/2017.

Photo 37: Impact *DA3B\_LW13\_006*, looking across pool at fracturing. Taken on 3/10/2017.

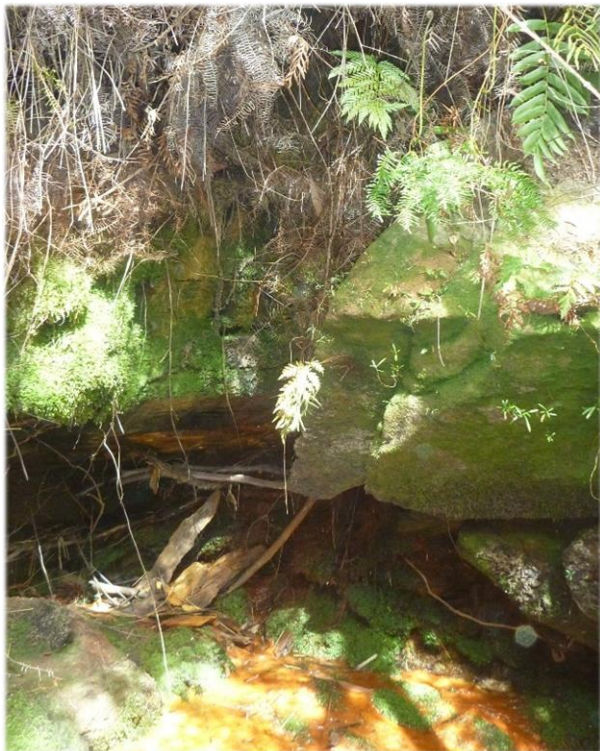
Level 1: Observable increase in iron staining within the mining area.

Photo 38: Impact *DA3B\_LW13\_007*, looking upstream. Taken on 3/10/2017.

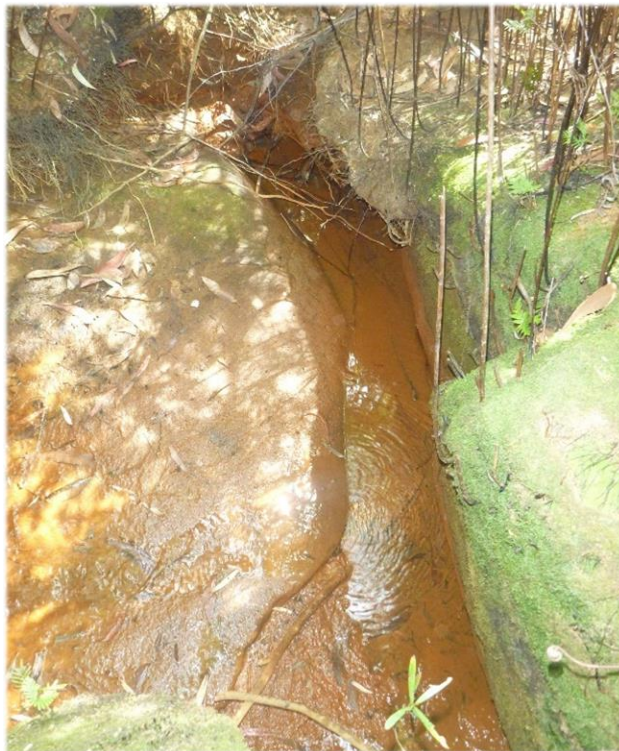
Photo 39: Impact *DA3B\_LW13\_007*, looking downstream. Taken on 3/10/2017.

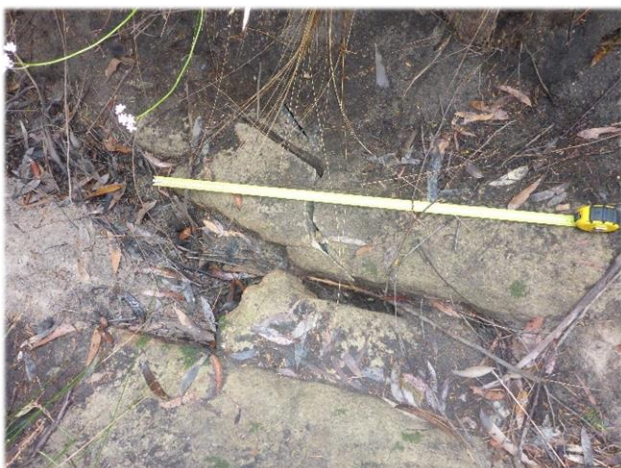
Level 1: Crack or fracture up to 100 mm at its widest point with no observable loss of surface water or erosion.

Photo 40: Impact *DA3B\_LW13\_009*, looking across stream, taken on 23/10/2017.

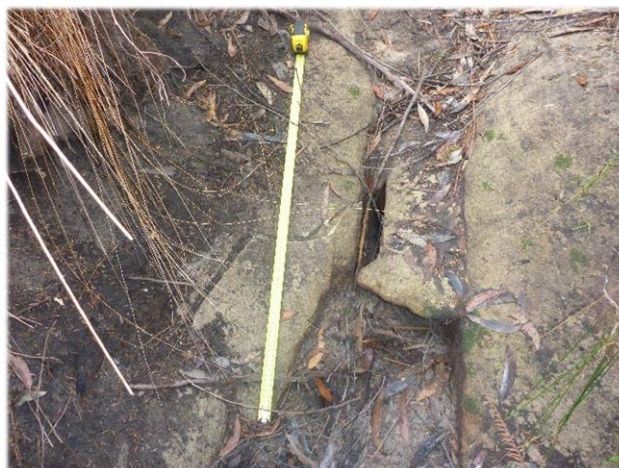
Impact *DA3B\_LW13\_009* was identified on the 27<sup>th</sup> October 2017. This impact consists of fracturing and fragmentation to the rockbar at the downstream extent of *WC21\_Pool 54*, which was mined beneath by Longwall 13 on the 24<sup>th</sup> September 2017. The largest fracture is 0.22 m wide, 0.37 m deep and 0.38 m long (Photo 40 and Photo 41). Surface water was not present at the site during the inspection.

Photo 41: Impact *DA3B\_LW13\_009*, looking upstream, taken on 23/10/2017.

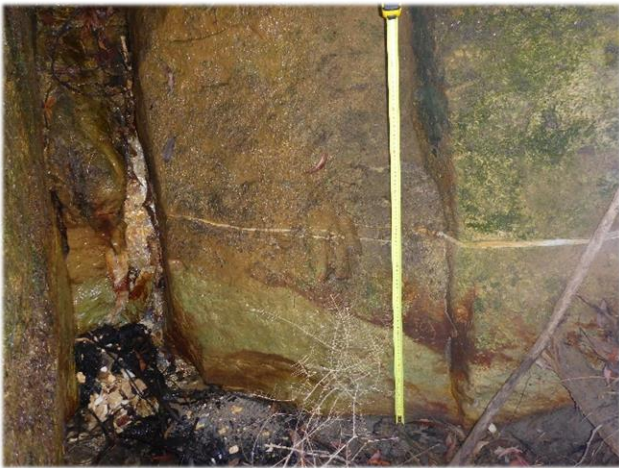
Level 2: Crack or fracture between 100 and 300 mm width at its widest point or any fracture which results in observable loss of surface water or erosion.

Photo 42: Impact *DA3B\_LW13\_010* looking upstream, taken 27/10/2017.

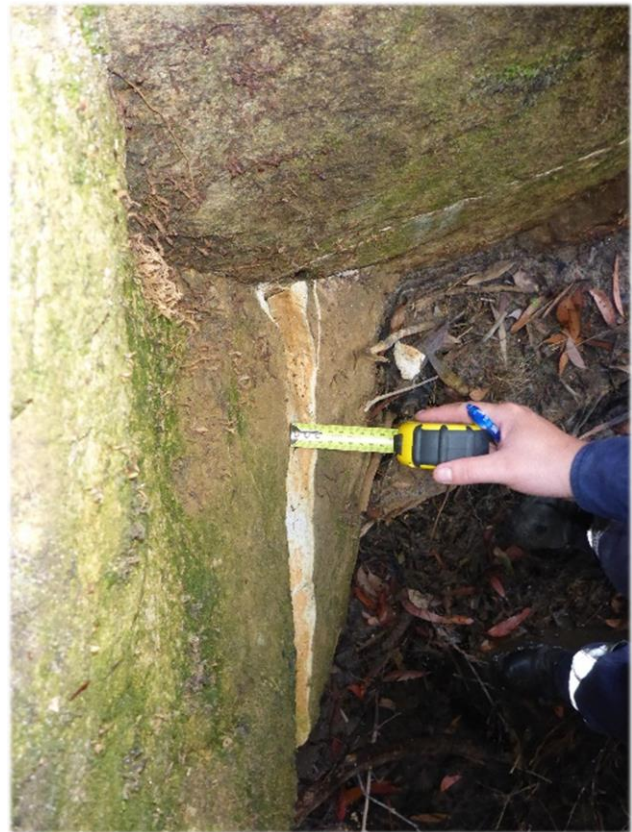
Impact *DA3B\_LW13\_010* was identified on the 27<sup>th</sup> October 2017. The impact consists of lateral fracturing to the step at the upstream extent of *WC21\_Pool 53*, which was mined beneath by Longwall 13 on the 24<sup>th</sup> September 2017. The largest fracture is approximately 2.5 m long, 0.01 m wide, and 0.03 m at its deepest measurable point (Photo 42). The portion of sandstone below the fracture has been displaced laterally by approximately 0.03 m (Photo 43). A smaller, approximately 1 m long, hairline fracture is present adjacent to the largest fracture (Photo 48). No flow diversion was observed at the site; however, the water level at *WC21\_Pool 53* has lowered considerably following being mined beneath by Longwall 13 (Photo 45 to Photo 47). It is likely there is an unobservable fracture at the base of the pool diverting water.

Photo 43: Impact *DA3B\_LW13\_010* looking top-down at the displaced rock, taken 27/10/2017.

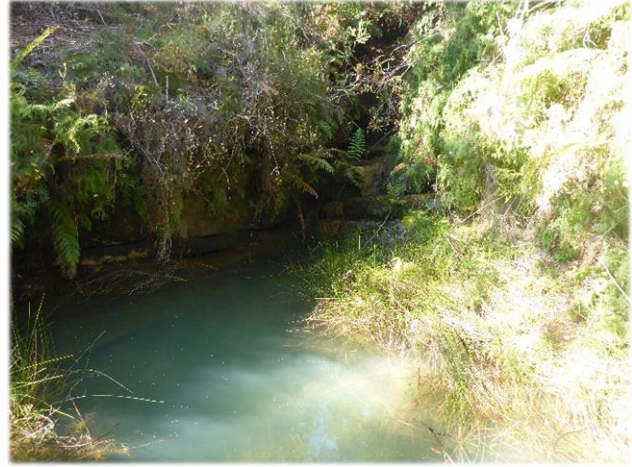
Photo 45: WC21\_Pool 53, looking upstream, taken 11/09/2017.

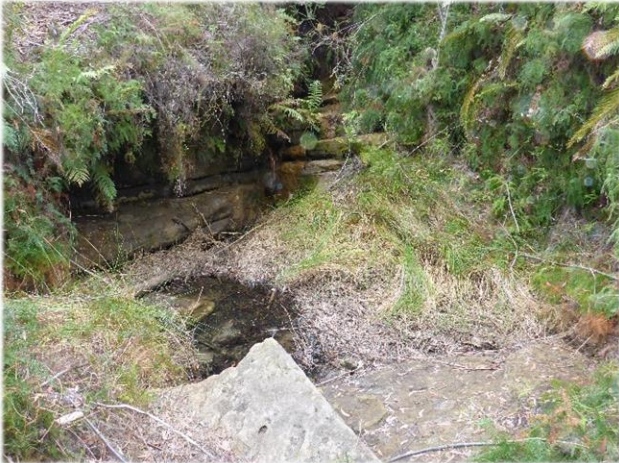
Photo 46: WC21\_Pool 53, looking upstream, taken 10/10/2017.

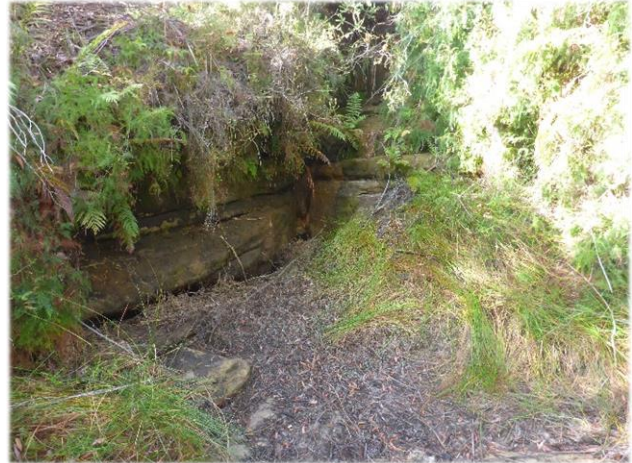
Photo 47: WC21\_Pool 53 looking upstream, taken 27/10/2017.

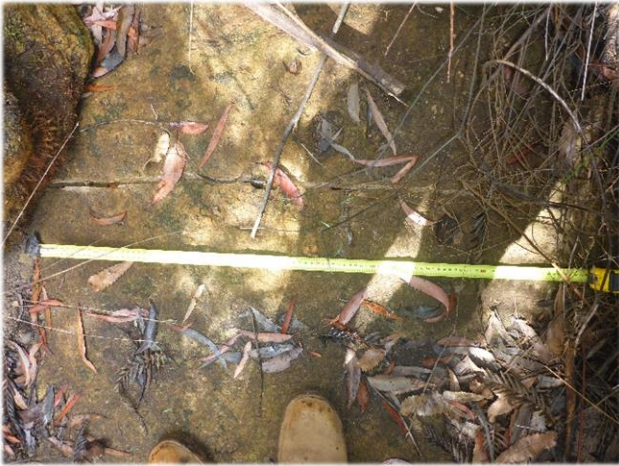
Level 2: Crack or fracture between 100 and 300 mm width at its widest point or any fracture which results in observable loss of surface water or erosion.

Photo 48: DA3B\_LW13\_011, looking top-down, taken 23/10/2017.

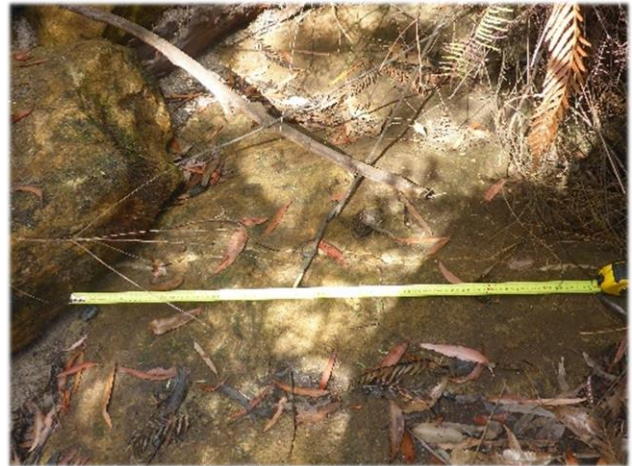
Impact DA3B\_LW13\_011 was identified on the 27<sup>th</sup> October 2017. This impact consists of fracturing to the rockbar base of WC21\_Pool 47, which was mined beneath by Longwall 13 on the 8<sup>th</sup> October 2017. The fracturing is 1.1 m long, 0.01 m wide and 0.3 m at its deepest measurable point (Photo 48 and Photo 49). Flow diversion has likely occurred at the site given the change in pool level over a relatively short period. Observations show surface water at WC21\_Pool 47 as of the 25<sup>th</sup> September 2017 (Photo 50. *Note: photo shows 20<sup>th</sup> September 2017*). The following observation, on the 3<sup>rd</sup> of October 2017, shows no surface water within the pool (Photo 51).

Photo 49: DA3B\_LW13\_011, looking upstream, taken 23/10/2017.

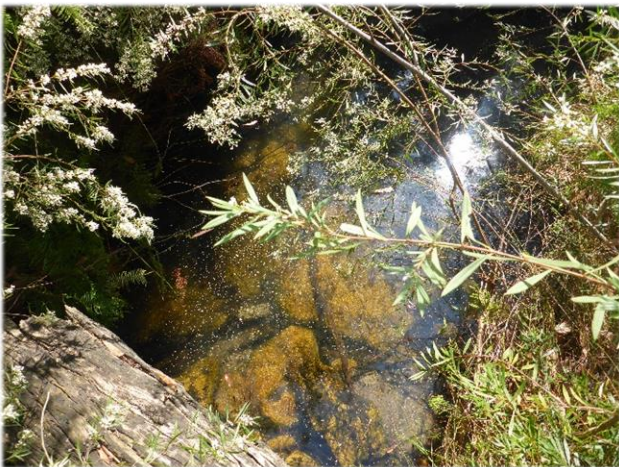
Photo 50: WC21\_Pool 47, looking downstream, taken 20/09/2017

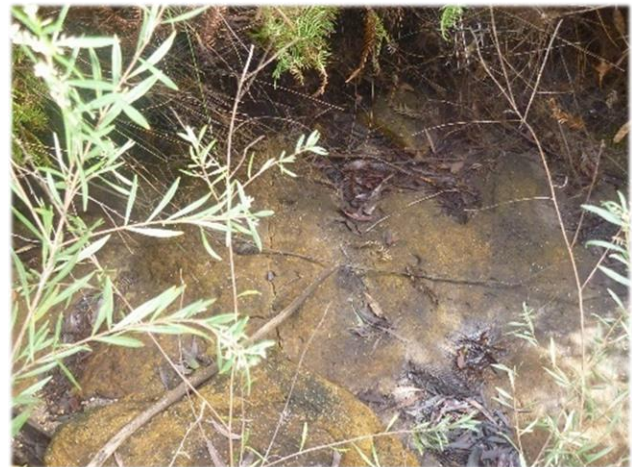
Photo 51: WC21\_Pool 47, looking across stream, taken 3/10/2017.

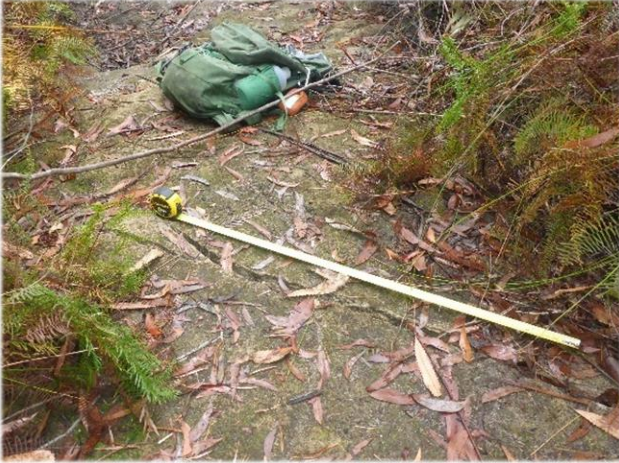
Photo 52: Impact *DA3B\_LW13\_017*, overall extent. Taken on 8/01/2018.

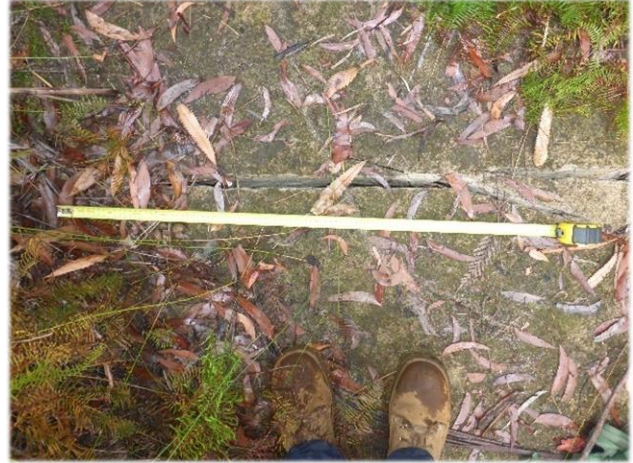
Impact DA3B\_LW13\_017 was identified during an inspection on the 8<sup>th</sup> January 2018. The impact consists of rock fracturing across tributary WC21. The crack is approximately 2 m long, 0.03 m wide and 0.22 m at its deepest measurable point (Photo 52 and Photo 53). Whilst there was no surface flow during the inspection, it is likely that the fracture would result in diversion of flow. Longwall 12 passed adjacent to the site in November 2016 with Longwall 13 passing the site in October 2017.

Photo 53: Impact *DA3B\_LW13\_017*, overall extent. Taken on 8/01/2018.

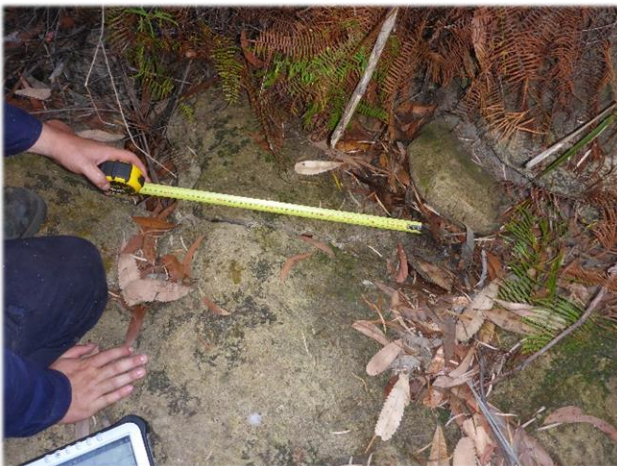
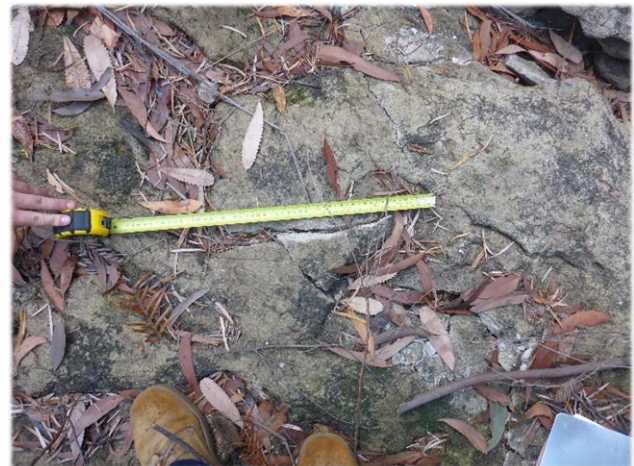
Photo 54: *DA3B\_LW13\_018*, looking across stream at the largest fracture. Taken on 12/02/2018.

Photo 55: *DA3B\_LW13\_018*, looking top-down at the largest fracture. Taken on 12/02/2018.

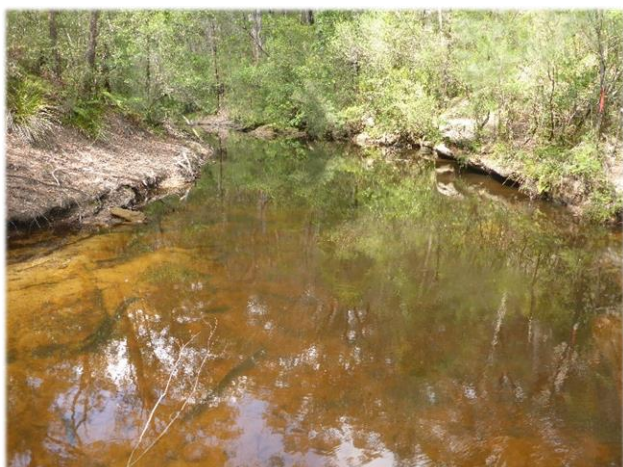
Photo 56: *WC\_Pool 43a*, looking upstream. Taken on 12/12/2017.

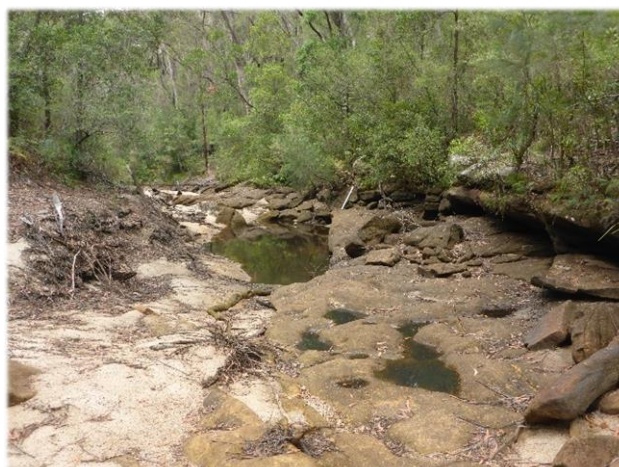
In November 2017, pool-water levels in *WC\_Pool 43a* were observed as the lowest for the monitoring period (Figure 13, Photo 56 and Photo 57). Following these observations, *DA3B\_LW13\_015* was reported as a Level 3 trigger (on the 28<sup>th</sup> November 2017) in accordance with the DA 3B Watercourse TARP, specifically: Fracturing resulting in diversion of flow such that <10% of the pools have water levels lower than baseline period.

Photo 57: *WC\_Pool 43a*, looking upstream. Taken on 10/01/2018.

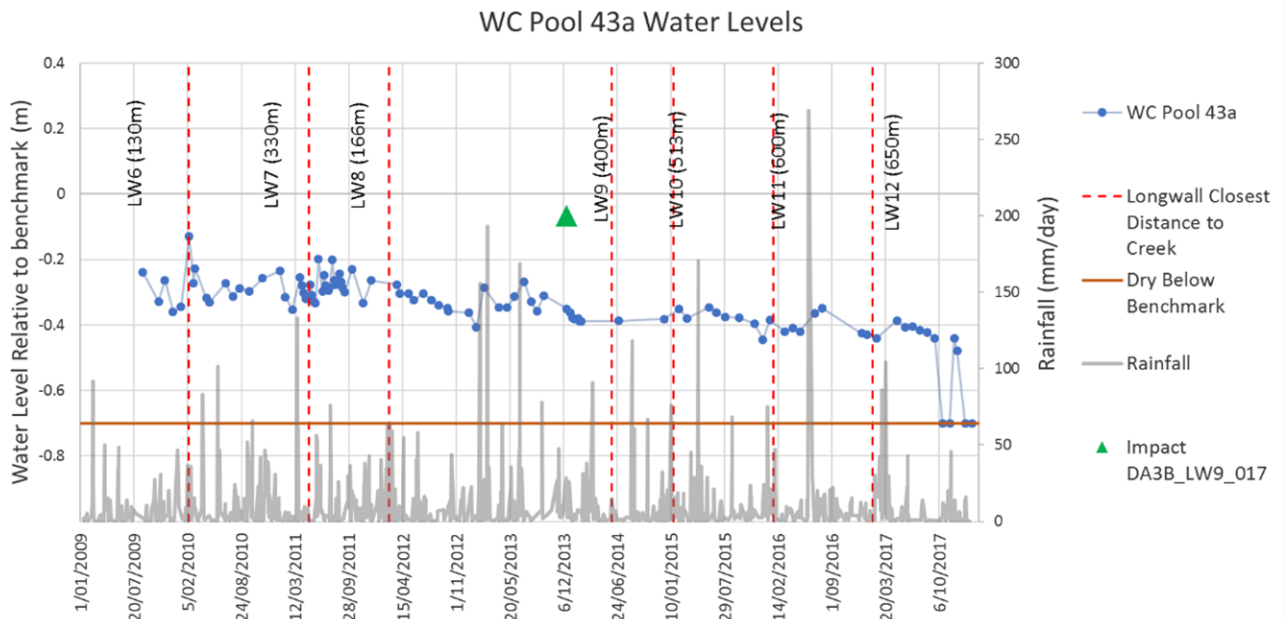
Figure 13: Pool water levels recorded in WC\_Pool 43a. Initial observation date of impact DA3B\_LW9\_017 is also displayed. Further analysis on Wongawilli Creek is presented in **Attachment D**.

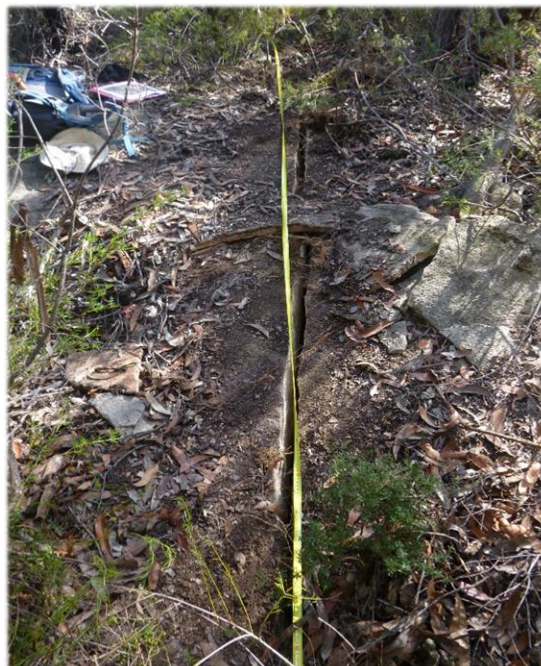
Photo 58: Photo DA3B\_LW13\_036, looking at the extent of the fracture. Taken 23<sup>rd</sup> April 2018.

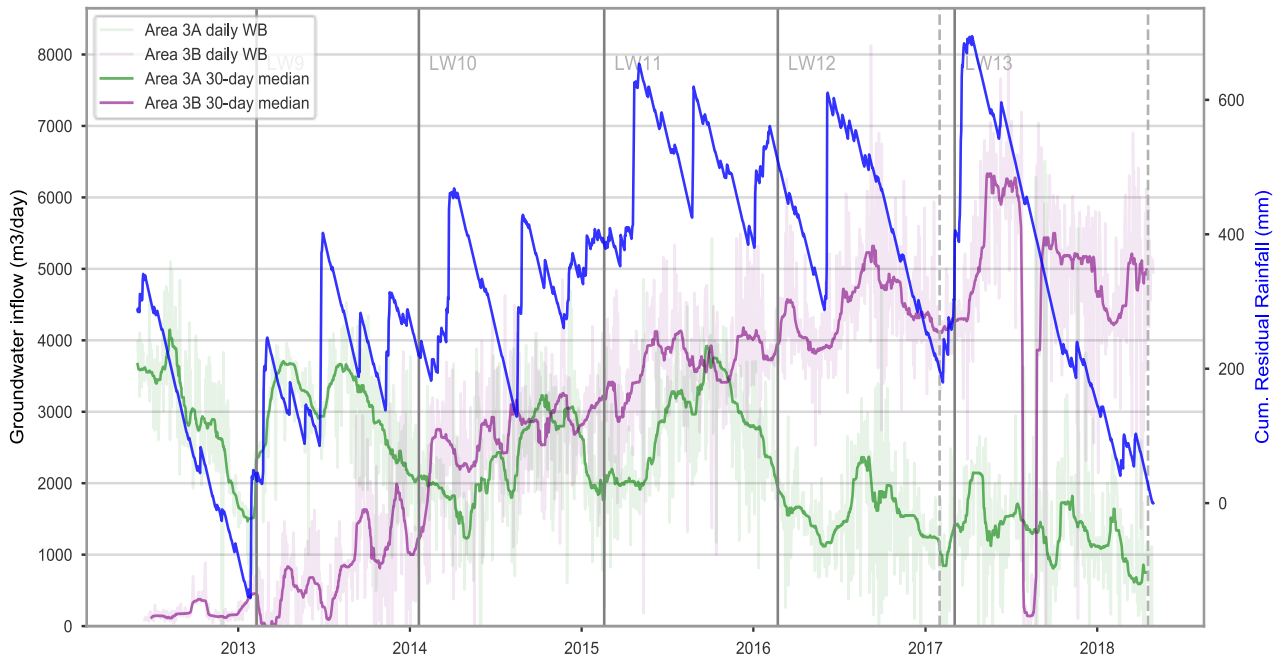
Figure 14: Groundwater inflow in to DA3A and DA3B.

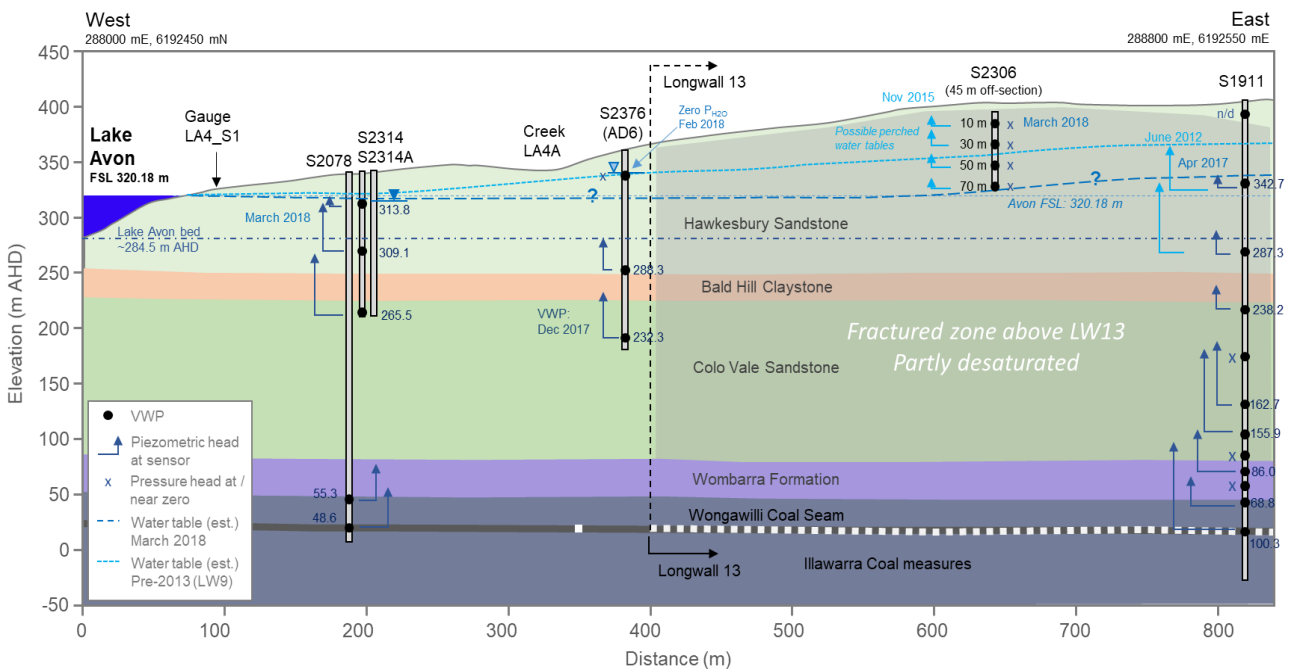
Figure 15: Hydrogeological cross-section of Lake Avon and relevant monitoring bores.

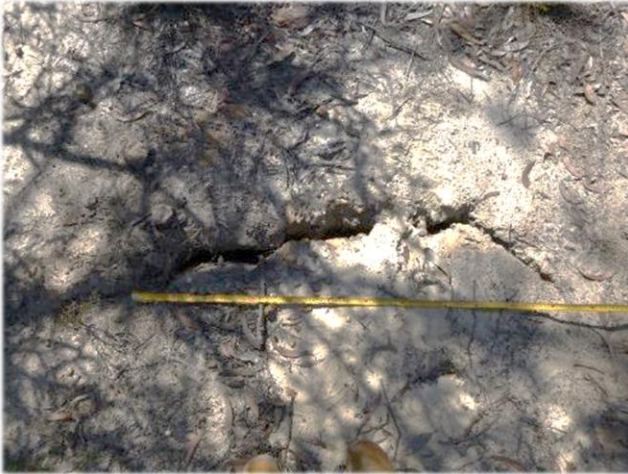
Photo 59: DA3B\_LW13\_032, soil cracking across Fire Road 6P. Taken 9th April 2018.

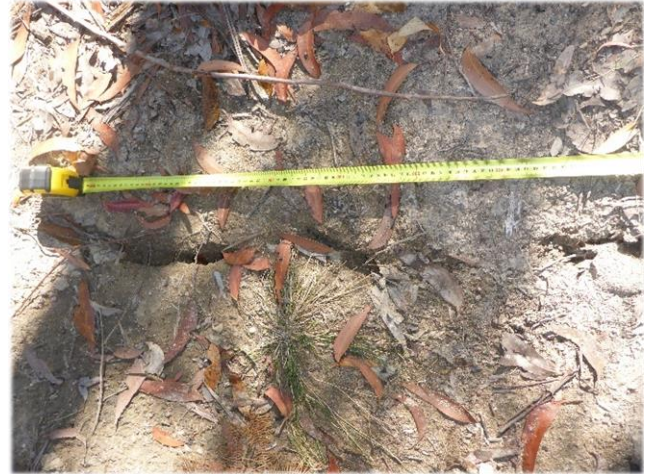
Photo 60: DA3B\_LW13\_012, largest section of surface cracking. Taken 30th October 2017.

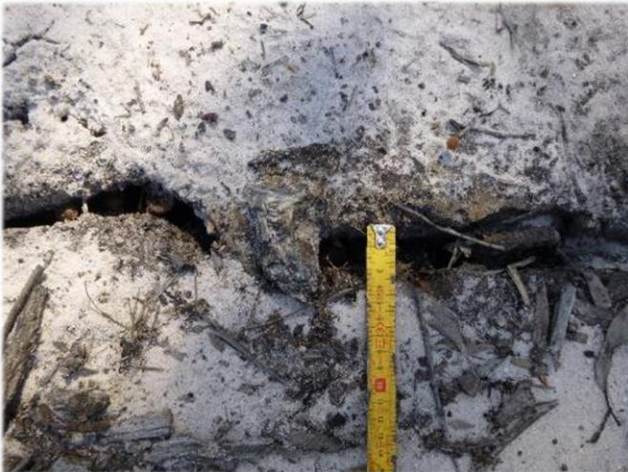
Photo 61: DA3B\_LW13\_034, close up of the widest section of the soil cracking impact. Taken 9th April 2018.

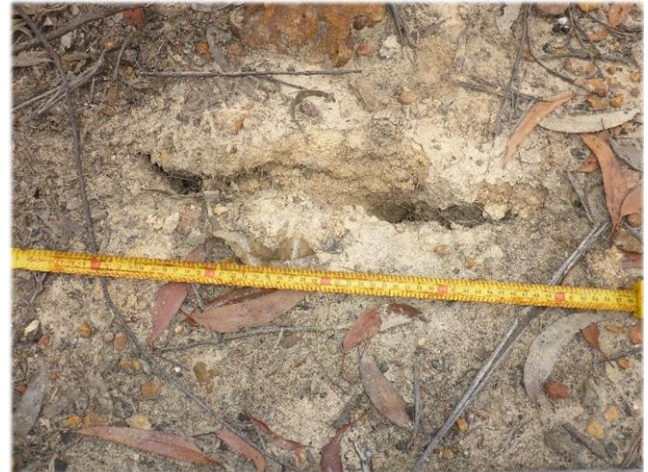
Photo 62: DA3B\_LW13\_020, looking across the access track. Taken on 16th March 2018.

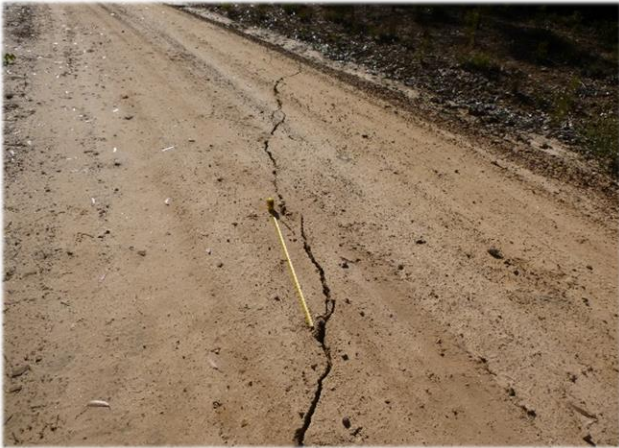
Photo 63: *DA3B\_LW13\_003*, showing the longest continuous section of cracking on *FR6A*, taken 26<sup>th</sup> June 2017.

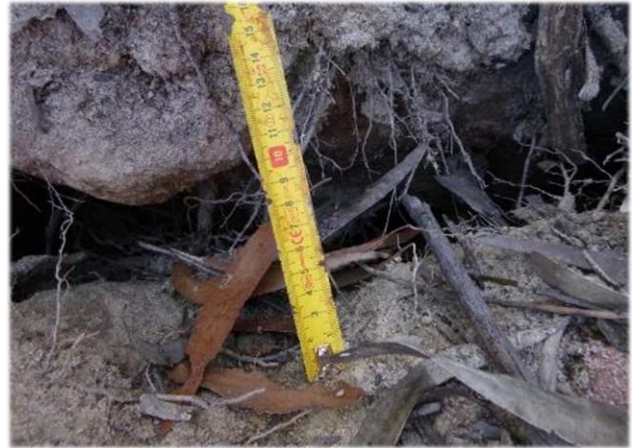
Photo 64: *DA3B\_LW13\_029*, close up of the widest section of cracking. Taken 9<sup>th</sup> April 2018.

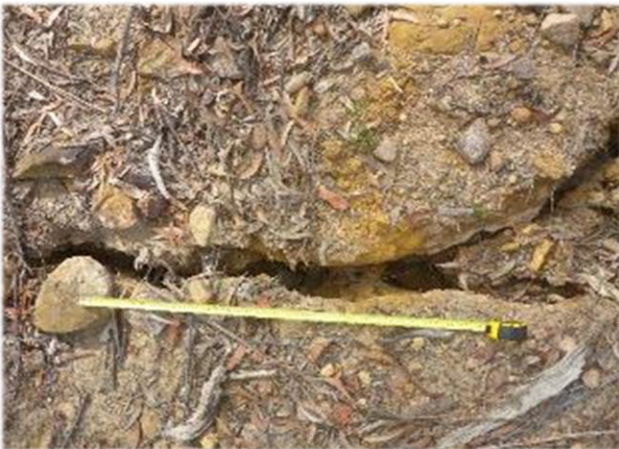
Photo 65: *DA3B\_LW13\_024*, looking across track. Taken 4<sup>th</sup> March 2018.

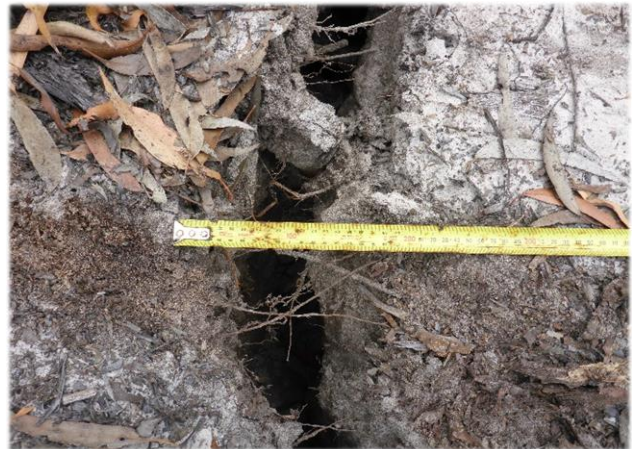
Photo 66: *DA3B\_LW13\_019*, looking inside soil crack. Taken on 2/03/2018.
