**DENDROBIUM AREA 3B
LONGWALL 14 END OF
PANEL REPORT**

September 2019

This End of Panel (EoP) report has been prepared in accordance with Schedule 3 Condition 9 of the Dendrobium Development Consent (DA 60-03-2001). The EoP report outlines the measured and observed impacts during the extraction of Dendrobium Area 3B (DA3B) Longwall 14, and presents monitoring results and analyses compared to relevant impact assessment criteria and predictions in the DA3B Subsidence Management Plan (SMP).

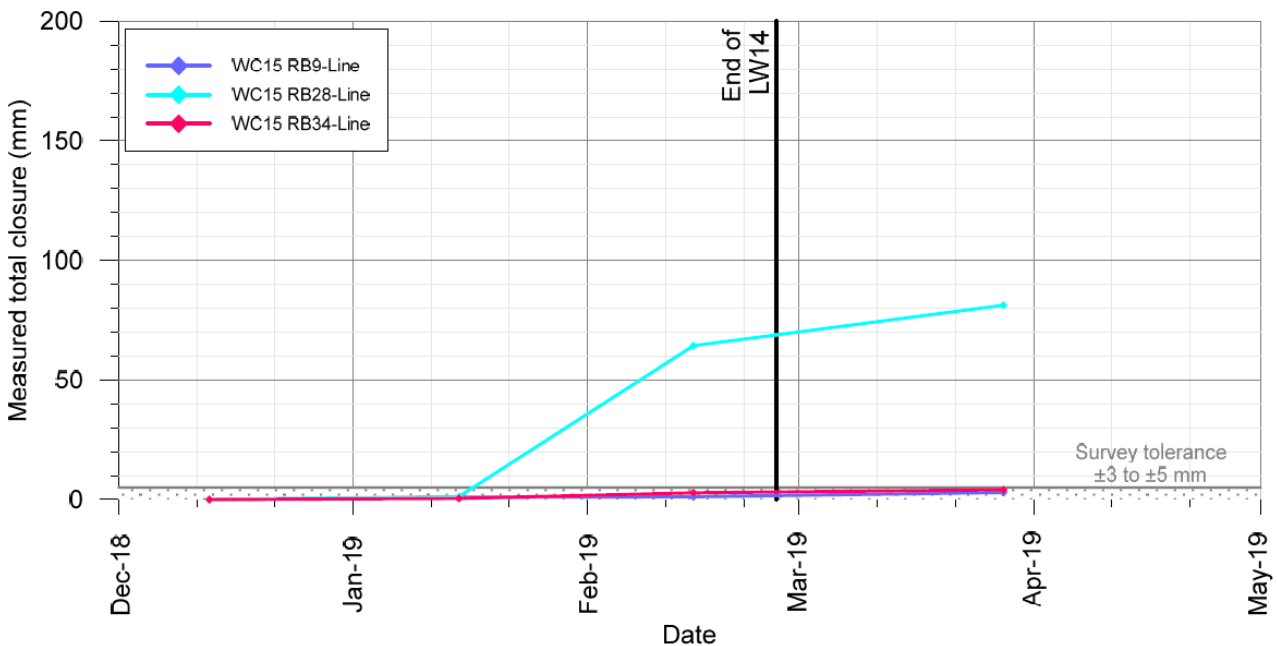
The mine subsidence movements across WC15 (a tributary to Wongawilli Creek) have been measured using 2D survey techniques at the WC15 RB9-Line, WC15 RB28-Line and WC15 RB34-Line (Figure 5). These monitoring lines were established in December 2018 during the mining of Longwall 14. Low level net uplift in the order of the survey tolerance for absolute height were measured at each of the WC15 RB9-Line, WC15 RB28-Line and WC15 RB34-Line. The closure measured at the WC15 RB28-Line was similar to the predicted value. Only low-level closure movements similar to the order of survey tolerance were measured at the WC15 RB9-Line and WC15 RB34-Line.

Figure 5: Measured incremental closure for the WC15 cross lines. (Source: Attachment B).

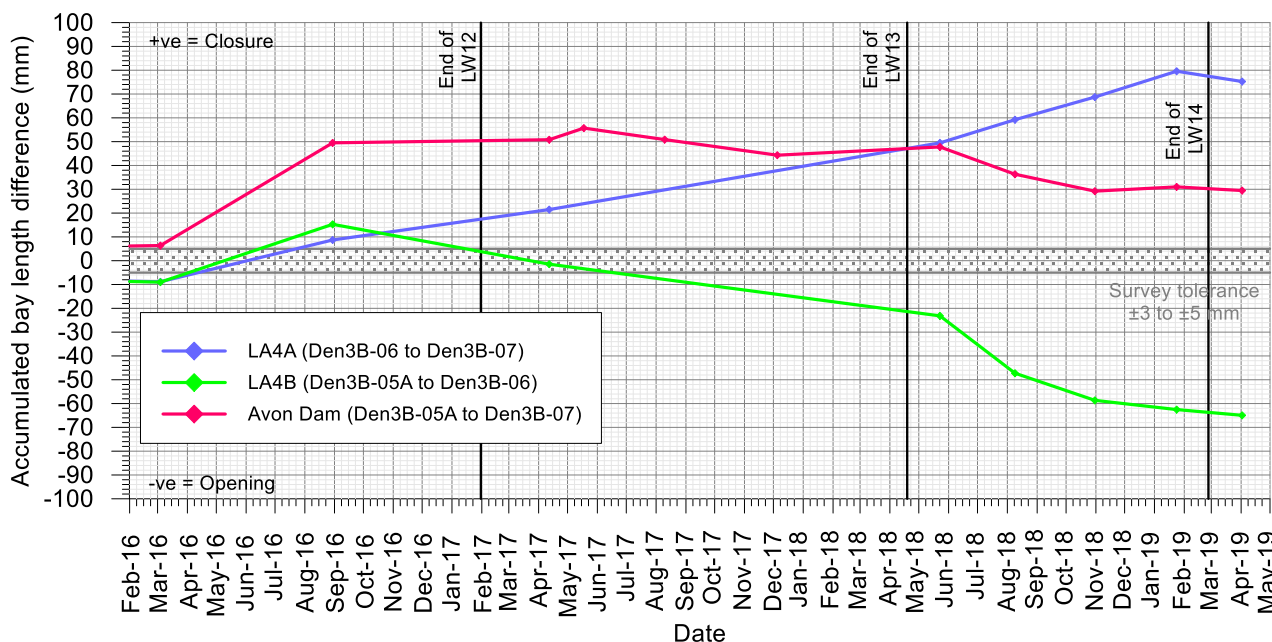
The closure across Avon Dam and two tributaries to Avon Dam (LA4A and LA4B), were measured with 2D survey technique (Figure 6). The base survey was carried out on 26 February 2013, prior to the commencement of Longwall 9. The maximum measured total movements across LA4A, LA4B and the Avon Dam are less than the predicted values at the completion of Longwall 14. It is considered that the ground movements measured using these monitoring lines are consistent with the predictions.

Figure 6: Measured accumulated closure for Tributaries LA4A, LA4B and the Avon Dam. (Source: Attachment B).

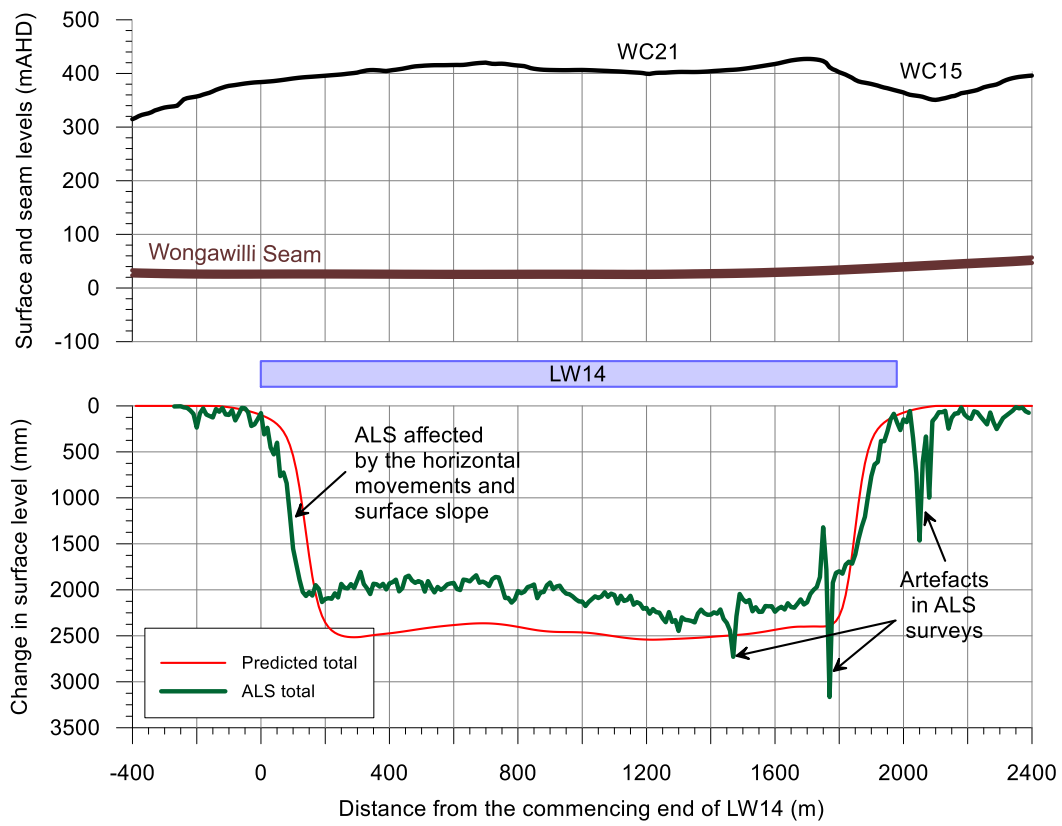
The mining-induced horizontal movement, therefore, results in the measured changes in level at a fixed position to be greater than the true vertical subsidence above the commencing end of Longwall 14. There are localised areas outside of the longwalls where the measured changes in surface level exceed the predicted vertical subsidence. However, these are artefacts of the ALS surveys and are not real movements. It is considered that the subsidence movements measured using the ALS surveys are consistent with the predicted subsidence movements.

Figure 14: Measured changes in surface level and predicted vertical subsidence along Long section 1. (Source: Attachment B).

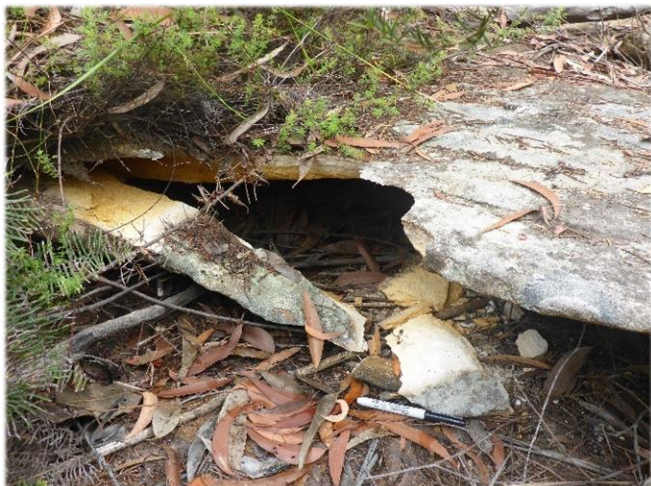
Site ID	Easting	Northing	Impact Type	Feature Affected	Identification Date	Trigger Level	Description	Refer to Impact Report/s Dated
DA3B_LW14_016 Photo 1	290345	6191835	Rock Fracturing, Uplift and Rock Displacement	WC15	21/01/2019	2	Multiple fractures, uplift and dislodged sections of rock on WC15. The longest fracture is up to 4.0 m long and 0.03 m wide.	24/01/2019
DA3B_LW14_017 Photo 2	290276	6191786	Rock Fracturing	WC15	20/02/2019	2	Rock fracturing to WC15. The rock fracturing has a maximum measurable length of 0.8m, a maximum width of 0.025 m and a maximum measurable depth of 0.17 m.	21/02/2019
DA3B_LW14_018 Photo 3	290282	6191791	Rock Fracturing	WC15	20/02/2019	2	Rock fracturing to WC15. The rock fracture has a maximum measurable length of 0.7 m, a maximum width of 0.015 m and a maximum measurable depth of 0.10 m.	21/02/2019
DA3B_LW14_019 Photo 4	290312	6191805	Rock Fracturing and Uplift	WC15	20/02/2019	1	Rock fracturing to WC15. The rock fracture has a maximum measurable length of 4.5 m, a maximum width of 0.05 m, a maximum measurable depth of 0.7 m.	21/02/19

Photo 1: DA3B_LW14_016, looking at fracturing and dislodged rock segments. Taken on 21/01/2019.

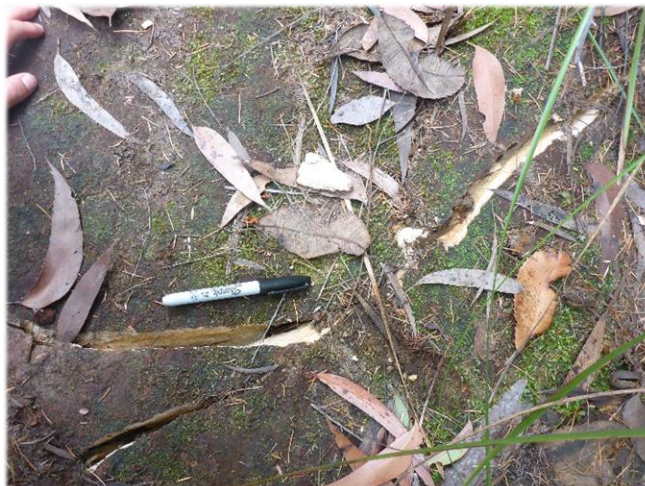
Photo 2: DA3B_LW14_017, looking at a section of rock fracturing. Taken 20/02/2019.

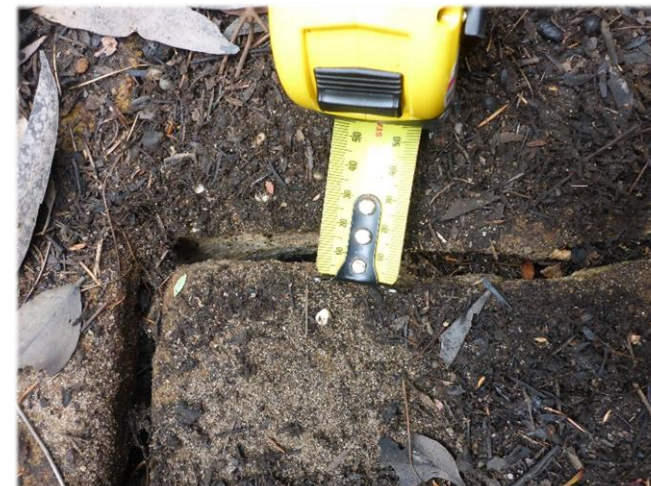
Photo 3: DA3B_LW14_018, looking at the width of the fracturing. Taken 20/02/2019.

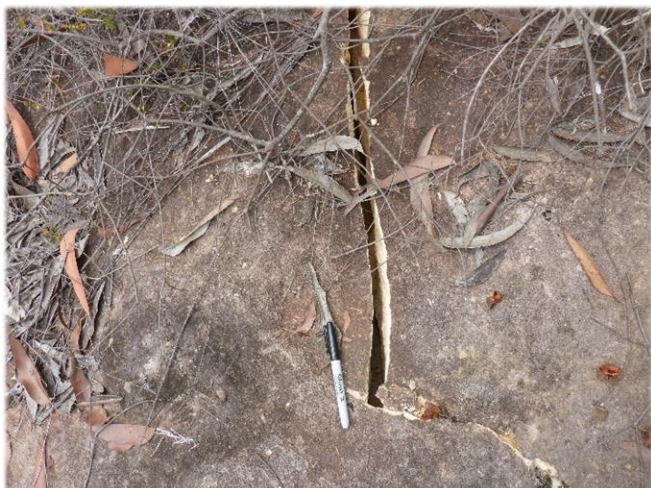
Photo 4: DA3B_LW14_019, looking at a section of rock fracturing. Taken 20/02/2019.

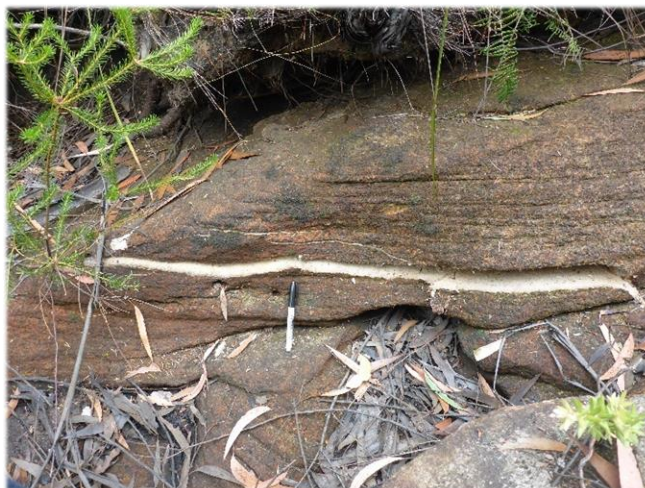
DA3B_LW14_020 Photo 5	290334	6191828	Rock Fracturing	WC15	20/02/2019	2	Rock fracturing to WC15. The rock fracture has a maximum measurable length of 1.3 m, a maximum width of 0.05 m and a maximum measurable depth of 1.13 m.	21/02/19
DA3B_LW14_021 Photo 6	290416	6191943	Rock Fracturing	WC15	20/02/2019	2	Rock fracturing to WC15. The rock fractures have a maximum measurable length of 1.1 m and a maximum width of 0.01 m.	21/02/19
DA3B_LW14_022 Photo 7	290283	6192052	Rock Fracturing	WC15	20/02/2019	2	Rock fracturing to WC15. The rock fracture has a maximum measurable length of 2.9 m, and a maximum width of 0.05 m.	21/02/19
DA3B_LW14_023 Photo 8	290398	6191907	Rock Fracturing	WC15	1/04/2019	1	Rock fracturing to WC15. The rock fracture has a maximum measurable length of 0.35 m, and a maximum width of 0.001 m.	3/04/19
DA3B_LW13_035 (Update) Photo 9	290406	6191915	Rock Fracturing	WC15	23/04/2018	2	Additional fracturing with flow diversion was observed on WC15. The largest fracture is up to 3.7 m long, with the widest fracture up to 0.02 m wide.	27/04/2018 24/01/2019

Photo 5: DA3B_LW14_020, looking at the extent of the rock fracturing. Taken 20/02/2019.

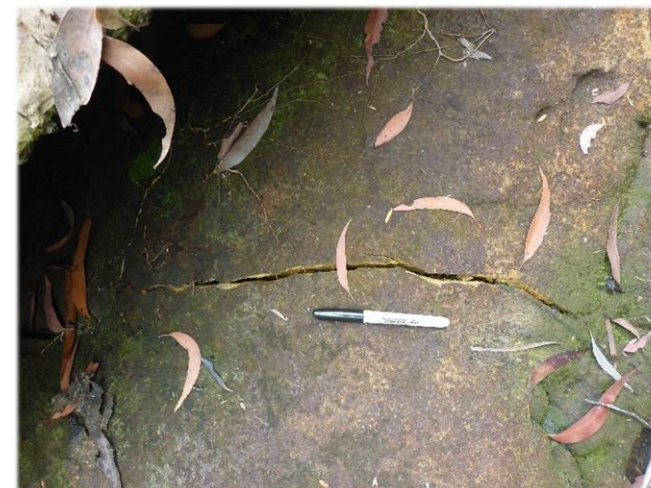
Photo 6: DA3B_LW14_021, looking at the section of rock fracturing. Taken 20/02/2019.

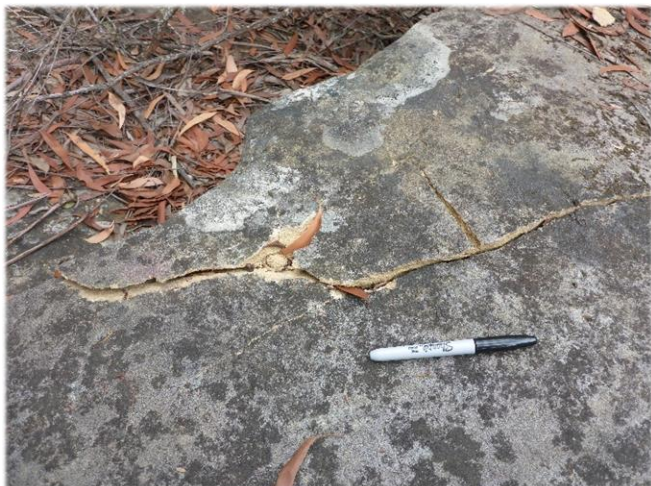
Photo 7: DA3B_LW14_022, looking at the section of rock fracturing. Taken 20/02/2019.

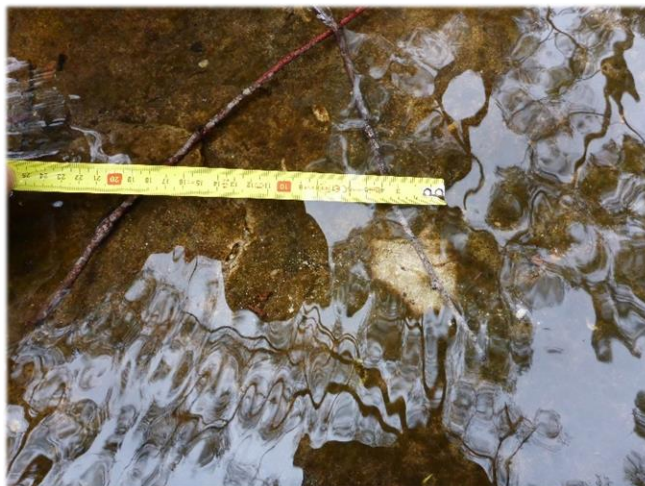
Photo 8: DA3B_LW14_023, looking at a section of rock fracturing. Taken 01/04/2019.

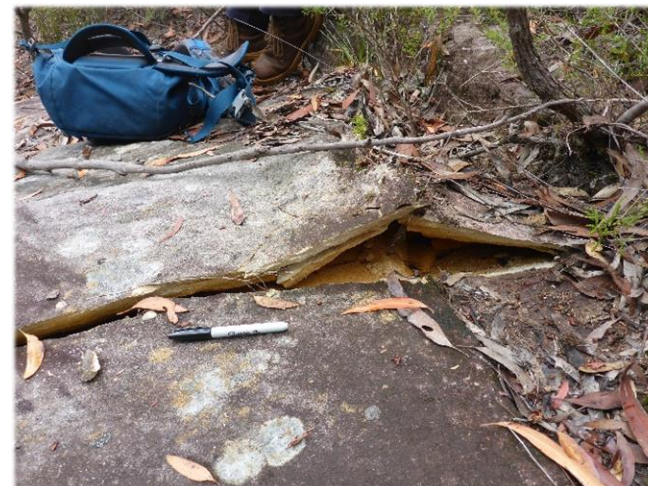
Photo 9: DA3B_LW13_035, fracturing and uplift on rockbar. Taken on 21/01/2019.

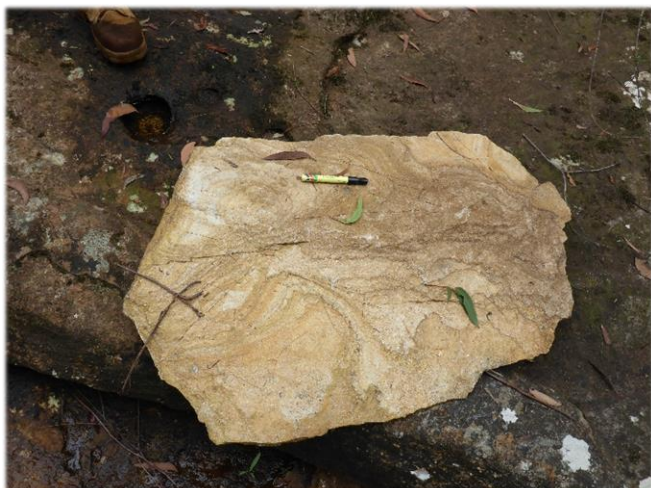
DA3B_LW13_042 (Update) Photo 10	290772	6192286	Rock Fracturing	WC15	16/05/2018	2	Additional fracturing and rock fragmentation were observed at WC15. The new rock fracturing has a	17/05/2018 3/04/2019

Photo 10: DA3B_LW13_042, looking at largest section of rock fragmentation. Taken 01/04/2019.

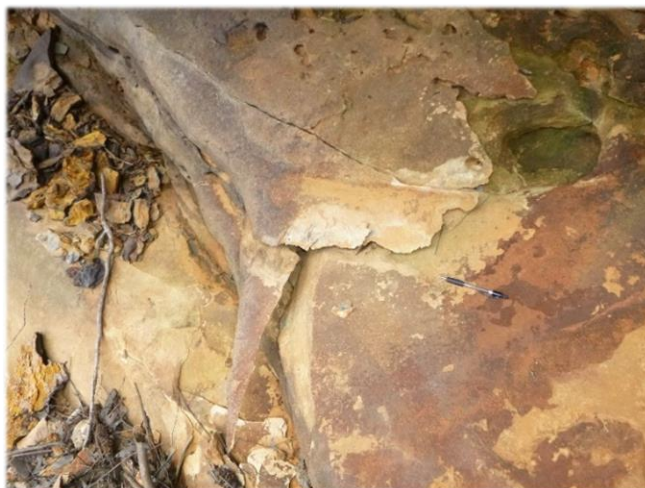
Photo 11: DA3B_LW13_043, looking at a section of rock fracturing and uplift. Taken 6/12/2018.

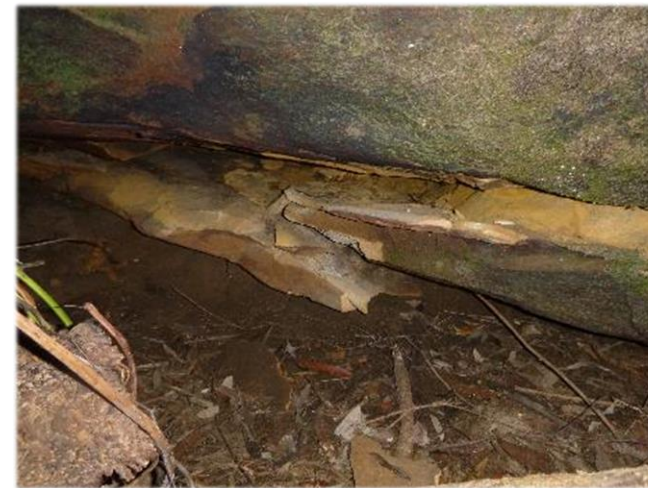
Photo 12: DA3b_LW13_044, looking at a section of rock fracturing. Taken 26/07/18.

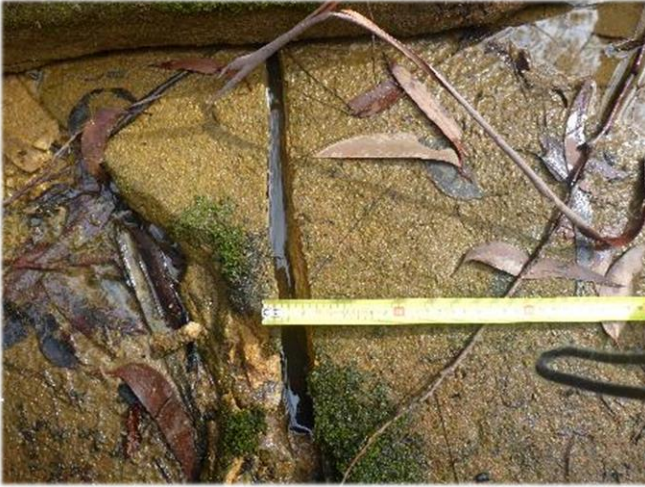
Photo 13: *DA3b_LW13_045*, Looking at the rock fracturing.
Taken 8/07/18.

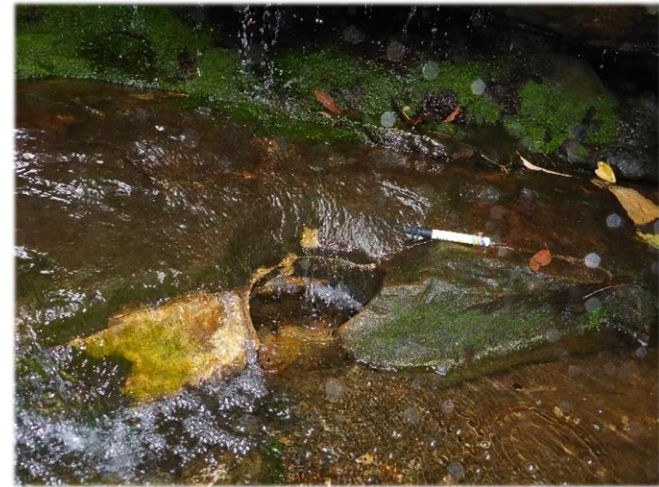
DA3B_LW13_046 Photo 14	290887	6192408	Rock Fracturing	WC15	1/04/2019	1	Rock fracturing to the base of a step on tributary WC15. Maximum length of 1.2 m, and a width of 0.02 m.	3/04/2018

Photo 14: *DA3B_LW13_046*, looking at the extent of the
rock fracturing. Taken 01/04/2019.

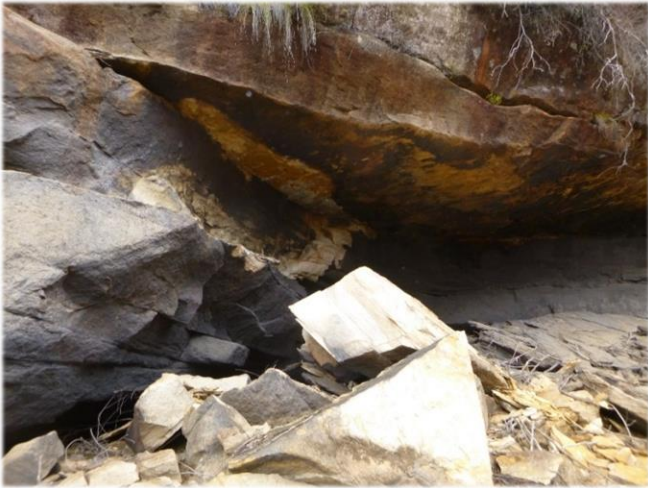
Site ID	Easting	Northing	Impact Type	Feature Affected	Identification Date	Trigger Level	Description	Refer to Impact Report/s Dated
DA3B_LW14_015 Photo 15	288070	6192528	Rock Fracturing and Rockfall	Step/ledge of Lake Avon	5/12/2018	1	Rockfall and rock fracturing on <i>Lake Avon</i> rock ledge. The rock fracturing has a maximum length of 1.8 m, a maximum width of 0.01 m and a maximum depth of 0.29 m. The rock fall is approximately 4 m x 1.5 m x 0.5 m.	18/12/2018
DA3B_LW14_024 Photo 16	290133	6191978	Rock Fracturing & Rock Fall & Soil Cracking	A3b-SS9-Pt2 (Steep Slope)	9/04/2019	1	Rock fracturing, rockfall and soil cracking at SLMMP site 'A3b-SS9-Pt2'. The rock fracturing has a maximum measurable length of 0.3 m, a width of 0.04 m and a measurable depth of 0.21 m.	10/04/2019
DA3B_LW14_025 Photo 17	290115	6192041	Rock Fracturing	Steep Slope/Step	9/04/2019	1	Rock fracturing and displacement at a steep slope/step between <i>WC15</i> and <i>Fire road 6P</i> . The rock fracturing has a maximum measurable length 5.15 m, a maximum width of 0.015 m and a maximum measurable depth of 0.4 m.	10/04/2019

Photo 15: DA3B_LW14_015, looking at the rockfall. Taken 5/12/2018.

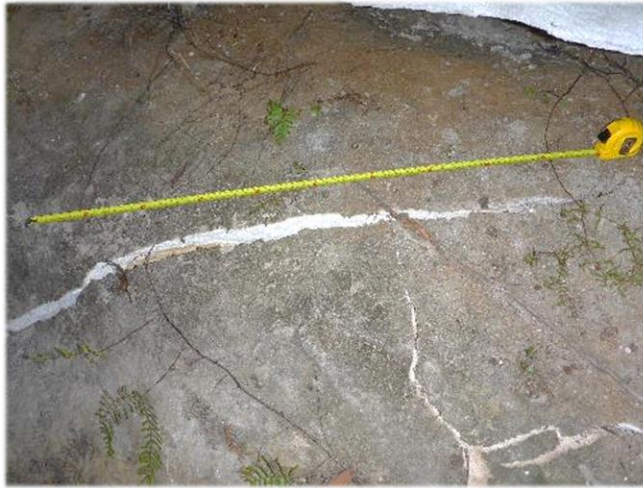
Photo 16: A3B_LW14_024, looking at a section of rock fracturing. Taken 09/04/2019.

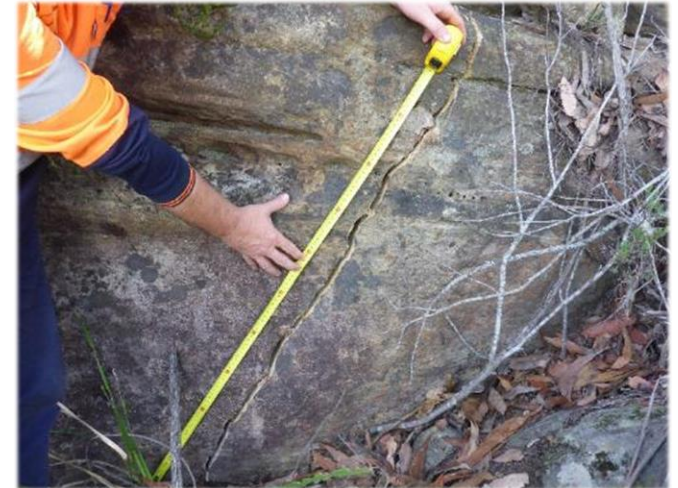
Photo 17: DA3B_LW14_025, looking at a section of the rock fracturing. Taken 09/04/2019.

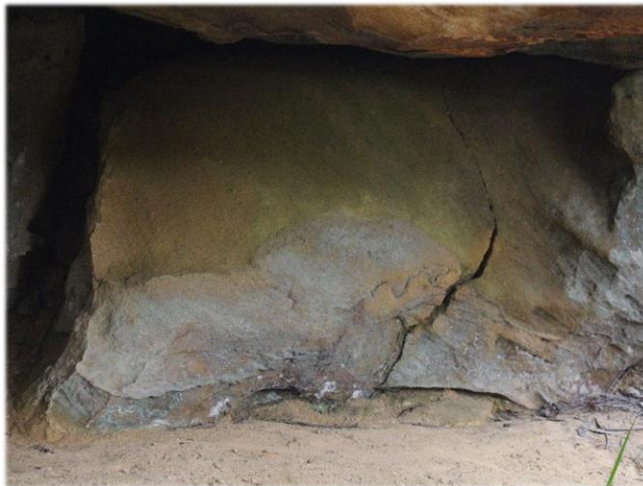
Photo 19: DA3B_LW14_027, looking at a section of rock fracturing. Taken 10/05/2019.

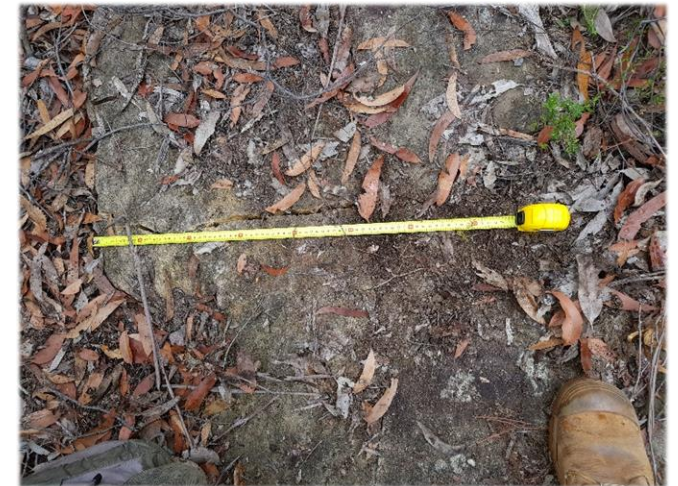
Photo 20: DA3B_LW14_028, looking at a section of rock fracturing. Taken 10/05/2019.

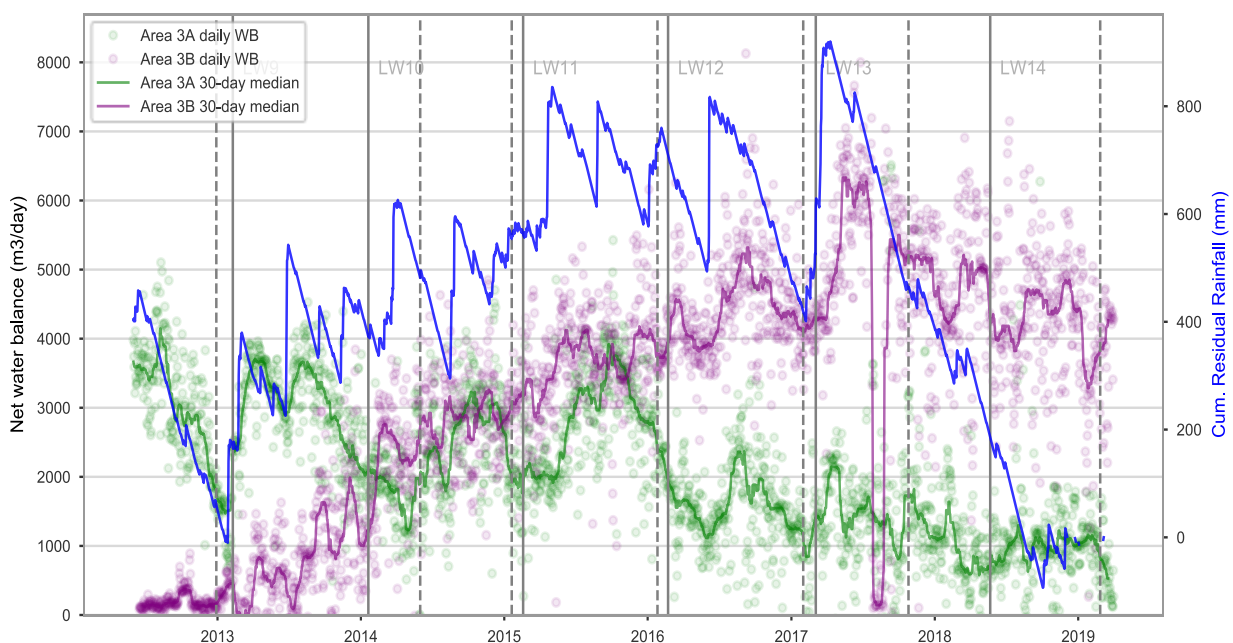
Figure 15: Groundwater inflow in to DA3A and DA3B.

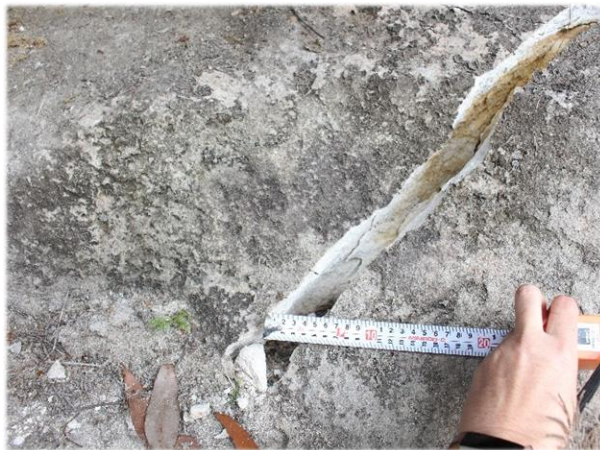
Photo 22: Subsidence cracking at the west end of the Browns Road Site 11 shelter. Taken: 10th May 2019.

Recommendations	
#	Browns Road Site 11 (AHIMS ID# 52-2-1626) and Site 1 DB 1 (AHIMS ID #52-2-2229)
1.	Notify relevant specialists and key stakeholders (e.g. Aboriginal community groups).
2.	Continue monitoring program with condition assessment and photographic records as per TARPS.

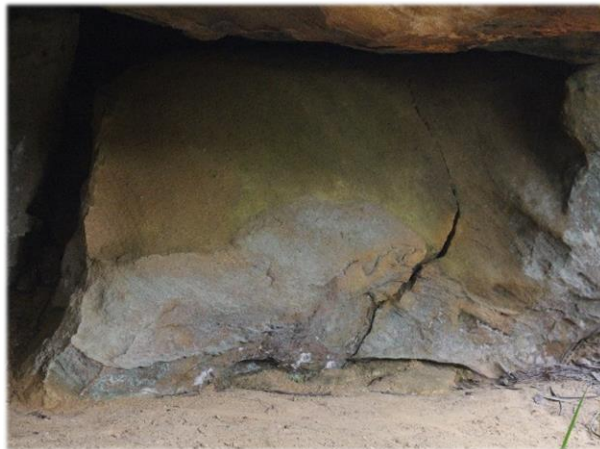
Photo 25: Subsidence related cracking in the north side of the Site 1-DB1 shelter. Taken: 10th May 2019.

Site ID	Impact Type	Feature Affected	Identification Date	Trigger Level	Description	Refer to Impact Report/s Dated
Site 1-DB1.	Cultural Heritage	Sandstone Shelter	10/05/2019	1	The sandstone shelter at Site 1 DB-1 has experienced diagonal and vertical cracking with block fall and exfoliation expedited with subsidence.	Niche (June 2019)

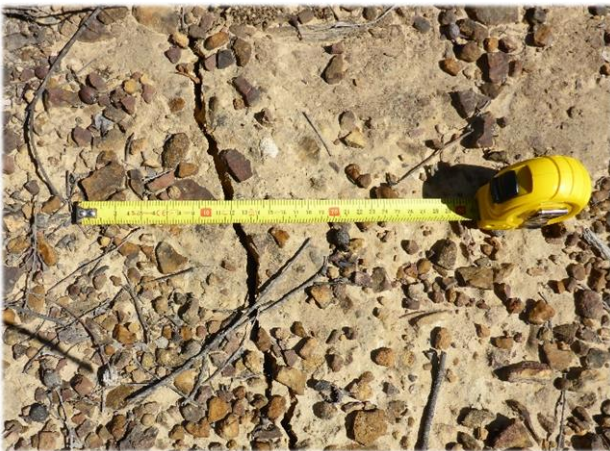
Photo 29: DA3B_LW14_012. Taken 16/09/18.

Site ID	Easting	Northing	Impact Type	Feature Affected	Identification Date	Trigger Level	Description	Refer to Impact Report/s Dated
DA3B_LW14_012	289062	6192097	Surface Cracking	<i>Fire Road 6A</i>	16/9/2018	1	Multiple surface cracks within a 20m section. Longest crack measuring approximately 9m long, 0.01m wide and 0.03m deep.	20/09/2018
DA3B_LW14_014	289432	6192021	Surface Cracking	Access Track	13/11/2018	1	Surface cracking on access track adjacent to Swamp 13. The crack is 1.1m long, 0.06m wide and 0.15m deep.	16/11/2018

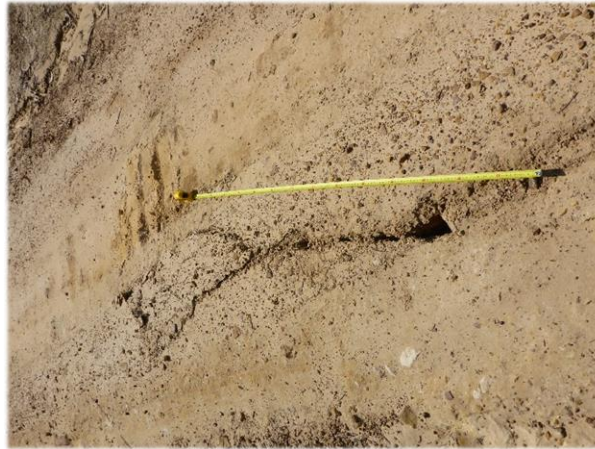
Photo 31: DA3B_LW14_010. Taken 10/09/18.

Site ID	Easting	Northing	Impact Type	Feature Affected	Identification Date	Trigger Level	Description	Refer to Impact Report/s Dated
DA3B_LW14_010	289038	6192227	Surface Cracking and Uplift	Fire Road 6A	10/09/2018	2	Continuous soil crack and uplift along Fire Trail 6A. The crack is approximately 12m long, 0.05m wide with a maximum uplift of 0.03m and 0.26m at the deepest measurable point.	20/09/2018
DA3B_LW14_013	289080	6192069	Surface Cracking	Access Track	26/09/2018	2	Surface cracking on access track adjacent to Fire Road 6A. The crack is approximately 14m long, 0.01m wide and 0.05m deep at the deepest measurable point.	27/09/2018
