**DENDROBIUM AREA 3B  
LONGWALL 15 END OF  
PANEL REPORT**

**May 2020**

## EXECUTIVE SUMMARY

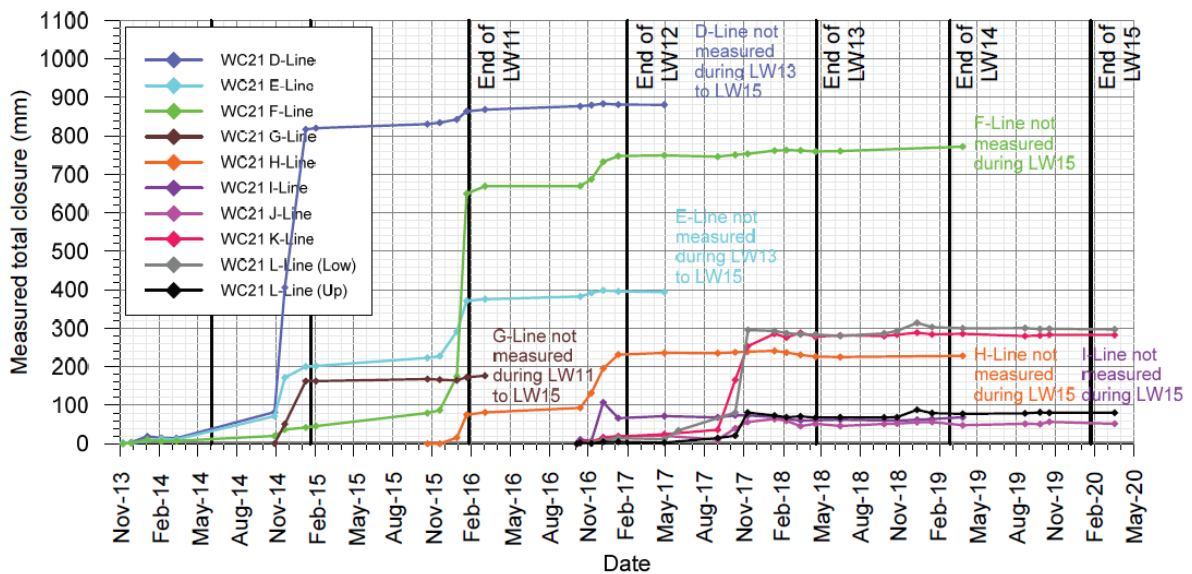
Figure 4: Measured total closure for WC21 cross lines. (Source: Attachment B).

The measured total vertical subsidence and closure for the WC21 cross lines are less than the predicted values at the completion of Longwall 15 (Figure 4). The measured vertical subsidence movements range is between 58 % and 64 % of the predicted values, with an average of 62 %. The measured closures range is between 17 % and 41 % of the predicted values, with an average of 32 %. It is considered, therefore, that the ground movements measured along WC21 are considerably less than the predictions.

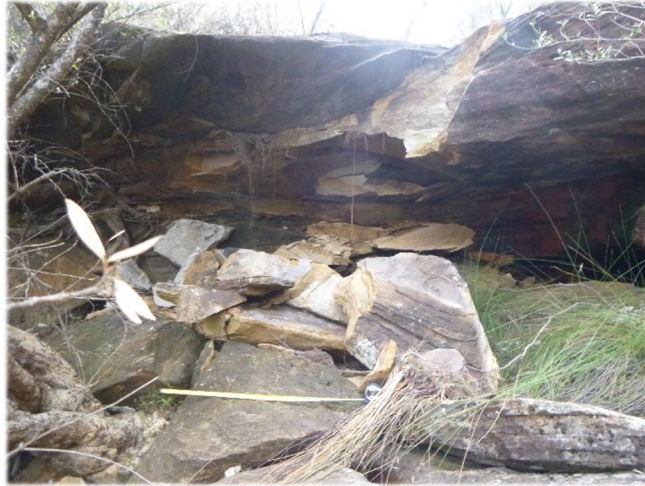
**Photo 2:** DA3B\_LW15\_014, an overview of the rockfall. Taken on 11/10/2019.

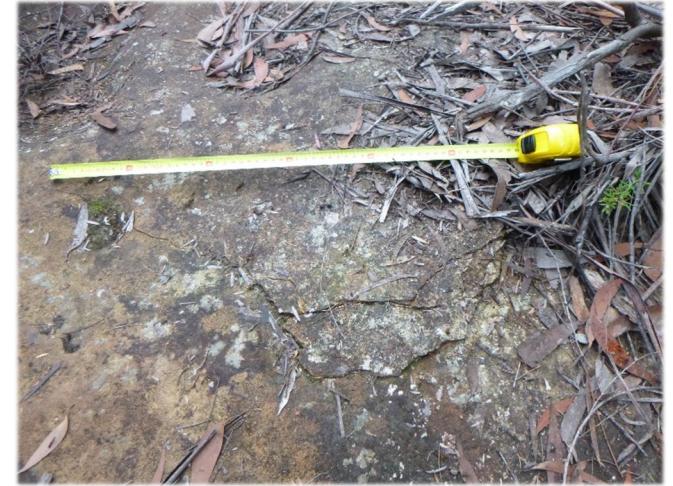
**Photo 3:** DA3B\_LW15\_015, looking at a section of rock fracturing. Taken on 11/10/2019.

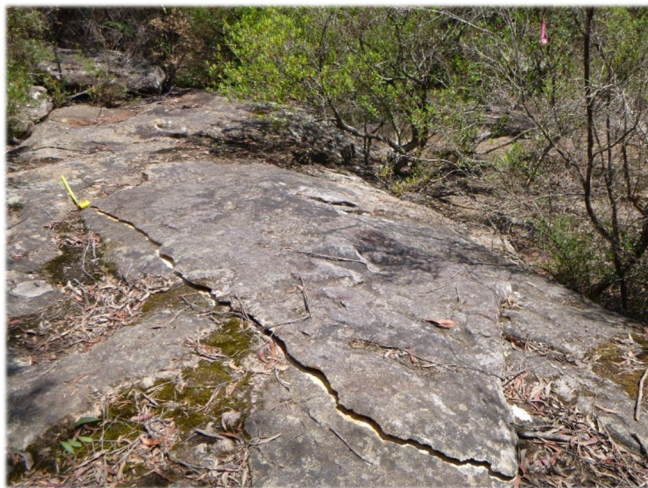
DA3B_LW15_027 Photo 4	290467	6192043	Rock Fracturing	WC15	21/01/2020	1	Rock fracturing to WC15_Rockbar 18. The rock fracture has a length of 6m, a width of 0.04m and a depth of approximately 2.5m.	23/01/2020
DA3B_LW13_010 (Update) Photo 5	289591	6192424	Rockfall	WC21	21/08/2019	2	Rockfall to a step at WC21_Pool 53. Additional rock fragments were dislodged from the step. The largest fragment was approximately 0.4m <sup>2</sup> .	23/08/2019
DA3B_LW13_035 (Update) Photo 6	290408	6191915	Rock Fracturing	WC15	21/01/2020	2	Additional rock fracturing to WC15_Rockbar 21. The rock fracture has a length of 1m and a width of 0.02m. Uplifted sections are associated with the fracturing.	23/01/2020
DA3B_LW13_046 (Update) Photo 7	290887	6192408	Rock Fracturing and Displacement	WC15	1/04/2020	1	Additional rock fracturing and displacement to WC15_Pool 2. Following a heavy rainfall event, a section of sandstone bedrock with a length of 1.42m, width of 1.05m and depth of 0.21m, had been displaced 3.2m downstream.	3/04/2019

**Photo 4:** DA3B\_LW15\_027, looking at the rock fracture. Taken on 21/01/2020.

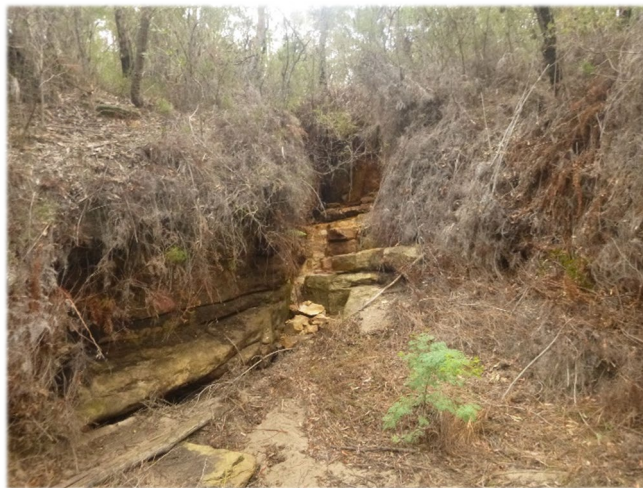
**Photo 5:** DA3B\_LW13\_010, rockfall at the inflow step to WC21\_Pool 53. Taken on 26/02/2020.

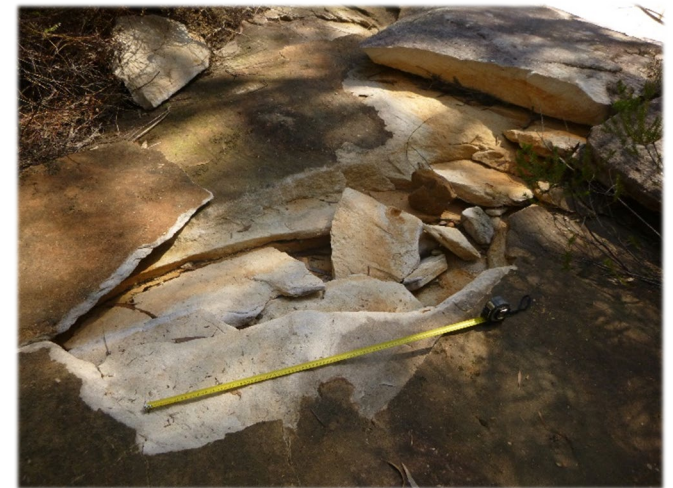
**Photo 6:** DA3B\_LW13\_035, looking at the rock fragmentation. Taken on 28/02/2020.

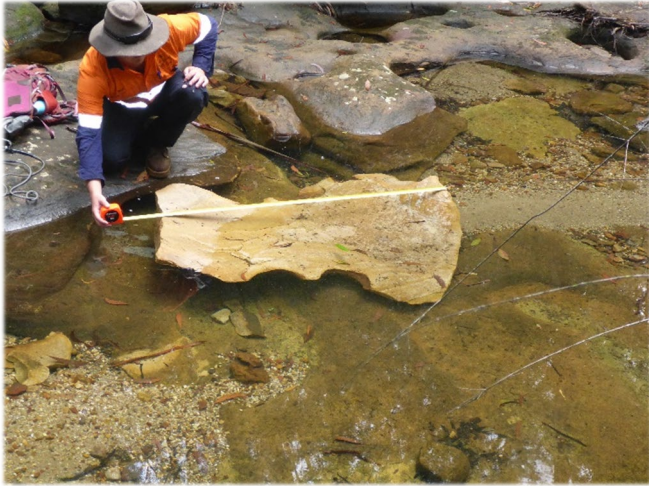
**Photo 7:** *DA3B\_LW13\_046*, looking at the section of rock displacement.  
Taken on 10/03/2020.

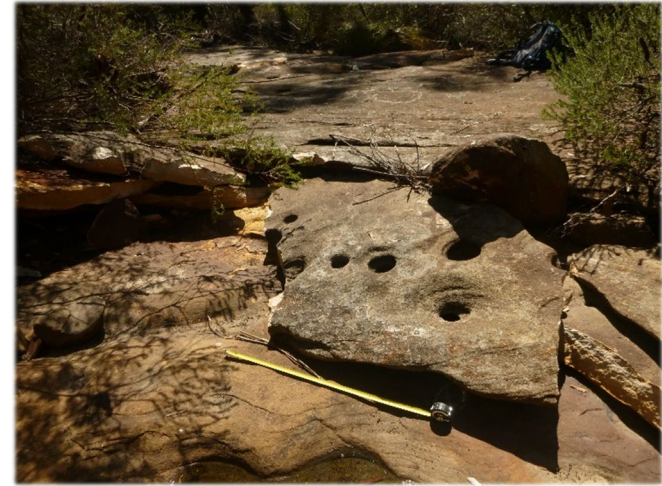
DA3B_LW14_016 (Update) Photo 8	290345	6191835	Rock Fracturing	WC15	21/01/2020	2	Additional rock fracturing to WC15_Rockbar 25. The fracturing has resulted in a 4m by 2m by 0.15m area of overhanging rock to be displaced approximately 0.1m onto underlying bedrock. Following a heavy rainfall event, the section of rockbar previously displaced has been further fractured into approximately 6 large pieces. The largest fragment has a length of 1.5m, width of 1.5m and depth of 0.2m.	23/01/2020

**Photo 8:** *DA3B\_LW14\_016*, looking at the rock fracture and displacement.  
Taken on 28/02/2020.

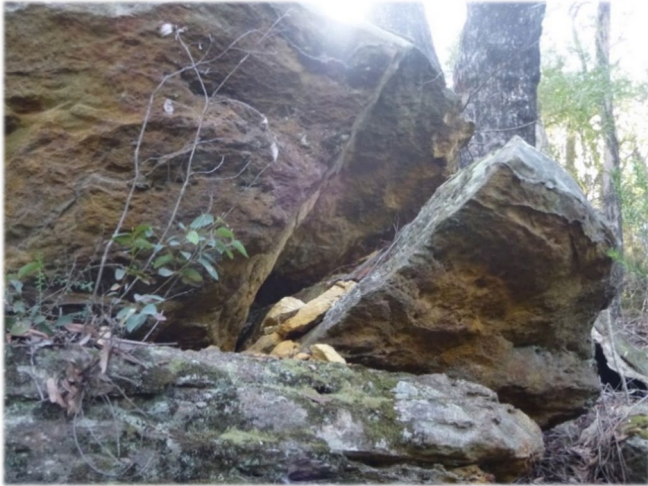
Site ID	Easting	Northing	Impact Type	Feature Affected	Identification Date	Trigger Level	Description	Refer to Impact Report/s Dated
DA3B_LW15_001 Photo 9	288679	6191767	Rock Fracturing and Rockfall	Steep Slope	29/05/2019	1	Rock fracturing and rockfall at a step adjacent to Swamp 23. The rock fracturing has a length of 1m and a width of 0.01m. The largest rock fragment resulting from the rockfall has a length of 0.40m, width of 0.15m and height of 0.15m.	31/05/2019
DA3B_LW15_002 Photo 10	288651	6191771	Rockfall	Steep Slope	29/05/2019	1	Rockfall at a step adjacent to Swamp 23. The impact is comprised of a rockfall with a length of 3m, width of 2m and height of 1m.	31/05/2019
DA3B_LW15_006 Photo 11	288876	6191945	Soil Cracking and Rock Fracturing	Access Track & Sandstone Outcrop	09/07/219	1	Soil cracking to a closed access track and fracturing to adjacent rock outcrop. The soil cracking has a length of 2.9m, width of 0.01m and maximum measurable depth of 0.3m. The rock fracturing has a length of 0.7m, width of 0.01m wide and depth of 0.3m.	11/07/2019

**Photo 9:** *DA3B\_LW15\_001*, looking at a section of the rockfall. Taken on 29/05/2019.

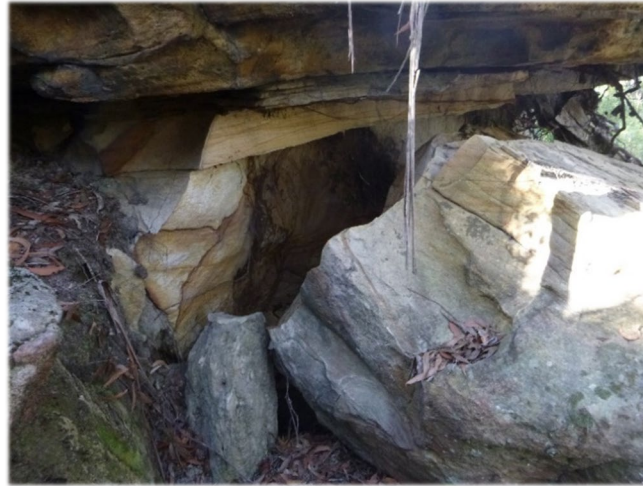
**Photo 10:** *DA3B\_LW15\_002*, looking at the rockfall. Taken on 29/05/2019.

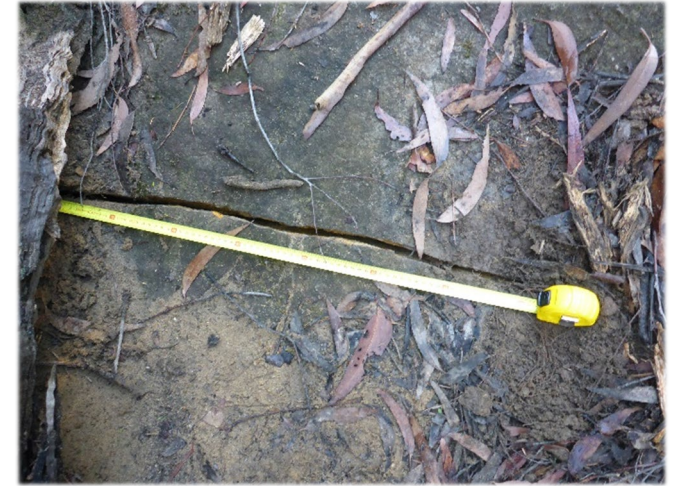
**Photo 11:** *DA3B\_LW15\_006*, looking at the rock fracture. Taken on 09/07/2019.

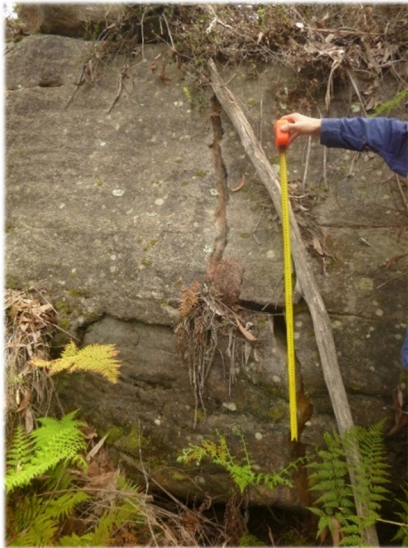
DA3B_LW15_007 Photo 12	288696	6191767	Rock Fracturing	Steep Slope	09/07/219	1	Fracturing to sandstone step, north of Swamp 23. The fracturing has a length of 2.3m and width of 0.05m.	11/07/2019
DA3B_LW15_009 Photo 13	288744	6191771	Rockfall	Steep Slope	29/07/2019	1	Small rockfall to ledge adjacent to Swamp 23. The fragment of rock fallen from the ledge is approximately 0.2m <sup>3</sup> .	30/07/2019
DA3B_LW15_013 Photo 14	288673	6191855	Rock Fracturing and Fragmentation	Steep Slope	05/09/2019	1	Rock fracturing and fragmentation near SLMMP site A3b-SS11. The rock fracturing has a length of 4m, a maximum width of 0.06m and a maximum measurable depth of 1.7m. The largest rock fragment resulting from the rock fracturing has an approximate volume of 0.2m <sup>3</sup> .	06/09/2019
DA3B_LW15_016 Photo 15	290011	6191602	Rock Displacement	Steep Slope	25/10/2019	1	Rock displacement at a steep slope between Fire Road 6P and Swamp 14. The displacement has a maximum measurable length of 2.5m, a maximum width of 0.02m and a depth of 0.6m.	28/10/2019

**Photo 12:** *DA3B\_LW15\_007*, looking at fracturing on the step. Taken on 26/02/2020

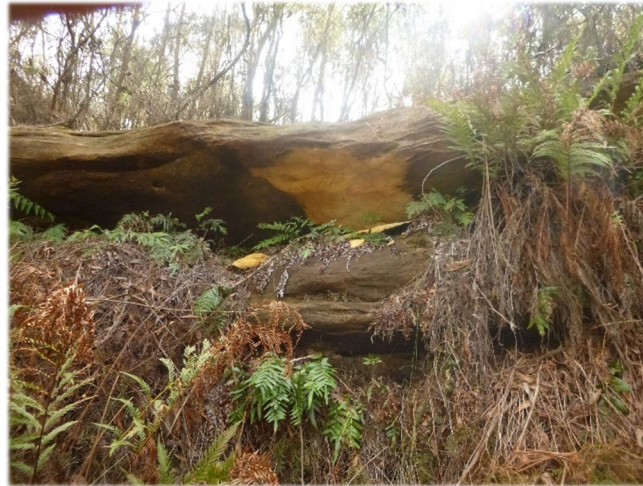
**Photo 13:** *DA3B\_LW15\_009*, looking at a section of rockfall. Taken on 26/02/2020.

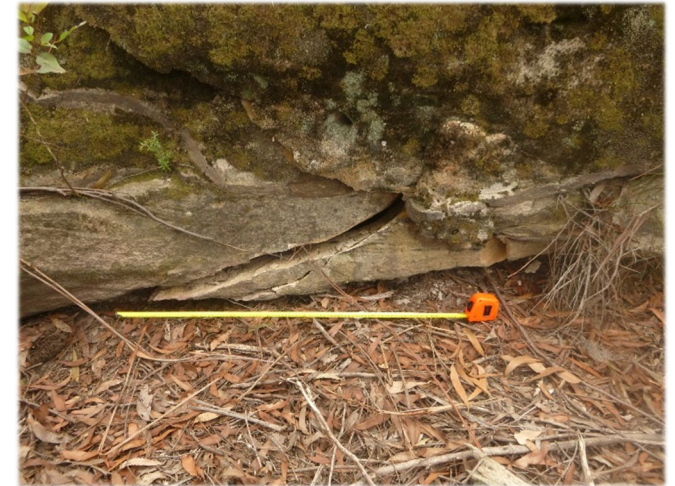
**Photo 14:** *DA3B\_LW15\_013*, looking at a section of rock fracturing. Taken on 26/02/2020

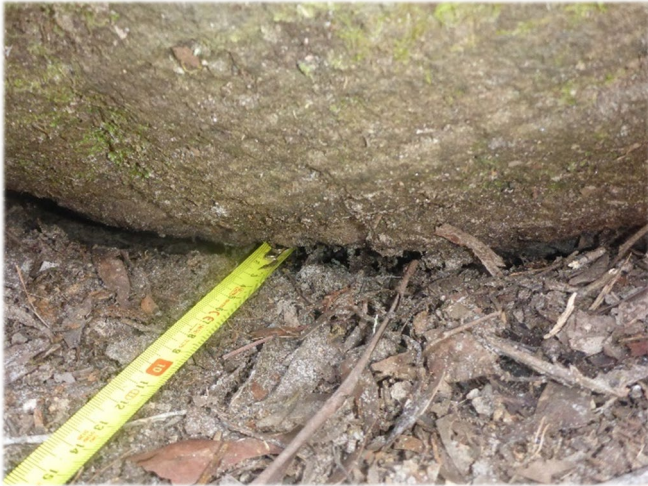
**Photo 15:** DA3B\_LW15\_016, looking at the width of displacement. Taken on 25/10/2019.

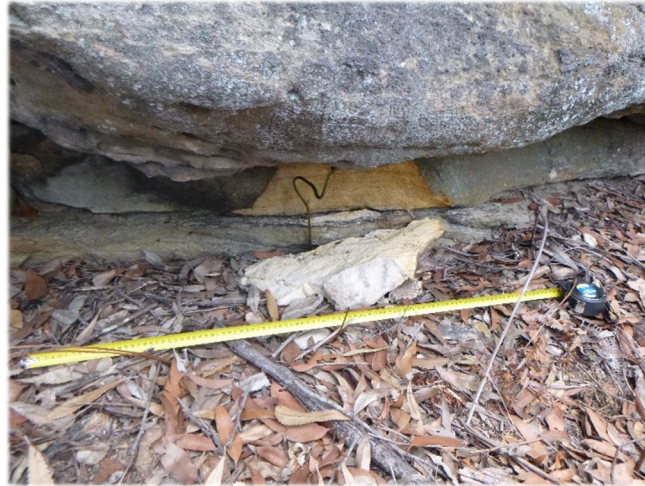
**Photo 16:** DA3B\_LW15\_017, looking at the area of rockfall. Taken on 27/02/2020.

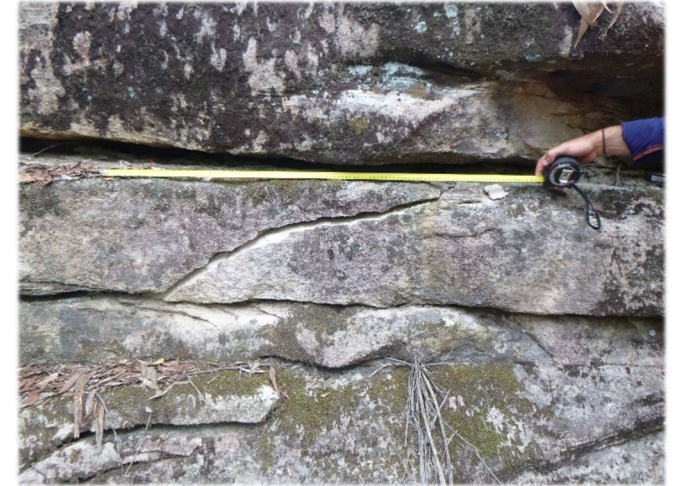
Site ID	Easting	Northing	Impact Type	Feature Affected	Identification Date	Trigger Level	Description	Refer to Impact Report/s Dated
DA3B_LW15_018 Photo 17	290090	6191892	Rock Fracturing	Steep Slope	25/10/2019	1	Rock fracturing at a steep slope between Fire Road 6P and WC15. The impact is comprised of a rock fracture with a length of 0.9m, width of 0.03m and horizontal depth of 0.25m.	28/10/2019
DA3B_LW15_019 Photo 18	290125	6191990	Rock Fracturing	Steep Slope	25/10/2019	1	Rock fracturing at a steep slope between Fire Road 6P and WC15. The impact is comprised of a rock fracture with a length of 1m, a width of 0.02m and a horizontal depth of 0.22m.	28/10/2019
DA3B_LW15_020 Photo 19	290140	6192074	Rockfall	Steep Slope	25/10/2019	1	Small rockfall at a steep slope between Fire Road 6P and WC15. The rock fragment resulting from the rockfall has a length of 0.4m, a width of 0.2m and a height of 0.09m.	28/10/2019

**Photo 17:** DA3B\_LW15\_018, looking at the rock fracture. Taken on 27/02/2020.

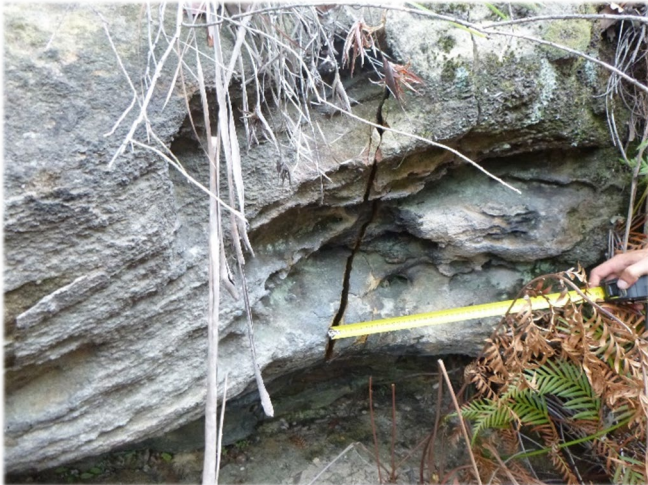
**Photo 18:** DA3B\_LW15\_019, looking at width of rock fracture. Taken on 27/02/2020.

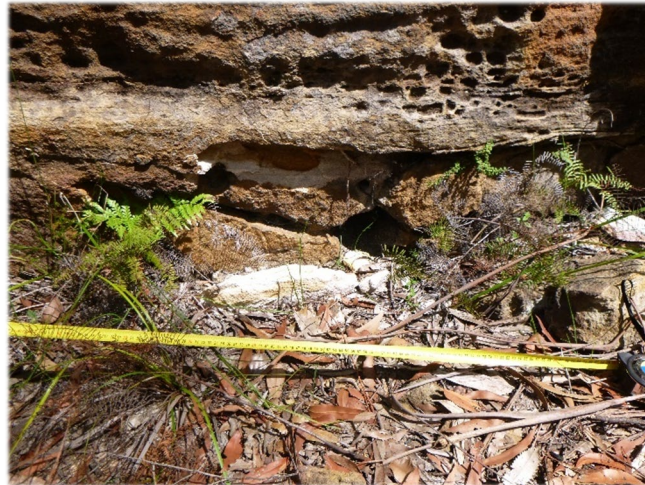
**Photo 19:** DA3B\_LW15\_020, looking at area of rockfall. Taken on 27/02/2020.

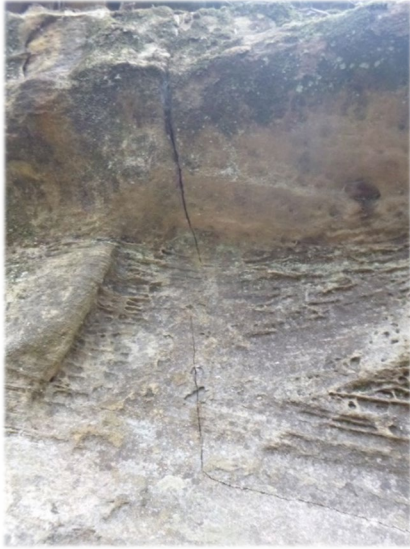
DA3B_LW15_021 Photo 20	290151	6192085	Rockfall	Steep Slope	25/10/2019	1	Small rockfall at SLMMP site A3b-SS9-Pt1. The area of exposed rock has a length of 0.4m, width of 0.27m and height of 0.2m.	28/10/2019
DA3B_LW15_022 Photo 21	290172	6192102	Rock Fracturing	Steep Slope	25/10/2019	1	Rock fracturing at a steep slope between Fire Road 6P and WC15. The rock fracture has a length of 4m and a width of 0.01m. The rock fragment resulting from the displacement has a length of 0.2m and a height of 0.08m.	28/10/2019
DA3B_LW15_023 Photo 22	290174	6192128	Rock Fracturing	Steep Slope	25/10/2019	2	Rock fracturing at a steep slope between Fire Road 6P and WC15. The rock fracture has a length of 25m, a maximum width of 0.08m and a depth greater than 5m.	28/10/2019
DA3B_LW15_024 Photo 23	290033	6191605	Rock Fracturing and Soil Uplift	Steep Slope	21/01/2020	1	Rock fracturing and uplift at a steep slope between Swamp 14 and WC15. The rock fracture has a length of 1.8m, a width of 0.005m and a depth of approximately 0.02m.	23/01/2020

**Photo 21:** DA3B\_LW15\_022, looking at the rock fracture. Taken on 27/02/2020.

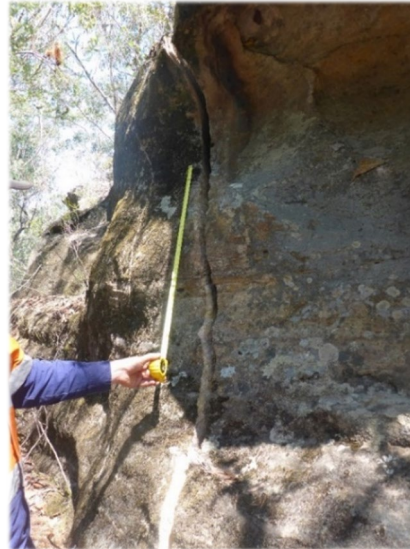
**Photo 22:** DA3B\_LW15\_023, looking at a section of rock fracturing. Taken on 25/10/2019.

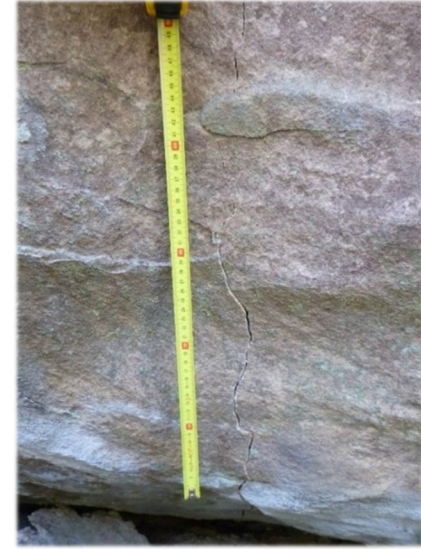
**Photo 23:** DA3B\_LW15\_024, looking at the rock fracturing. Taken on 21/01/2020.

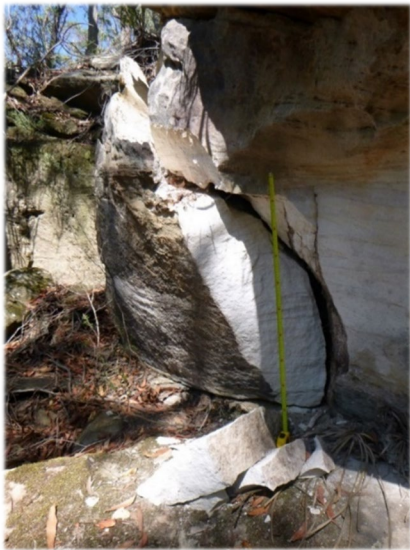
DA3B_LW15_025 Photo 24	290057	6191622	Rockfall	Steep Slope	21/01/2020	1	Rockfall at a steep slope between Swamp 14 and WC15. The largest rock fragment resulting from the rockfall has a length of 1.7m, width of 0.5m and height of 1.7m.	23/01/2020
DA3B_LW15_026 Photo 25	290056	6191749	Soil Cracking and Displacement	Steep Slope	21/01/2020	1	Soil cracking and displacement at SLMMP site A3B-SS13. The displacement has a length of 1.05m, a width of 0.03m and a depth of approximately 0.2m.	23/01/2020
DA3B_LW15_028 Photo 26	290142	6192091	Rock Fracturing	Rock Outcrop	30/01/2020	1	Rock fracturing to sandstone outcrop between Fire Road 6P and WC15. The rock fracturing has a length of 5.2m, width of 0.07m and maximum measurable depth of 1.3m.	07/02/2020

**Photo 24:** DA3B\_LW15\_025, overview of the rockfall. Taken on 21/01/2020

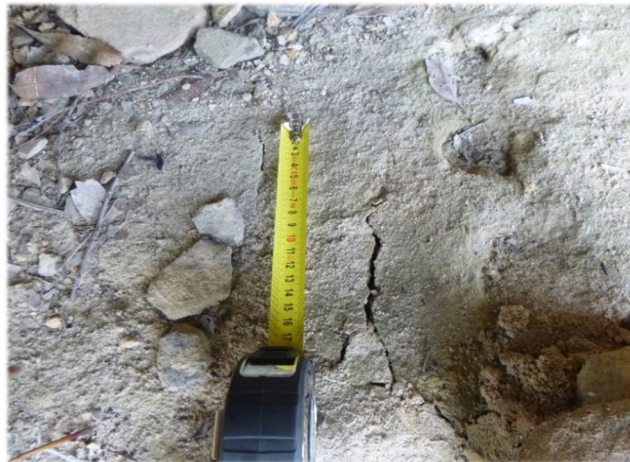
**Photo 25:** DA3B\_LW15\_026, looking at the soil cracking. Taken on 27/02/2020.

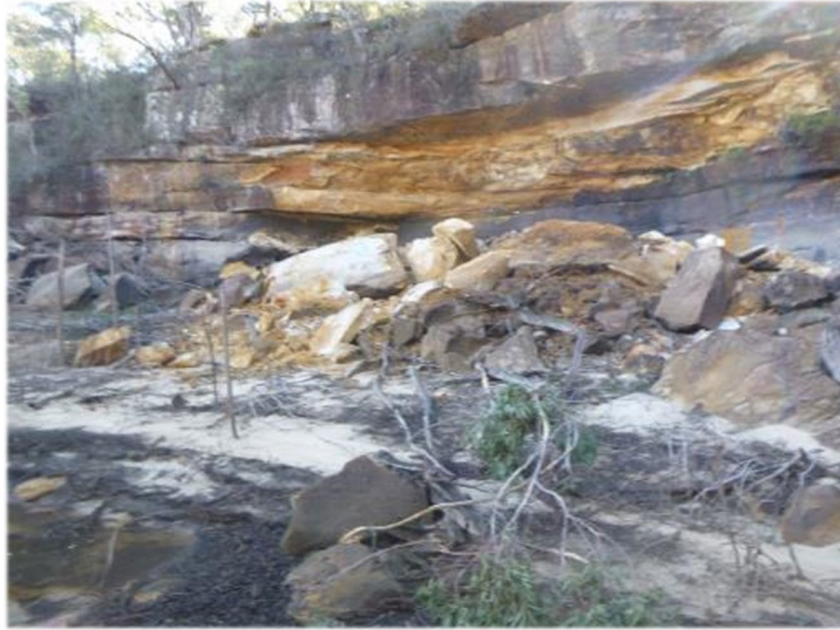
Site ID	Easting	Northing	Impact Type	Feature Affected	Identification Date	Trigger Level	Description	Refer to Impact Report/s Dated
DA3B_LW14_015 (Update) Photo 27	288070	6192528	Rockfall	Cliff line	5/12/2019 and 11/06/2019	2	Rockfall on Avon Dam cliff edge. The impacted length of the cliff line increased to approximately 20m, with eight large boulders, multiple smaller boulders and a tree observed at the base of the cliff. The largest boulder has an approximate length of 5m, width of 3m and height of 1.5m.	06/12/2018 and 12/06/2019

**Photo 27:** *DA3B\_LW14\_015*, an overview of the impact site. Taken on 11/6/2019.

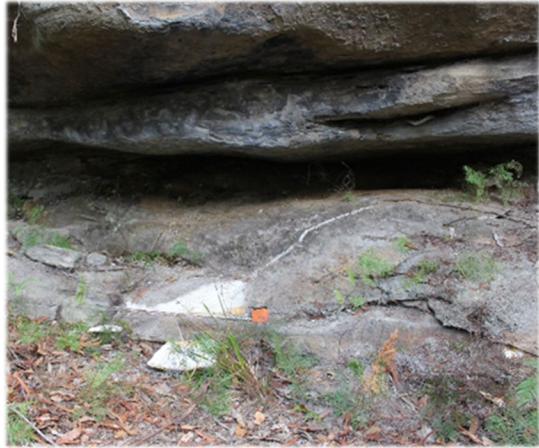
**Photo 28:** Browns Road Site 11, Looking at a section of fracturing. Taken: 15th March 2020.

Recommendations	
#	Browns Road Site 11 (AHIMS ID# 52-2-1626) and DM21 (AHIMS ID #52-3645)
1.	Notify relevant specialists, key agency stakeholders and Registered Aboriginal Parties of impacts to <i>Browns Road Site 11</i> and <i>DM 21</i> of Level 1 Action in accordance with the Trigger Action Response Plan.
2.	Ongoing monitoring of <i>Browns Road Site 11</i> after large rain events (>142mm rainfall in one day) to observe and record a change in seepage patterns in areas of fissuring and opening of joints as a result of indirect mining impacts to the Art Panels.
3.	Include <i>DM 21</i> in the Longwall 16 End of Panel monitoring program and continue to monitor for further impacts as a result of subsidence at the site.
4.	Continue monitoring program for remaining longwalls with condition assessment and photographic records as per the TARPS.

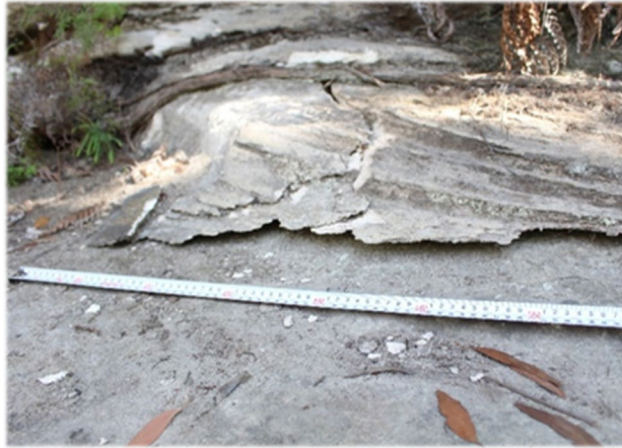
**Photo 29:** Browns Road Site 11, subsidence related fracturing and exfoliation. Taken: 15th March 2020.

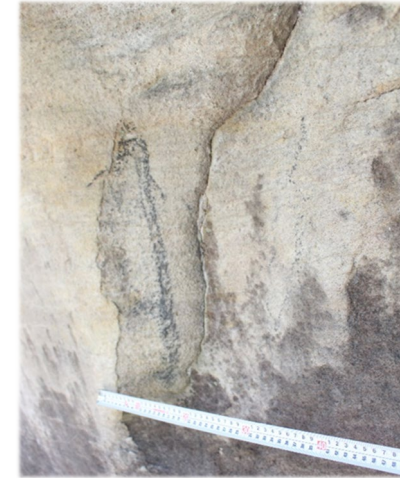
**Photo 30:** Browns Road Site 11, opening of bedding plane adjacent to Art Panel to the south of the shelter. Taken: 15th March 2020.

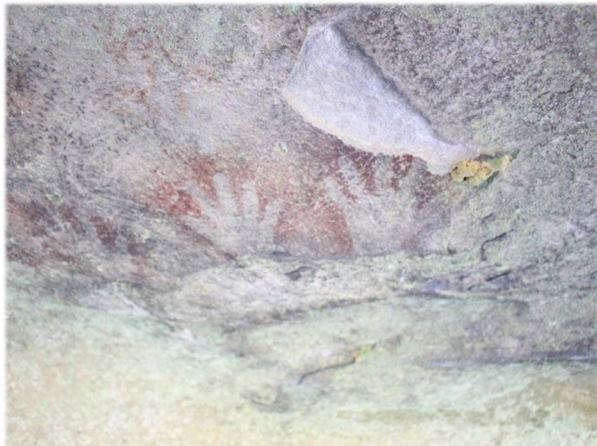
**Photo 31:** DM 21, Image of fading ochre hand stencils located on the roof shelter. Taken: 15th March 2020.

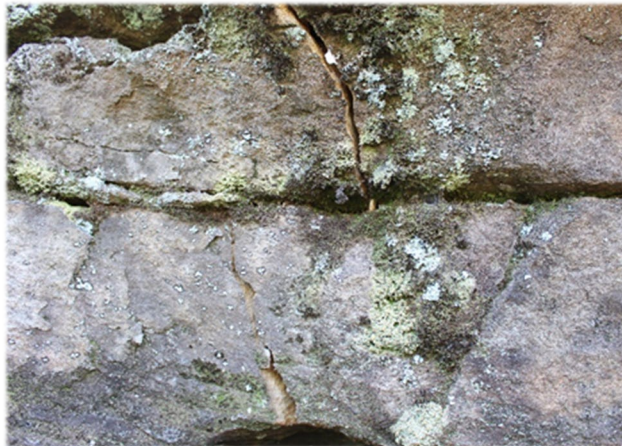
**Photo 32:** DM 21, Two vertical fractures located at the northern exterior of the shelter cavern area. Taken: 15th March 2020.

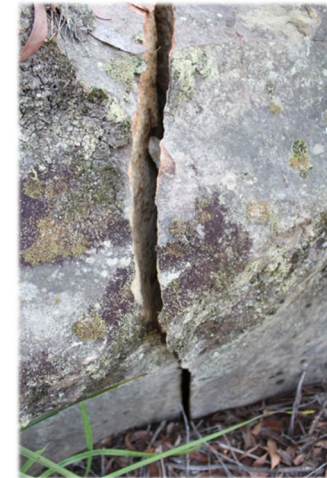
**Photo 33:** DM 21, Close up of vertical fracturing located at the base of the northern exterior of the shelter cavern area. Taken: 15th March 2020.

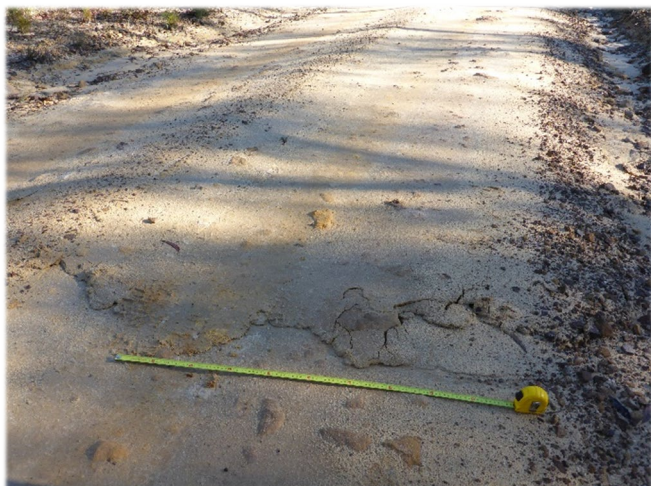
**Photo 34:** DA3B\_LW15\_005. Taken: 09/07/2019.

Site ID	Easting	Northing	Impact Type	Feature Affected	Identification Date	Trigger Level	Description	Refer to Impact Report/s Dated
DA3B_LW15_005	289151	6191960	Soil Cracking	Fire Road 6A	09/07/2019	1	Soil cracking and uplift across Fire Road 6A. The cracking is up to 5m long and 0.01m wide, with up to 0.02m of uplift.	11/07/2019
DA3B_LW15_008	289221	6191783	Soil Cracking and Uplift	Fire Road 6A	29/07/2019	1	Soil cracking and uplift across Fire Road 6A. The largest soil crack is 9.5m in length, 0.02m wide, and has a maximum measurable depth of 0.08m.	30/07/2019
DA3B_LW15_010	289323	6191824	Soil Cracking and Uplift	Closed Access Track	13/08/2019	1	Soil cracking and uplift to a closed access track adjacent to Swamp 23. Discontinuous cracking and uplift occurred over a length of approximately 3.5m, with a width of 0.002m and uplift of 0.01m.	23/08/2019
DA3B_LW15_012	289249	6191777	Soil Cracking	Access Track	28/08/2019	1	Soil cracking to access track connecting Fire Road 6A and railway ballast, near Swamp 23. The largest soil crack is 4.1m in length, 0.002m wide.	30/08/2019

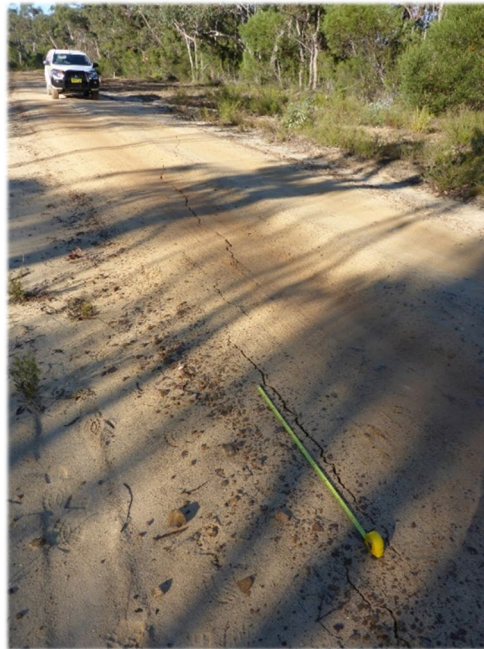
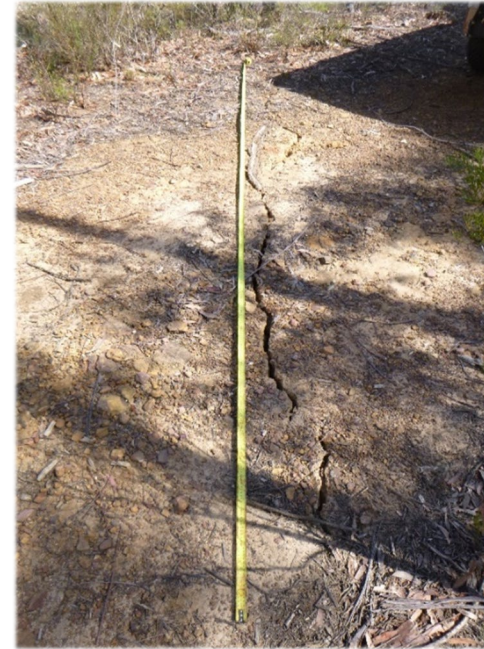
**Photo 37:** DA3B\_LW15\_004. Taken: 09/07/2019.

Site ID	Easting	Northing	Impact Type	Feature Affected	Identification Date	Trigger Level	Description	Refer to Impact Report/s Dated
DA3B_LW15_004	289196	6191848	Soil Cracking	Fire Road 6A	09/07/2019	2	Soil cracking along Fire Road 6A. Discontinuous cracking runs for approximately 80m and is up to 0.05m wide and 0.09m deep. The longest continuous section of cracking is approximately 12m long.	11/07/2019
DA3B_LW15_011	289399	6191703	Soil Cracking	Fire Road 6P and railway ballast	28/08/2019	2	Soil cracking to railway ballast and entrance of Fire Road 6P. Multiple cracks are located across an area of approximately 25m <sup>2</sup> , with the largest continuous crack having a length of 12m, width of 0.06m and maximum measurable depth of 0.5m.	30/08/2019
