# DENDROBIUM MINE

End of Panel Surface Water and Shallow Groundwater  
Assessment: Longwall 16 (Area 3B)

**HGEO Pty Ltd**

Date: March 2021

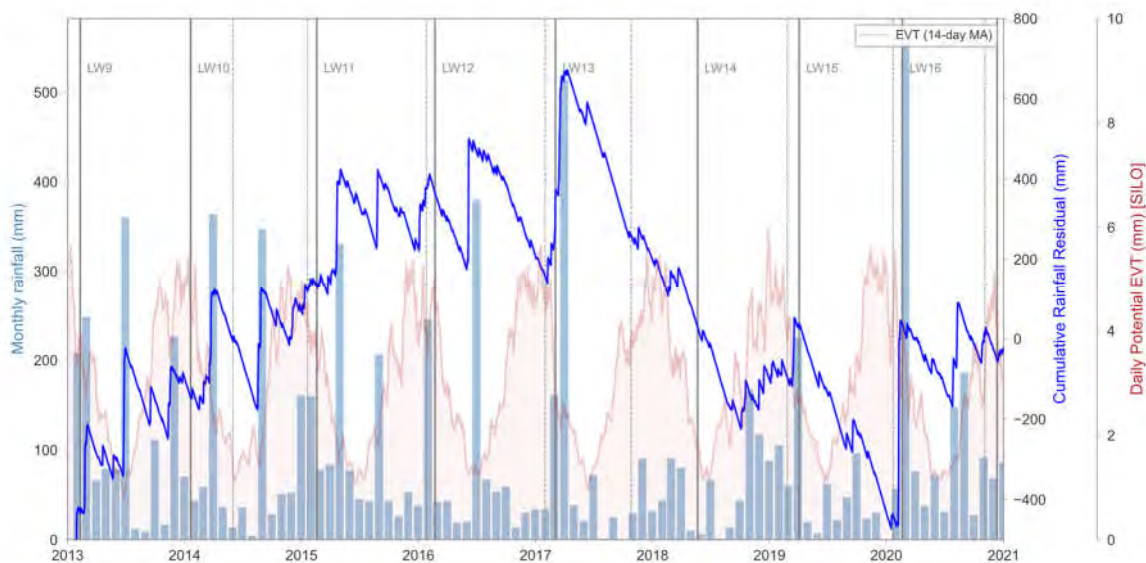
Rainfall data are collected from several gauging stations across the mining lease. Weather observations at Area 3B since the start of Longwall 9 are summarized in Figure 4. Potential evapotranspiration (EVT) is calculated from SILO data (DSITI, 2011) derived for Dendrobium Area 3B, using the FAO Penman-Monteith formula (Allen et al., 1998). The average annual rainfall for Dendrobium is 1029 mm (2002 – 2010; Dendrobium site data). Rainfall events occur year-round but tend to be more frequent in the summer and early autumn months. It is common for a substantial proportion of the annual rainfall to be delivered in a small number of large rainfall events, during which significant surface water runoff and groundwater recharge is generated.

**Figure 4. Rainfall and potential evapotranspiration (EVT) at Area 3 for the reporting period**

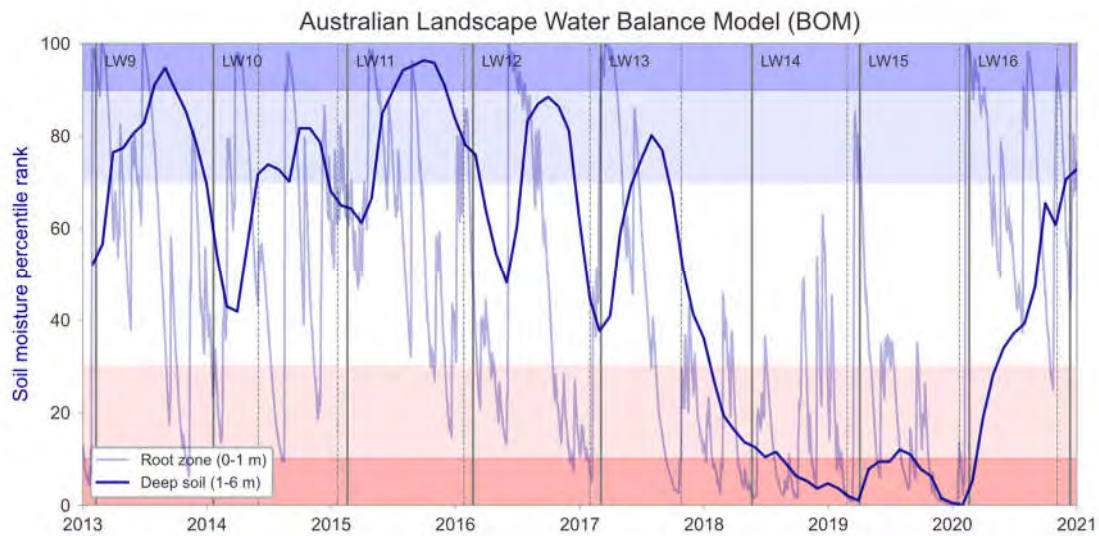
Soil moisture levels derived from the Australian Water Resources Assessment Landscape model (AWRA-L) are published by the Bureau of Meteorology (BOM). A timeseries of estimated soil moisture storage for the Woronora Plateau in the vicinity of Dendrobium Mine is shown in Figure 5. The model calculated severely depleted soil moisture conditions during 2017-2019 drought period, with significant recovery during 2020.

**Figure 5. Calculated soil moisture from BOM's AWRA Landscape Model**

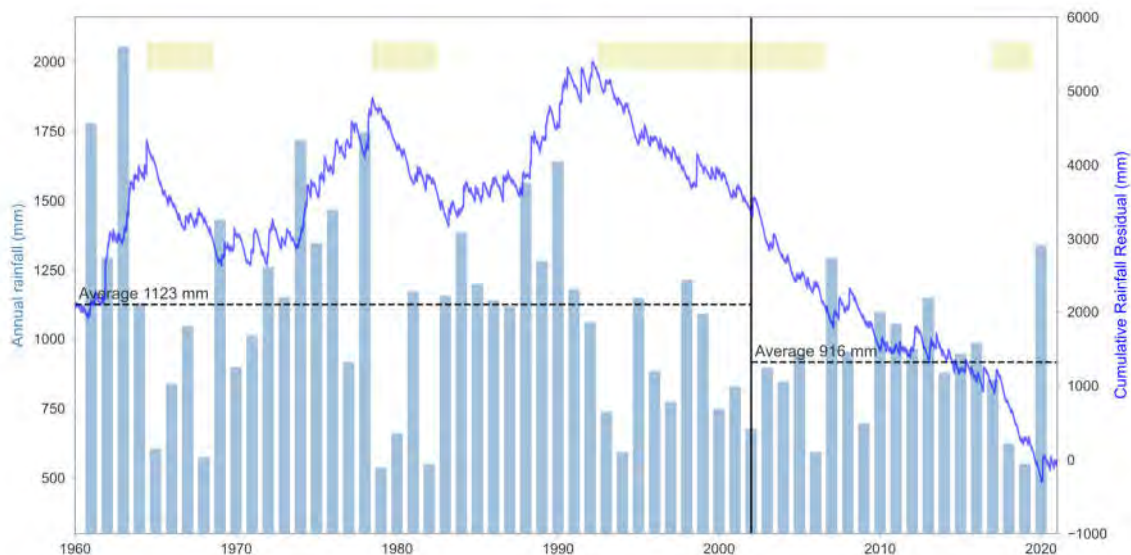
Longer term rainfall trends for the plateau are shown in Figure 6 which is based on data from SILO (slightly different from site measurements). Since 1960 there have been four periods of drought on the plateau (yellow shading), the most severe being the Millennium Drought which ended in 2004. Severe drought conditions returned between 2017-2019. The plot shows that, in general, below average rainfall conditions prevailed since about 1991. The period from 2002 for which rainfall data have been collected at Dendrobium (vertical black line) is slightly below the long-term average (~1120 mm), accounting for the difference in appearance of the cumulative rainfall trends in Figure 4 (based on site data) and Figure 6 (based on long term SILO data).

**Figure 6. Long-term rainfall trends at Dendrobium (1960-2020)**

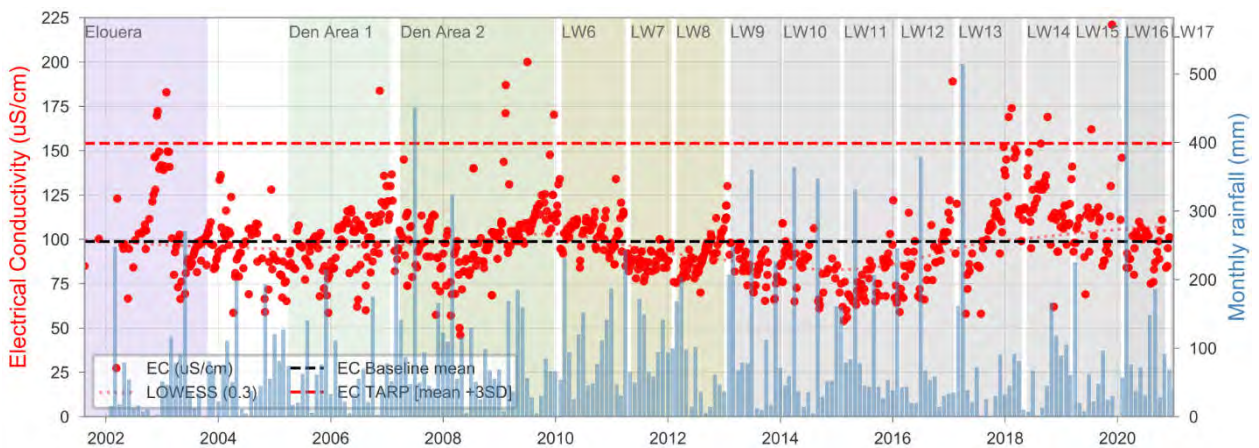
Plots of key field parameters from Wongawilli Creek at FR6 are shown in Figure 14, Figure 15 and Figure 16. Water EC increased and DO decreased during 2017 and 2018 in response to drought conditions. EC has trended downward since 2018 and was well-within the baseline range during 2020. There were no water quality TARP triggers for the Longwall 16 reporting period.

Figure 14. Field measured Electrical Conductivity (EC) at Wongawilli Creek (FR6)

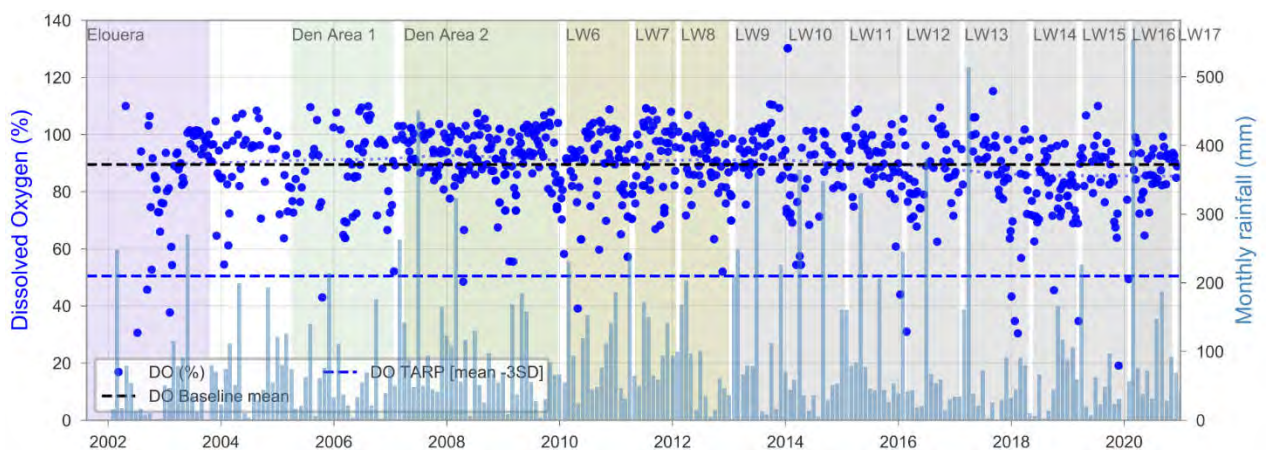
Figure 16. Field measured DO at Wongawilli Creek (FR6)

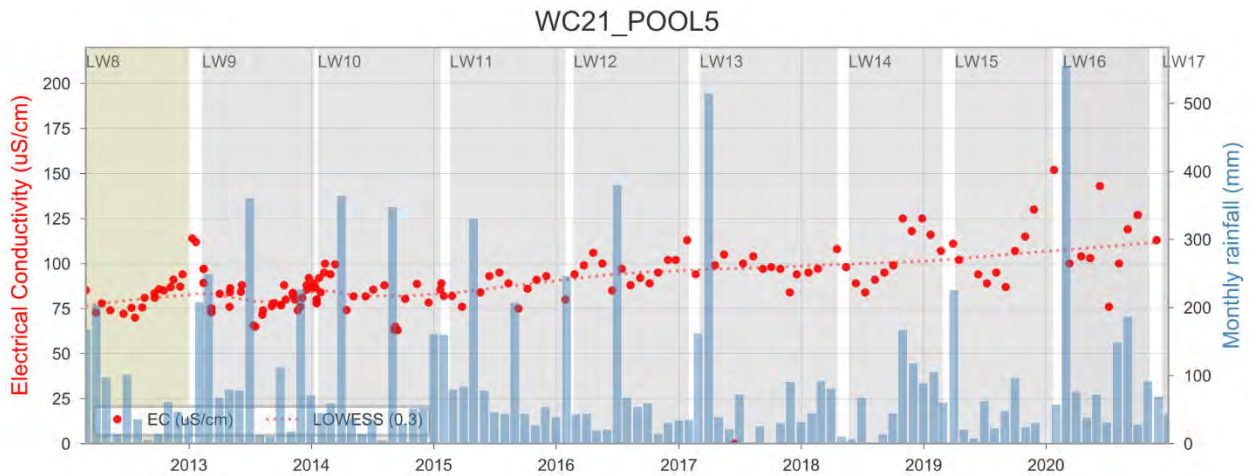
At WC21 Pool 5, water EC has remained slightly elevated relative to the mean baseline EC since Longwall 11 (Figure 17) and is trending higher. Similar trends are noted in Pools 6 and 10. The increasing EC trend contrasts with the decline in EC seen in many pools following the end of the 2017-2019 drought and it is likely that subsidence impacts and redirection of water through fracture networks is contributing to the elevated EC in the lower pools of WC21. Water pH in Pools 5, 6 and 10 increased during Longwall 10 and have remained elevated relative to the baseline mean since that

Figure 17. Field measured EC at WC21 Pool 5, downstream of Area 3B

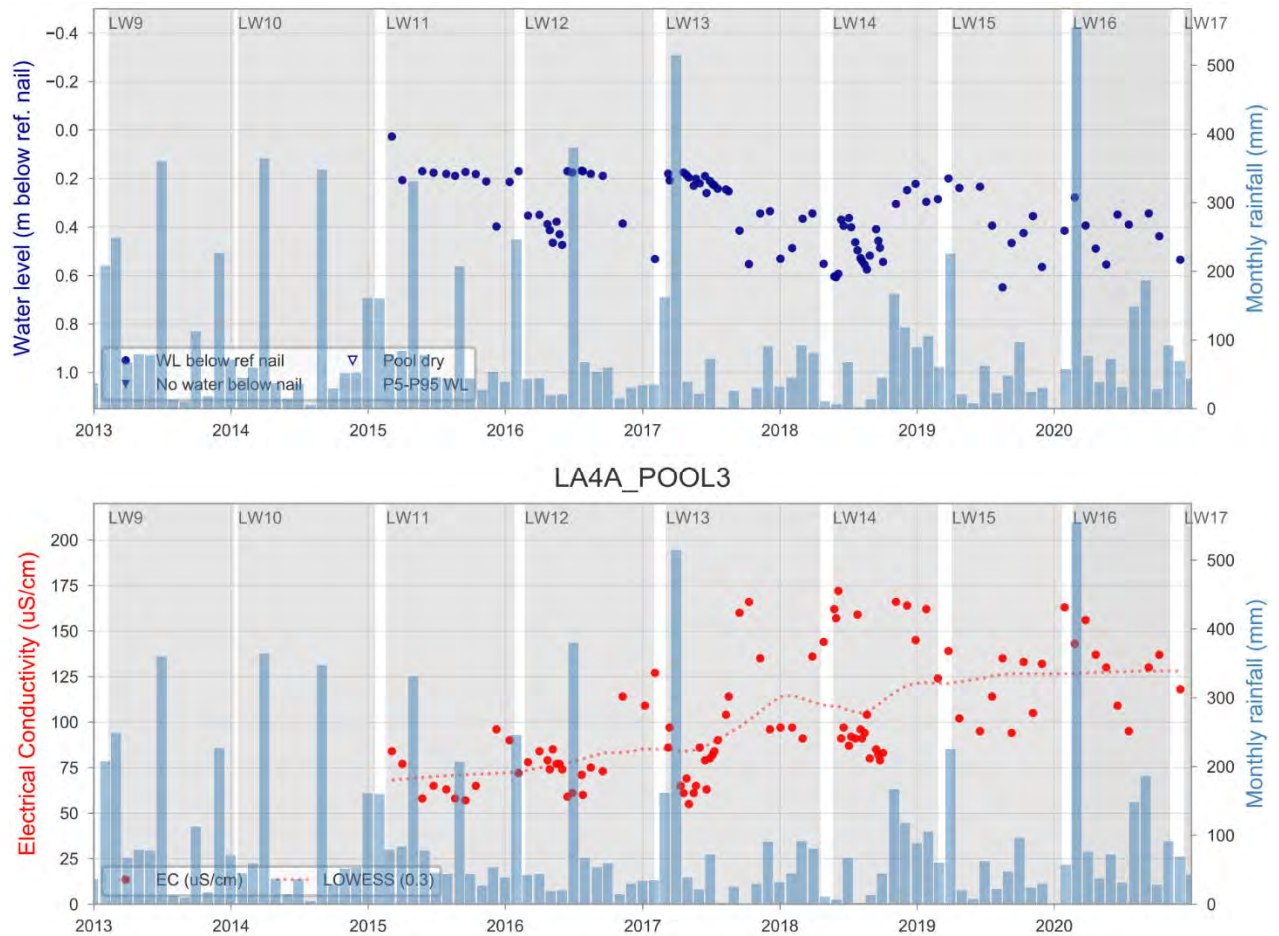
Dissolved metals are analysed from LA4\_S1. Due to subsidence fracturing, LA4\_S1 is typically dry and no samples were collected between mid-2017 and mid-2020. Three samples were collected in 2020 which indicate elevated Sulphate and metals, including Al and Zn relative to baseline sampling.

Figure 20. Field measured EC at Lake Avon tributary (LA4A\_Pool 3)

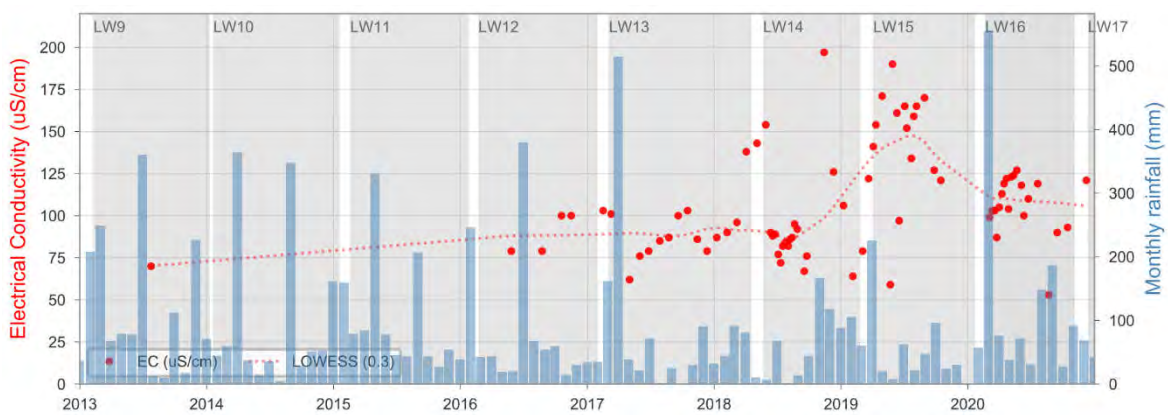
Pool 4 on tributary LA3 shows an increase in EC and decrease in DO starting in early to mid-2018 (Figure 22), corresponding with the extraction of Longwalls 13 to 15 (reported previously), but also corresponding to the drought period. During 2020, EC and DO returned to within or close to the baseline range. Although EC remains slightly elevated compared with the baseline.

Figure 22. Field measured EC in Lake Avon tributary LA3 (Pool 4)

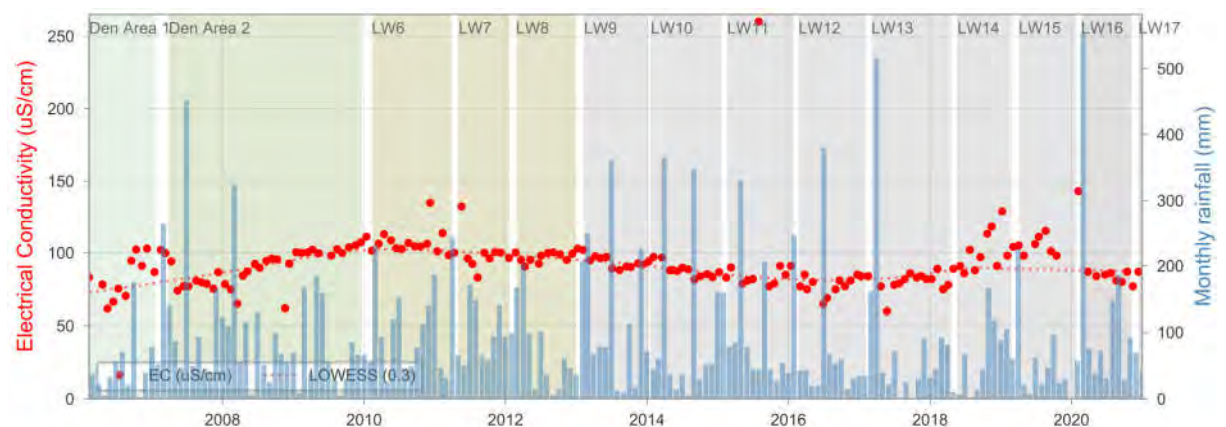
- At Lake Cordeaux (Sandy Creek Arm), water quality generally fluctuates with long-term weather patterns, with EC gradually rising during dry periods and declining during high rainfall periods (Figure 28). Over 14 years of monitoring, EC has ranged between ~75 and 110  $\mu\text{S}/\text{cm}$  with a near-neutral pH. Trace metal concentrations are low, although slightly elevated Fe and Mn were recorded towards the end of the 2017-2019 drought period, returning to baseline levels in 2020. Trends in EC and the spike in metals do not correlate with trends observed in tributary SC10C.

Figure 28. Field measured EC in Lake Cordeaux, Sandy Creek Arm

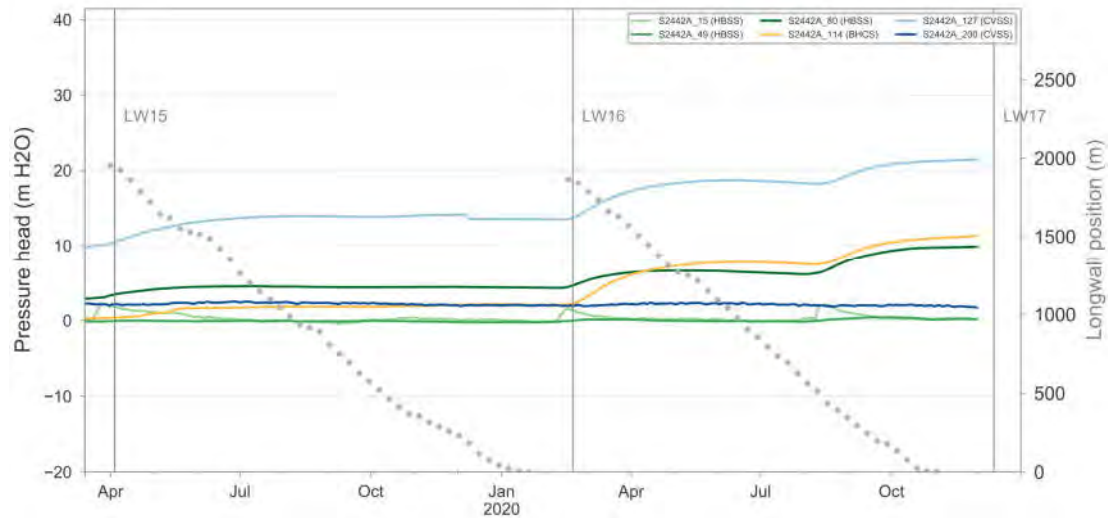
the mechanism whereby subsidence fractures that were previously unsaturated, have become flooded due to groundwater recovery following high rainfall in 2020, and possibly for the first time since longwall extraction. The appearance of iron staining in October 2020 is consistent with observed lags in groundwater response to large rainfall events.

Figure 29. Groundwater hydrograph of pressure head at monitoring bore S2442A

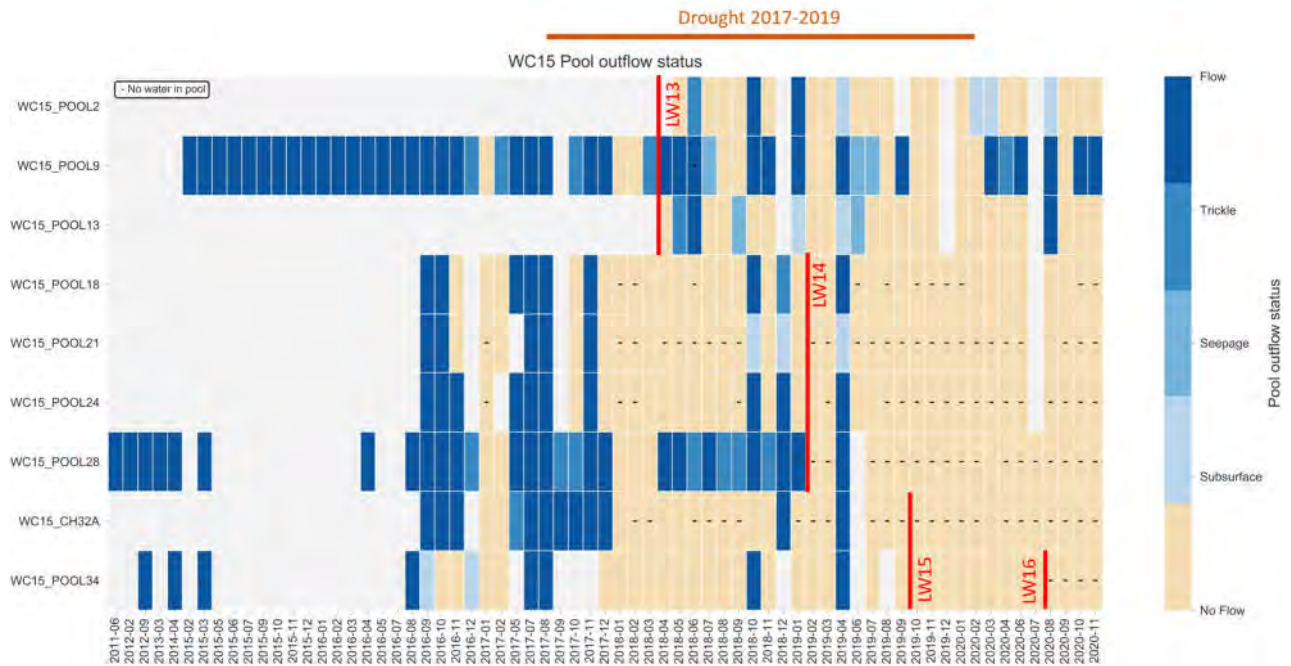
Nine pools are routinely monitored along the WC15 watercourse. Figure 44 summarises observations of flow status of each pool for monthly monitoring periods prior to and following the passage or close approach of Longwalls 13 to 15 (red lines). Pools are arranged from upstream (bottom of the plot) to downstream (top), to correspond geographically if looking at a plan view of WC15. Observations are semi-quantitative, ranging from no observable flow through to observable outflow from the pool. In addition, observations of “no water in the pool” are overlain as “-“ symbols. Where more than one monitoring round was carried out in a month, the minimum condition was used in the figure. Baseline data, prior to Longwall 13 and the 2017-2018 drought, show that all monitored pools are filled and overflow for several months following large rainfall events (and near-continuously at Pool 9). All pools ceased to flow or became dry during prolonged low-rainfall conditions. As with other watercourses, pool levels and flow were affected by the 2017-2019 drought such that all pools were observed to have no flow and/or were dry on several occasions during the drought.

**Figure 44. Flow status of pools on the WC15 watercourse**

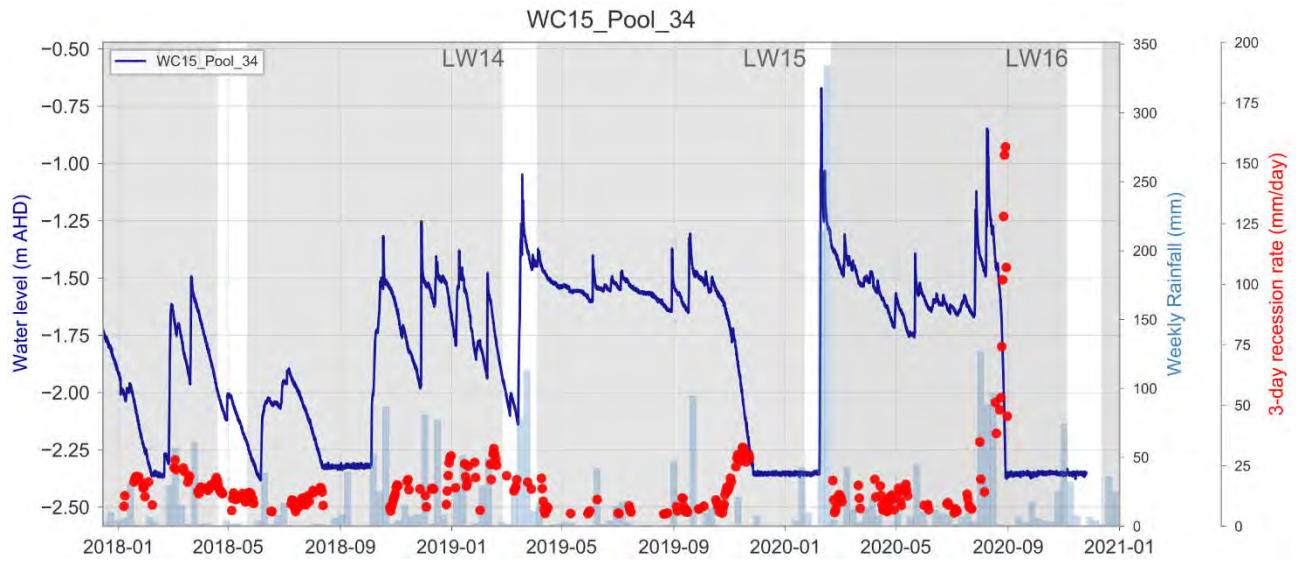
Figure 45. Water level in WC15 Pool 34

Monthly monitoring is currently being undertaken at the site in accordance with the SMP and no further actions are recommended.

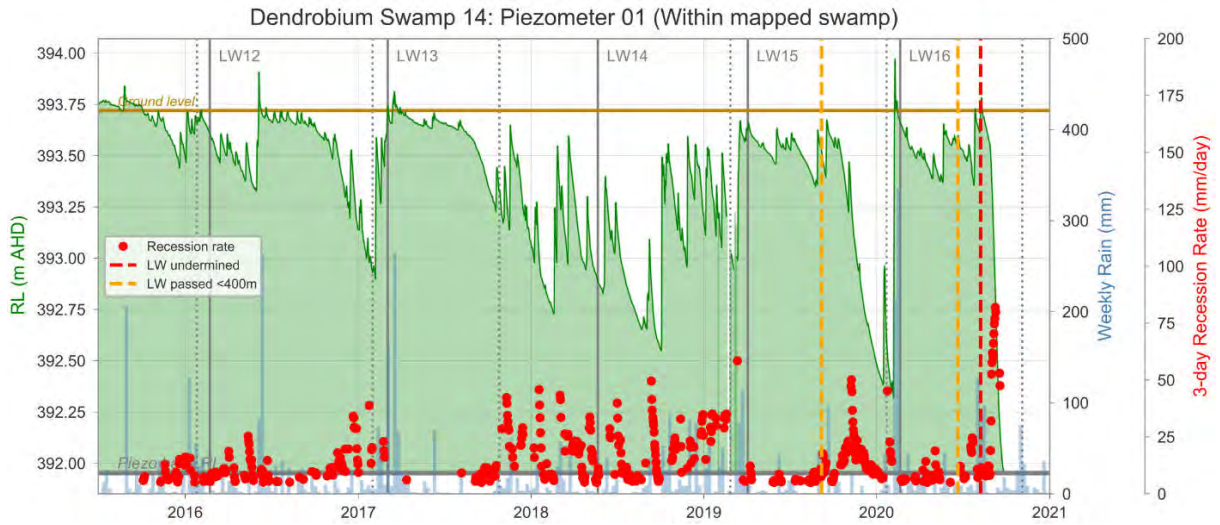
Hydrographs for piezometers 14\_01 and 14\_02, screened within swamp sediments are shown in Figure 47 and Figure 48. Hydrographs for VWP sensors within the deeper sandstone substrate at monitoring bores S2354 and SW2351, located near Swamp 14, are shown in Figure 49 and Figure 50, respectively. The shallow groundwater hydrographs show slightly different baseline groundwater conditions within the two swamp areas prior to the approach of Longwalls 15 and 16. Piezometer 14\_01 in the upper swamp area shows that sediments were continuously saturated since the start of monitoring in July 2015, including during the 2017-2019 drought. Hydrographs for the deeper sandstone substrate (at S2351; Figure 50) show that piezometric levels within the HBSS were typically above the base of the swamp sediments, implying that the upper swamp was sustained by groundwater (not perched).

Figure 47. Shallow groundwater hydrograph for Swamp 14, piezometer 01

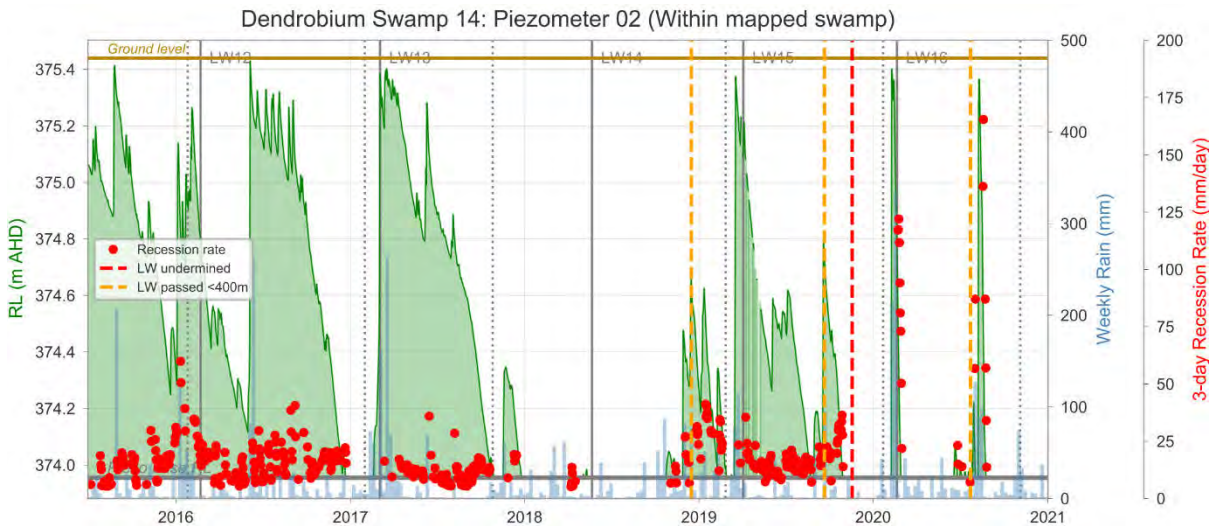
Figure 48. Shallow groundwater hydrograph for Swamp 14, piezometer 02

Piezometer 14\_02 in the lower Swamp 14 area shows saturated conditions most of the time between July 2015 and late 2017 and, like several reference sites, recorded groundwater levels below the base of the piezometer for more than 50% of the time during the 2017-2019 drought period. This behaviour indicates that lower swamp area groundwater levels were not sustained by groundwater in the sandstone substrate to the same extent as in the upper swamp area, despite being at a lower elevation (367 – 387 m AHD).

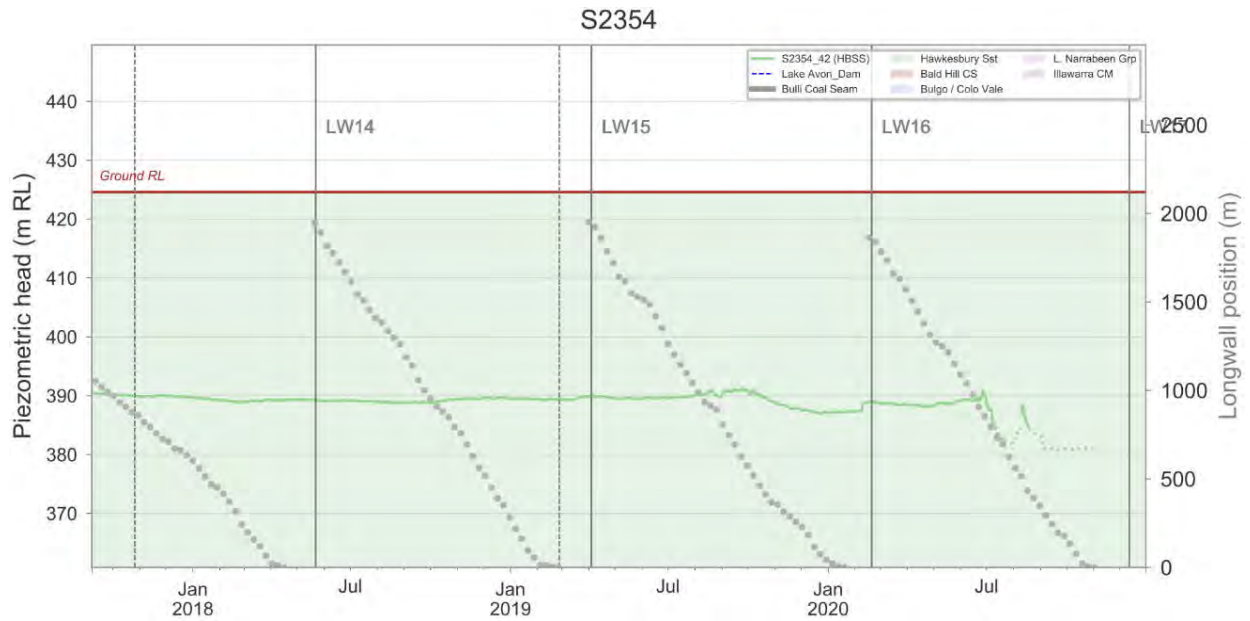
Figure 49. Groundwater hydrograph for S2354 (215 m from Swamp 14 piezo 01)

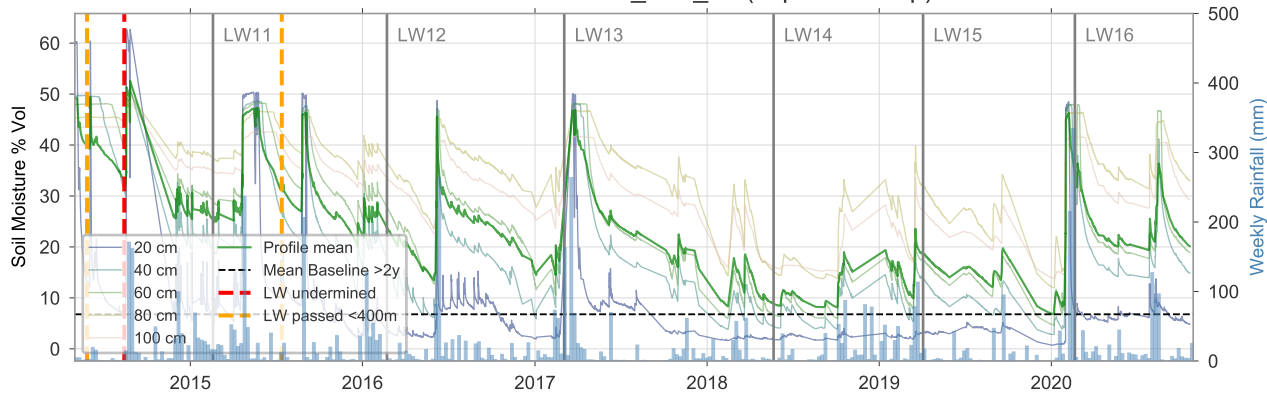
Soil moisture sensor S08\_S05 (impact swamp)
