DENDROBIUM MINE

End of Panel Surface Water and Shallow Groundwater
Assessment: Longwall 17 (Area 3B)

HGEO Pty Ltd

Date: February 2022

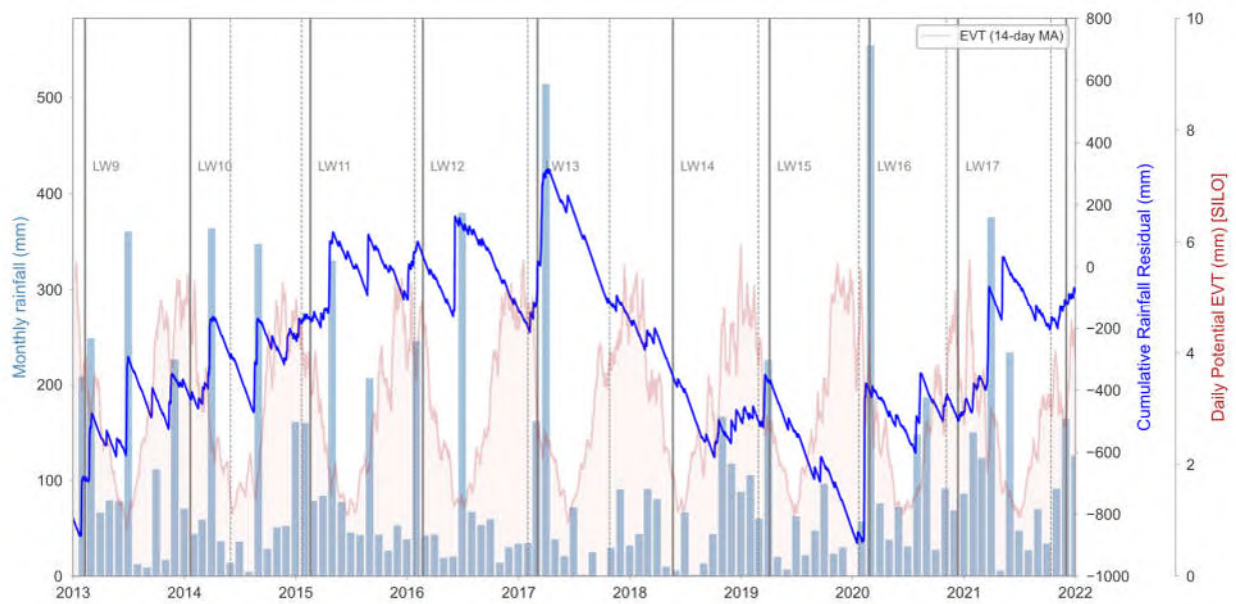
Rainfall data are collected from several gauging stations across the mining lease. Weather observations at Area 3B since the start of Longwall 9 are summarized in Figure 4. Potential evapotranspiration (EVT) is calculated from SILO data (DSITI, 2011) derived for Dendrobium Area 3B, using the FAO Penman-Monteith formula (Allen et al., 1998). The average annual rainfall for Dendrobium is 1050 mm (2002 – 2021; Dendrobium site data). Rainfall events occur year-round but tend to be more frequent in the summer and early autumn months. It is common for a substantial proportion of the annual rainfall to be delivered in a small number of large rainfall events, during which significant surface water runoff and groundwater recharge is generated.

Figure 4. Rainfall and potential evapotranspiration (EVT) at Area 3 for the reporting period

Maximum daily temperature varies seasonally from approximately 20 °C in the winter months (June – August) to 40 °C or higher in the summer (December – February). Evapotranspiration varies seasonally in line with temperature and solar radiation, peaking during the summer months.

Rainfall during 2021 and during Longwall 17 extraction was well above average, totalling 1448 mm, the highest rainfall year since 2007. Heavy rainfall was experienced in March, May and November 2021. This follows similarly high rainfall in 2020 (1436 mm). As a result, there has been a broad recovery in stream flow, shallow groundwater levels and soil moisture across all catchments since the severe drought of 2017-2019.

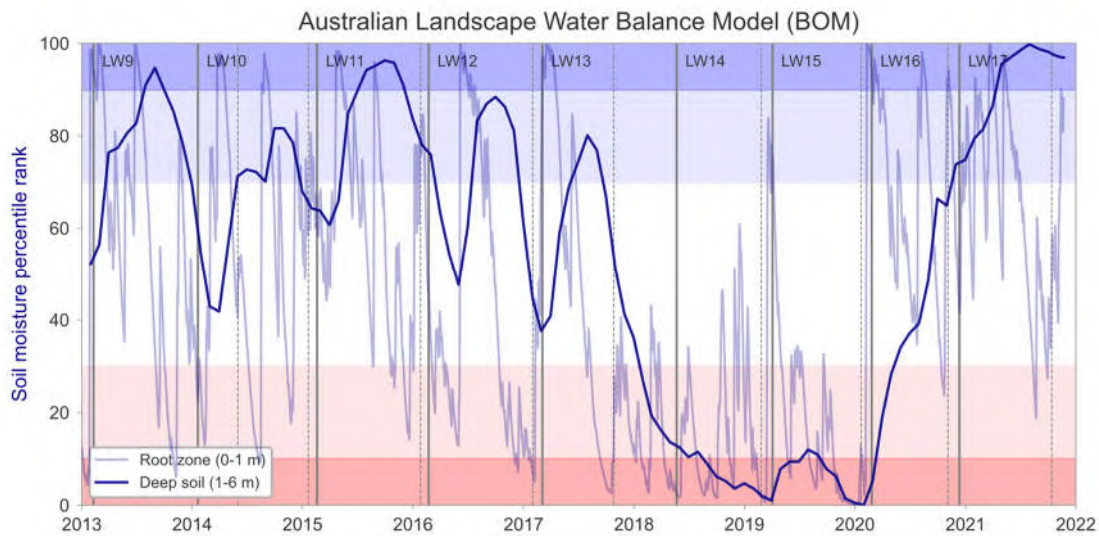
Soil moisture levels derived from the Australian Water Resources Assessment Landscape model (AWRA-L) are published by the Bureau of Meteorology (BOM). A timeseries of estimated soil moisture storage for the Woronora Plateau in the vicinity of Dendrobium Mine is shown in Figure 5. The model calculated severely depleted soil moisture conditions during 2017-2019 drought period, with full recovery during 2020 and 2021.

Figure 5. Calculated soil moisture from BOM's AWRA Landscape Model

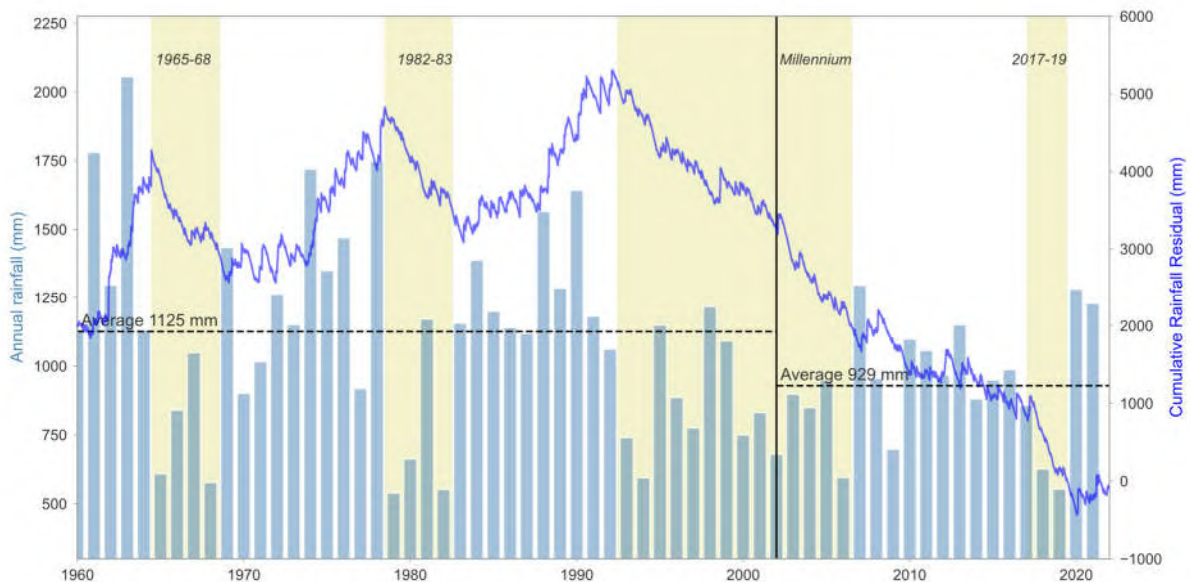
Longer term rainfall trends for the plateau are shown in Figure 6 which is based on data from SILO (slightly different from site measurements). Since 1960 there have been four periods of drought on the plateau (yellow shading), the most severe being the Millennium Drought which ended in 2004. Severe drought conditions returned between 2017-2019. The plot shows that, in general, below average rainfall conditions prevailed since about 1991. The period from 2002 for which rainfall data have been collected at Dendrobium (vertical black line) is slightly below the long-term average (~1125 mm), accounting for the difference in appearance of the cumulative rainfall trends in Figure 4 (based on site data) and Figure 6 (based on long term SILO data).

Figure 6. Long-term rainfall trends at Dendrobium (1960-2021)

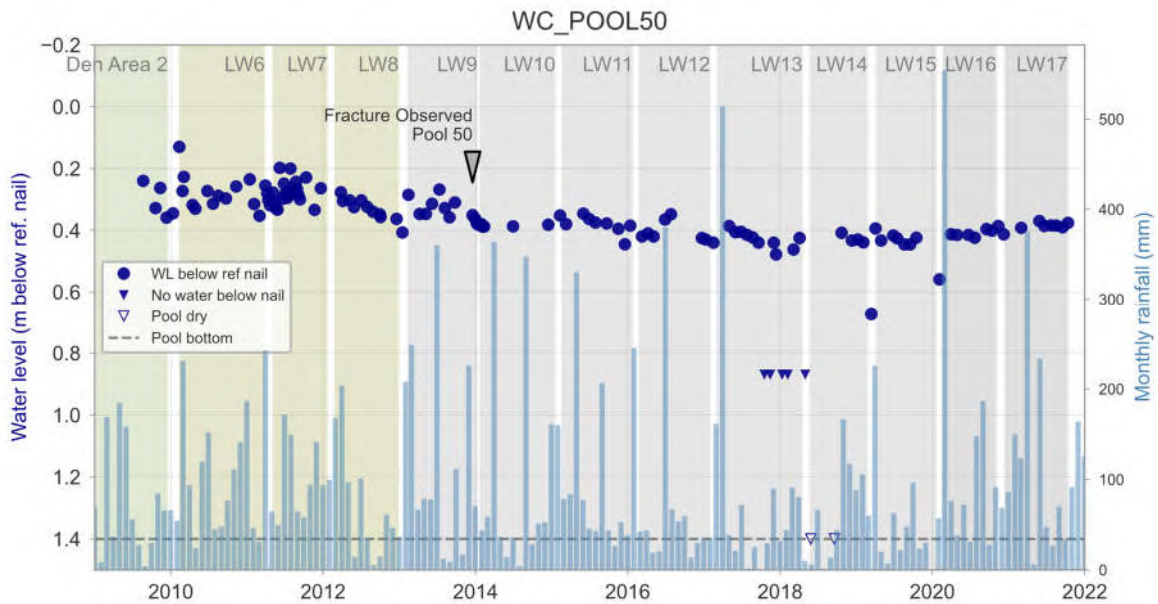
since 2016. Water levels in Pool 50 have trended higher over the last 2 years in response to both higher rainfall conditions and recovering groundwater levels.

Figure 26. Time series plot of water level observations in Pool 50

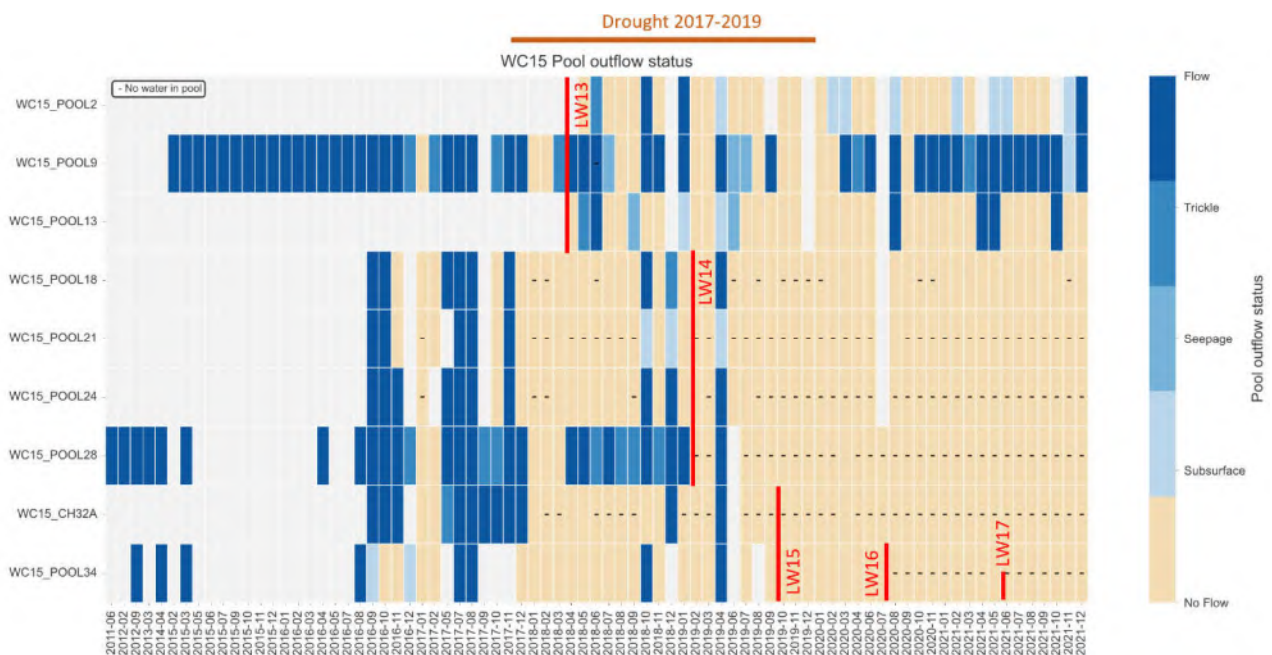
Nine pools are routinely monitored along the WC15 watercourse. Figure 28 summarises observations of flow status of each pool for monthly monitoring periods prior to and following the passage or close approach of Longwalls 13 to 17 (red lines). Pools are arranged from upstream (bottom of the plot) to downstream (top), to correspond geographically if looking at a plan view of WC15. Observations are semi-quantitative, ranging from no observable flow through to observable outflow from the pool. In addition, observations of “no water in the pool” are overlain as “-“ symbols. Where more than one monitoring round was carried out in a month, the minimum condition was used in the figure. Baseline data, prior to Longwall 13 and the 2017-2018 drought, show that all monitored pools are filled and overflow for several months following large rainfall events (and near-continuously at Pool 9). All pools ceased to flow or became dry during prolonged low-rainfall conditions. As with other watercourses, pool levels and flow were affected by the 2017-2019 drought such that all pools were observed to have no flow and/or were dry on several occasions during the drought.

Figure 28. Flow status of pools on the WC15 watercourse

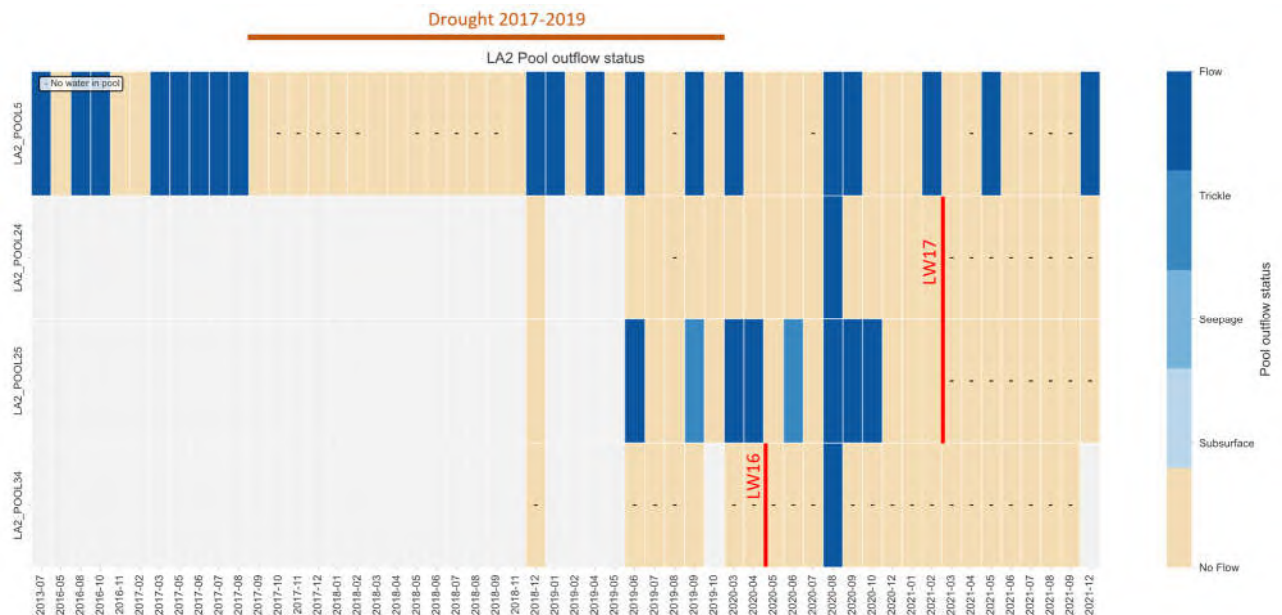
The observed changes represent a mining effect at Pools 24 and 25. Mining effects are not clear at Pools 5 and 34 based on available data.

Figure 29. Flow status of pools on the LA2 watercourse

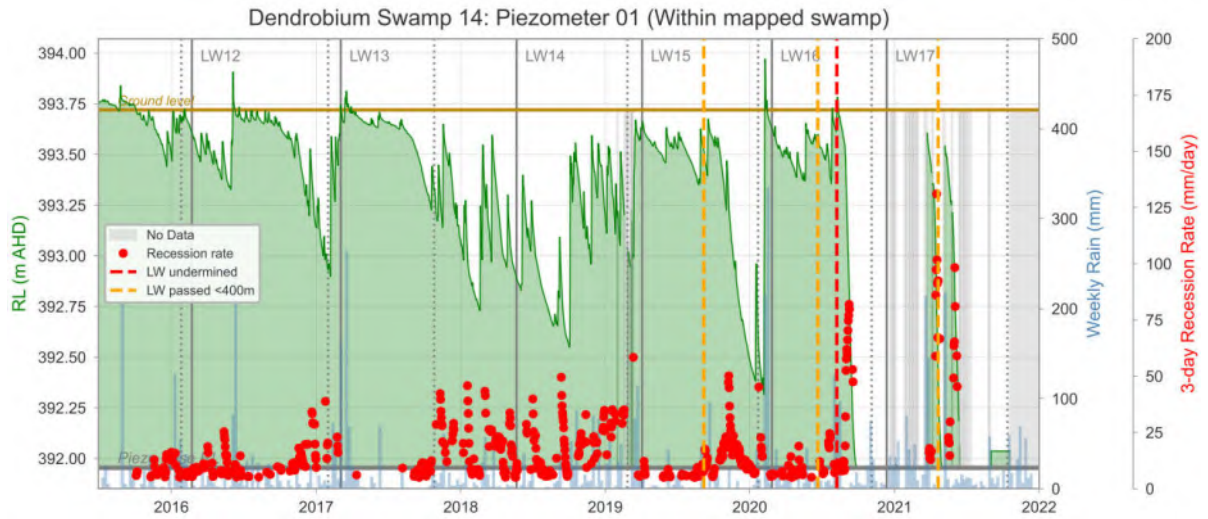
Hydrographs for piezometers 14_01 and 14_02, screened within swamp sediments are shown in Figure 34 and Figure 35. The shallow groundwater hydrographs show slightly different baseline groundwater conditions within the two swamp areas prior to the approach of Longwalls 15 and 16. Piezometer 14_01 in the upper swamp area shows that sediments were continuously saturated since the start of monitoring in July 2015, including during the 2017-2019 drought. It is likely that Swamp 14 was sustained by groundwater in the underlying and adjacent sandstone substrate. Piezometer 14_02 in the lower Swamp 14 area shows saturated conditions most of the time between July 2015 and late 2017 and, like several reference sites, recorded groundwater levels below the base of the piezometer for more than 50% of the time during the 2017-2019 drought period. This behaviour indicates that lower swamp area groundwater levels were not sustained by groundwater in the sandstone substrate to the same extent as in the upper swamp area, despite being at a lower elevation (367 – 387 m AHD).

Figure 34. Shallow groundwater hydrograph for Swamp 14, piezometer 01

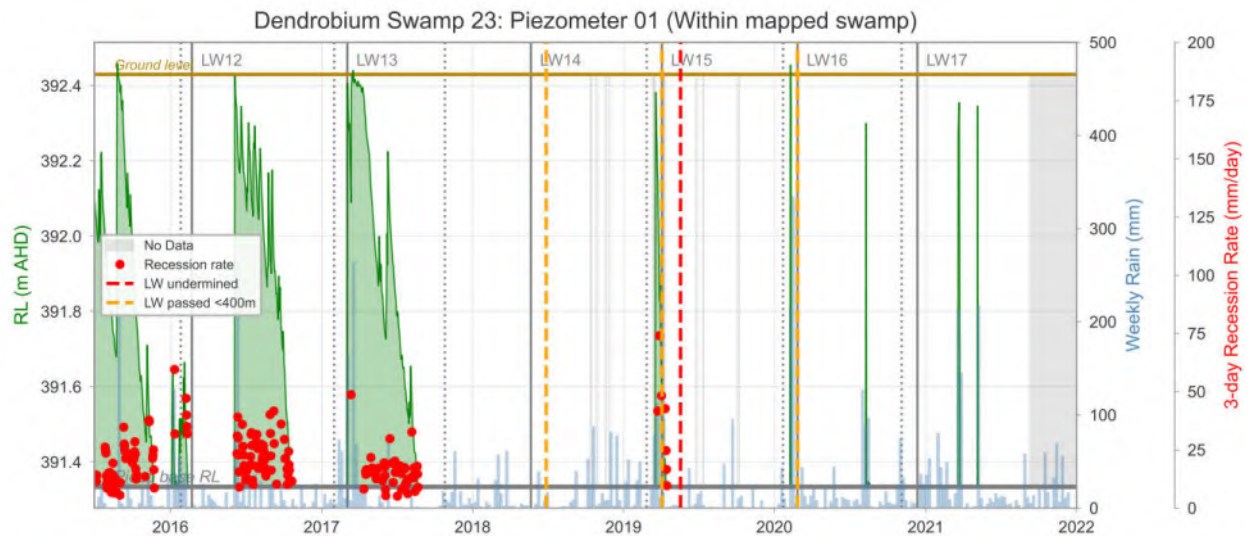
These observations indicate mine related impacts to shallow groundwater at both piezometers, with the effects at 23_02 (located over a longwall pillar) being less severe than at 23_01. The observed impacts trigger a Level 3 TARP (previously Level 2). It should be noted that lower shallow groundwater levels have been observed in several reference swamps (e.g. Swamps 02, 07, 33, 85, 87 and 88) during 2020-2021 compared with pre-2017 and therefore this TARP level should be reassessed when more data become available.

Figure 36. Shallow groundwater hydrograph for Swamp 23, piezometer 01

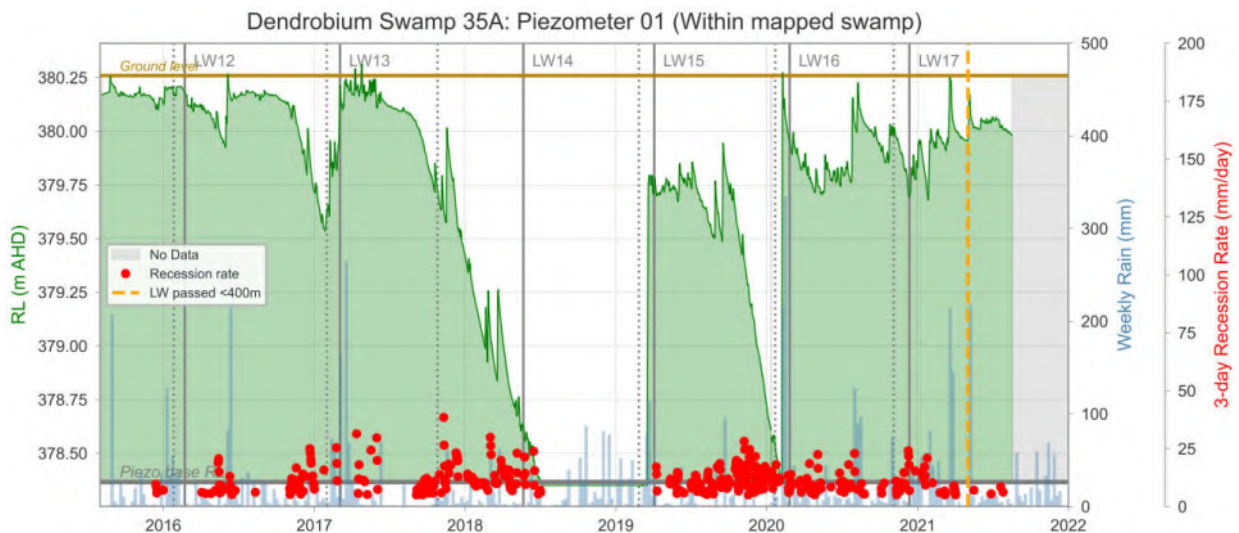
to 2017. The lower groundwater levels were apparent prior to the passage of Longwall 17. The same behaviour is noted at reference Swamp 87 and at Swamp 7 both of which also appear to be connected to underlying HBSS groundwater systems. This suggests that swamp groundwater levels (and underlying sandstone groundwater) have not completely recovered from the drought, despite high rainfall in 2020 and 2021.

Figure 38. Shallow groundwater hydrograph for Swamp 35a, piezometer 01

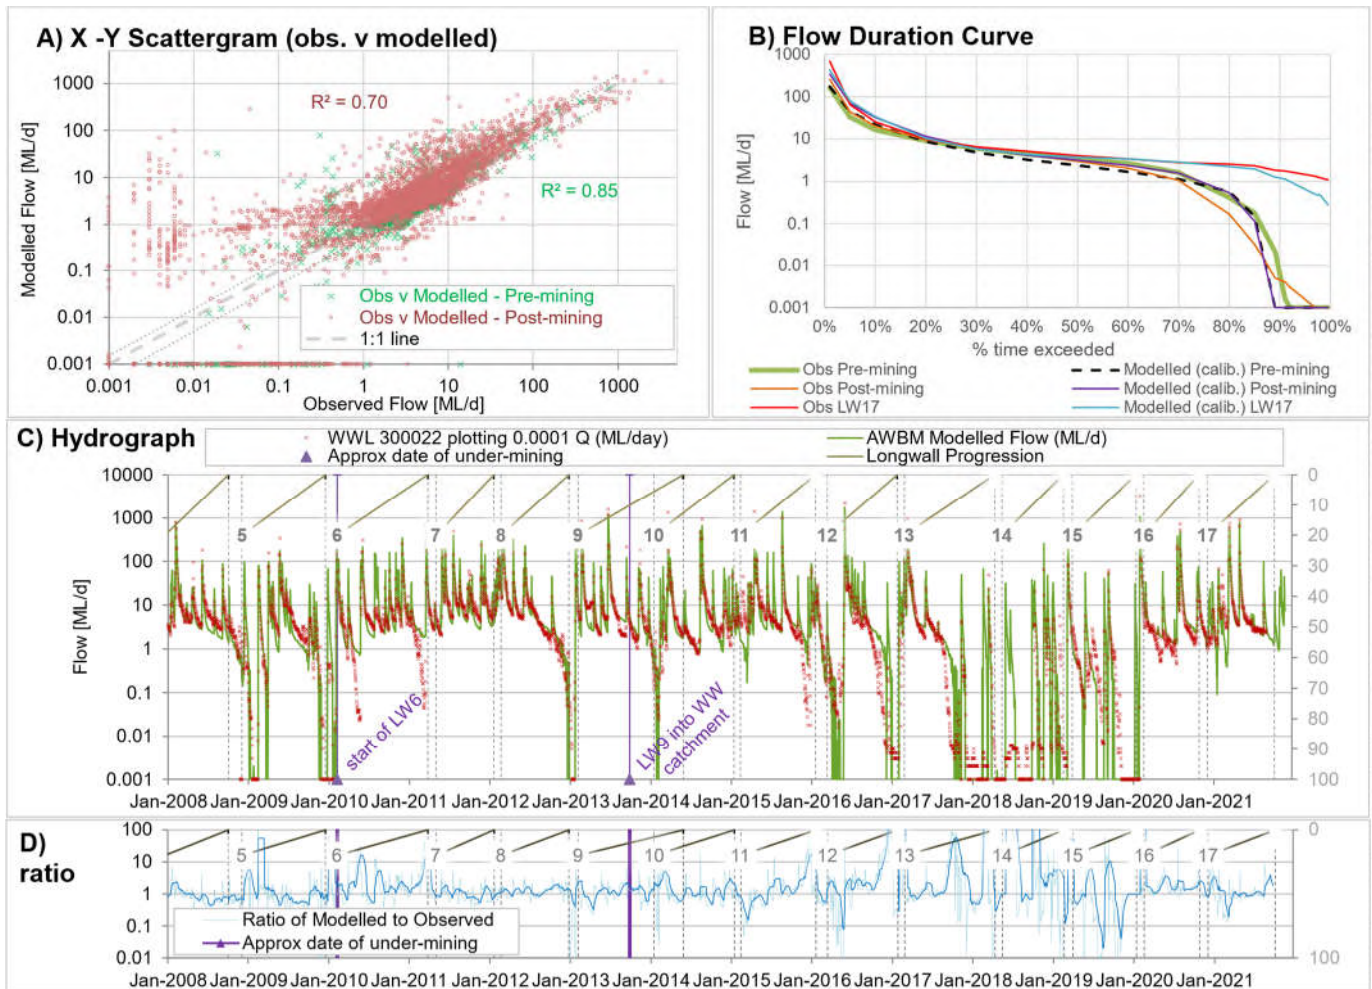
Wongawilli Creek lies between Areas 3A and 3B. The watercourse is not directly mined under by longwalls, but some tributaries (e.g. WC21, WC15, among others) have been mined under by Area 3A and 3B longwalls, including by Longwall 17.

Figure H3 Comparison of observed flow against AWBM simulated flow: WWL

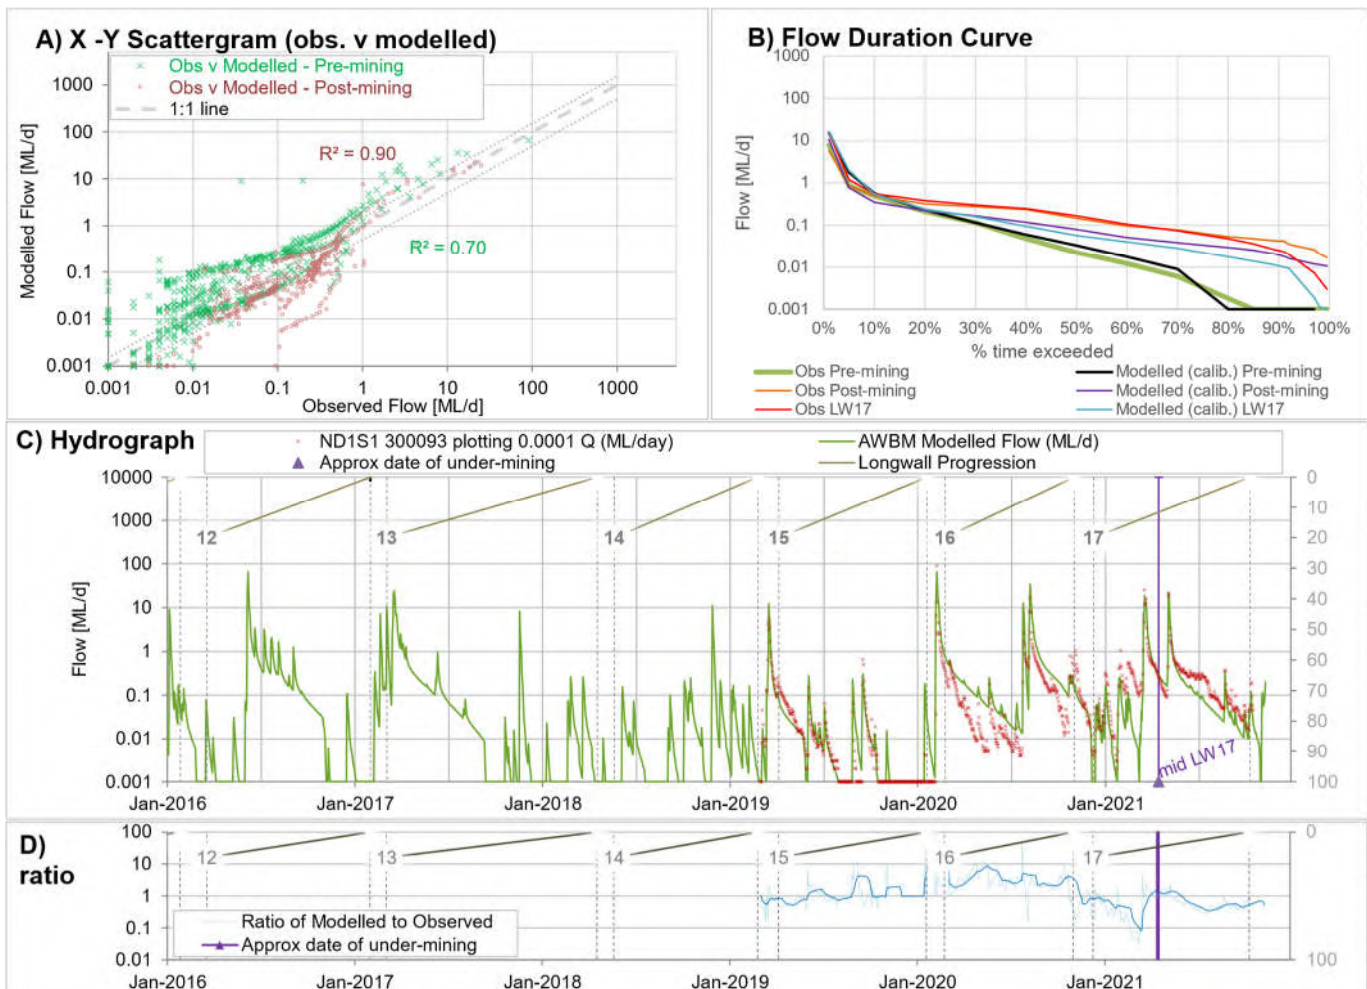
ND1 is a tributary to Native Dog Creek, which flows into Lake Avon. Elouera Colliery longwalls are within or close to this sub-catchment, but were not directly beneath this watercourse or its tributaries. Dendrobium Longwall 17 mined under the edge of the ND1 catchment, but not under the watercourse.

Figure H3 Comparison of observed flow against AWBM simulated flow: ND1

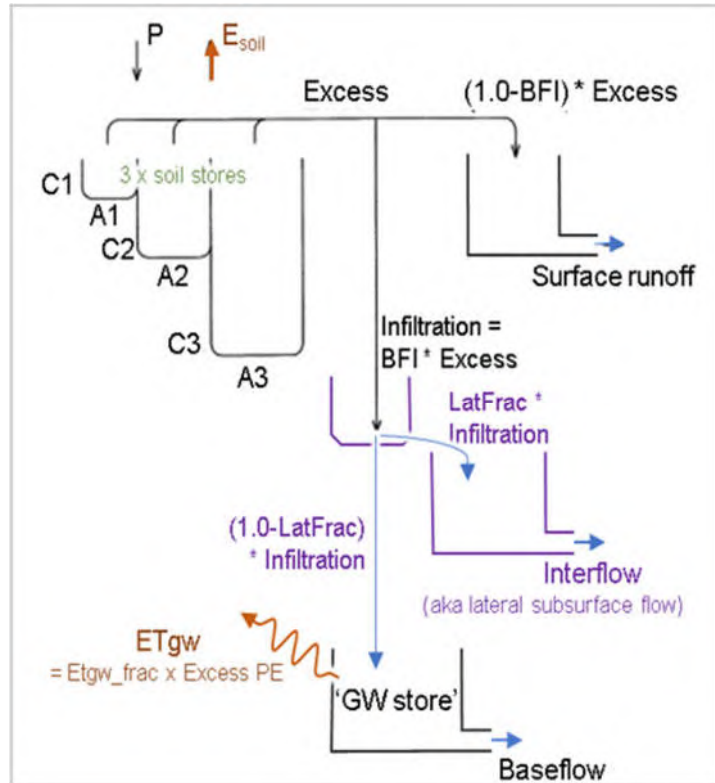
Most of the parameters relate in part to the simulated connected groundwater system in the catchment. For this project, AWBM has been populated and run via a spreadsheet version of the AWBM model.

Figure H5. AWBM Rainfall-runoff model flow diagram
