DENDROBIUM MINE

End of Panel Surface Water and Shallow Groundwater
Assessment: Longwall 18 (Area 3B)

HGEO Pty Ltd

Date: October 2022

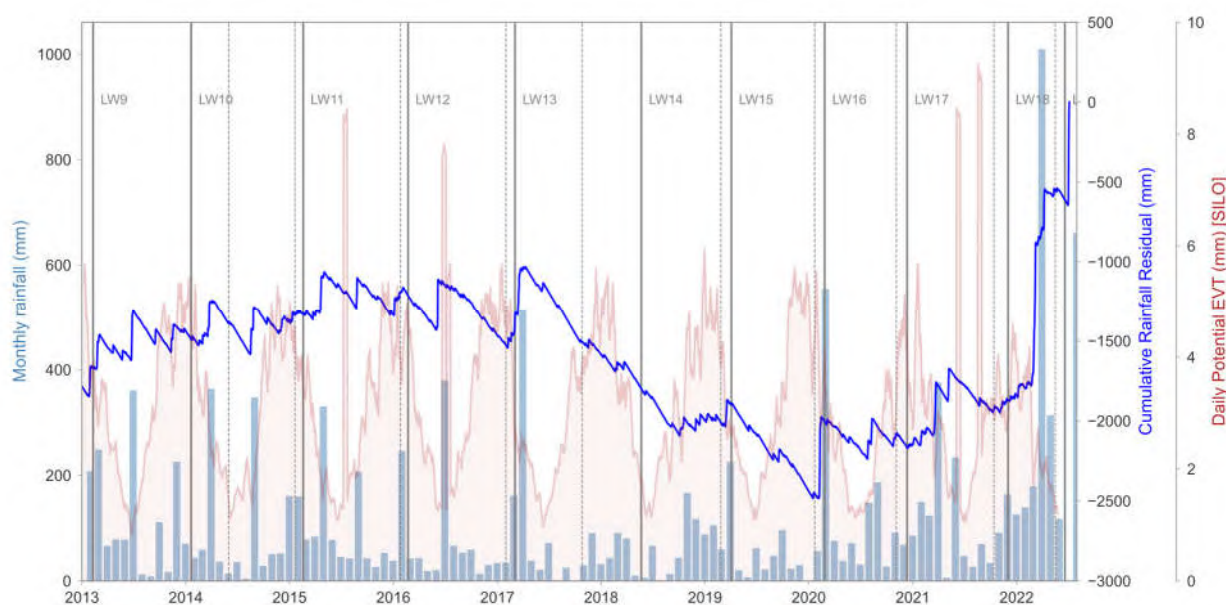
Figure 4. Rainfall and potential evapotranspiration (EVT) at Area 3 for the reporting period

Rainfall during Longwall 18 extraction was well above average, totalling 2281 mm in the calendar year to the end of the longwall (18/5/2021 – 17/5/2022). Extremely heavy rainfall was experienced in March 2022 when 1010 mm was recorded in a single month. This follows similarly high rainfall in 2020 (1436 mm) and 2021 (1448 mm) due to sustained La Nina conditions over that period. As a result, there has been a full recovery in stream flow, shallow groundwater levels and soil moisture across all catchments since the severe drought of 2017-2019.

Rainfall data are collected from several gauging stations across the mining lease. Weather observations at Area 3B since the start of Longwall 9 are summarized in Figure 4. Potential evapotranspiration (EVT) is calculated from SILO data (DSITI, 2011) derived for Dendrobium Area 3B, using the FAO Penman-Monteith formula (Allen et al., 1998). The average annual rainfall for Dendrobium is 1050 mm (2002 – 2021; Dendrobium site data). Rainfall events occur year-round but tend to be more frequent in the summer and early autumn months. It is common for a substantial proportion of the annual rainfall to be delivered in a small number of large rainfall events, during which significant surface water runoff and groundwater recharge is generated.

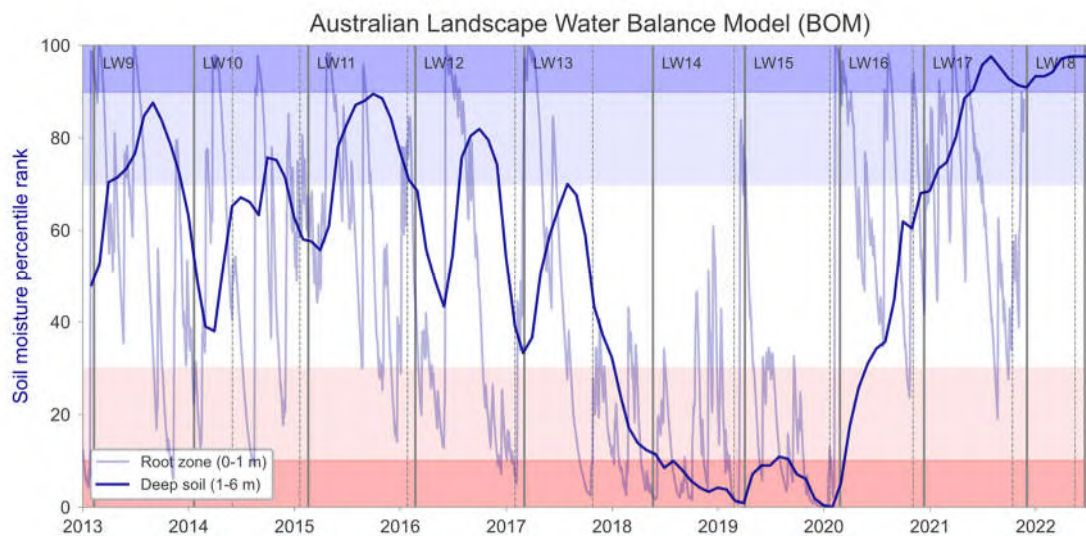
Soil moisture levels derived from the Australian Water Resources Assessment Landscape model (AWRA-L) are published by the Bureau of Meteorology (BOM). A timeseries of estimated soil moisture storage for the Woronora Plateau in the vicinity of Dendrobium Mine is shown in Figure 5. Soil moisture storage declined to record low levels during the 2017-2019 drought. Due to the higher-than-average rainfall since 2020, soil moisture levels are at their highest levels than at any other time during mining in Area 3B.

Figure 5. Calculated soil moisture from BOM’s AWRA Landscape Model

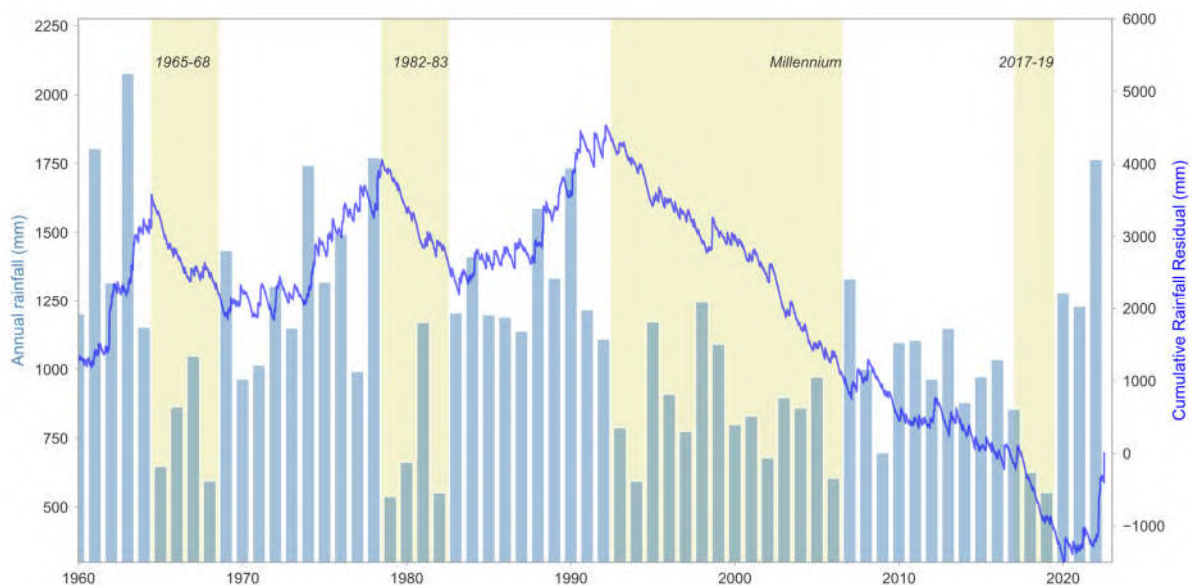
Longer term rainfall trends for the plateau are shown in Figure 6 which is based on data from SILO (slightly different from site measurements). Since 1960 there have been four periods of drought on the plateau (yellow shading), the most severe being the Millennium Drought which ended in 2004. Severe drought conditions returned between 2017-2019. The high rainfall since 2020 has been similar to rainfall conditions during much of the 1980s and early 1990s, prior to the Millennium Drought.

Figure 6. Long-term rainfall trends at Dendrobium (1960-2021)

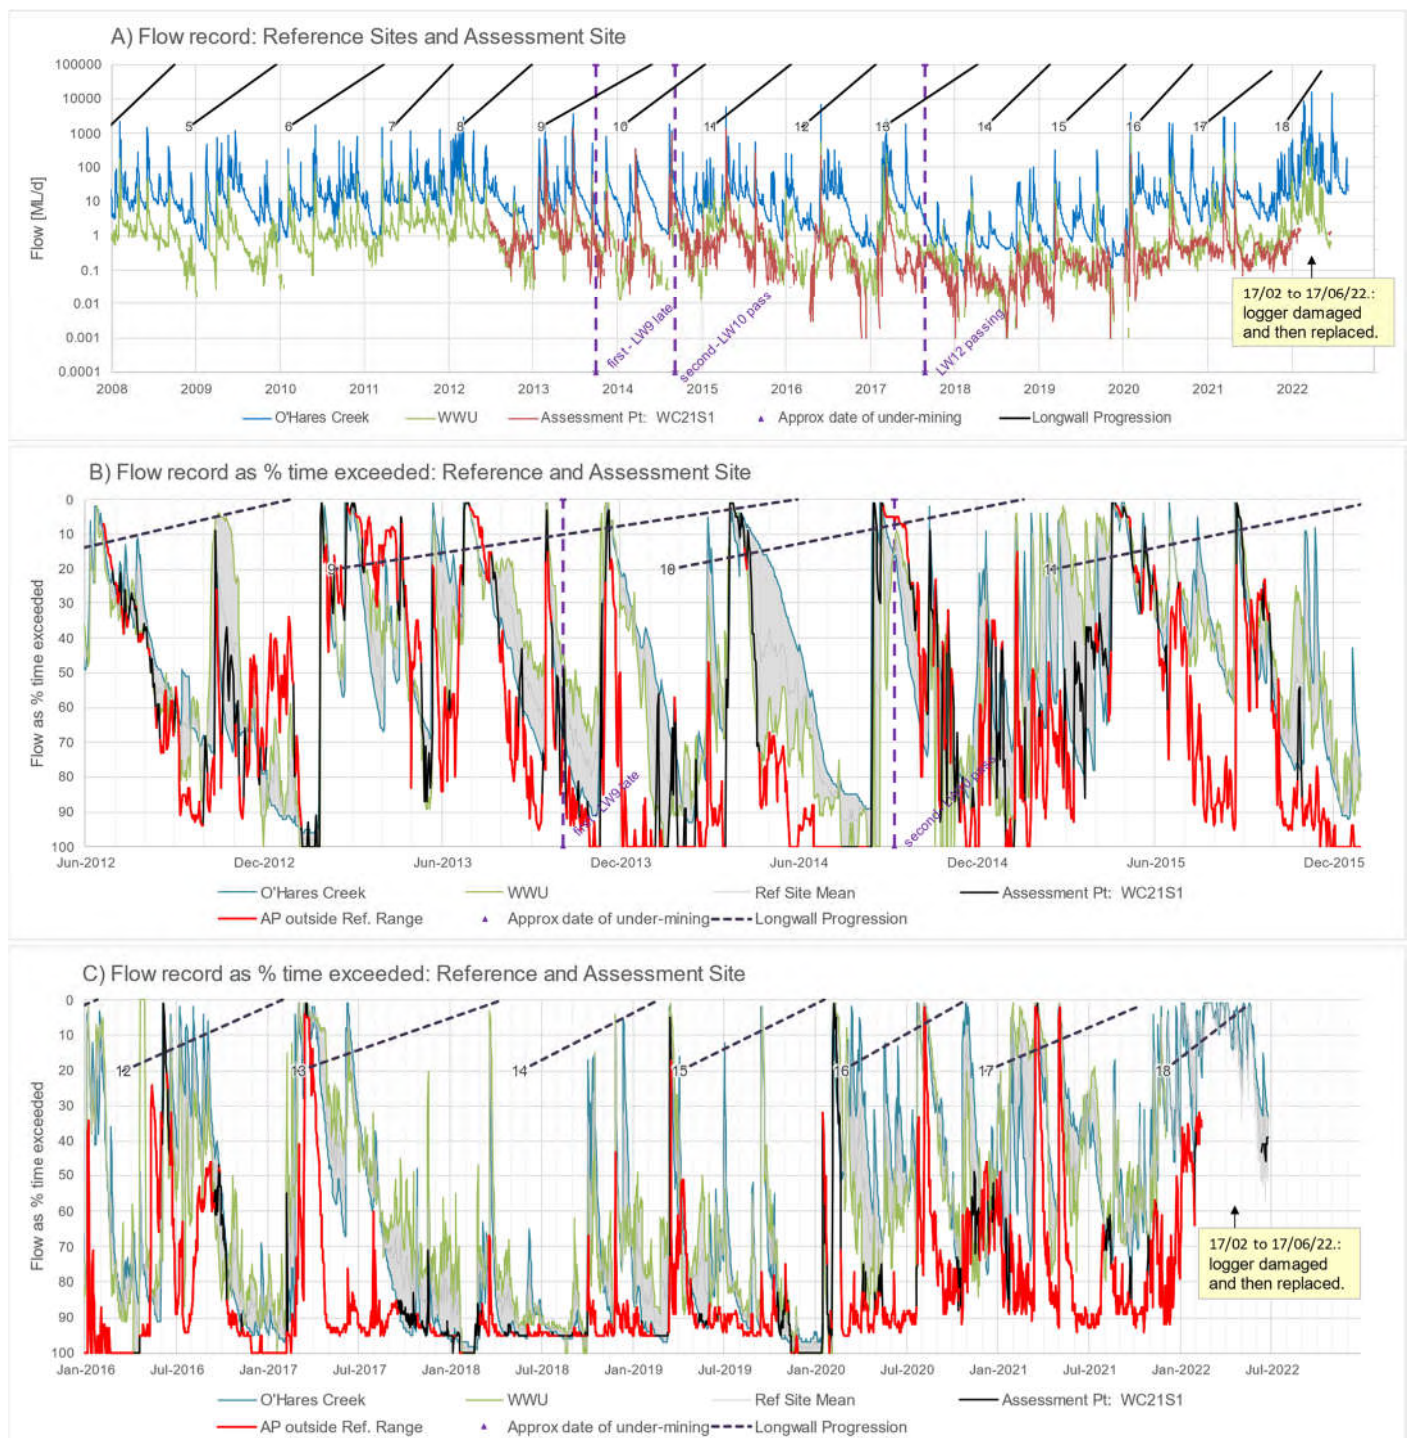
Figure 18. WC21S1 vs Reference Sites A) flows; B) and C) flow duration statistics [Q%iles]

Figures B and C show the Q%ile hydrograph for the WC21S1 Assessment Point versus the Q%ile hydrographs for the Reference Sites, O'Hares Creek and WWU. For this assessment 'natural variability' is defined as the range between the Q%ile for the Reference Sites on each day.

WC21, a tributary to Wongawilli Creek, was mined under late in Longwall 9, and has since been mined under by Longwalls 10-15. Longwalls 16-18 are located south of this sub-catchment. During flooding in early 2022, the logger was damaged and data was unrecoverable. Logger replaced in June-2022.

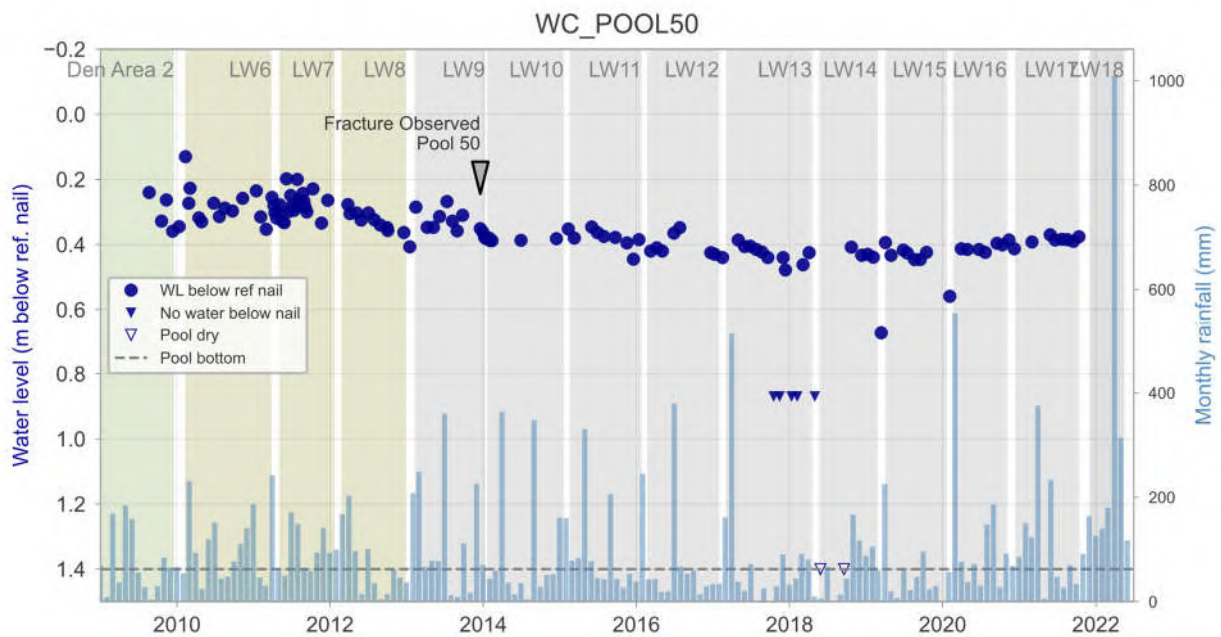
Figure 27. Time series plot of water level observations in Pool 50

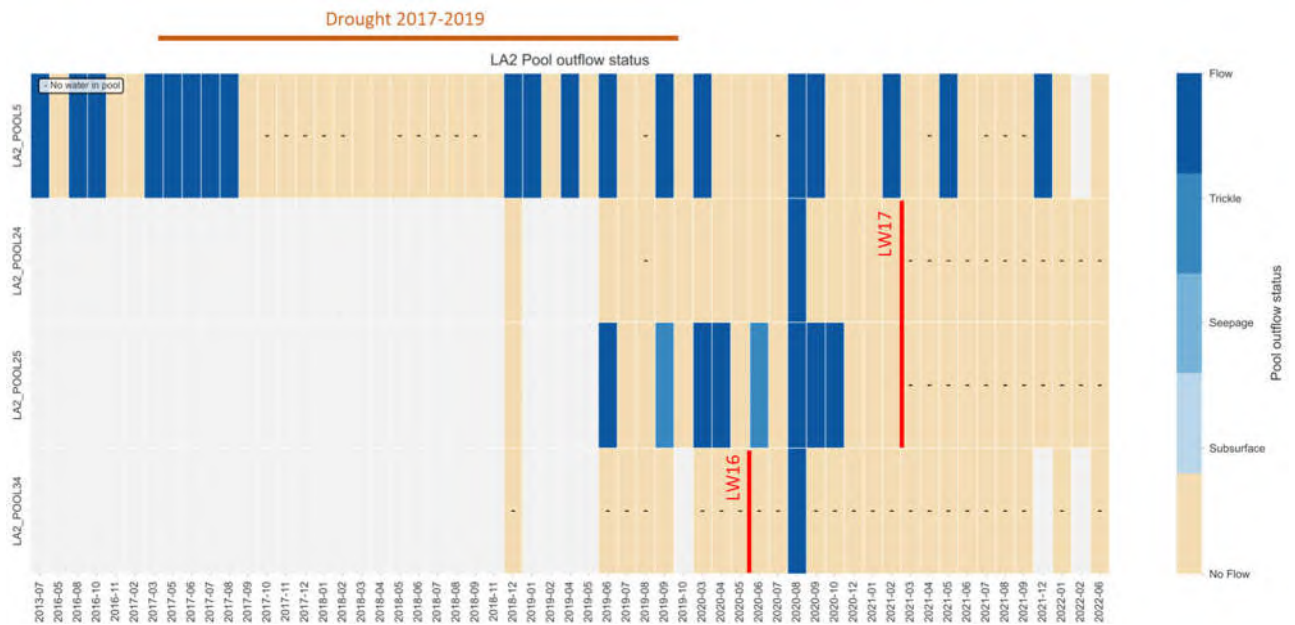
Figure 29. Flow status of pools on the LA2 watercourse

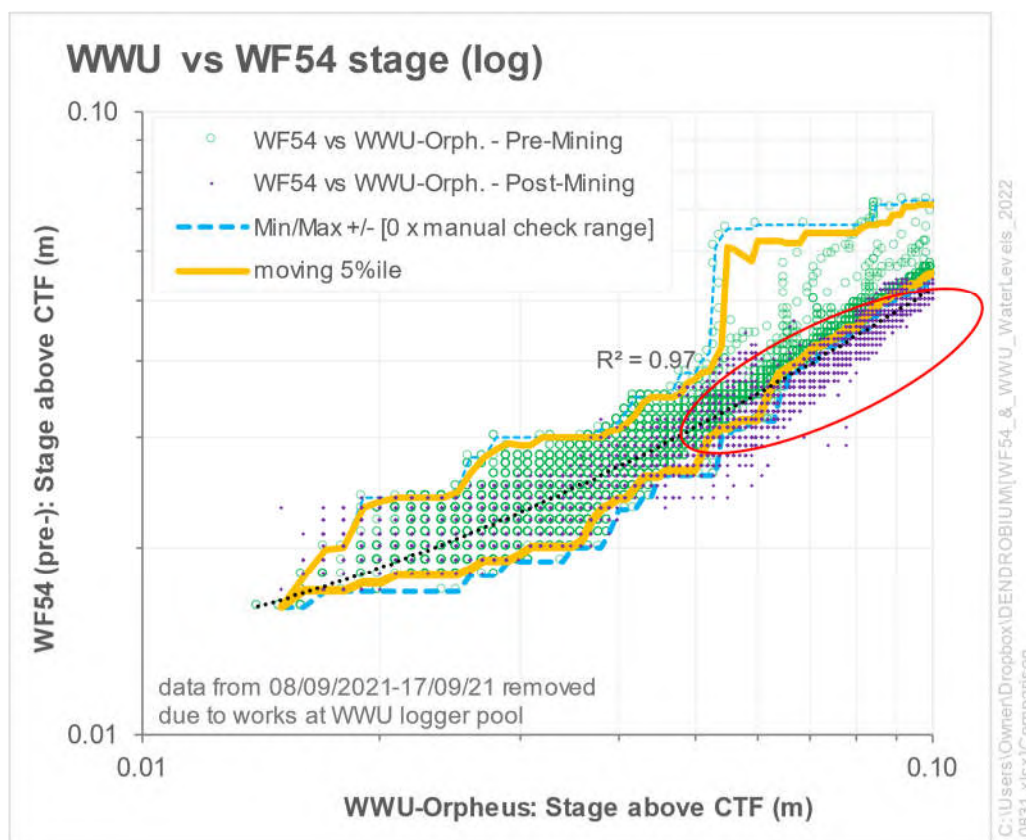
Figure 31. Relationship between water level (stage) at WWU and WF54

On Figure 31, the solid orange lines represent a moving 5%/95%ile (approximately), and the dashed blue lines show the minimum/maximum bounds on this relationship. These ranges do not consider the error in the manual measurements noted earlier. The solid orange lines are used for this analysis to

A relationship in water levels at the two sites has been developed by plotting the data against one another for the pre-mining period as a natural and logarithmic relationship (detail on a log-scale is shown in Figure 31).

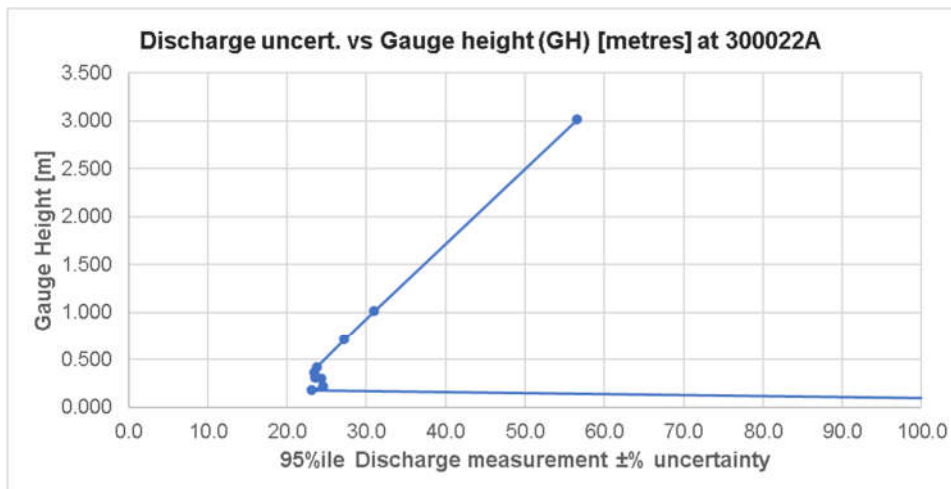
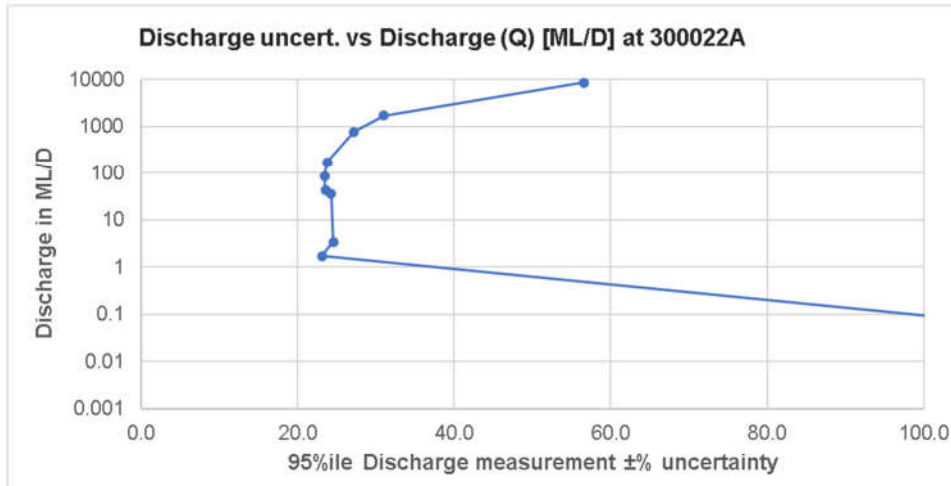
Gauge 300022A – WWL_A

The use of an artificial control (halfpipe) leads to generally lower uncertainty than for the natural control sites (e.g. DCS2, WC21 or WWL). High flow uncertainty related to flow above the structure and few high flow gaugings. High flow gaugings, possibly via alternative methods, are recommended.

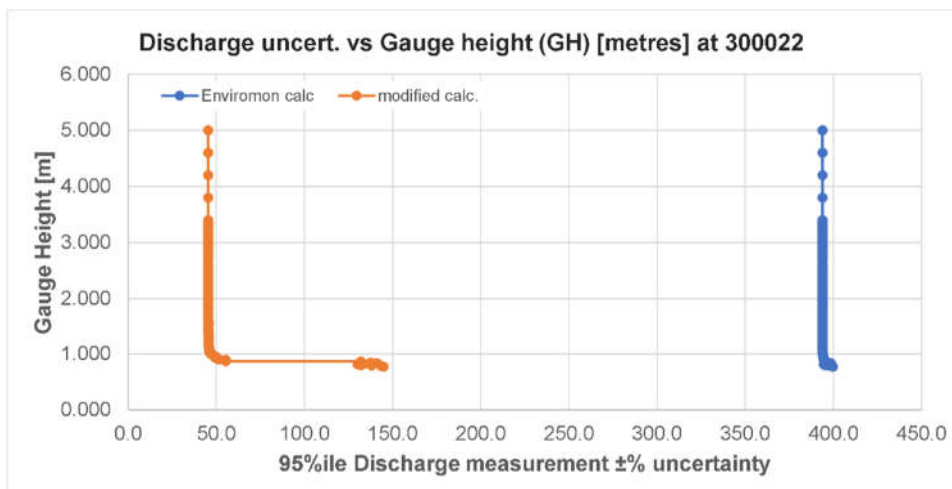
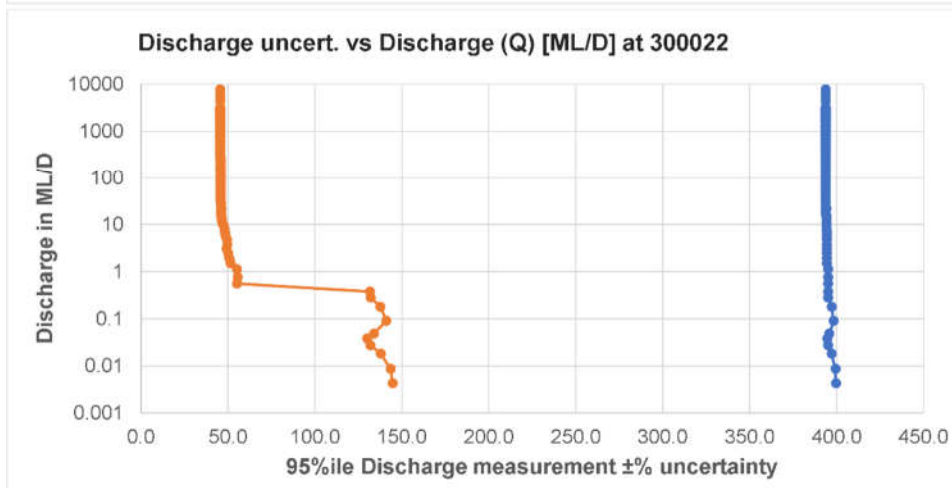
Gauge 300022 – WWL

Enviromon developed the blue uncertainty curve, and a modified version of that has been calculated by Watershed HydroGeo (orange series). The high uncertainty at low flow relates to underflow at the (permeable) control. High flow gaugings, possibly via alternative methods, are recommended.

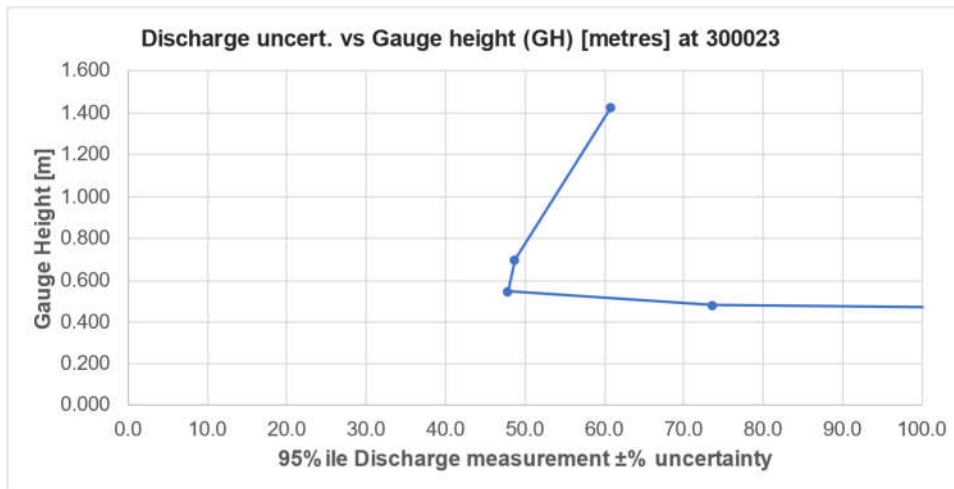
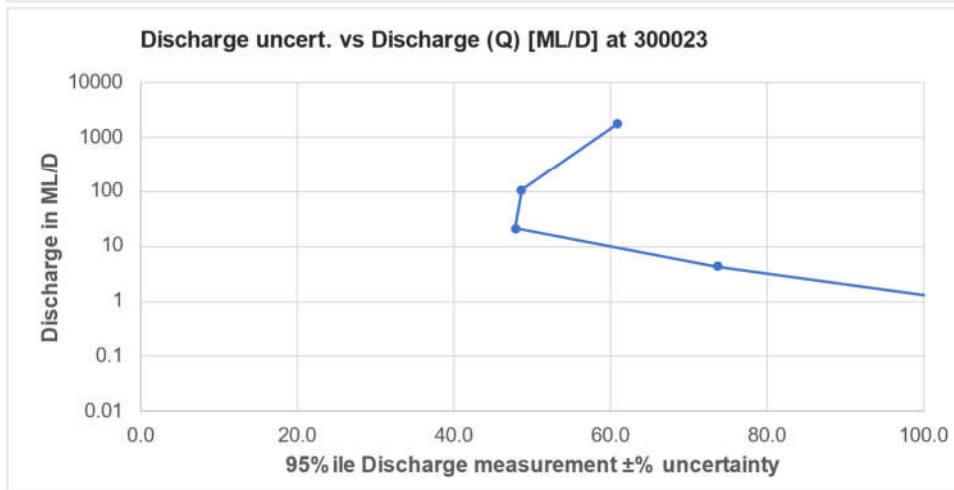
Gauge 300023 – DCU

- 1) Out of the 29 gauging records, only 9 were valid for this analysis, due to 20 being either zero flow or so low that no valid measurement could be taken
- 2) Gauging 28 on 4/3/21 had the highest deviation- South 32 noted leakage:- Serviced by S32. Pygmy av. = 0.05844 MLD and comment of 'approx. 10% leakage'
 Could this be a general issue with this site?
- 3) Level uncertainty used is the generic +/-8.2mm for a Diver sensor, as there were no comparative field difference readings to analyse

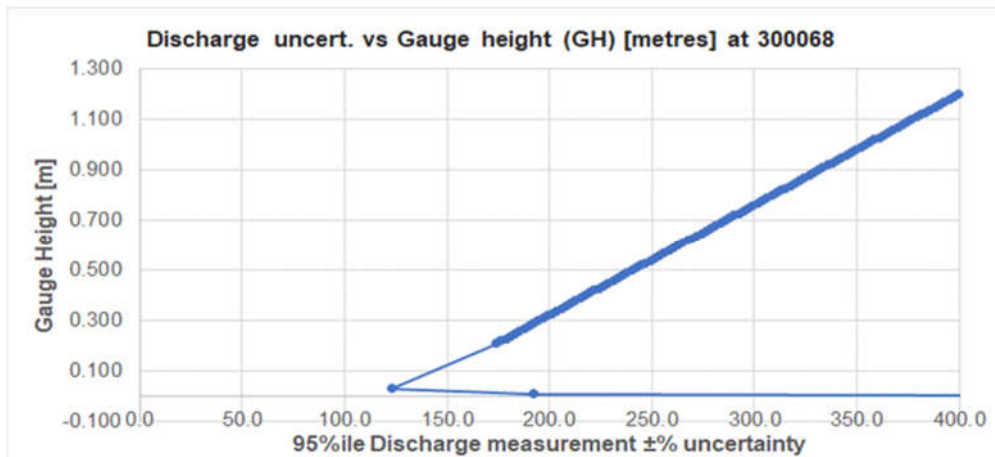
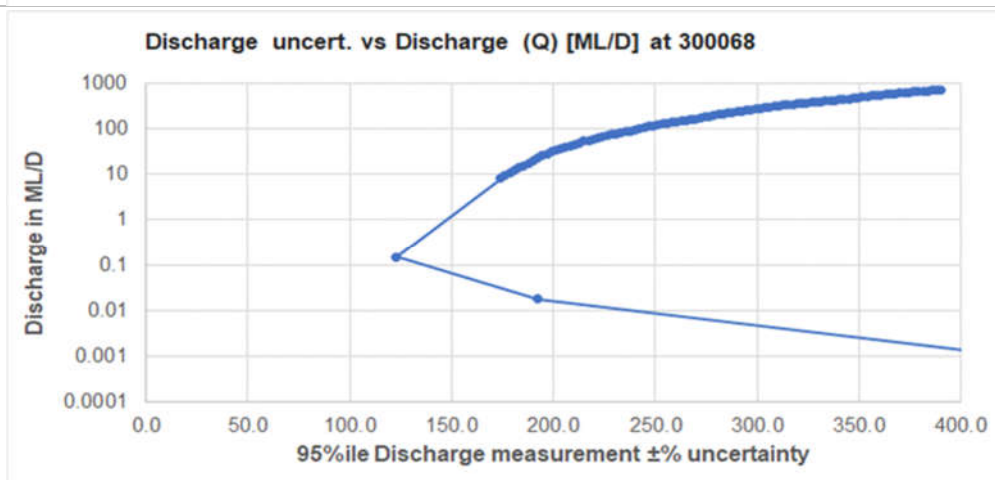
Gauge 300098 – DCS2

Enviromon (2022) noted that there is not a tight reliable and unique rating relationship between water level and discharge, ranging from -36% to +175% different from the rating. Based on this analysis, Enviromon has sent questions to ALS relating to the quality of gaugings used to develop the rating curve and the rock bar control.

High flow gaugings, possibly via alternative methods, are required to improve high flow.

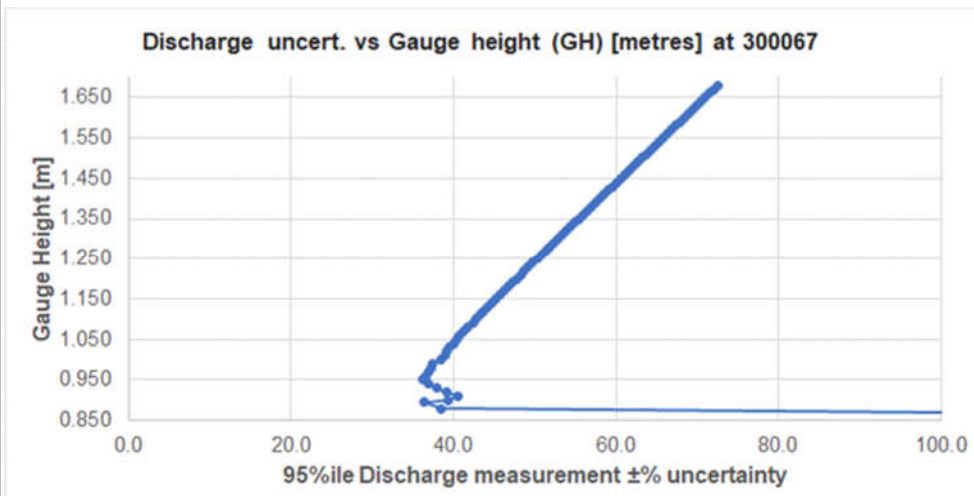
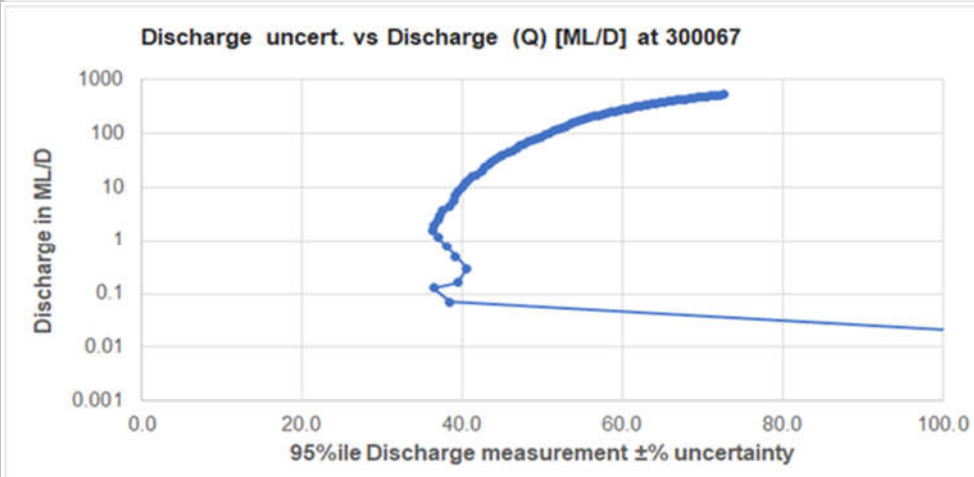
Gauge 300067 – DC13S1

Enviromon (2022) noted that there is not a tight reliable and unique rating relationship between water level and discharge, ranging from -29% to +44% different from the rating. The rock bar control makes low flow measurement very sensitive to level measurement uncertainty. Enviromon has sent questions to ALS relating to the quality of gaugings used for the rating curve and other issues.

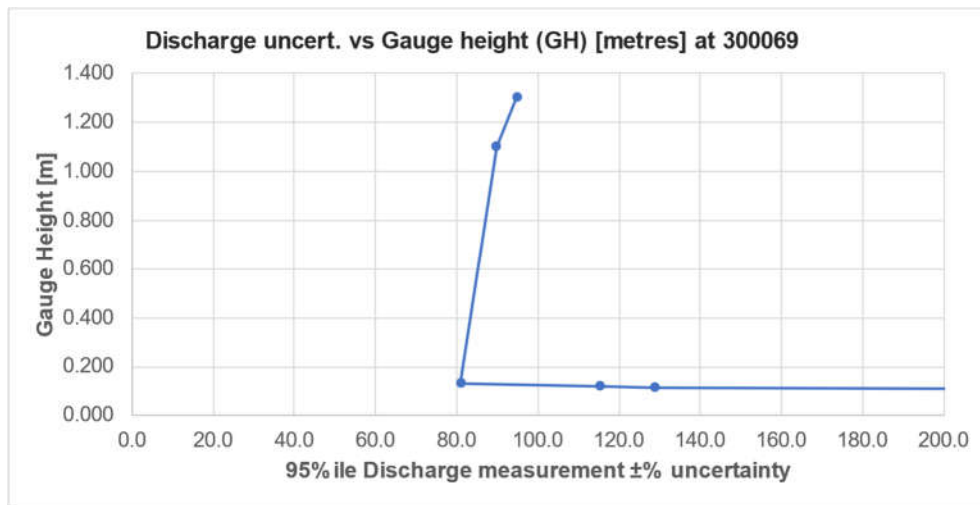
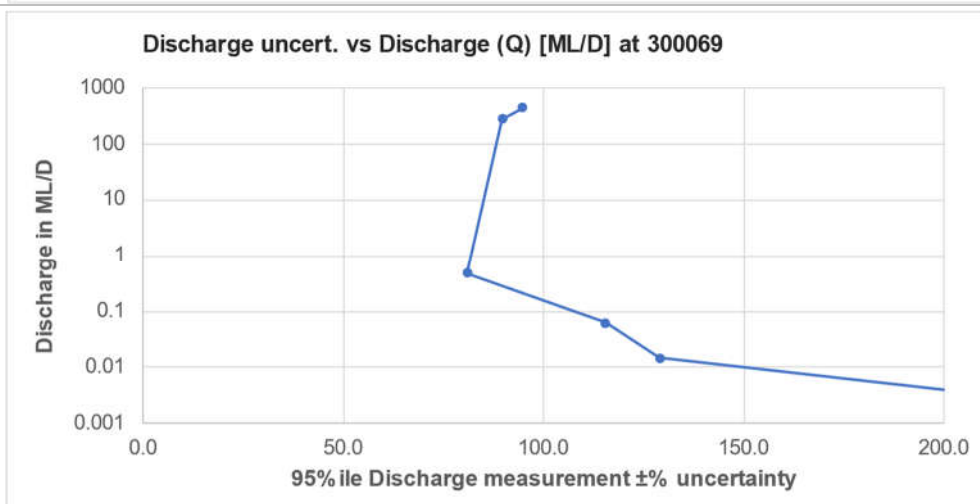
Gauge 300069 – WC21S1

There is not a tight reliable and unique rating relationship between water level and discharge, ranging from - 76% to +121% different from the rating. Intermittent leakage under the control is suspected as the main cause of this scatter of gaugings (which could be mining-related?).

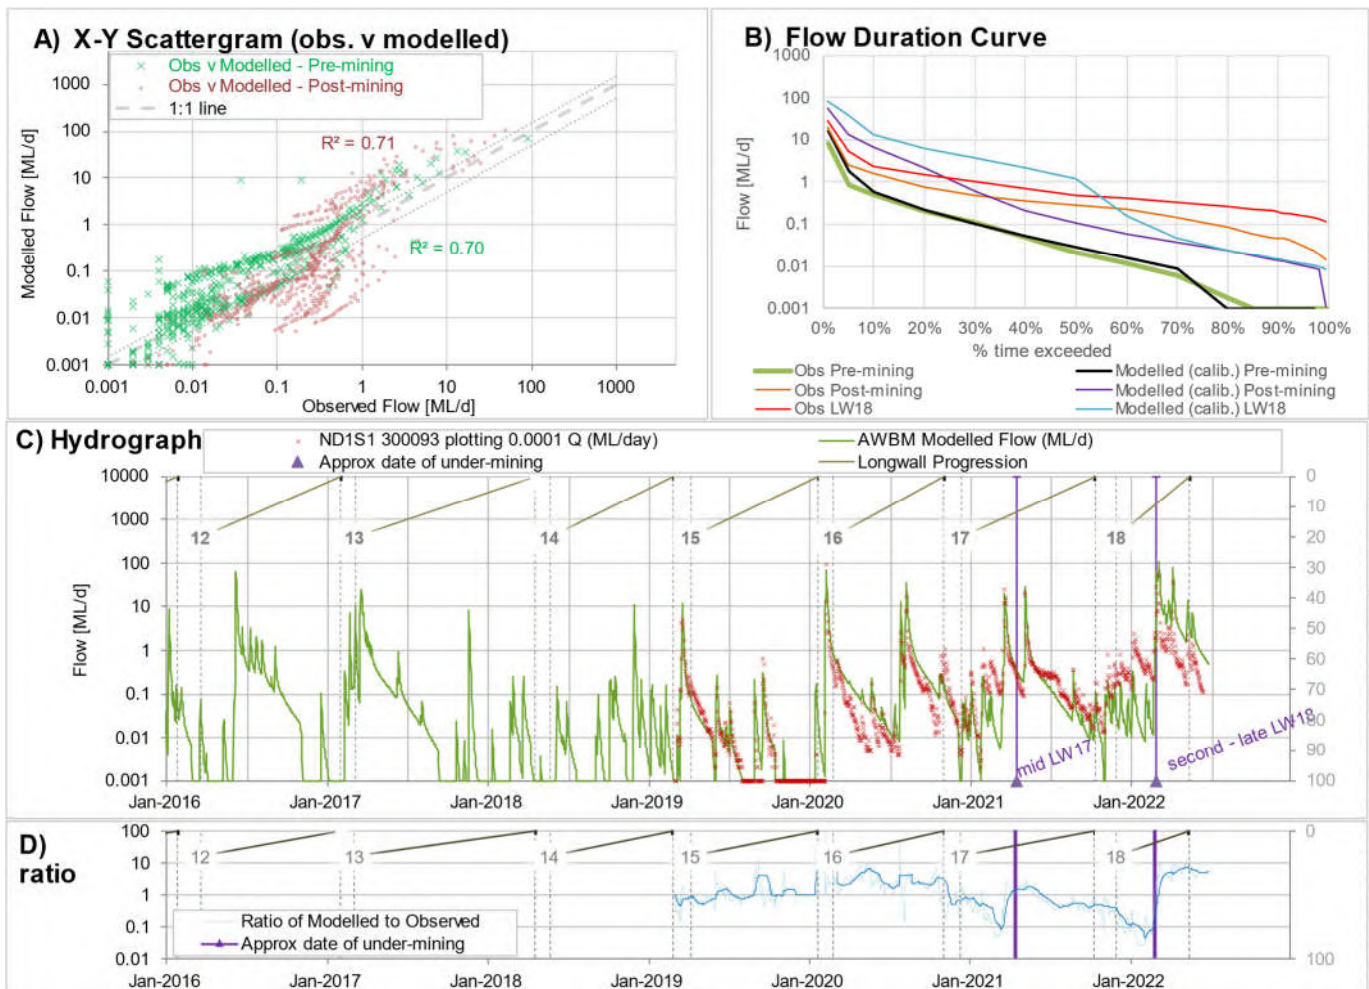
Figure H3 Comparison of observed flow against AWBM simulated flow: ND1

- A** This shows that during the pre-mining period the model is a good fit to observed data. The fit is similar ($R^2 = 0.71$) in the post-mining period.

ND1 is a tributary to Native Dog Creek, which flows into Lake Avon. Elouera Colliery longwalls are within or close to this sub-catchment, but were not directly beneath this watercourse or its tributaries. Dendrobium Longwall 18 mined under the upstream parts of the ND1 catchment.

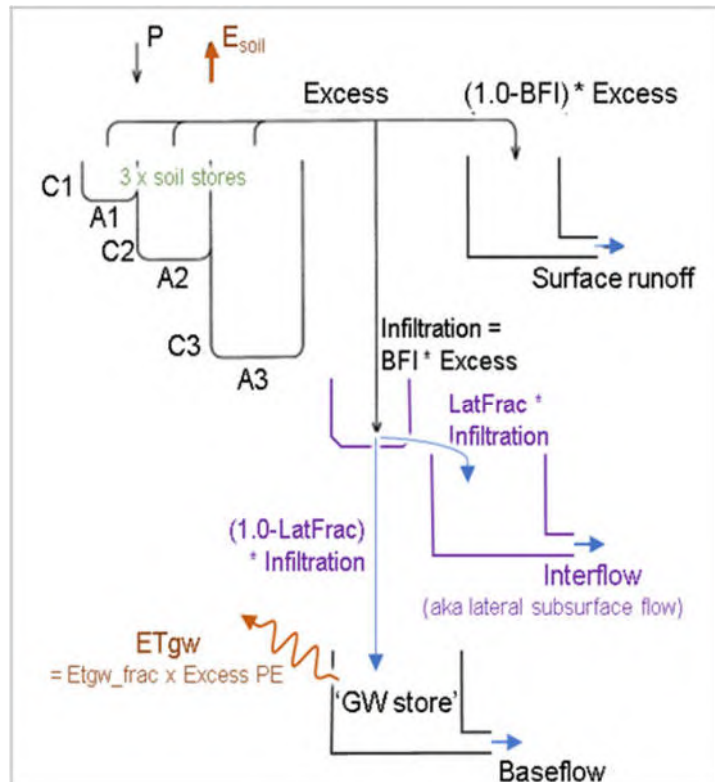
Most of the parameters relate in part to the simulated connected groundwater system in the catchment. For this project, AWBM has been populated and run via a spreadsheet version of the AWBM model.

Figure H5. AWBM Rainfall-runoff model flow diagram
