APPIN MINE ANNUAL REVIEW FY23

The Annual Review has been prepared to meet the requirements of Condition 4 of Schedule 6 of the BSO Project Approval 08_0150 (the Project Approval).

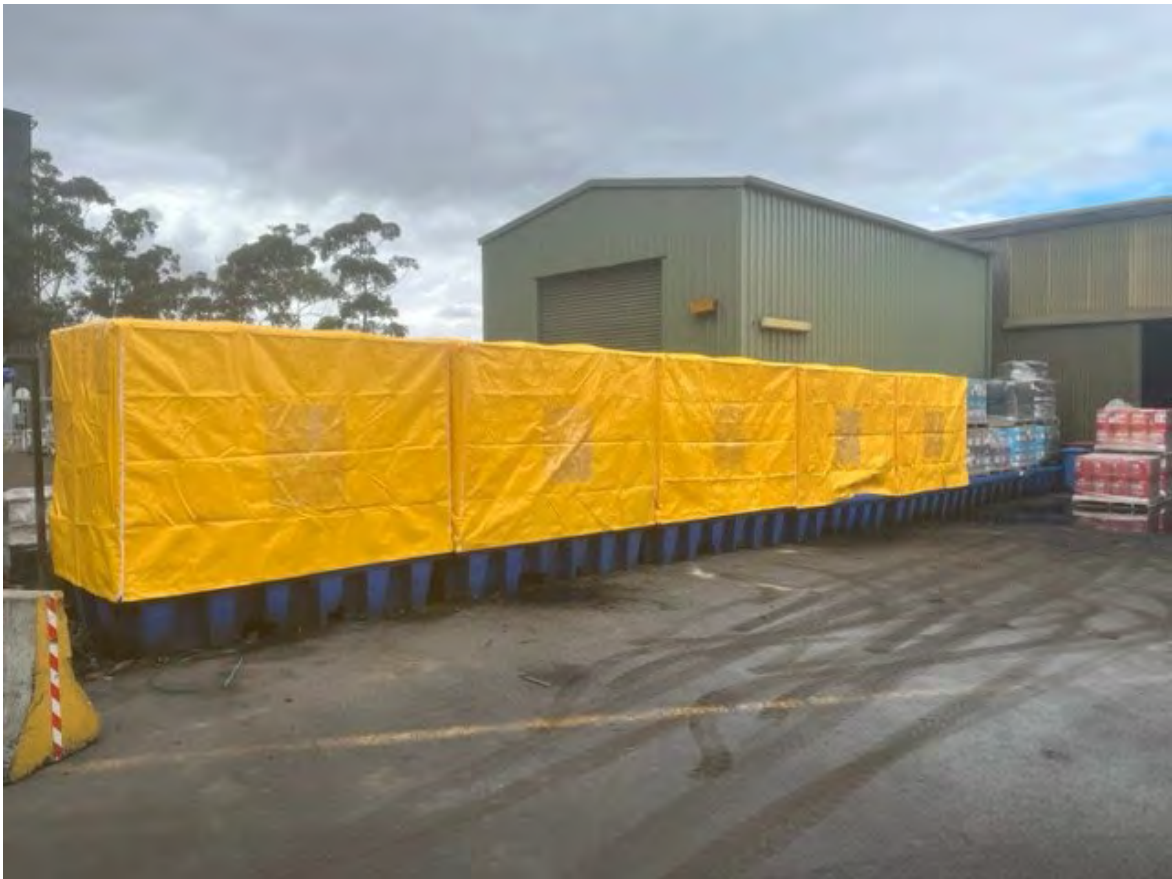
Plate 1: Weatherproof covers on storage bunds

As part of an ongoing initiative to improve environmental standards with respect to chemical and hazardous goods handling and storage, IMC installed weatherproof covers on portable bunds dedicated to hydrocarbon storage in May 2023 (see Plate 1). IMC also upgraded the bulk solcenic refilling bund with a new concrete foundation (see Plate 2).

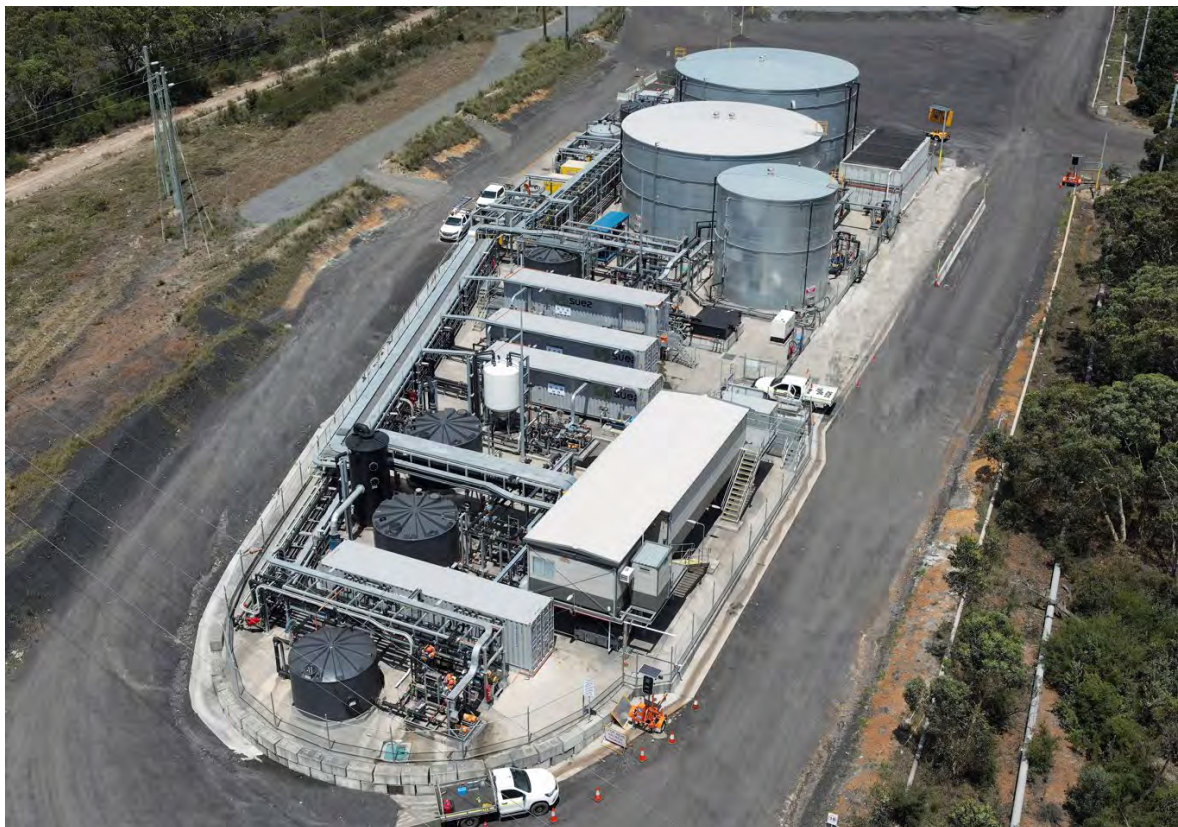
Plate 3: Appin North WTP

The WTP layout is shown in Plate 3.

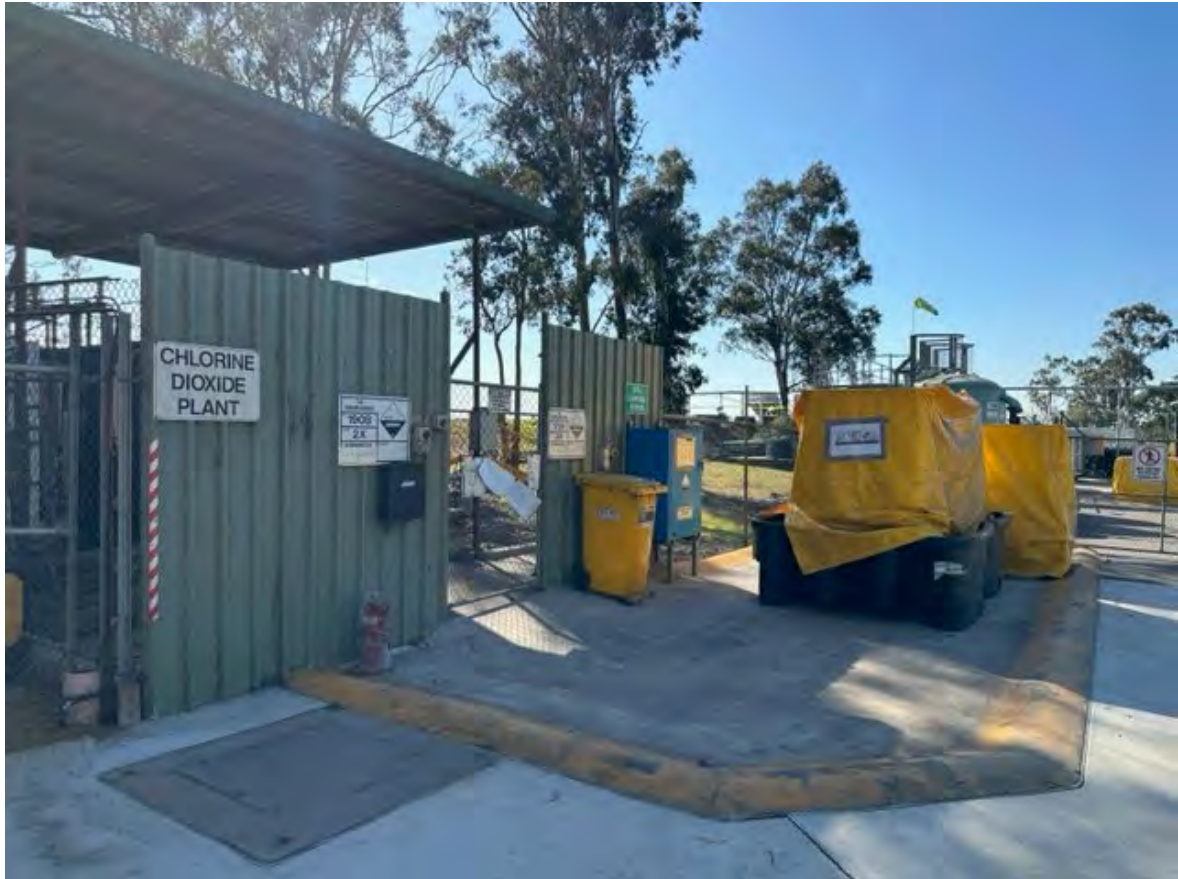
Plate 4: AW WTP Chlorine dioxide refilling bund

A chlorine dioxide refilling bund was implemented in February 2023 to improve handling and storage of chlorine dioxide on site (see Plate 4).

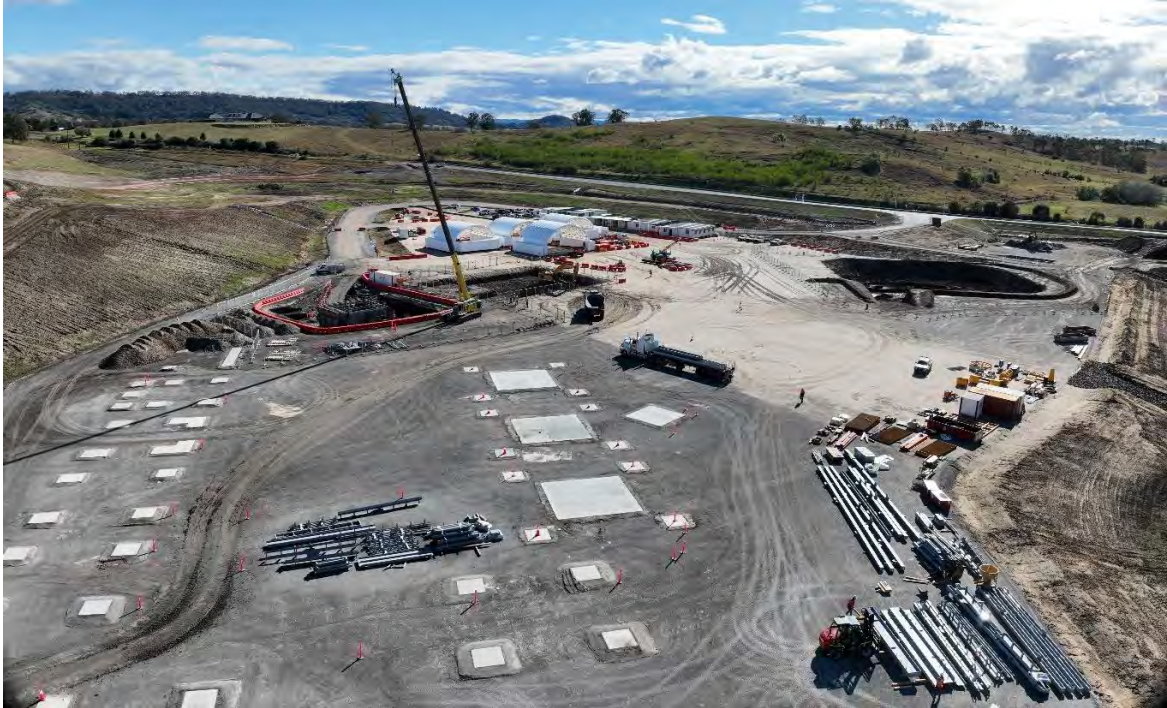
Plate 5: AMVA Project site

Progress at the AMVA Project site at the end of June 2023 is shown in Plate 5.

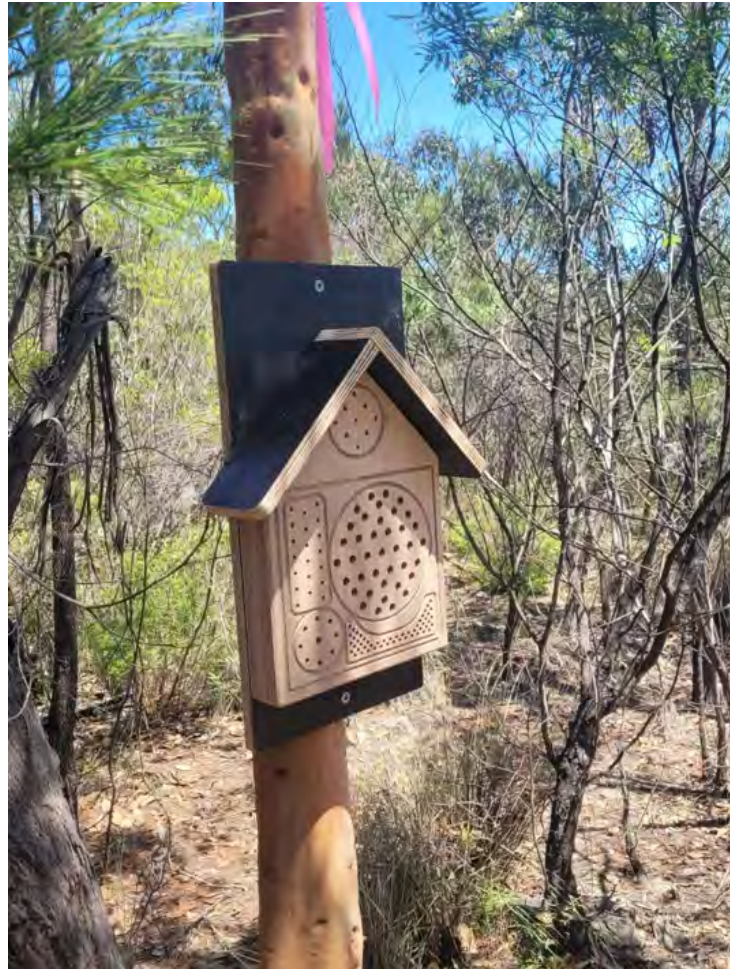
Plate 7: Artificial Bee Habitat installed in the Stage 2 *P. hirsuta* translocation area

In FY23 IMC installed nine (9) artificial bee habitats (see Plate 7) to help support native pollinator networks around Appin North. Habitats were installed within the *P. hirsuta* Offset Area, *P. hirsuta* translocation sites and around the CWEA rehabilitation area. This was undertaken to enhance pollinator populations around the site and in turn increase pollinator plant interactions. This aims to support outcrossing within the *P. hirsuta* populations and the rehabilitation areas, creating genetic diversity within ecosystems and in turn assist in long term restoration.

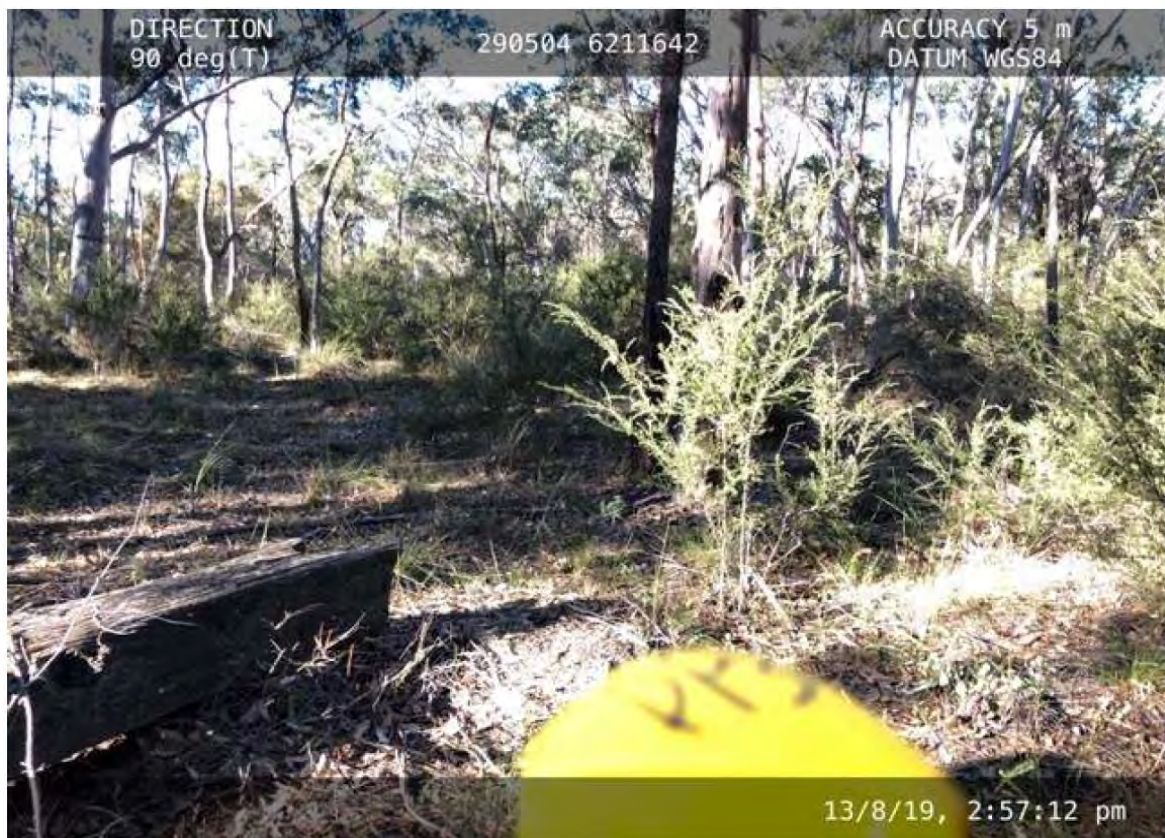
Plate 8: Vegetation growth from photo point 3 at the Cataract River Biobank Site (FY20)

No stock or evidence of grazing was observed over the 2023 reporting period. There was a noticeable increase in the native vegetation and (to a lesser extent) weed growth across the site, which is likely attributed to La Niña wet weather events during the reporting period and the installation of the exclusion fencing in 2021. An example of this notable increase in vegetation can be observed in the comparison photos below in Plate 8 and Plate 9, which shows an image of photo point 3 from FY20 compared to FY23 respectively.

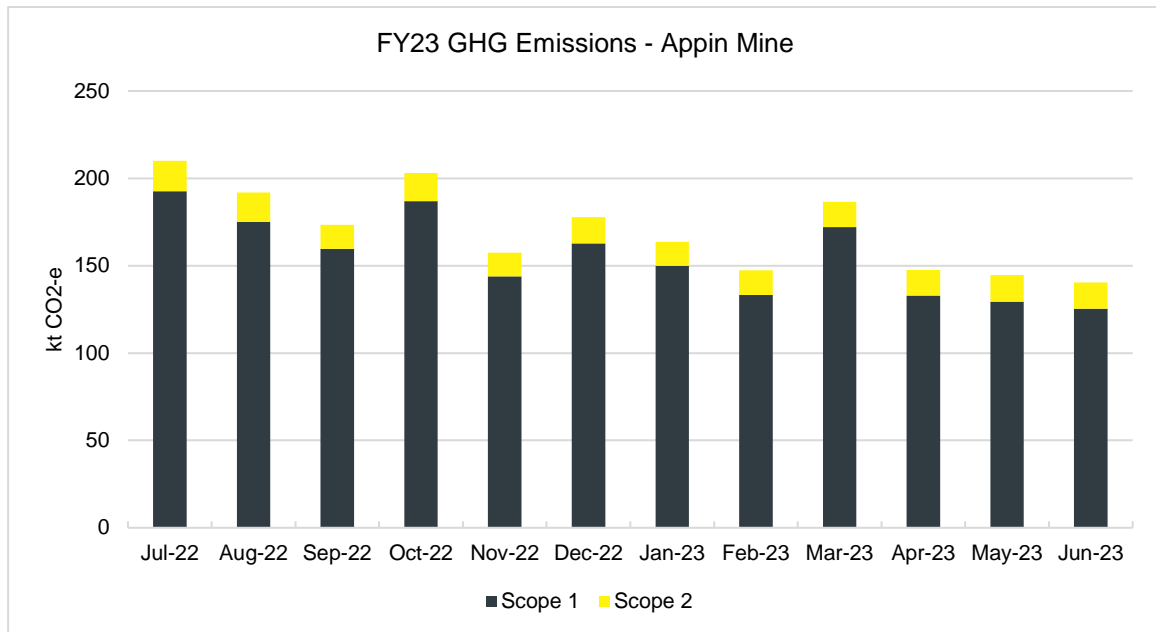
Figure 9: FY23 GHG Emissions - Appin Mine

Emission Type	Unit	FY22 Total	FY23 Total
Scope 1	kt CO ₂ -e	1590	1864
Scope 2	kt CO ₂ -e	216	180

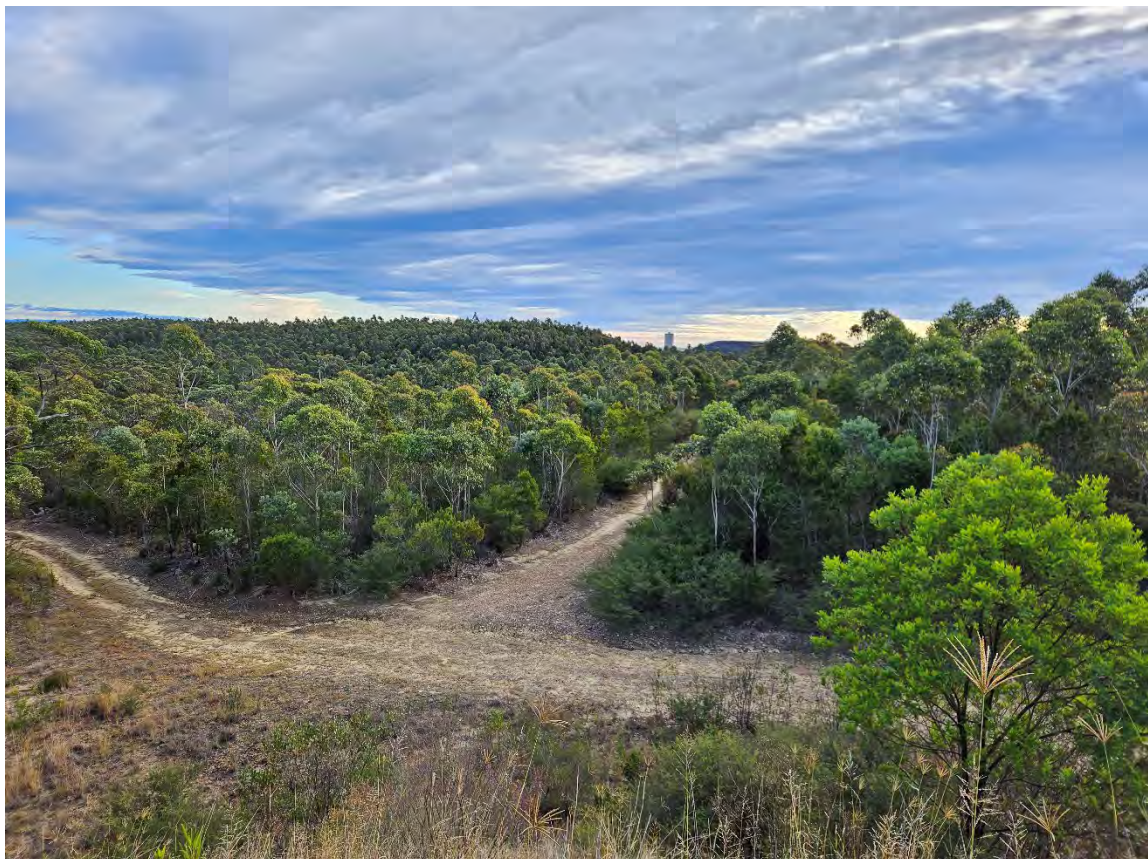
Plate 11: Stage 2 emplacement rehabilitation FY23 (Seeded in 2007)

The success of the rehabilitation in Stage 2 is shown in Plate 11. Progress of rehabilitation in the CWEA is detailed in the Annual CWEA Monitoring Report (See Appendix 7).

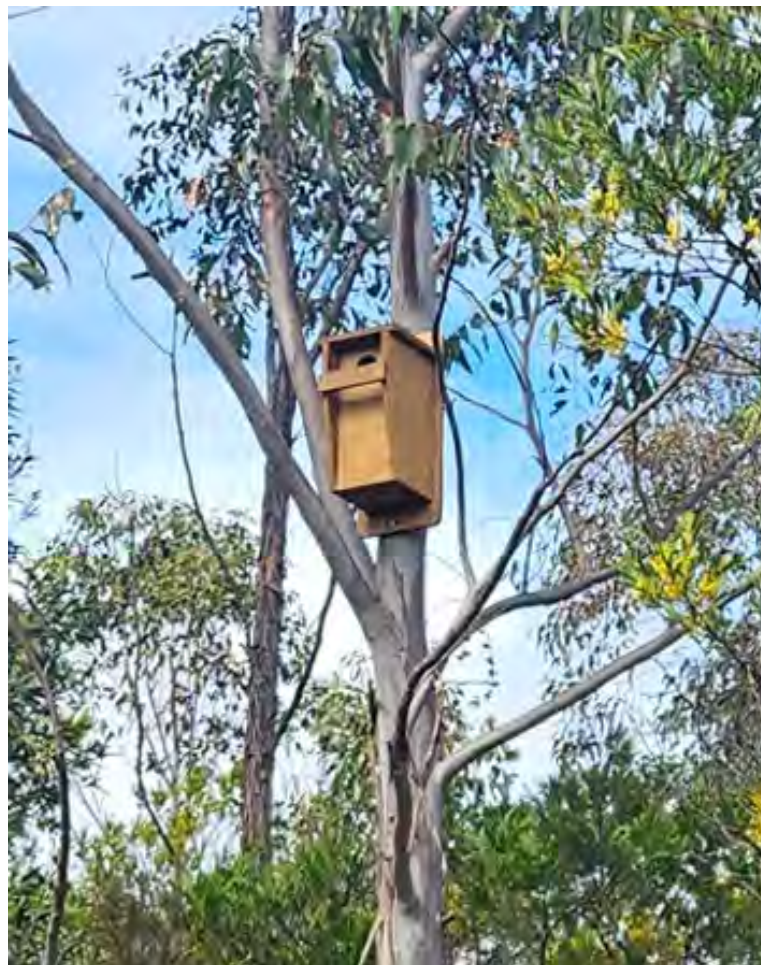
Plate 12: Small Parrot nest box installed in a Eucalypt in the Stage 1 Rehabilitation Area

Eight timber nest box habitats were installed in the CWEA rehabilitation during the reporting period. The nest boxes were placed at various heights (5 – 10 m) depending on type and were attached to existing mature trees. Individual habitats will provide shelter for Small Parrots, Large Owls/Cockatoos, Barn Owls, Brushtail/Ringtail Possums and Micro Bats. The nest box shown in Plate 12 is for a Small Parrot.
