DENDROBIUM MINE

End of Panel Groundwater Assessment for Longwall 18 (Area 3B)

HGEO Pty Ltd
Date: September 2022
Project number: J21543
Report: D22191

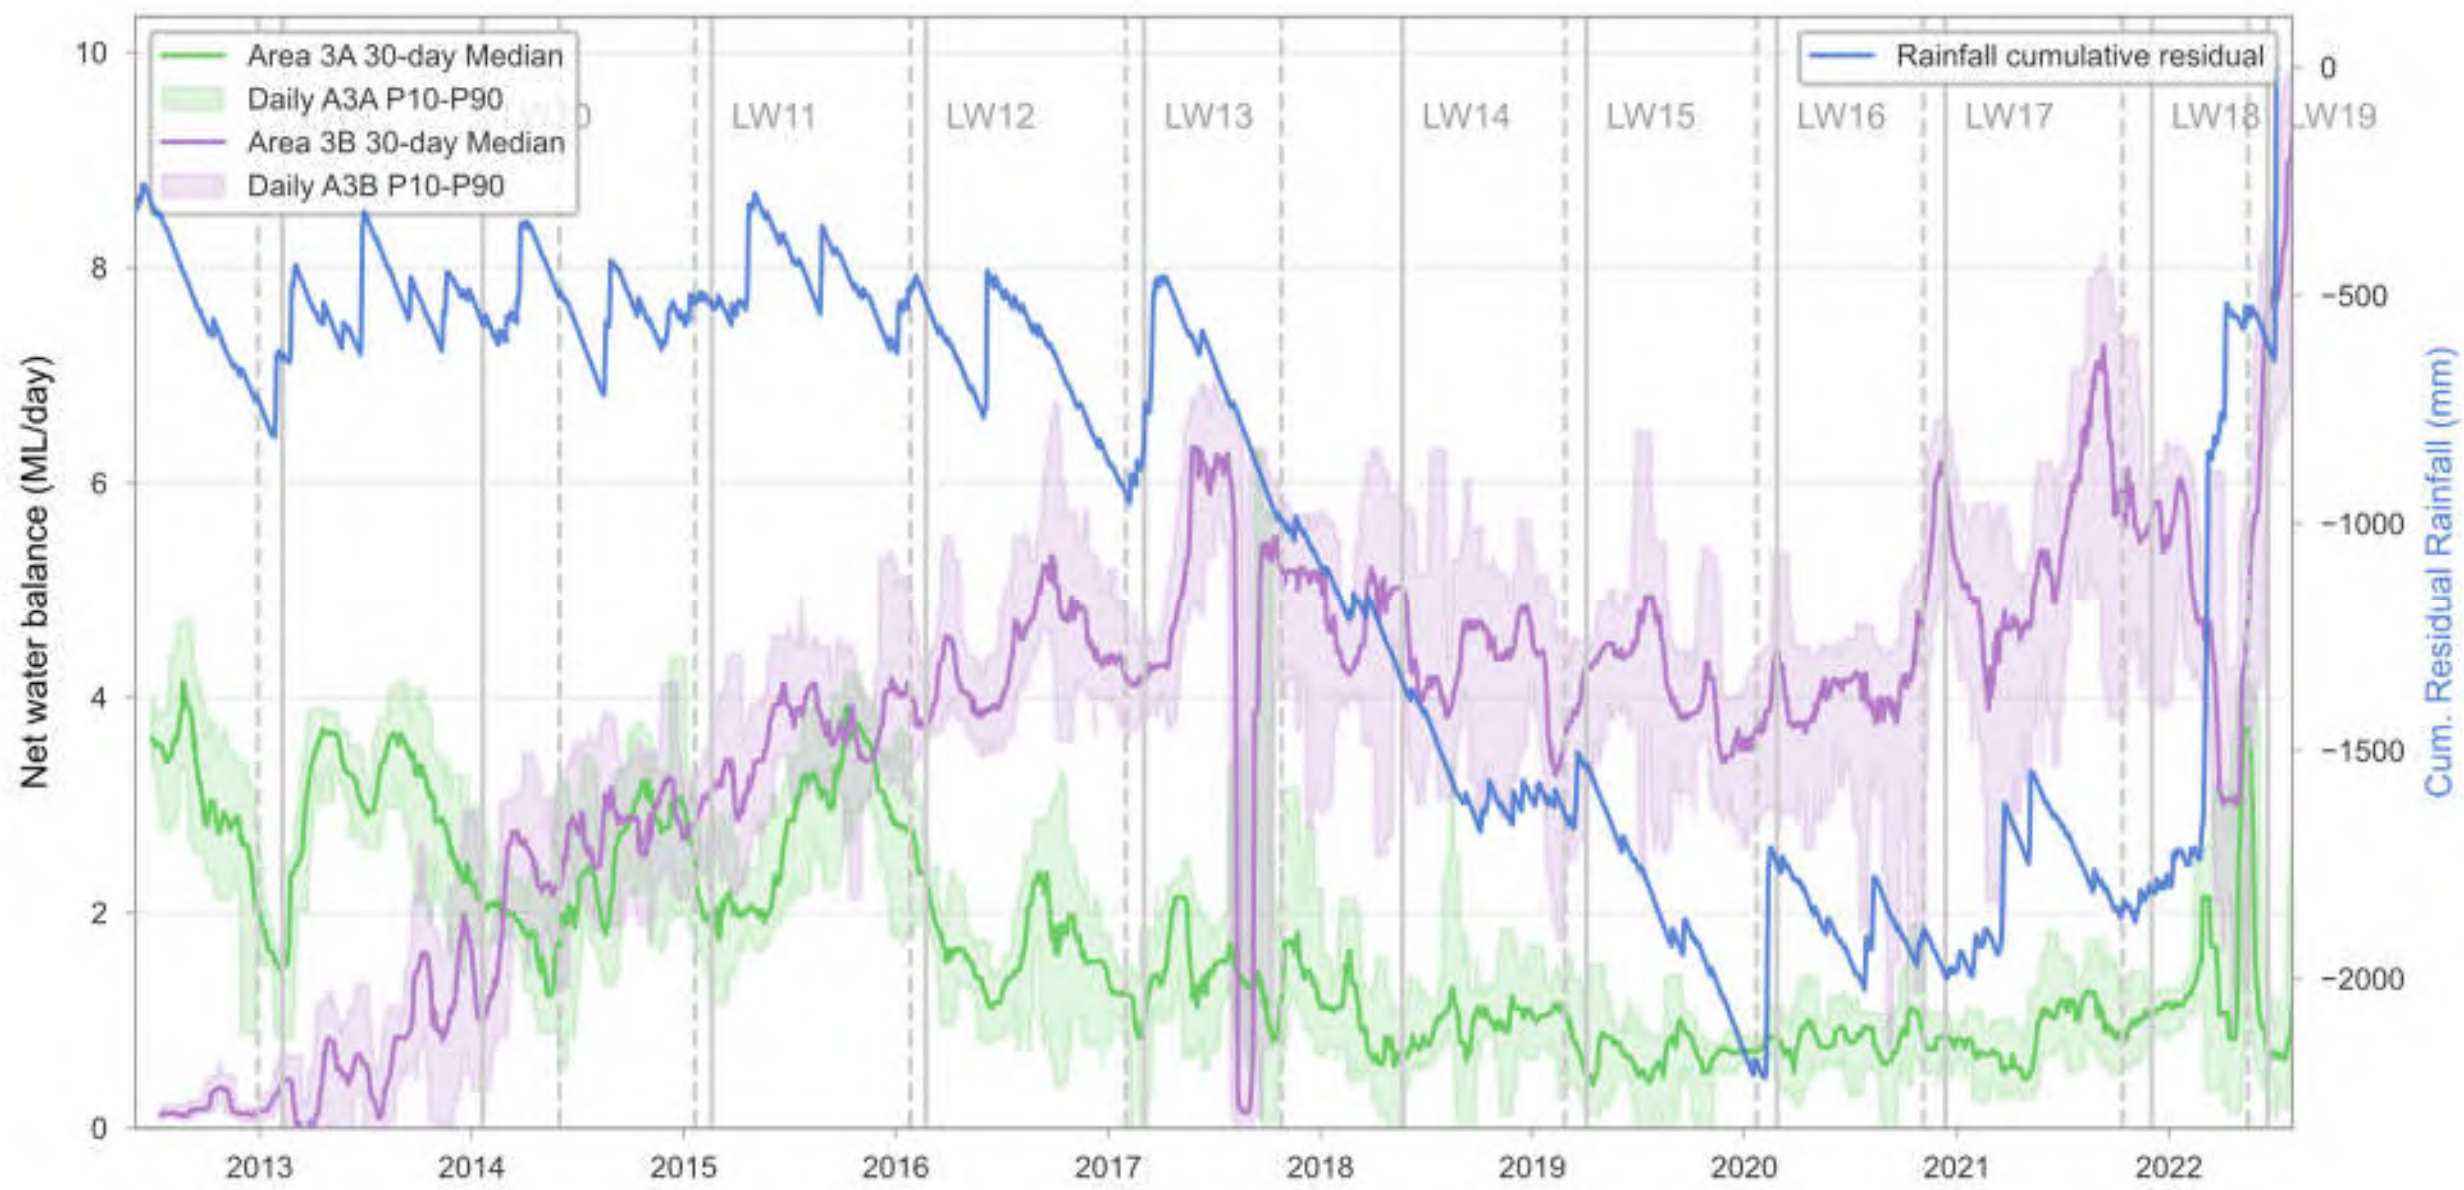
Figure 7. Groundwater inflow to the mine for Areas 3A and 3B (ML/d)

The mine water balances for Areas 3A and 3B are shown in Figure 7. Groundwater ingress to Area 3B increased steadily since the start of mining in that area (2013), initially correlating with the total area mined. Inflows to Area 3B plateaued and declined between 2017 and 2020, corresponding to the severe drought in south eastern Australia during that time. Since the start of 2020, the water balance for Area 3B has trended higher, correlating with the higher-than-average rainfall over the last two years. As of Longwall 12, peaks in inflow to Area 3B appear to correlate with periods of high rainfall with a lag time of between two and three months. Prior to Longwall 12, the influence of rainfall on the water balance was less distinct.

Groundwater ingress to Area 3A has declined by more than 50% as mining has progressed in Area 3B. The correlation of inflow peaks to major rainfall events in Area 3A has become less distinct since the end of Longwall 12.

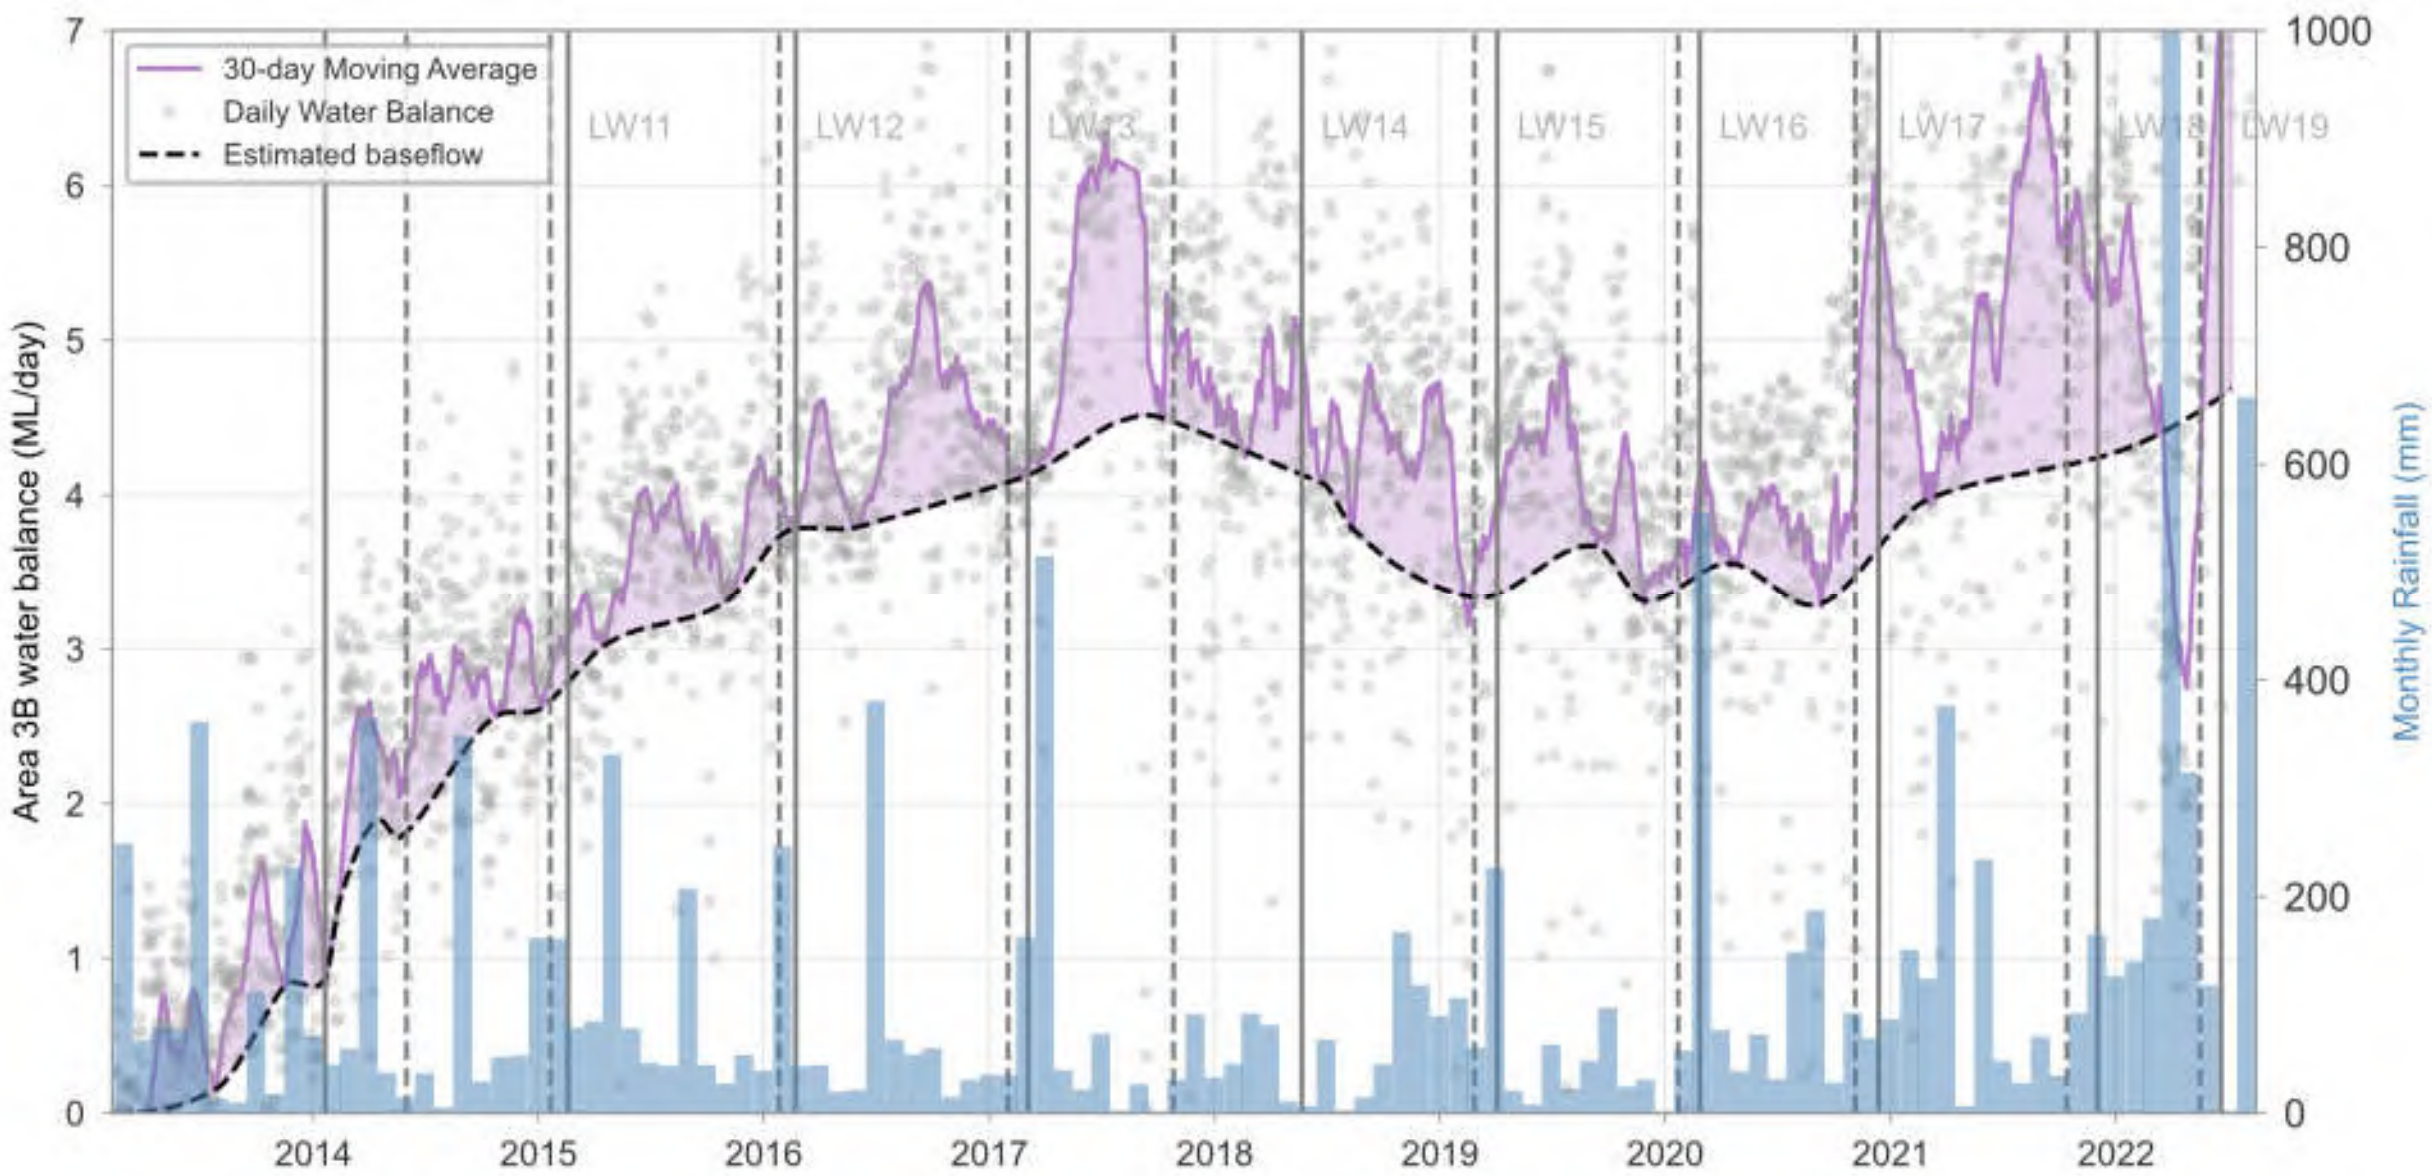
Figure 8. Estimate of potential surface water component to Area 3B water balance

A base-flow separation analysis of Area 3B water balance data is shown in Figure 8. The daily water balance data (grey circles) is highly variable due to the nature of pumping cycles in the underground mine and the trend is best represented as a 30-day moving average (the blue line). The moving average clearly defines peaks in net mine inflow following large rainfall events, with a two to three-month delay. Since the end of Longwall 16 there have been two major peaks in water balance at Area 3B with a third currently underway, reflecting the higher-than-average rainfall during 2020 - 2022.

Applying digital stream baseflow separation filters to the water balance data is problematic due to the high variability of the data (including negative values). Therefore, the baseflow component has been approximated by interpolating between troughs in the 30-day moving average water balance. The potential rainfall-induced inflow component is defined by the difference between the two curves (blue shading). Using this method, the rainfall-induced component of inflow has averaged ~15% since the start of Longwall 12. The apparent contribution during Longwall 18 was just 8%, but is not representative due to the limited pumping from Area 3B in March-April 2022 as described above.

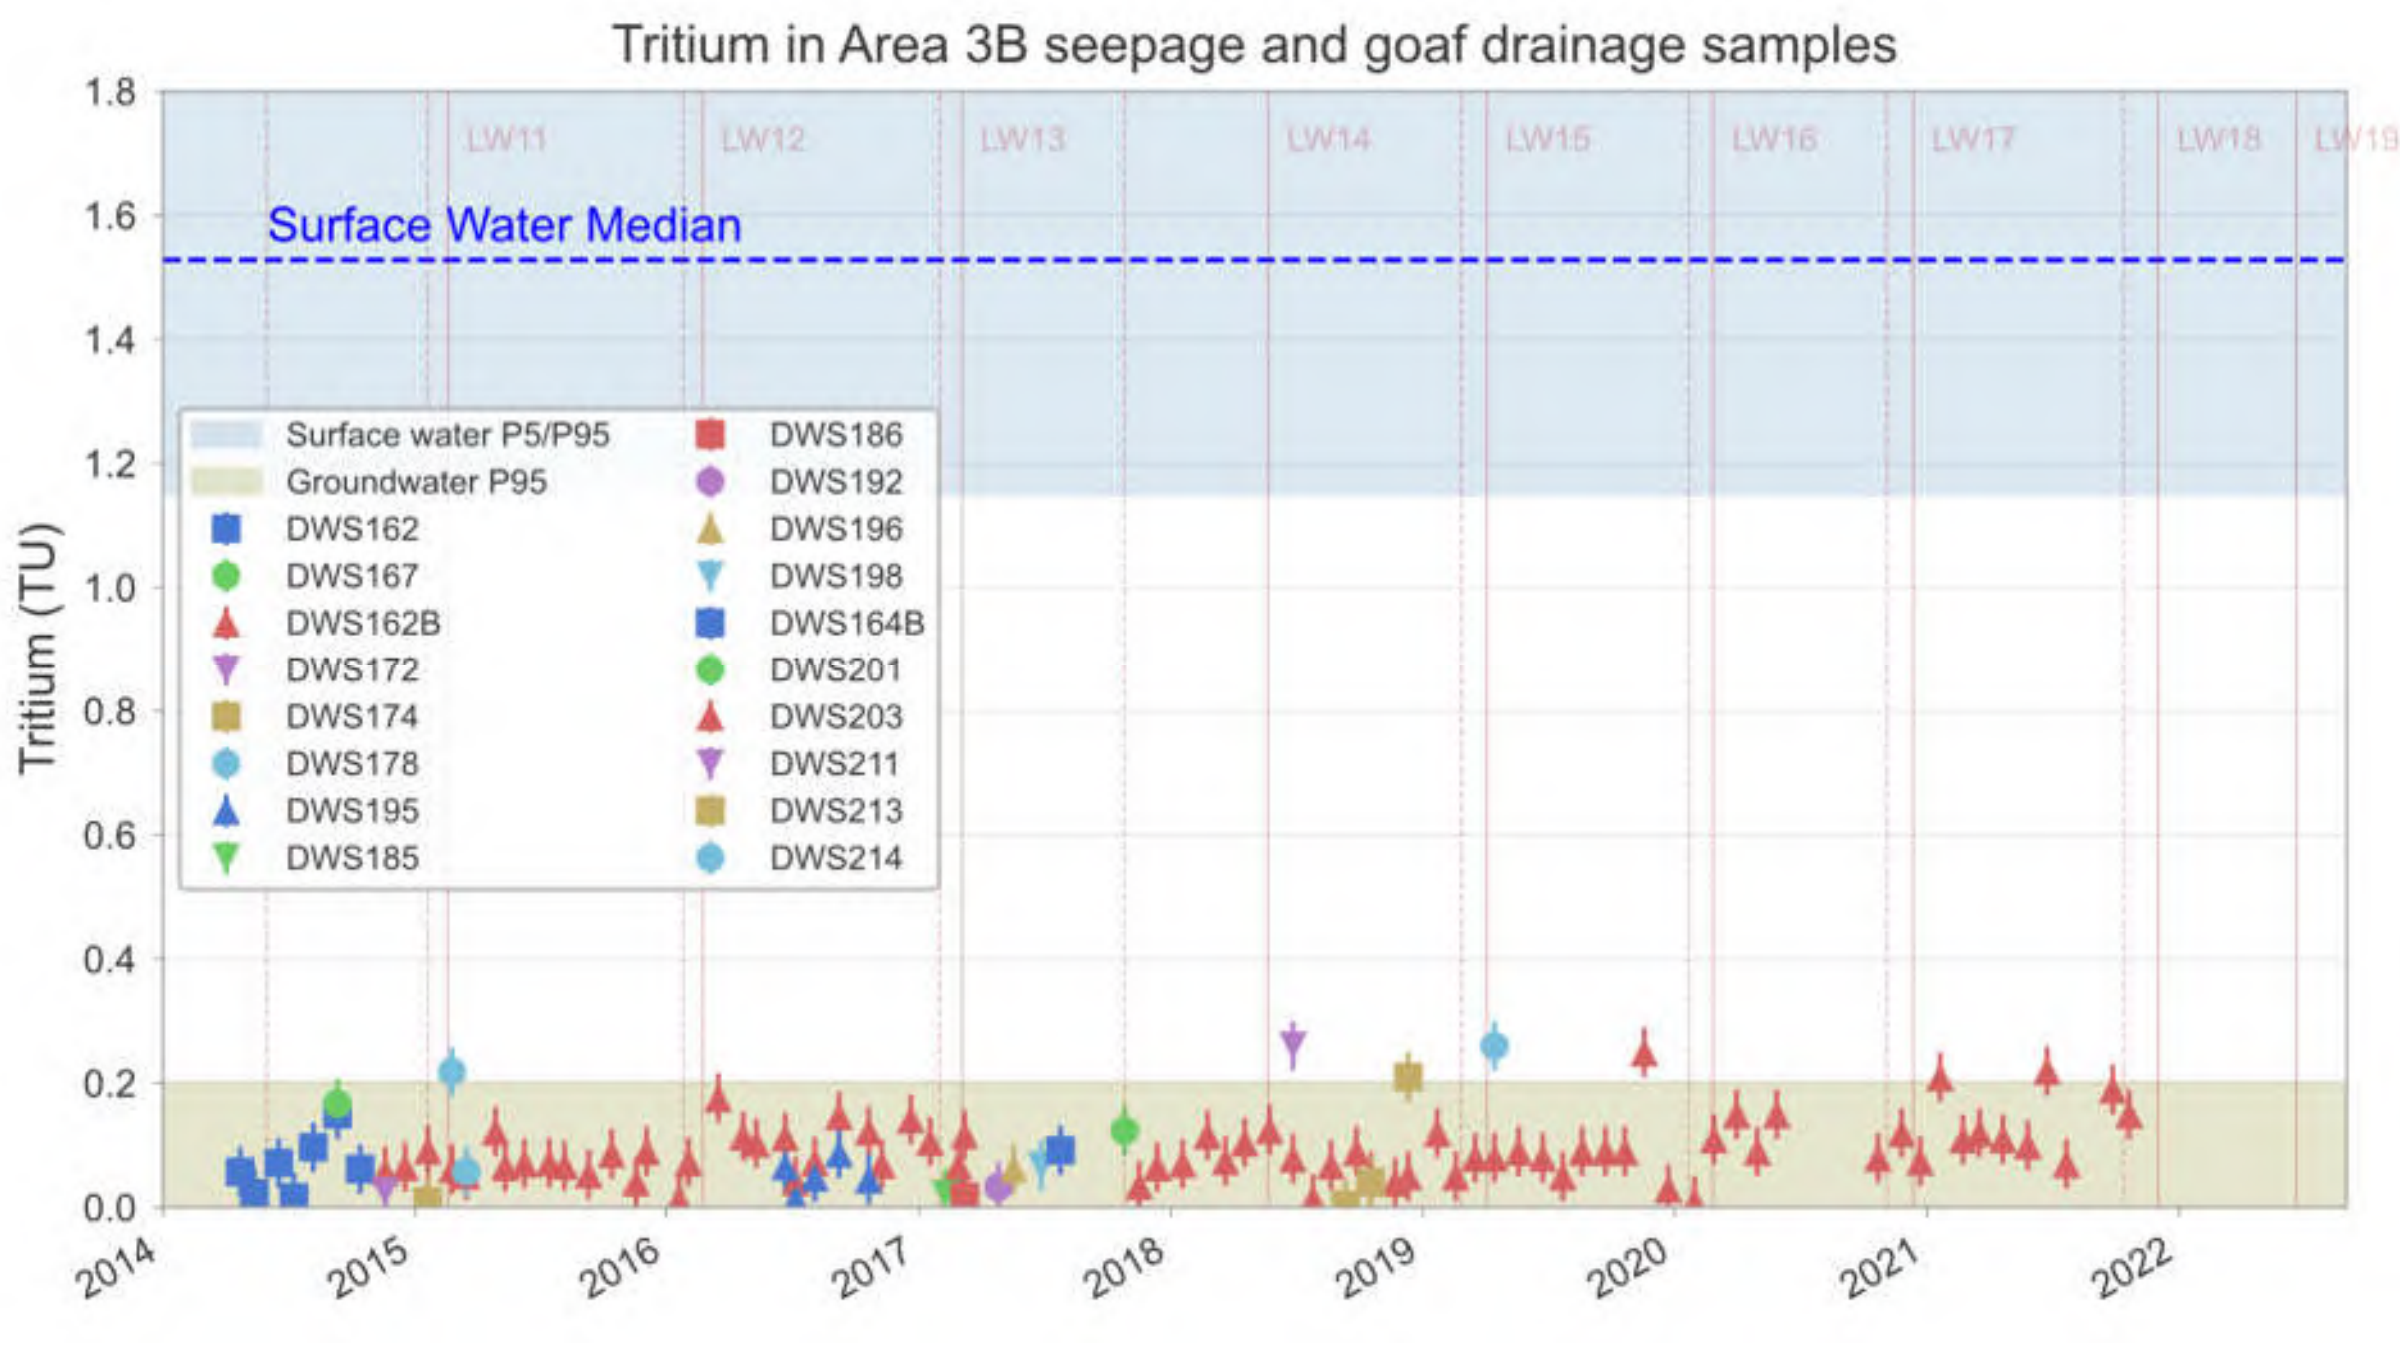
Figure 9. Tritium concentration in water samples from Area 3B

A timeseries plot of tritium in groundwater samples from Area 3B goaf (at the outflow point) is shown in Figure 9. Tritium in samples collected from Area 3B goaf outflow is typically within or close to baseline concentrations in deep groundwater (represented by the shaded area below 0.2 TU in Figure 9, from (HGEO, 2022), implying that the component of modern water in mine inflow to Area 3B is very low - likely less than 9% which is the 90th percentile estimate based on binary mixing calculations. Samples are collected approximately monthly; however, analysis and reporting of results from ANSTO can take 6 to 12 months. The most recent analysis of inflow water from Area 3B is of a sample collected on 21/10/2021, 6 weeks prior to the start of Longwall 18. The latest sample contained tritium at 0.15 TU, within the range of deep groundwater.

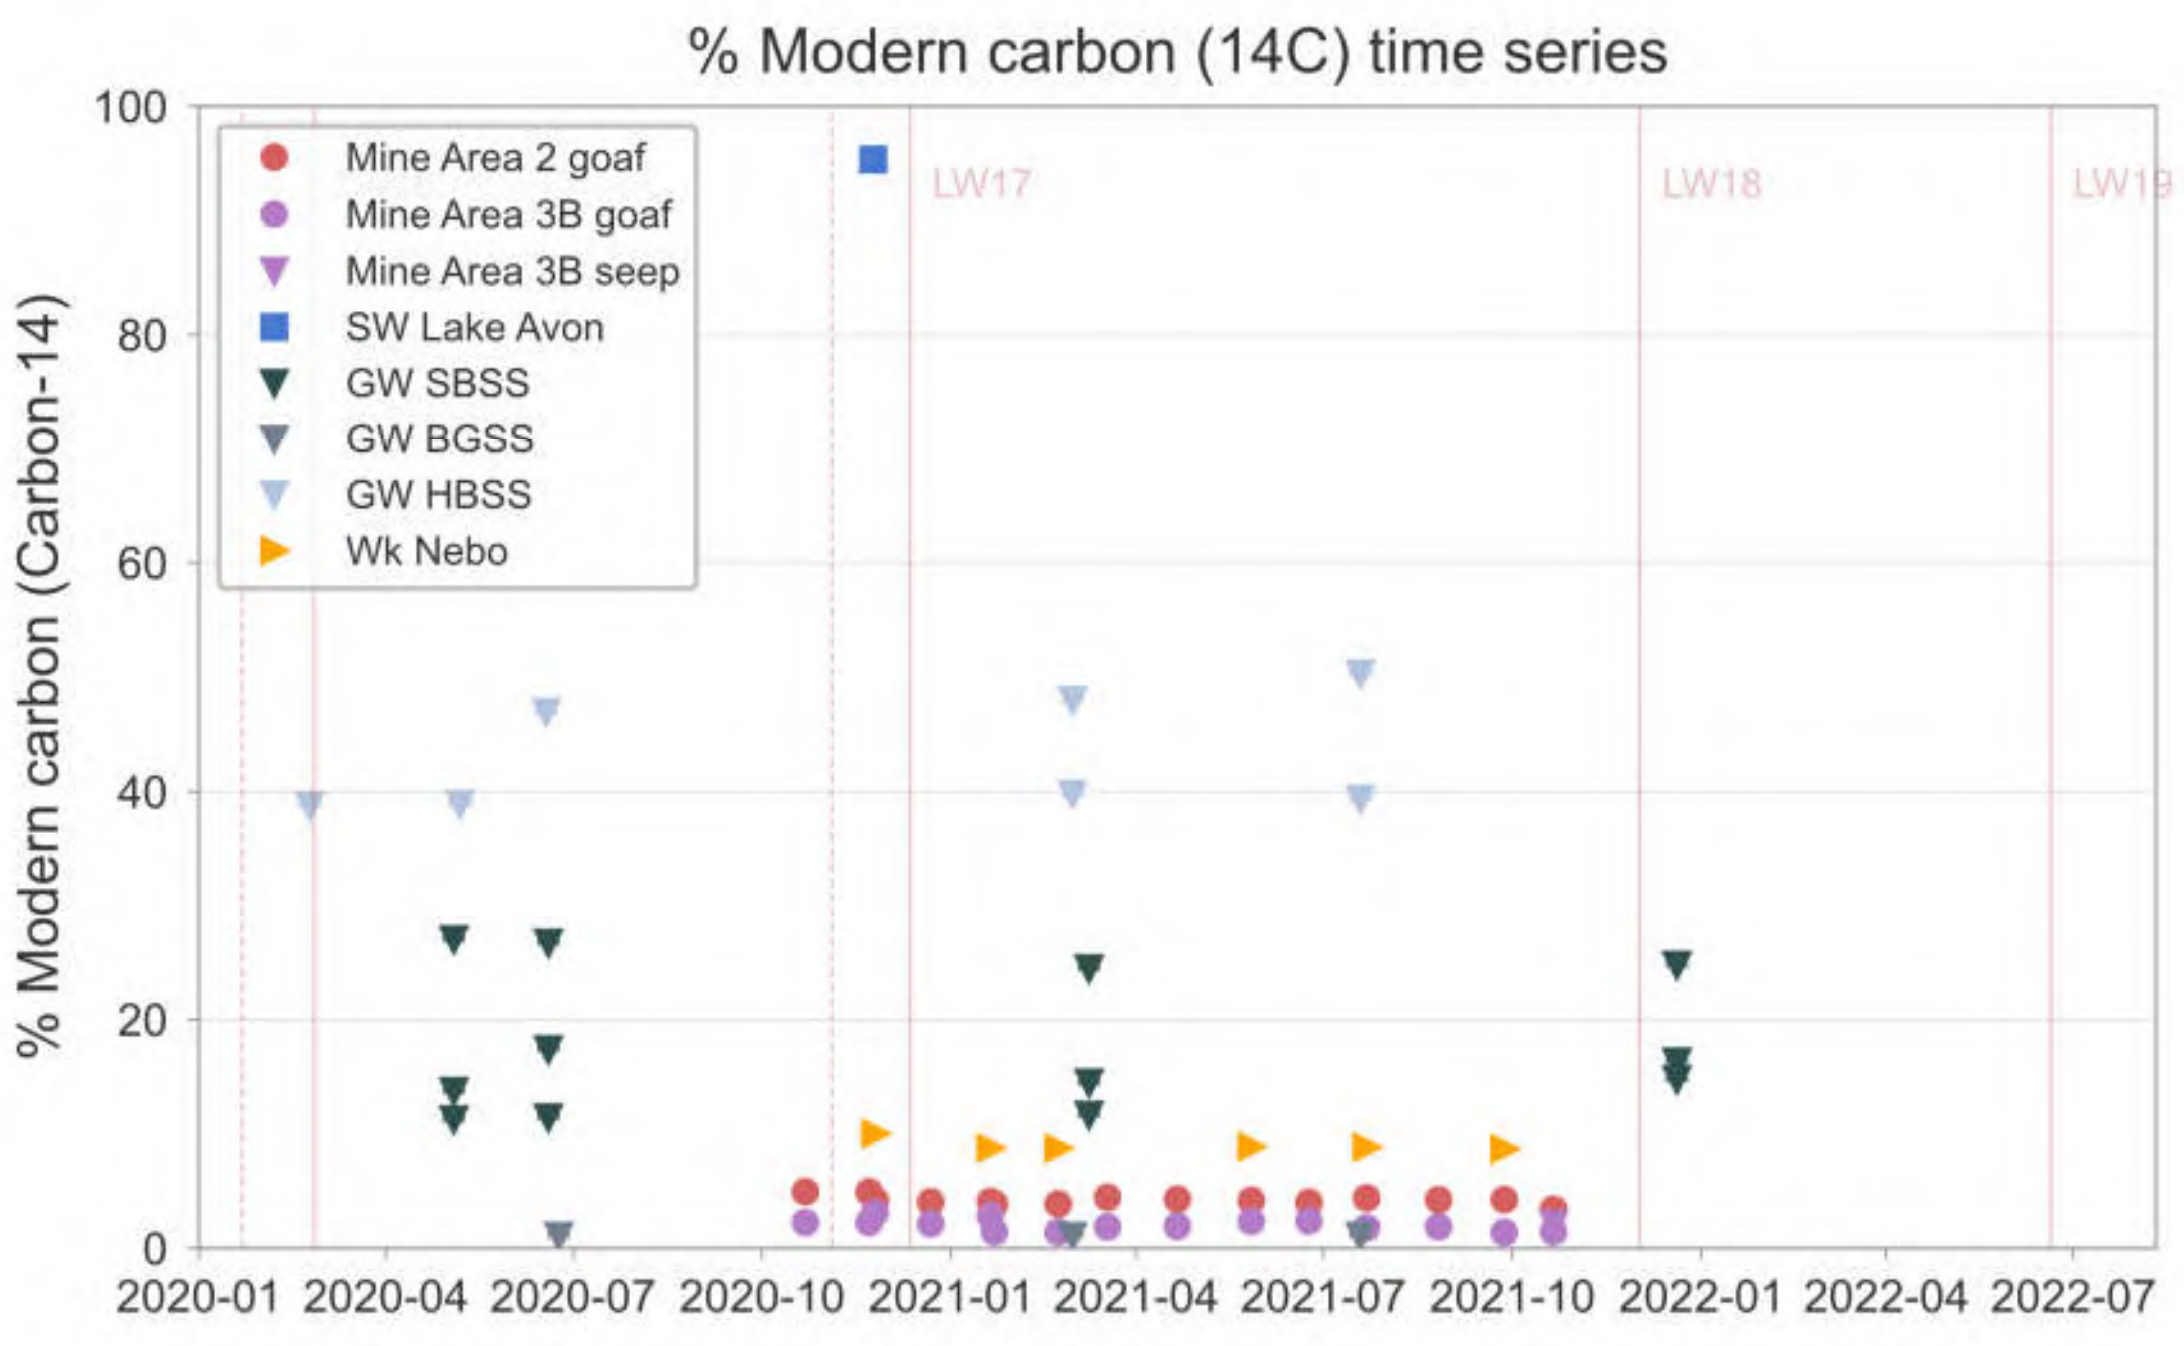
Figure 10. Timeseries of % modern carbon in mine water samples

Sixteen sample results have been received from Area 3B goaf inflow since 2020. A timeseries of all sample results is shown in Figure 10. Sample location prefixes are SW = surface water, GW = groundwater (bore sample), Wk = adjacent mine workings (specifically Nebo Mine workings used for water supply). All samples collected from the Area 3B goaf outflow tank (DWS203) have low pMC (≤ 3.1%) which, together with low corresponding tritium concentrations, implies that inflow to Area 3B is dominated by deep, old groundwater sources with a very small proportion of modern water. In contrast, samples from Hawkesbury Sandstone (HBSS) have a significantly higher modern carbon content.

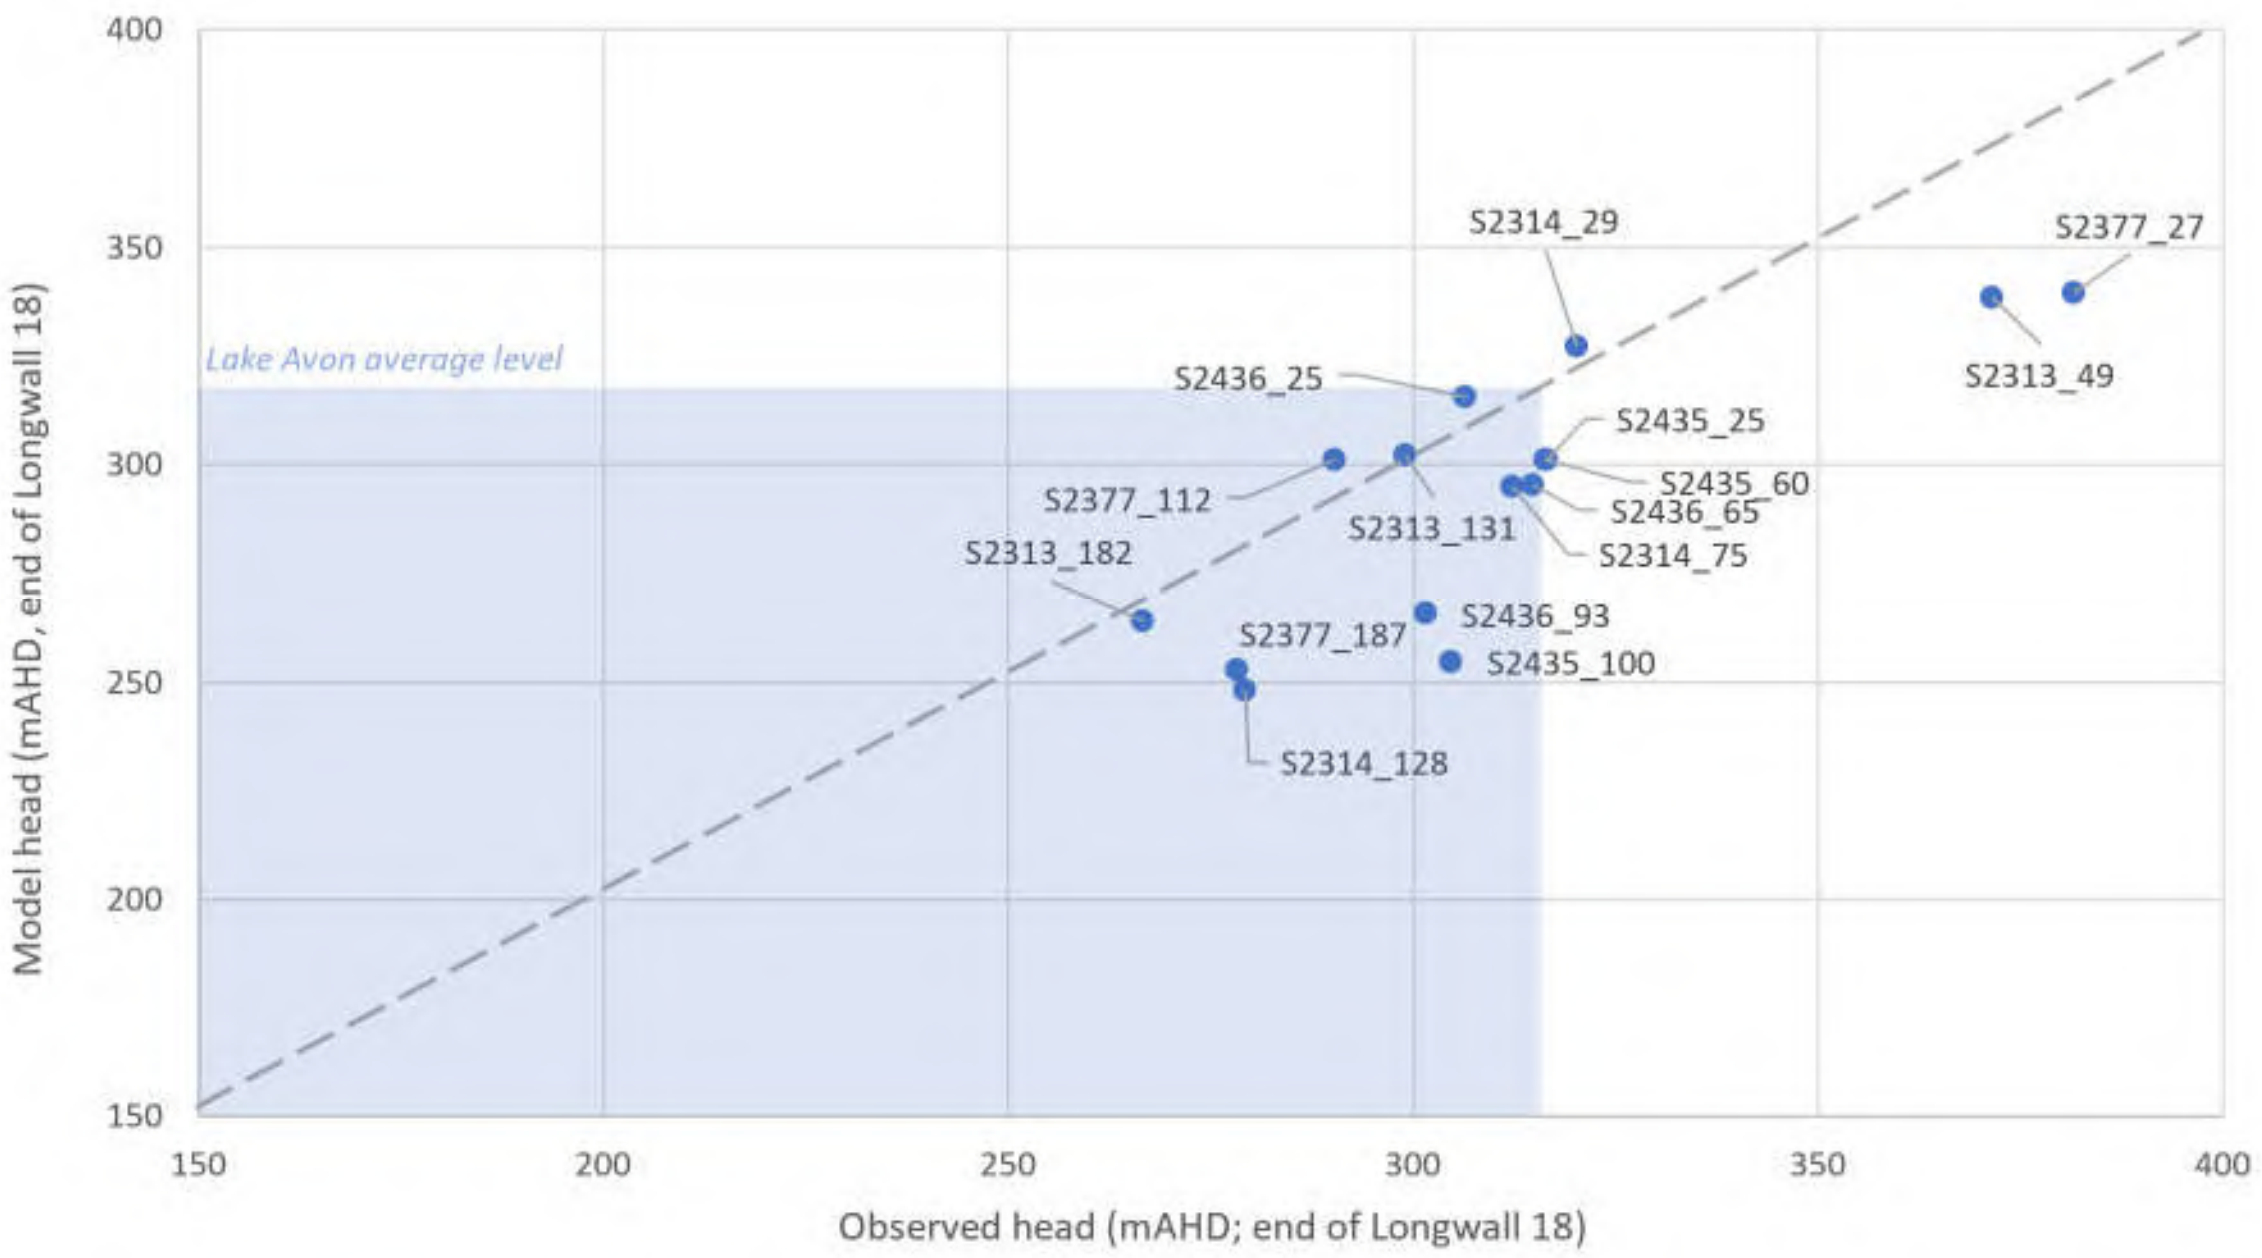
Figure 11. Modelled versus observed piezometric head for Avon Dam monitoring sites

A plot of model predicted piezometric head versus observed head at piezometers adjacent to lake Avon as of the end of Longwall 18 is shown in Figure 11. The plot shows that, for most piezometers, observed head is similar to, or higher than, the numerical model prediction. Therefore, the model predictions are generally accurate as of Longwall 18 or tend to over-estimate groundwater drawdown.

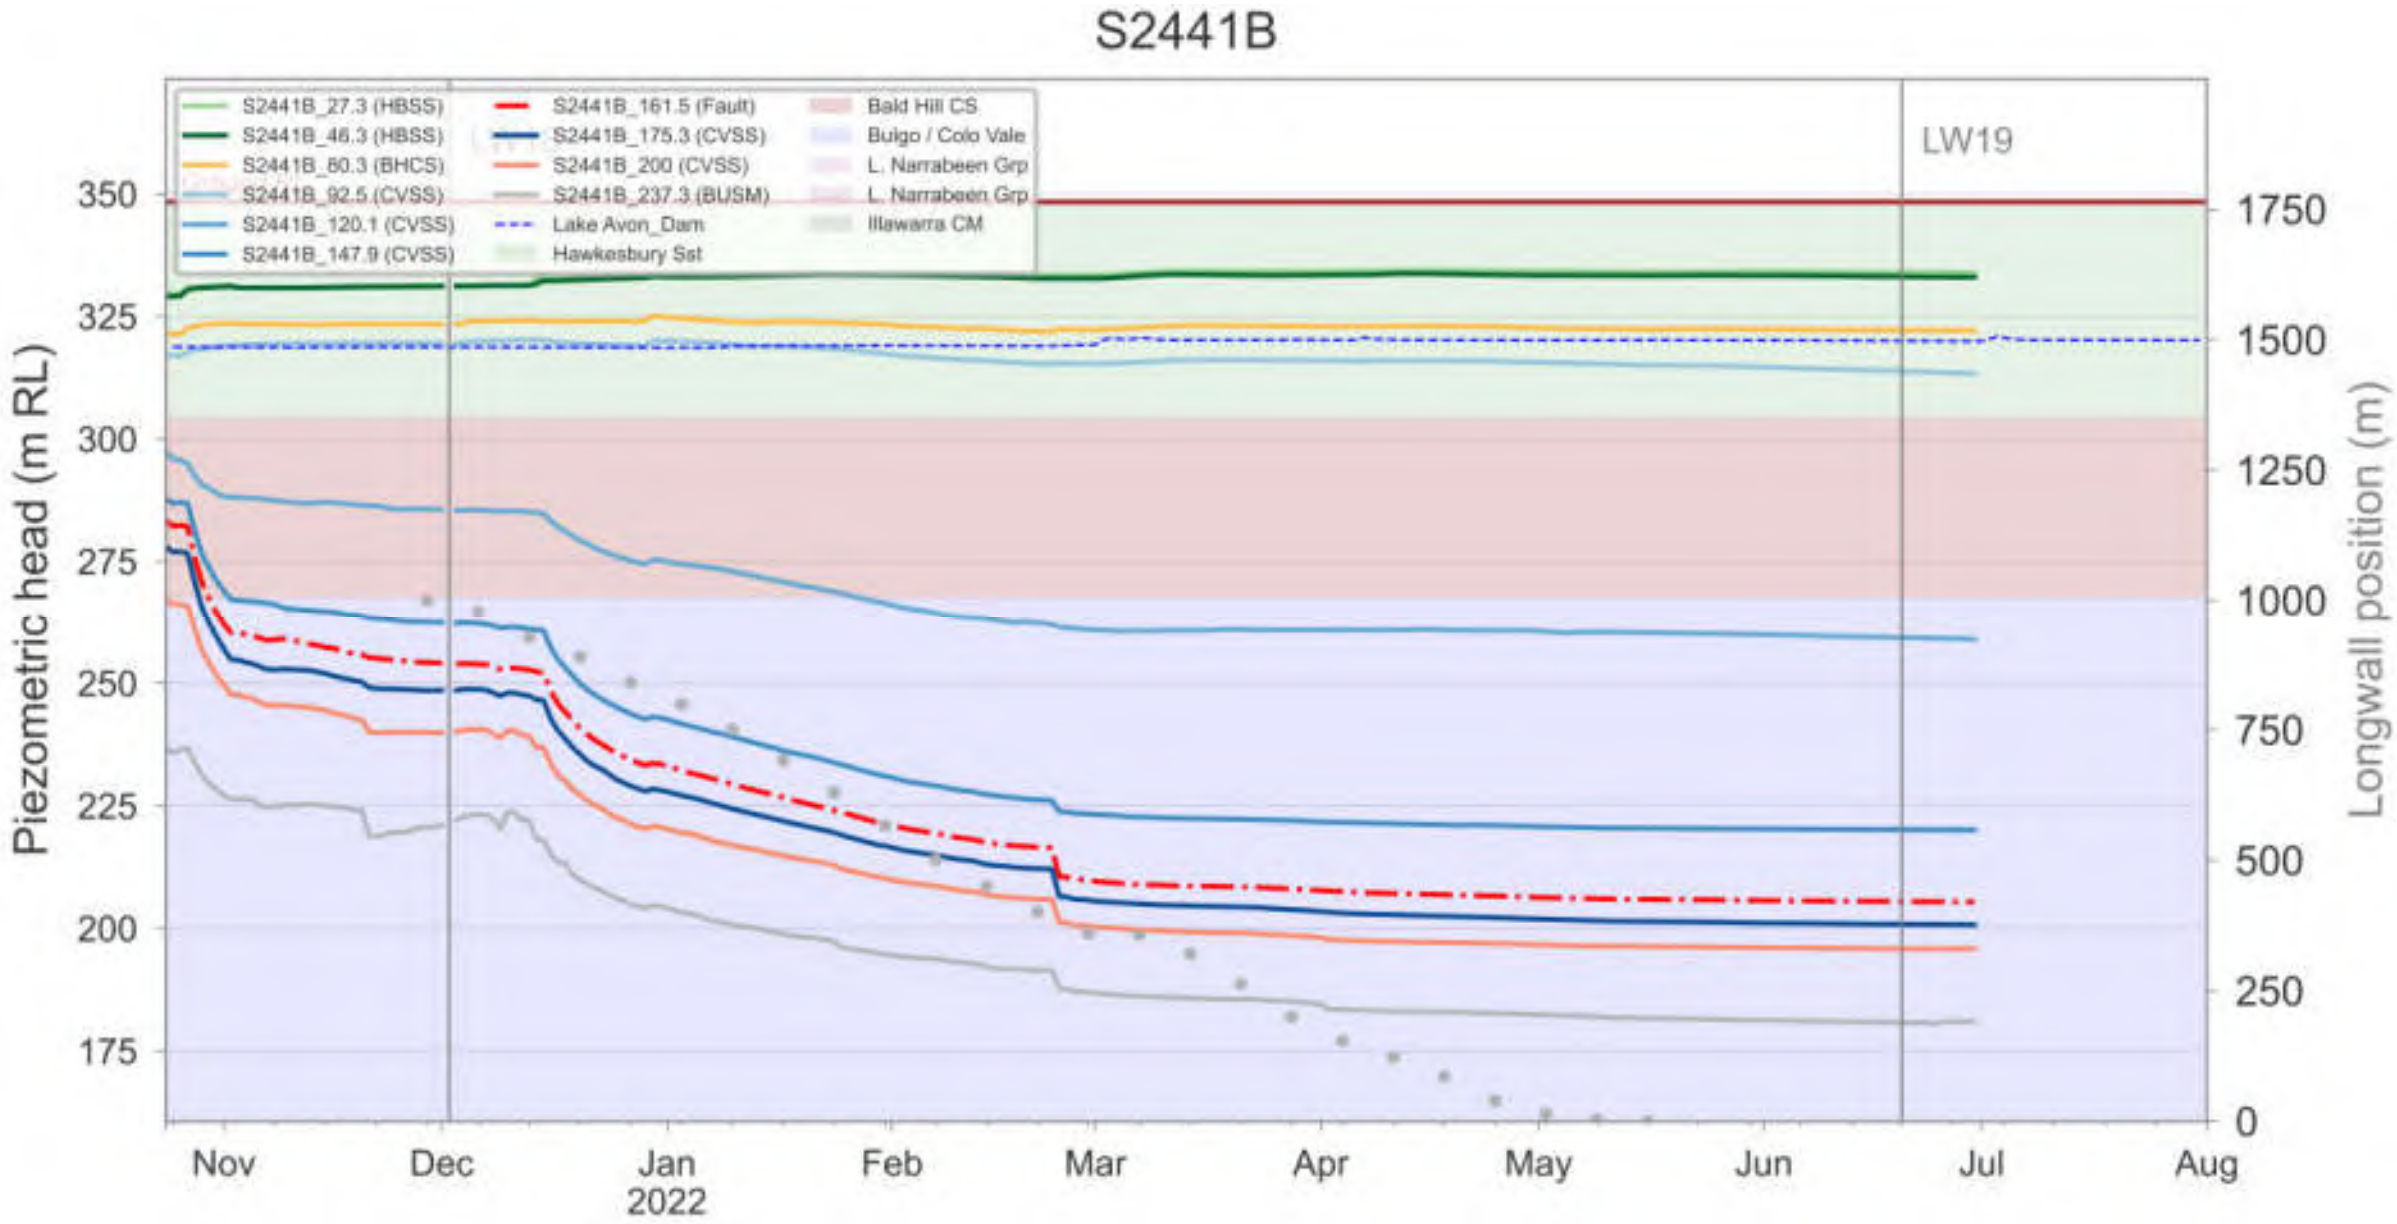
Figure 13. Groundwater hydrograph for Elouera fault monitoring bore S2441B (Site 1)

- Groundwater pressures in deeper strata show drawdown related to Area 3B, including Longwall 18 (and also previous mining at Elouera Mine immediately to the south). Drawdown is similar on both sides of the fault at the same elevation indicating that the fault is not a significant transverse barrier.

- At all three sites, there is no evidence for groundwater drawdown in shallow strata (HBSS and BACS); groundwater levels have generally increased over the course of Longwall 18, including at Site 3 (S2490) close to the projected surface trace of the fault.

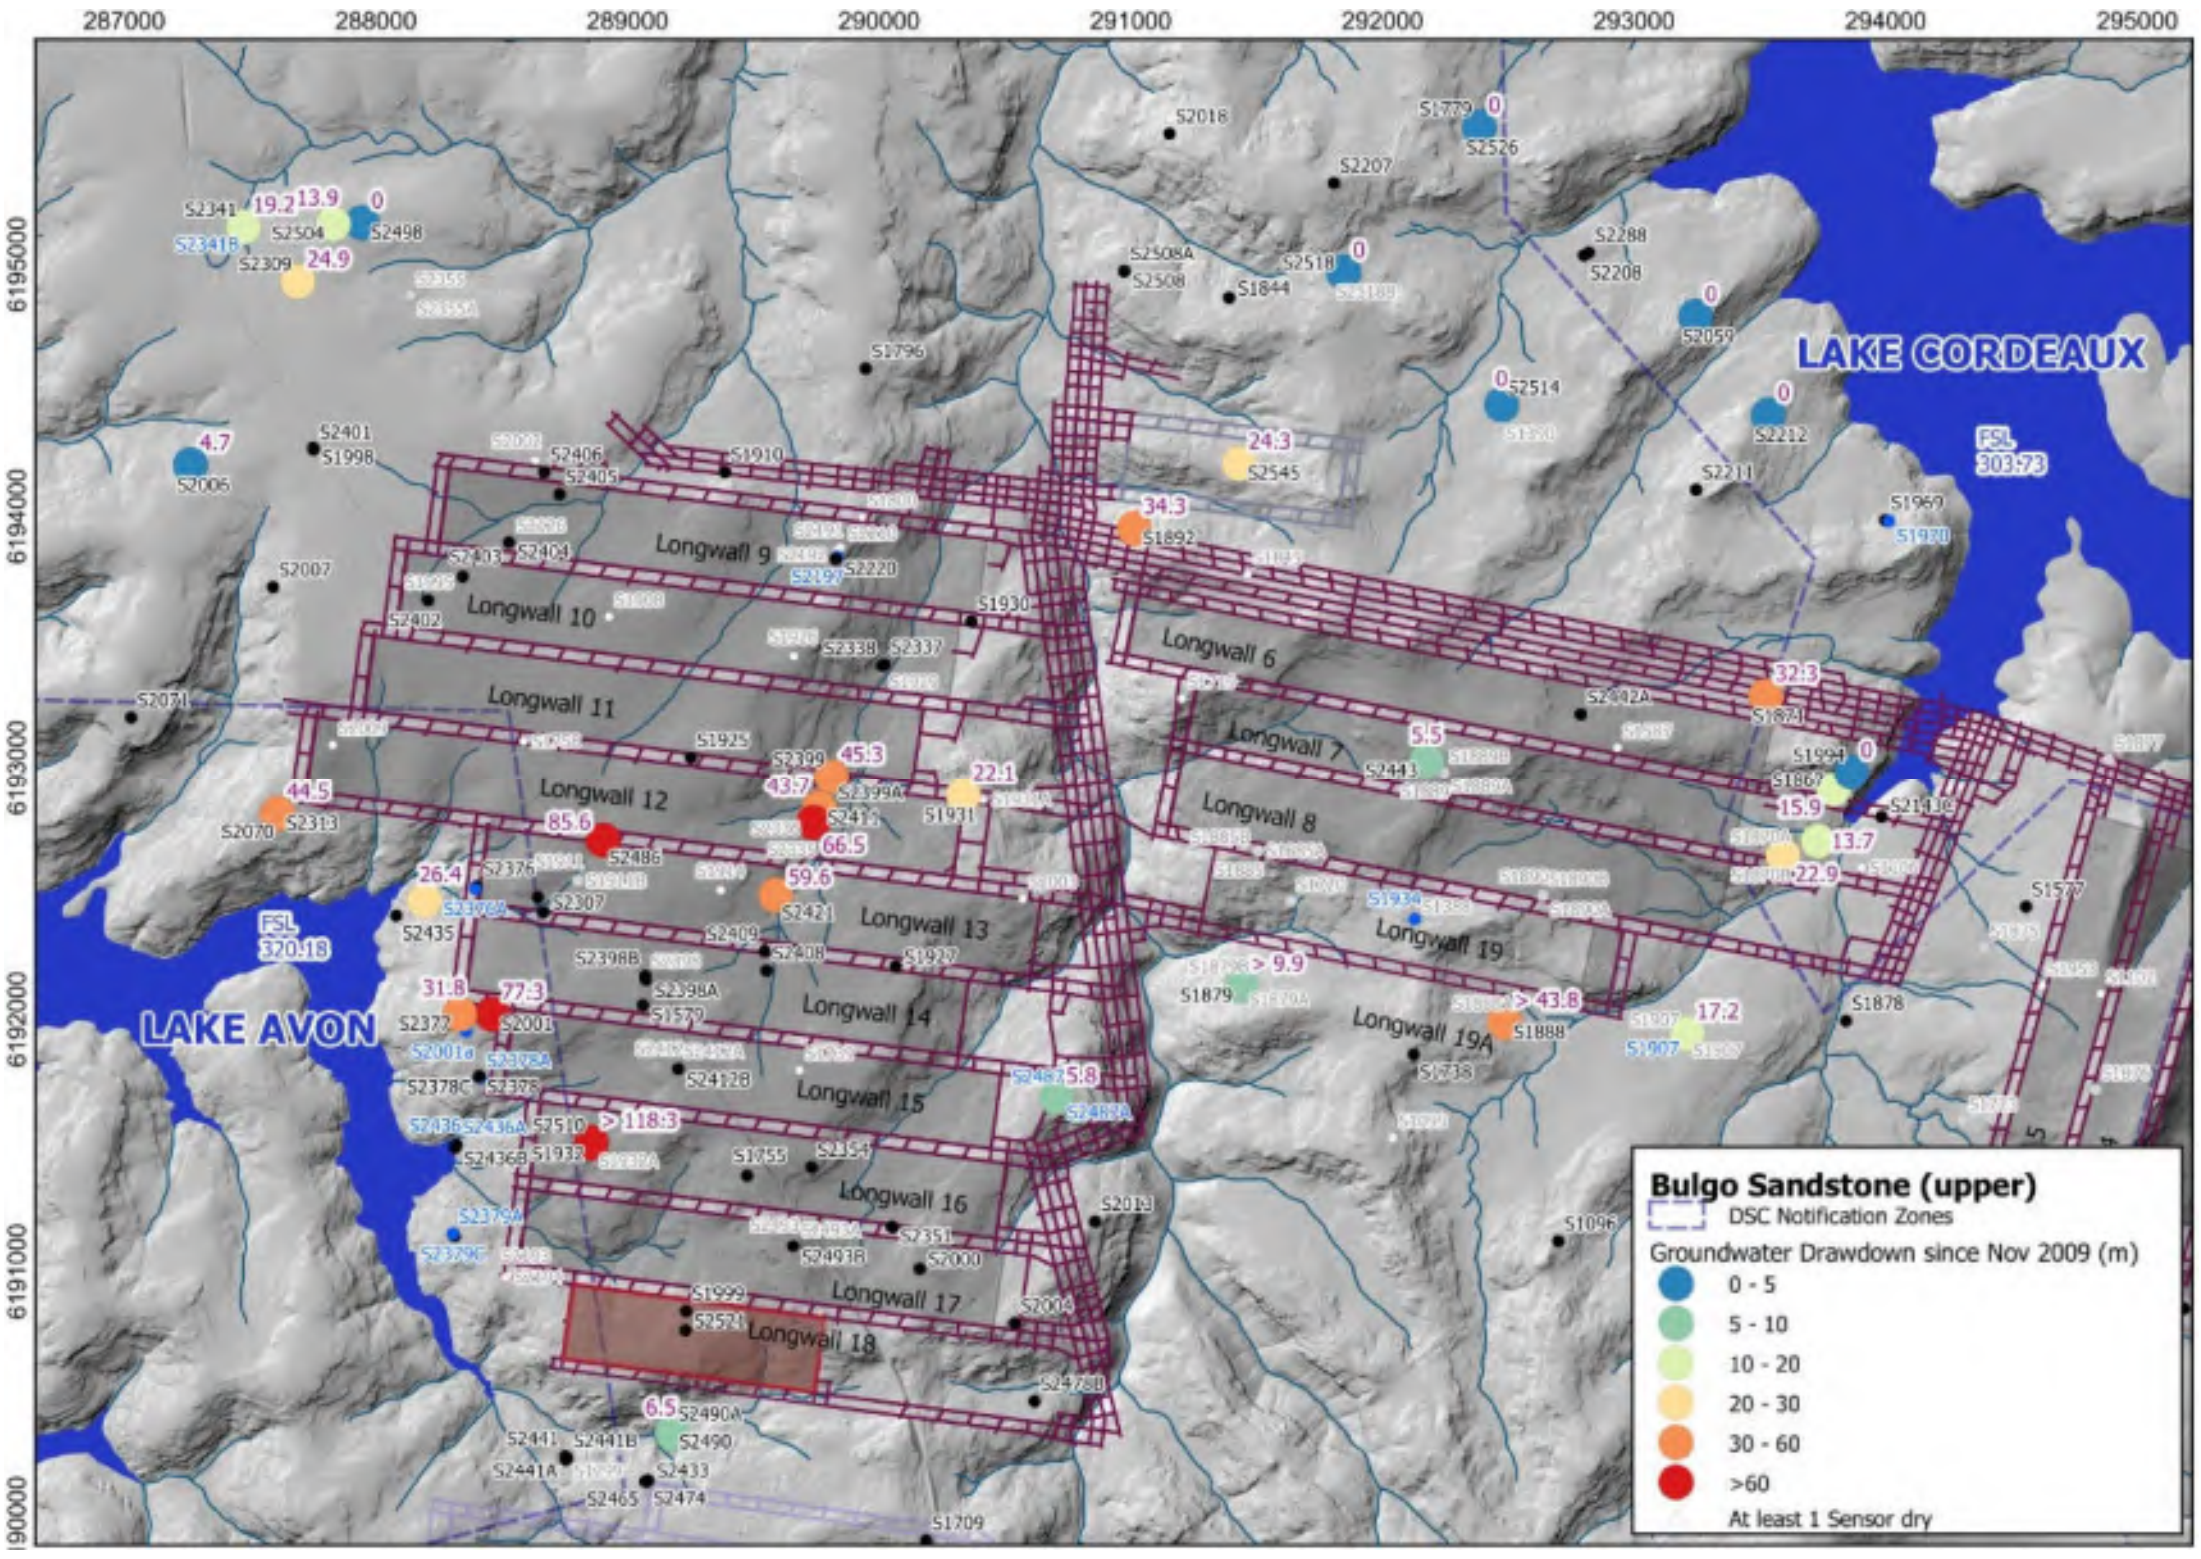
Figure 19. Drawdown in piezometric head in the upper Bulgo Sandstone (2009-2022)

Observations of piezometric head in the BGSS are mainly restricted to near the extracted and planned longwalls (Figure 19 and Figure 20). Drawdown exceeding 100 m is estimated at several bores (e.g. S2486, S2510). Drawdown decreases away from the mined areas such that less than 30 m of drawdown is estimated at distances of 1.2 km or more north of Area 3B (S2341, S2006). Significant depressurisation is expected in the BGSS (and units below) due to subsidence-related fracturing extending upwards from the goaf into these units.
