DENDROBIUM MINE

End of Panel Groundwater Assessment for Longwall 18 (Area 3B)

HGEO Pty Ltd
Date: September 2022
Project number: J21543
Report: D22191

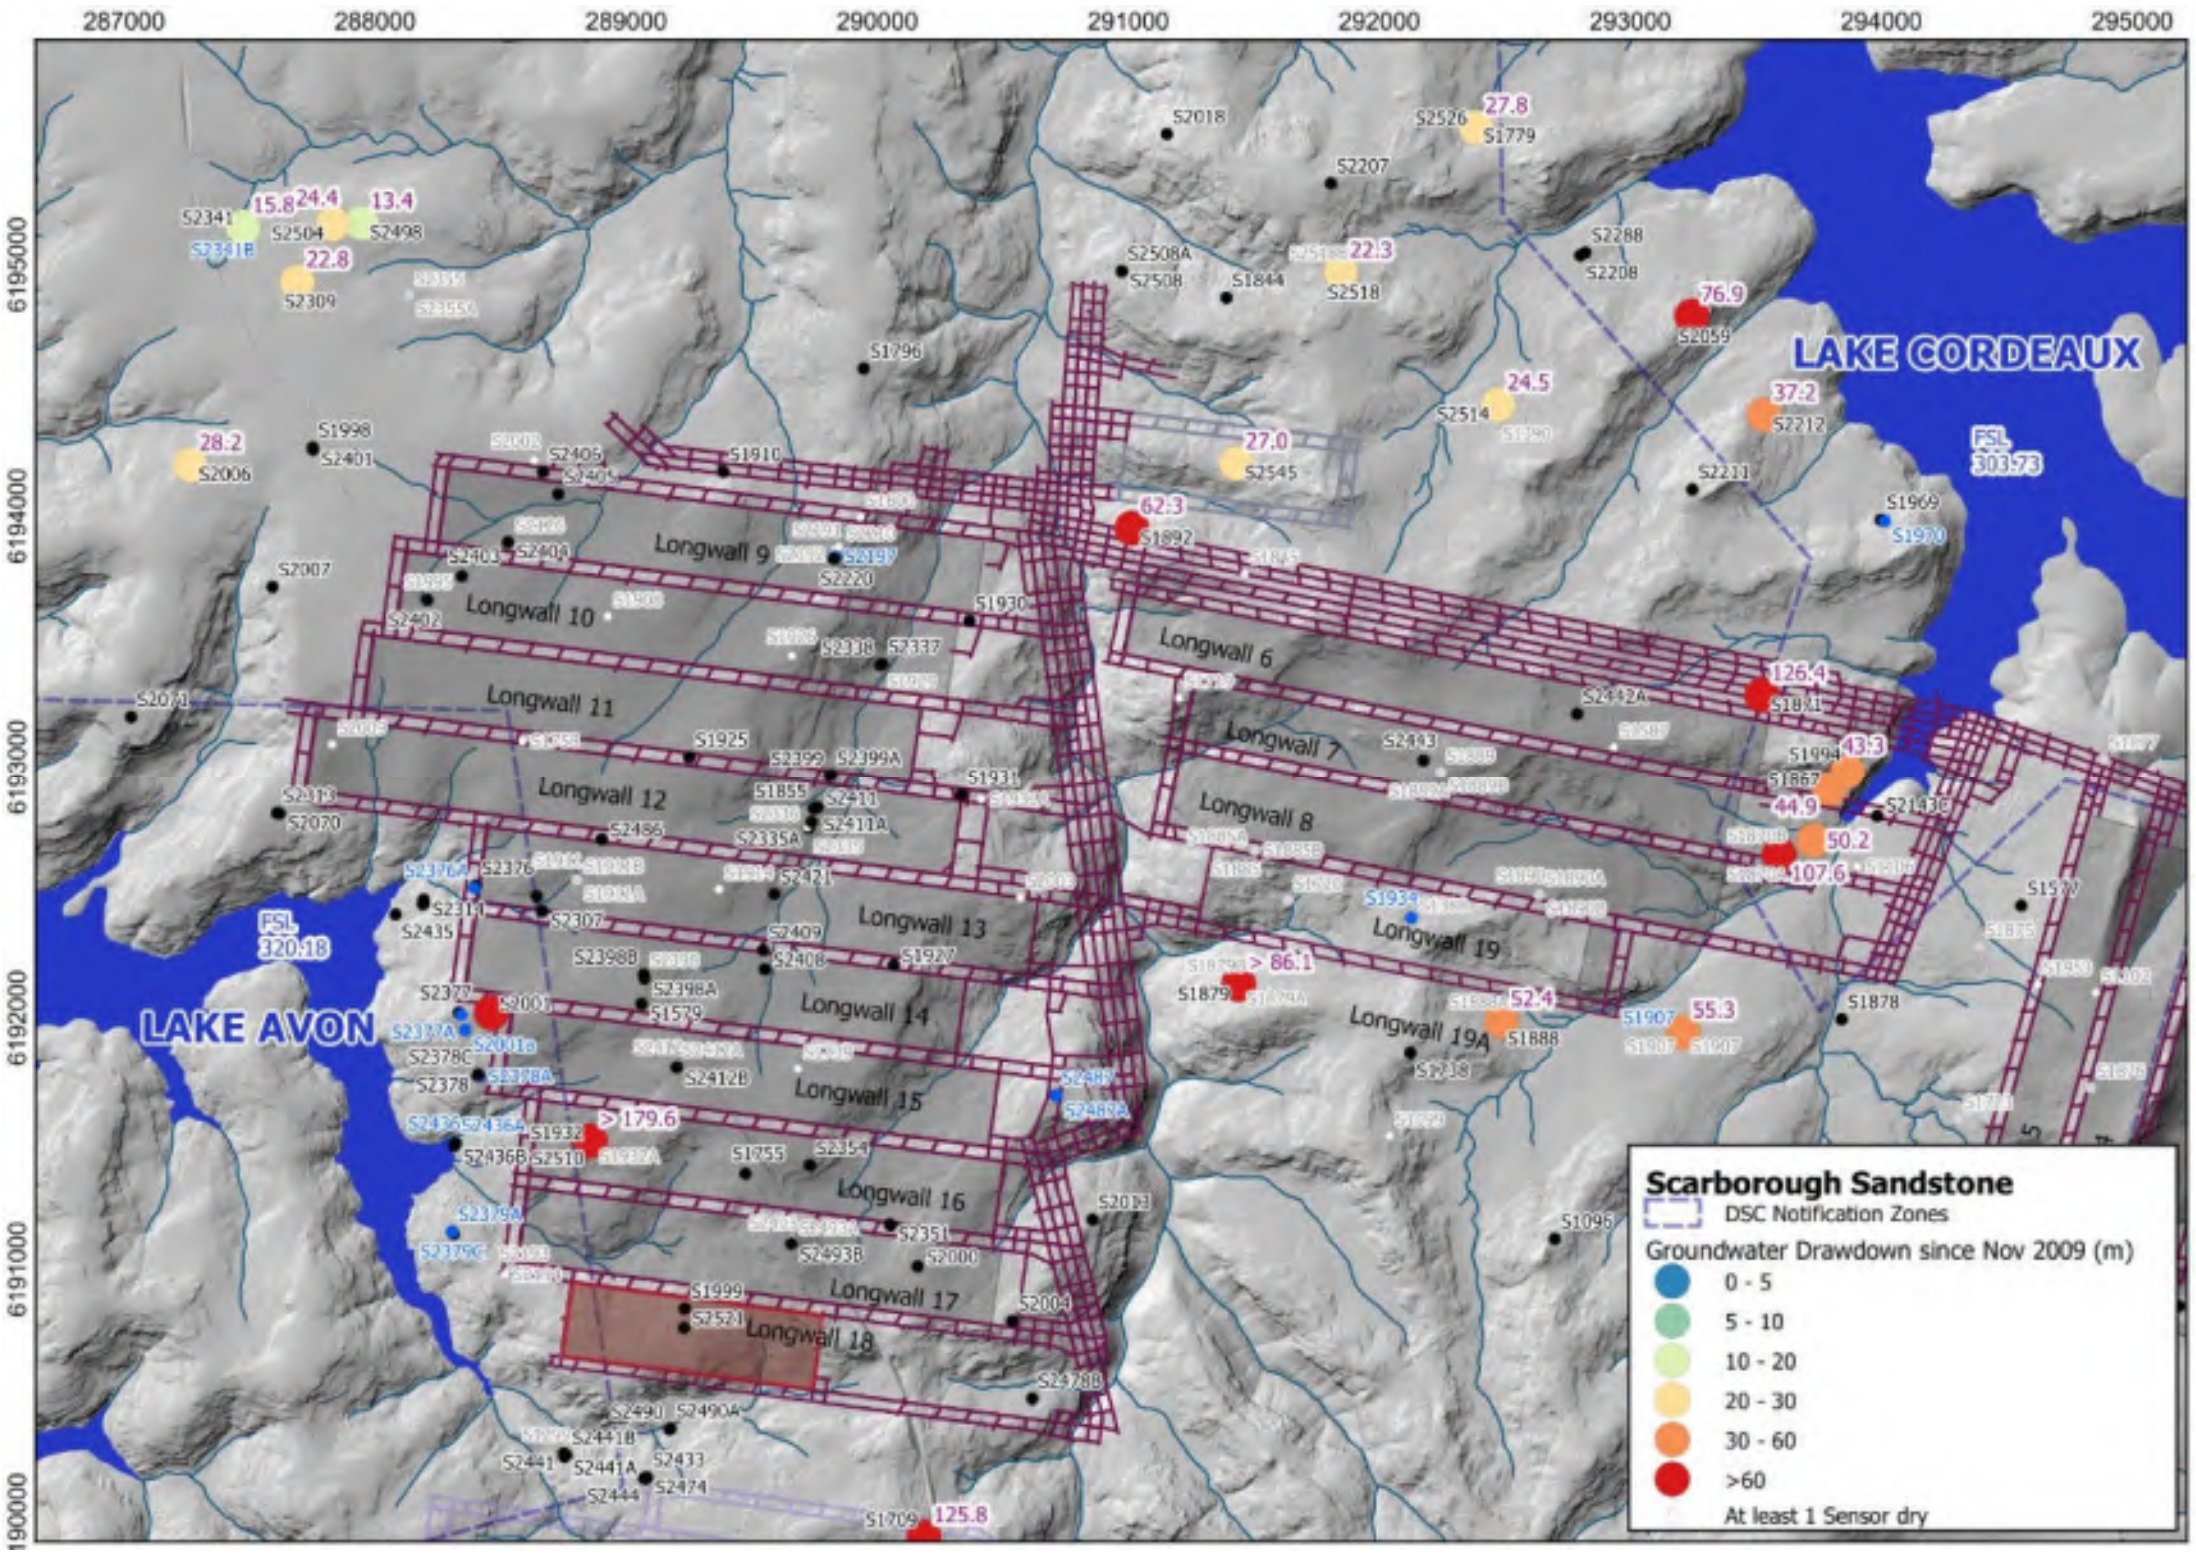
Figure 21. Drawdown in piezometric head in the Scarborough Sandstone (2009-2022)

The SBSS (Figure 21) is depressurised in the vicinity of the mined areas. As with the BGSS, estimated drawdown decreases to the northwest with distance from Area 3B; however, depressurisation of ~77 m is observed to the northeast (S2059) due to residual drawdown from neighbouring mines.

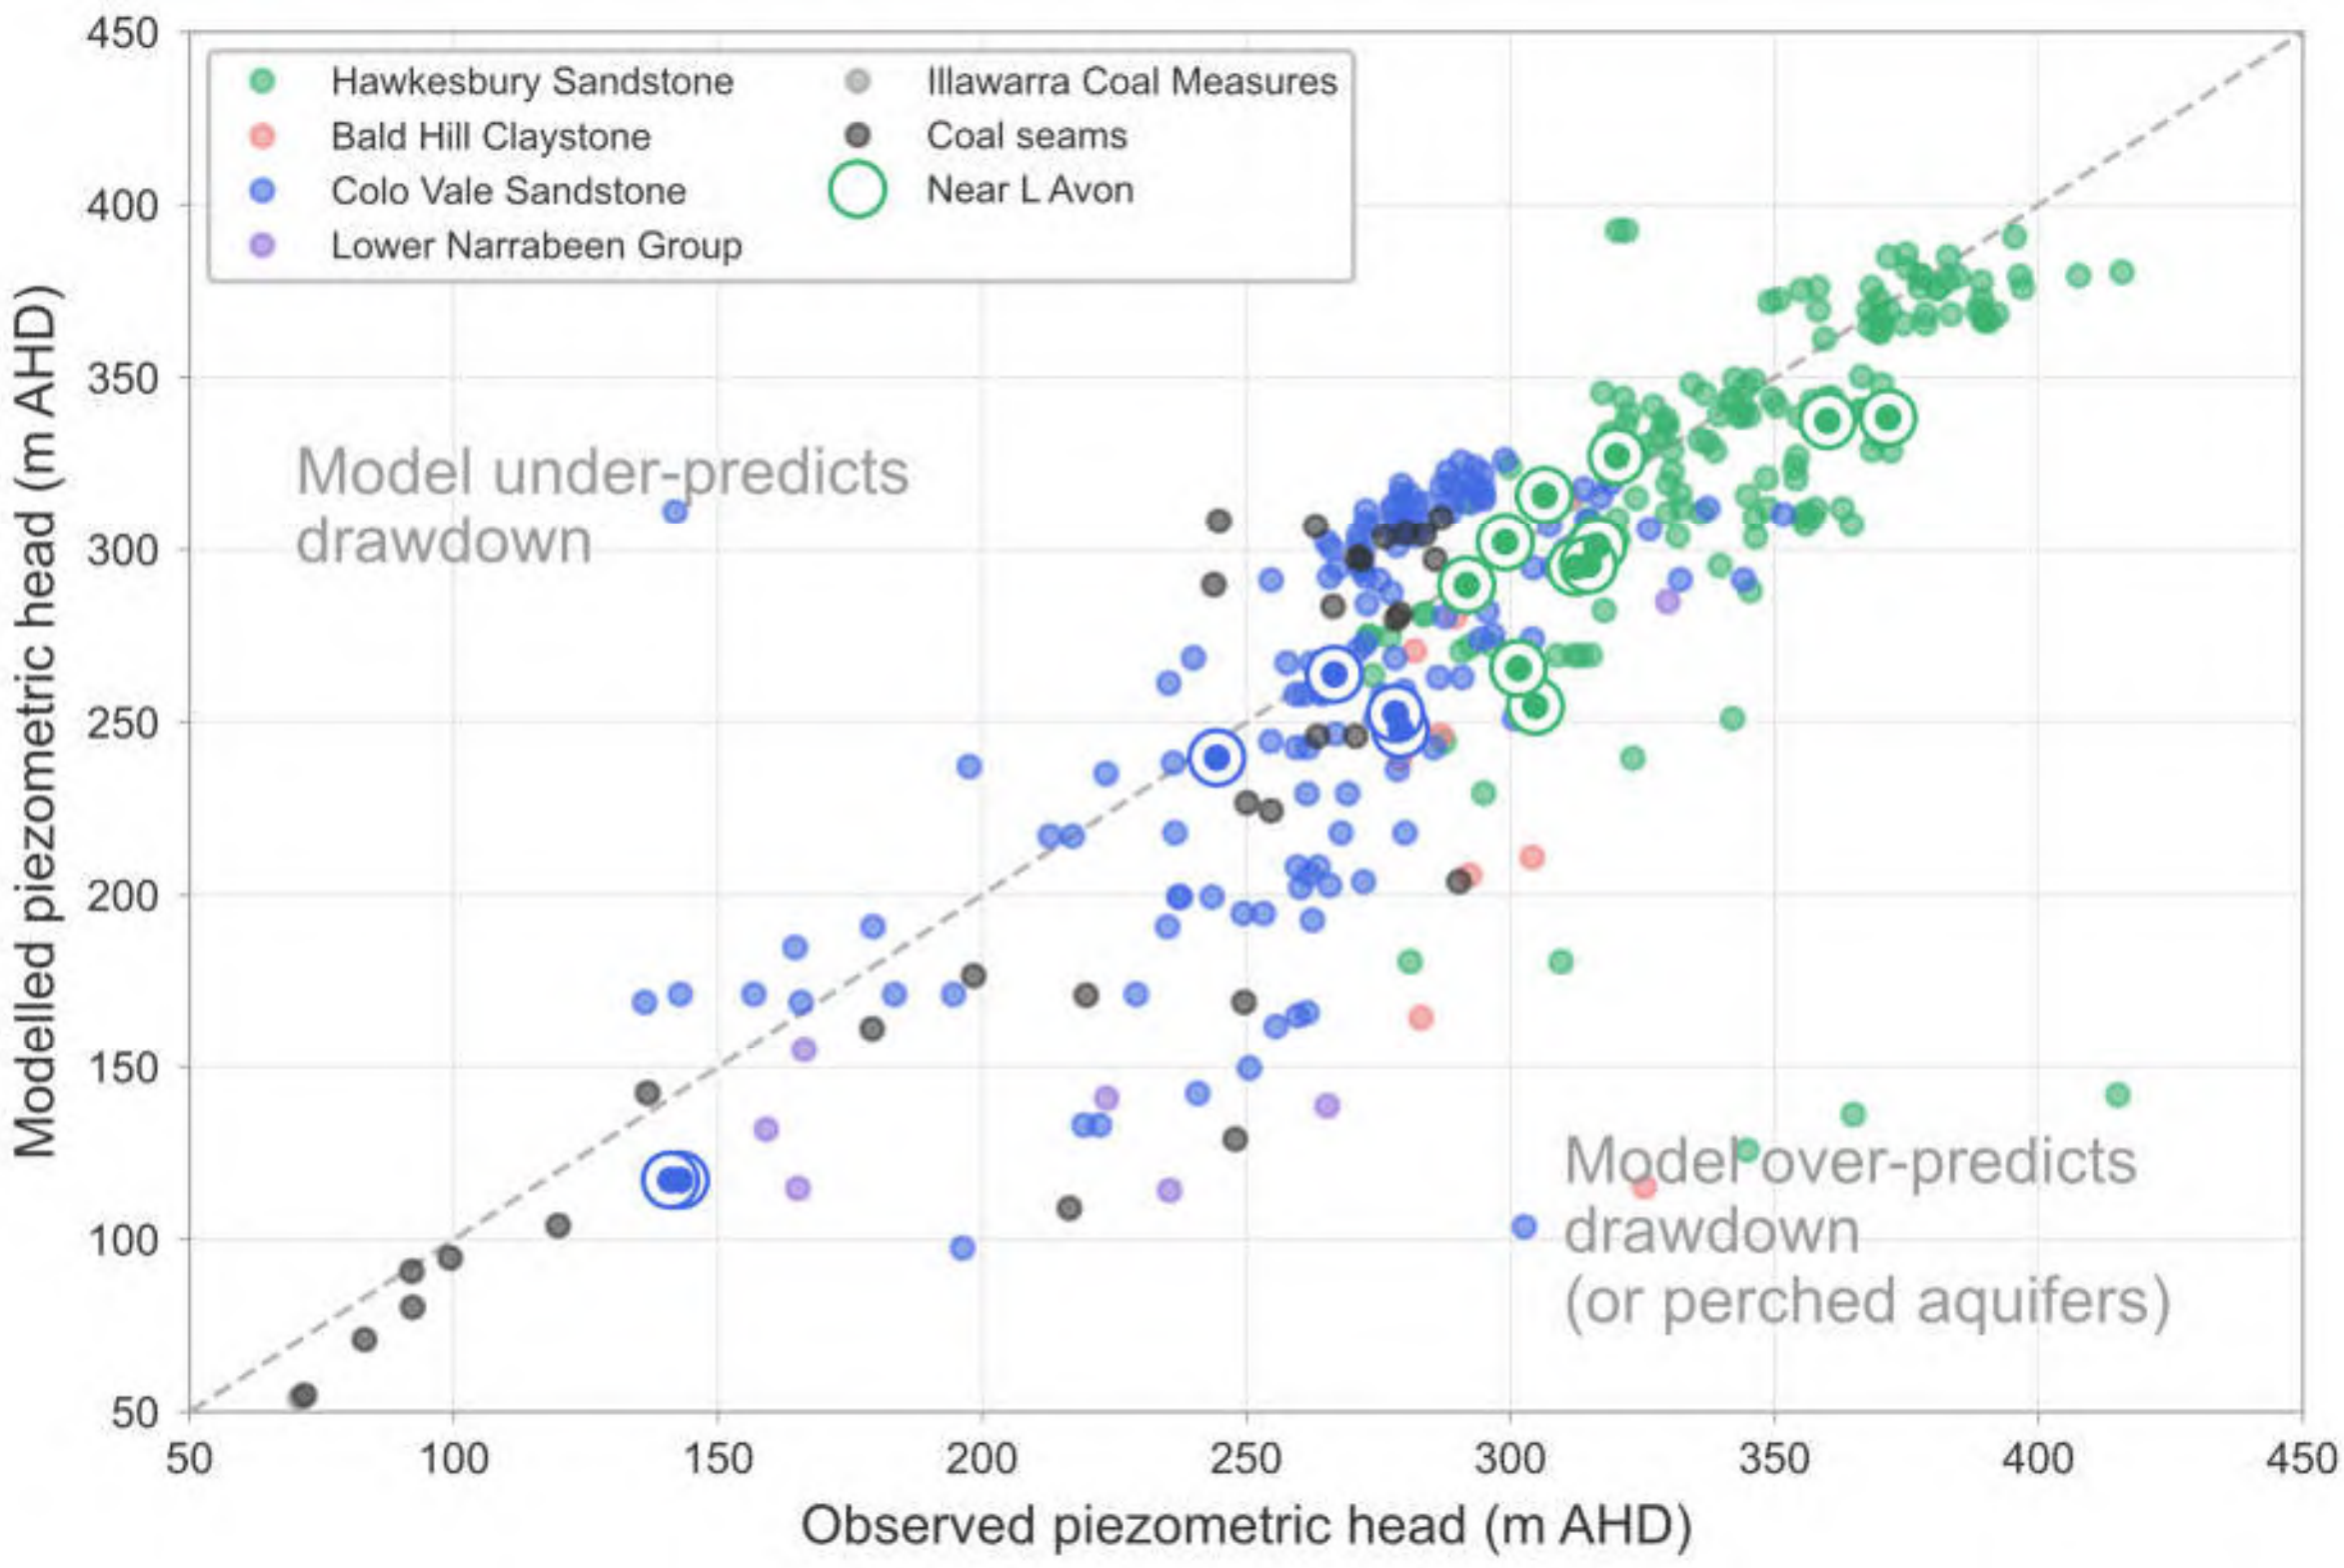
Figure 22. Observed versus model predicted heads at the end of Longwall 18

Figure 22 is a plot of the modelled and observed heads as of the end of Longwall 18. The data are coloured according to the formation, and bores that are located adjacent to Lake Avon are highlighted with concentric circles (holes, S2313, S2314, S2376, S2377, S2378, S2379, S2435, S2436, and holes S2001, S2194). Data from an accurate and well-calibrated model should cluster along the diagonal 1:1 line. Points plotting below the line indicate that observed heads are higher than predicted (i.e. the model over-predicts drawdown and is conservative), while points that plot above the line indicate that the model under-predicts drawdown at those locations.

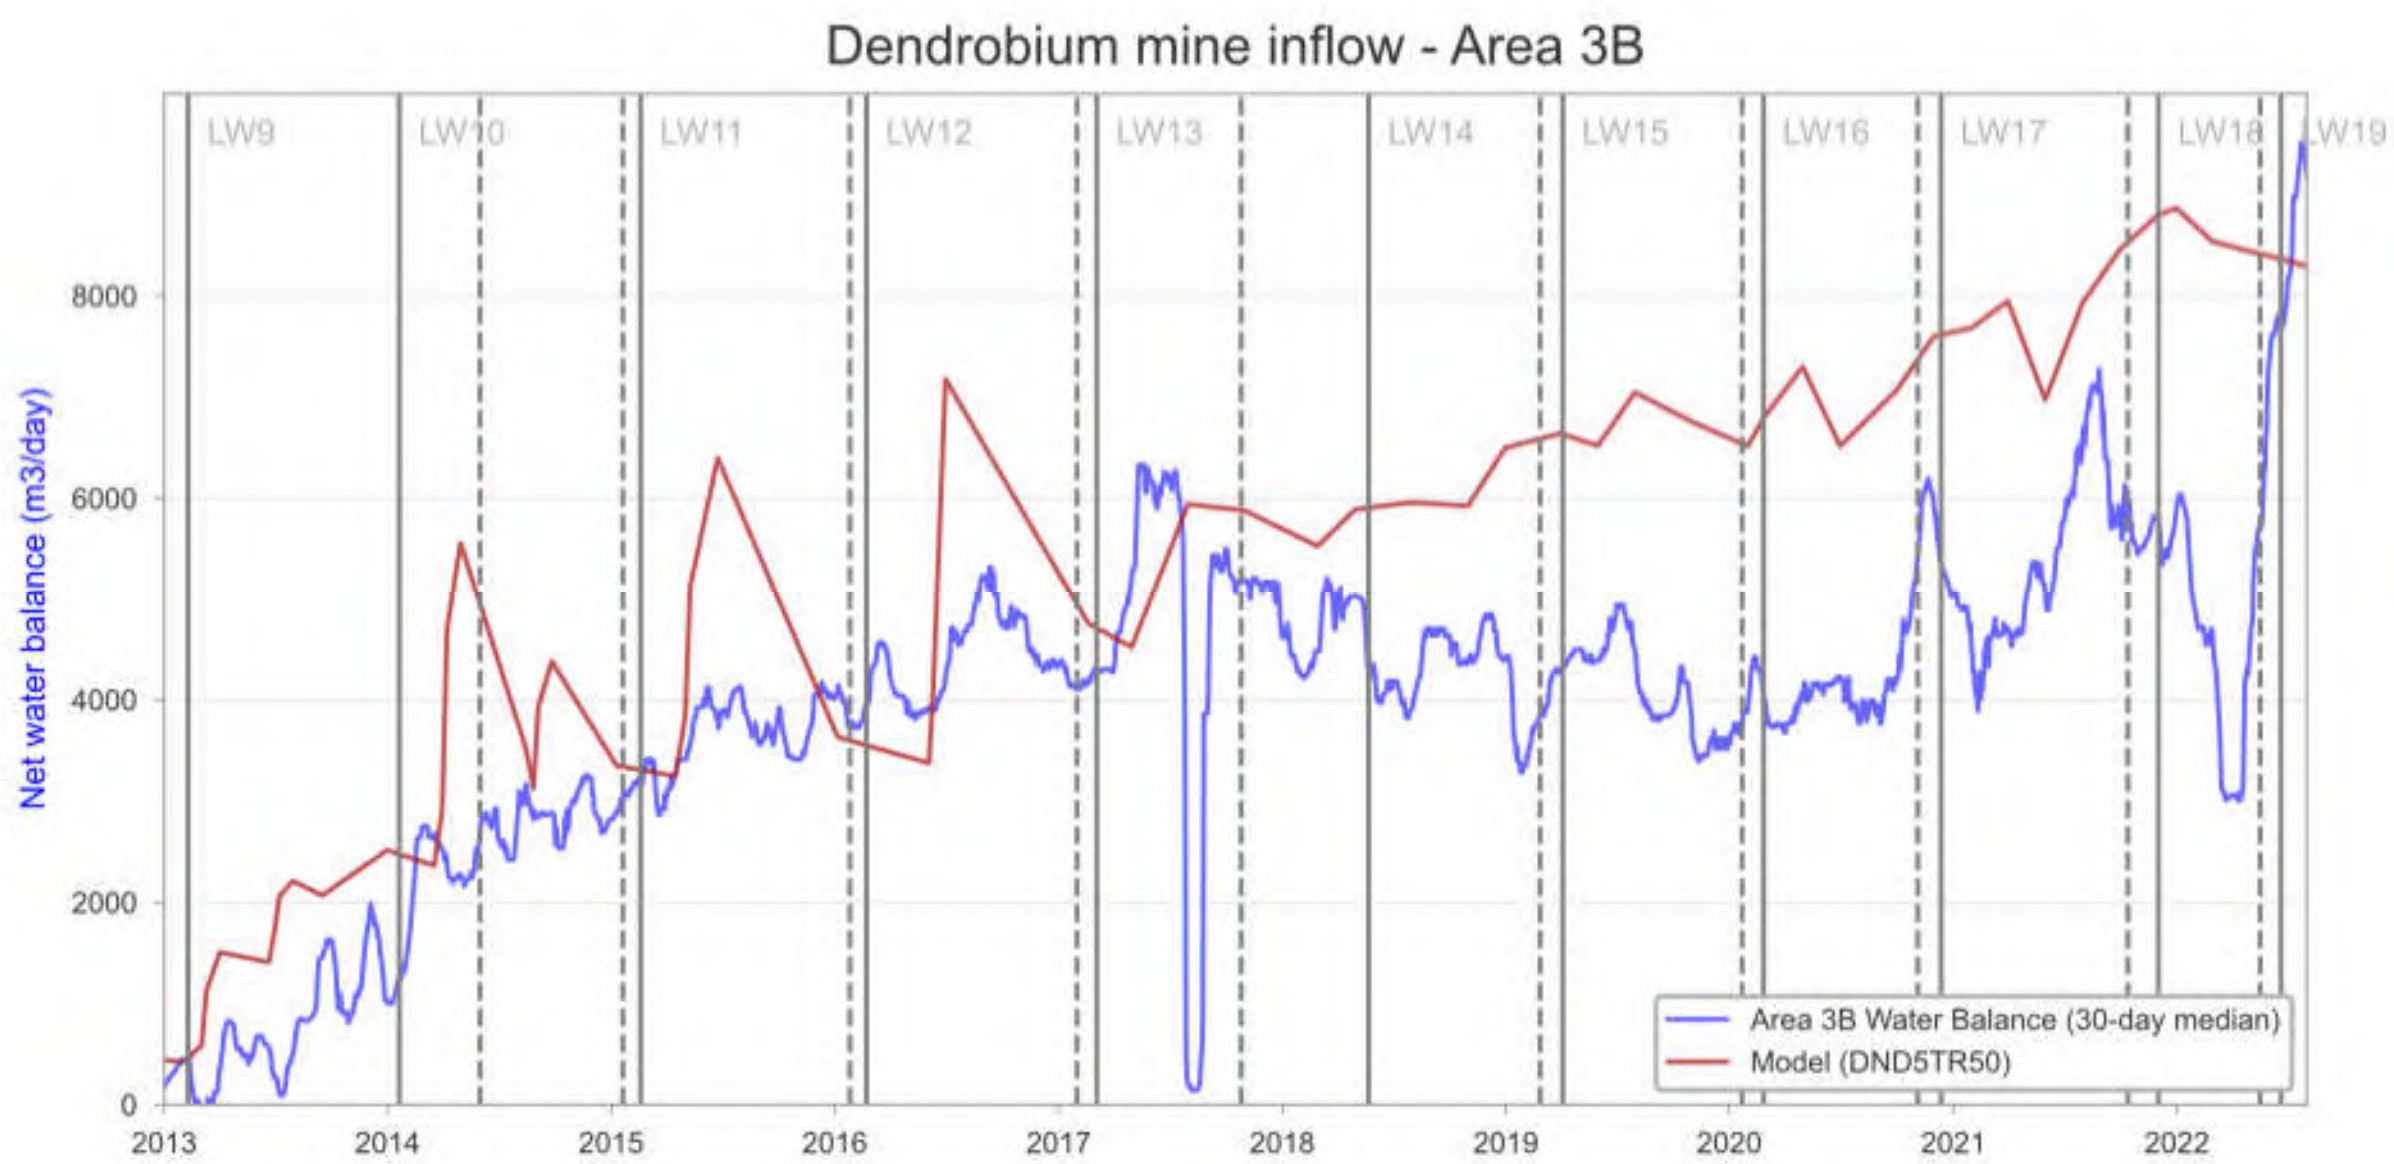
Figure 23. Observed versus model predicted mine groundwater inflow to mine Area 3B

Figure 23 is a plot of the modelled and observed groundwater inflow to Area 3B during the extraction of Longwalls 9 to 18. The numerical model is set up with stress periods corresponding to the originally planned longwall start and end dates (approximately yearly). The plot shows that the numerical model simulates groundwater inflow to Area 3B accurately up to Longwall 13 (mid-2017). From approximately mid-2017, the model simulated groundwater inflow continues to increase in line with the cumulative area mined, whereas the mine water balance records a decline in groundwater inflow to Area 3B until 2020. From 2020, the observed mine inflow resumes an upward trend, peaking above the predicted inflow in mid-2022. The decline in observed inflow between 2017 and 2019 and the steeper increase from 2020 corresponds with record drought conditions and record high rainfall, respectively over those periods. These trends demonstrate a clear relationship between rainfall and mine inflow in Area 3B that was not apparent prior to the extreme weather events. As noted in Section 3.1, there is no clear evidence from isotopic tracers of an increase in the proportion of modern water in mine inflow since 2020.

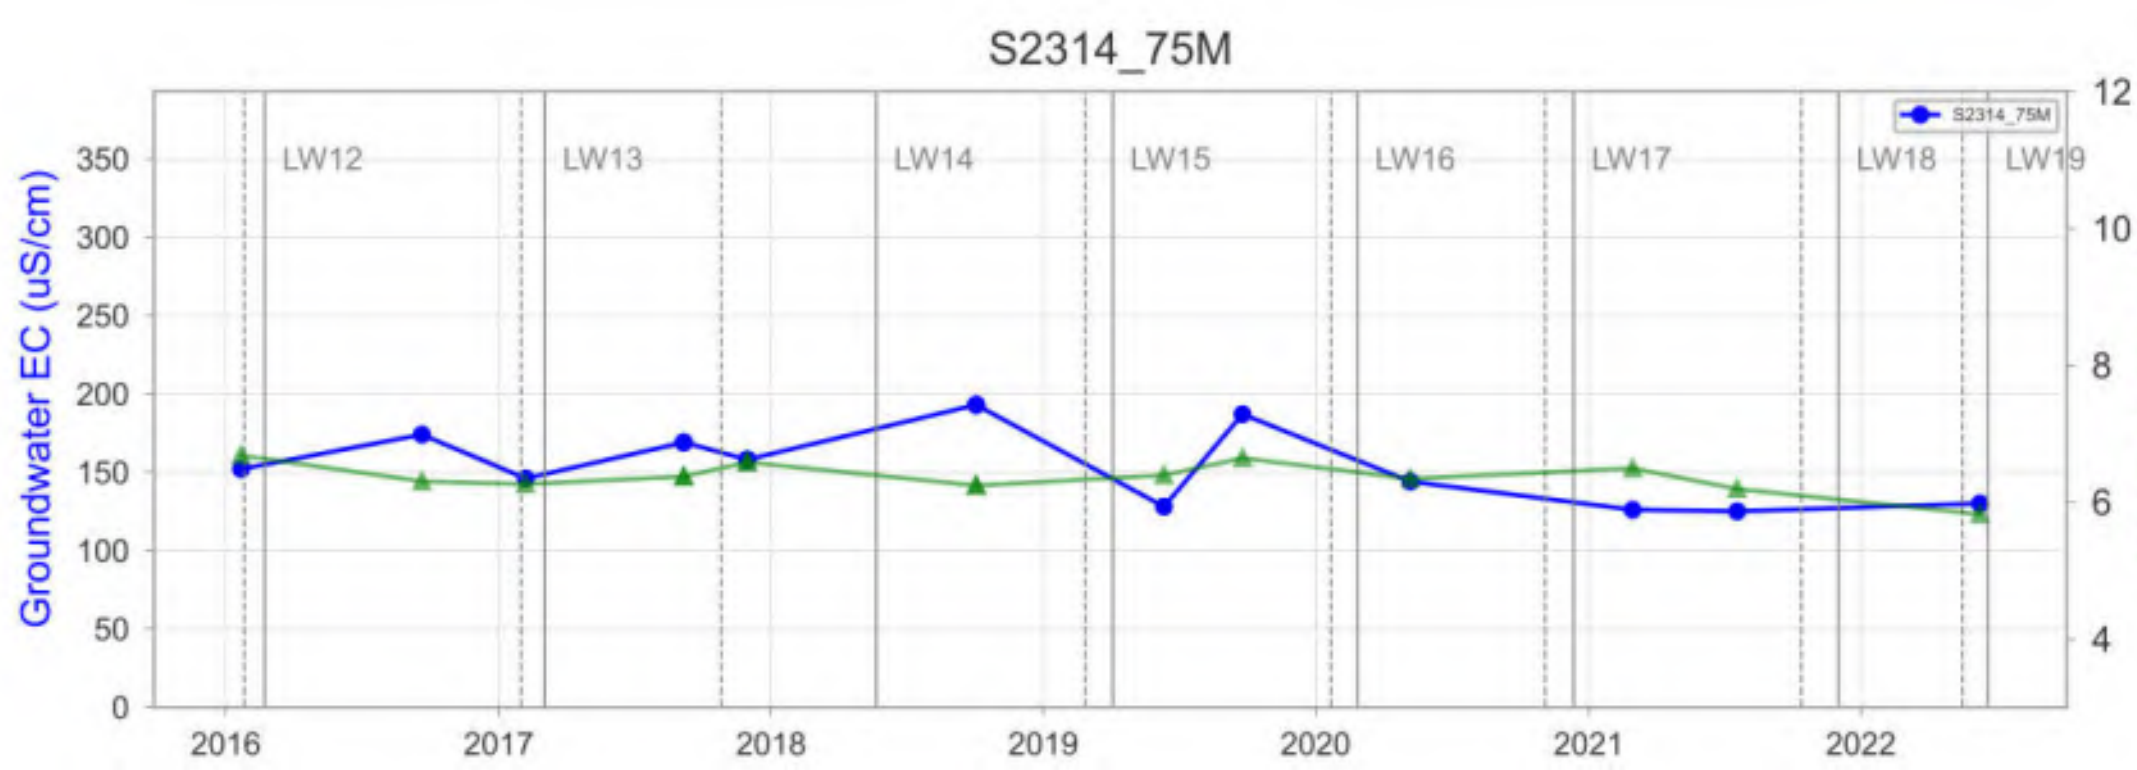
Figure 25. Time series of groundwater EC and pH at S2314_75m (AD2)

- **2314_75m**, located between Lake Avon and Area 3B within the Hawkesbury Sandstone (Avon Dam hole AD2). A time series plot of EC and pH (Figure 25) shows that, despite the apparent decline in EC since Longwall 15, there is no clear freshening trend. The most recent sample following the end of Longwall 18 (9/6/2022) returned an EC of 130 µS/cm, similar to that reported for Longwall 17. A time series of radiogenic isotopes tritium and Carbon-14 (indicators of groundwater age) in Figure 26 shows that tritium remains very low in samples from S2314_75m with no adverse (rising) trend. Similarly, percent Modern carbon (pMC) has been consistent at ~40% for the last 2 years, again with no adverse trend. It is concluded that the declining EC noted in previous reports does not reflect an increase in water seepage from Lake Avon impinging on the monitoring bore site.
