GEORGES RIVER REHABILITATION PLAN

| Document ID | APNMP0134 | Version | 1.0 | |

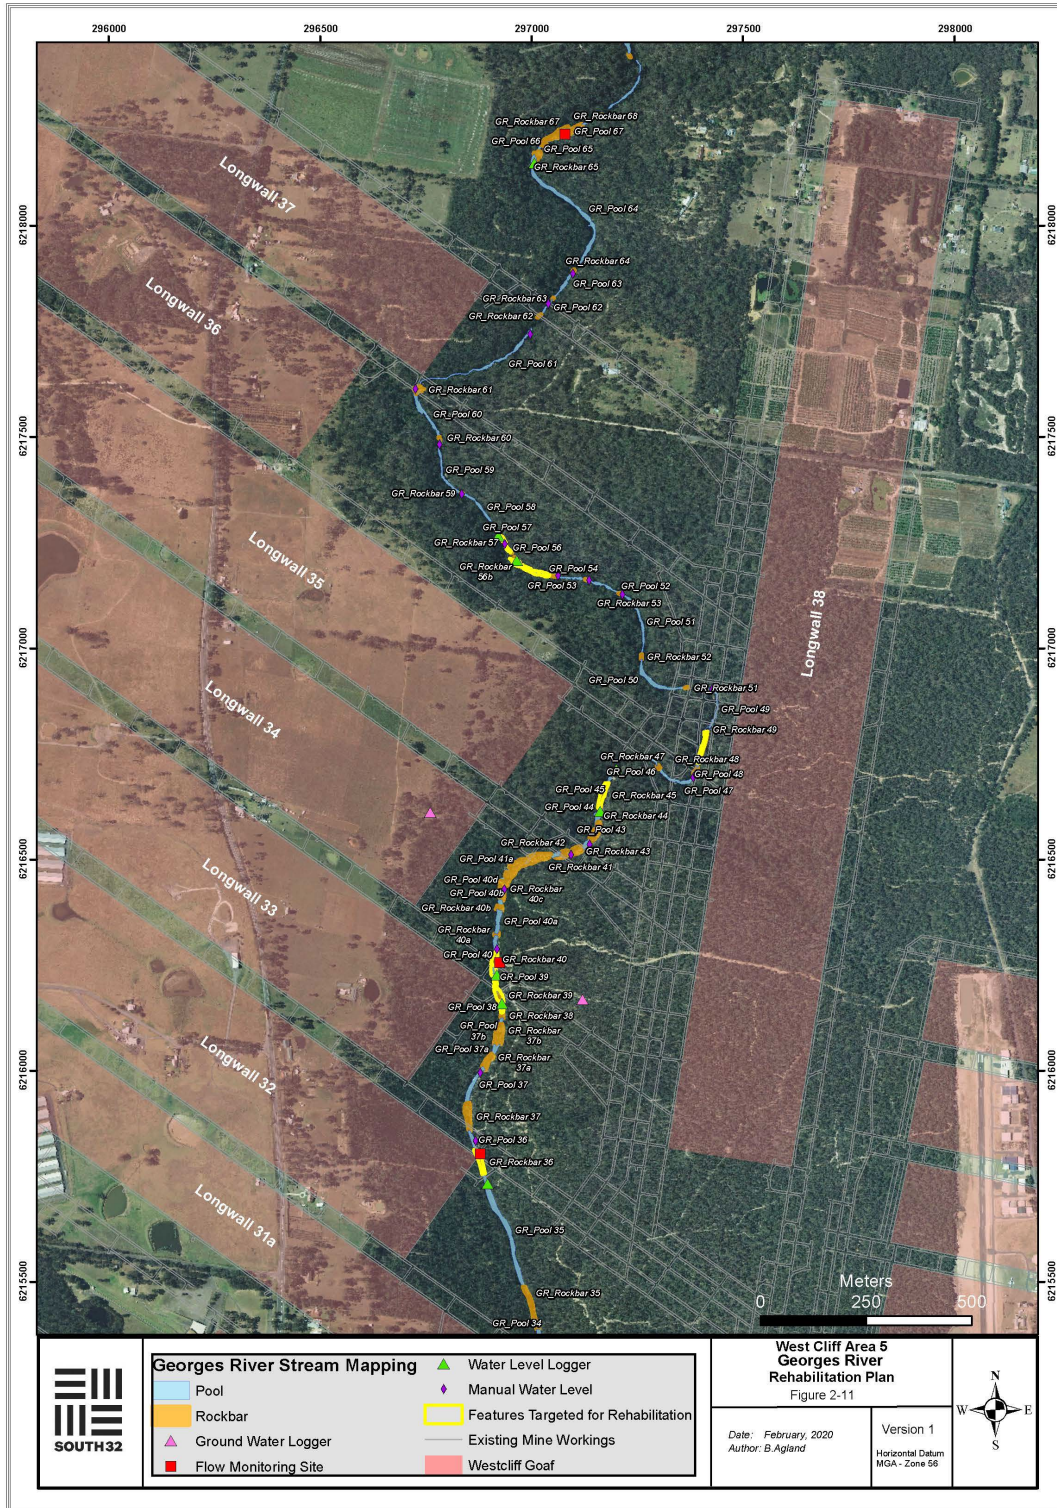
Figure 2-11 Georges River Rehabilitation Overview Plan

Fracturing, iron staining and gas releases have been observed during routine monitoring of the Georges River (Table 1). The impacts have been identified as Level 1 and 2 when assessed against the GRMP for Longwalls 34-36 and the EP for Longwalls 37 and 38. Trigger Action Response Plans (TARPs) from both the GRMP and EP are included as Appendix 2 of this document. Figure 2-1 to Figure 2-11 show the location of impacts in relation to each pool, and also depicts features targeted for rehabilitation.
