This post-mining report includes observations and field data recorded for relevant features on Lot 900 DP1072947, including borehole GW101986 and property dam (MSEC ID: F17d01) (Figure 1).

This report includes pre- and post-mining observations and results gathered for borehole GW072874 and dam (MSEC ID: F11d01) on Lot 10 DP245756 (Figure 1).

This post-mining report includes observations and field data recorded for relevant features on Lot 73 DP883462, including borehole GW105376 and the property dam (MSEC ID: D21d01).

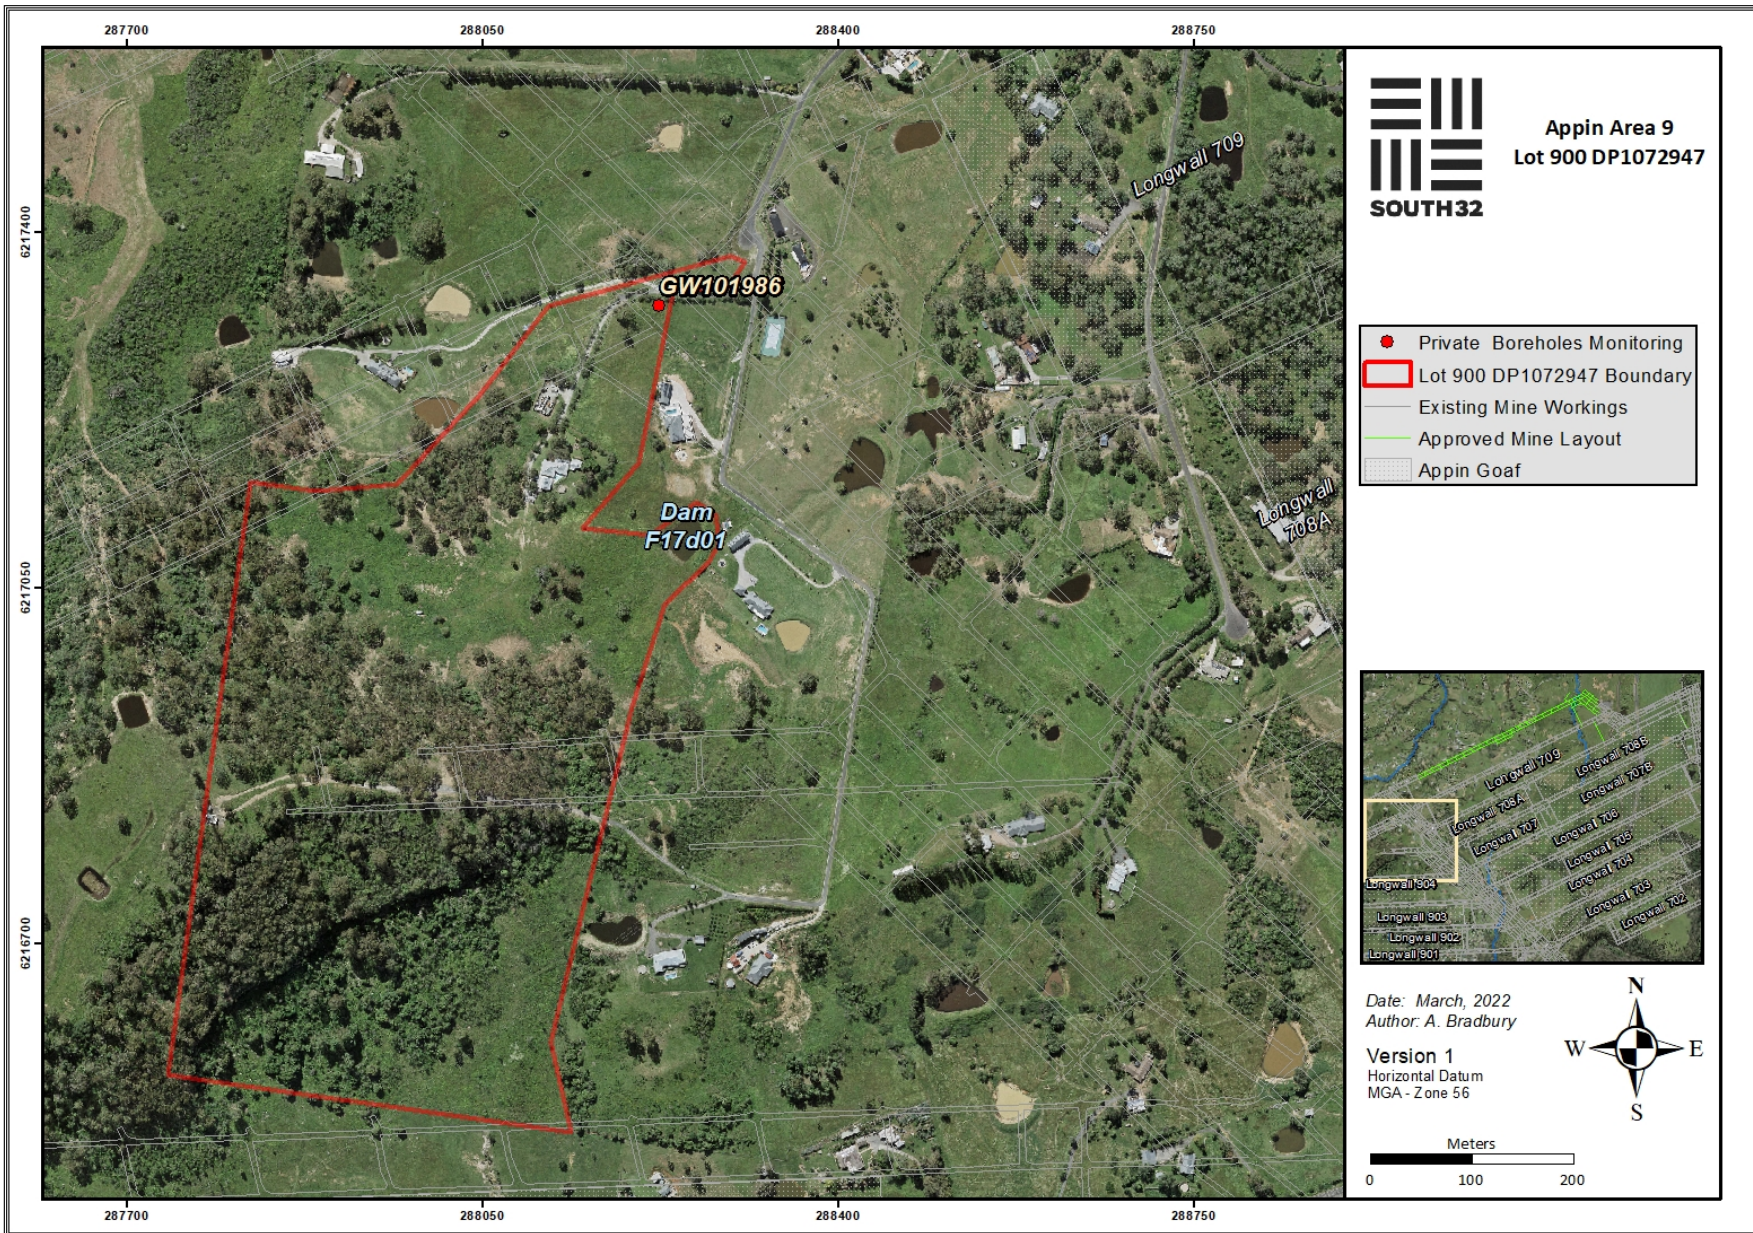
Figure 1: Map showing location of inspected borehole GW101986 and dam F17d01 on Lot 900 DP1072947.

Borehole/Aquifer Properties: The borehole is located approximately 200 metres northeast of the residence (Figure 1). The borehole was drilled to a depth of 210m and was completed on 20 February 1998. On 22 February 2018 a pre-mining inspection was completed on the property with field water quality measured and samples were taken for laboratory analysis. On 6 August 2018 and 14 September 2018 post-mining inspections were completed on the property, with field water quality measured and samples taken (Photo 3 to Photo 6). The Longwall 708 post-mining inspection was undertaken on 17 March 2022 (Photo 7 and Photo 8). The borehole water is now pumped directly into a water tank. Borehole water samples were unable to be collected on the latest inspection.

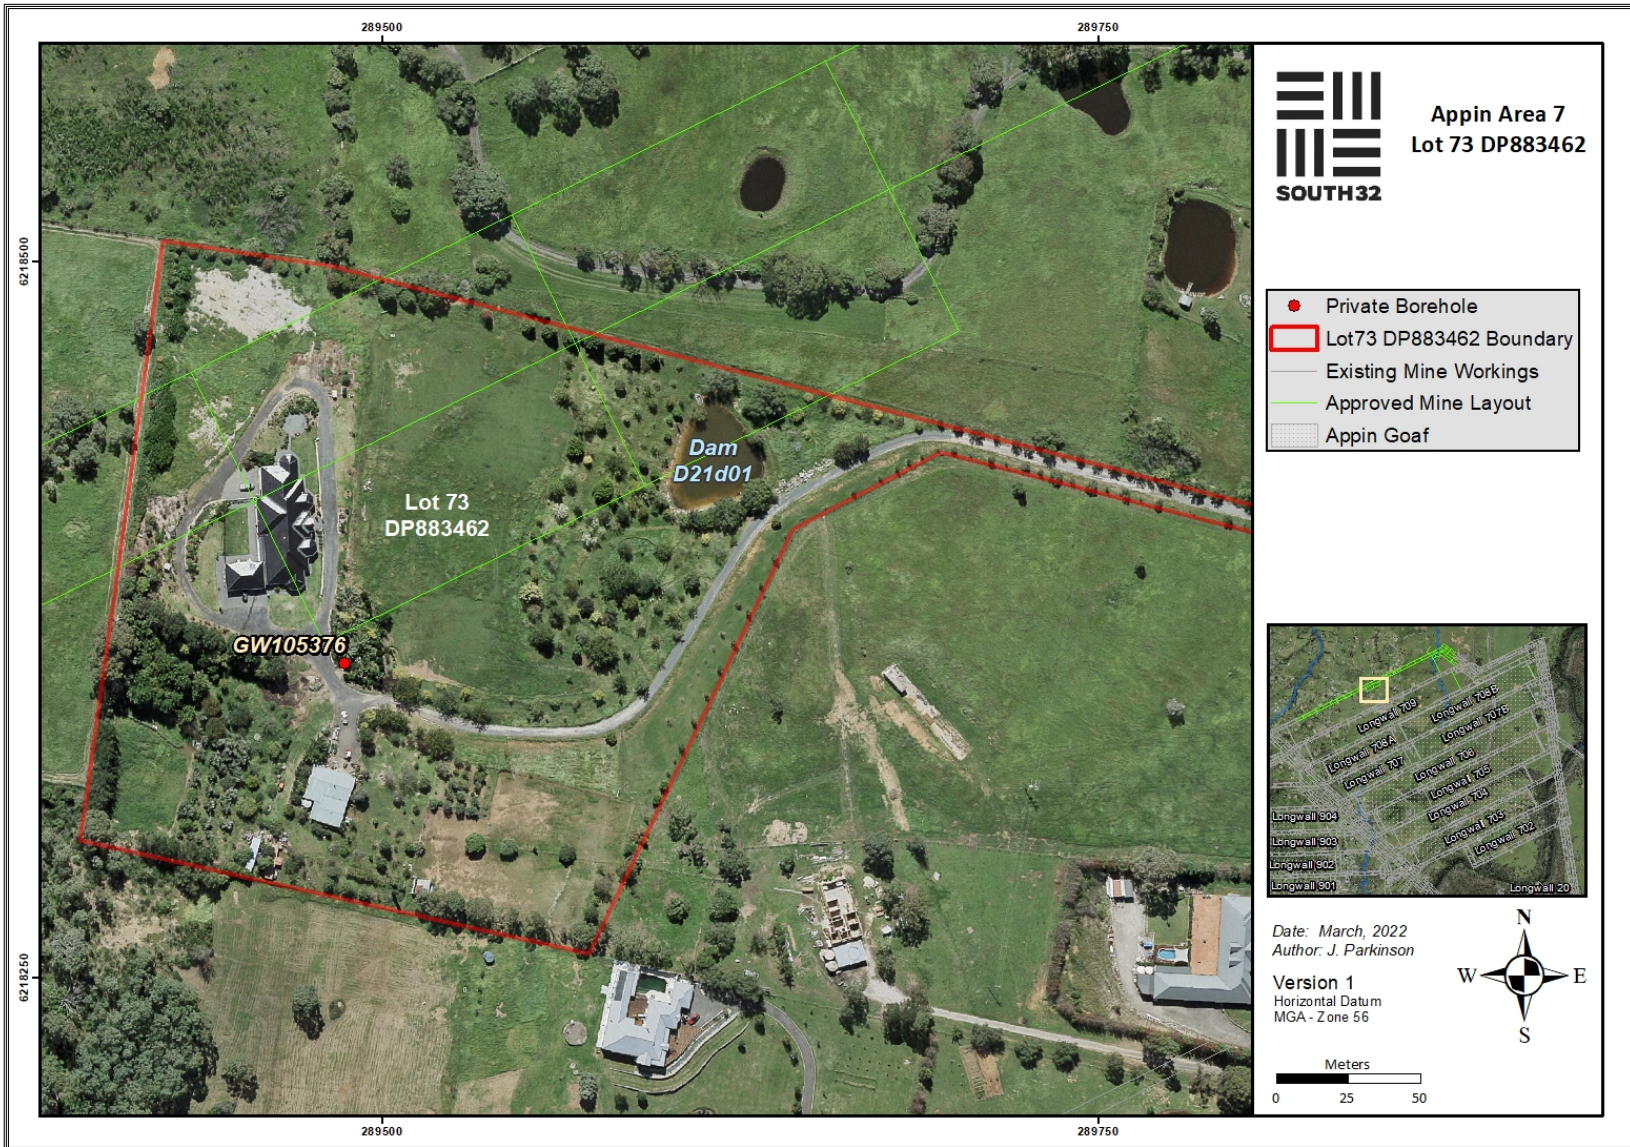
Figure 1: Location of borehole GW105376 and dam on Lot 73 DP883462.

The dam is located to the northeast of the residence (Figure 1, Photo 3 and Photo 4), and is routinely supplied with water from the borehole. During the pre-mining inspection the landholder advised that the dam was relatively low. Soil cracking was found around the extent of the dam during the pre-mining inspection (Photo 5), with major soil cracking also found on the walls of the dam. In the post-mining inspection, on 17 March 2022, the water level was much higher compared to previous inspections. The soil cracking previously reported was engulfed by the dam's water (Photo 6). Water quality parameters were measured in-situ and water samples were taken for laboratory analysis.
