DENDROBIUM  
AREA 3B  
WC21  
REHABILITATION  
PLAN

DECEMBER 2015

# WC21 REHABILITATION PLAN

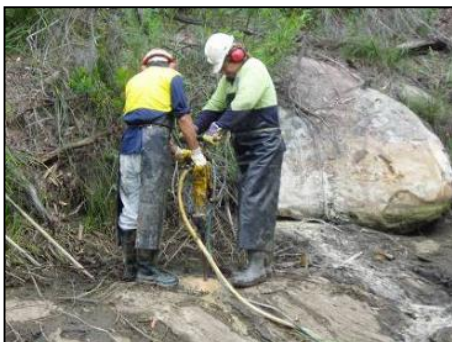
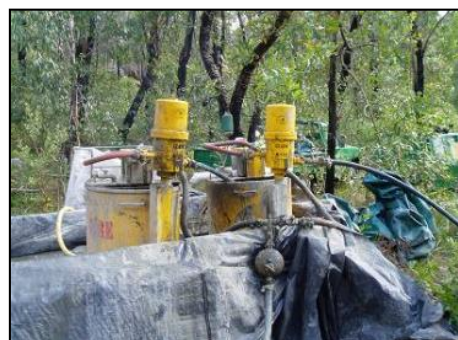
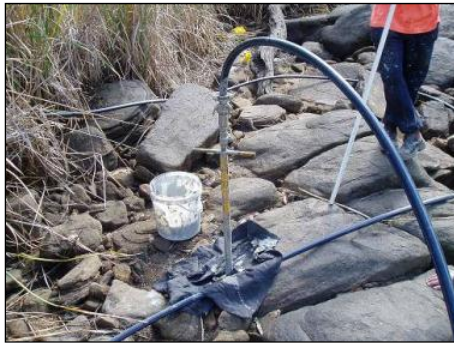
Figure 4-1 Rockbar Grouting in the Georges River

(a) Drilling into the bedrock

(b) Grout pump station setup

(c) Injecting grout into bedrock via a specially designed packer system

Grouting volumes and locations are recorded and high volume areas identified for monitoring purposes. The rate at which the water drains is measured and compared to pre-grouting results. The grouting process is iterative; relying on monitoring of grout injection quantities, grout backpressures and measurements of water holding capacity. In the Georges River the majority of pools were sealed with two to three grout passes.

Where flow diversion is observed through a large rockbar it may be more appropriate to implement alternative grouting techniques such as a deeper grout curtain which can be delivered via traditional or directional drilling (track or wheel mounted). These techniques will be implemented where there is limited success using hand-held equipment. Grouting will be undertaken at the completion of subsidence movements in the area to reduce the risk of the area being re-impacted. **Figure 4-1** shows grouting operations in the Georges River.

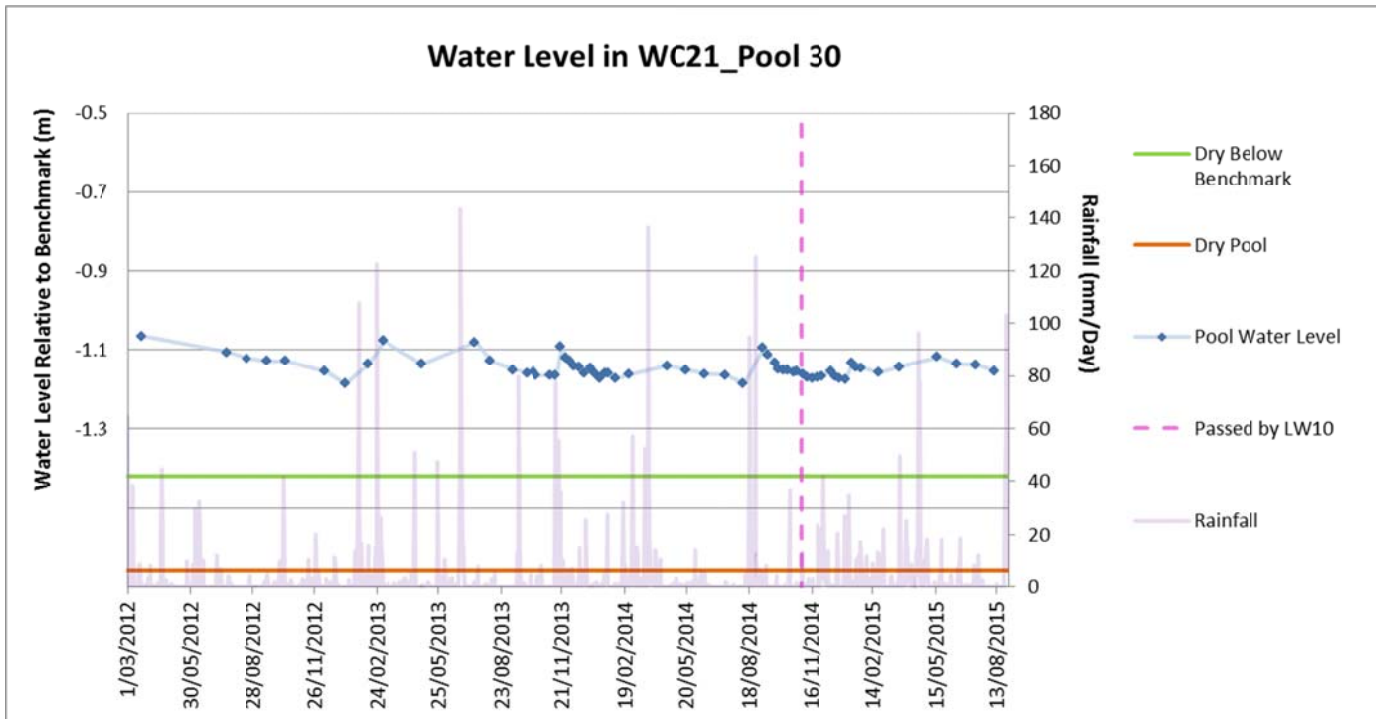
Graph 1: Water level recorded in WC21\_Pool 30 throughout the monitoring period.

**Impacts to feature:** No surface impacts have been identified and no change in water levels following extraction of Longwall 11 (**Graph 1**) has been observed to date. **Photo 1** and **Photo 2** show recent conditions at Pool 30.

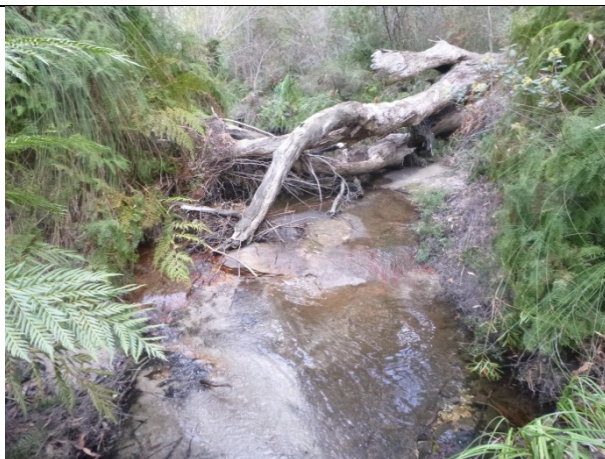
**Impacts to features:** No surface impacts have been identified to date. Localised subsurface flow diversion into the upstream sediment bank was recorded during baseline monitoring. Surface water flow reappears directly upstream from Pool 28 (**Photo 3**). **Photo 4** and **Photo 5** show recent pool conditions. A drop in water level, below baseline, was experienced following passing of Longwall 10 (**Graph 2**).

Photo 5: Outflow from WC21\_Pool 28, looking upstream. Taken on 10/09/2015.

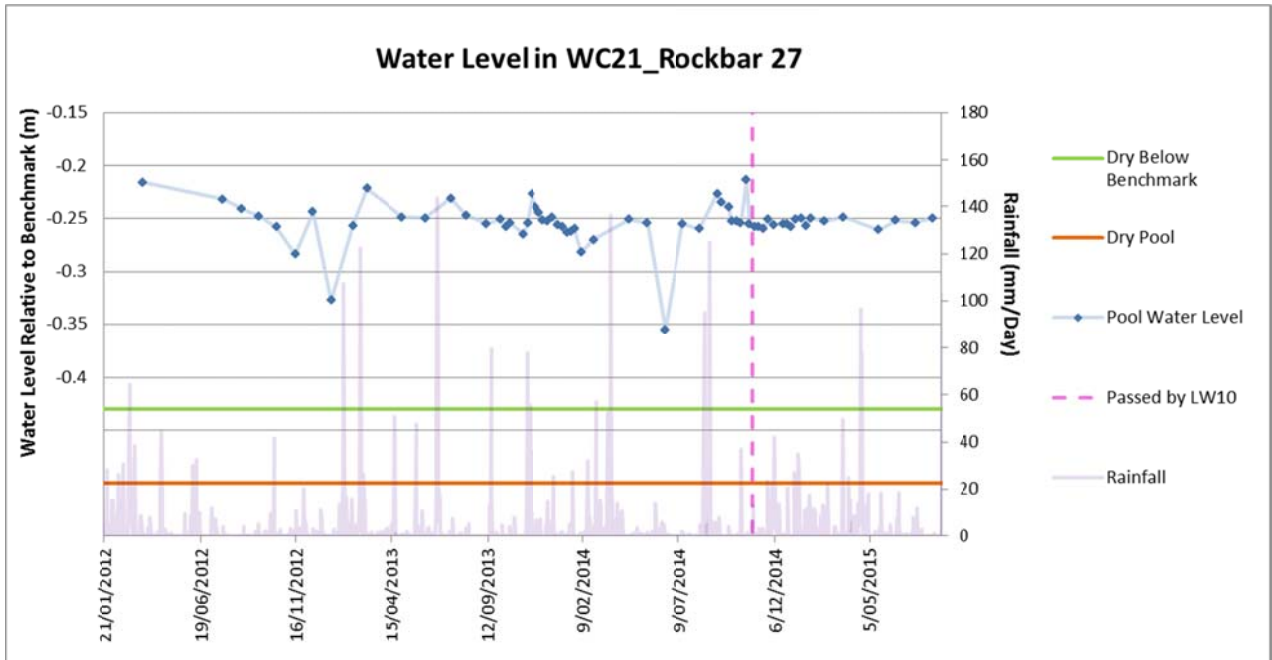
Graph 3: Water level recorded in WC21\_Rockbar 27 throughout the monitoring period.

**Impacts to features:** No surface impacts or changes in water level have been observed to date (Graph 3). Photo 6 and Photo 7 show recent pool conditions.

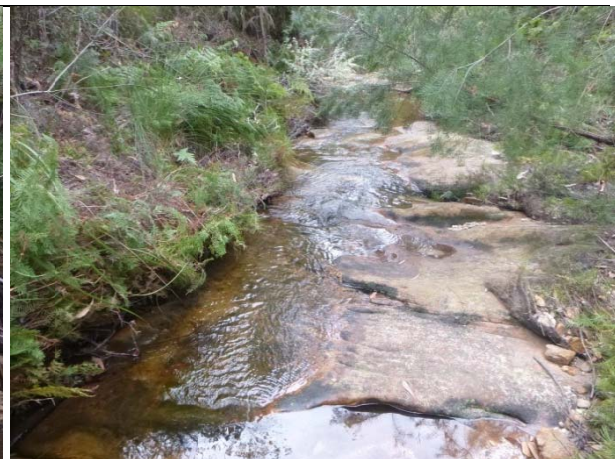
**Impacts to features: Impact LW10\_007-** Fracturing was observed to the downstream end of Rockbar 26 (Photo 10). Some localised flow diversion was observed during low flow conditions. Figure 4-2 shows the location of the impact. The water level dropped below baseline following the mining of Longwall 10 (Graph 4). Photo 8 and Photo 9 show recent conditions.

Photo 9: WC21\_Rockbar 26, looking downstream. Taken on 10/09/2015.

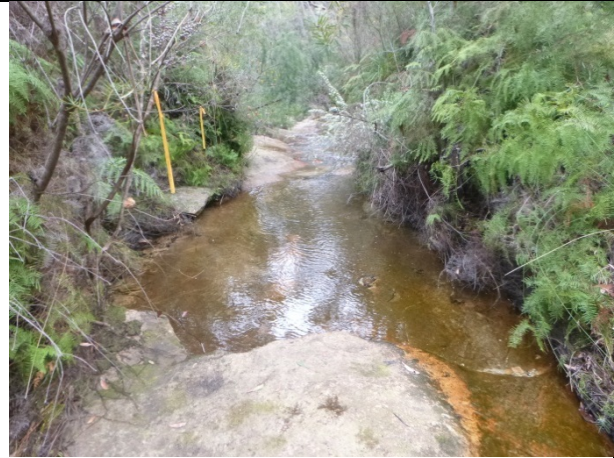
**Impacts to features: Impact LW10\_010-** Dilation of a joint on the base of Pool 26 (Photo 11). No flow diversion has been observed to date. Figure 4-2 shows the location of the impact.

Photo 12: WC21\_Pool 26, looking upstream. Taken on 10/09/2015.

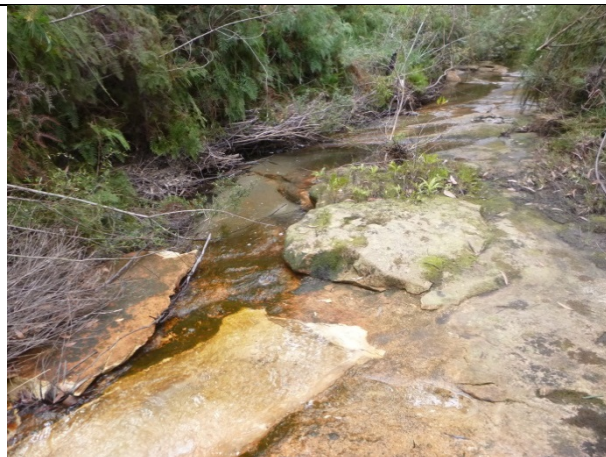
Photo 13: WC21\_Pool 26, looking downstream. Taken on 10/09/2015.

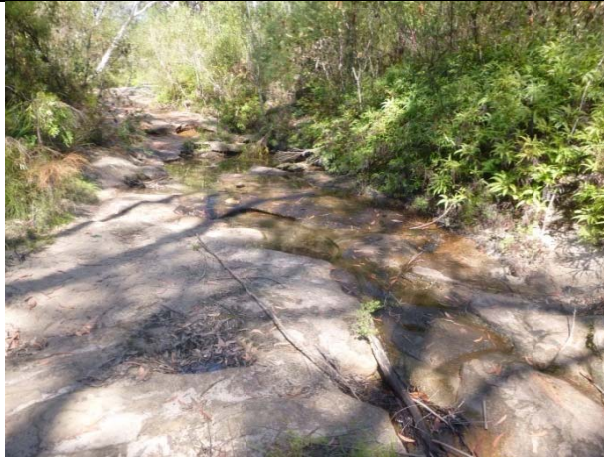
**Impact LW10\_020-** Rock fractures to the downstream section of Rockbar 24 has been observed (**Photo 16**). **Figure 4-3** shows the location of surface impacts. Water levels and surface flow have returned to Rockbar 24 during recent monitoring (**Graph 5**). **Photo 17** and **Photo 18** show recent flow conditions.

Photo 18: Downstream end of WC21\_Rockbar 24, looking upstream. Taken on 15/10/2015.

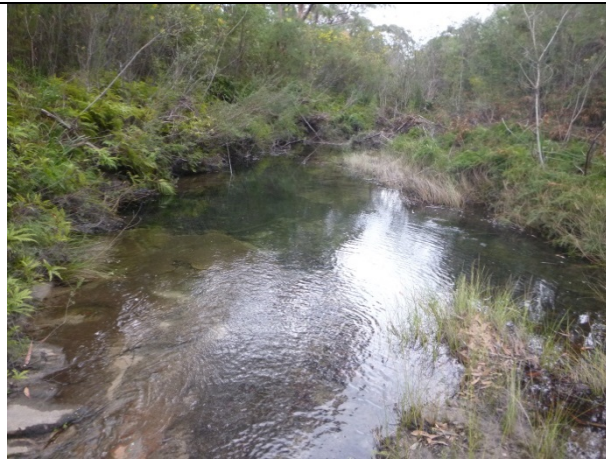
Subsurface inflow to the sediment base of the upstream section of the pool is evident (**Photo 20**). The pool continues to hold water for periods following rainfall (**Photo 21**).

Photo 21: Upstream end of WC21\_Pool 24, with water in pool, looking downstream. Note: this is often dry. Taken on 10/09/2015.

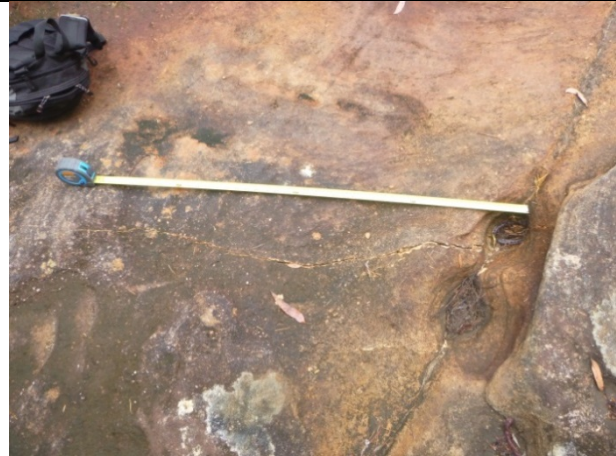
Photo 25: Impact DA3B\_LW10\_019. Taken on 18/12/2014

**Impact LW10\_019 -** Multiple rock fractures to Rockbar 23. Surface flow absent (**Photo 25**).

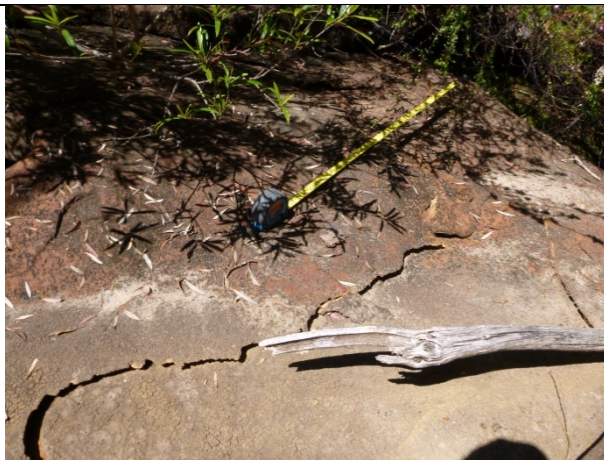
Photo 26: Impact DA3B\_LW10\_009. Taken on 18/11/2014

**Impacts LW10\_009-** Multiple fractures to the downstream end of Rockbar 23. Surface flow absent (**Photo 26**).

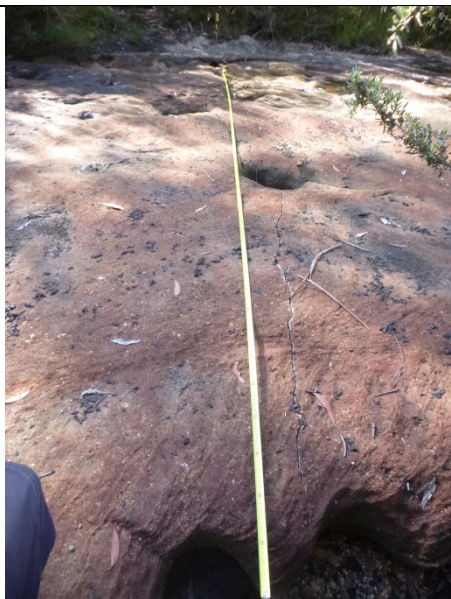
Photo 28: Impact DA3B\_LW10\_026. Taken on 3/3/2015.

**Impacts LW10\_026-** Multiple rock fractures to the downstream section of Rockbar 23. Surface flow absent (**Photo 28**).

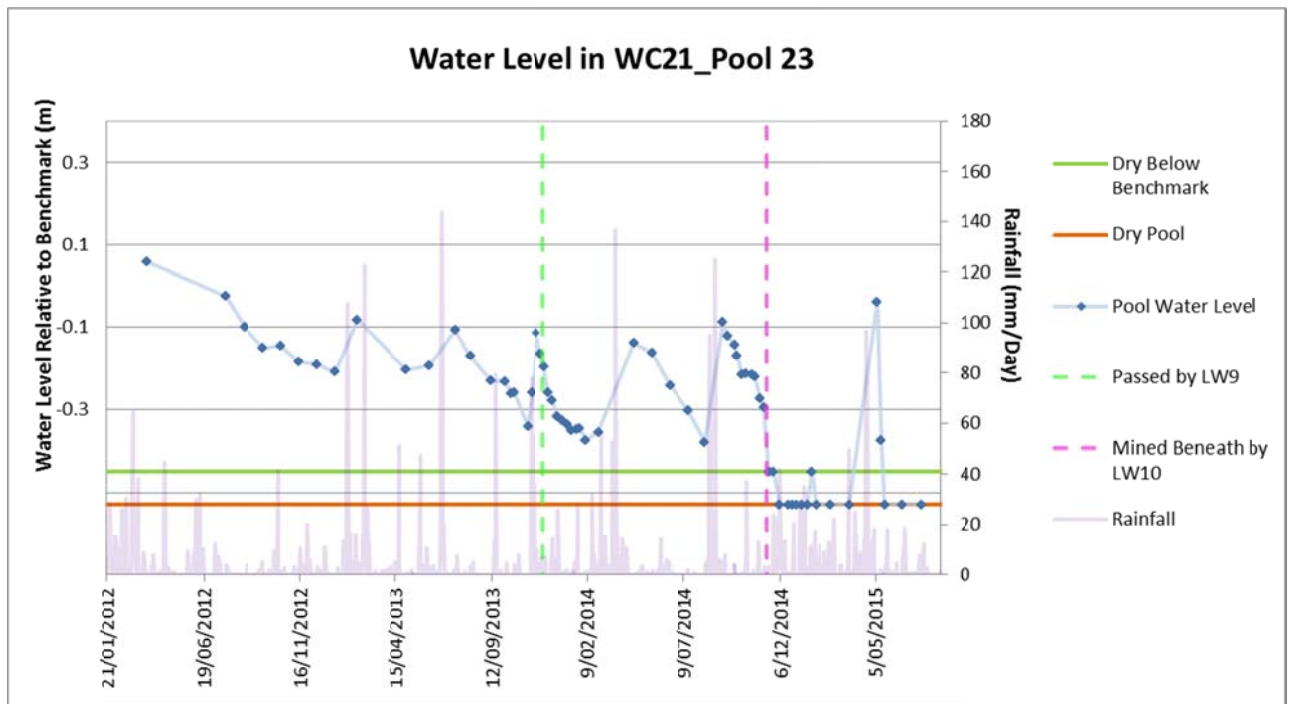
Graph 7: Water level at WC21\_Pool 23 throughout the monitoring period.

Pool 23 has been dry on the majority of inspections since Longwall 10 mined under the site (**Graph 7**). **Photo 35** and **Photo 36** show recent conditions at the site. **Figure 4-3** shows the impact locations.

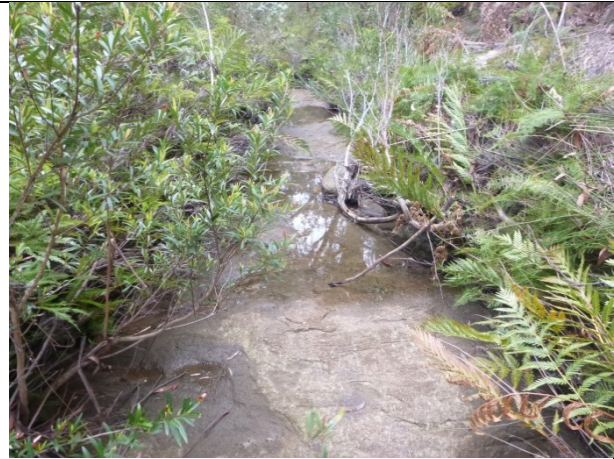
**Impacts to feature:** No surface impacts have been observed however a reduction in surface water is evident following mining (**Photo 37** and **Photo 38**).

Photo 38: WC21\_Pool 22, looking downstream. Taken on 10/09/2015.

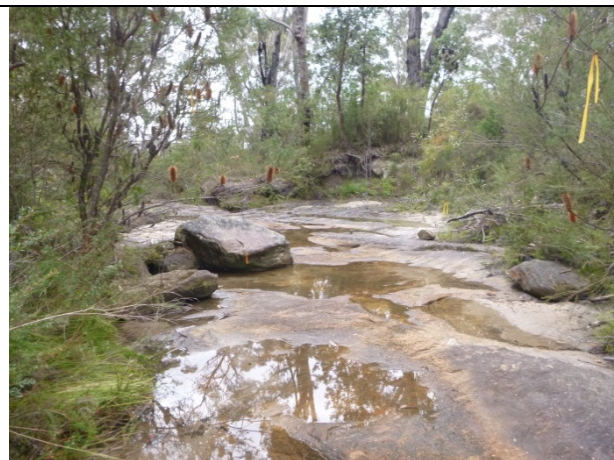
No surface impacts have been observed however a reduction in surface water is evident following mining (**Photo 39** and **Photo 40**).

Photo 40: WC21\_Rockbar 21, looking downstream. Taken on 10/09/2015.

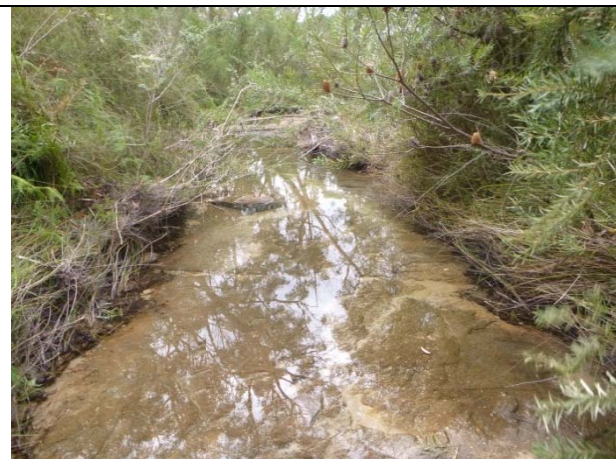
**Impacts to feature:** No surface impacts have been observed however a reduction in surface water is evident following mining (**Photo 41** and **Photo 42**).

Photo 42: WC21\_Pool 21, looking downstream. Taken on 10/09/2015.

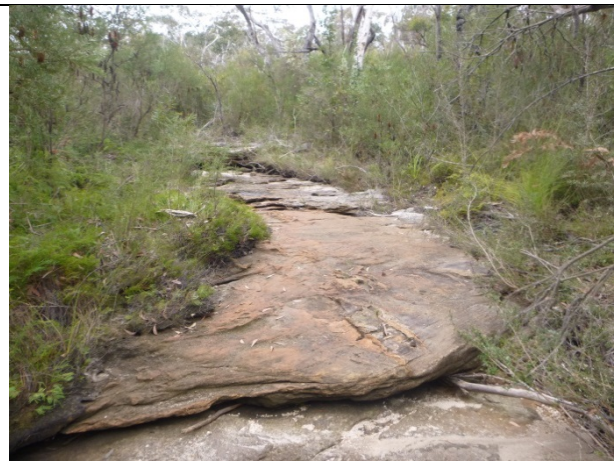
**Impacts to feature: Impact LW10\_016-** Rock fracturing and dilation of an existing joint on Rockbar 20 and an absence of surface flow observed (**Photo 45**). Flow diversion has not been observed through the fracture; however there has been a reduction in surface flow reaching the site (**Photo 43** and **Photo 44**).

Photo 44: WC21\_Rockbar 20, looking downstream. Taken on 10/09/2015.

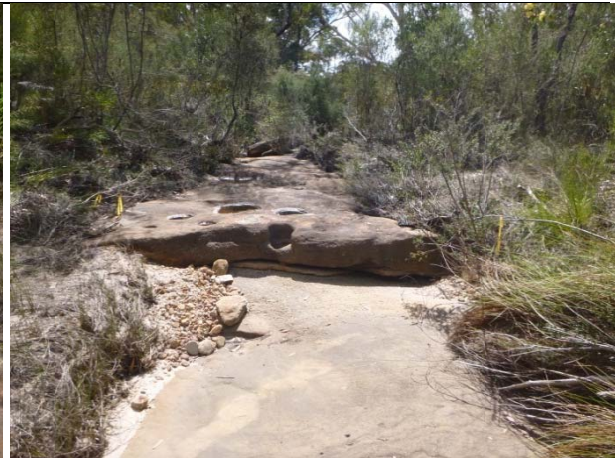
**Impacts to feature:** No surface impacts have been observed however a reduction in pool water level has been recorded following Longwall 9. The pool has been dry on most inspections following Longwall 9 (**Graph 10**). **Photo 52** and **Photo 53** show recent conditions at the site.

Photo 53: WC21\_Pool 18, looking downstream. Taken on 10/09/2015.

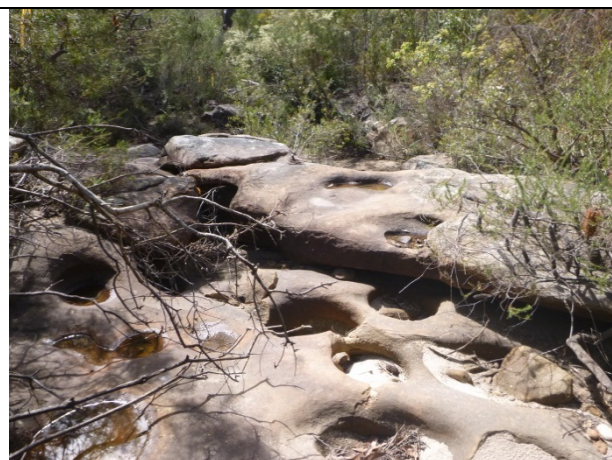
**Impacts to feature:** No surface impacts have been observed in the pool however a reduction in pool water level has been recorded following Longwall 9 (**Photo 56** and **Photo 57, Graph 11**). The pool has been dry on multiple inspections following Longwall 9.

Photo 56: WC21\_Pool 17, looking upstream. Taken on 10/09/2015.

**Recommendation:** The absence of any visible fracturing or observation of flow diversion makes any initial remediation difficult at this pool. The pool's position directly upstream and 'above' Pool 16 suggests that any loss of water ultimately flows into Pool 16, where targeted remediation is proposed. Any flow diversion identified in Pool 17 would be targeted with grouting.

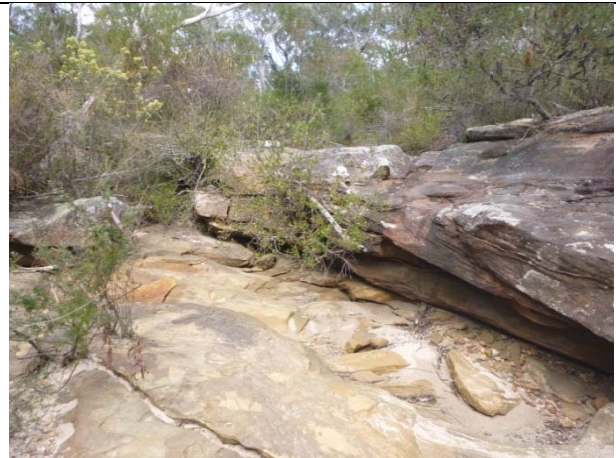
Photo 58: WC21\_Pool 16, looking downstream. Taken on 10/09/2015.

**Recommendation:** Injection grouting is recommended at the site (**Figure 4-9**). Cofferdams and diversion piping will be used to temporarily divert surface flow if required. Equipment and materials needed for remediation works will be stored at Staging Area 4. From this location, grout can be pumped approximately 20m to Pool 16. Primary clearing will be required to position Staging Area 4 directly adjacent to an existing, previously cleared seismic track. Secondary clearing of this track is required for vehicular access (**Figure 4-9**).

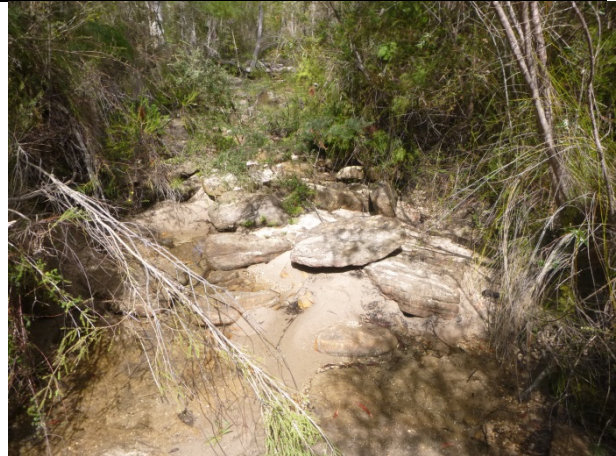
**Impact LW9\_018-** hairline fracture and dilation of jointing on Rockbar 12 (**Figure 4-5**) and an absence of surface flow observed (**Photo 64**).

Photo 64: Impact LW9\_018, looking across stream. Taken on 24/12/2013.

**Recommendation:** Visible fracturing is negligible in size and influence to surface flow across this section of tributary, making any initial remediation difficult. No remediation of this pool is proposed due to the small size of Pool 11 and re-emergence of flow directly downstream.

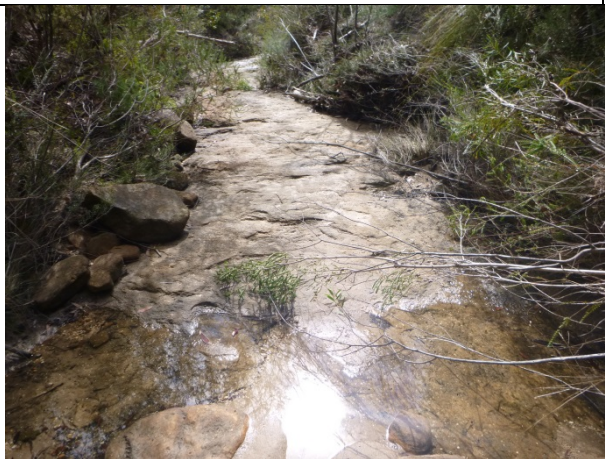
No other surface impacts have been observed throughout this section of the tributary. There is an absence of surface flow across the majority of this section of WC21. It continues to hold surface water in sections following rainfall (**Photo 65** to **Photo 72**). **Graph 13** shows WC21\_Pool 11, which has been dry on various occasions following extraction of Longwall 9.

Photo 65: WC21\_Pool 14, looking upstream. Taken on 10/09/2015.

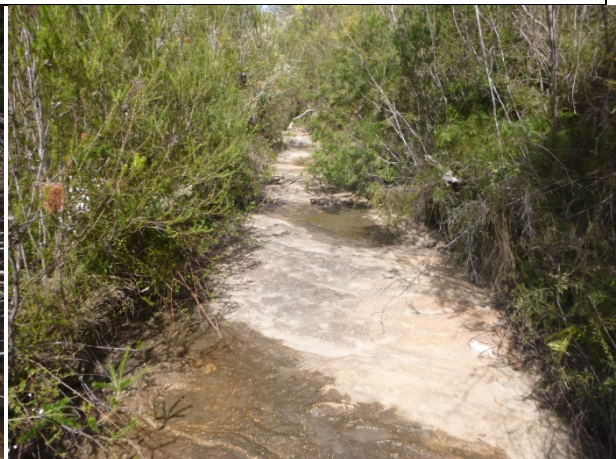
Photo 66: WC21\_Pool 14, looking downstream. Taken on 10/09/2015.

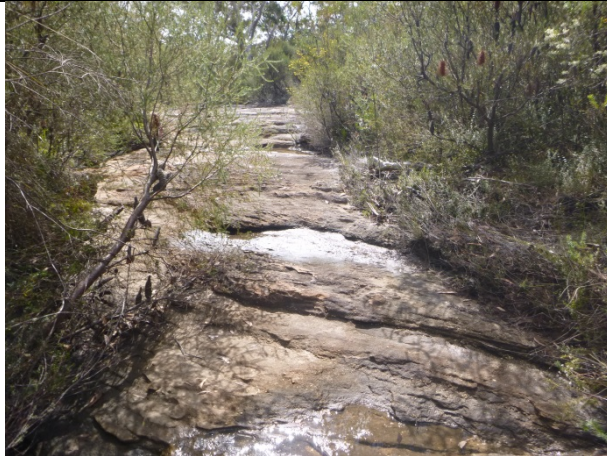
Photo 67: WC21\_Pool 13, looking upstream. Taken on 10/09/2015.

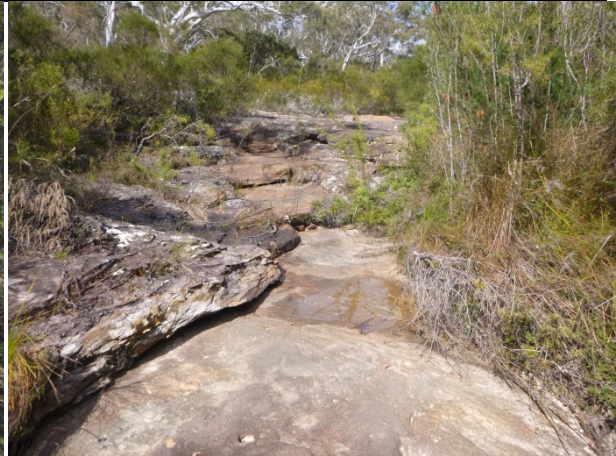
Photo 68: WC21\_Pool 13, looking downstream. Taken on 10/09/2015.

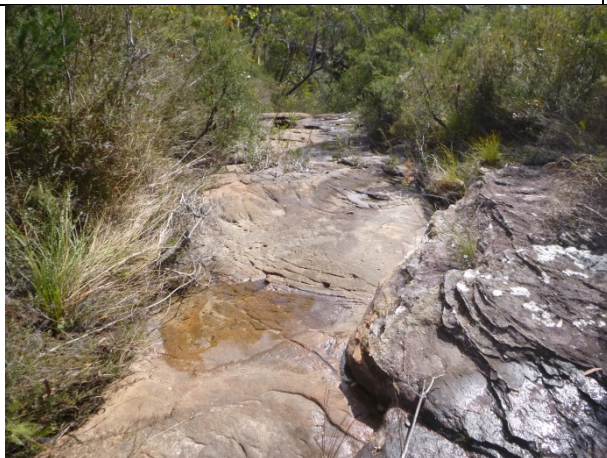
Photo 69: WC21\_Pool 12, looking upstream. Taken on 10/09/2015.

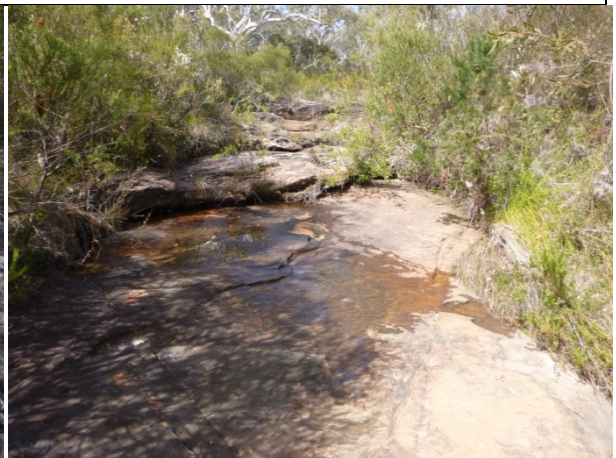
Photo 70: WC21\_Pool 12, looking downstream. Taken on 10/09/2015.

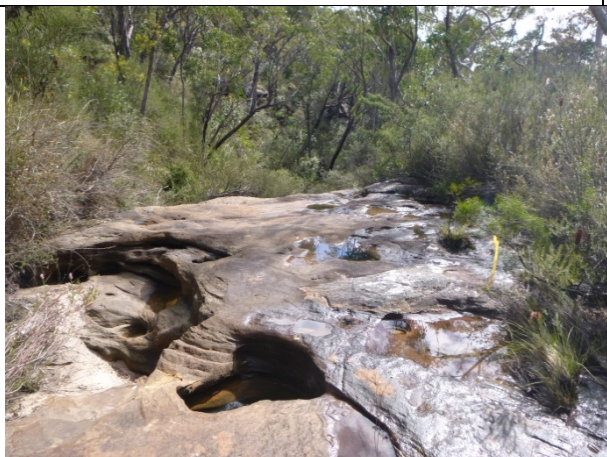
Photo 71: WC21\_Pool 11, looking upstream. Taken on 10/09/2015.

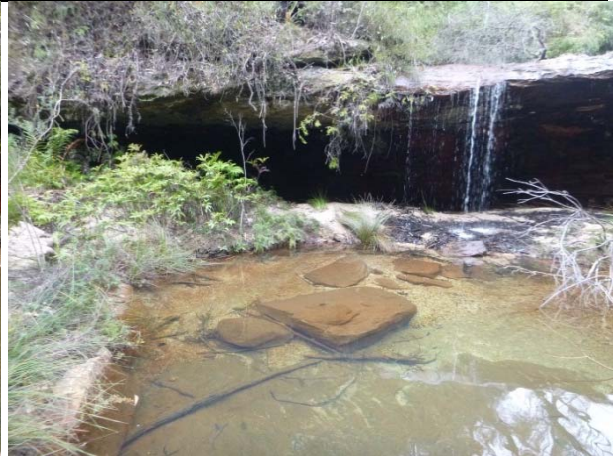
Photo 73: WC21\_Pool 10, looking upstream. Taken on 10/09/2015.

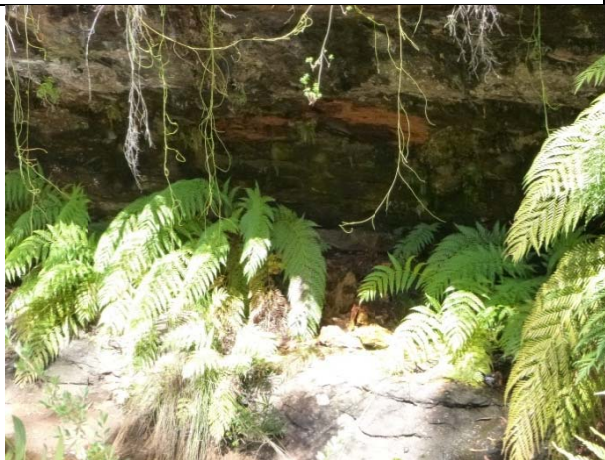
**Impact LW9\_027-** small rockfall to overhang directly to the west of Pool 10 (**Photo 75**).

Photo 74: WC21\_Pool 10, looking across stream. Taken on 10/09/2015.

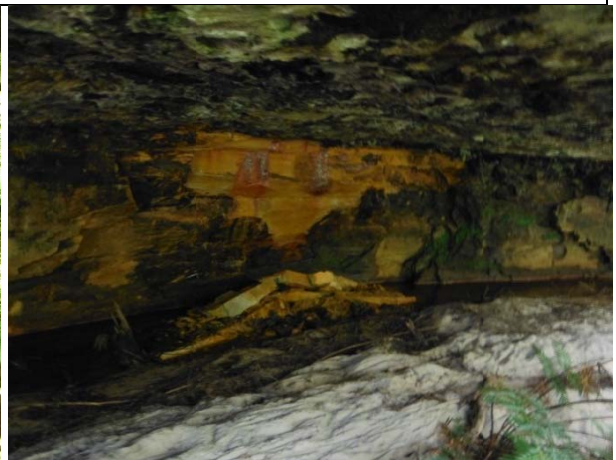
**Impact LW9\_028-** small rockfall to overhang directly to the east of Pool 10 (**Photo 76**).

Photo 75: Impact LW9\_027, small rockfall adjacent to Pool 10. Taken on 28/01/2014.

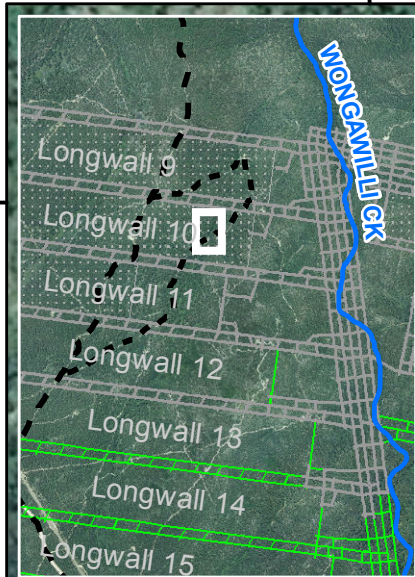
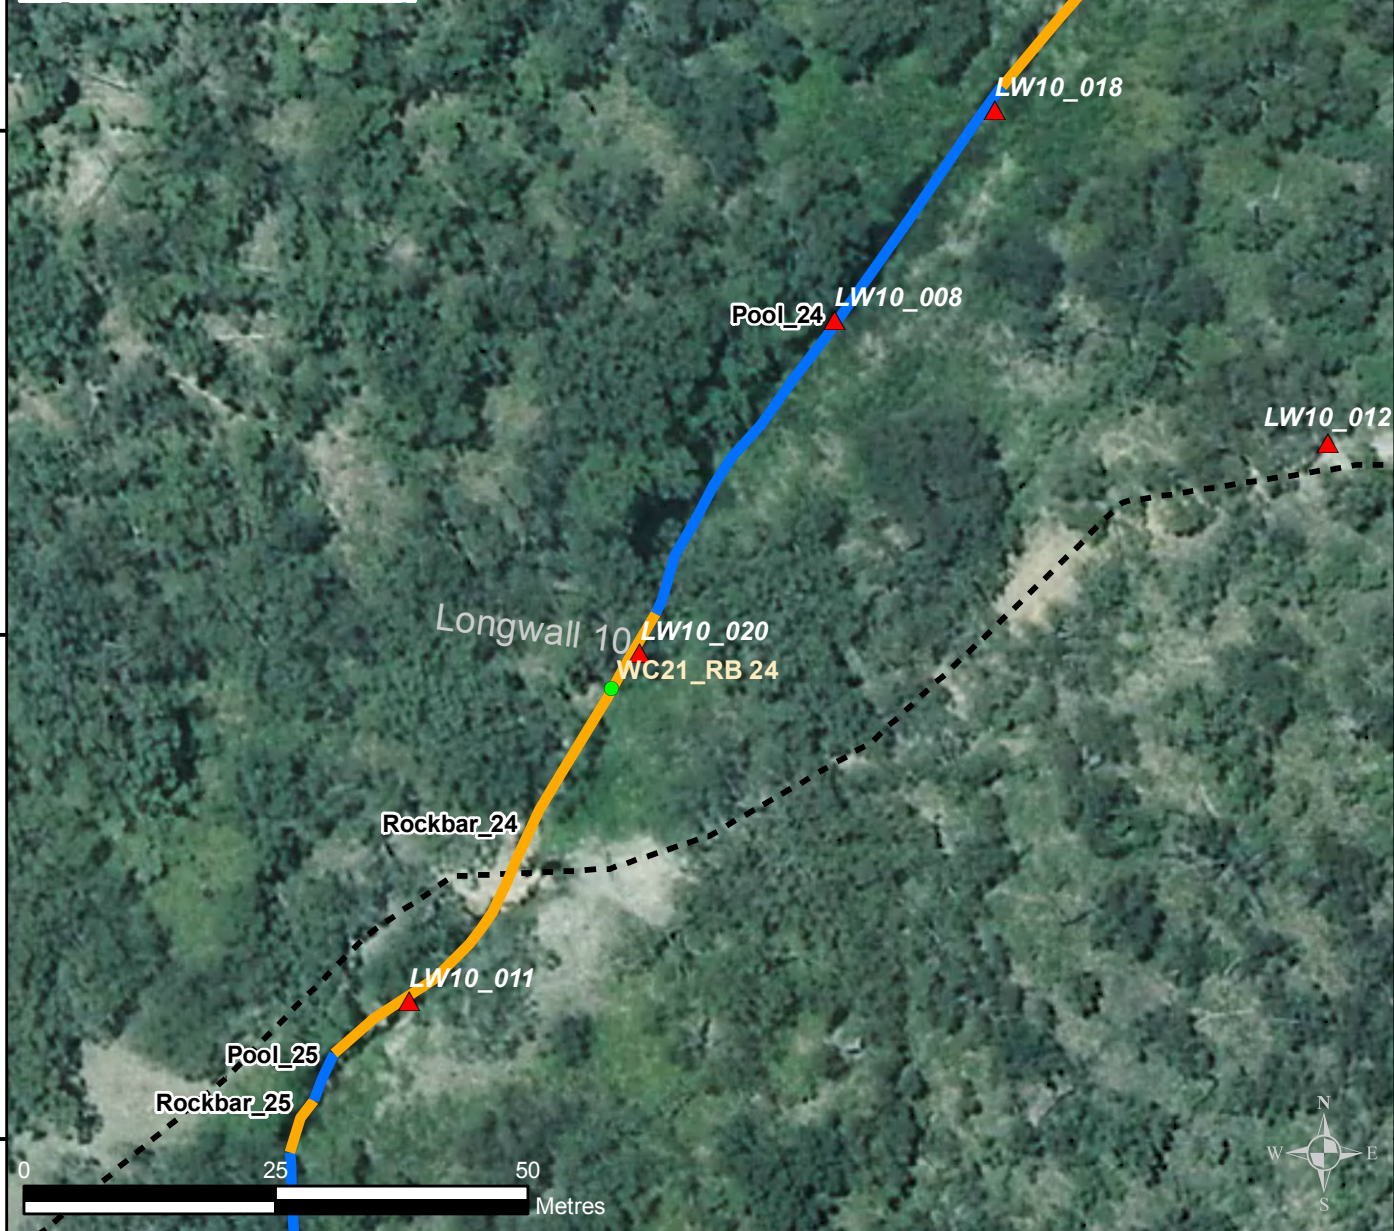
Dendrobium Area 3B  
**WC21 Remediation Plan**  
**Surface Impacts- Figure 4-3**

**Impacts to features: Impact LW10\_008-** Rock fracturing and uplift was identified in the base of Pool 24 towards the downstream section of the pool (**Photo 19**). There is an absence of surface water during most inspections. **Figure 4-3** shows the location of the impact.

An absence of surface flow has been identified following Longwall 10 mining beneath the site. Recorded water levels at the site are below baseline conditions (**Graph 6**). **Figure 4-3** shows the location of the impacts.

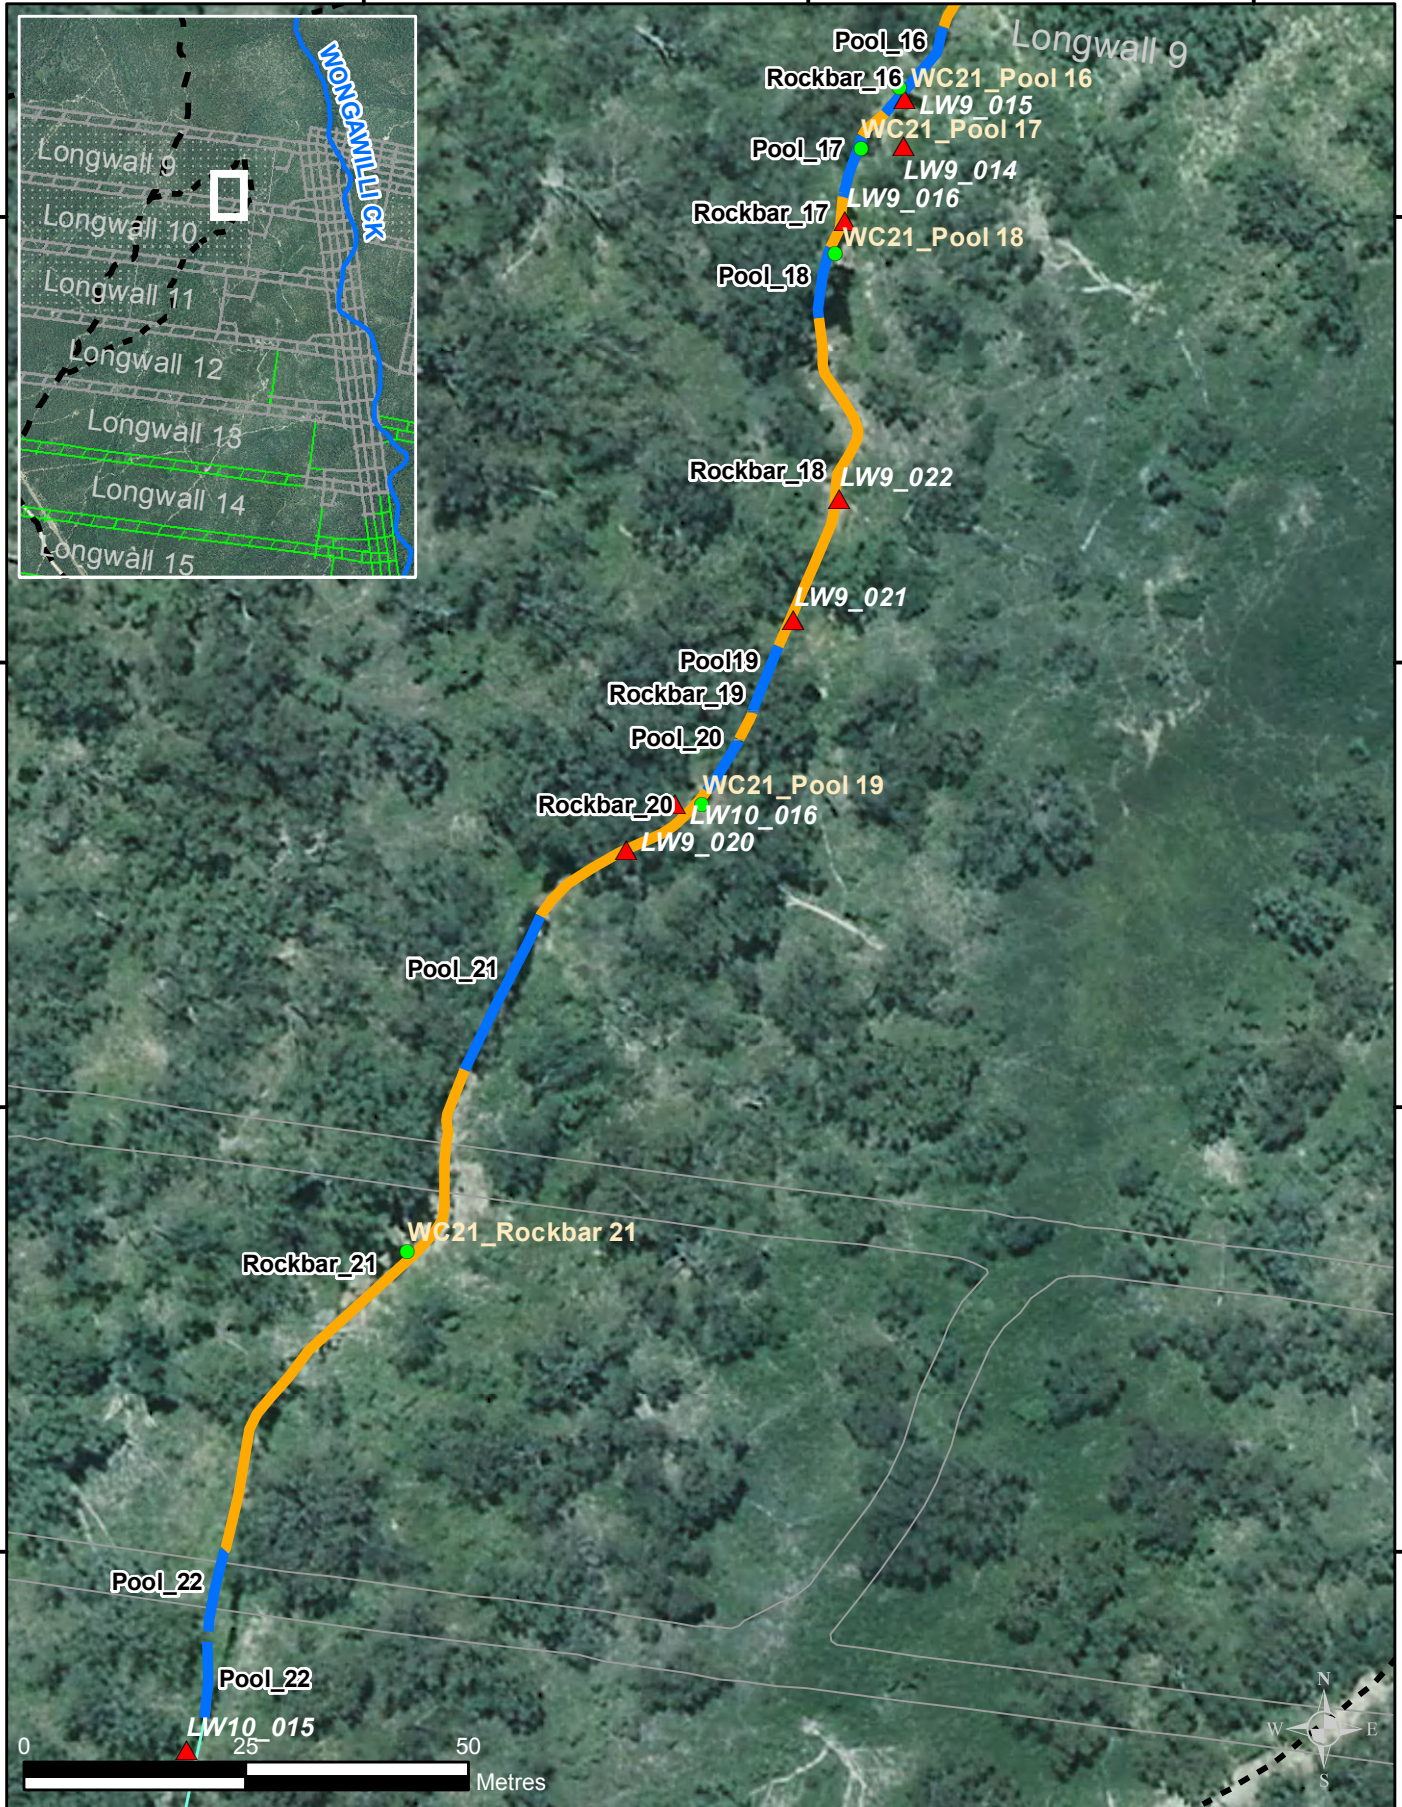
Dendrobium Area 3B  
**WC21 Remediation Plan**  
**Surface Impacts- Figure 4-4**

**Impact LW9\_015-** Fracturing, uplift and dilation of jointing on the base of Pool 16 with an absence of surface flow observed (**Photo 61**). **Figure 4-4** shows the location of surface impacts. The pool retains water for short periods following rainfall (**Graph 12**).

**Recommendation:** Grouting of Impact DA3B\_021 is recommended due to the open nature of the fracture (**Figure 4-4**). Material will be carried from Staging Area 3 (**Figure 4-8**). Cofferdams and diversion piping will be used to temporarily divert surface flow if required.
