## WC21 AND DONALDS CASTLE CREEK REHABILITATION PLAN

<b>Document ID</b>	IMCMP0265	<b>Version</b>	4.0	Page i of 116
<b>Last Date Updated</b>	31/01/2023	<b>Next Review Date</b>	31/01/2026

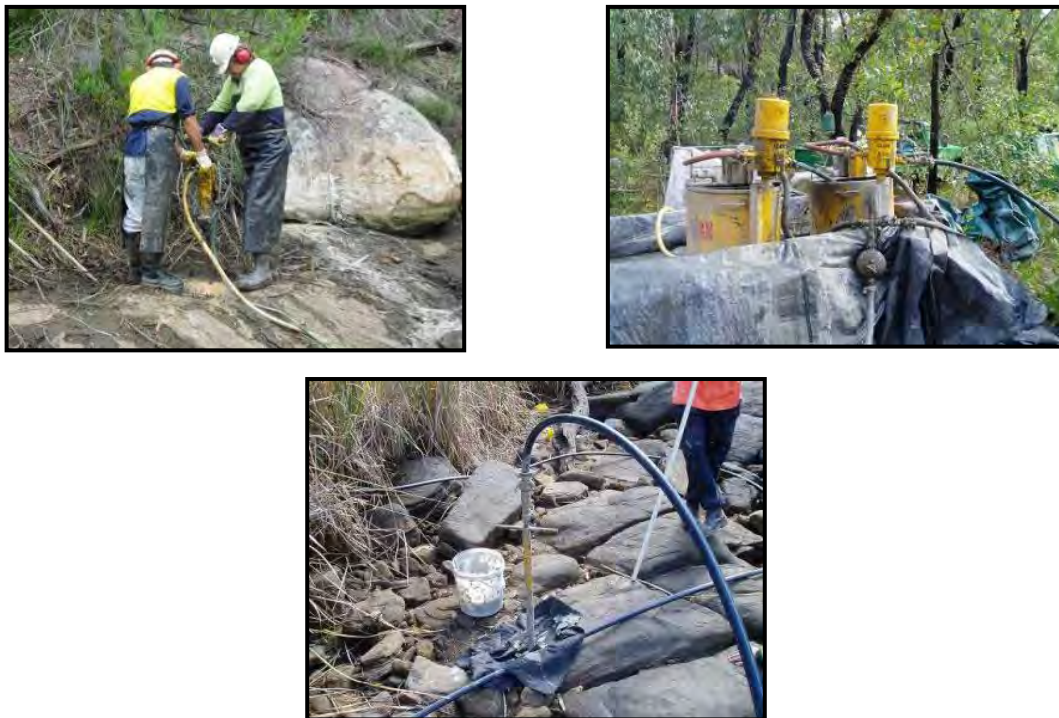
**Figure 2-5: Rockbar Grouting in the Georges River**

(clockwise from top-left): (a) Drilling into the bedrock; (b) Grout pump station setup; (c) Injecting grout into bedrock via a specially designed packer system

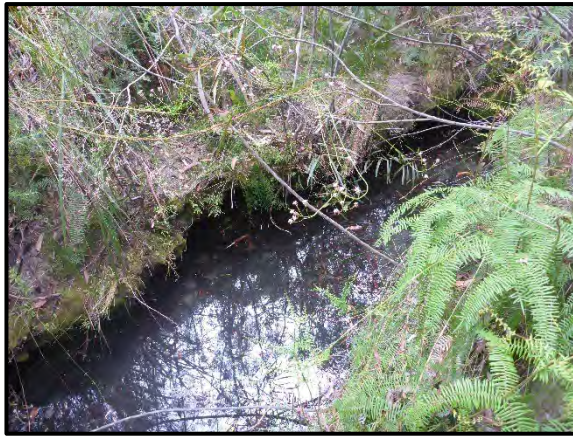
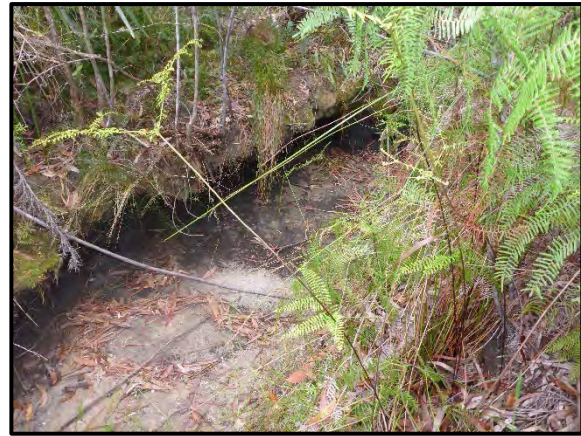
WC21\_Pool 54 was passed by Longwall 12 on 22 October 2016 at an approximate distance of 297 m and was mined beneath by Longwall 13 on 22 September 2017. A reduction in pool water level was first observed on 20 September 2017. Rock fracturing (*DA3B\_LW13\_009*) at the downstream extent of Pool 54 was observed on 23 October 2017, although the fractures did not appear to extend to the base of the pool (**Graph 4-1, Photo 1, Photo 2**).

Photo 1: WC21\_Pool 54 looking upstream, taken 8 November 2016.

Photo 2: WC21\_Pool 54 looking upstream, 20 November 2017.

The pool is not recommended for remediation due to its relatively small size and largely sediment-covered base.

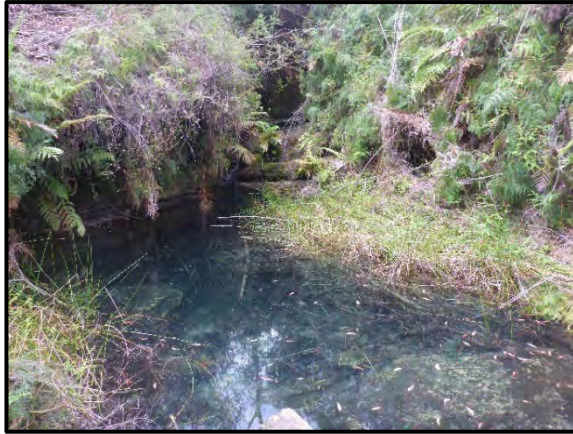
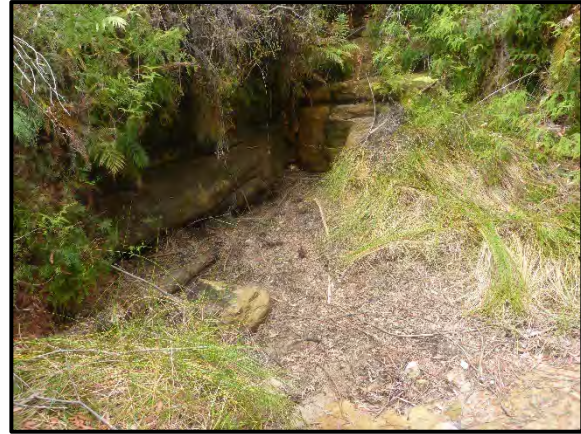
Longwall 12 passed Pool 53 on 22 October 2017 at an approximate distance of 232 m; Longwall 13 mined beneath Pool 53 on 21 September 2017. Rock fracturing to the step at the upstream extent of Pool 53 was observed on 23 October 2017 (DA3B\_LW13\_010). Although there is no benchmark installed to measure water level, a visible decline in water level was observed at the site (Graph 4-2, Photo 3 and Photo 4). Water has not been observed in the pool since 18 November 2017.

Photo 3: WC21\_Pool 53 looking upstream, taken 8 November 2016.

Photo 4: WC21\_Pool 53 looking upstream, taken 20 November 2017.

Due to the potential for aquatic habitat in Pool 53, it is recommended that the site is targeted for remediation. Because there are no observable surface cracks in the base of the pool, it is recommended that the site be remediated by means of pattern grouting and potentially a grout curtain. Safety factors need to be considered due to the fractured steps on either side of the pool. This may affect what remediation options can be safely implemented at the site. Staging Area 7 would be used for works at the site.

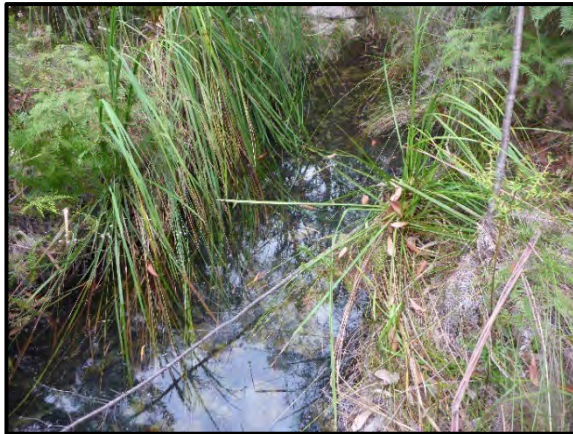
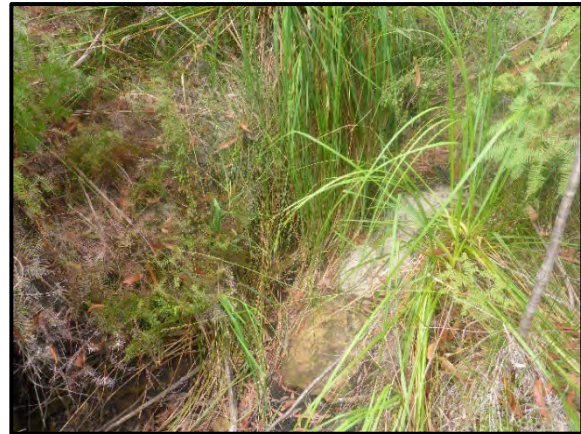
Longwall 12 passed Pool 51, at an approximate distance of 154 m, on 29 October 2016. Longwall 13 mined beneath Pool 51 on 24 September 2017. No surface impacts have been observed at the site; however, water has not been observed in the pool since 20 September 2017, which has been attributed to subsidence impacts from Longwall 13 (Graph 4-3, Photo 5 and Photo 6).

Photo 5: WC21\_Pool 51 looking upstream, taken 8 November 2016.

Photo 6: WC21\_Pool 51 looking upstream, taken 20 November 2017.

Given that no surface impacts have been observed at the site, remediation is not recommended.

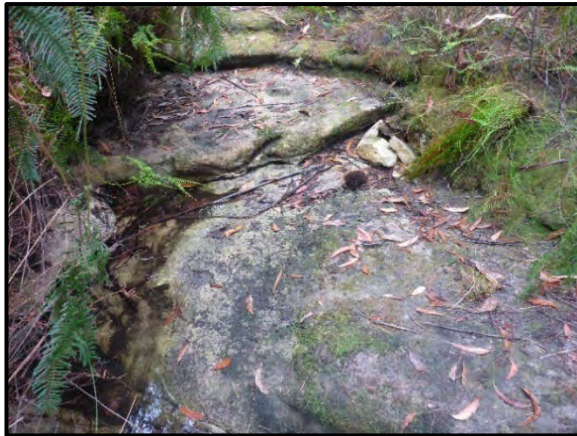
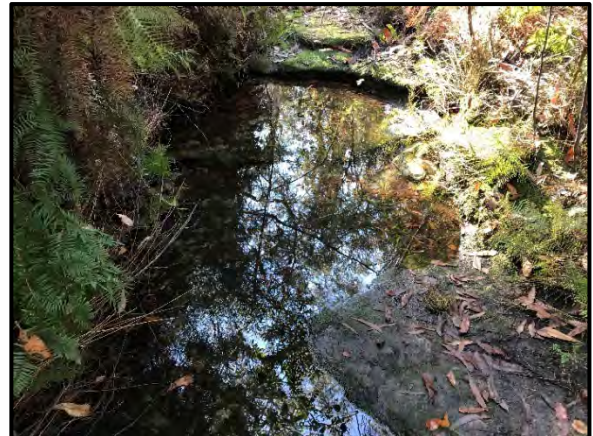
Longwall 12 passed Pool 49 at an approximate distance of 130 m, on 29 October 2016. No surface impacts have been observed at Pool 49. Observations show a downward trend in water level at Pool 49, which is coincident with the passing of Longwall 12. Pool 49 was mined beneath by Longwall 14 on 7 October 2017 and has since exhibited consistently dry pool levels (**Graph 4-4, Photo 7 and Photo 8**).

Photo 7: WC21\_Pool 49, looking downstream. Taken on 6 December 2016.

Photo 8: WC21\_Pool 49, looking downstream. Taken on 15 June 2017.

Given that no surface impacts have been observed at the site, remediation is not recommended.

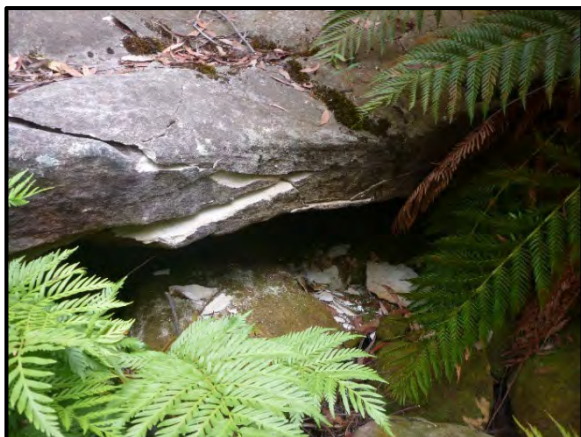
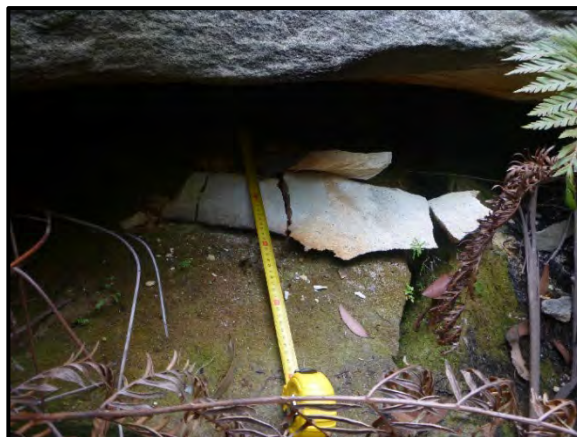
Longwall 12 passed Pool 48 at an approximate distance of 100 m, on 5 November 2016. Fracturing and associated uplift to the step upstream of Pool 48 was identified on 9 November 2016 (DA3B\_LW12\_019); no signs of flow diversion were identified (Photo 9 and Photo 10). Routine monitoring has been established for Pool 48, but there is no suitable feature to install a benchmark to monitor surface water level; instead, categorical observations of whether water is present, or not present on the feature. Pool 48 was mined beneath by Longwall 13 on 11 October 2017 and has since exhibited consistently dry conditions (Graph 4-5).

Photo 9: Impact DA3B\_LW12\_019, upstream of Pool 48, looking upstream. Taken 22 December 2016.

Photo 10: Impact DA3B\_LW12\_019, upstream of Pool 48, looking upstream. Taken 22 December 2016.

Rehabilitation to the impacted step is not recommended at this stage; however, Pool 48 is recommended for rehabilitation given the relatively high water-holding capacity of the pool and potential for aquatic habitat (Photo 11 and Photo 12). Staging Area 8 would be used for works at the site.

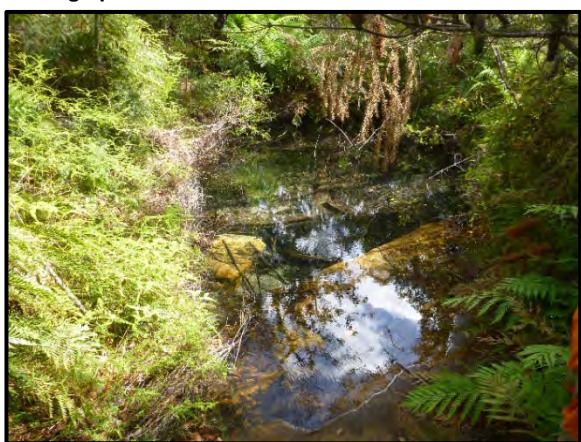
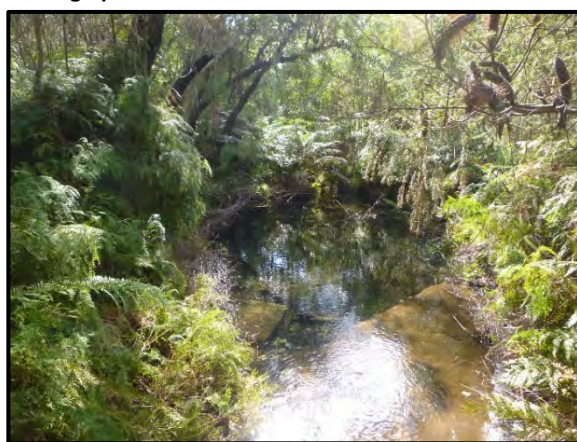
Photo 11: WC21\_Pool 48, looking downstream. Taken on 29 November 2016.

Photo 12: WC21\_Pool 48, looking downstream. Taken on 18 April 2017.

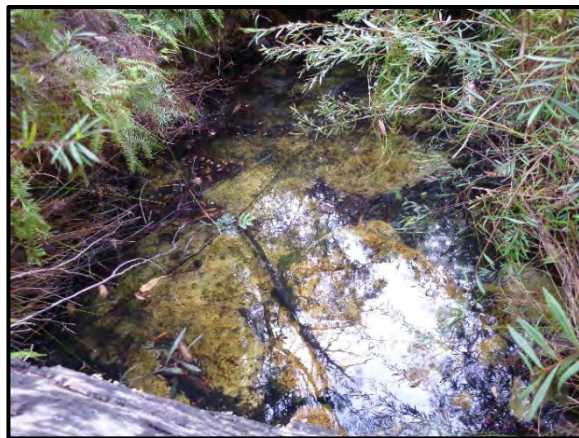
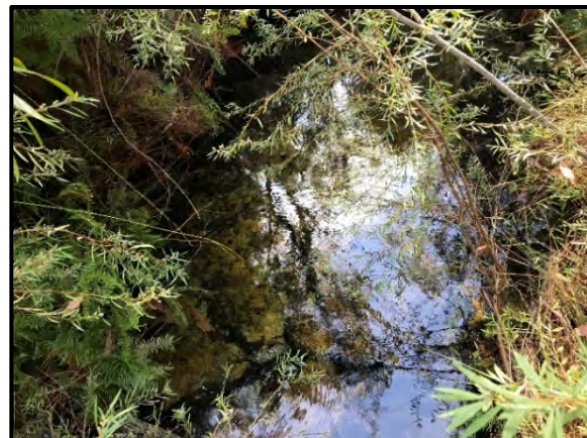
Photo 13: WC21\_Pool 47, looking downstream. Taken on 12 December 2016.

Photo 14: WC21\_Pool 47, looking downstream. Taken on 15 June 2017.

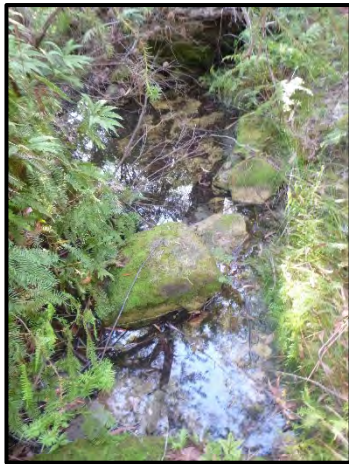
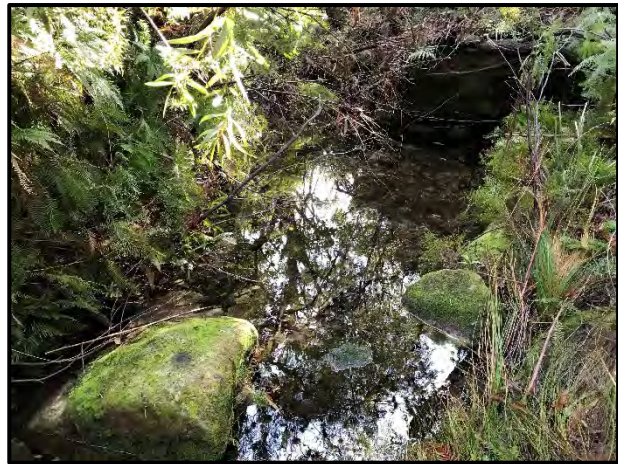
Photo 15: WC21\_Pool 46, looking downstream. Taken on 18 May 2016.

Photo 16: WC21\_Pool 46, looking downstream. Taken on 15 June 2017

Pool 46 is recommended for rehabilitation given the relatively high water-holding capacity of the pool and potential for aquatic habitat (Photo 16). Staging Area 6 would be used for works at the site.

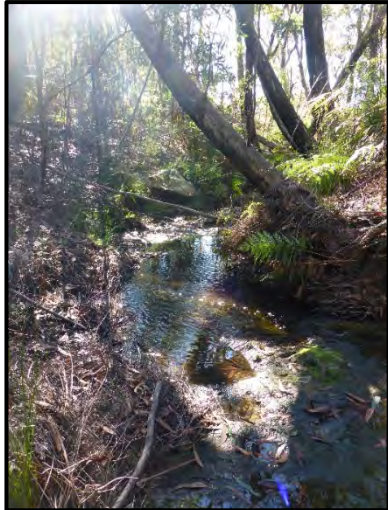
Photo 17: WC21\_Rockbar 43, looking downstream. Taken on 11 July 2017.

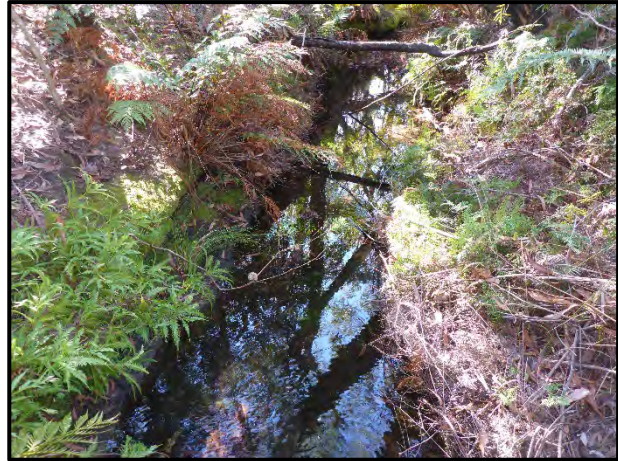
Photo 18: WC21\_Pool 43, looking downstream. Taken 1 July 2017

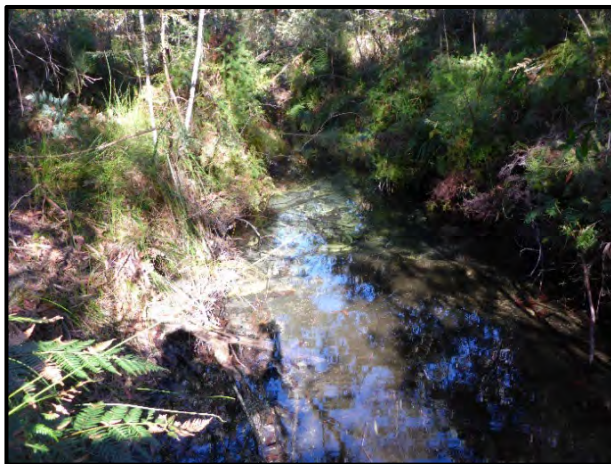
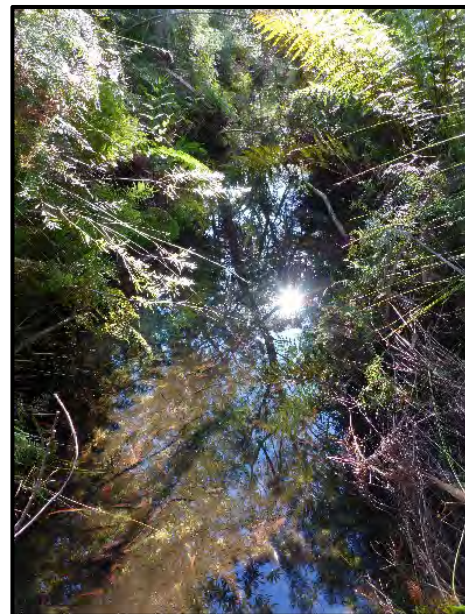
Photo 19: WC21\_Pool 45, looking upstream. Taken on 11 July 2017.

Photo 20: WC21\_Pool 45, looking downstream. Taken 11 July 2017.

Pool 45 is recommended for rehabilitation at this stage. Staging Area 6 would be used for works at the site.

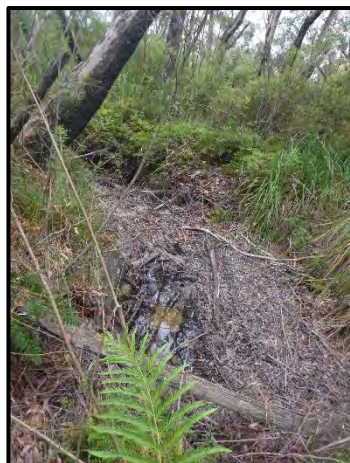
Photo 21: WC21\_Pool 42 looking downstream. Taken on 22 December 2016.

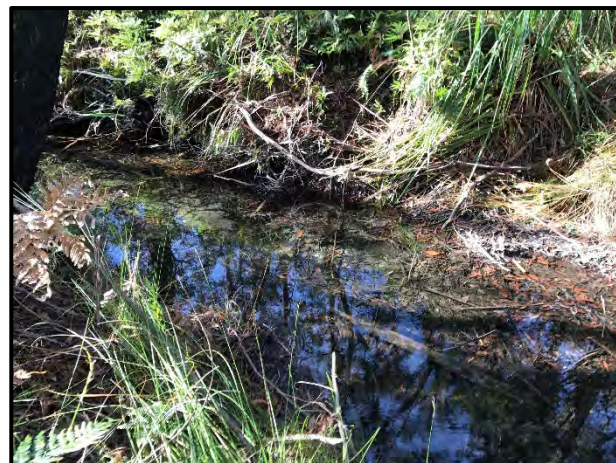
Pool 42 was undermined by Longwall 12 on 12 November 2016. Pool 42 is monitored regularly but due to a lack of suitable features, a benchmark was not installed to measure water level. No surface impacts have been observed at the site; however, since being undermined, a considerable drop in water level has been observed (**Graph 4-8**). Additionally, since Longwall 13 mined beneath the upper reaches of WC21, there has been an observable decrease in water at Pool 42 (**Graph 4-1**).

Photo 22: WC21\_Pool 42 looking downstream. Taken on 15 June 2017.

Given the morphology of Pool 42, it is not recommended that this feature be considered a priority target for remediation.

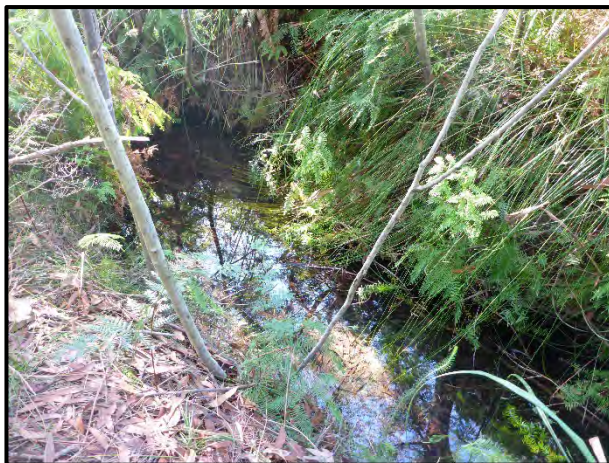
Routine monitoring has been established for Pool 41, but there is no suitable feature to install a benchmark to monitor surface water level; instead, categorical observations of whether water is present, or not present on the feature. Pool 41 was undermined by Longwall 12 on 12 November 2016. No surface impacts have been observed at Pool 41; however, a considerable reduction in pool water level has been observed (**Graph 4-9, Photo 23 and Photo 24**).

Photo 23: WC21\_Pool 41, looking downstream. Taken on 20 April 2016.

Given the morphology of Pool 41, remediation is not recommended at the site.

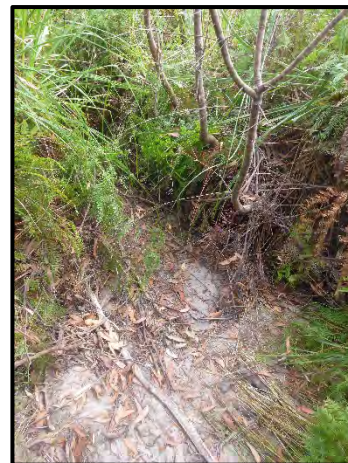
Photo 24: WC21\_Pool 41, looking downstream. Taken on 12 December 2016.

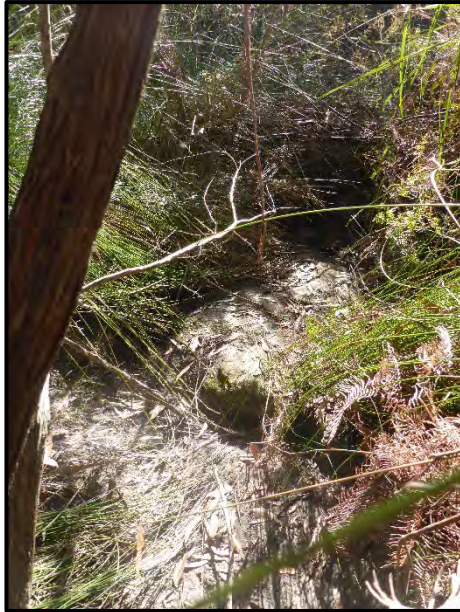
No routine monitoring of this section of the tributary has been established. The area was undermined by Longwall 12 on 19 November 2016. No surface impacts have been identified on this section of the tributary. However, a considerable decrease in surface flow has been observed since undermining by Longwall 12; these conditions have persisted and were recorded during recent inspections (**Photo 25** and **Photo 26**).

Photo 25: WC21\_Pool 40, looking downstream. Taken on 11 July 2017.

Given the morphology of these features, it is not recommended that they are targeted for remediation.

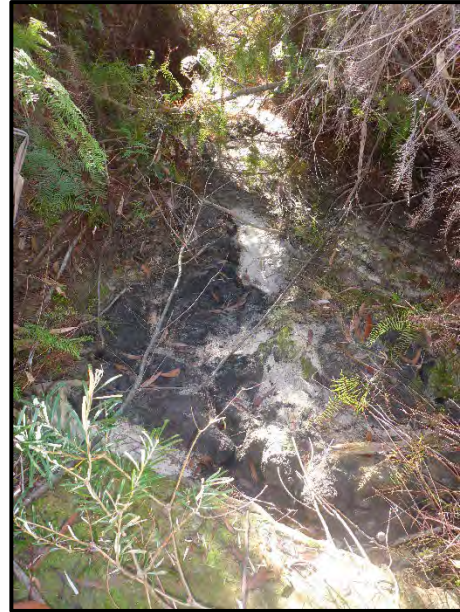
Photo 26: WC21\_Pool 39, looking downstream. Taken on 11 July 2017.

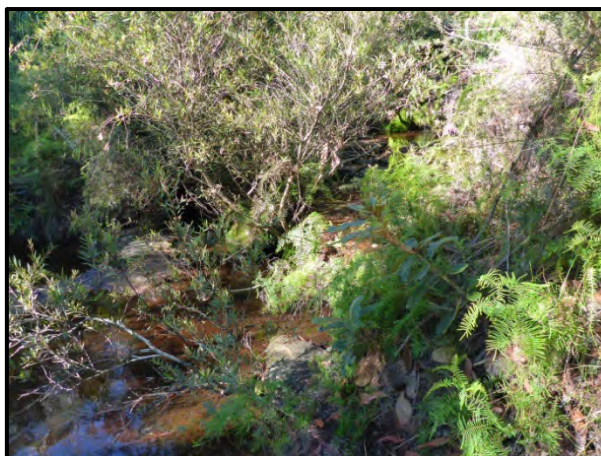
WC21\_Pool 38 was passed by Longwall 11 on 2 January 2016 and undermined by Longwall 12 on 19 November 2016. No surface impacts have been observed at WC21\_Pool 38. However, there has been an appreciable decrease in water level since the pool was undermined by Longwall 12 (**Graph 4-10, Photo 27** and **Photo 28**).

Photo 27: WC21\_Pool 38, looking upstream. Taken on 23 March 2016.

No remediation works are recommended at the site due to the morphology of the pool.

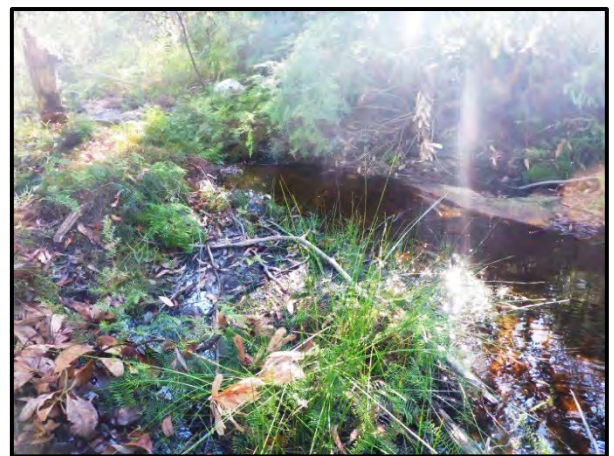
Photo 28: WC21\_Pool 38, looking downstream. Taken on 23 March 2016.

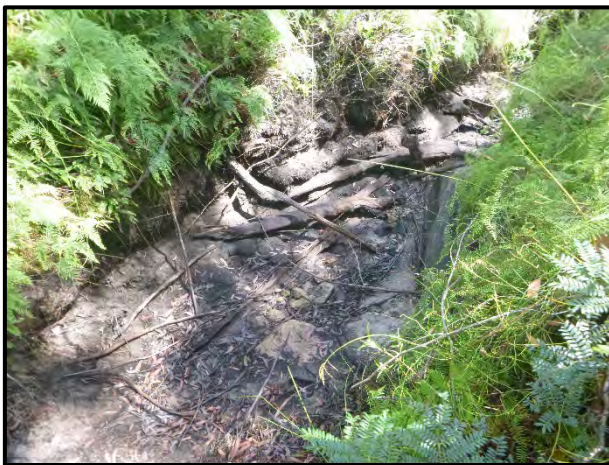
WC21\_Pool 37 was undermined by the southern edge of Longwall 11 on 5 January 2016. No surface impacts have been observed at the pool. Whilst no quantitative water level monitoring could be established at the site, a categorical 'Water Level Observation' has been recorded during monitoring (**Graph 4-11**). These observations show a period (10 January 2017 – 13 February 2017) where the pool has no observable surface water (**Graph 4-11**), which follows when the pool was undermined by Longwall 11.

Photo 33: WC21\_Pool 37, looking upstream. Taken on 10 January 2017.

The sediment base and lack of visible fracturing at Pool 37 makes targeted remediation difficult at this site; no remediation is proposed at this stage.

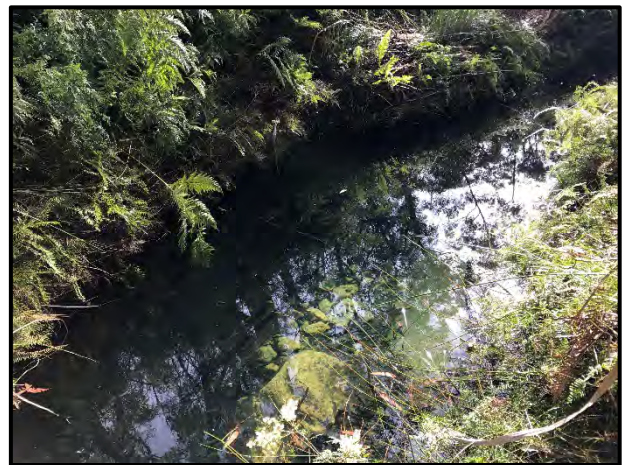
Photo 34: WC21\_Pool 37, looking upstream. Taken on 15 June 2017.

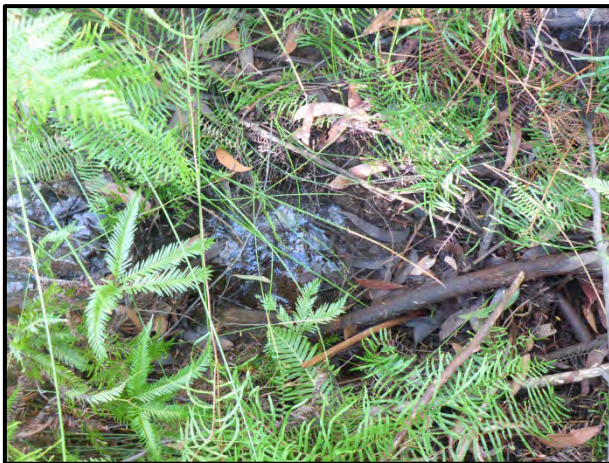
No surface impacts have been observed at Pool 36; however, an absence in surface flow has been identified since the site was undermined, on 6 January 2016, by Longwall 11 (**Graph 4-12**). Whilst no quantitative water level monitoring could be established at the site, a categorical 'Water Level Observation' has been recorded during monitoring. The nature of flow transitions from surface to subsurface just upstream from Pool 36 (**Graph 4-12**).

Photo 37: Flow becomes subsurface, upstream from WC21\_Pool 36 looking across stream. Taken on 20 April 2016.

The sediment base and lack of visible fracturing at Pool 36 makes targeted remediation difficult at this site; no remediation is proposed at this stage.

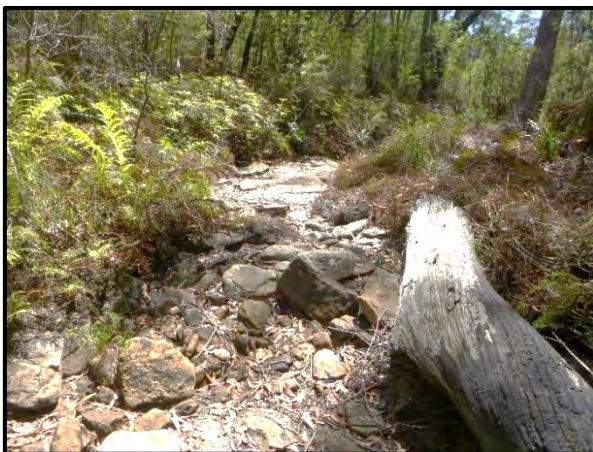
WC21\_Pool 30 was undermined by Longwall 11 on 28 December 2015; a zone of fracturing (*Impact LW11\_008*) was observed upstream from the site (**Photo 43**, **Photo 44** and **Photo 45**). Since being undermined, an absence of surface water at WC21\_Pool 30 has been observed (**Graph 4-13**).

Photo 45: WC21\_Pool 30, looking downstream. Taken on 13 February 2017.

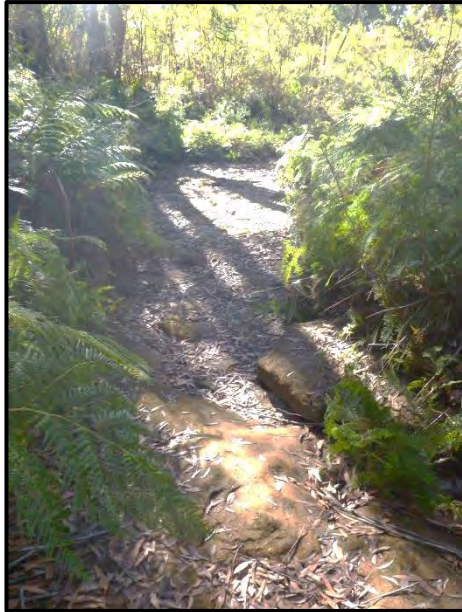
WC21\_Pool 29 was undermined by the northern edge of Longwall 11 on 2 January 2016. No routine water level monitoring is installed at this pool. No surface impacts have been identified at the site, however, there is an absence of surface flow from upstream (**Photo 47**).

**Photo 47: WC21\_Pool 29, looking downstream. Taken on 17 May 2016.**

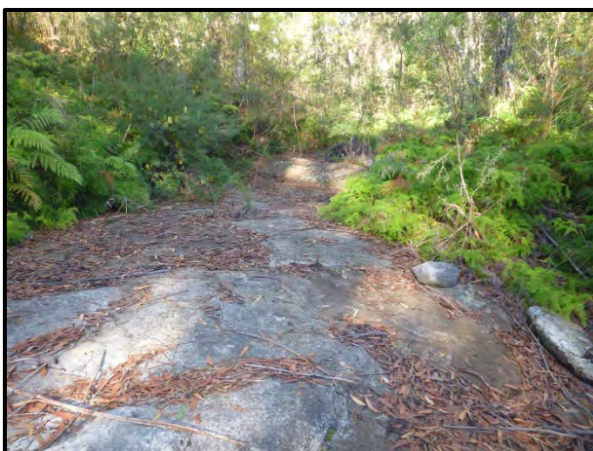
WC21\_Pool 28 overlies the chain pillar between Longwall 10 and Longwall 11. No surface impacts have been identified at the site to date. A reduction in pool water level has been observed, progressively, following the passing of Longwalls 10, 11 and 12 (**Graph 4-14, Photo 48, Photo 49, Photo 50 and Photo 51**).

**Photo 48: WC21\_Pool 28, looking upstream. Taken on 23 March 2016.**

The sediment banks and pool base, and pre-mining subsurface flow conditions make any targeted remediation difficult at the site. The downstream end of the pool continues to hold water. No works are proposed at this site.

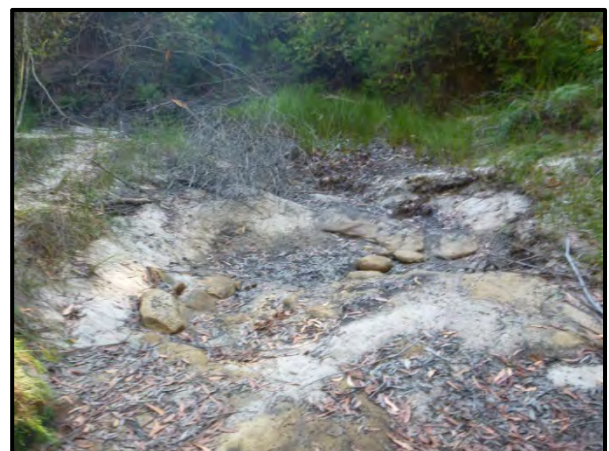
**Photo 49: WC21\_Pool 28, looking downstream. Taken on 23 March 2016.**

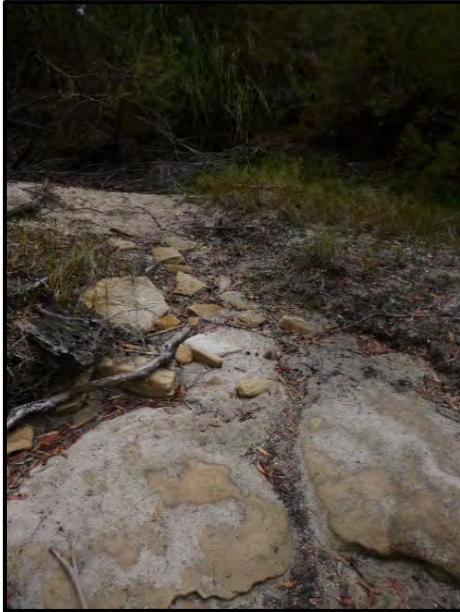
Photo 50: WC21\_Pool 28, looking downstream. Taken 25 January 2017.

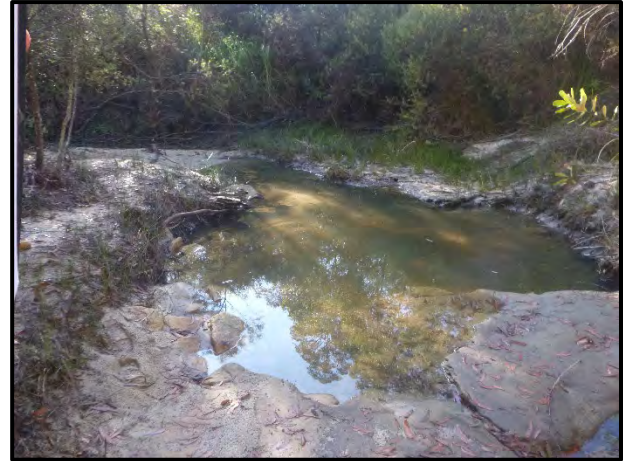
Photo 51: WC21\_Pool 28, looking downstream. Taken 15 June 2017.

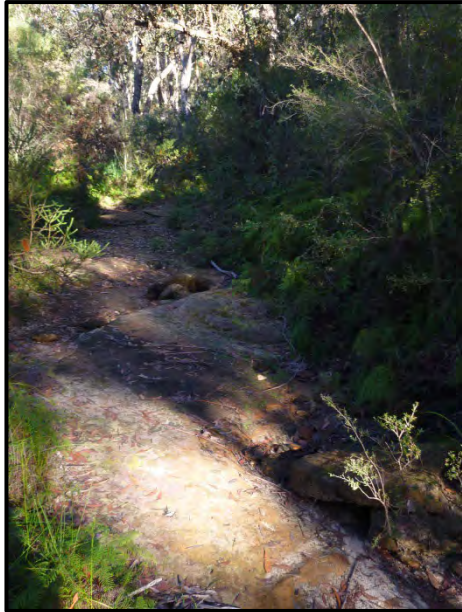
WC21\_Pool 27 overlies the southern edge of Longwall 10. No routine water level monitoring is installed at this pool. No surface impacts have been identified at the site. However, a reduction in surface flow has been observed following mining (**Photo 56** and **Photo 57**).

Photo 56: WC21\_Pool 27, looking upstream. Taken on 17 May 2016.

No remediation is proposed at the site at this stage.

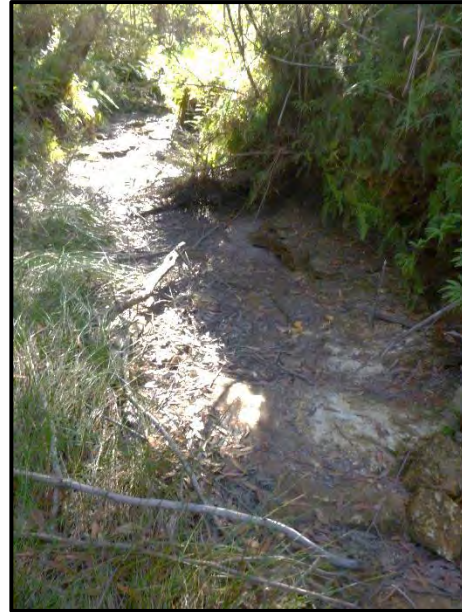
Photo 57: WC21\_Pool 27, looking upstream. Taken on 17 May 2016.

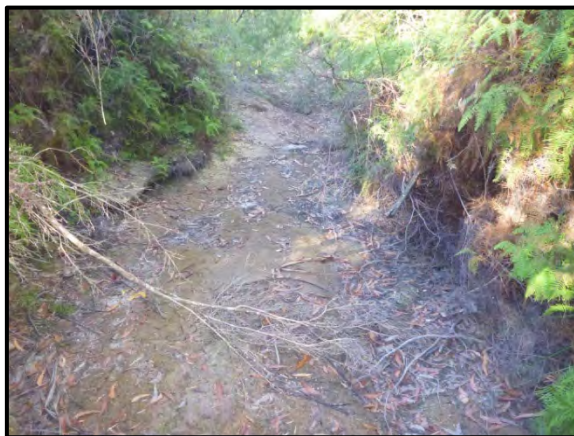
Rockbar 26 was undermined by Longwall 10 on 6 November 2014. Fracturing was identified to the downstream end of Rockbar 26 (*Impact LW10\_007*); some localised flow diversion was observed during low flow conditions. A reduction in pool water level has been recorded following undermining by Longwall 10, and the upstream passing of Longwall 11 (**Photo 58, Photo 59, Photo 60, Photo 61 and Graph 4-16**).

Photo 58: WC21\_Rockbar 26, looking upstream. Taken on 23 March 2016.

The morphology of the feature makes targeted remediation difficult at this site. No remediation is proposed at this stage.

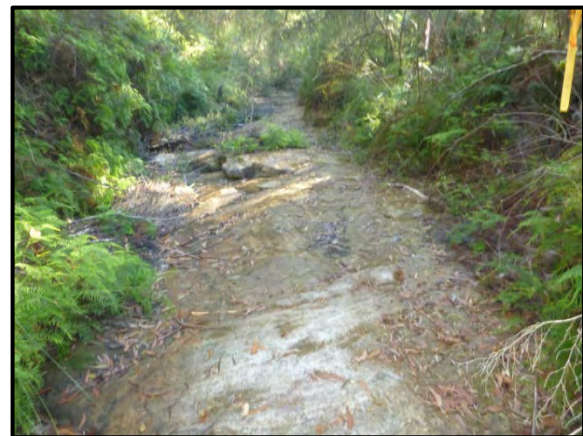
Photo 59: WC21\_Rockbar 26, looking downstream. Taken on 23 March 2016.

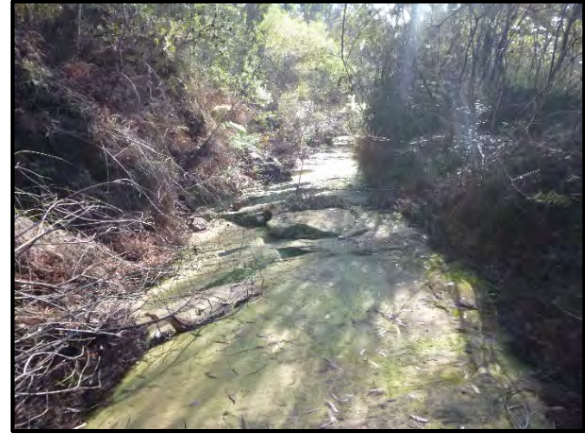
Photo 61: WC21\_Rockbar 26, looking downstream. Taken on 15 May 2017

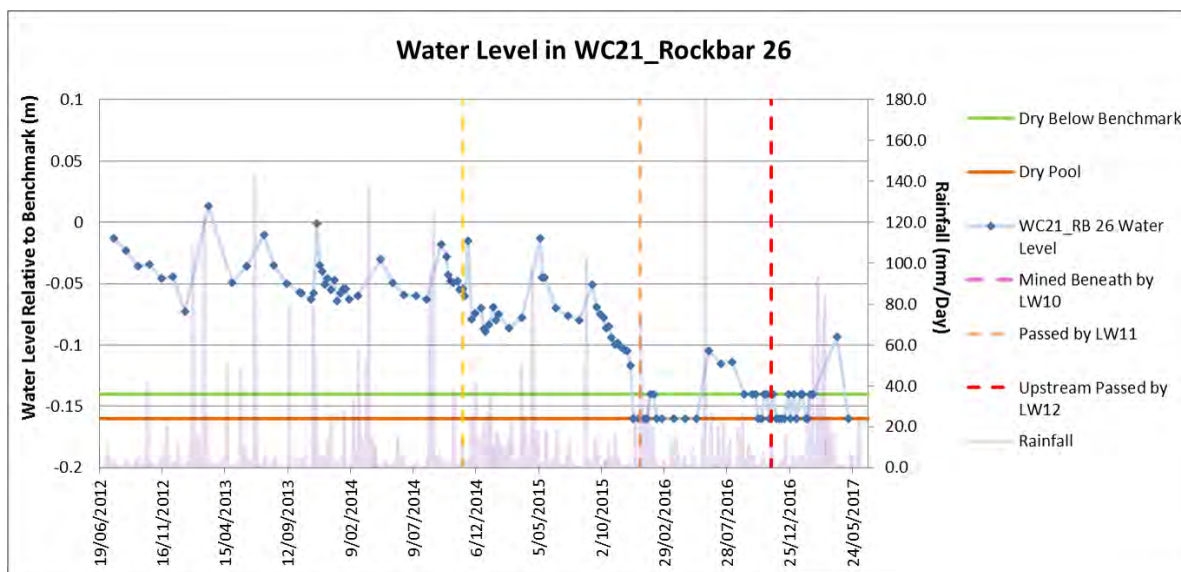
Graph 4-16: Water level measurements relative to installed benchmark at WC21\_Rockbar 26.

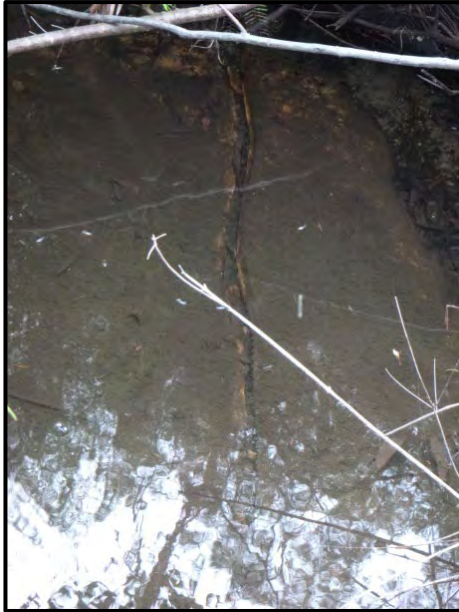
Pool 26 was undermined by Longwall 10 on 8 November 2014. No routine water level monitoring is installed at this pool. Dilation of a joint on the base of Pool 26 (*Impact LW10\_010*) was identified (**Photo 62**); no active flow diversion has been observed to date. A visible decrease in surface water at the pool has been observed since being undermined by Longwall 10 (**Photo 63** and **Photo 64**).

Photo 62: Impact LW10\_010- dilation of joint on base of pool, looking downstream. Taken on 25 November 2014.

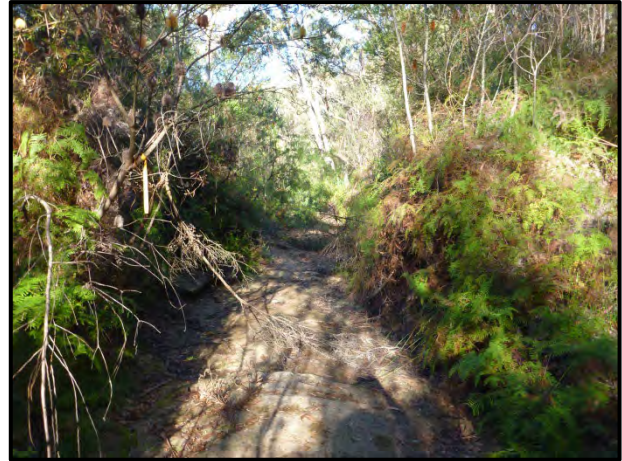
Photo 63: WC21\_Pool 26, looking upstream. Taken on 17 May 2016.

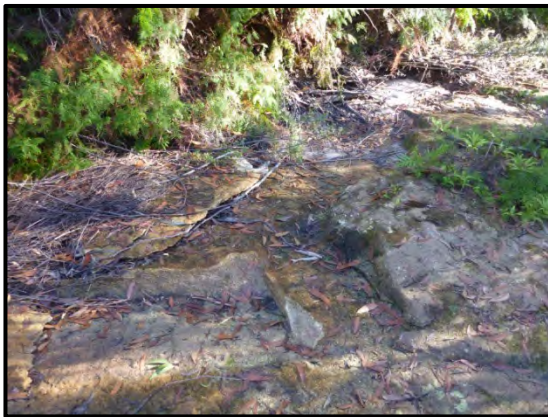
Photo 64: WC21\_Pool 26, looking downstream. Taken on 17 May 2016.

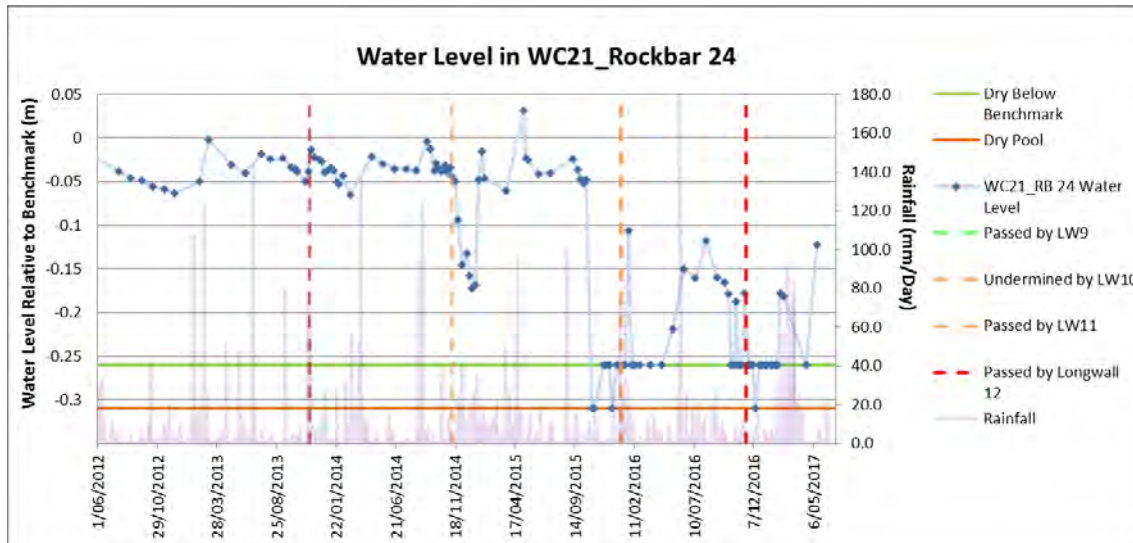
Rockbar 24 was undermined by Longwall 10 on 8 November. Multiple fractures and uplift have been observed at Rockbar 24 (*Impact LW10\_011*); flow diversion is evident with a general decline in surface water over both the rockbar and pool (**Graph 4-17**). Additionally, rock fractures to the downstream section of Rockbar 24 were observed (*Impact LW10\_020*).

Graph 4-17: Water level measurements relative to installed benchmark at WC21\_Rockbar 24.

Flow diversion has been observed through fracturing and an existing joint which runs perpendicular to the rockbar. The site is proposed as a remediation trial site. Pending results of the investigation at the

site, injection grouting is recommended to target fracturing in the joint. Staging Area 1 will be used for works at the site.

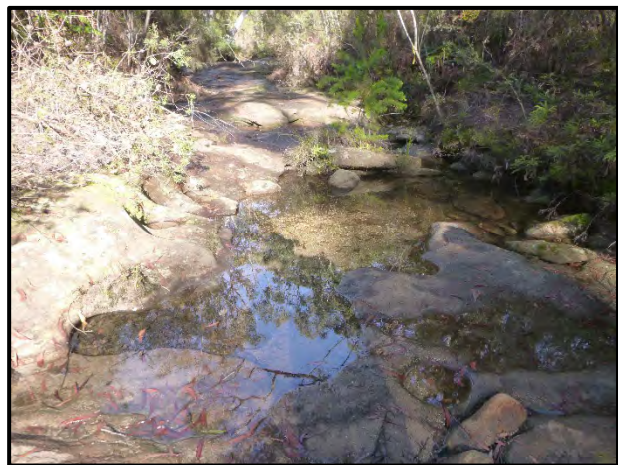
Photo 68: WC21\_Rockbar 24, looking upstream. Taken on 17 June 2017.

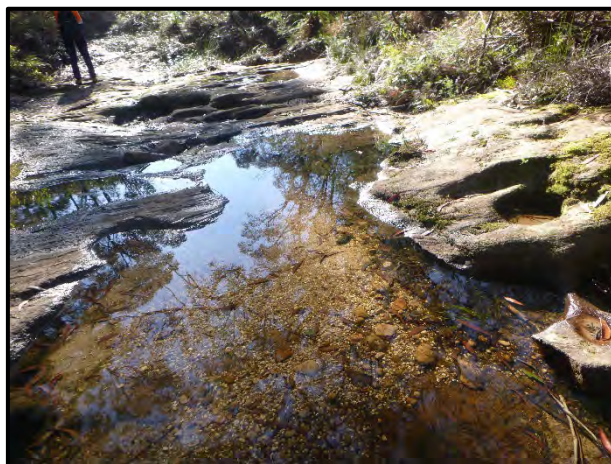
Photo 69: WC21\_Rockbar 24, looking upstream. Taken on 17 June 2017.

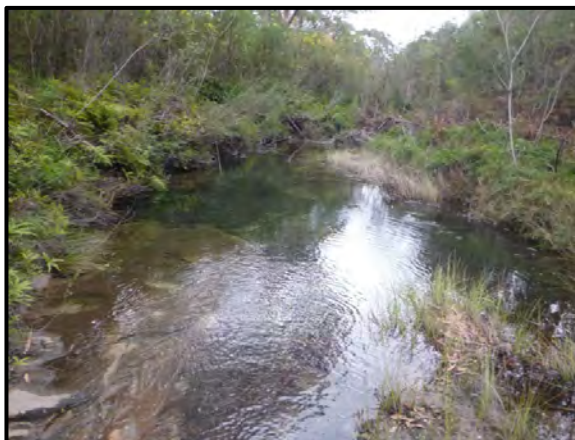
Pool 24 was undermined by Longwall 10 on 10 November 2014. No routine pool water level monitoring is installed at this site. Rock fracturing and uplift was identified in the base of Pool 24 towards the downstream section of the pool (*Impact LW10\_008*) (**Photo 70**). There is an absence of surface water during most inspections. Subsurface inflow to the sediment base of the upstream section of the pool is evident. The pool continues to hold water for periods following rainfall (**Photo 72**).

Photo 72: Upstream end of WC21\_Pool 24, with water in pool, looking downstream. Note: this is often dry. Taken on 10 September 2015.

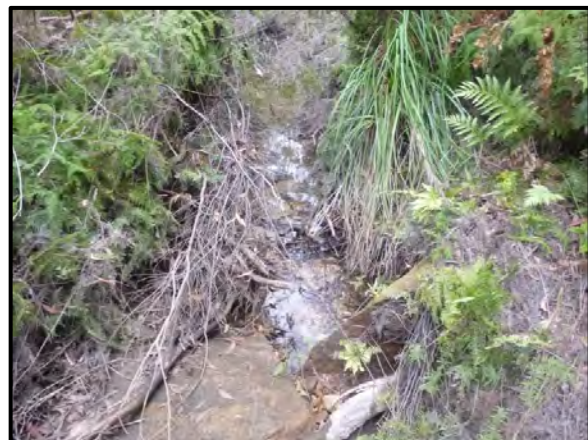
Photo 73: Downstream section of WC21\_Pool 24, looking upstream. Taken on 10 September 2015.

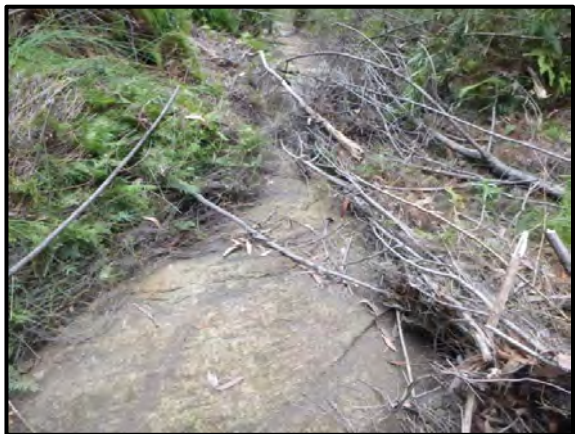
Photo 74: Downstream section of WC21\_Pool 24, looking downstream. Taken on 10 September 2015.

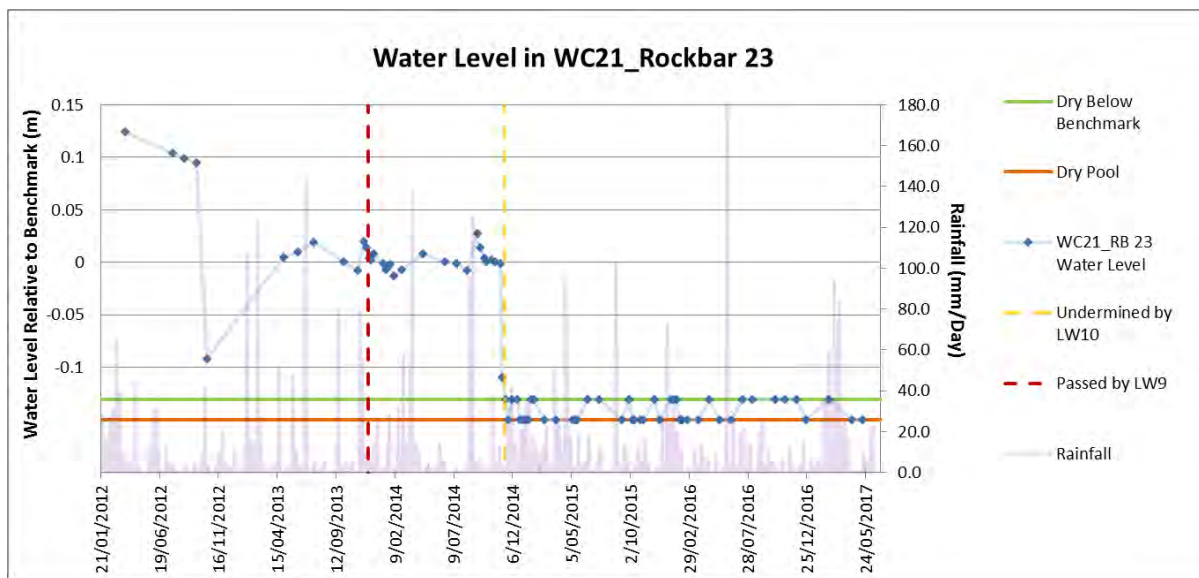
A reduction in water level, below baseline, was observed following after Rockbar 23 was undermined by Longwall 10. These reduced water levels have persisted throughout periods of considerable rainfall (**Graph 4-18**).

**Graph 4-18: Water level measurements relative to installed benchmark at WC21\_Rockbar 23.**

Reassessment of surface flow conditions on the rockbar are proposed following return of surface flow to upstream features. Grouting of any flow diversion is recommended. It is recommended that remediation initially target Pool 23.

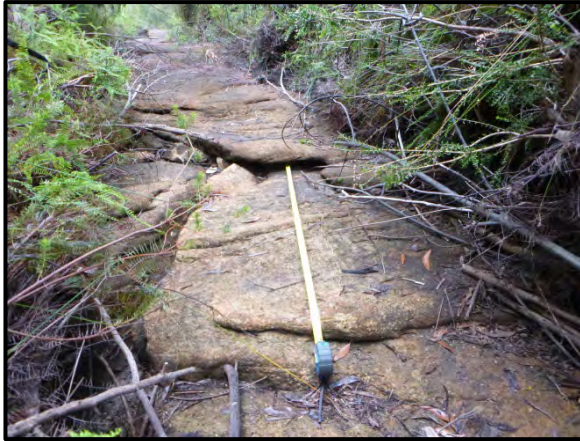
- *Impact LW10\_018* - Rock fracture upstream from Rockbar 23. Surface flow absent (**Photo 75**).
- *Impact LW10\_019* - Multiple fractures to Rockbar 23. Surface flow absent (**Photo 76**).
- *Impact LW10\_009* - Multiple fractures to the downstream end of Rockbar 23. Surface flow absent (**Photo 77**).
- *Impact LW10\_013* - Rock fracturing to base of Pool 23 on western margin (**Photo 78**).
- *Impact LW10\_026* - Multiple rock fractures to the downstream section of Rockbar 23. Surface flow absent (**Photo 79**).

Photo 75: Impact DA3B\_LW10\_018. Taken on 18 December 2014

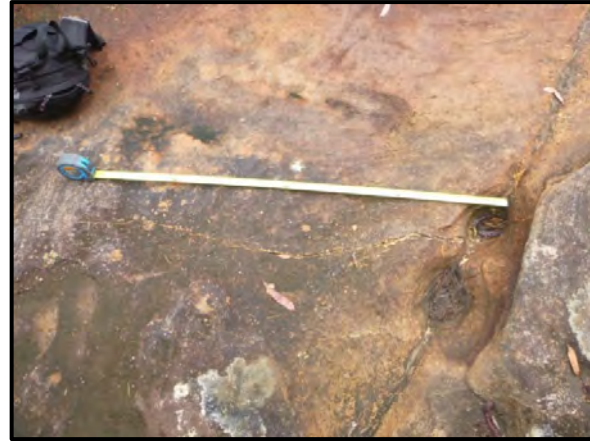
Photo 76: Impact DA3B\_LW10\_019. Taken on 18 December 2014

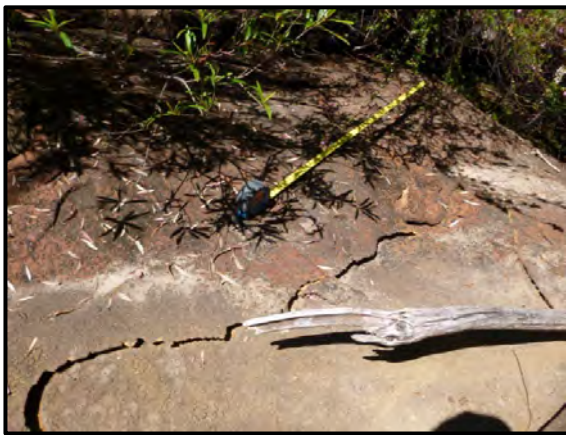
Photo 77: Impact DA3B\_LW10\_009. Taken on 18 November 2014

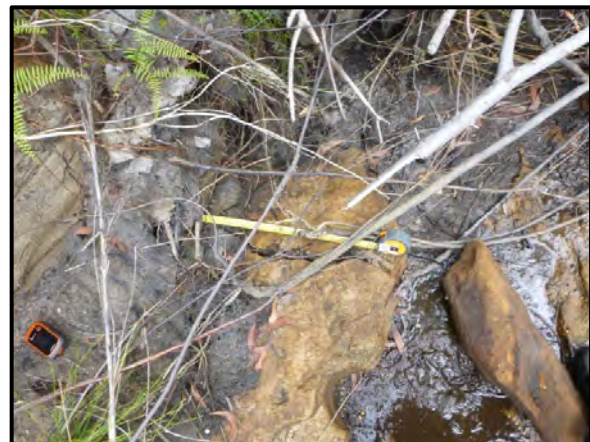
Photo 78: Impact DA3B\_LW10\_013. Taken on 4 December 2014

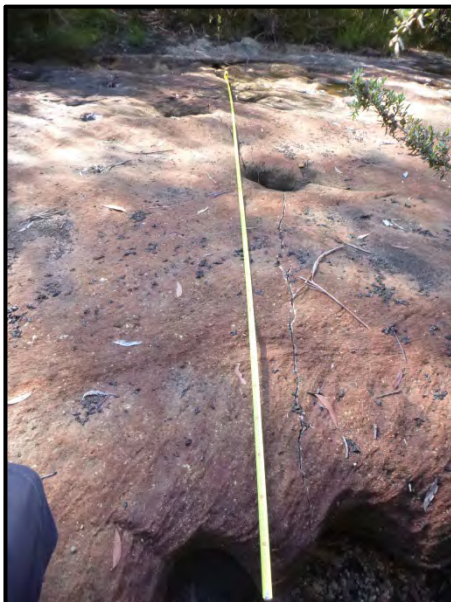
Photo 79: Impact DA3B\_LW10\_026. Taken on 3 March 2015.

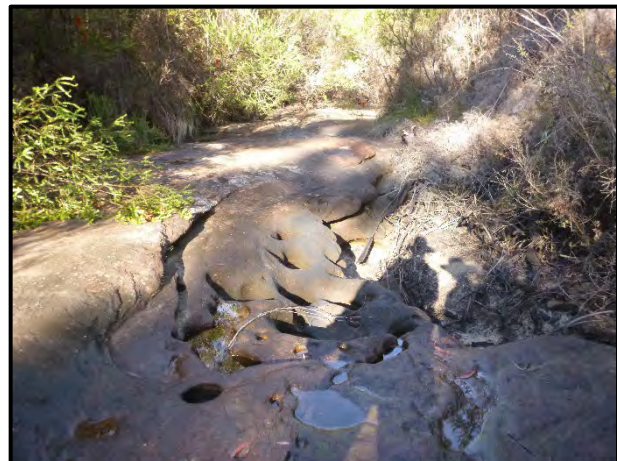
Photo 80: WC21\_Rockbar 23, looking upstream. Taken on 15 July 2017.

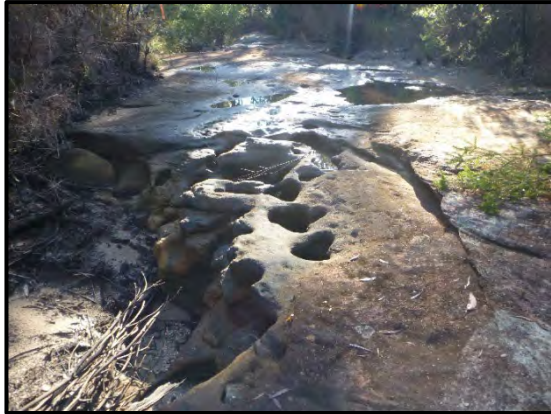
**Photo 81: WC21\_Rockbar 23, looking downstream.**  
Taken on 15 July 2017.

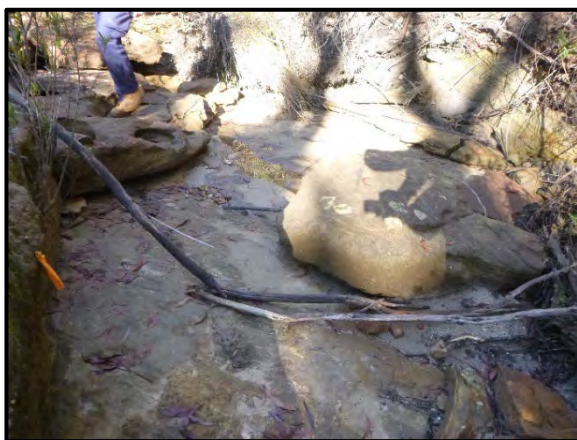
Photo 86: WC21\_Pool 23, looking upstream. Taken on 17/06/2017.

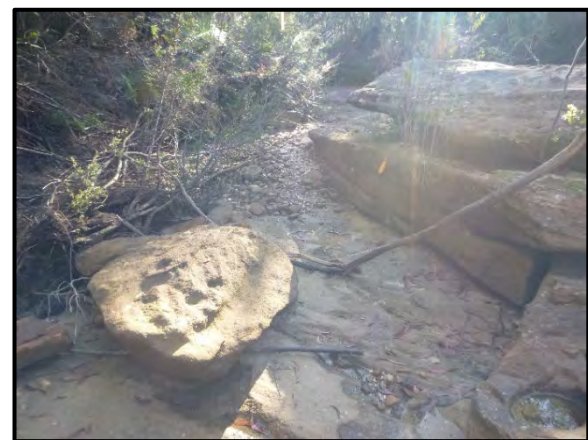
Photo 87: WC21\_Pool 23, looking downstream. Taken on 17/06/2017.
