## WC21 AND DONALDS CASTLE CREEK REHABILITATION PLAN

<b>Document ID</b>	IMCMP0265	<b>Version</b>	4.0	Page i of 116
<b>Last Date Updated</b>	31/01/2023	<b>Next Review Date</b>	31/01/2026

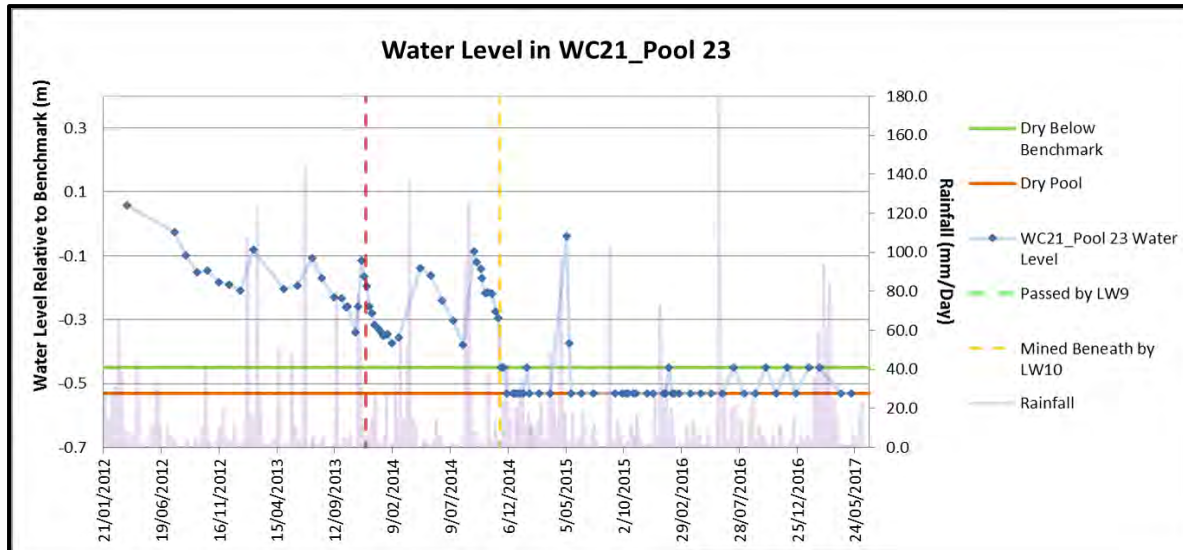
Pool 23 was undermined by Longwall 10 on 15 November 2014. Fracturing to the base of WC21\_Pool 23, with an absence of surface flow, was identified (*Impact LW10\_014*) (**Photo 82** and **Photo 83**). Additionally, hairline fracturing, with an absence of surface flow, was identified downstream from Pool 23 (*Impact LW10\_015*) (**Photo 84** and **Photo 85**). Regular observation show that Pool 23 has consistently been dry (or dry below the benchmark) since it was undermined by Longwall 10 (**Graph 4-19**).

Graph 4-19: Water level measurements relative to installed benchmark at WC21\_Pool 23.

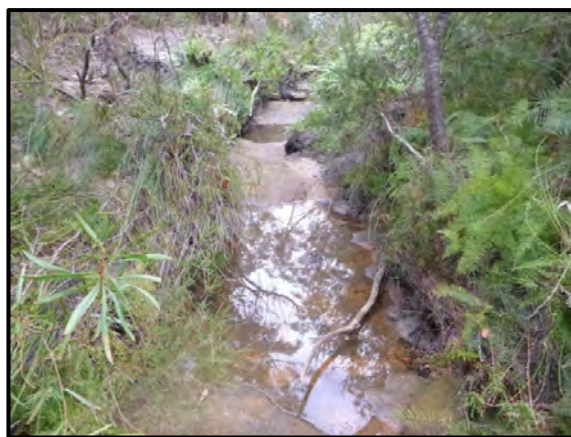
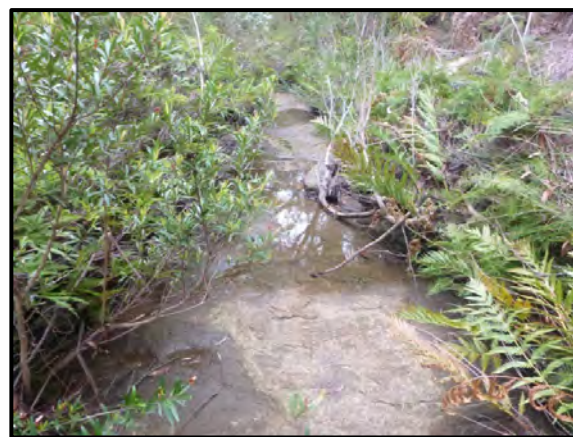
No surface impacts have been observed; however, a reduction in surface water is evident following mining.

Photo 88: WC21\_Pool 22, looking upstream. Taken on 10 September 2015.

Photo 89: WC21\_Pool 22, looking downstream. Taken on 10 September 2015.

Targeted remediation is not currently proposed at this site.

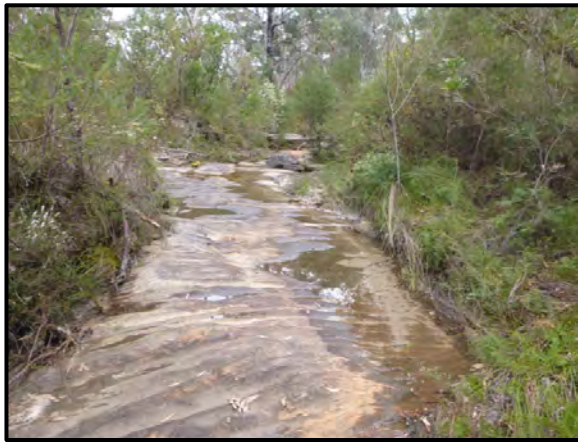
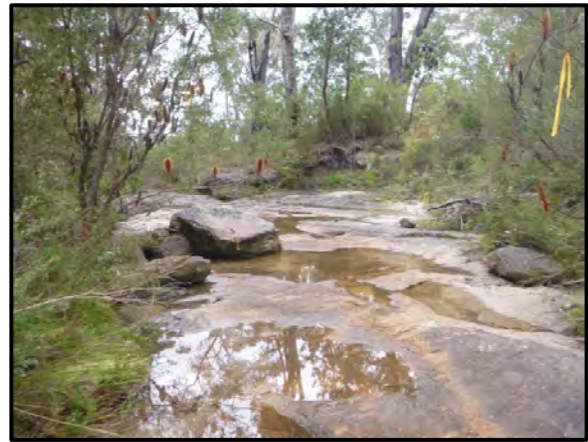
No surface impacts have been observed, however, an appreciable reduction in surface water level was observed, especially after the site was passed by Longwall 10. The reduction in surface water at the site may be due to the diversion of surface water upstream, as a result of mining; hence the sequential decrease of surface water following the passing of Longwalls 10, 11 and 12 (**Graph 4-20**). The site, however, continues to retain water and responds to rainfall.

Photo 90: WC21\_Rockbar 21, looking upstream. Taken on 10 September 2015.

Photo 91: WC21\_Rockbar 21, looking downstream. Taken on 10 September 2015.

The rockbar continues to hold areas of surface water for periods after rainfall. Targeted remediation is not currently proposed at this site.

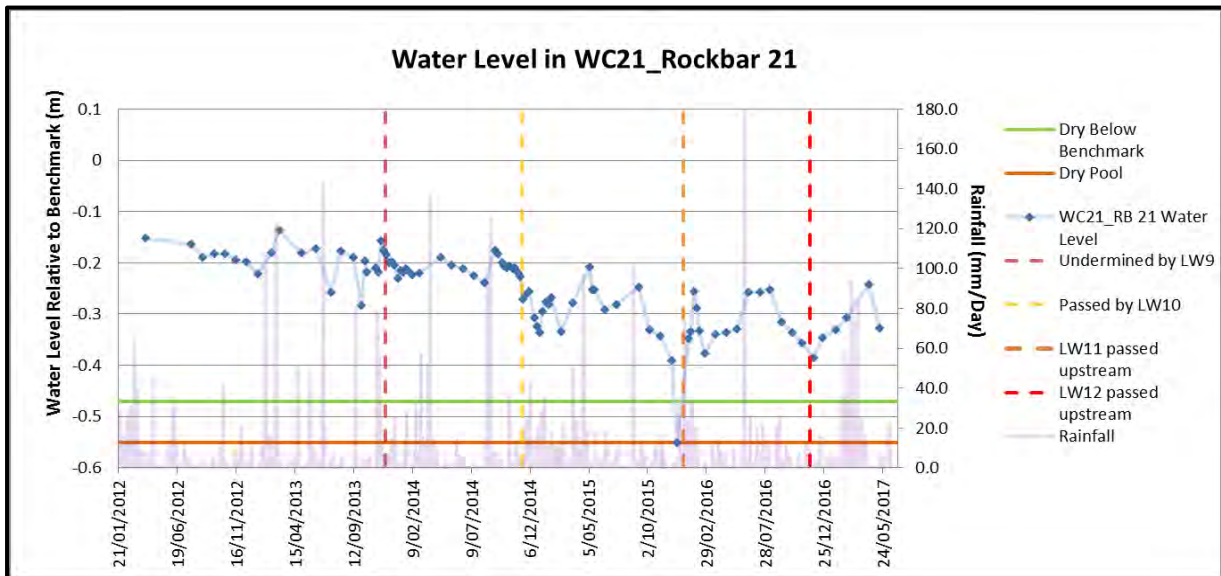
Graph 4-20: Water level measurements relative to installed benchmark at WC21\_Pool 21.

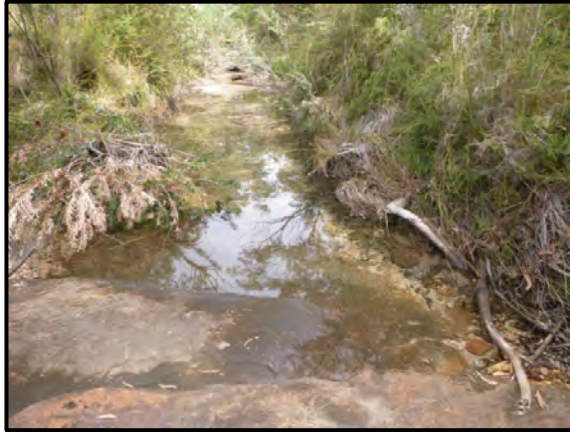
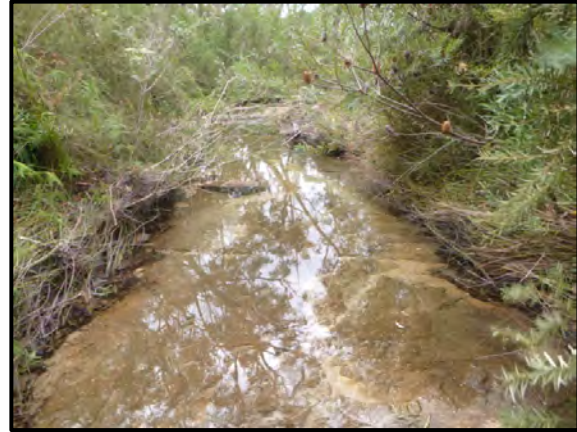
Pool 21 was undermined by Longwall 9 on 7 December 2013. No routine pool water level monitoring is installed at this site. No surface impacts have been observed, however, a reduction in surface water is evident following mining (**Photo 92** and **Photo 93**).

Photo 92: WC21\_Pool 21, looking upstream. Taken on 10/09/2015.

Photo 93: WC21\_Pool 21, looking downstream. Taken on 10/09/2015.

The pool continues to hold areas of surface water. No targeted remediation is proposed at the site.

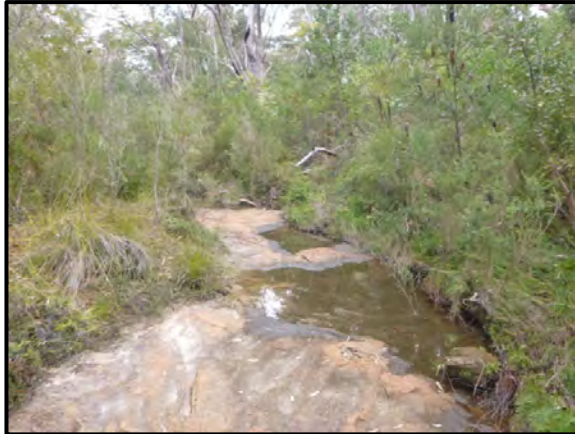
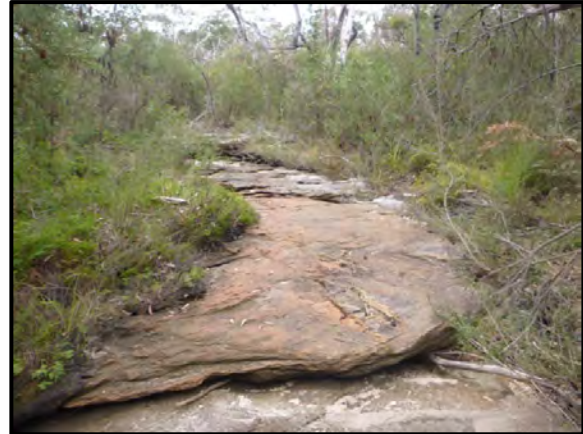
Rockbar 20 was undermined by Longwall 9 on 7 December 2013. No routine pool water level monitoring is installed at this site. Rock fracturing and dilation of an existing joint on Rockbar 20 was identified at the site (*Impact LW10\_016*), with an absence of surface flow (**Photo 96**). Flow diversion has not been observed through the fracture; however there has been a reduction in surface flow at the site.

Photo 94: WC21\_Rockbar 20, looking upstream. Taken on 10 September 2015.

Photo 95: WC21\_Rockbar 20, looking downstream. Taken on 10 September 2015.

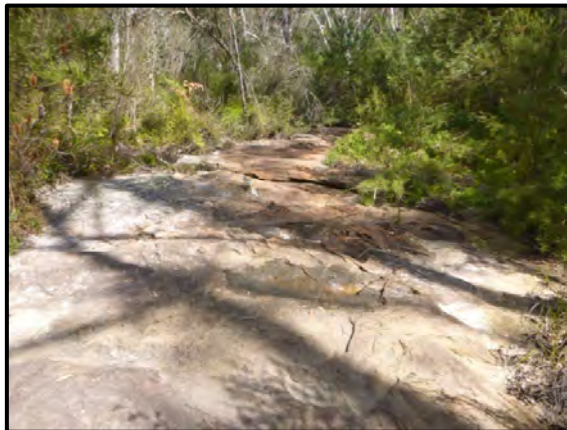
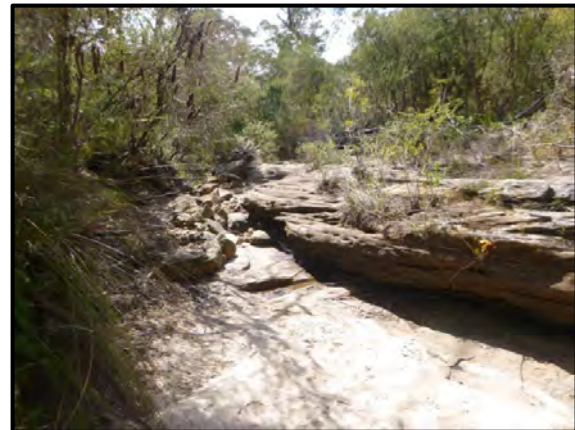
Pool 19 was undermined by Longwall 9 on 7 December 2013. No surface impacts have been observed; however, a reduction in pool water level has been recorded following Longwall 9 and Longwall 10. The pool has been dry on most inspections following Longwall 10 (**Graph 4-21**).

Photo 97: WC21\_Pool 19, looking upstream. Taken on 10 September 2015.

Photo 98: WC21\_Pool 19, looking downstream. Taken on 10 September 2015.

Targeted remediation is proposed at the site. Staging Area 3 will be used for works at the site.

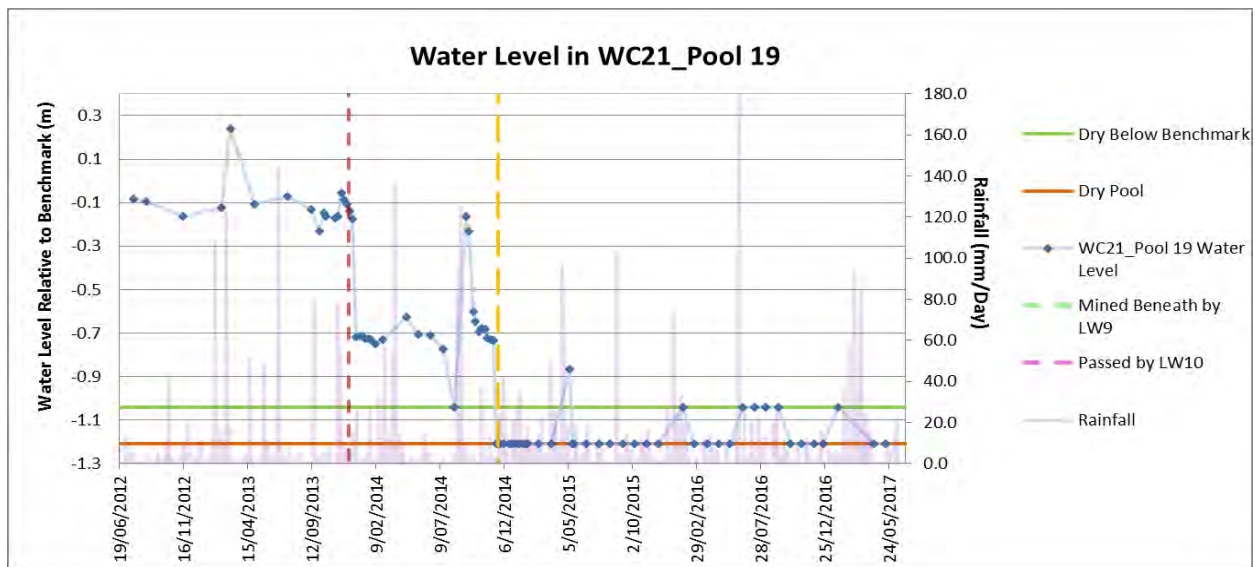
Graph 4-21: Water level measurements relative to installed benchmark at WC21\_Pool 19. Note: feature retains the mapping name of 'Pool 20'.

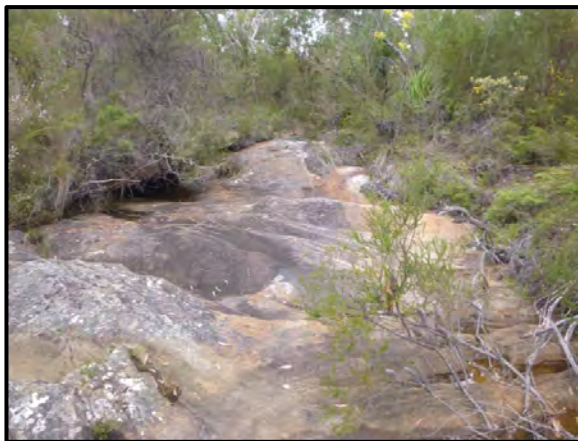
Photo 101: WC21\_Rockbar 18, looking upstream. Taken on 10 September 2015.

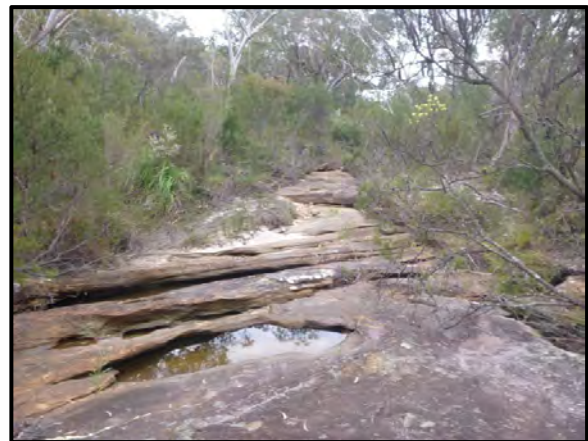
Photo 102: WC21\_Rockbar 18, looking downstream. Taken on 10 September 2015.

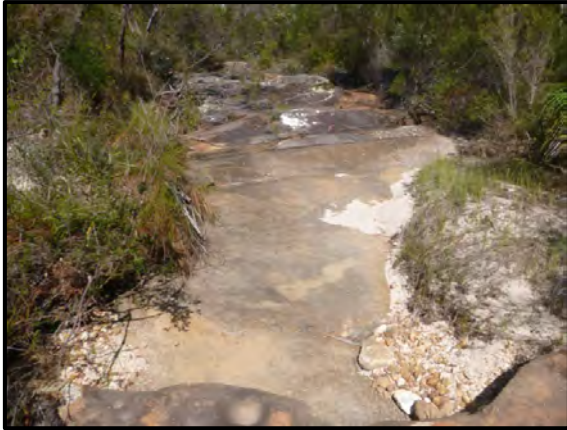
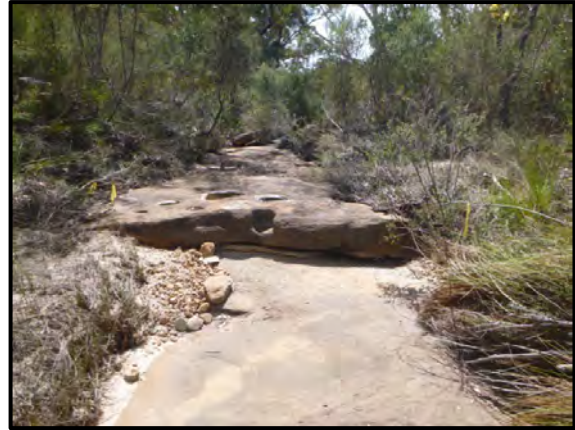
Pool 18 was undermined by Longwall 9 on 7 December 2013. No surface impacts have been observed however a reduction in pool water level has been recorded following Longwall 9. The pool has been dry on most inspections following Longwall 9 (**Graph 4-22**).

Photo 103: WC21\_Pool 18, looking upstream. Taken on 10 September 2015.

Photo 104: WC21\_Pool 18, looking downstream. Taken on 10 September 2015.

Targeted remediation is not currently proposed at the site.

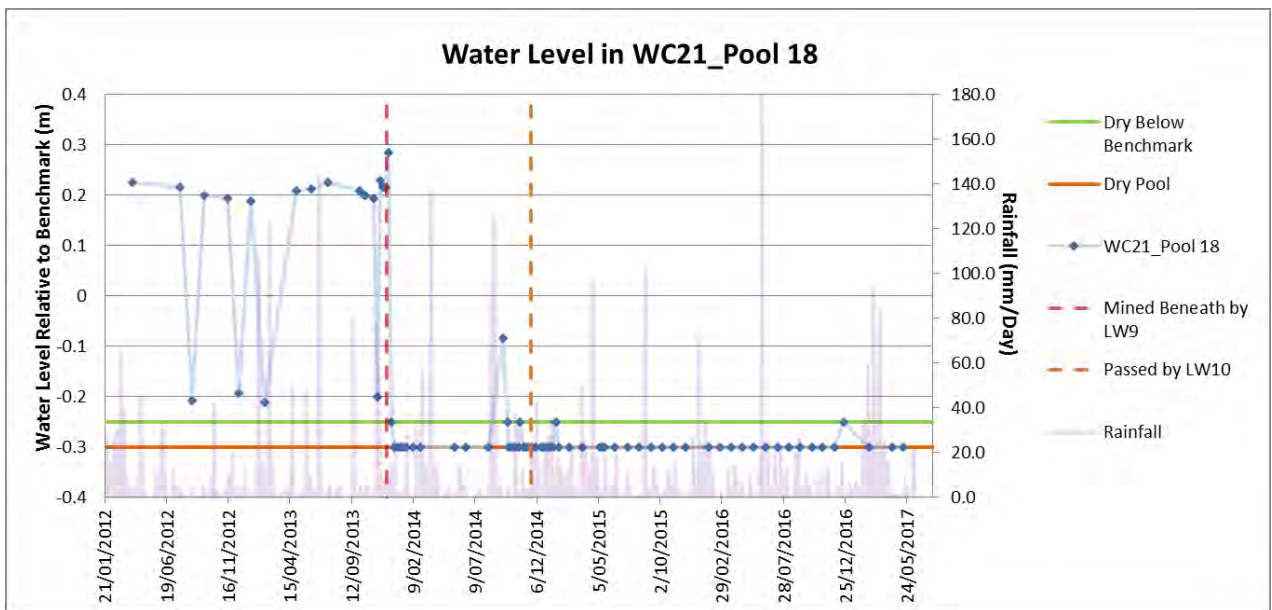
Graph 4-22: Water level measurements relative to installed benchmark at WC21\_Pool 18.

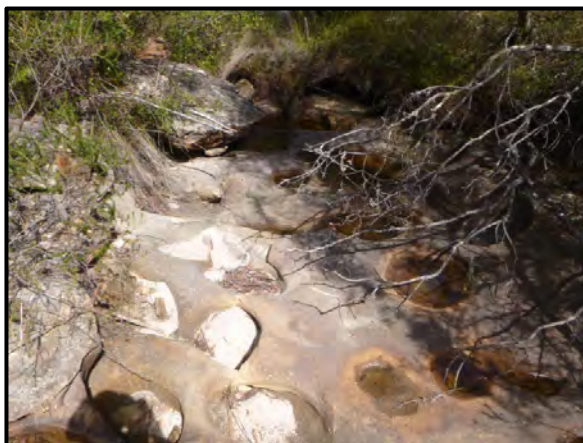
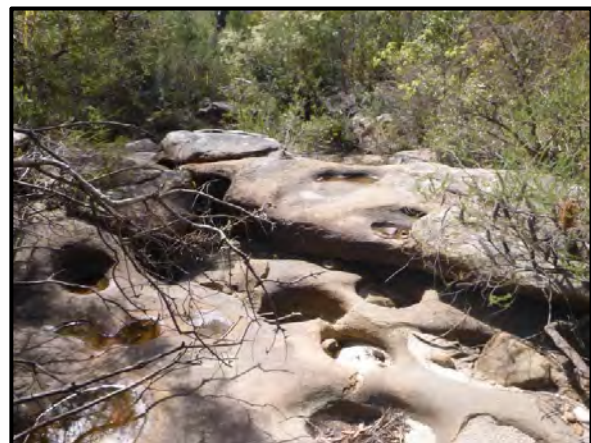
Pool 17 was mined beneath by Longwall 9 on 7 December 2013. No surface impacts have been observed in the pool; however, a reduction in pool water level has been recorded following Longwall 9 (**Graph 4-23, Photo 107** and **Photo 108**). The pool has been dry on multiple inspections following Longwall 9.

**Photo 107:** WC21\_Pool 17, looking upstream. Taken on 10 September 2015.

**Photo 108:** WC21\_Pool 17, looking downstream. Taken on 10 September 2015.

No remediation is currently proposed at the site.

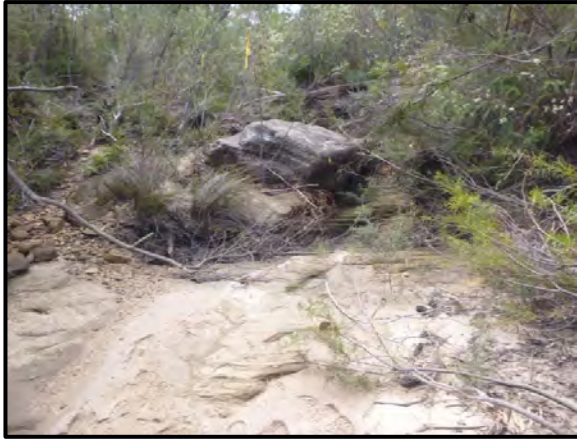
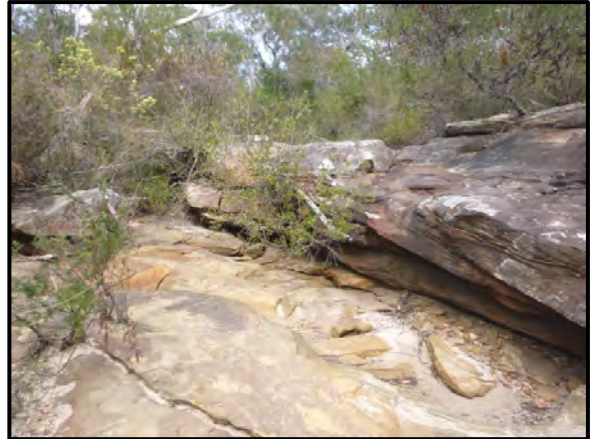
Pool 16 was undermined by Longwall 9 on 7 December 2013. Multiple surface impacts were observed at the site:

Photo 109: WC21\_Pool 16, looking downstream. Taken on 10 September 2015.

Photo 110: WC21\_Pool 16, looking upstream. Taken on 10 September 2015.

Targeted remediation is proposed at Pool 16. Staging Area 4 will be used for works at the site.

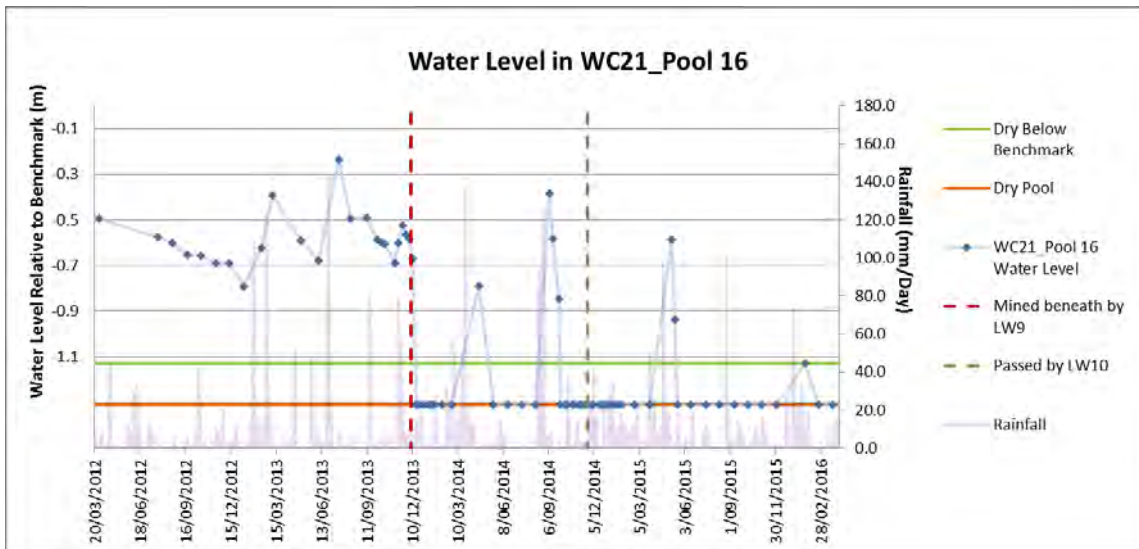
Graph 4-24: Water level measurements relative to installed benchmark at WC21\_Pool 16.

- *Impact LW9\_014* - Fracturing to the rock shelf adjacent Pool 16 (**Photo 111**) which does not intersect the pool.
- *Impact LW9\_015* - Fracturing, uplift and dilation of jointing on the base of Pool 16 with an absence of surface flow observed (**Photo 112**) shows the location of surface impacts. The pool retains water for short periods following rainfall (**Graph 4-24**).

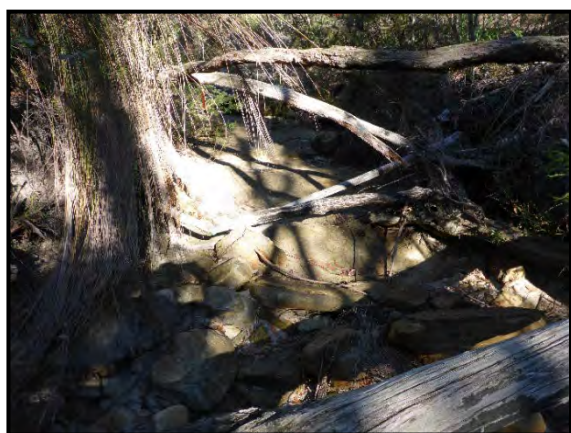
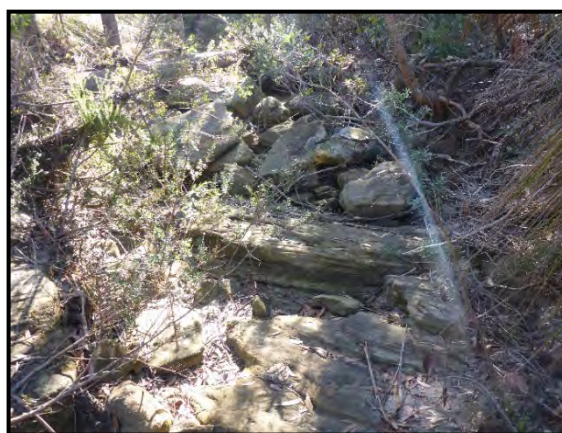
Pool 15 was undermined by Longwall 9 on 7 December 2013. No surface impacts have been observed at this site; however, there is a consistent absence of surface water during inspections at the site (**Photo 113** and **Photo 114**).

Photo 113: WC21\_Pool 15, looking upstream. Taken on 11 July 2017.

Photo 114: WC21\_Pool 15, looking downstream. Taken on 11 July 2017.

The absence of any visible fracturing and observed flow diversion makes any initial remediation difficult at this pool. Reassessment of the site is proposed following return of flow upstream. Any flow diversion identified will be targeted with grouting.

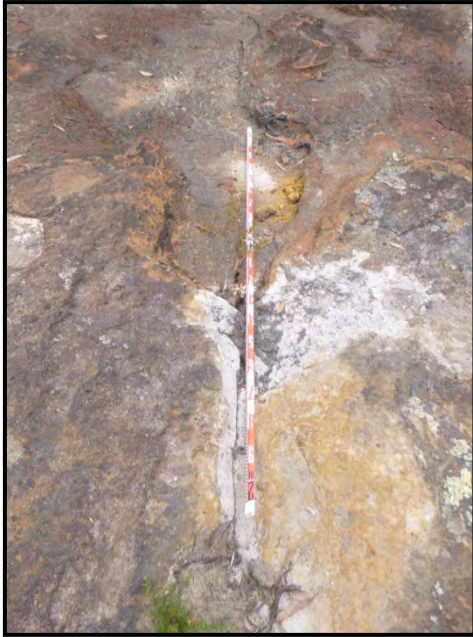
Pools 14 to 11 were undermined by Longwall 9 on 7 December 2013. Hairline fracturing and dilation of jointing on Rockbar 12 and an absence of surface flow identified during inspections (*Impact LW9\_018*) (**Photo 115**). No other surface impacts have been observed throughout this section of the tributary. There is an absence of surface flow across the majority of this section of WC21. It continues to hold surface water in sections following rainfall (**Photo 122** to **Graph 4-25**). **Photo 123** shows WC21\_Pool 11, which has been dry on various occasions following the extraction of Longwall 9.

Photo 115: Impact LW9\_018, looking across stream. Taken on 24 December 2013.

Visible fracturing is negligible in this area and any initial remediation would be difficult. No remediation of this pool is proposed due to the small size of Pool 11 and re-emergence of flow directly downstream. An investigation site is proposed adjacent to Rockbar 12.

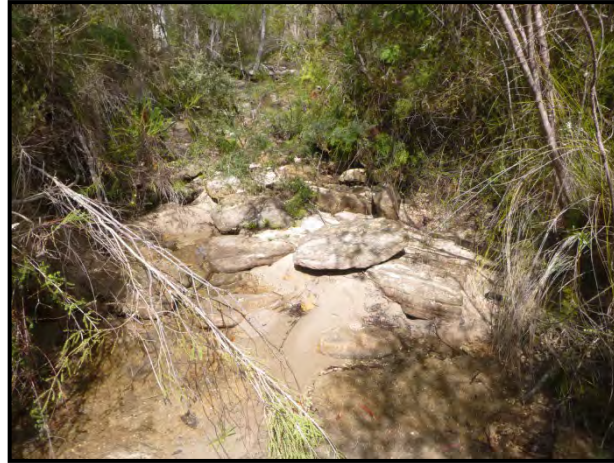
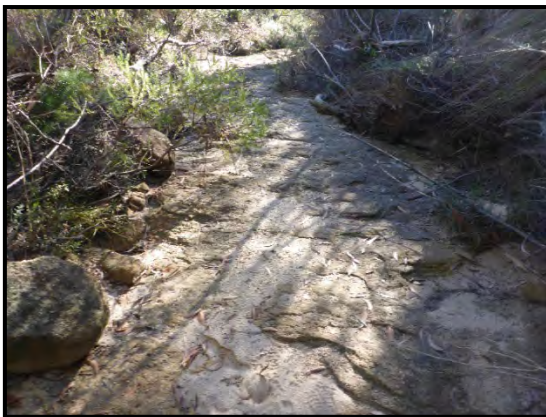
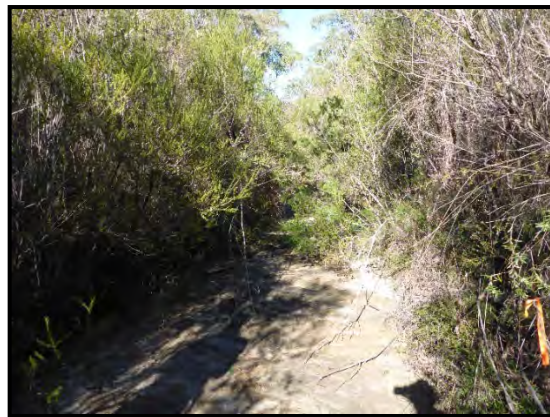
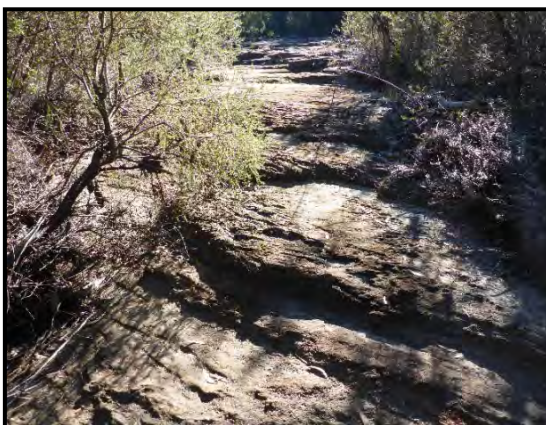
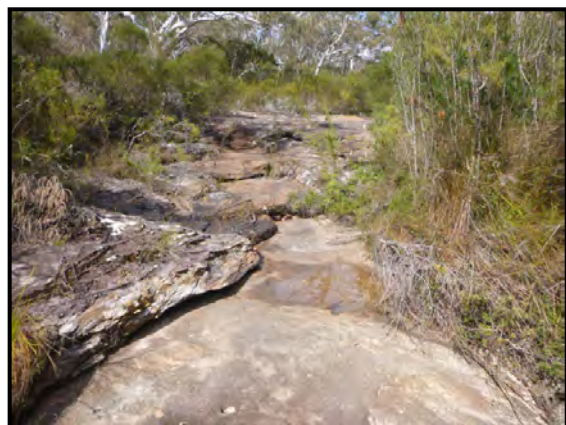
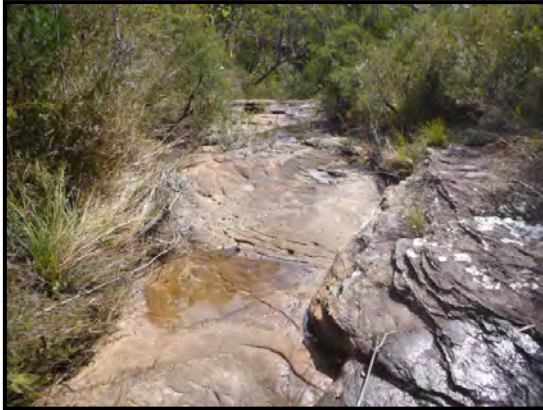
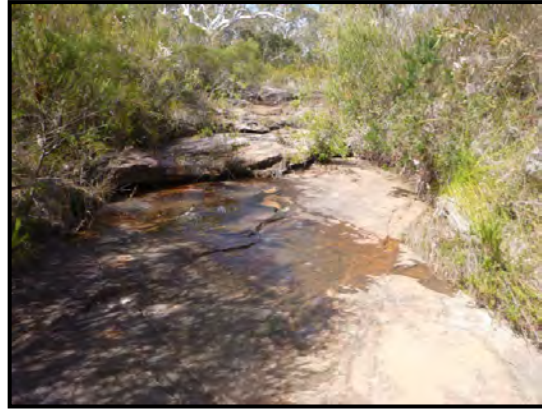
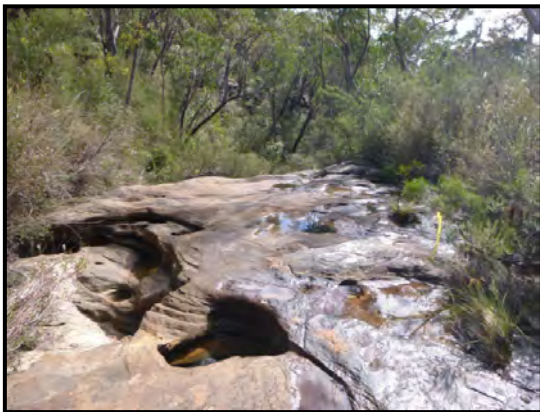
Photo 116: WC21\_Pool 14, looking upstream. Taken on 10 September 2015.

Photo 117: WC21\_Pool 14, looking downstream. Taken on 11 July 2017.

Photo 118: WC21\_Pool 13, looking upstream. Taken on 11 July 2017.

Photo 119: WC21\_Pool 13, looking downstream. Taken on 11 July 2017.

Photo 120: WC21\_Pool 12, looking upstream. Taken on 10 September 2015.

Photo 121: WC21\_Pool 12, looking downstream. Taken on 10 September 2015.

Photo 122: WC21\_Pool 11, looking upstream. Taken on 10 September 2015.

Photo 123: WC21\_Pool 11, looking upstream. Taken on 10 September 2015.

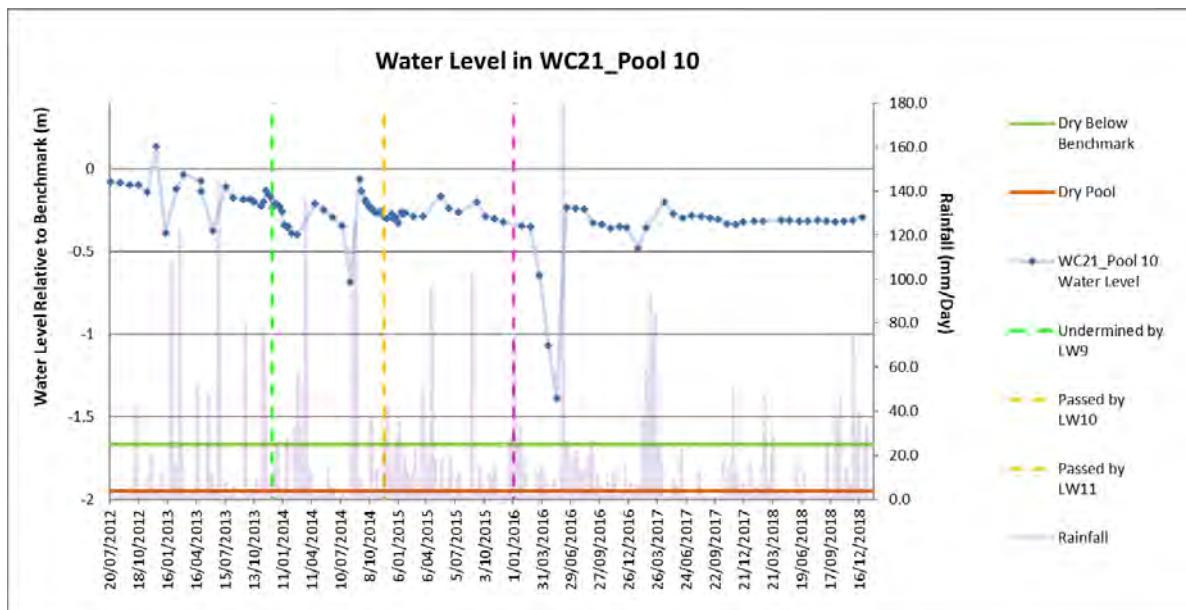
**Graph 4-26: Water level measurements relative to installed benchmark at WC21\_Pool 10.**

Surface water levels at Pool 10 do not appear to be directly impacted by mining (**Graph 4-26**). However, post-mining surface water levels at Pool 10 have been observed below baseline levels during periods of low rainfall. It is likely that the reduced surface flow into Pool 10 can be attributed to both low rainfall, and reduced inflows, as a result of mining impacts to WC21 previously mentioned (upstream of Pool 10).

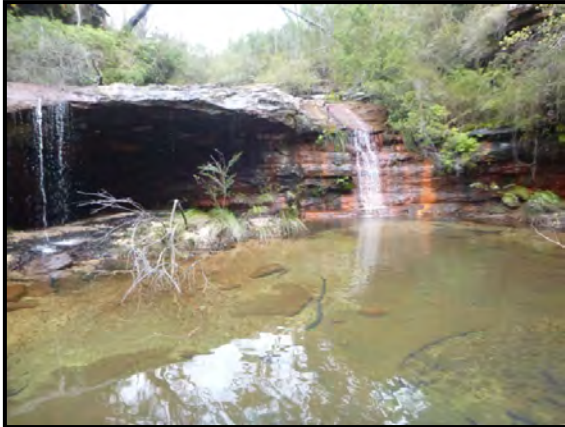
- *Impact LW9\_027*- small rockfall to overhang directly to the west of Pool 10 (**Photo 126**);
- *Impact LW9\_028* - small rockfall to overhang directly to the east of Pool 10 (**Photo 127**);
- *Impact LW9\_019* - iron staining originating from subsurface outflow upstream from Pool 10 (**Photo 124**).

Photo 124: WC21\_Pool 10, looking upstream. Taken on 10 September 2015.

No remediation is proposed at this site. It is recommended that the site be monitored during the implementation of upstream remediation and an assessment be made of any changes at this pool. Pools 5 and 10 is proposed as a tracer section site to be used in association with upstream investigation sites (**Figure 2-6**).

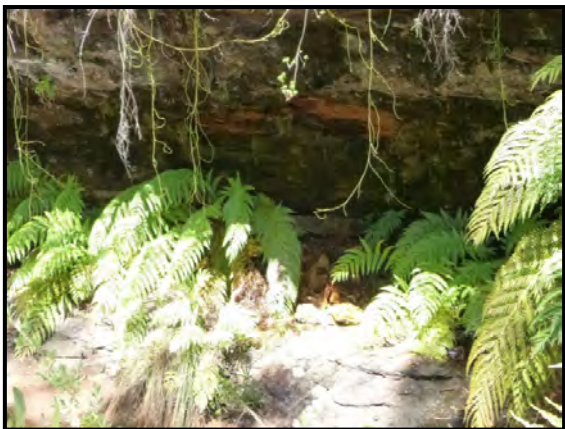
Photo 126: Impact LW9\_027, small rockfall adjacent to Pool 10. Taken on 28 January 2014.

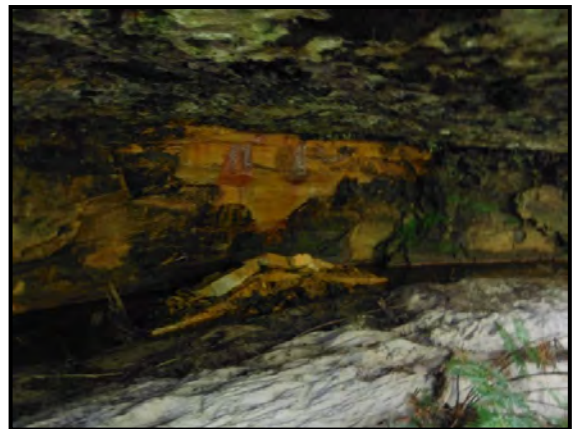
Photo 127: Impact LW9\_028, small rockfall to overhang adjacent to Pool 10. Taken on 17 March 2014.

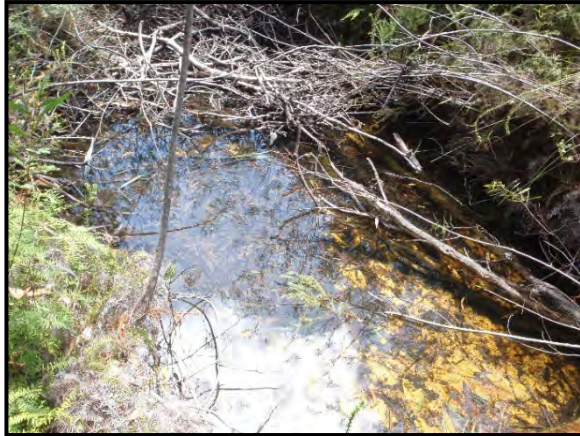
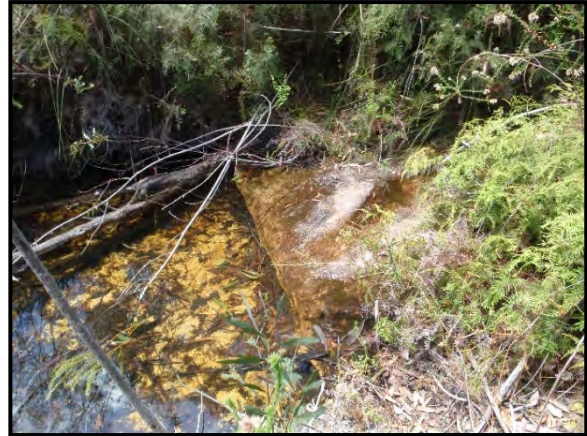
Shallow, rock-based pool, approximately 6 m long and 2 m wide (**Photo 128** and **Photo 129**).

Photo 128: DC\_Pool 34, looking downstream. Taken on 13 November 2012.

Photo 129: DC\_Pool 34, looking across stream. Taken on 13 November 2012.

No remediation is recommended at Pool 34. While there is a lack of surface flow upstream from this site, there is an absence of exposed bedrock or visible surface impacts.

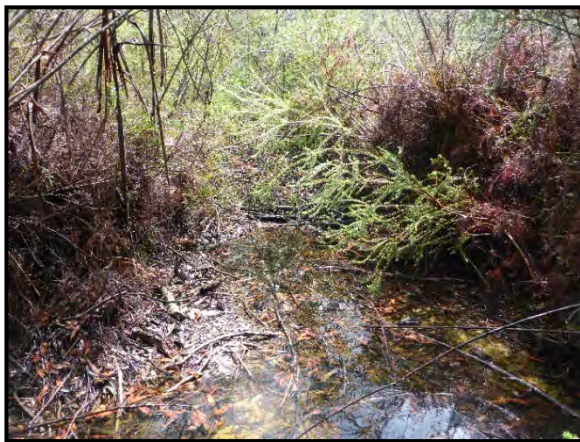
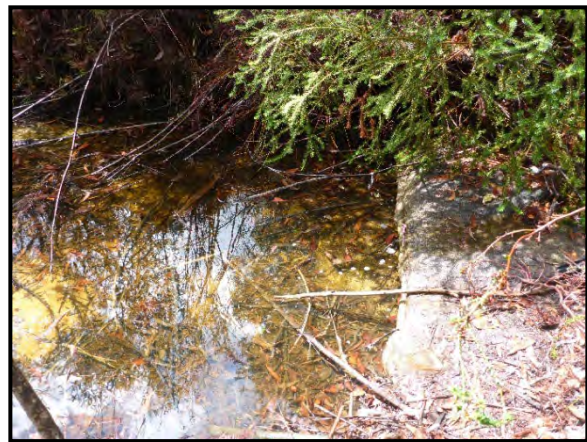
Longwall 9 passed Pool 34 at an approximate distance of 85 m on 22 July 2015. Whilst no surface impacts have been detected at Pool 34, a reduction in surface flow at the site has been observed since the passing of Longwalls 9, 10 and 11 (**Photo 130** and **Photo 131**; **Graph 4-27**). Pool 34 often holds water following rainfall events, however, it receives minimal water from the catchment upstream, i.e. Swamp 5.

Photo 130: DC\_Pool 34, looking downstream. Taken on 28 February 2017.

Photo 131: DC\_Pool 34, looking across stream. Taken on 28 February 2017.

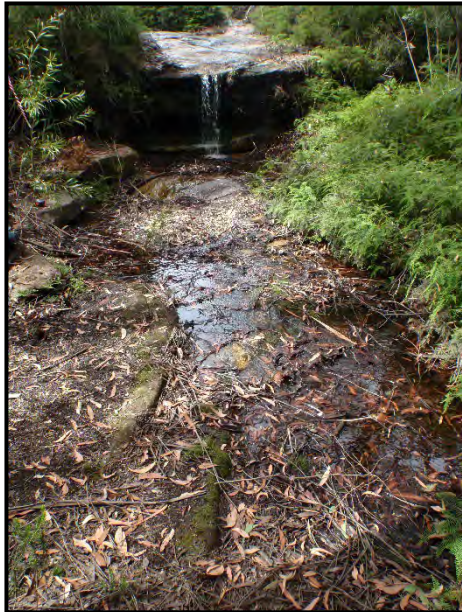
Photo 132: DC\_Pool 33, looking upstream. Taken on 10 January 2012.

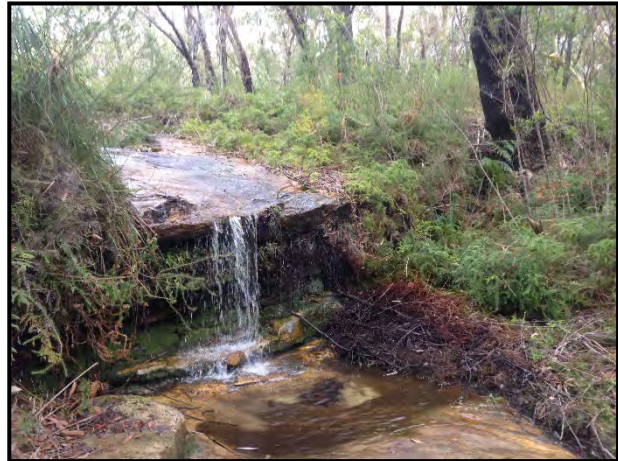
Photo 133: DC\_Pool 33, looking upstream. Taken on 26 July 2012.

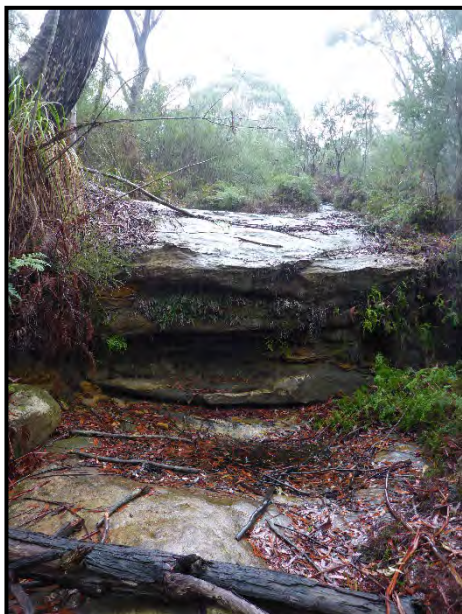
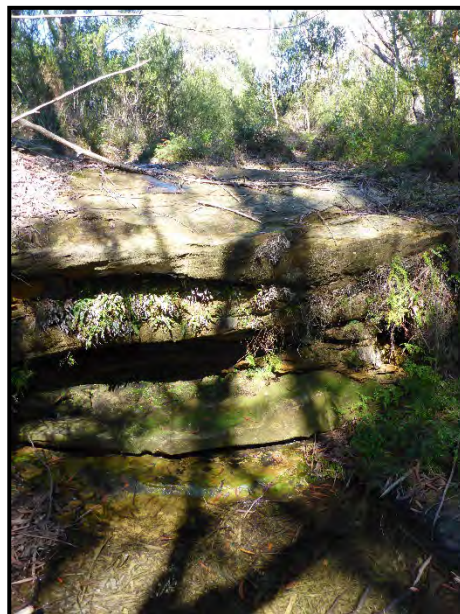
Longwall 9 passed this section of the creek at an approximate distance of 108 m, on the 27<sup>th</sup> of July 2013. Multiple fractures, with some associated flow diversion, were identified on Rockbar 33, continuing downstream to the step (DA3B\_LW9\_006). Pool 33 is routinely monitored but due to the shallow nature of the pool, it is unsuitable for quantitative water level monitoring. Observations show a reduction in surface flow over these features after the extraction of Longwalls 9, 10 and 11 (Photo 134 and Photo 135).

Photo 134: DC\_Pool 33, looking upstream. Taken on 28 February 2017.

Photo 135: DC\_Pool 33, looking upstream. Taken on 24 April 2017

Targeted remediation is proposed for Rockbar 33 and Pool 33. This would include injection grouting of the rockbar and base of the pool, as well as surface grouting of any visible fracturing within the stream bed.

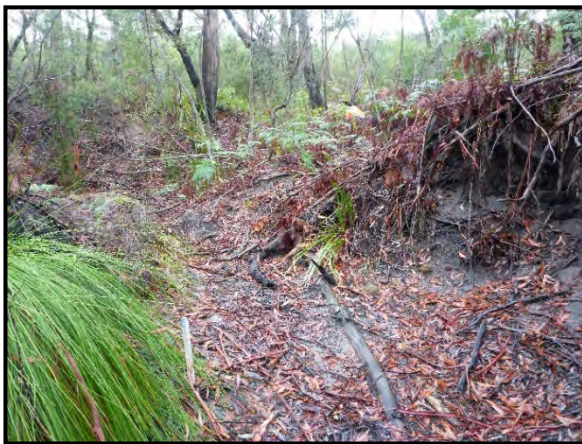
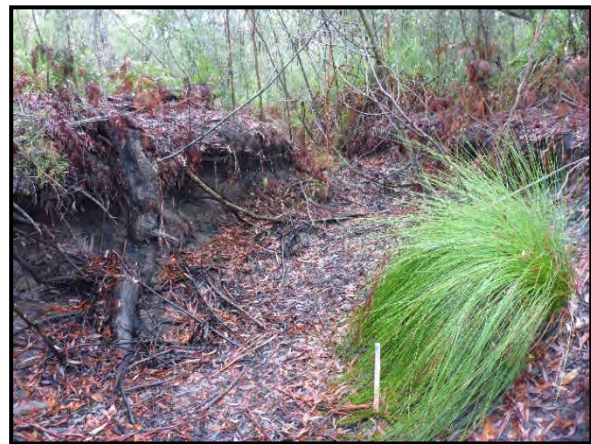
Longwall 9 passed Pool 32 at an approximate distance of 155 m, on 27 July 2013. No surface impacts have been observed at Pool 32, however, an increase in the frequency of ‘dry below benchmark’ and ‘dry pool’ readings, relative to baseline monitoring, is indicative of a decrease in surface flow to the site (**Photo 138** and **Photo 139**).

Photo 138: DC\_Pool 32, looking upstream. Taken on 28 February 2017.

Photo 139: DC\_Pool 32, looking downstream. Taken on 28 February 2017.

No surface impacts have been observed to DC\_Pool 32. Additionally, the pool continues to hold water for extended periods (**Graph 4-28**). As a result, no targeted remediation is proposed at the site. Results of upstream remediation on Pool 32 water levels will be assessed.

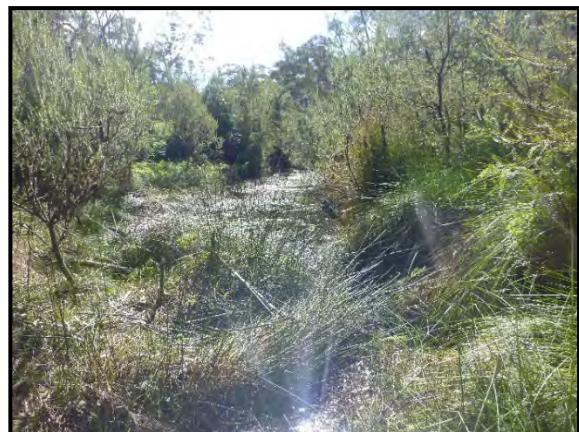
Longwall 9 passed Pool 30 at an approximate distance of 26 m, on 27 July 2017. No surface impacts have been identified at Pool 30. However, observations show a decrease in surface water level at the site, particularly an increase in the frequency of ‘dry below benchmark’ measurements, relative to baseline monitoring (**Photo 143**; **Graph 4-29**).

Photo 143: DC\_Pool 30, looking downstream. Taken on 09 May 2017

No remediation is recommended for this feature.

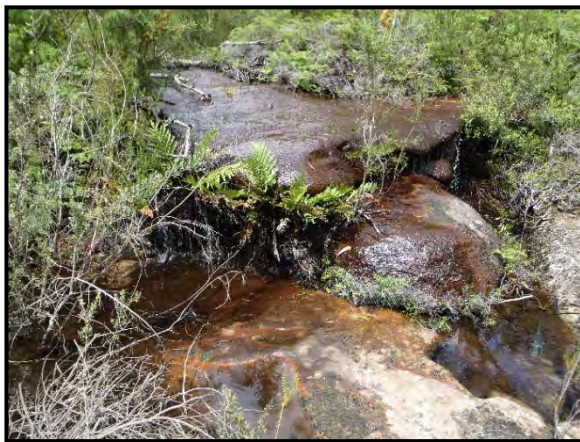
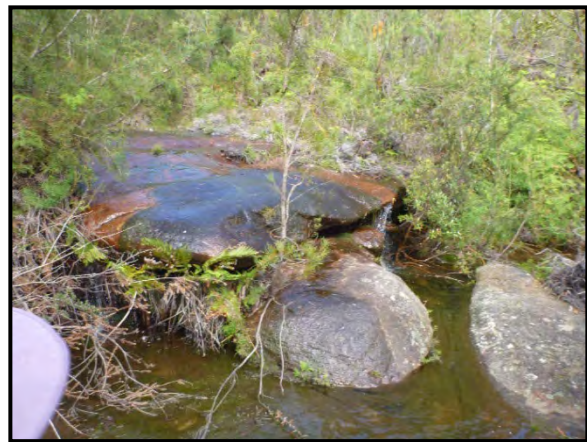
No surface impacts have been observed at these features. No reduction in surface water level has been observed at Pool 29, in relation to the extraction of Longwalls 9 and 10 (**Photo 144** and **Photo 145**; **Graph 4-30**).

**Photo 144: DC\_Pool 29, looking upstream. Taken on 14 February 2013.**

**Photo 145: DC\_Pool 29, looking upstream. Taken on 16 May 2017.**

No remediation is recommended for these features.

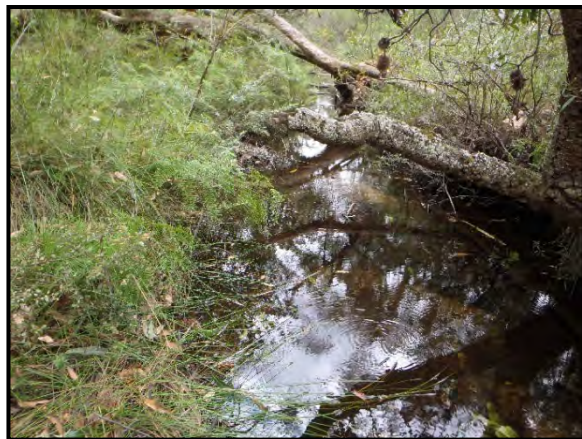
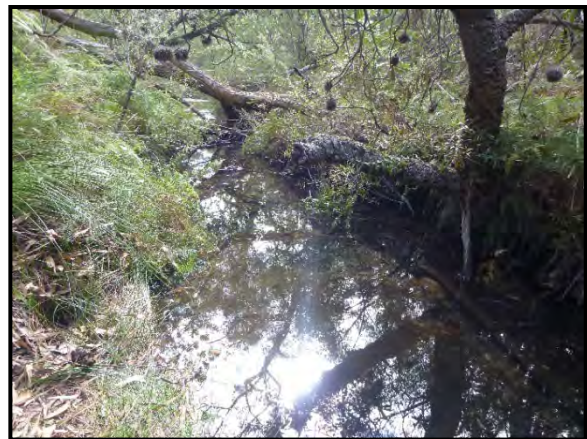
No surface impacts have been observed at Pool 23 (**Photo 146** and **Photo 147**). No reductions in surface water level resulting from the extraction of Longwalls 9 and 10 have been observed at Pool 23 (**Graph 4-31**).

**Photo 146: DC\_Pool 23, looking downstream. Taken on 14 February 2013.**

**Photo 147: DC\_Pool 23, looking downstream. Taken on 26 May 2017.**

No remediation is recommended for Pool 23.

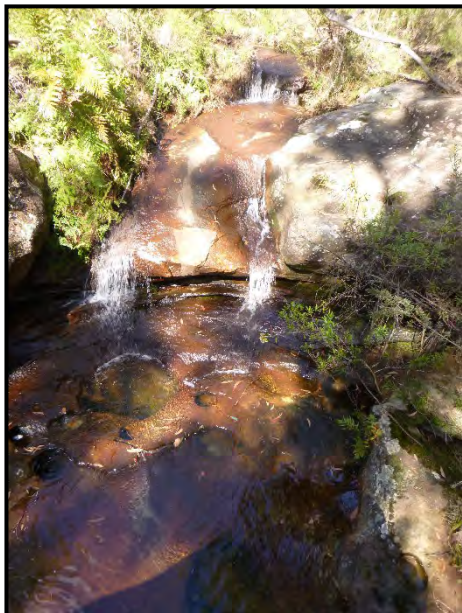
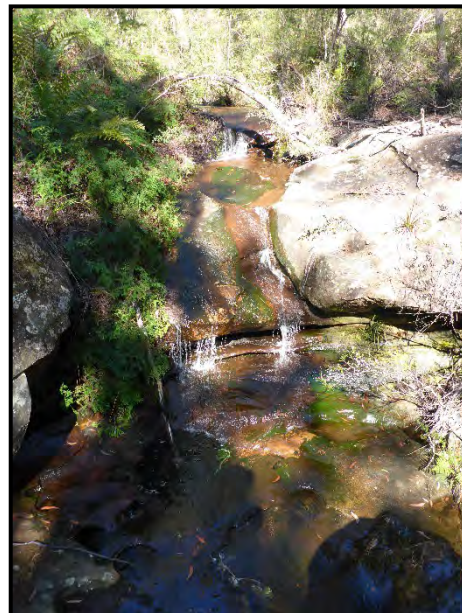
No surface impacts have been observed at Pool 19 (**Photo 148** and **Photo 149**). No reductions in Pool 19 water level has been observed as a result of the extraction of Longwalls 9 and 10 (**Graph 4-32**).

Photo 148: DC\_Pool 19, looking upstream. Taken on 6 May 2013

Photo 149: DC\_Pool 19, looking upstream. Taken on 24 April 2017.

No remediation is recommended at this site.
