Illawarra Coal

Dendrobium Area 3B Longwall 10 End of Panel Report

May 2015

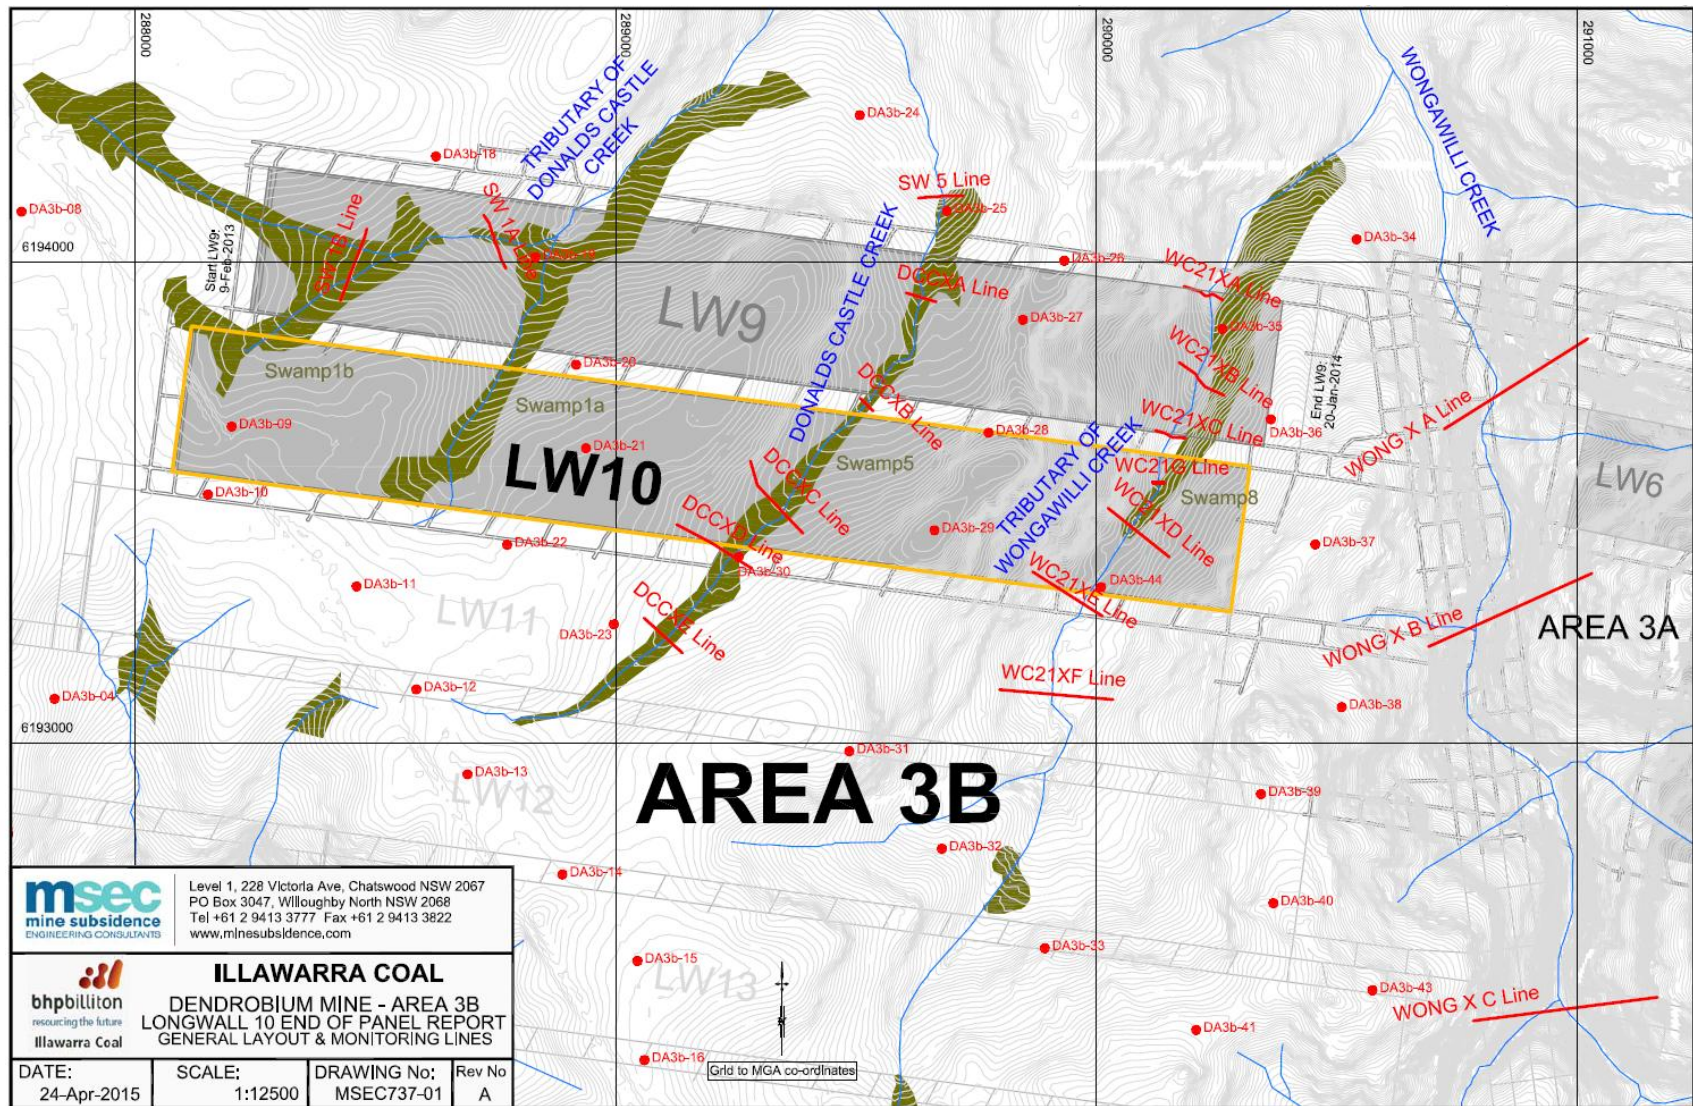
Figure 5: Location of monitoring points and lines in relation to Dendrobium Mine Area 3B Longwall 10

Closure movements across Wongawilli Creek were measured using 2D survey techniques at the Wong X A-Line, Wong X B-Line and Wong X C-Line. The location of these monitoring lines is shown in Figure 5 (MSEC737, 2015). The maximum observed closures at each of the Wongawilli cross lines were less than predictions.

Vertical and horizontal movements above and in the vicinity of Longwall 10 were measured using the DA3B 3D points. The location of these monitoring points is shown in Figure 5.

Observed subsidence and closures at the Wongawilli Creek Tributary Cross Lines were measured using 2D survey techniques at the WC21XA Line, WC21XB Line, WC21XC Line, WC21XD Line, WC21XE Line, WC21XF Line and WC21XG Line. The locations of the tributary cross lines are shown in Figure 5.

The mine subsidence movements across Donalds Castle Creek lines were measured using 2D survey techniques using the DCCXA-Line, DCCXB-Line, DCCXC-Line, DCCXD-Line and DCCXE-Line. The locations of the Donalds Castle Creek Lines are shown in Figure 5.

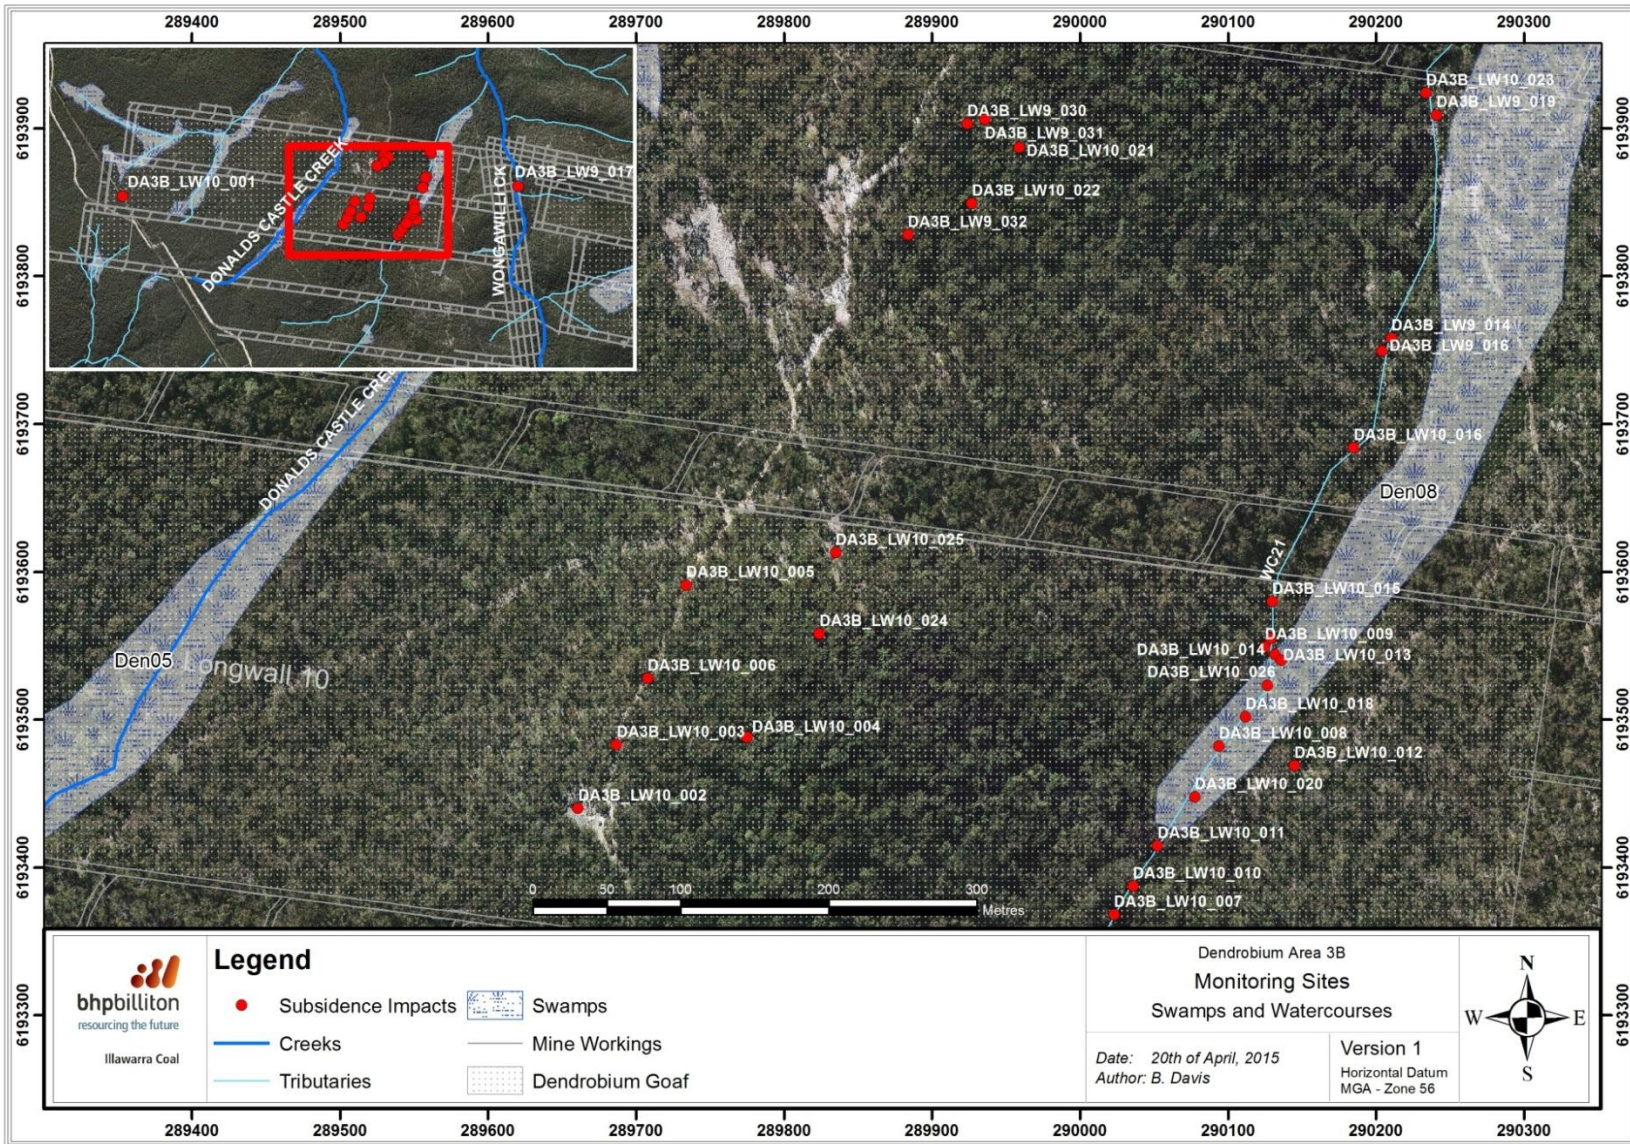
Figure 6: Location of Longwall 10 Surface Impacts

The results of the ICEFT monitoring are provided in this section of the report, the Landscape Report (Attachment C) and the Impact Reports submitted during Longwall 10 extraction (Attachment C2). This section should be read in conjunction with other relevant reports by specialist consultants provided in the Attachments. Figure 6 illustrates the location of impacts identified during Longwall 10 extraction.

Three TARP Level 1 fractures have been observed in WC21 (Photo 3, Photo 4 and Photo 5) and have been identified as DA3B_LW10_010, 013 and 020 respectively (Figure 6). No water loss or flow diversion was observed from these impacts.

Thirteen TARP Level 2 fractures have been identified in WC21 (Figure 6), resulting in an observable diversion of surface water (Photo 6 and Photo 7). Two of these fractures were identified during Longwall 10 extraction as extensions of existing Longwall 9 impacts DA3B_LW9_014 and 016 (Photo 12 and Photo 13).

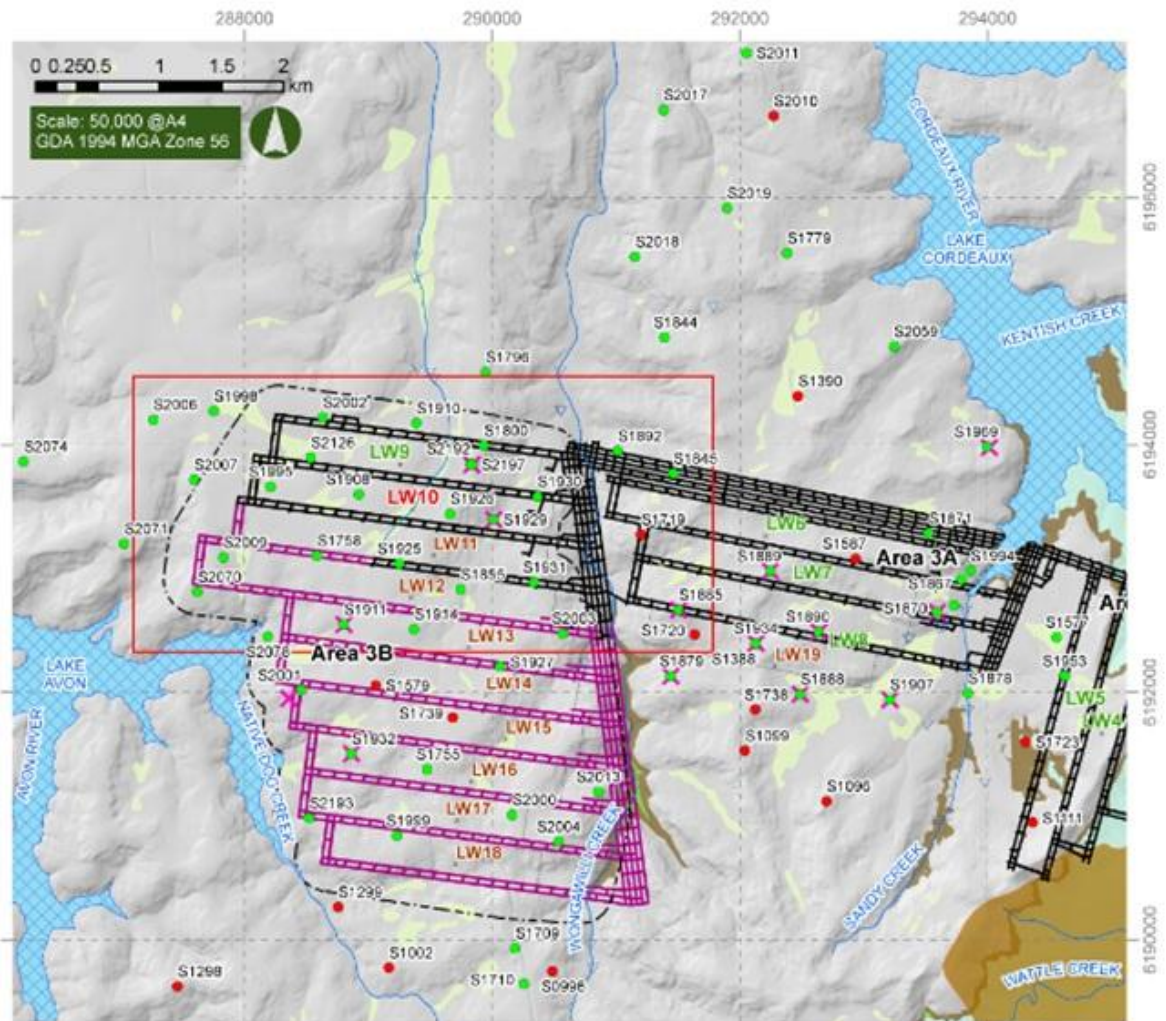
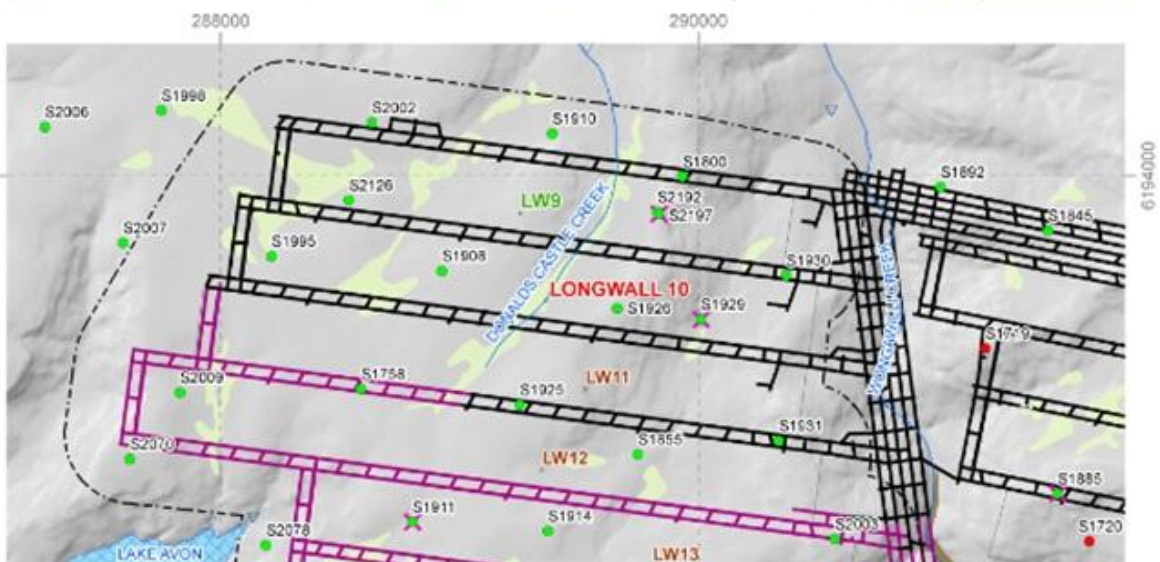
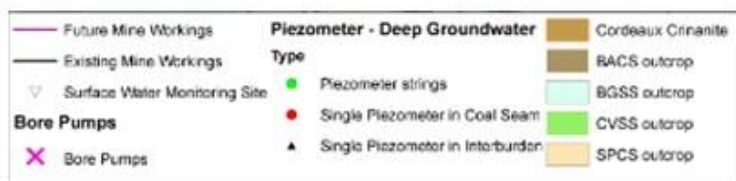
Figure 7: Location of Deep Groundwater Monitoring Sites

<p>Large drawdowns of 60-80 m were predicted for the Scarborough Sandstone during the mining of Longwall 10. Further south of Longwall 11 drawdown was expected to be around 10-40 m.</p>	<p>Near to Longwall 10 observed drawdown within the Scarborough Sandstone was up to 20 m. Observed drawdown generally ranged from 5-20 m further to the south of Longwall 11.</p>
<p>Drawdowns of more than 40-45 m were predicted in the Bulgo Sandstone over the western half of Longwall 10, and 35-45 m drawdown was expected in the eastern half of Longwall 10. Drawdown was expected to decline to 25 m over a short distance to the south (above Longwall 11). Drawdown magnitude was predicted to decline to less than 10 m further to the south.</p>	<p>The observed drawdown in the Bulgo Sandstone during the mining of Longwall 10 was about 20-25 m above the eastern half of Longwall 10 and 15-20 m above the western half.</p> <p>Further to the south of Longwall 11, the drawdown observed was generally in the range 0-15 m.</p>

<p>Modelled drawdowns in the lower Hawkesbury Sandstone above Longwall 10 was in the range 10-26 m.</p>	<p>In the lower Hawkesbury Sandstone, observed drawdowns ranged from 8-14 m over Longwall 10 in Area 3B, increasing in a southerly direction across the longwall.</p>

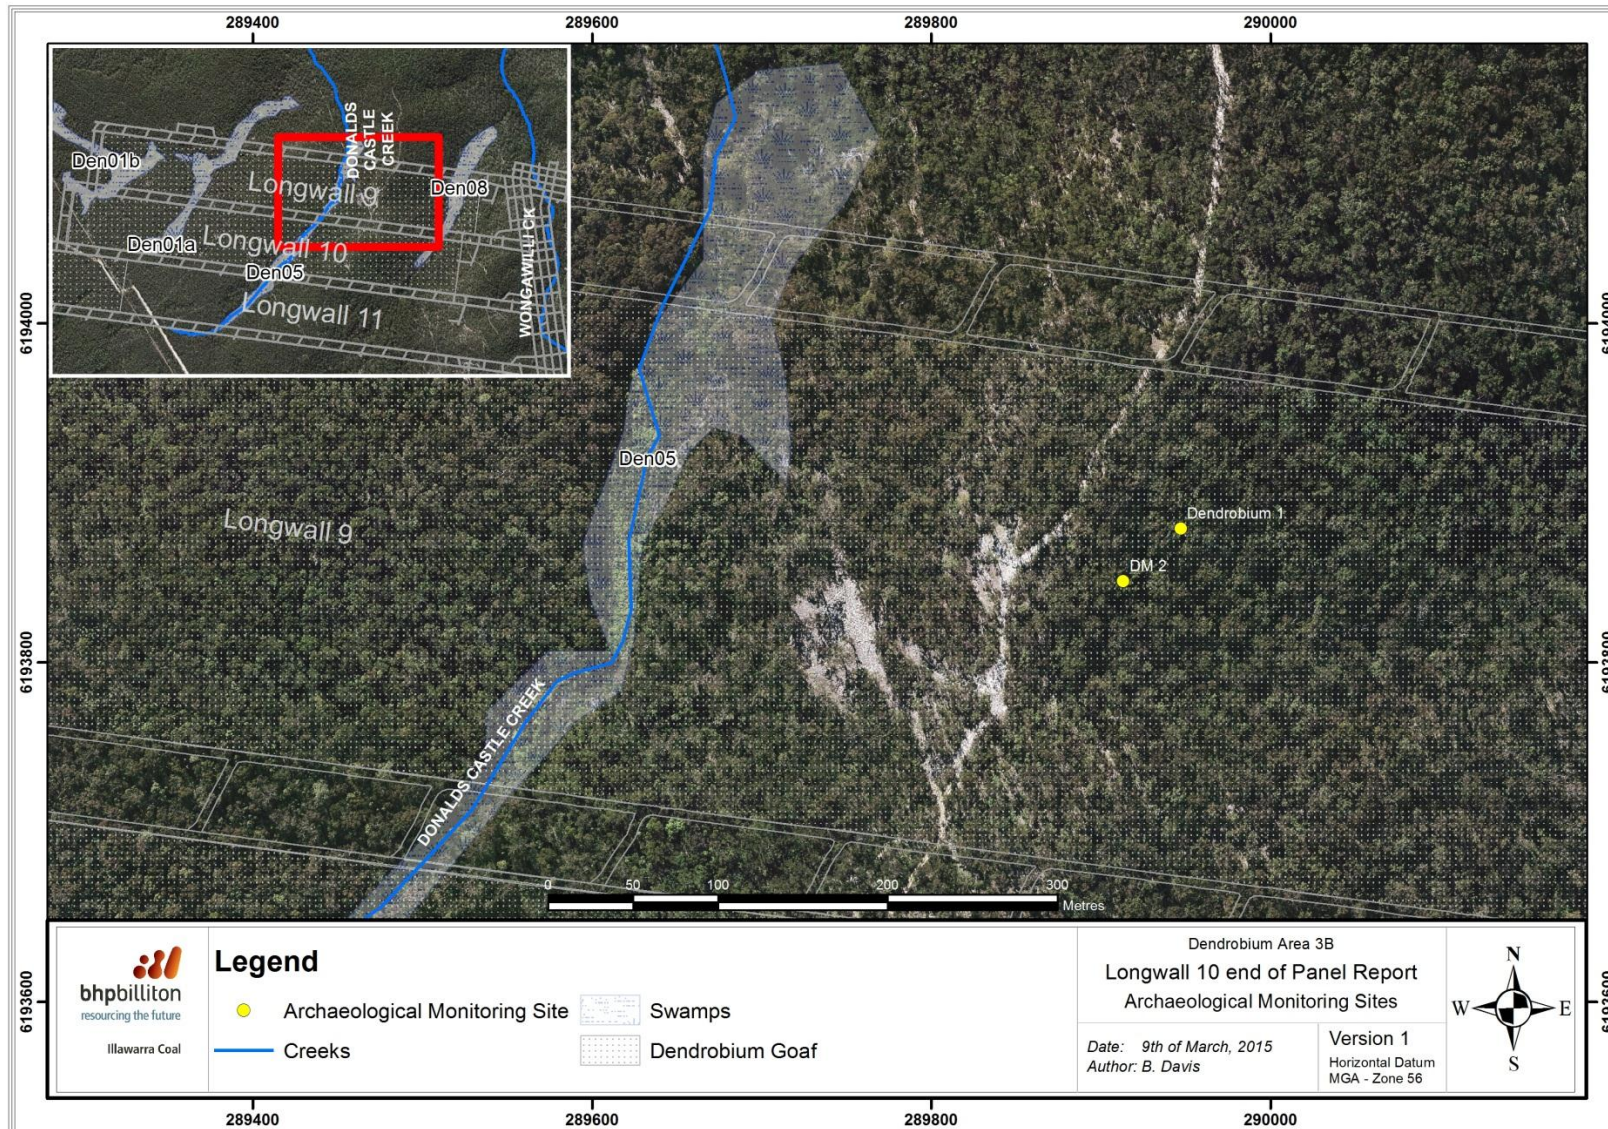
Figure 8: Location of Archaeological Sites Monitored following Longwall 10 Extraction

The assessment of cultural heritage and archaeological sites potentially impacted by Longwall 10 was conducted by Biosis. Two shelters with deposit were inspected as part of the assessment. Figure 8 illustrates the location of monitored sites. These sites were inspected because they were within the zone of possible subsidence associated with Longwall 10. There were no European heritage sites identified as being potentially affected by the extraction of Longwall 10.

Site	Predicted Impacts	Observed Impacts
52-2-2208	Possible fracturing and shear movement of strata and rock falls. Impacts to heritage values are unlikely as the shelter has a volume larger than 50 cubic metres and maximum predicted subsidence of greater than 300mm. Overall risk of impact is low	No observed impacts since the minor expansion and extension of vertical cracking in horizontal bedding plane during Longwall 9 extraction
52-2-3878	Possible fracturing and shear movement of strata and rock falls. Impacts to heritage values are unlikely as the shelter has a volume larger than 50 cubic metres and maximum predicted subsidence of greater than 300mm. Overall risk of impact is low	No observed impacts
