DA3B LONGWALL 11 END OF PANEL LANDSCAPE REPORT

MARCH 2016

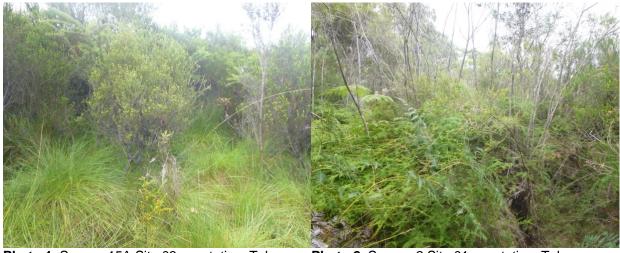
Photo 1: Swamp 15A Site 03 vegetation. Taken on 29/01/2016.

Photo 2: Swamp 2 Site 01 vegetation. Taken on 15/02/2016.

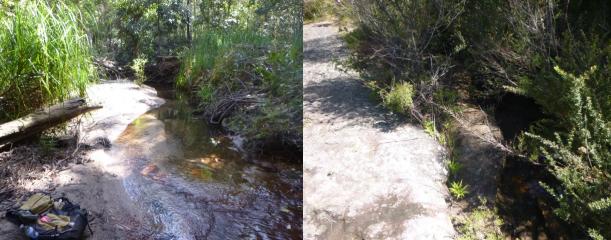
Photo 3: Sandy Creek Pool 23 looking downstream. Taken on 23/09/2015.

Photo 4: Site NDC1 on Native Dog Creek looking downstream. Taken on 13/11/2015.

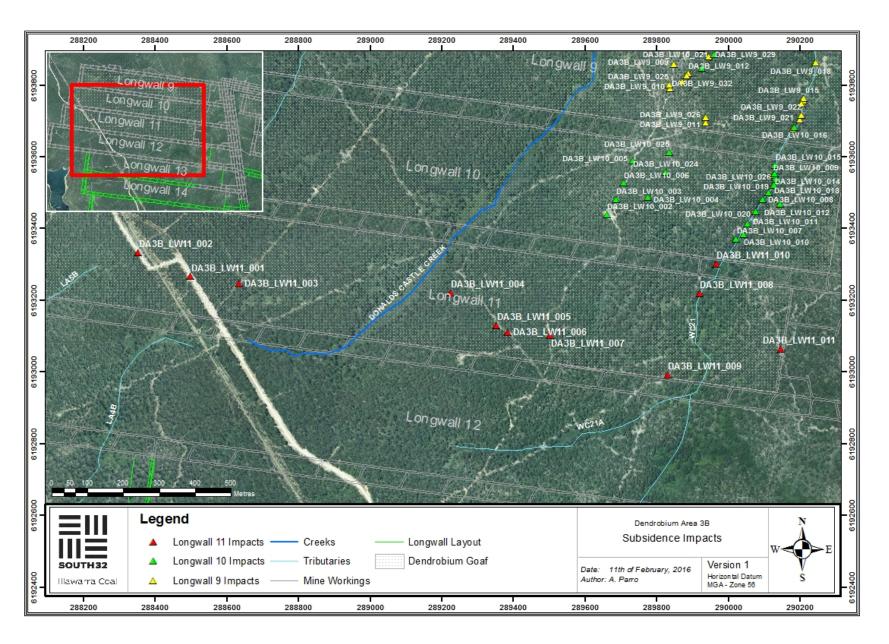
Figure 3.1: Dendrobium Area 3B Impacts

Eleven new impacts were identified during the extraction of Longwall 11. These impacts have been labelled as "DA3B_LW11_001" to "DA3B_LW11_011". The impacts are summarised in Table 3-1. For a detailed description of these impacts refer to the relevant impact reports provided as an attachment to the Longwall 11 EoP Report. Figure 3.1 provides the location of the observed impacts.

Six surface cracks identified during the extraction of Longwall 11 were identified as Level 1 impacts in the TARP as defined in the Dendrobium Area 3B SMP, Volume 2 (November 2012). Impact DA3B_LW11_003 was identified to the west of Swamp 5 and consists of a zone of soil cracking approximately 5m long by 3m wide, the largest crack is 1.9m with a depth of approximately 0.015m to 0.03m (Photo 9). Three soil cracking impacts; DA3B_LW11_004, 005 and 006, were identified on an access track between Swamp 5 and Access Track 6000 (Figure 3.1). The largest crack on this access track measured 4.0m long, with a maximum width of 0.03m and depth of 0.08m (Photos 10 and 11). Impact DA3B_LW11_009 was identified as a zone of soil cracking across a seismic track that runs alongside WC21, the largest crack is 2.7m long and 0.01m wide (Photo 12). Additional soil cracking was identified on a seismic track above the eastern edge of Longwall 11, east of WC21, consisting of surface cracks totalling a length of 2.5m with a maximum width of 0.04m and depth of 0.30m, DA3B_LW11_011.

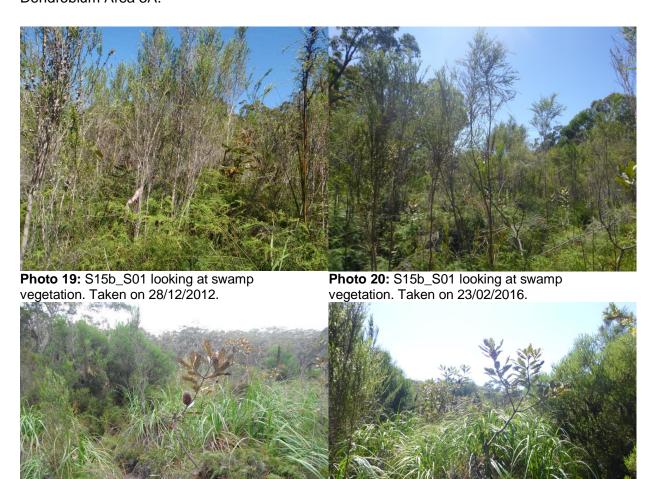
Photo 21: S15b_S04 looking at swamp vegetation. Taken on 17/12/2012.

Photo 22: S15b_S04 looking at swamp vegetation. Taken on 23/02/2016.

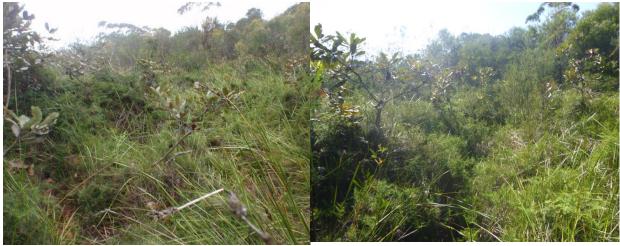
Photo 29: S16_S05 looking at swamp vegetation. Taken on 17/11/2011.

Photo 30: S16_S05 looking at swamp vegetation. Taken on 23/02/2016.

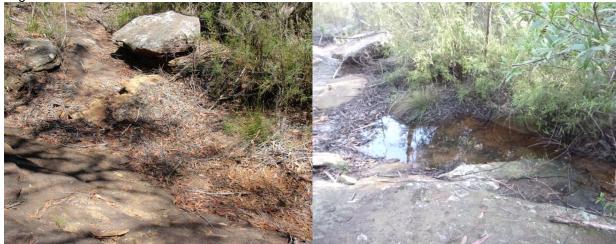
Photo 31: WC17_Pool 12 looking downstream. Taken on 12/11/2012.

Photo 32: WC17_Pool 12 looking downstream. Taken on 27/02/2015.

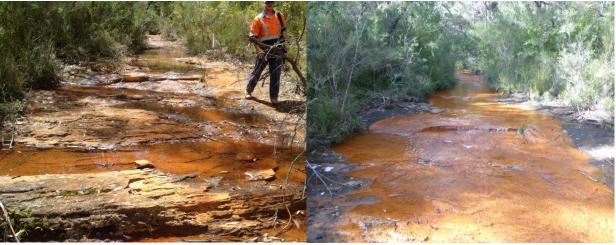
Photo 33: WC17_Pool 6 looking upstream. Taken on 12/10/2012.

Photo 34: WC17_Pool 6 looking upstream. Taken on 11/05/2015.

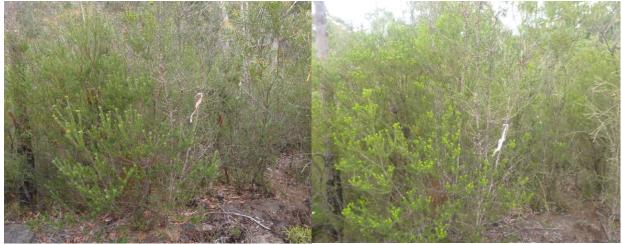
Photo 35: S12_S02 looking at swamp vegetation. Taken on 11/12/2012.

Photo 36: S12_S02 looking at swamp vegetation. Taken on 30/01/2015.

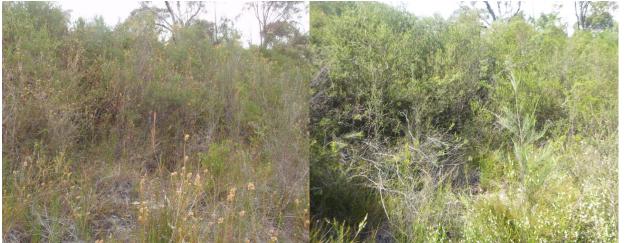
Photo 37: S12_S04 looking at swamp vegetation. Taken on 11/12/2012.

Photo 38: S12_S04 looking at swamp vegetation. Taken on 30/01/2016.
