DENDROBIUM MINE – LW11 EOP REPORT

ILLAWARRA COAL

LW11 EOP REPORT

ILLAWARRA COAL
 DENDROBIUM COLLIERY - AREA 3B
 LONGWALL 11 END OF PANEL REPORT
 GENERAL LAYOUT & MONITORING LINES

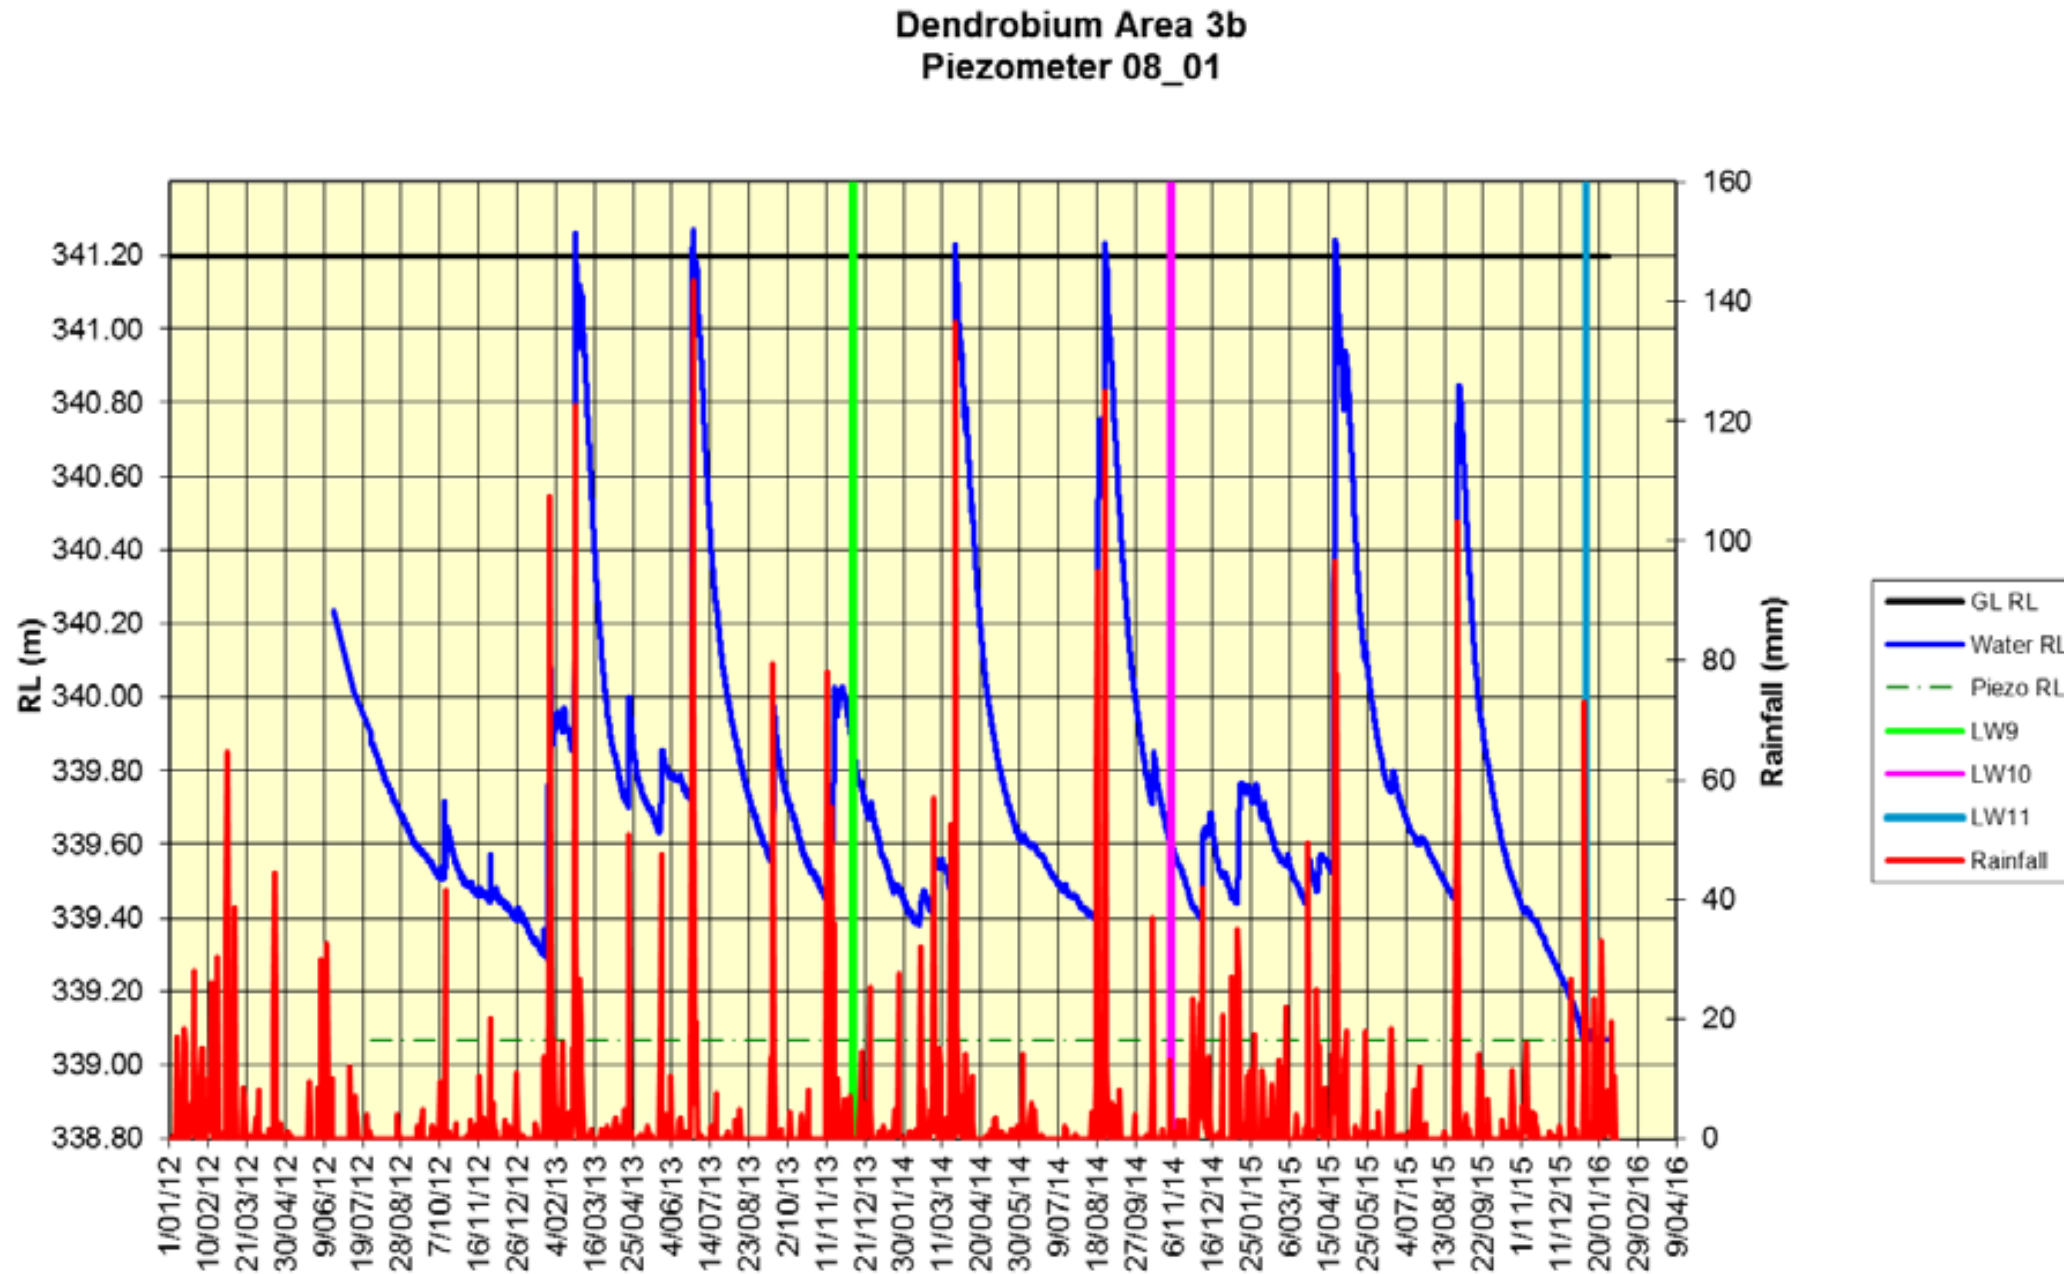
Figure 5.1: Groundwater levels measured borehole site 08_01.

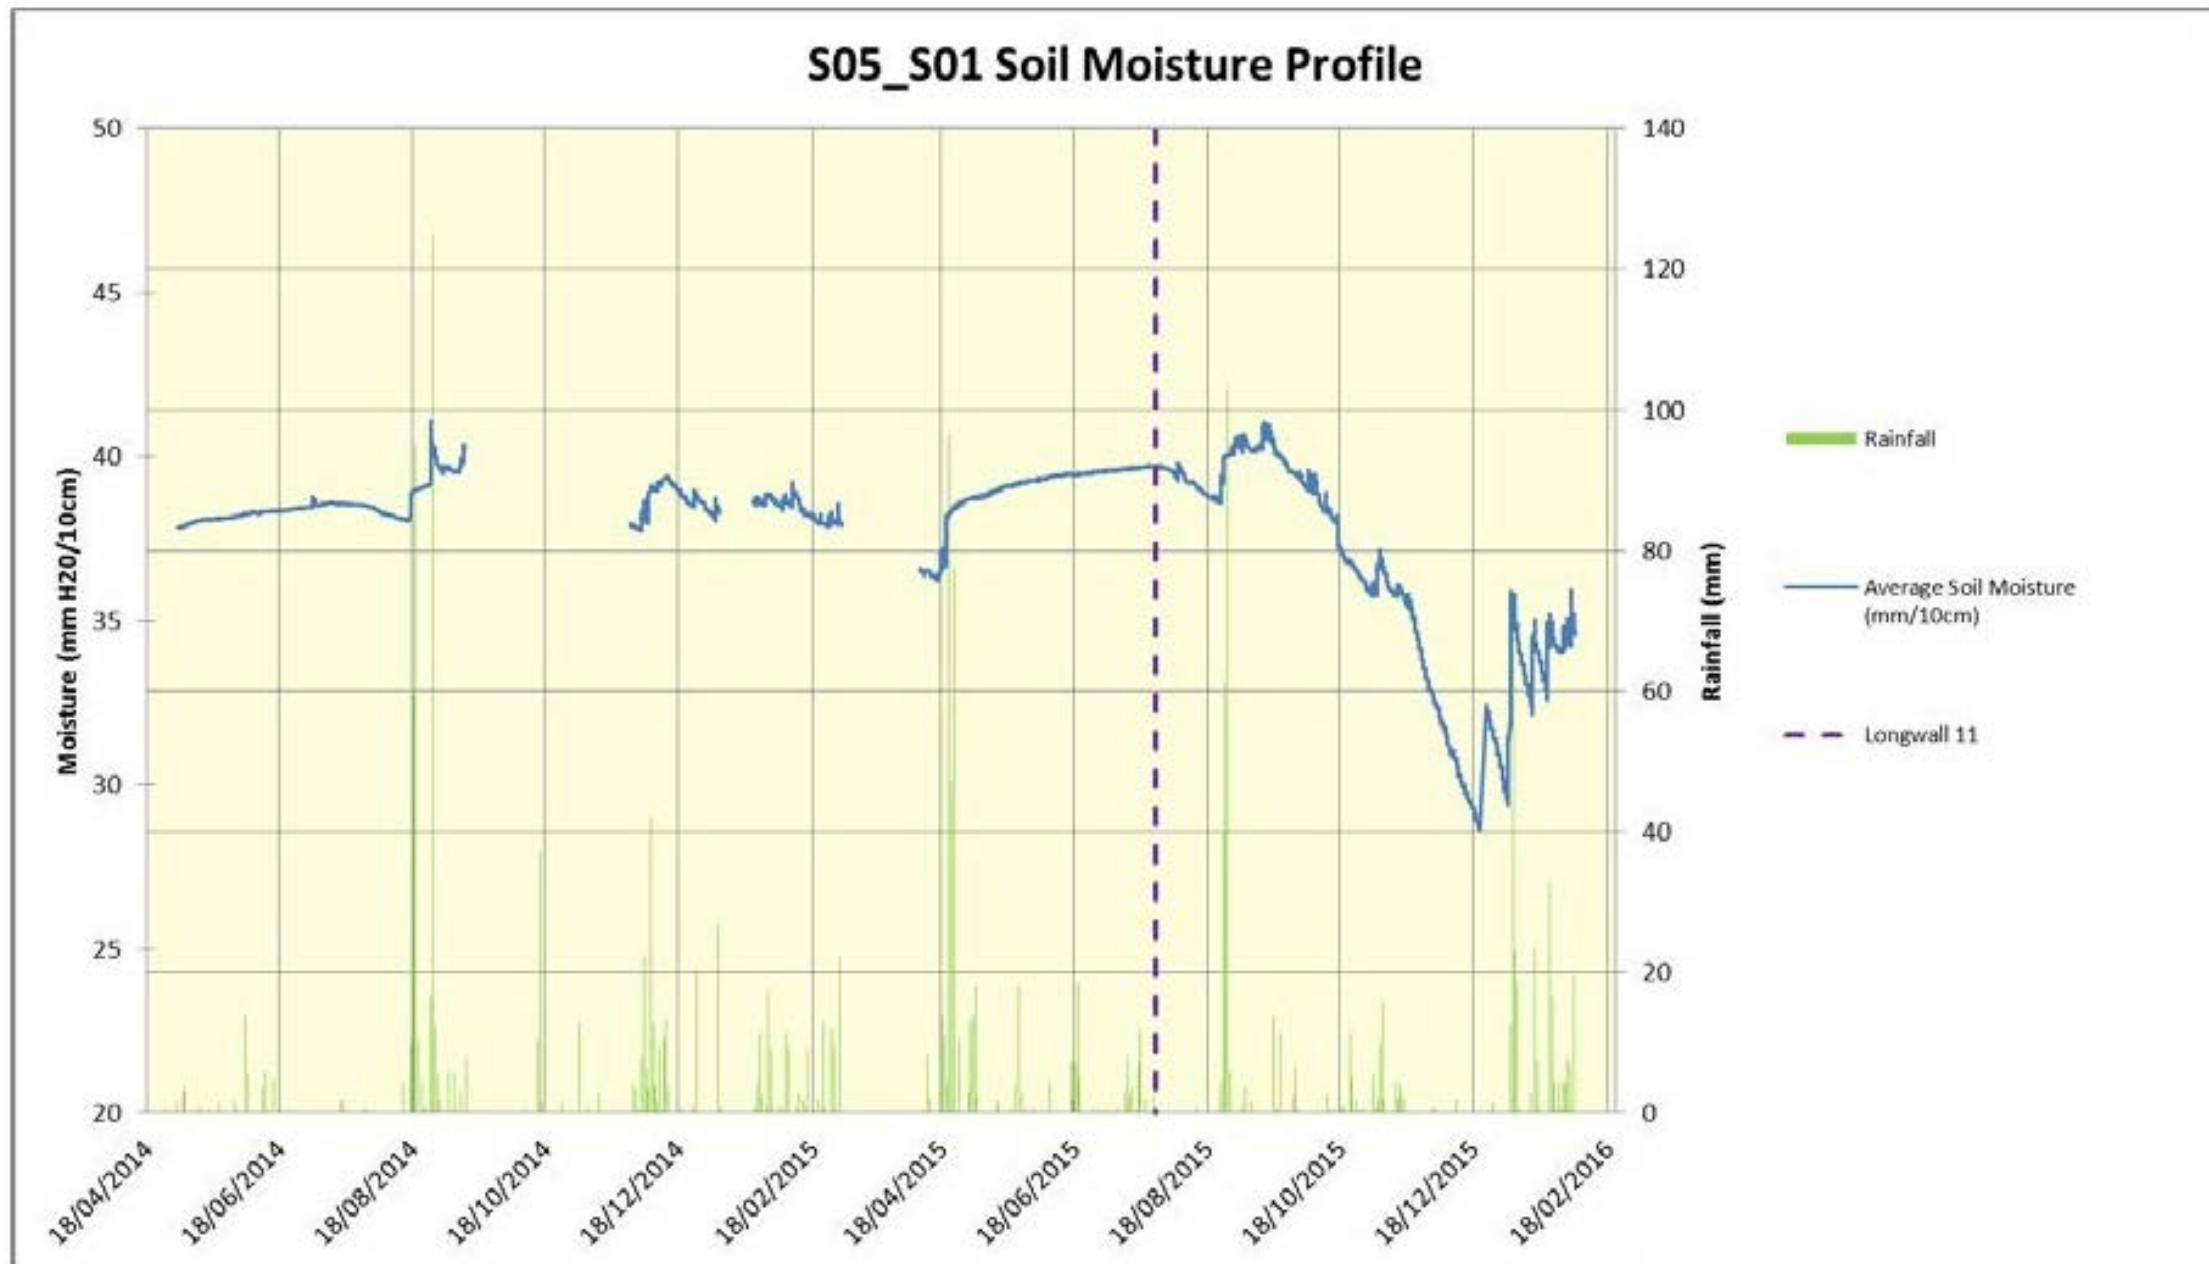
Figure 5.2: Soil moisture levels recorded at S05_S01.

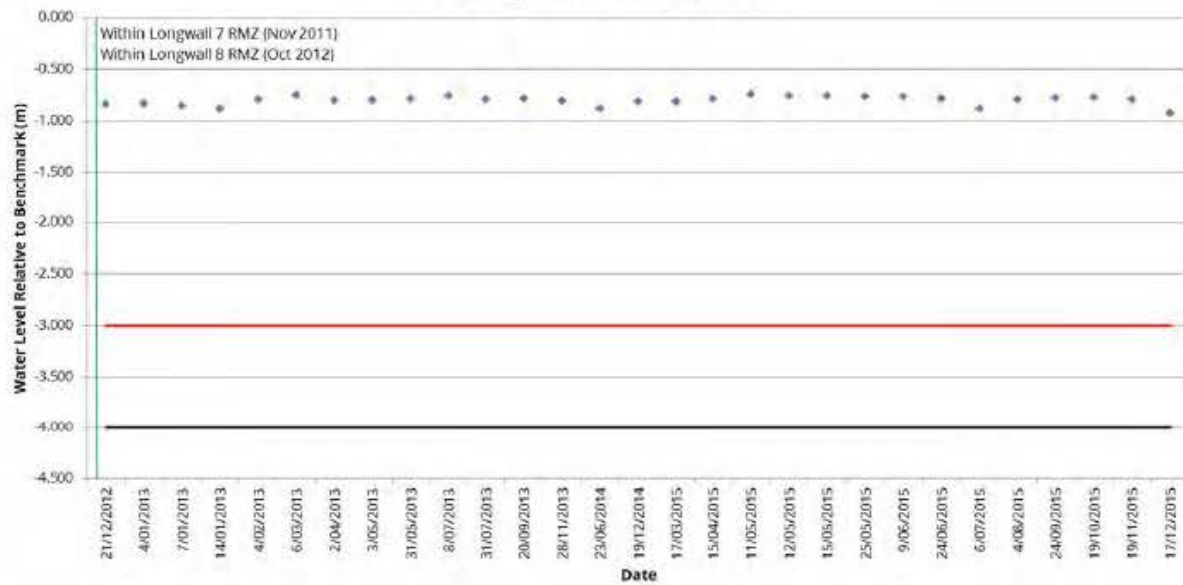
SC10C_Pool 1 Water Level

Graph 1 Water level at four pools along SC10C including three known breeding pools for Littlejohn's Tree Frog; Pool 1, Pool 3 and Pool 5 (data provided by Illawarra Coal Environmental Field Team). Red lines represent water levels below nail and black lines represent dry pool.

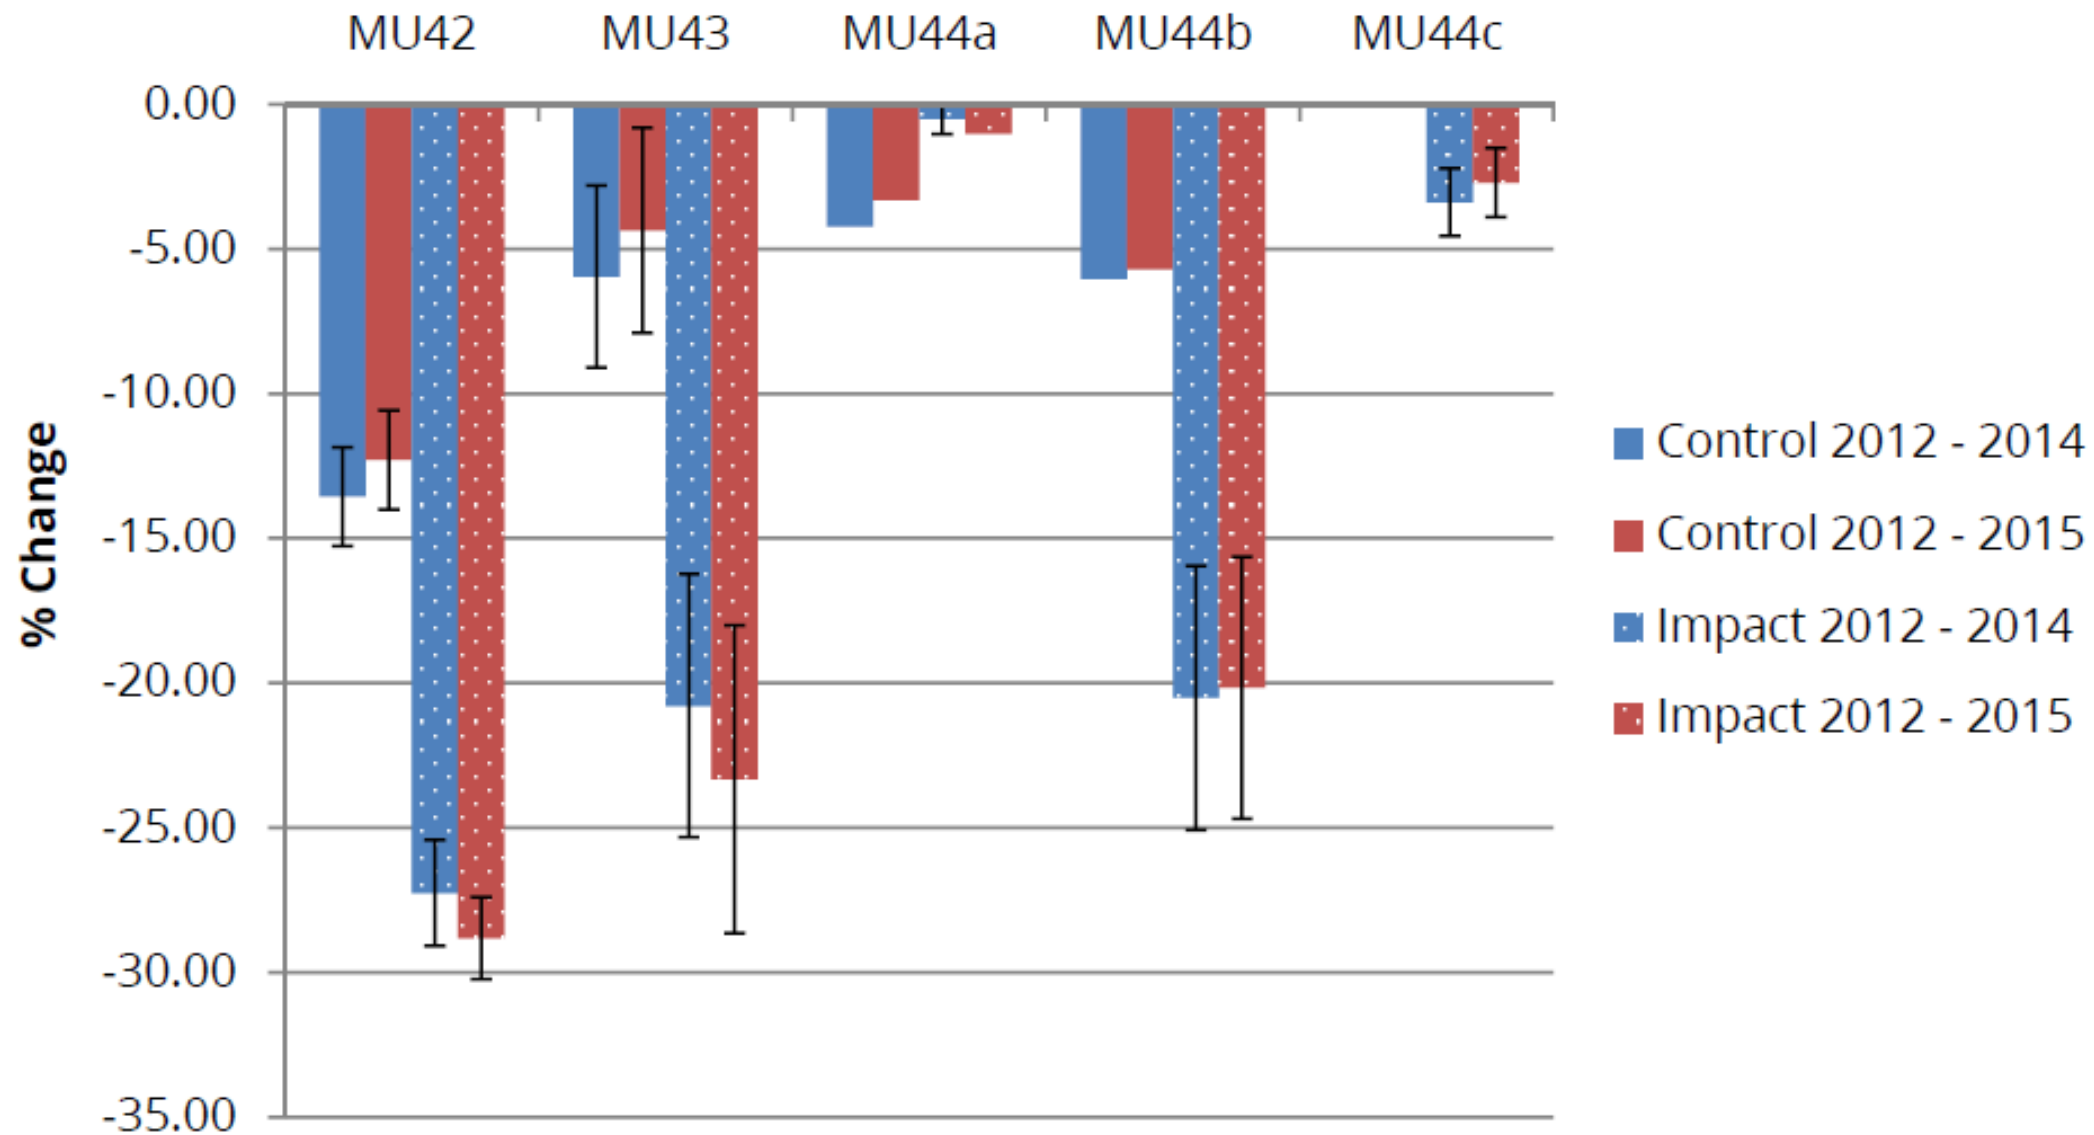
Graph 8 Mean (\pm SE) decrease in swamp sub-community extent at impacted and control swamps across the Dendrobium 3A and 3B Areas during the periods 2012 - 2014 and 2012 - 2015.
