**DENDROBIUM LONGWALL 13
END OF PANEL LANDSCAPE
REPORT**

JUNE 2018

This report summarises the observed and measured subsidence effects on landscape features resulting from the extraction of Dendrobium Longwall 13.

Longwall 13 is the fifth panel extracted from Dendrobium Area 3B. Extraction began on the 4th of March 2017 and was completed on the 19th of April 2018.

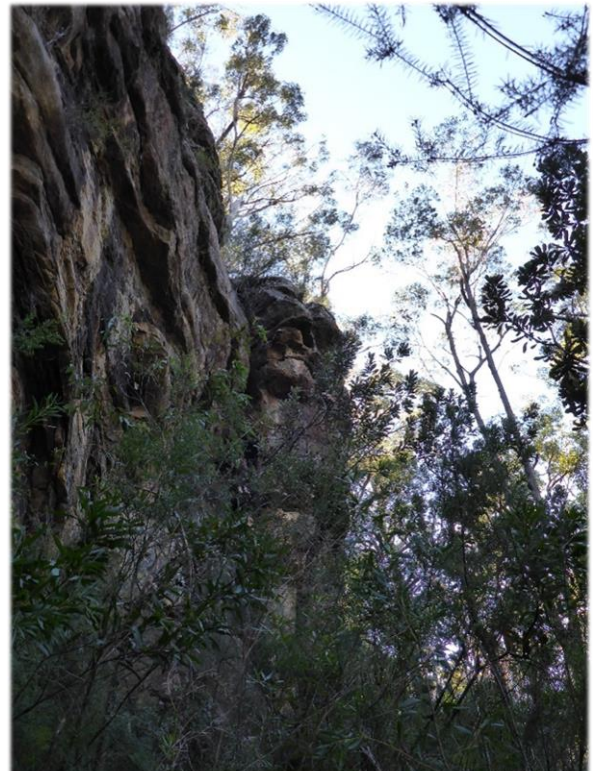
In accordance with the Dendrobium Area 3B SMP approvals, landscape monitoring sites (SLMMP photo points) within the active mining area were monitored at monthly intervals. Monitoring photos from SLMMP sites are compared to baseline photos at each site (examples shown in Photo 1 and Photo 2). A total of 15 landscape sites (SLMMP photo points) were monitored before, during and after the Longwall 13 extraction period (Table 1). A Longwall 13 post-mining inspection was carried out on the 25th of May 2018 and no additional impacts were observed.

Photo 2: A3b-CF2 Post mining photo. Taken 23/05/2018.

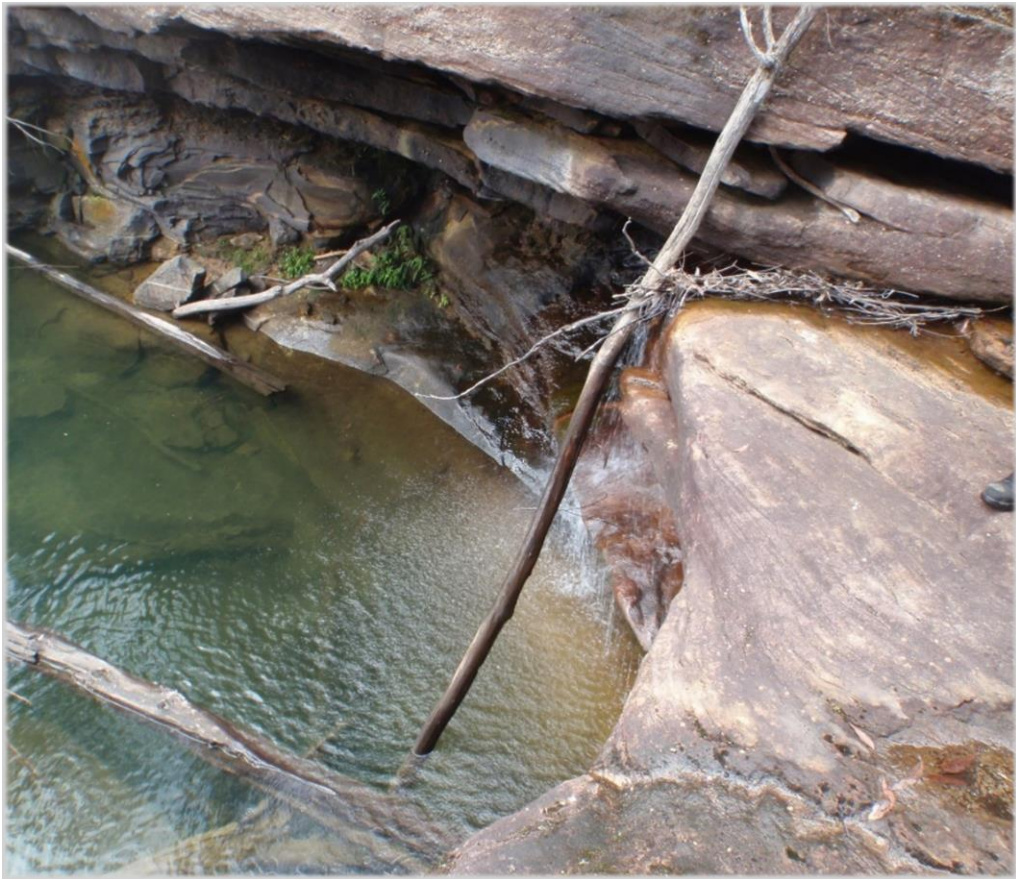
Impact *DA3B_LW13_043* is located on *LA4*, a tributary to *Lake Avon*, 300m from the commencing end of Longwall 13, and 300m from the southern edge of Longwall 12. The impact was identified on the 18th May 2018. The impact is comprised of rock fracturing, associated rock fragmentation and iron staining to *LA4_Step 0* (Photo 9), which is the most downstream feature before entering *Lake Avon*. The fracturing is 2m in length and 0.02m in width; the rock fragment is 1.5m in length, 0.5m in width and 0.3m in height (Photo 9). These impacts are not evident in baseline photos from 2011 (Photo 10). There was no surface flow at the site during the inspection; however, diversion of flow is likely to occur to some degree. Given the proximity of the site to the commencing end of Longwall 13 and previously recorded impacts (i.e. *DA3B_LW13_001*), it is probable that the impact originated approximately one year before it was first identified. Previously the site has been inundated by reservoir water, which would have obscured identification of the impact.

Photo 10: LA4_Step 0, looking across stream; the pooling to the left of the image is *Lake Avon reservoir* water. Taken during baseline mapping of the area 14th November 2011.

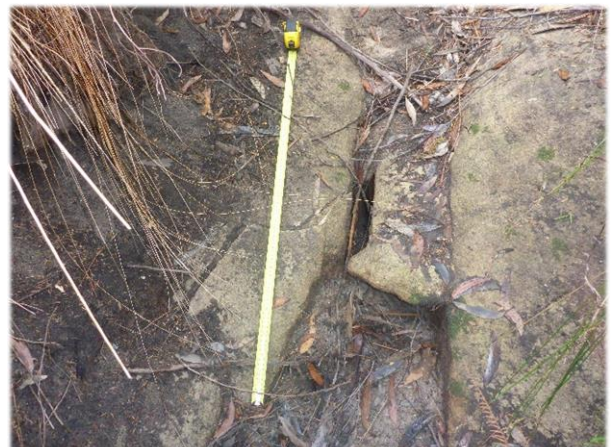
Impact *DA3B_LW13_009* was identified on the 27th of October 2017. This impact consists of fracturing and fragmentation to the rockbar at the downstream extent of *WC21_Pool 54*, which was mined beneath by Longwall 13 on the 24th of September 2017. The largest fracture is 0.22m wide, 0.37m deep and 0.38m long (Photo 44 and Photo 45). Surface water was not present at the site during the inspection.

Photo 45: Impact *DA3B_LW13_009*, looking upstream, taken on 23/10/2017.

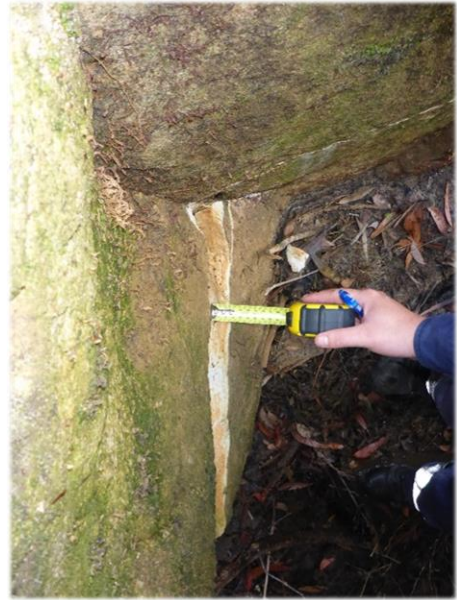
Impact *DA3B_LW13_010* was identified on the 27th of October 2017. This impact consists of lateral fracturing to the step at the upstream extent of *WC21_Pool 53*, which was mined under by Longwall 13 on the 24th of September 2017. The largest fracture is approximately 2.5m long, 0.01m wide, and 0.03m at its deepest measurable point (Photo 46). The portion of sandstone below the fracture has been displaced laterally by approximately 0.03m (Photo 47). A smaller, approximately 1m long, hairline fracture is present adjacent to the largest fracture (Photo 48). No flow diversion was observed at the site; however, the water level at *WC21_Pool 53* has lowered considerably following being mined under by Longwall 13 (Photo 49 to Photo 51). It is likely there is an unobservable fracture at the base of the pool diverting water.

Photo 47: Impact *DA3B_LW13_010* looking top-down at the displaced rock, taken 27/10/2017.

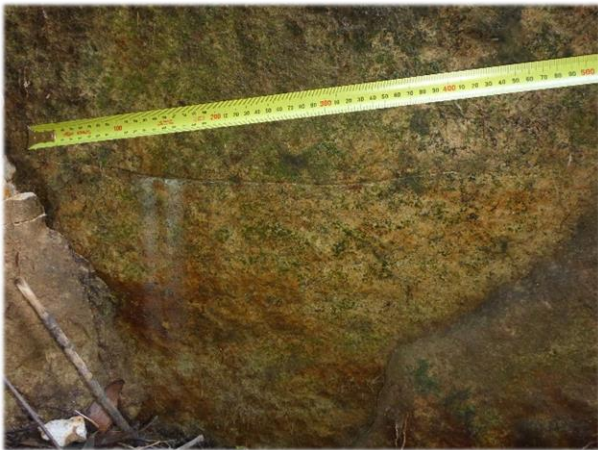
Photo 48: Impact *DA3B_LW13_010* looking across stream, taken 27/10/2017.

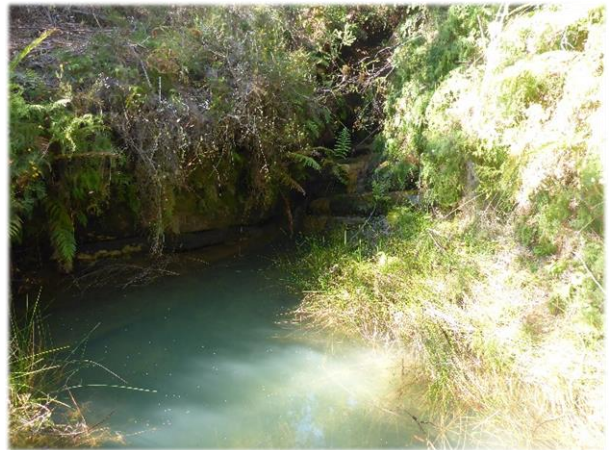
Photo 49: *WC21_Pool 53*, looking upstream, taken 11/09/2017.

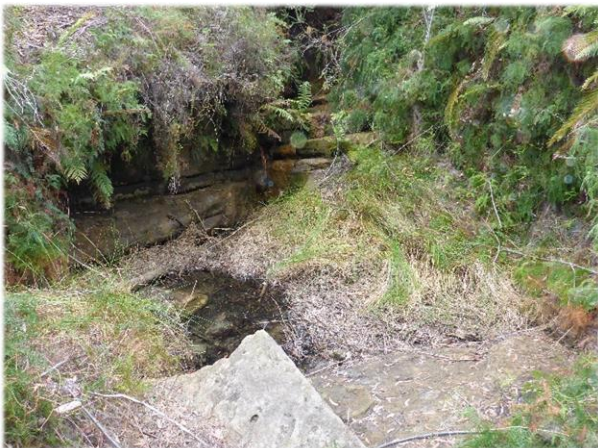
Photo 50: *WC21_Pool 53*, looking upstream, taken 10/10/2017.

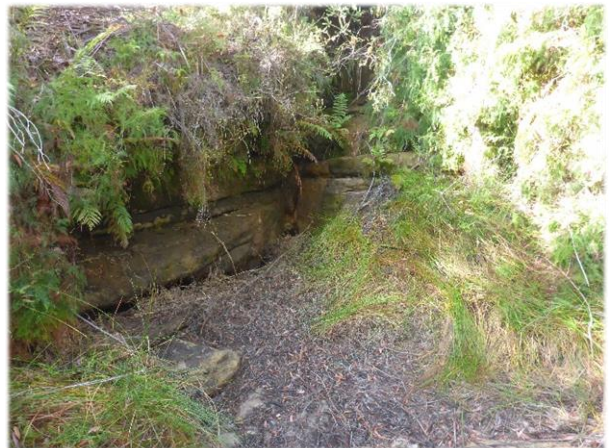
Photo 51: *WC21_Pool 53* looking upstream, taken 27/10/2017.

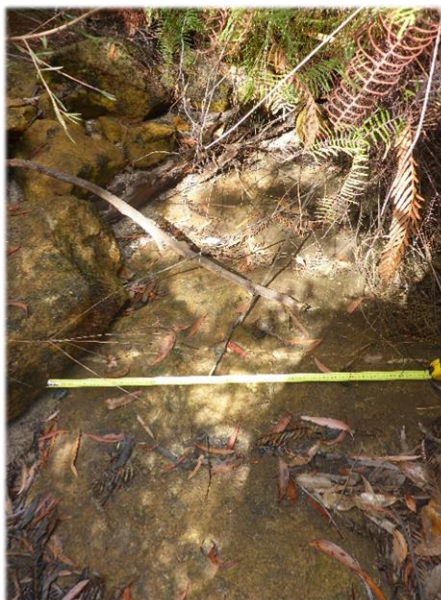
Impact *DA3B_LW13_011* was identified on the 27th of October 2017. This impact consists of fracturing to the rockbar base of *WC21_Pool 47*, which was mined under by Longwall 13 on the 8th of October 2017. The fracturing is 1.1m long, 0.01m wide and 0.3m at its deepest measurable point (Photo 52 and Photo 53). Flow diversion has likely occurred at the site given the change in pool level over a relatively short period. Observations show water at *WC21_Pool 47* as of the 25th of September 2017 (Photo 54. *Note photo shows 20th of September 2017*). The following observation, on the 3rd of October 2017, shows no water within the pool (Photo 55).

Photo 53: *DA3B_LW13_011*, looking upstream, taken 23/10/2017.

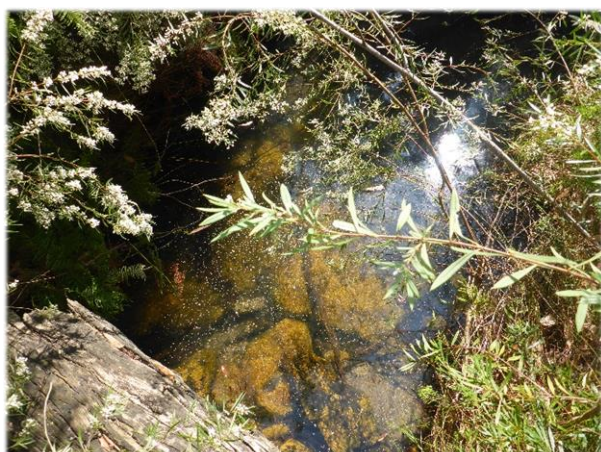
Photo 54: *WC21_Pool 47*, looking downstream, taken 20/09/2017

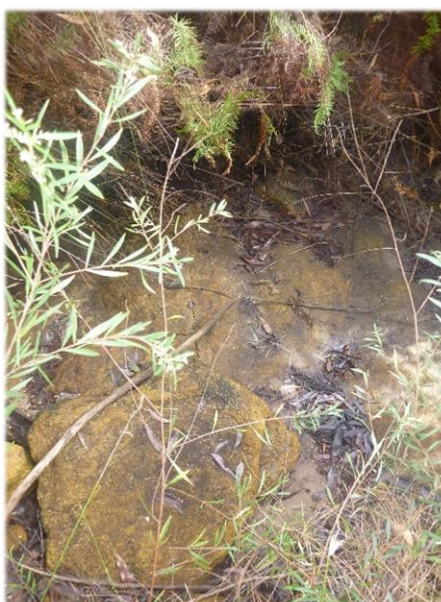
Photo 55: *WC21_Pool 47*, looking across stream, taken 3/10/2017.

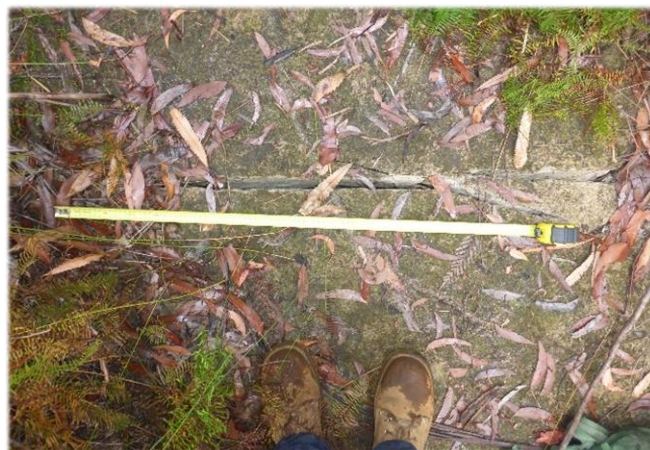
Impact DA3B_LW13_017 was identified during an inspection on the 8th of January 2018. The impact consists of rock fracturing across tributary WC21. The crack is approximately 2m long, 0.03m wide and 0.22m at its deepest measurable point (Photo 56 and Photo 57). While there was no surface flow during the inspection it is likely that the fracture would result in diversion of flow. Longwall 12 passed adjacent to the site in November 2016 with Longwall 13 passing the site in October 2017.

Photo 57: Impact DA3B_LW13_017, overall extent. Taken on 8/01/2018.
