**DENDROBIUM AREA 3B
LONGWALL 14 END OF PANEL
LANDSCAPE REPORT
APRIL 2019**

This report summarises the observed and measured subsidence effects on landscape features resulting from the extraction of Dendrobium Area 3B (DA3B) Longwall 14.

Longwall 14 is the sixth panel extracted from DA3B. Extraction began on 22 May 2018 and was completed on 26 February 2019.

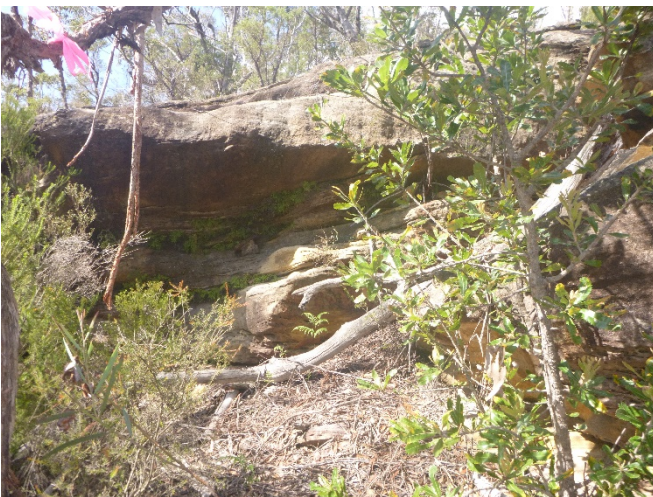
Photo 1: A3b-SS8 baseline inspection. Taken 13/04/2017.

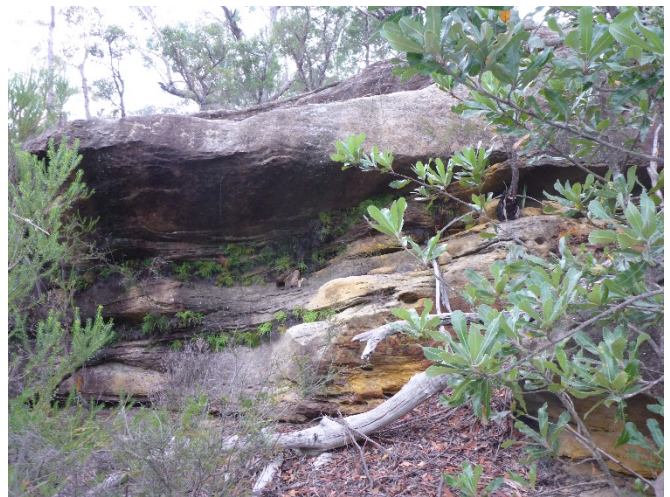
Photo 2: A3b-SS8 post-mining inspection. Taken 4/04/2019.

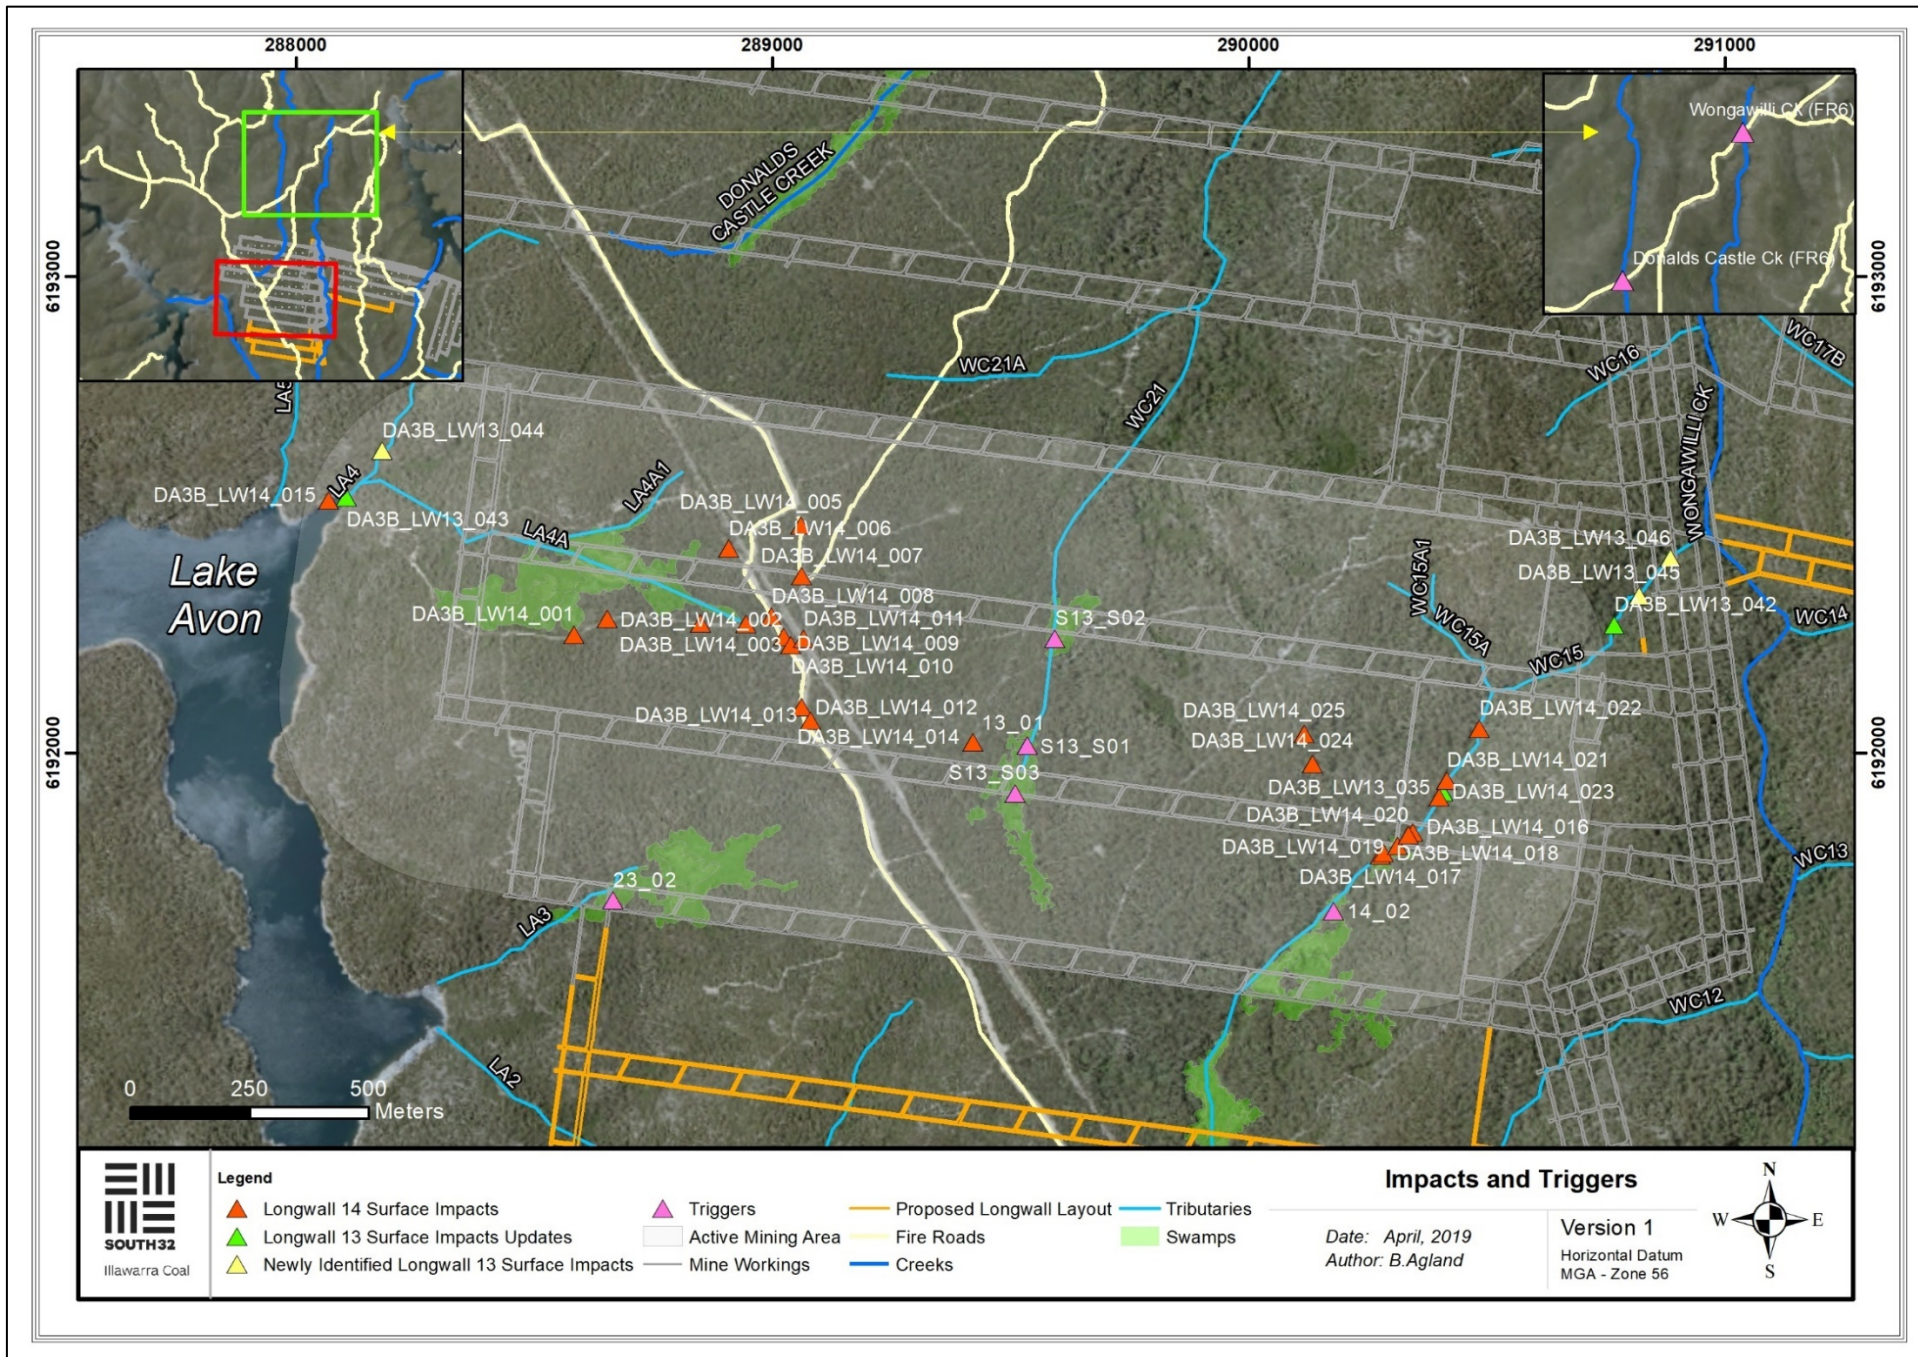
During the extraction of Longwall 14, 25 new surface impacts were identified (Table 3, Figure 2). These impacts are labelled as *DA3B_LW14_001* to *DA3B_LW14_025*. Three additional Longwall 13 impacts were identified; these impacts are labelled as *DA3B_LW13_044* to *DA3B_LW14_046*. Updates are provided for three existing Longwall 13 impacts; these impacts are labelled as *DA3B_LW13_035 (Update)*, *DA3B_LW13_042 (Update)* and *DA3B_LW14_043 (Update)*. An additional three water quality triggers, four soil moisture triggers and two shallow groundwater triggers were identified. These triggers will be addressed in the Longwall 14 Surface Water and Shallow Groundwater Assessment.

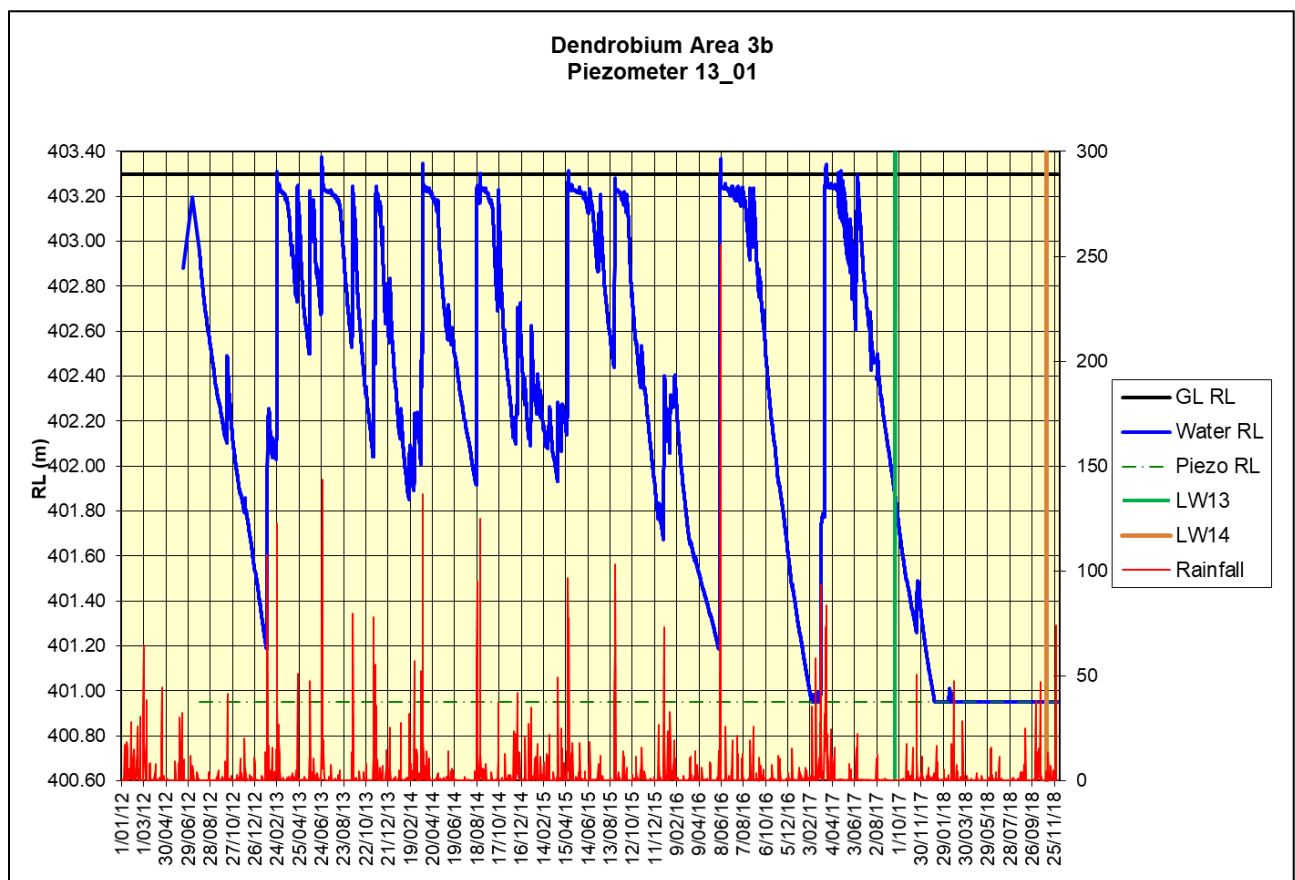
During analysis of shallow groundwater levels for borehole 13_01, changes to the typical rainfall response were observed. A piezometer and logger were installed at the site in June 2012. The site was passed by Longwall 13 on 21 September 2017 and mined beneath by Longwall 14 on 4 November 2018 (Figure 3). The lowest recorded baseline water level was RL 400.95 m, which corresponds to water levels below the piezometer, however groundwater levels typically increased following rainfall events during the baseline period. Following Longwall 14 passing beneath the site, groundwater levels had not responded to rainfall events (Figure 3).

Level 3: Groundwater level lower than baseline level at >80% of monitoring sites* (within 400m of mining) within a swamp (in comparison to reference swamps) *Note- there is one shallow groundwater site in Swamp 13, hence the >80% trigger.

Figure 3: Shallow groundwater levels at 13_01, logged hourly interval.

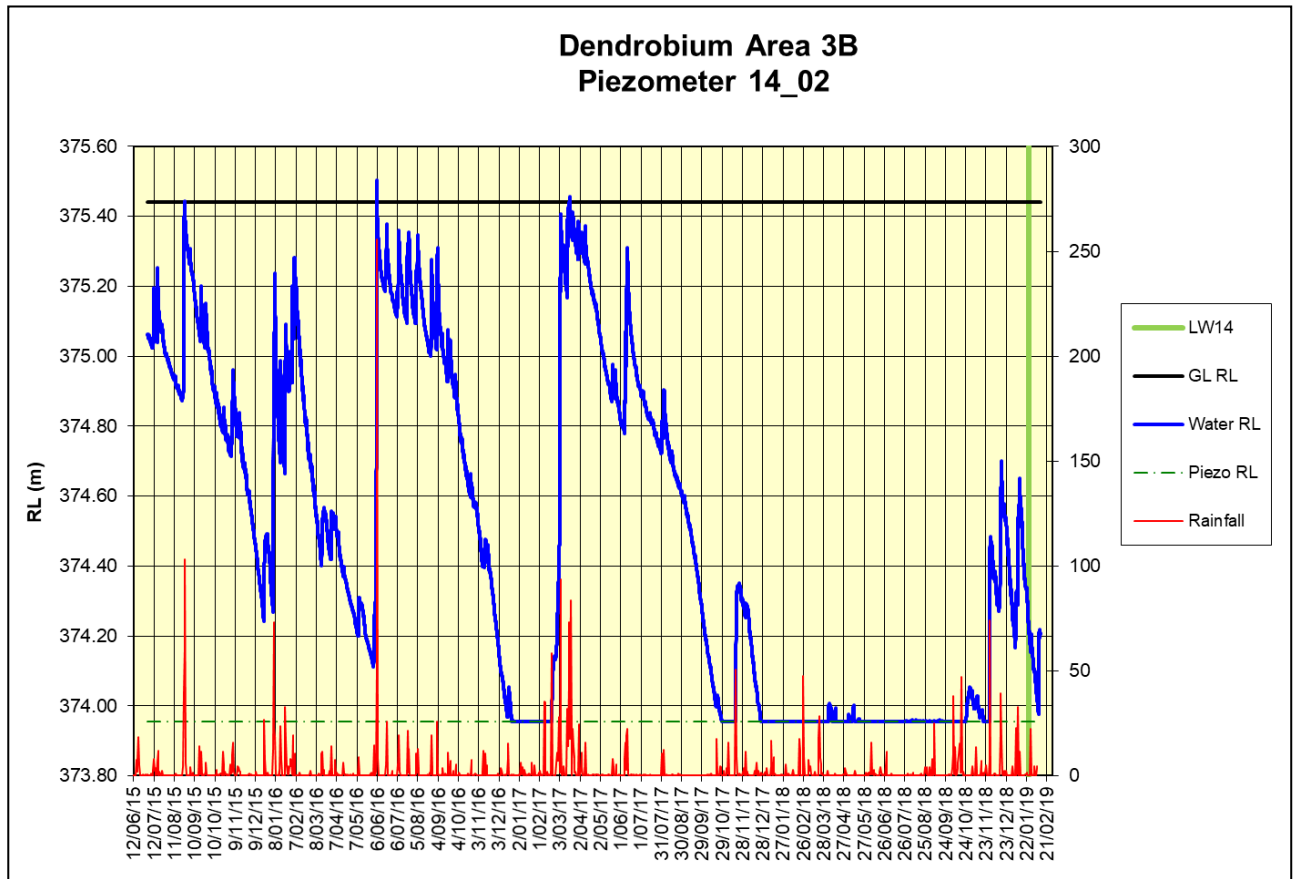
A shallow groundwater trigger was recorded at borehole 14_02 during analysis of piezometer data for Swamp 14. A piezometer and logger were installed in a hand-augured borehole at 14_02 in July 2015. This site is situated approximately 205m south of Longwall 14 at its closest point. The post-mining rate of water level recession (0.89 mm/hour calculated between 29/01/2019 11:00 and 7/02/2019 14:00) has exceeded the rate recorded before mining (0.64 mm/hour calculated between 9/12/2017 15:00 and 22/12/2017 14:00) (Figure 4).

Level 2: Rate of groundwater level reduction exceeds rate of groundwater level reduction during baseline period at 50% of monitoring sites (within 400m of mining) within the swamp.

Figure 4: Shallow groundwater levels at 14_02, logged hourly.

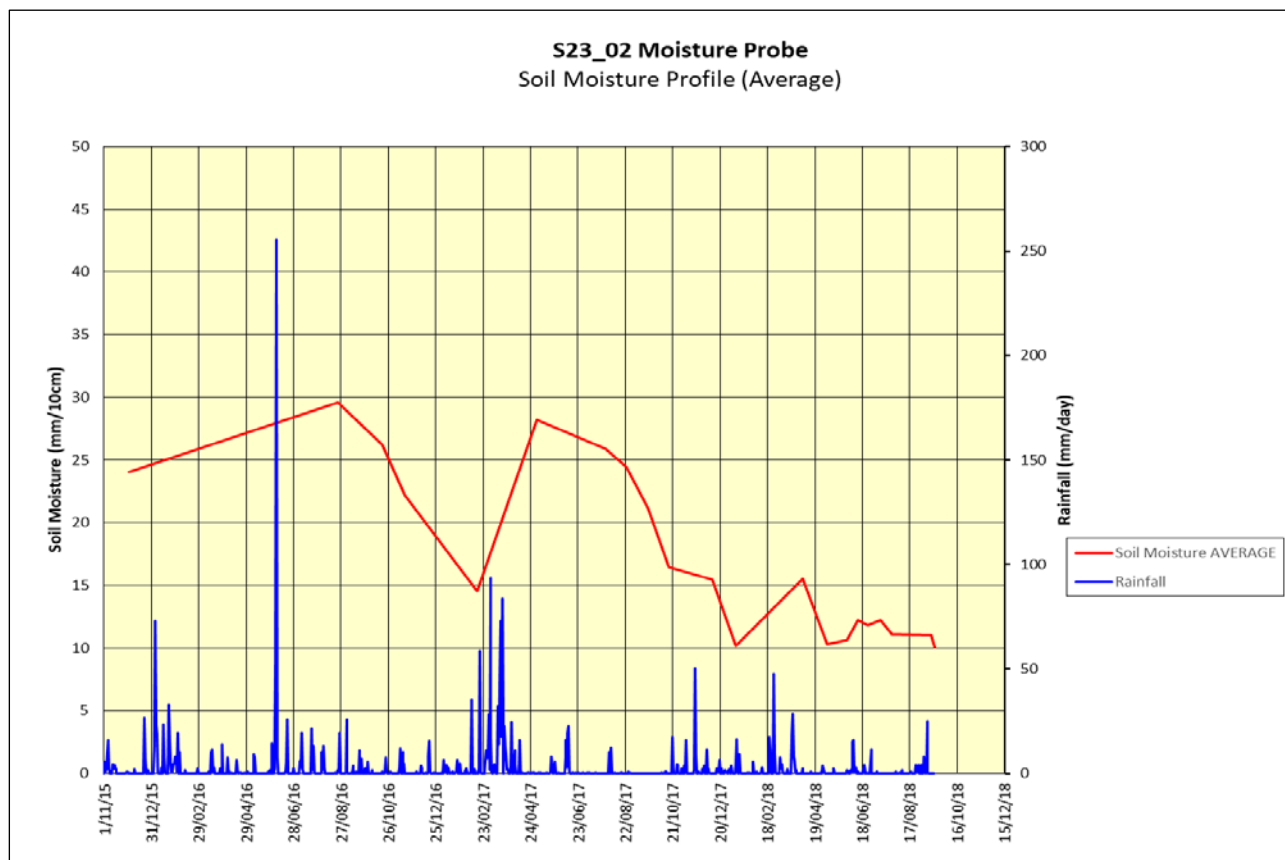
A soil moisture trigger was measured at site S23_02 during analysis of Swamp 23 soil moisture data. The site was established in July 2015, in a hand-augured hole. The site was passed by Longwall 14 on 8 July 2018. Data indicates that soil moisture levels at this site have dropped below baseline levels (Figure 5).

Level 1: Soil moisture level lower than baseline level at any monitoring sites (within 400m of mining) within a swamp

Figure 5: Soil moisture levels at S23_02.

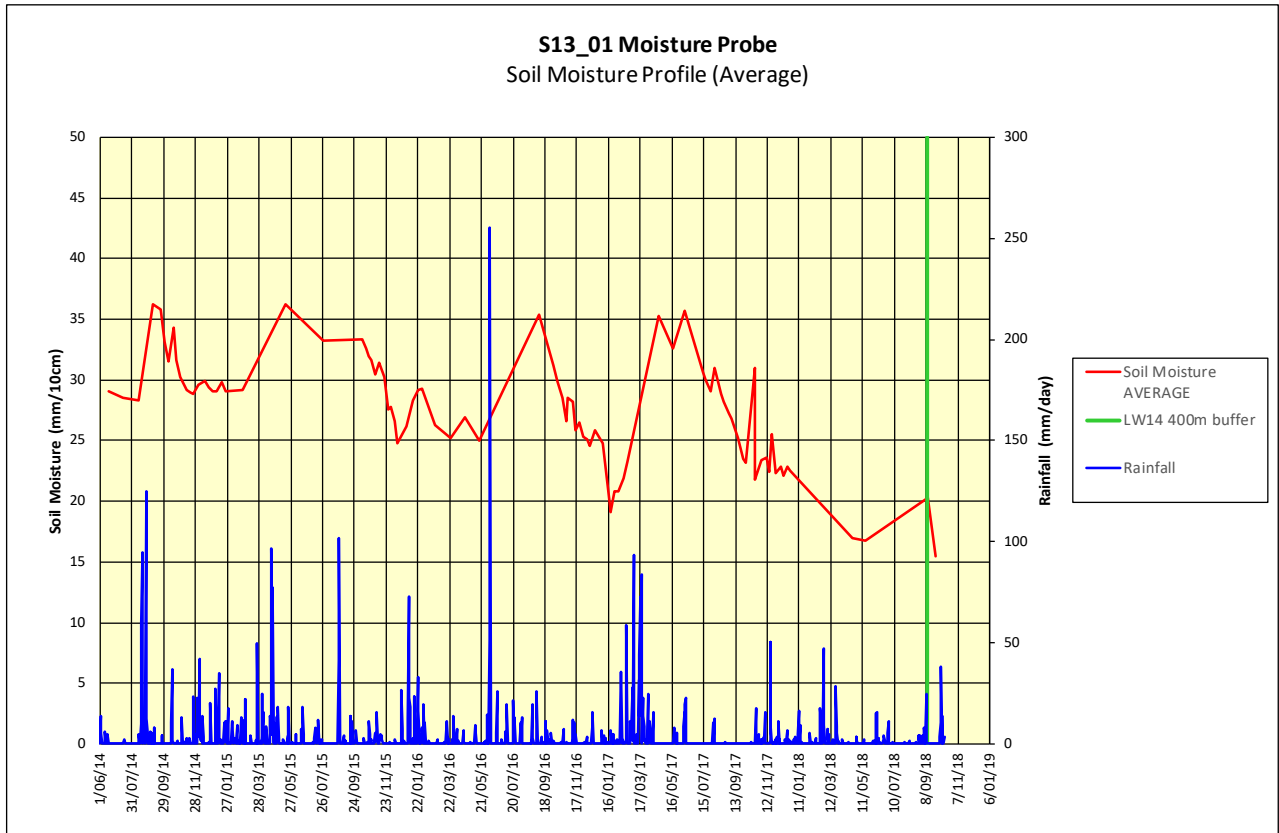
A soil moisture trigger was measured at S13_01 during analysis of Swamp 13 data. The site was established in 2014, in a hand-augured hole. The site entered the Longwall 14 active mining area on the 8th of September 2018. Data indicates that soil moisture levels dropped below baseline levels (Figure 6).

Level 3: Soil moisture level lower than baseline level at >80% of monitoring sites (within 400m of mining) within a swamp.

Figure 6: Soil moisture levels at site S13_01.

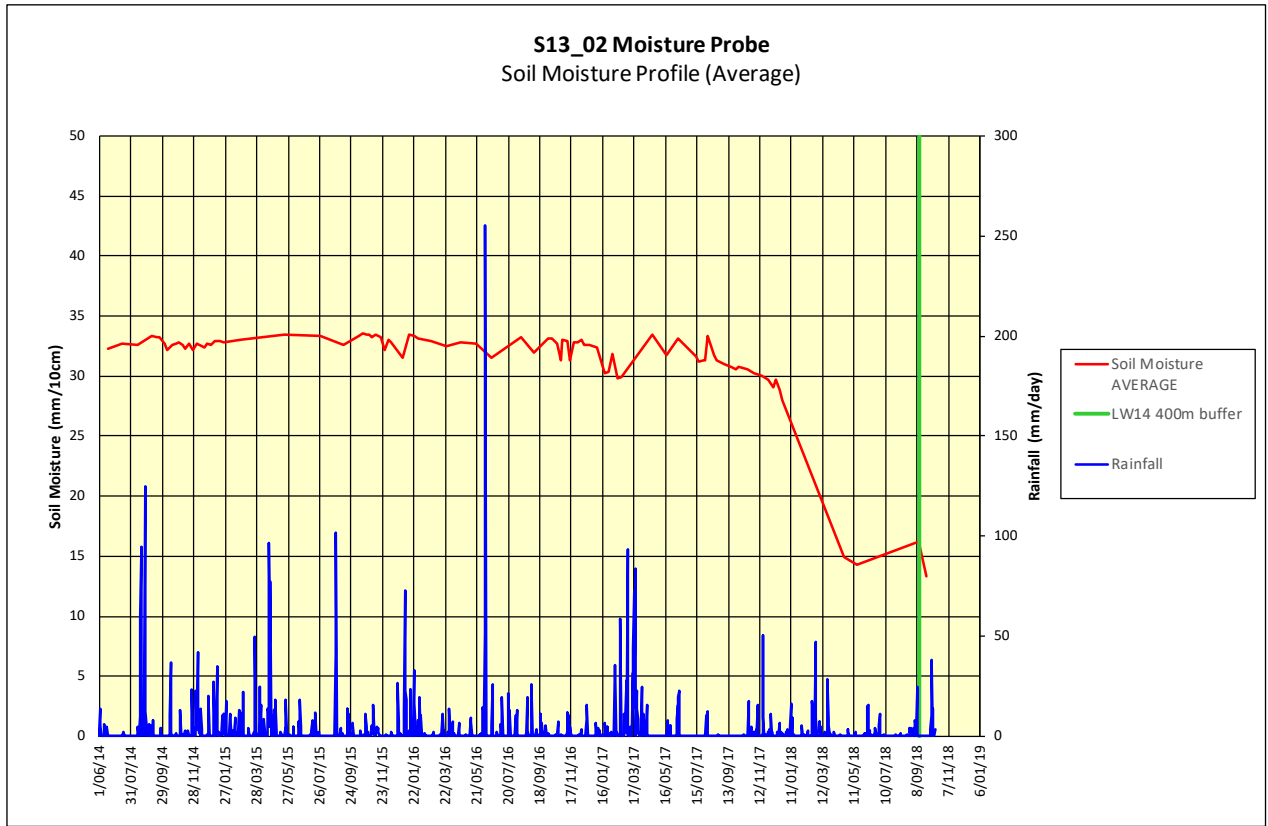
A soil moisture trigger was measured at S13_02 during analysis of Swamp 13 data. The site was established in 2014, in a hand-augured hole. The site entered the Longwall 14 active mining area on 11 of September 2018. Data indicates that soil moisture levels dropped below baseline levels (Figure 7).

Level 3: Soil moisture level lower than baseline level at >80% of monitoring sites (within 400m of mining) within a swamp

Figure 7: Soil moisture levels at site S13_02.

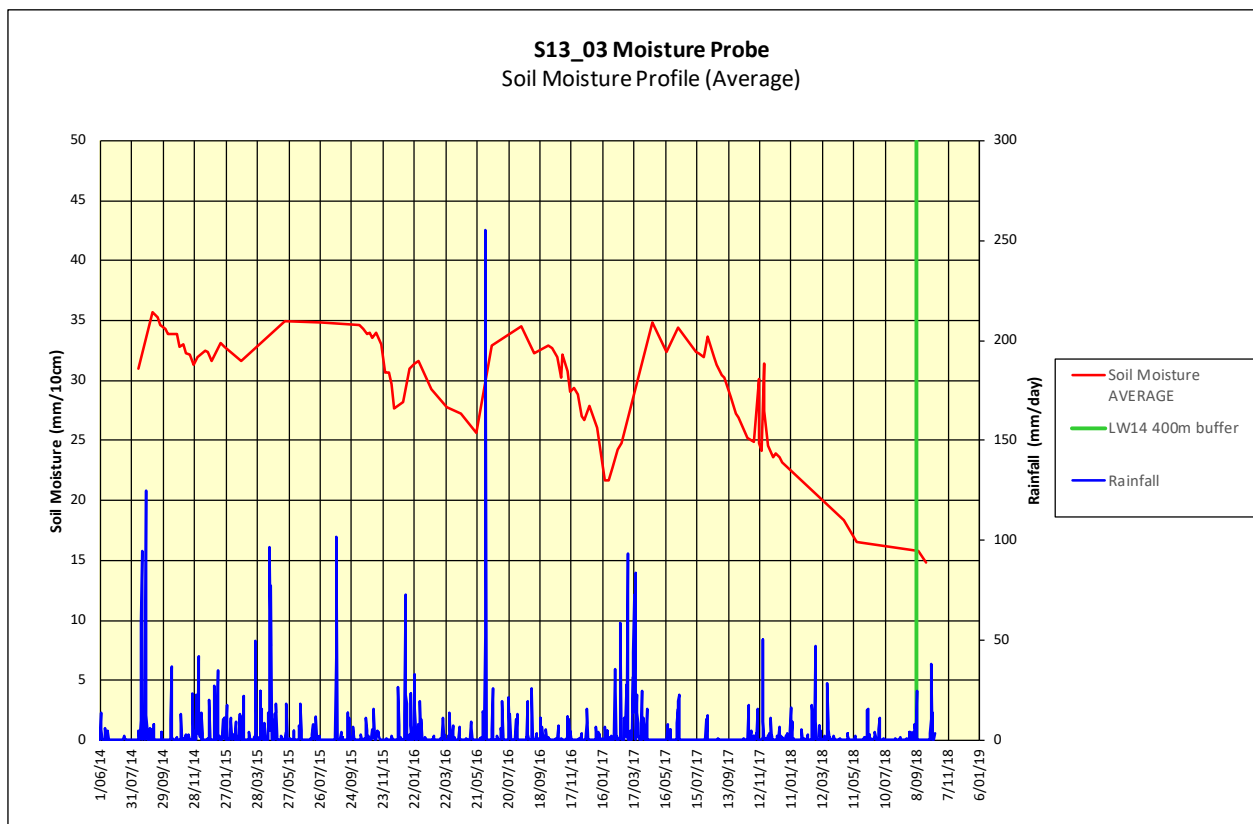
A soil moisture trigger was measured at S13_03 during analysis of Swamp 13 data. The site was established in 2014, in a hand-augured hole. The site entered the Longwall 14 active mining area on 8 September 2018. Data indicates that soil moisture levels dropped below baseline levels (Figure 8).

Level 3: Soil moisture level lower than baseline level at >80% of monitoring sites (within 400m of mining) within a swamp

Figure 8: Soil moisture levels at site S13_03.

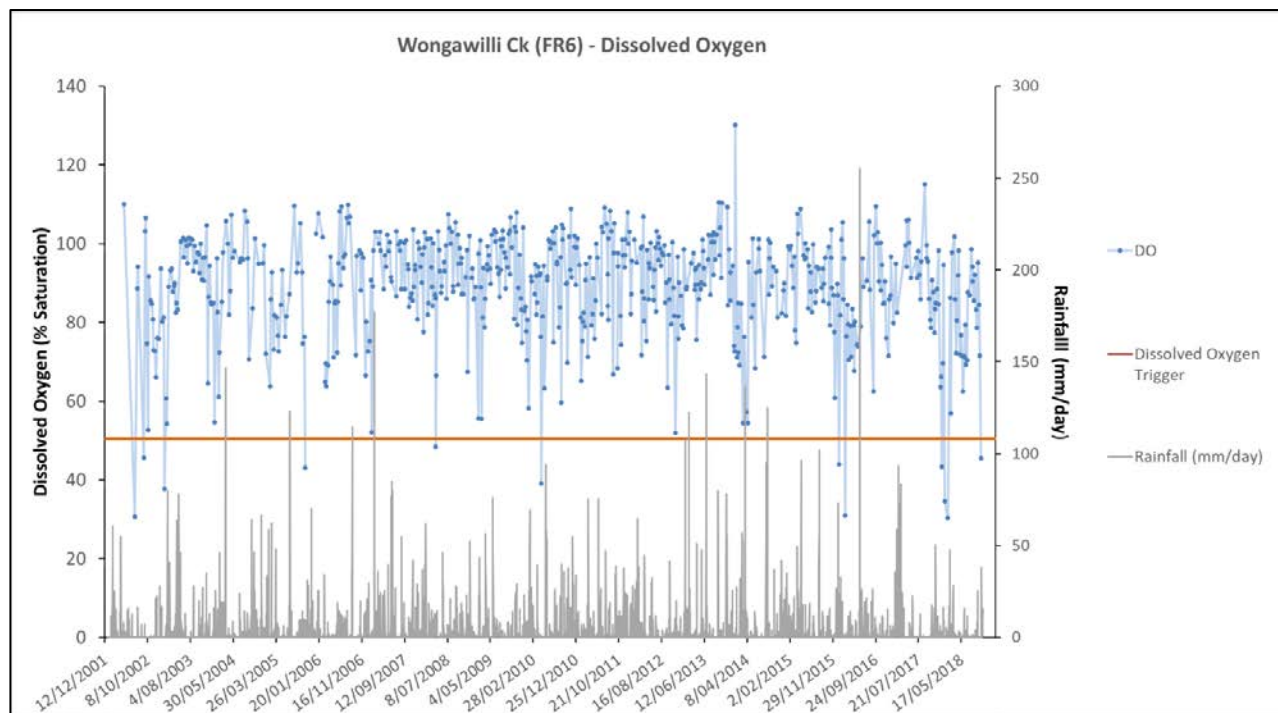
Wongawilli Ck (FR6) is a water quality monitoring site approximately 3.5km downstream from DA3B. During an inspection of Wongawilli Ck (FR6), on 3 October 2018, water quality triggers for Dissolved Oxygen (DO) and Electrical Conductivity (EC) were identified. During the inspection, a DO of 45.5 % saturation and an EC of 169 $\mu\text{S}/\text{cm}$ were recorded (Figure 9 and Figure 10). DO and EC triggers have previously been recorded during the baseline and mining periods. No surface flow was present at Wongawilli Ck (FR6) leading up to and including this inspection.

These water quality observations contribute to Level 3 Triggers according to the Dendrobium Area 3B WIMMCP:

- Three exceedances of the ± 3 standard deviation level (positive for EC, negative for pH and DO) from the baseline mean during the monitoring period:
 - pH 4.45
 - **EC 154.1 $\mu\text{S}/\text{cm}$**
 - **DO 50.5%**

Figure 9: Dissolved Oxygen recorded at site Wongawilli Ck (FR6), downstream from DA3B operations.

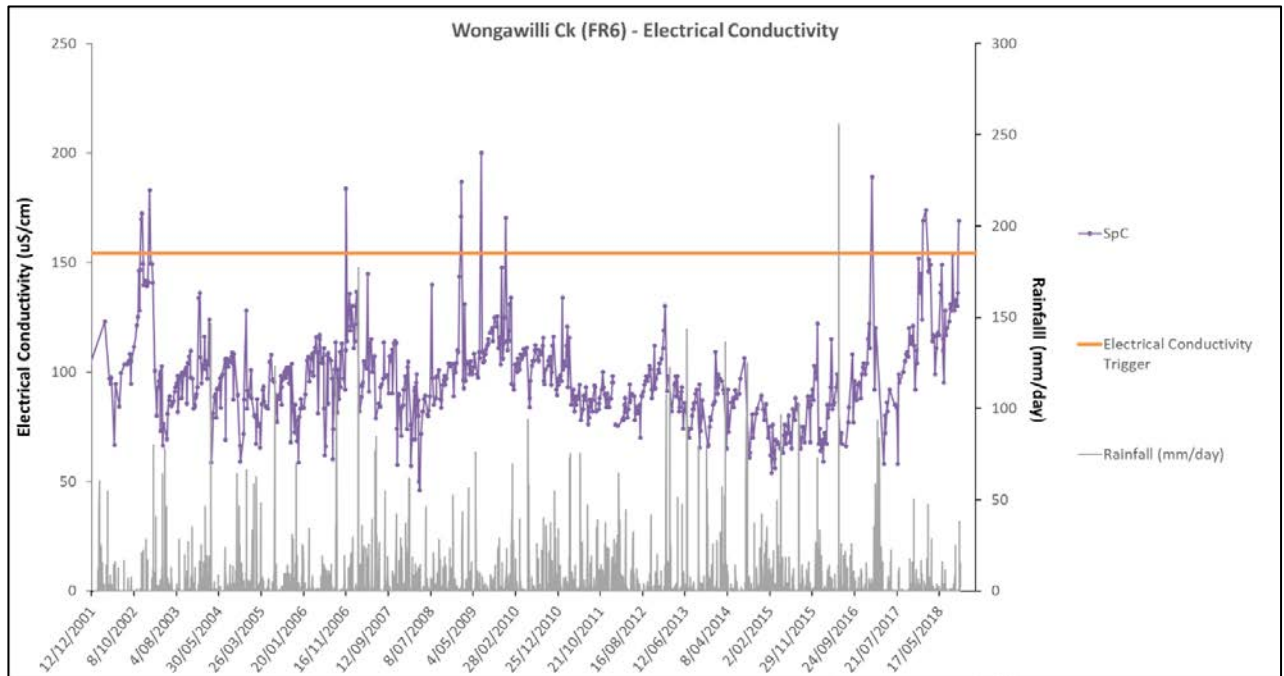
Figure 10: Electrical Conductivity recorded at site *Wongawilli Ck (FR6)*, downstream from DA3B operations.

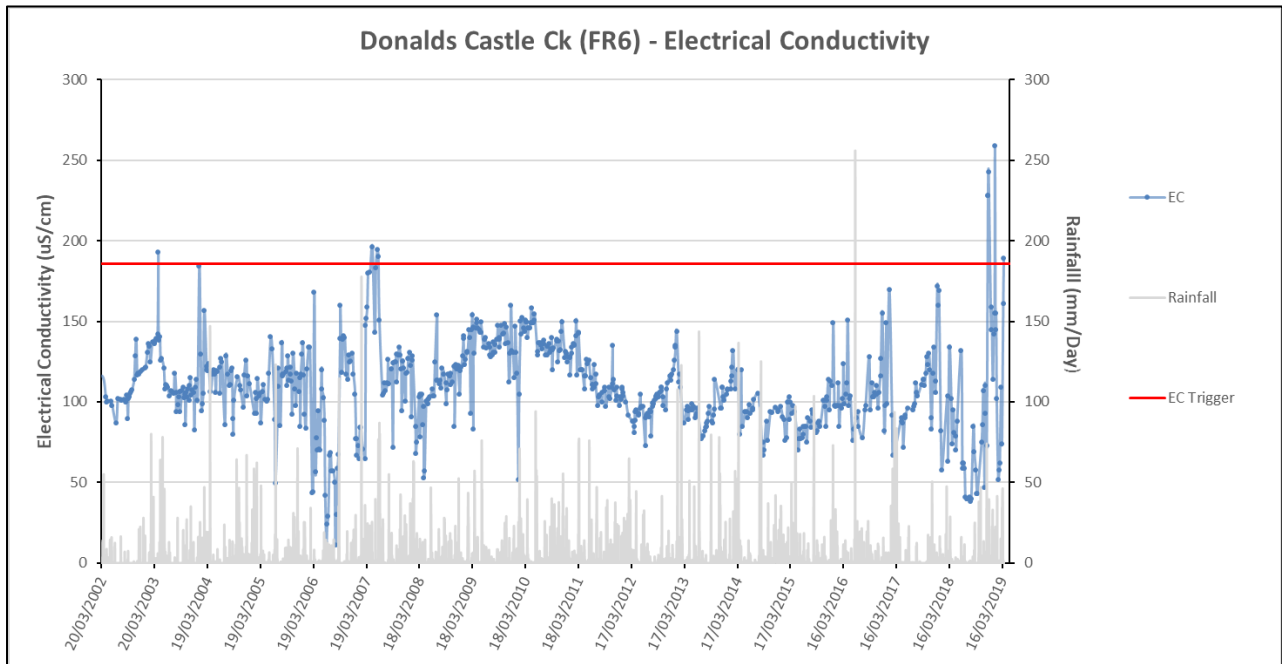
This water quality observation contributes to a Level 3 Trigger according to the Dendrobium Area 3B Watercourse Impacts, Triggers and Response Plan (Appendix A, Table 2), specifically:

- Three exceedances of the ± 3 standard deviation level (positive for EC, negative for pH and DO) from the baseline mean during the monitoring period:
 - pH <3.60
 - **EC >185.8 $\mu\text{S/cm}$**
 - DO <40.1%

Figure 11: Electrical Conductivity recorded at site *Donalds Castle Ck (FR6)*, downstream from DA3B operations.

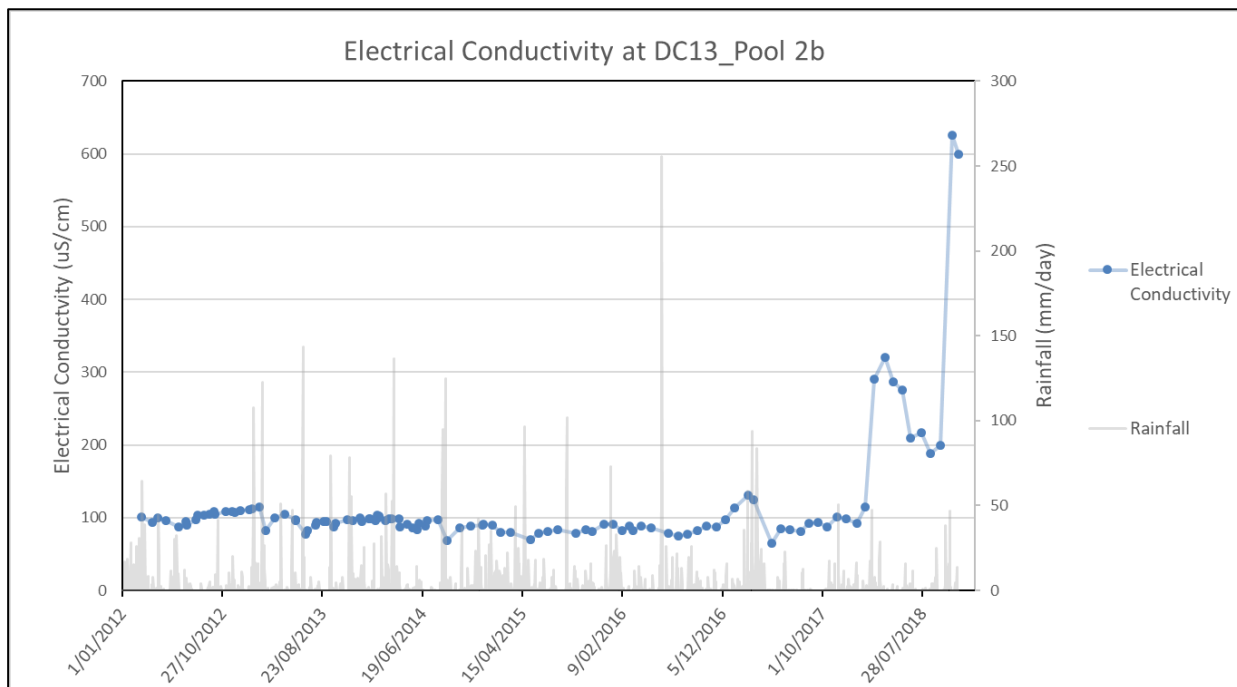
DC13_Pool 2b is a water quality monitoring site on Donald's Castle Creek tributary DC13 which is approximately 680m downstream from DA3B. During analyses of DC13 water quality data, an increase in electrical conductivity (EC) was observed at Pool 2b (Figure 12). A decrease in pH was also observed (Figure 13). The site is approximately 2.4km away from Longwall 14. The changes in field parameters don't appear to be reflected at other nearby sites. These changes will be addressed in the Surface Water and Shallow Groundwater Assessment.

Figure 12: Electrical conductivity recorded at site DC13_Pool 2b, downstream from DA3B operations.

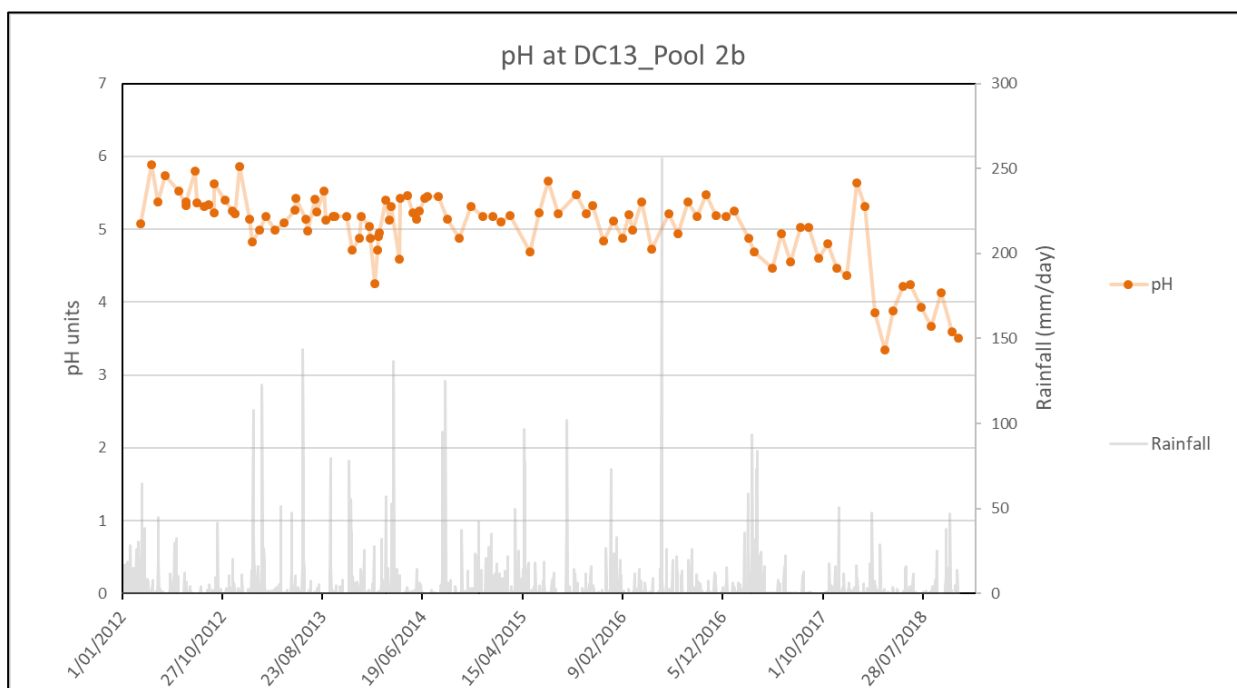
Figure 13: pH recorded at site DC13_Pool 2b, downstream from DA3B operations.

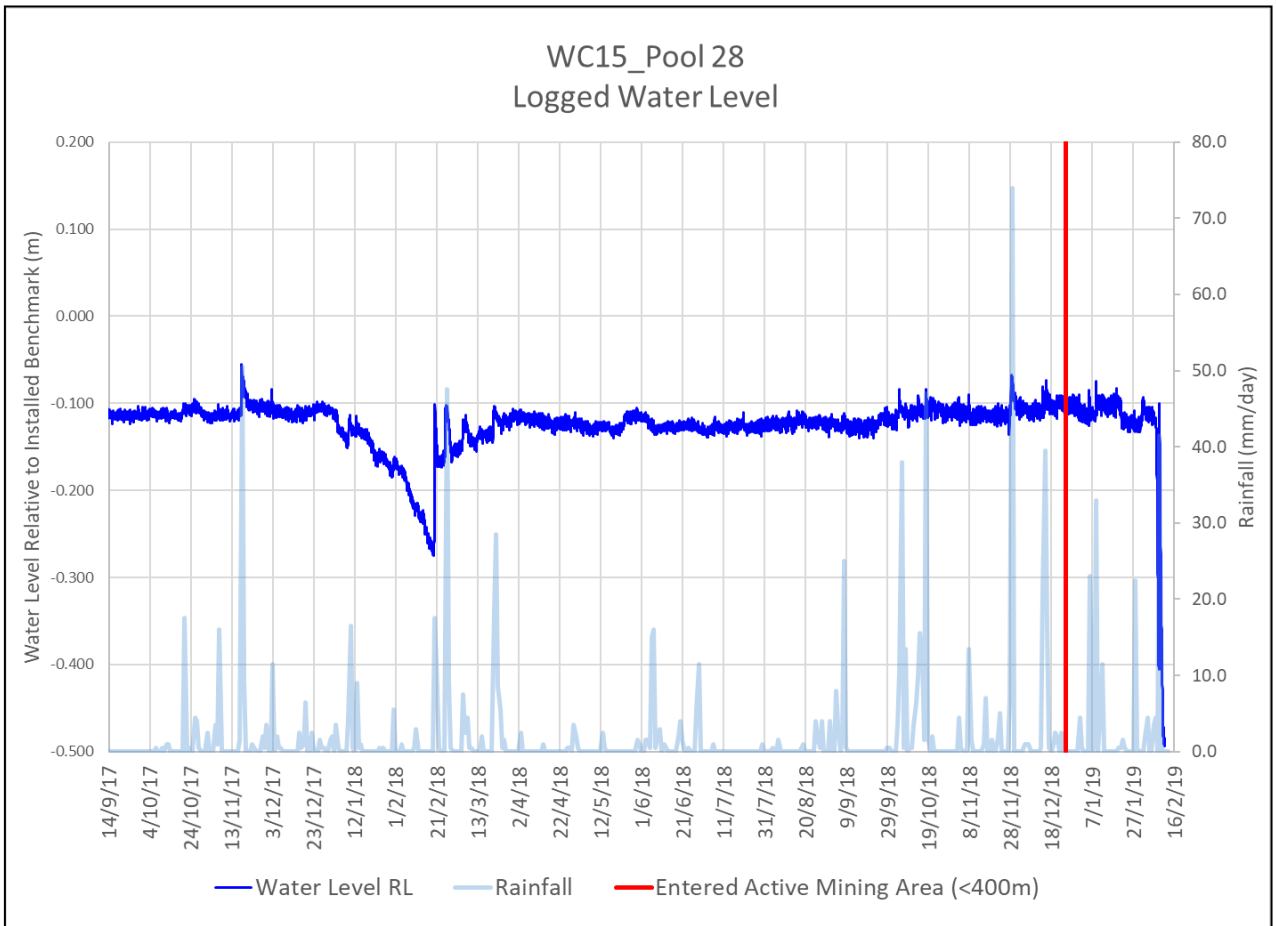
WC15_Pool 28 is located on WC15, a tributary to Wongawilli Creek. The pool is situated approximately 47m south east of Longwall 14. Recent data and observations show water levels have decreased despite rainfall events (Photo 41 to Photo 44, Figure 14). No fractures have been identified in the pool however three surface impacts to WC15 have been recorded upstream.

Figure 14: Pool water level results from logger installed at WC15_Pool 28.

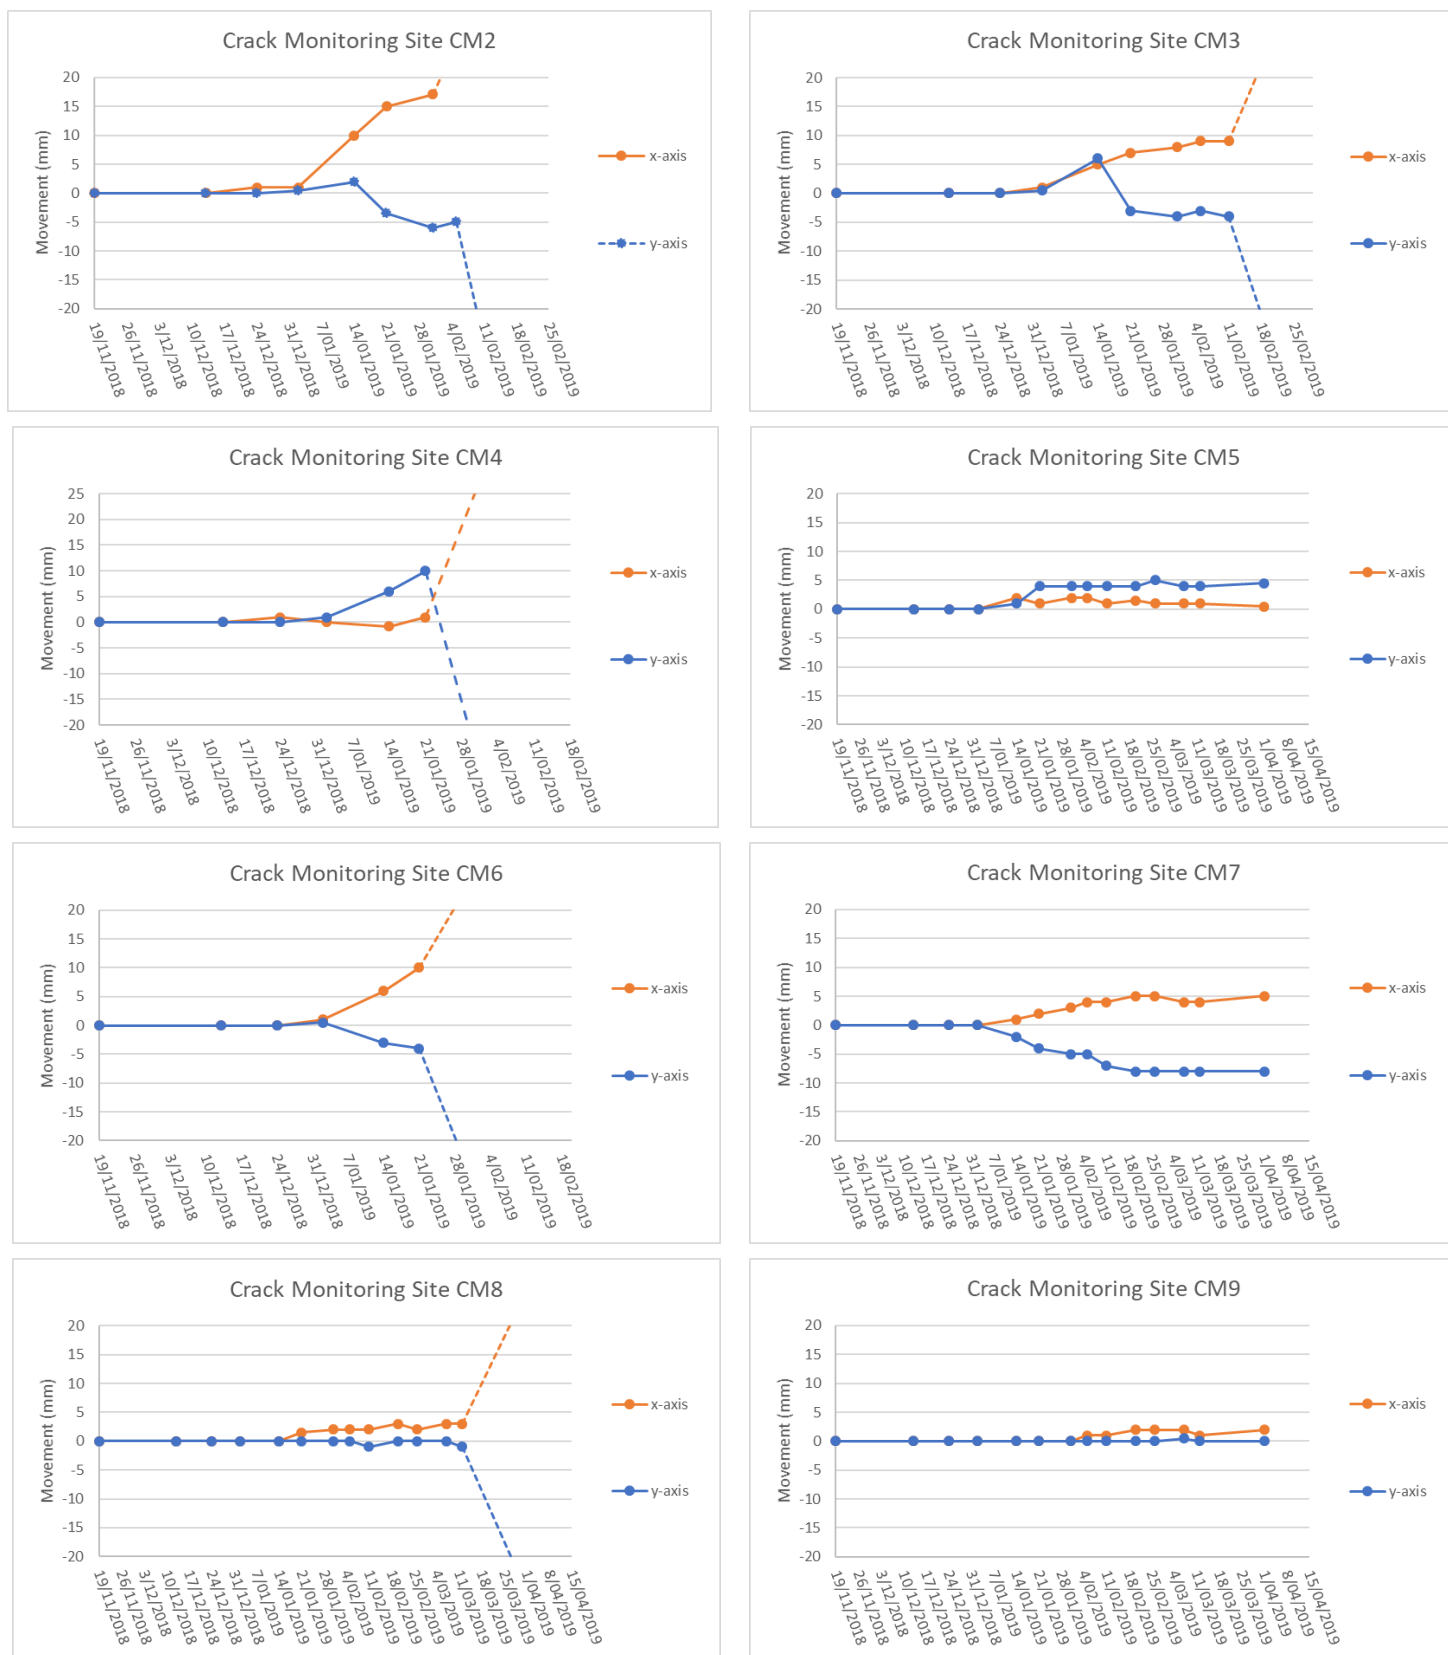
Crack monitoring devices were installed 9 November 2018 on pre-existing rock fractures resulting from Longwall 13. These devices were installed to measure the movement of fractures resulting from Longwall 14. Figure 15 outlines the movement of each fracture. Devices dislodged by subsidence movements are represented with a dotted line.

Figure 15: WC15 crack monitoring - crack movements due to Longwall 14. Dotted lines indicate movement past the measurable range.
