Monitoring of watercourses, swamps and landscape features is undertaken to identify subsidence impacts. These features are monitored by the Illawarra Coal Environmental Field Team (ICEFT) monthly prior to mining and weekly during mining. Monitoring is conducted in accordance with the approved Subsidence Management Plan (SMP) for Dendrobium Area 3B (DA3B). Extraction of Longwall 14 began on the 22nd of May 2018. During the most recent inspection, carried out on the 3rd of July, 2018, one new impact was identified.

DA3B_LW14_001 (288584 E, 6192249 N)

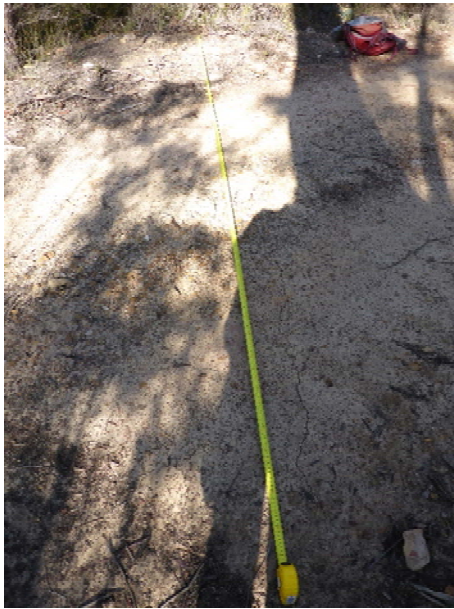
Impact DA3B_LW14_001 is located on Fire Trail 6N adjacent to Swamp 11 (Figure 1) and comprises soil cracking. The soil cracking was found to occur within an area of approximately 34m² on the Fire Trail. The largest crack is approximately 4.6m long, 0.005m wide and 0.09m at its deepest measurable point (Photo 1 and Photo 2). Impact DA3B_LW14_001 does not impede access along the track and is a Level 1 impact as per the Dendrobium Area 3B Landscape TARP (Appendix A: Table 1), specifically:

- Crack or fracture up to 10m in length and 100mm width
- Crack in a fire trail that should not result in erosion or impede access

Photo 1: Impact DA3b_LW14_001, largest crack length. Taken on 3/7/18.

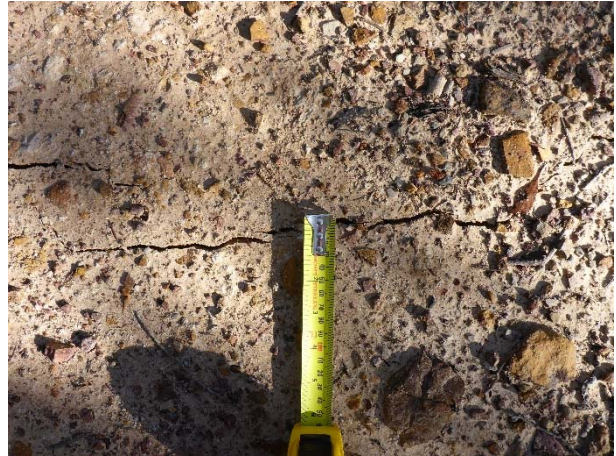
Photo 2: Impact DA3B_LW14_001, largest crack width. Taken on 3/7/18.

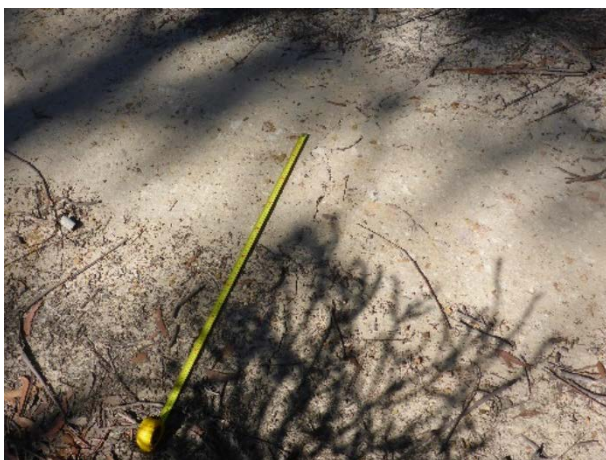
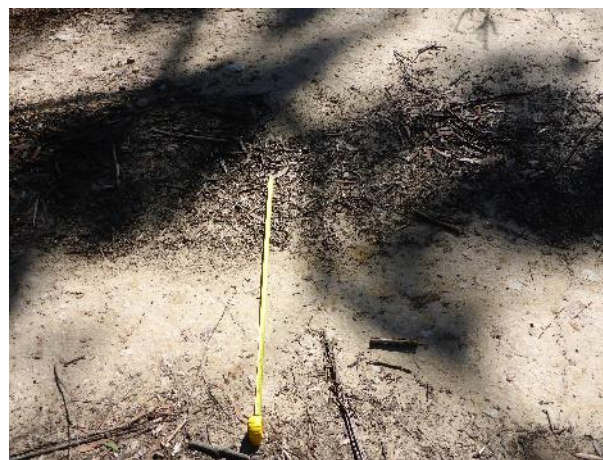
Impact DA3B_LW14_002 consists of five soil cracks along a 30m section of Fire Trail 6N adjacent to Swamp 11 (Figure 1). The largest crack is approximately 3m long, 0.01m wide and 0.01m at the deepest measurable point (Photo 1 and 2). The cracking does not impede access along the track and is a Level 1 trigger as per the Dendrobium Area 3B Landscape TARP (Appendix A: Table 1), specifically:

- Crack or fracture up to 10m in length and 100mm width
- Crack in a fire trail that should not result in erosion or impede access

Photo 1: Impact DA3b_LW14_002. Taken on 7/07/18.

Photo 2: Impact DA3B_LW14_002. Taken on 7/07/18.

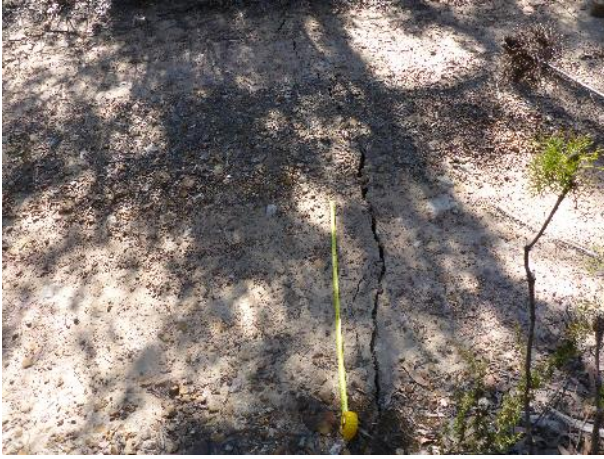
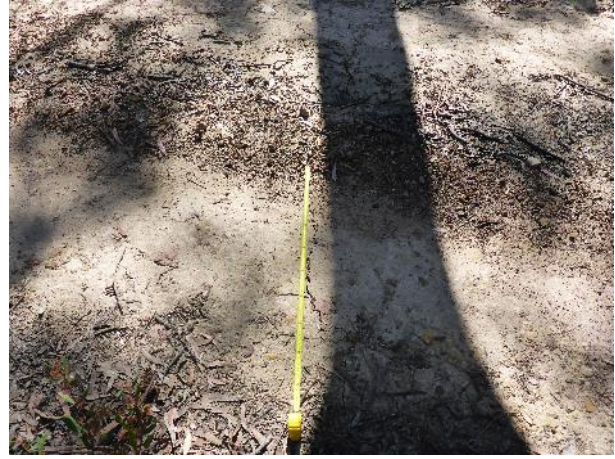
DA3B_LW14_003 (E 288849, N 6192272)

Impact DA3B_LW14_002 consists of four soil cracks along a 70m section of Fire Trail 6N adjacent to Swamp 11 (Figure 1). The largest crack is approximately 4.5m long, 0.03m wide and 0.23m at the deepest measurable point (Photo 3 and 4). The cracking does not impede access along the track and is a Level 1 trigger as per the Dendrobium Area 3B Landscape TARP (Appendix A: Table 1), specifically:

- Crack or fracture up to 10m in length and 100mm width
- Crack in a fire trail that should not result in erosion or impede access

Photo 3: Impact DA3b_LW14_003. Taken on 7/07/18.

Photo 4: Impact DA3b_LW14_003. Taken on 7/07/18.

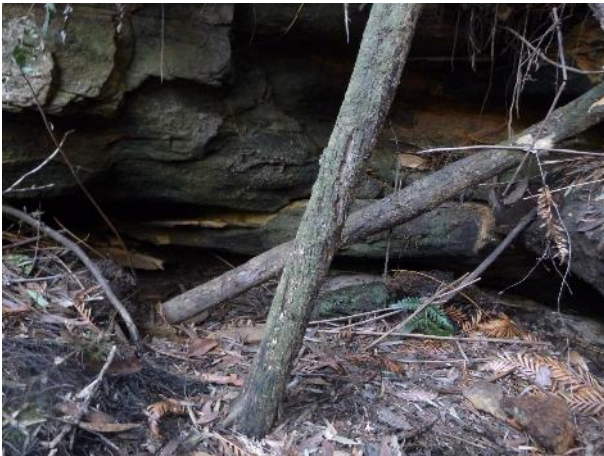
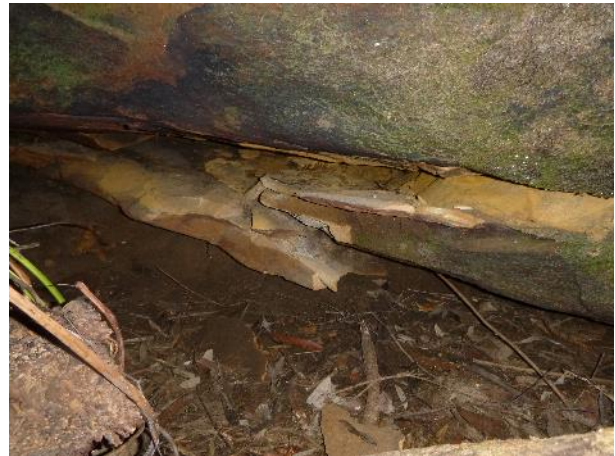
DA3B_LW13_044 (E 288180, N 6192634)

Impact DA3B_LW13_044 consists of rock fracturing to the base of a step on tributary LA4B (Figure 1). The fracturing likely occurred as a result of Longwall 13 but was only recently identified due to thick vegetation and safety concerns accessing this step during active subsidence. The fracturing has a maximum length of approximately 1.7m, with a horizontal depth of 1.05m at its deepest measurable point. The width of the fracturing is approximately 0.1m (Photo 5 and 6). The fracture has been recorded as a Level 2 trigger as per the Dendrobium Area 3B Watercourse TARP (Appendix A: Table 2), specifically:

- Crack or fracture between 100mm and 300mm width

Photo 5: Impact DA3b_LW13_044. Taken on 26/07/18.

Photo 6: Impact DA3b_LW13_044. Taken on 26/07/18.

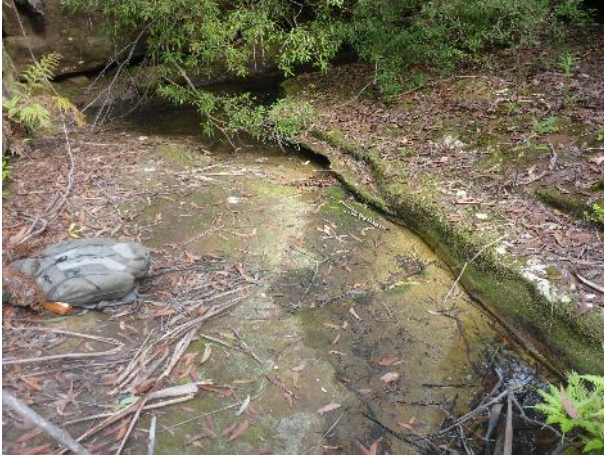
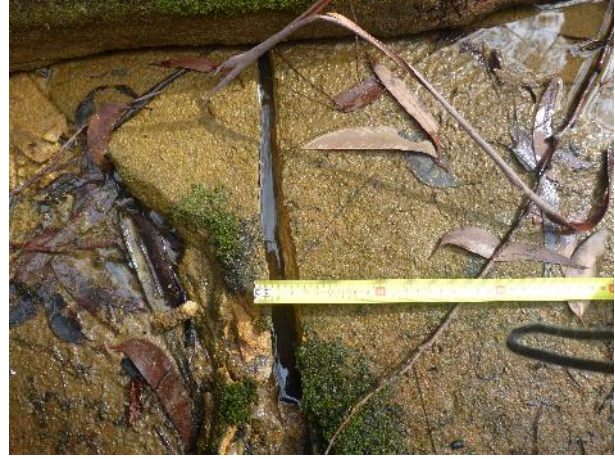
DA3B_LW13_045 (E 290819, N 6192330)

Impact DA3B_LW14_004 consists of a rock fracture across Rockbar 5 on tributary WC15 (Figure 2). The fracture is approximately 0.3m long, 0.03m wide and 0.03m at the deepest measurable point (Photo 7 and 8). No flow diversion could be observed at the site however the fracture is across the main flow path and flow diversion is possible during higher flow conditions at the site. The fracture has been recorded as a Level 2 trigger as per the Dendrobium Area 3B Watercourse TARP (Appendix A: Table 2), specifically:

- Crack or fracture that results in observable loss of surface water or erosion

Photo 7: Impact DA3b_LW13_045, site overview. Taken on 8/07/18.

Photo 8: Impact DA3b_LW13_045. Taken on 8/07/18.

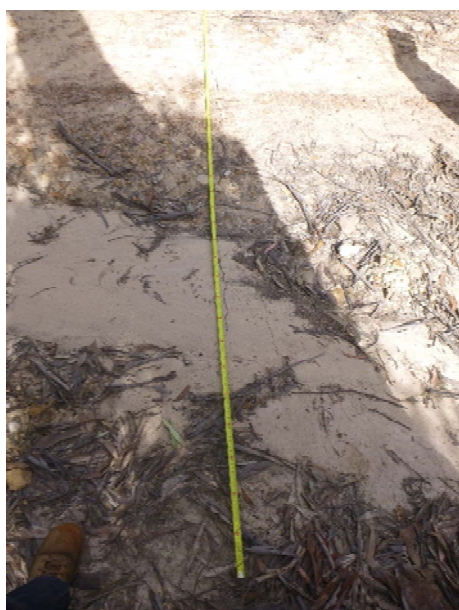
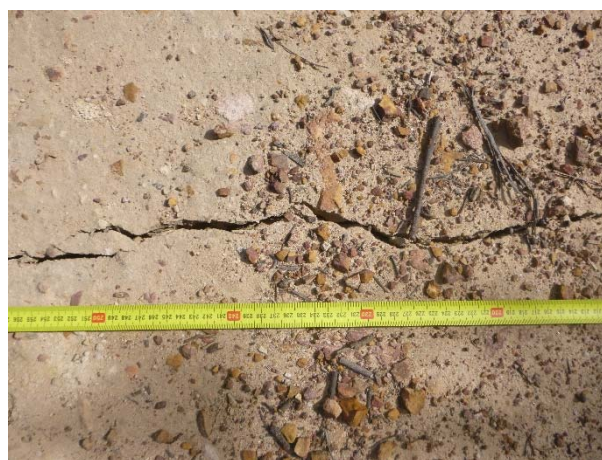
Impact DA3B_LW14_004 consists of five soil cracks along 40 m of Fire Trail 6N, adjacent to Swamp 11 (Figure 1). The largest crack is approximately 5 m long, 0.025m wide and 0.122 m at the deepest measurable point (Photo 1 and 2). The cracking does not impede access along the track and is a Level 1 trigger as per the Dendrobium Area 3B Landscape TARP (Appendix A: Table 1), specifically:

- Crack or fracture up to 10m in length and 100mm width
- Crack in a fire trail that should not result in erosion or impede access

Photo 1: Impact DA3B_LW14_004. Taken on 13/08/18.

Photo 2: Impact DA3B_LW14_004. Taken on 13/08/18.

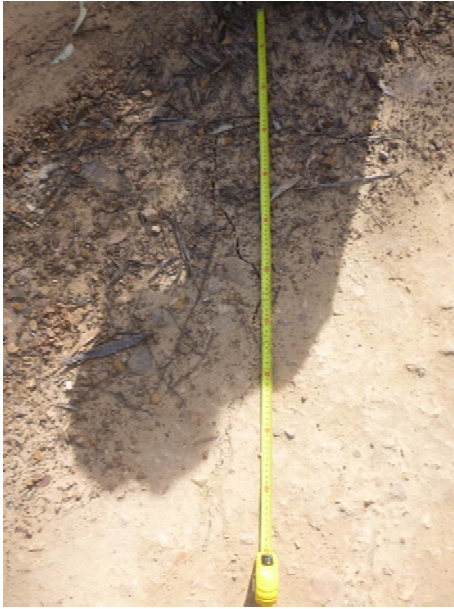
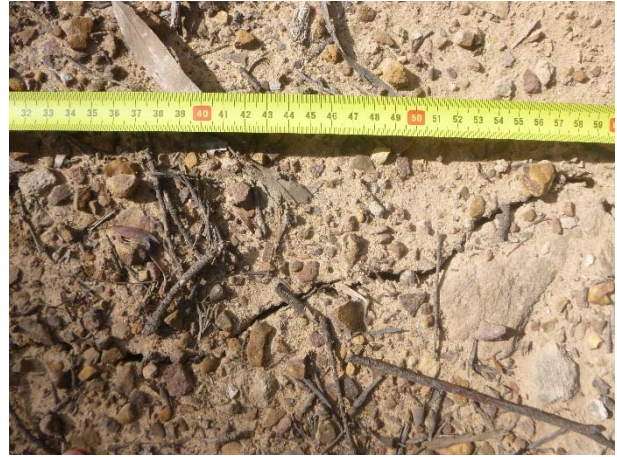
DA3B_LW14_005 (E 289060, N 6192478)

Impact DA3B_LW14_005 consists of two soil cracks along a 10 m section of Fire Road 6AA (Figure 1). The largest crack is approximately 3.3 m long, 0.007 m wide and 0.066 m at the deepest measurable point (Photo 3 and 4). The cracking does not impede access along the track and is a Level 1 trigger as per the Dendrobium Area 3B Landscape TARP (Appendix A: Table 1), specifically:

- Crack or fracture up to 10m in length and 100mm width
- Crack in a fire trail that should not result in erosion or impede access

Photo 3: Impact DA3B_LW14_005. Taken on 13/08/18.

Photo 4: Impact DA3B_LW14_005. Taken on 13/08/18.

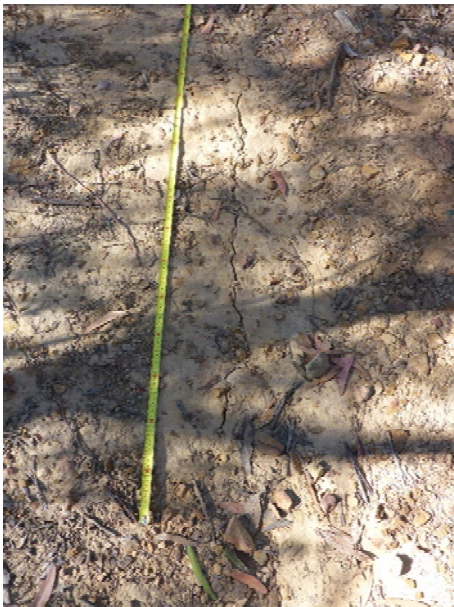
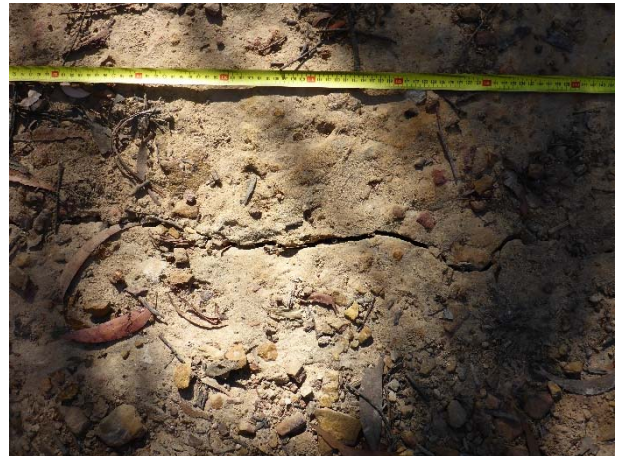
DA3B_LW14_006 (E 288908, N 6192429)

Impact DA3B_LW14_006 consists of two soil cracks along a 10 m section on a minor track adjacent to Fire Road 6A (Figure 1). The largest crack is approximately 2.1 m long and 0.01 m wide (Photo 5 and 6). The depth was not measurable. The cracking does not impede access along the track and is a Level 1 trigger as per the Dendrobium Area 3B Landscape TARP (Appendix A: Table 1), specifically:

- Crack or fracture up to 10m in length and 100mm width
- Crack in a fire trail that should not result in erosion or impede access

Photo 5: Impact DA3B_LW14_006. Taken on 19/08/18.

Photo 6: Impact DA3B_LW14_006. Taken on 19/08/18.

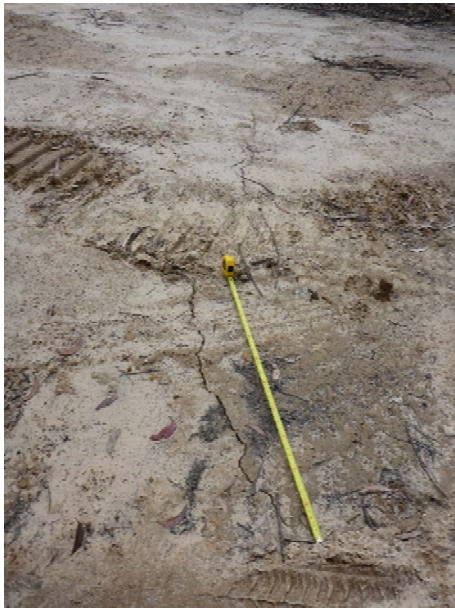
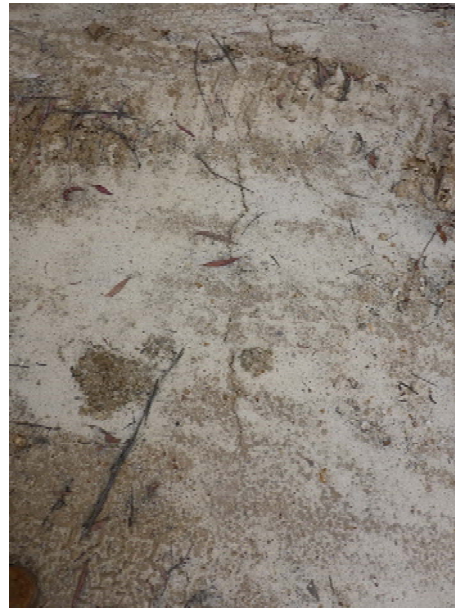
DA3B_LW14_007 (E 289061, N 6192371)

Impact DA3B_LW14_007 consists of a singular soil crack on Fire Road 6AA (Figure 1). The soil crack is approximately 3 m long, 0.01 m wide and 0.07 m at the deepest measurable point (Photo 7 and 8). The cracking does not impede access along the track and is a Level 1 trigger as per the Dendrobium Area 3B Landscape TARP (Appendix A: Table 1), specifically:

- Crack or fracture up to 10m in length and 100mm width
- Crack in a fire trail that should not result in erosion or impede access

Photo 7: Impact DA3B_LW14_007. Taken on 28/08/18.

Photo 8: Impact DA3B_LW14_007. Taken on 28/08/18.

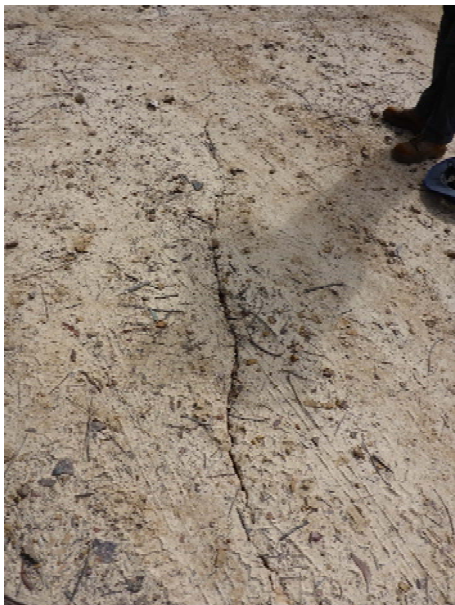
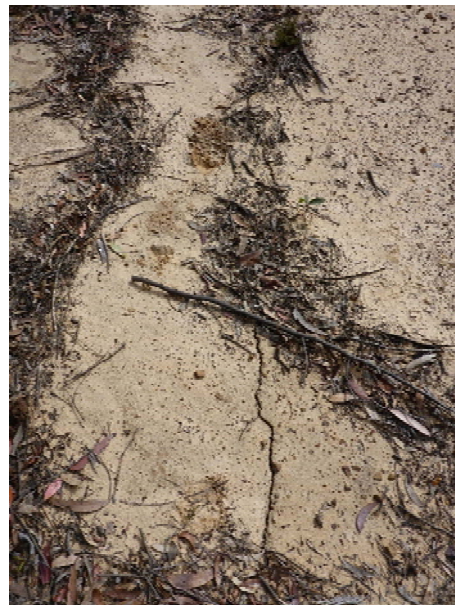
DA3B_LW14_008 (E 288998, N 6192286)

Impact DA3B_LW14_008 consists of two soil cracks along a 20 m section of Fire Road 6A at the entrance to Fire Trail 6N (Figure 1). The largest soil crack is approximately 4.5 m long, 0.02 m wide and 0.15 m at the deepest measurable point (Photo 9 and 10). The cracking does not impede access along the track and is a Level 1 trigger as per the Dendrobium Area 3B Landscape TARP (Appendix A: Table 1), specifically:

- Crack or fracture up to 10m in length and 100mm width
- Crack in a fire trail that should not result in erosion or impede access

Photo 9: Impact DA3B_LW14_008. Taken on 28/08/18.

Photo 10: Impact DA3B_LW14_008. Taken on 28/08/18.

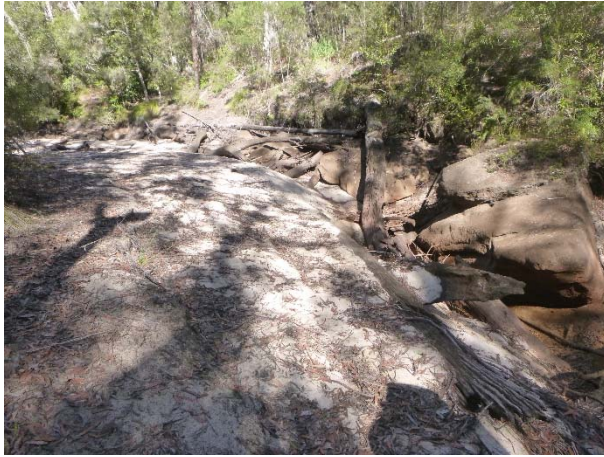
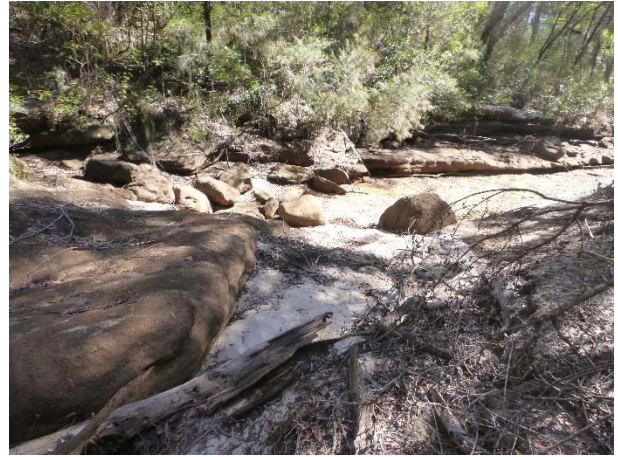
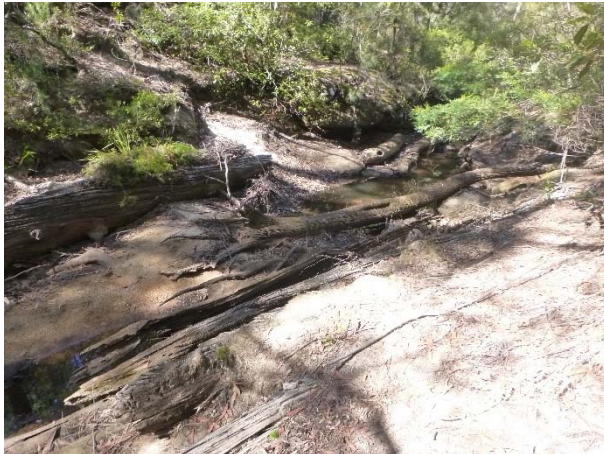
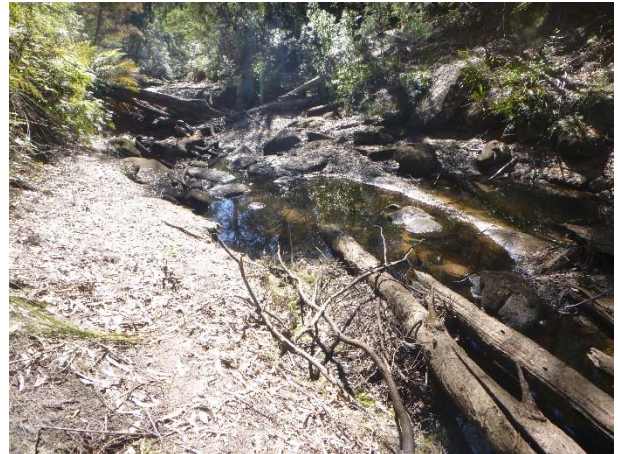
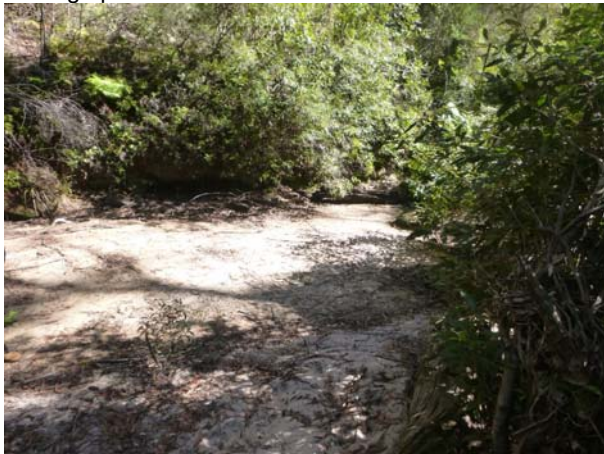
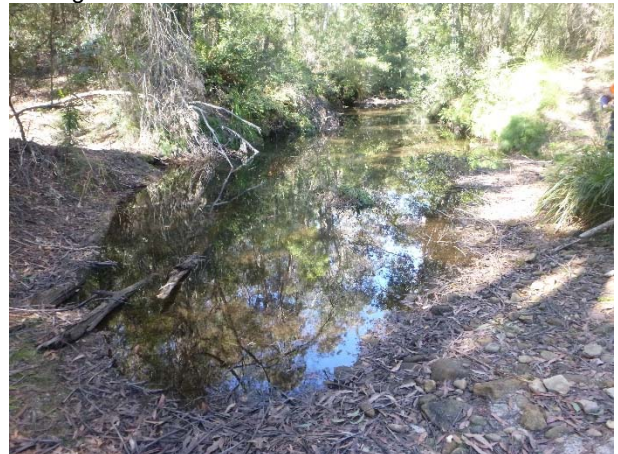
A decrease in pool water levels has been observed in Wongawilli Creek (Photo 11 to Photo 16). The length of Wongawilli Creek now displaying dry creek bed or minimal pooling is 1,543m (Figure 2).

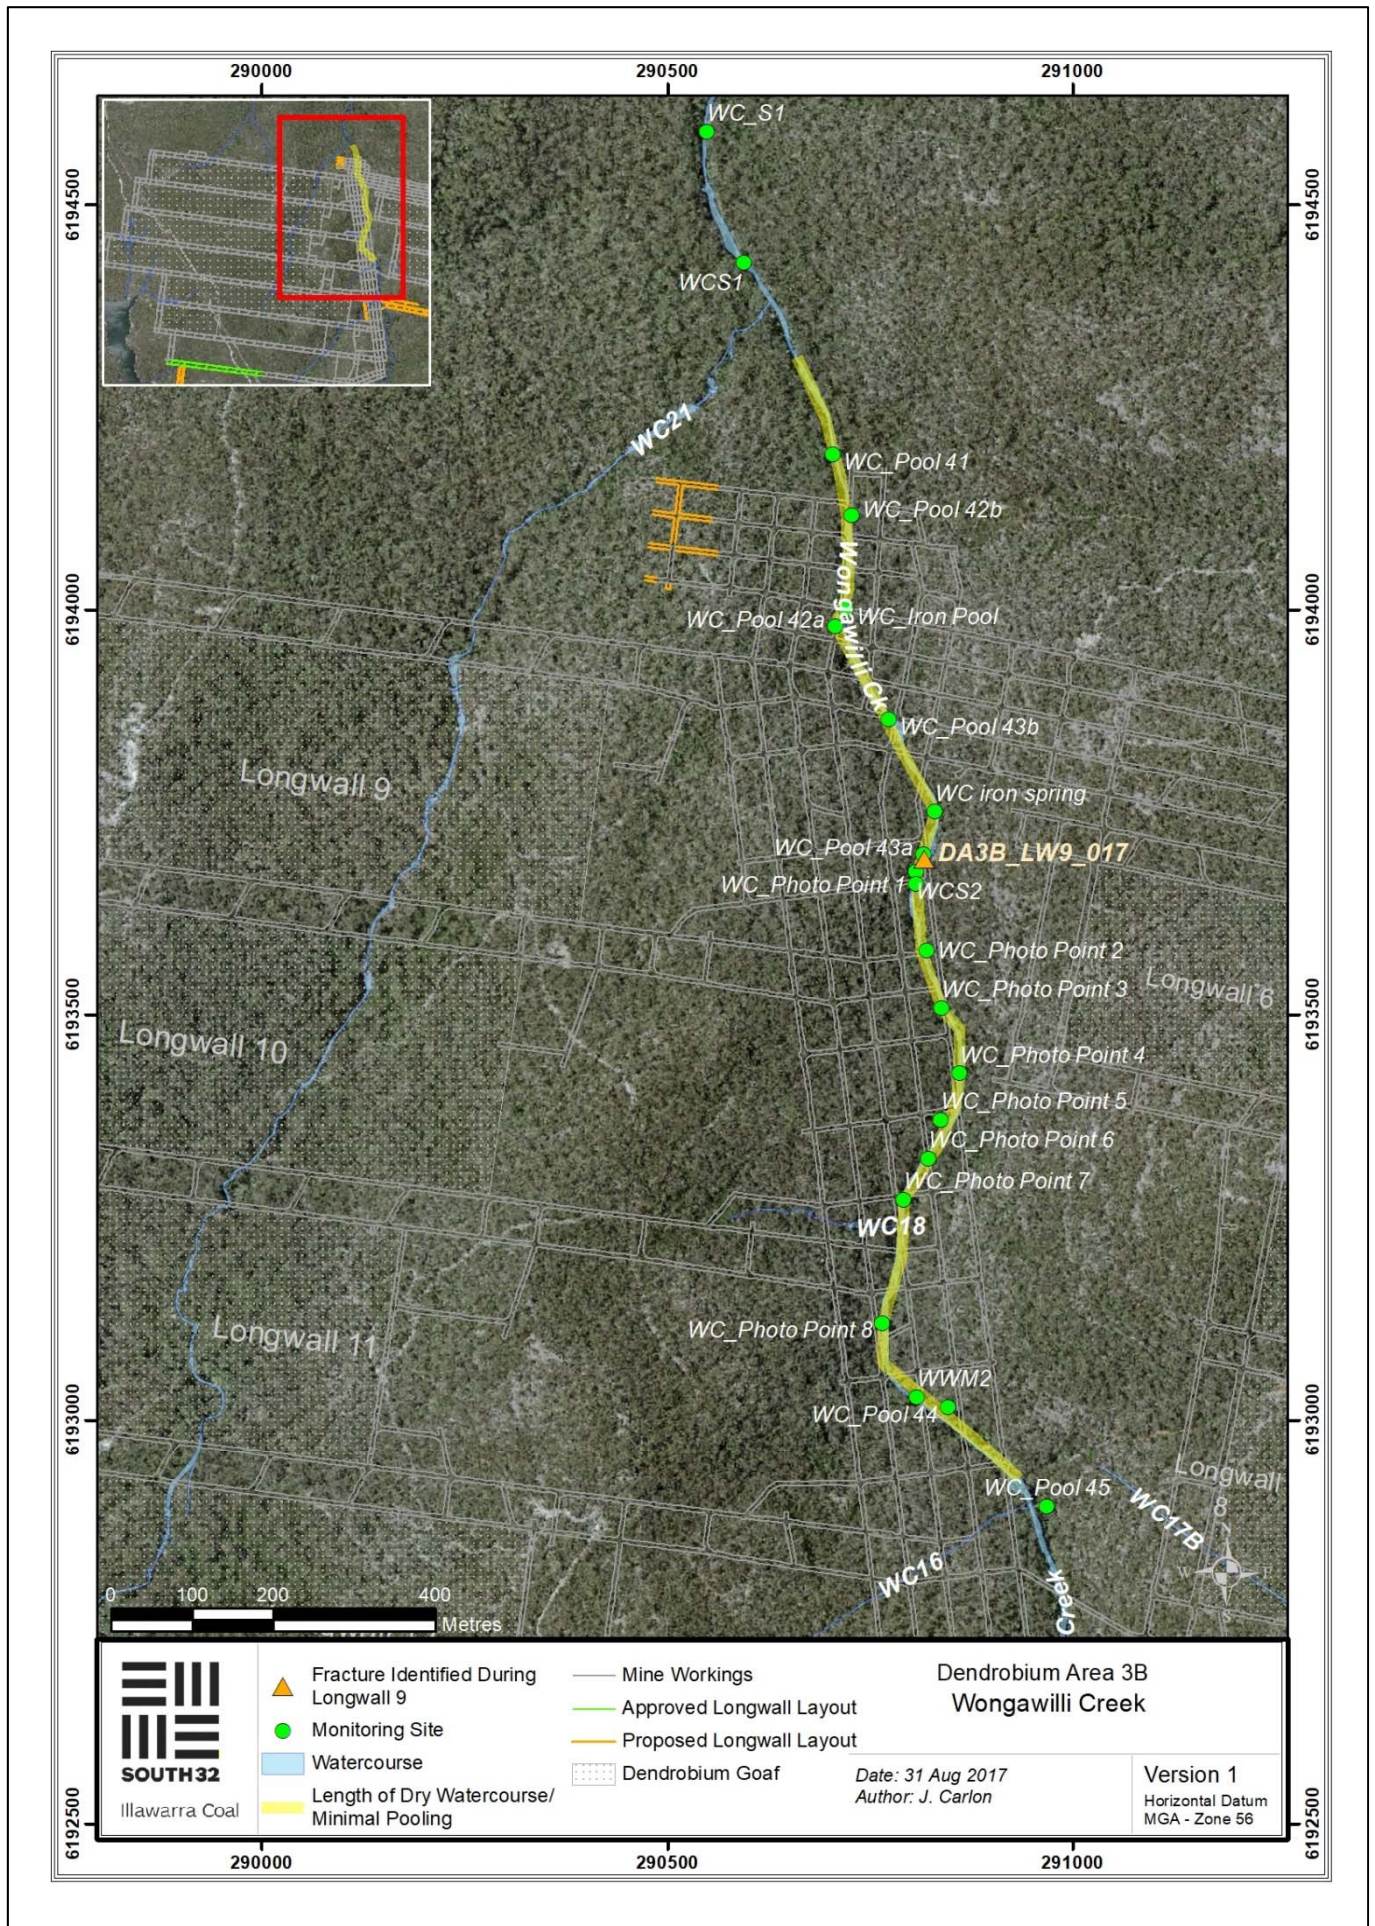
Figure 2: Length of Wongawilli Creek with observable drying and minimal pooling.

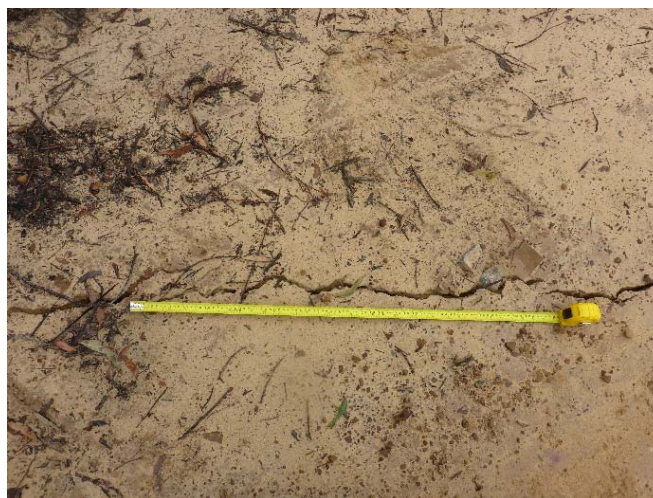
Impact DA3B_LW14_009 consists of three soil cracks along 20 m of Fire Road 6A, adjacent to the intersection with Fire Trail 6N (Figure 1). The largest continuous crack is approximately 5 m long, 0.02 m wide and 0.4 m at the deepest measurable point (Photo 1 and 2). The cracking does not impede access along the track and is a Level 1 trigger as per the Dendrobium Area 3B Landscape TARP (Appendix A: Table 1), specifically:

- Crack or fracture up to 10m in length and 100mm width
- Crack in a fire trail that should not result in erosion or impede access

Photo 2: Impact DA3B_LW14_009. Taken on 03/09/18.

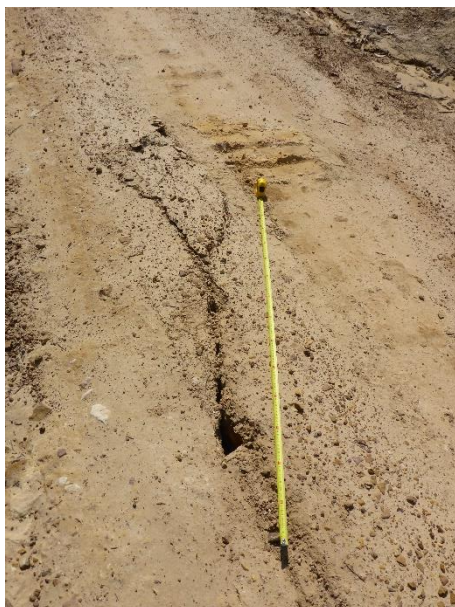
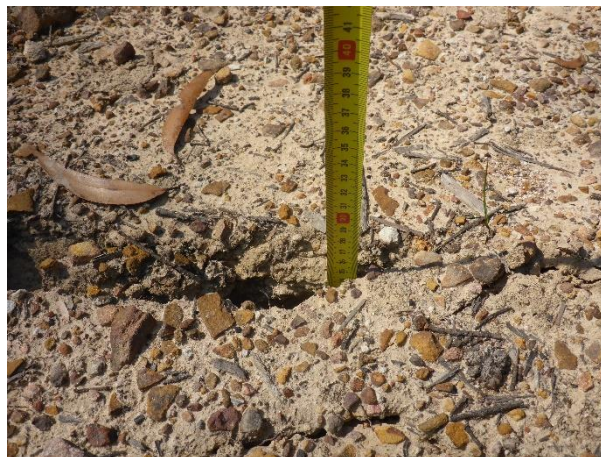
Impact DA3B_LW14_010 consists of a continuous soil crack and uplift along Fire Trail 6A (Figure 2). The crack is approximately 12m long, 0.05m wide with a maximum uplift of 0.03m and 0.26m at the deepest measurable point (Photo 1 and 2). The cracking does not impede access along the track and is a Level 2 trigger as per the Dendrobium Area 3B Landscape TARP (Appendix A: Table 1), specifically:

- Crack or fracture between 10m and 50m in length

Photo 1: Impact DA3B_LW14_010. Taken on 10/09/18.

Photo 2: Impact DA3B_LW14_010. Taken on 10/09/18.

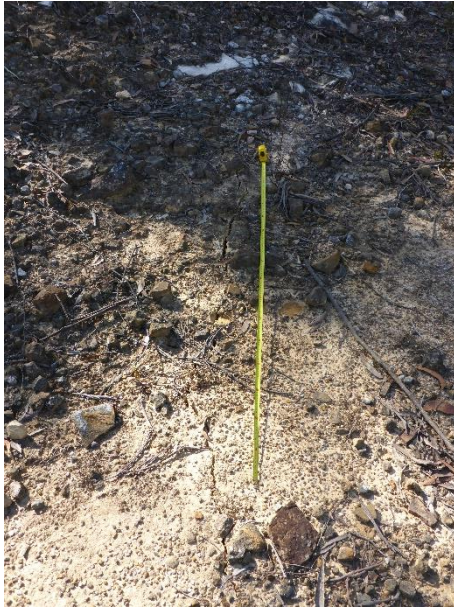
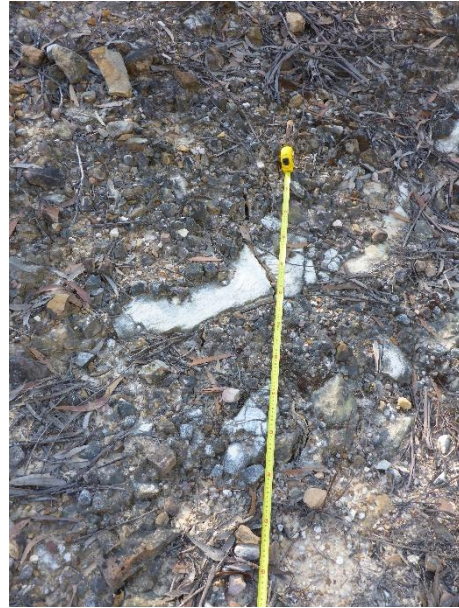
DA3B_LW14_011 (E 289065, N 6192240)

Impact DA3B_LW14_011 consists of a rock fracture with a continuous soil crack and uplift across an unused rail corridor adjacent to Fire Trail 6A (Figure 2). The combined length of the fracture and cracking is approximately 5m, with the fracture measuring approximately 0.25m. Maximum width of this impact is 0.03m and 0.1m at the deepest measurable point (Photos 3 and 4). Uplift across the rail corridor has caused a bump in the ballast approximately 0.05m high. The movement appears stable and should not result in erosion. It does

not pose a risk to vehicles and does not impede access. This impact is a Level 1 trigger as per the Dendrobium Area 3B Landscape TARP (Appendix A: Table 1), specifically:

- Crack or fracture up to 10m in length
- Surface movement or rock displacement with negligible soil surface exposed

Photo 3: Impact DA3B_LW14_011. Taken on 16/09/18.

Photo 4: Impact DA3B_LW14_011. Taken on 16/09/18.

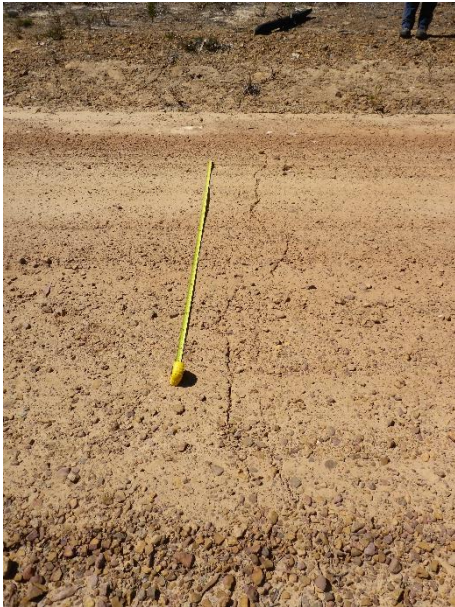
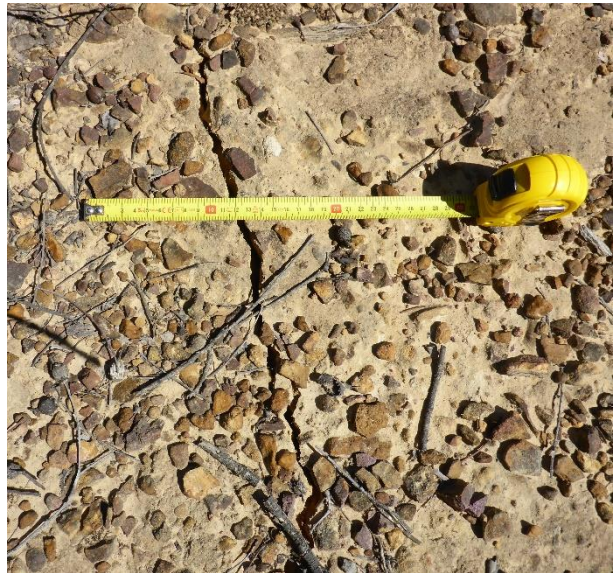
DA3B_LW14_012 (E 289062, N 6192097)

Impact DA3B_LW14_012 consists of multiple soil cracks along Fire Trail 6A (Figure 2). The cracks are within a 20m section and run perpendicular to the trail, with the longest crack measuring approximately 9m long, 0.01m wide and 0.03m deep (Photo 5 and 6). The cracking should not result in erosion and does not impede access, and are expected to self-remediate. This impact is a Level 1 trigger as per the Dendrobium Area 3B Landscape TARP (Appendix A: Table 1), specifically:

- Crack or fracture up to 10m in length
- Crack in a fire trail which should not result in erosion or impede access

Photo 5: Impact DA3B_LW14_012. Taken on 16/09/18.

Photo 6: Impact DA3B_LW14_012. Taken on 16/09/18.

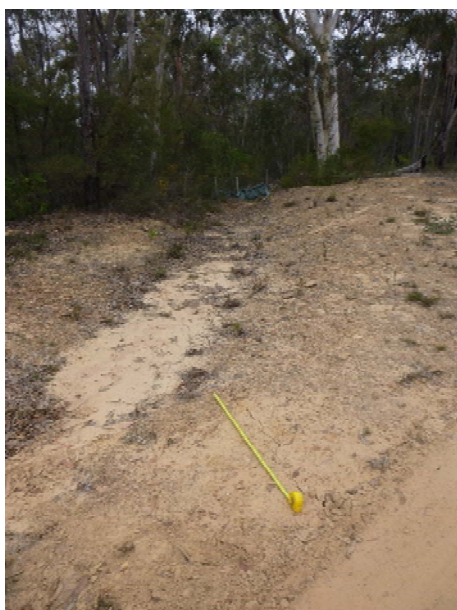
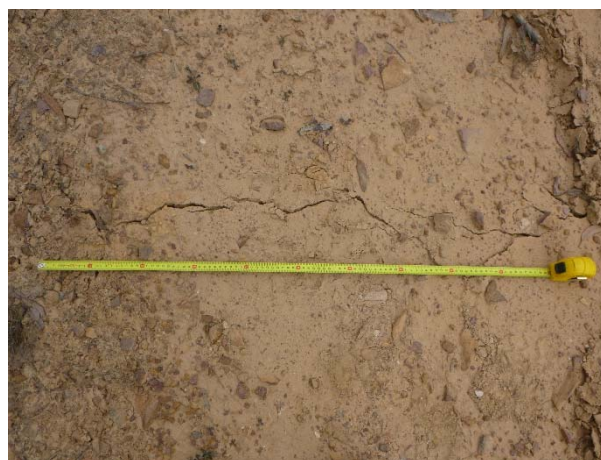
Impact DA3B_LW14_013 consists of a continuous soil crack along, and perpendicular to Fire Trail 6A (Figure 1). The crack is approximately 14m long, 0.01m wide and 0.05m deep at the deepest measurable point (Photo 1 and 2). The cracking does not impede access and is expected to self-remediate. This impact is a Level 2 trigger as per the Dendrobium Area 3B Landscape TARP (Appendix A: Table 1), specifically:

- Crack or fracture between 10m and 50m in length

Photo 1: Impact DA3B_LW14_013. Taken on 26/09/18.

Photo 2: Impact DA3B_LW14_013. Taken on 26/09/18.

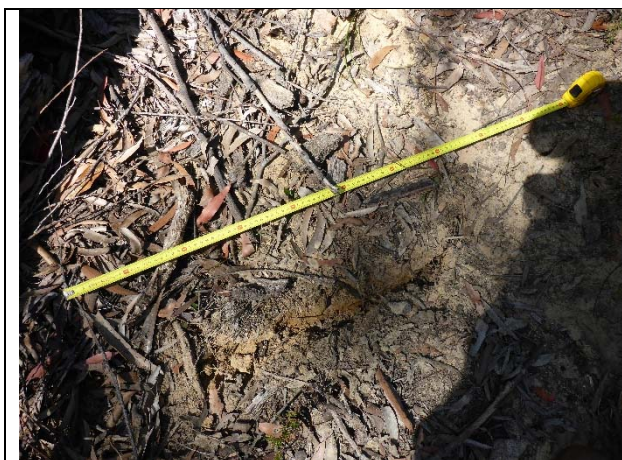
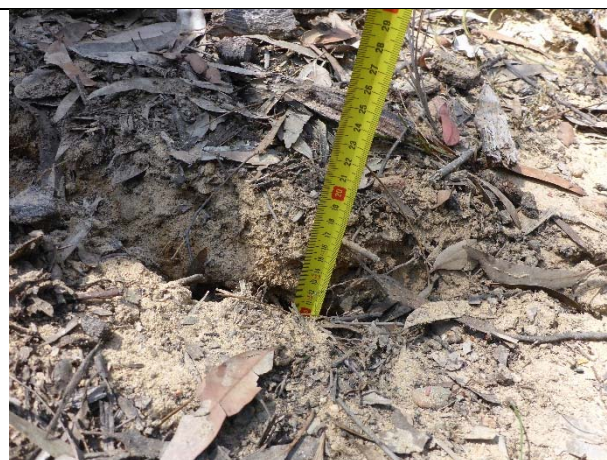
During the latest inspection of the surface over Longwall 14 a soil crack was identified on an access track (Photo 1 and 2). The crack is approximately 1.1m long, 0.06m wide and 0.15m deep. The crack does not pose a risk to safety or serviceability of the track and will likely self-remediate. No additional actions are recommended.

This impact is a Level 1 trigger according to the DA3B Landscape Impact Monitoring, Management and Contingency Plan, specifically:

- Crack or fracture up to 100mm width
- Crack or fracture up to 10m length

Photo 1: Impact DA3B_LW14_014, soil cracking. Taken on 13/11/2018.

Photo 2: Impact DA3B_LW14_014, soil cracking. Taken on 13/11/2018.

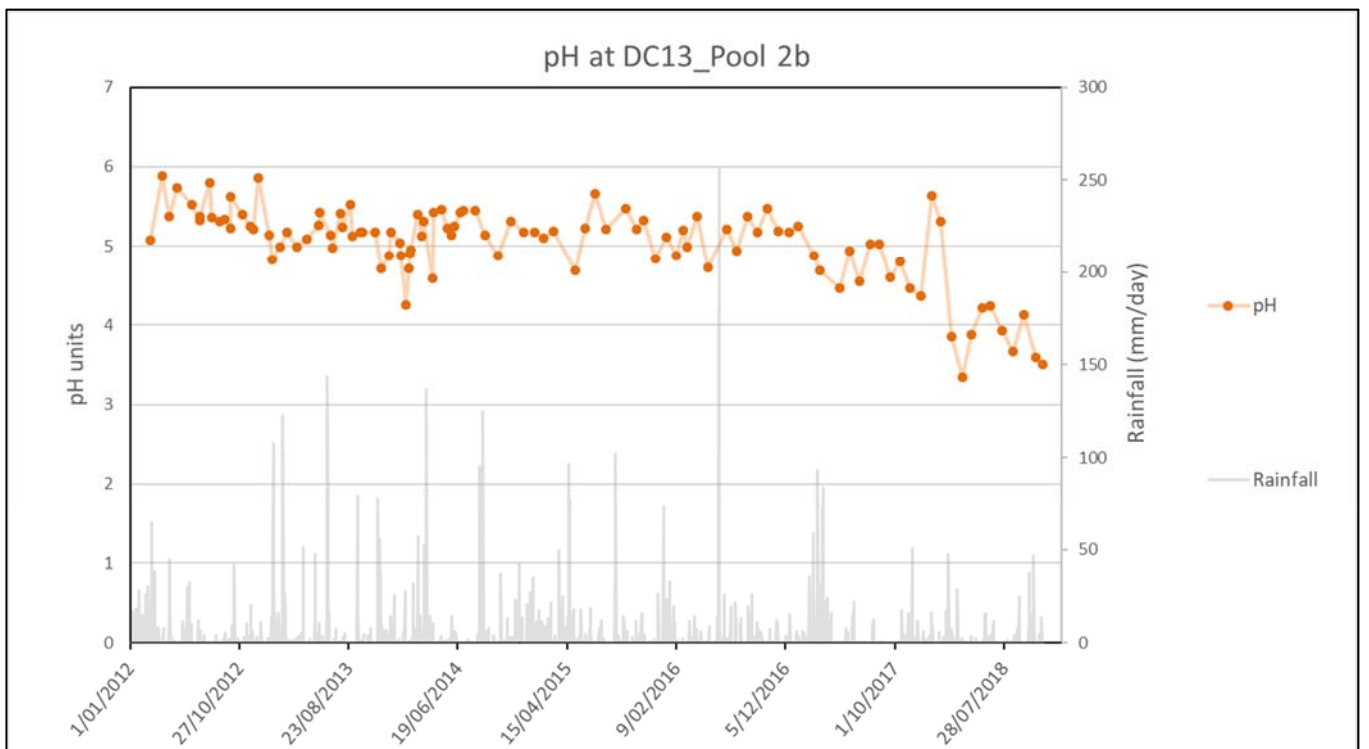
DC13_Pool 2b is a water quality monitoring site on tributary DC13, approximately 680m downstream from DA3B (Figure 1, inset). During recent inspections of DC13, an increase in electrical conductivity (EC) has been observed at Pool 2b (Graph 1). A drop in pH has also been observed (Graph 2). During the latest inspection an EC of 599 $\mu\text{S}/\text{cm}$ and pH of 3.51 was recorded at the site. On the latest inspection no surface flow was observed entering Pool 2b however it is probable that subsurface flow is entering from the boulderfield directly upstream.

Graph 2: pH recorded at site *DC13_Pool 2b*, downstream from DA3B operations.

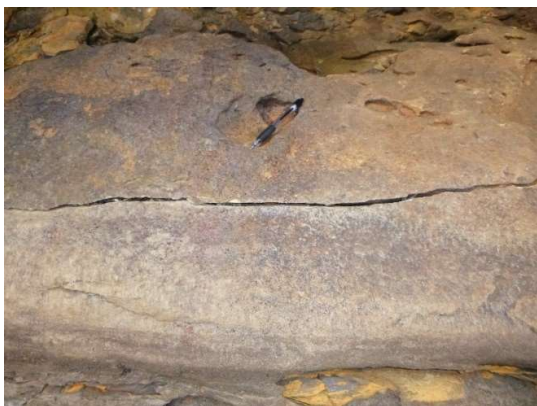
Impact DA3B_LW13_043 is located on LA4, a tributary to Lake Avon, 300 m from the commencing end of Longwall 13 and 300 m from the southern edge of Longwall 12 (**Figure**). The impact is comprised of rock fracturing at LA4_Step 0 (**Photos 1 to 3**), which is the most downstream feature before entering Lake Avon. Lowering lake water levels has enabled recent access to areas that were previously under water. Additional rock fracturing was observed during the latest inspection. The additional fracturing has a maximum length of 1.5m and a maximum width of 0.01m. An increase of iron staining was also identified during this inspection (**Photo 4**).

DA3B_LW13_043 is a Level 2 trigger as per the Dendrobium Area 3B Watercourse TARP (**Appendix A: Table 1**), specifically:

- Crack or fracture that results in observable loss of surface water or erosion
- Observable increase in iron staining within the mining area continues to outside the mining area.

Photo 1: DA3B_LW13_043, looking at a section of rock fracturing. Taken on 6 December 2018.

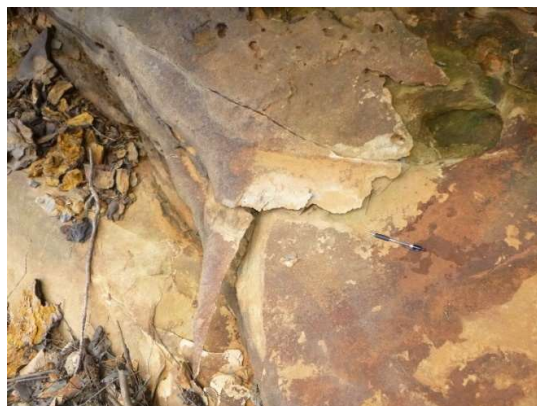
Photo 2: DA3B_LW13_043, looking at a section of rock fracturing and uplift. Taken on 6 December 2018.

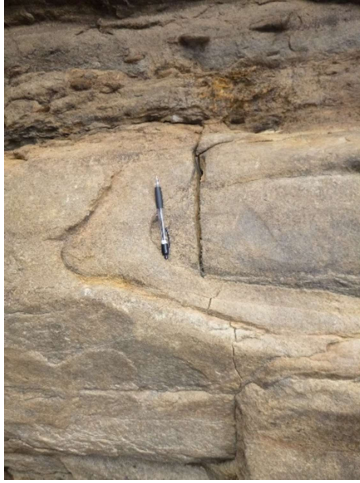
Photo 3: DA3B_LW13_043, looking at a section of rock fracturing.. Taken on 6 December 2018.

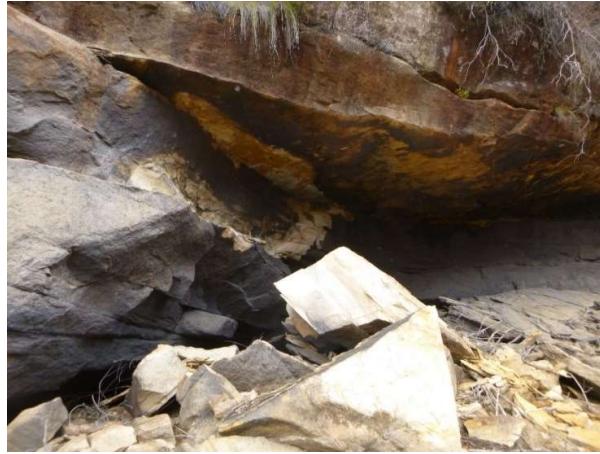
Impact DA3B_LW14_015 is located on the cliff line edge of Lake Avon, approximately 350 m from the commencing end of Longwall 13 and Longwall 14, and 330 m from the southern edge of Longwall 12 (**Figure**). The impact is comprised of two distinct rock fractures and a rock fall (**Photo 5 and Photo 6**). The rock fracturing has a maximum length of 1.8m, a maximum width of 0.01m and a maximum measurable depth of 0.29m. The rock fall is approximately 4m x 1.5m x 0.5m. It is probable that the impact occurred during the extraction of Longwall 13 (**Figure 1**) Previously, the site has been inundated by lake water, which prevented observation of the impact.

Photo 6: DA3B_LW14_015, looking at the rockfall. Taken on 6 December 2018.

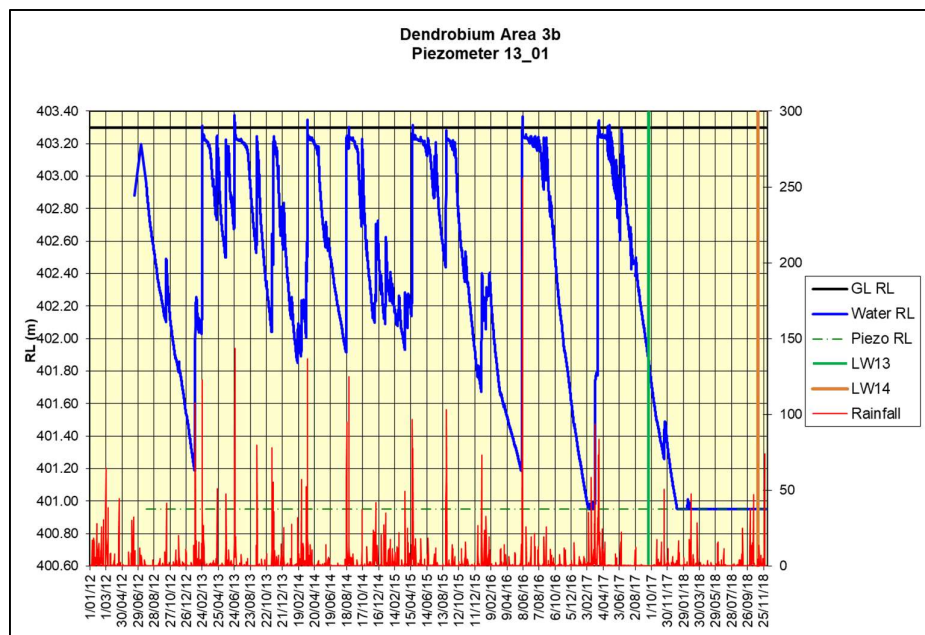
During recent analysis of shallow groundwater levels for borehole 13_01 (**Figure 1**), changes to the typical rainfall response were observed (**Graph 1**). A piezometer and logger were installed at the site in June 2012. The site was passed by Longwall 13 on the 21st September 2017 and mined beneath by Longwall 14 on the 4th November 2018 (**Graph 1**). The lowest recorded baseline water level was RL 400.95 m, which corresponds to water levels below the piezometer, however groundwater levels typically increased following rainfall events during the baseline period (**Graph 1**). Following Longwall 14 passing beneath the site, groundwater levels have not responded to rainfall events to date.

Groundwater levels at 13_01 contribute to a Level 3 trigger according to the Dendrobium Swamps Impacts, Triggers and Response (**Appendix A, Table 3**), specifically:

- Groundwater level lower than baseline level at >80% of monitoring sites* (within 400m of mining) within a swamp (in comparison to reference swamps) *Note- there is one shallow groundwater site in Swamp 13, hence the >80% trigger.

Graph 1: Shallow groundwater levels at 13_01, logged hourly interval

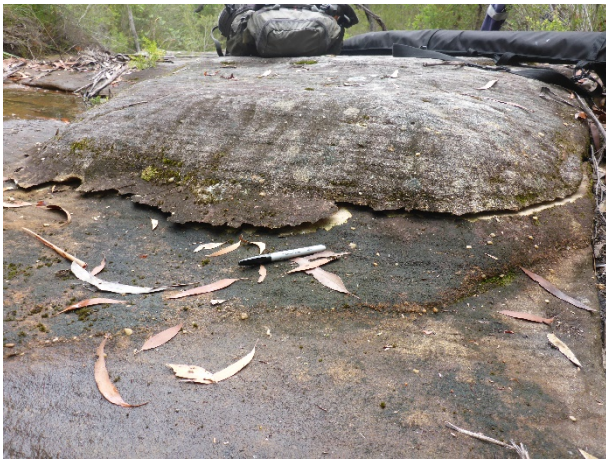
Impact DA3B_LW13_035 is located on WC15_Rockbar 21 and was originally identified during Longwall 13 (Figure 1). Additional fracturing with flow diversion was observed on the latest inspection (Photo 1 to 5). The largest fracture is up to 3.7m long, with the widest fracture up to 0.02m wide. Uplifted sections of rock are associated with the fracturing.

DA3B_LW13_035 is now a Level 2 trigger as per the Dendrobium Area 3B Watercourse TARP (Appendix A: Table 1), specifically:

Photo 1: Circular fracture and uplift on rockbar. Taken on 21/01/2019.

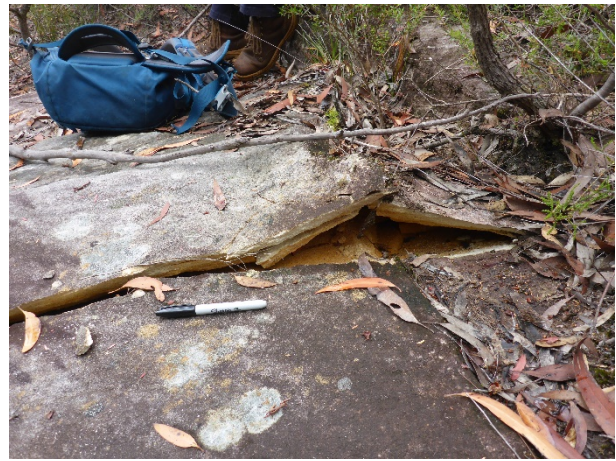
Photo 2: Fracturing and uplift on rockbar. Taken on 21/01/2019.

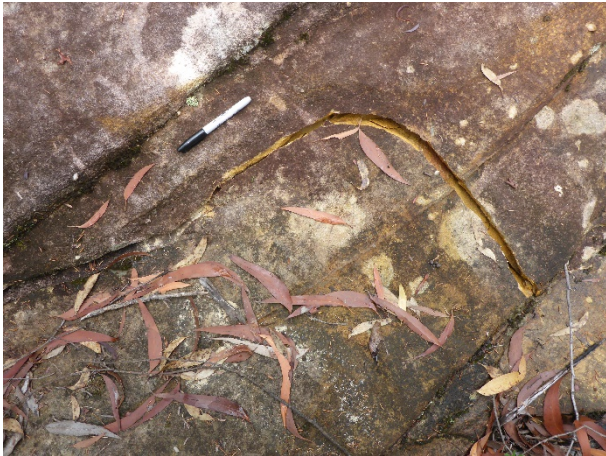
Photo 3: Fracturing to rockbar. Taken on 21/01/2019.

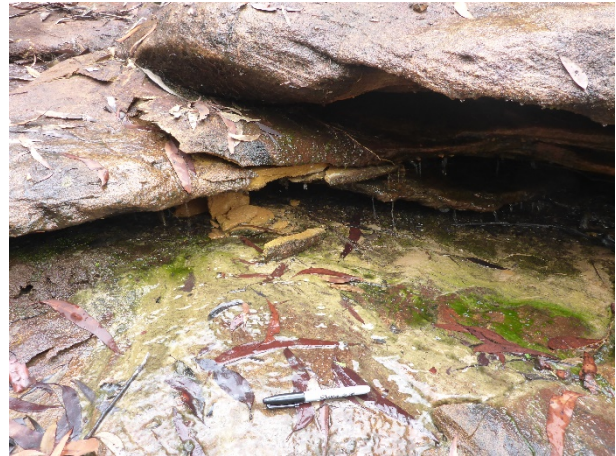
Photo 4: Fracturing with flow diversion across small step on rockbar. Taken on 21/01/2019.

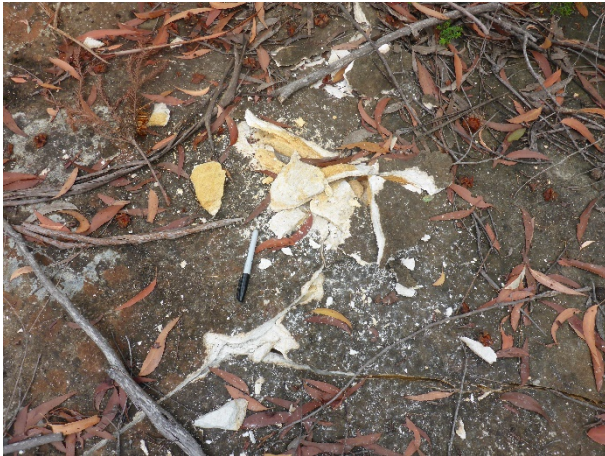
Impact DA3B_LW14_016 is located on WC15_Rockbar 25 and Step 25 (Figure 1). The impact consists of multiple fractures, uplift and dislodged sections of rock (Photo 6 to 11). The longest fracture is up to 4.0m long and 0.03m wide. Surface flow diversion was recorded at the site during baseline mapping on WC15. While there was no active flow diversion observed through fractures, it is likely diversion would occur during higher flow conditions.

Photo 8: Fracturing and uplift on rockbar. Taken on 21/01/2019.

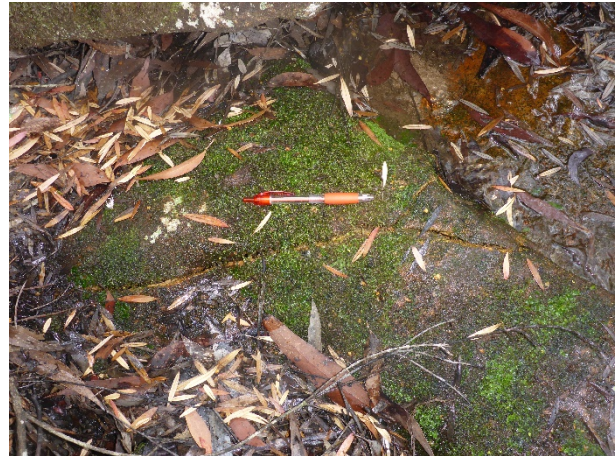
Photo 9: Fracturing at base of step. Taken on 21/01/2019.

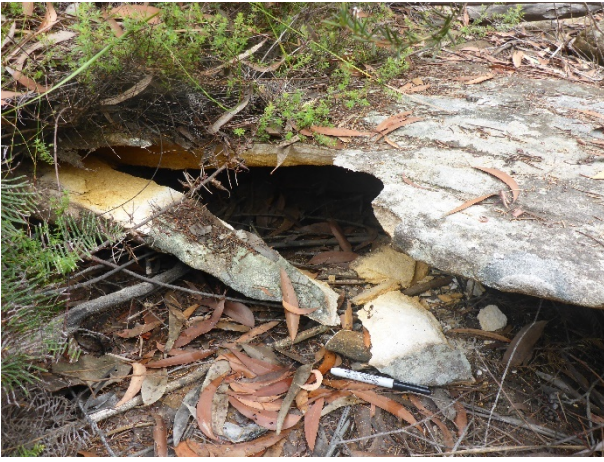
Photo 10: Fracturing and dislodged rock segment to incised step. Taken on 21/01/2019.
