Monitoring of watercourses, swamps and landscape features is undertaken to identify subsidence impacts. These features are monitored by the Illawarra Coal Environmental Field Team (ICEFT) monthly prior to mining and weekly during mining. Monitoring is conducted in accordance with the approved Subsidence Management Plan (SMP) for Dendrobium Area 3B (DA3B). Extraction of Longwall 14 began on the 22nd of May 2018. During the most recent inspection, carried out on the 3rd of July, 2018, one new impact was identified.

DA3B_LW14_001 (288584 E, 6192249 N)

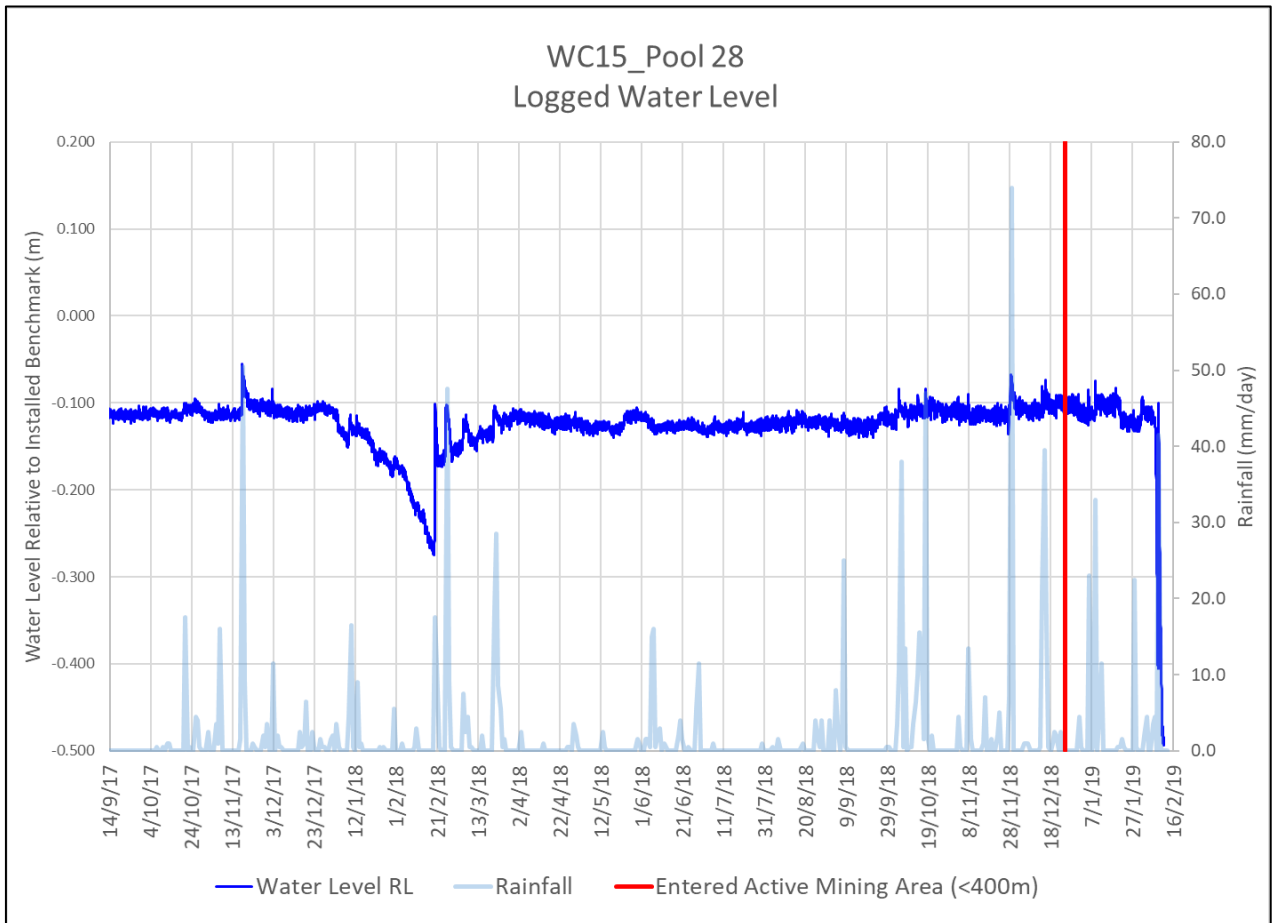
The fracturing is located approximately 30m downstream from monitoring site WC15_Pool 28. The site had a water level logger installed in 2017. Pool water levels at the site to date do not appear to be affected by subsidence movements (Graph 1).

Graph 1: Pool water level results from logger installed at WC15_Pool 28.

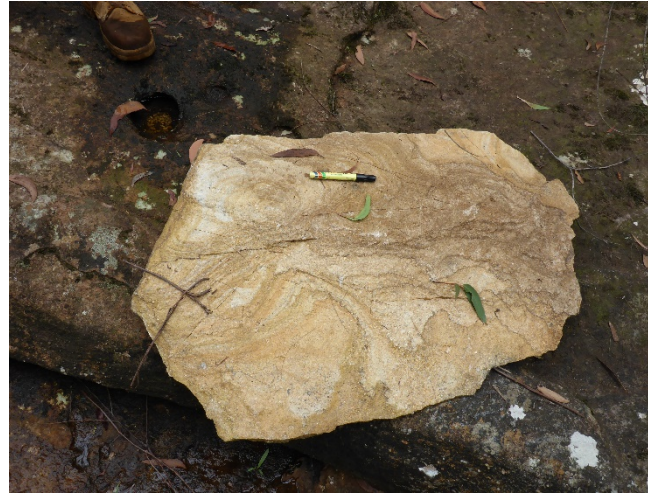
DA3B_LW13_042 is located on *WC15*, a tributary to *Wongawilli Creek*. The impact site is situated approximately 150m east of Longwall 13 (Figure 1). The impact was first identified on 16 May 2018 during the extraction of Longwall 13. The impact was originally comprised of multiple rock fractures, with associated rock fragmentation and iron staining to *WC15_Rockbar 7*, an incised rockbar. Additional fracturing and rock fragmentation was observed during the most recent inspection (Photos 5 to 8). The new rock fracturing has a maximum measurable length of 0.2m and a maximum width of 0.002m. The largest rock fragment has a length of 0.8m, width of 0.65m and height of 0.1m. Recent heavy rainfall events (187.5mm between 15 March and 20 March 2019) have cleared vegetation and debris which has allowed the new fractures to be identified. Additionally, the rainfall events have likely caused dislodgement of the new rock fragments and transport downstream (Photo 9).

Photo 6: DA3B_LW13_042, looking at largest section of rock fragmentation. Taken 01/04/2019.

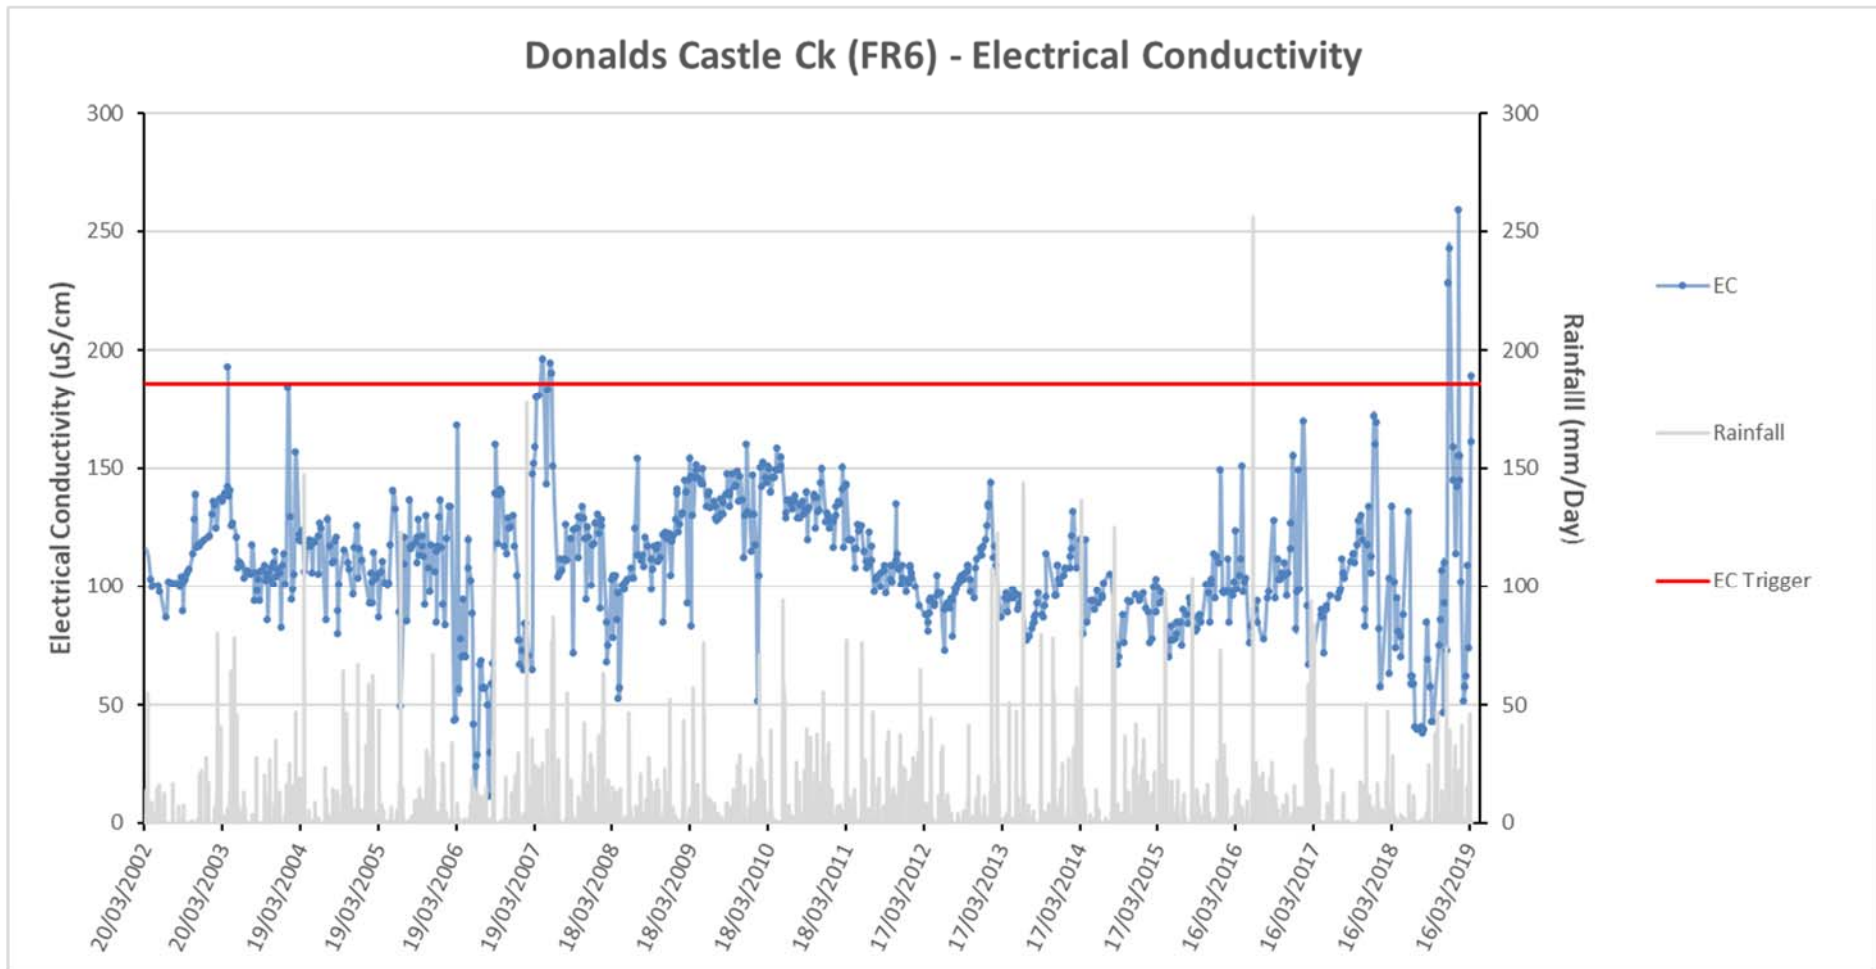
- Three exceedances of the ± 3 standard deviation level (positive for EC, negative for pH and DO) from the baseline mean during the monitoring period:
 - pH <3.60
 - **EC >185.8 $\mu\text{S}/\text{cm}$**
 - DO <40.1%

This water quality observation will be assessed in the specialist Surface Water and Shallow Groundwater Assessment (underway) for the Longwall14 End of Panel Report.

Graph 1: Electrical Conductivity recorded at site *Donalds Castle Ck (FR6)*, downstream from DA3B operations.

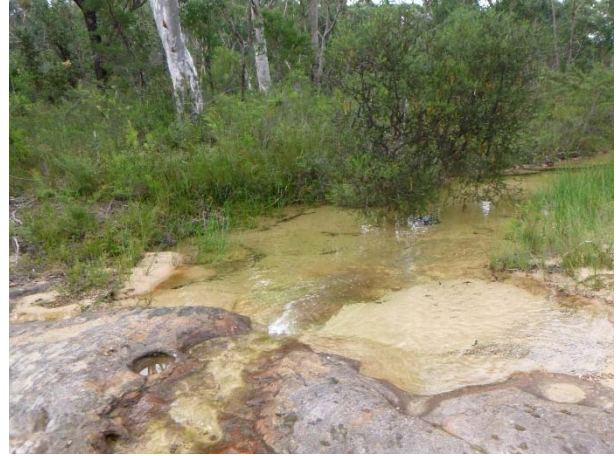
Photo 8: *Donalds Castle Ck (FR6)*, looking downstream. Taken 25/03/2019

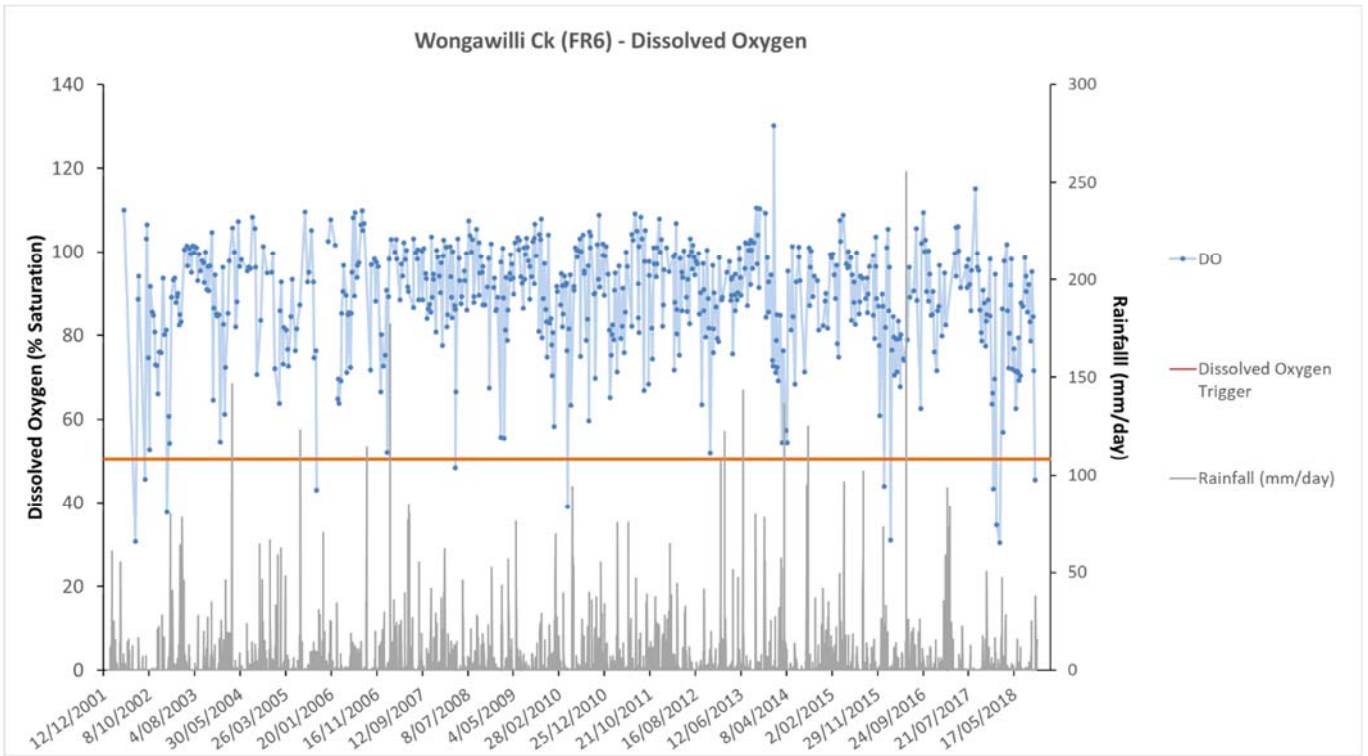
This water quality observation contributes to a Level 3 Trigger according to the Dendrobium Area 3B Watercourse Impacts, Triggers and Response Plan (Appendix A, Table 1.2), specifically:

- Three exceedances of the ± 3 standard deviation level (positive for EC, negative for pH and DO) from the baseline mean during the monitoring period:
 - pH 4.45
 - **EC 154.1 $\mu\text{S}/\text{cm}$**
 - **DO 50.5%**

Graph 1: Dissolved Oxygen recorded at site *Wongawilli Ck (FR6)*, downstream from DA3B operations.

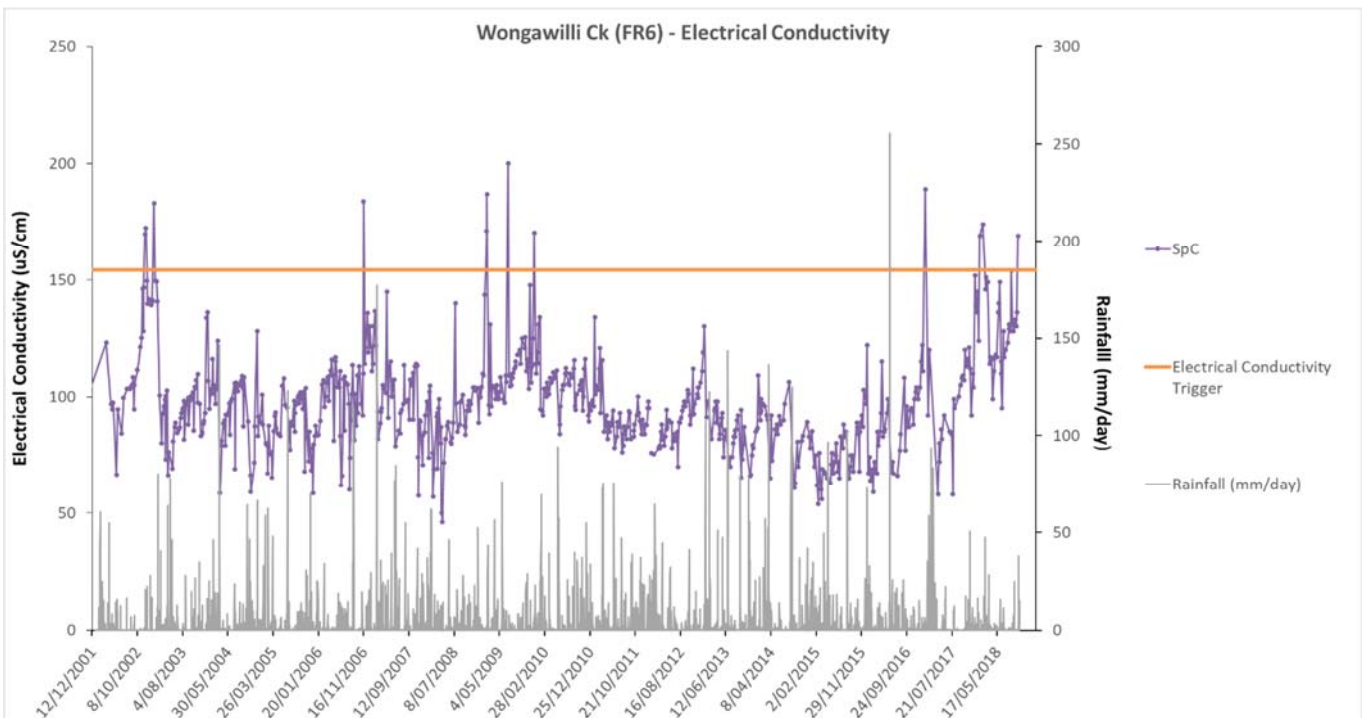
Graph 2: Electrical Conductivity recorded at site *Wongawilli Ck (FR6)*, downstream from DA3B operations.

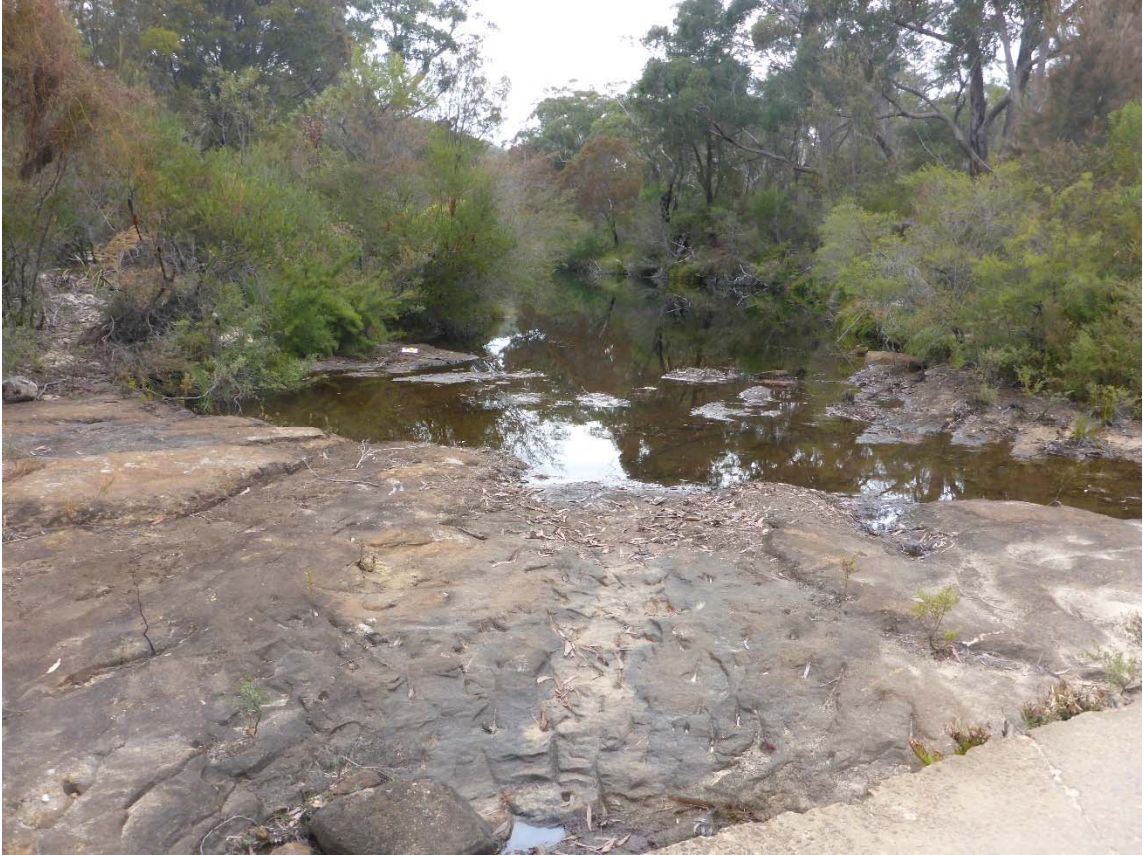
Photo 1: *Wongawilli Ck (FR6)*, looking upstream. Taken 3/10/2018

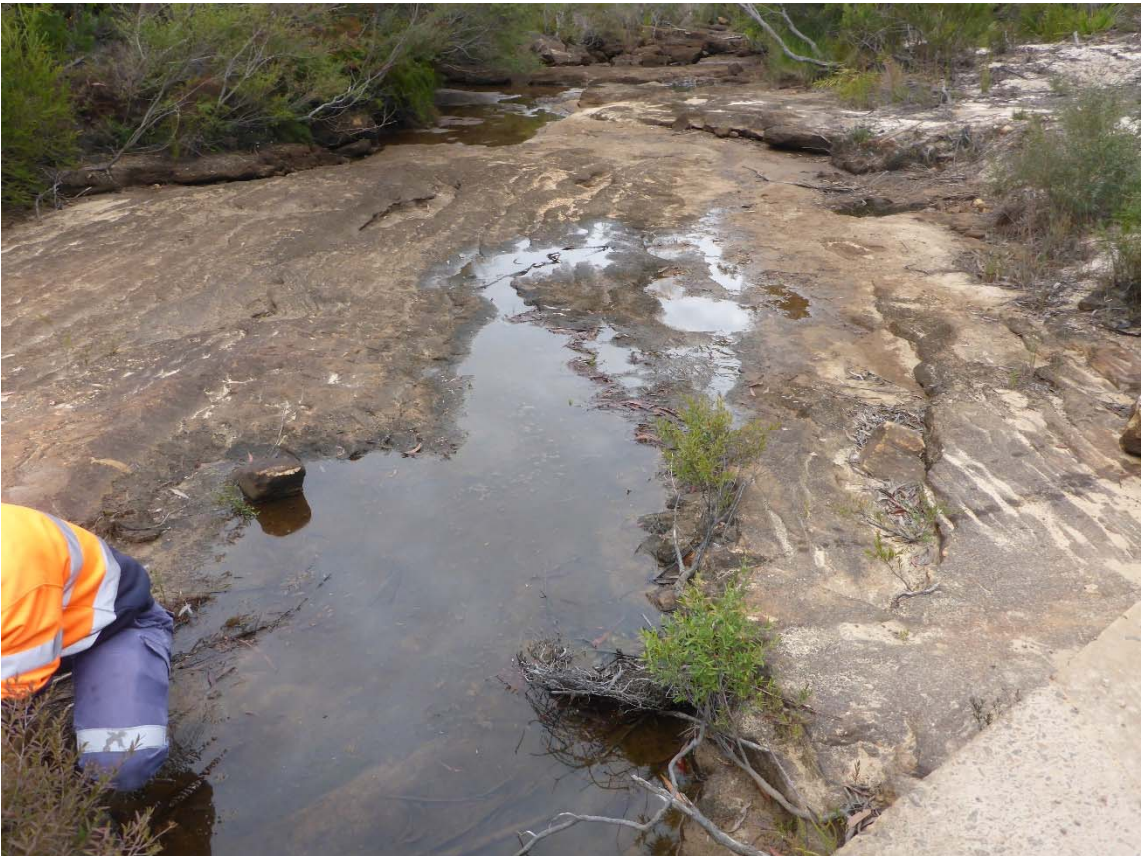
Photo 2: *Wongawilli Ck (FR6)*, looking downstream. Taken 3/10/2018

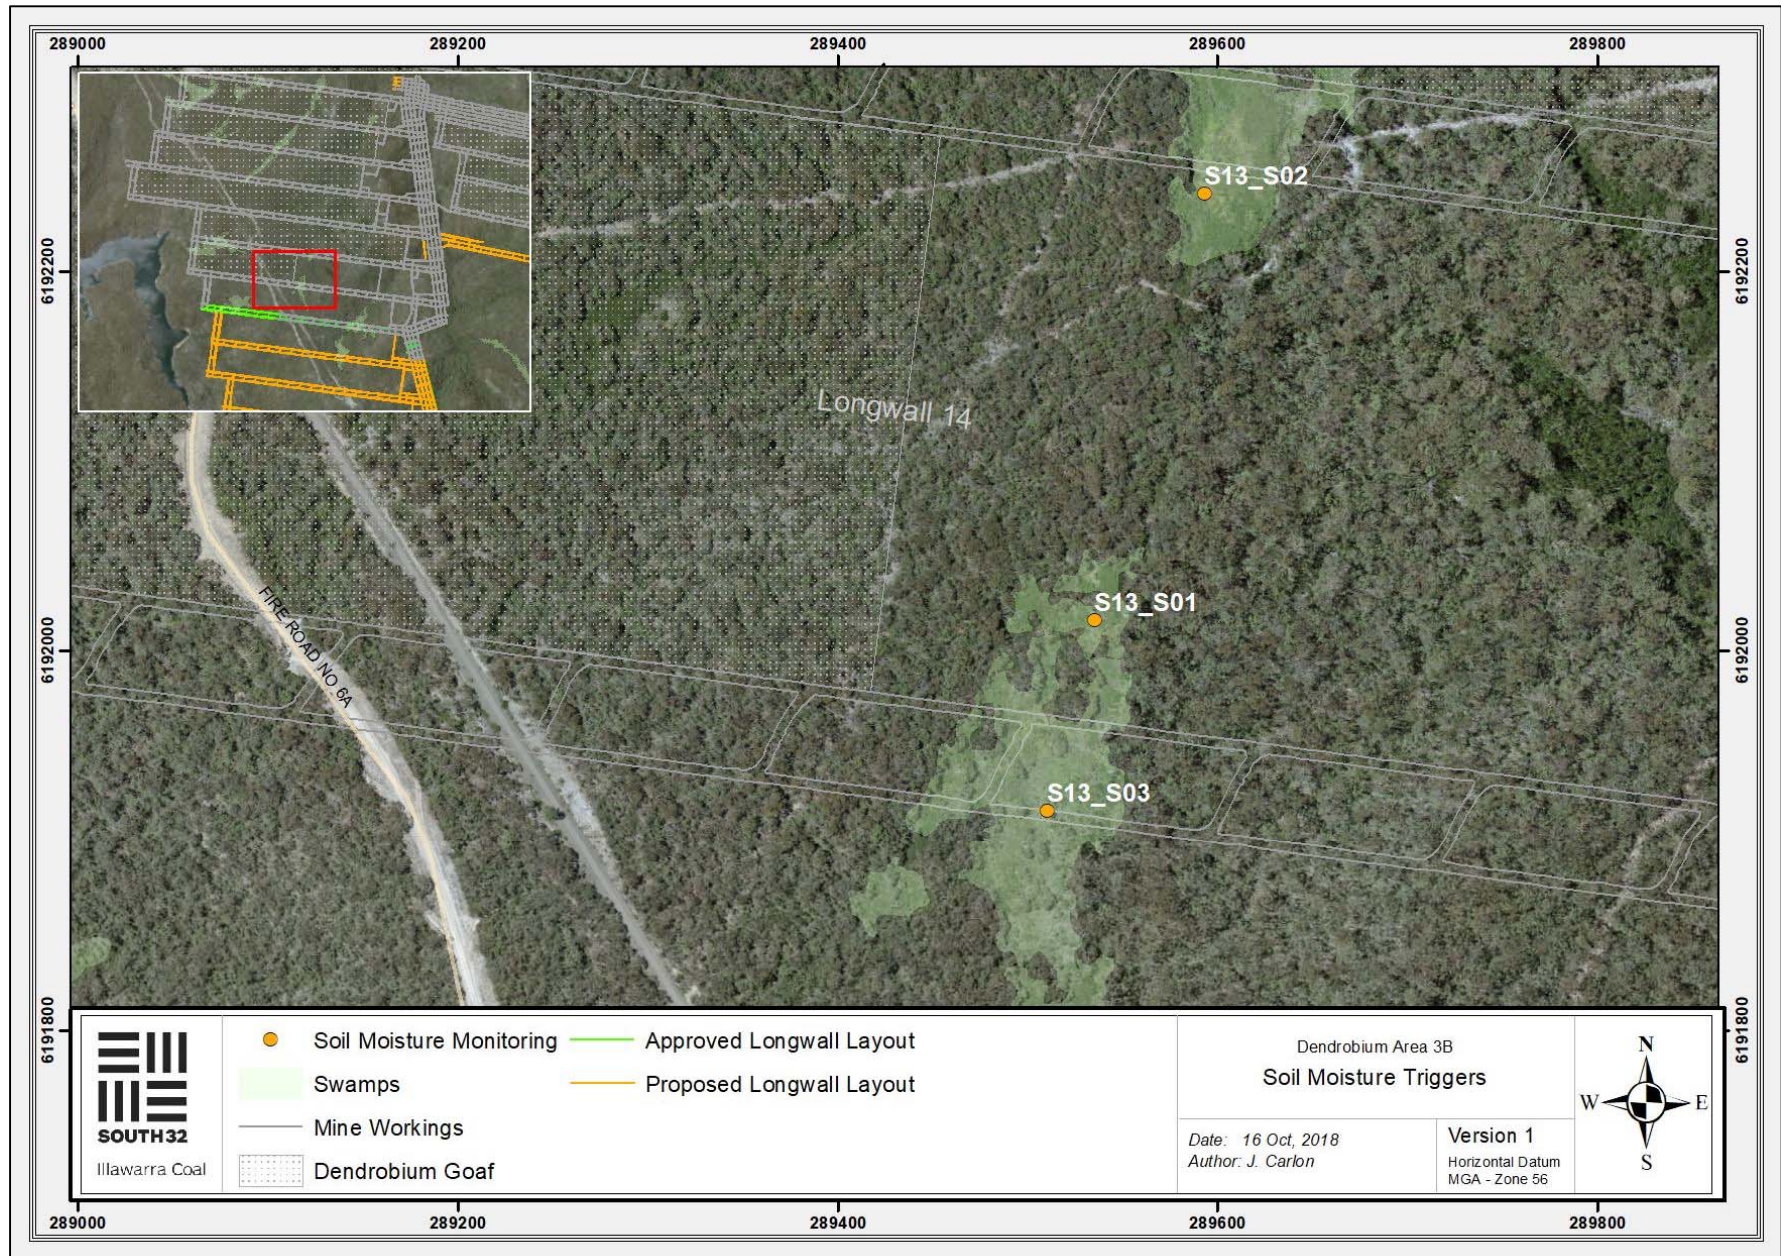
A soil moisture trigger was measured at sites S13_01, S13_02 and S13_03 during recent analysis of Swamp 13 data. The sites were established in 2015, in hand-augured holes. The sites entered the Longwall 14 400 m risk management zone between the 8th and 11th September 2018. Recent data indicates that soil moisture levels at all three sites have dropped below baseline levels (Graph 3 to Graph 5). This is a Level 3 trigger as per the Dendrobium Area 3B Swamp TARP (Appendix A, Table 2), specifically:

- Soil moisture level lower than baseline level at >80% of monitoring sites (within 400m of mining) within a swamp.

Figure 2: Soil moisture sites in Swamp 13 in relation to Dendrobium Area 3B mining operations.

Vegetation monitoring is currently at weekly frequency. More frequent monitoring is not proposed at this stage. Specialist technical advice has been sought regarding any additional recommended actions.
