END OF PANEL
LANDSCAPE REPORT
DENDROBIUM AREA 3B

DENDROBIUM AREA 3B
LONGWALL 15 END OF PANEL
LANDSCAPE REPORT
MARCH 2020

This report summarises the observed and measured subsidence effects on landscape features resulting from the extraction of Dendrobium Area 3B (DA3B) Longwall 15.

Longwall 15 is the seventh panel extracted from DA3B. Extraction began on 4 April 2019 and was completed on 22 January 2020.

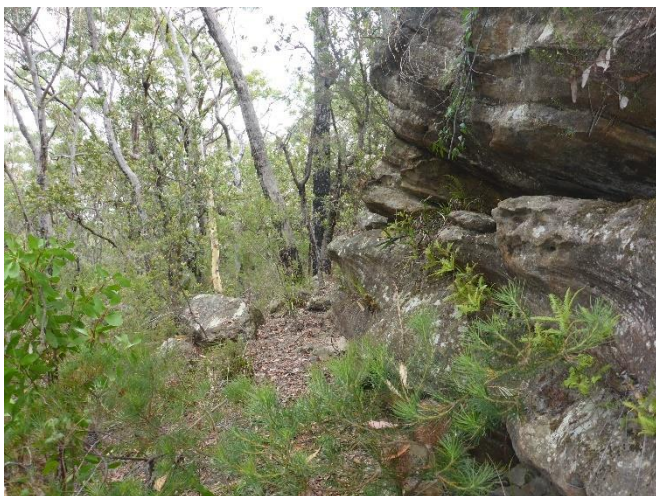
Photo 1: A3b-SS13 baseline inspection. Taken on 25/01/18.

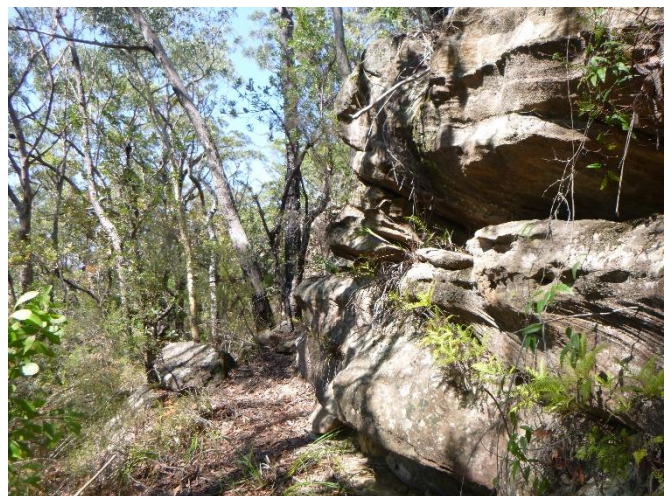
Photo 2: A3b-SS13 post-mining inspection. Taken on 21/01/20.

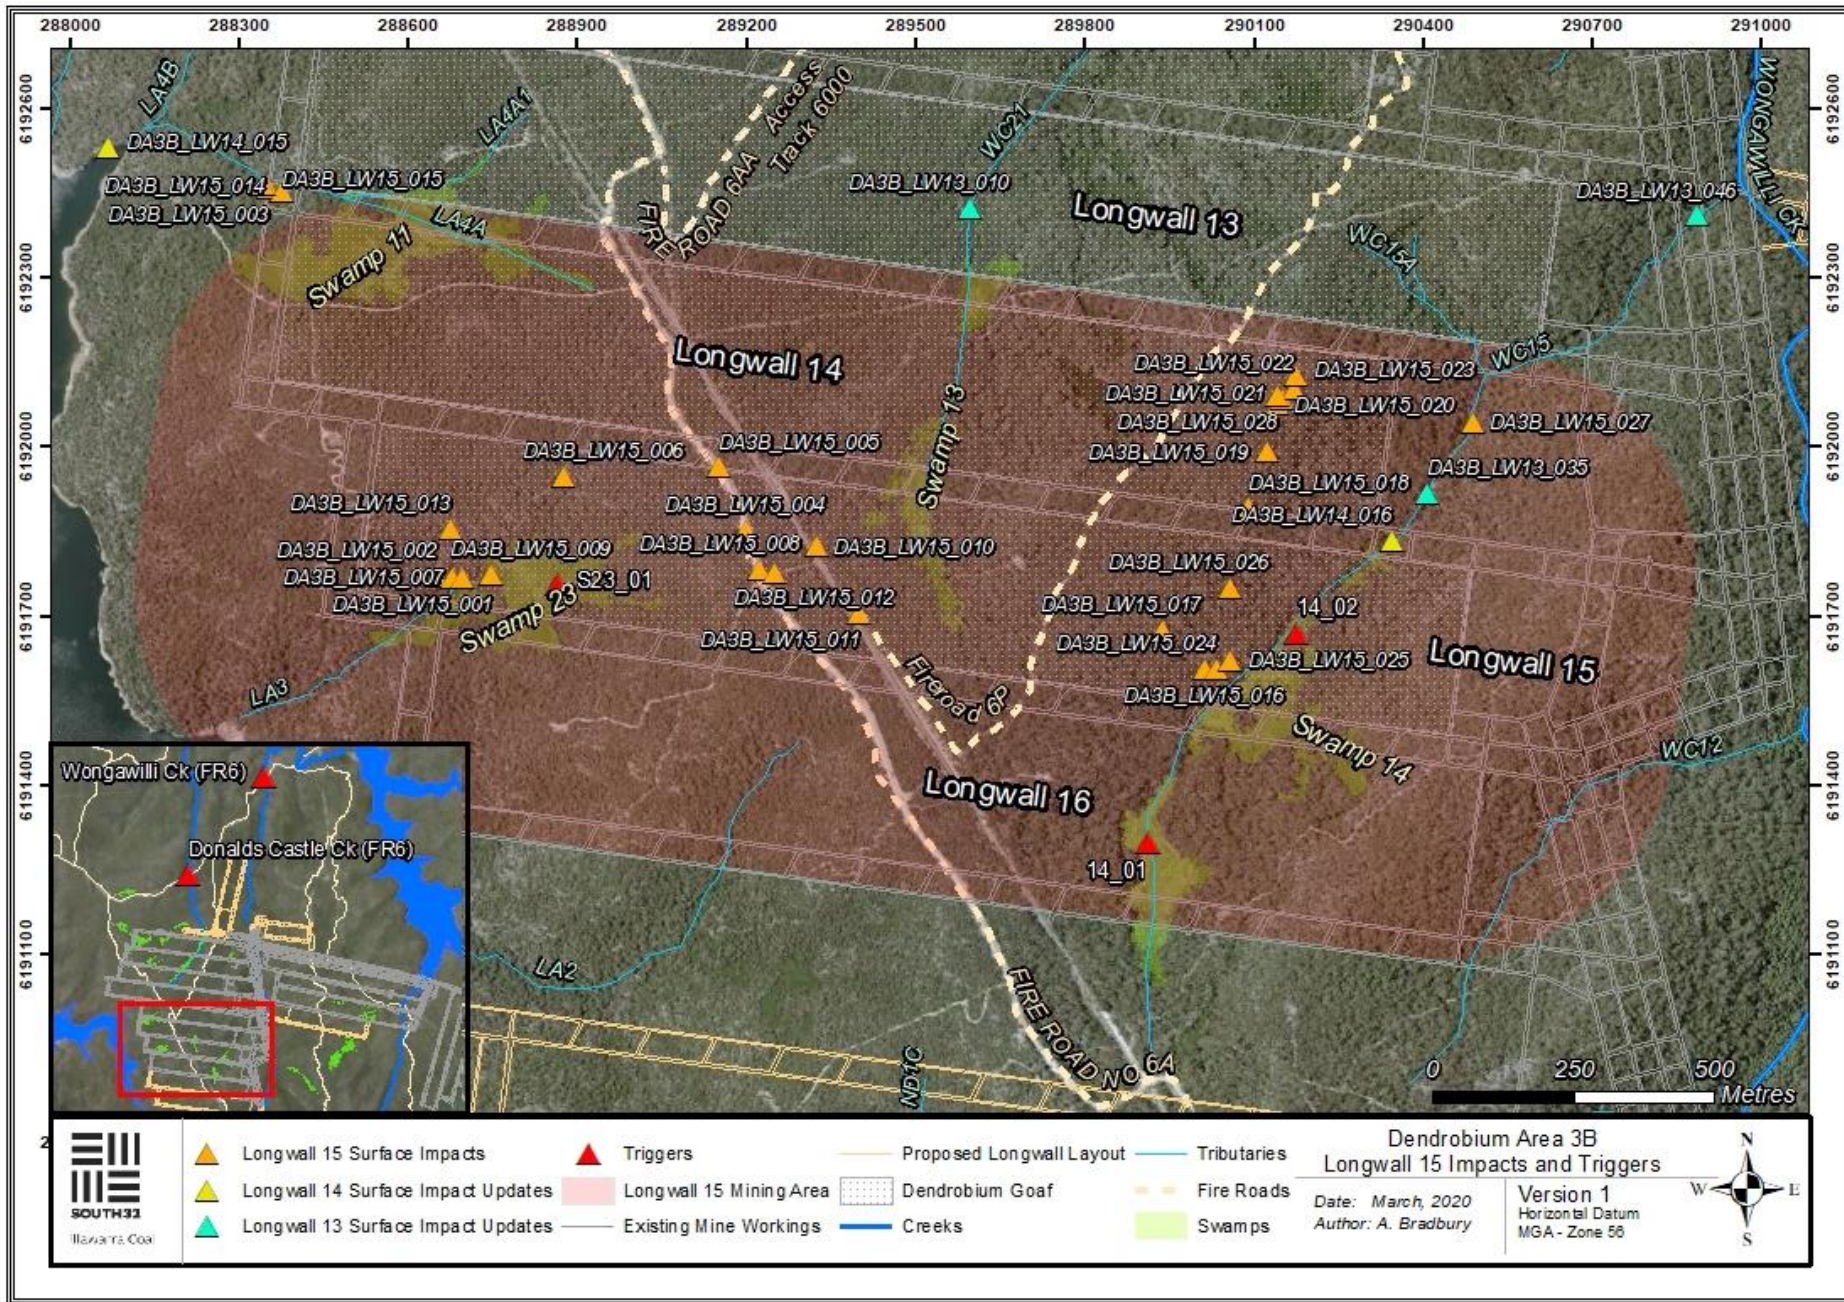
Figure 2: Map showing surface impacts and triggers recorded during Longwall 15.

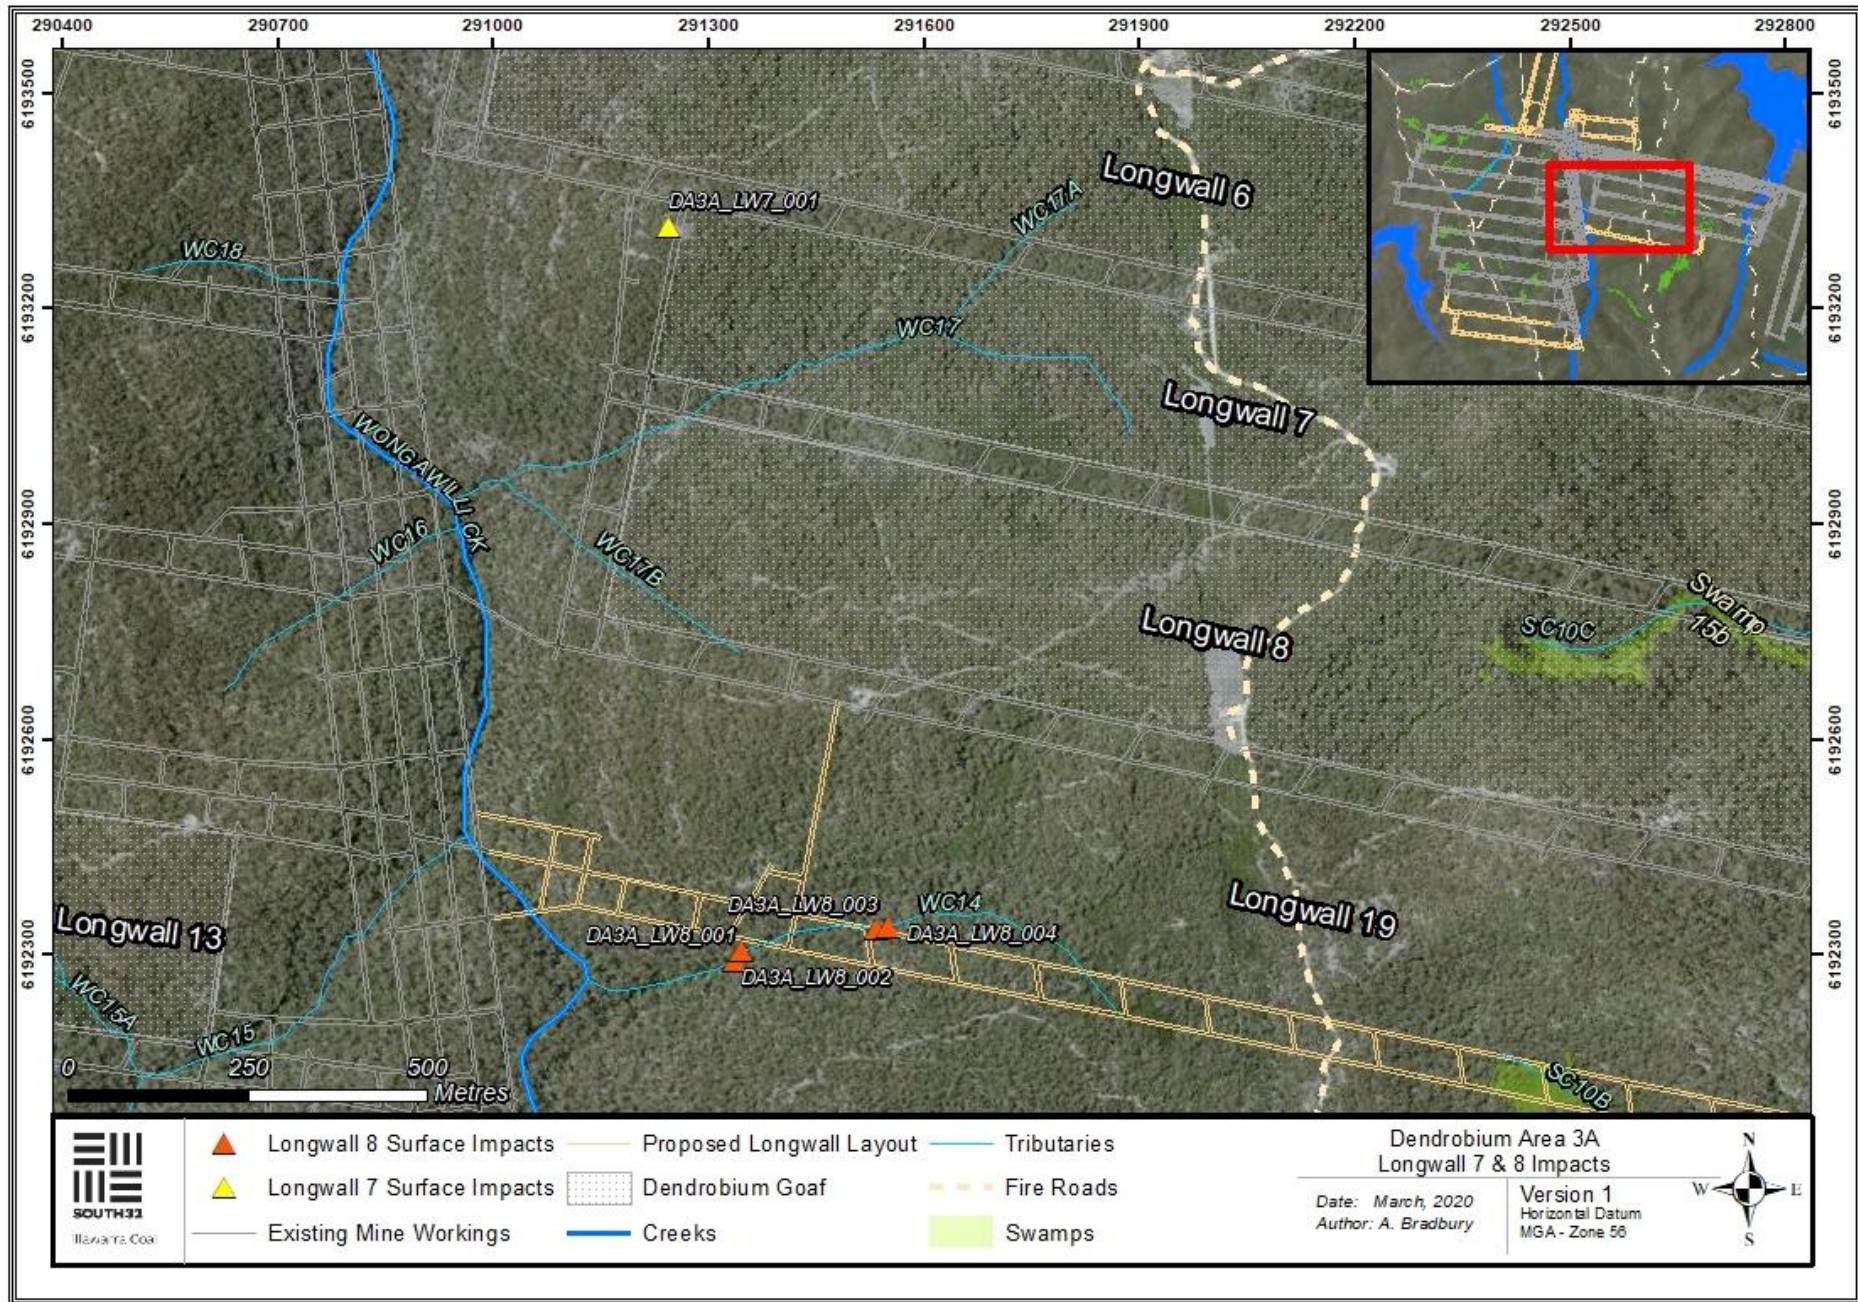
Figure 3: Map showing surface impacts and triggers over Longwall 7 and 8, recorded during Longwall 15.

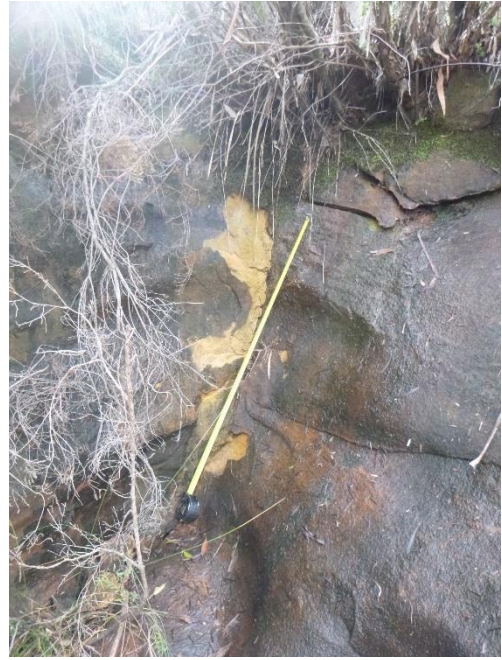
DA3B_LW15_003 is located on LA4A, a tributary to Lake Avon. The impacted feature, LA4A_Step 3A, is situated 80m north-west of the commencing end of Longwall 14 (Figure 2). It is likely this impact occurred during the extraction of Longwall 14, however, only later become visible due to rainfall events which dislodged vegetation and rock fragments. The impact includes rock fracturing and associated rock fragmentation (Photo 5 to Photo 7). The rock fracturing has a maximum measurable length of 0.5m and a maximum width of 0.02m. The largest rock fragment has a length of 0.30m, a width of 0.03m and a height of 0.19m. No flow diversion was evident due to the location of the fracture on the step. DA3B_LW15_003 was inspected on 27 February 2020 and remains unchanged from original identification (Photo 8).

Photo 8: *DA3B_LW15_003*, overview of impacted area. Taken on 27/02/2020.

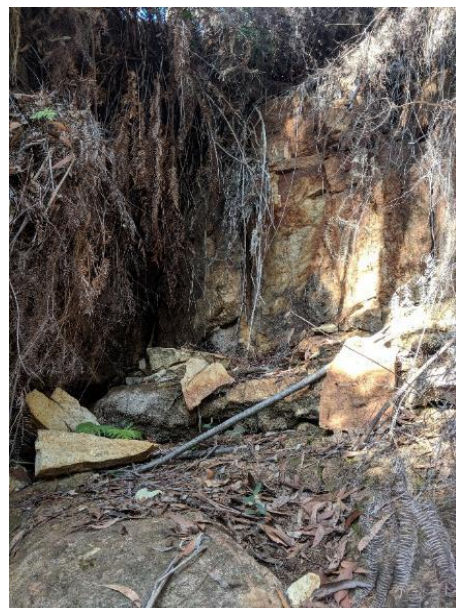
Photo 16: DA3B_LW13_010, showing rockfall at step. Taken on 21/08/2019.

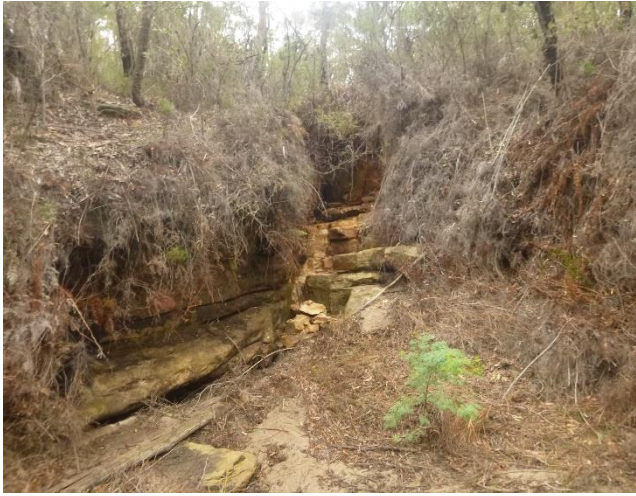
Photo 17: DA3B_LW13_010, step at WC21_Pool 53.
Taken on 26/02/2020.

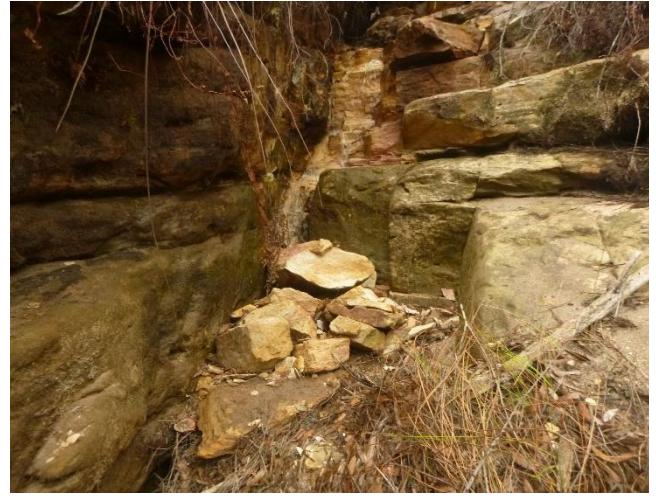
Photo 18: DA3B_LW13_010, showing rockfall at step.
Taken on 26/02/2020.

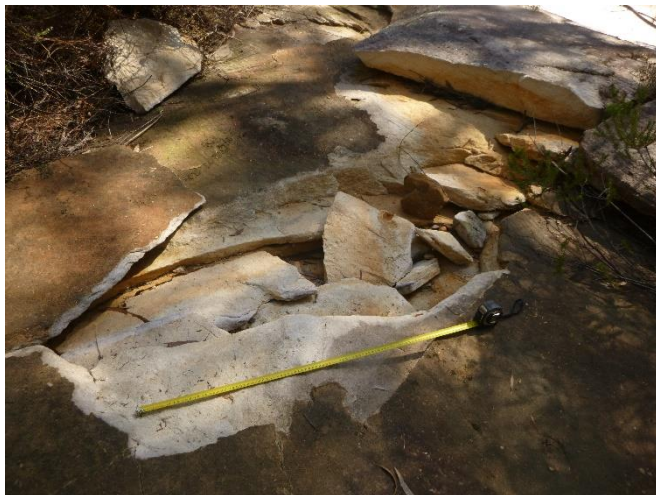
Photo 22: *DA3B_LW13_035*, looking at the rock fragmentation. Taken on 28/02/2020.

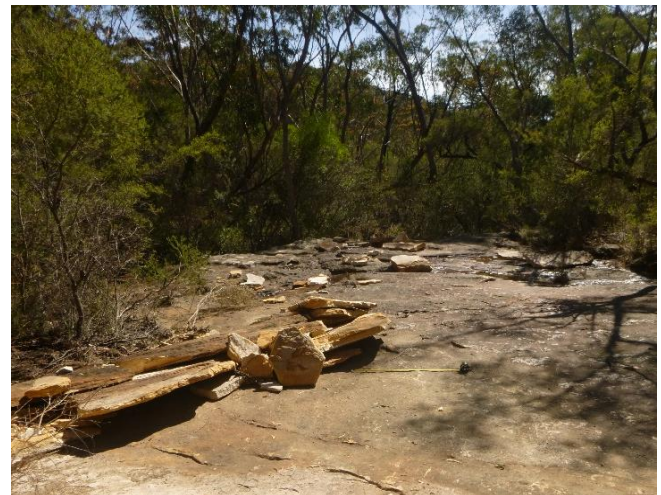
Photo 23: *DA3B_LW13_035*, overview of rock fragmentation and displacement. Taken on 28/02/2020.

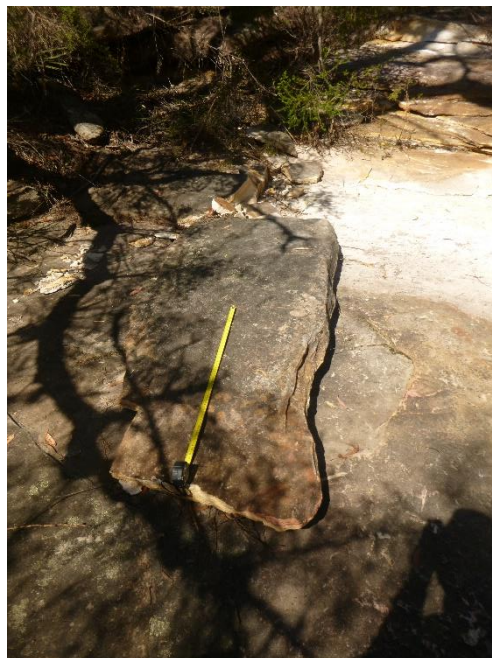
DA3B_LW13_035 is located on WC15_Rockbar 21 and was originally identified during the extraction of Longwall 13 on 23 April 2018 (Figure 2). The impact site is situated approximately 123m north of Longwall 15 at its closest point. Additional fracturing with flow diversion was identified and reported during the extraction of Longwall 14. On 21 January 2020, further fracturing and uplift was observed (Photo 24). The rock fracture has a length of 1m and a width of 0.02m. Uplifted sections are associated with the fracturing. On 26 February 2020, due to recent rainfall events, further rock fragmentation and displacement was evident. Previous rock fragmentation and uplift has been displaced downstream with the largest fragment having a maximum length of 2m, width of 1m and height of 0.4m (Photo 25 to Photo 26).

Photo 26: *DA3B_LW13_035*, looking at largest displaced rock fragment. Taken on 28/02/2020.

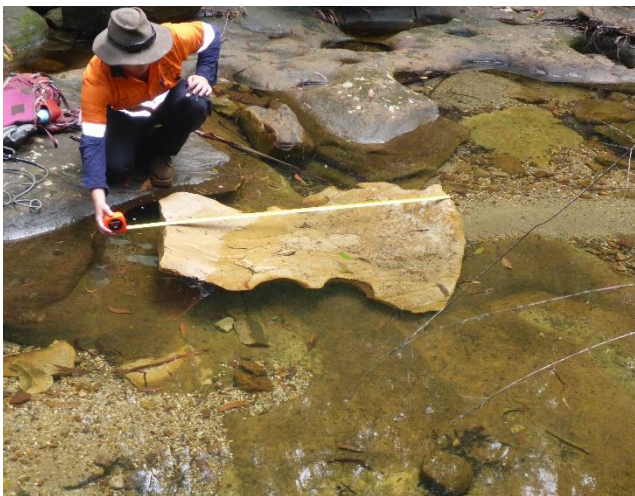
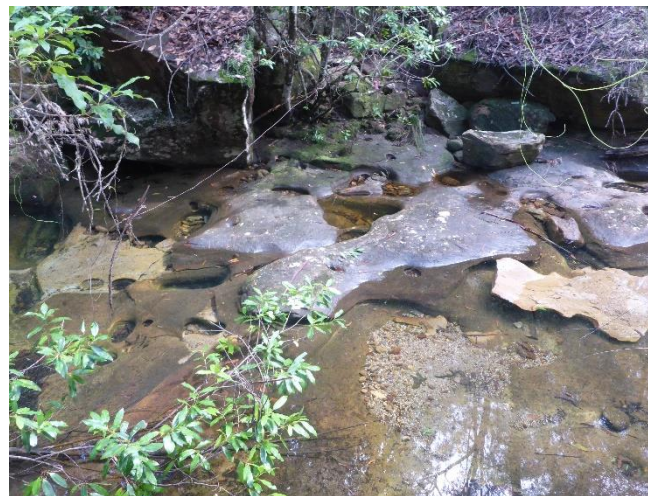
DA3B_LW13_046 is located on WC15, a tributary to Wongawilli Creek. The impacted feature, WC15_Step 2, is situated approximately 245m east of Longwall 13 and 590m north-east of Longwall 14 (Figure 2). It is likely that this impact occurred during the extraction of Longwall 13 however only become visible on 1 April 2019, due to heavy rainfall events (187.5mm between 15 March and 20 March 2019) which dislodged vegetation and rock fragments. The impact is comprised of a rock fracture and minor rock displacement (Photo 27 and Photo 28). The rock fracture has a maximum measurable length of 1.2m and a maximum width of 0.02m. On 10 March 2020, additional rock fracturing and displacement was evident at WC15_Pool 2, following a heavy rainfall event. A section of sandstone bedrock with a length of 1.42m, width of 1.05m and depth of 0.21m, had been displaced 3.2m downstream (Photo 29 and Photo 30). No flow diversion was observed during inspection.

Photo 29: DA3B_LW13_046, looking at the section of rock displaced. Taken on 10/03/2020.

Photo 30: DA3B_LW13_046, an overview of the rock displacement. Taken on 10/03/2020.

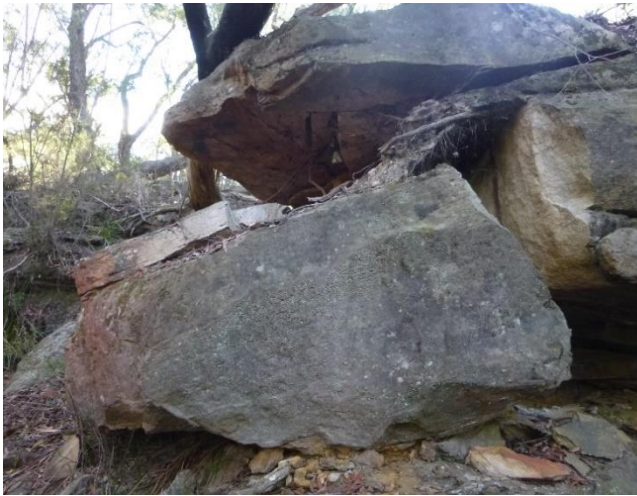
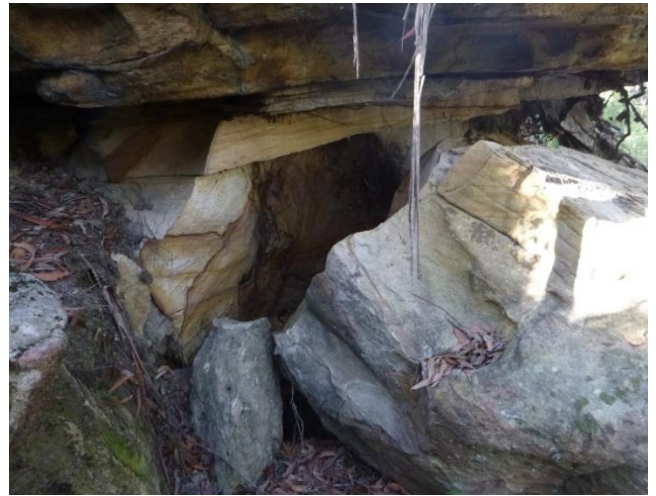
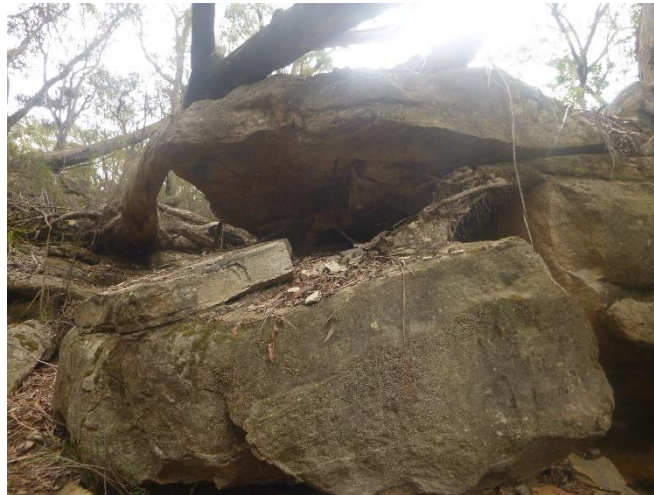
DA3B_LW15_002 is located on a 4m step adjacent to Swamp 23 (Figure 2). The site was mined beneath by Longwall 15 on 25 April 2019. The impact is comprised of a rockfall with a length of 3m, width of 2m and height of 1m (Photo 48 and Photo 49). DA3B_LW15_002 was inspected on 26 February 2020 and remains unchanged from original identification (Photo 50).

Level 1: Rockfall from a cliff (step) which is left mostly intact (<10% length) resulting in insignificant ground disturbance.

Photo 48: DA3B_LW15_002, looking at the rockfall.
Taken on 29/05/2019.

Photo 49: DA3B_LW15_002, looking at the rockfall.
Taken on 29/05/2019.

Photo 50: DA3B_LW15_002, looking at the rockfall.
Taken on 26/02/2020.

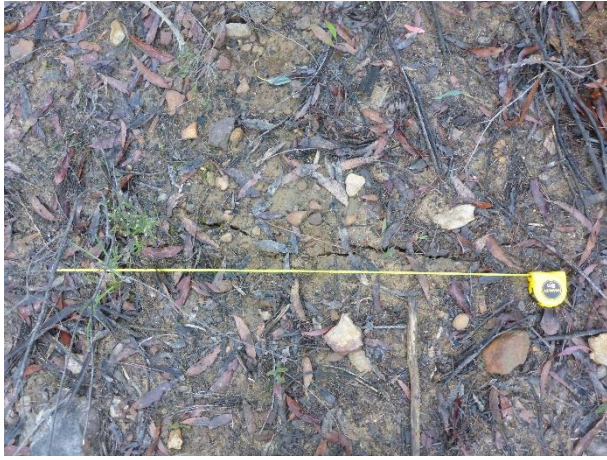
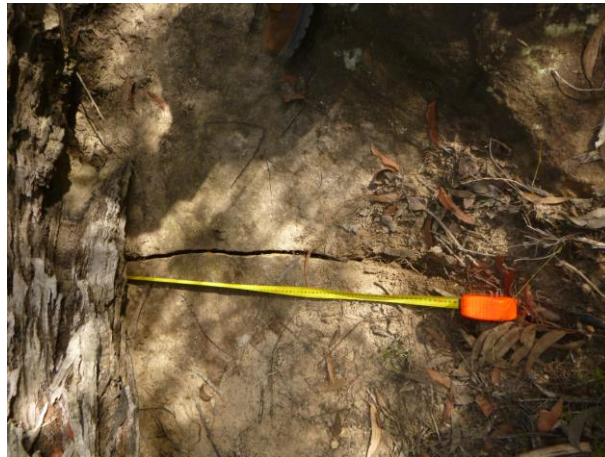
DA3B_LW15_006 consists of soil cracking and rock fracturing to access track and sandstone outcrop, north of Swamp 23 (Figure 2). The soil cracking has a length of 2.9m, width of 0.01m and maximum measurable depth of 0.3m (Photo 51). The rock fracturing has a maximum measurable length of 0.7m, width of 0.01m wide and depth of 0.3m (Photo 52). The soil cracking appears stable and should self-remediate over time through natural processes.

Level 1: Crack or fracture less than 10m in length, and/or, crack or fracture up to 100mm width.

Photo 51: DA3B_LW15_006, looking at soil cracking.
Taken on 09/07/2019.

Photo 53: DA3B_LW15_006, looking at soil cracking. Taken on 09/07/2019.

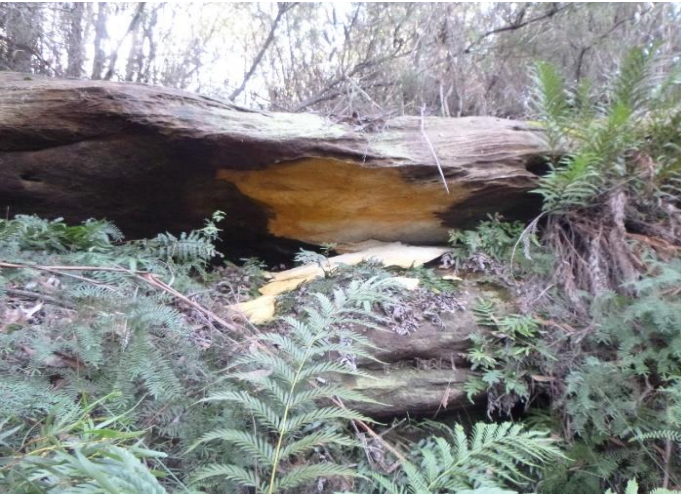
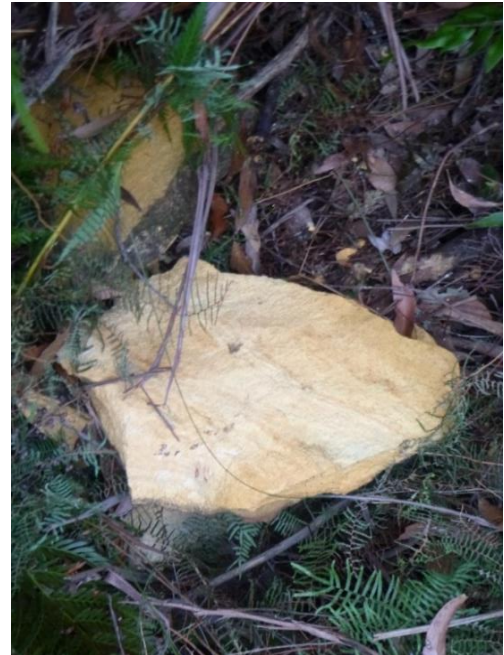
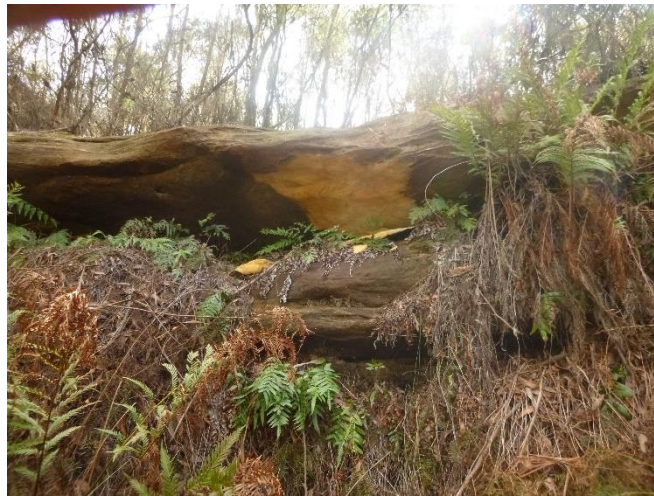
DA3B_LW15_009 consists of a small rockfall to an overhanging ledge, north of Swamp 23 (Figure 2). The site was mined beneath by Longwall 15 on 4 April 2019. The fragment of rock fallen from the ledge is approximately 0.2m³ (Photo 57 and Photo 58). DA3B_LW15_009 was inspected on 26 February 2020 and remains unchanged from original identification (Photo 59).

Level 1: Rockfall from a cliff (step) which is left mostly intact (<10% length) resulting in insignificant ground disturbance.

Photo 57: DA3B_LW15_009, looking at a section of rockfall.
Taken on 29/07/2019.

Photo 58: DA3B_LW15_009, looking at rock fragment on ground. Taken on 29/07/2019.

Photo 59: DA3B_LW15_009, looking at a section of rockfall.
Taken on 26/02/2020.

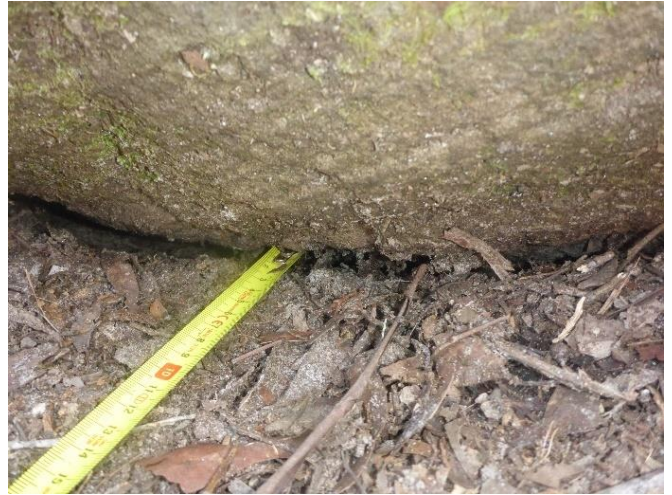
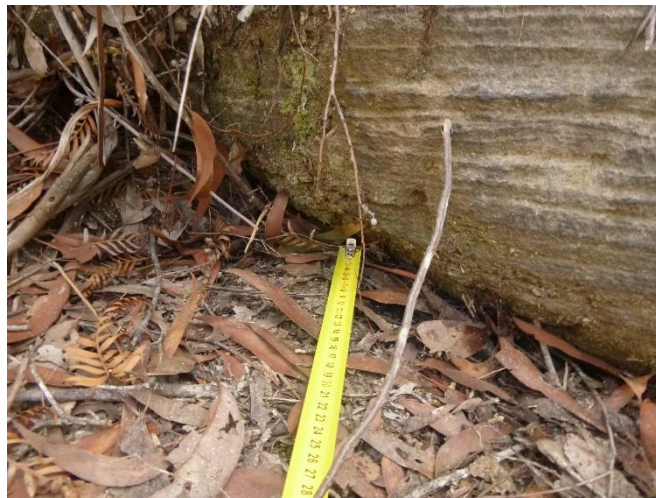
DA3B_LW15_016 is located at the base of a steep slope/step between *Swamp 14* and *Fire Road 6P* (Figure 2). The site was mined beneath by Longwall 15 on 22 October 2019. The impact includes displacement of rock from adjacent soil (Photo 63 and Photo 64). The displacement has a maximum measurable length of 2.5m, a maximum width of 0.02m and a depth of 0.6m. DA3B_LW15_016 was inspected on 28 February 2020. The displacement has naturally infilled with sediment and debris (Photo 65).

Photo 64: DA3B_LW15_016, looking at the width of displacement. Taken on 25/10/2019.

Photo 65: DA3B_LW15_016, looking at area of previous displacement. Taken on 28/2/2020.

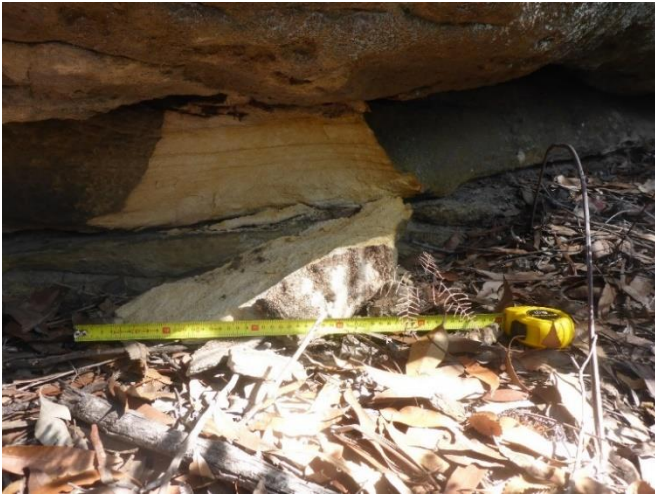
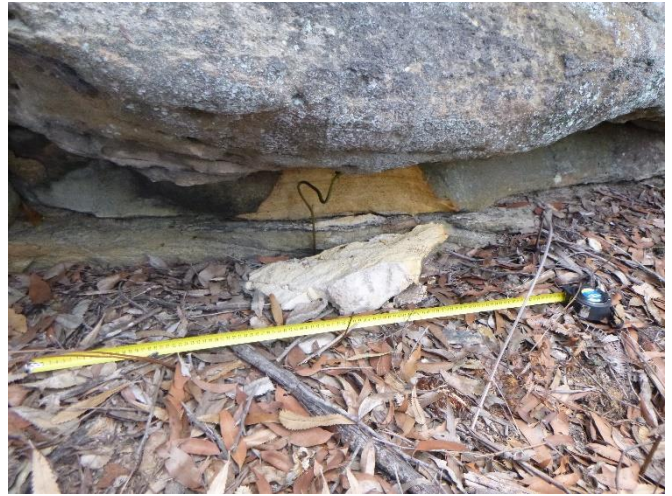
DA3B_LW15_017 is located at the base of a steep slope/step between *Swamp 14* and *Fire Road 6P* (Figure 2). The site was mined beneath by Longwall 15 on 11 October 2019. The impact is comprised of a small rockfall (Photo 66). The rock fragment resulting from the rockfall has a length of 0.5m, a width of 0.17m and a height of 0.1m. DA3B_LW15_017 was inspected on 27 February 2020 and remains unchanged from original identification (Photo 67).

Level 1: Rockfall from a cliff (step) which is left mostly intact (<10% length) resulting in insignificant ground disturbance.

Photo 66: DA3B_LW15_017, looking at the area of rockfall.
Taken on 25/10/2019.

Photo 67: DA3B_LW15_017, looking at the area of rockfall.
Taken on 27/02/2020.

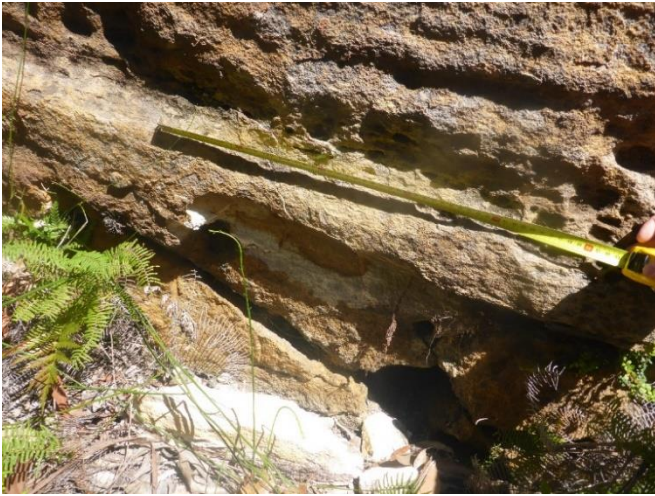
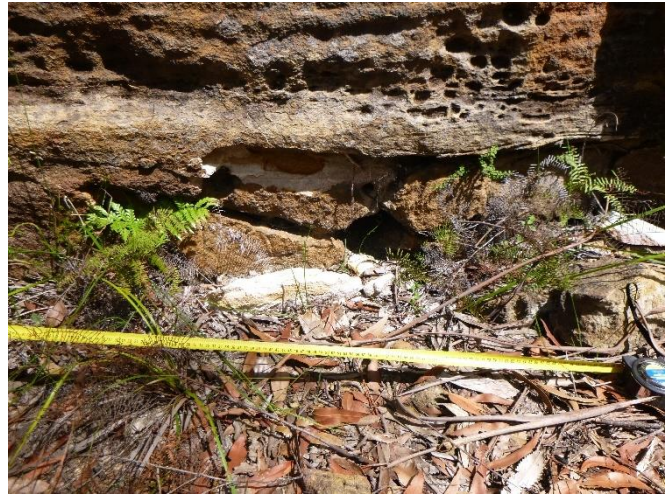
DA3B_LW15_020 is located at the base of a steep slope between tributary WC15 and Fire Road 6P (Figure 2). The site was mined beneath by Longwall 14 on 15 January 2019. The impact is comprised of a small rockfall (Photo 73). The rock fragment resulting from the rockfall has a length of 0.4m, a width of 0.2m and a height of 0.09m. DA3B_LW15_020 was revisited on 27 February 2020 and remains unchanged from original identification (Photo 74).

Level 1: Rockfall from a cliff (step) which is left mostly intact (<10% length) resulting in insignificant ground disturbance.

Photo 73: DA3B_LW15_020, looking at area of rockfall. Taken on 25/10/2019.

Photo 74: DA3B_LW15_020, looking at area of rockfall. Taken on 27/02/2020.

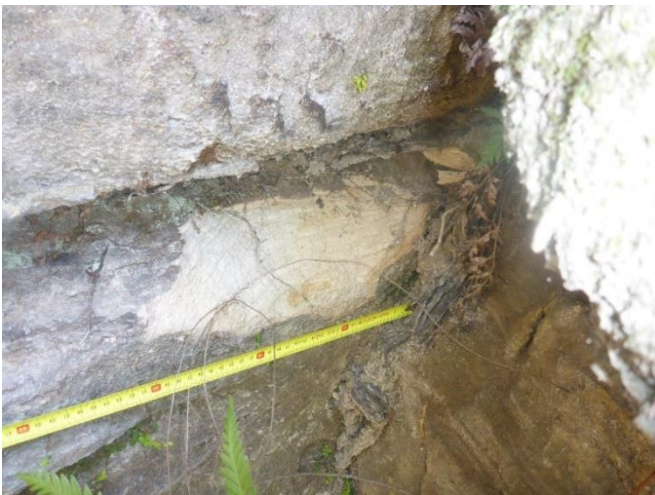
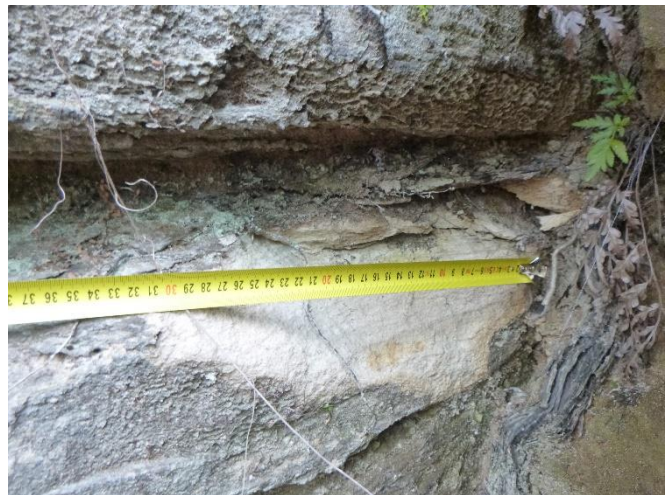
DA3B_LW15_021 is located at SLMMP site A3b-SS9-Pt1 which is a steep slope/step located between tributary WC15 and Fire Road 6P (Figure 2). The site was mined beneath by Longwall 14 on 16 January 2019. The impact is comprised of a small rockfall (Photo 75). The area of exposed rock has a length of 0.4m, width of 0.12m and height of 0.2m. On 27 February 2020, the width of exposed rock was identified to have increased to 0.27m (Photo 76).

Level 1: Rockfall from a cliff (step) which is left mostly intact (<10% length) resulting in insignificant ground disturbance.

Photo 75: DA3B_LW15_021, looking at the area of rockfall. Taken on 25/10/2019.

Photo 76: DA3B_LW15_021, looking at the area of rockfall. Taken on 27/02/2020.

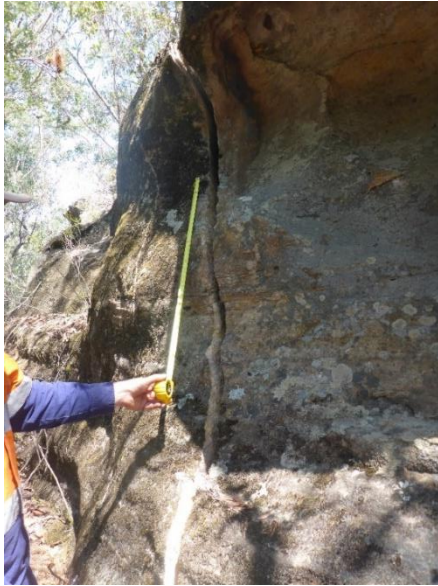
DA3B_LW15_023 is located at a steep slope/step between tributary WC15 and Fire Road 6P (Figure 2). The site was mined beneath by Longwall 14 on 18 January 2019. The impact is comprised of two rock fractures with a maximum length of 25m, a maximum width of 0.08m and a depth greater than 5m (Photo 80 and Photo 81). DA3B_LW15_023 was revisited on 27 February 2020 and remains unchanged from original identification.

Level 2: Crack or fracture between 10m to 50m in length.

Photo 80: DA3B_LW15_023, looking at section of rock fracture. Taken on 25/10/2019.

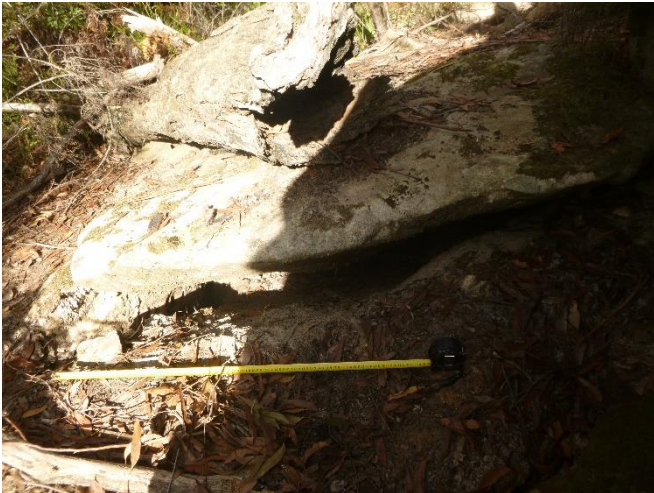
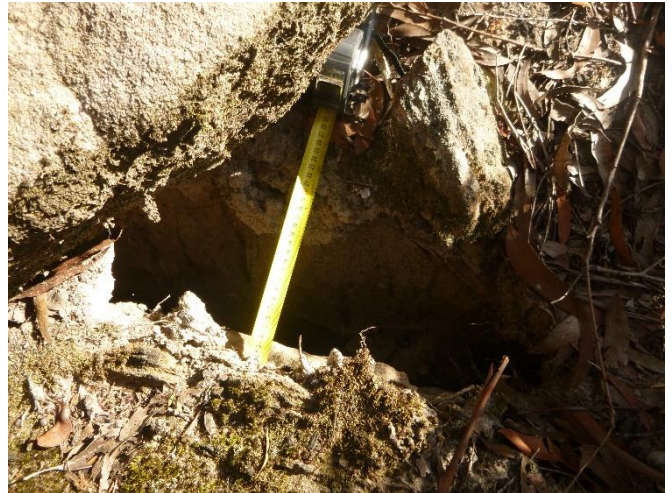
DA3B_LW15_024 is located at a steep slope/step between Swamp 14 and Fire Road 6P (Figure 2). The site was mined beneath by Longwall 15 on 25 October 2019. The impact was first reported on 23 January 2020. The impact was comprised of a rock fracture and soil uplift (Photo 82 and Photo 83). The rock fracture has a length of 1.8m, a width of 0.005m and a depth of approximately 0.02m. A 1m² area of soil uplift was evident at the base of the steep slope. On 28 February 2020, additional rock uplift was observed approximately 5m from the rock fracturing. The rock fragment had a length of 2m, width of 1.8m, depth 0.7m and uplift of 0.25m.

Photo 84: DA3B_LW15_024, looking at rock uplift. Taken on 28/02/2020.

Photo 85: DA3B_LW15_024, looking at rock uplift. Taken on 28/02/2020.

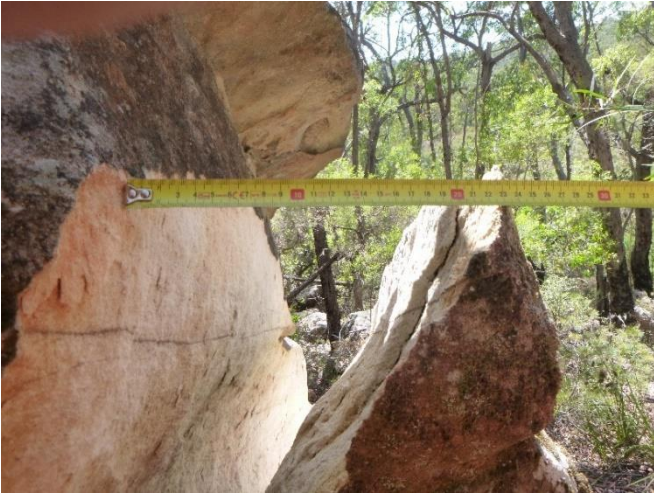
DA3B_LW15_025 is located at a steep slope/step between *Swamp 14* and *Fire Road 6P* (Figure 2). The site was mined beneath by Longwall 15 on 29 October 2019. The impact is comprised of a rockfall with associated displacement and fragmentation (Photo 86 and Photo 88). The largest rock fragment resulting from the rockfall has a length of 1.7m, width of 0.5m and height of 1.7m. DA3B_LW15_025 was inspected on 28 February 2020 and remains unchanged from original identification (Photo 89).

Level 1: *Rockfall from a cliff (step) which is left mostly intact (<10% length) resulting in insignificant ground disturbance.*

Photo 86: DA3B_LW15_025, looking at the rockfall. Taken on 21/01/2020.

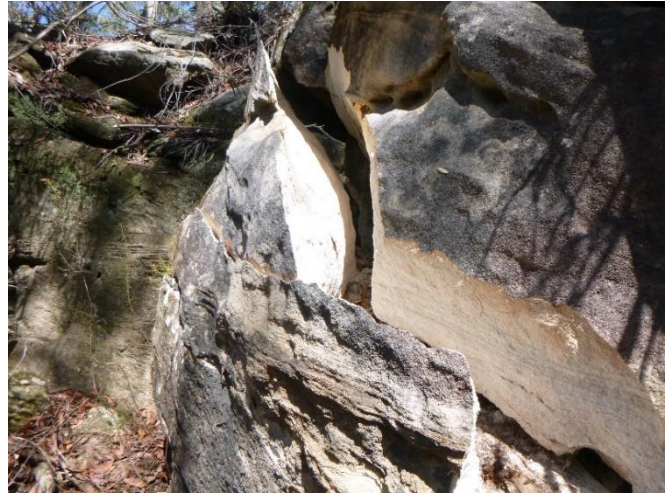
Photo 87: DA3B_LW15_025, looking at the rockfall. Taken on 21/01/2020.

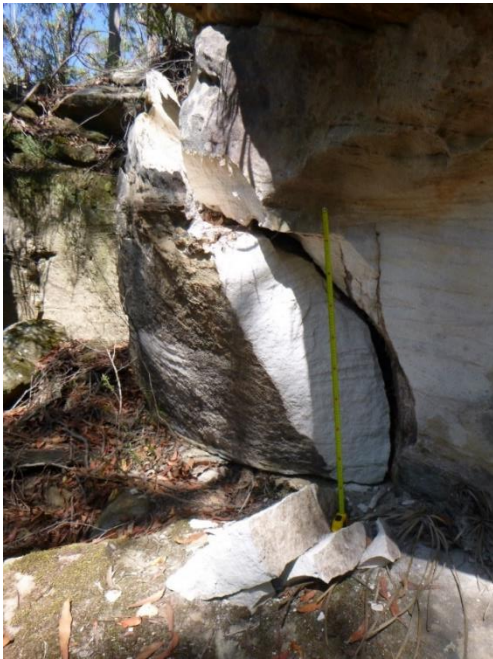
Photo 88: DA3B_LW15_025, overview of the rockfall. Taken on 21/01/2020.

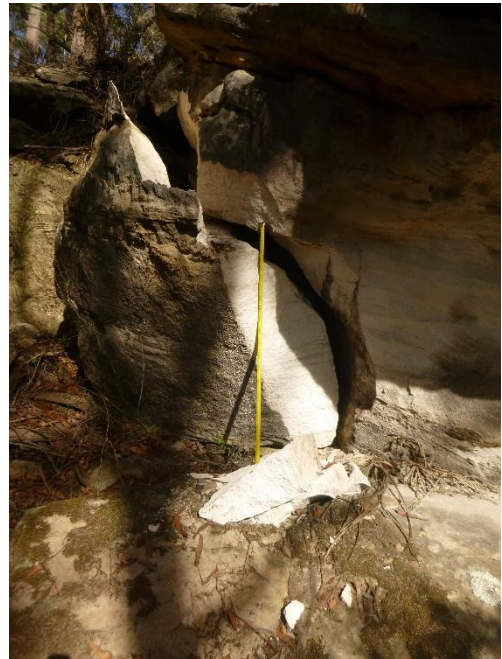
Photo 89: DA3B_LW15_025, overview of the rockfall. Taken on 28/02/2020.

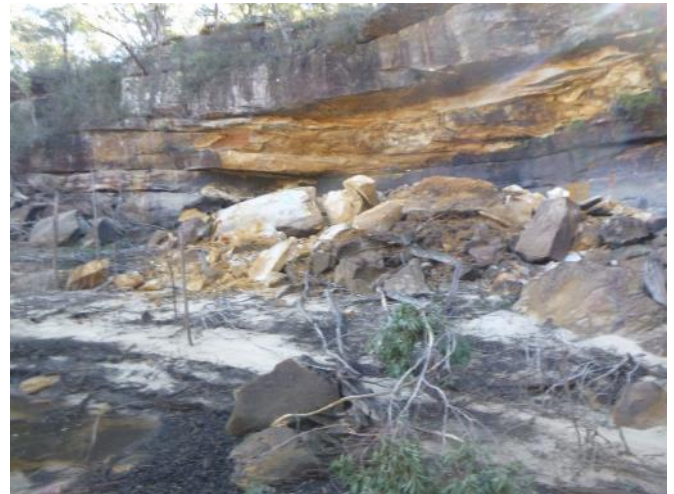
DA3B_LW14_015 is located on the cliffline/step edge of Avon Reservoir, approximately 330m from the southern edge of Longwall 12, 350m from the commencing end of Longwall 13 and Longwall 14, and 700m north-west of Longwall 15 (Figure 2). The impact was first reported on 6 December 2018 and was comprised of two distinct rock fractures and a rockfall (Photo 96). The original rockfall had an approximate length of 4m, width of 1.5m and height of 0.5m. On 11 June 2019, additional rockfalls were observed (Photo 97 and Photo 98). The impacted length of the cliff line increased to approximately 20m, with eight large boulders, multiple smaller boulders and a tree observed at the base of the cliff. The largest boulder has an approximate length of 5m, width of 3m and height of 1.5m. The site experienced a 42mm rainfall event on 6 June 2019, prior to the changes being identified. DA3B_LW14_015 was revisited on 26 February 2020 and remains unchanged from previous update (Photo 99).

Photo 97: DA3B_LW14_015, an overview of the impact site.
Taken on 11/6/2019.

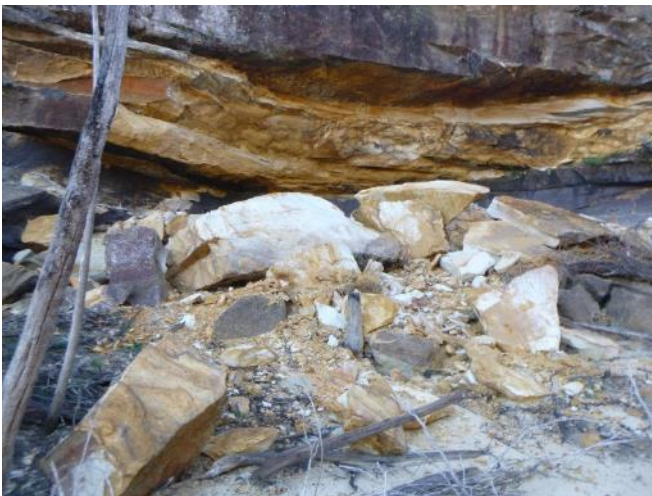
Photo 98: DA3B_LW14_015, looking at the rockfall and associated debris. Taken on 11/6/2019.

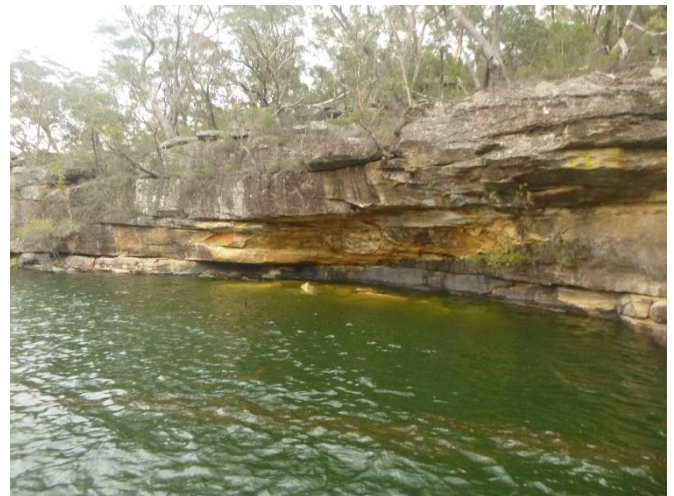
Photo 99: DA3B_LW14_015, an overview of the impact site.
Taken on 26/02/2020.

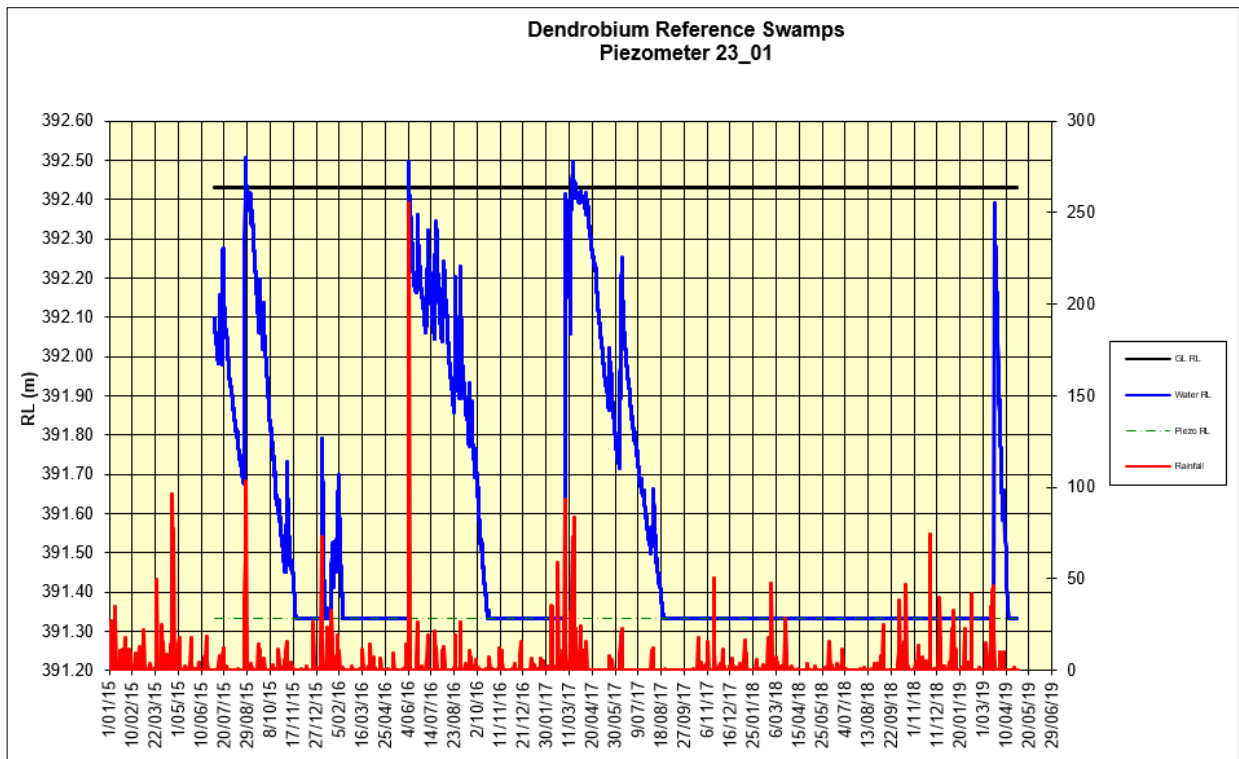
A swamp groundwater trigger was recorded at borehole 23_01 during analysis of piezometer data for Swamp 23 (Figure 2). The borehole is located 350 m from the commencing end of Longwall 15. The rate of water level recession (2.79 mm/hour calculated between 24/03/2019 3:00 and 29/03/2019 10:00) has exceeded the rate recorded before mining (0.94 mm/hour calculated between 11/06/17 3:00 and 26/06/17 19:00) (Figure 4).

Level 2: Rate of groundwater level reduction exceeds rate of groundwater level reduction during baseline period at 50% of monitoring sites (within 400 m of mining) within the swamp.

Figure 4: Shallow groundwater level at 23_01, logged hourly. Date range: 02/07/2015 to 28/04/2019.

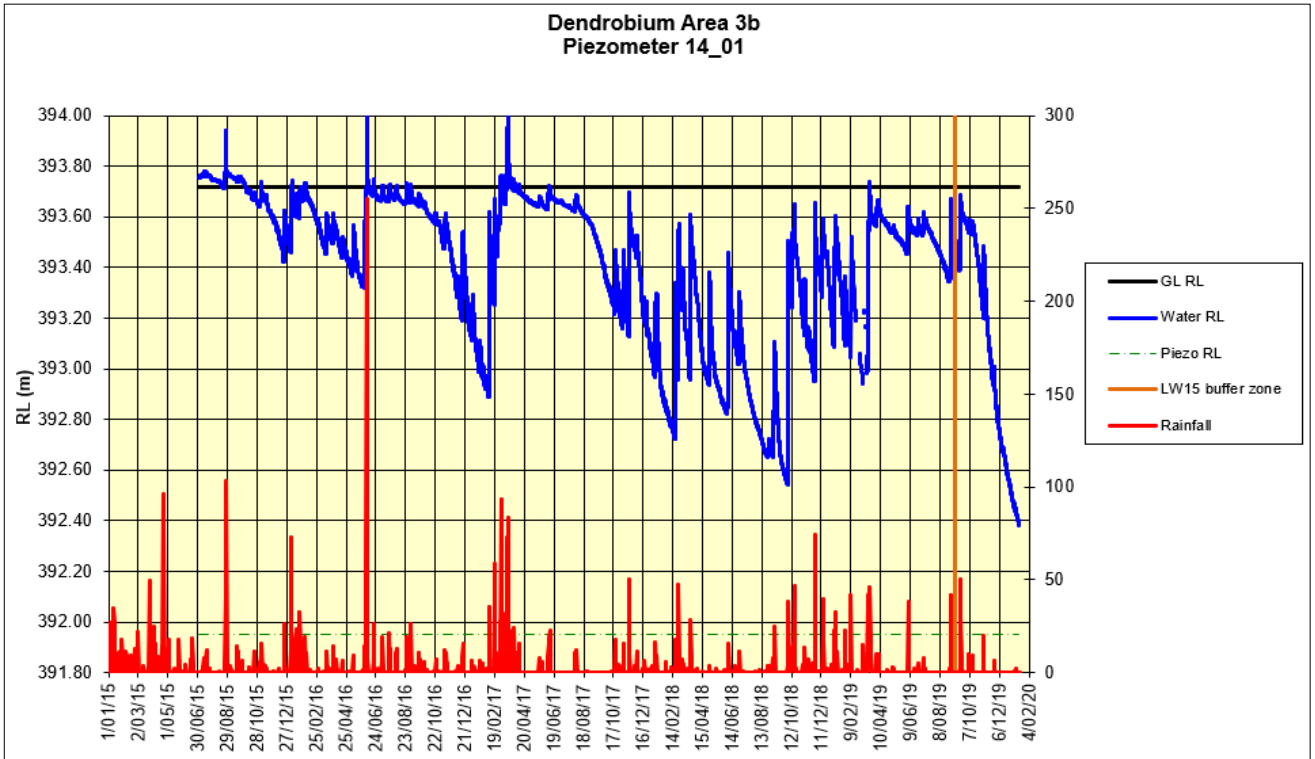
A swamp groundwater trigger was recorded at borehole 14_01 during analysis of piezometer data for Swamp 14 (Figure 2). A piezometer and datalogger were installed at site 14_01 in July 2015. This site is situated over the proposed Longwall 16 and, at its closest point, is approximately 260m south of Longwall 15. Analysis of records at piezometer 14_01 (Figure 5) show water level being lower than the lowest level recorded during the baseline period.

Level 2: Groundwater level lower than baseline level at 50% of monitoring sites (within 400 m of mining) within a swamp.

Figure 5: Shallow groundwater levels at 14_01, logged hourly. Date range: 02/07/2015 to 15/01/2020.
