END OF PANEL
LANDSCAPE REPORT
DENDROBIUM AREA 3B

DENDROBIUM AREA 3B
LONGWALL 15 END OF PANEL
LANDSCAPE REPORT
MARCH 2020

This report summarises the observed and measured subsidence effects on landscape features resulting from the extraction of Dendrobium Area 3B (DA3B) Longwall 15.

Longwall 15 is the seventh panel extracted from DA3B. Extraction began on 4 April 2019 and was completed on 22 January 2020.

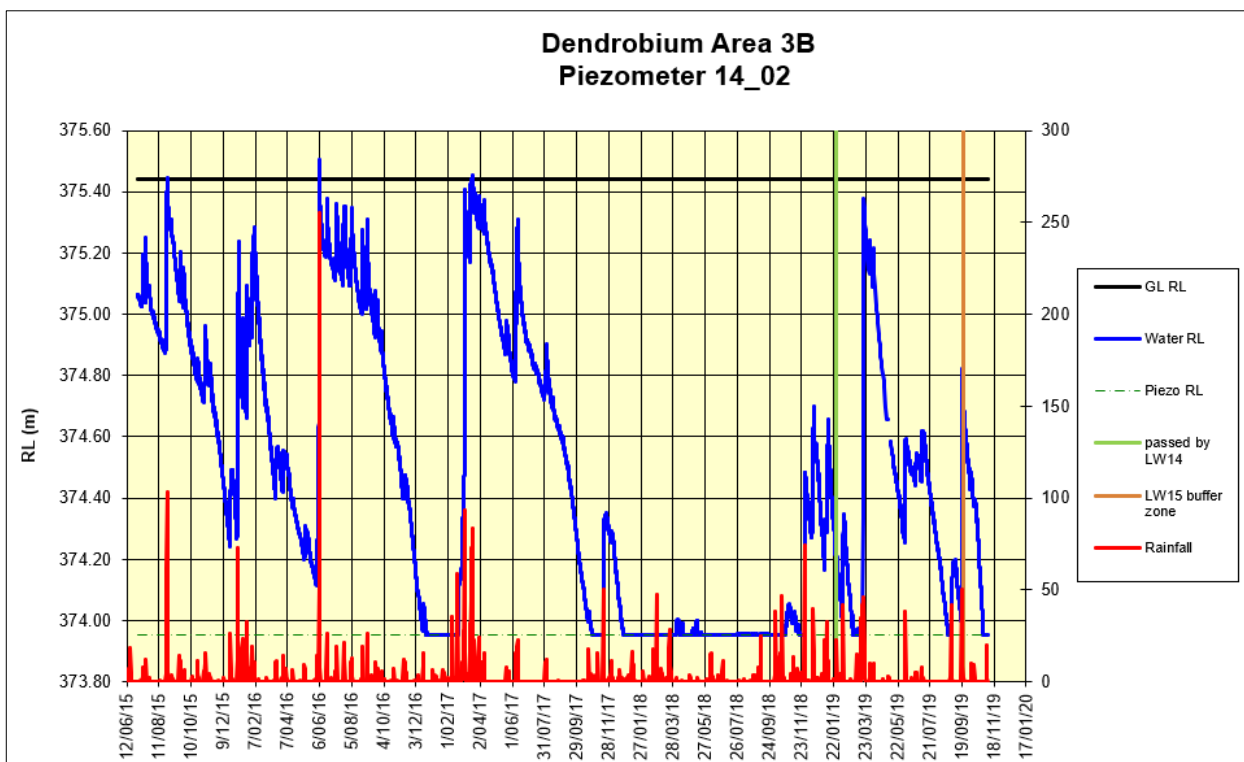
During analysis of shallow groundwater levels for borehole 14_02, changes to the rate of water level recession were observed (Figure 2). A piezometer and logger were installed in a hand-augured borehole at site 14_02 in July 2015. A rate of recession trigger was initially reported on 13 February 2019. Specialist assessment undertaken as part of the Longwall 14 End of Panel Report concluded that this trigger was not mining related as a similar effect was observed at reference swamp sites, away from the mining area (HGEO, 2019). Analysis of latest swamp groundwater levels at 14_02 show the recently recorded rate of water level recession (1.35 mm/hour calculated between 20/10/19 19:53 and 28/10/19 15:53) has exceeded the rate recorded before mining (0.64 mm/hour calculated between 9/12/2017 15:00 and 22/12/2017 14:00) (Figure 6). This rate is also greater than the recession rate reported during Longwall 14 (0.89 mm/hour calculated between 29/01/2019 11:00 and 7/02/2019 14:00).

Level 2: Rate of groundwater level reduction exceeds rate of groundwater level reduction during baseline period at 50% of monitoring sites (within 400m of mining) within the swamp.

Figure 6: Shallow groundwater levels at 14_02, logged hourly. Date range: 02/07/2015 to 31/10/2019.

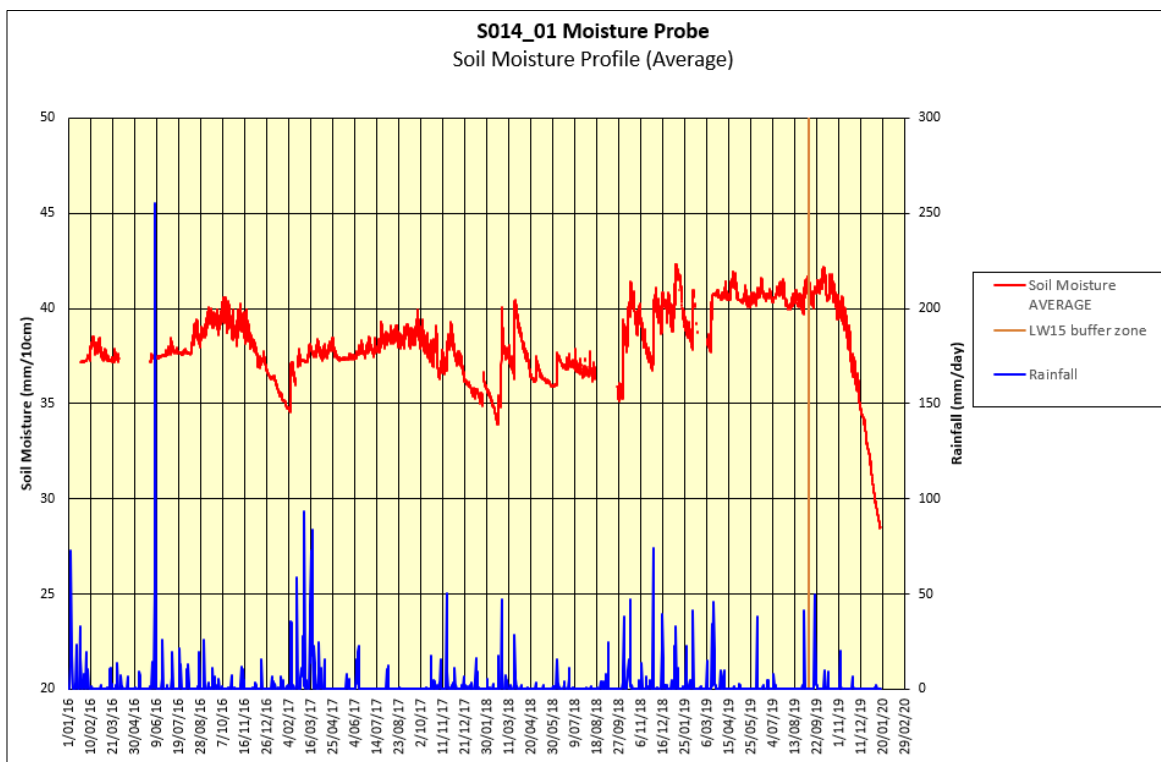
A soil moisture trigger was measured at site S14_01 during analysis of Swamp 14 soil moisture data (Figure 2). A soil moisture probe and datalogger were installed in January 2016. This site is situated over the proposed Longwall 16 and, at its closest point, is approximately 260m south of Longwall 15. Analysis of records show the average soil moisture level being lower than the lowest baseline record (Figure 7).

Level 3: Soil moisture level lower than baseline level at >80% of monitoring sites (within 400m of mining) within a swamp.

Figure 7: Average soil moisture records at S14_01, logged hourly. Date range: 22/01/2016 to 15/01/2020.

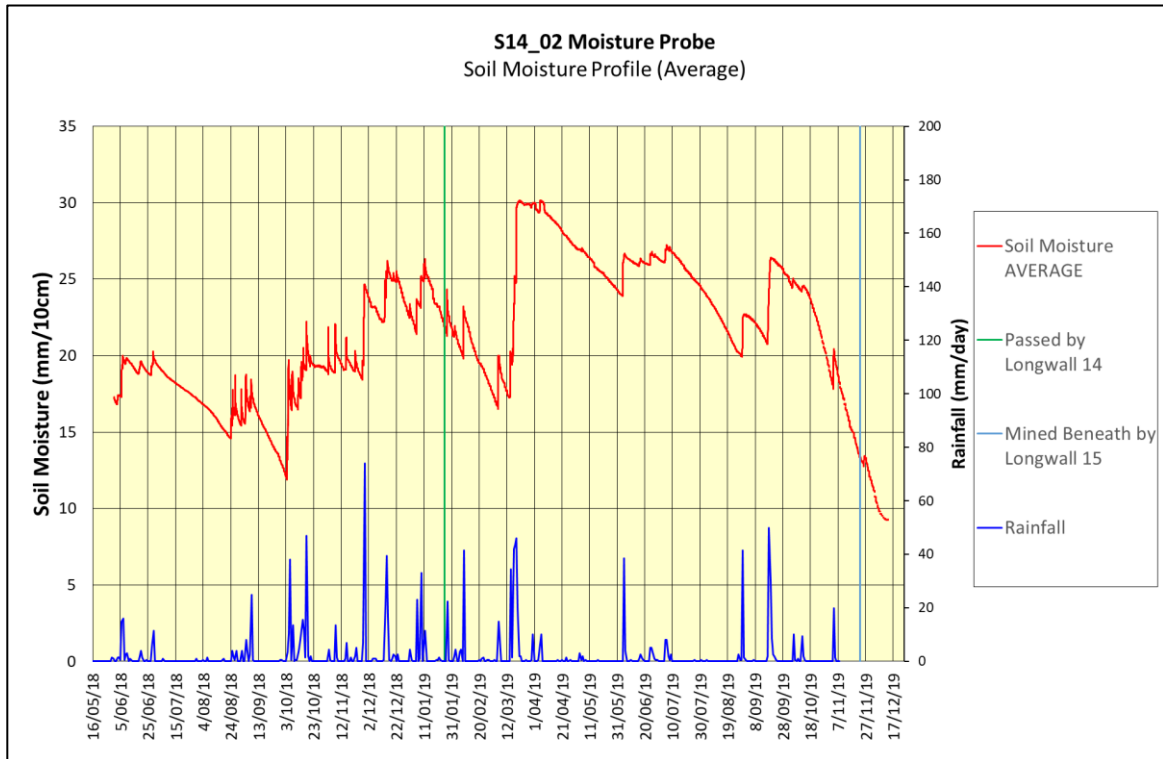
A soil moisture trigger was measured at site S14_02 during analysis of Swamp 14 soil moisture data (Figure 2). A soil moisture probe and datalogger were installed at site S14_02 in May 2018. Site S14_02 was mined beneath by Longwall 15 on 23 November 2019. Analysis of records at S14_02 show the average soil moisture level being lower than the lowest level recorded during the baseline period (Figure 8). Site S14_02 was originally reported as a Level 2 trigger according to the DA3B Swamp TARP, however has been increased to a Level 3 due to the identified trigger at S14_01.

Level 3: Soil moisture level lower than baseline level at >80% of monitoring sites (within 400m of mining) within a swamp.

Figure 8: Average soil moisture records at S14_02, logged hourly. Date range: 31/05/2018 to 13/12/2019.

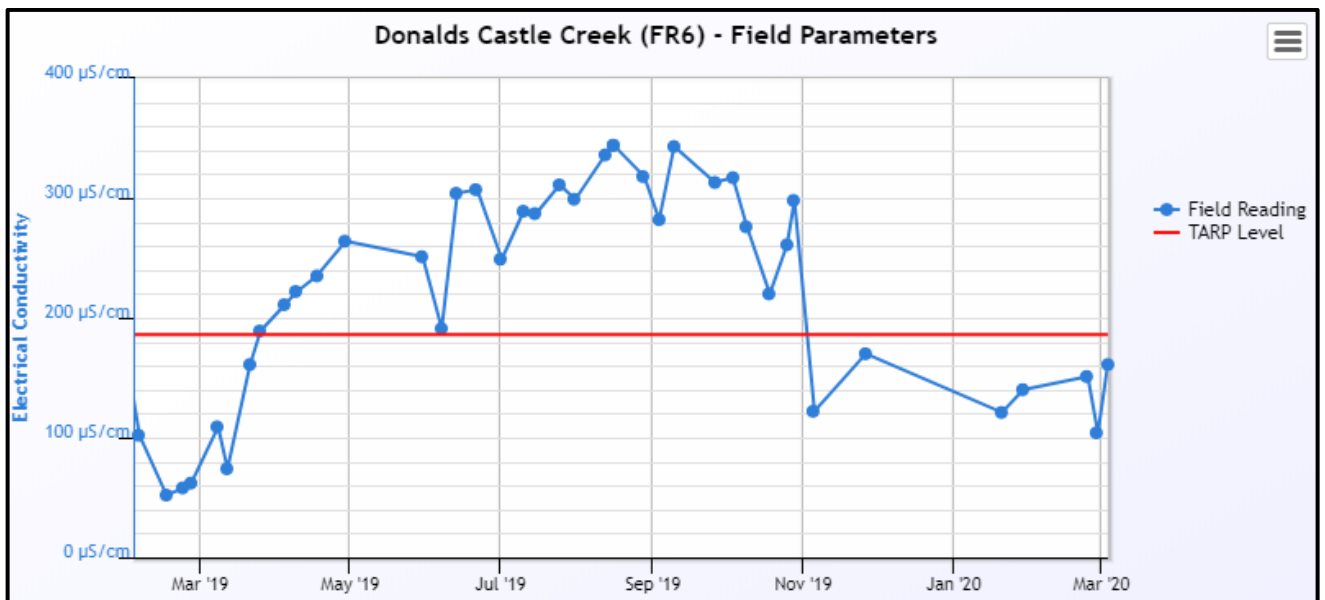
Donalds Castle Ck (FR6) is a water quality monitoring site approximately 1.4km downstream from DA3B (Figure 2). Water quality triggers for electrical conductivity (EC) were identified during inspections of the site. EC values from 25 March 2019 to 28 October 2019 exceeded the 185.8 μ S/cm trigger level for EC. The maximum EC value recorded was 344 μ S/cm on 16 August 2019 (Figure 9). EC values exceeding the trigger level have previously been recorded during the baseline monitoring period. Analysis of mining effect will be included in the specialist Surface and Shallow Groundwater Assessment.

Level 3: Three exceedances of the ± 3 standard deviation level (positive for EC, negative for pH and DO) from the baseline mean during the monitoring period:

Figure 9: Electrical conductivity recorded at Donalds Castle Creek (FR6) during Longwall 15 extraction.

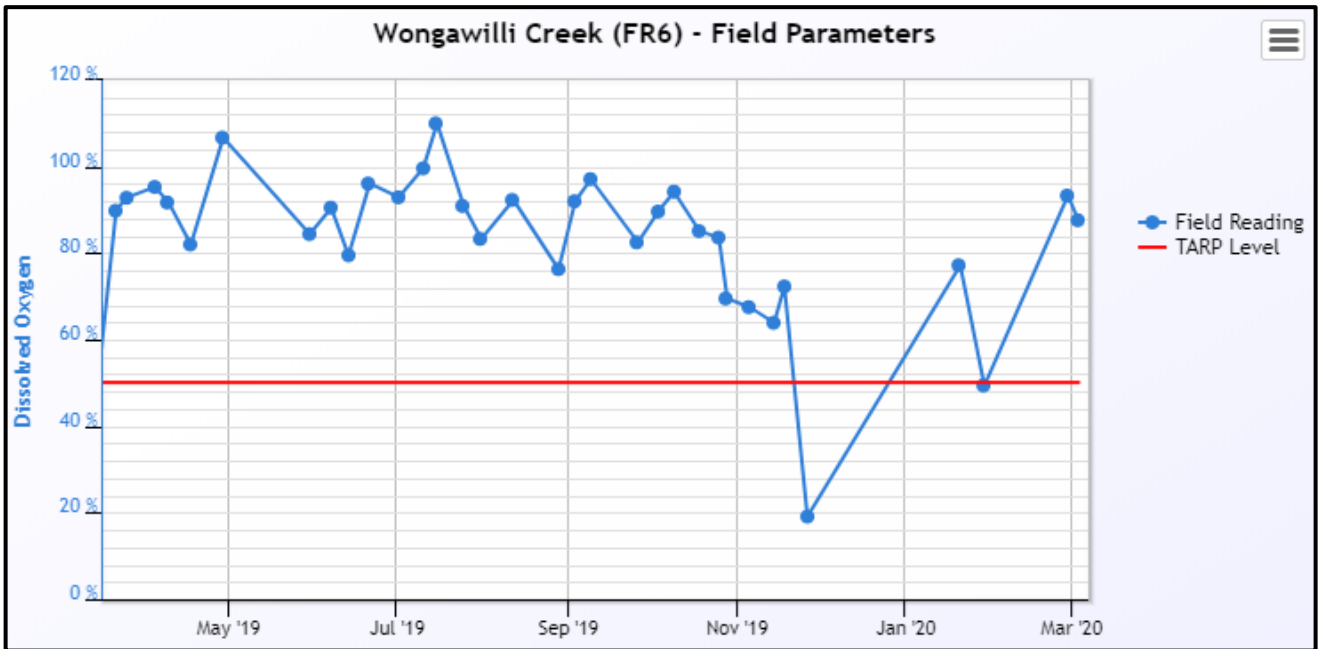
Wongawilli Ck (FR6) is a water quality monitoring site approximately 3.5km downstream from DA3B (Figure 2). During inspections, water quality triggers for dissolved oxygen (DO) and electrical conductivity (EC) were identified. Two DO readings have been recorded below the 50.5% trigger level (19.1% on 26 November 2019 and 49.4% on 29 January 2020) (Figure 10). Two EC readings have been recorded above the 154.1 μ S/cm trigger level (162 μ S/cm on 15 July 2019 and 221 μ S/cm on 26 November 2019) (Figure 11). DO and EC values outside the trigger level have previously been recorded during the baseline and mining period.

Level 2: Two exceedances of the ± 3 standard deviation level (positive for EC, negative for pH and DO) from the baseline mean during the monitoring period:

Figure 10: Dissolved oxygen recorded at Wongawilli Creek (FR6) during Longwall 15 extraction.

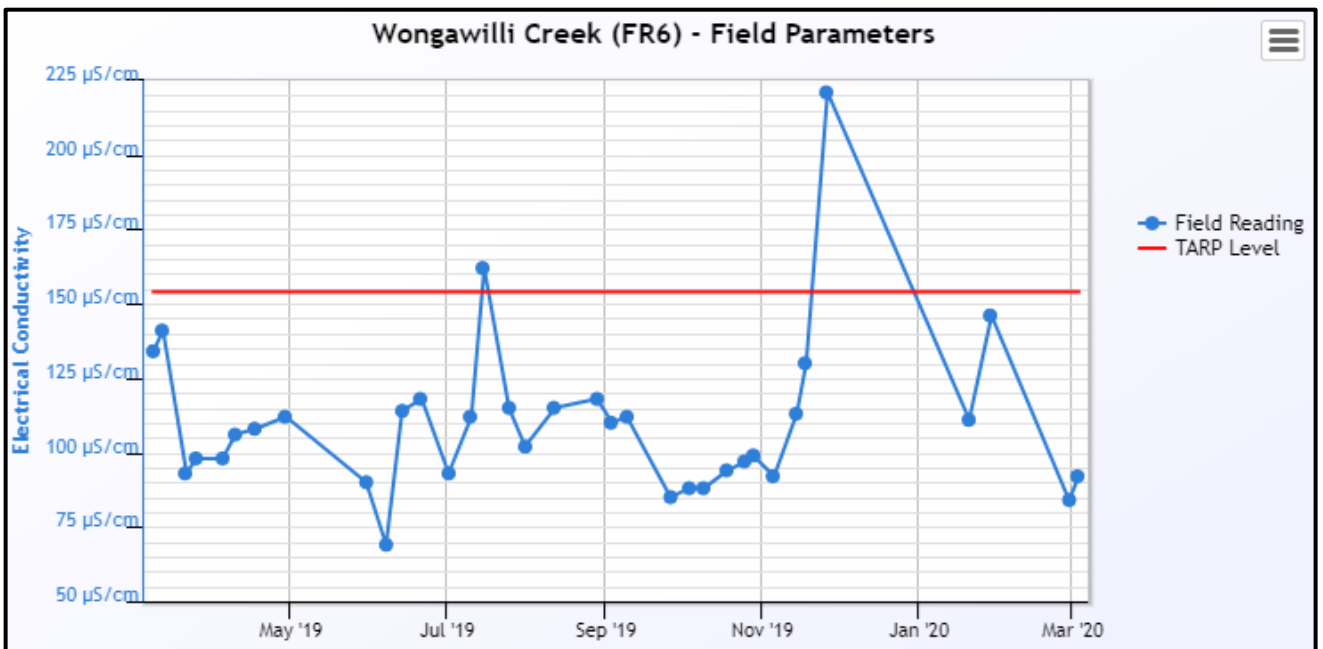
Figure 11: Electrical conductivity recorded at Wongawilli Creek (FR6) during Longwall 15 extraction.

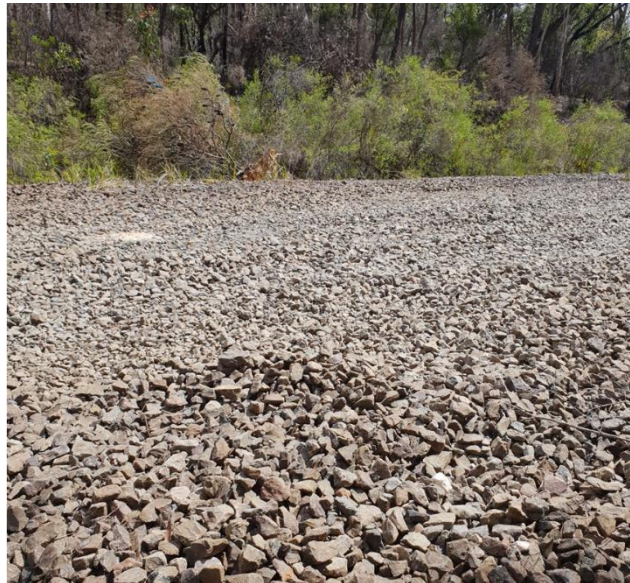
Photo 114: DA3B_LW15_011. Taken on 26/02/2020.

Following approval from WaterNSW, surface cracking across railway corridor ballast and *FR6P* was remediated. Some additional remediation was required following a large rainfall event. The latest inspection showed no further change (Photo 114). Minor soil cracks in other areas are expected to continue to infill through natural processes.

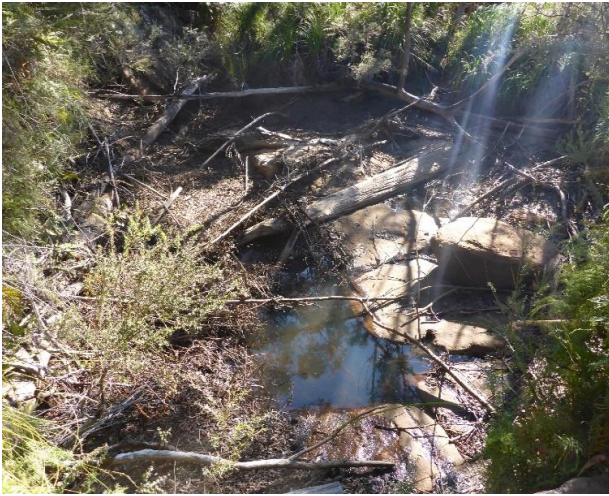
WC15_Pool 34 experienced low pool water levels during the extraction of Longwall 15 (Figure 12). Water level receded below the installed water level logger, however similar patterns have been observed during the baseline period (Photo 115 to Photo 116). Water level has since risen due to a recent rainfall event (Photo 117). No surface impacts have been observed to date. Monitoring will continue at site.

Photo 115: WC15_Pool 34, looking downstream at pool.
Taken 29/08/2018.

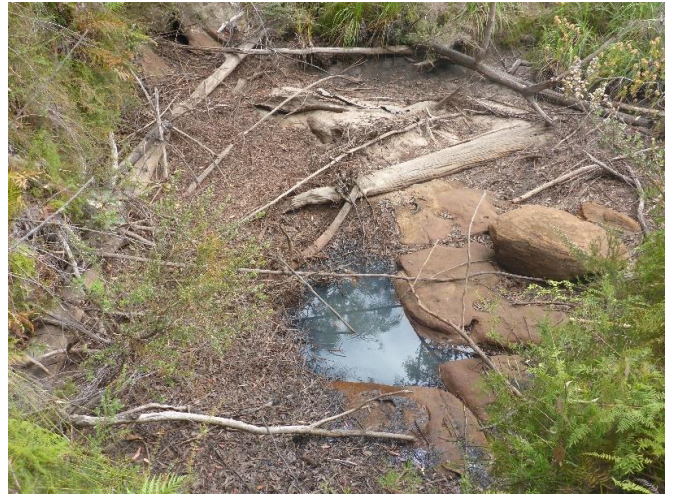
Photo 116: WC15_Pool 34, looking downstream at pool.
Taken 13/12/2019.

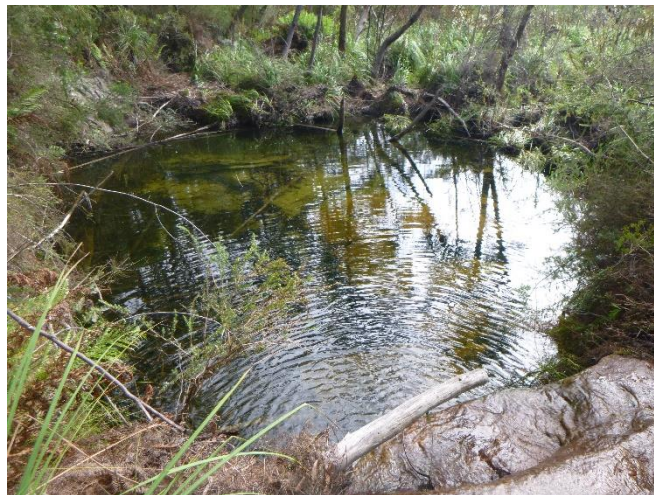
Photo 117: WC15_Pool 34, looking downstream at pool.
Taken 24/02/2020.

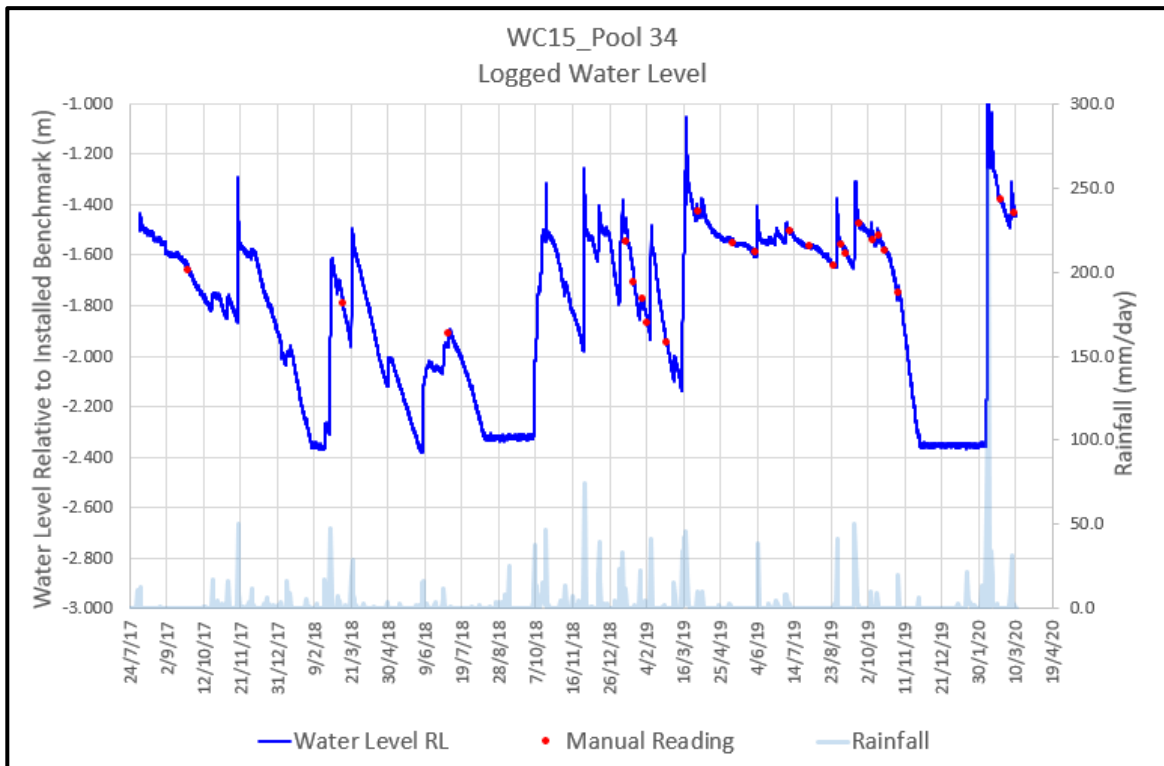
Figure 12: Water levels recorded in *WC15_Pool 34*, logged hourly. ‘Flat line’ levels indicate water level is below the installed level logger.

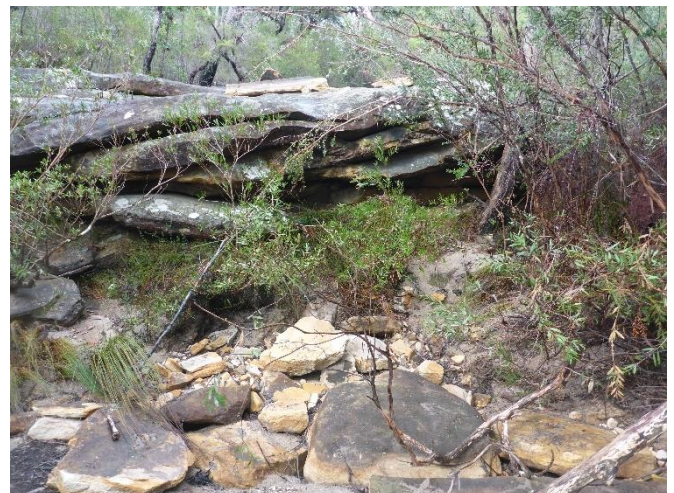
Increased rock fragmentation and displacement has been observed at *WC15*, following a heavy rainfall event (455.5mm between 8 February 2020 to 10 February 2020). Existing rock fracturing and uplift has been dislodged and displaced downstream from original site (Photo 118 and Photo 119). Monitoring will continue along *WC15* with any further changes reported.

Photo 119: *WC15_Pool 21*, looking upstream at rock debris. Taken on 10/03/2020.

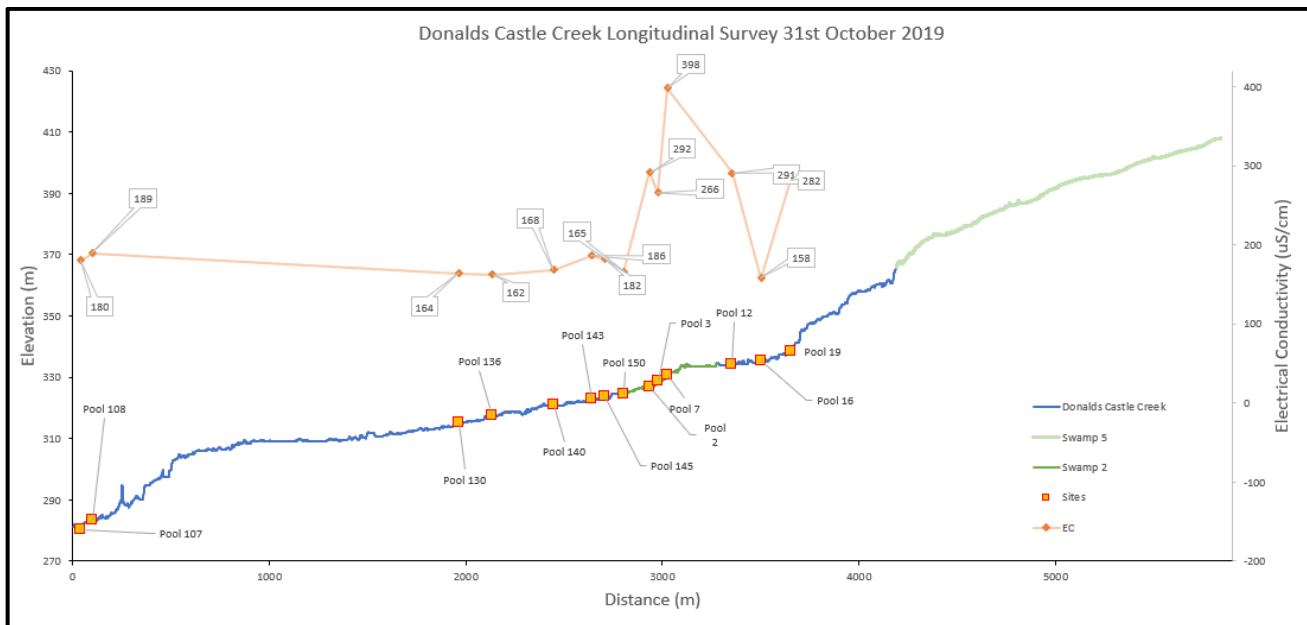
Quarterly longitudinal surveys have been conducted in pools along *Donalds Castle Creek* to identify the source of increased electrical conductivity (EC) recorded at *Donalds Castle Creek (FR6)*. The EC trigger level for *Donalds Castle Creek (FR6)* is 185.8 μ S/cm. Longitudinal surveys were completed on 31 October 2019 and 24 February 2020, including pools that are not routinely monitored. On 31 October 2019, the highest recorded EC value was in *DC_Pool 7* (398 μ S/cm), located approximately 190m upstream of *Donalds Castle Creek (FR6)* (Electrical conductivity recorded along Donalds Castle Creek on 31/10/2019.. On 24 February 2020, the highest recorded EC value was in *DC_Pool 10* (152 μ S/cm), located approximately 410m upstream of *Donalds Castle Creek (FR6)* (Figure 14). Results will be further discussed in the specialist Surface Water and Shallow Groundwater Assessment.

Figure 13: Electrical conductivity recorded along *Donalds Castle Creek* on 31/10/2019.

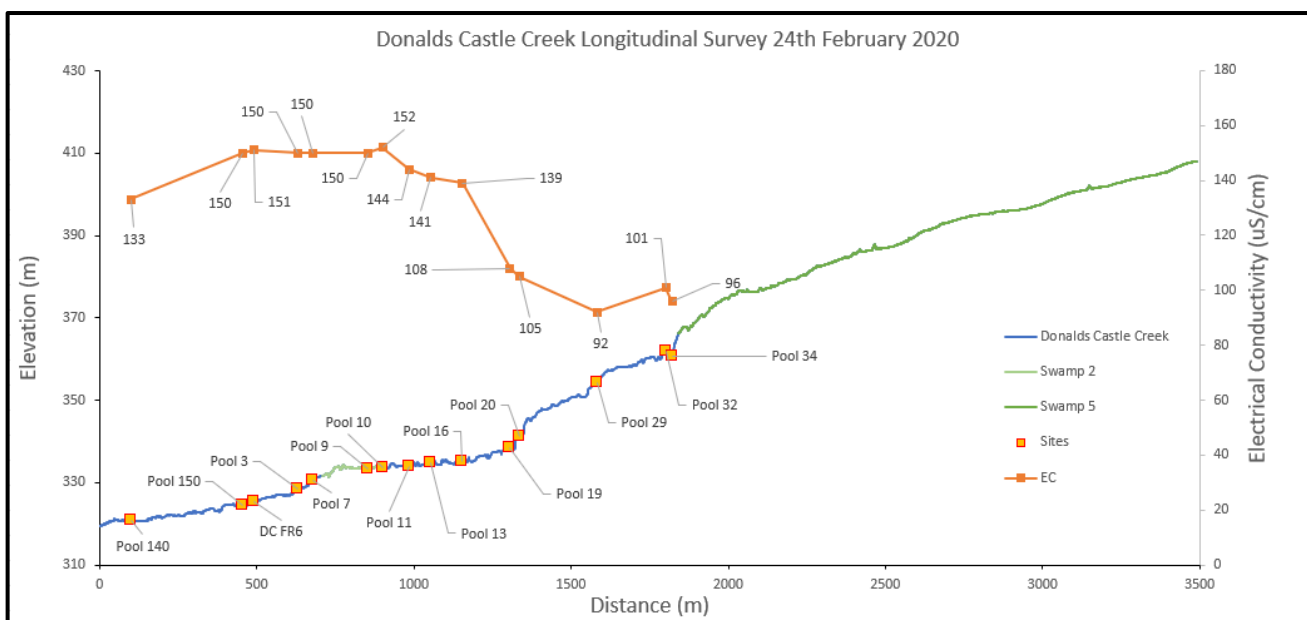
Figure 14: Electrical conductivity recorded along *Donalds Castle Creek* on 24/02/2020.
