DA3B_LW16_003 Update (E288849, N6191590)

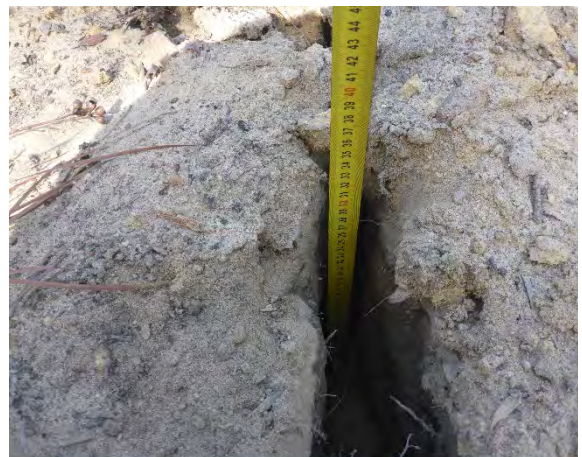
DA3B_LW16_005 is situated on an access track between *Lake Avon* and *Fire Road 6A* (Figure 1). The site was undermined by Longwall 16 on 27 March 2020. The impact is comprised soil cracking (Photo 3 to Photo 5). The soil cracking has a maximum length of 12.3m, a maximum width of 0.12m and a maximum measurable depth of 0.3m.

Photo 5: DA3B_LW16_004, looking at the depth of the soil cracking. Taken on 22/04/2020.

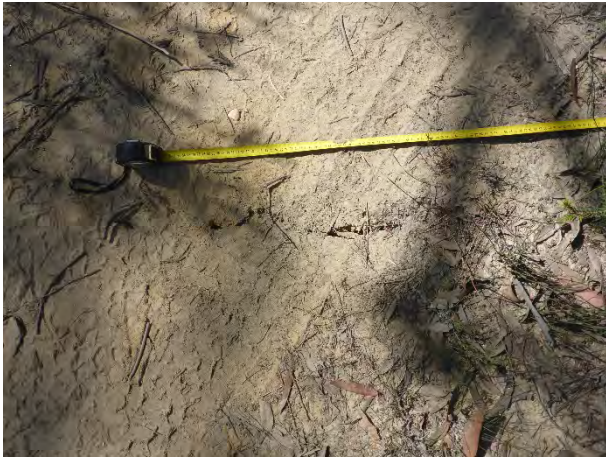
DA3B_LW16_006 is situated on an access track between *Lake Avon* and *Fire Road 6A* (Figure 1). The site was undermined by Longwall 16 on 9 April 2020. The impact is comprised of soil cracking (Photo 6 and Photo 7). The soil cracking has a maximum length of 1.8m, a maximum width of 0.05m and a maximum measurable depth of 0.05m.

DA3B_LW16_006 is a Level 1 trigger as per the *Dendrobium Area 3B Landscape TARP* (Appendix A: Table 1), specifically:

Photo 6: DA3B_LW16_006, looking at the soil cracking. Taken on 22/04/2020.

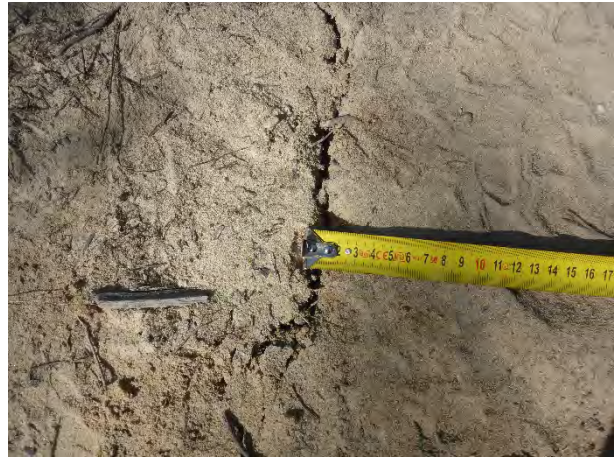
Photo 7: DA3B_LW16_006, looking at the width of the soil cracking. Taken on 22/04/2020.

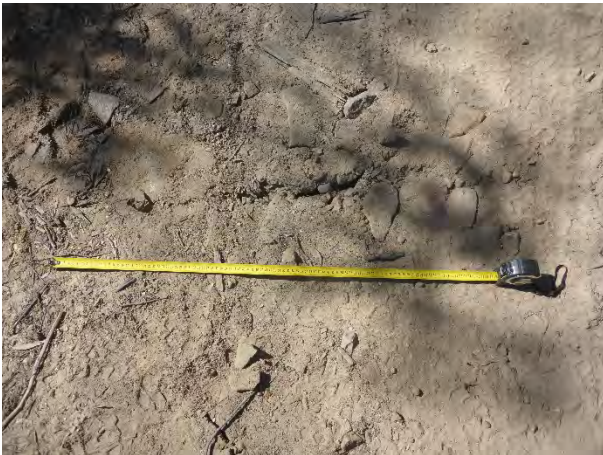
DA3B_LW16_007 is situated on an access track between *Lake Avon* and *Fire Road 6A* (Figure 1). The site was undermined by Longwall 16 on 12 April 2020. The impact is comprised of soil cracking (Photo 8 and Photo 9). The soil cracking has a maximum length of 3.5m and a maximum width of 0.02m.

DA3B_LW16_007 is a Level 1 trigger as per the Dendrobium Area 3B Landscape TARP (Appendix A: Table 1), specifically:

Photo 8: DA3B_LW16_007, looking at the soil cracking. Taken on 22/04/2020.

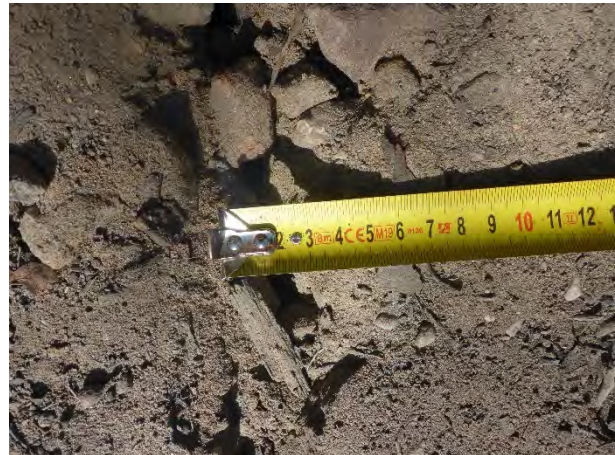
Photo 9: DA3B_LW16_007, looking at the width of the soil cracking. Taken on 22/04/2020.

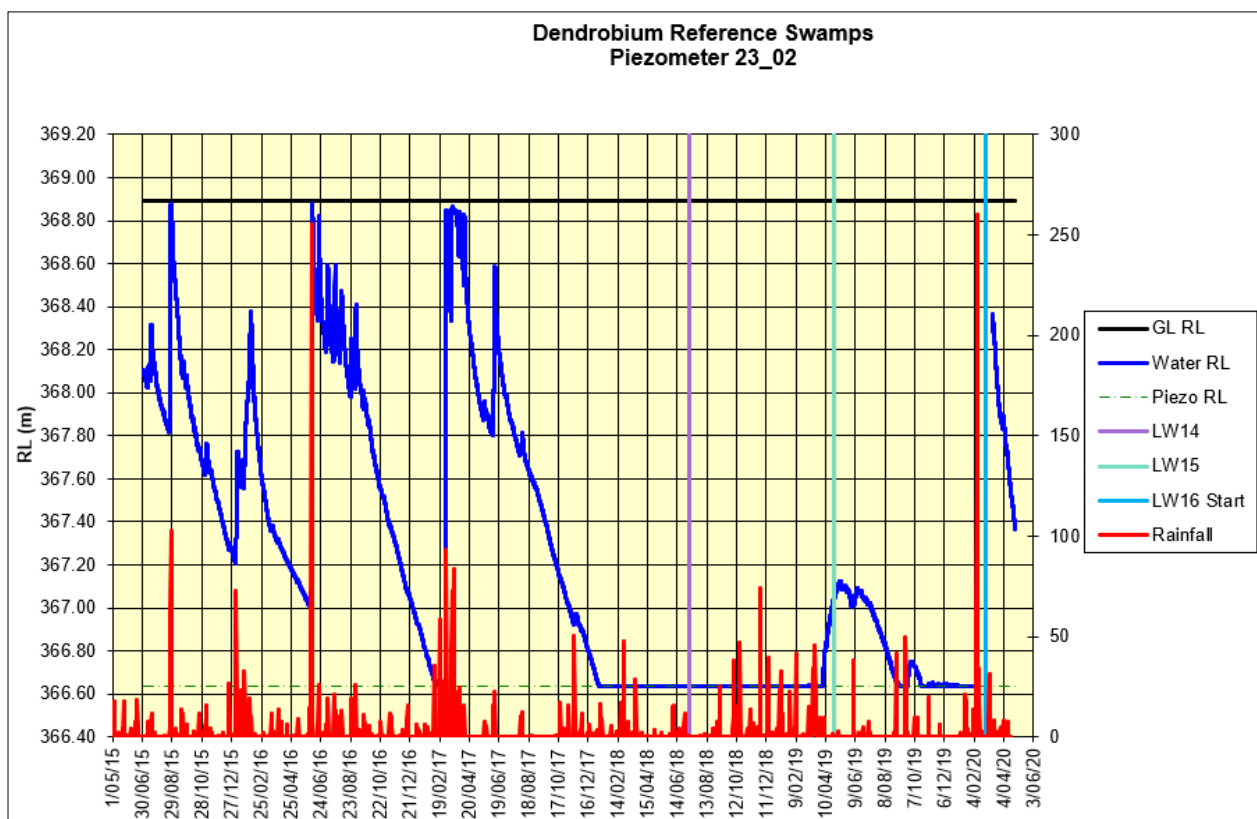
A near-surface groundwater trigger was recorded at borehole 23_02 during recent analysis of piezometer data for *Swamp 23*. The borehole is located approximately 20m to the north of Longwall 16 (Figure 1). The recent rate of water level recession (0.94 mm/hour calculated between 04/04/2020 04:00 and 27/04/2020 09:00) has exceeded the rate recorded at the same depth interval before mining (0.73 mm/hour calculated between 13/02/2016 12:00 and 14/03/2016 16:00) (Graph 1). The rate of recession trigger for borehole 23_01 was reported on 03 May 2019 during Longwall 15 extraction therefore the current groundwater results at 23_02 contribute to a Level 3 trigger according to the Dendrobium Swamps TARP (Appendix A, Table 1), specifically:

Graph 1: Near-surface groundwater levels at 23_02, logged hourly, date range: 01/05/2015 to 27/04/2020.

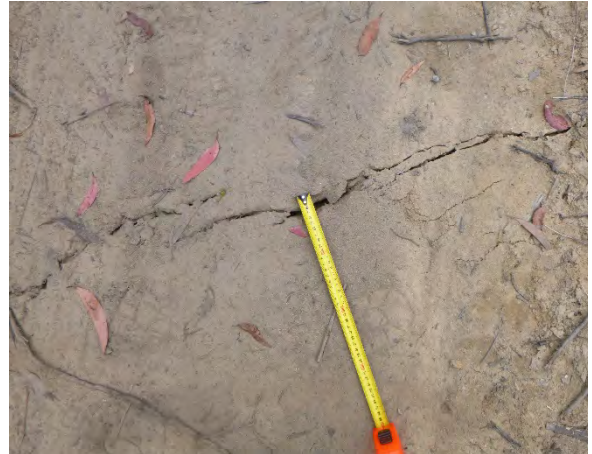
DA3B_LW16_008 is situated on an access track between *Lake Avon* and *Fire Road 6A* (Figure 1). The site was undermined by Longwall 16 on 16 April 2020. The impact is comprised of eight soil cracks within an area of 10m by 2m (Photo 1 to Photo 3). The soil cracking has a maximum length of 3.6m, a maximum width of 0.03m and a maximum measurable depth of 0.25m.

Photo 2: DA3B_LW16_008, looking at the width of the soil cracking. Taken on 27/04/2020.

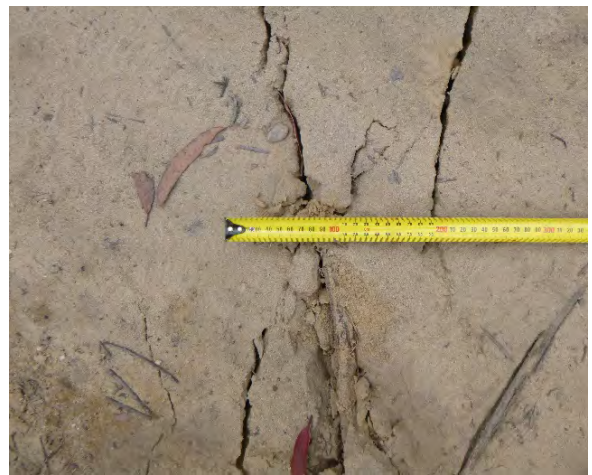
Photo 3: DA3B_LW16_008, looking at a section of the soil cracking. Taken on 27/04/2020.

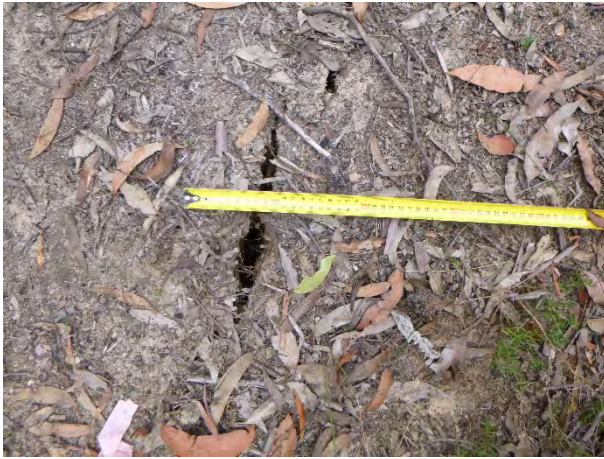
DA3B_LW16_009 is situated on a rehabilitated seismic track between *Lake Avon* and *Fire Road 6A* (Figure 1). The site was undermined by Longwall 16 on 20 April 2020. The impact is comprised of five soil cracks (Photo 4 and Photo 5). The soil cracking has a maximum length of 4.6m, a maximum width of 0.05m and a maximum measurable depth of 0.45m.

DA3B_LW16_009 is a Level 1 trigger as per the *Dendrobium Area 3B Landscape TARP* (Appendix A: Table 2), specifically:

Photo 4: DA3B_LW16_009, looking at a section of soil cracking. Taken on 27/04/2020.

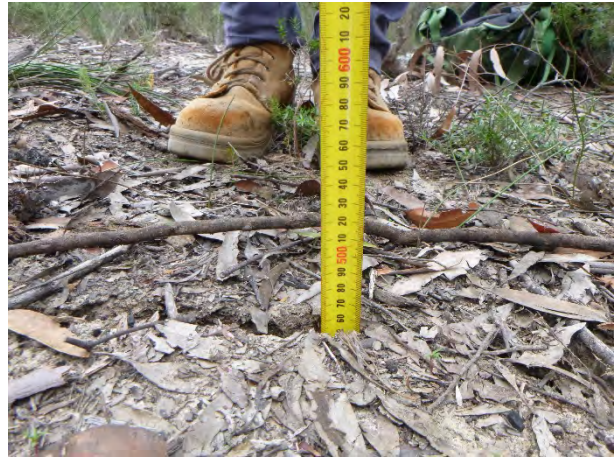
Photo 5: DA3B_LW16_009, looking at the depth of the soil cracking. Taken on 27/04/2020.

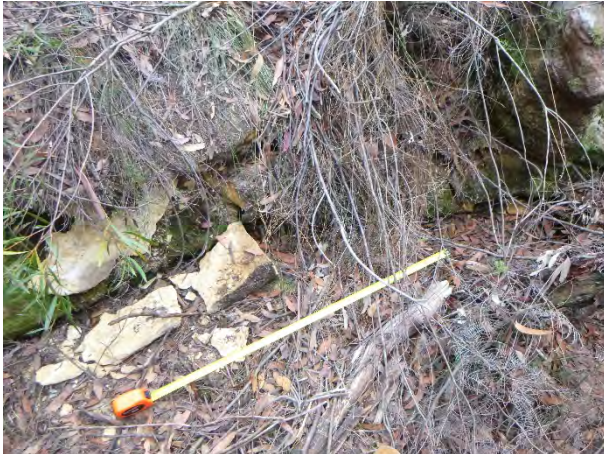
DA3B_LW16_011 is a Level 1 trigger as per the Dendrobium Area 3B Landscape TARP (Appendix A: Table 2), specifically:

Photo 8: DA3B_LW16_011, overview of the rockfall.
Taken on 27/04/2020.

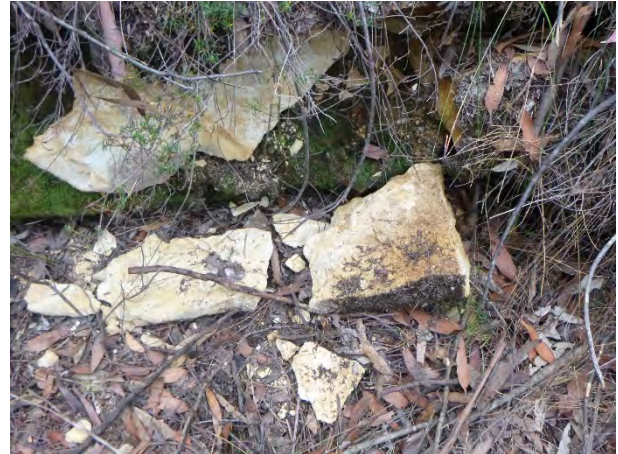
Photo 9: DA3B_LW16_011, overview of the rockfall.
Taken on 27/04/2020.

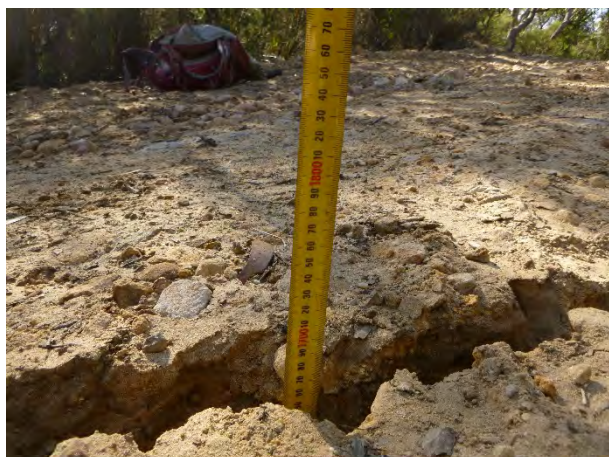
DA3B_LW16_013 is situated on an access track between *Lake Avon* and *Fire Road 6A* (Figure 1). The site was mined beneath by Longwall 16 on 24 April 2020. The impact is comprised of multiple soil cracks spanning approximately 40m in length. The soil cracking has a maximum continuous length of approximately 25m, a maximum width of 0.09m and a maximum depth of 1.67m (Photo 1 to Photo 3).

Photo 1: DA3B_LW16_013, looking at the depth of soil cracking. Taken on 12/05/2020.

The crack will be filled as part of ongoing works to the track.

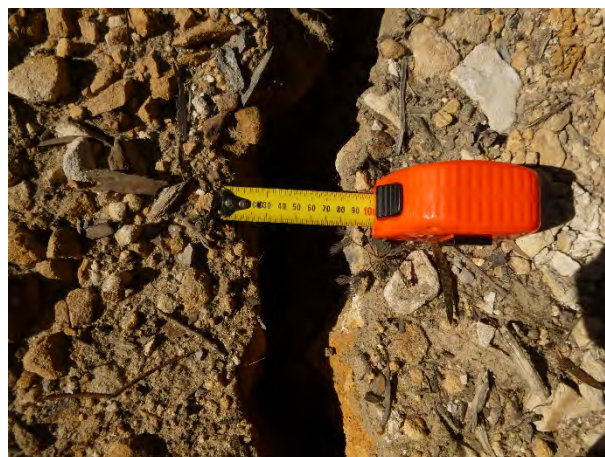
Photo 2: DA3B_LW16_013, looking at the width of soil cracking. Taken on 12/05/2020.

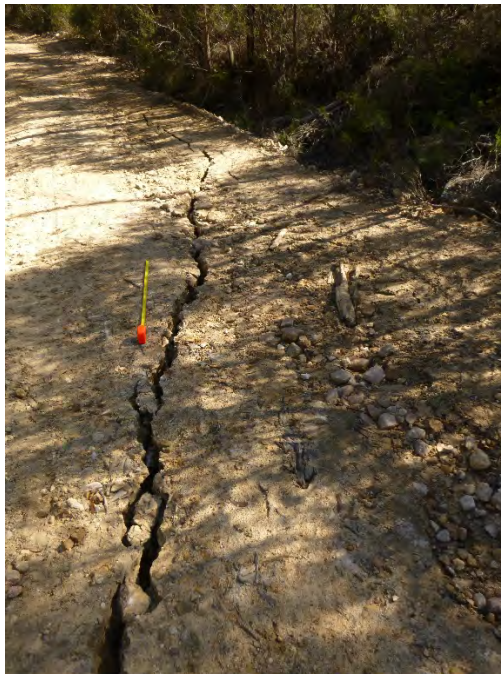
Photo 3: *DA3B_LW16_013*, looking at a section of soil cracking. Taken on 12/05/2020.

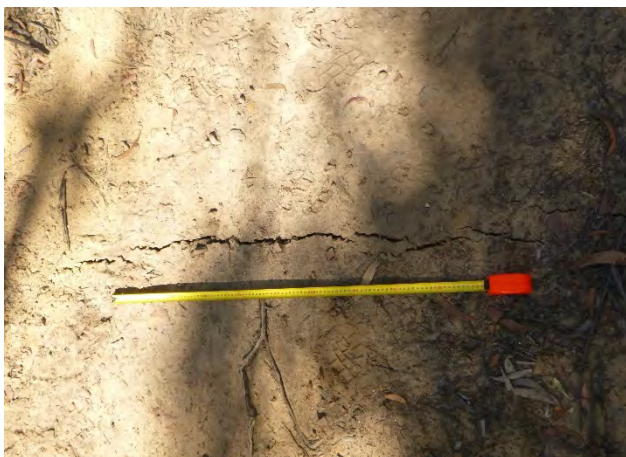
DA3B_LW16_014 is situated on an access track between *Lake Avon* and *Fire Road 6A* (Figure 1). The site was undermined by Longwall 16 on 27 April 2020. The impact is comprised of 5 soil cracks (Photo 4 and Photo 5). The soil cracking has a maximum length of 1.5m, maximum width of 0.01m and maximum measurable depth of 0.12m.

DA3B_LW16_014 is a Level 1 trigger as per the DA3B Landscape TARP (Appendix A: Table 2), specifically:

Photo 4: *DA3B_LW16_014*, looking at a section of soil cracking. Taken on 12/05/2020.

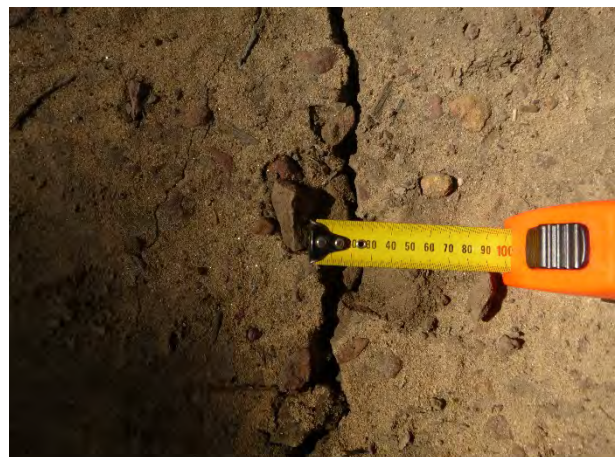
Photo 5: *DA3B_LW16_014*, looking at the width of soil cracking. Taken on 12/05/2020.

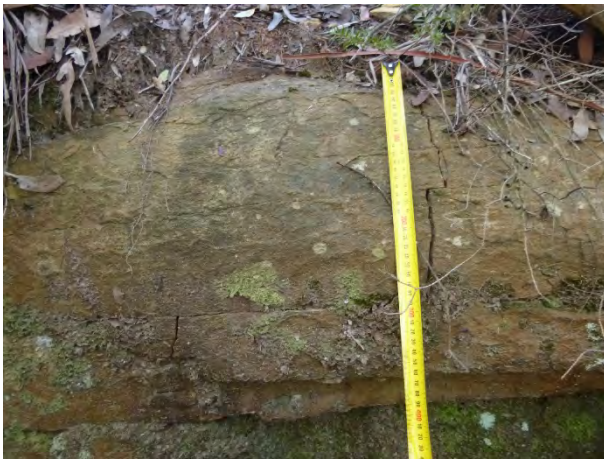
DA3B_LW15_002 is located on a 4m step adjacent to Swamp 23 (Figure 1). The site was undermined by Longwall 15 on 25 April 2019 and is located approximately 100m from the start of Longwall 16. The impact was previously reported as a rockfall. During a recent inspection additional rock fracturing was identified 5m from the rockfall (Photo 6 and Photo 7). The fracture likely occurred during Longwall 15 and has only now become visible. The rock fracturing has a maximum length of 1.3m, a maximum width of 0.005m and maximum measurable depth of 0.15m.

DA3B_LW15_002 remains a Level 1 trigger as per the DA3B Landscape TARP (Appendix A: Table 2), specifically:

Photo 6: DA3B_LW15_002, looking at a section of soil cracking. Taken on 05/05/2020.

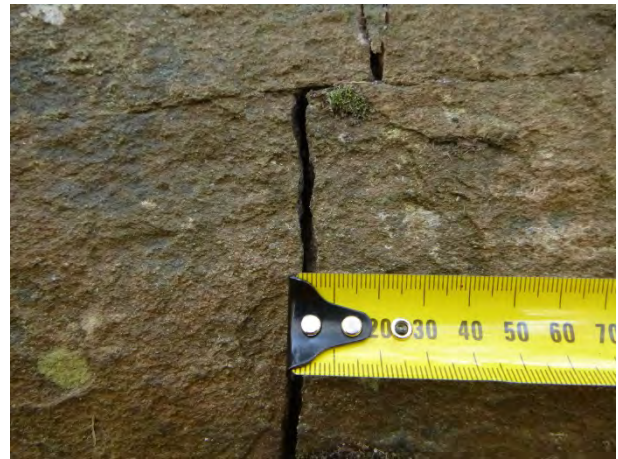
Photo 7: DA3B_LW15_002, looking at the width of soil cracking. Taken on 05/05/2020.

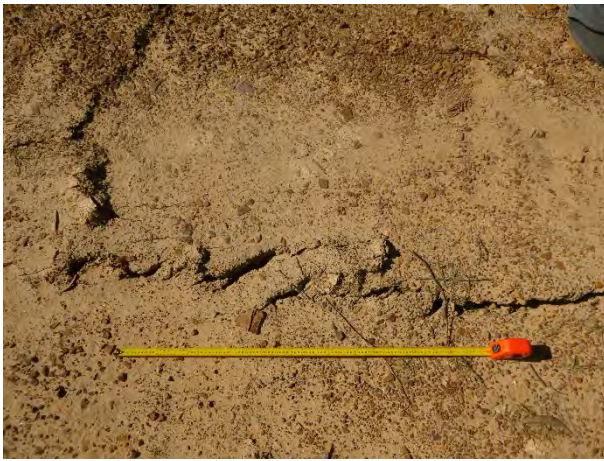
Impact DA3B_LW15_008 consists of soil cracking and uplift along Fire Road 6A (Figure 1). DA3B_LW15_008 is situated above Longwall 15, approximately 185m from Longwall 16. The site was previously remediated during road re-surfacing. During a recent inspection, soil cracking and uplift was evident. Discontinuous cracking and uplift runs for approximately 15m, with the longest continuous section is approximately 8m in length. The soil cracking has a maximum width of 0.04m, a maximum measurable depth of 0.28m and an uplift of 0.05m (Photo 8 and Photo 9). The soil cracking and uplift appear to be stable and should self-remediate over time through natural processes. Monitoring will continue at the site to identify any changes.

DA3B_LW15_008 remains a Level 1 trigger as per the DA3B Landscape TARP (Appendix A: Table 2), specifically:

Photo 8: DA3B_LW15_008, looking at a section of soil cracking and uplift. Taken on 12/05/2020.

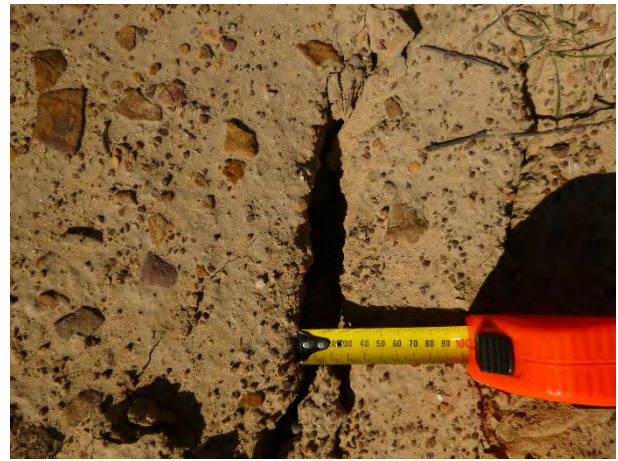
Photo 9: DA3B_LW15_008, looking at the width of soil cracking. Taken on 12/05/2020.

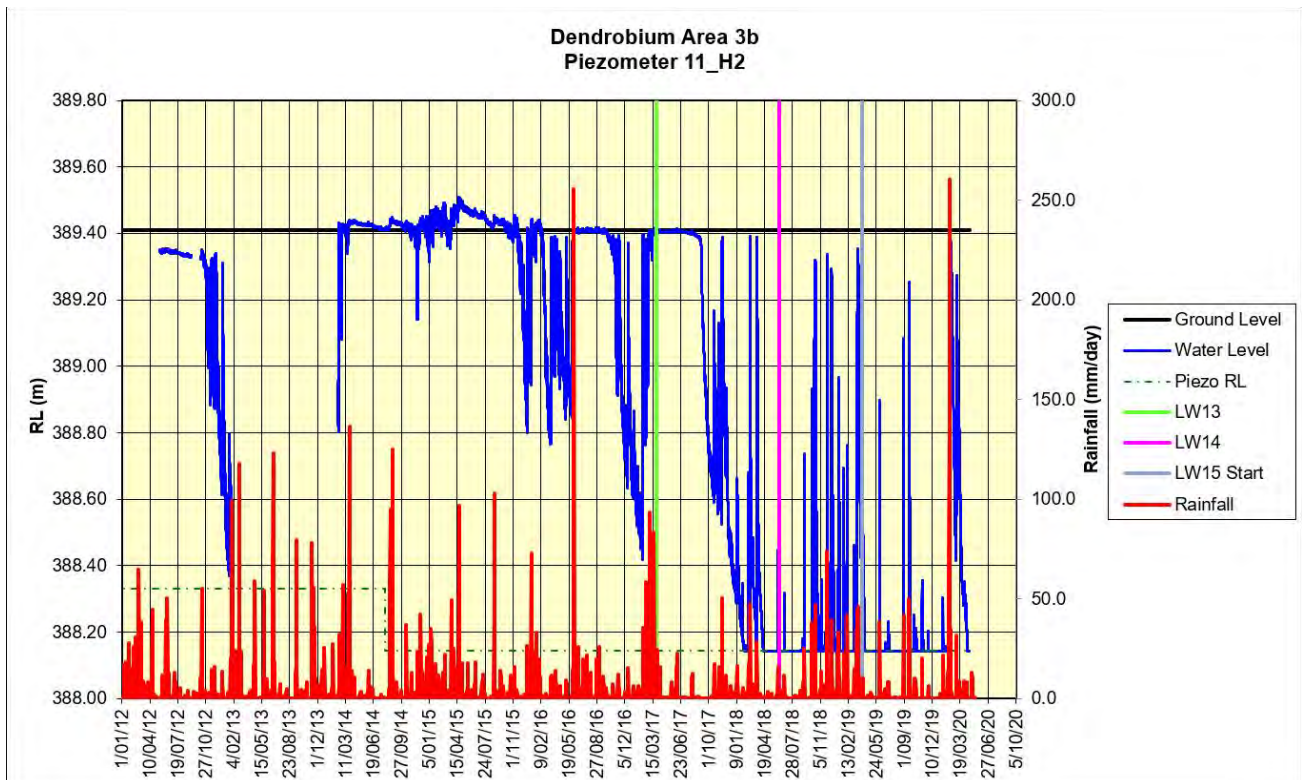
Groundwater results at 11_H1 and 11_H2 contribute to a Level 2 Trigger according to the Dendrobium Swamps Impacts, Triggers and Response (Appendix A, Table 1), specifically:

Graph 1: Near-surface groundwater levels at 11_H2, logged hourly, date range: 16/05/2012 to 20/04/2020.

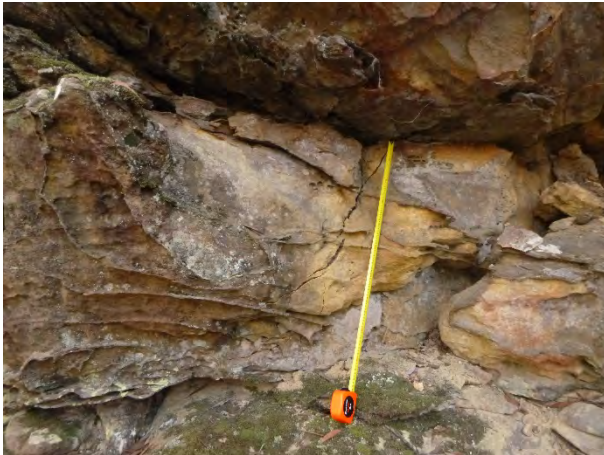
DA3B_LW16_015 is located at the base of a steep slope/step between *Lake Avon* and *Fire Road 6A* (Figure 1). The site was undermined by Longwall 16 on 9 March 2020. The impact is comprised of rock fracturing (Photo 10 and Photo 11). The rock fracturing has a length of 1.2m, a width of 0.014m and a maximum measurable horizontal depth of 0.19m.

DA3B_LW16_015 is a Level 1 trigger as per the DA3B Landscape TARP (Appendix A: Table 2), specifically:

Photo 10: DA3B_LW16_015, overview of the rock fracturing. Taken on 15/05/2020.

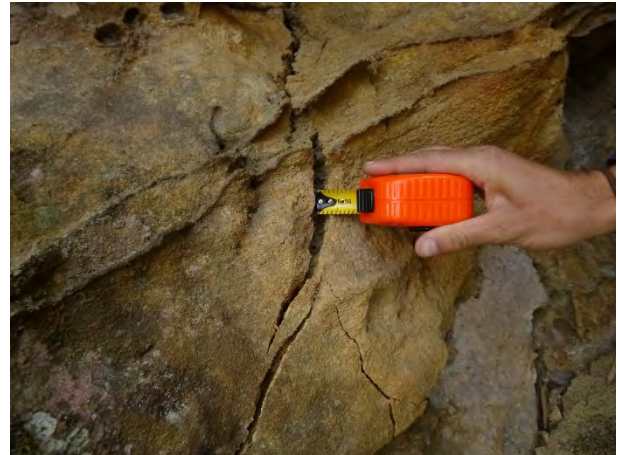
Photo 11: DA3B_LW16_015, looking at the width of rock fracturing. Taken on 15/05/2020.

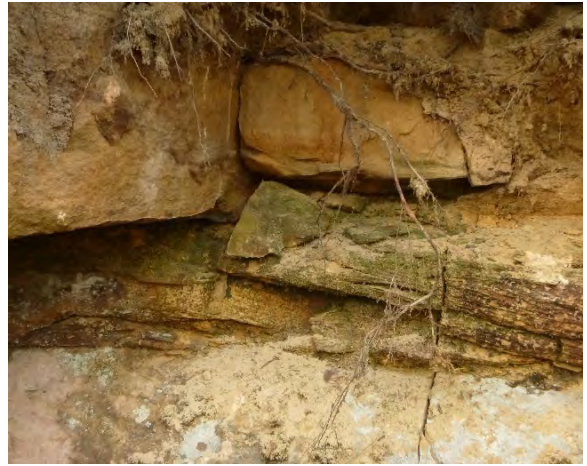
DA3B_LW16_016 is located at a steep slope/step between *Lake Avon* and *Fire Road 6A* (Figure 1). The site was undermined by Longwall 16 on 1 May 2020. The impact is comprised of a rock fall and rock fracturing (Photo 12 to Photo 14). Four boulders were dislodged from the step with the largest boulder measuring 0.8m by 0.9m by 0.5m. The rock fracturing has a length of 2m and a width of 0.015m.

Photo 13: DA3B_LW16_016 looking at a section of rock fracturing. Taken on 15/05/2020.

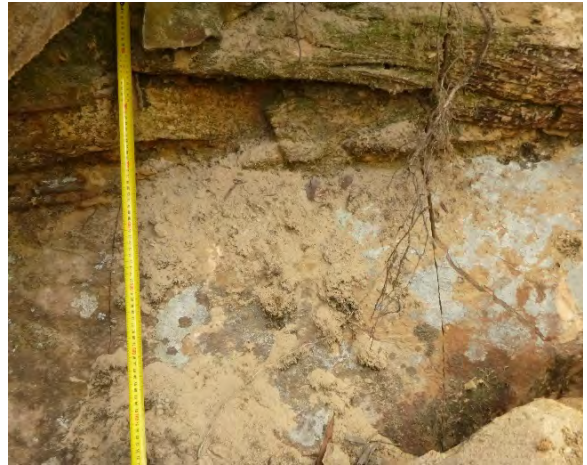
Photo 14: DA DA3B_LW16_016 looking at a section of rock fracturing. Taken on 15/05/2020.

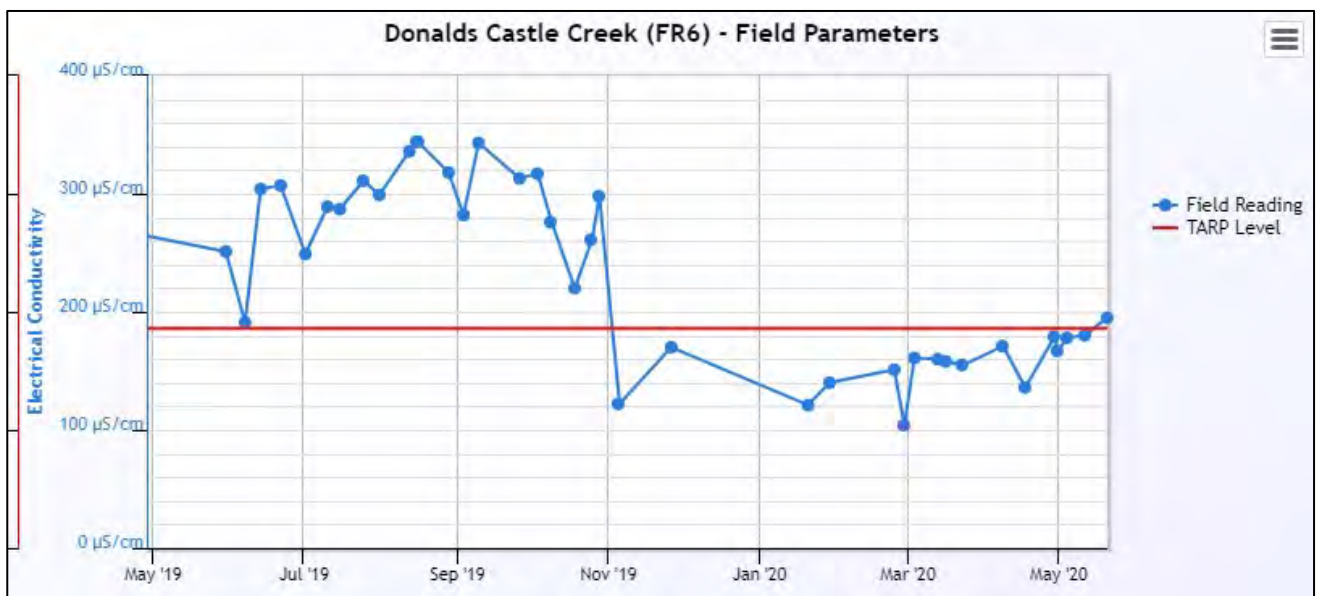
One exceedance of the ± 3 standard deviation level (positive for EC, negative for pH and DO) from the baseline mean within six months:

Graph 1: Electrical conductivity results recorded at Donalds Castle Ck (FR6) over the past year.

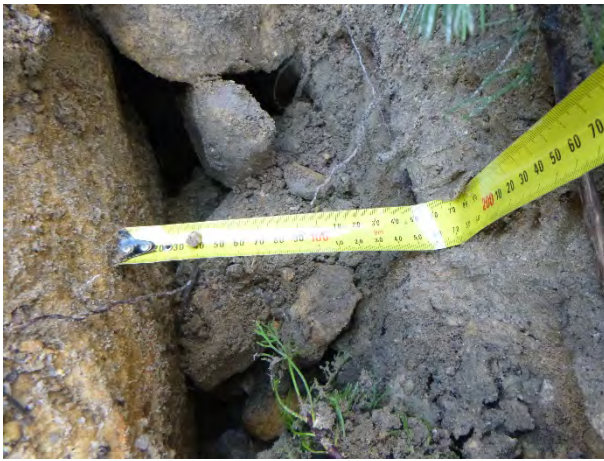
- Crack or fracture between 10 and 50m length;
- Crack or fracture between 100 and 300mm width;
- Significant erosion at any site which is not likely to naturally stabilise within the monitoring period.

Photo 1: DA3B_LW16_013, looking at the width of soil cracking. Taken on 28/05/2020.

Access to the track has been restricted until remediation is completed.

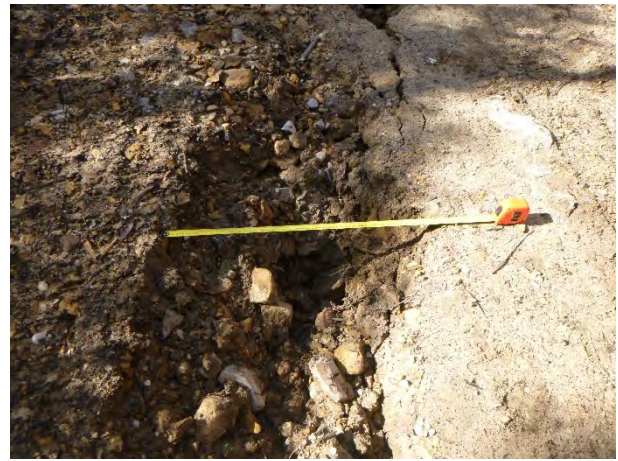
Photo 2: DA3B_LW16_013, looking at the width of surface erosion. Taken on 28/05/2020.

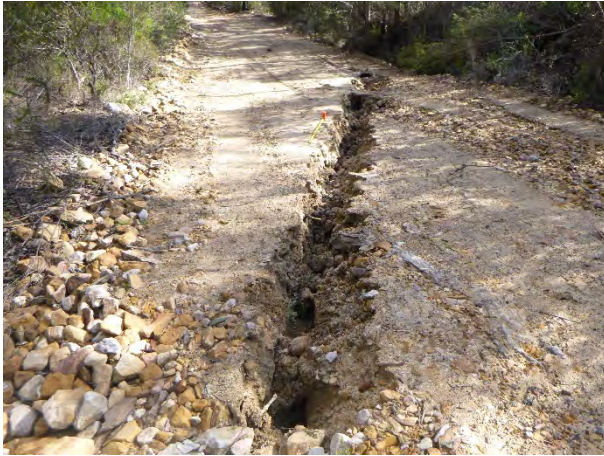
Photo 3: DA3B_LW16_013, looking at a section of soil cracking. Taken on 28/05/2020.

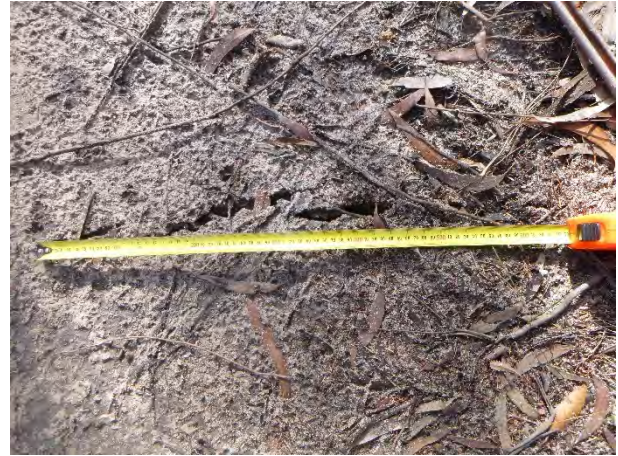
Photo 4: DA3B_LW16_013, looking at a section of soil cracking. Taken on 28/05/2020.

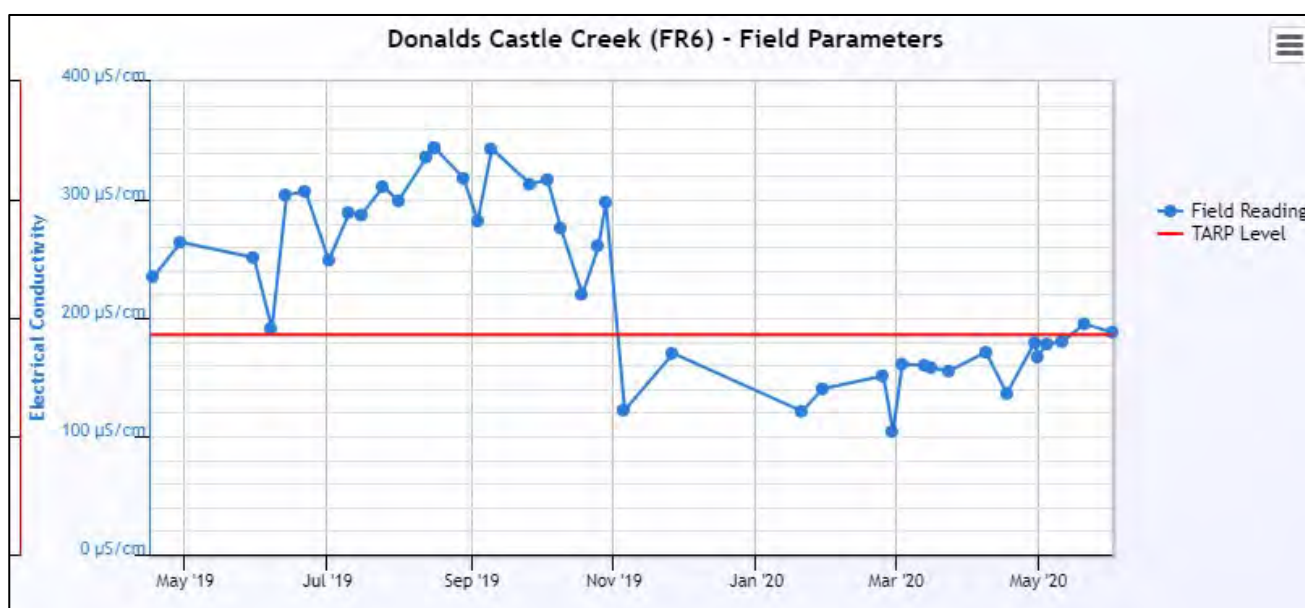
- pH 3.60
- **EC 185.8 $\mu\text{S}/\text{cm}$**
- DO 40.1%

Graph 1: Electrical conductivity results recorded at Donalds Castle Ck (FR6) over the past year.

Specialist advice on further actions is currently being sought.

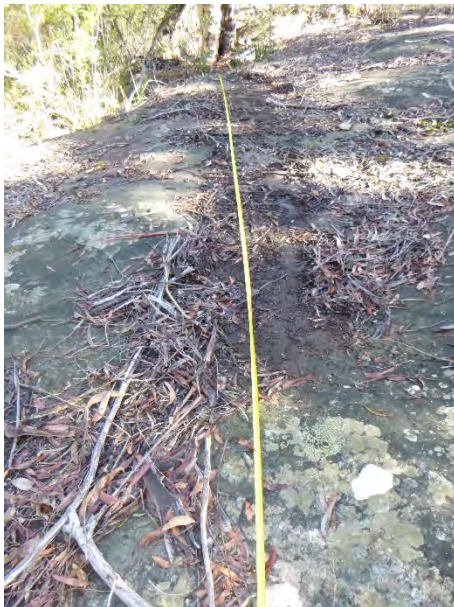
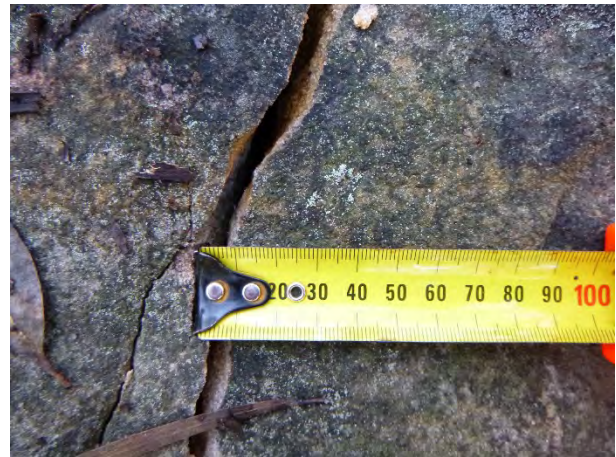
DA3B_LW16_017 is situated on a rock outcrop between *Swamp 23* and tributary *LA2* (Figure 1). The site was mined beneath by Longwall 16 on 22 April 2020. The impact is comprised of rock fracturing with a maximum length of 9m, a maximum width of 0.005m and a maximum measurable depth of 0.16m (Photo 1 and Photo 2).

DA3B_LW16_017 is a Level 1 trigger as per the DA3B Landscape TARP (Appendix A: Table 1), specifically:

- Crack or fracture up to 10m length;
- Crack or fracture up to 100mm width.

Photo 1: *DA3B_LW16_017*, looking at the length of rock fracturing. Taken on 16/06/2020.

Photo 2: *DA3B_LW16_017*, looking at width of rock fracturing. Taken on 16/06/2020.

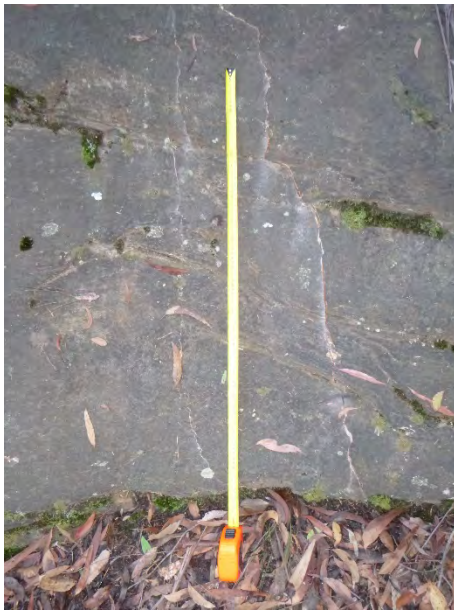
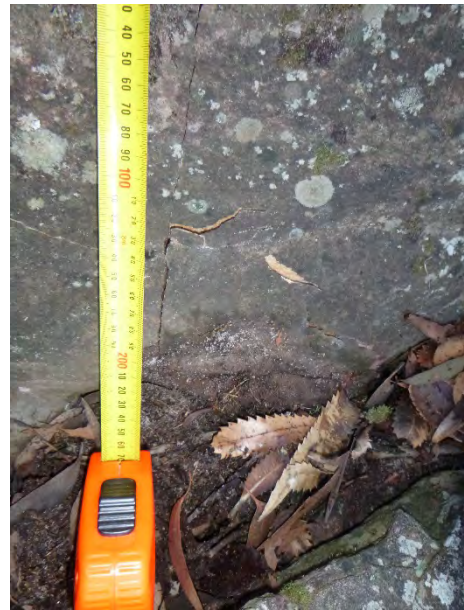
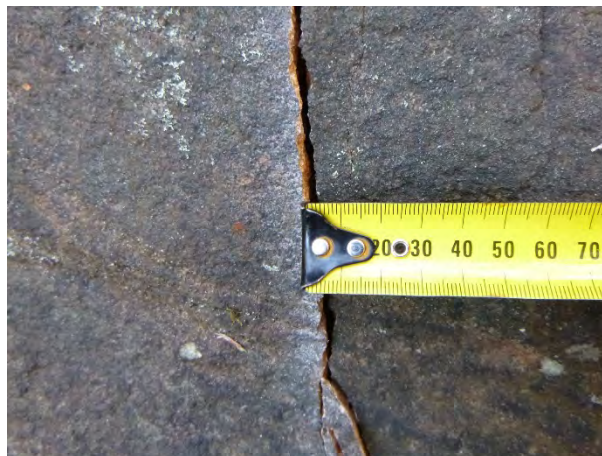
DA3B_LW16_018 is situated at Subsidence, Landscape Monitoring and Management Plan (SLMMP) Site A3b-SS16, located between Swamp 23 and tributary LA2 (Figure 1). The site was mined beneath by Longwall 16 on 6 May 2020. The impact is comprised of two rock fractures and minor rock fragmentation (Photo 3 to Photo 5). The rock fracturing has a maximum continuous length of 4.5m, a maximum width of 0.004m and a maximum measurable depth of 0.21m. The rock fragmentation has a maximum length of 0.1m and a maximum width of 0.05m.

DA3B_LW16_018 is a Level 1 trigger as per the DA3B Landscape TARP (Appendix A: Table 1), specifically:

Photo 3: DA3B_LW16_018, looking at a section of rock fracturing. Taken on 16/06/2020.

Photo 4: DA3B_LW16_018, looking at a section of rock fragmentation. Taken on 16/06/2020.

Photo 5: DA3B_LW16_018, looking at the width of rock fracturing. Taken on 16/06/2020.

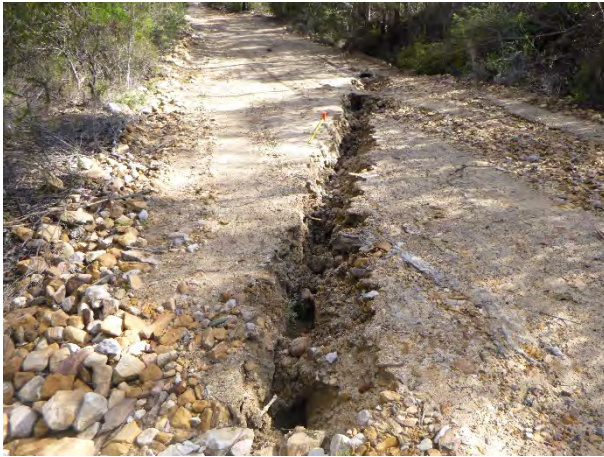
DA3B_LW16_013 is situated on an access track between *Lake Avon* and *Fire Road 6A* (Figure 1). The site was mined beneath by Longwall 16 on 24 April 2020. The impact was first identified on 12 May 2020, comprising of multiple soil cracks spanning approximately 40m in length. The soil cracking had a maximum continuous length of approximately 25m, a maximum width of 0.09m and a maximum measurable depth of 1.67m. On 28 May 2020, the maximum width of soil cracking was identified to have increased to 0.15m, with a maximum surface erosion width of 0.85m (Photo 6). On 29 May 2020, soil cracking on the access track was remediated (Photo 7).

Photo 6: DA3B_LW16_013, looking at a section of soil cracking. Taken on 28/05/2020.

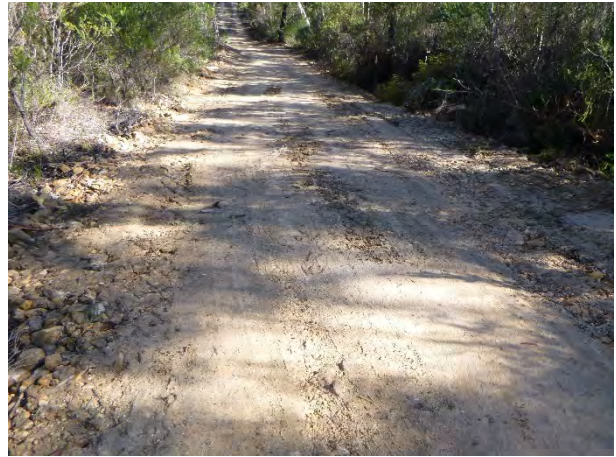
Photo 7: DA3B_LW16_013, looking at the remediated access track. Taken on 11/06/2020.

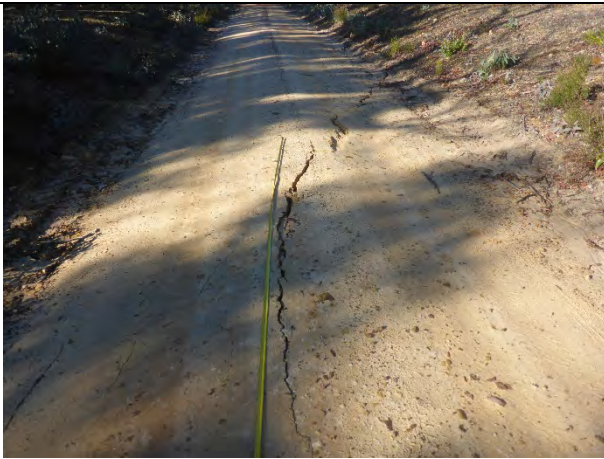
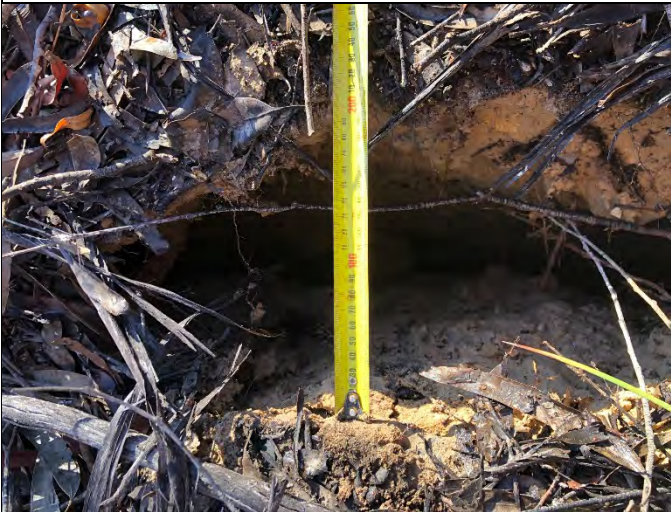
DA3B_LW16_019 consists of soil cracking located on Fire Road 6A, over Longwall 16 (Figure 1). The site was mined beneath by Longwall 16 on 10 June 2020. The impact was initially observed on 19 June 2020, with a continuous length of 7.7m, a width up to 0.07m and a measurable depth of 1.2m (Photo 1). A follow-up inspection revealed changes to the cracking, now with a continuous length of approximately 19m, maximum width of 0.21m and measurable depth of 2.4m (Photo 2 to Photo 4). The crack extends either side of Fire Trail 6A with a total discontinuous length of approximately 50m. The widest part of the cracking is located adjacent to Fire Road 6A and should not impact vehicles using the road. Flagging and signage has been placed at the site and the cracking will be remediated in the coming days, pending approval from WaterNSW. The cracking will be monitored daily until remediation is complete, once remediation is complete, monitoring will return to a weekly basis as per the SMP.

DA3B_LW16_019 is a Level 2 trigger as per the DA3B Landscape Trigger Action Response Plan (TARP) (Appendix A: Table 1), specifically:

- Crack or fracture between 10m and 50m length; and
- Crack or fracture between 100mm and 300mm width.

Photo 1: DA3B_LW16_019, looking at the length of initial cracking. Taken on 19/06/2020.

Photo 3: DA3B_LW16_019, looking at width of cracking. Taken on 23/06/2020.

- Continue monitoring program as required in the DA3B SMP;
- Report impacts to key stakeholders;
- Summarise impacts and report in the End of Panel Report and Annual Environmental Management Report;
- Provide safety signage and barricades as appropriate;
- Implement approved repairs to ensure safety and serviceability on fire trails; and
- Implement approved CMS's as required.

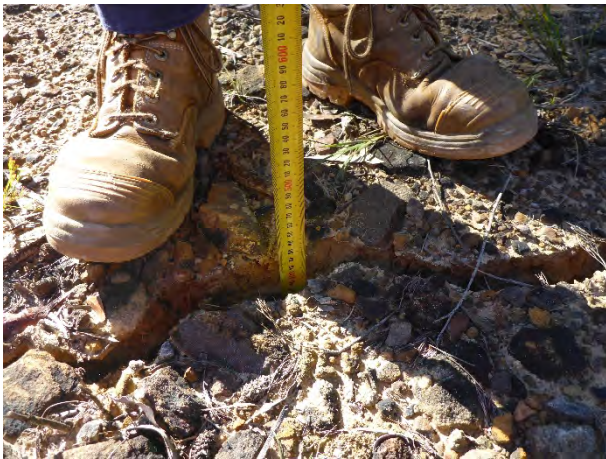
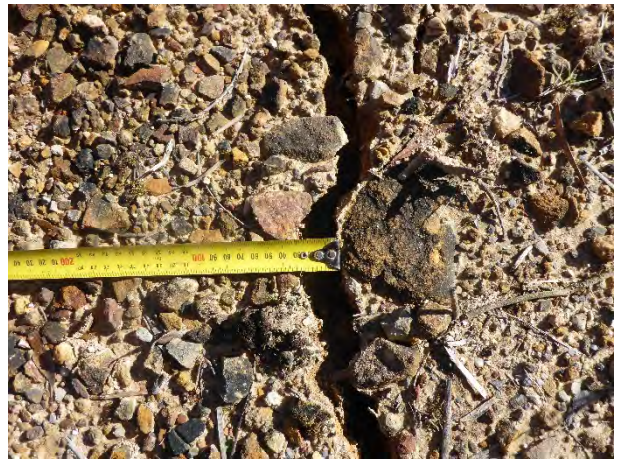
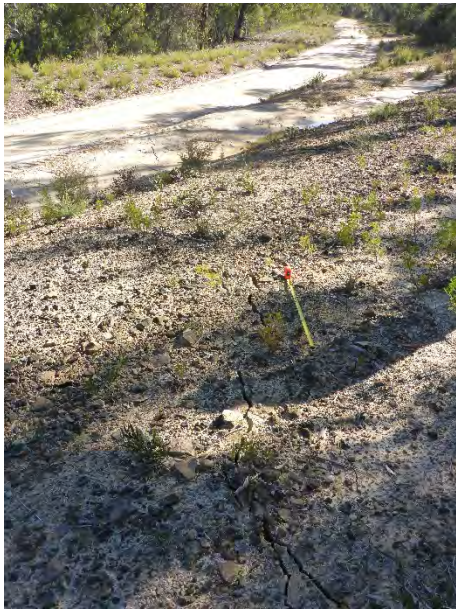
DA3B_LW16_019 consists of soil cracking located on Fire Road 6A, over Longwall 16 (Figure 1). The site was mined beneath by Longwall 16 on 10 June 2020. The impact was initially observed on 19 June 2020, with a continuous length of 7.7m, a width up to 0.07m and a maximum measurable depth of 1.2m. A follow-up inspection revealed changes to the cracking, with a continuous length of approximately 19m, maximum width of 0.21m and maximum measurable depth of 2.4m. The crack extends either side of Fire Trail 6A with a total discontinuous length of approximately 50m. On 25 June 2020, 8 additional soil cracks were identified 10m north of the initial cracking. The soil cracking has a maximum length of 2m, maximum width of 0.03m and maximum measurable depth of 0.4m (Photo 1 to Photo 3). *DA3B_LW16_019* was remediated on 29 June 2020 following approval from Water NSW (Photo 4 and Photo 5). Monitoring will continue a weekly basis as per the DA3B SMP.

DA3B_LW16_019 is a Level 2 trigger as per the DA3B Landscape Trigger Action Response Plan (TARP) (Appendix A: Table 1), specifically:

Photo 1: DA3B_LW16_019, looking at the depth of recent soil cracking. Taken on 25/06/2020.

Photo 2: DA3B_LW16_019, looking at the width of recent soil cracking. Taken on 25/06/2020.

Photo 3: DA3B_LW16_019, looking at a section of soil cracking. Taken on 25/06/2020.

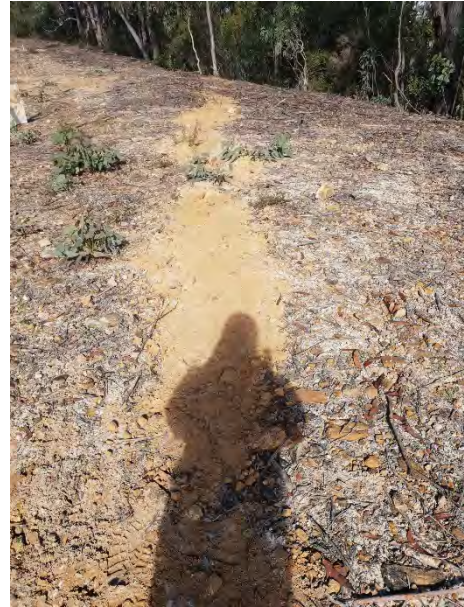
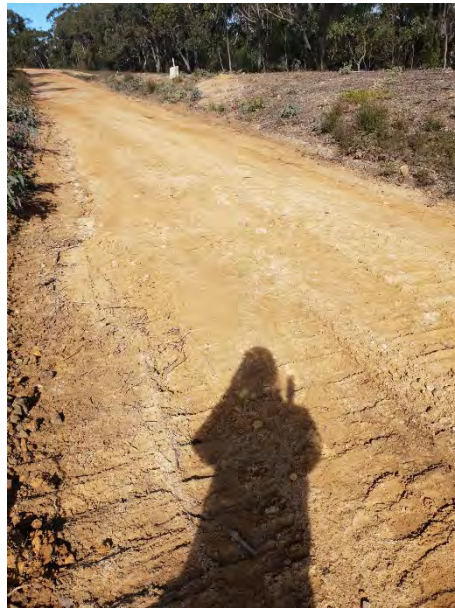
Photo 4: DA3B_LW16_019, looking along the remediated soil cracking. Taken on 29/06/2020.

Photo 5: DA3B_LW16_019, looking at the remediated soil cracking. Taken on 29/06/2020.

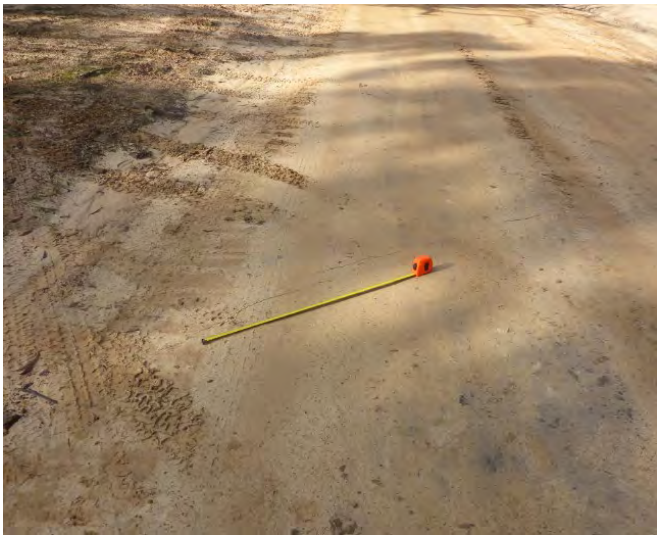
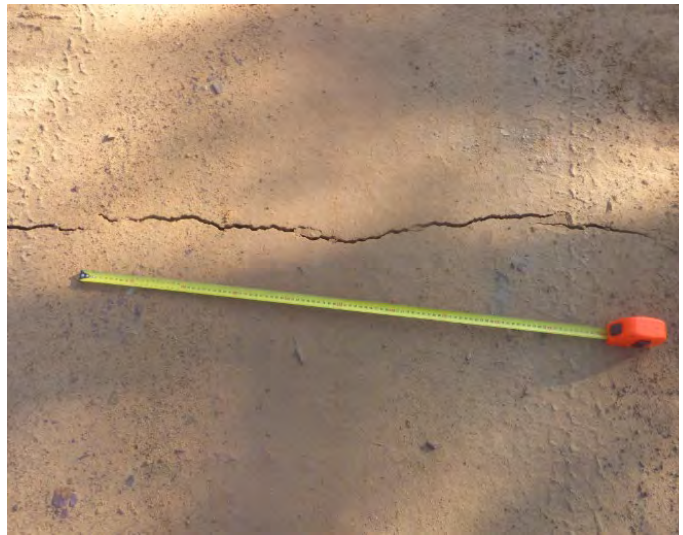
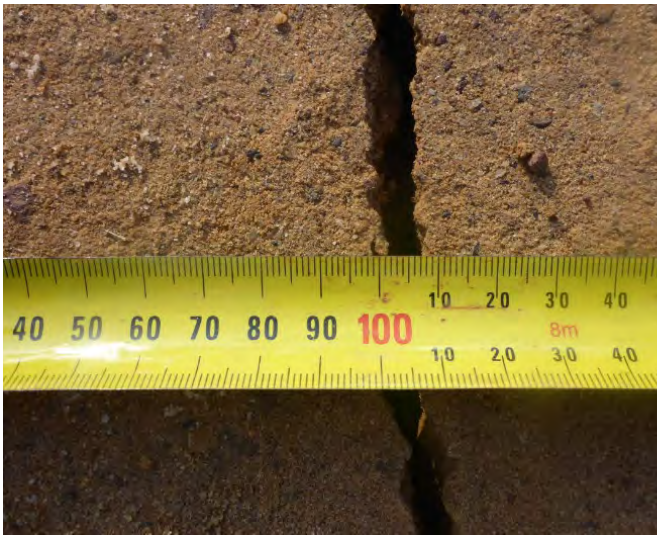
DA3B_LW16_020 consists of a series of soil cracks across Fire Road 6A, over Longwall 16 (Figure 1). The site was mined beneath by Longwall 16 on 15 June 2020. The soil cracks are up to 0.008m wide and 4m long with a measurable depth of up to 0.7m (Photo 1 to Photo 3). The cracking does not currently impede traffic or cause safety issues to field personnel walking in the area. The site will be monitored on a sub-weekly basis to identify any potential changes to the cracks.

DA3B_LW16_020 is a Level 1 trigger as per the DA3B Landscape Trigger Action Response Plan (TARP) (Appendix A: Table 1), specifically:

Photo 1: *DA3B_LW16_020*, looking at the cracking across fire road. Taken on 30/06/2020.

Photo 2: *DA3B_LW16_020*, looking at the cracking across fire road. Taken on 30/06/2020.

Photo 3: *DA3B_LW16_020*, looking at width of cracking across fire road. Taken on 30/06/2020.

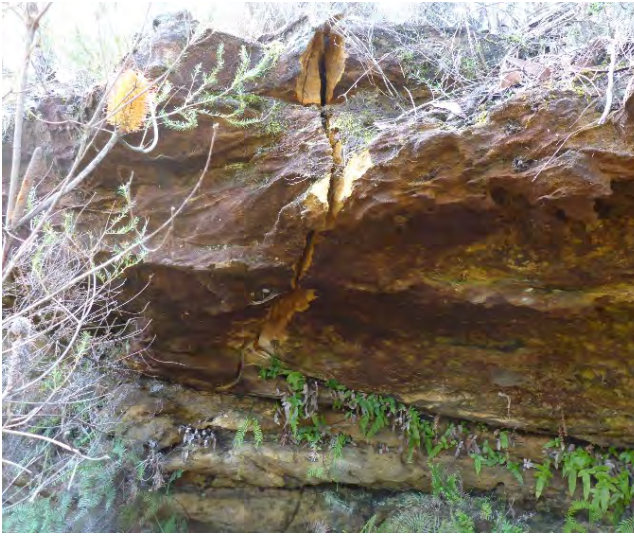
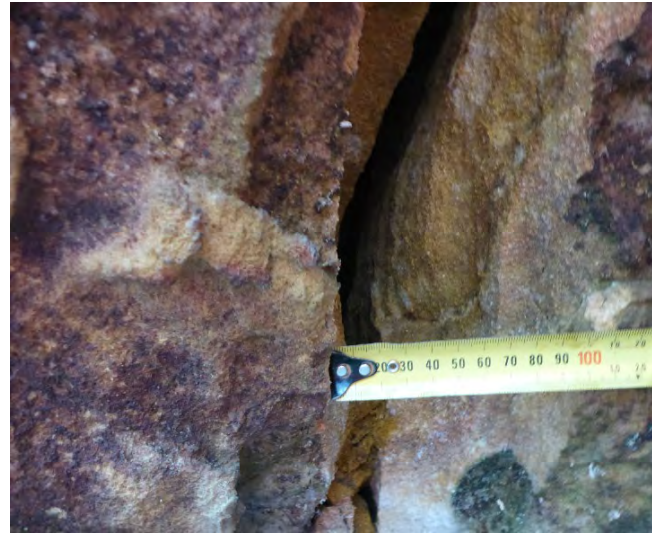
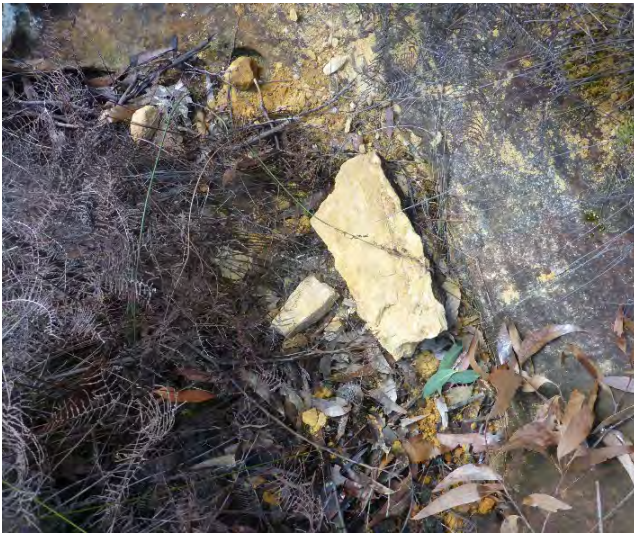
DA3B_LW16_021 consists of rock fracturing and small rockfall to a 2m high step over Longwall 16 (Figure 1). The fracture is approximately 2m long, 0.12m wide and has a measurable depth of approximately 1m (Photo 4 and Photo 5). The largest rock fragment fallen from step is 0.35m long, with several smaller pieces also observed (Photo 6).

DA3B_LW16_021 is a Level 2 trigger as per the DA3B Landscape Trigger Action Response Plan (TARP) (Appendix A, Table 1), specifically:

Photo 4: *DA3B_LW16_021*, looking at fracture down step. Taken on 30/06/2020.

Photo 5: *DA3B_LW16_021*, looking at width of fracture on step. Taken on 30/06/2020.

Photo 6: *DA3B_LW16_021*, looking at small rock fragments fallen from step. Taken on 30/06/2020.
