DA3B_LW16_003 Update (E288849, N6191590)

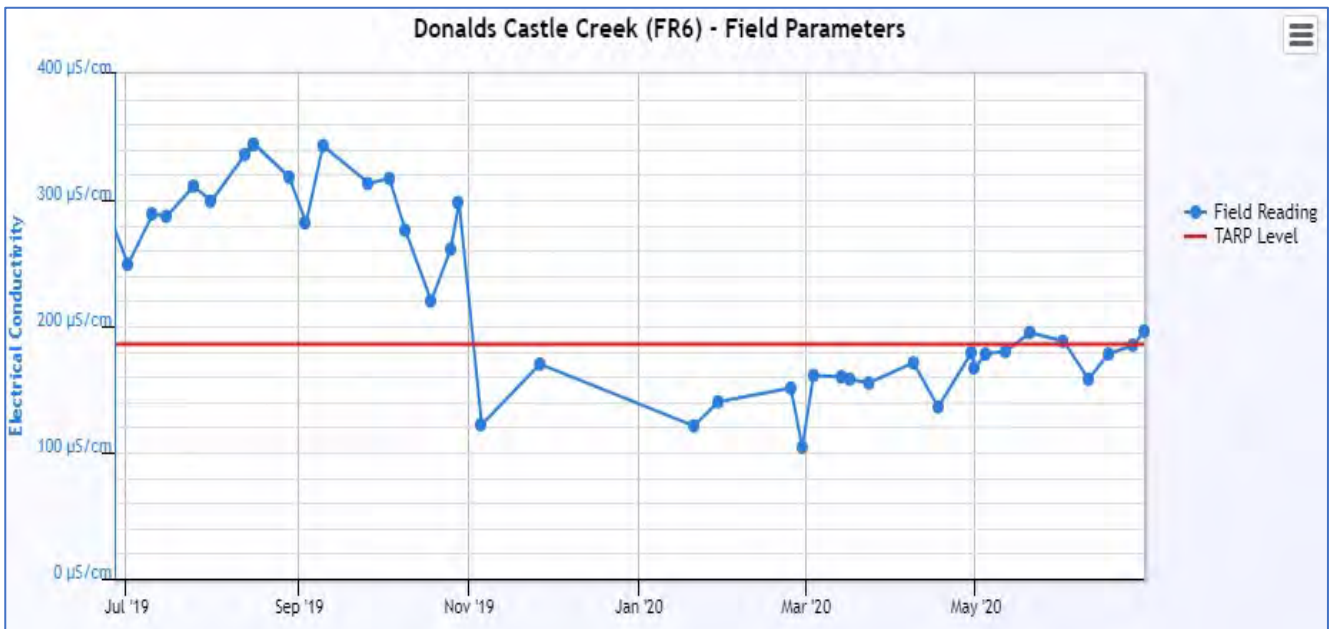
Three exceedances of the ± 3 standard deviation level (positive for EC, negative for pH and DO) from the baseline mean within six months:

- pH 3.60
- **EC 185.8 $\mu\text{S}/\text{cm}$**
- DO 40.1%

Graph 1: Electrical conductivity results recorded at Donalds Castle Ck (FR6) over the past 12 months.

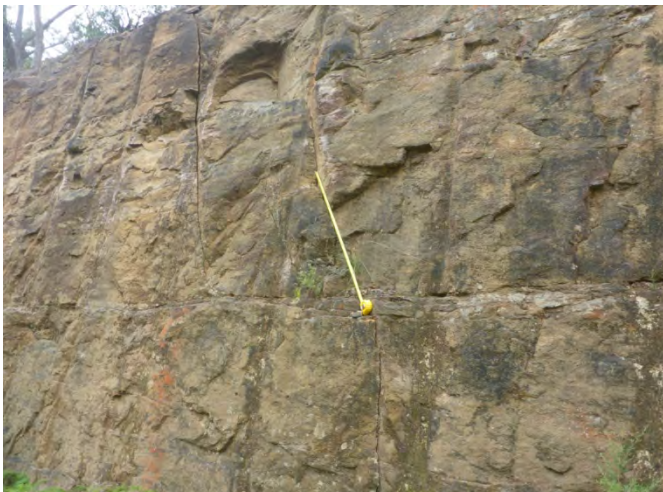
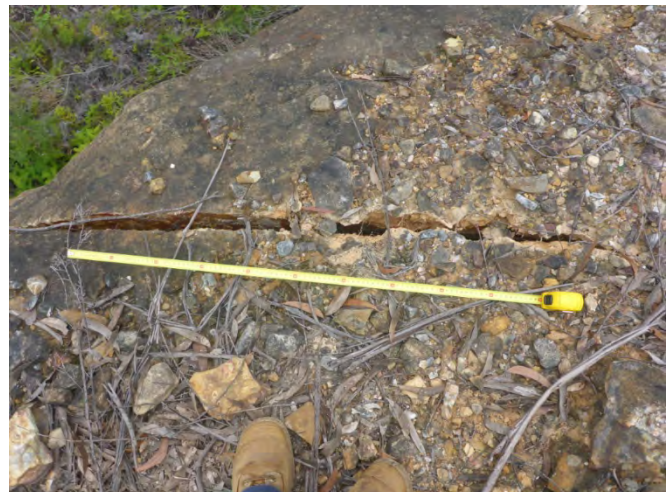
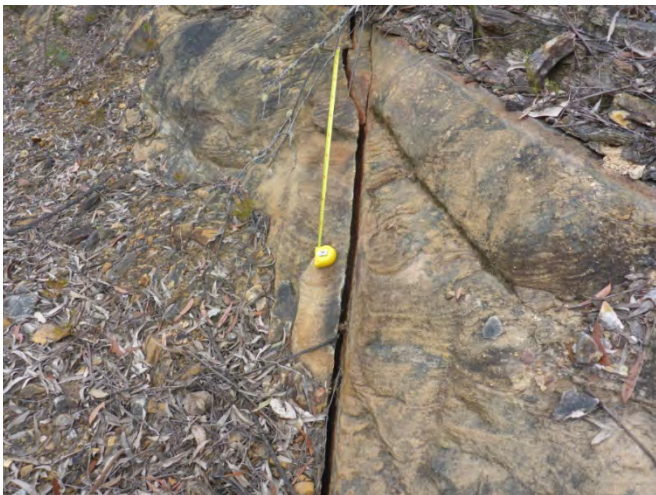
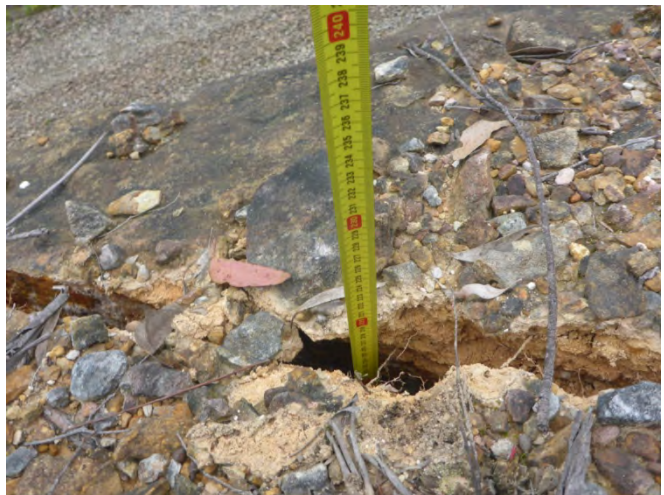
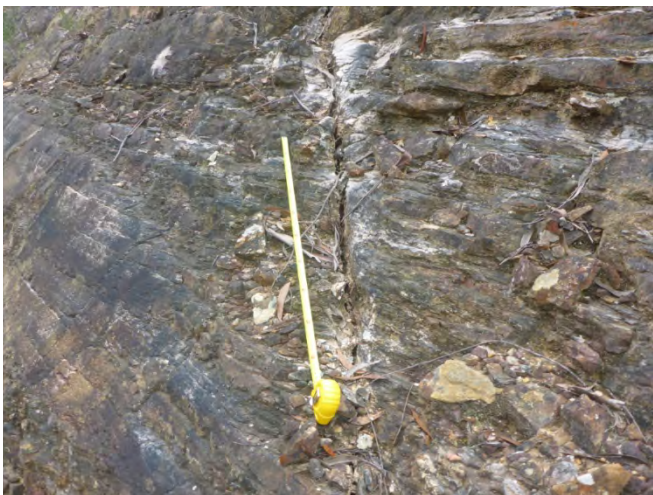
DA3B_LW16_022 is comprised of three rock fractures running up the face of a cut through which forms part of the Maldon Dombarton railway corridor adjacent to Fire Road 6A (Figure 1). Two of the fractures are on the eastern side of the corridor with the longest up to 15m in length, with a width of approximately 0.08m and a measurable depth of 1.53m (Photo 1 to Photo 4). The fracture on the western side of the corridor is up to 6m long, 0.07m wide and has a measurable depth of 2.9m (Photo 5 to Photo 7). This section of corridor has been barricaded until subsidence movements cease to prevent people driving past the fractured rock face.

DA3B_LW16_022 is a Level 2 trigger as per the DA3B Landscape Trigger Action Response Plan (TARP) (Appendix A: Table 1), specifically:

Photo 1: DA3B_LW16_022- fracturing down face of cut-through. Taken on 7/07/2020.

Photo 2: DA3B_LW16_022- fracturing fracture to top of cut-through. Taken on 7/07/2020.

Photo 5: DA3B_LW16_022- fracturing down face of cut-through. Taken on 7/07/2020.

Photo 6: DA3B_LW16_022- fracturing fracture to top of cut-through. Taken on 7/07/2020.

Photo 7: DA3B_LW16_022- fracturing down face of cut-through. Taken on 7/07/2020.

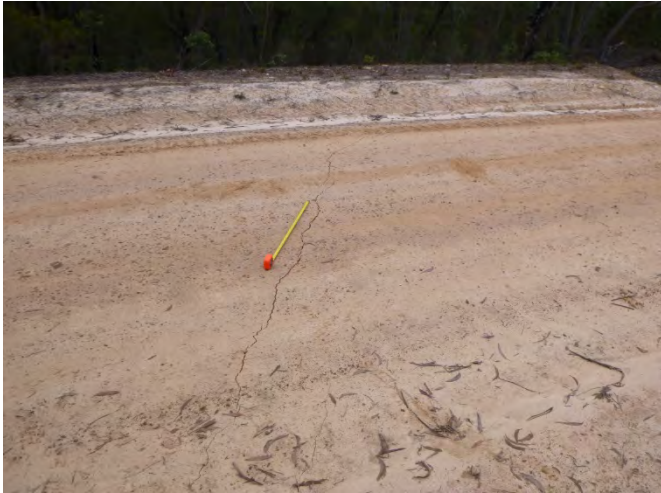
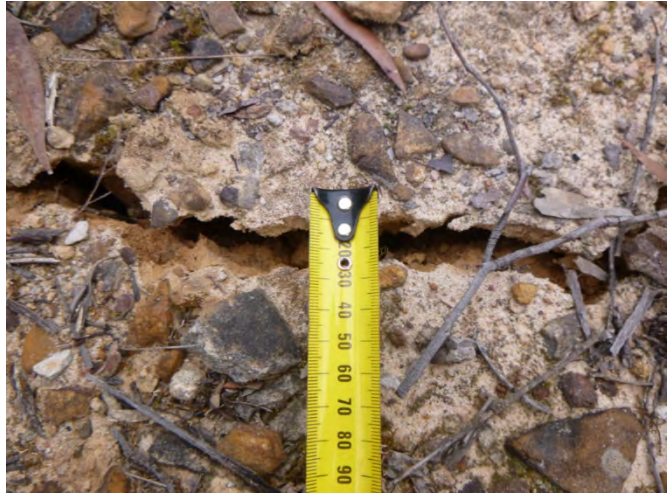
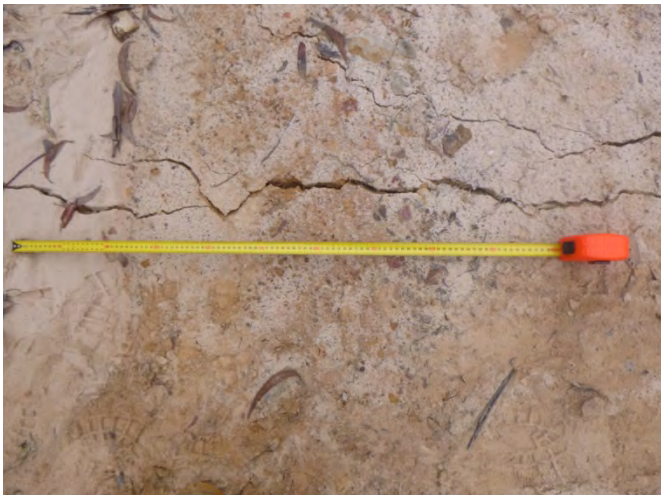
DA3B_LW16_023 is comprised of two adjacent soil cracks across Fire Road 6A (Figure 1). The longest continuous crack is 4.2m long, with a maximum width of up to 0.02m and a measurable depth of 0.1m (Photo 8 to Photo 10). The cracks do not pose a safety issue to vehicles using the fire road.

DA3B_LW16_023 is a Level 1 trigger as per the DA3B Landscape TARP (Appendix A, Table 1), specifically:

Photo 8: DA3B_LW16_023- cracking across Fire Road 6A. Taken on 7/07/2020.

Photo 9: DA3B_LW16_023- cracking adjacent to Fire Road 6A. Taken on 7/07/2020.

Photo10: DA3B_LW16_023- cracking on Fire Road 6A. Taken on 7/07/2020.

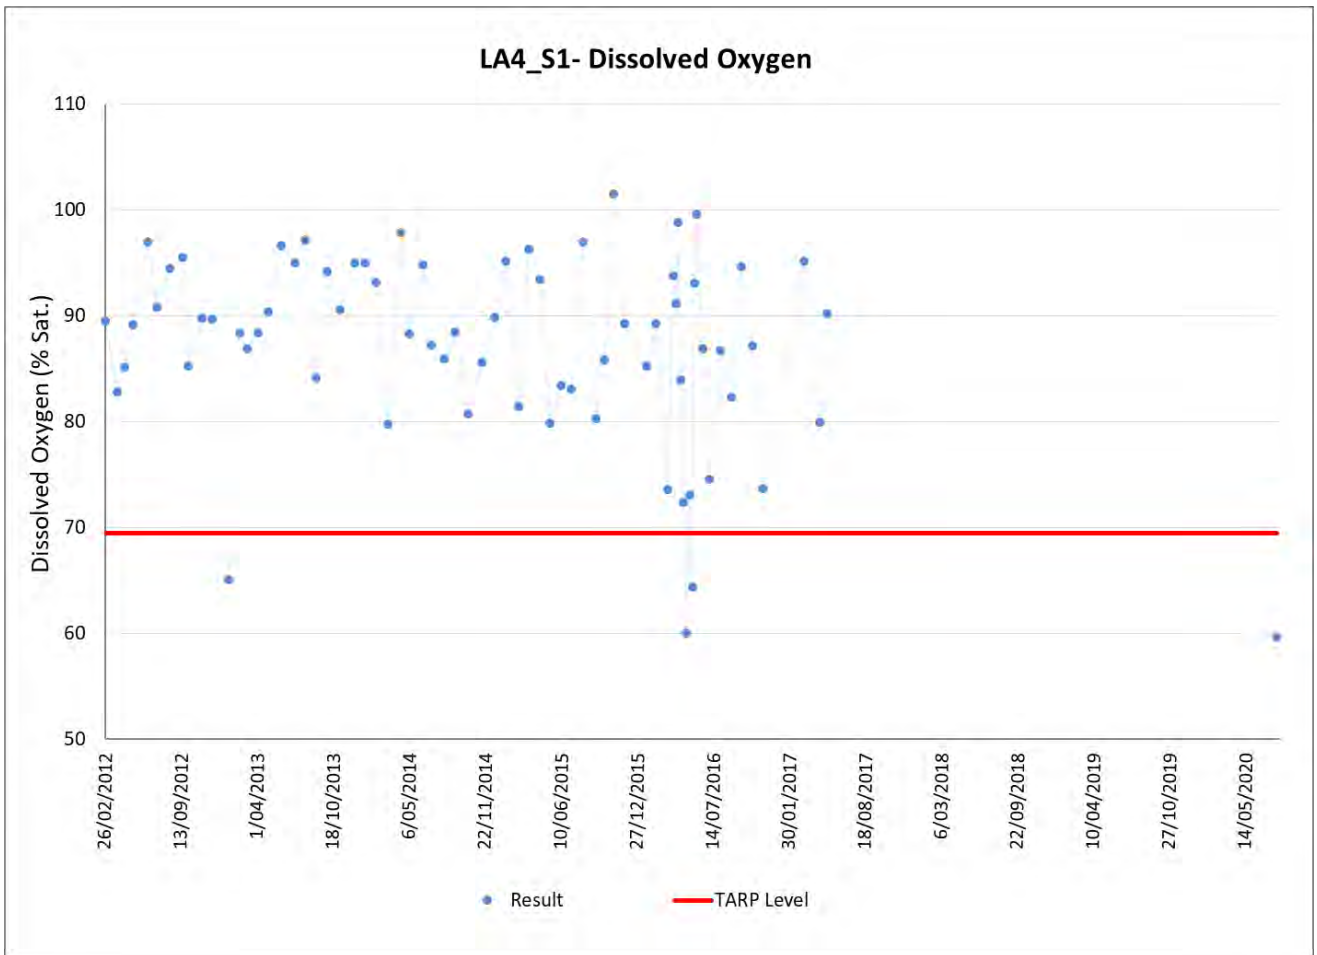
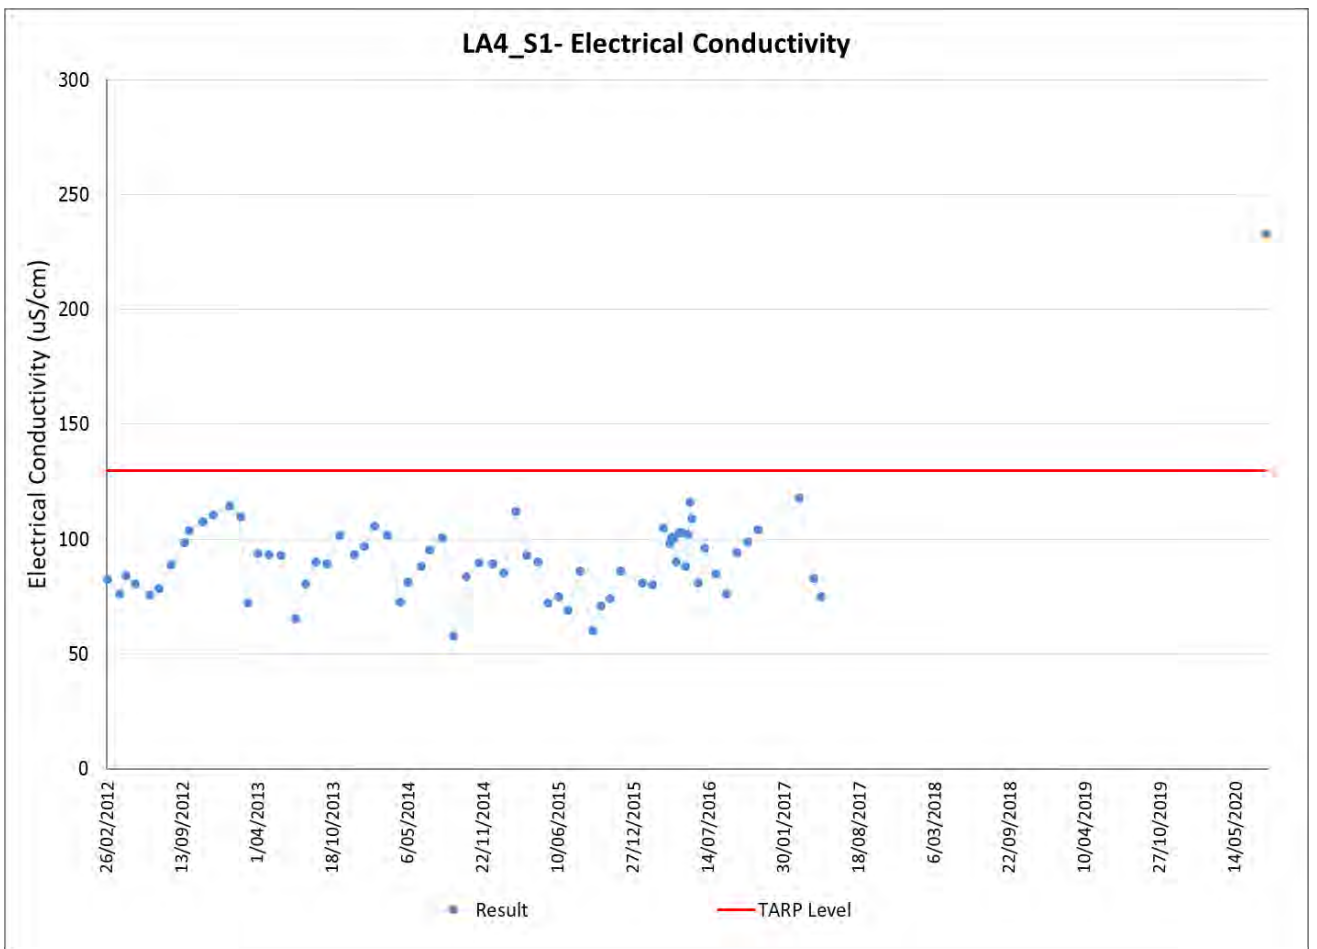
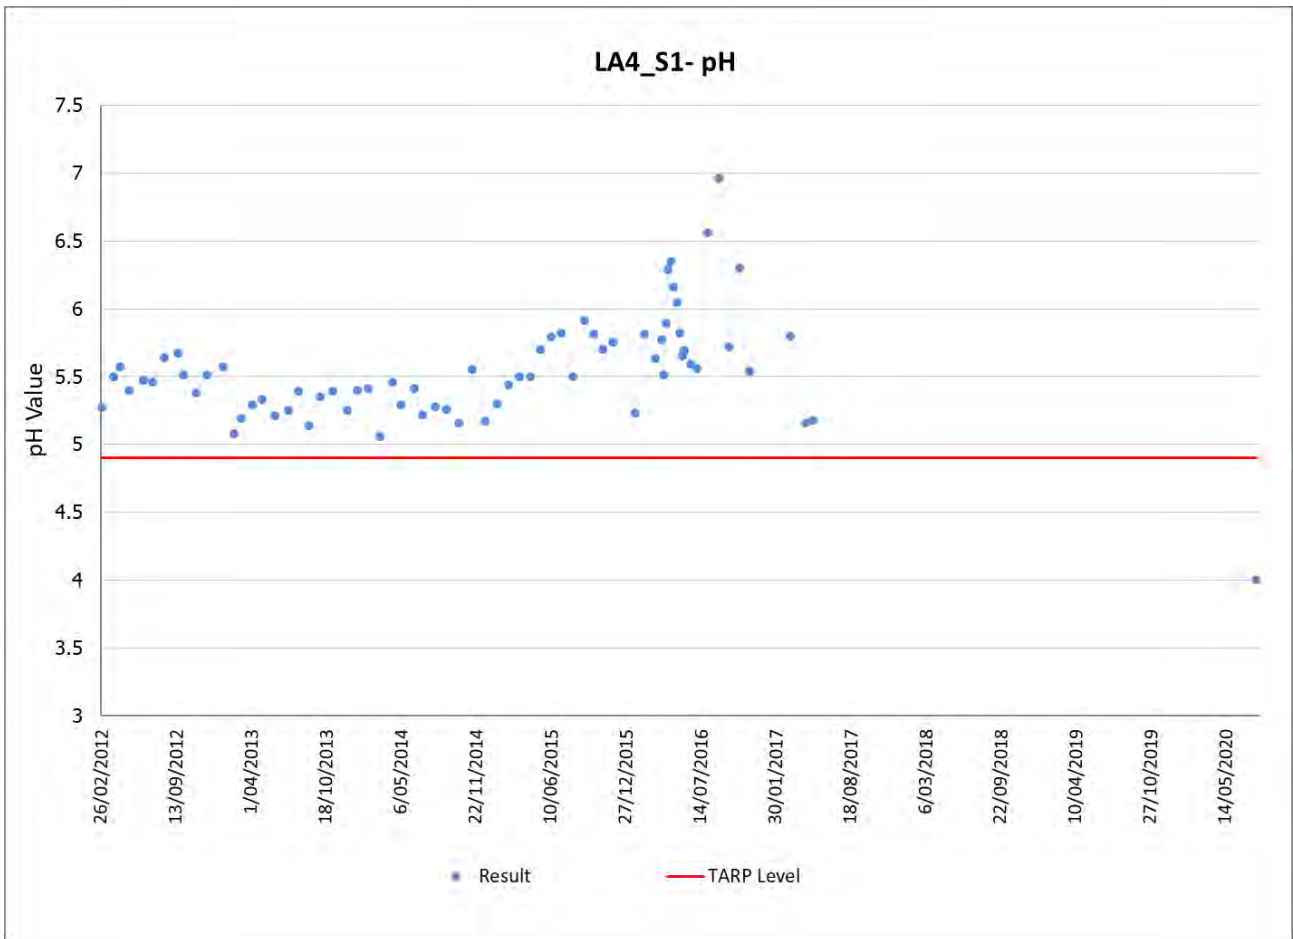
One exceedance of the ± 3 standard deviation level (positive for EC, negative for pH and DO) from the baseline mean within six months:

- pH 4.90
- EC 129.8 $\mu\text{S}/\text{cm}$
- DO 69.5%

Graph 1: Dissolved oxygen results recorded at LA4_S1, a water quality monitoring site on Lake Avon tributary LA4.

Graph 2: Electrical conductivity results recorded at LA4_S1, a water quality monitoring site on Lake Avon tributary LA4.

Graph 3: pH results recorded at LA4_S1, a water quality monitoring site on Lake Avon tributary LA4.

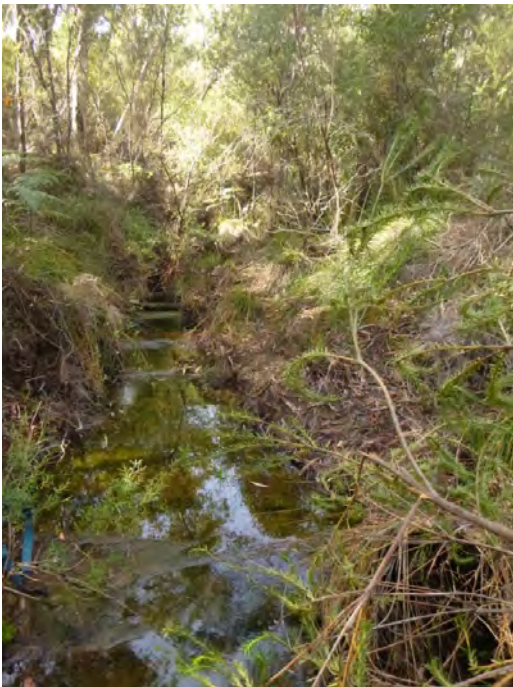
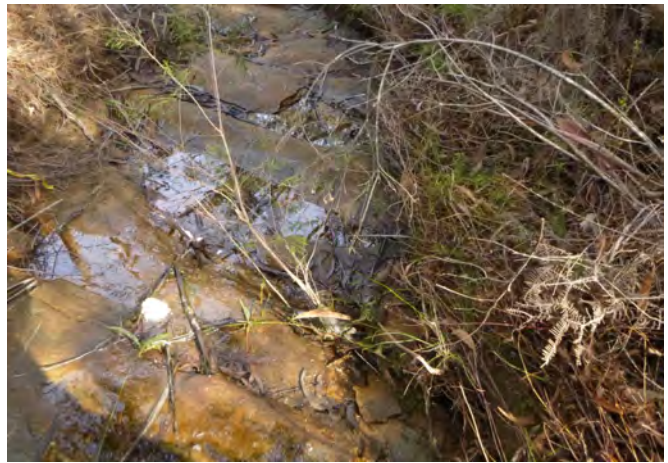
LA4 is a small tributary of Lake Avon that flows southward from DA3B mining operations (Figure 1). The LA4 sub catchment was mined beneath by Longwall 12 in April 2016 and Longwall 13 in March 2017. Rock fracturing and subsequent flow diversion was recorded in the tributary following extraction of Longwall 12 and 13. This led to a reduction of surface water at the site. As a result, water sampling was unable to be undertaken at the site since mid-2017. On the latest inspection of LA4, surface water was observed at the site. This was following 160 mm of rainfall, as recorded at Cordeaux Colliery, in the previous 7-day period. Water quality parameters were recorded at LA4_S1, with latest results reaching the TARP level for dissolved oxygen, electrical conductivity, and pH, as shown in Table 1 and presented in Graph 1 to Graph 3. During this latest inspection, some surface flow was observed entering the site; however, flow is then diverted subsurface directly downstream through existing surface fractures (Photo 1 and Photo 2).

Photo 1: LA4_S1, looking upstream. Taken on 3/08/2020.

Photo 2: LA4_S1, looking downstream. Taken on 3/08/2020.

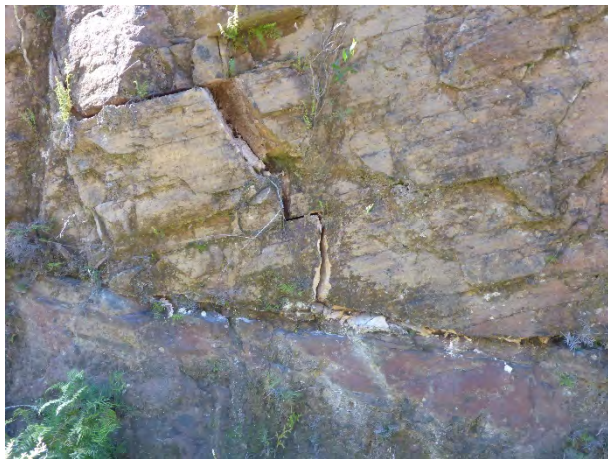
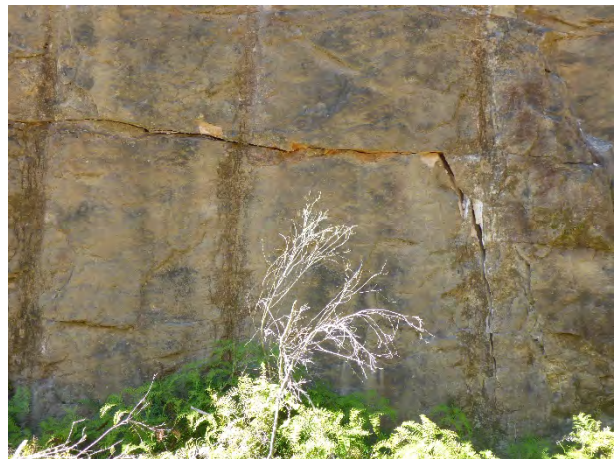
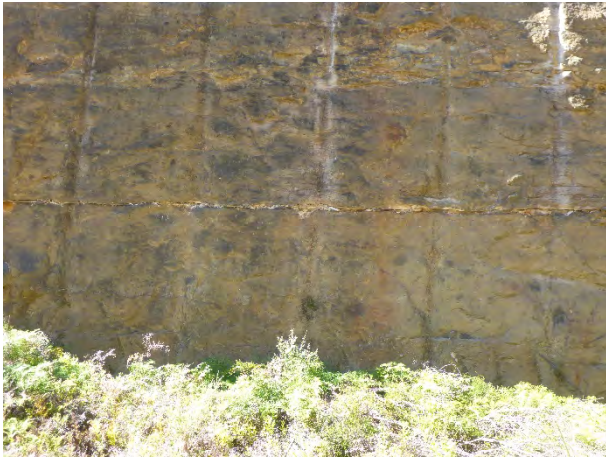
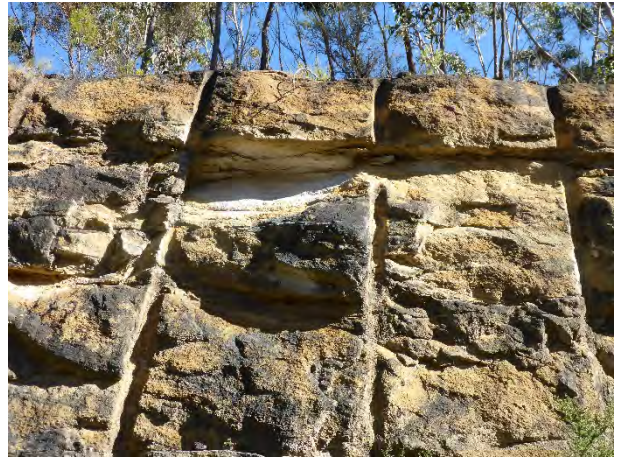
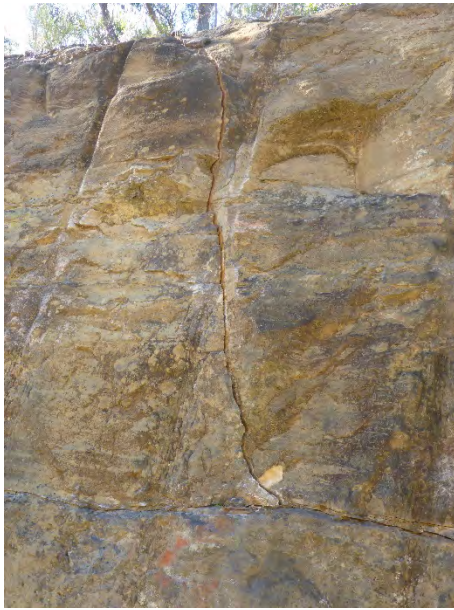
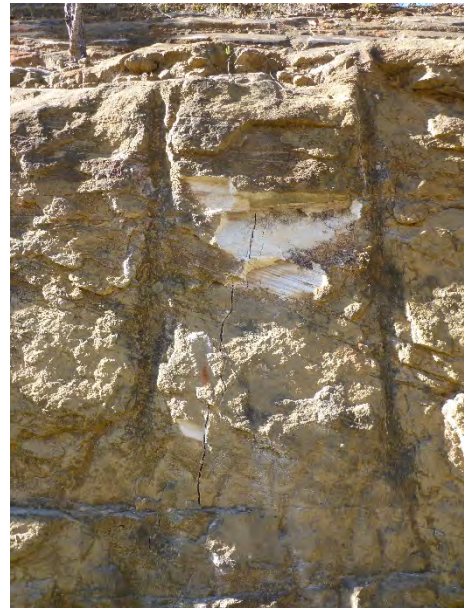
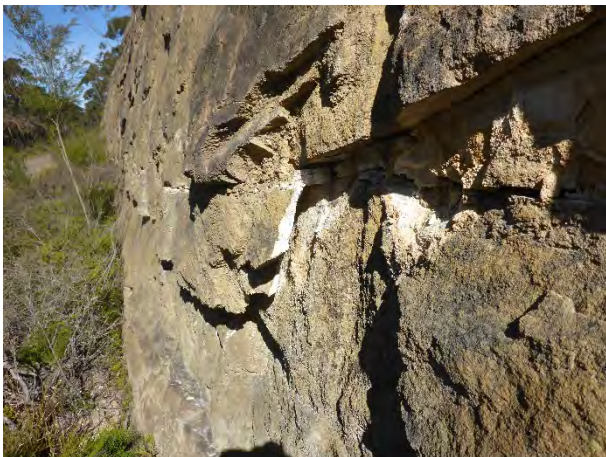
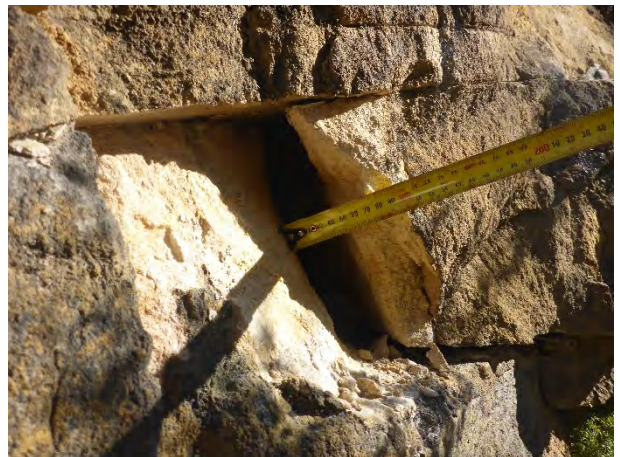
Photo 1: *DA3B_LW16_022*, looking at a section of rock fracturing. Taken on 6/08/2020.

Photo 2: *DA3B_LW16_022*, looking at a section of rock fracturing. Taken on 6/08/2020.

Photo 3: DA3B_LW16_022, looking at a section of rock fracturing. Taken on 6/08/2020.

Photo 4: DA3B_LW16_022, looking at a rockfall. Taken on 6/08/2020.

Photo 5: DA3B_LW16_022, looking at a section of rock fracturing. Taken on 6/08/2020.

Photo 6: DA3B_LW16_022, looking at a section of rock fracturing and rockfall. Taken on 6/08/2020.

Photo 7: DA3B_LW16_022, looking at a section of rock fracturing. Taken on 6/08/2020.

Photo 8: DA3B_LW16_022, looking at a section of rock fracturing. Taken on 6/08/2020.

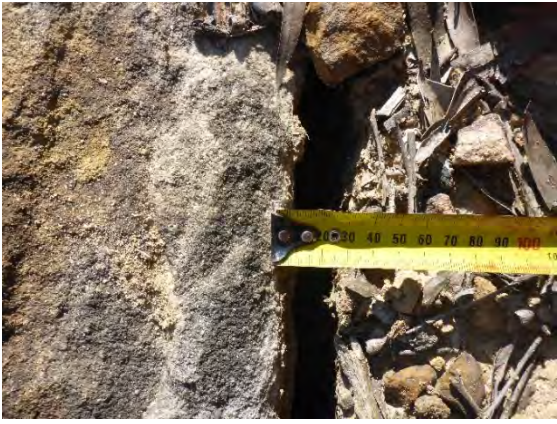
DA3B_LW16_024 is situated on a rehabilitated access track between *Swamp 14* and *Fire Road 6A* (Figure 1). The site was undermined by Longwall 16 on 1 July 2020. The impact is comprised of rock fracturing and soil cracking (Photo 9 to Photo 11). The impact has a maximum length of 3.2m, a maximum width of 0.03m and a maximum depth of 0.45m.

Photo 10: DA3B_LW16_024, looking at the width of the rock fracture. Taken on 6/08/2020.

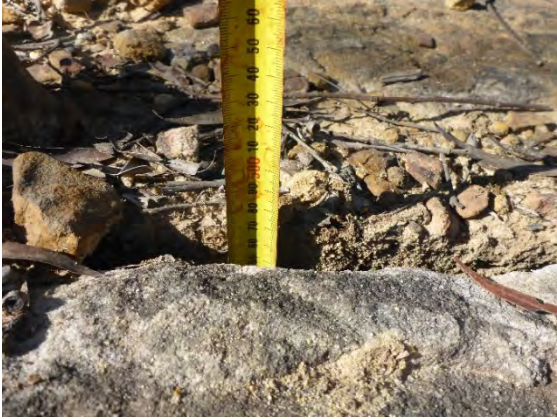
Photo 11: DA3B_LW16_024, looking at the depth of the rock fracture. Taken on 6/08/2020.

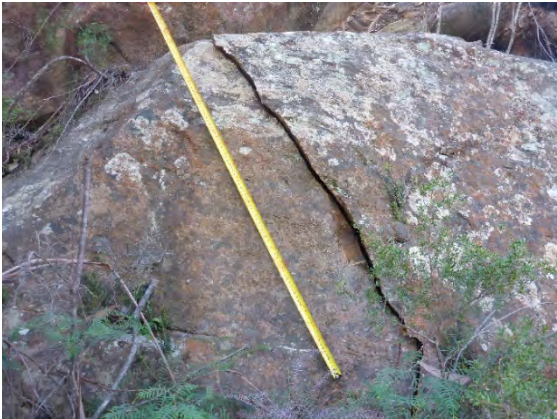
DA3B_LW16_025 is situated at a steep slope/step between *Swamp 14* and *Fire Road 6A* (Figure 1). The site was undermined by Longwall 16 on 15 July 2020. The impact is comprised of multiple rock fractures (Photo 12 to Photo 14). The rock fracturing has a maximum length of 2.5m, a maximum width of 0.035m and a maximum depth of 0.34m.

Photo 13: DA3B_LW16_025, looking at a section of rock fracturing. Taken on 6/08/2020.

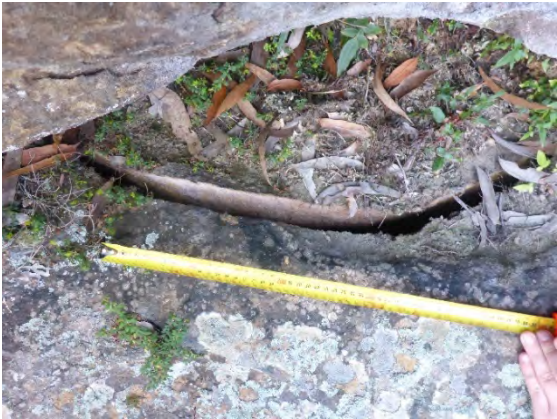
Photo 14: DA3B_LW16_025, looking at a section of rock fracturing. Taken on 6/08/2020.

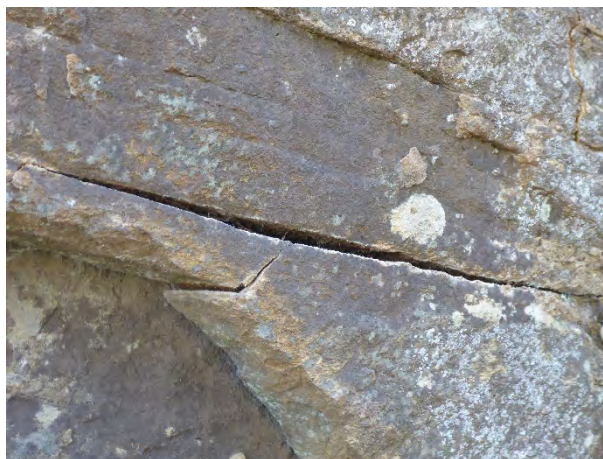
DA3B_LW16_026 is situated at a steep slope/step between *Swamp 14* and *Fire Road 6P* (Figure 1). The site was undermined by Longwall 16 on 30 July 2020. The impact is comprised of multiple rock fractures (Photo 15 and Photo 16). The rock fracturing has a maximum length of 2m and a maximum width of 0.02m.

DA3B_LW16_026 is a Level 1 trigger as per the Dendrobium Area 3B Landscape TARP (Appendix A: Table 2), specifically:

- Crack or fracture up to 100mm width.
- Crack or fracture up to 10m length.

Photo 16: *DA3B_LW16_026*, looking at a section of rock fracturing. Taken on 6/08/2020.

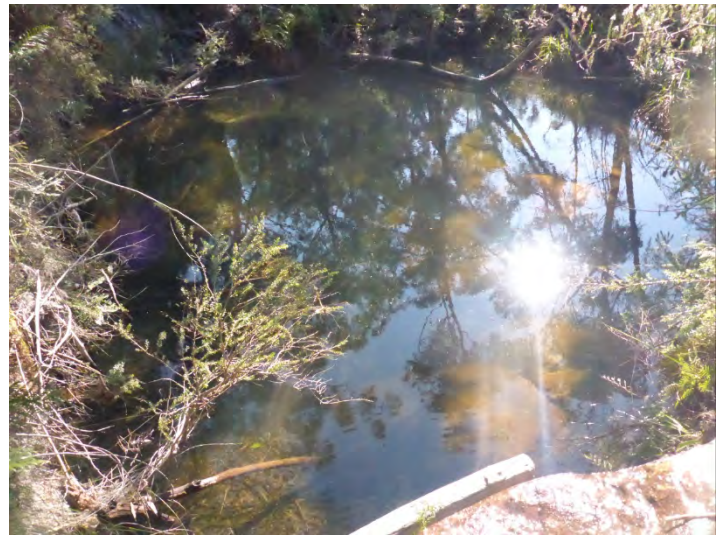
Photo 4: WC15_Pool 34, looking downstream over step. Taken on 24/08/2020.

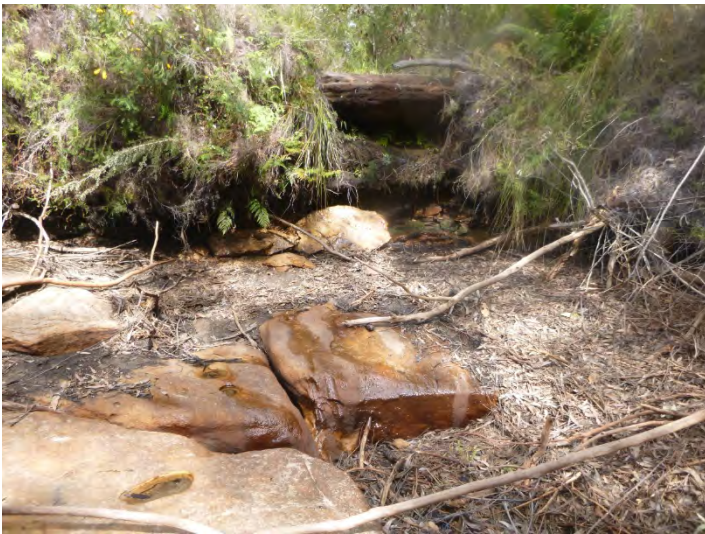
Photo 5: WC15_Pool 34, taken standing in pool, looking upstream towards step. Taken on 31/08/2020.

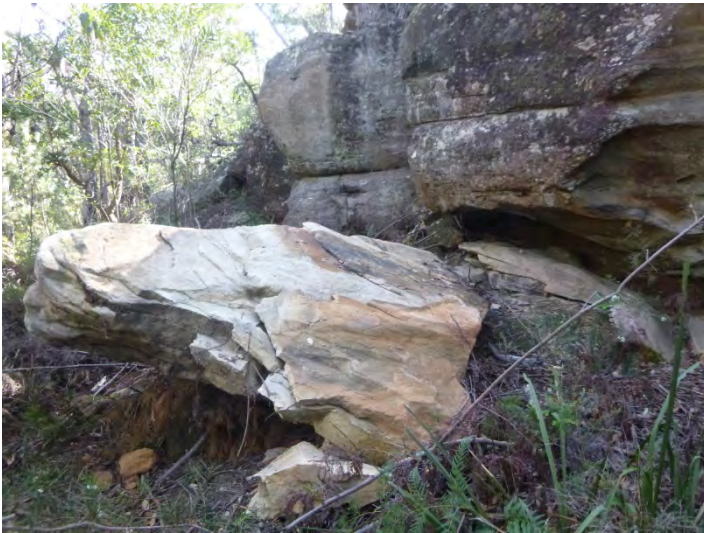
DA3B_LW16_029 consists of a rockfall from a step on the western slope of the WC15 valley (Figure 1). The rockfall is primarily made up of one large rock fragment, approximately 5m³ in volume (Photo 6), with some smaller broken rock fragments in the path of the fall (Photo 7). The site appears stable.

DA3B_LW16_029 is a Level 1 trigger as per the Dendrobium Area 3B Landscape TARP (Table 3), specifically:

- Rock fall from a cliff (step) which is left mostly intact (<10% length), resulting in insignificant ground disturbance.

Photo 6: DA3B_LW16_029- rockfall from step, looking at main large rock fragment. Taken on 31/08/2020.

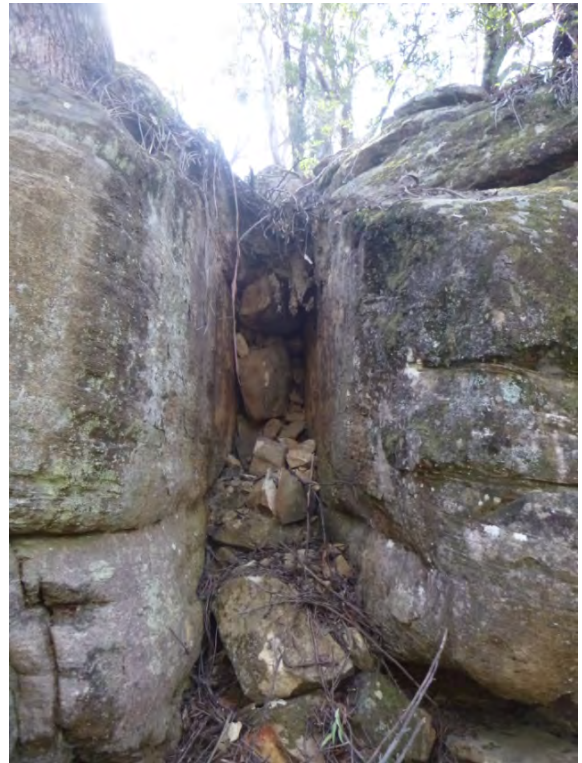
Photo 7: DA3B_LW16_029- rockfall from step, looking at top of step where fragment originated. Taken on 31/08/2020.

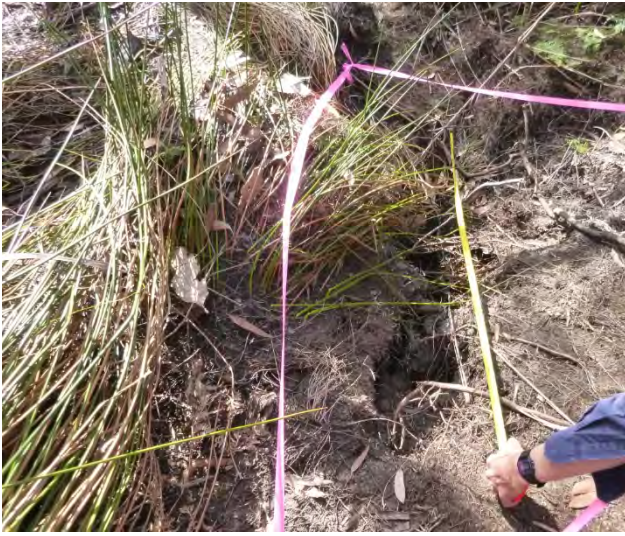
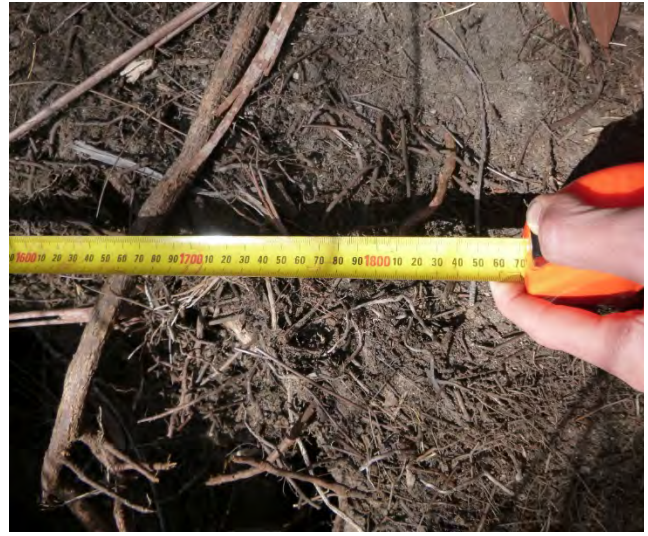
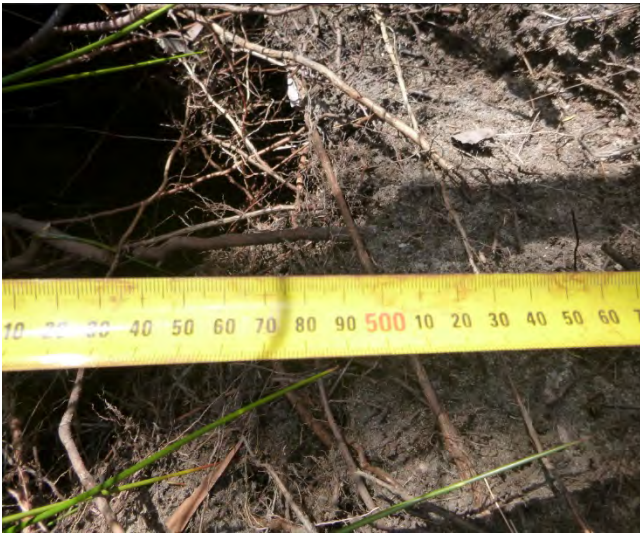
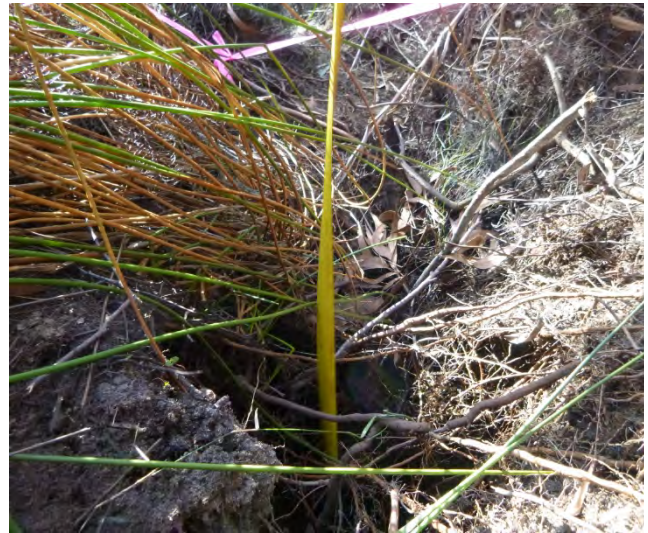
DA3B_LW16_030 consists of some localised erosion on tributary WC15 (Figure 1). The erosion has formed a hole in the soil and root matter in a section of the tributary which has displayed surface and subsurface flow during the baseline period. The hole has a length of 1.8m, a width of 0.5m and a measurable depth of 1.1m (Photo 8 to Photo 11). There is no evidence of subsidence cracking or fracturing associated with the erosion. The hole has been flagged for safety reasons and will be monitored to identify any potential changes.

DA3B_LW16_030 is a Level 1 trigger as per the Dendrobium Area 3B Landscape TARP (Table 3), specifically:

- Erosion in a localised area which would be expected to naturally stabilise without CMA and within the period of monitoring

Photo 8: DA3B_LW16_030- localised erosion observed on tributary WC15. Taken on 31/08/2020.

Photo 9: DA3B_LW16_030- localised erosion, looking at length. Taken on 31/08/2020.

Photo 10: DA3B_LW16_030- localised erosion, looking at width. Taken on 31/08/2020.

Photo 11: DA3B_LW16_030- localised erosion, looking at measurable depth. Taken on 31/08/2020.

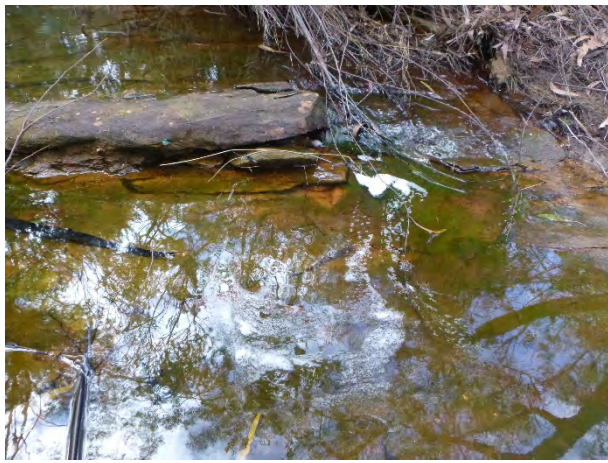
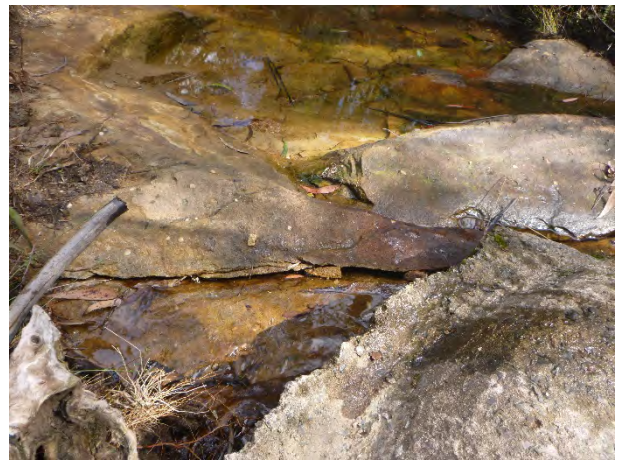
These observations constitute a Level 2 trigger as per the DA3B Watercourse Impact, Monitoring Management and Contingency Plan (Table 3), specifically:

- Two non-consecutive exceedances of the ± 3 standard deviation level (positive for EC, negative for pH and DO) from the baseline mean within six months:
 - pH 4.90
 - EC 129.8 $\mu\text{S}/\text{cm}$

Photo 1: LA4_S1, looking upstream. Taken on 1/09/2020.

Photo 2: LA4_S1, looking downstream. Taken on 1/09/2020.

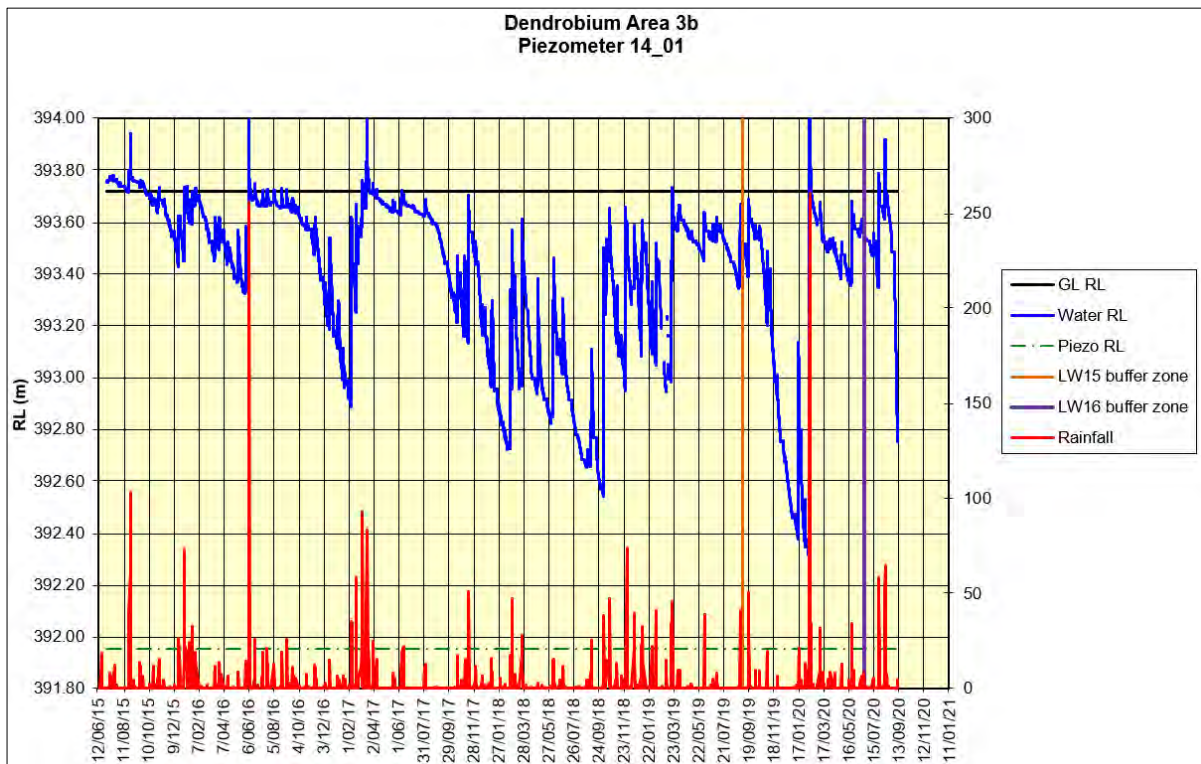
The rate of recession trigger for borehole 14_02 was reported on 08 November 2019 during Longwall 15 extraction, therefore the current groundwater results at 14_01 contribute to a Level 3 trigger according to the Dendrobium Swamps Impacts, Triggers and Response (Table 4), specifically:

- Rate of groundwater level reduction exceeds rate of groundwater level reduction during baseline period at >80% of monitoring sites (within 400m of mining) within the swamp.

Graph 3: Near-surface groundwater levels at 14_01, logged hourly, date range: 02/07/2015 to 09/09/2020.

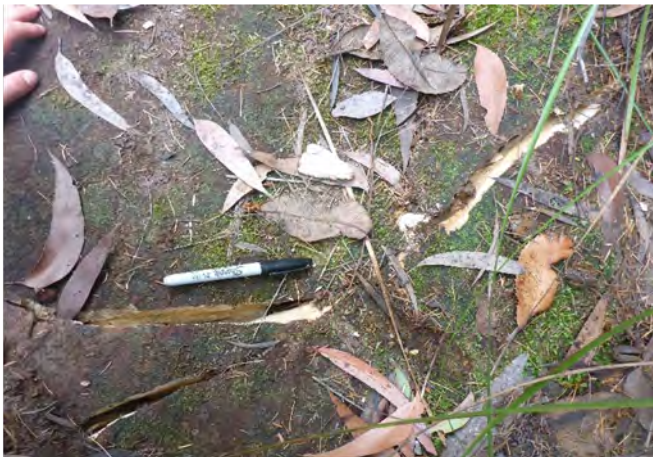
DA3B_LW14_017 remains a Level 2 trigger as per the DA3B Watercourse TARP (Table 5), specifically:

- Crack or fracture that results in observable loss of surface water or erosion.

Photo 3: DA3B_LW14_017, looking at the original rock fracturing. Taken 20/02/2019.

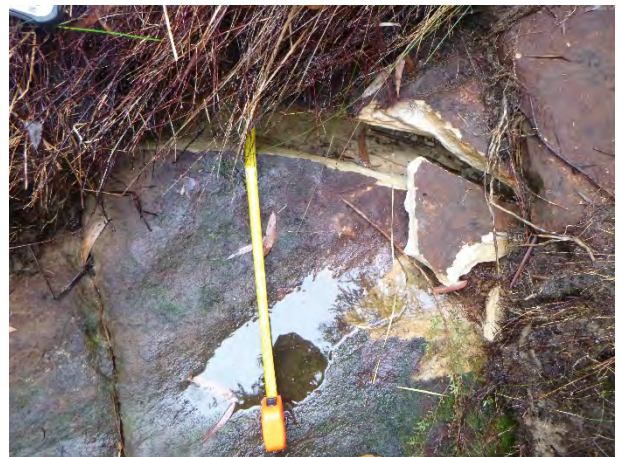
Photo 4: DA3B_LW14_017, looking at the rock fracturing and displacement. Taken on 9/09/2020.

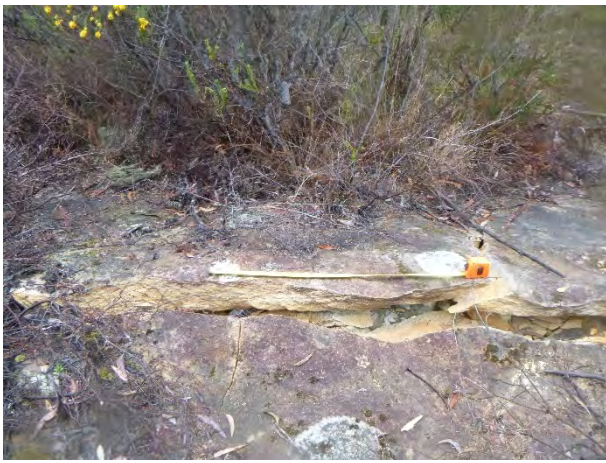
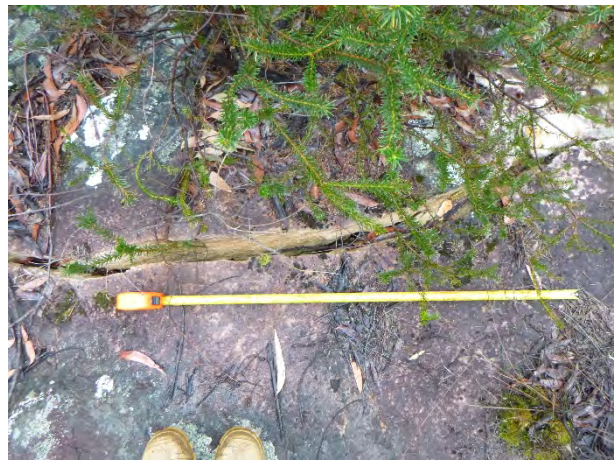
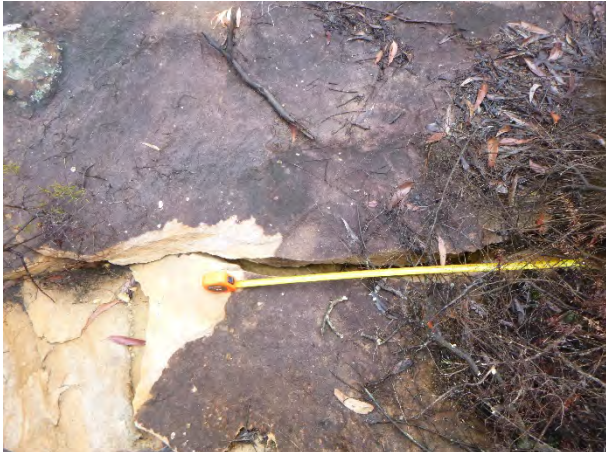
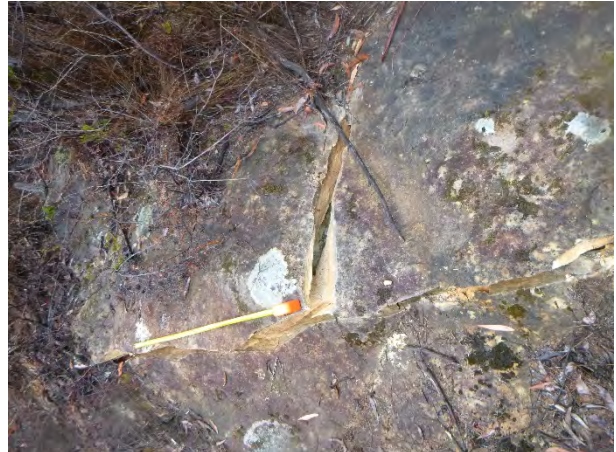
DA3B_LW14_019 is now a Level 2 trigger as per the DA3B Watercourse TARP (Table 5), specifically:

- Crack or fracture **between 100 and 300mm width at its widest point** or any fracture which results in observable loss of surface water or erosion.

Photo 5: DA3B_LW14_019, looking at a section of rock fracturing and uplift. Taken on 9/09/2020.

Photo 6: DA3B_LW14_019, looking at a section of rock fracturing. Taken on 9/09/2020.

Photo 7: DA3B_LW14_019, looking at a section of rock fracturing and displacement. Taken on 9/09/2020.

Photo 8: DA3B_LW14_019, looking at a section of rock fracturing and uplift. Taken on 9/09/2020.

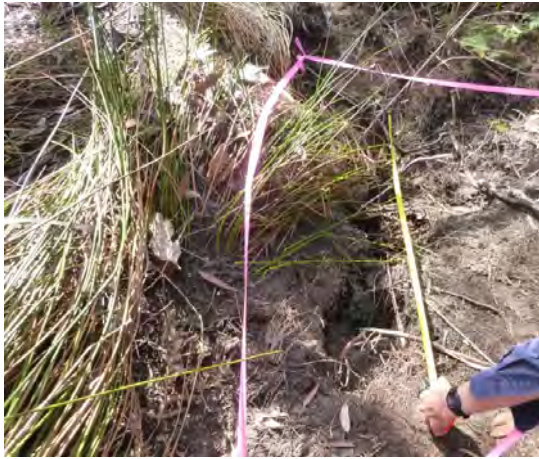
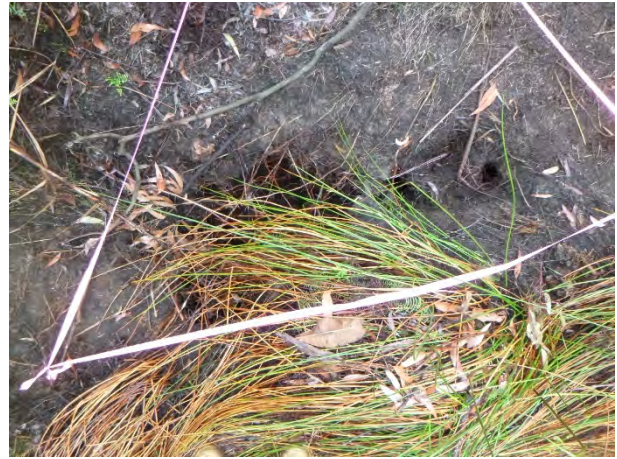
DA3B_LW16_030 remains a Level 1 trigger as per the DA3B Landscape TARP (Table 6) specifically:

- Erosion in a localised area which would be expected to naturally stabilise without CMA and within the period of monitoring.

Photo 9: DA3B_LW16_030, localised erosion observed on tributary WC15. Taken on 31/08/2020.

Photo 10: DA3B_LW16_030, localised erosion observed on tributary WC15. Taken on 09/09/2020.

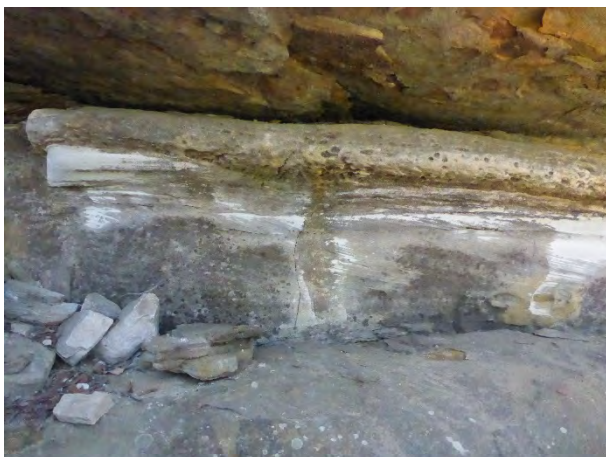
DA3B_LW16_031 is a Level 1 trigger as per the DA3B Landscape TARP (Table 2), specifically:

- Rockfall from a cliff which is left mostly intact (<10% length), resulting in insignificant ground disturbance
- Crack or fracture up to 100mm width
- Crack or fracture up to 10m length

Photo 1: *DA3B_LW16_031*, looking at the rock fracturing. Taken 28/09/2020.

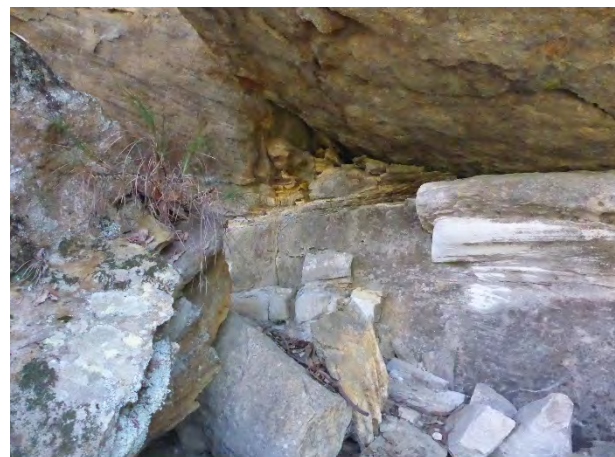
Photo 2: *DA3B_LW16_031*, looking at the rockfall. Taken on 28/09/2020.

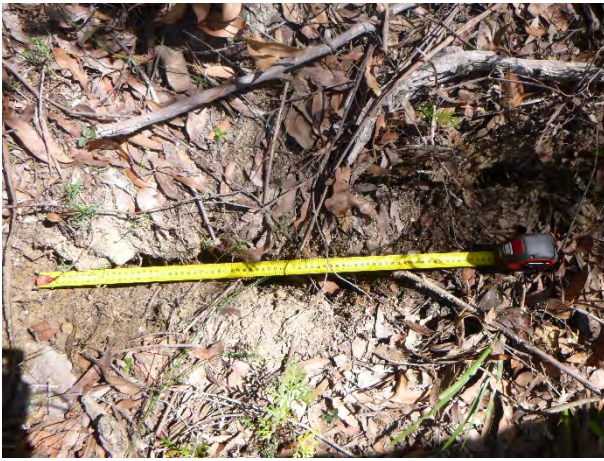
DA3B_LW16_032 is a Level 1 trigger as per the DA3B Landscape TARP (Table 2), specifically:

- Crack or fracture up to 100mm width
- Crack or fracture up to 10m length

Photo 3: DA3B_LW16_032, looking at the length of soil cracking. Taken 28/09/2020.

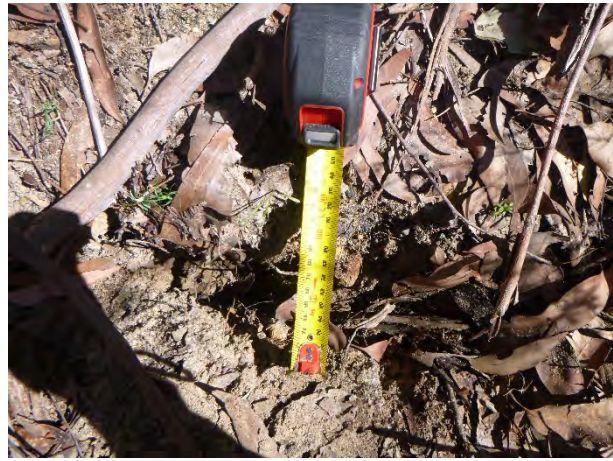
Photo 4: DA3B_LW16_032, looking at the width of soil cracking. Taken on 28/09/2020.

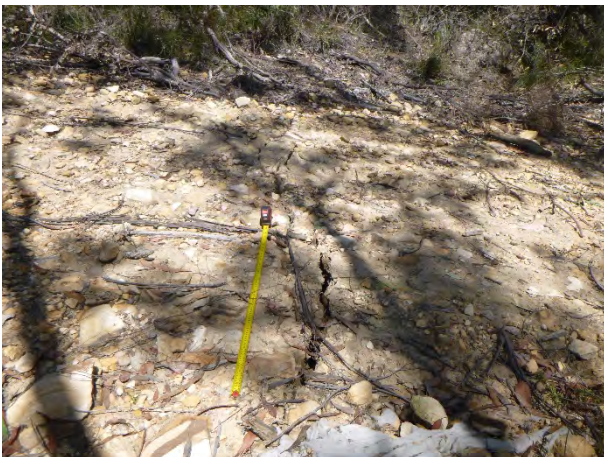
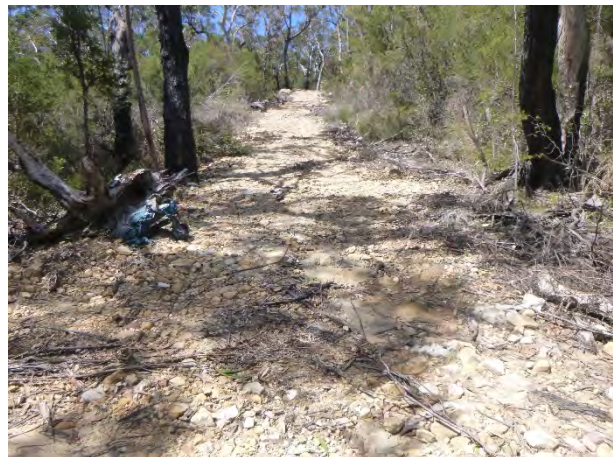
DA3B_LW16_033 is located on an access track running parallel to WC15 and was mined beneath by Longwall 16 on 13 September 2020 (Figure 1). The impact is comprised of multiple soil cracks spanning over a 60m length of the access track. The largest soil crack has a maximum continuous length of 8m, a maximum width of 0.075m, and a maximum measurable depth of 0.54m.

DA3B_LW16_033 is a Level 1 trigger as per the DA3B Landscape TARP (Table 2), specifically:

- Crack or fracture up to 100mm width
- Crack or fracture up to 10m length

Photo 5: DA3B_LW16_033, looking at a length of soil cracking. Taken 28/09/2020.

Photo 6: DA3B_LW16_033 looking at an overview of soil cracking. Taken on 28/09/2020.
